2006-42

Final Report

Stopping Behavior at Real-World
Stop-Controlled Intersections
with and without In-Lane Rumble Strips

**Center for Human Factors Systems Research and Design
University of Minnesota**

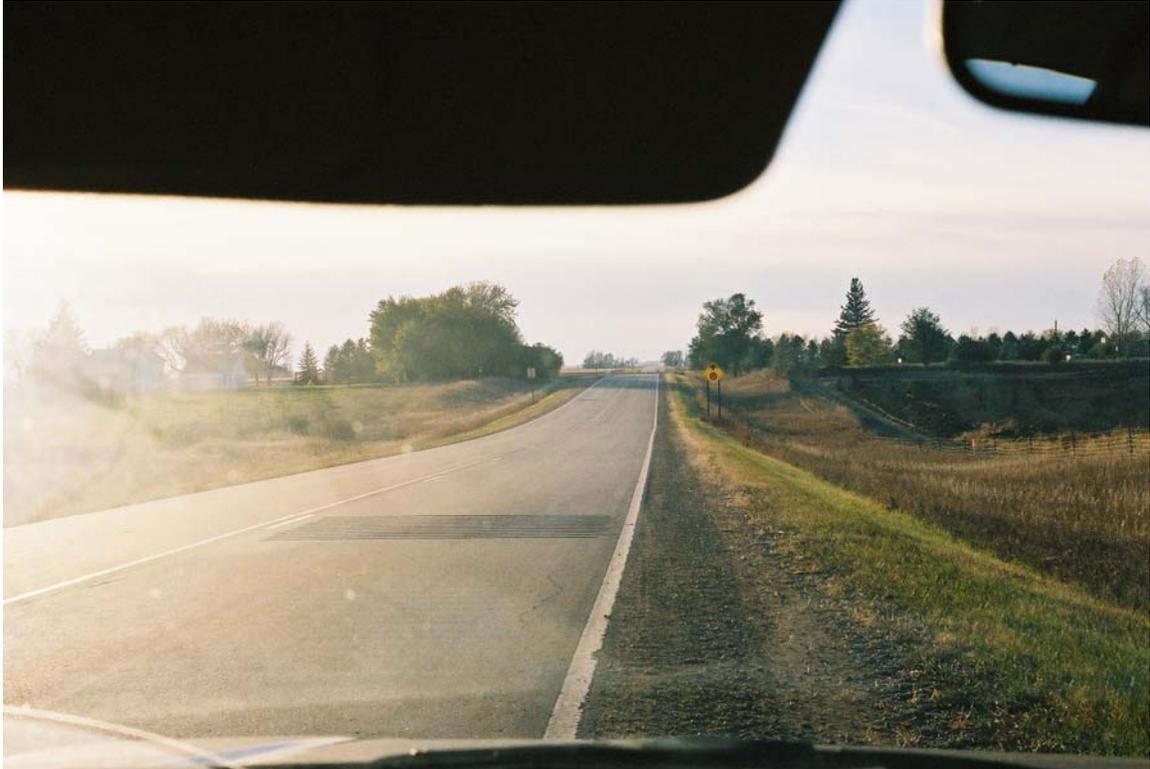
On East Side (looking West): on both sides—trees obscure view of traffic on major road.

Photograph #61 (Reel #4, 5A) (from East, looking West): first rumble strip and warning sign in view.

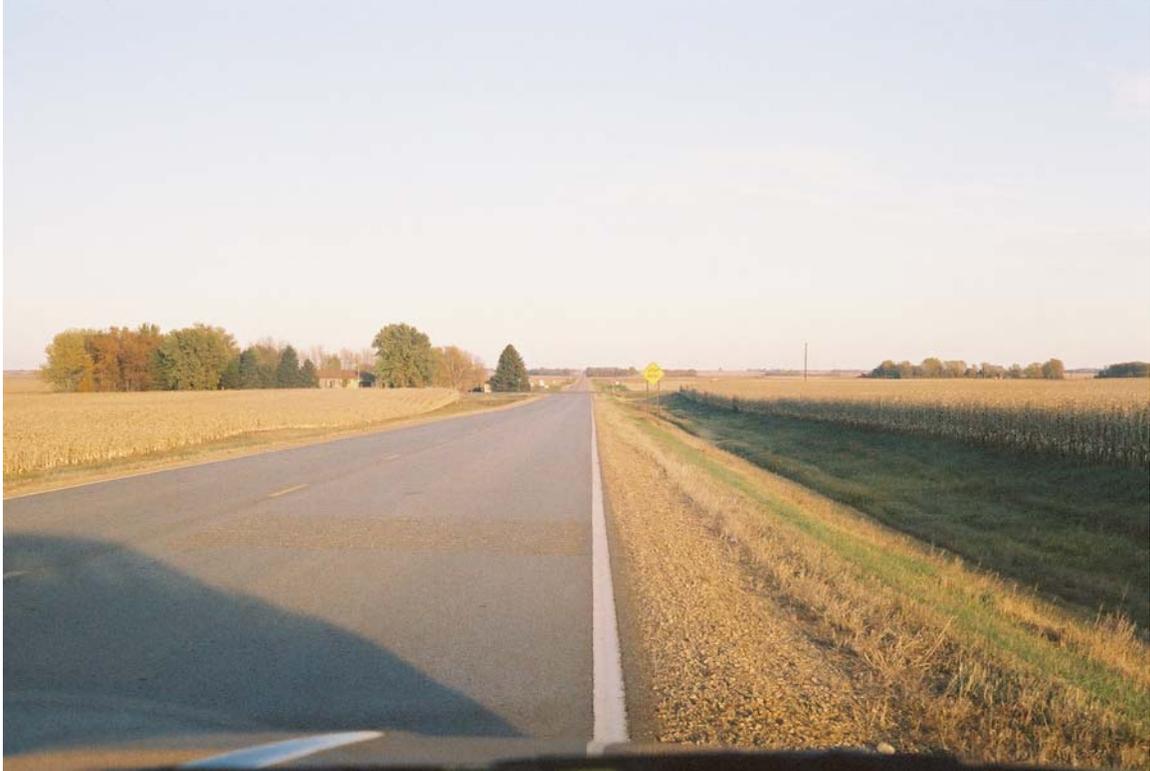
On East Side (looking West): on both sides—corn obscures view of traffic on major road.

Photograph #63 (Reel #4, 7A) (from East, looking West): first rumble strip and warning sign in view.

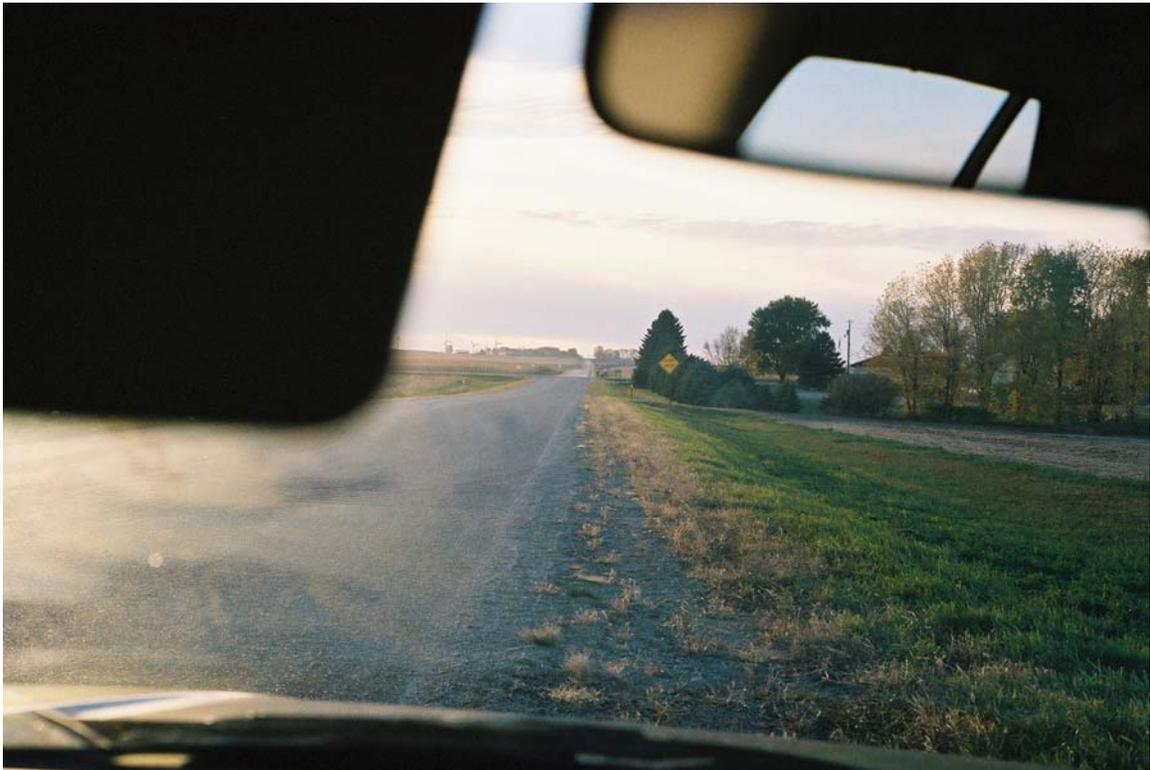
On West Side (looking East): to North—trees obscure view of traffic on major road; to South—clear view of traffic on major road.

Photograph #65 (Reel #4, 9A) (from West, looking East): first rumble strip and warning sign in view.

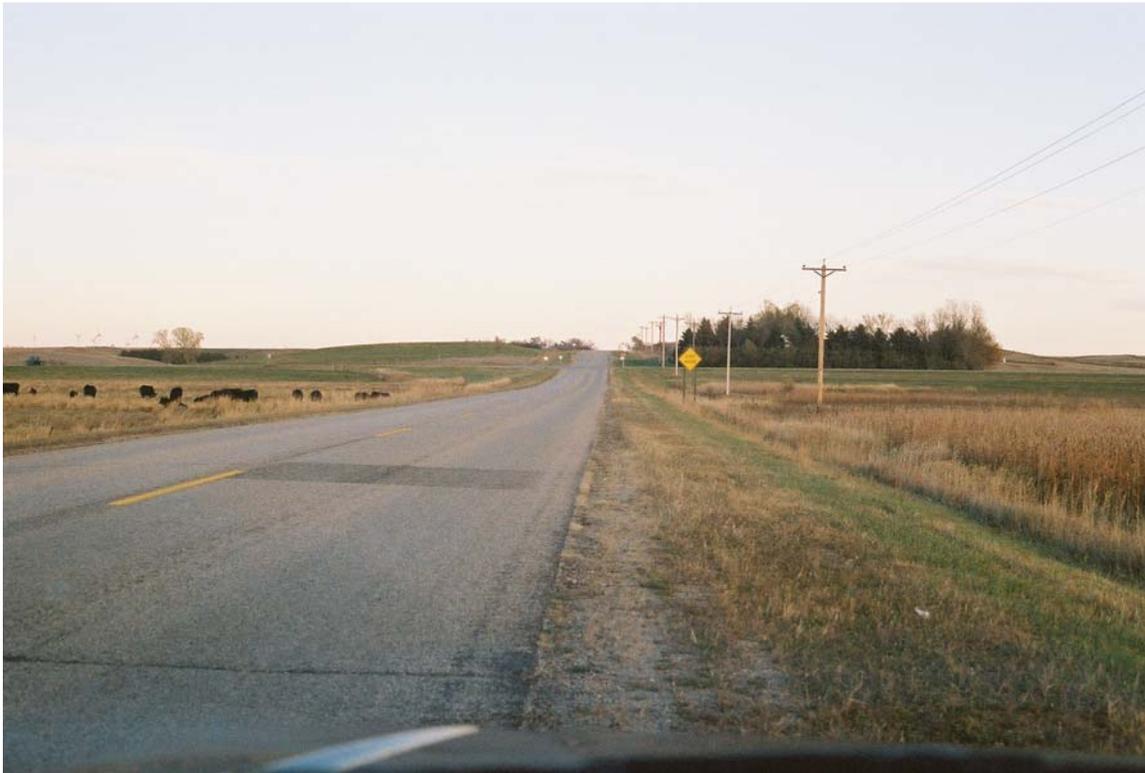
Photograph #68 (Reel #4, 12A) (from West, looking East): first rumble strip and warning sign in view.

On West Side (looking East): to North—partial view of traffic on major road; to South—view of traffic unobstructed.

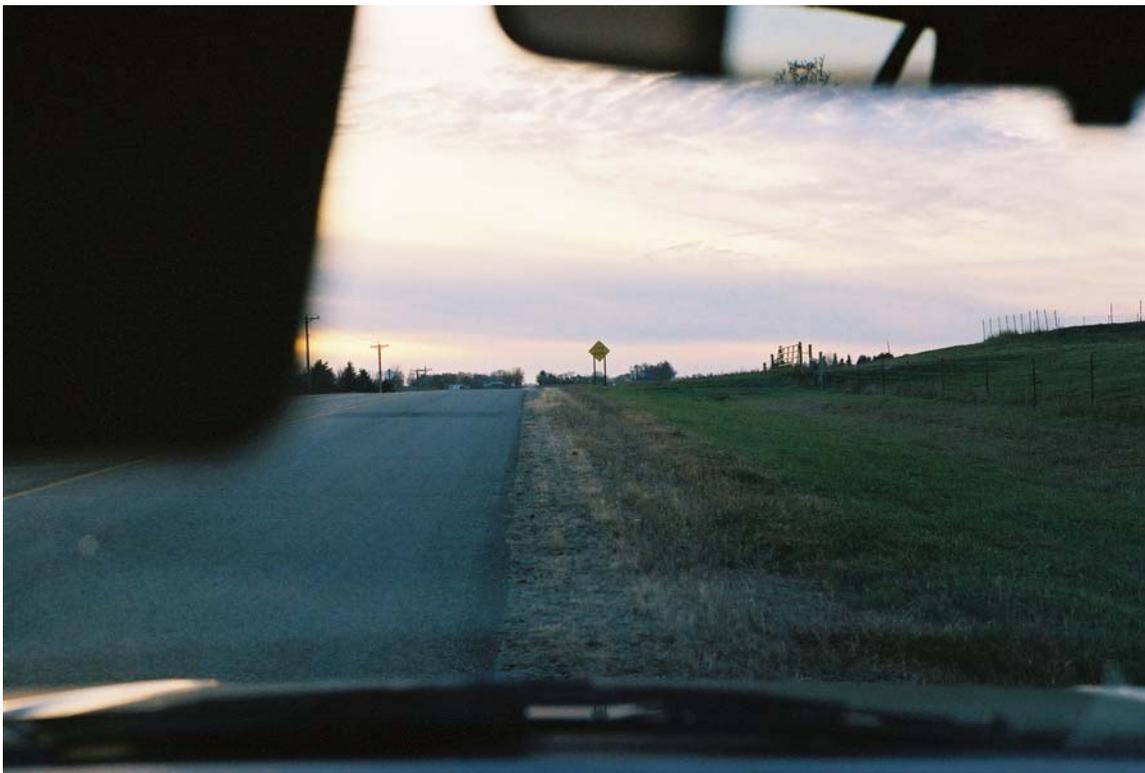
Photograph #70 (Reel #4, 14A) (from East, looking West): first rumble strip and warning sign in view.

On East Side (looking West): to North—vertical curve obscures view of traffic on major road; to South—vertical curve and trees obscure view of traffic on major road.

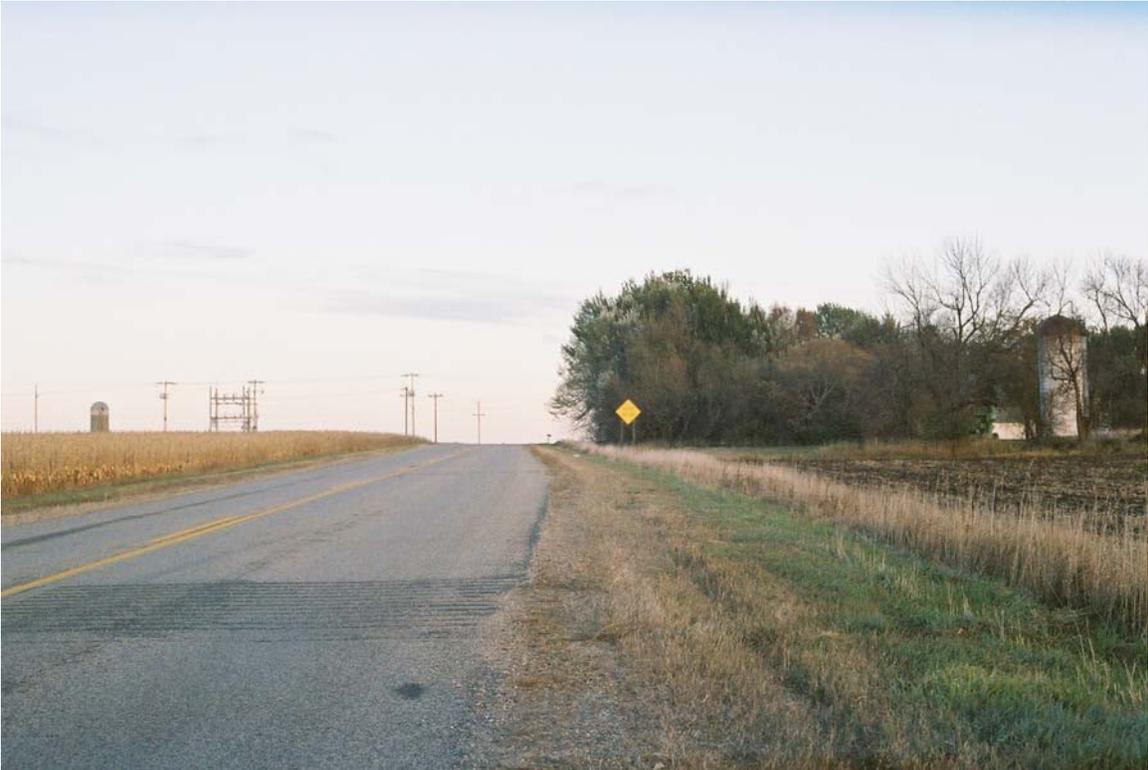
Photograph #72 (Reel #4, 16A) (from East, looking West): first rumble strip and warning sign in view.

On East Side (looking West): to North—vertical curve and corn obscure traffic on major road; to South—vertical curve and trees obscure major road.

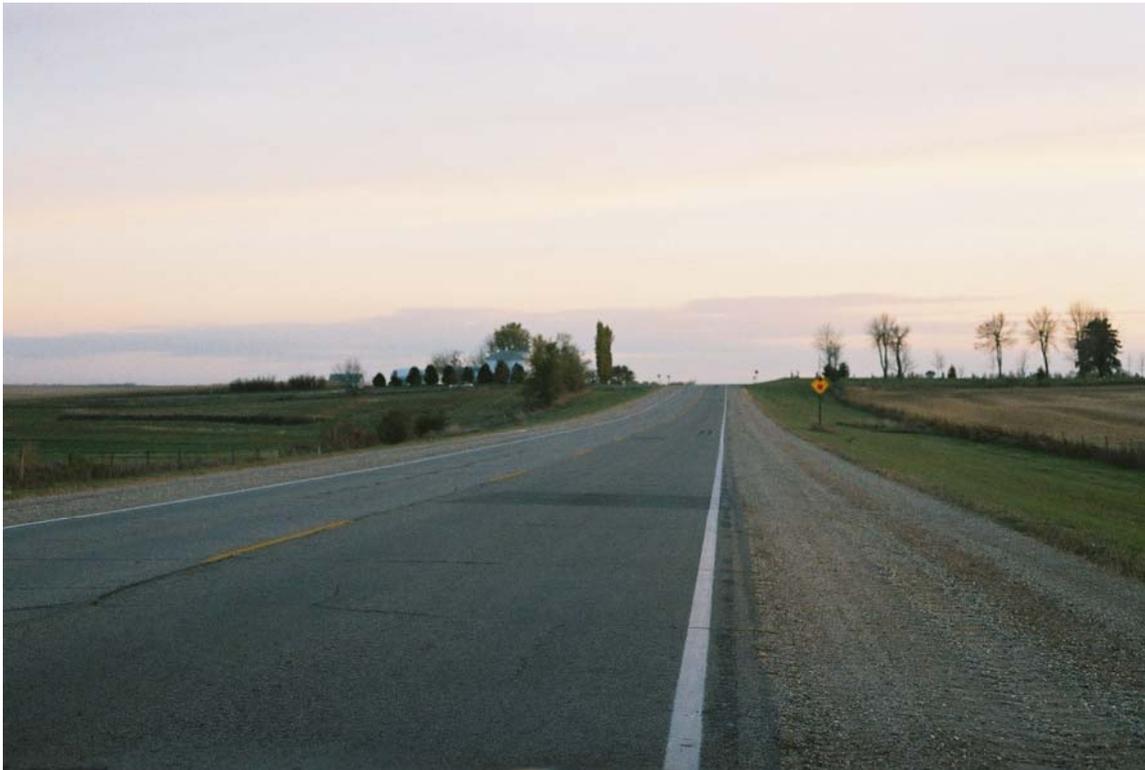
Photograph #74 (Reel #4, 18A) (from North, looking South): first rumble strip and warning sign in view. [Note: additional half rumble strip to center of road.]

On North Side (looking South): to East—vertical rise & cemetery obscure traffic on major road; to West—partial view of traffic on major road

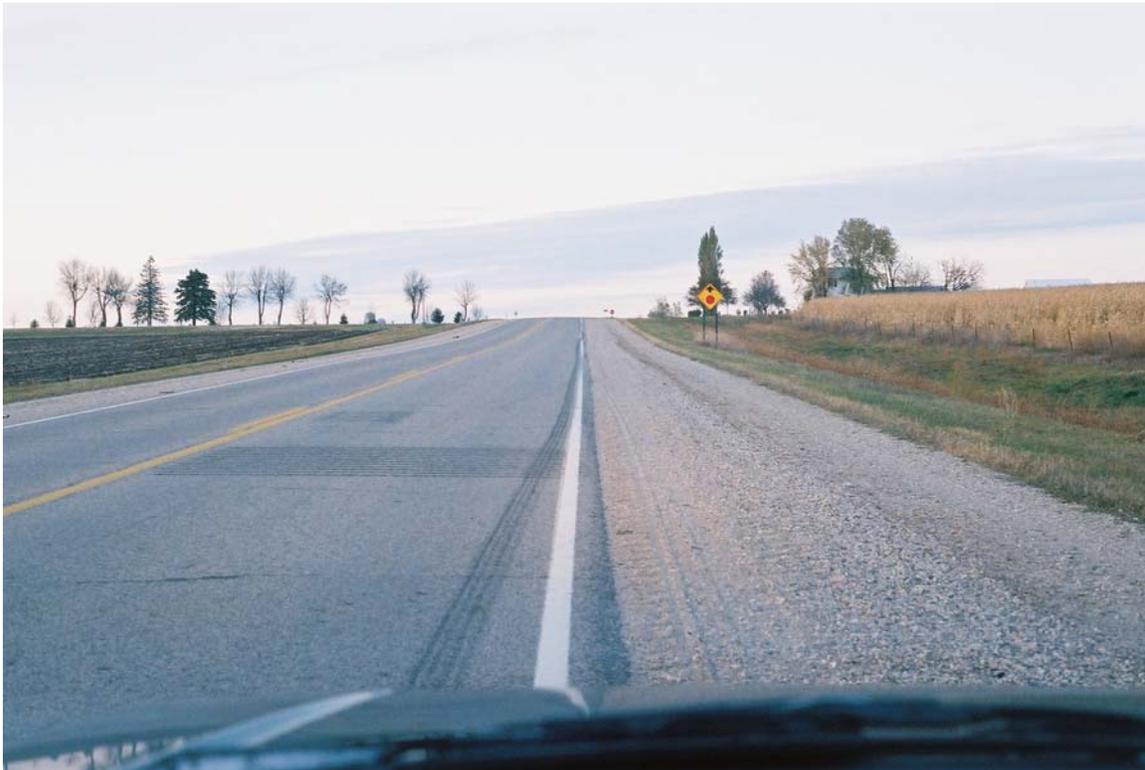
Photograph #76 (Reel #4, 20A) (from South, looking North): first rumble strip and warning strip in view. [Note: additional half rumble strip to center of road.]

On South Side (looking North): to East—corn obscures view of traffic on major road; to West—clear view of traffic on major road.

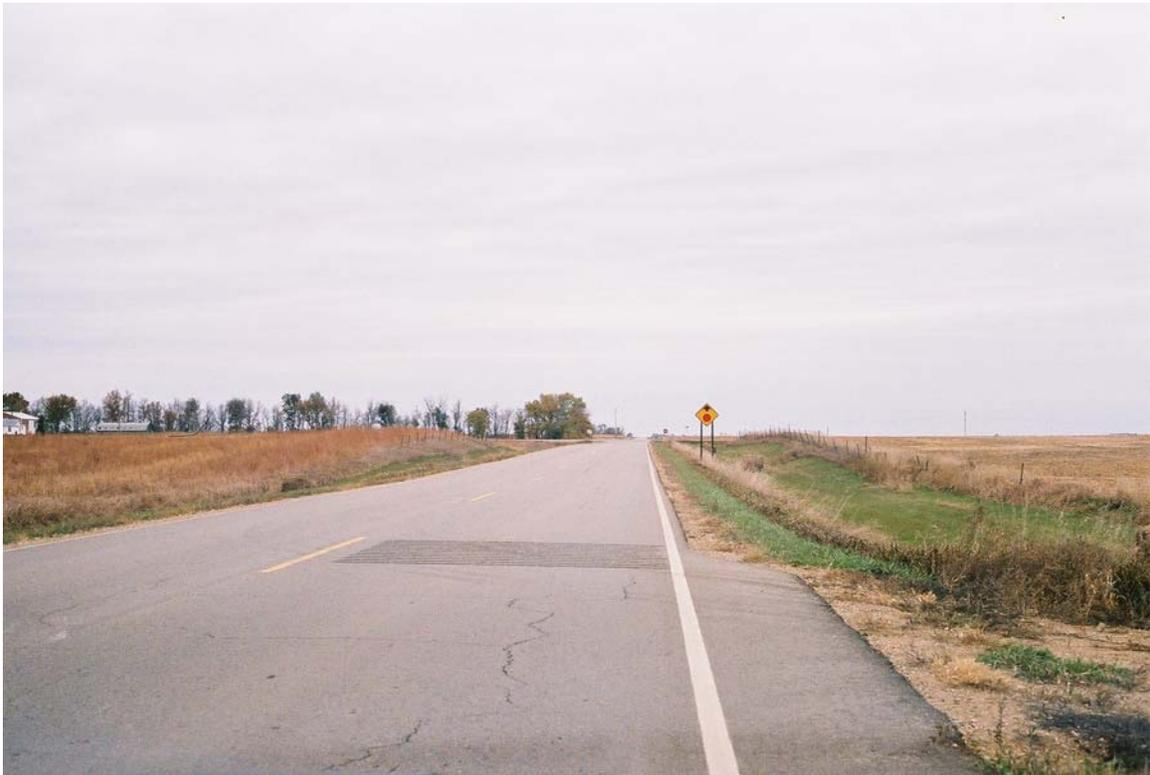
Photograph #79 (Reel #4, 23A) (from South, looking North): first rumble strip and warning sign in view.

On South Side (looking North): on both sides—vertical curves obscure traffic on major road.

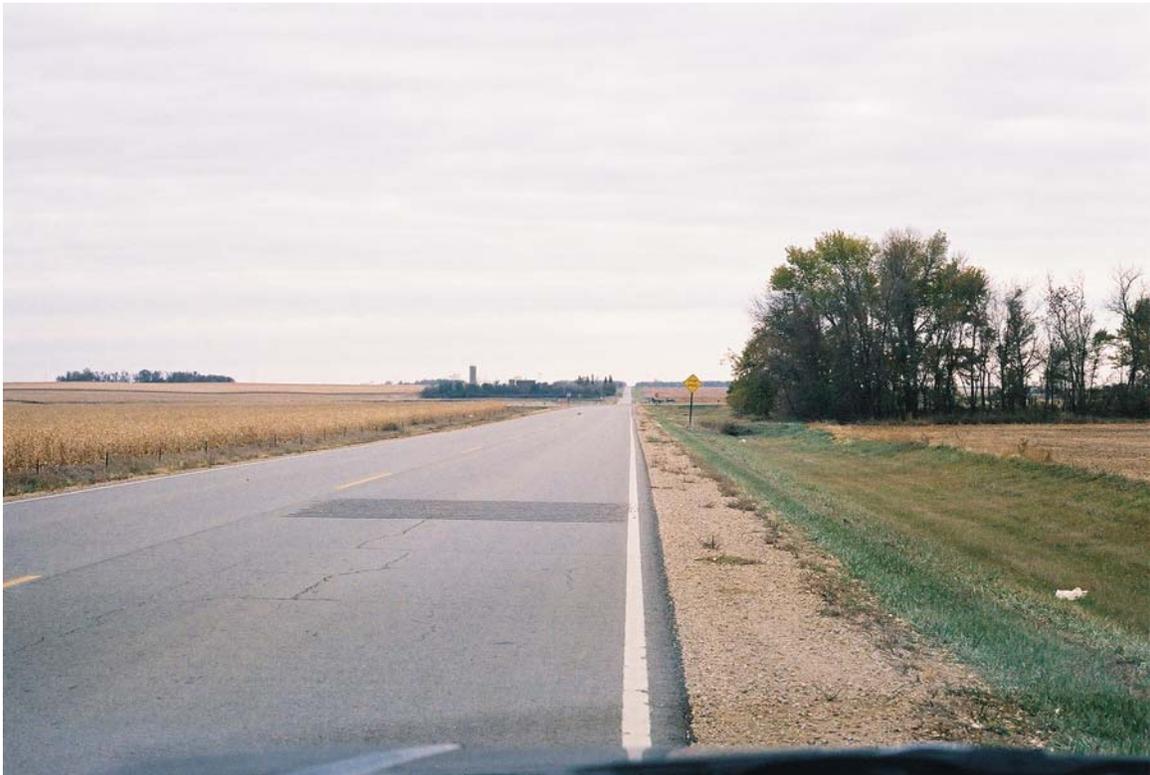
Photograph #82 (Reel #5, 1A) (from North, looking South): first rumble strip and warning sign in view.

On North Side (looking South): to East—clear view of traffic on major road; to West—trees obscure traffic on major road.

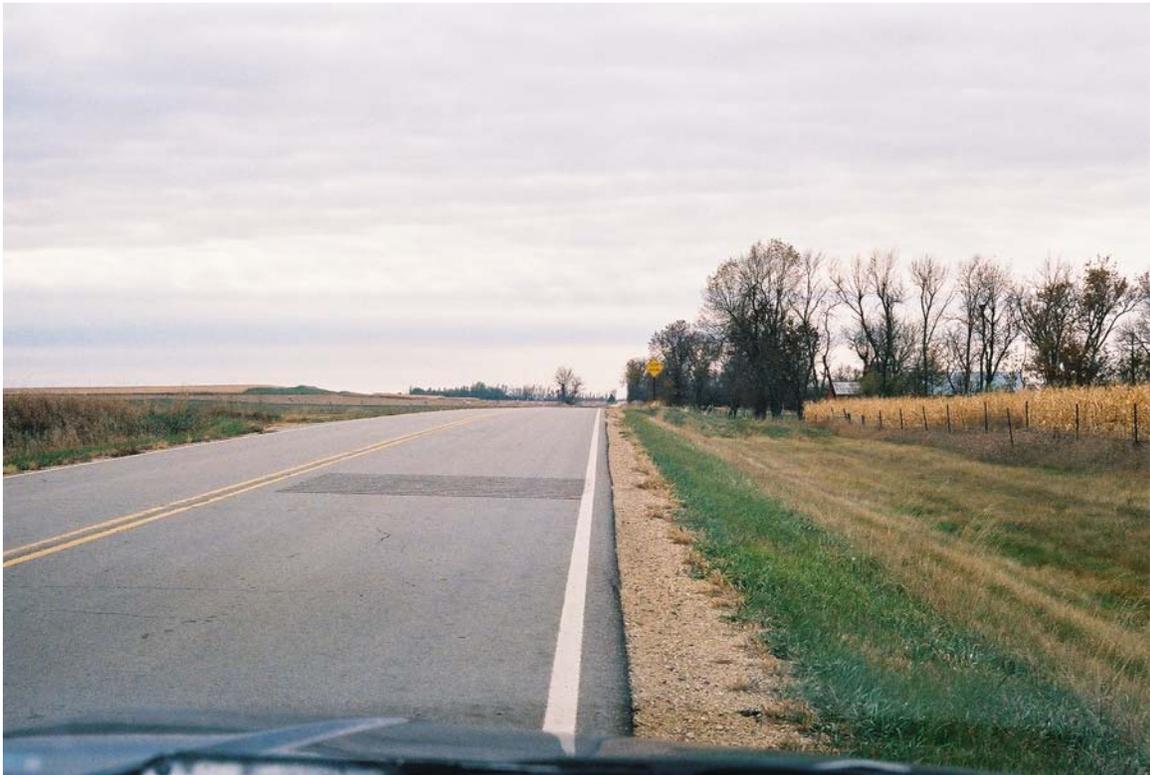
Photograph #84 (Reel #5, 3A) (from North, looking South): first rumble strip and warning sign in view.

On North Side (looking South): to East—vertical curve partially obscures traffic on major road; to West—trees and buildings obscure traffic on major road.

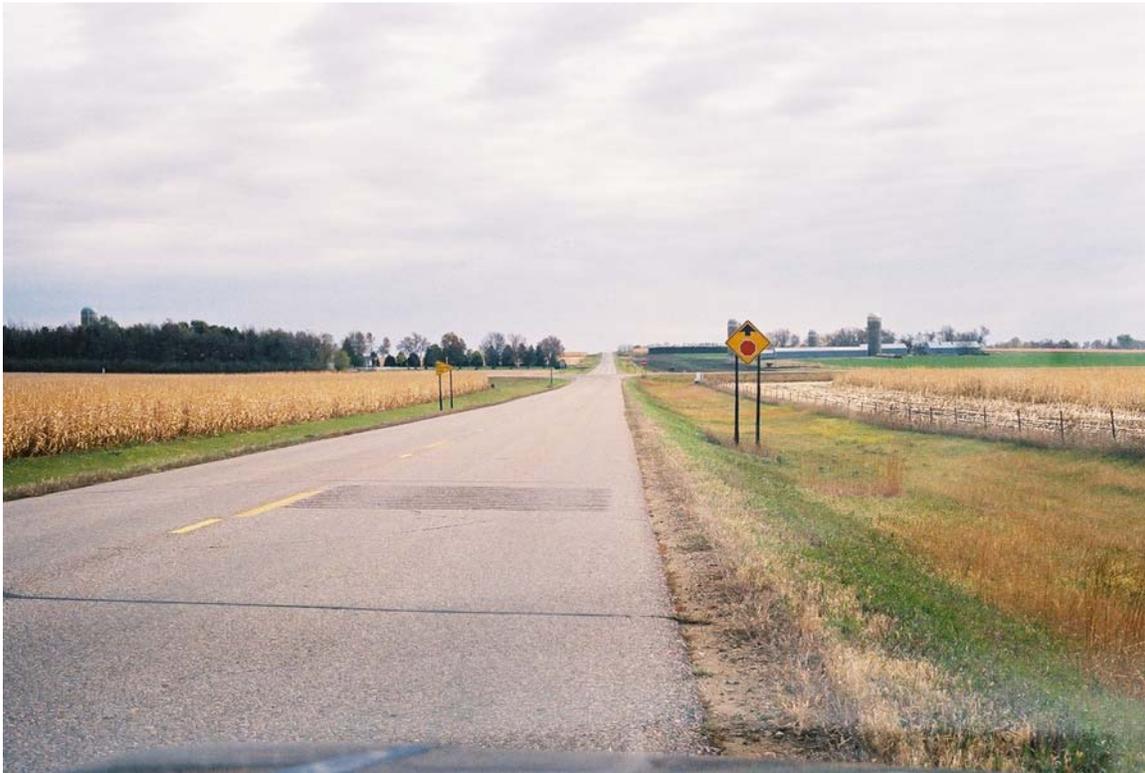
Photograph #86 (Reel #5, 5A) (from West, looking East): first rumble strip and warning sign in view.

Rumble strips worn

On West Side (looking East): to North—corn obscures traffic on major road; to South—clear view of traffic on major road.

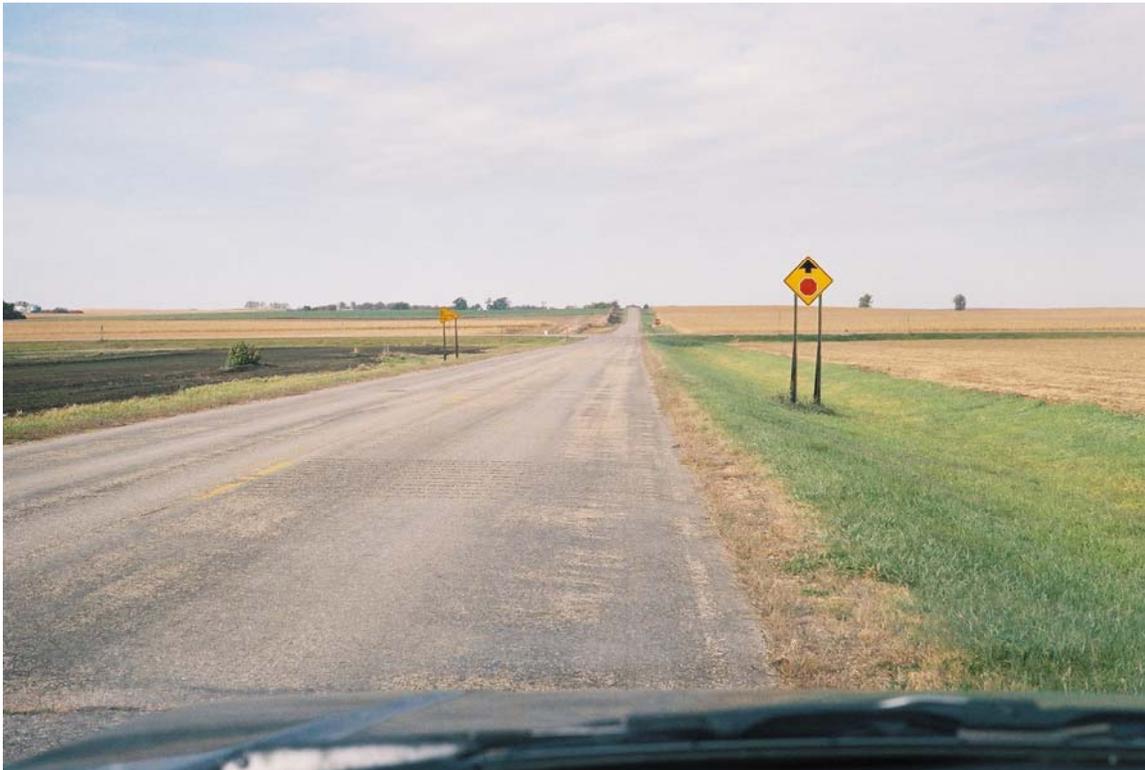
Photograph #88 (Reel #5, 7A) (from East, looking West): first rumble strip and warning sign in view.

Rumble strips worn

On East Side (looking West): on both sides—clear view of traffic on major road.

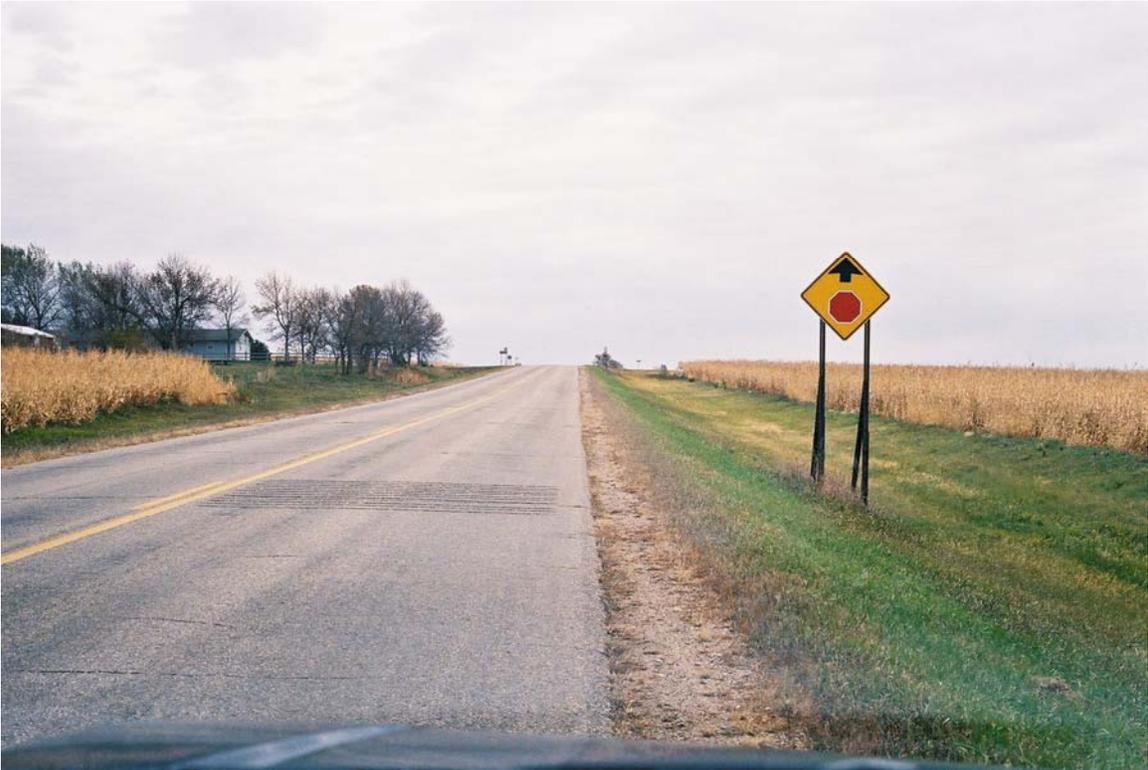
Photograph #90 (Reel #5, 9A) (from West, looking East): first rumble strip and warning sign in view.

On West Side (looking East): to North—trees and buildings obscure traffic on major road (6); to South—corn obscures traffic on major road.

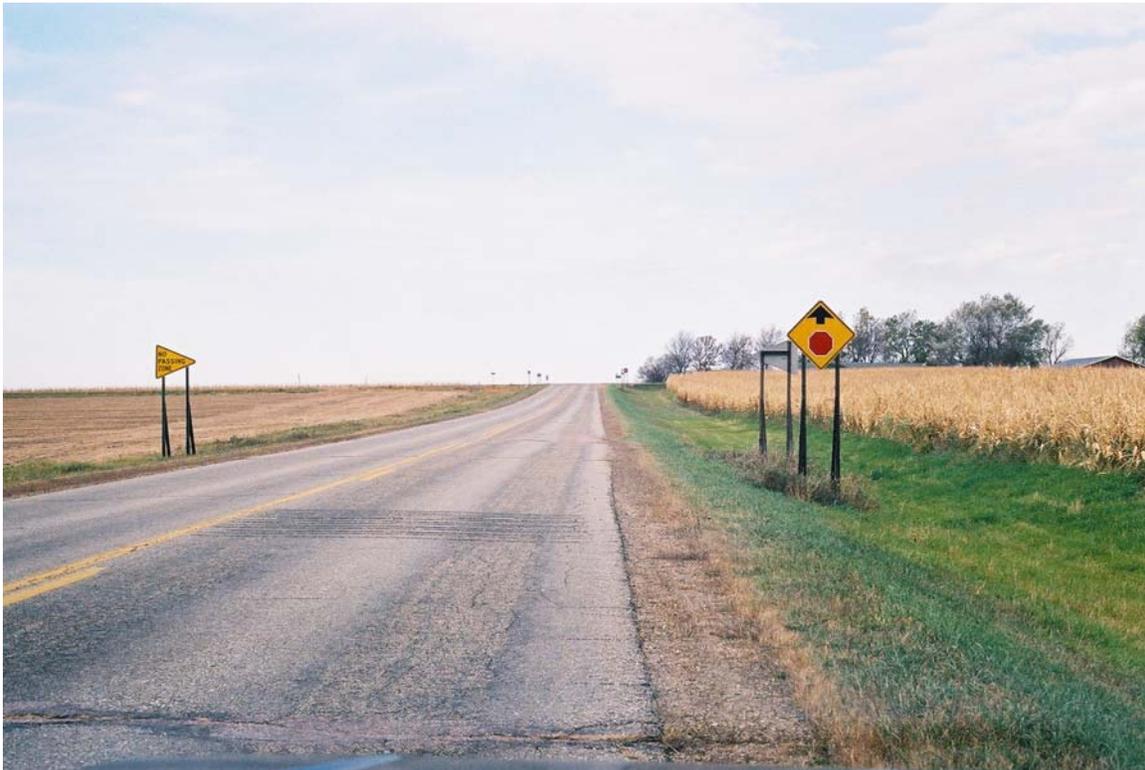
Photograph #92 (Reel #5, 11A) (from East, looking West): first rumble strip and warning sign in view.

On East Side (looking West): to North—corn obscures traffic on major road; to South—
clear view of traffic on major road.

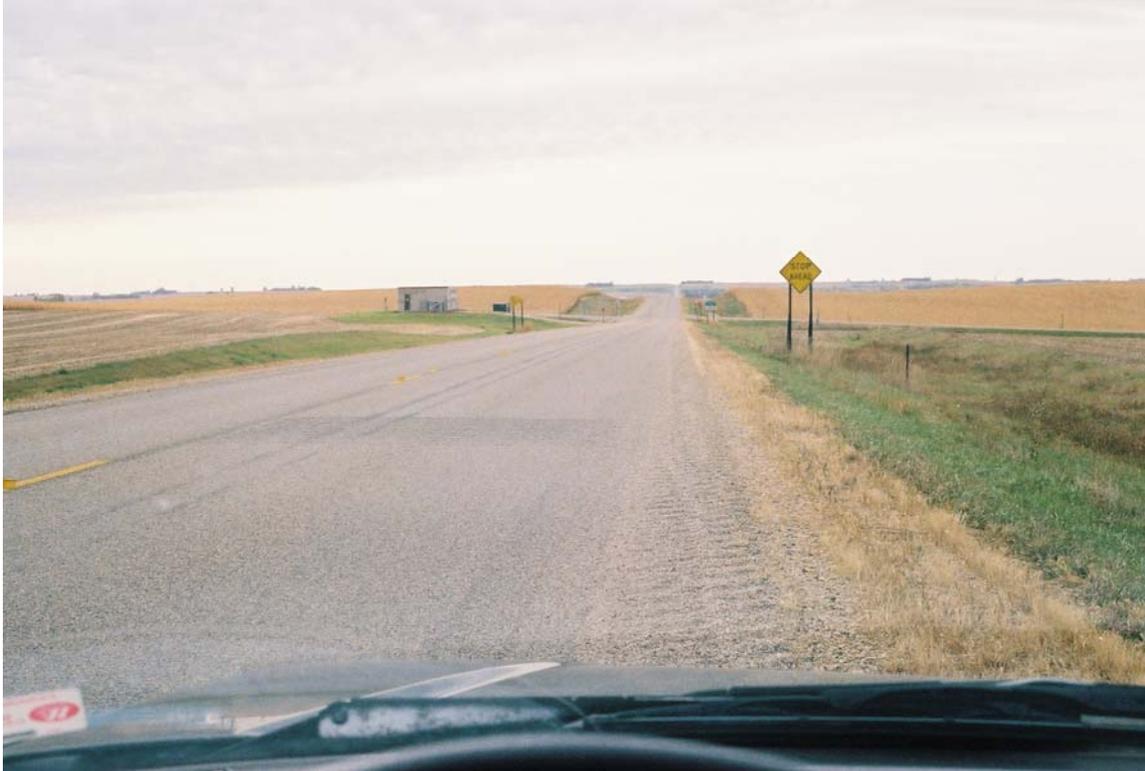
Photograph #95 (Reel #5, 14A) (from North, looking South): first rumble strip and warning sign in view.

On North Side (looking South): to East—vertical curve & building obscure traffic on cross road; to West—clear view of traffic on cross road.

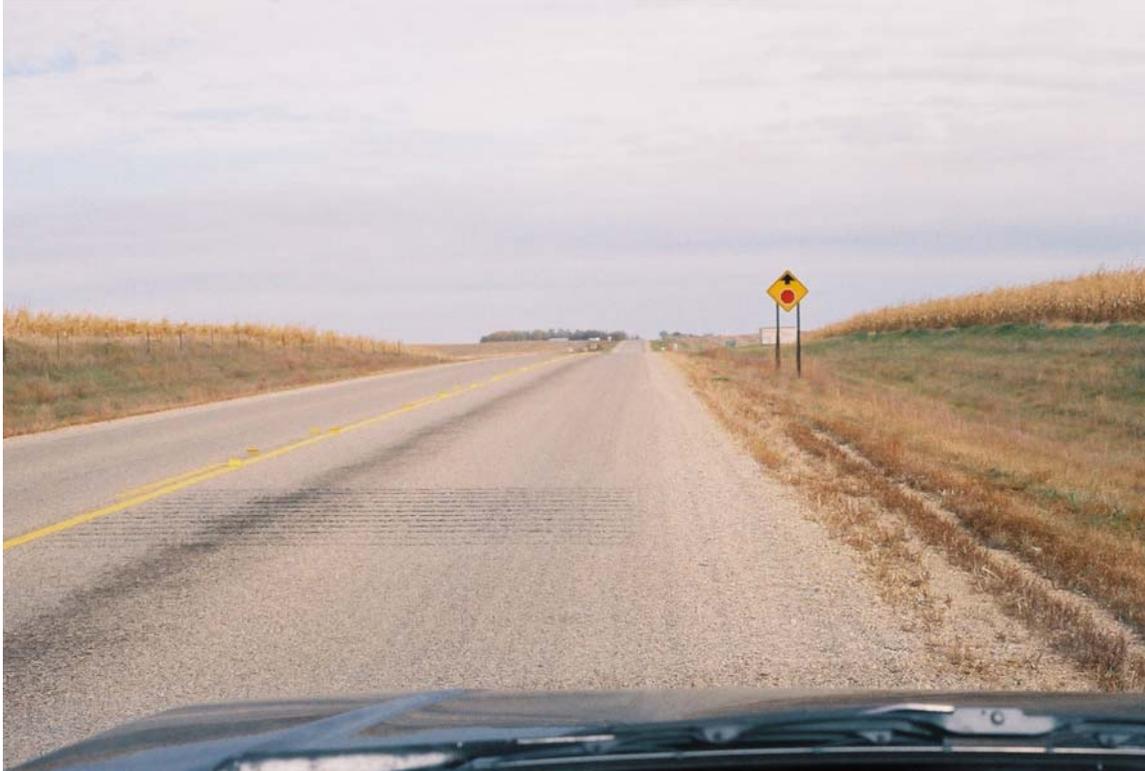
Photograph #97 (Reel #5, 16A) (from South, looking North): first rumble strip and warning sign (with red center unlike warning signs on other three approaches to the four-way stop) in view.

On South Side (looking North): vertical curve obscures intersection; on both sides—
vertical curve also obscures traffic on cross road.

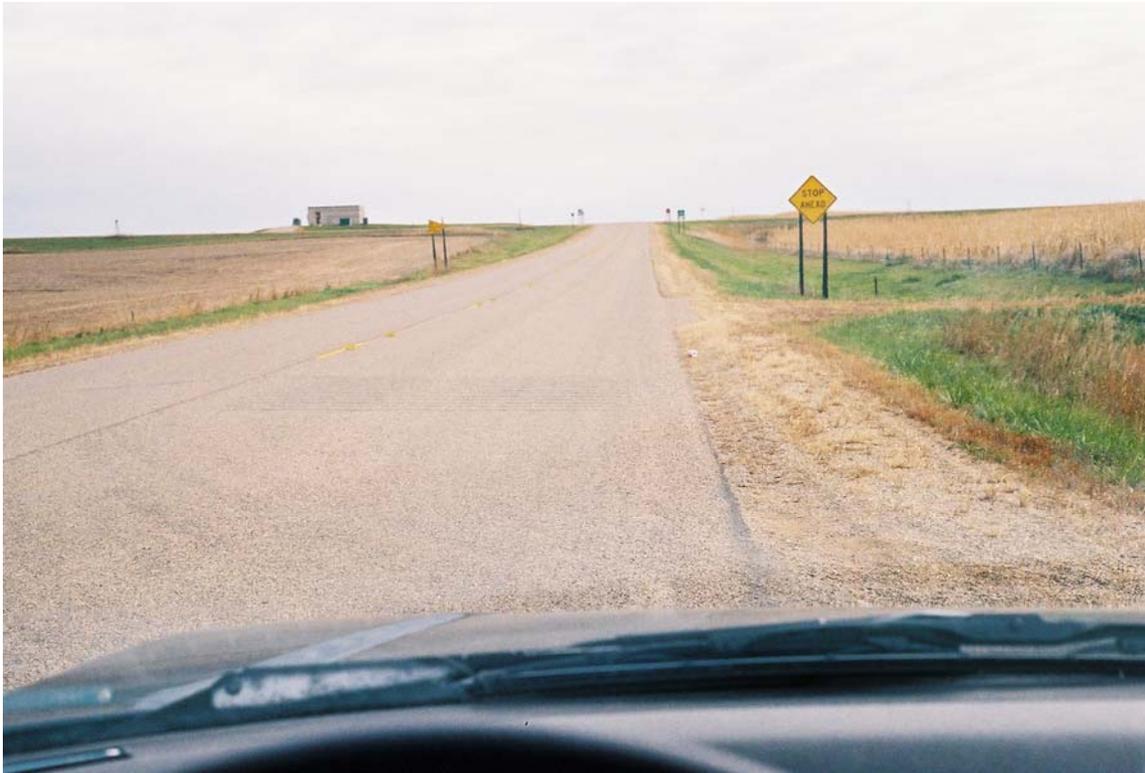
Photograph #99 (Reel #5, 18A) (from West, looking East): first rumble strip and warning sign in view.

On West Side (looking East): to North—clear view of traffic on cross road: to South—
vertical curve obscures traffic on cross road.

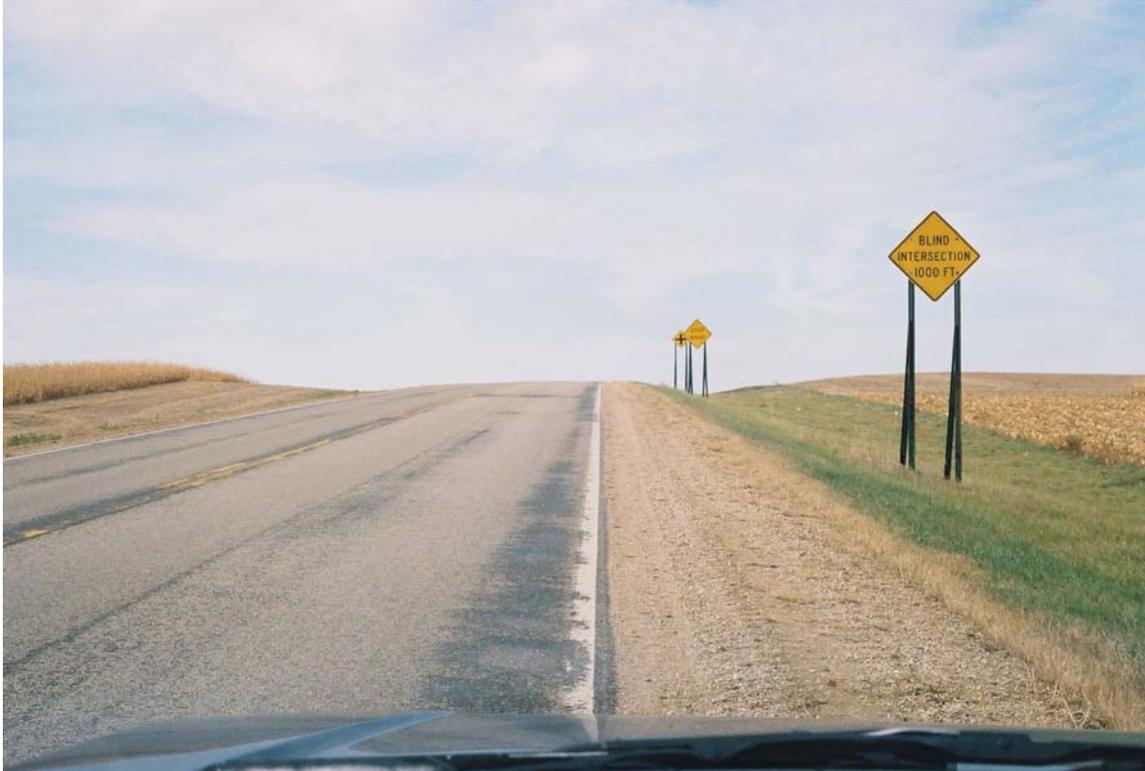
Photograph #101 (Reel #5, 20A) (from East, looking West): first rumble strip, warning sign, and “blind intersection” sign in view.

On East Side (looking West): vertical curve obscures intersection; on both sides—vertical curve obscures traffic on cross road.

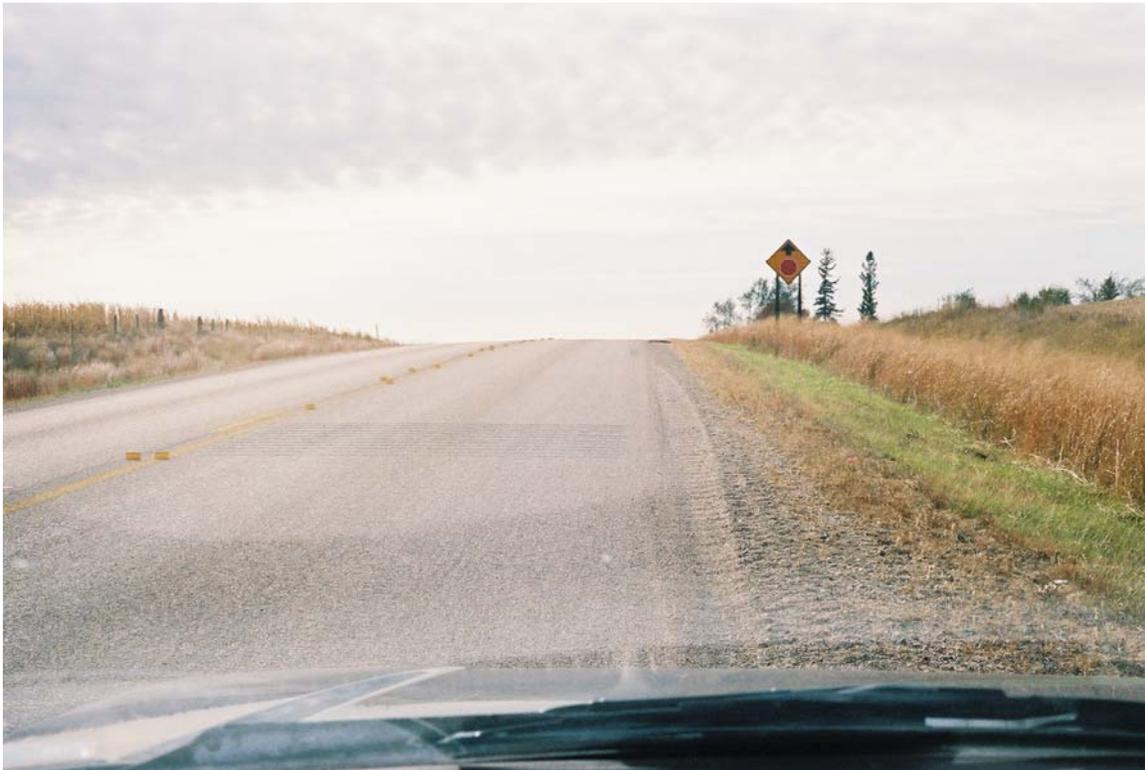
Photograph #103 (Reel #5, 22A) (from North, looking South): first rumble strip and warning sign in view.

On North Side (looking South): intersection obscured by vertical curve; on both sides—
vertical curve obscures traffic on major road.

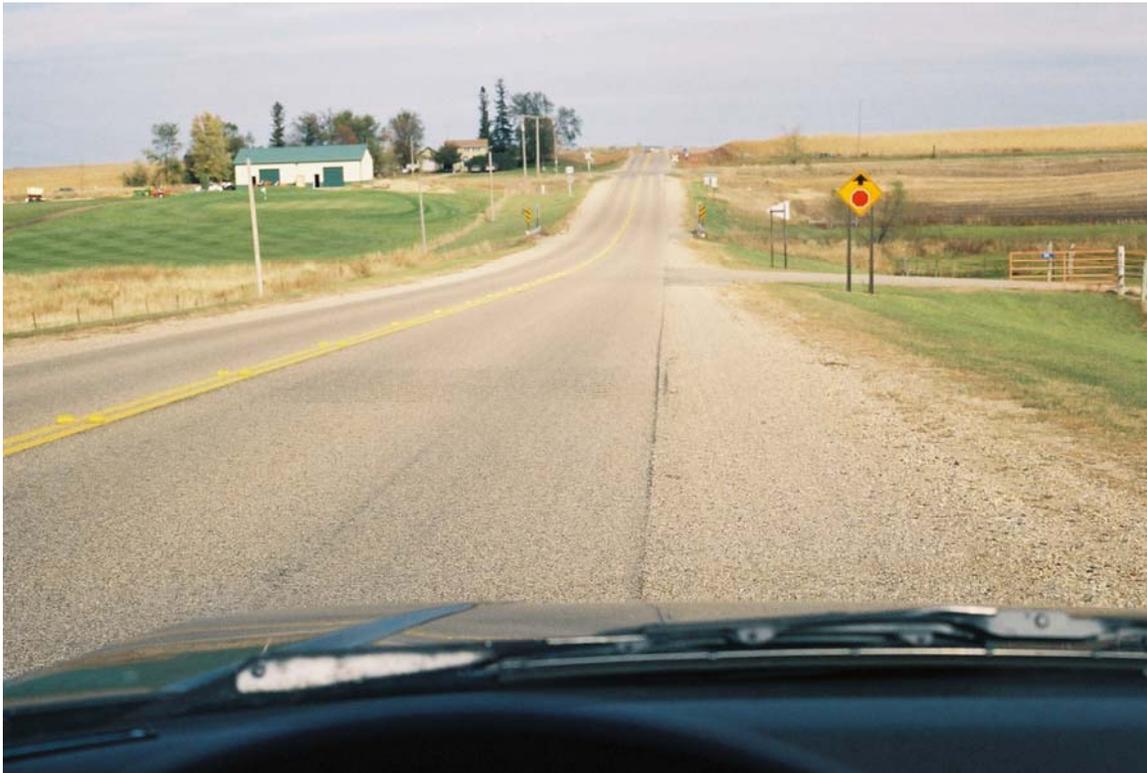
Photograph #105 (Reel #5, 24A) (from South, looking North): first rumble strip and warning sign in view.

On South Side (looking North): to East—clear view of traffic on major road; to West—building and trees partially obscure traffic on major road.

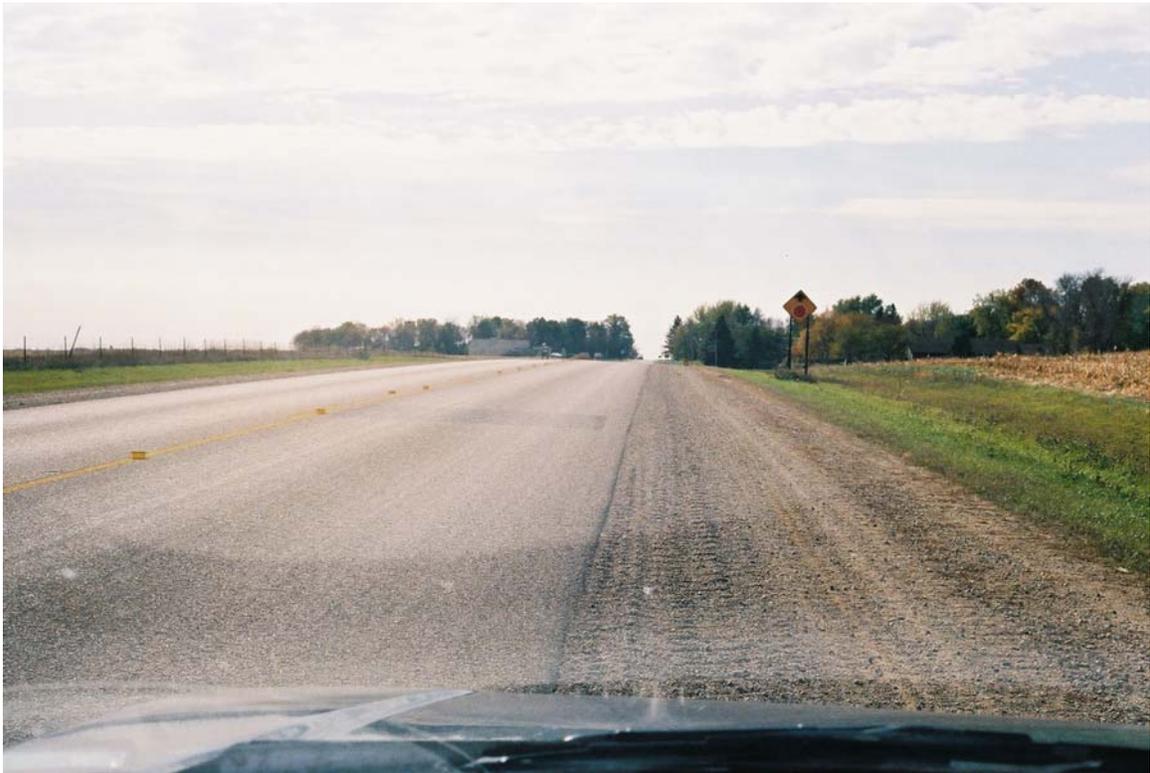
Photograph #107 (Reel #6, 2A) (from North, looking South): first rumble strip and warning sign in view.

On North Side (looking South): to East—partial view of traffic on major road; to West—trees obscure traffic on major road.

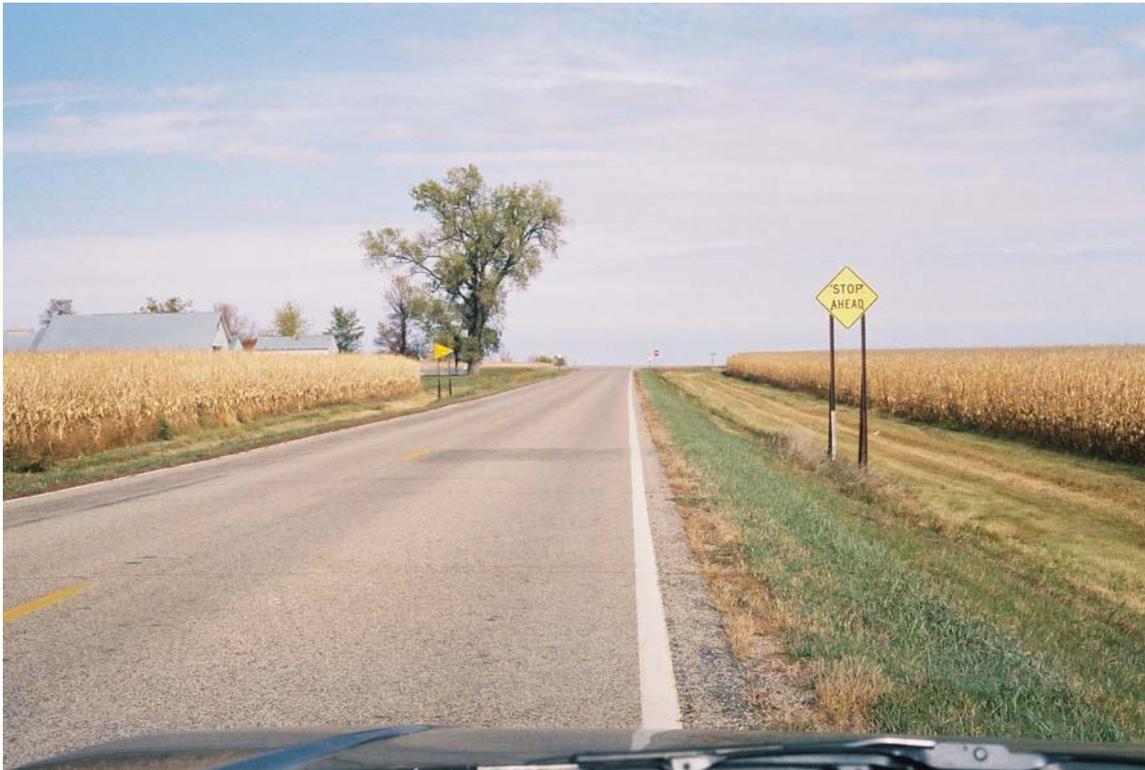
Photograph #109 (Reel #6, 4A) (from South, looking North): first rumble strip and warning sign in view.

On South Side (looking North): to East—corn obscures traffic on major road; to West—
corn and buildings obscure traffic on major road.

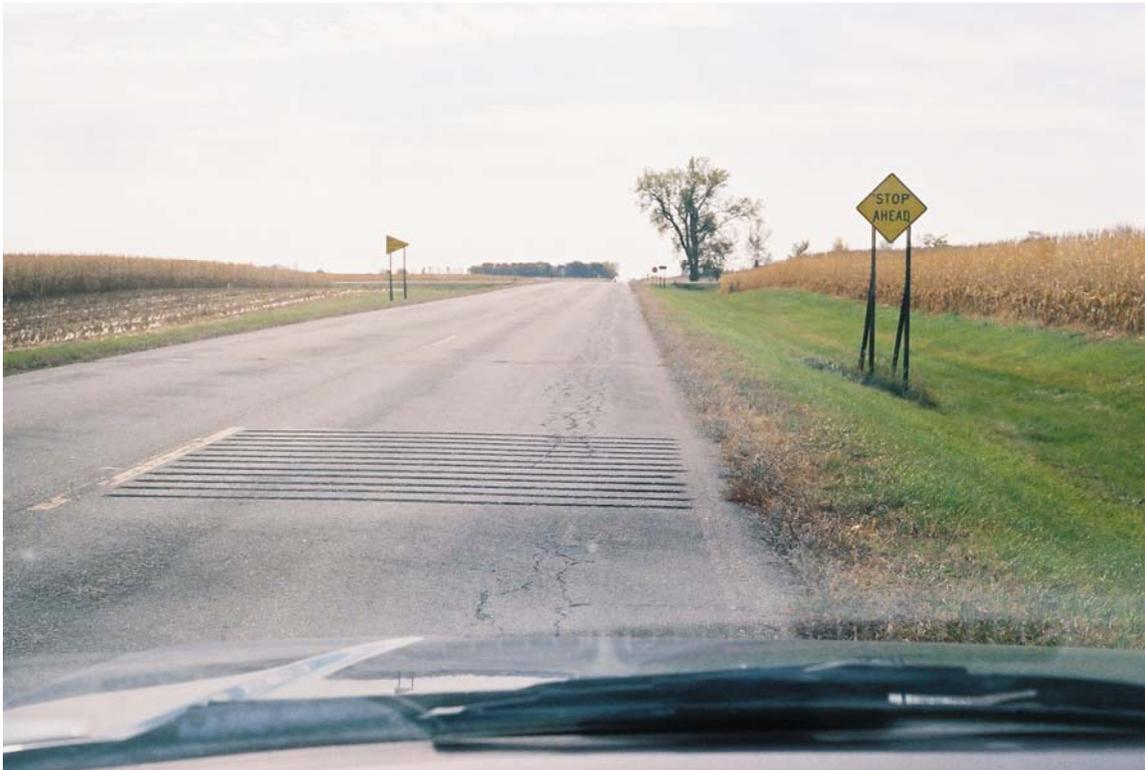
Photograph #111 (Reel #6, 6A) (from North, looking South): first rumble strip and warning sign in view.

On North Side (looking South): to East—corn obscures traffic on major road; to West—
corn and vertical curve obscure traffic on major road.
