2006-42

Final Report

Stopping Behavior at Real-World
Stop-Controlled Intersections
with and without In-Lane Rumble Strips

**Center for Human Factors Systems Research and Design
University of Minnesota**

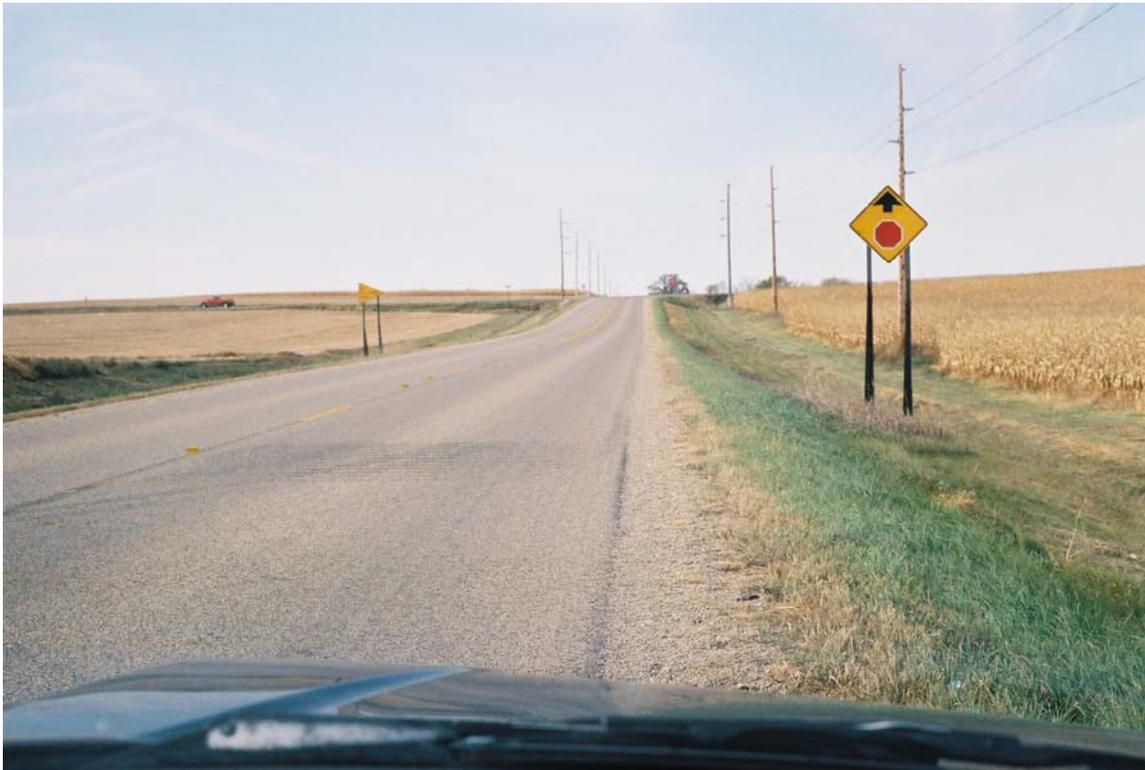
Photograph #113 (Reel #6, 8A) (from East, looking West): first rumble strip and warning sign in view.

On East Side (looking West): to North—corn obscures traffic on major road; to South—clear view of traffic on major road.

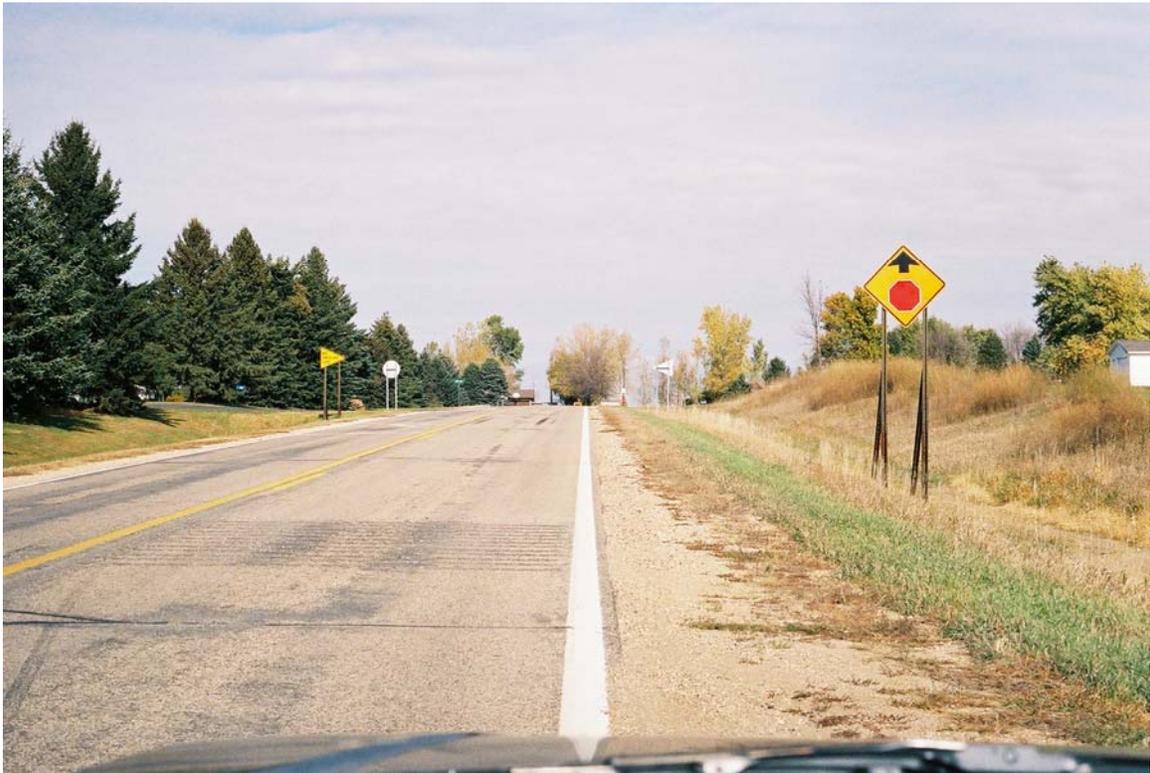
Photographs #116 & 117 (Reel #6, 11A & 12 A) (from South, looking North): first rumble strip and warning in view.

On South Side (looking North): to East—vertical curve and trees obscure traffic on major road; to West—trees obscure traffic on major road.

[Note: at this point driver approaching intersection has just crossed railway track.]

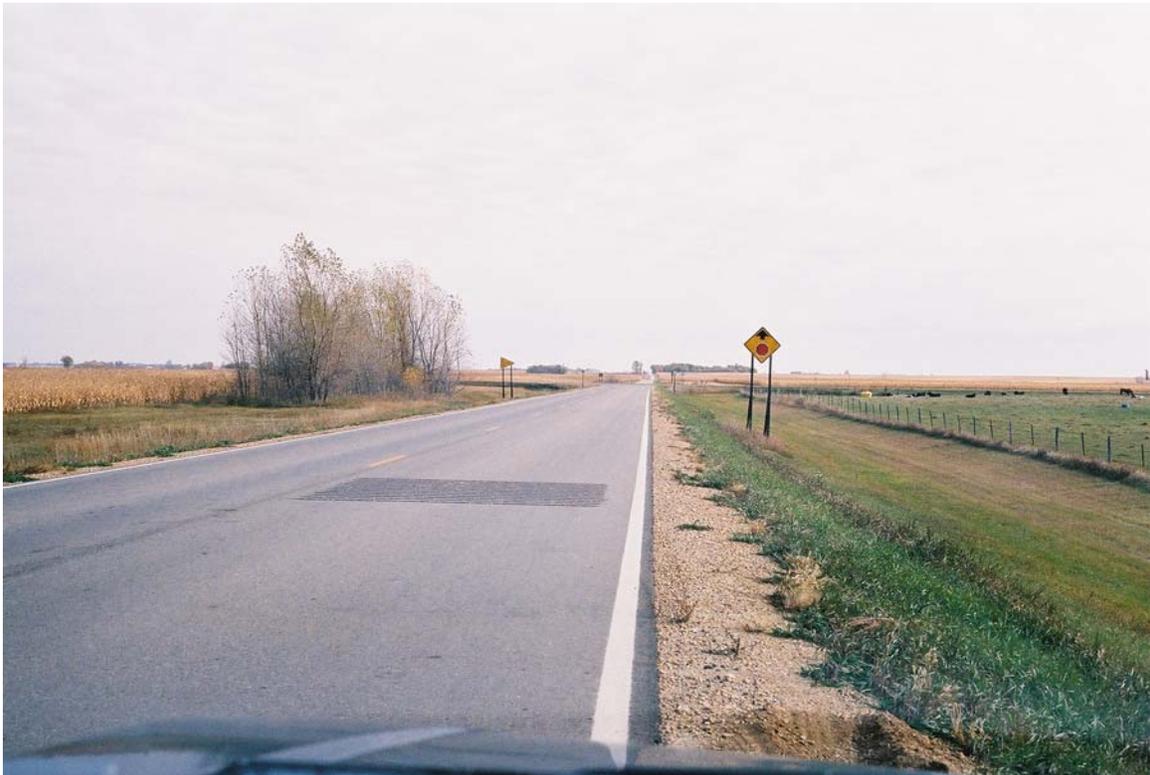
Photograph #119 (Reel #6, 14A) (from East, looking West): first rumble strip and warning sign in view.

On West Side (looking East): to North—trees and corn obscure traffic on major road; to South—clear view of traffic on major road.

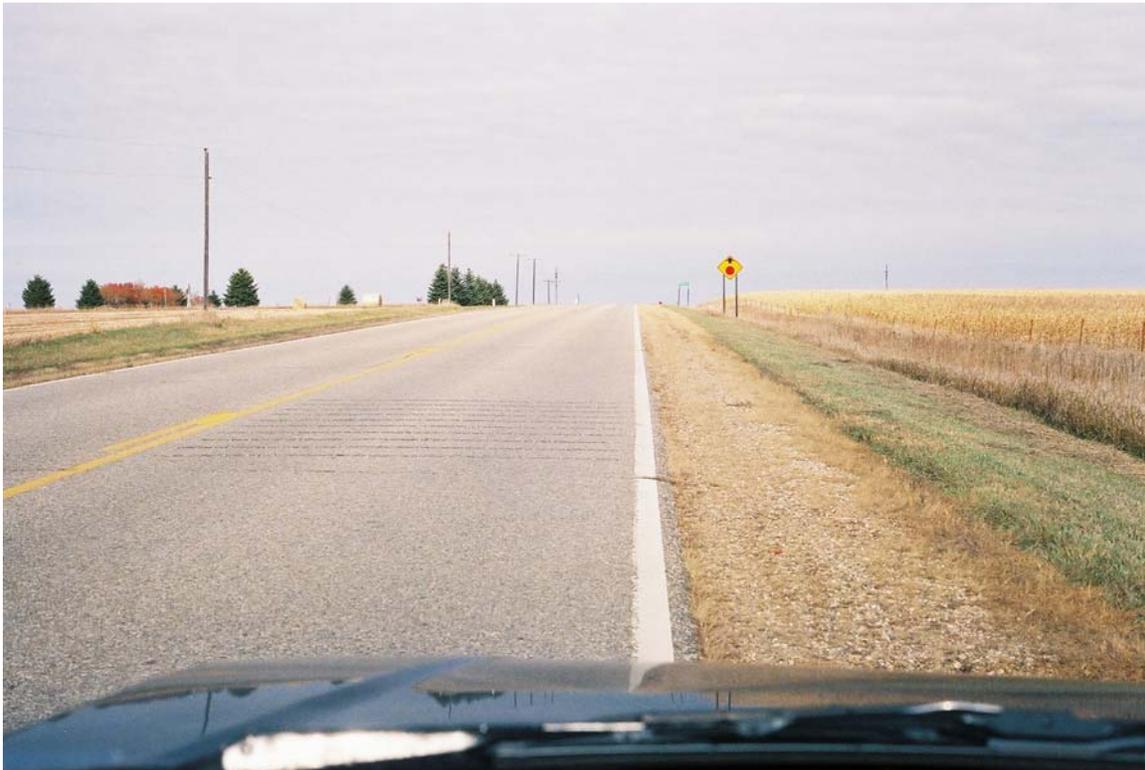
Photograph #121 (Reel #6, 16A) (from South, looking North): first rumble strip and warning sign in view.

On South Side (looking North): intersection obscured by vertical curve; on both sides—
vertical curve obscures traffic on major road.

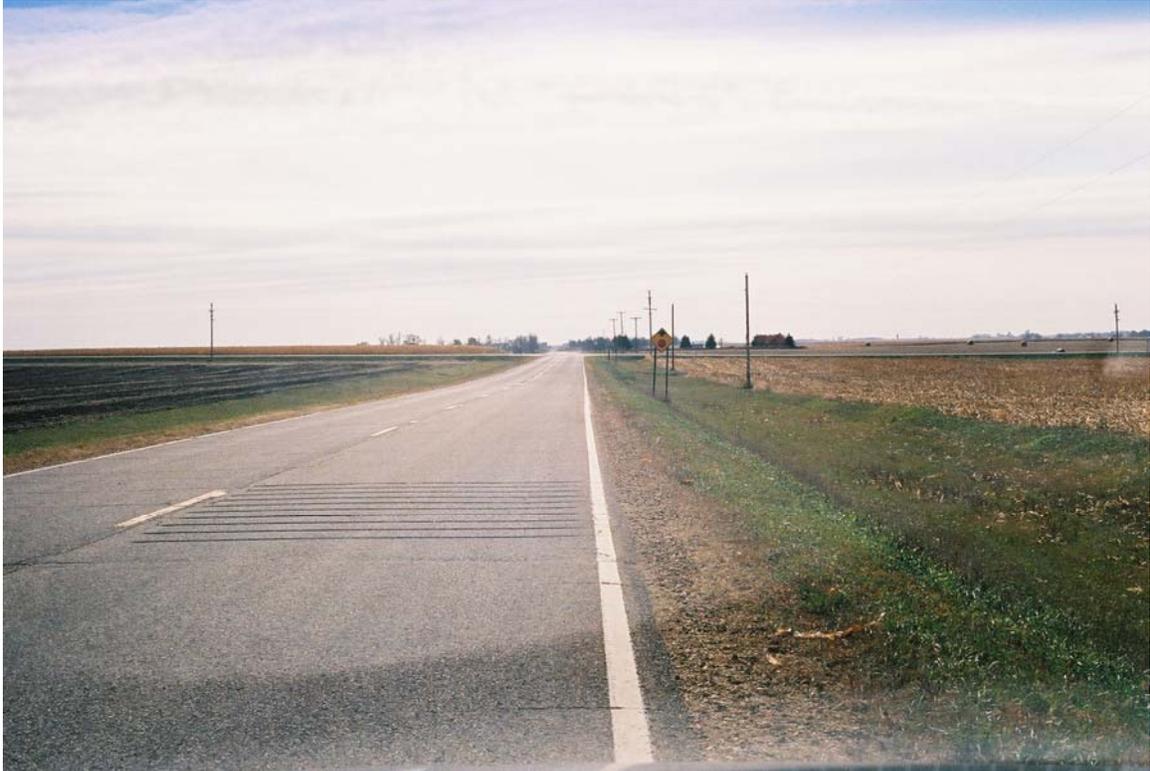
Photograph #123 (Reel #6, 18A) (from North, looking South): first rumble strip and warning sign in view.

On North Side (looking South): on both sides—clear view of traffic on major road.

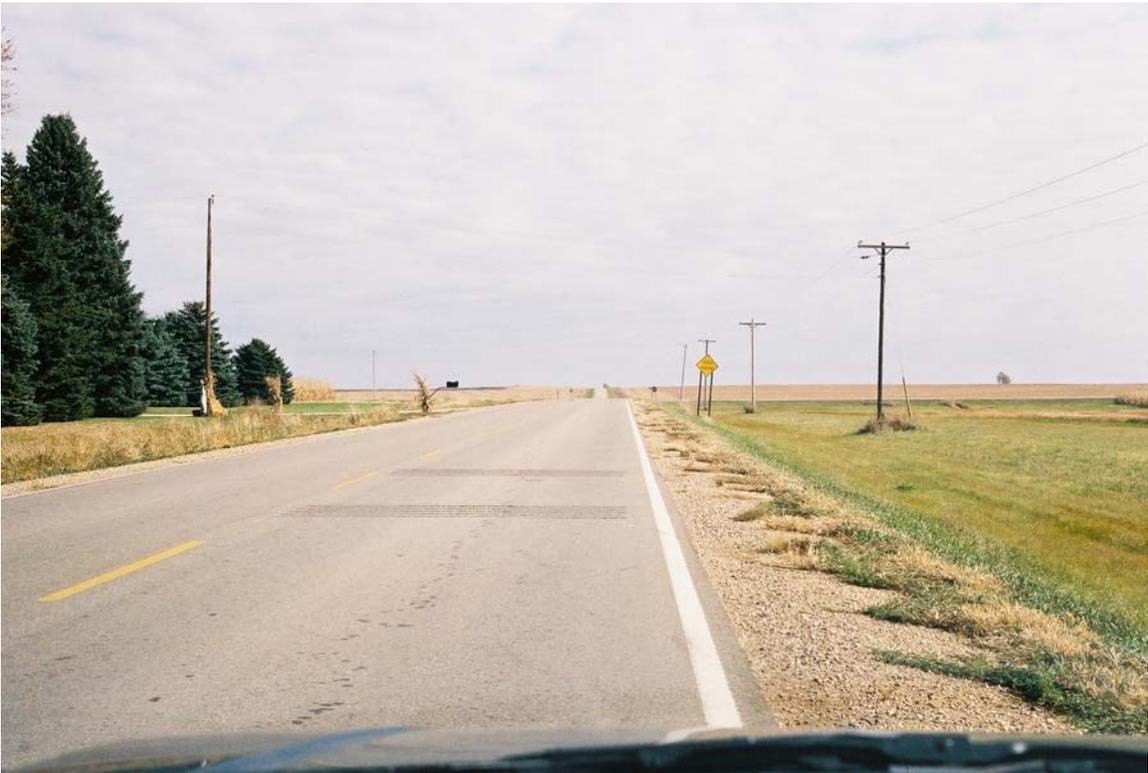
Photograph #125 (Reel #6, 20A) (from West, looking East): first set of rumble strips and warning sign in view.

On West Side (looking East): to North—trees obscure traffic on major road; to South—clear view of traffic on major road.

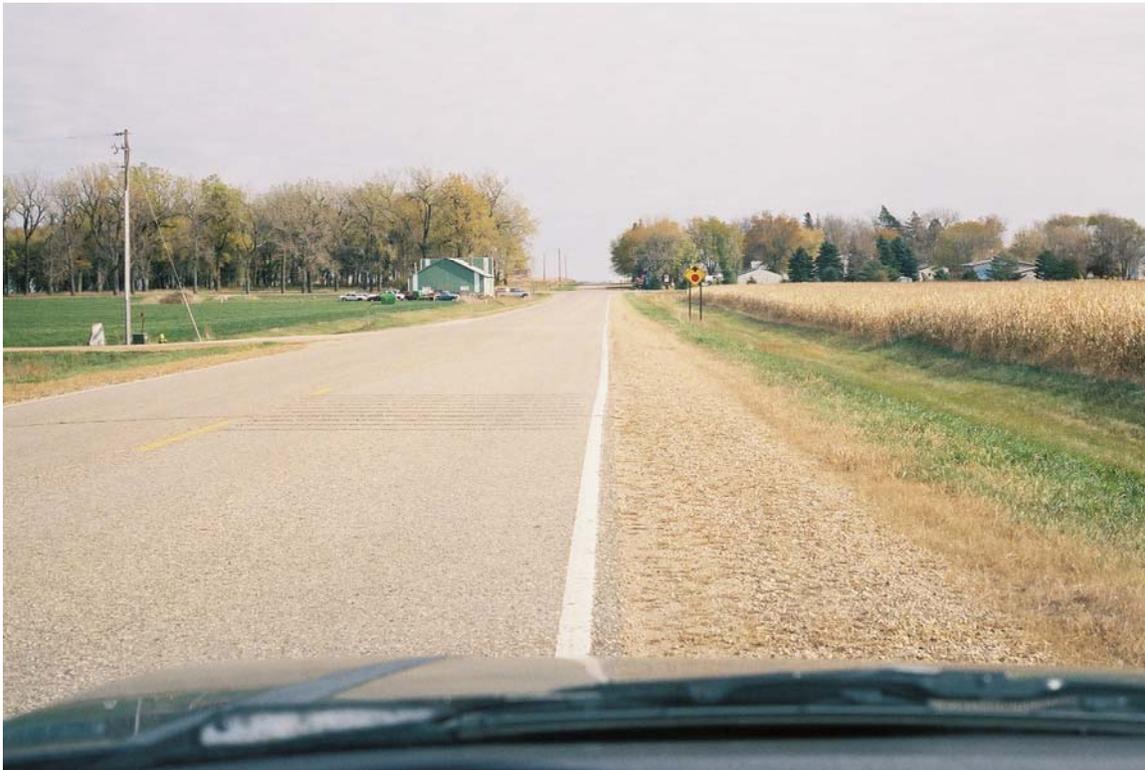
Photograph #127 (Reel #6, 22A) (from West, looking East): first rumble strip and warning strip in view.

On West Side (looking East): to North—buildings and trees obscure traffic on major road; to South—corn obscures traffic on major road.

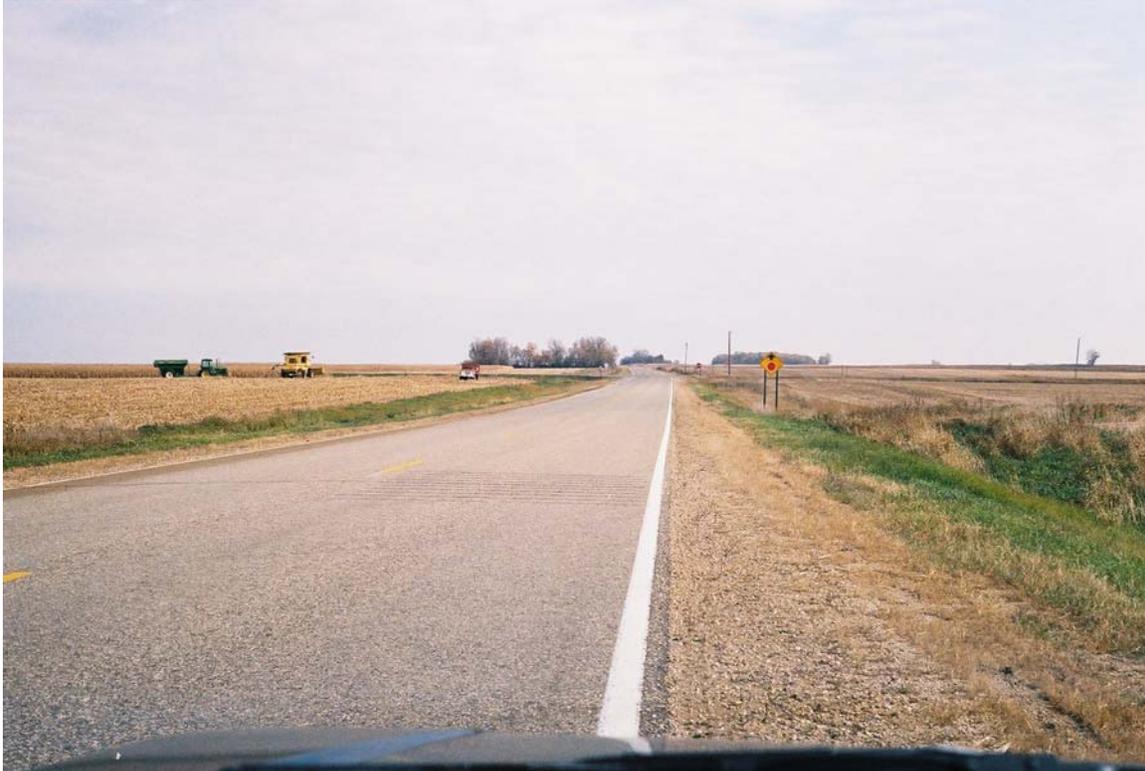
Photograph #129 (Reel #6, 24A) (from West, looking East): first rumble strip and warning sign in view.

On West Side (looking East): on both sides—clear view of traffic on major road.

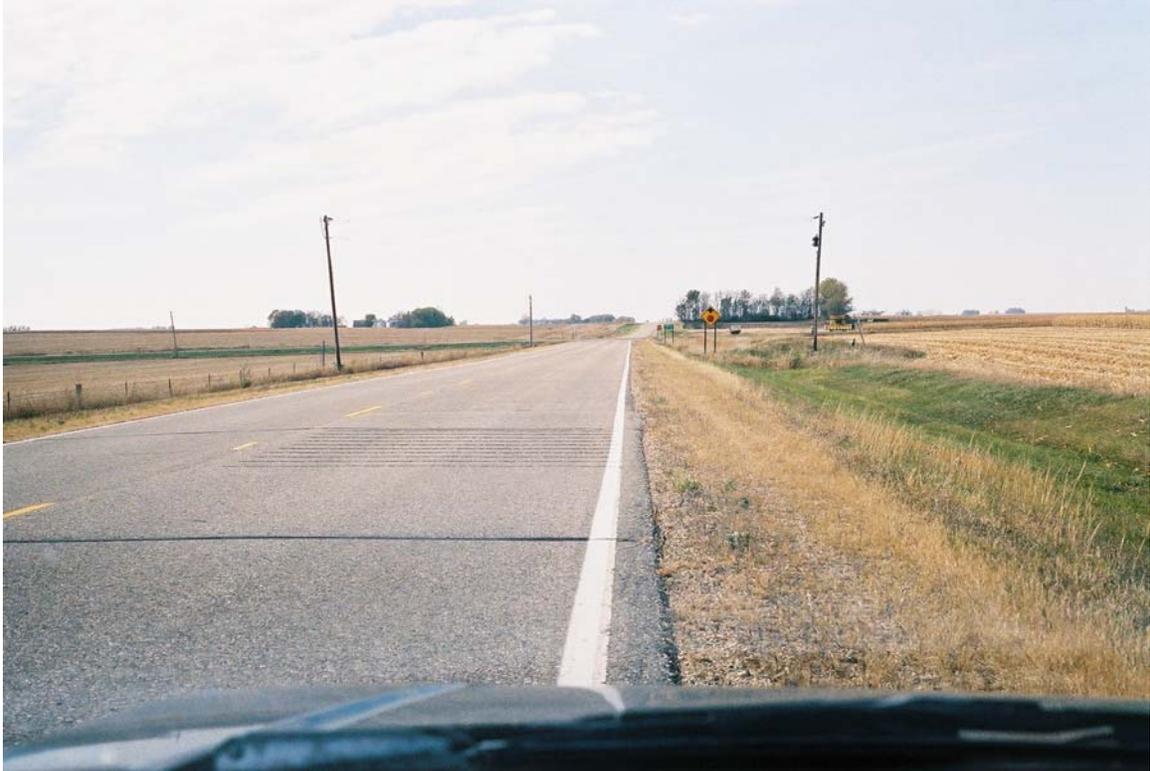
Photograph #131 (Reel #7, 2A) (from East, looking West): first rumble strip and warning sign in view.

On East Side (looking West): on both sides—clear view of traffic on major road.

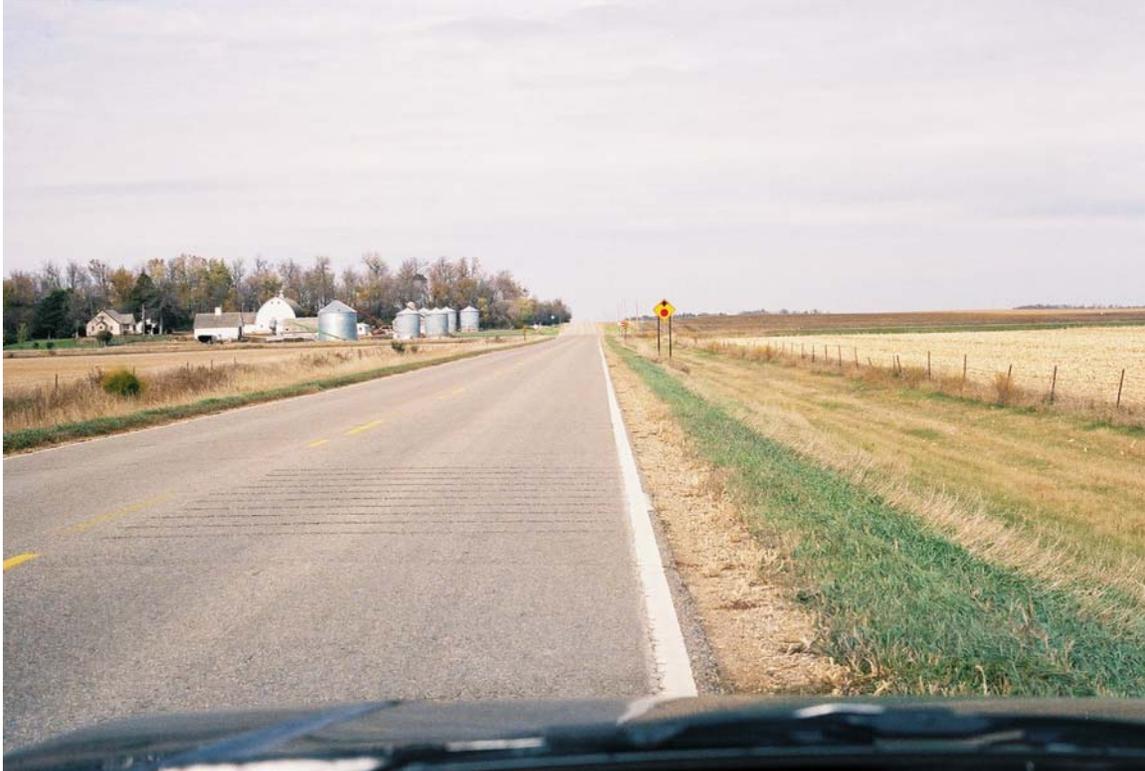
Photograph #133 (Reel #7, 4A) (from South, looking North): first rumble strip and warning sign in view.

On South Side (looking North): on both sides—clear view of traffic on major road.

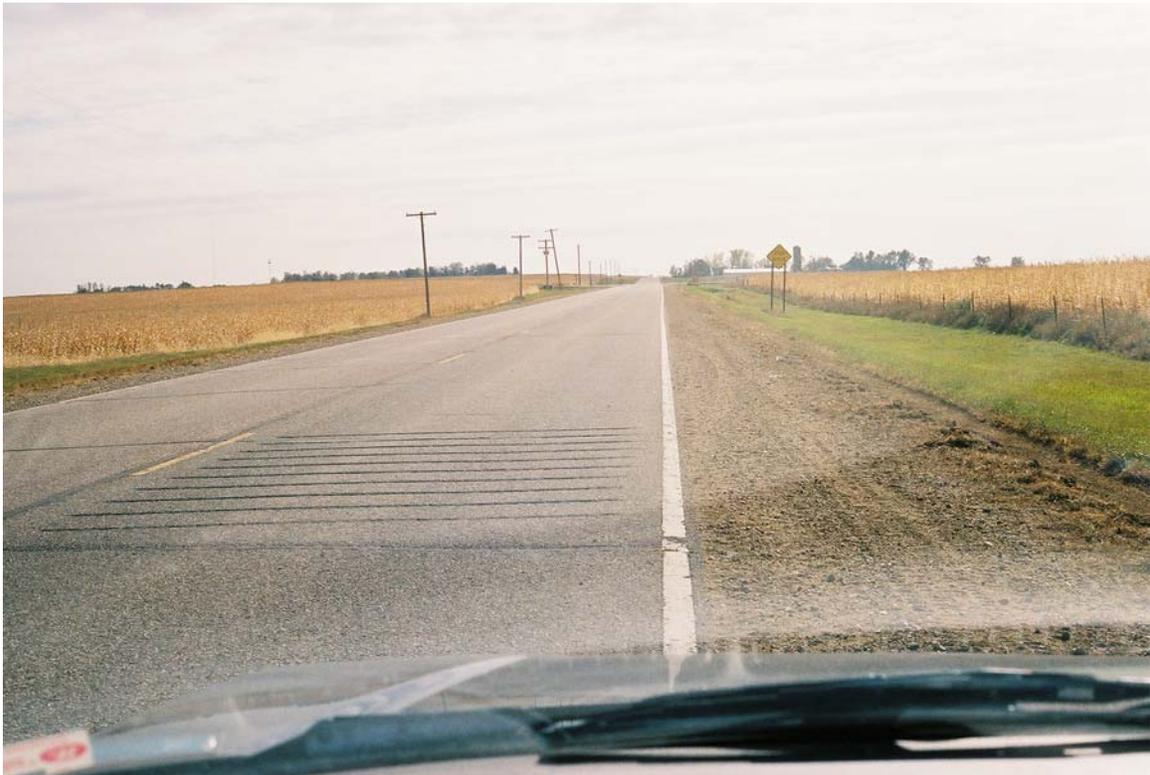
Photograph #135 (Reel #7, 6A) (from North, looking South): first rumble strip and warning sign in view.

On North Side (looking South): to East—clear view of traffic on major road; to West—trees (behind which are buildings) obscure traffic on major road.

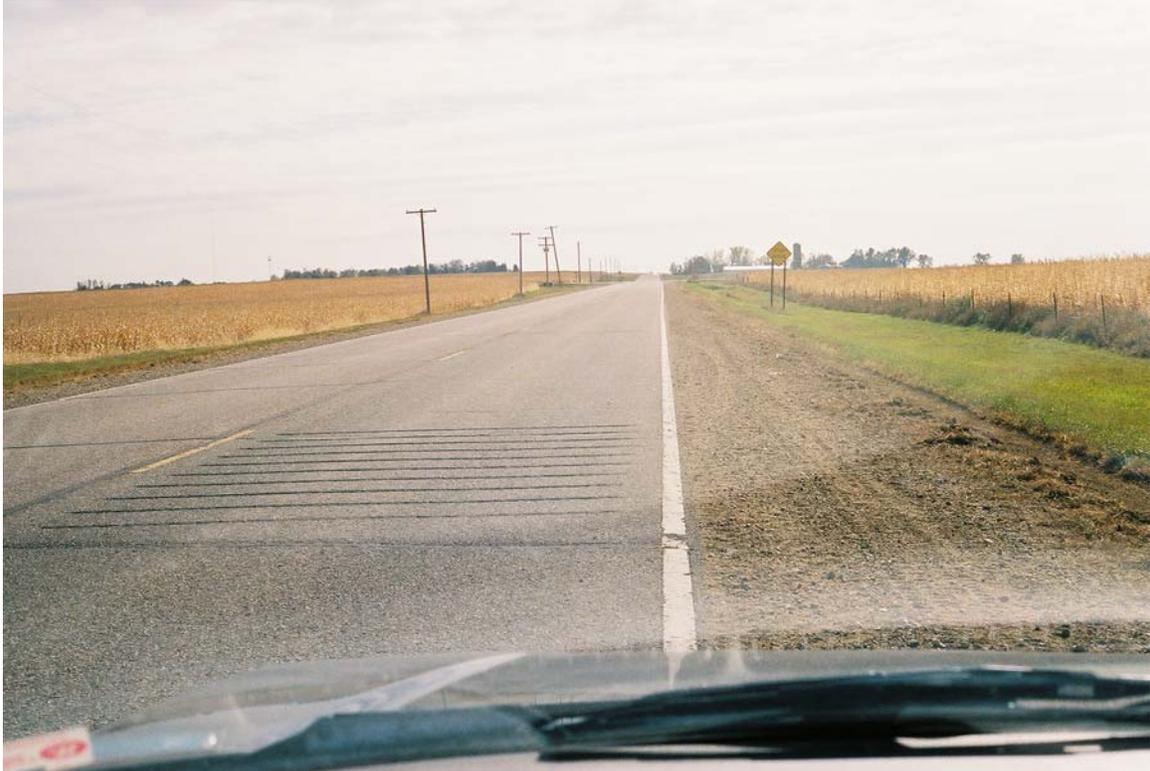
Photograph #137 (Reel #7, 8A) (from North, looking South): first rumble strip and warning sign in view.

On North Side (looking South): on both sides—corn obscures traffic on major road.

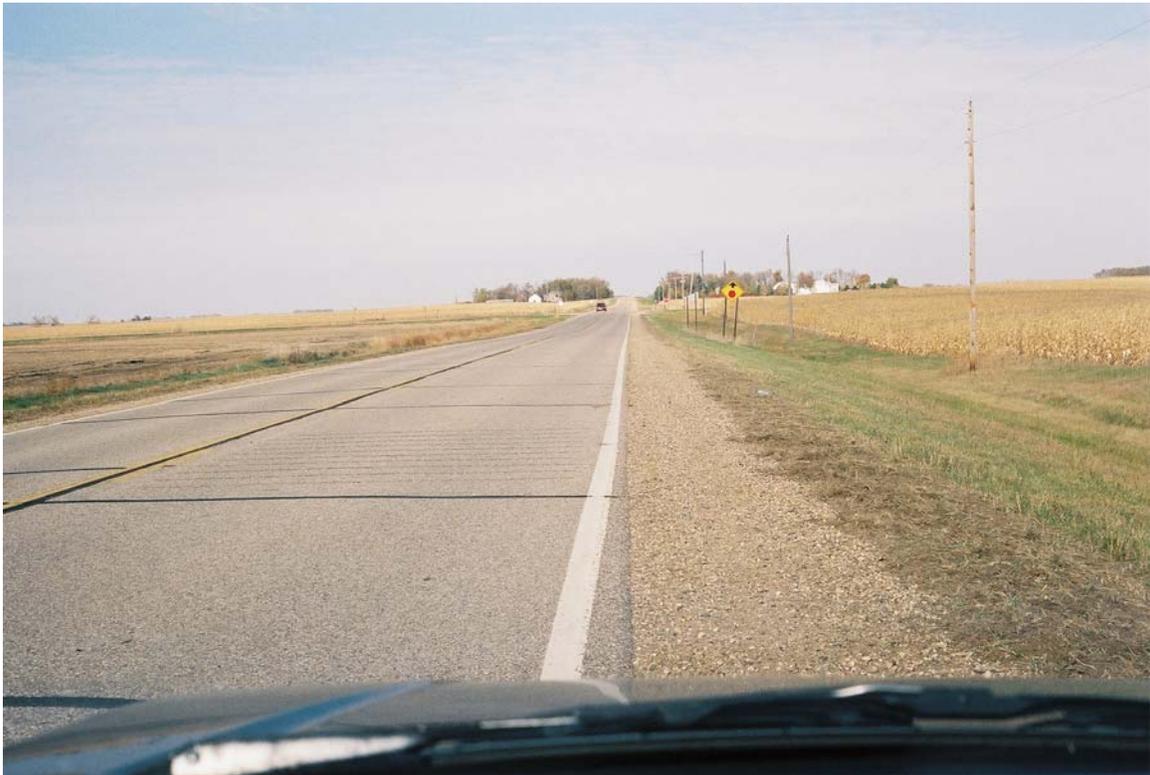
Photograph #139 (Reel #7, 10A) (from South, looking North): first rumble strip and warning sign in view.

On South Side (looking North): to East— corn obscures traffic on major road; to West—
clear view of traffic on major road.

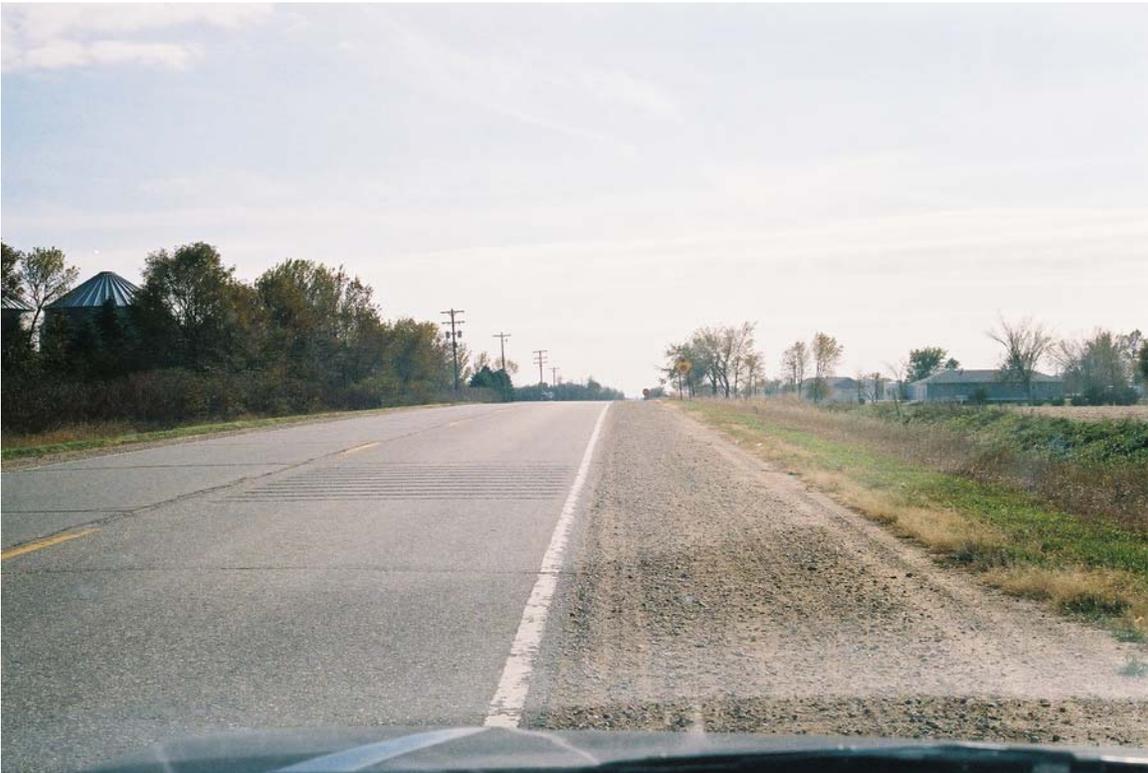
Photograph #141 (Reel #7, 12A) (from North, looking South): first rumble strip and warning sign in view.

On North Side (looking South): intersection obscured by slight vertical curve; on both sides—slight vertical curve, trees and buildings obscure traffic on major road.

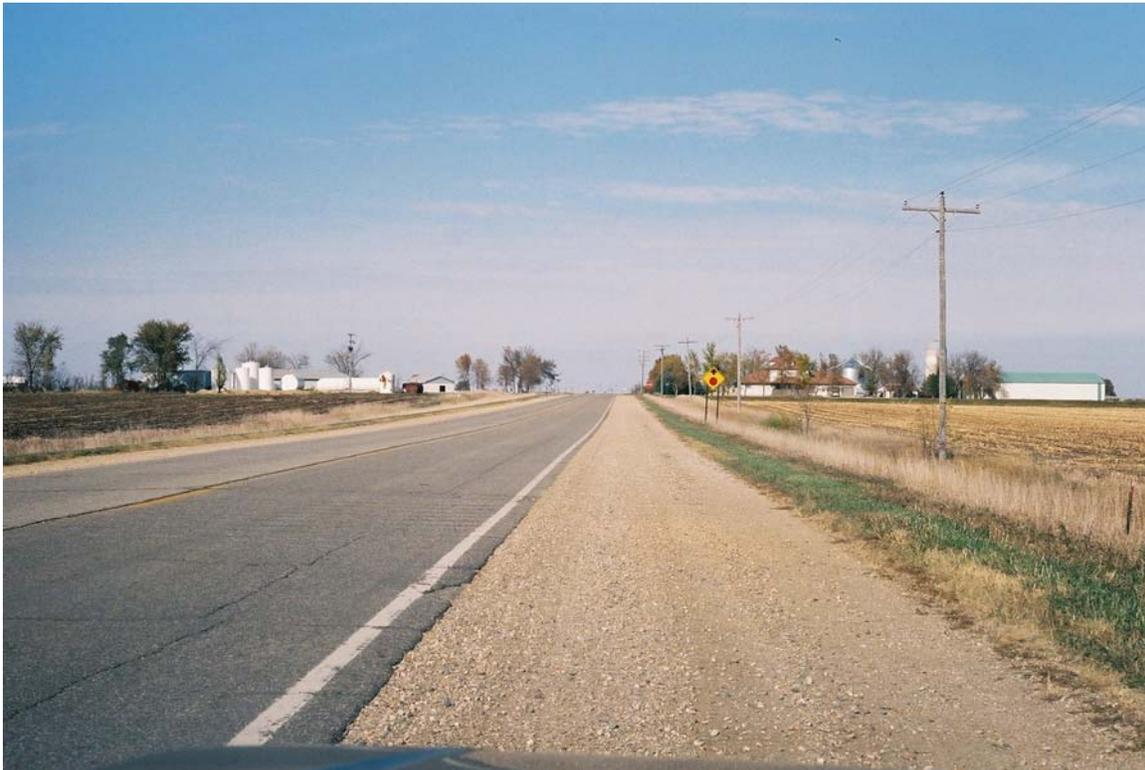
Photograph #143 (Reel #7, 14A) (from South, looking North): first rumble strip and warning sign in view.

On South Side (looking North): to East—clear view of traffic on major road (in front of buildings); to West—buildings obscure traffic on major road.

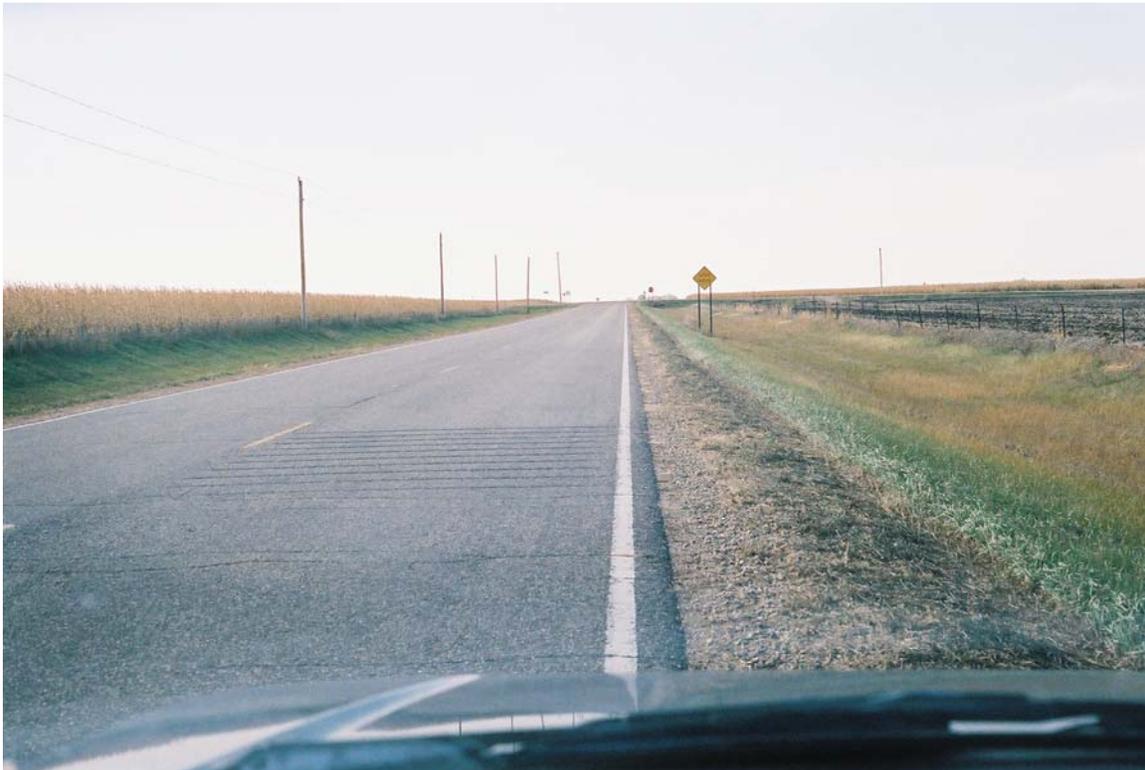
Photograph #145 (Reel #7, 16A) (from East, looking West): first rumble strip and warning sign in view.

On East Side (looking West): to North—clear view of traffic on major road; to South—vertical curve and corn obscure traffic on major road.

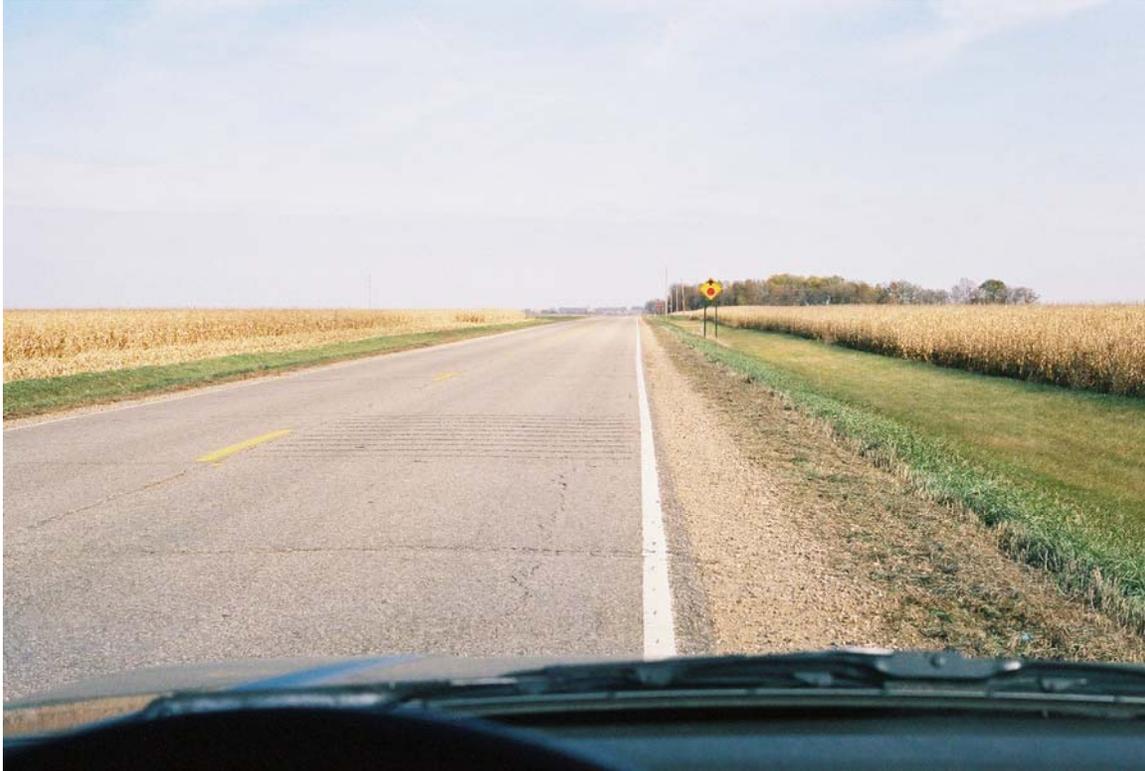
Photograph #147 (Reel #7, 18A) (from West, looking East): first rumble strip and warning sign in view.

On West Side (looking East): to both sides—corn obscures traffic on major road.

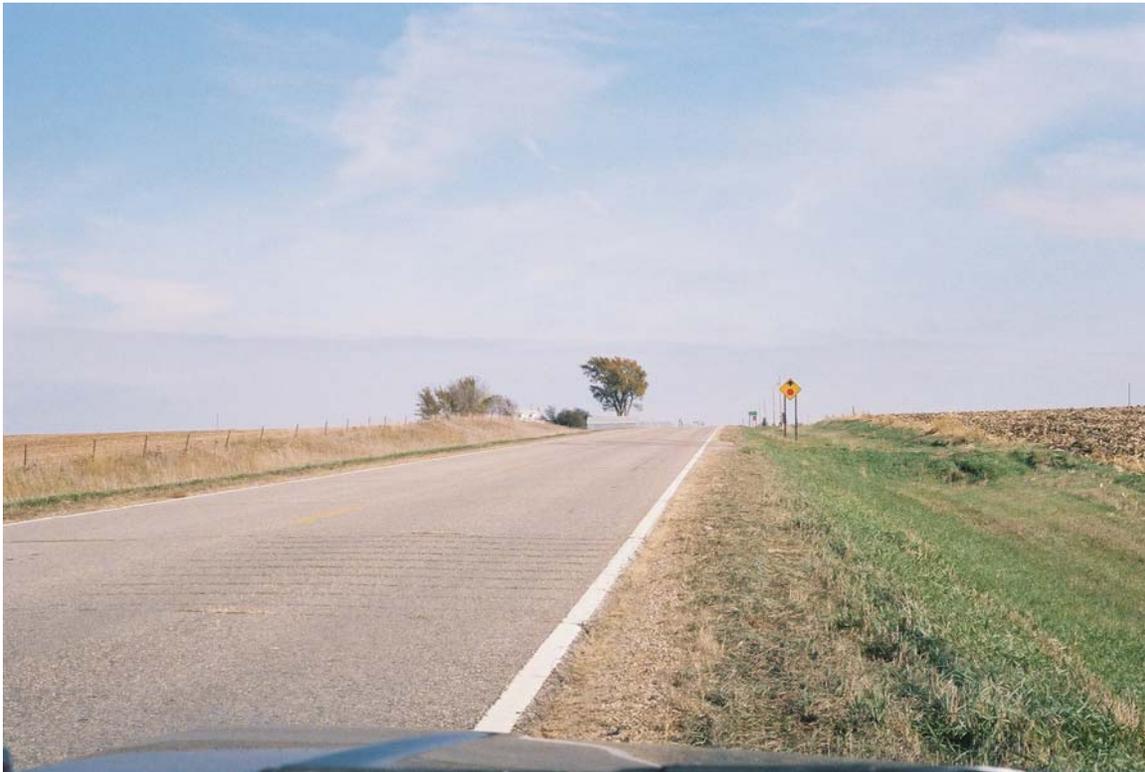
Photograph #149 (Reel #7, 20A) (from West, looking East): first rumble strip and warning sign in view.

On West Side (looking East): on both sides—vertical curve obscures traffic on major road.

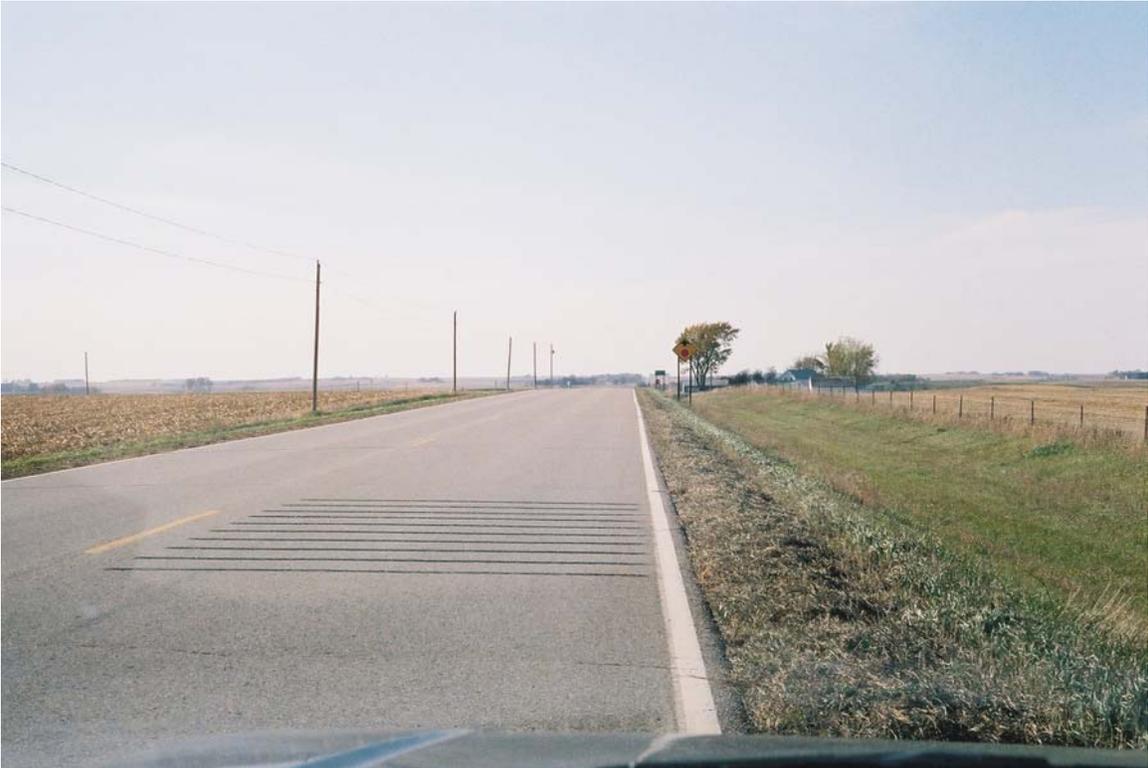
On East Side (looking West): on both sides—reasonably clear view of traffic on major road (road is in front of buildings on North side).

Photograph #151 (Reel #7, 22A) (from East, looking West): first rumble strip and warning sign in view.

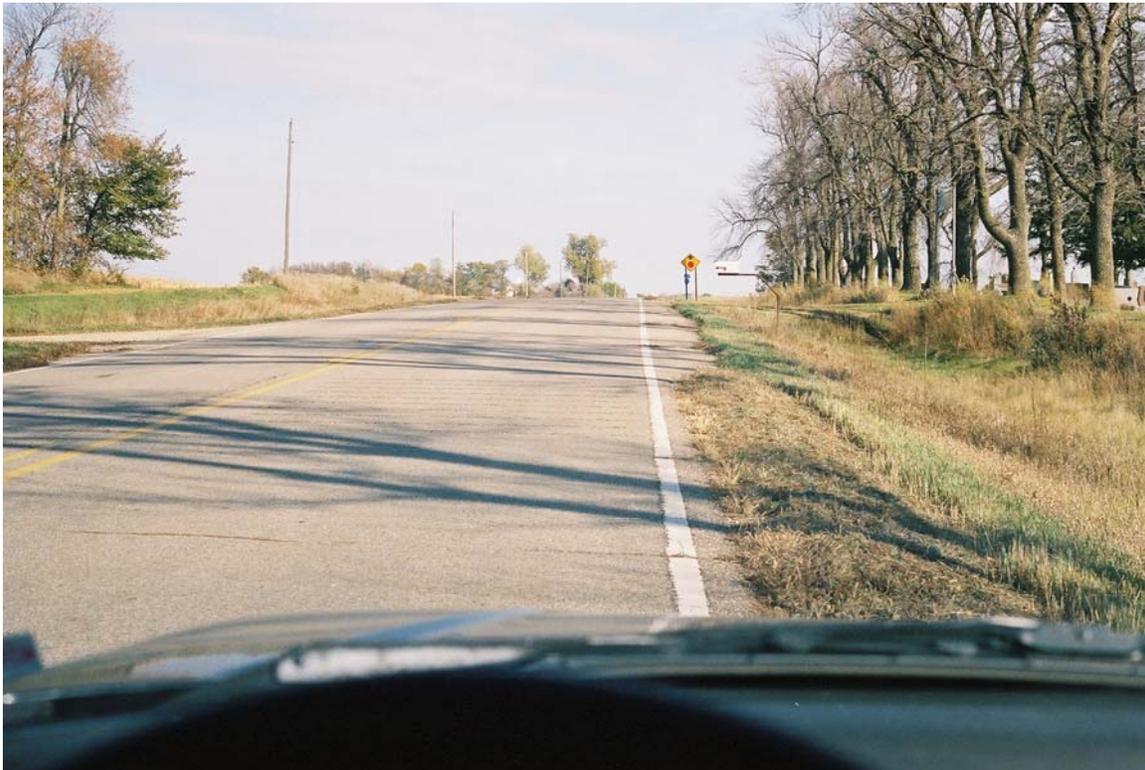
On West Side (looking East): rise obscures intersection; on both sides—rise obscures traffic on major road.

Photograph #153 (Reel #7, 24A) (from West, looking East): first rumble strip and warning sign in view.

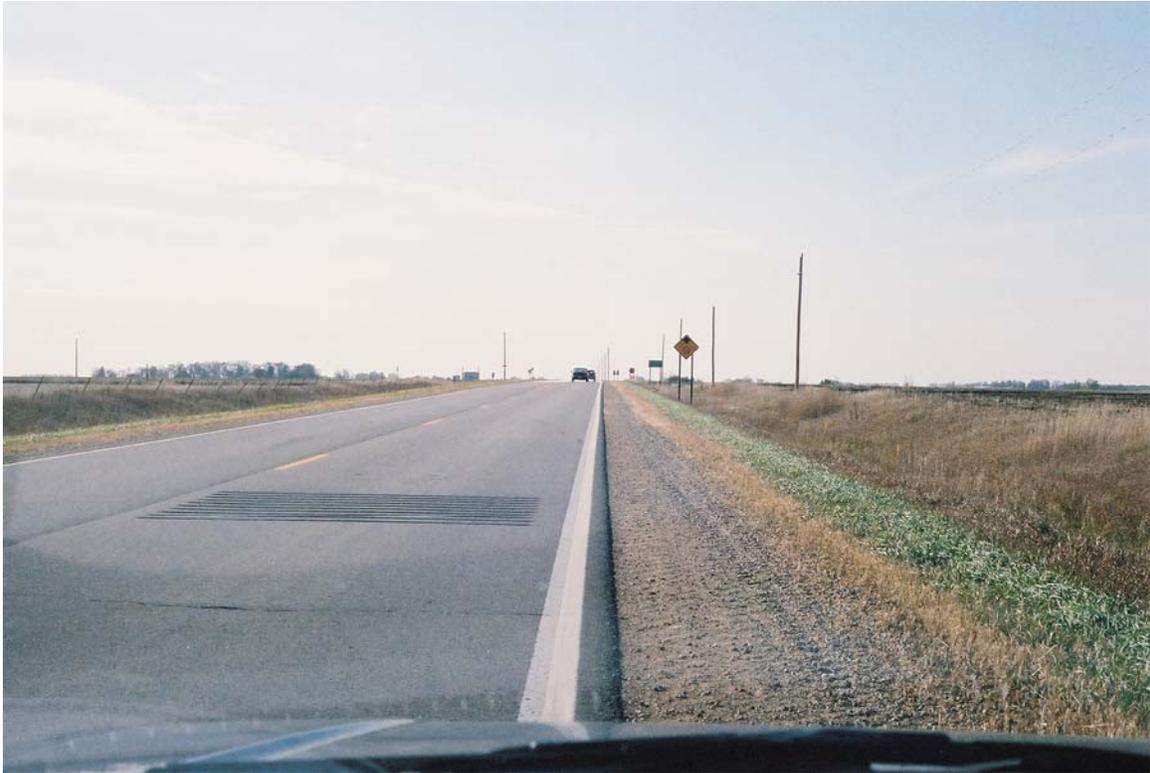
On East Side (looking West): on both sides—clear view of traffic on major road.

Photograph #155 (Reel #8, 2) (from East, looking West): first rumble strip and warning sign in view.

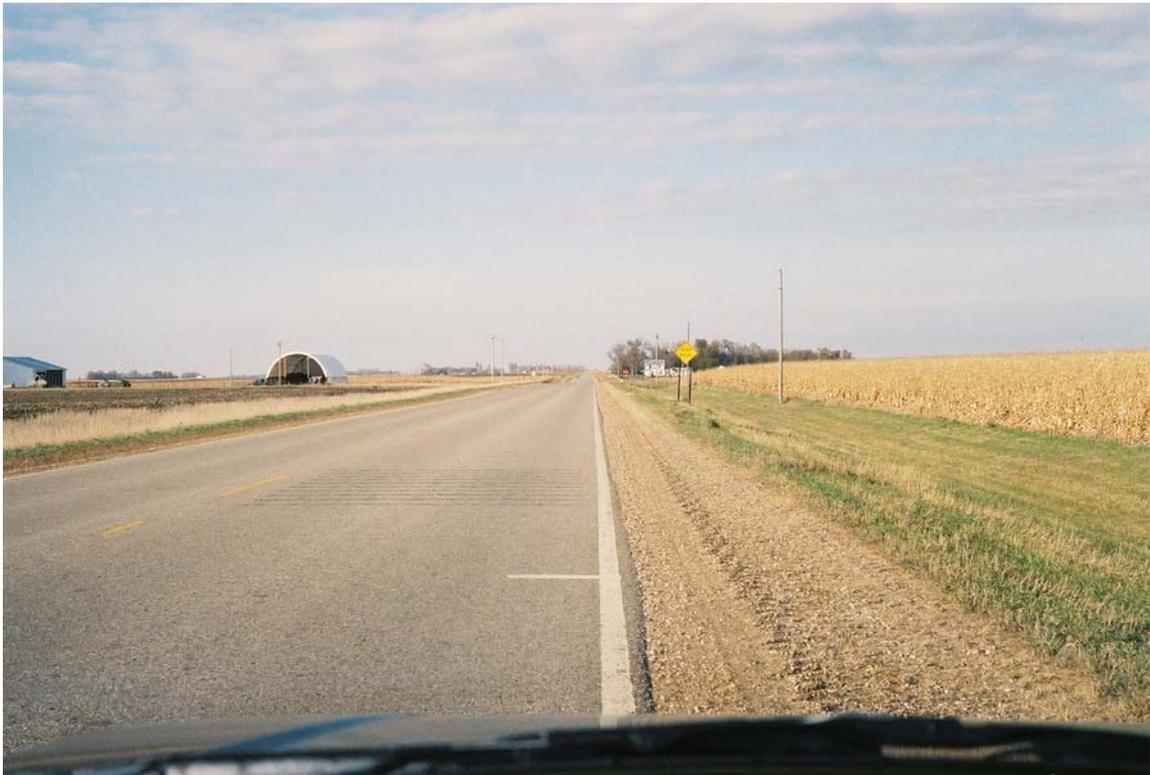
On South Side (looking North): to East—corn obscures traffic on major road; to West—buildings and corn obscure traffic on major road.

Photograph #157 (Reel #8, 4) (from South, looking North): first rumble strip and warning sign in view.

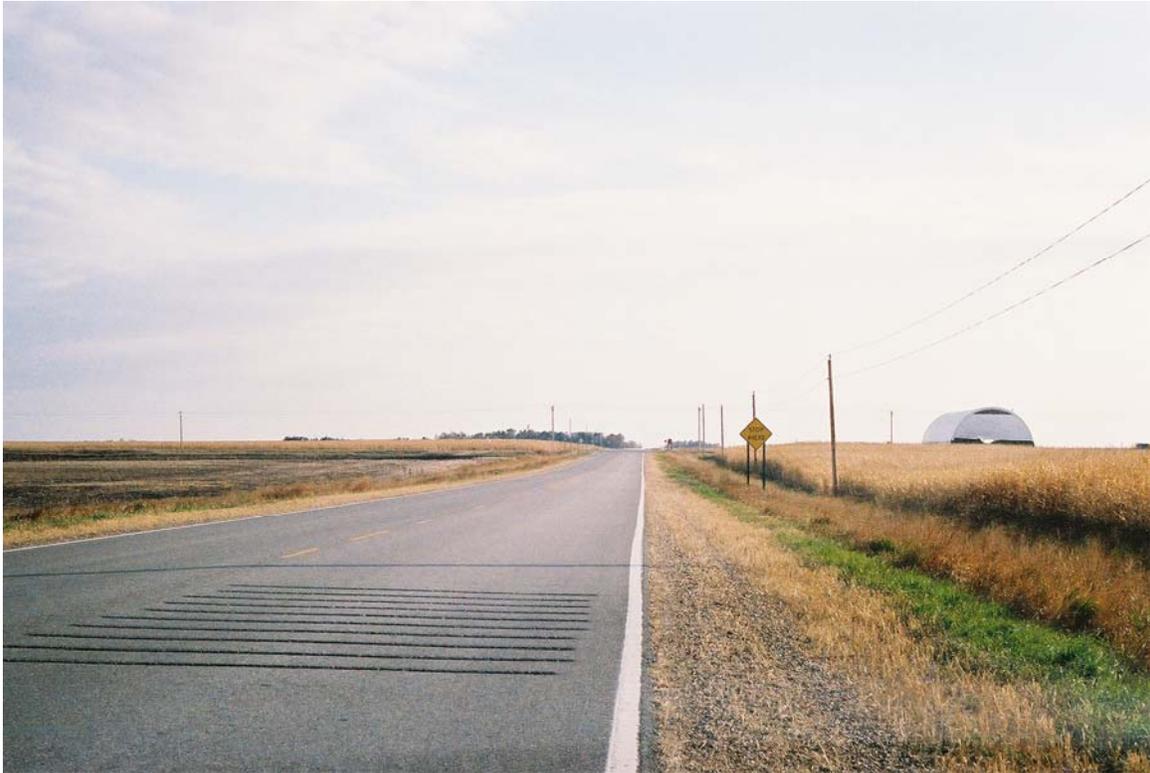
On North Side (looking South): on both sides—corn obscures traffic on major road.

Photograph #159 (Reel #8, 6) (from North, looking South): first rumble strip and warning sign in view.

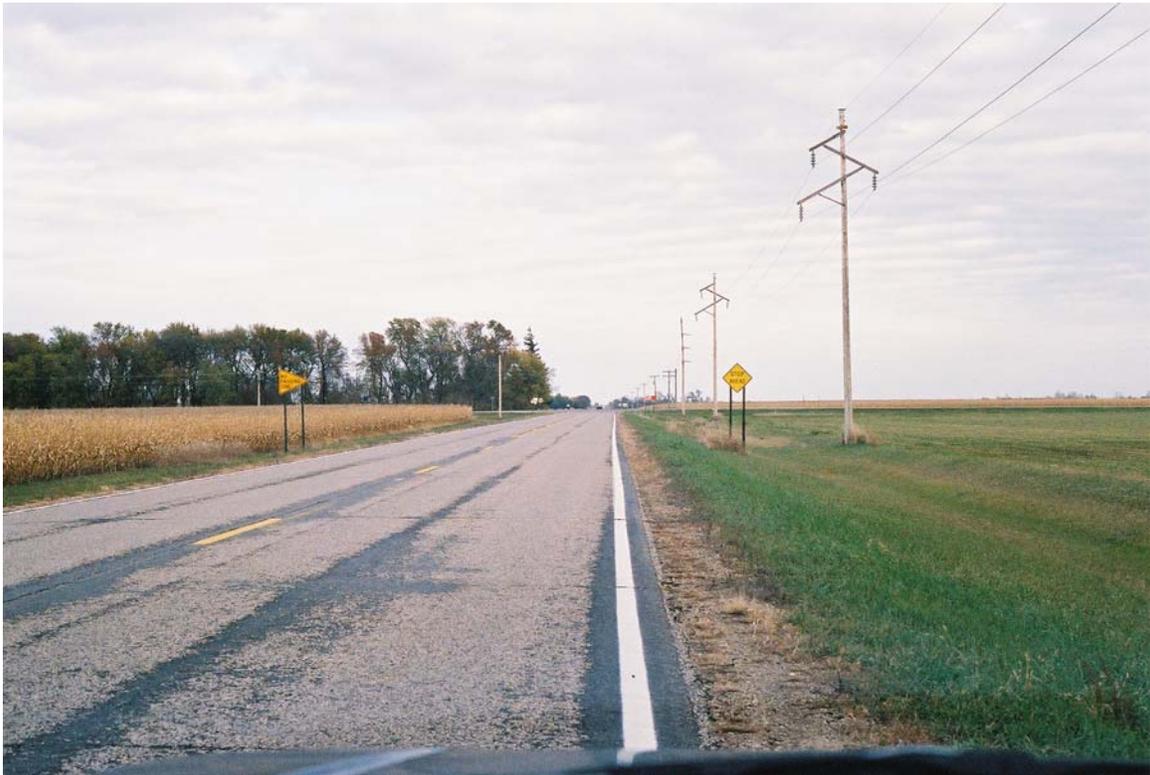
On West Side (looking East): on South—clear view of traffic on major road.; on North—
corn obscures traffic on major road.

Photograph #161 (Reel #8,) (from West, looking East): from approximately where first rumble strip would be; warning sign in view.
