2006-42

Final Report

Stopping Behavior at Real-World
Stop-Controlled Intersections
with and without In-Lane Rumble Strips

**Center for Human Factors Systems Research and Design
University of Minnesota**

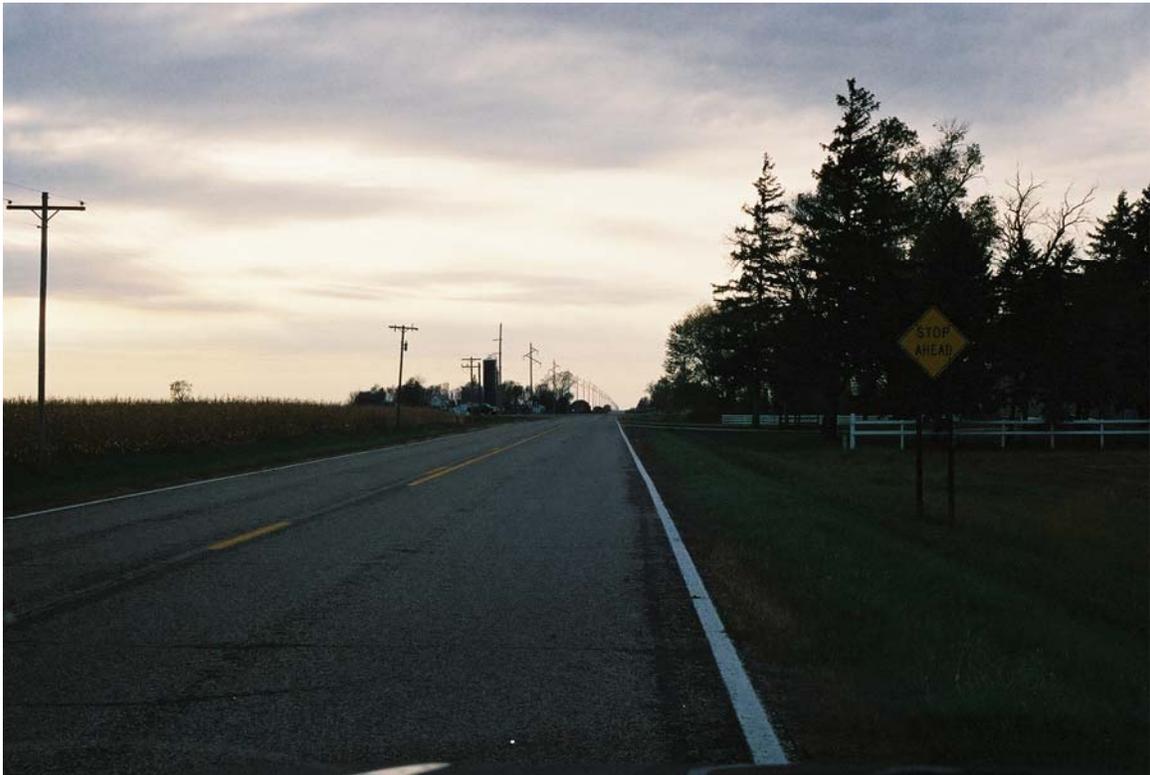
On East Side (looking West): to North—trees obscure traffic on major road; to South—
corn obscures traffic on major road.

Photograph #162 (Reel #8,) (from East, looking West): from approximately where first rumble strip would be; warning sign in view.

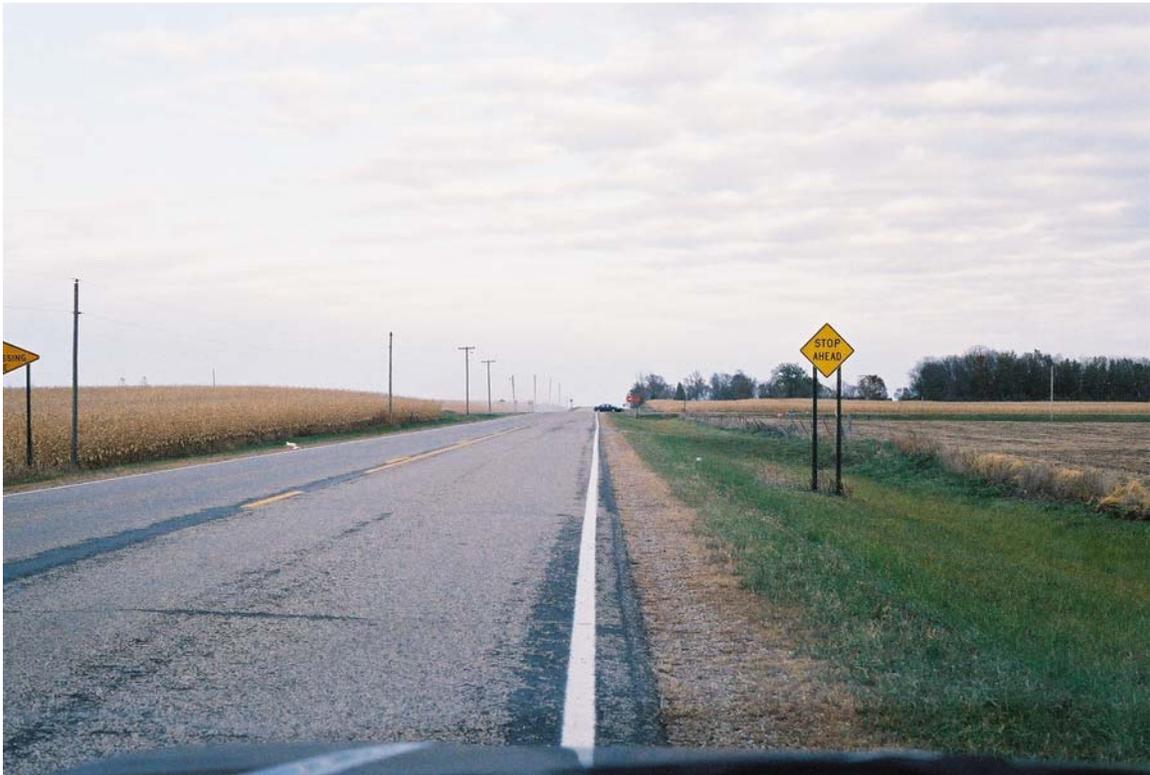
On West Side (looking East): to South—clear view of traffic on major road; to North
corn obscures traffic on major road.

Photograph #163 (Reel #8, 11) (from West, looking East): from approximately where first rumble strip would be; warning sign in view.

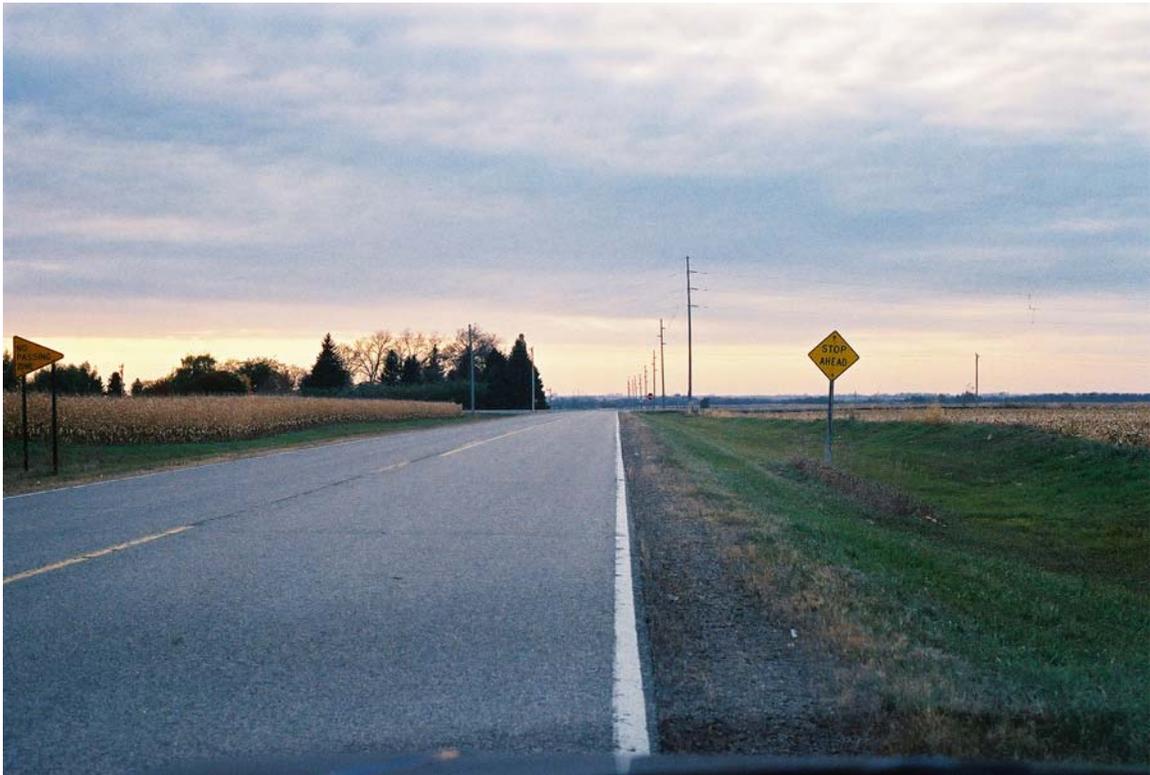
On East Side (looking West): to South—corn obscures traffic on major road; to North—
clear view of traffic on major road.

Photograph #165 (Reel #8, 12) (from East, looking West): from approximately where first rumble strip would be; warning sign in view.

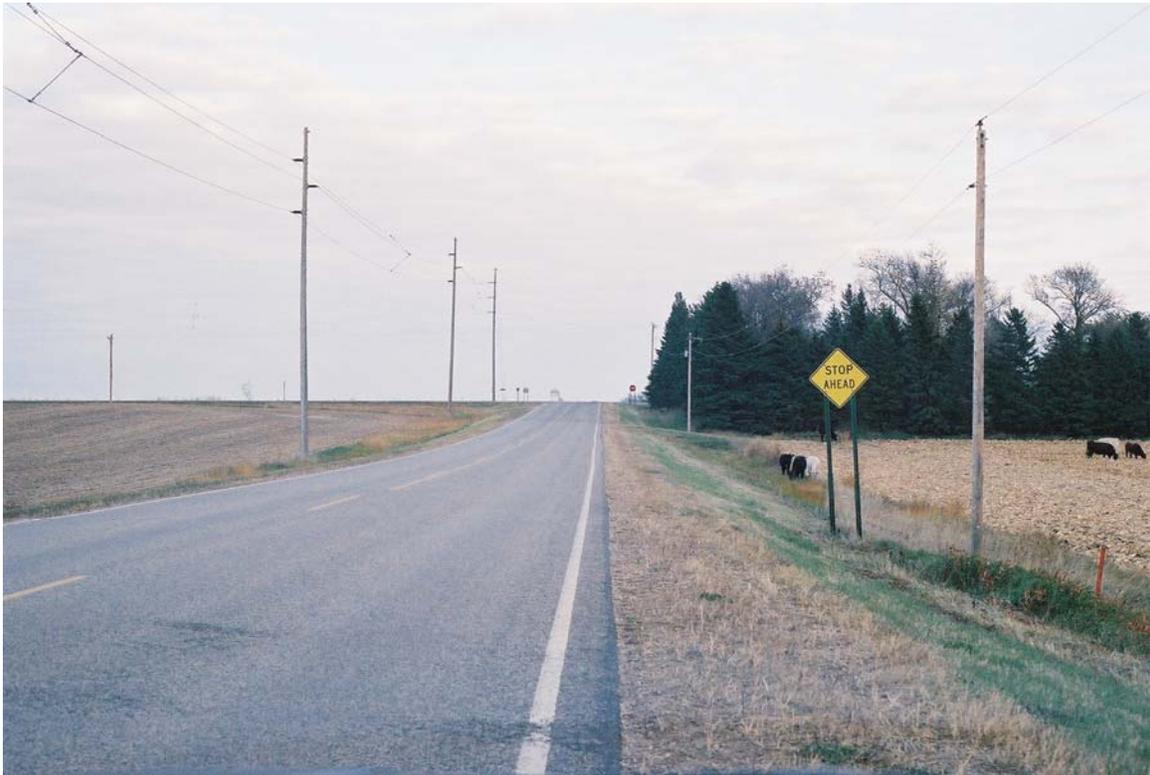
On West Side (looking East): to South—trees obscures traffic on major road; to North—clear view of traffic on major road.

Photograph #166 (Reel #8, 13) (from West, looking East): from approximately where first rumble strip would be; warning sign in view.

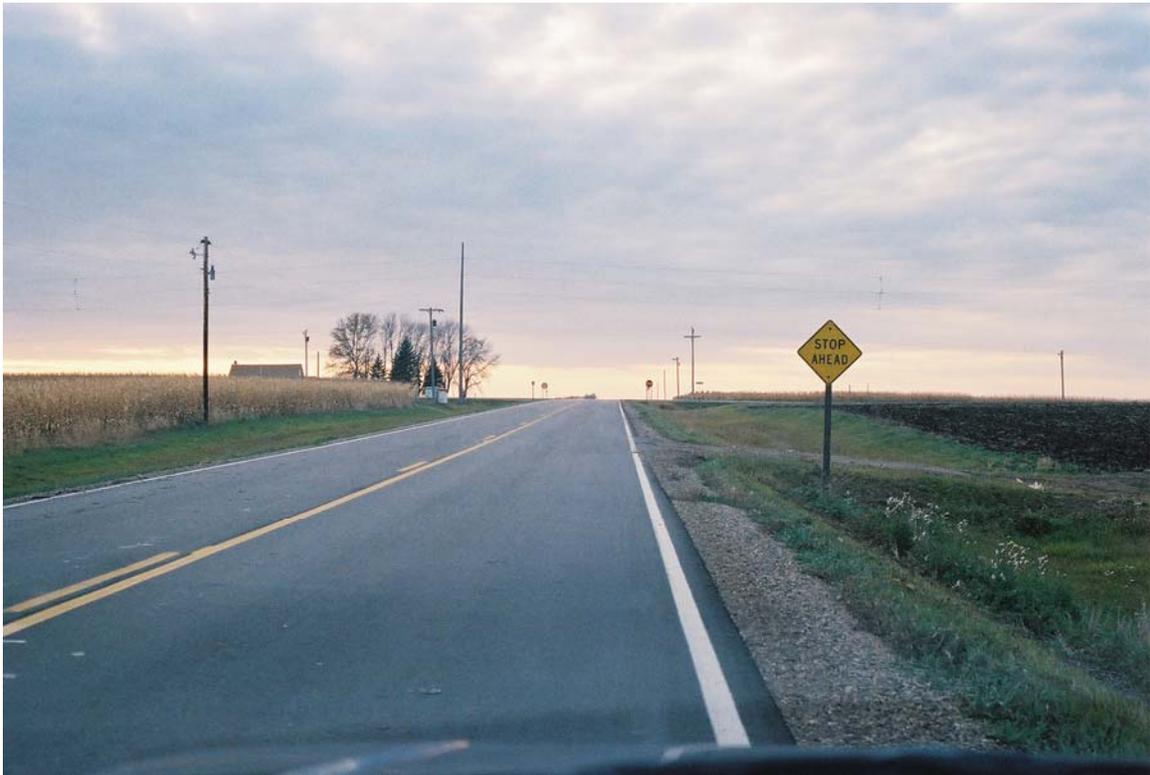
On East Side (looking West): to South—corn obscures traffic on major road; to North—clear view of traffic on major road.

Photograph #167 (Reel #8, 14) (from East, looking West): from approximately where first rumble strip would be; warning sign in view.

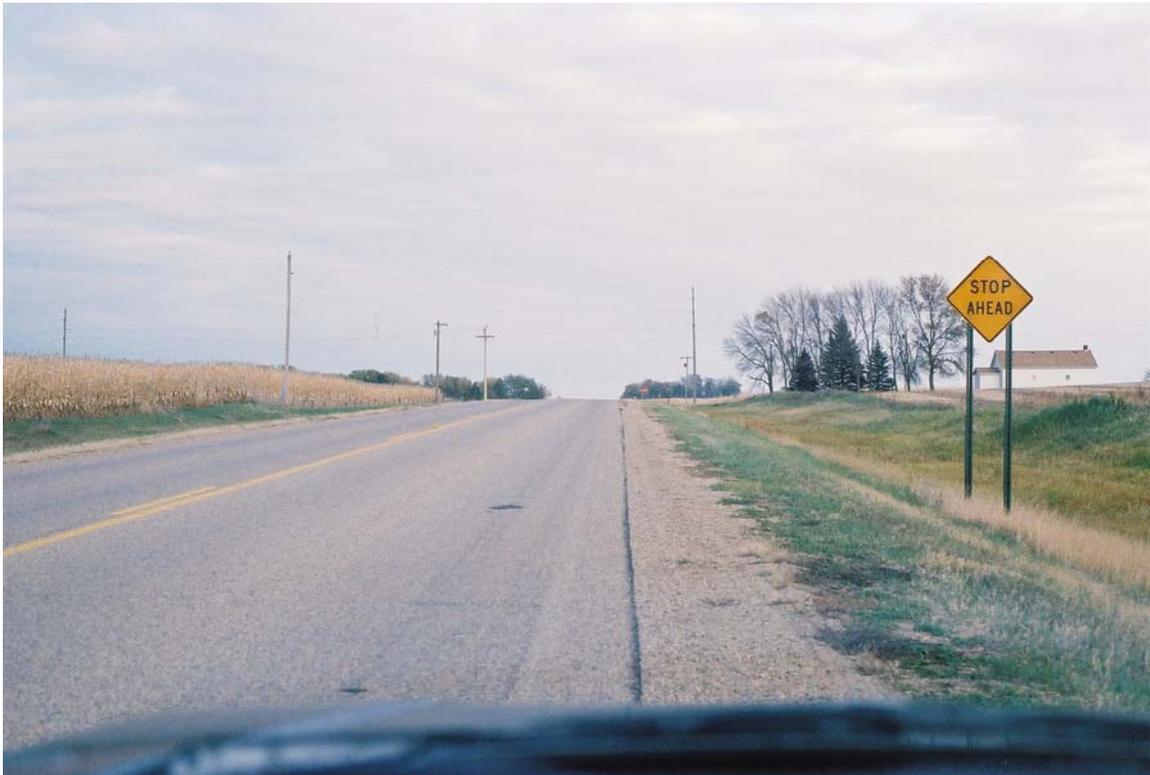
On West Side (looking East): to South—trees, buildings and rise obscure traffic on major road; to North—corn and rise obscure traffic on major road.

Photograph #168 (Reel #8, 15) (from West, looking East): from approximately where first rumble strip would be; warning sign in view.

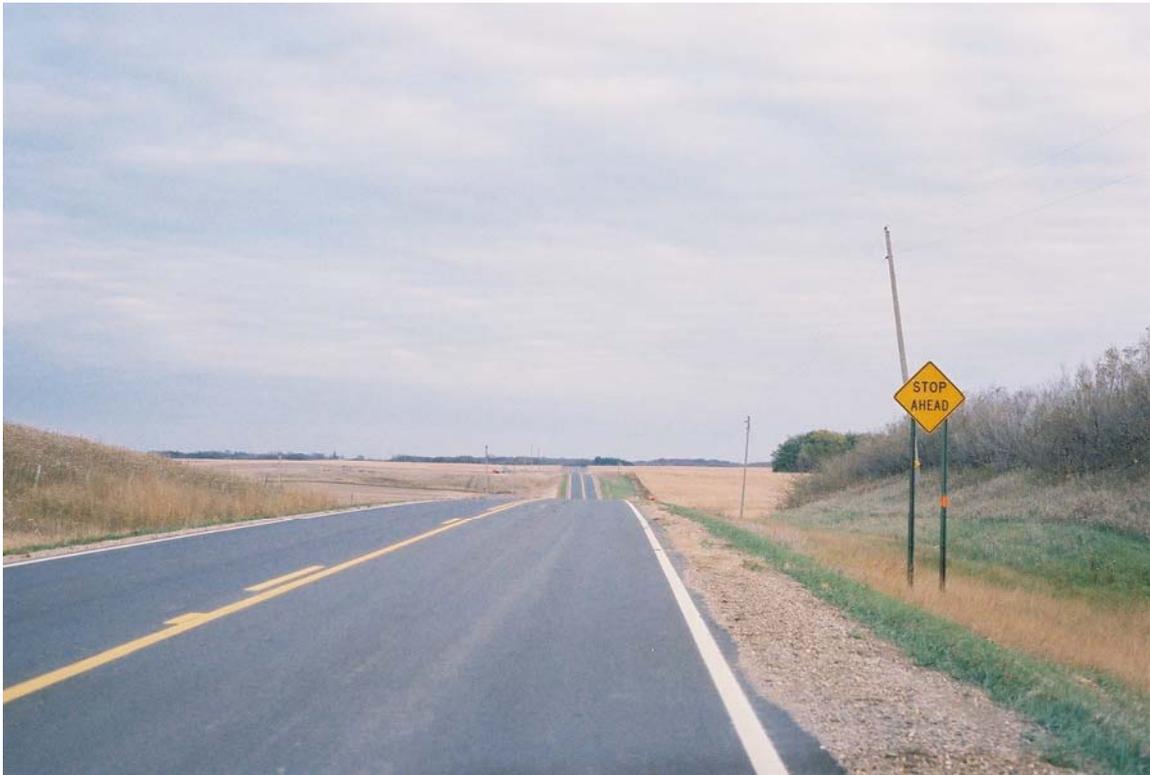
On West Side (looking East): rise obscures intersection; on both sides—rise obscures traffic on major road.

Photograph #169 (Reel #8, 16) (from West, looking East): from approximately where first rumble strip would be; warning sign in view.

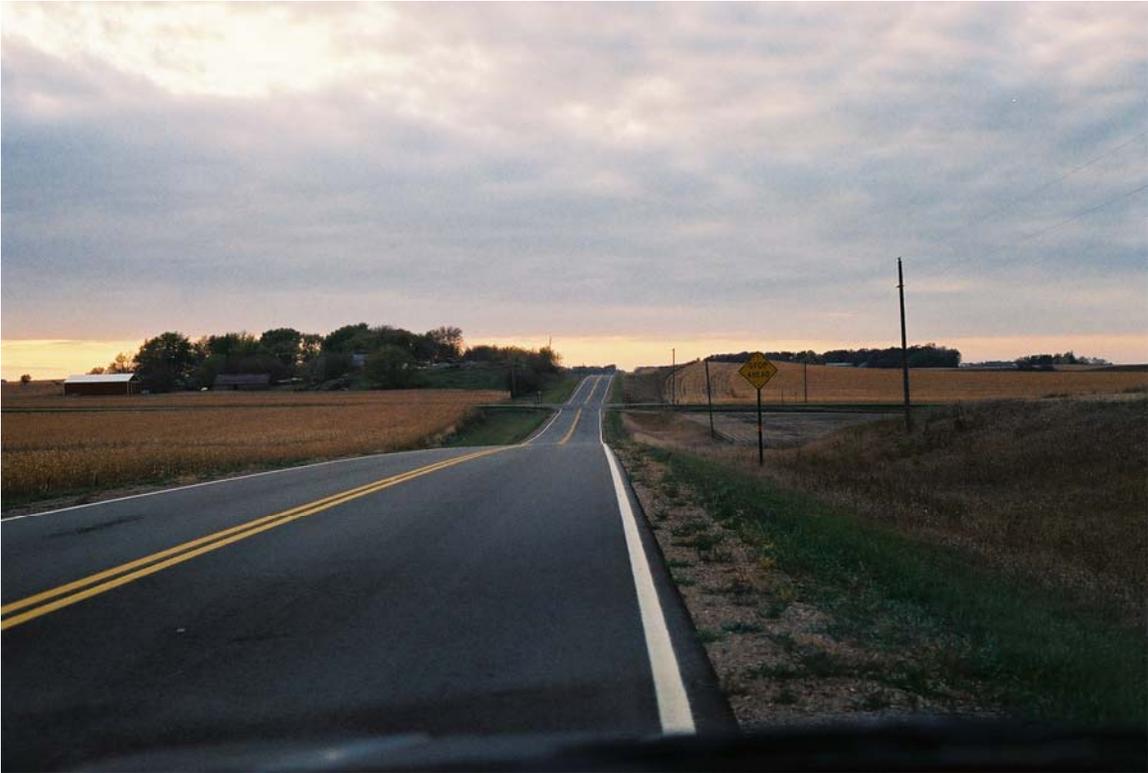
On East Side (looking West): on both sides—clear view of traffic on major road.

Photograph #171 (Reel #8, 18) (from East, looking West): from approximately where first rumble strip would be; warning sign in view.

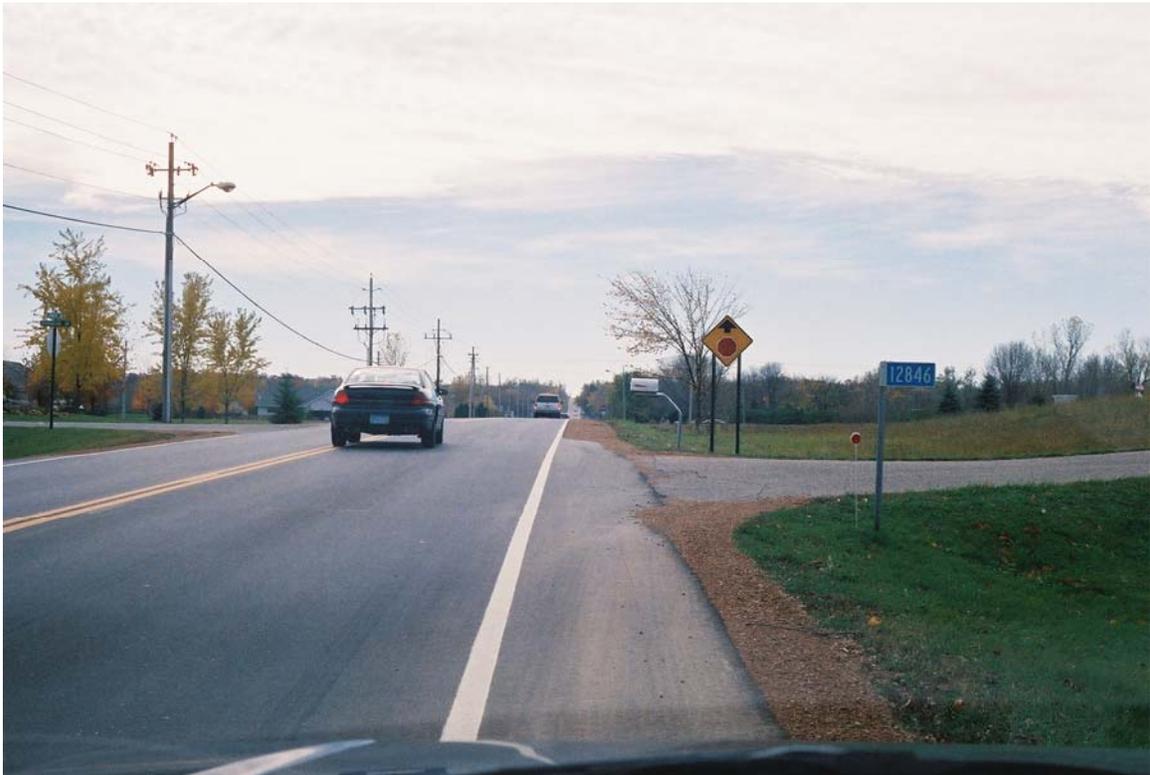
On North Side (looking South): rise obscures intersection; on both sides—rise obscure traffic on major road.

Photograph #172 (Reel #8, 19) (from North, looking South): from approximately where first rumble strip would be; warning sign in view.

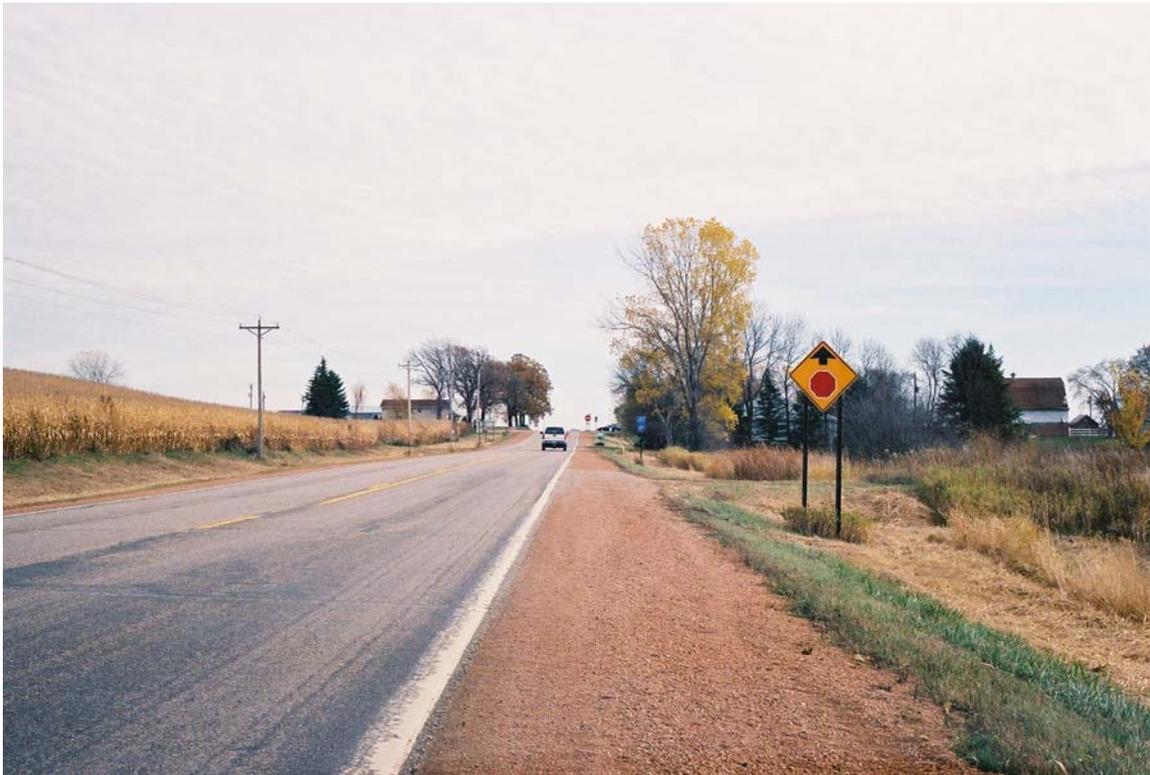
On West Side (looking East): to North—rise, corn, and building obscure traffic on major road; to South—trees and building obscure traffic on major road.

Photograph #174 (Reel #8, 21) (from West, looking East): from approximately where first rumble strip would be; warning sign in view.

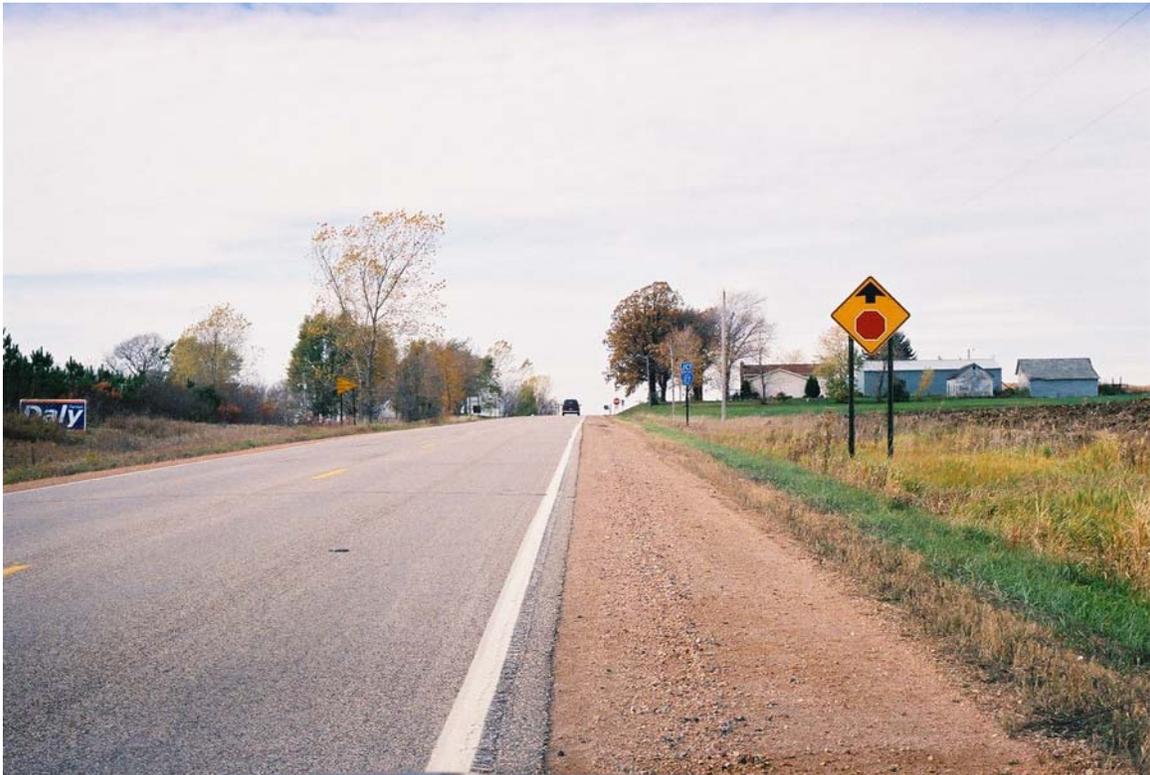
On East Side (looking West): to South—trees obscure traffic on major road; to North—
rise and buildings obscure traffic on major road.

Photograph #176 (Reel #8, 23) (from East, looking West): from approximately where
first rumble strip would be; warning sign in view.

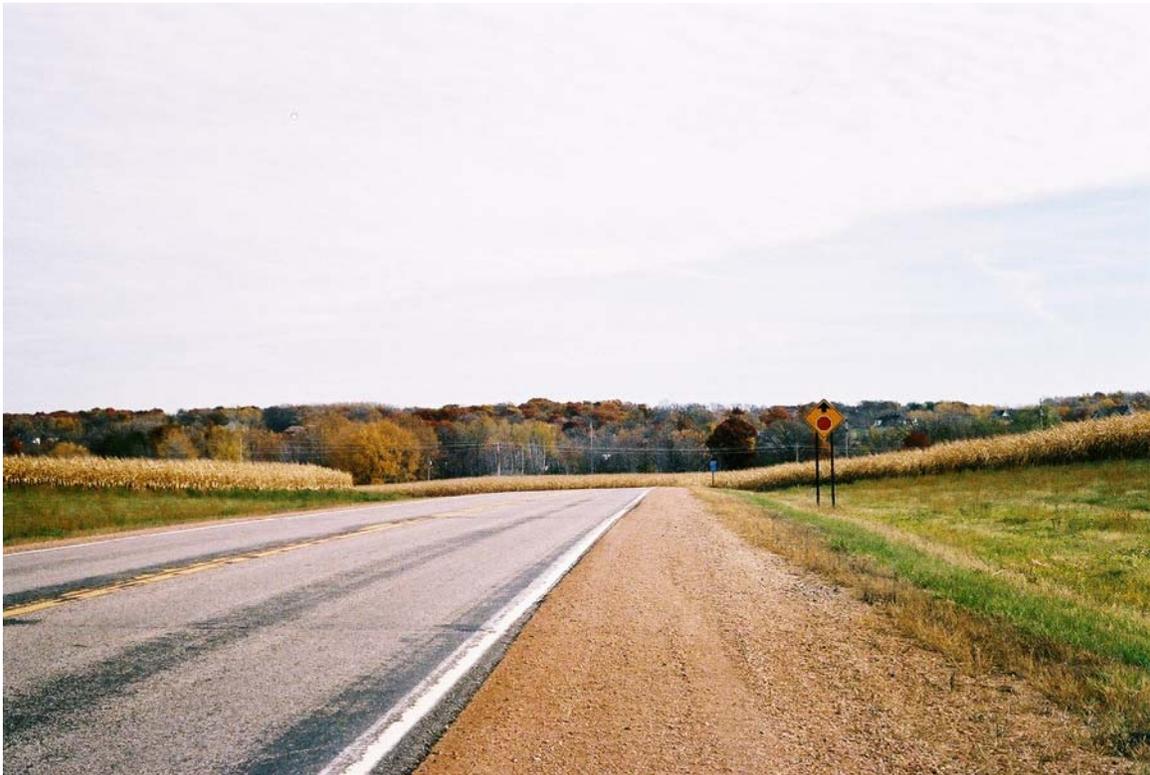
On South Side (looking North): curve and corn obscure intersection; on both sides—corn obscures traffic on major road.

Photograph #178 (Reel #9, 1) (from South, looking North): from approximately where first rumble strip would be; warning sign in view.

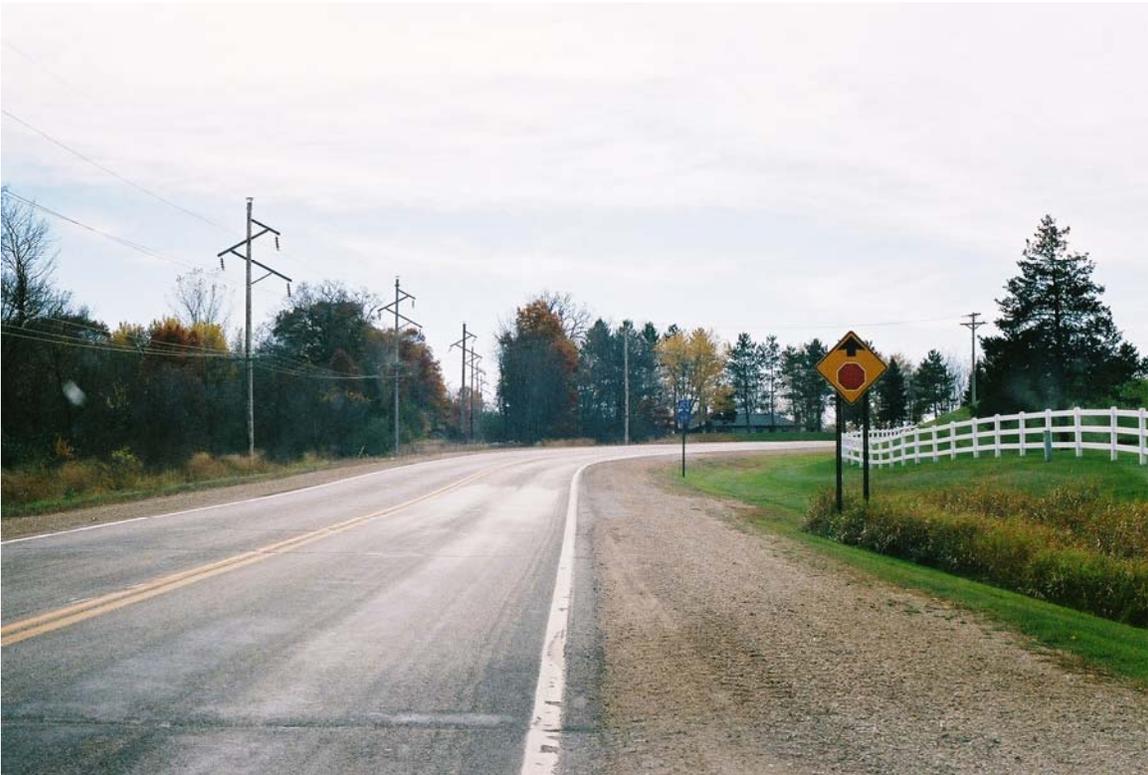
On North Side (looking South): curve, trees, and rise obscure intersection; to West—rise and trees obscure traffic on major road; to East—trees obscure traffic on major road.

Photograph #180 (Reel #9, 3) (from North, looking South): from approximately where first rumble strip would be; warning sign in view.

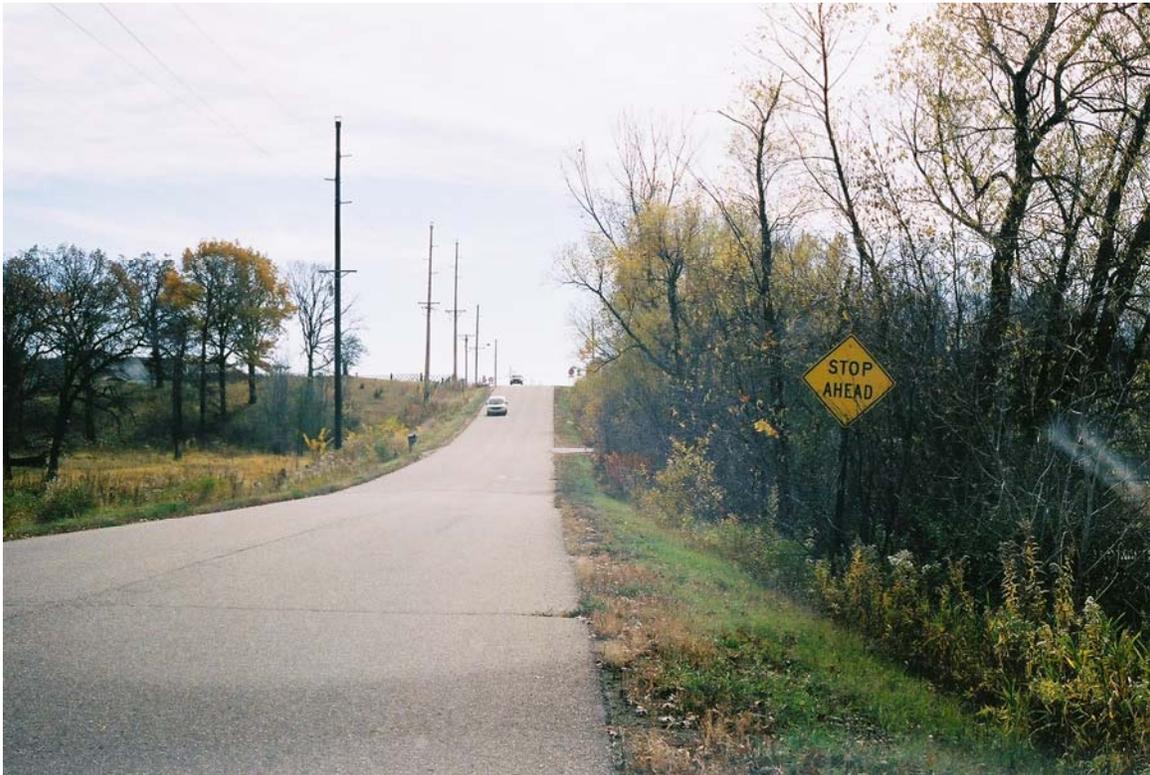
On North Side (looking South): to East—trees and buildings partially obscure traffic on major road; to West—trees obscure traffic on major road.

Photograph #182 (Reel #9, 5) (from North, looking South): from approximately where first rumble strip would be; warning sign in view.

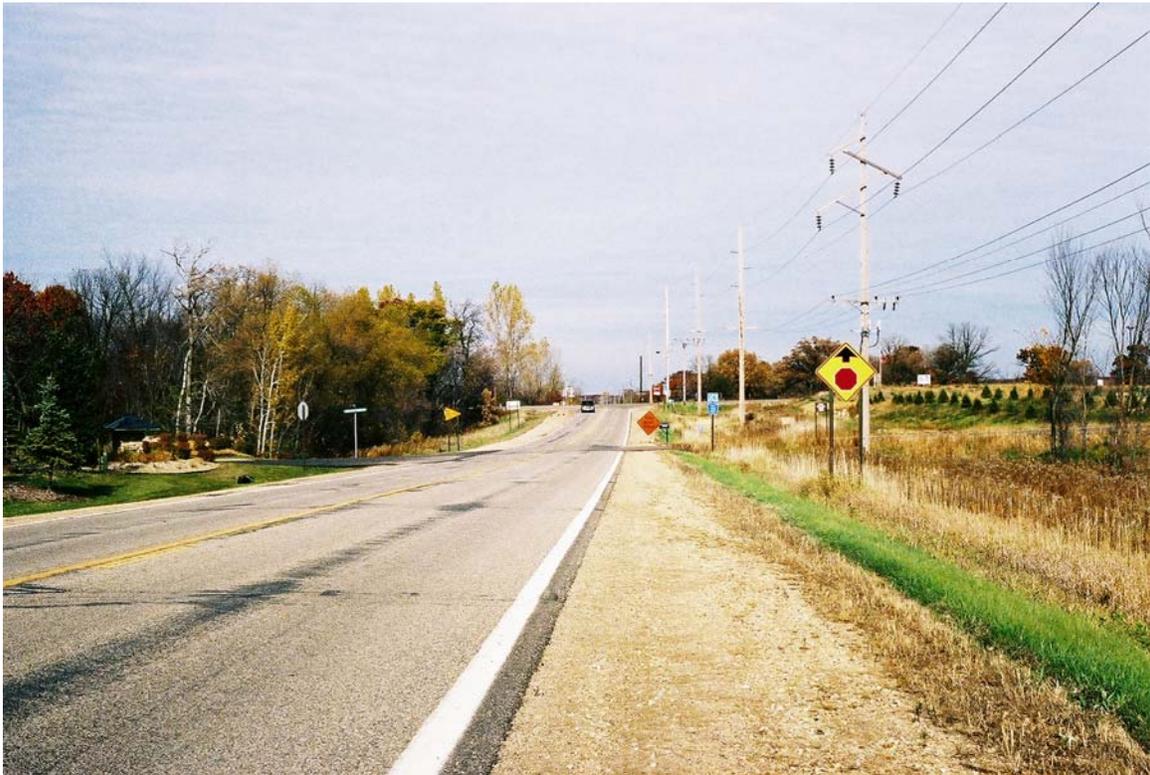
On South Side (looking North): to West—trees obscure traffic on major road; to East—close in to intersection, traffic on major road visible, while further away rise obscures traffic.

Photograph #183 (Reel #9, 6) (from South, looking North): from approximately where first rumble strip would be; warning sign in view.

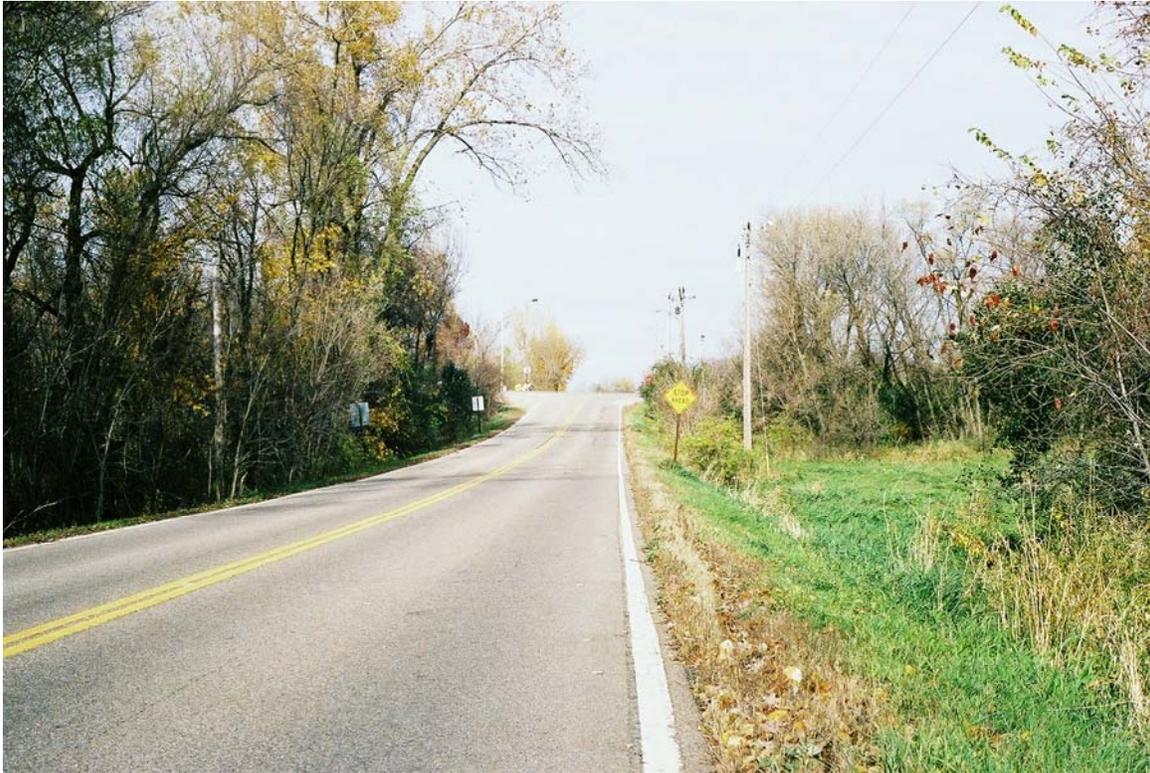
On South Side (looking North): on both sides—trees obscure traffic on major road.

Photograph #184 (Reel #9, 7) (from South, looking North): from approximately where first rumble strip would be; warning sign in view.

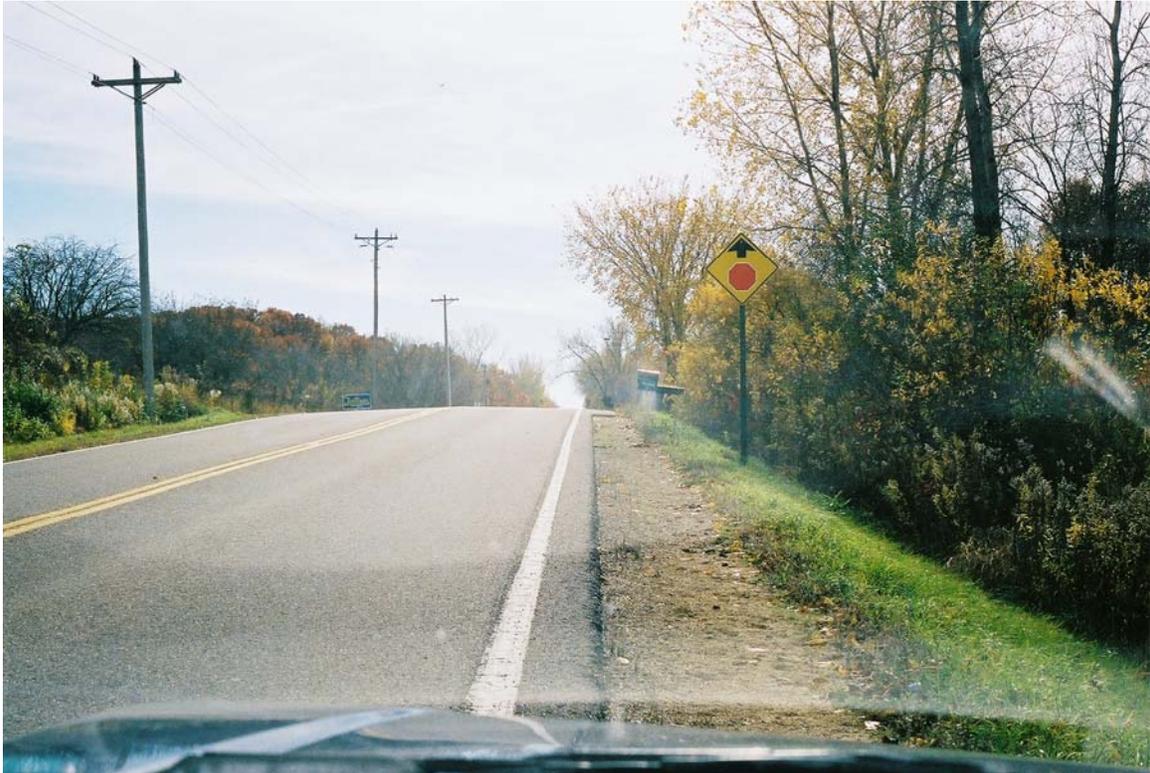
On North Side (looking South): rise obscures intersection; on both sides—hill and trees
obscure traffic on major road.

Photograph #185 (Reel #9, 8) (from North, looking South): from approximately where first rumble strip would be; warning sign in view.

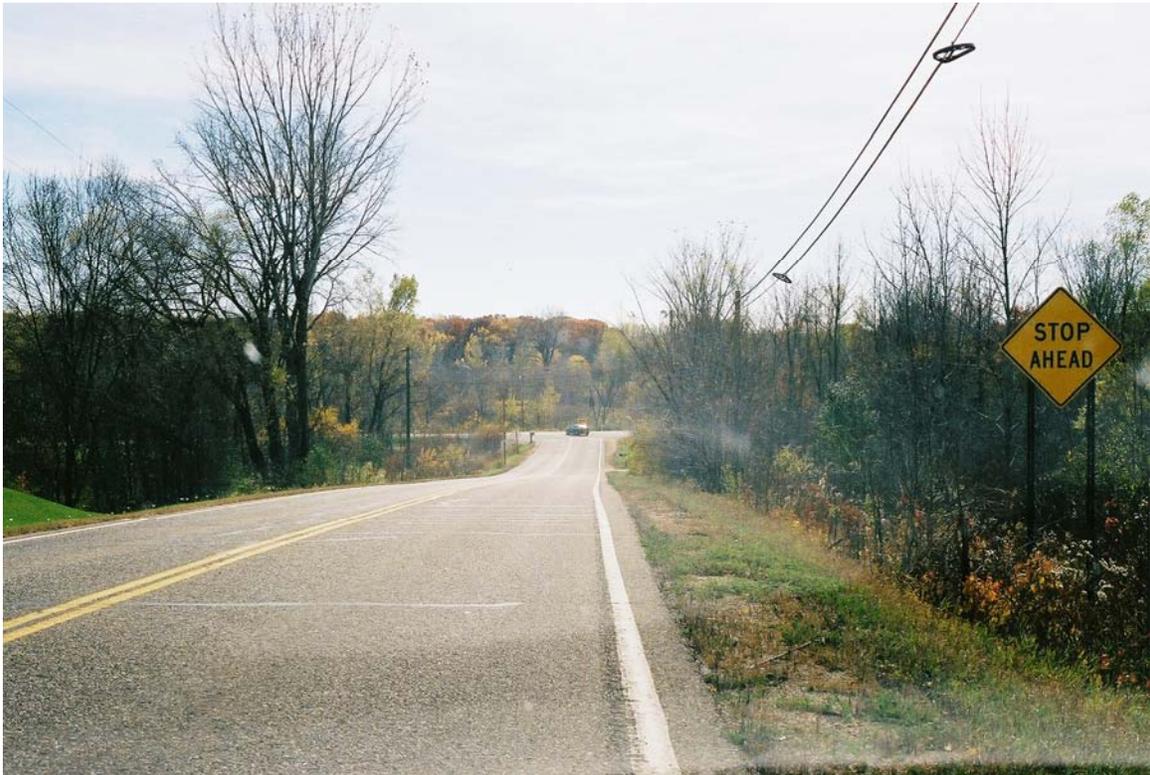
On North Side (looking South): on both sides—trees obscure traffic on major road.

Photograph #187 (Reel #9, 10) (from North, looking South): from approximately where first rumble strip would be; warning sign in view.

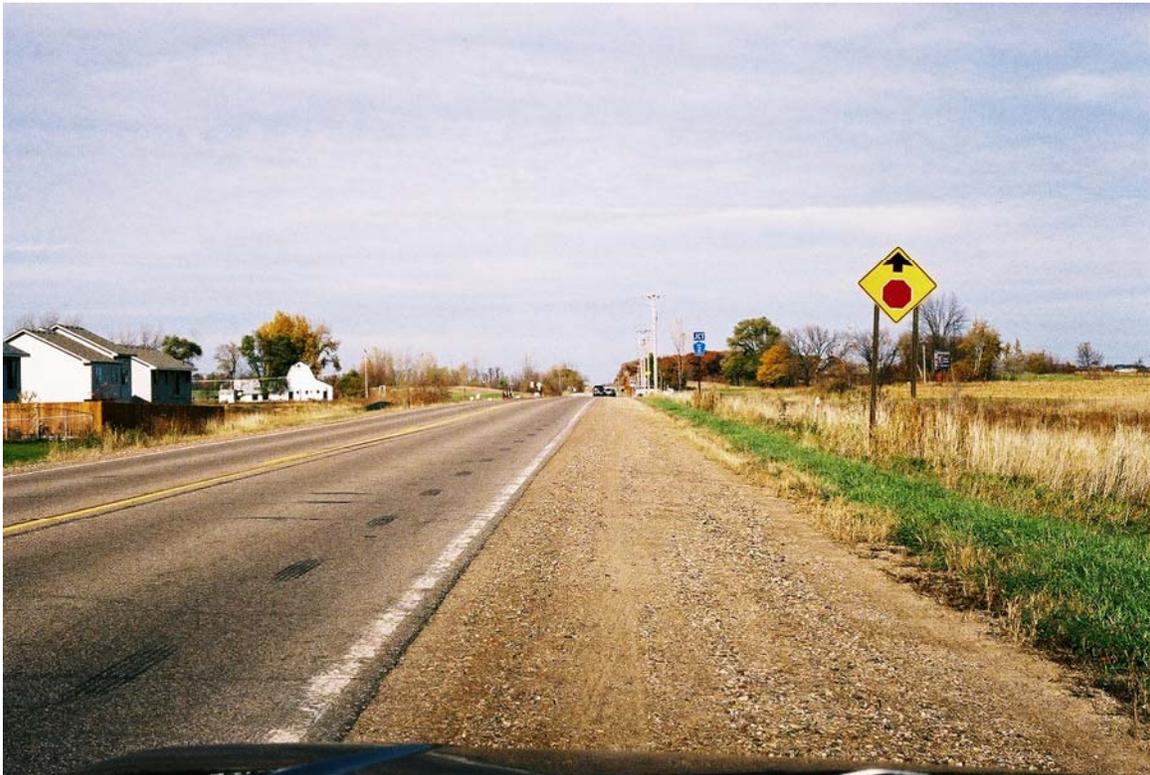
On South Side (looking North): to West—houses obscure traffic on major road; to East—tops of traffic on major road visible.

Photograph #188 (Reel #9, 11) (from South, looking North): from approximately where first rumble strip would be; warning sign in view.

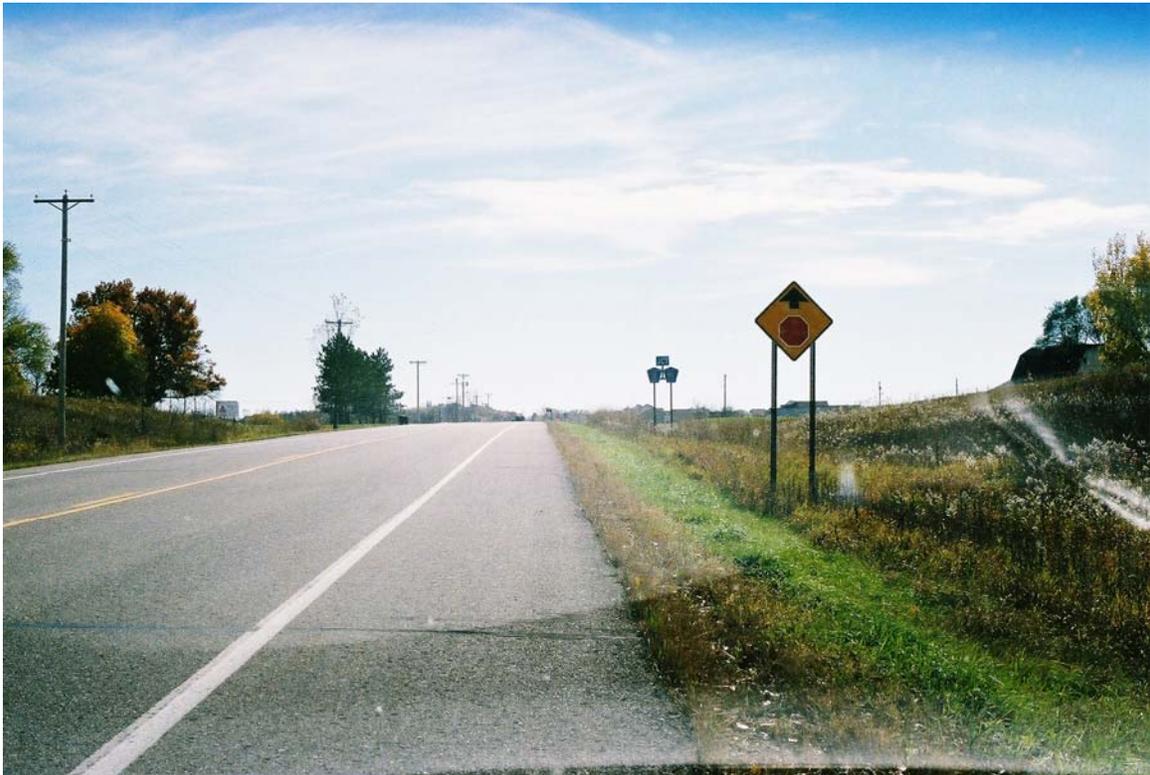
On North Side (looking South): rise partially obscures intersection; on both sides—rise and trees obscure traffic on major road.

Photograph #189 (Reel #9, 12) (from South, looking North): from approximately where first rumble strip would be; warning sign in view.

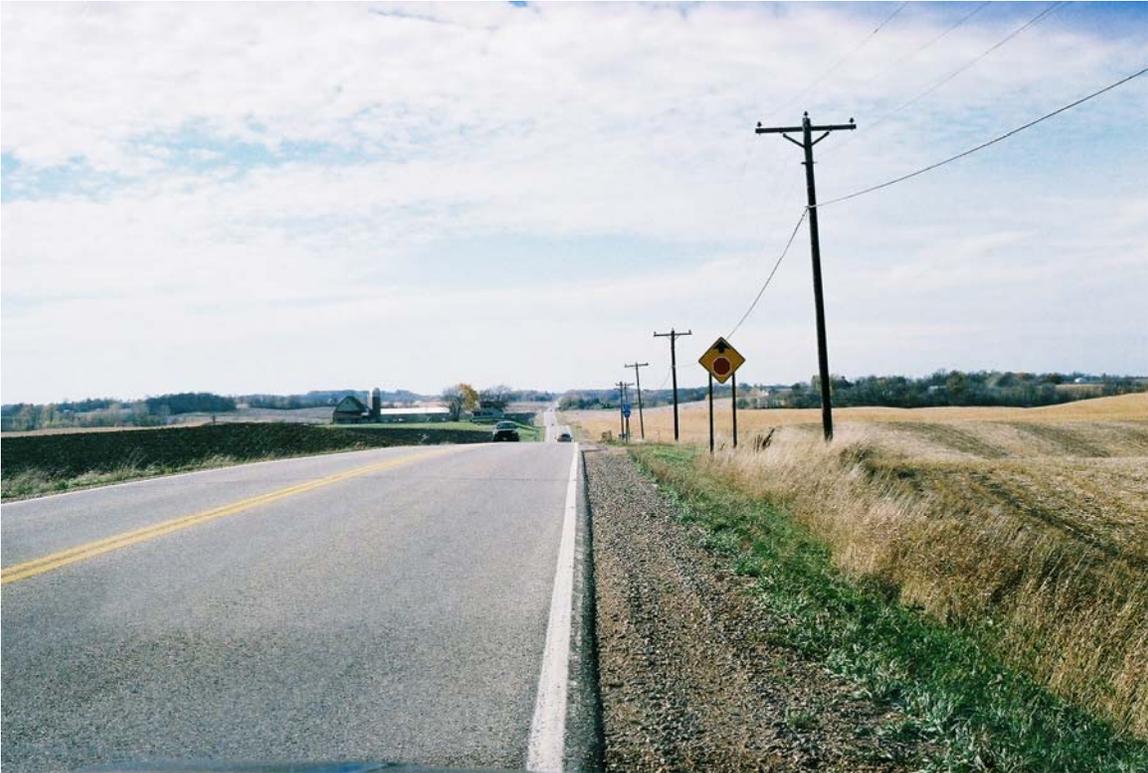
On East Side (looking West): on both sides—rise obscures traffic on cross road.

Photograph #191 (Reel #9, 14) (from East, looking West): from approximately where first rumble strip would be; warning sign in view.

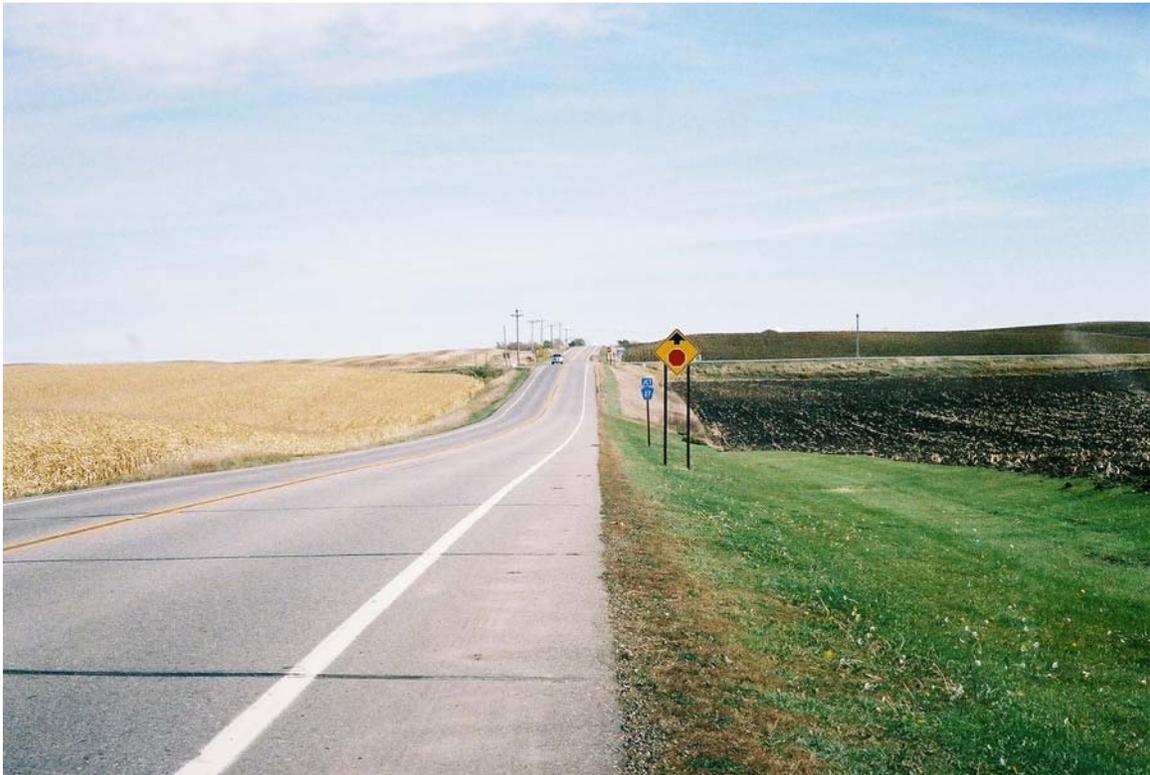
On West Side (looking East): to North—rise and corn obscures traffic on major road; to South—clear view of traffic on major road.

Photograph #192 (Reel #9, 15) (from West, looking East): from approximately where first rumble strip would be: warning sign in view.

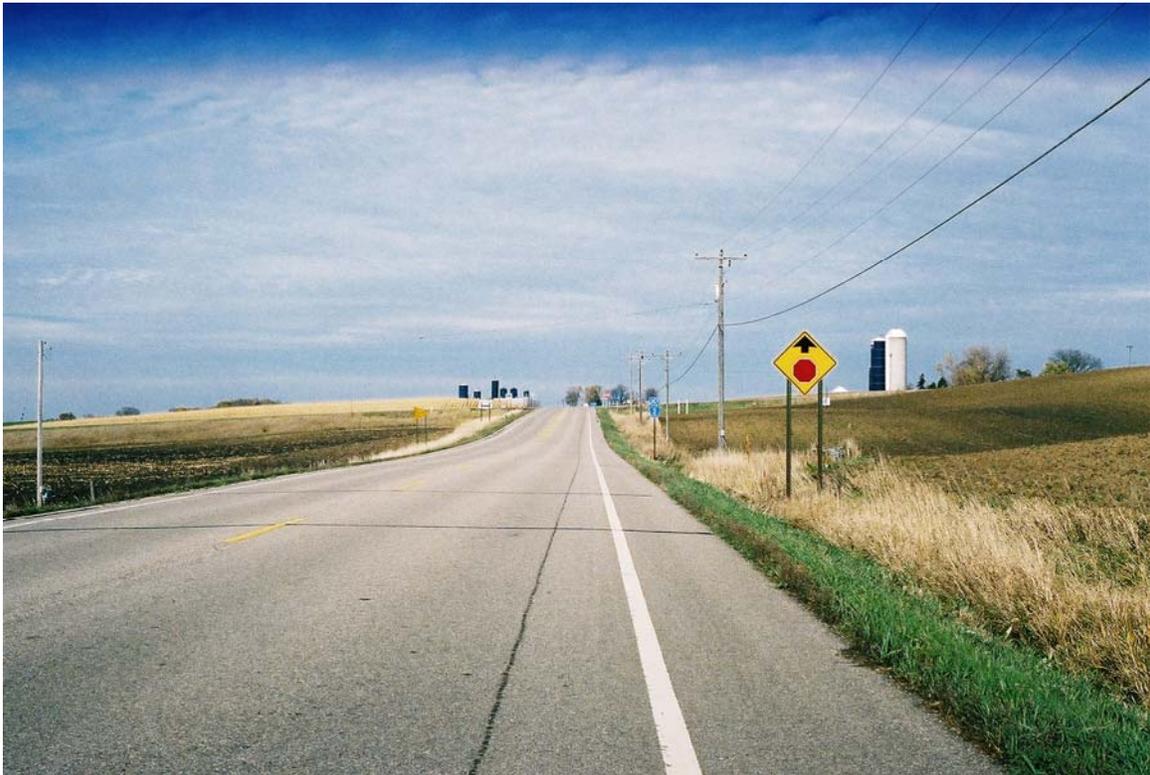
On South Side (looking North): to East—rise partially obscures traffic on major road; to West—clear view of traffic on major road.

Photograph #193 (Reel #9, 16) (from South, looking North): from approximately where first rumble strip would be: warning sign in view.

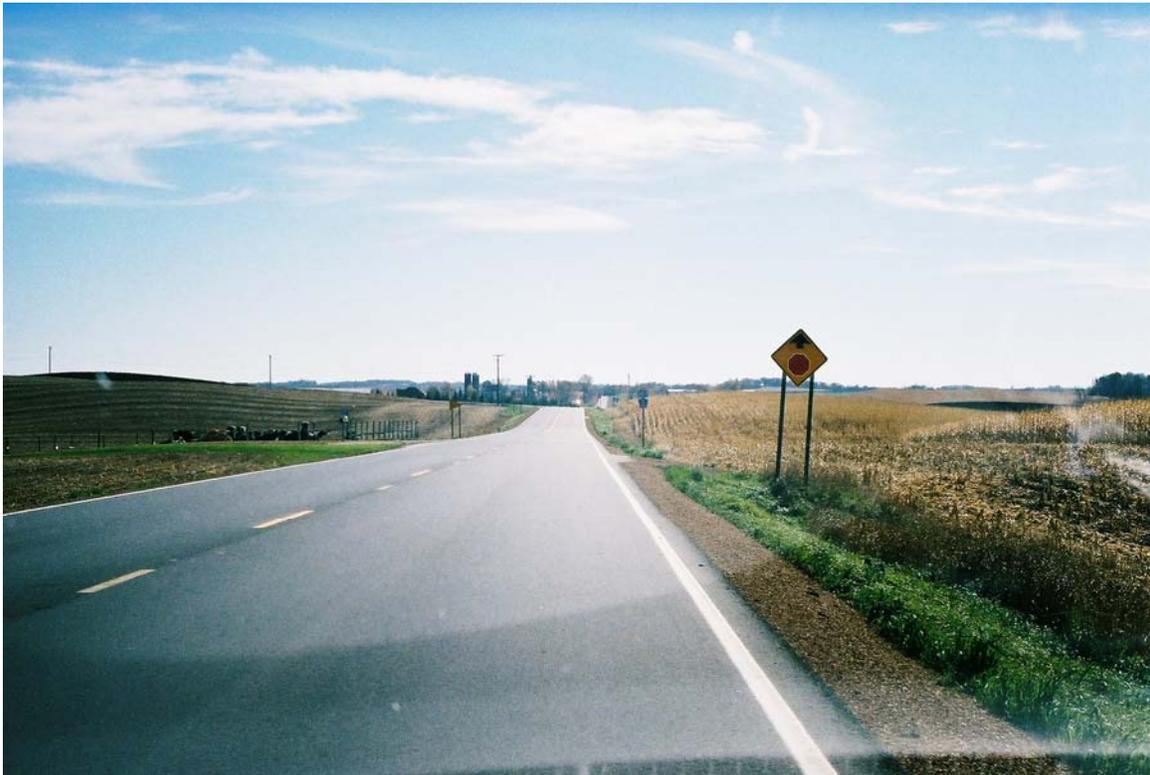
On North Side (looking South): to East—rise partially obscures traffic on major road; to West—rise obscures traffic on major road.

Photograph #194 (Reel #9,) (from North, looking South): from approx where first rumble strip would be—"Stop Ahead" sign in view.
