2006-42

Final Report

Stopping Behavior at Real-World
Stop-Controlled Intersections
with and without In-Lane Rumble Strips

**Center for Human Factors Systems Research and Design
University of Minnesota**

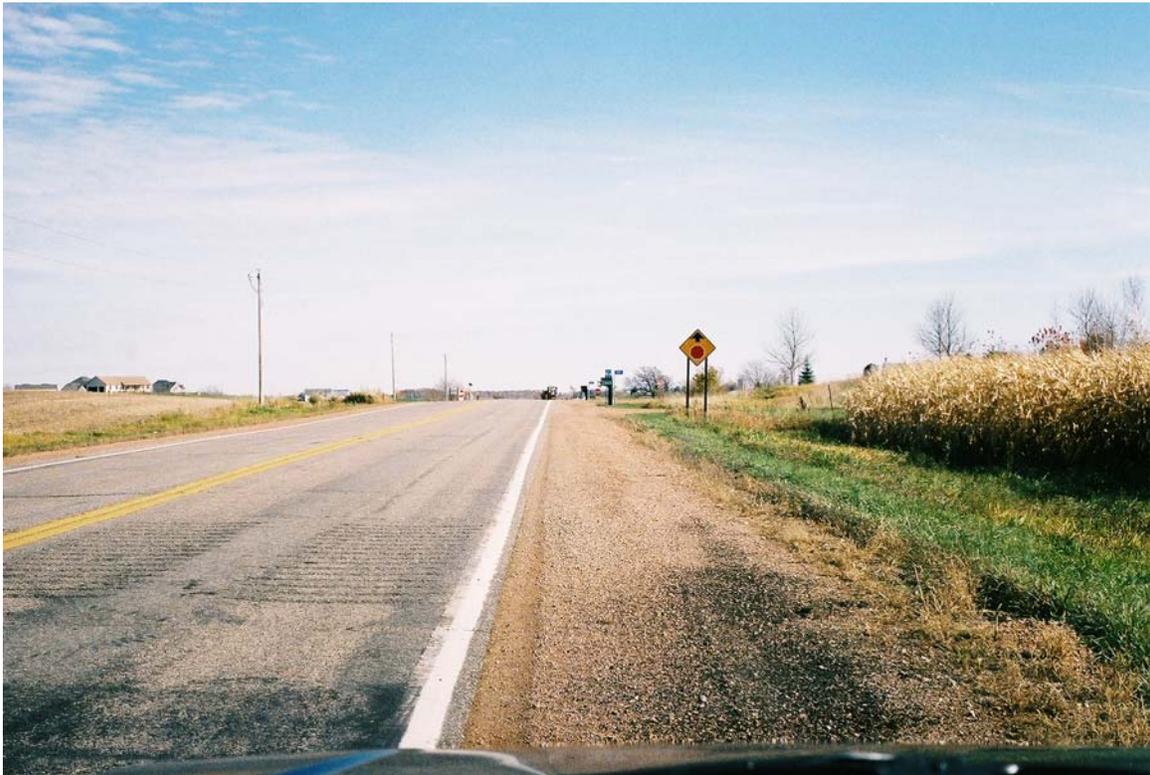
On West Side (looking East): to North—rise obscures traffic on major road; to South—rise and corn obscures traffic on major road.

Photograph #195 (Reel #9, 18) (from West, looking East): first rumble strip and warning sign in view.

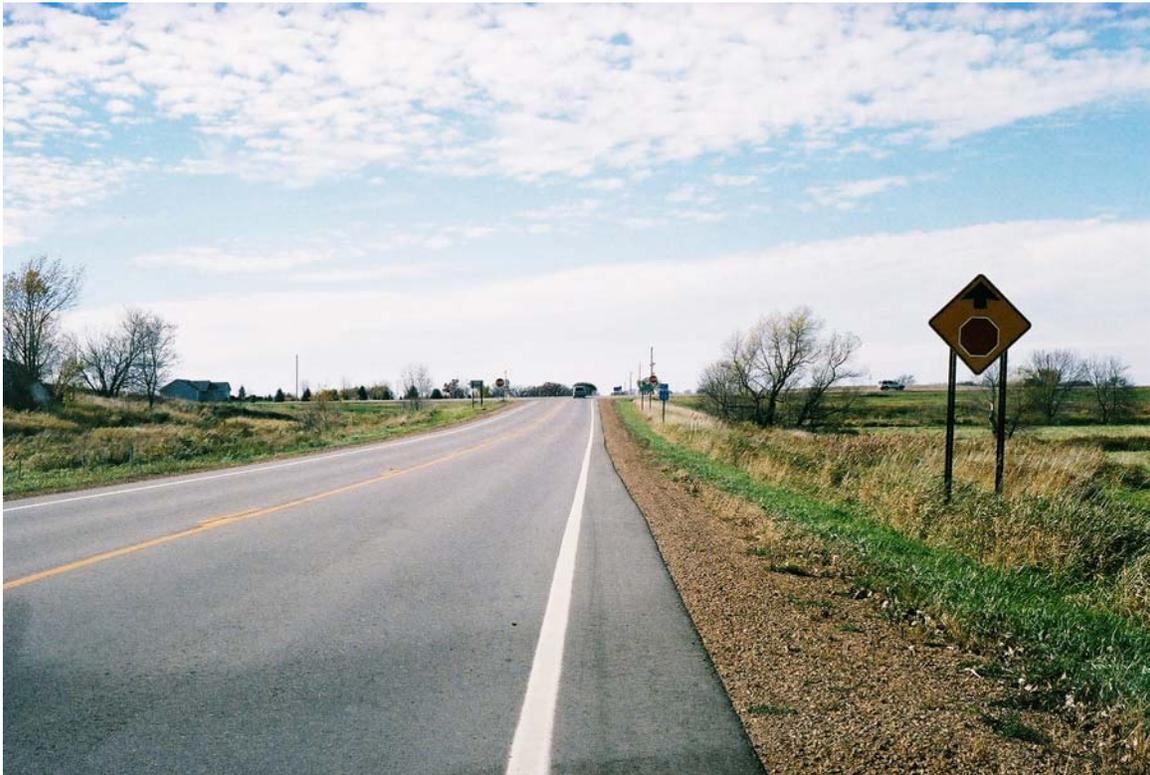
On East Side (looking West): to South—near to intersection traffic on major road is visible, while further away rise partially obscures traffic; to North—clear view of traffic on major road.

Photograph #197 (Reel #9, 20) (from East, looking West): from approximately where first rumble strip would be; warning sign in view; also, there is a *flasher on top* of the actual STOP sign.

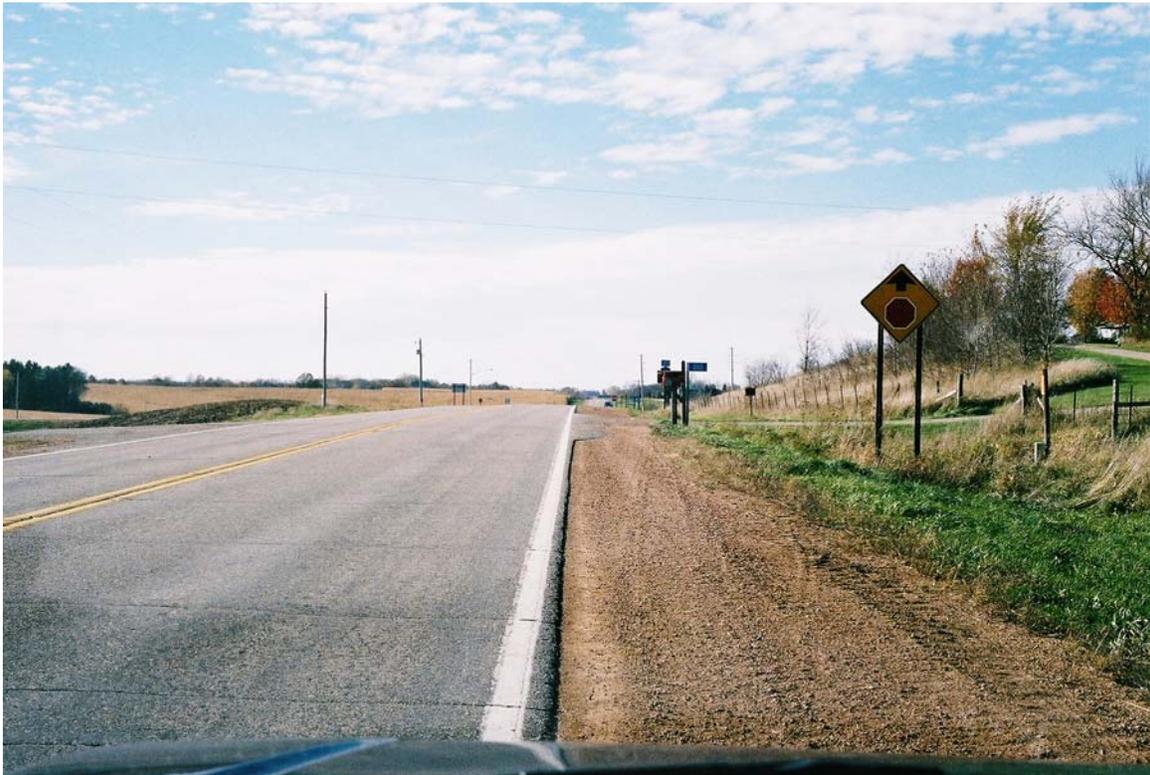
On East Side (looking West): rise partially obscures intersection; to North—rise obscures traffic on major road: to South—near to intersection rise obscures traffic on major road, while further out traffic is visible.

Photograph #198 (Reel #9, 21) (from East, looking West): from approximately where first rumble strip would be, warning sign in view.

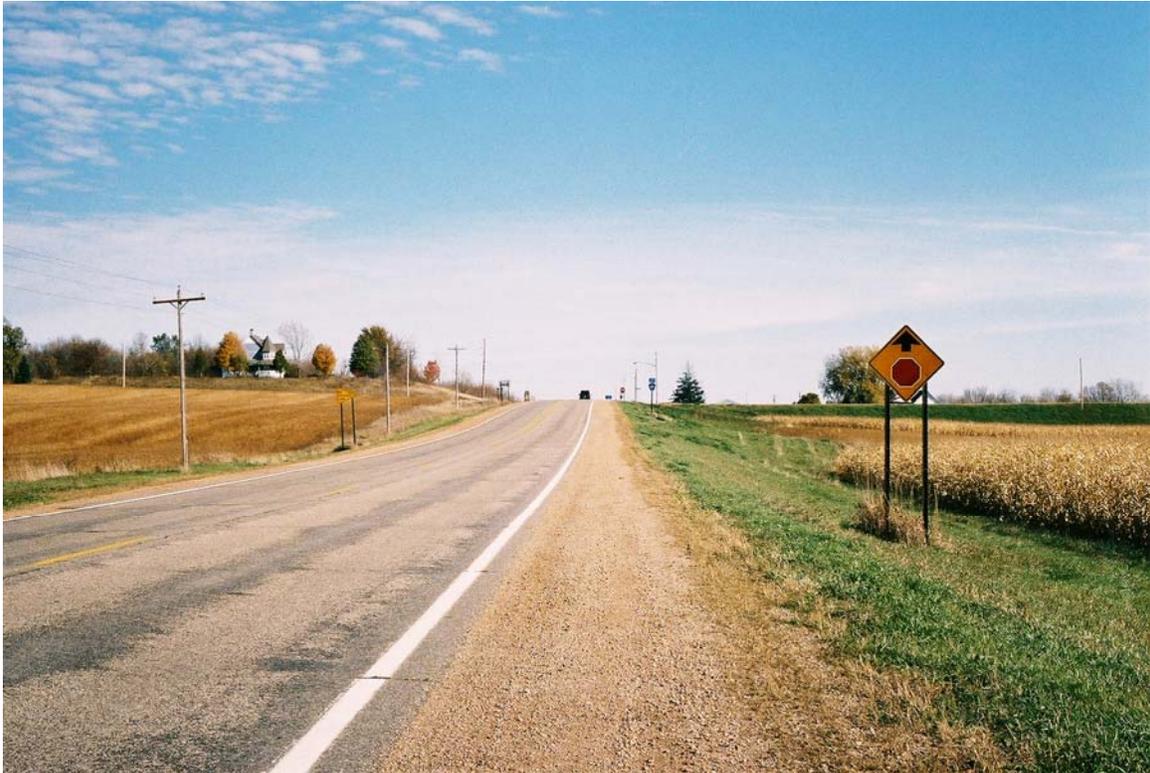
On West Side (looking East): on both sides—clear view of traffic on major road.

Photograph #200 (Reel #9, 24) (from West, looking East): from approximately where first rumble strip would be; warning sign in view.

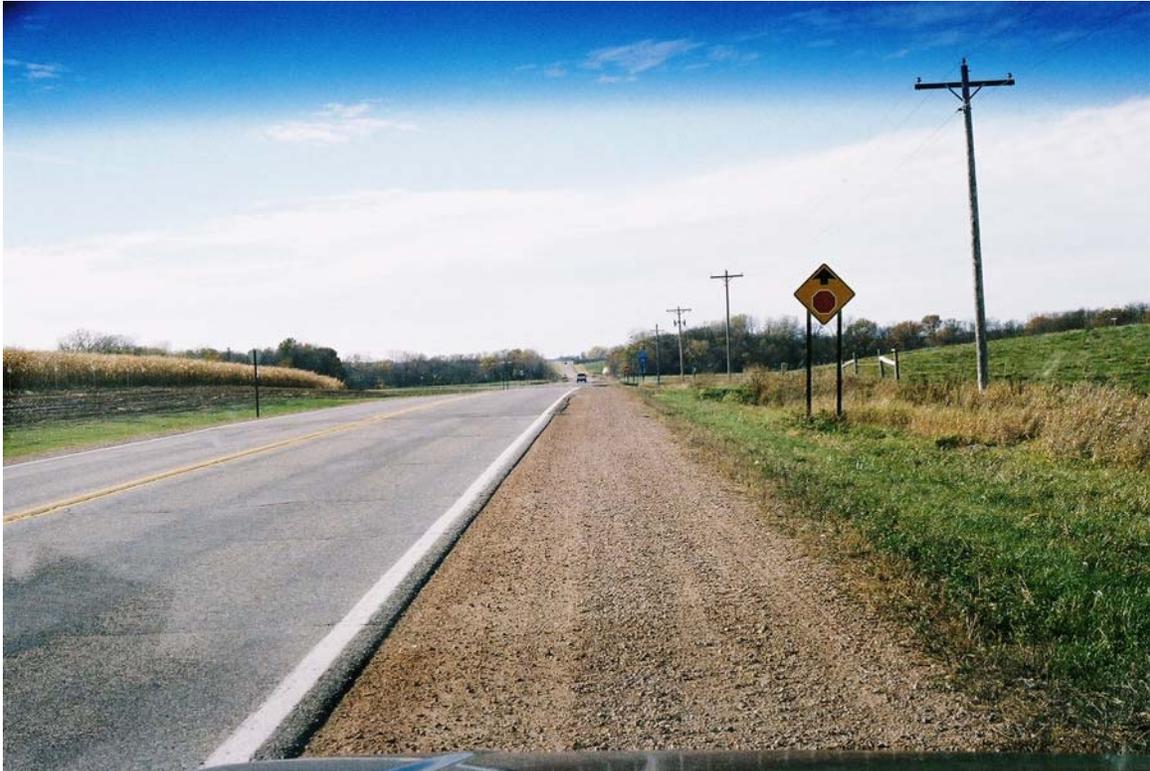
On East Side (looking West): on both sides—rise obscures traffic on major road.

Photograph #201 (Reel #10, 1) (from East, looking West): from approximately where first rumble strip would be; warning sign in view.

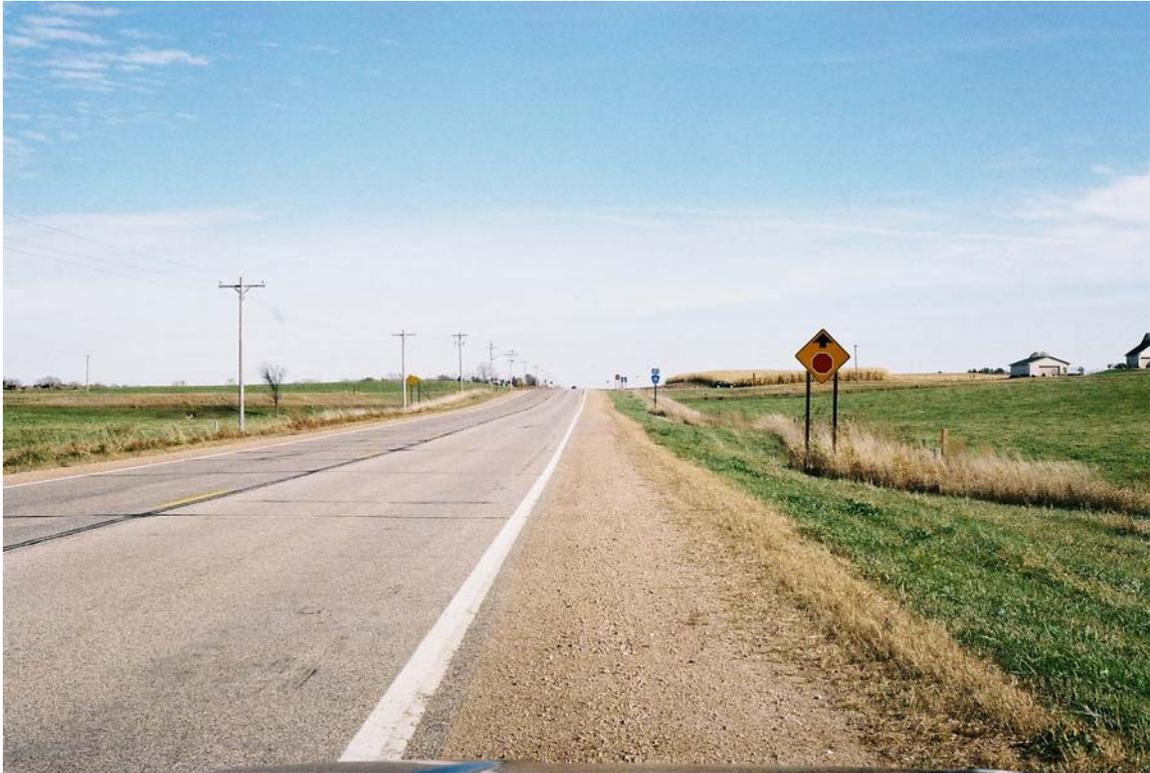
On West Side (looking East): on both sides—clear view of traffic on major road.

Photograph #202 (Reel #10, 2) (from West, looking East): from approximately where first rumble strip would be; warning sign in view.

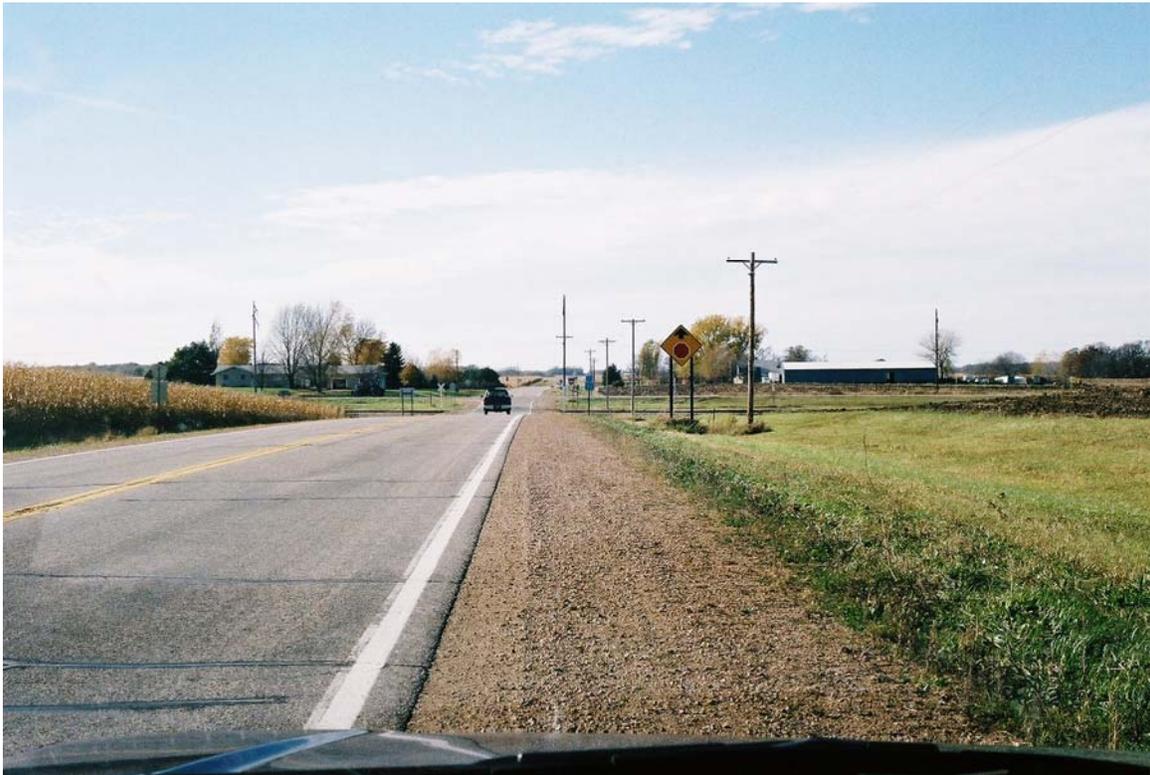
On East Side (looking West): to South—rise obscures traffic on major road; to North—clear view of traffic on major road.

Photograph #203 (Reel #10, 3) (from East, looking West): from approximately where first rumble strip would be; warning sign in view.

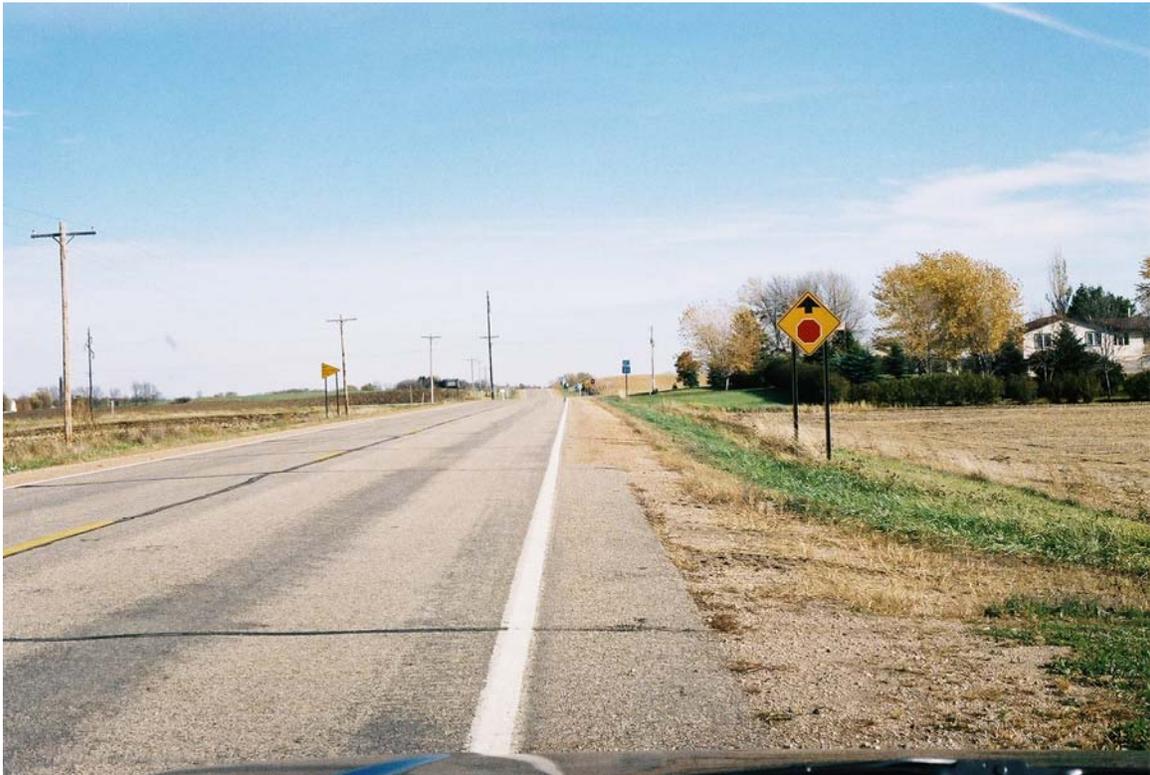
Photograph #204 (Reel #10, 4) (from West, looking East): from approximately where first rumble strip would be; warning sign in view.

On West Side (looking East): to South—trees & building obscure traffic on major road;
to North—clear view of traffic on major road.

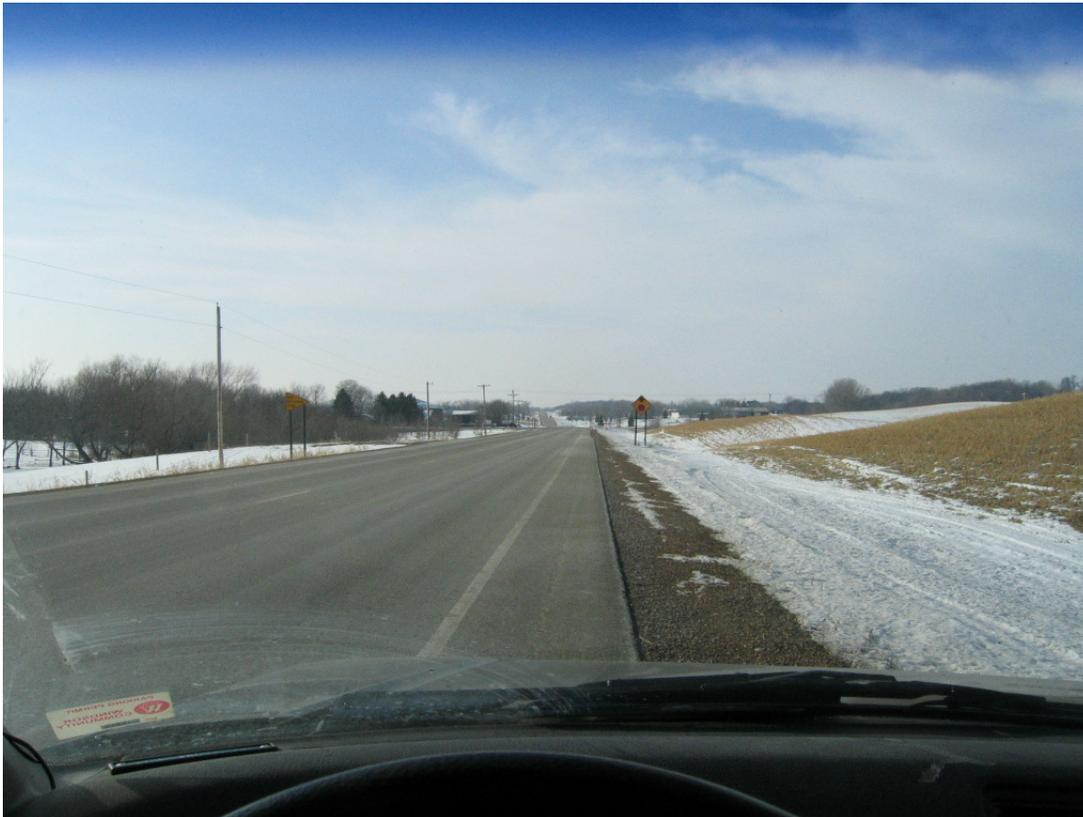
Photograph #474 (Reel #E2, 1) (from East, looking West): *no rumble strip*; warning sign in view.

On East Side (looking West): to South—trees & building obscure traffic on major road;
to North—rise obscures traffic on major road.

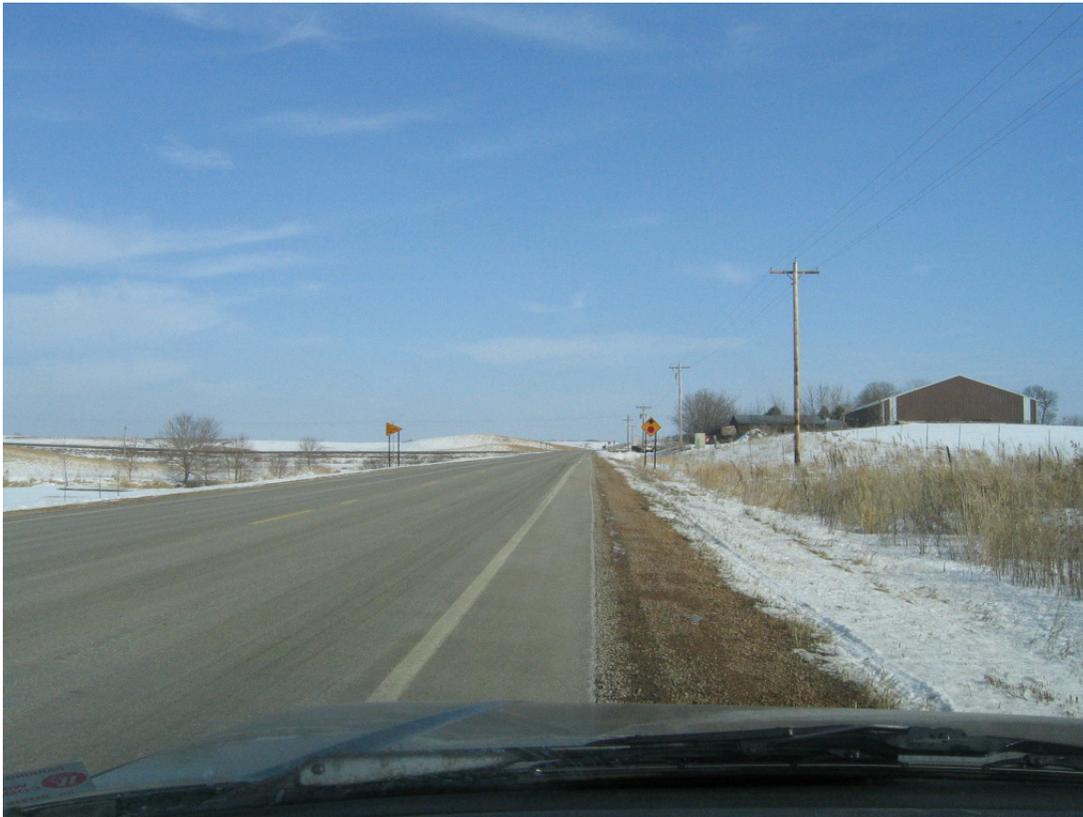
Photograph #475 (Reel #E2, 2) (from West, looking East): *no rumble strip*; warning sign in view.

On West Side (looking East): to South—building obscure traffic on major road; to North—clear view of traffic on major road.

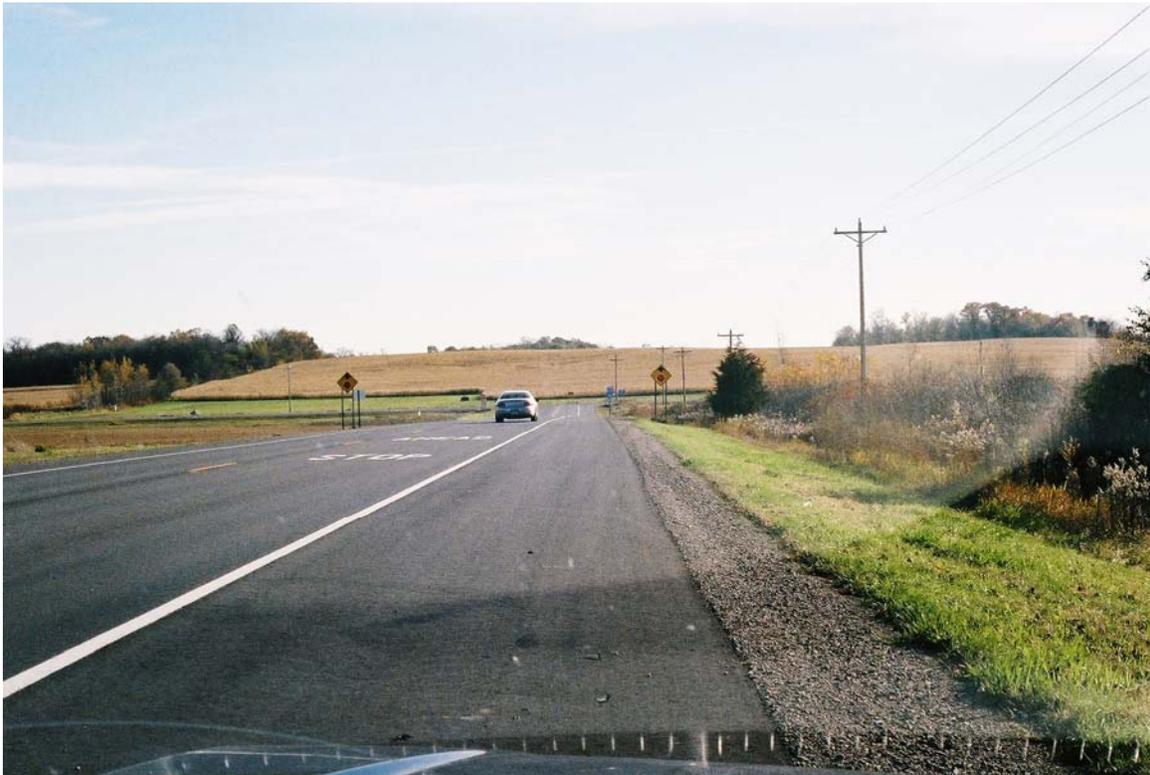
Photograph #201 (Reel #10, 6) (from North, looking South): from approximately where first rumble strip would be; warning sign in view; also, STOP AHEAD on road; and road has very wide shoulder.

On North Side (looking South): to West—trees obscure traffic on major road; to East—clear view of traffic on major road.

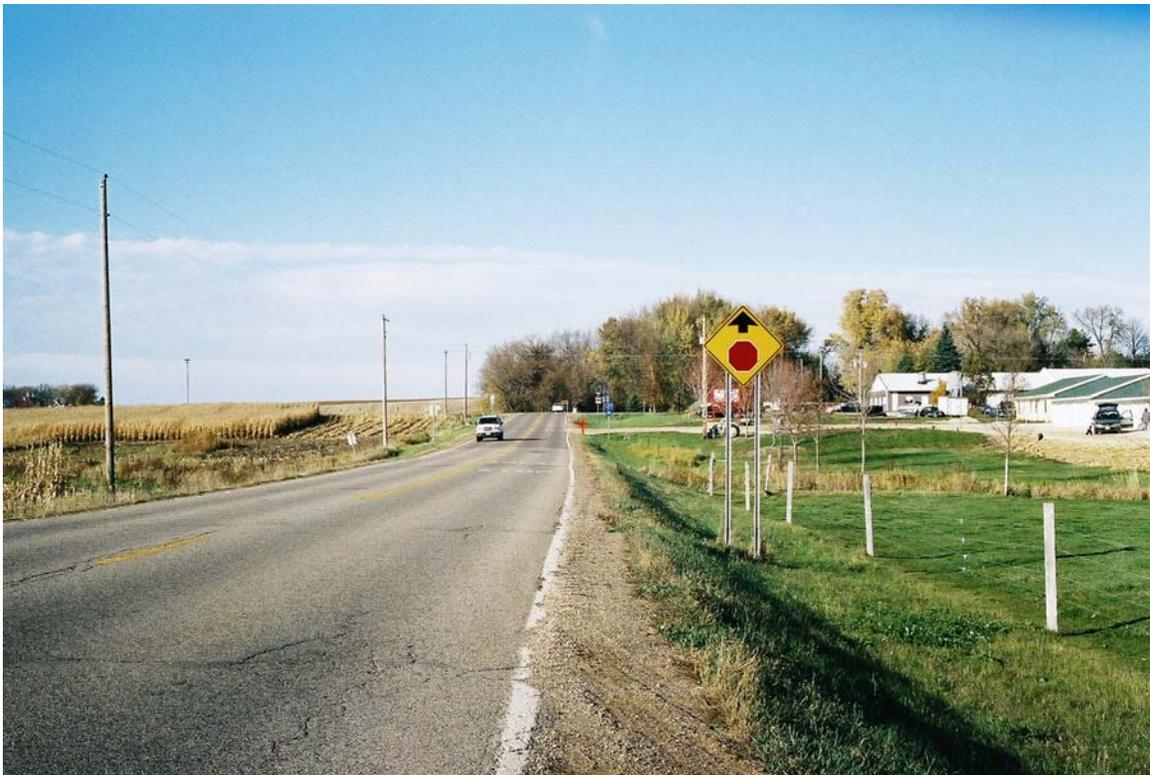
Photograph #203 (Reel #10, 7) (from South, looking North): from approximately where first rumble strip would be; warning sign in view; also, STOP AHEAD on road.

On South Side (looking North): to East—buildings and trees obscure traffic on major road; to West—further from intersection on major road corn obscures traffic on major road, nearer in traffic clear.

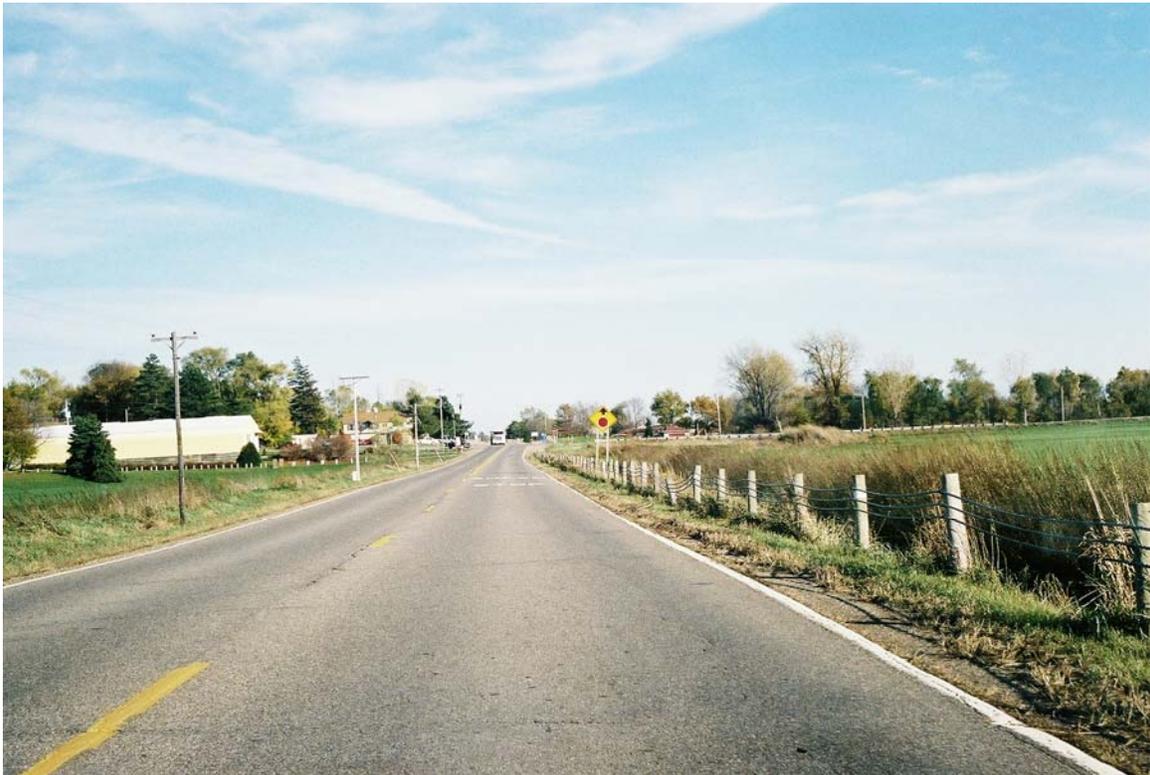
Photograph #208 (Reel #10, 8) (from West, looking East): from approx where first rumble strip would be—with “Stop Ahead” in view

On West Side (looking East): to West—buildings and trees obscure traffic on major road;
to East—partial view of traffic on major road.

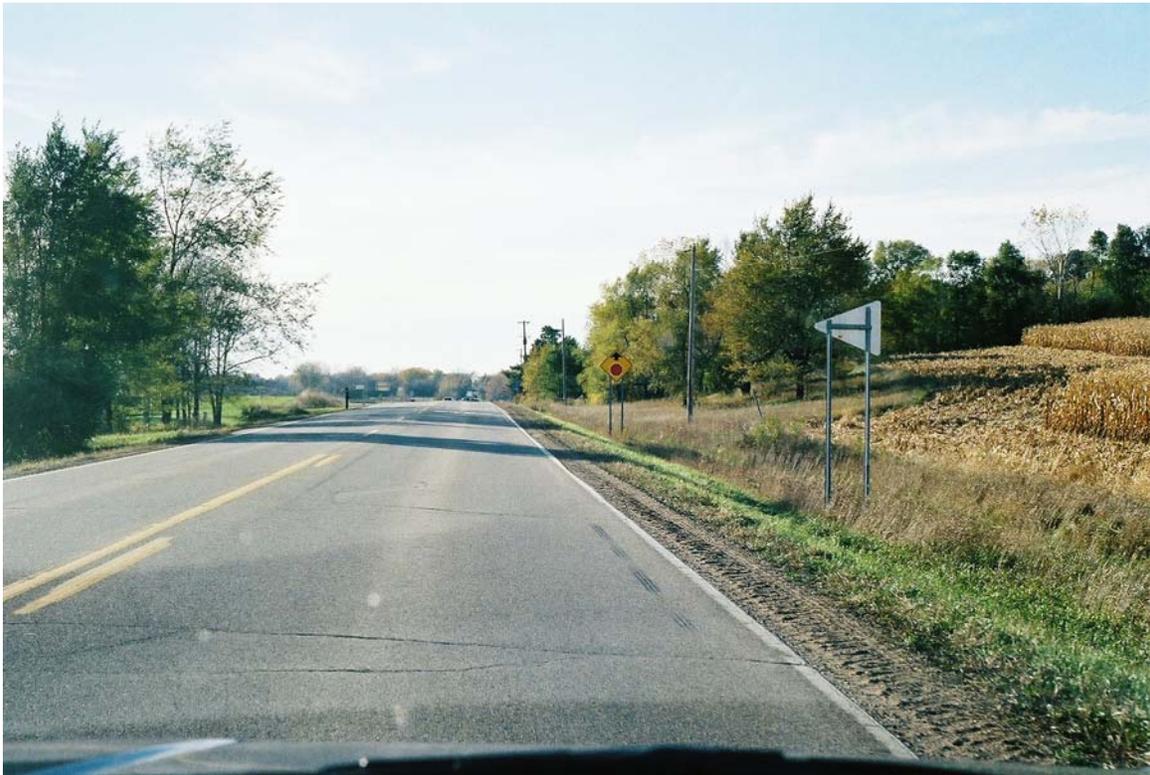
Photograph #209 (Reel #10, 9) (from East, looking West): from approximately where first rumble strip would be; warning sign in view; also, STOP AHEAD on road.

On East Side (looking West): to North—trees obscure traffic on major road; to South—
rise and trees obscure traffic on major road.

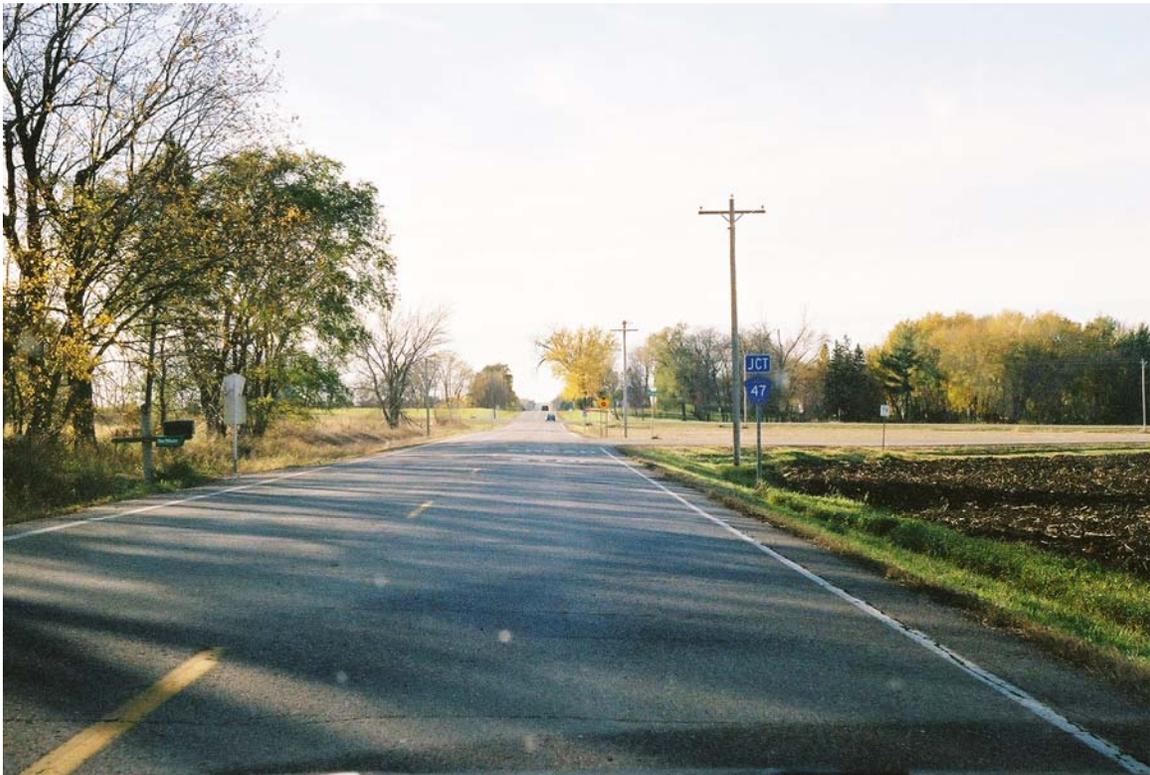
Photograph #214 (Reel #10, 14) (from East, looking West): from approximately where first rumble strip would be; warning sign in view; also, STOP AHEAD on road; and, dirt road to North arm of major road is immediately before the warning sign.

On East Side (looking West): to South—trees obscure traffic on major road; to North—clear view of traffic on major road (it runs in front of trees).

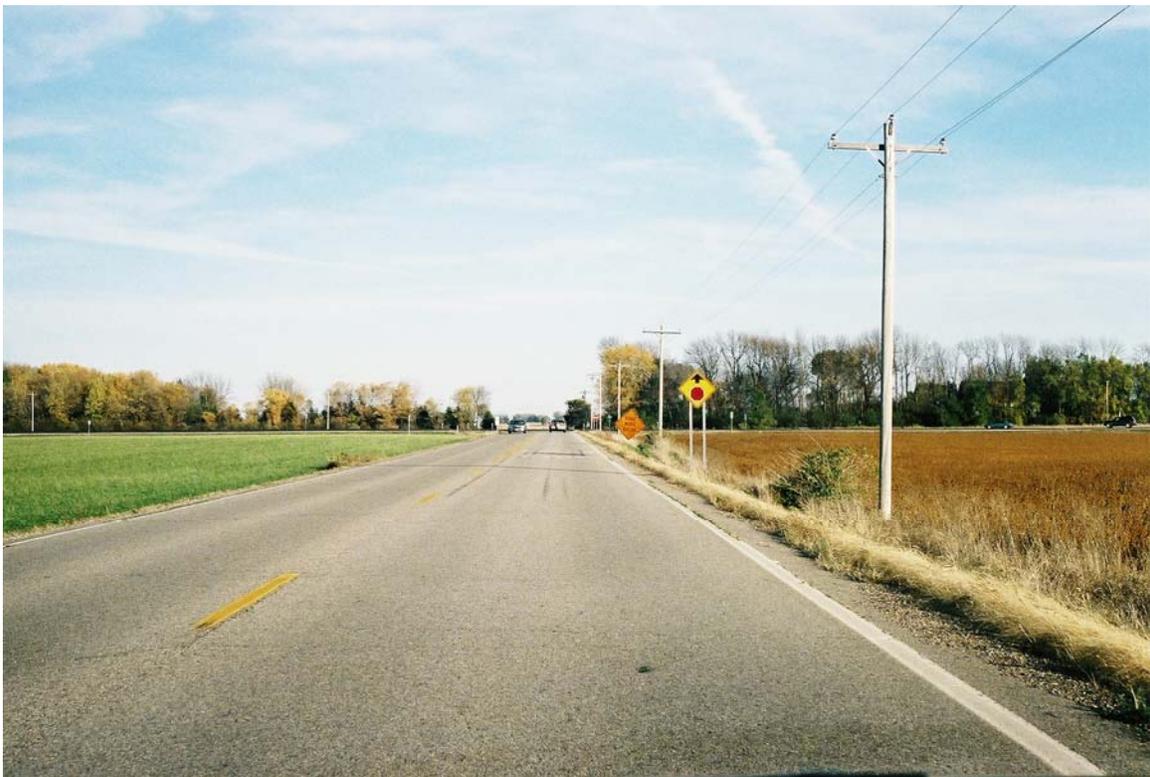
Photograph #215 (Reel #10, 15) (from West, looking East): from approximately where first rumble strip would be; warning sign in view; also, STOP AHEAD on road.

On West Side (looking East): on both sides—clear view of traffic on major road (on both sides road runs in front of trees).

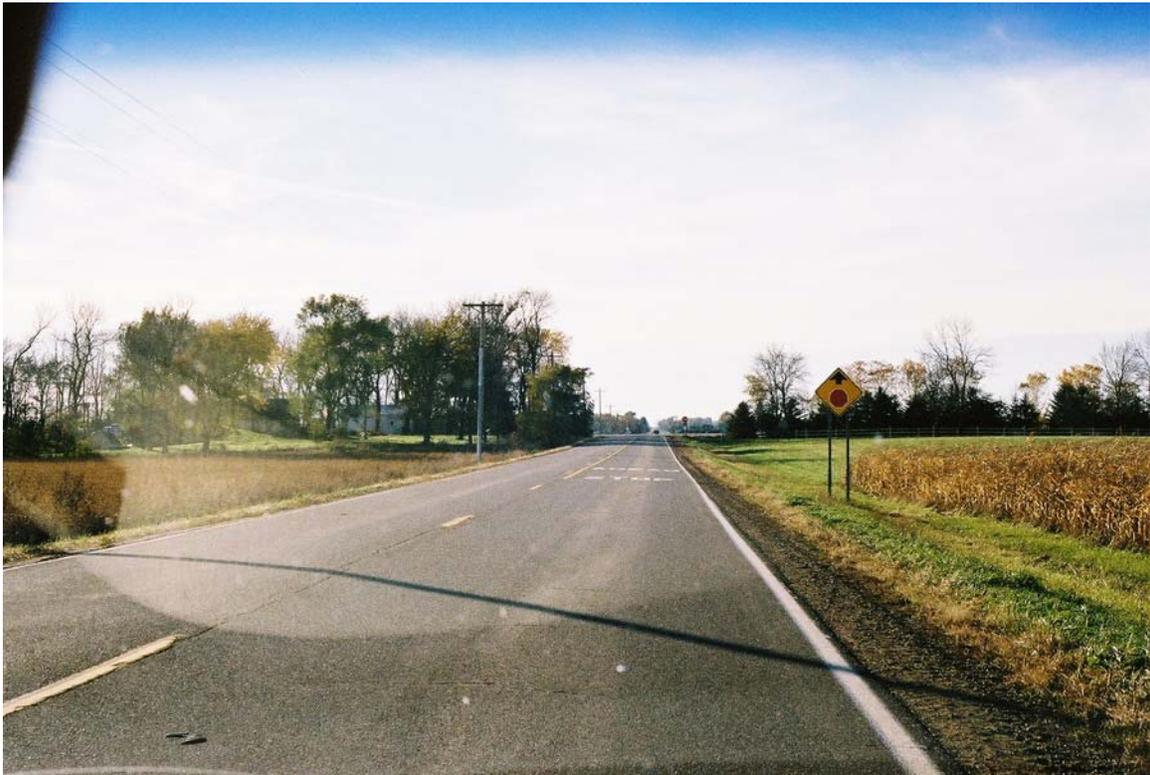
Photograph #216 (Reel #10, 16) (from East, looking West): from approximately where first rumble strip would be; warning sign in view, also, STOP AHEAD on road.

On East Side (looking West): on both sides—trees obscure traffic on major road.

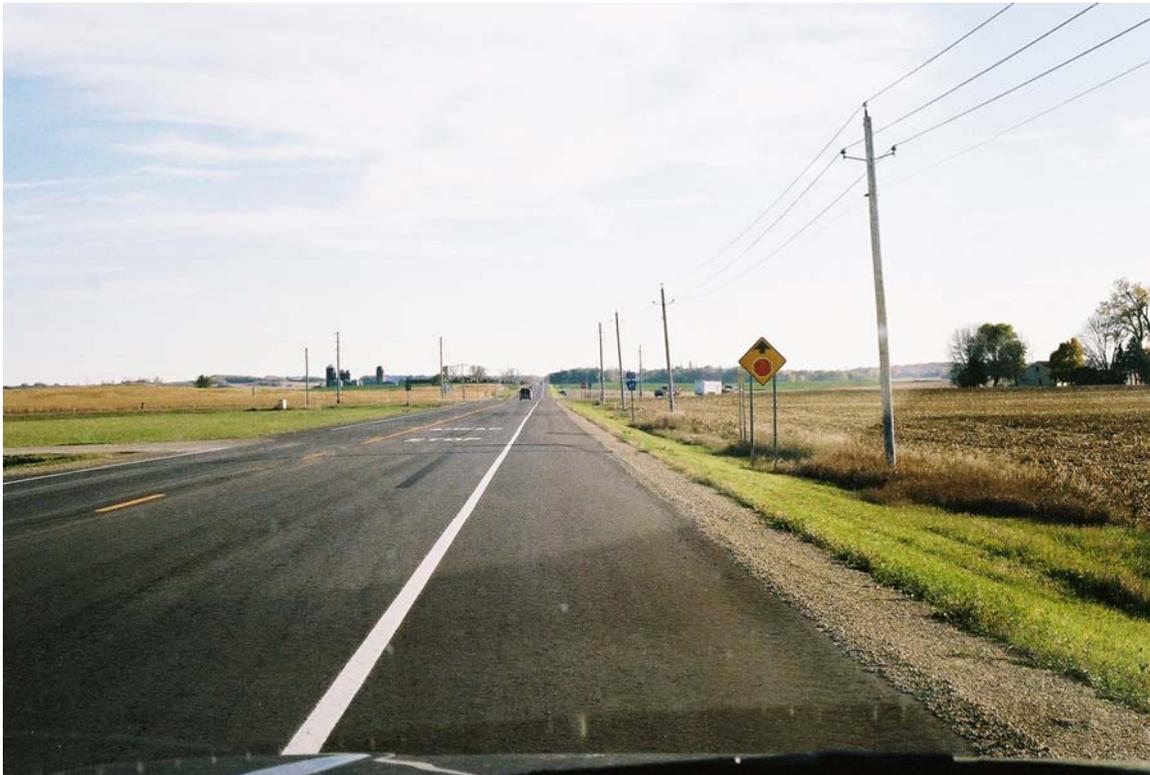
Photograph #217 (Reel #10, 17) (from North, looking South): from approximately where first rumble strip would be; warning sign in view; also, STOP AHEAD on road; and road has very wide shoulder.

On North Side (looking South): on both sides—clear view of traffic on major road.

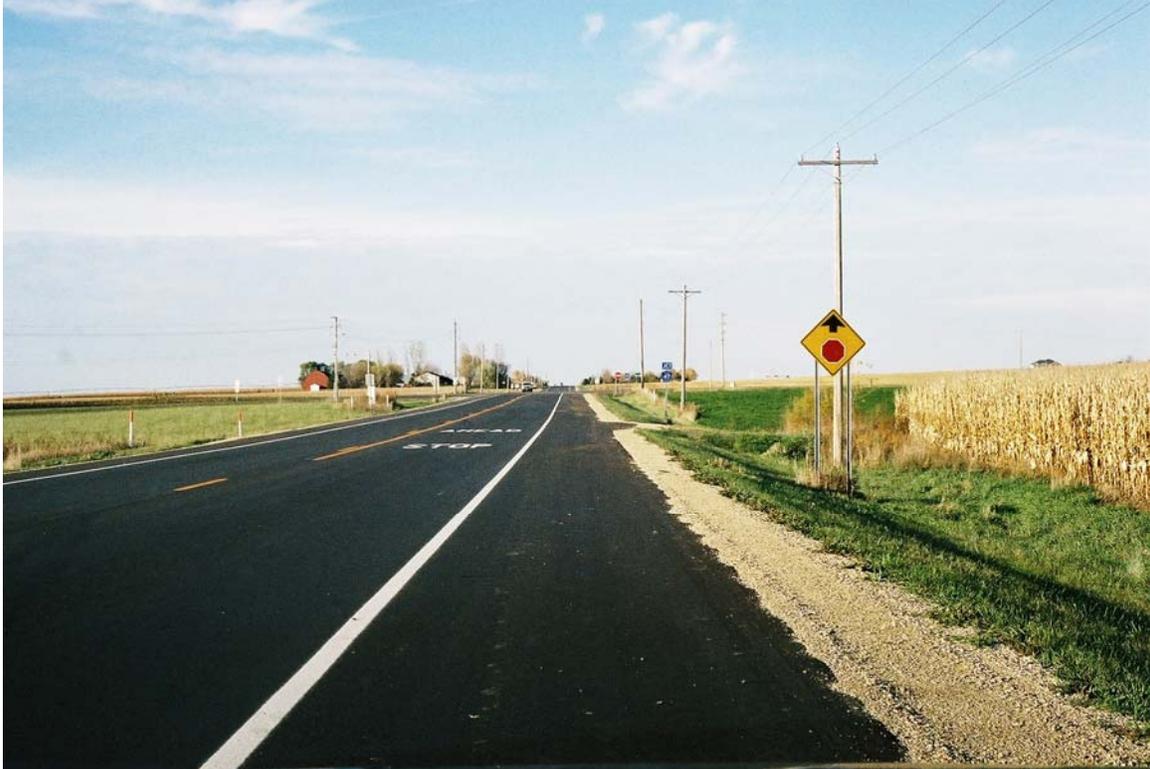
Photograph #218 (Reel #10, 18) (from South, looking North): from approximately where first rumble strip would be; warning sign in view; also, STOP AHEAD on road; and road has very wide shoulder.

On South Side (looking North): on both sides—clear view of traffic on major road

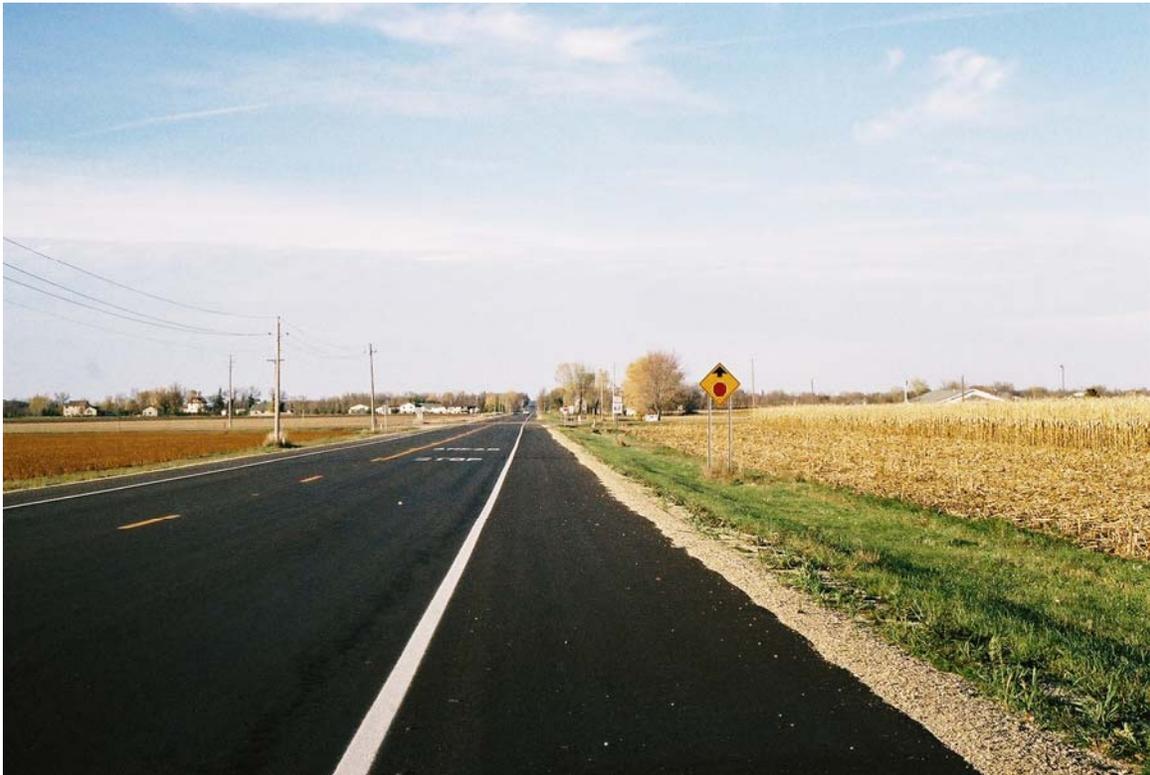
Photograph #219 (Reel #10, 19) (from South, looking North): from approximately where first rumble strip would be; warning sign in view; also, STOP AHEAD on road; and road has very wide shoulder.

On South Side (looking North): to East—corn obscures traffic on major road; to West—clear view of traffic on major road.

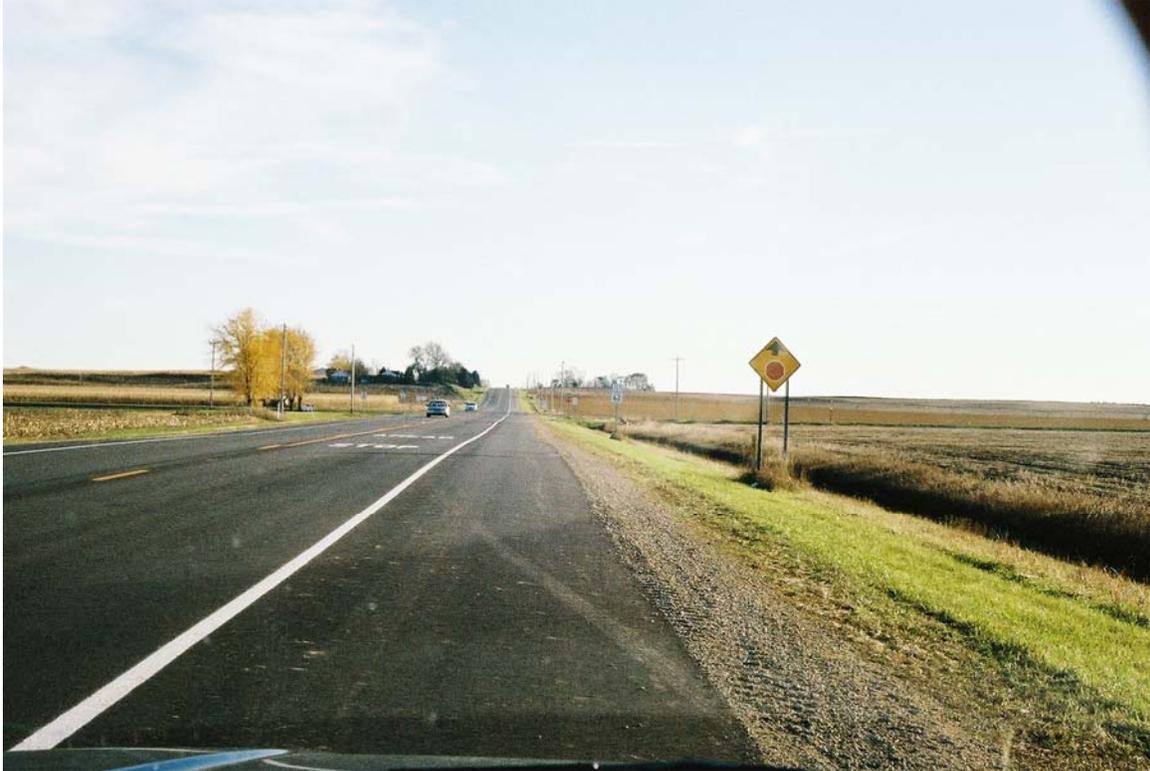
Photograph #219 (Reel #10,) (from North, looking South): from approximately where first rumble strip would be; warning sign in view; also, STOP AHEAD on road; and road has very wide shoulder.

On North Side (looking South): on both sides—clear view of traffic on major road.

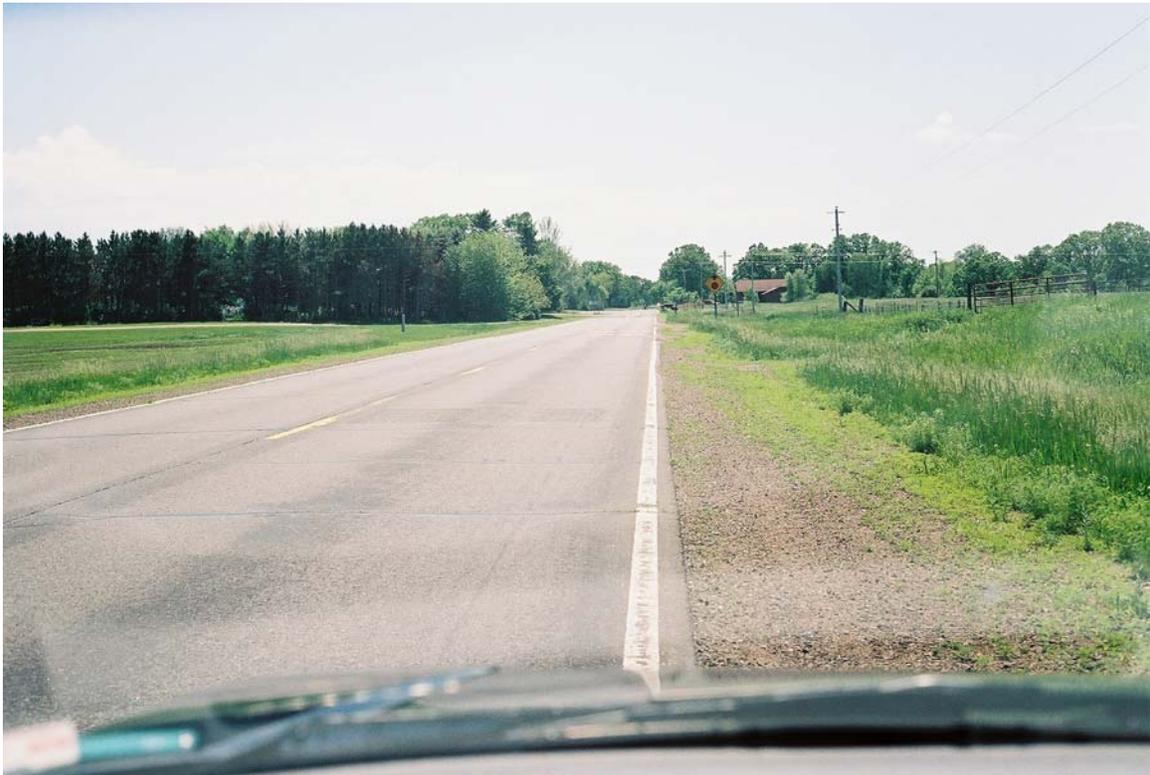
Photograph #216 (Reel #11, 2A) (from North, looking South): first rumble strip and warning sign in view—also STOP AHEAD on road.

On North Side (looking South): to West—slight vertical curve obscures traffic on major road; to East—trees obscure traffic on major road.

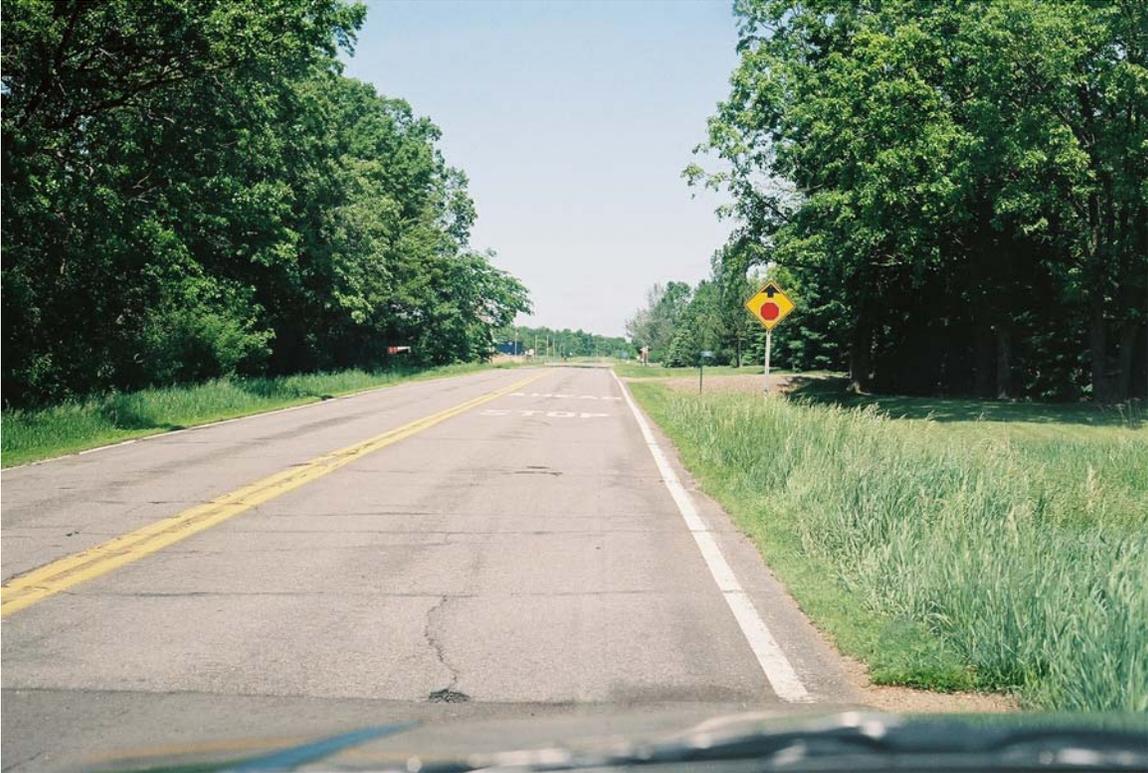
Photograph #218 (Reel #11, 4A) (from South, looking North): first rumble strip *missing* (because of new road surface) but warning sign in view and STOP AHEAD visible on road.

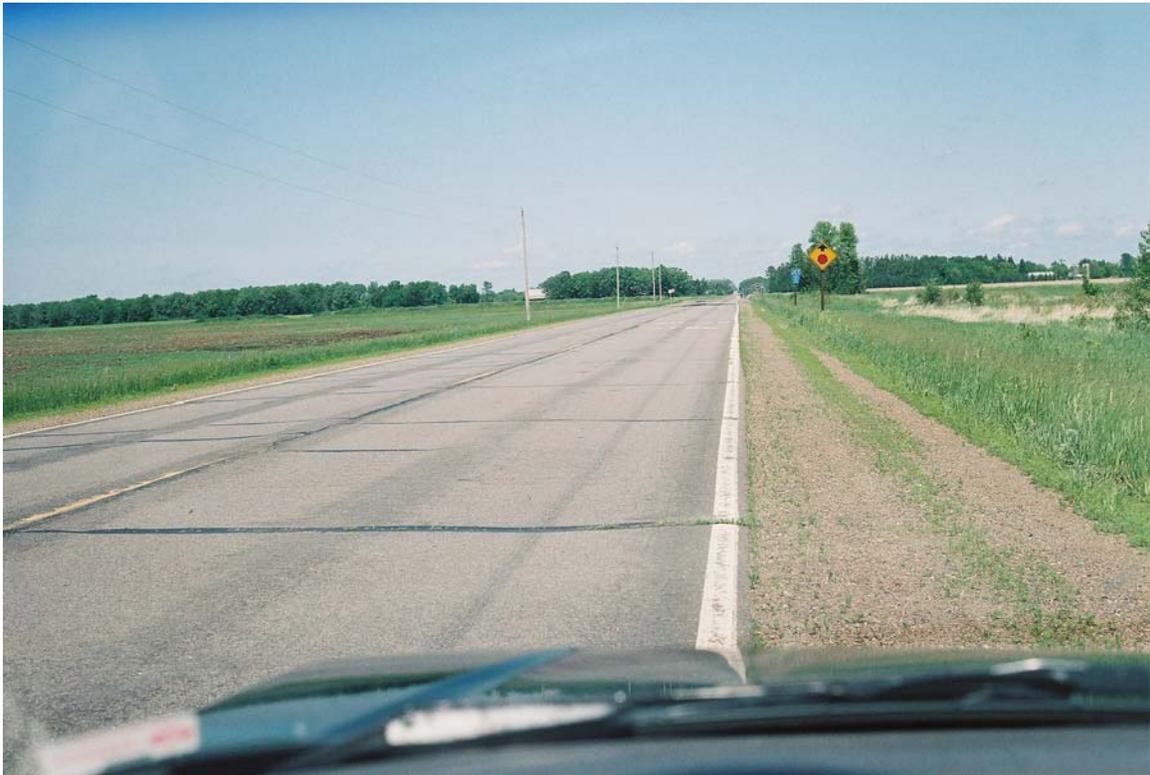
Photograph #220 (Reel #11, 6A) (from South, looking North): first rumble strip *barely visible* in foreground; warning sign in view; STOP AHEAD on road.

On South Side (looking North): to West—clear view of traffic on major road; to East—some obscuration from trees of traffic on major road.
