2006-42

Final Report

Stopping Behavior at Real-World
Stop-Controlled Intersections
with and without In-Lane Rumble Strips

**Center for Human Factors Systems Research and Design
University of Minnesota**

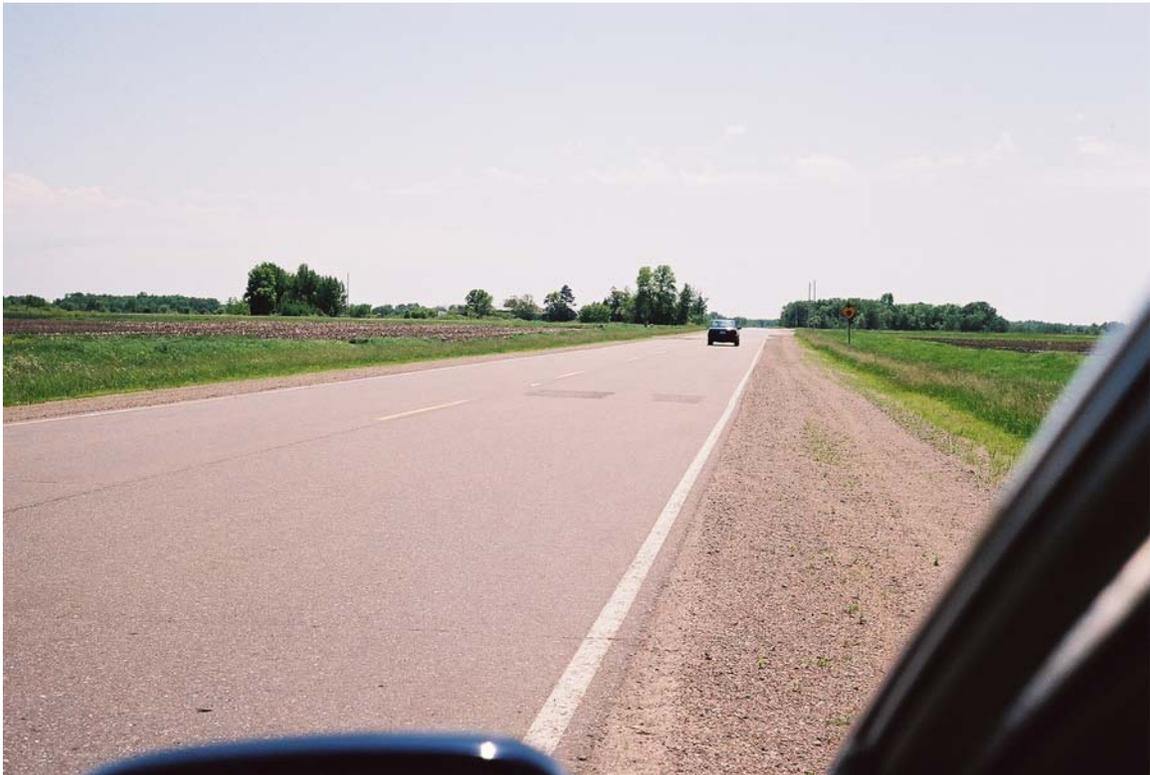
Photograph #222 (Reel #11, 8A) (from North, looking South): first rumble strip and warning sign in view—also, STOP AHEAD on road (just in front of car traveling toward the intersection).

On North Side (looking South): on both sides—clear view of traffic on major road.

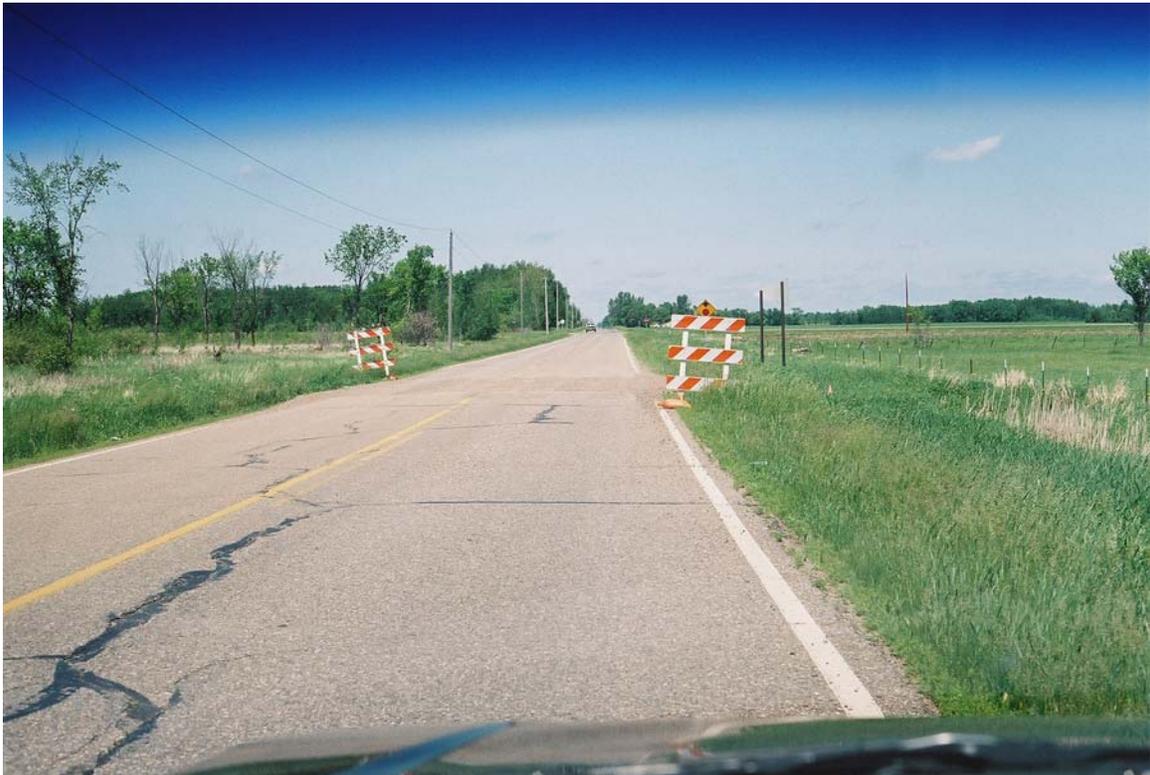
Photograph #224 (Reel #11, 10A) (from South, looking North): first rumble strip difficult to see—it is just before new construction; warning sign in view; STOP AHEAD on road also difficult to see.

On South Side (looking North): to West—trees obscure traffic on major road; to East—
clear view of traffic on major road.

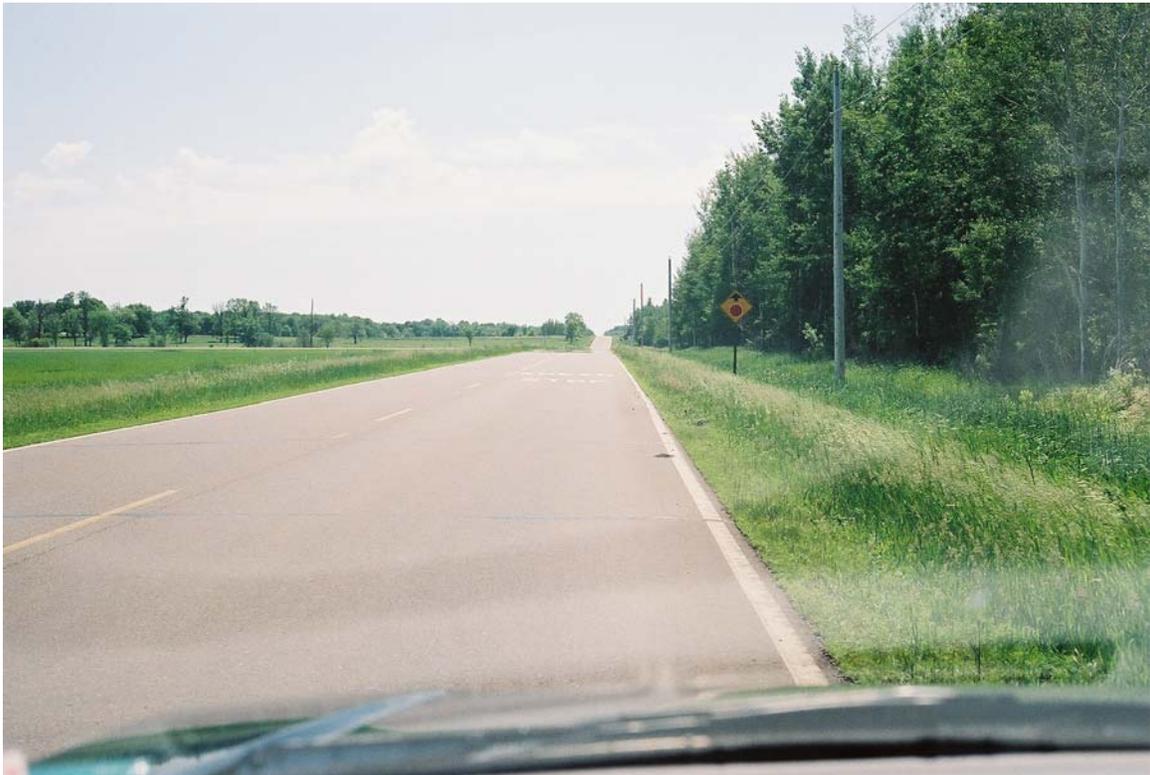
Photograph #226 (Reel #11, 12A) (from North, looking South): first rumble strip *missing*;
warning sign in view; STOP AHEAD on road.

On North Side (looking South): to West—trees obscure traffic on major road; to East—
clear view of traffic on major road.

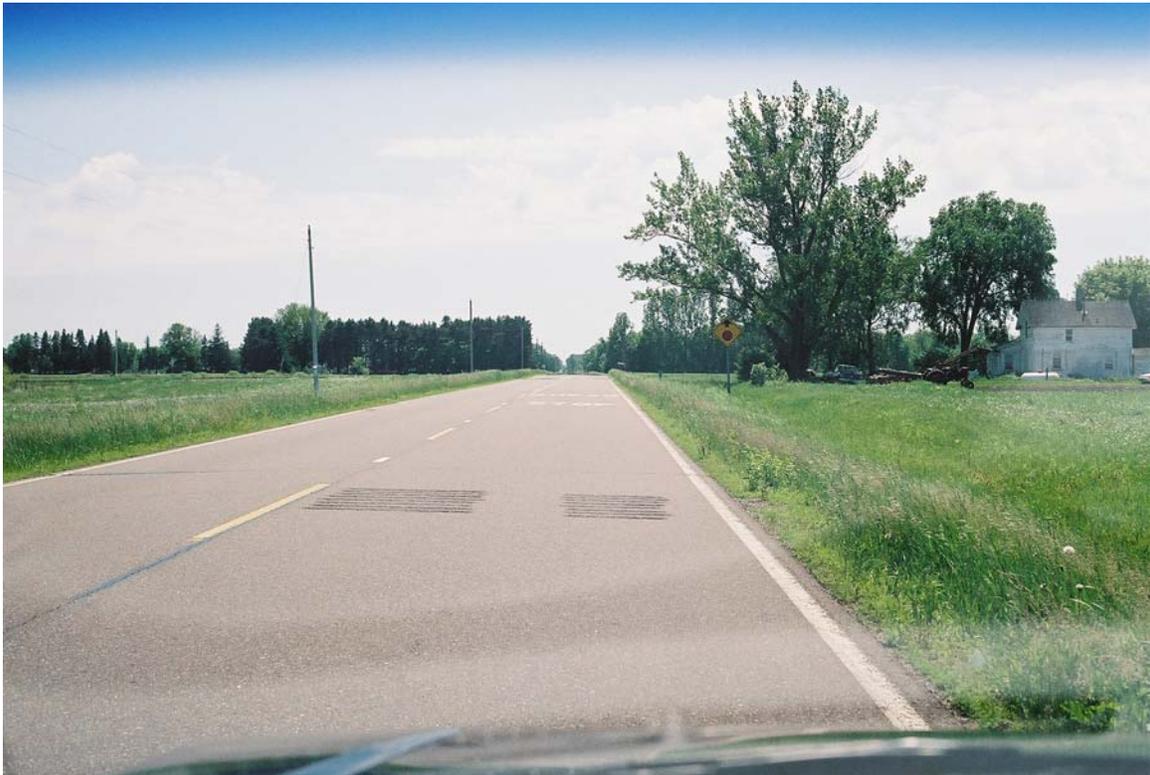
Photograph #228 (Reel #11, 14A) (from North, looking South): first rumble strip and warning sign in view, also STOP AHEAD on road.

On North Side (looking South): to West—trees and buildings obscure traffic on major road; to East—clear view of traffic on major road (in front of trees).

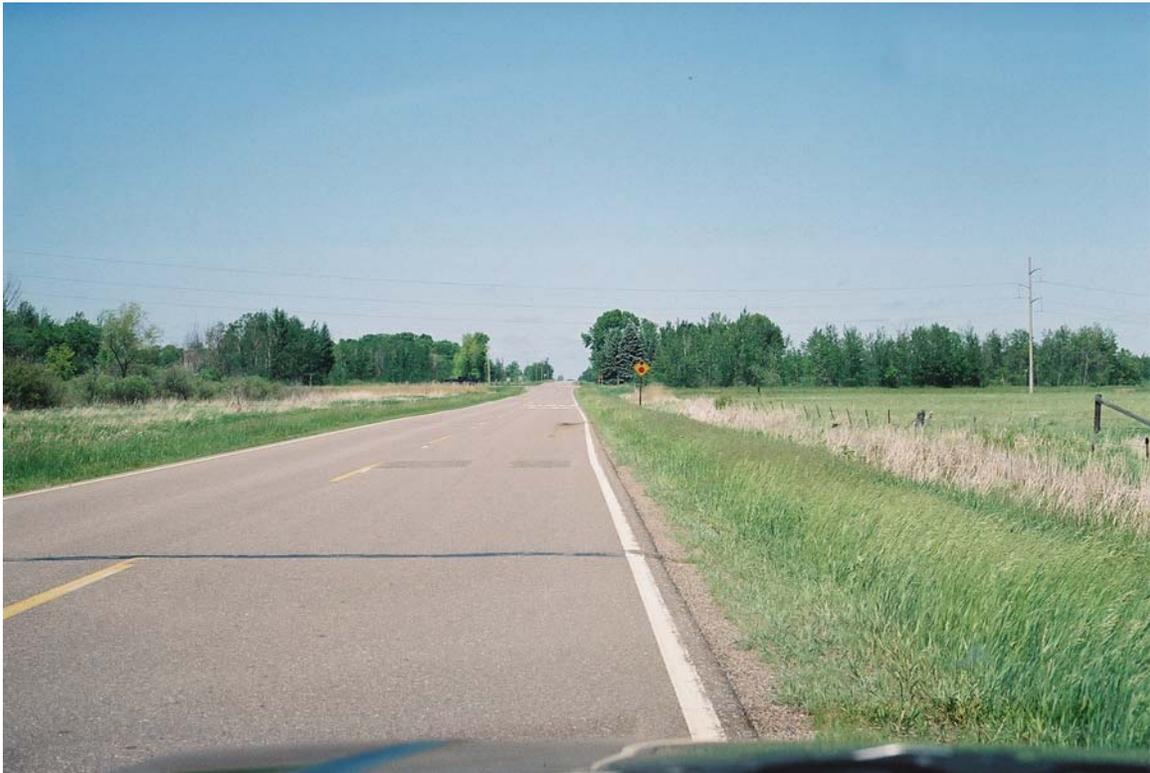
Photograph #232 (Reel #11, 18A) (from South, looking North): first rumble strip and warning strip in view—also, STOP AHEAD on road.

On South Side (looking North): on both sides—view of traffic on major road is clear from further out, but obscured at position of first rumble strip.

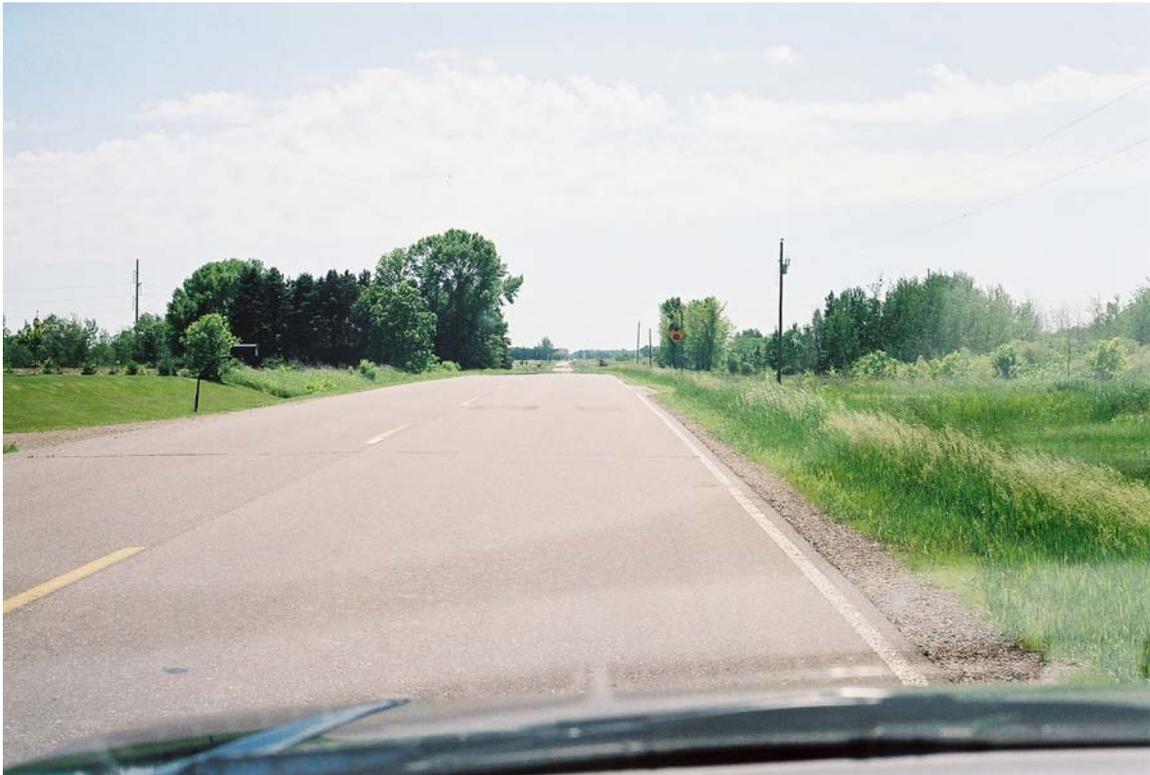
Photograph #234 (Reel #11, 20A) (from North, looking South): first rumble strip and warning strip in view; also, faint STOP AHEAD on road.

On North Side (looking South): on both sides—trees obscure traffic on major road.

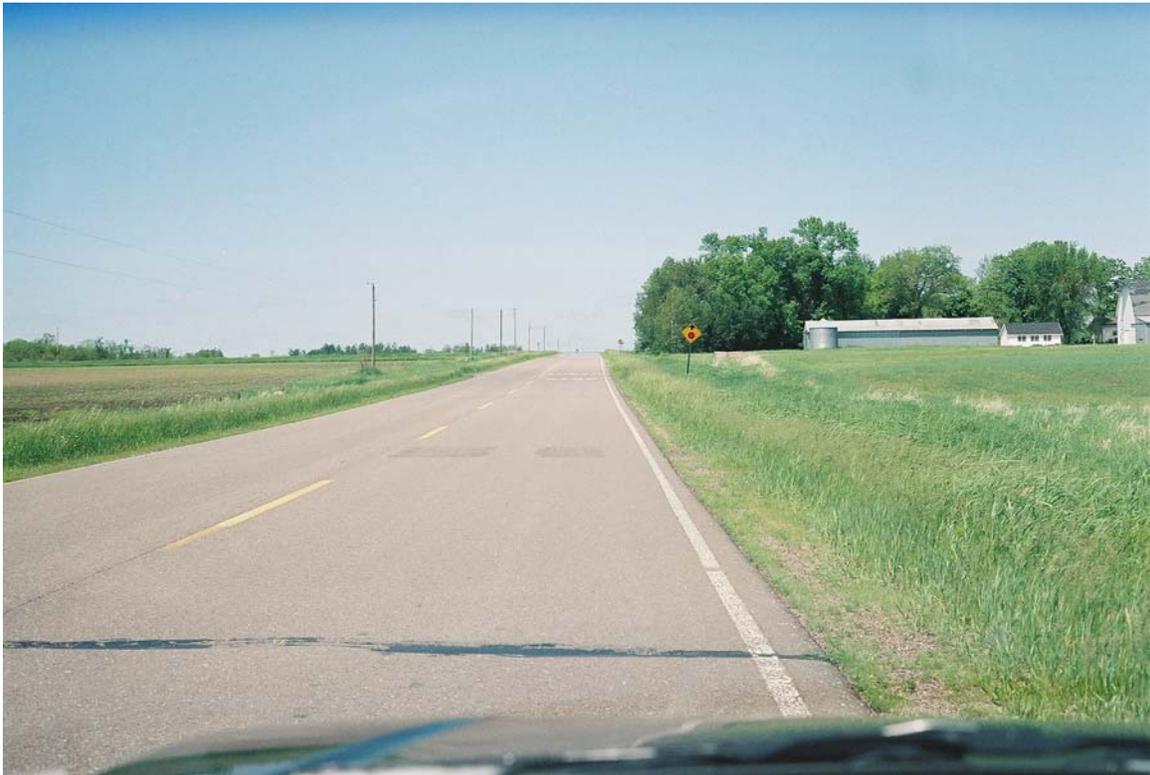
Photograph #236 (Reel #11, 22A) (from South, looking North): first rumble strip and warning sign in view; also, STOP AHEAD on road.

On South Side (looking North): to West—clear view of traffic on major road; East—trees and buildings obscure traffic on major road.

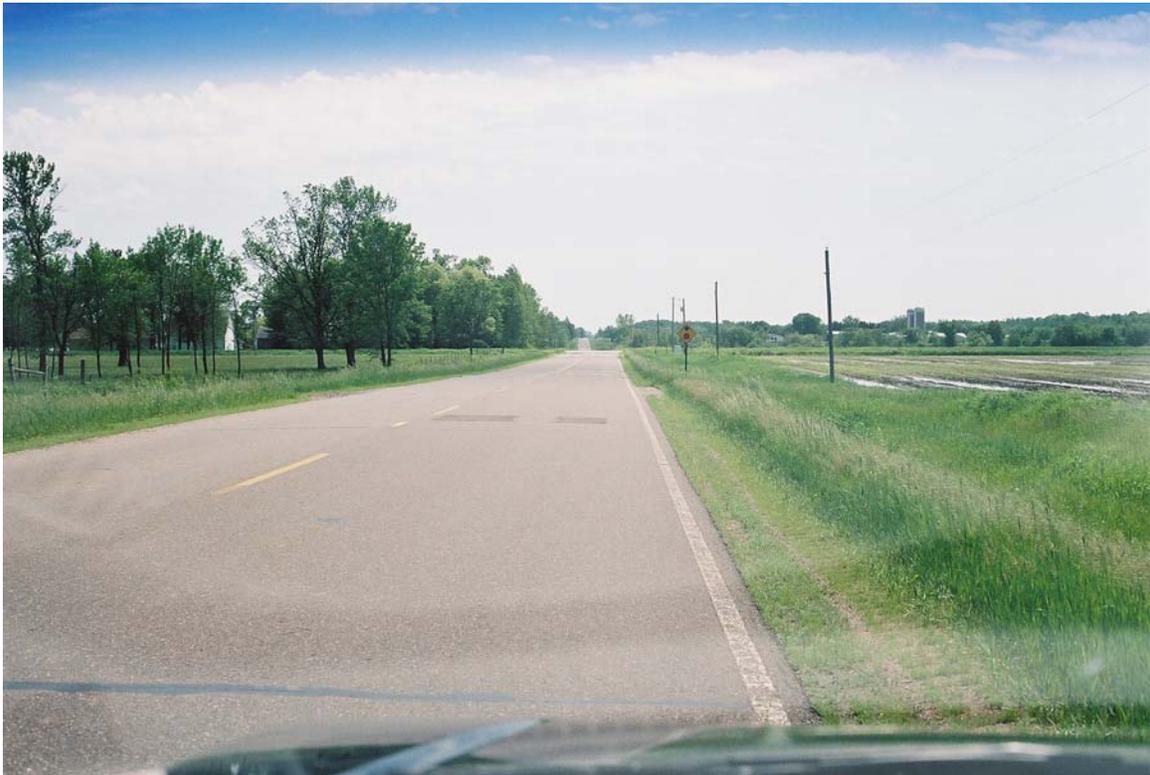
Photograph #238 (Reel #11, 24A) (from North, looking South): first rumble strip and warning sign in view; also, STOP AHEAD on road.

On North Side (looking South): to West—clear view of traffic on major road; to East—trees partially obscure traffic on major road.

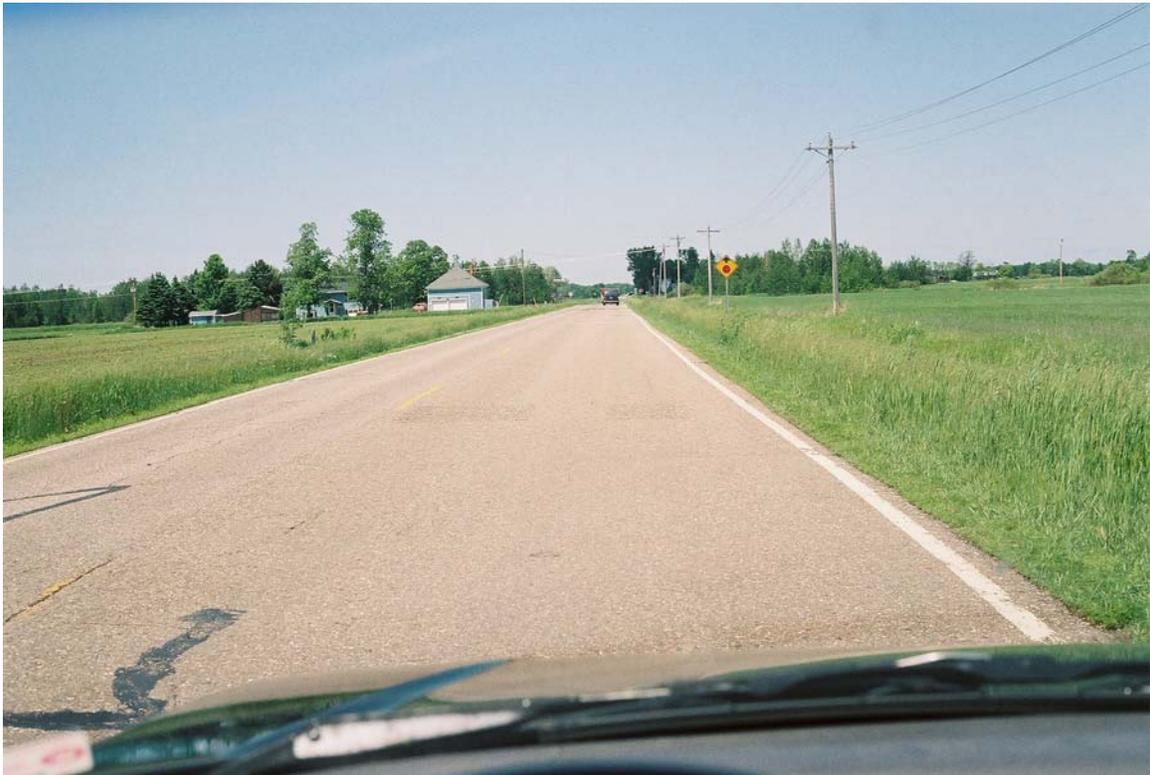
Photograph #240 (Reel #12, 2A) (from South, looking North): first rumble strip and warning sign in view; also, STOP AHEAD on road.

On South Side (looking North): to West—trees and buildings obscure traffic on major road; East—clear view of traffic on major road.

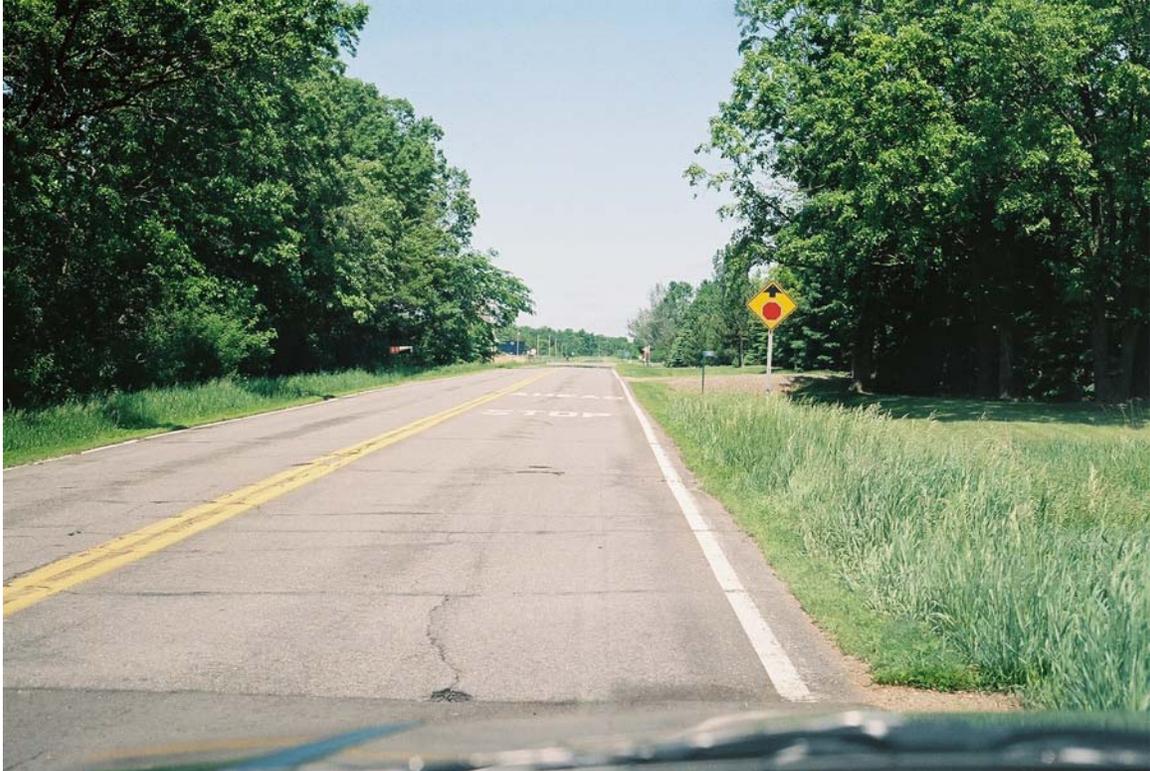
Photograph #242 (Reel #12, 4A) (from North, looking South): first rumble strip in view (though barely visible in photograph), warning sign in view and STOP AHEAD on road.

On North Side (looking South): obscured by trees on both sides.

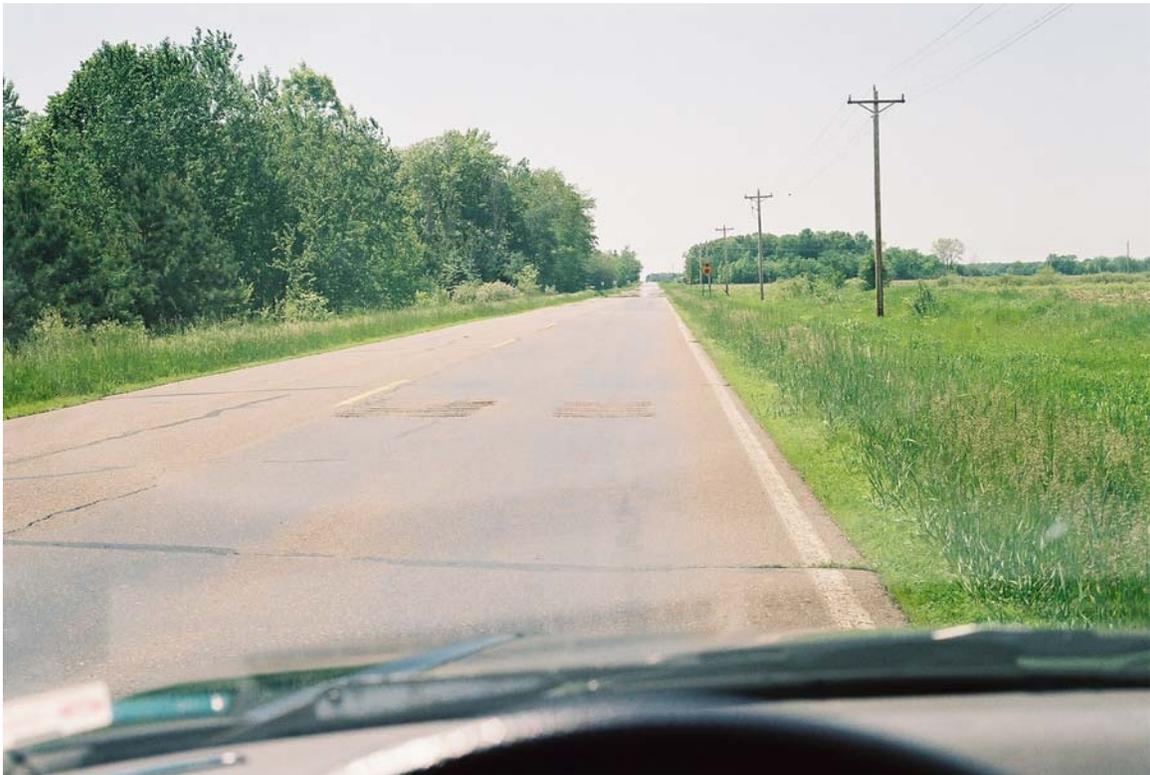
Photograph #244 (Reel #12, 6A) (from East, looking West): first of *three* sets of rumble strips and warning sign in view; also STOP AHEAD on road (though not visible in this photograph).

On East Side (looking West): to North—clear view of traffic on major road; to South—trees obscure traffic on major road.

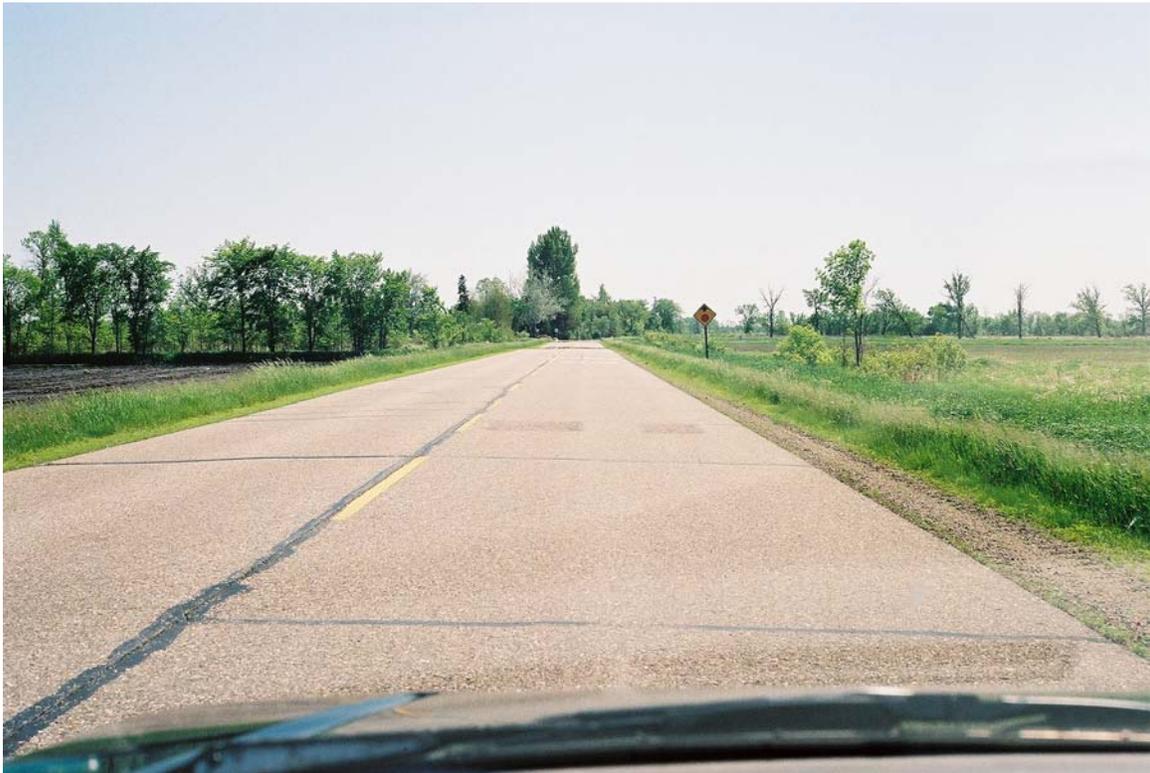
Photograph #251 (Reel #12, 13A) (from North, looking South): first rumble strip and warning sign in view; also, STOP AHEAD on road.

On North Side (looking South): to West—slight rise obscures traffic on major road; to East—trees obscure traffic on major road.

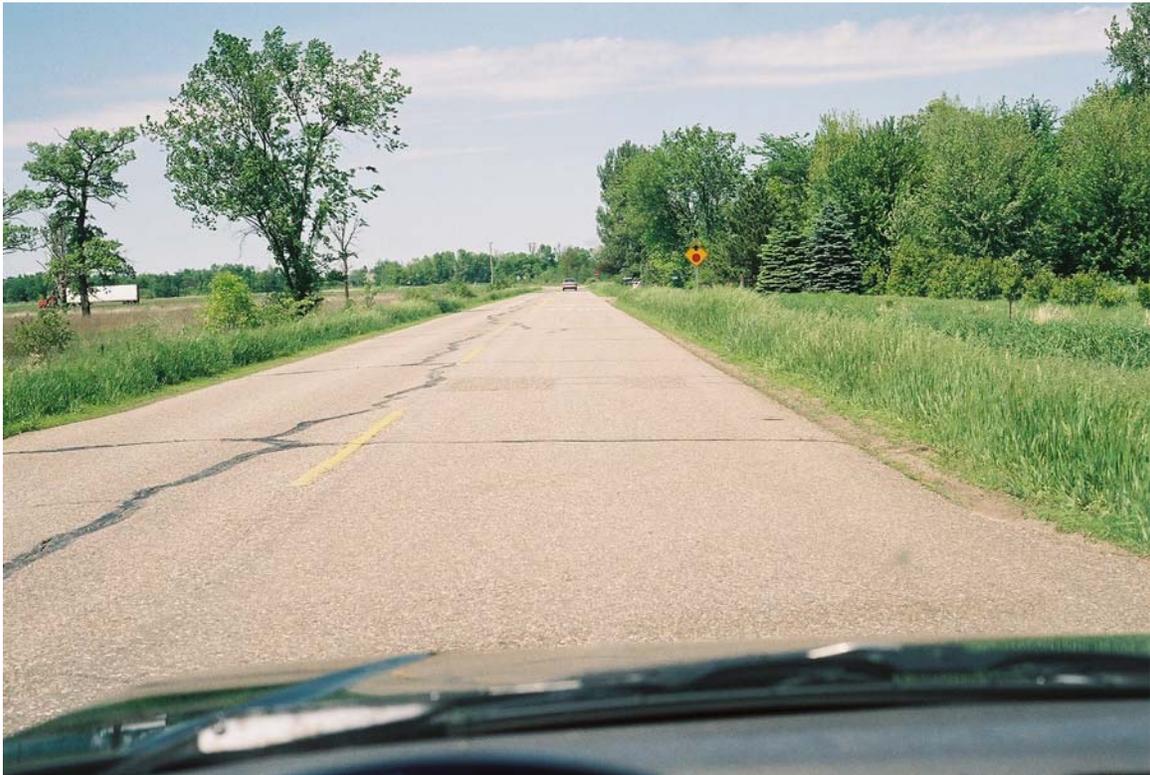
Photograph #253 (Reel #12, 15A) (from South, looking North): first rumble strip and warning sign in view; also, STOP AHEAD on road.

On South Side (looking North): to West—partially obstructed view of traffic on major road; to East—trees obscure traffic on major road.

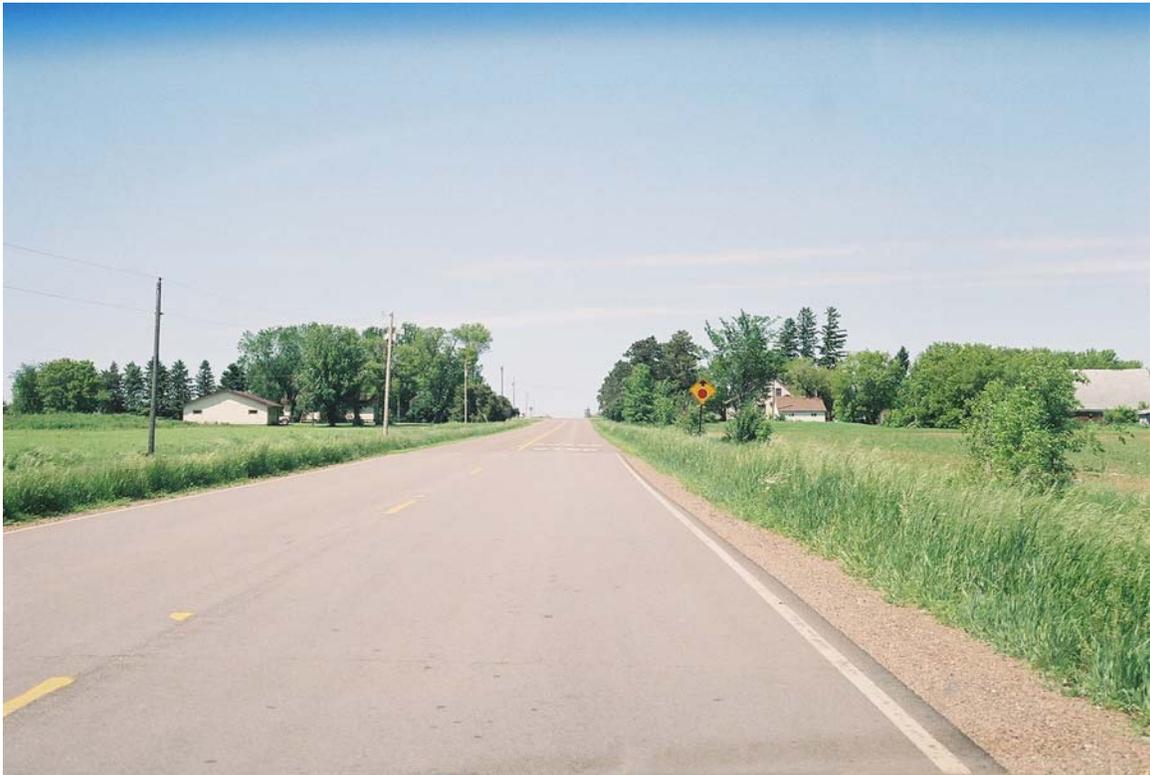
Photograph #255 (Reel #12, 17A) (from South, looking North): warning sign in view; also, STOP AHEAD on road.

On South Side (looking North): on both sides—trees and buildings obscure traffic on major road.

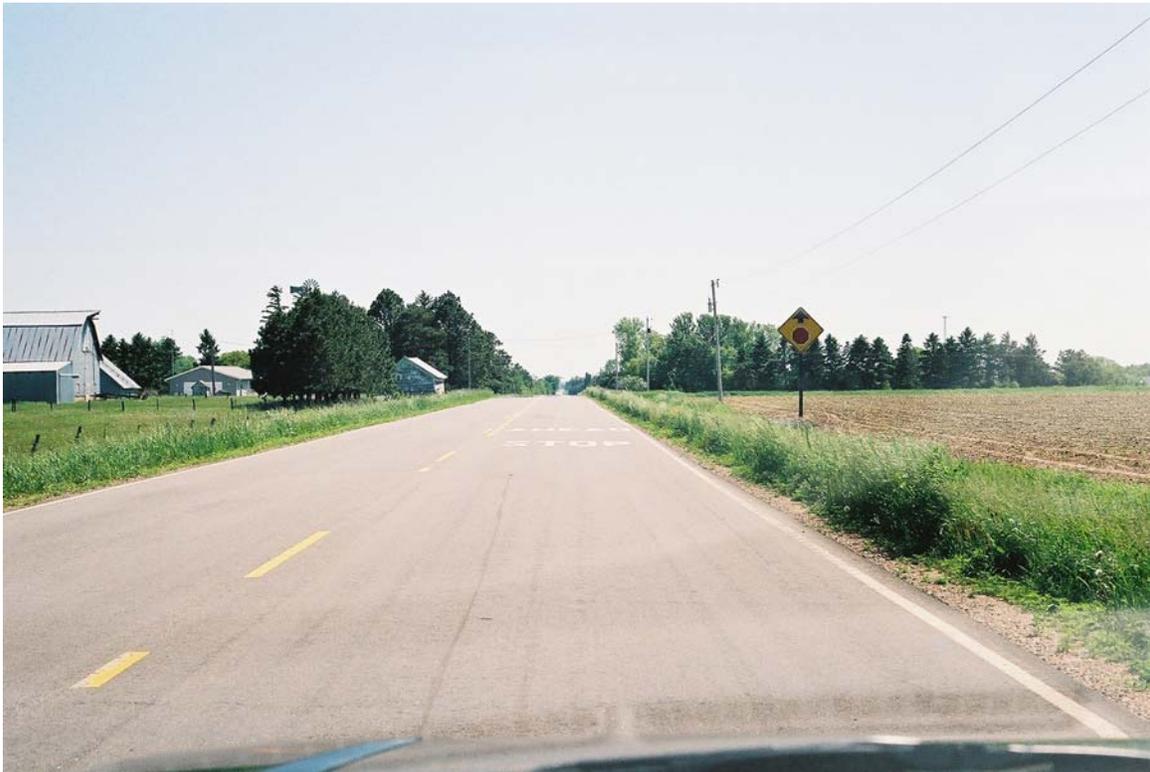
Photograph #256 (Reel #12, 18A) (from North, looking South): warning sign in view; also, STOP AHEAD on road.

On North Side (looking South): on both sides—trees and buildings obscure traffic on major road.

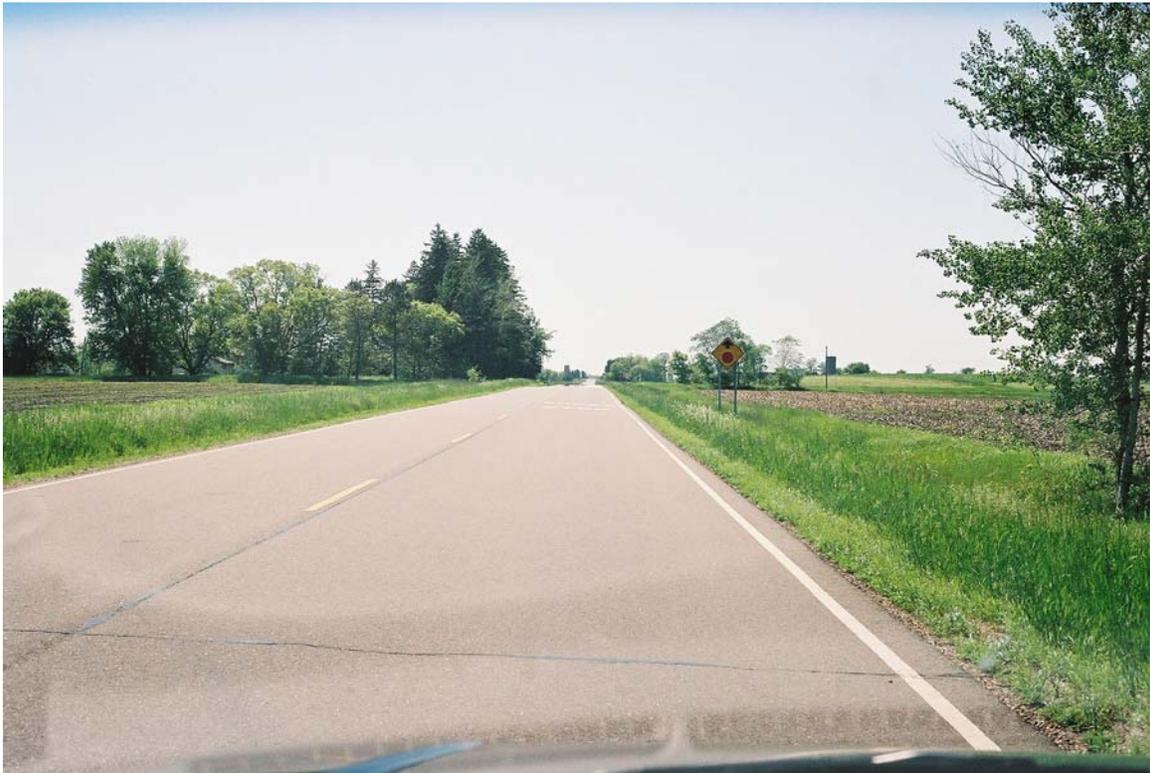
Photograph #257 (Reel #12, 19A) (from East, looking West): first rumble strip *missing* (note second set—a double se—is in place closer to intersection); warning sign in view; also, STOP AHEAD on road.

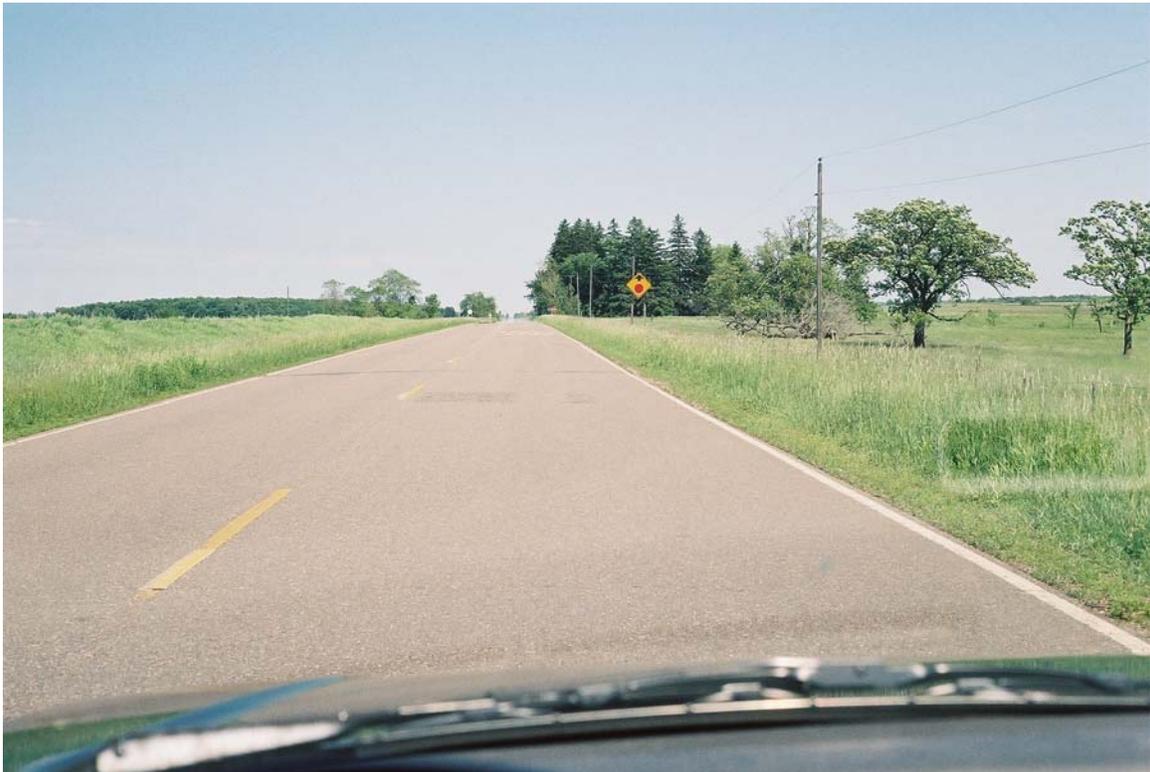
Photograph #259 (Reel #12, 21A) (from East, looking West): first rumble strip and warning sign in view; also, STOP AHEAD on road.

On West Side (looking East): to North—rise obscures traffic on major road; to South
trees partially obscure traffic on major road.

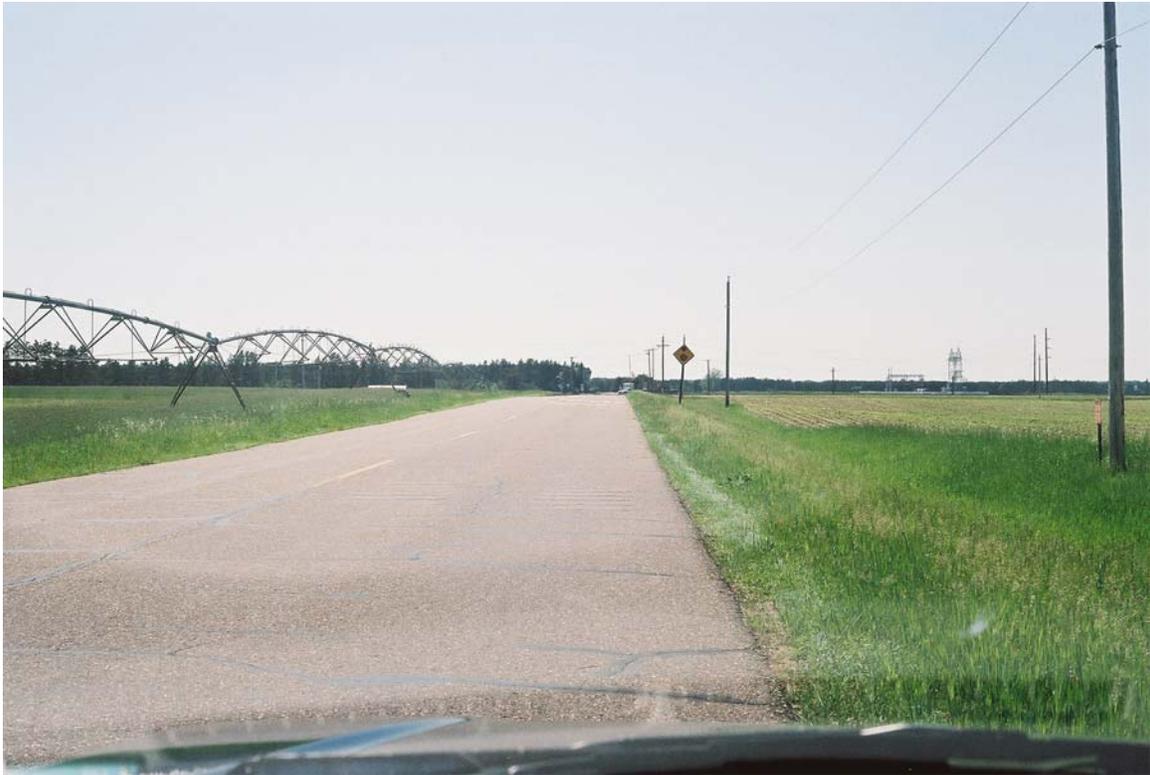
Photograph #261 (Reel #12, 23A) (from East, looking West): first rumble strips *filled in* (note second set—a double set—is in place closer to intersection); warning sign in view; also, STOP AHEAD on road.

On East Side (looking West): to North—clear view of traffic on major road; to South rise partially obscures traffic on major road.

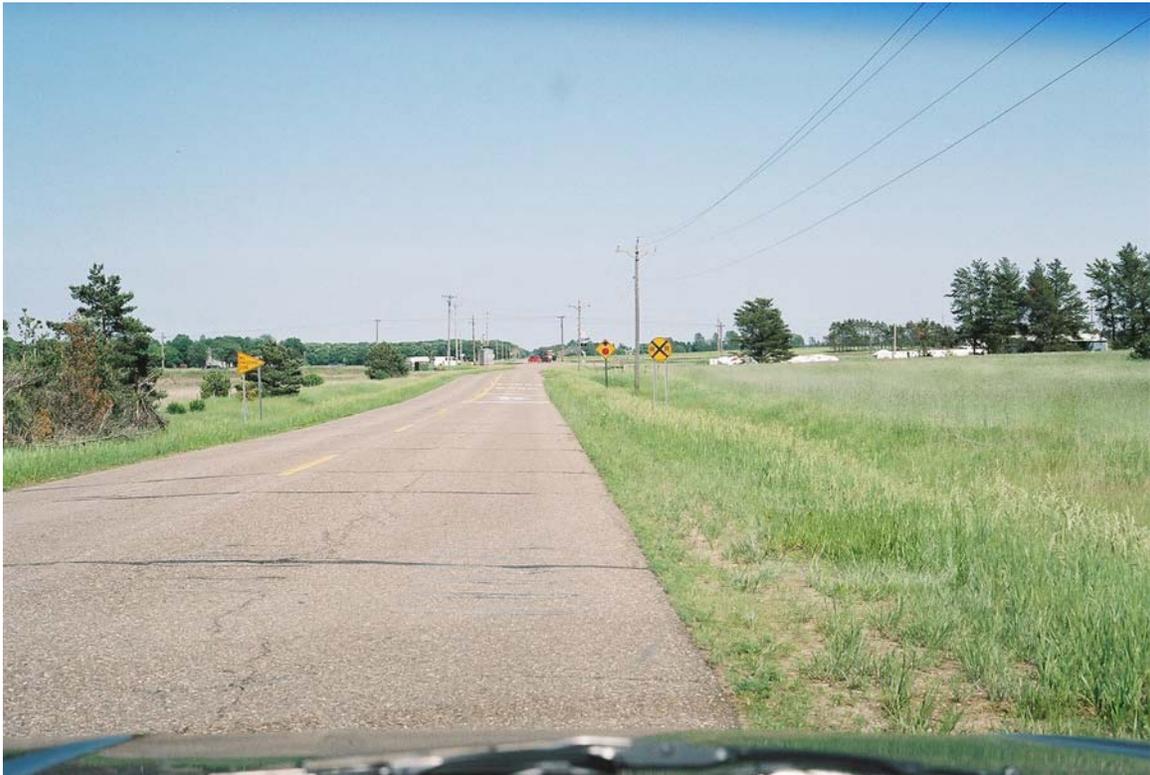
Photograph #263 (Reel #13, 1) (from West, looking East): first rumble strip is filled in (as are second rumble strips; warning sign in view; also, rail crossing sign in view and STOP AHEAD on road.

On West Side (looking East): to North—rise and trees partially obscure traffic on major road; to South—rise, trees, and buildings partially obscure traffic on major road.

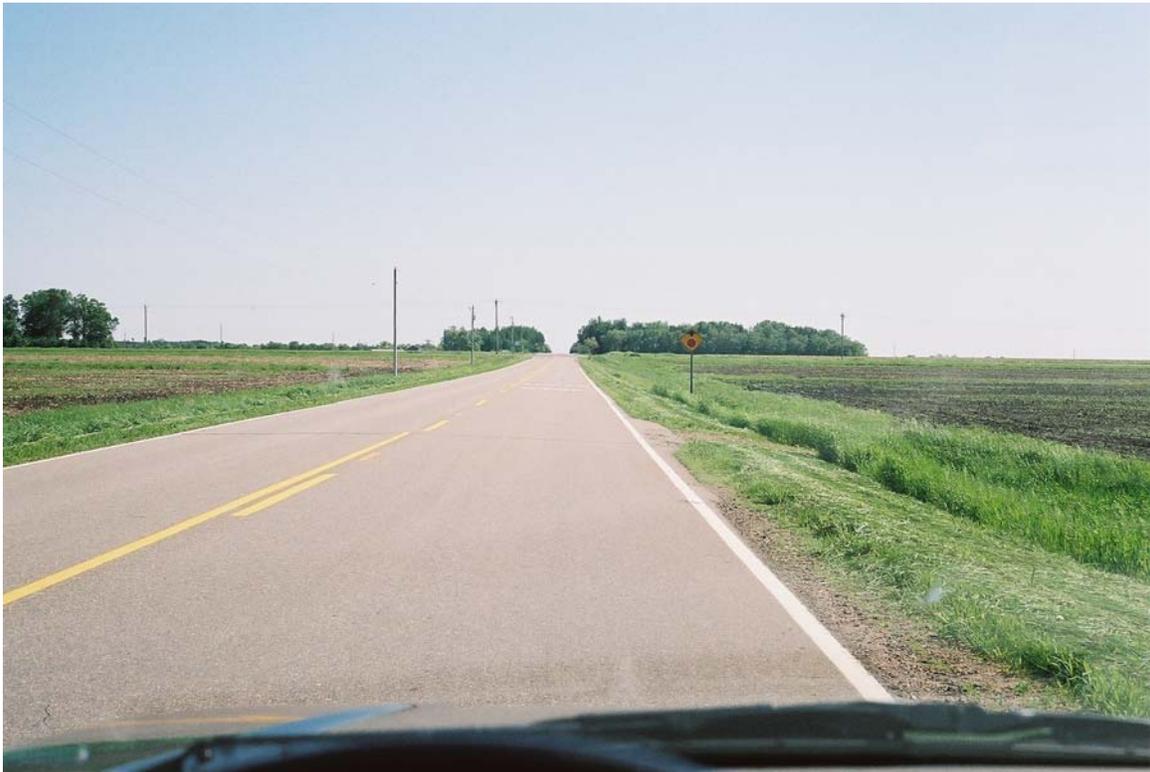
Photograph #265 (Reel #13, 3) (from North, looking South): warning sign in view and STOP AHEAD on road [New road surface—No rumble strips].

On North Side (looking South): on both sides—clear view of traffic on major road.

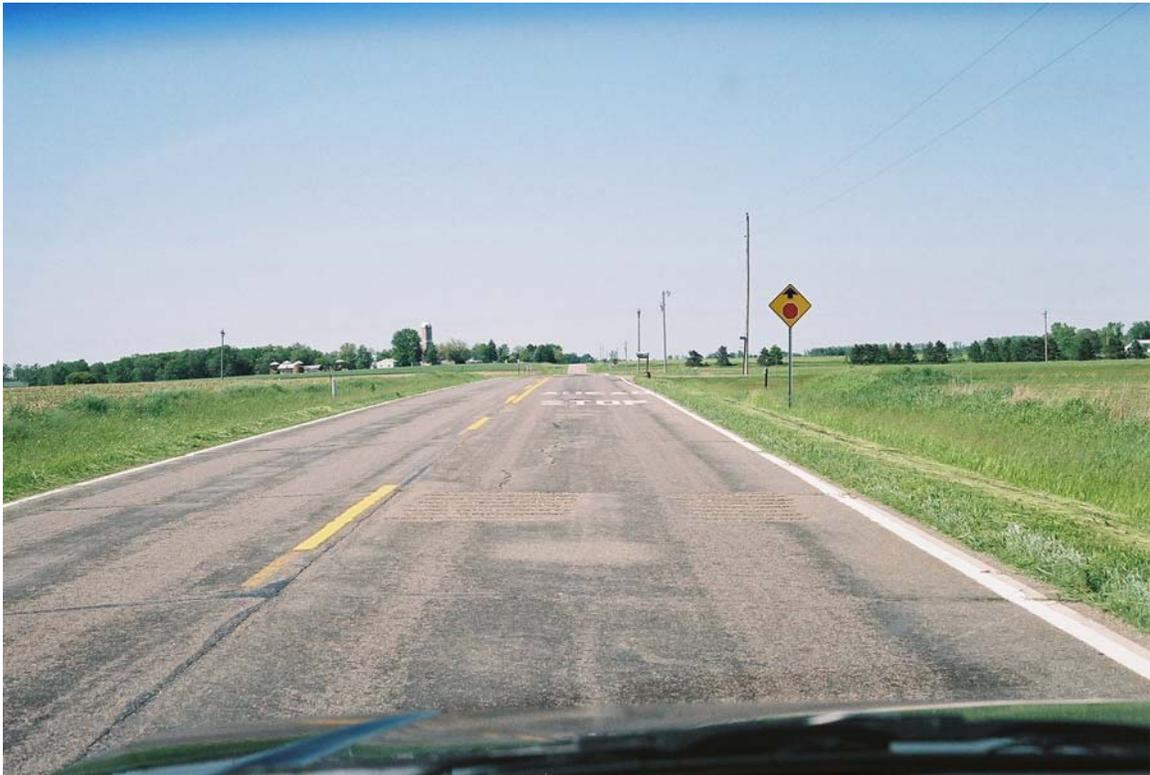
Intersection #86 (South Side)

On South Side (looking North): on both sides—clear view of traffic on major road.

Photograph #266 (Reel #13, 4) (from South, looking North): first rumble strips and sign in view; also, STOPAHEAD on road.

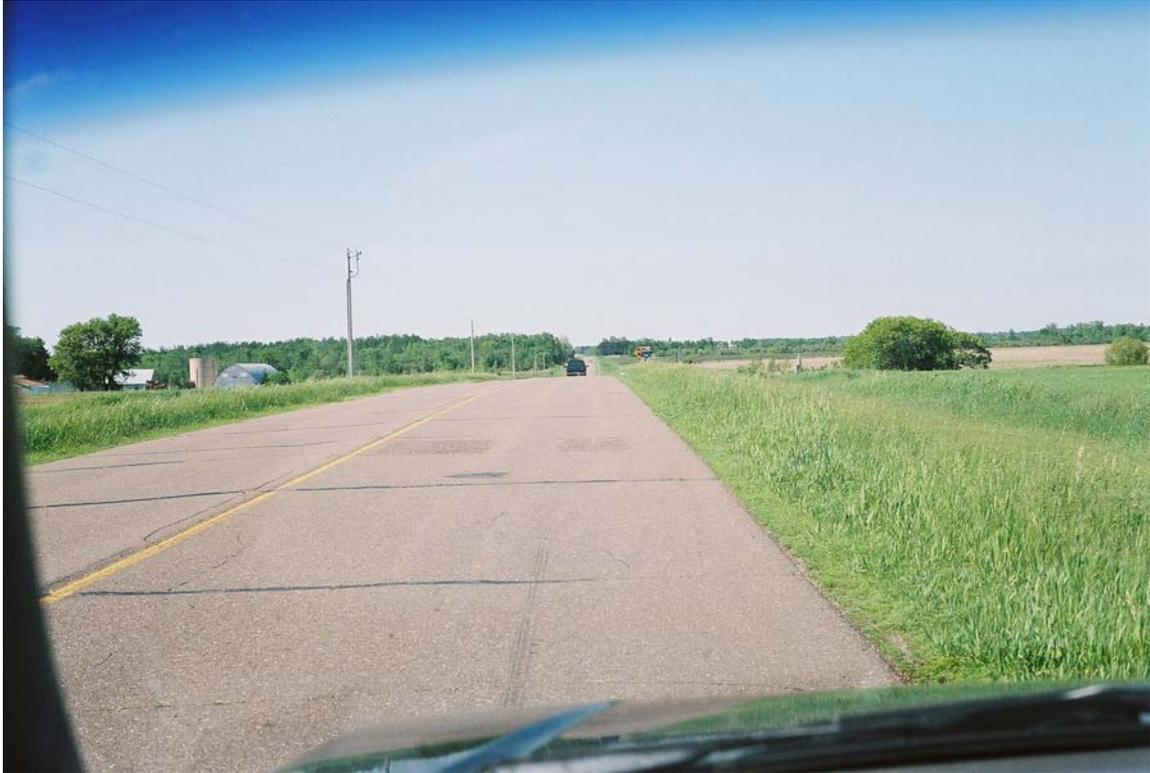
Intersection #86 (North Side)

On South Side (looking North): on both sides—rise obscures traffic on major road.

Photograph #268 (Reel #13, 6) (from South, looking North): first rumble strips but *No* warning sign.

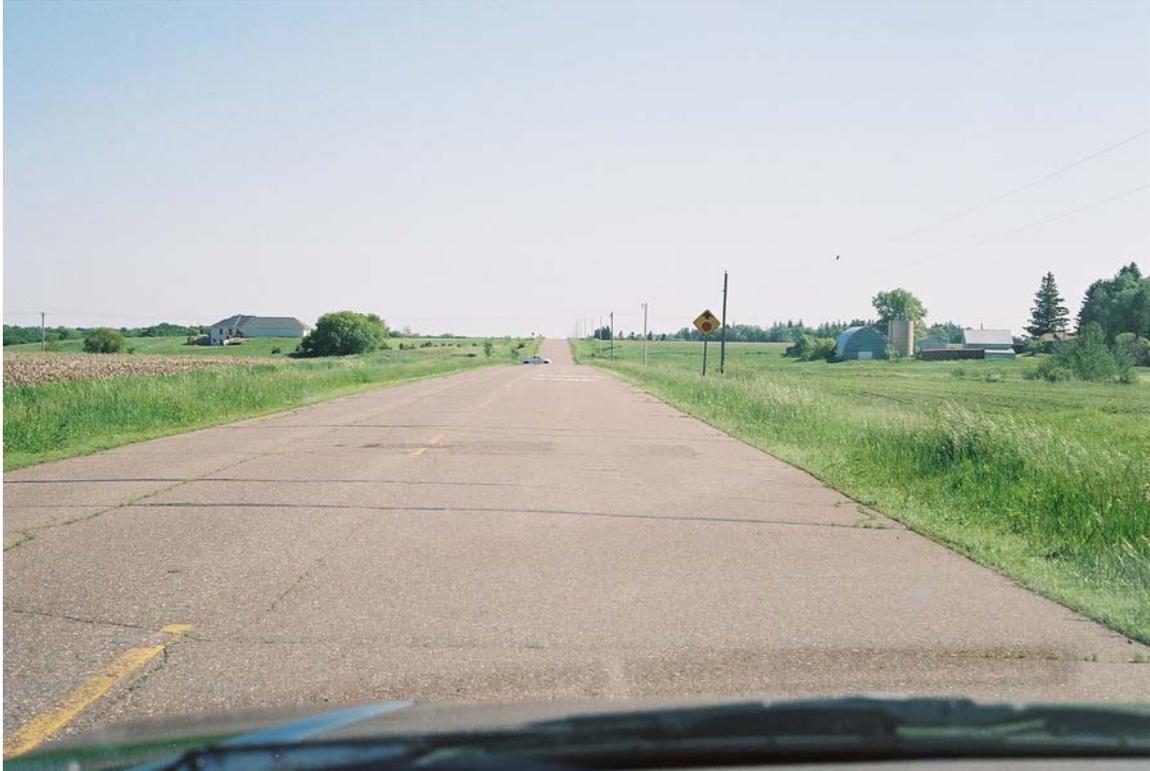
Intersection #87 (West Side)

On North Side (looking South): on both sides—rise obscures traffic on major road.

Photograph #270 (Reel #13, 8) (from North, looking South): first rumble strips and warning sign in view: also, STOP AHEAD on road.

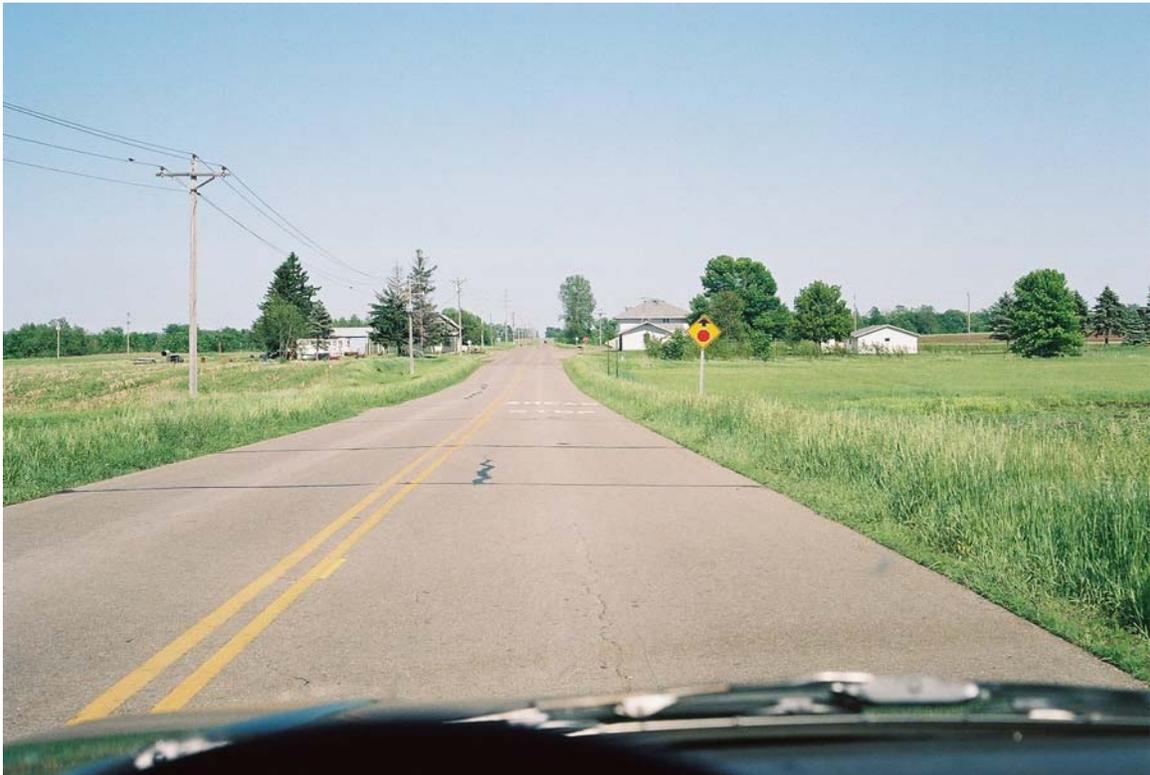
Intersection #87 (East Side)

Condition: **Rumble Strips (wheel)** on Minor Road (1st rumble strips *missing*)

On West Side (looking East): both sides obscured close in, by buildings, trees.

Photograph #272 (Reel #13, 10) (from West, looking East): first rumble strips *missing*; warning sign in view; also, STOPAHEAD on road.
