2006-42

Final Report

Stopping Behavior at Real-World
Stop-Controlled Intersections
with and without In-Lane Rumble Strips

**Center for Human Factors Systems Research and Design
University of Minnesota**

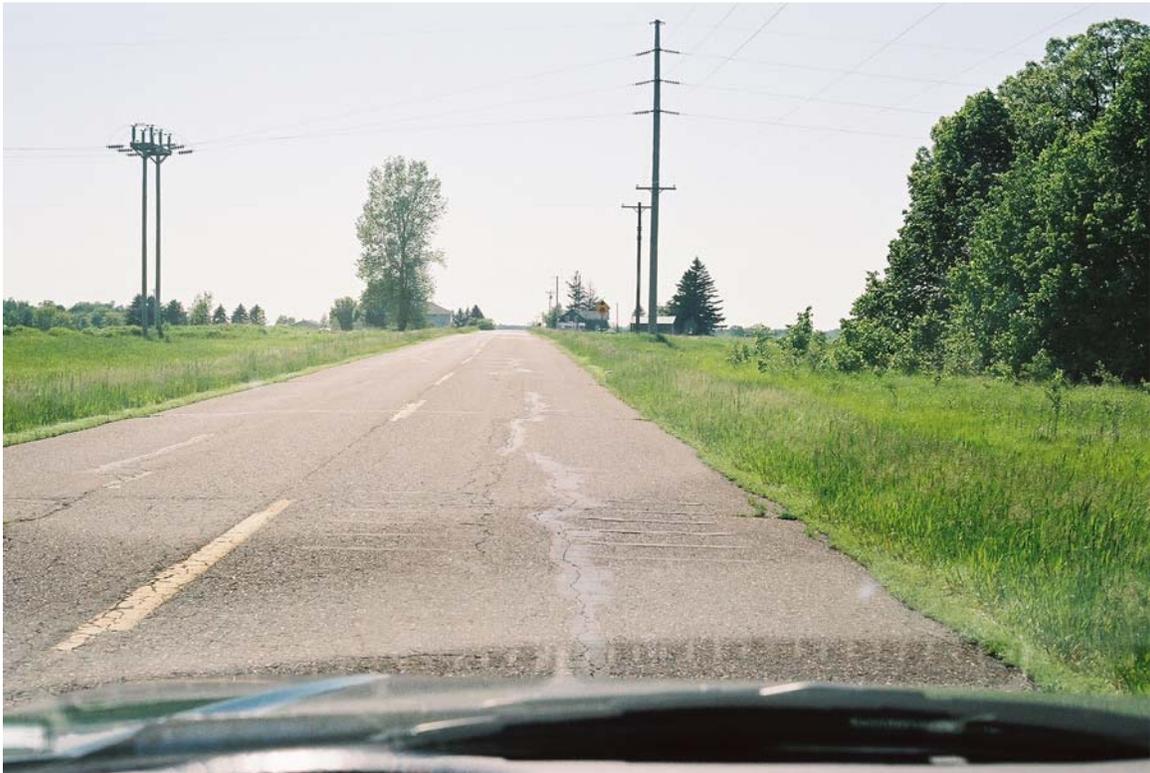
Intersection #88 (South Side)

Condition: **Rumble Strips (wheel)** on Minor Road (1st rumble strips *filled in*)

On East Side (looking West): on both sides—trees and buildings obscure traffic on major road.

Photograph #274 (Reel #13, 12) (from East, looking West): first rumble strips *filled in*; but, warning sign in view.

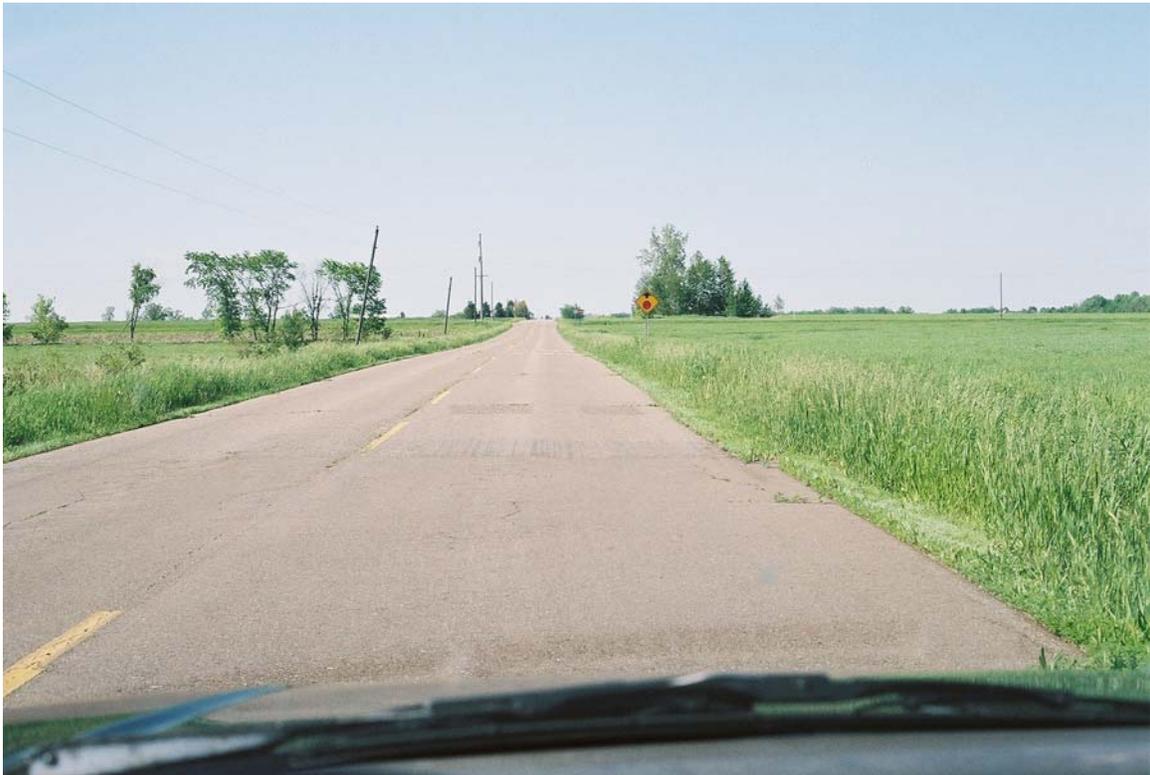
Intersection #88 (North Side)

On South Side (looking North): to West—trees partially obscure traffic on major road; to East—clear view of traffic on major road (in front of trees).

Photograph #276 (Reel #13, 14) (from South, looking North): first rumble strips and warning sign in view; also, STOP AHEAD on road.

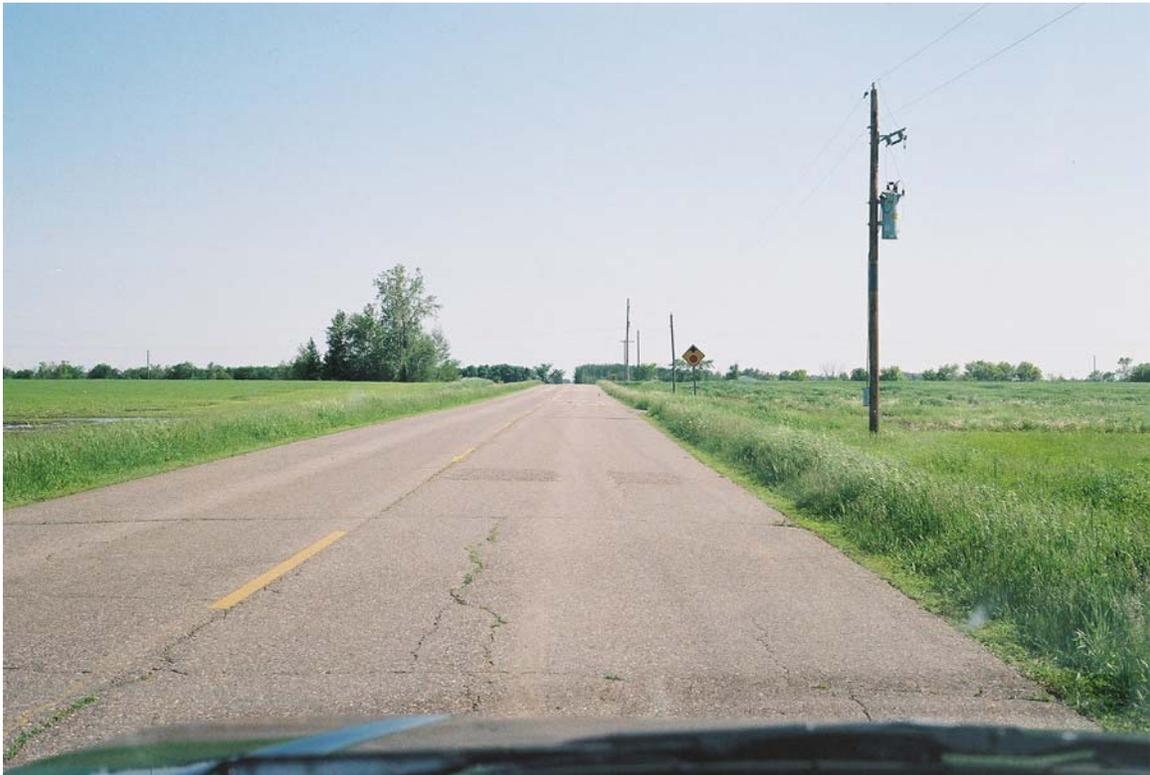
Intersection #89 (North Side)

On North Side (looking South): to East—rise and trees obscures traffic on major road; to West—rise obscures traffic on major road.

Photograph #278 (Reel #13, 16) (from North looking South): first rumble strips and warning sign in view; also, STOP AHEAD on road.

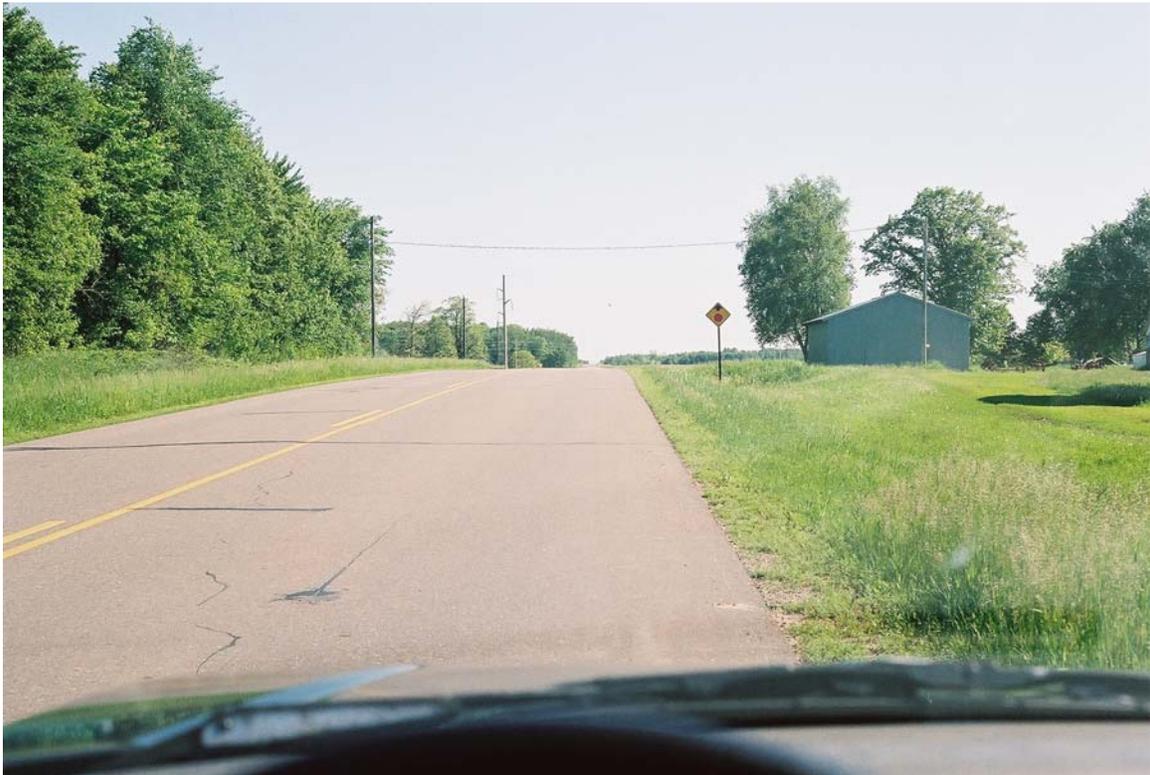
Intersection #89 (South Side)

Condition: **Rumble Strips (wheel)** on Minor Road (1st rumble strips *missing*)
Major road at angle; it runs North-East to South-West

On North Side (looking South): to East—rise and trees obscure traffic on major road; to
West—rise, trees, and buildings obscure traffic on major road.

Photograph #280 (Reel #13, 18) (from North looking South): first rumble strips *missing*;
warning sign in view.

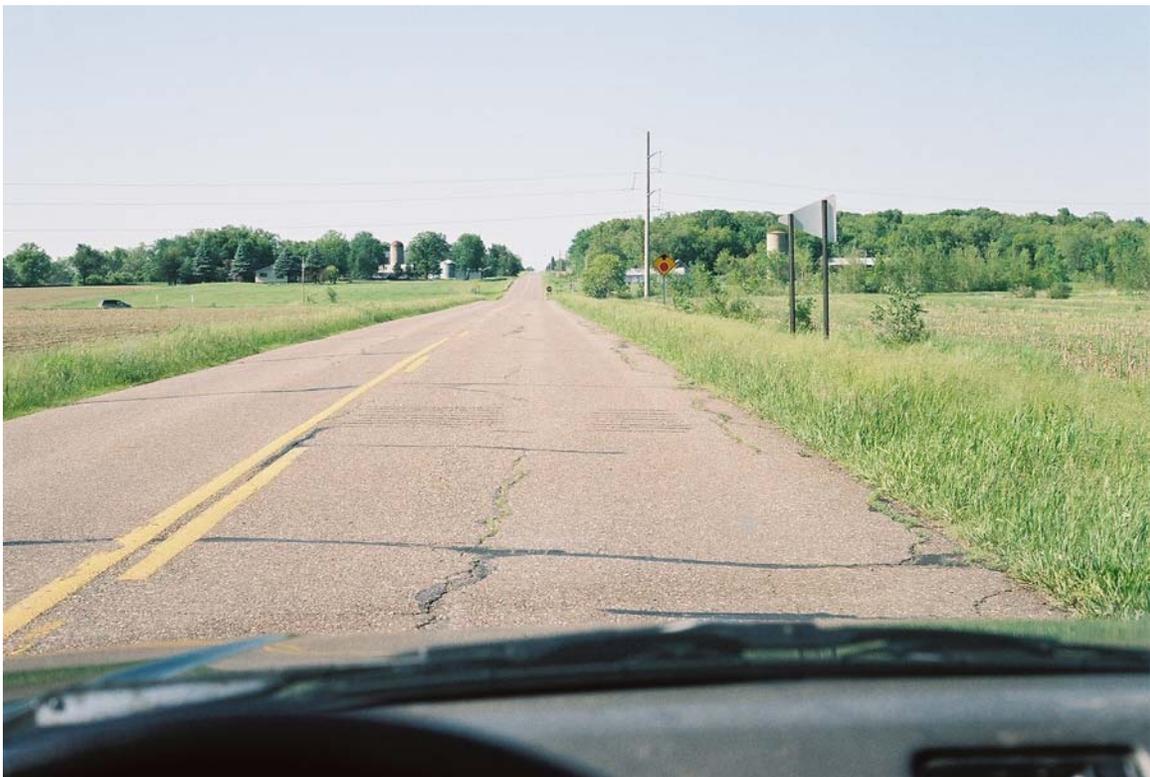
Intersection #90 (North Side)

On South Side (looking North): to West—clear view of traffic on major road; to East—
trees and buildings obscure traffic on major road.

Photograph #282 (Reel #13, 20) (from South looking North): first rumble strips and warning sign in view.

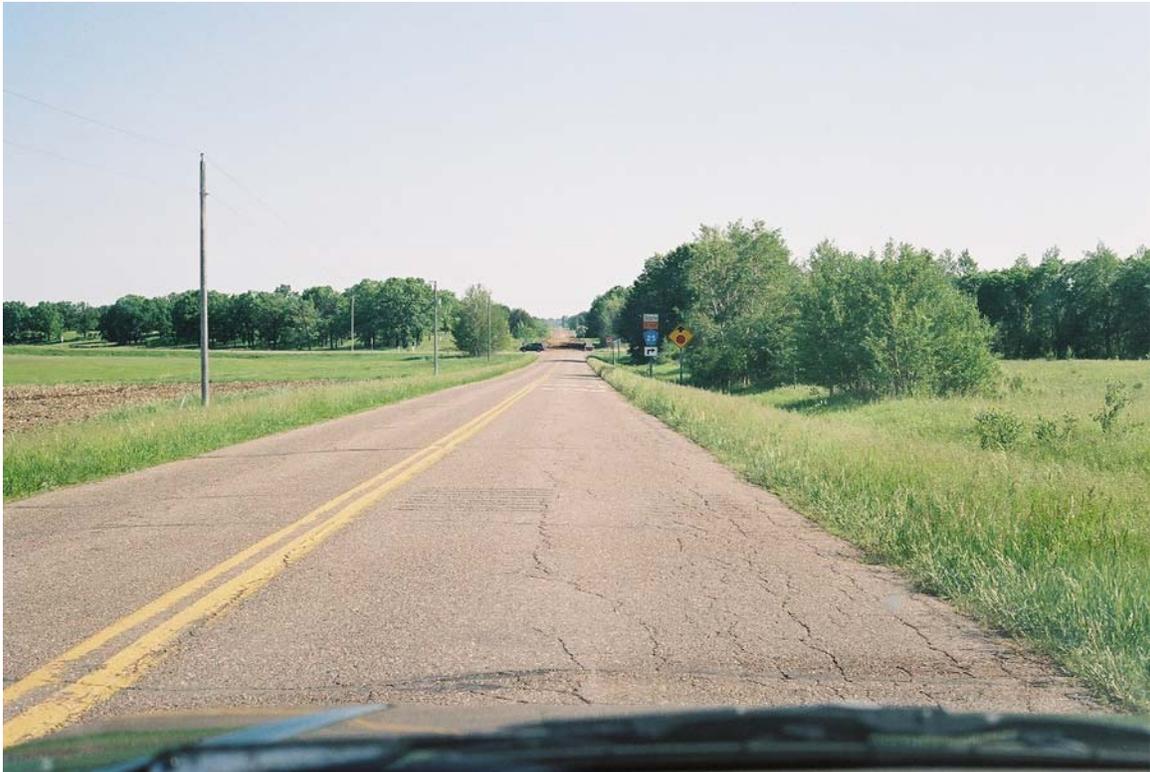
Photograph #284 (Reel #13, 22) (from North looking South): first rumble strip *with right side missing*; warning sign in view; also, STOP AHEAD on road.

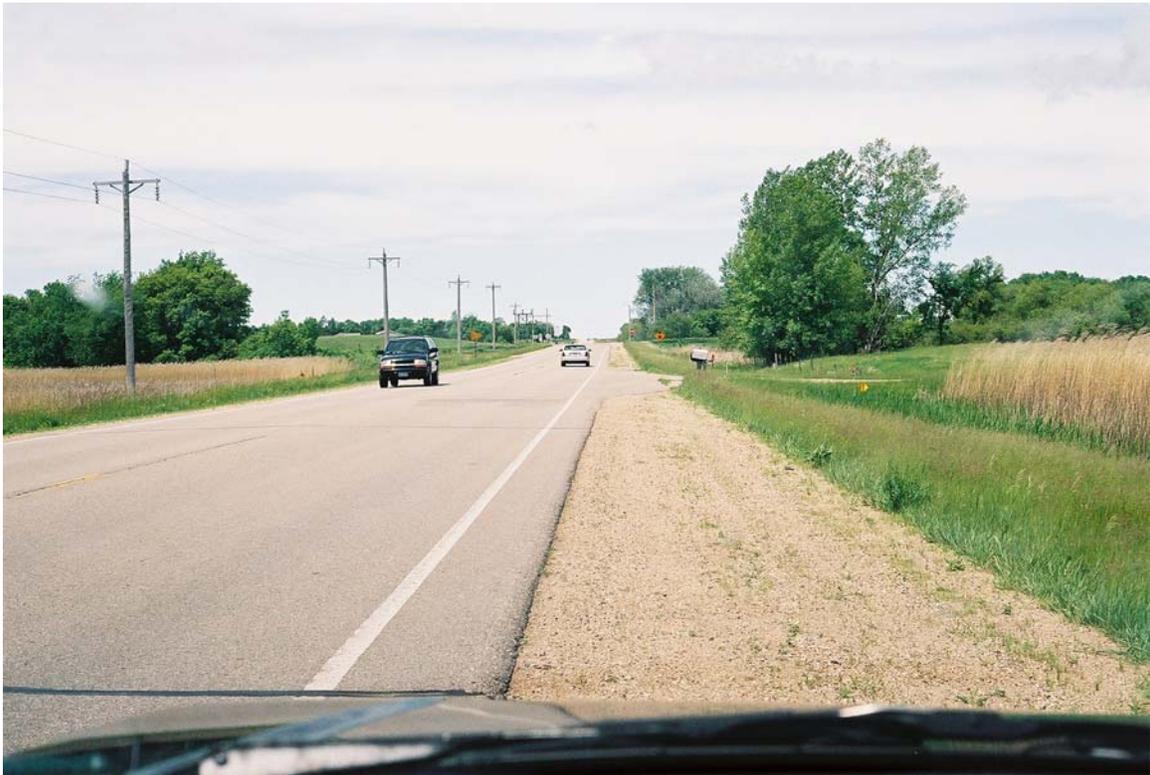
Intersection #91 (West Side)

On East Side (looking West): to South—rise and trees obscures traffic on major road; to
North—trees obscure traffic on major road.

Photograph #286 (Reel #13, 24) (from East looking West): first rumble strip and warning sign in view.

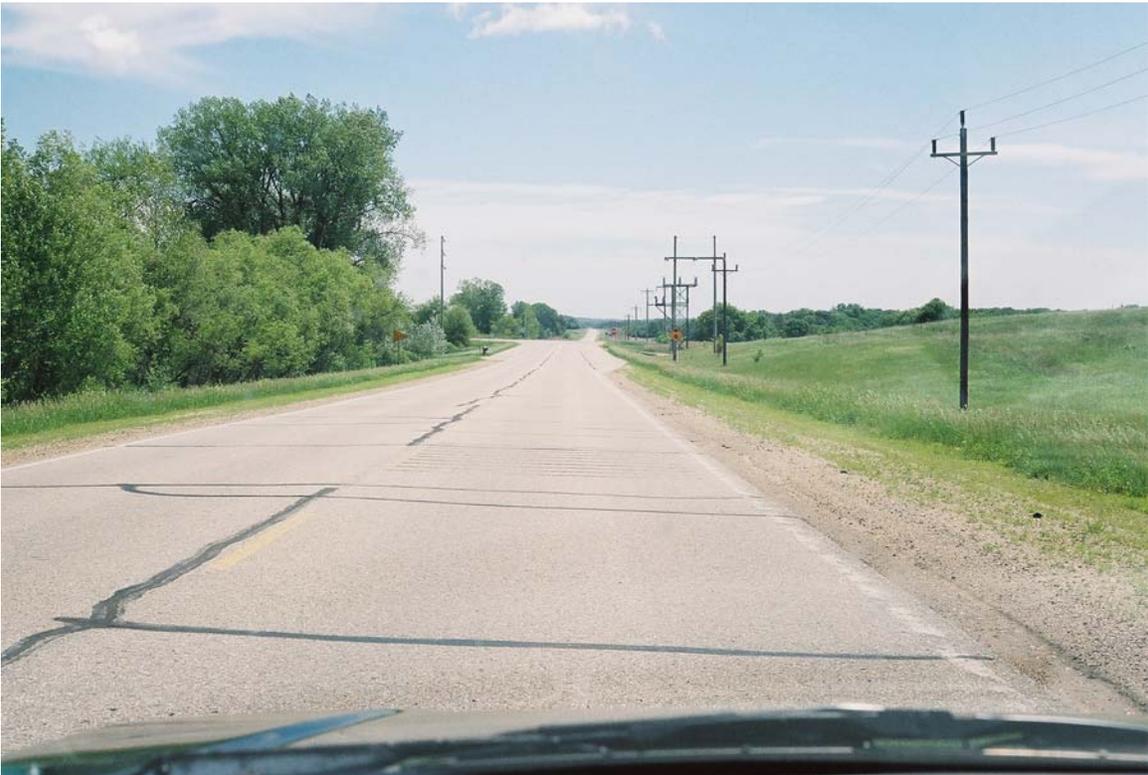
Intersection #92 (South Side)

On West Side (looking East): to North—trees obscure traffic on major road; to South—
rise obscures traffic on major road.

Photograph #288 (Reel #14, 2A) (from East looking West): first rumble strip and warning sign in view.

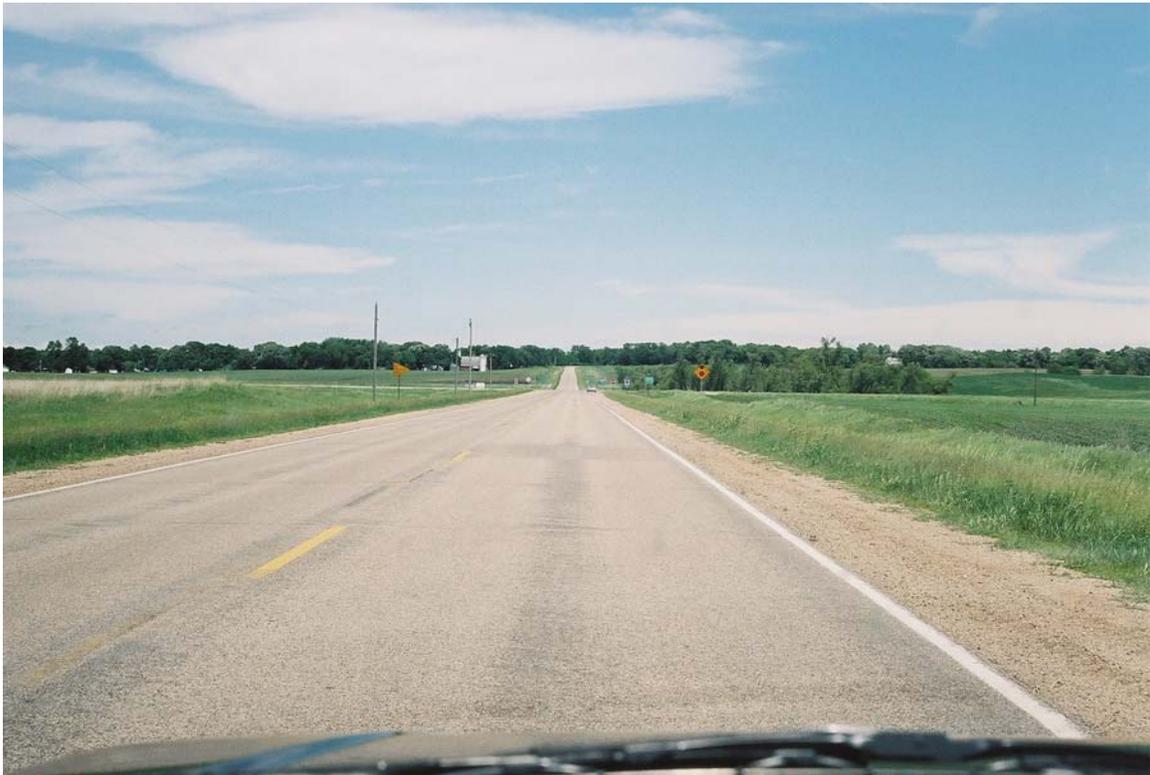
Intersection #92 (North Side)

On South Side (looking North): on both side—clear view of traffic on major road.

Photograph #290 (Reel #14, 4A) (from South looking North): first rumble strip and warning sign in view.

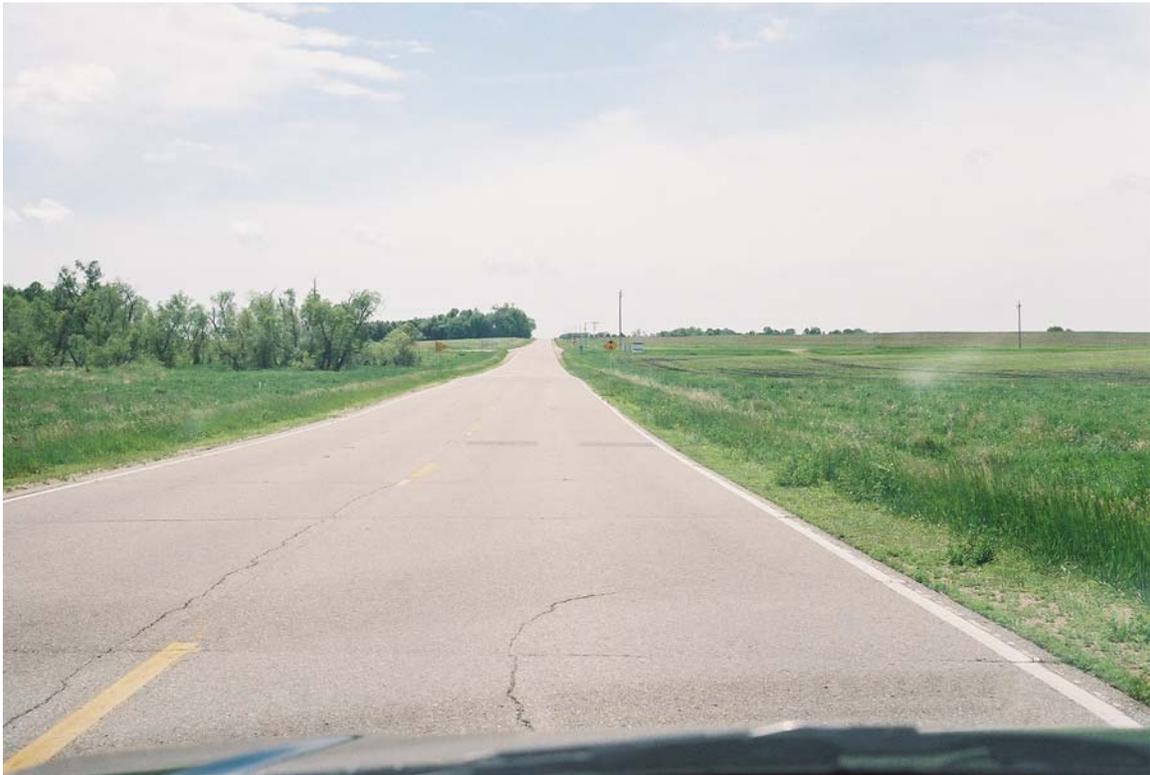
Intersection #93 (North Side)

On North Side (looking South): to East—trees obscure traffic on major road; to West—clear view of traffic on major road.

Photograph #292 (Reel #14, 6A) (from North looking South): first rumble strip and warning sign in view.

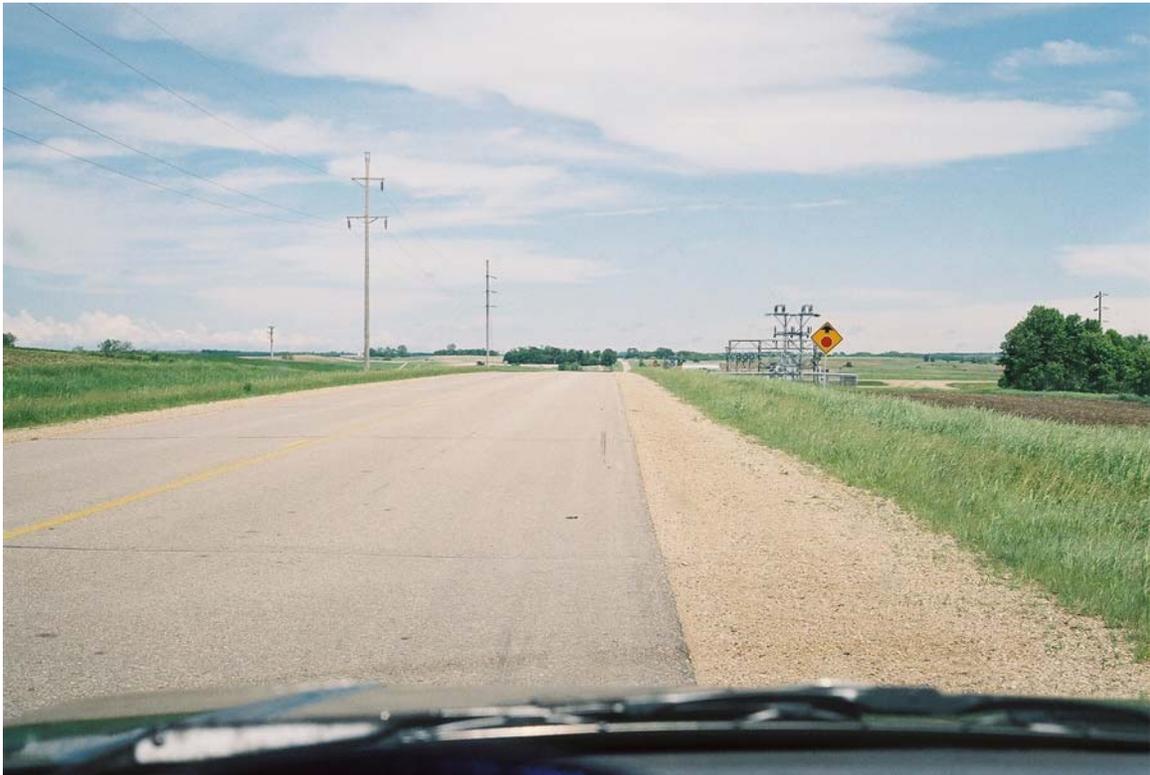
Intersection #93 (South Side)

On North Side (looking South): rise obscures intersection; on both sides rise obscures traffic on major road.

Photograph #294 (Reel #14, 8A) (from North looking South): from approximately where rumble strips would be; warning sign in view.

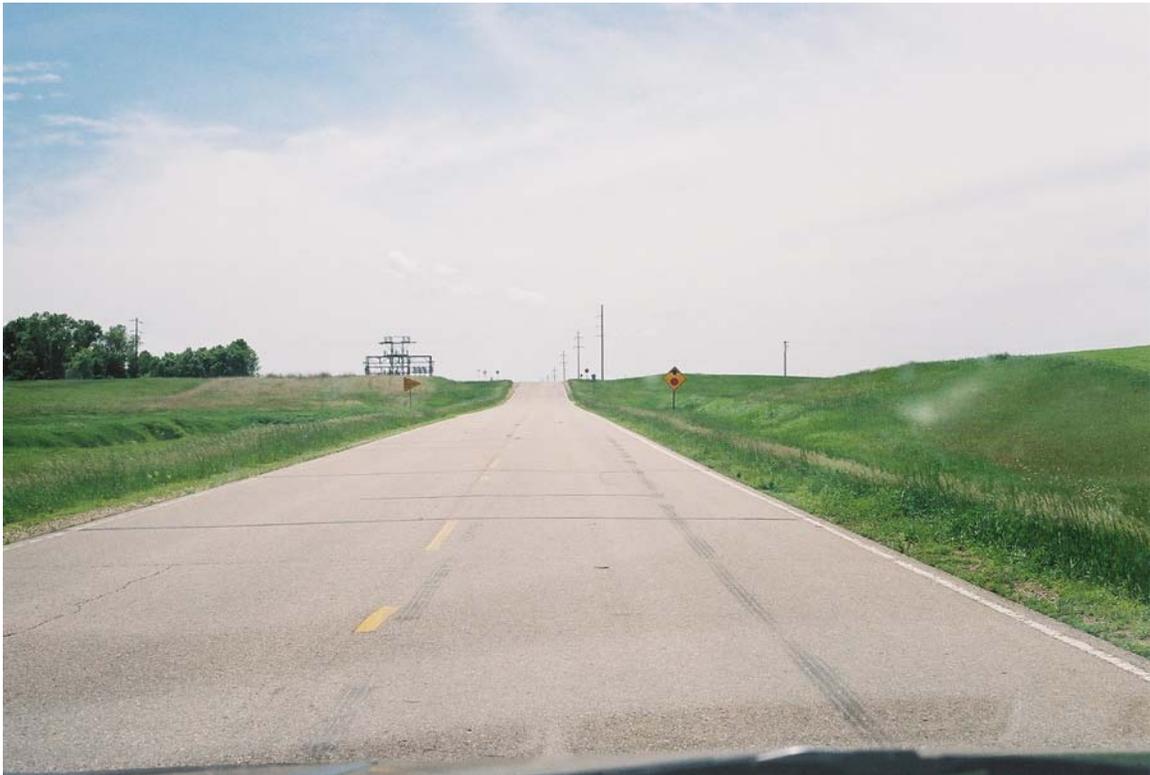
Intersection #94 (West Side)

On South Side (looking North): on both sides—rise partially obscures traffic on major road.

Photograph #295 (Reel #14, 9A) (from South looking North): from approximately where rumble strips would be; warning sign in view.

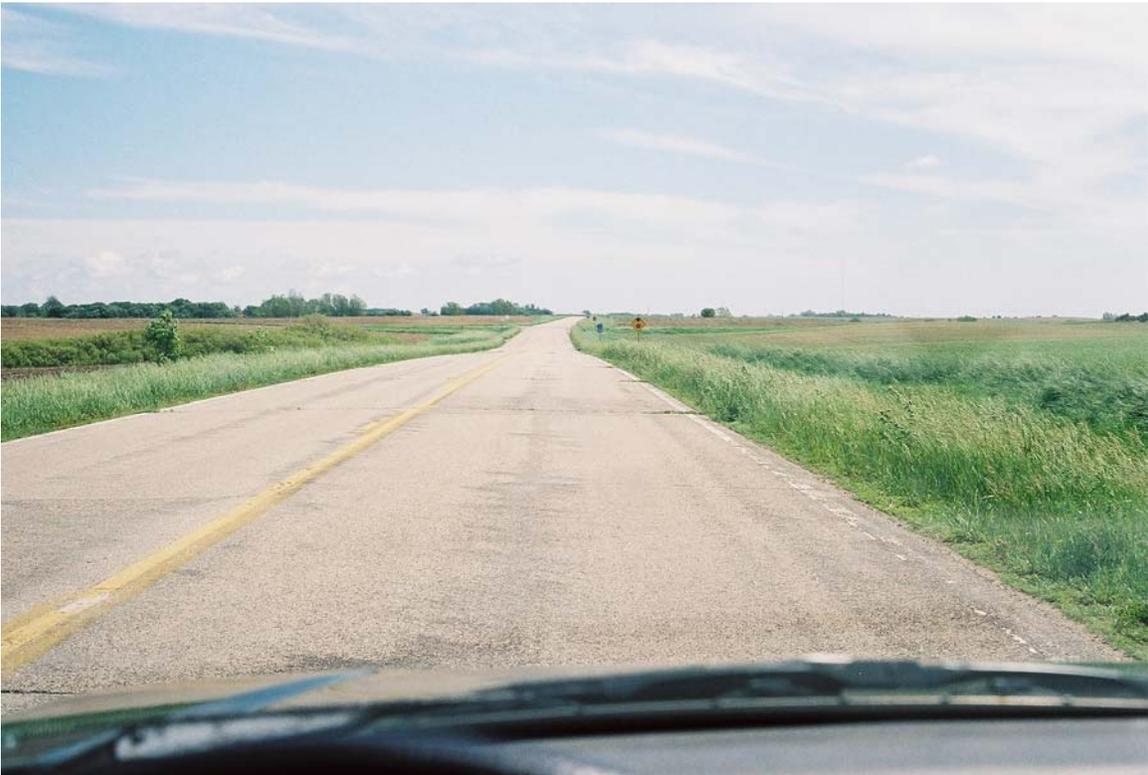
Intersection #94 (East Side)

On West Side (looking East): on both sides—nearer in to the intersection on the major road there is a clear view of traffic on major road; while further away, rise obscures traffic.

Photograph #296 (Reel #14, 10A) (from West looking East): first rumble strips and warning sign in view.

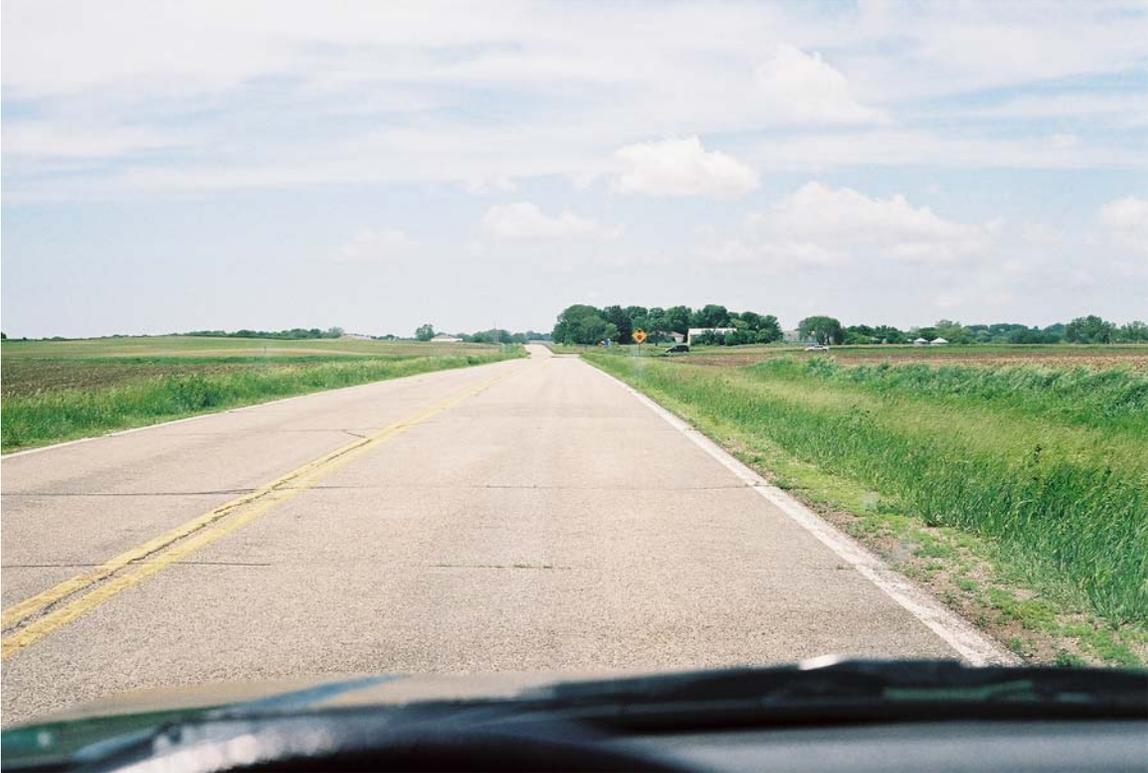
Intersection #95 (North Side)

On East Side (looking West): on both sides—clear view of traffic on major road.

Photograph #298 (Reel #14, 12A) (from East looking West): first rumble strips warning sign in view.

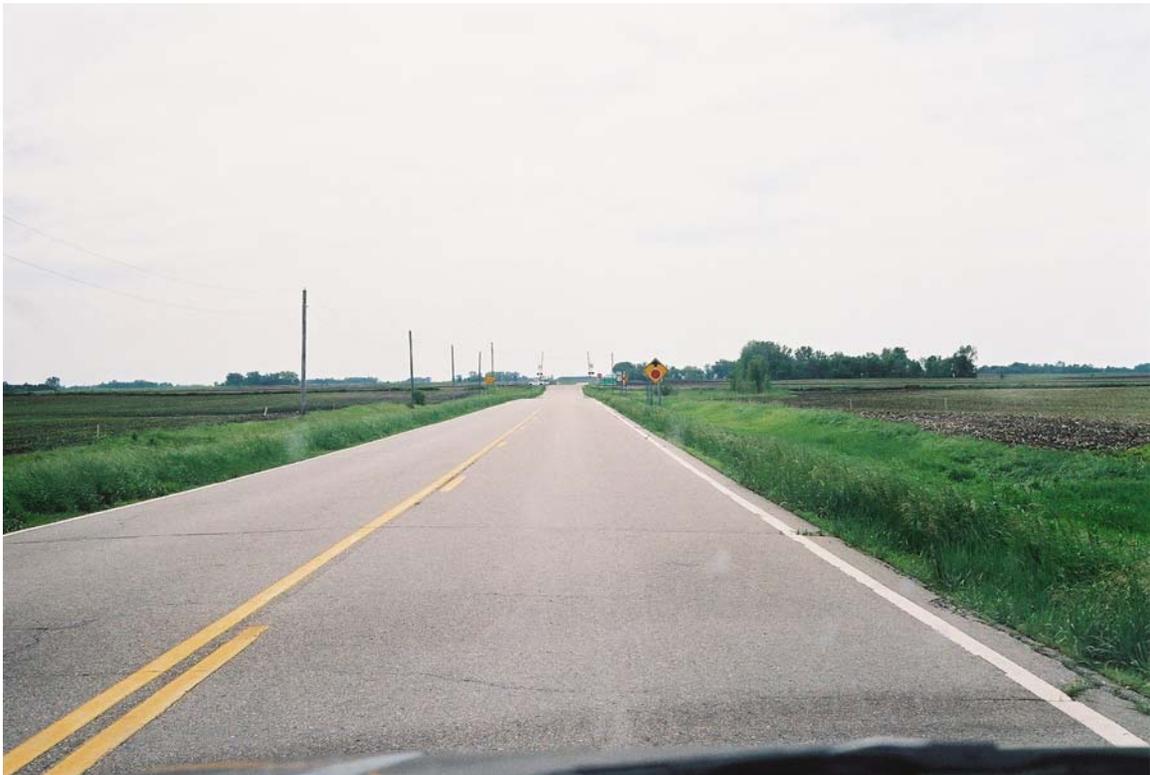
Intersection #95 (South Side)

On North Side (looking South): on both sides—traffic on major road visible.

Photograph #300 (Reel #14, 14A) (from North looking South): from approximately where rumble strips would be; warning sign in view.

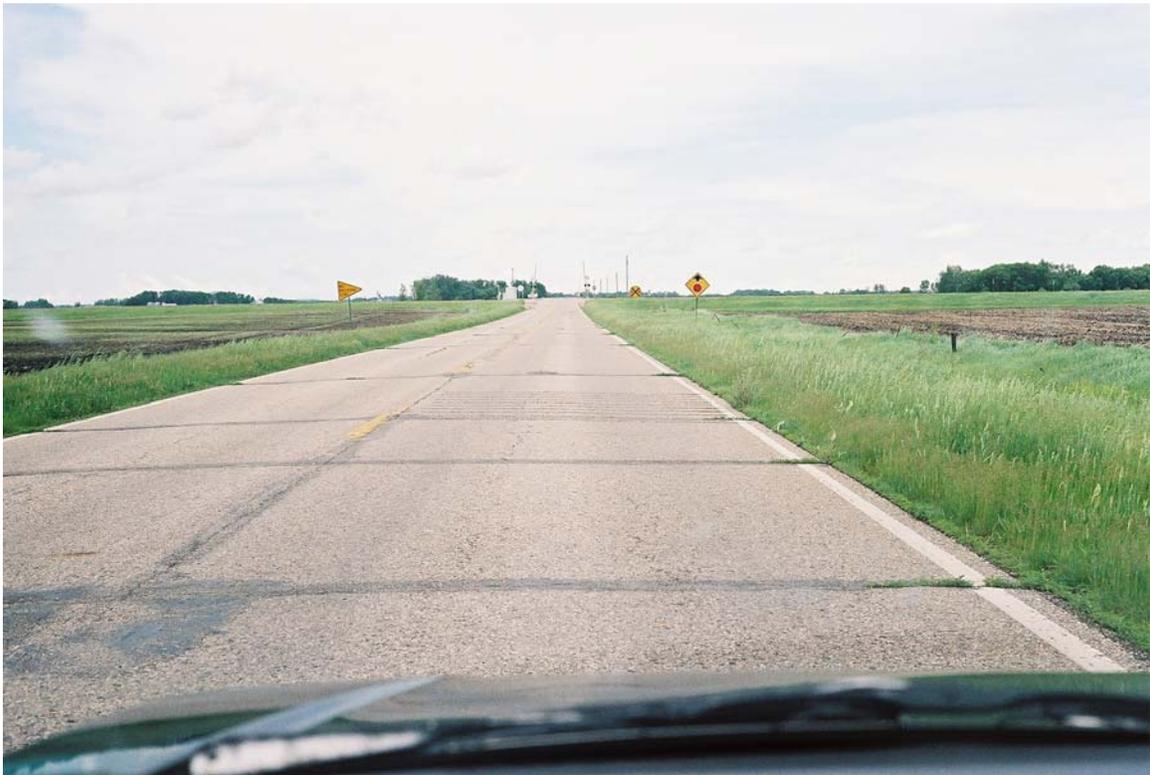
Intersection #96 (North Side)

On South Side (looking North): on both sides—clear view of traffic on major road.

Photograph #301 (Reel #14, 15A) (from South looking North): first rumble strips and warning sign in view.

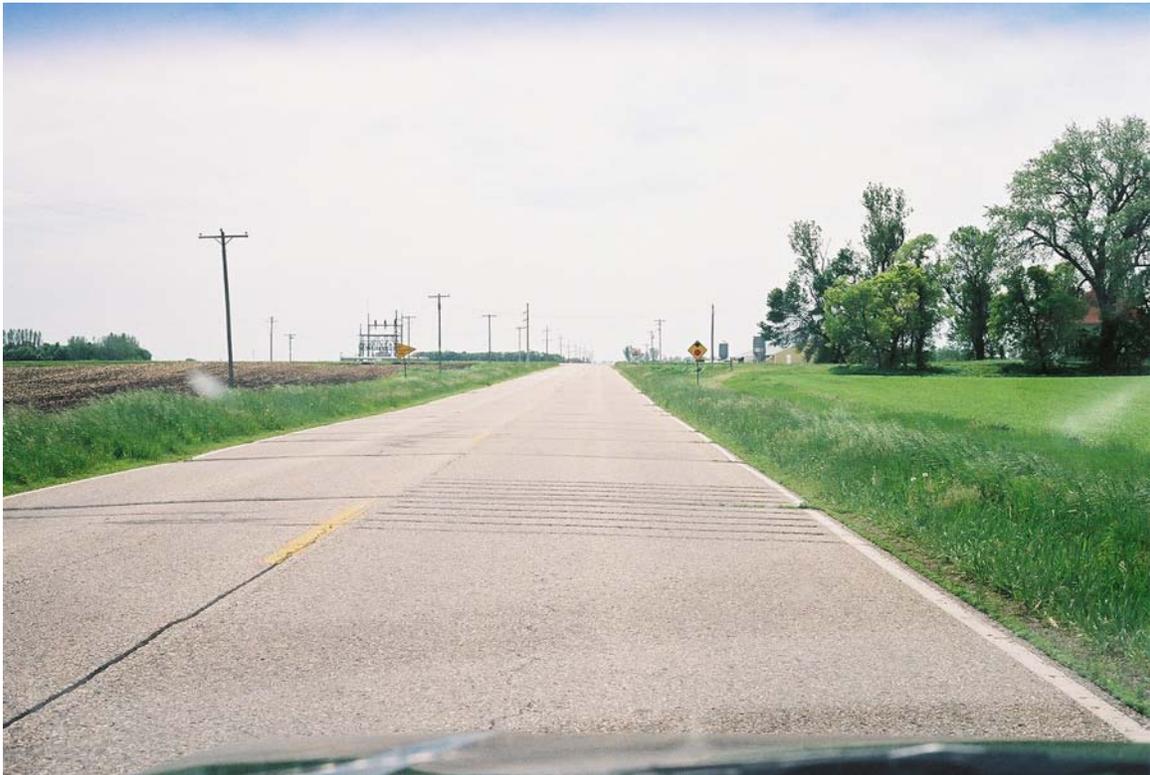
Intersection #96 (South Side)

On North Side (looking South): to West—trees obscure traffic on major road; to East—
clear view of traffic on major road.

Photograph #303 (Reel #14, 17A) (from North looking South): first rumble strips and warning sign in view.

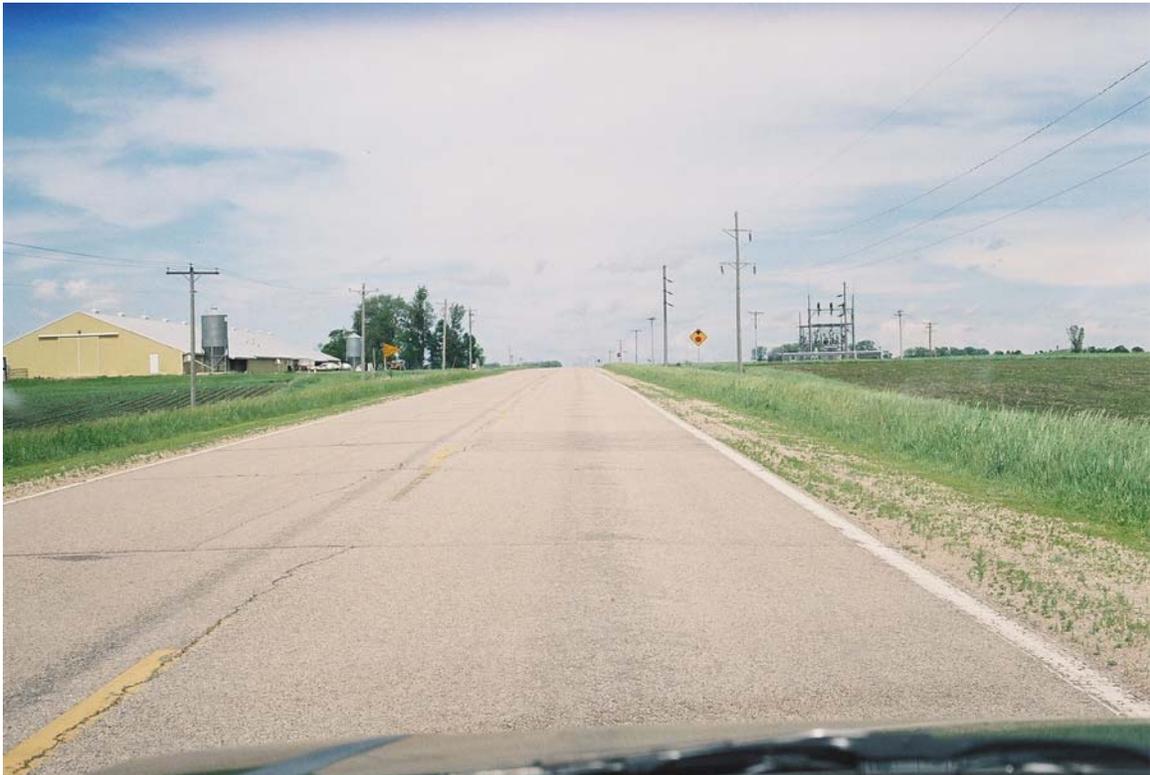
Intersection #97 (North Side)

On South Side (looking North): to West—buildings and trees obscure traffic on major road; to East— power plant partially obscures traffic on major road.

Photograph #305 (Reel #14, 19A) (from South looking North): first rumble strips and warning sign in view.

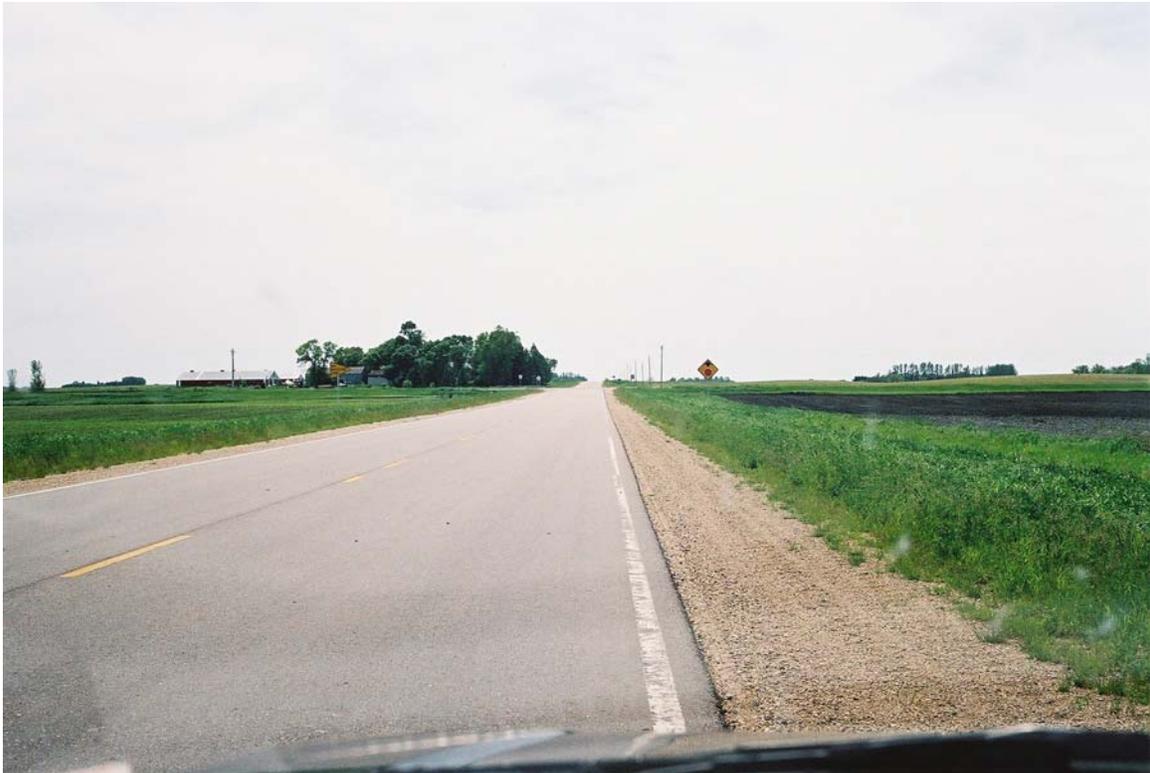
Intersection #97 (South Side)

On North Side (looking South): on both sides—clear view of traffic on major road.

Photograph #307 (Reel #14, 21A) (from North looking South): from approximately where rumble strips would be; warning sign in view.

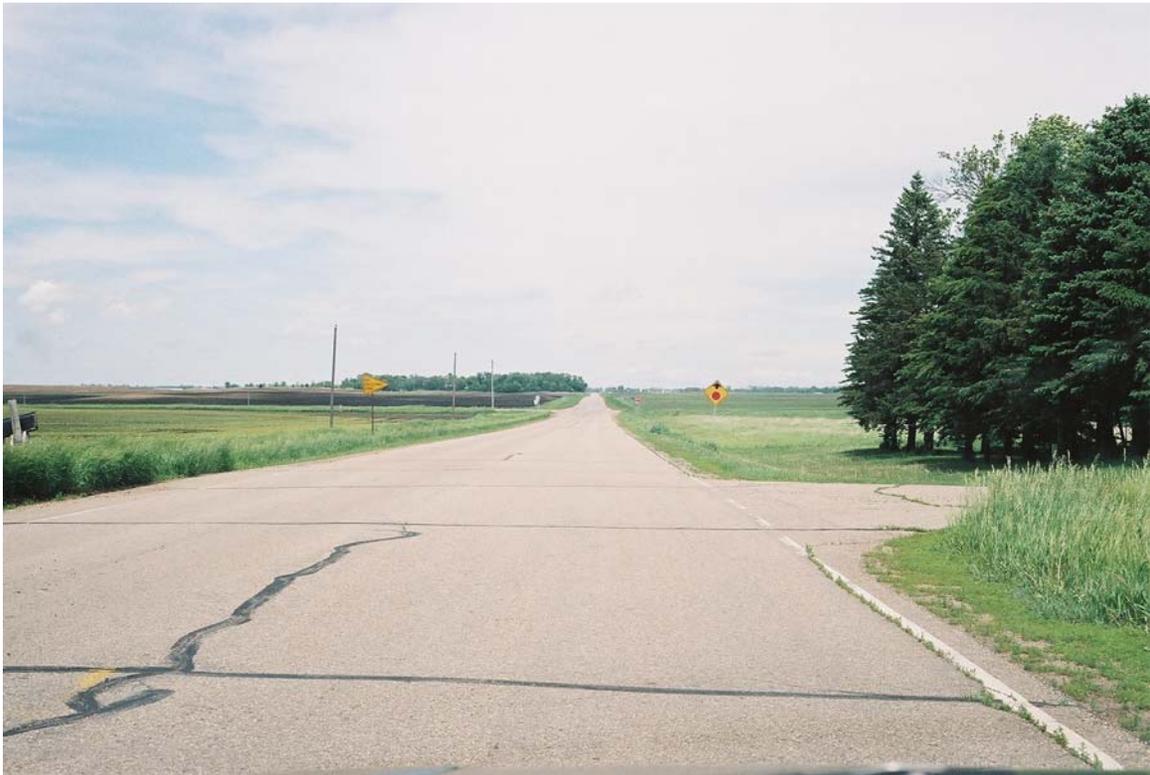
Intersection #98 (North Side)

On South Side (looking North): to West—clear view of traffic on major road; to East—trees obscure traffic on major road.

Photograph #308 (Reel #14, 22A) (from South looking North): from approximately where rumble strips would be; warning sign in view.

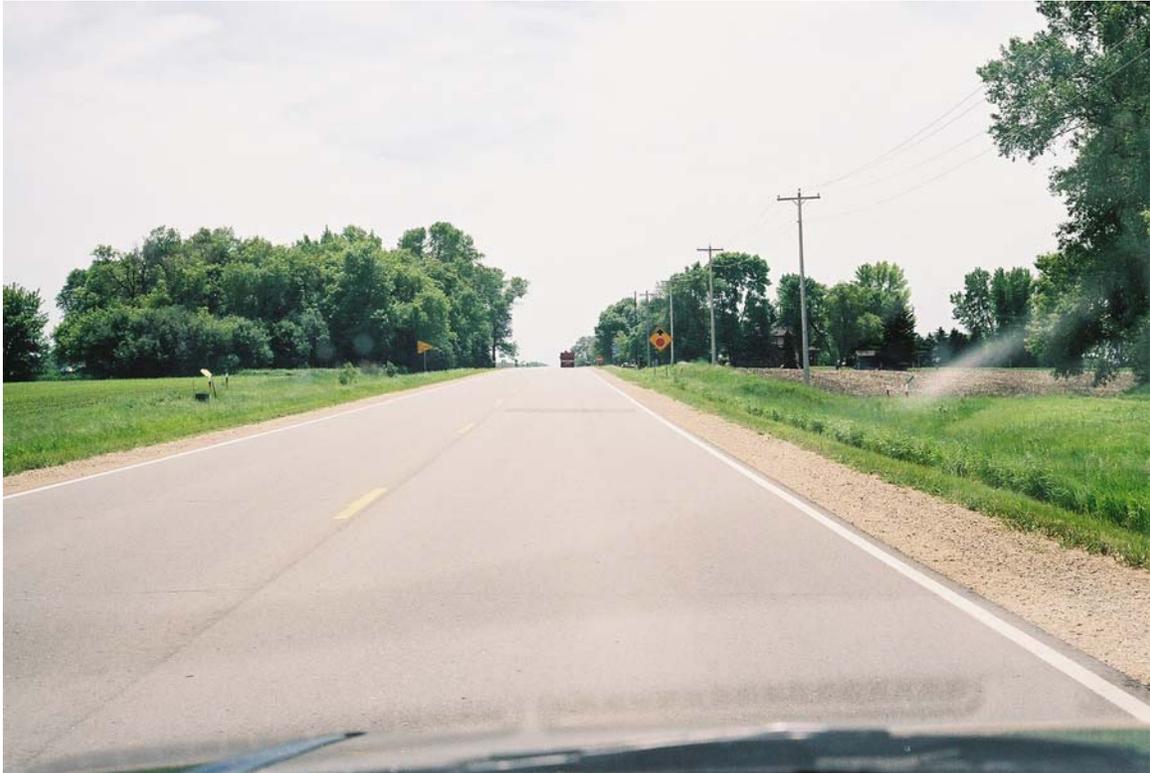
Intersection #98 (South Side)

On North Side (looking South): to West—trees and buildings obscure traffic on major road; to East—trees obscure traffic on major road.

Photograph #309 (Reel #14, 23A) (from North looking South): first rumble strips and warning sign in view.

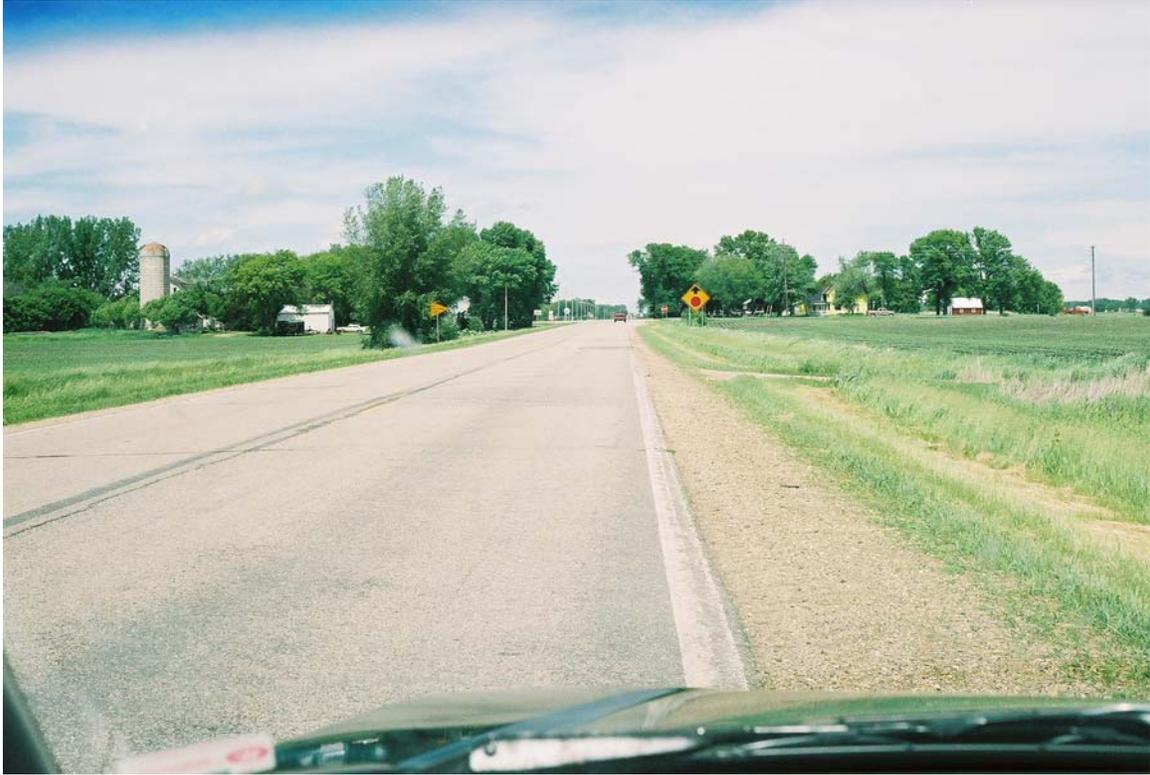
Intersection #99 (West Side)

Condition: **Rumble Strips (half-full @ 1st, full @ 2nd)** on Minor Road.

On South Side (looking North): to West—trees and buildings obscure traffic on major road; to East—clear view of traffic on major road.

Photograph #311 (Reel #15, 2) (from South looking North): first rumble strips (*but only half-strip—on right side of road*) and warning sign in view.

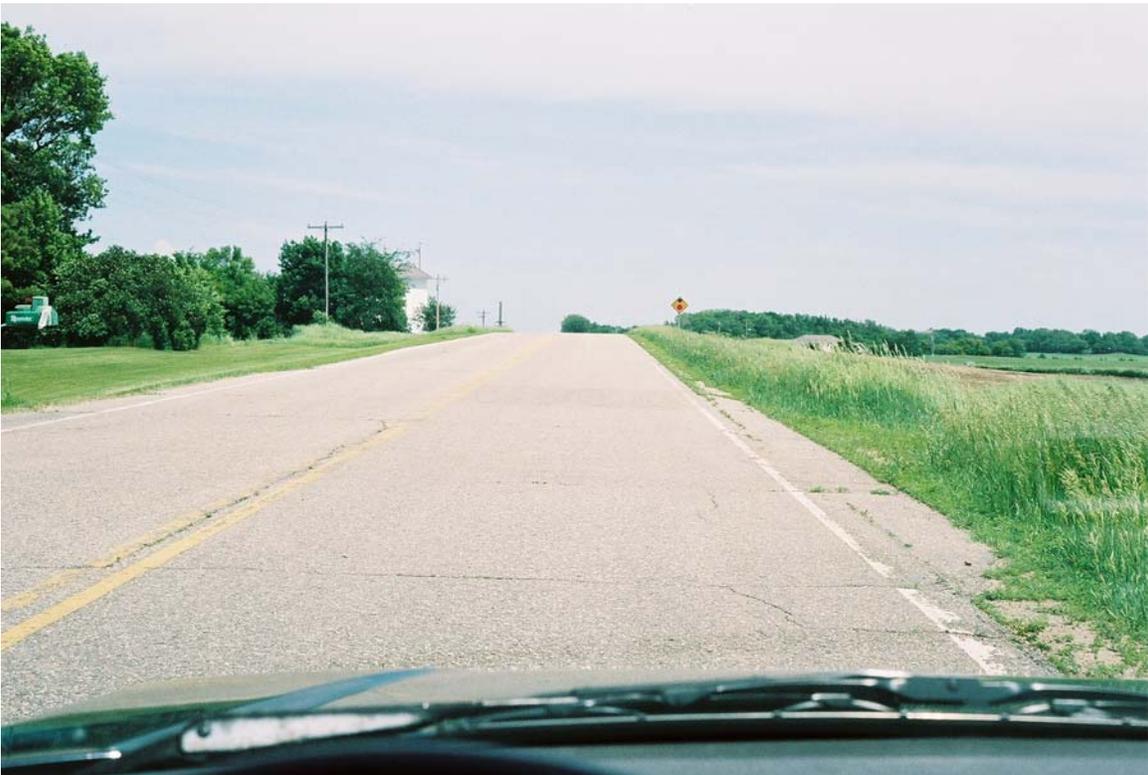
Intersection #99 (East Side)

On West Side (looking East): rise obscures intersection; to North—rise, trees, and buildings obscure traffic on major road; to East—close to intersection on major road, rise obscures traffic on major road, while further away traffic is clear.

Photograph #313 (Reel #15, 4) (from West looking East): first rumble strips & warning sign in view.
