2006-42

Final Report

Stopping Behavior at Real-World
Stop-Controlled Intersections
with and without In-Lane Rumble Strips

**Center for Human Factors Systems Research and Design
University of Minnesota**

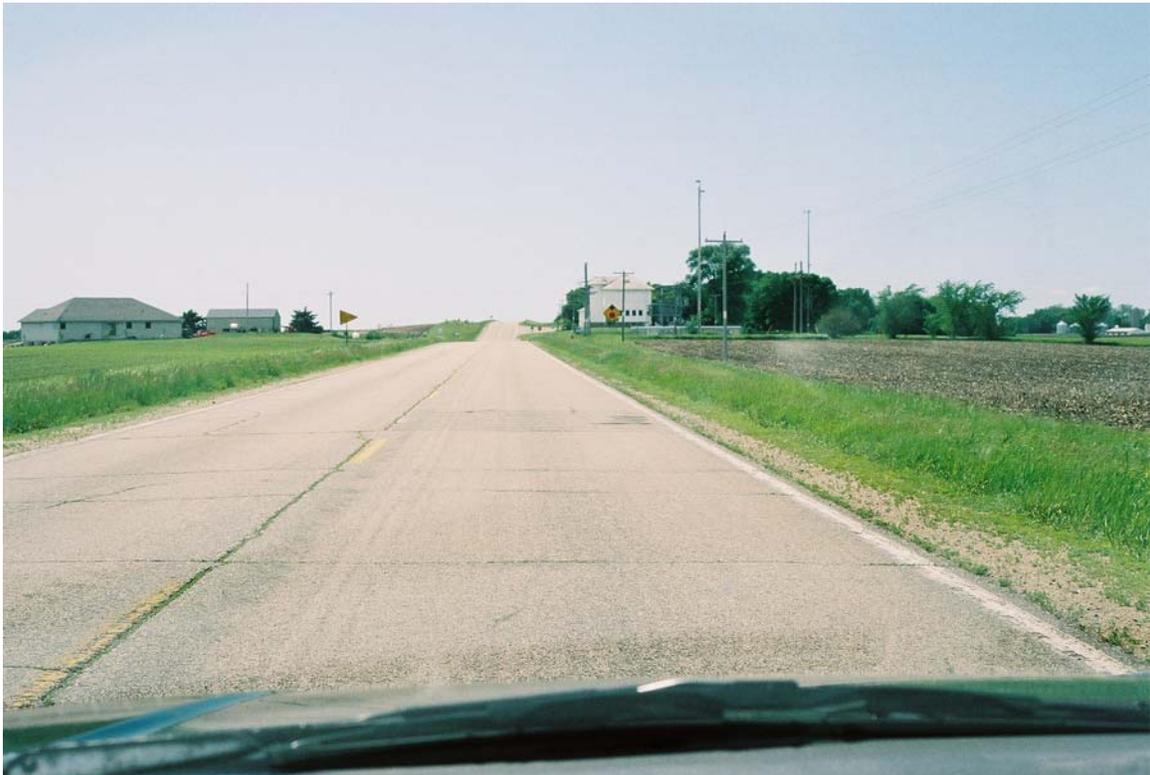
Intersection #100 (North Side)

On East Side (looking West): to North—power plant and trees partially obscures traffic on major road; to South—buildings obscure traffic on major road.

Photograph #315 (Reel #15, 6) (from East looking West): first rumble strips and warning sign in view.

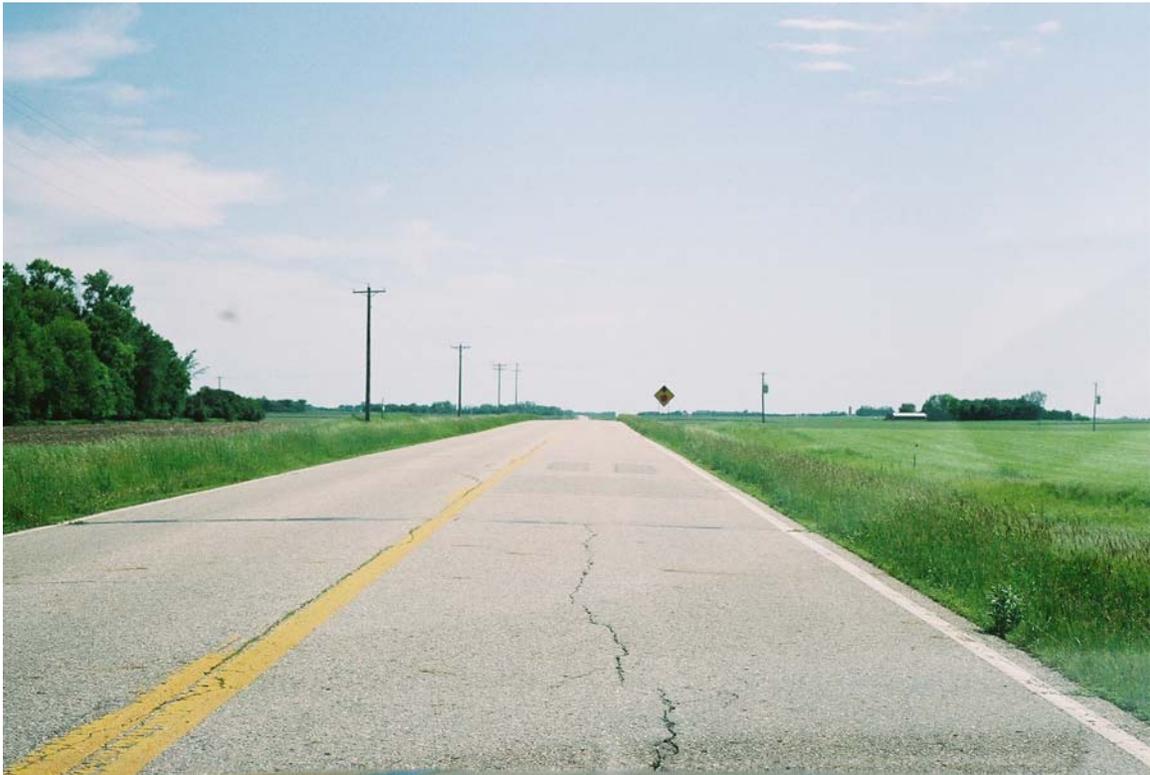
Intersection #100 (South Side)

Condition: **Rumble Strips (full & wheel)** on North side of Minor Road.

On North Side (looking South): rise obscures intersection; to East—rise and trees obscure traffic on major road; to West—rise partially obscures traffic on major road.

Photograph #317 (Reel #15, 8) (from East looking West): first rumble strips (*which are both new full and old wheel*) and warning sign in view.

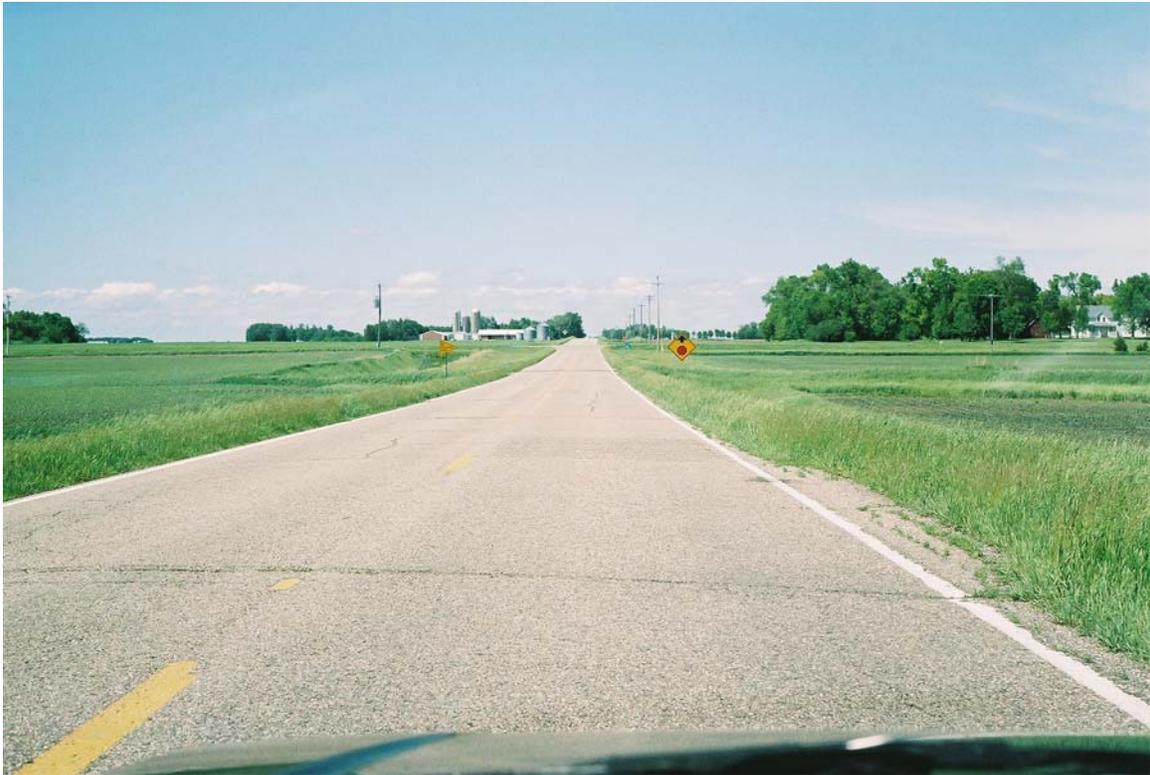
Intersection #101 (South Side)

On South Side (looking North): on both sides—clear view of traffic on major road.

Photograph #320 (Reel #15, 11) (from South looking North): first rumble strips and warning sign in view. [Note, rumble strips and warning sign are preceded by a “Dangerous intersection 1500 feet” sign that is not shown in this photograph.]

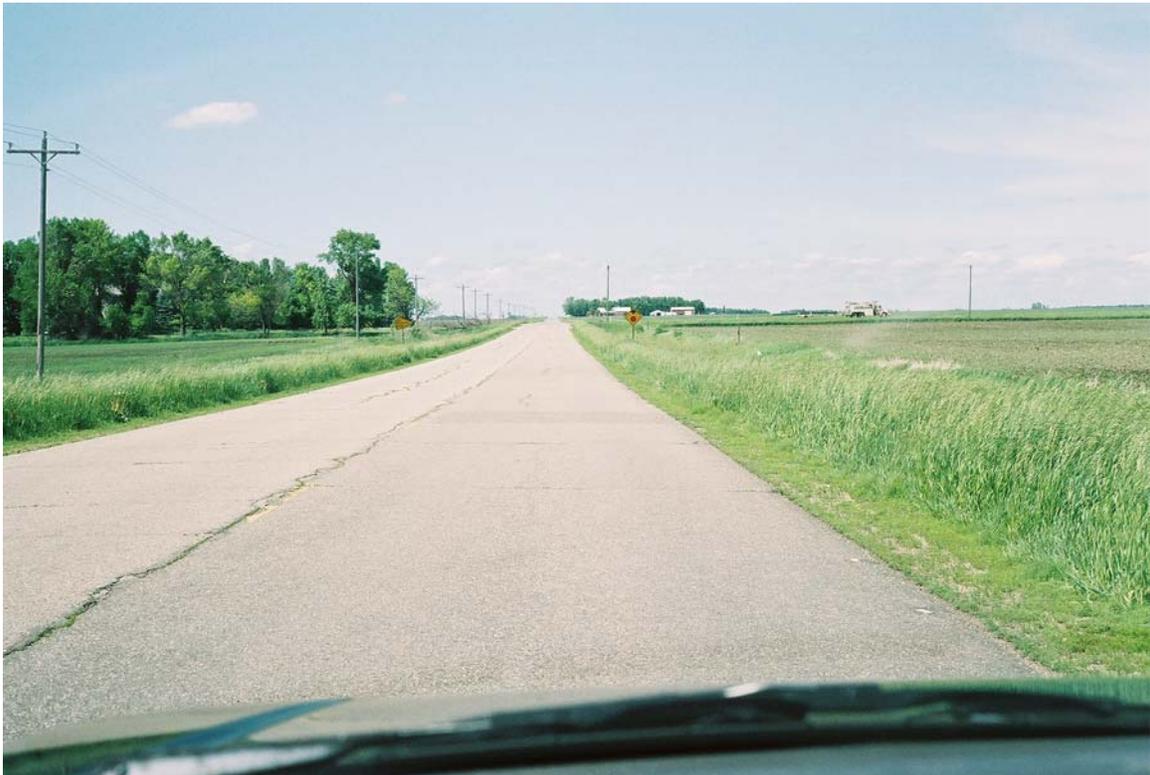
Intersection #101 (North Side)

On South Side (looking North): to West—trees obscure traffic on major road; to East—
clear view of traffic on major road.

Photograph #322 (Reel #15, 13) (from South looking North): first rumble strips and warning sign in view.

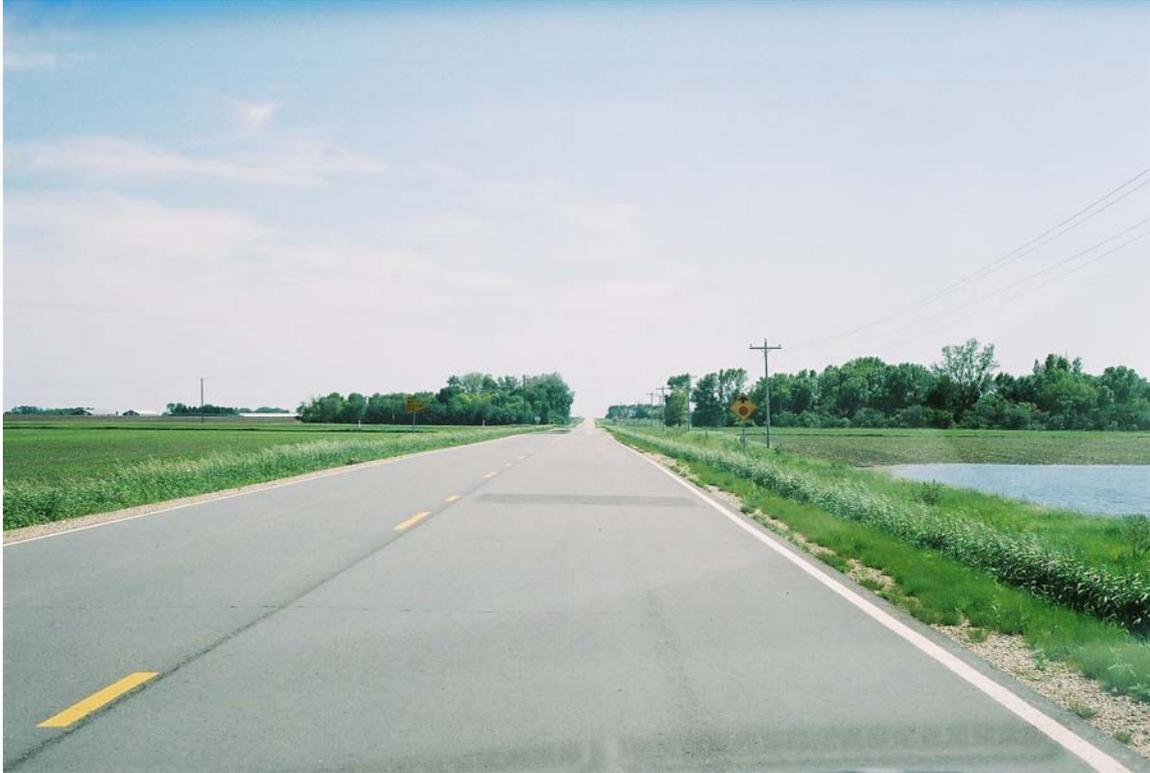
Intersection #102 (South Side)

On North Side (looking South): on both sides—clear view of traffic on major road.

Photograph #324 (Reel #15, 15) (from North looking South): first rumble strips and warning sign in view.

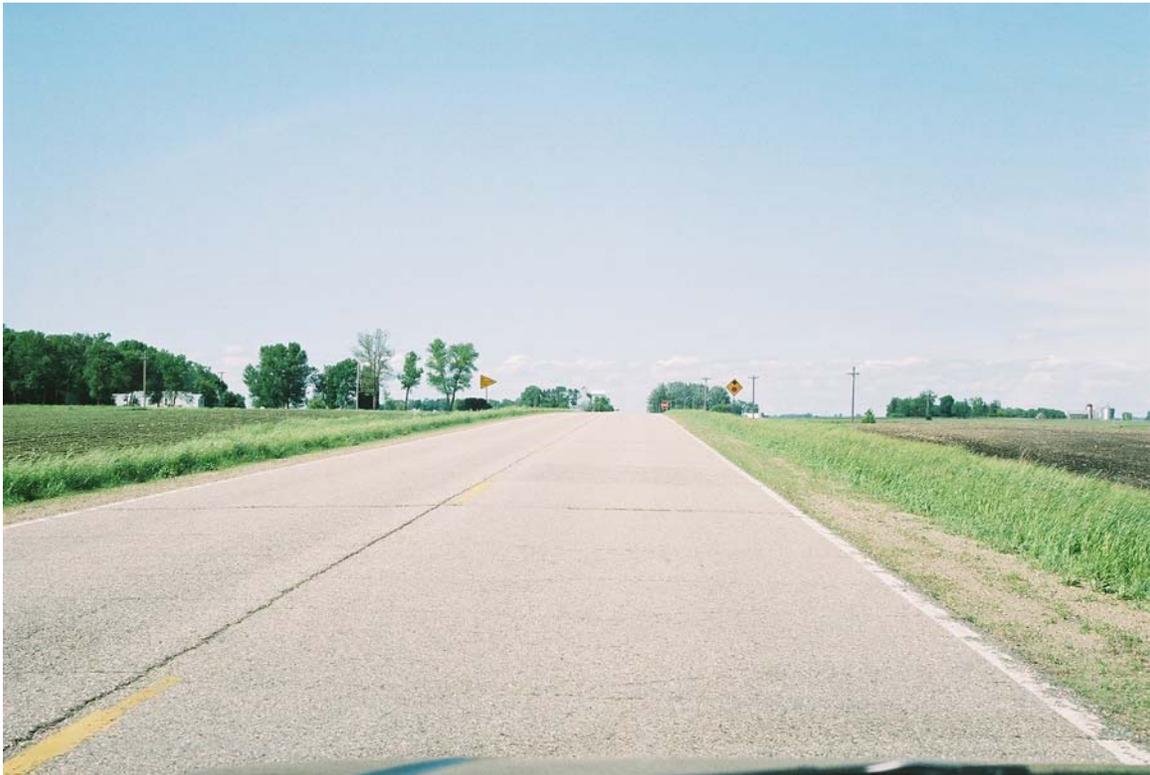
Intersection #102 (North Side)

On South Side (looking North): rise partially obscures intersection; on both sides—rise obscures traffic on major road.

Photograph #326 (Reel #15, 17) (from South looking North): first rumble strips and warning sign in view.

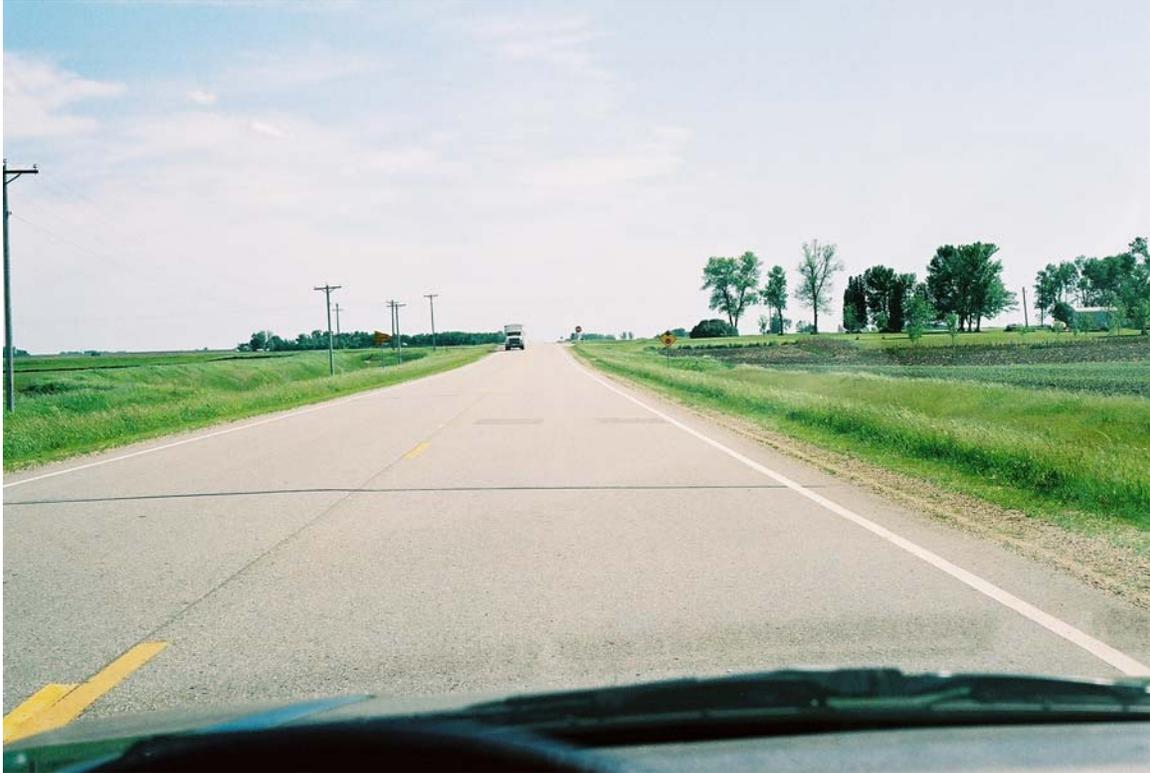
On North Side (looking South): to East—clear view of traffic on major road; to West—trees partially obscure traffic on major road.

Photograph #328 (Reel #15, 19) (from North looking South): first rumble strips and warning sign in view.

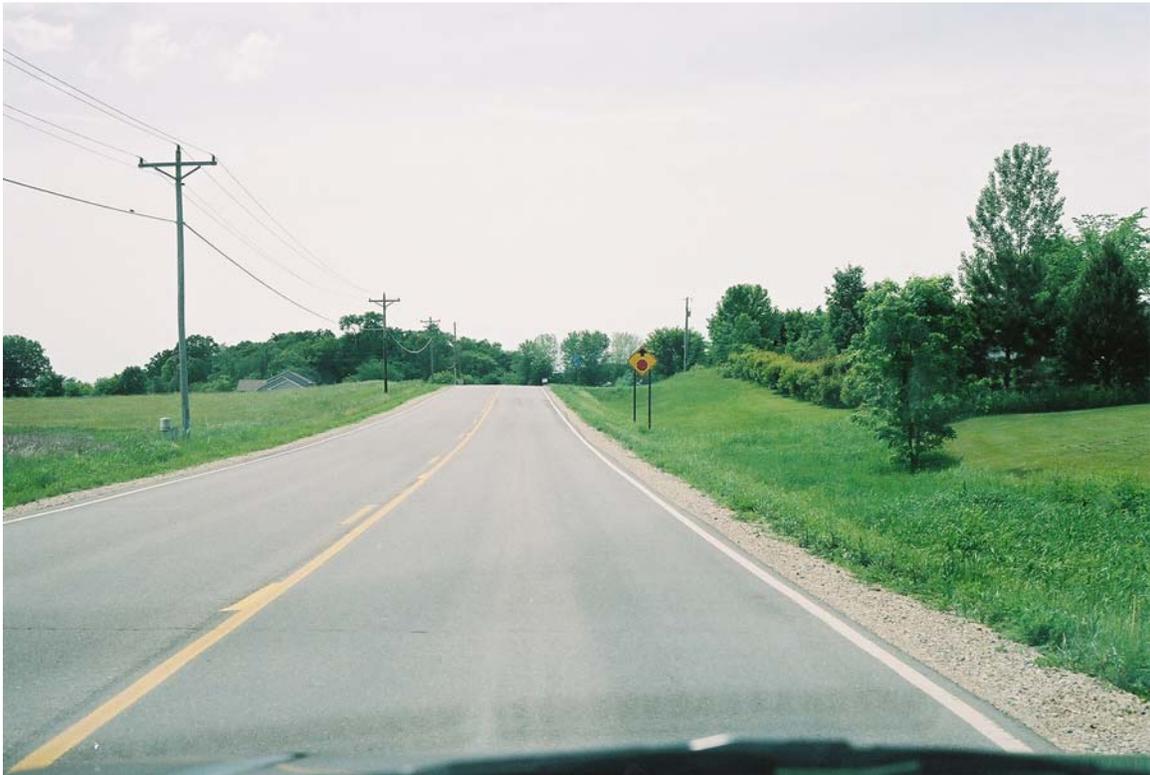
Intersection #104 (West Side)

On East Side (looking West): to North—rise and trees obscure traffic on major road; to South—trees obscure traffic on major road.

Photograph #330 (Reel #15, 24) (from East looking West): from approximately where rumble strips would be; warning sign in view.

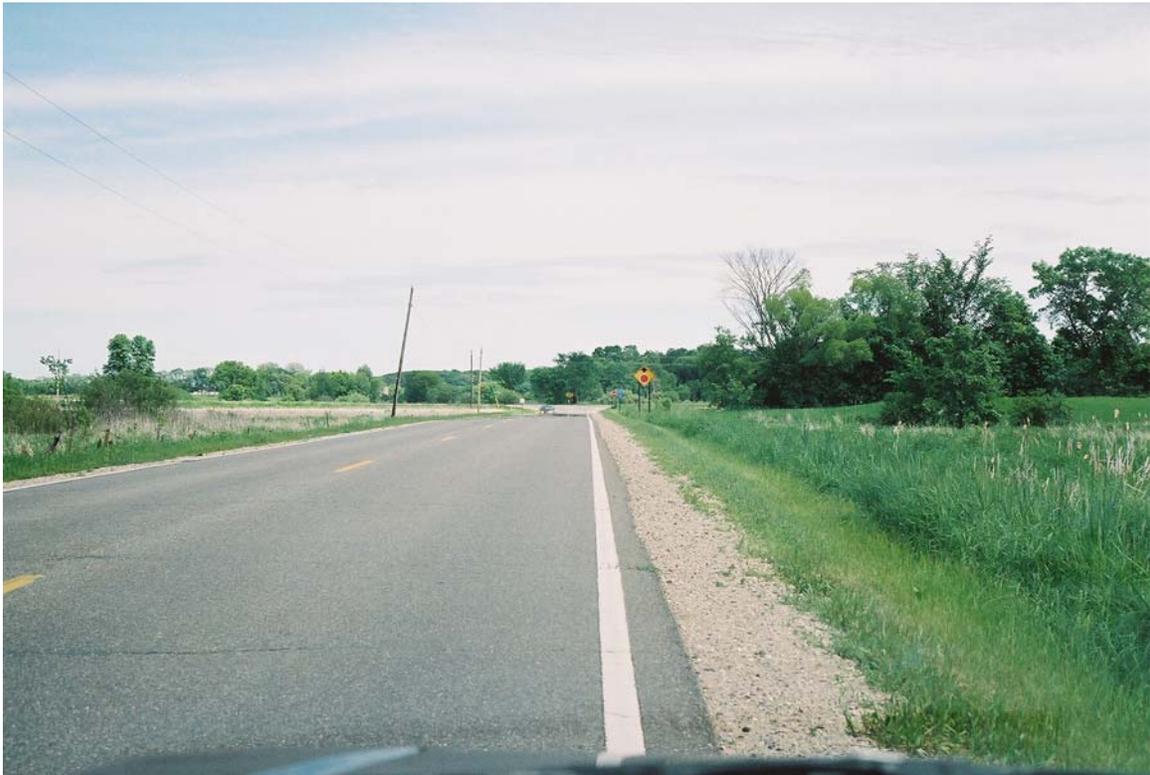
Intersection #105 (South Side)

On West Side (looking East): to North—relatively clear view of traffic on major road; to South—trees obscure traffic on major road.

Photograph #332 (Reel #16, 0A) (from West looking East): from approximately where rumble strips would be; warning sign in view.

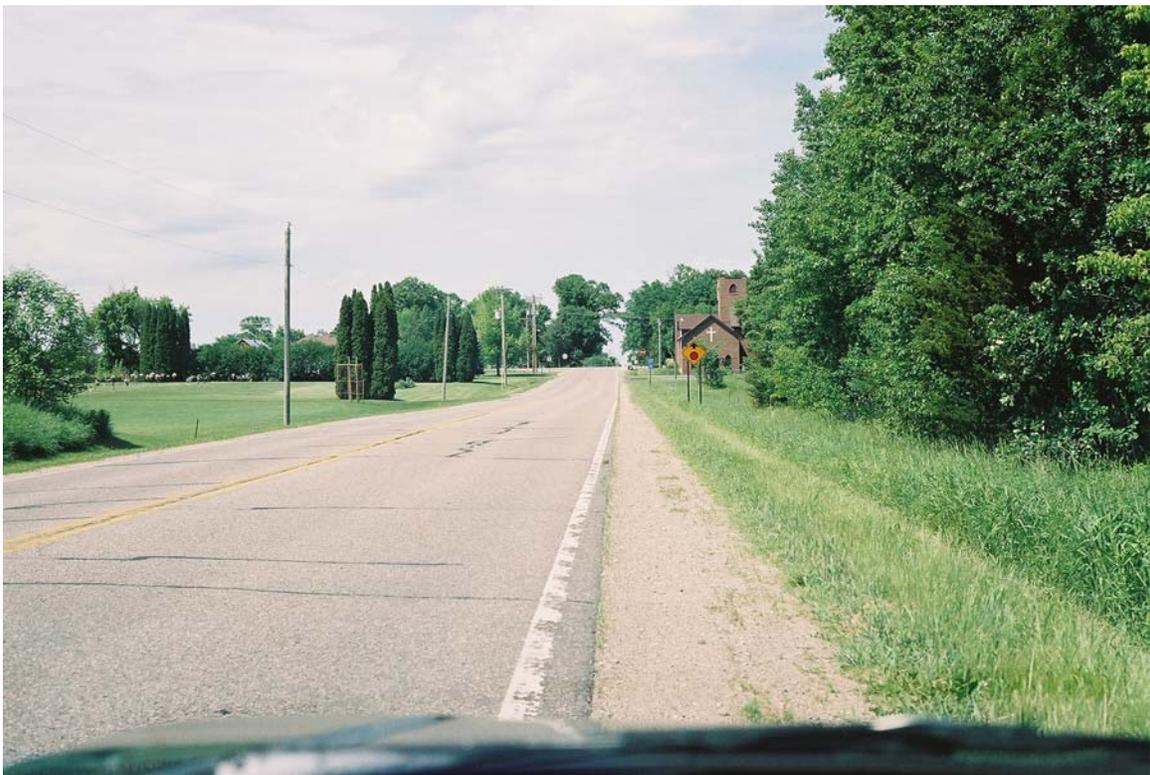
Intersection #105 (North Side)

On South Side (looking North): to East—trees and building obscure traffic on major road; to West—trees obscure traffic on major road.

Photograph #333 (Reel #16, 1A) (from South looking North): from approximately where rumble strips would be; warning sign in view.

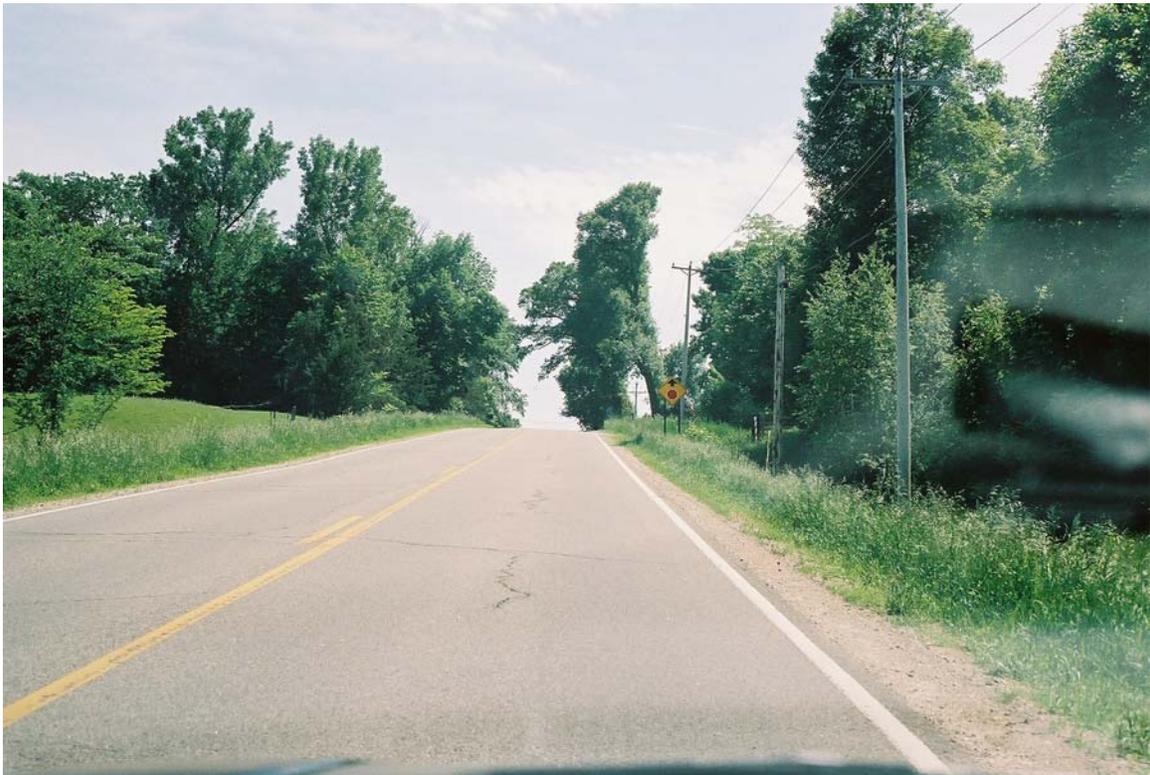
Intersection #106 (South Side)

On North Side (looking South): rise obscures intersection; on both sides—rise and trees obscure traffic on major road.

Photograph #334 (Reel #16, 2A) (from North looking South): from approximately where rumble strips would be; warning sign in view.

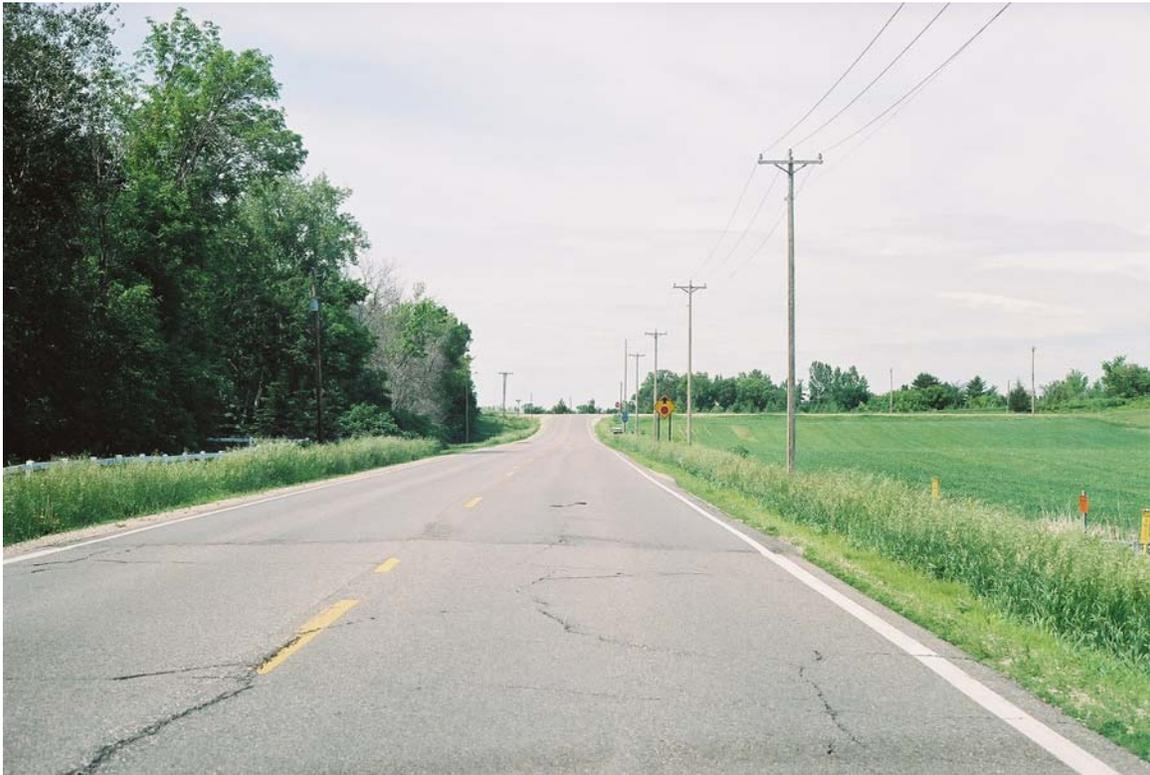
Intersection #106 (North Side)

On South Side (looking South): to West—trees obscure traffic on major road, to East—
clear view of traffic on major road.

Photograph #335 (Reel #16, 3A) (from South looking North): from approximately where rumble strips would be; warning sign in view.

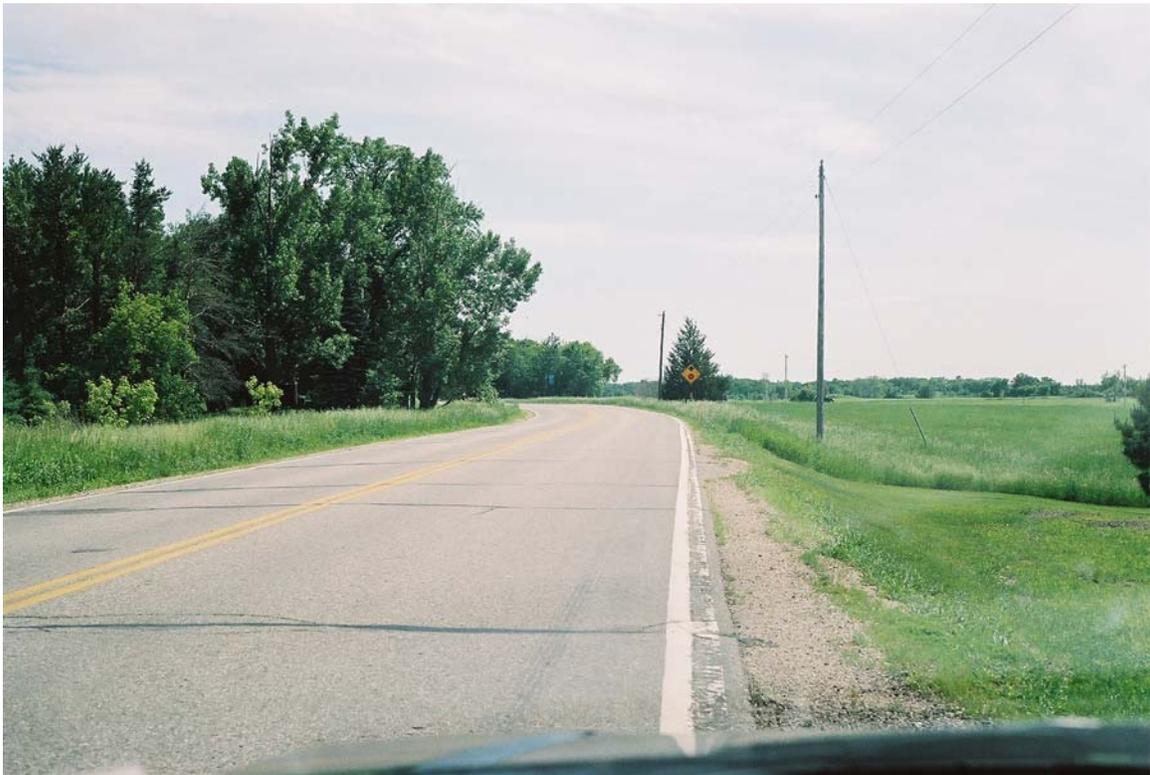
Intersection #107 (East Side)

On North Side (looking South): trees and curve obscure intersection; to East—trees obscure traffic on major road, to West—trees and slight rise partially traffic on major road.

Photograph #336 (Reel #16, 4A) (from North looking South): from approximately where rumble strips would be; warning sign in view.

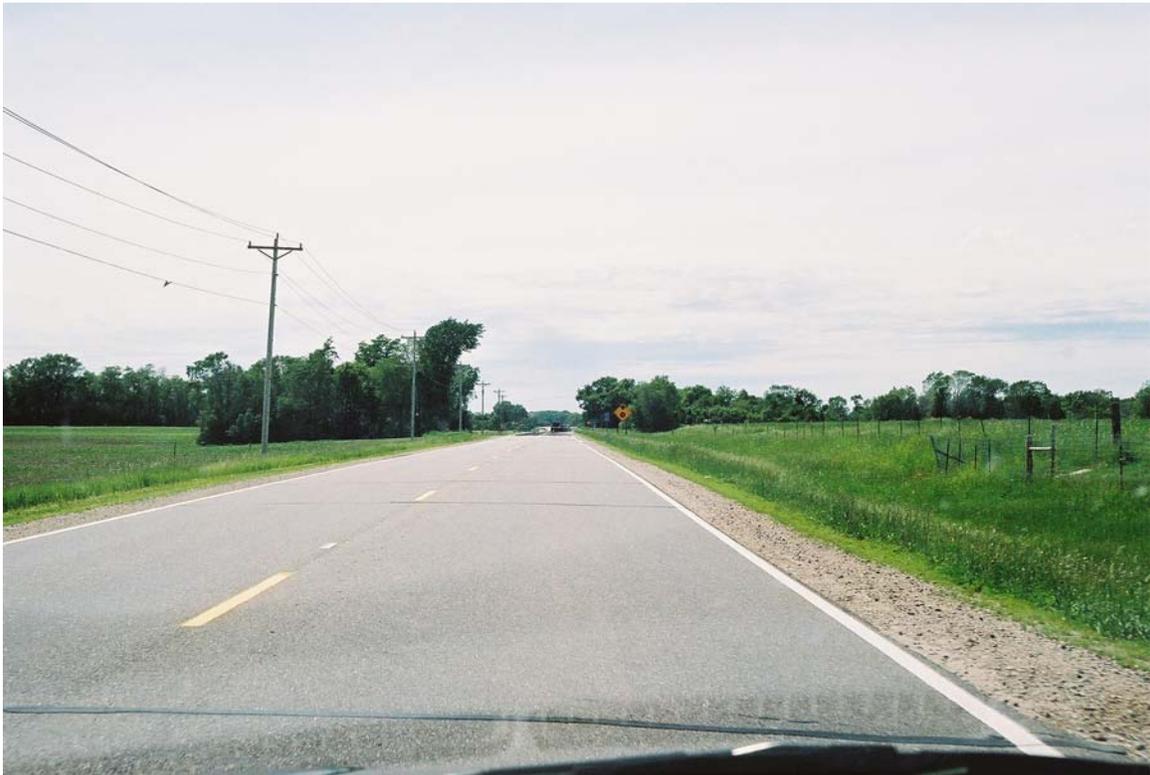
Condition: ***Ineffectual Rumble Strips (wheel)*** on Minor Road.

On East Side (looking West): on both sides—rise and trees obscure traffic on major road.

Photograph #338 (Reel #16, 6A) (from East looking West): first *ineffectual* rumble present, but not visible; warning sign in view.

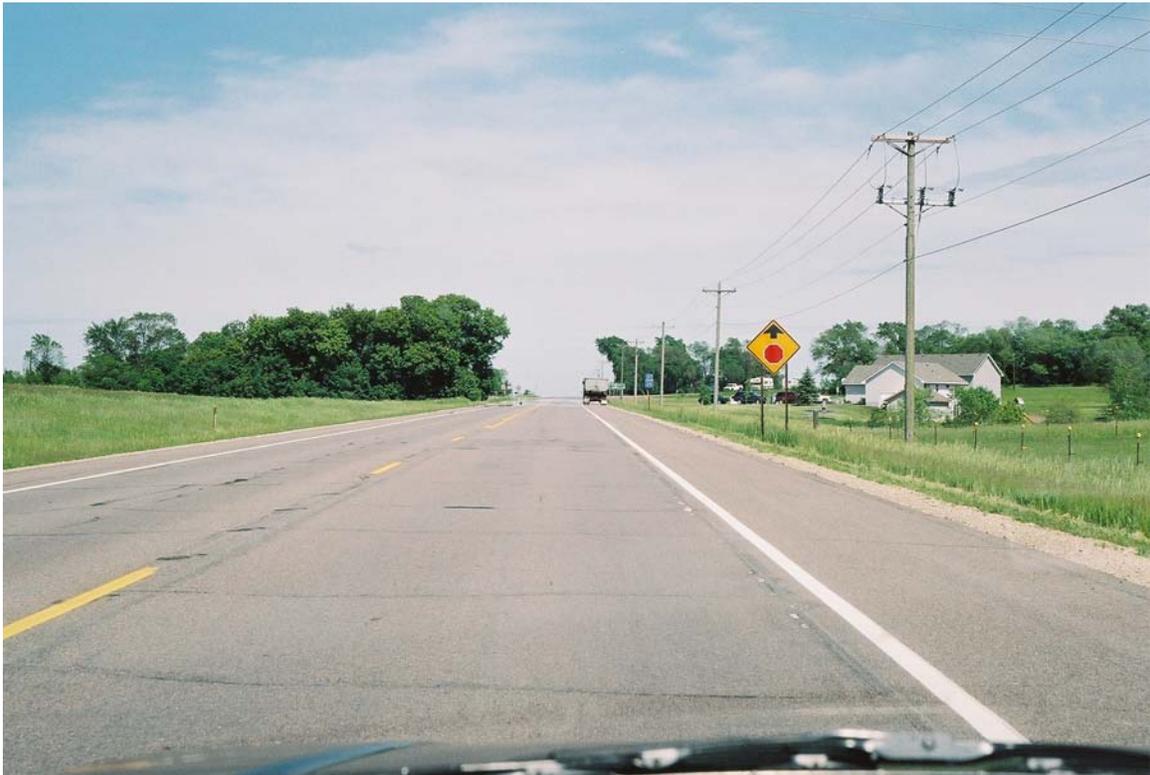
Condition: ***Ineffectual Rumble Strips (wheel)*** on Minor Road.

On West Side (looking East): to North—rise and trees obscure traffic on major road; to South—buildings partially obscure traffic on major road.

Photograph #340 (Reel #16, 8A) (from West looking East): first *ineffectual* rumble is visible; warning sign in view; also, very wide shoulder (note parked truck).

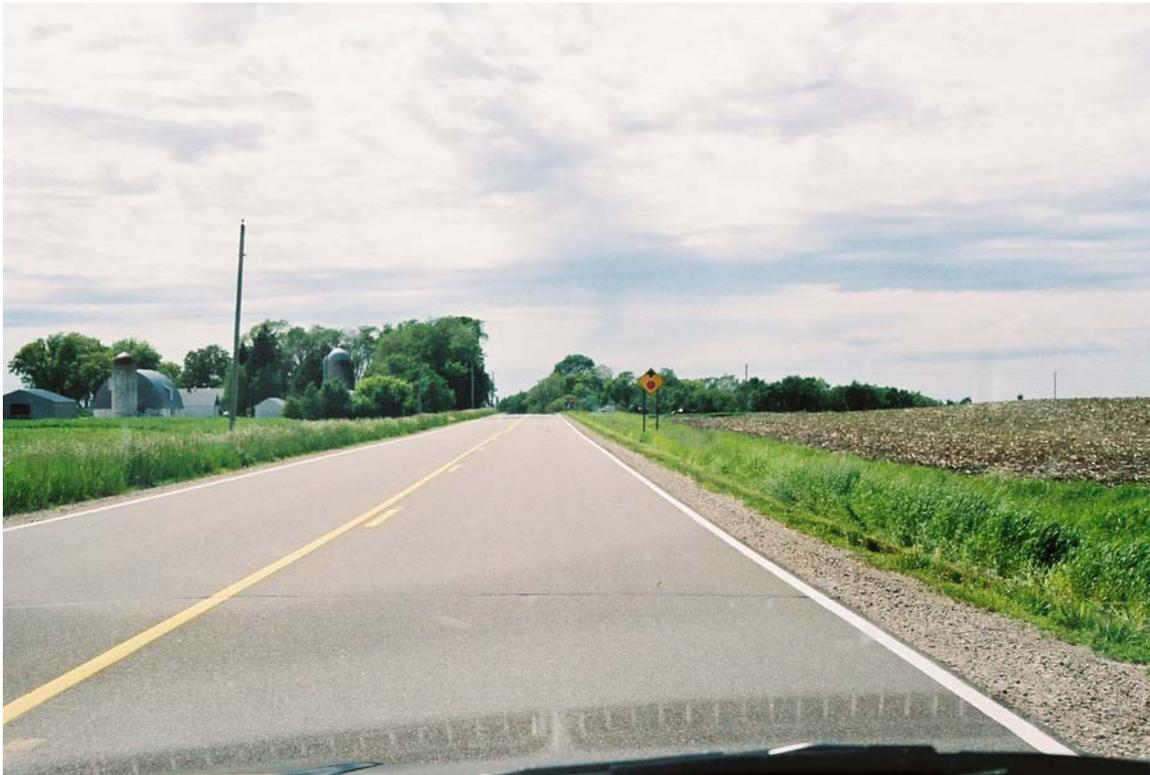
Condition: *4-way stop, No Rumbles.*

On East Side (looking West): to North—rise obscures traffic on cross road; to South—
rise and trees obscure traffic on cross road.

Photograph #342 (Reel #16, 10A) (from East looking West): from approximately where first rumble strips would be; warning sign in view.

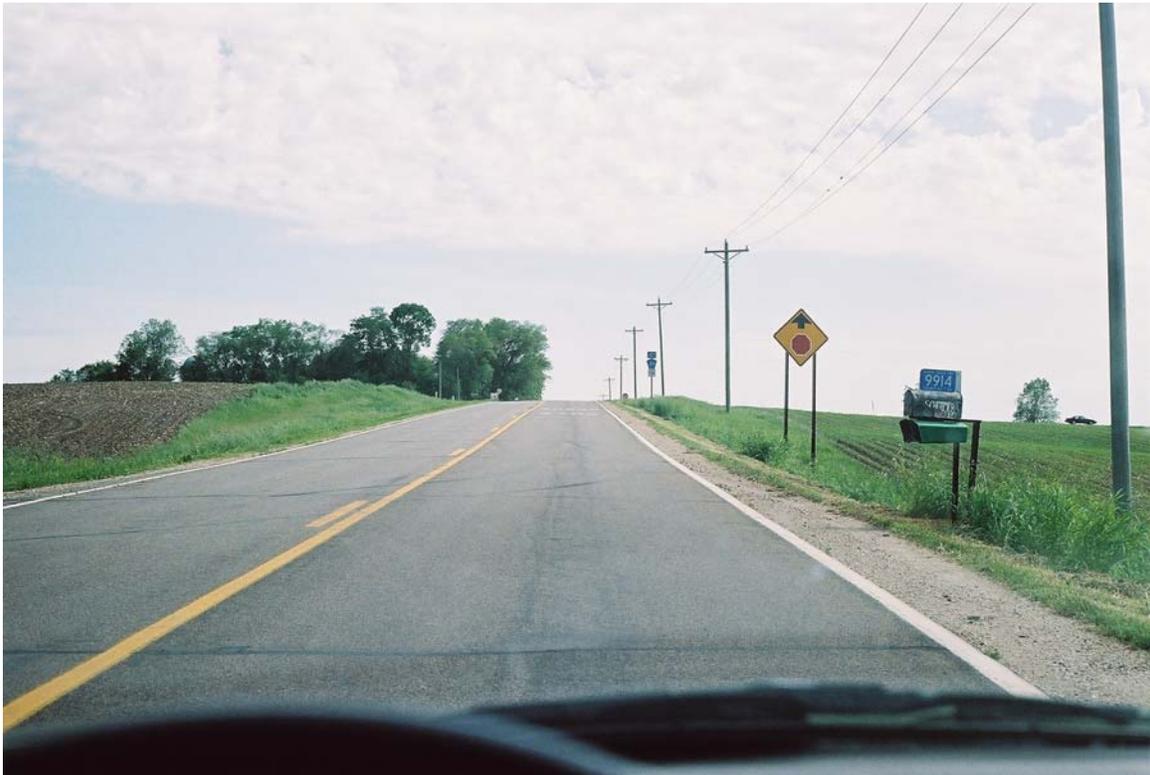
Condition: *4-way stop, No Rumbles.*

On North Side (looking South): rise obscures intersection; to East—rise obscures traffic
on cross road; to West—rise partially obscures traffic on cross road.

Photograph #343 (Reel #16, 12A) (from North looking South): from approximately where first rumble strips would be; warning sign in view; also, STOP AHEAD on road.

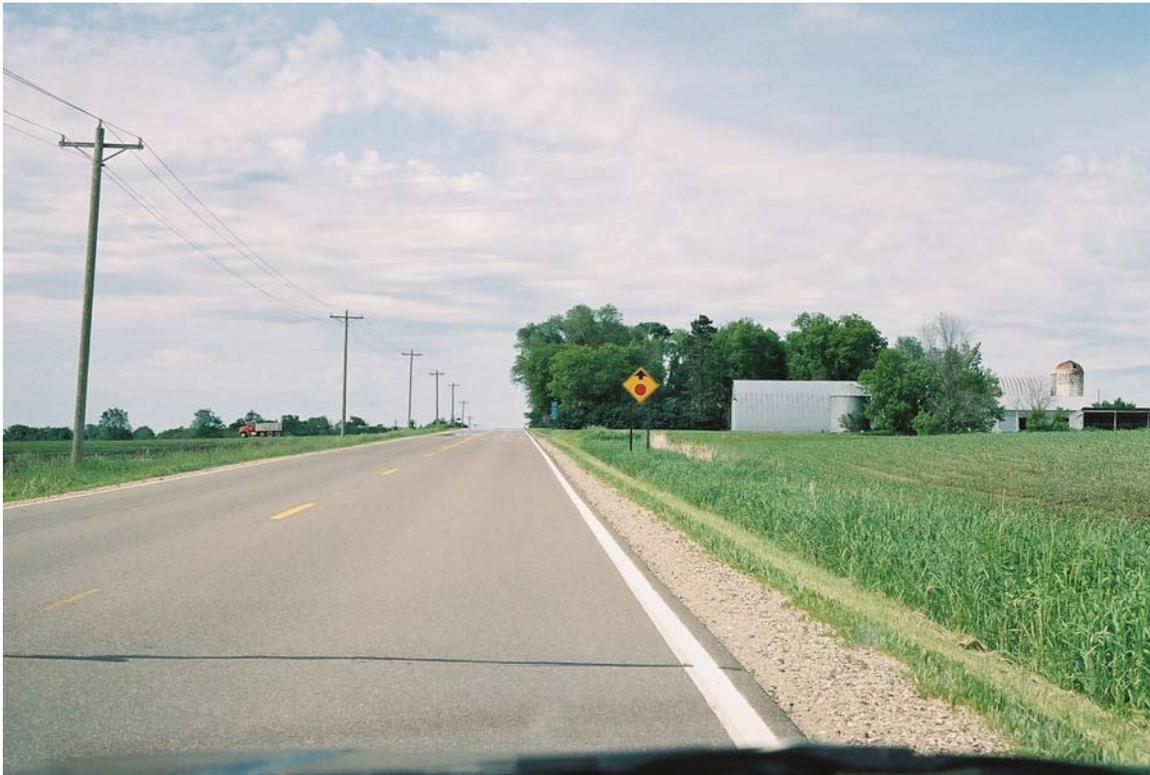
Condition: ***4-way stop, No Rumbles.***

On South Side (looking North): to East—buildings and trees obscure traffic on cross road; to West—clear view of traffic on cross road.

Photograph #344 (Reel #16, 13A) (from South looking North): from approximately where first rumble strips would be; warning sign in view; also, STOP AHEAD on road.

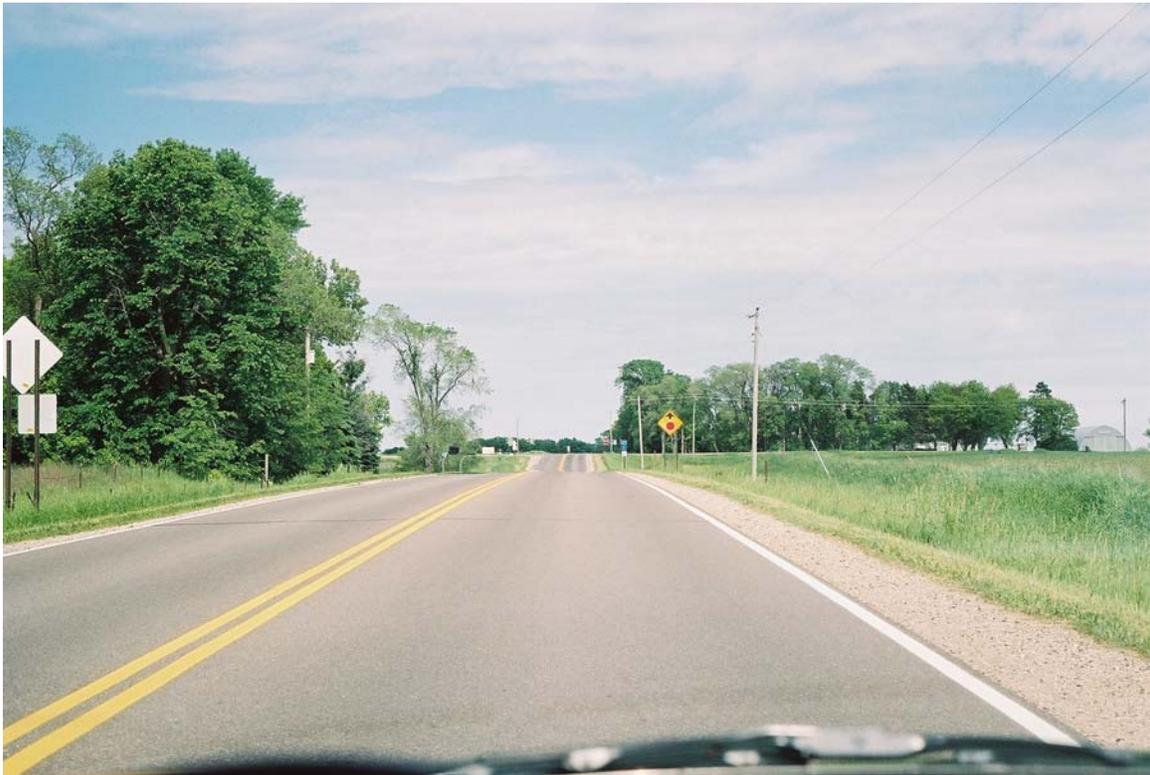
Condition: *4-way stop, No Rumbles.*

On West Side (looking East): to North—trees obscure traffic on cross road; to South—
clear view of traffic on cross road.

Photograph #345 (Reel #16, 14A) (from West looking East): from approximately where first rumble strips would be; warning sign in view.

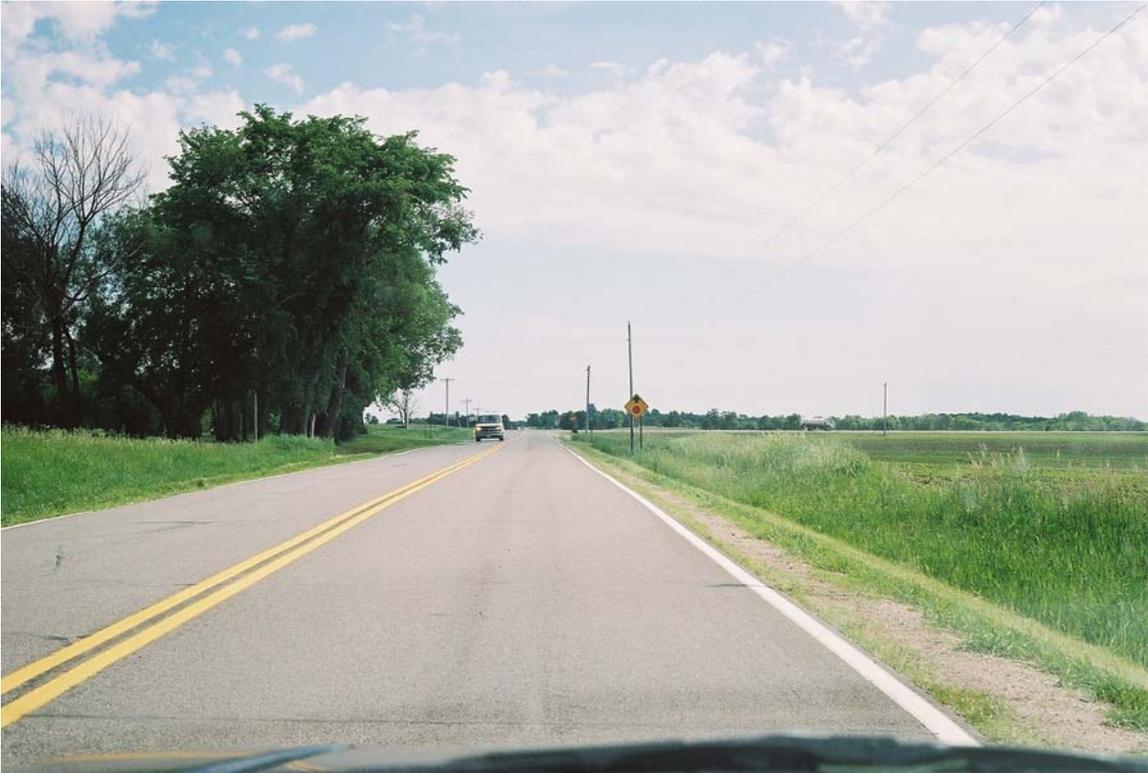
Condition: *No Rumbles* on Minor Road.

On North Side (looking South): to East—trees obscure traffic on major road; to West—clear view of traffic on major road.

Photograph #346 (Reel #16, 15A) (from North looking South): from approximately where first rumble strip would be; warning sign in view.

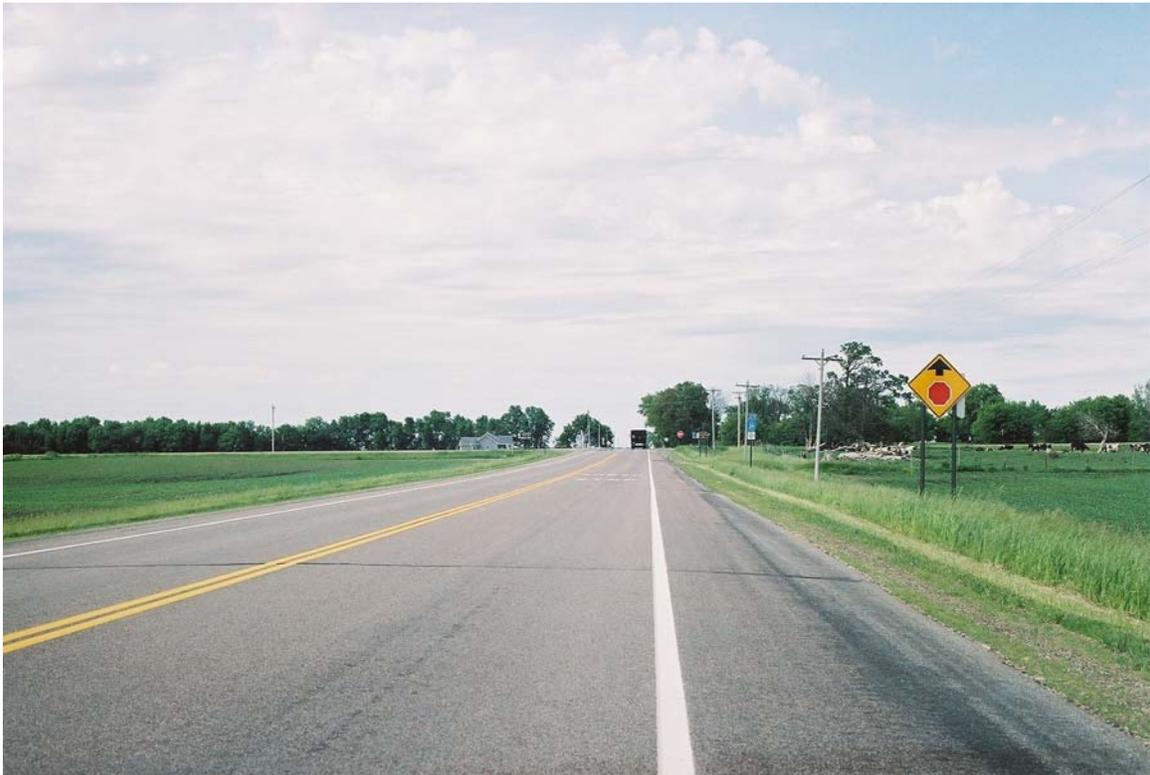
Condition: *No Rumbles* on Minor Road.

On South Side (looking North): to East—trees partially obscure traffic on major road; to West—clear view of traffic on major road.

Photograph #347 (Reel #16, 16A) (from North looking South): from approximately where first rumble strips would be; warning sign in view; also, STOP AHEAD on road.

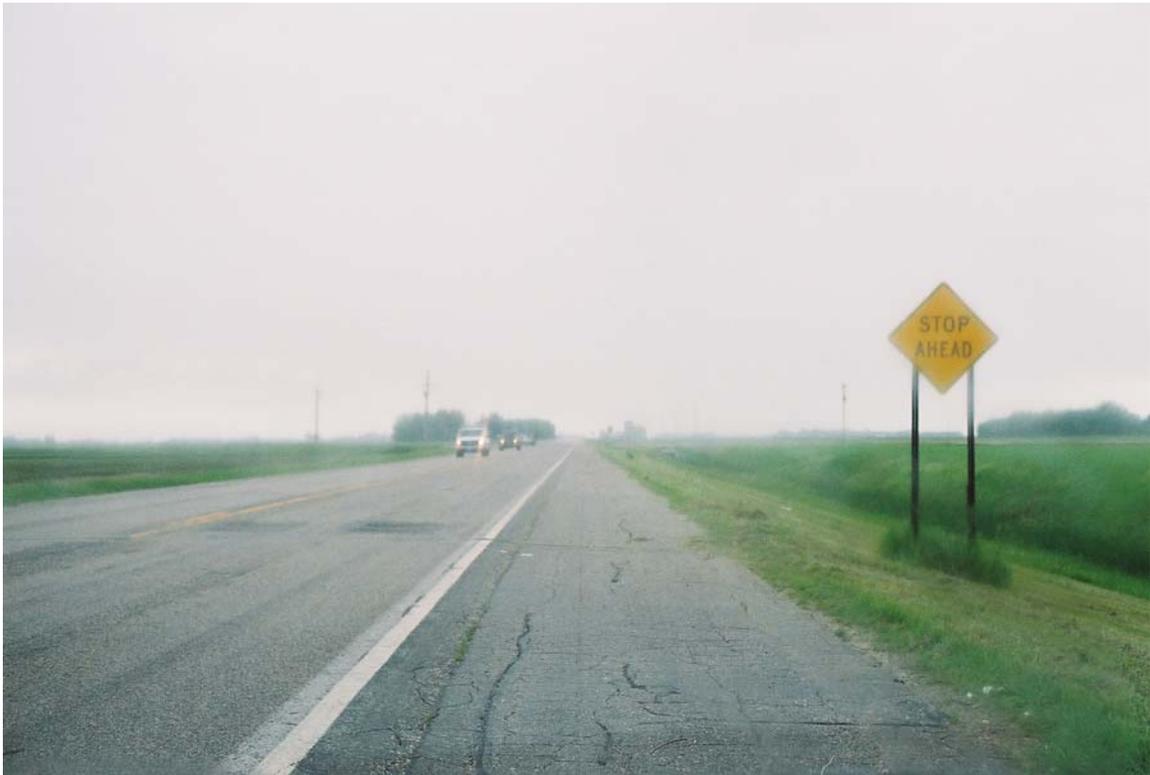
Condition: **Rumble Strips (wheel)** on Minor Road.

On West Side (looking East): on both sides—clear view of traffic on major road (when there is no mist).

Photograph #348 (Reel #16, 17A) (from West looking East): first rumble strip and warning sign in view.

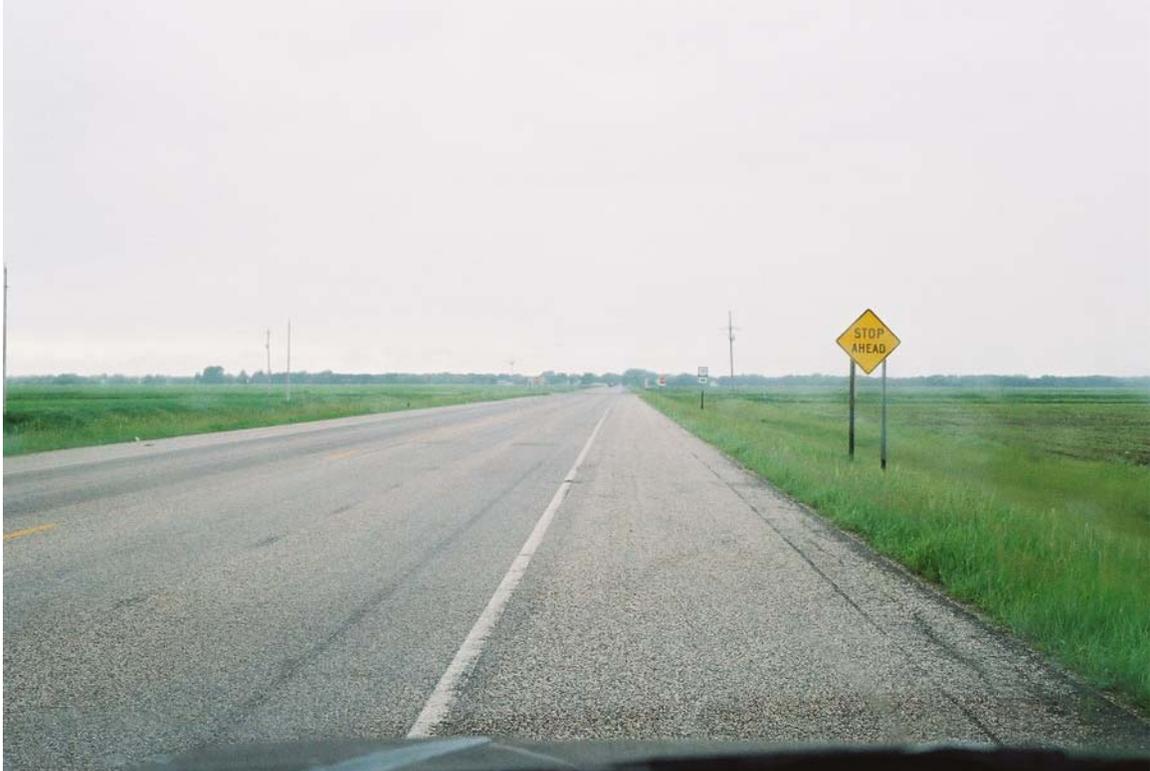
Condition: **Rumble Strips (wheel)** on Minor Road.

On East Side (looking West): on both sides—clear view of traffic on major road.

Photograph #350 (Reel #16, 19A) (from East looking West): first rumble strip and warning sign in view.
