2006-42

Final Report

Stopping Behavior at Real-World
Stop-Controlled Intersections
with and without In-Lane Rumble Strips

**Center for Human Factors Systems Research and Design
University of Minnesota**

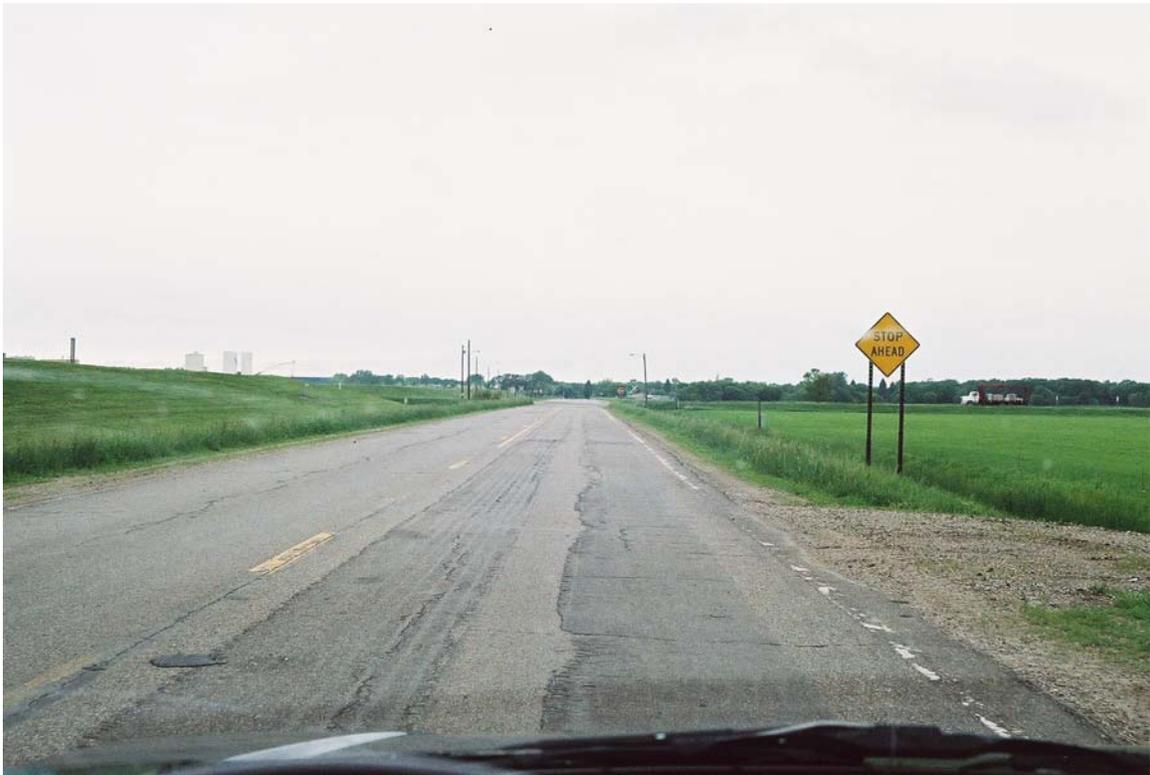
Condition: **Rumble Strips (wheel)** on East side; **No Rumble Strips** on West side.

On East Side (looking West): to North—clear view of traffic on major road; to South—
rise obscures traffic on major road.

Photograph #352 (Reel #16, 21A) (from East looking West): first rumble strip and warning sign in view.

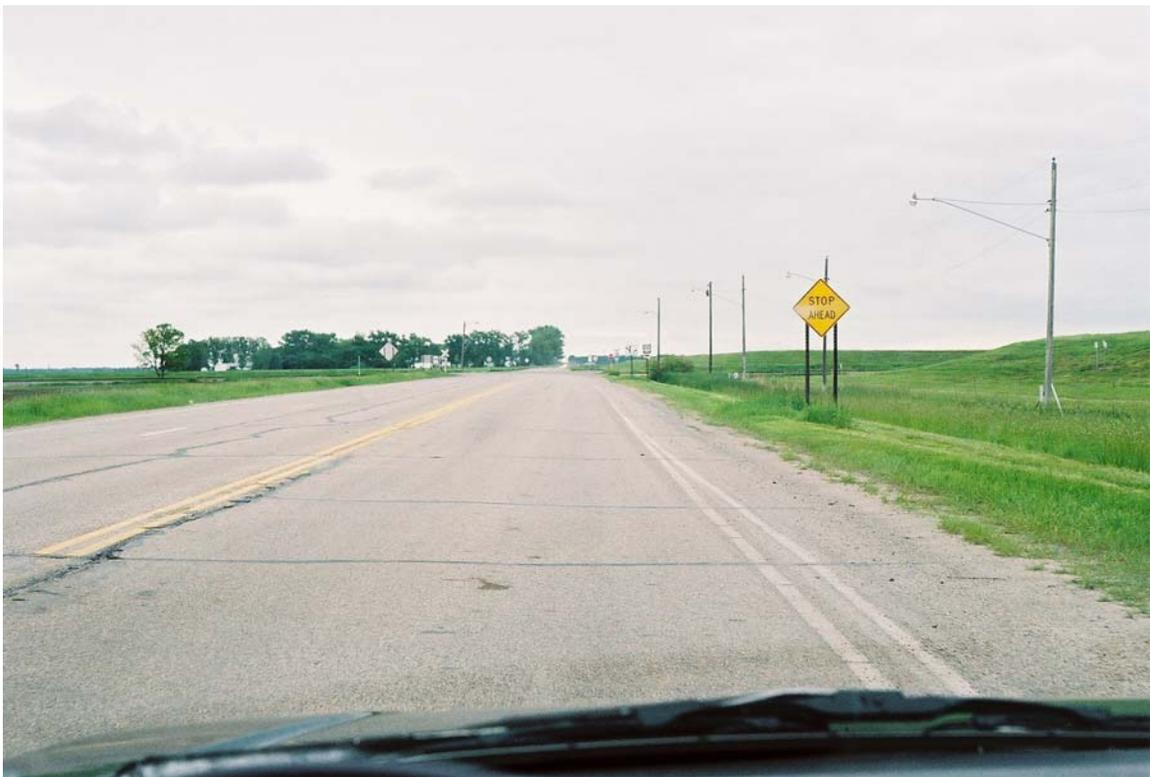
Condition: **Rumble Strips (wheel)** on East side; **No Rumble Strips** on West side.

On West Side (looking East): to North—clear view of traffic on major road; to South—
rise obscures traffic on major road.

Photograph #355 (Reel #16, 24A) (from West looking East): from approximately where first rumble strips would be; warning sign in view; also, although not in photograph, a Rail Crossing warning precedes the rumble strip and warning sign.

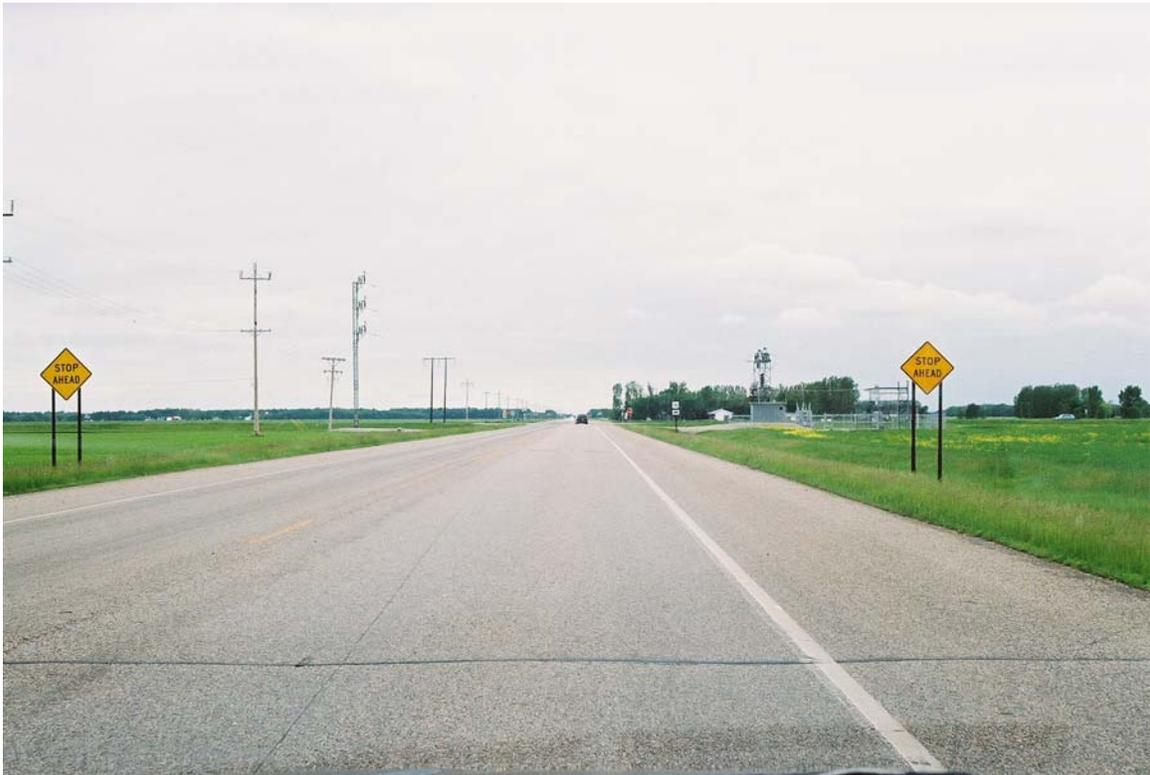
Condition: **Rumble Strips (wheel)** on Minor Road.

On East Side (looking West): to North—power station partially obscures traffic on major road; to South—clear view of traffic on major road.

Photograph #357 (Reel #17, 3) (from East looking West): first rumble strips in view; also, warning signs *on both sides of road*.

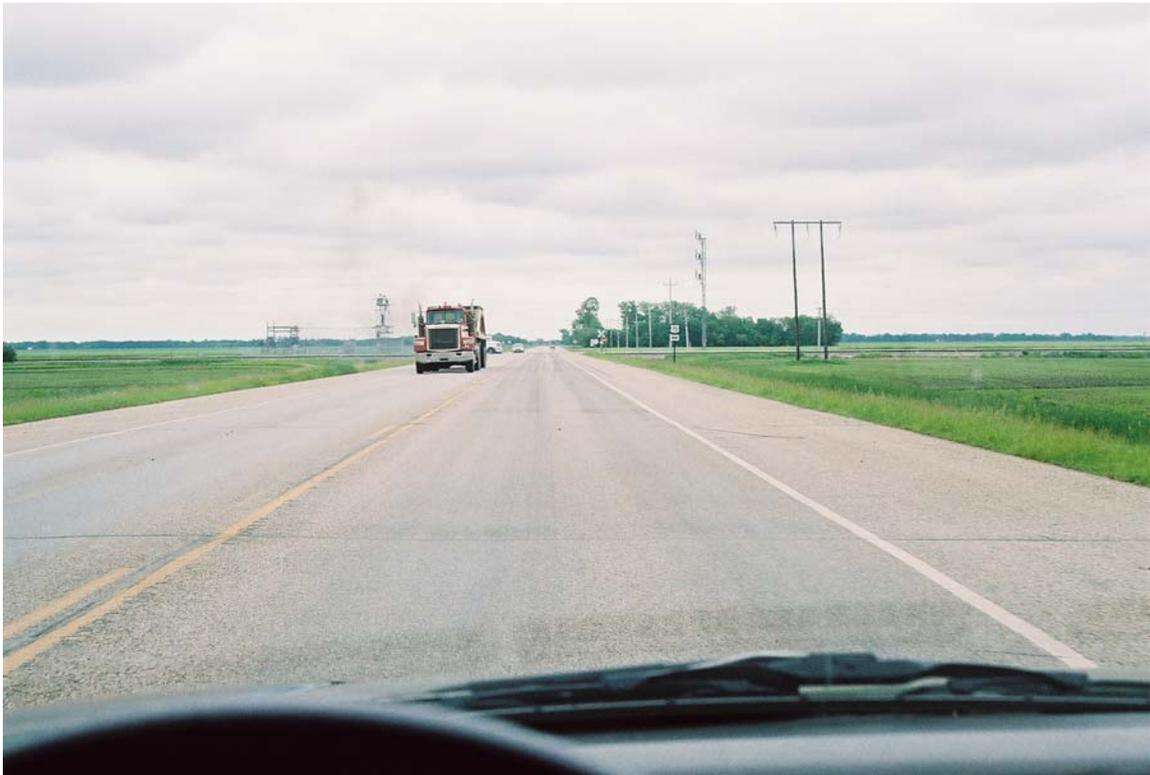
Condition: **Rumble Strips (wheel)** on Minor Road.

On West Side (looking East): on both sides—clear view of traffic on major road.

Photograph #361 (Reel #17, 7) (from West looking East): first rumble strips in view. [Note: a rail crossing warning and a warning sign (on the left-hand side of the road) both precede the first rumble strip. In addition, the distance between the “stop ahead” warning and the location of the rumble strips is unusually long.].

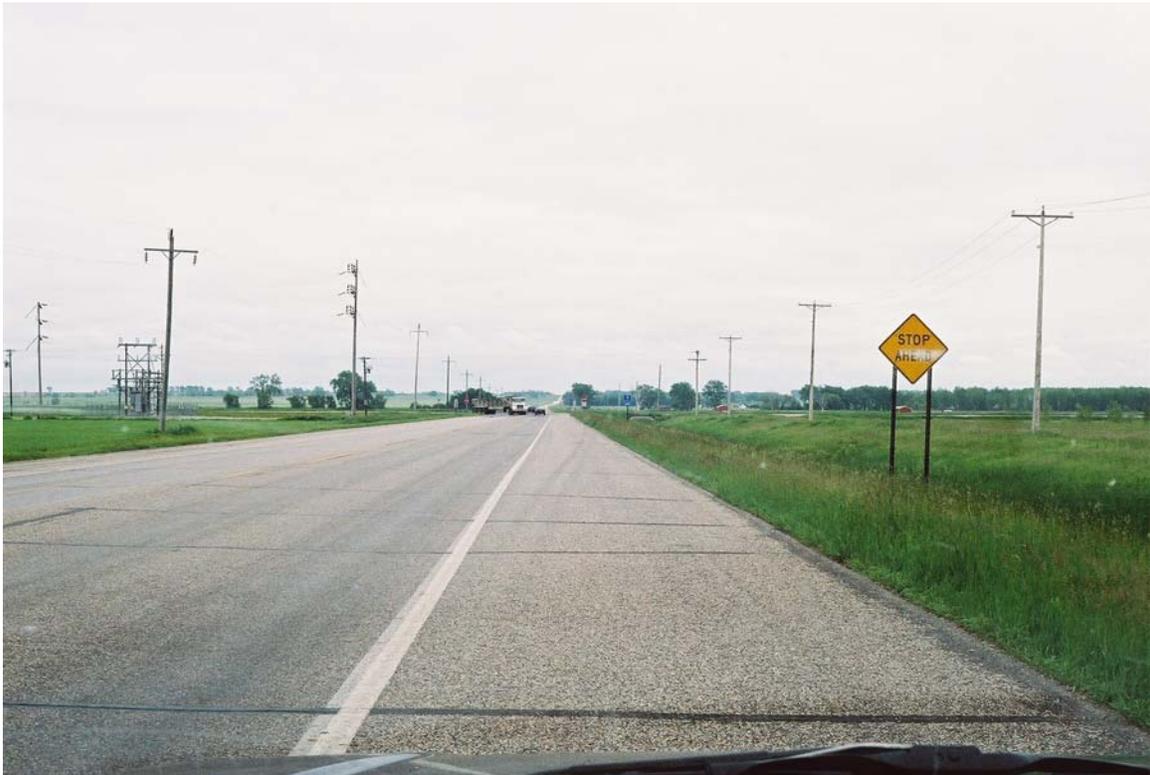
Condition: **Rumble Strips (wheel)** on Minor Road.

On West Side (looking East): on both sides—clear view of traffic on major road.

Photograph #362 (Reel #17, 8) (from West looking East): first rumble strips and warning sign in view.

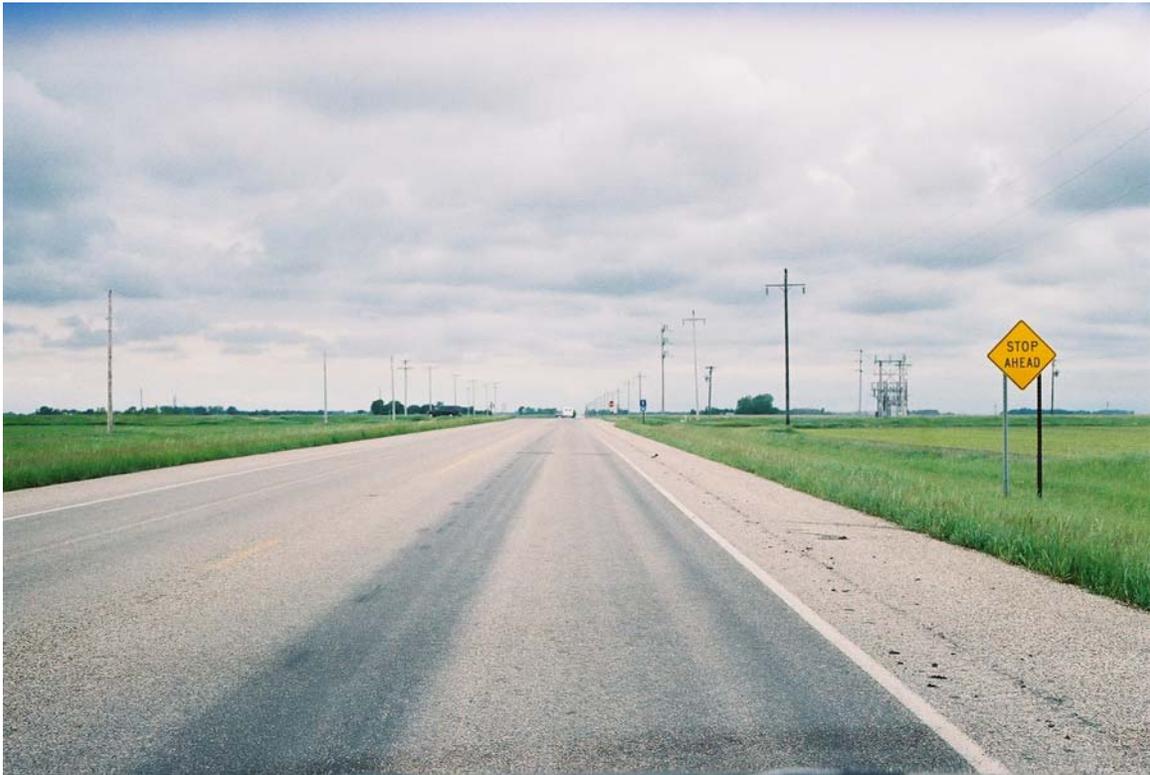
Condition: **Rumble Strips (wheel)** on Minor Road.

On East Side (looking West): on both sides—clear view of traffic on major road.

Photograph #364 (Reel #17, 10) (from East looking West): first rumble strips and warning sign in view.

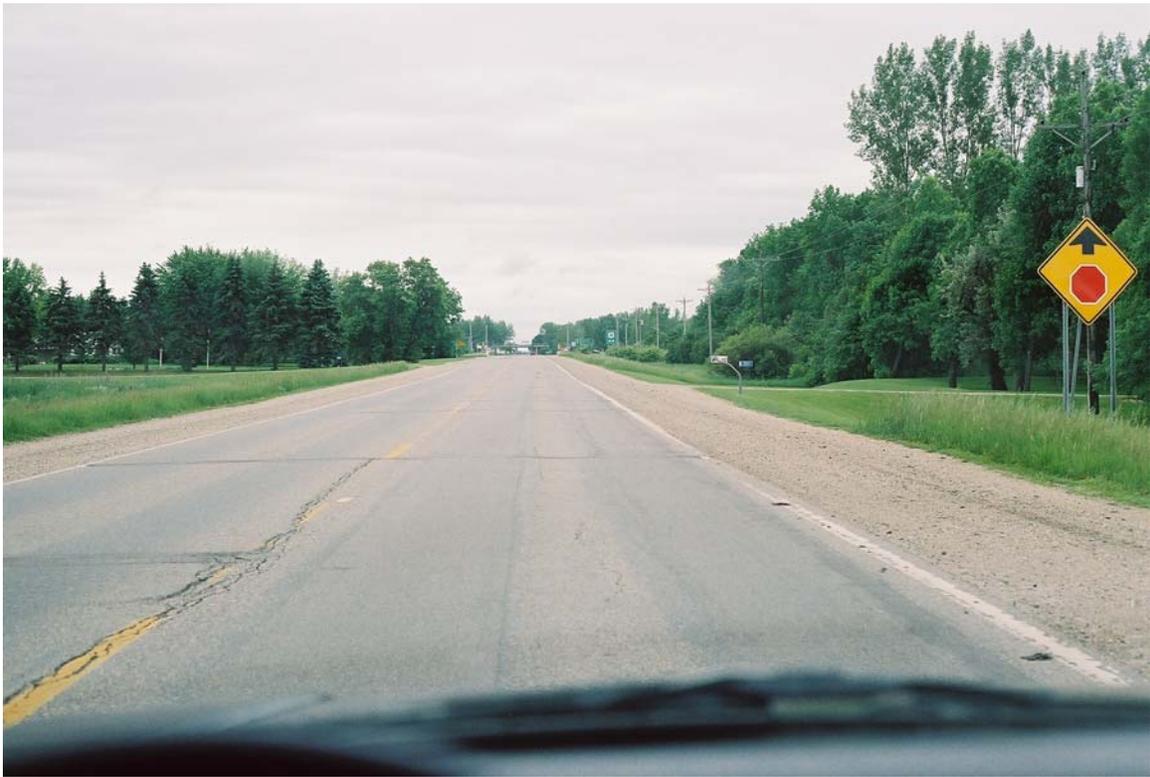
Condition: *No Rumble Strips* on Minor Road.

On North Side (looking South): on both sides—trees obscure traffic on major road.

Photograph #367 (Reel #17, 13) (from North looking South): warning sign in view—
further away from intersection than usual (perhaps because of bridge over Buffalo River);
also STOP AHEAD on road nearer to intersection.

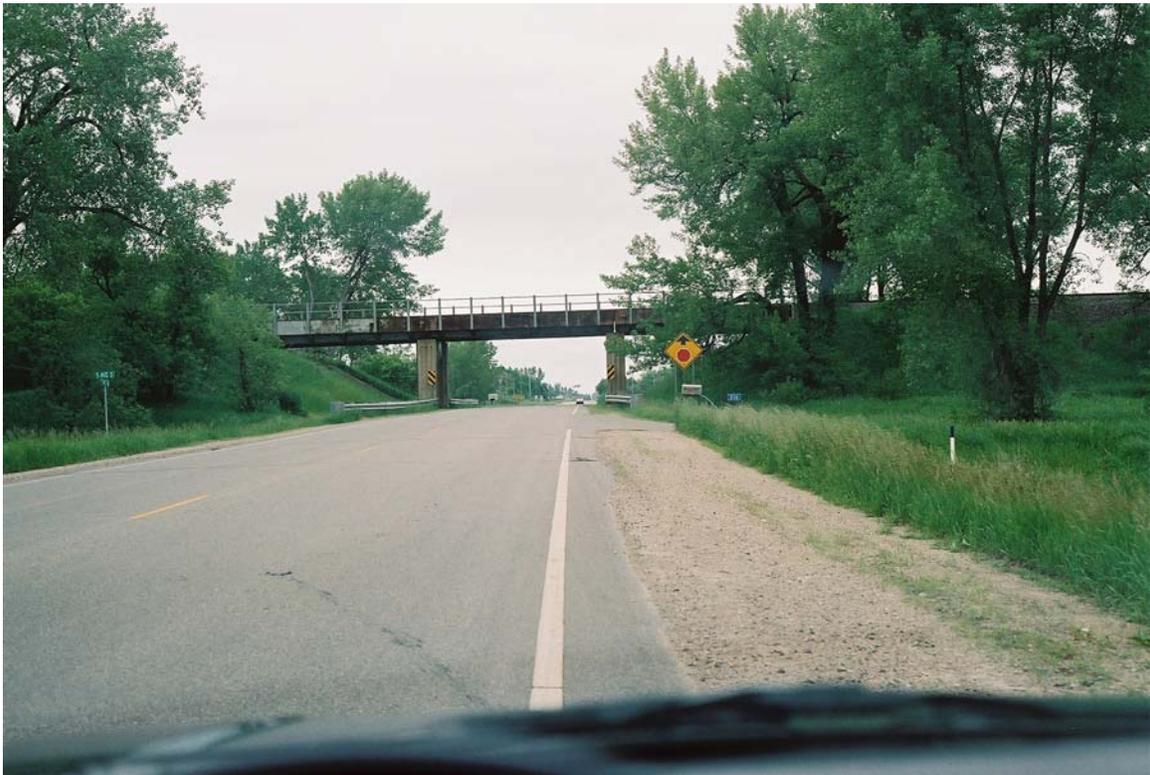
Condition: **No Rumble Strips** on Minor Road.

On North Side (looking South): on both sides—bridge and trees obscure traffic on major road.

Photograph #369 (Reel #17, 16) (from North looking South): warning sign in view—further away from intersection than usual (perhaps because of rail bridge on minor road); also STOP AHEAD on road nearer to intersection.

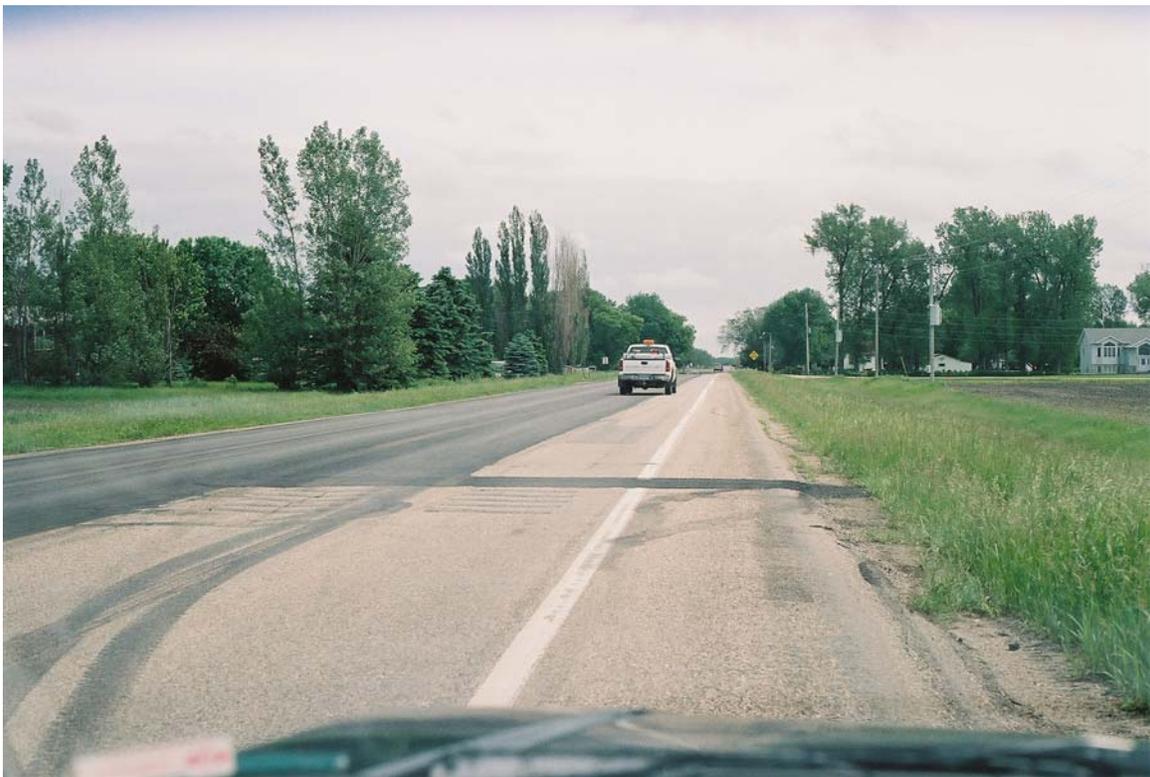
Photograph #371 (Reel #17, 17) (from West looking East): rumble strips on old road surface are filled in, then to the right there is an operational *half rumble* strip on old road surface (new surface does *not* have other half rumble strip to left); warning sign in view [note distance between warning sign and rumble strip greater than usual].

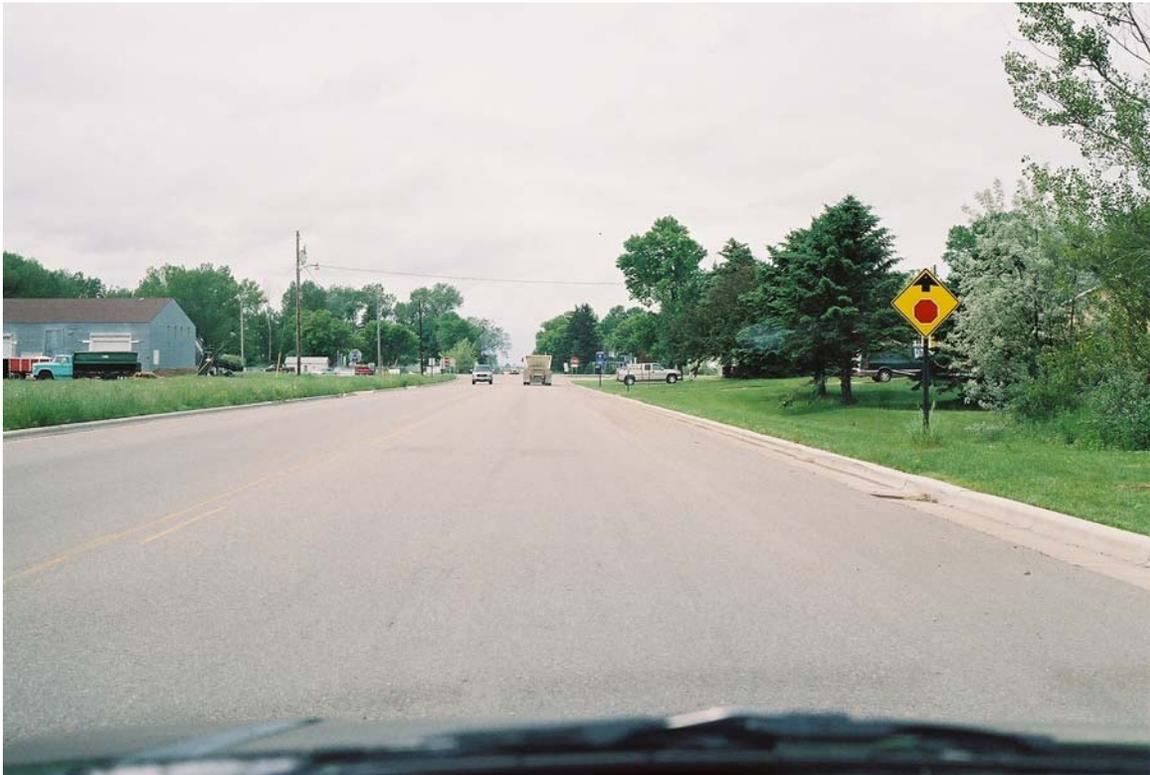
Condition: **Rumble Strips (wheel—reduced number—1.5 to West, 1 to East).**

On East Side (looking West): on both sides—buildings and trees obscure traffic on major road.

Photograph #373 (Reel #17, 19) (from East looking West): *first (& only)* rumble strips and warning sign in view.

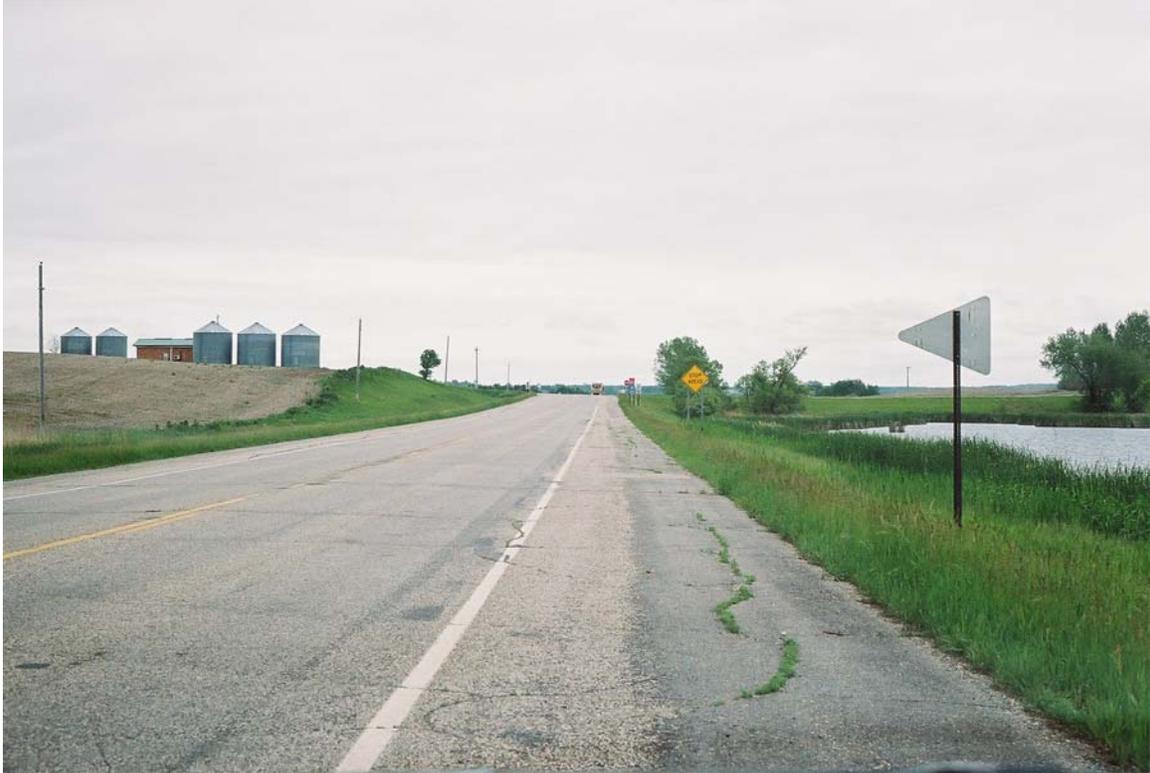
Condition: **4-way stop, No Rumble Strips.**

On West Side (looking East): to North—rise obscures traffic on cross road; to South—
trees partially obscure traffic on cross road.

Photograph #374 (Reel #17, 20) (from West looking East): warning sign in view.

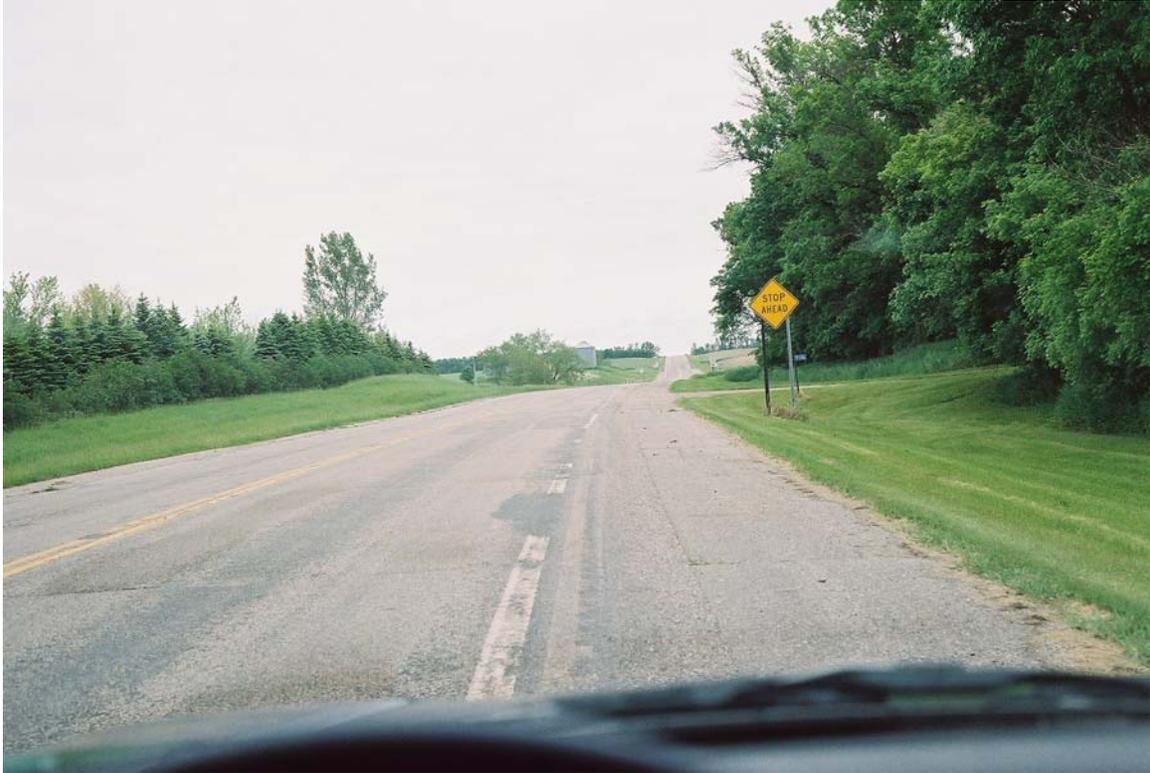
Condition: **4-way stop, No Rumble Strips.**

On South Side (looking North): to East—trees obscure traffic on cross road; to West—
rise bushes obscure traffic on cross road.

Photograph #375 (Reel #17, 21) (from South looking North): warning sign in view.

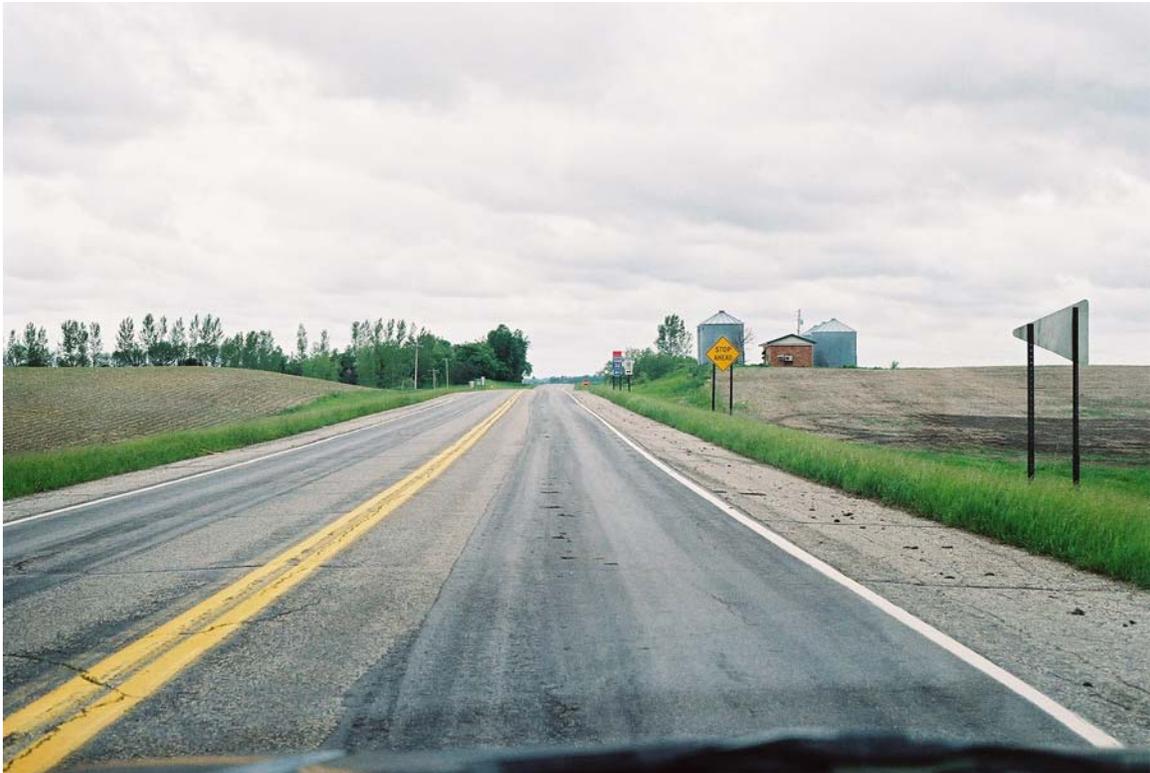
Condition: **4-way stop, No Rumble Strips.**

On East Side (looking West): on both sides—rise obscures traffic on cross road.

Photograph #376 (Reel #17, 22) (from East looking West): warning sign in view.

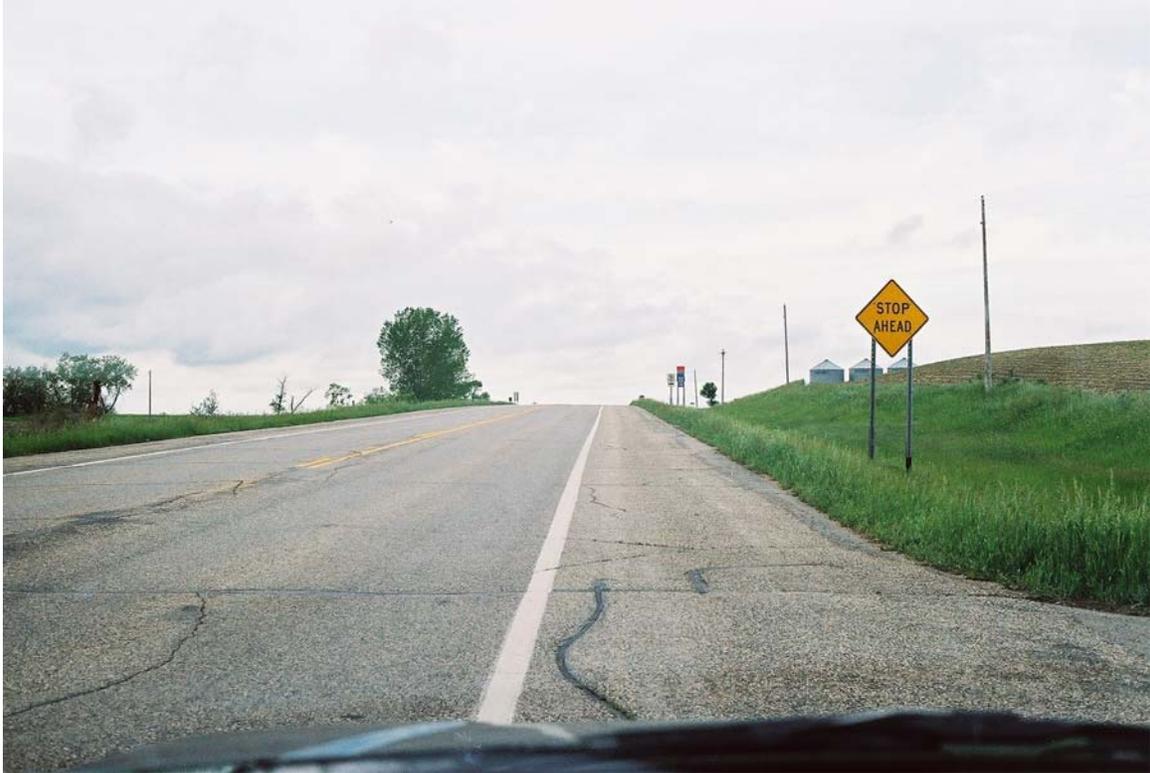
Condition: **4-way stop, No Rumble Strips.**

On North Side (looking South): rise obscures intersection; on both sides—rise obscures traffic on cross road.

Photograph #377 (Reel #17, 23) (from North looking South): warning sign in view.

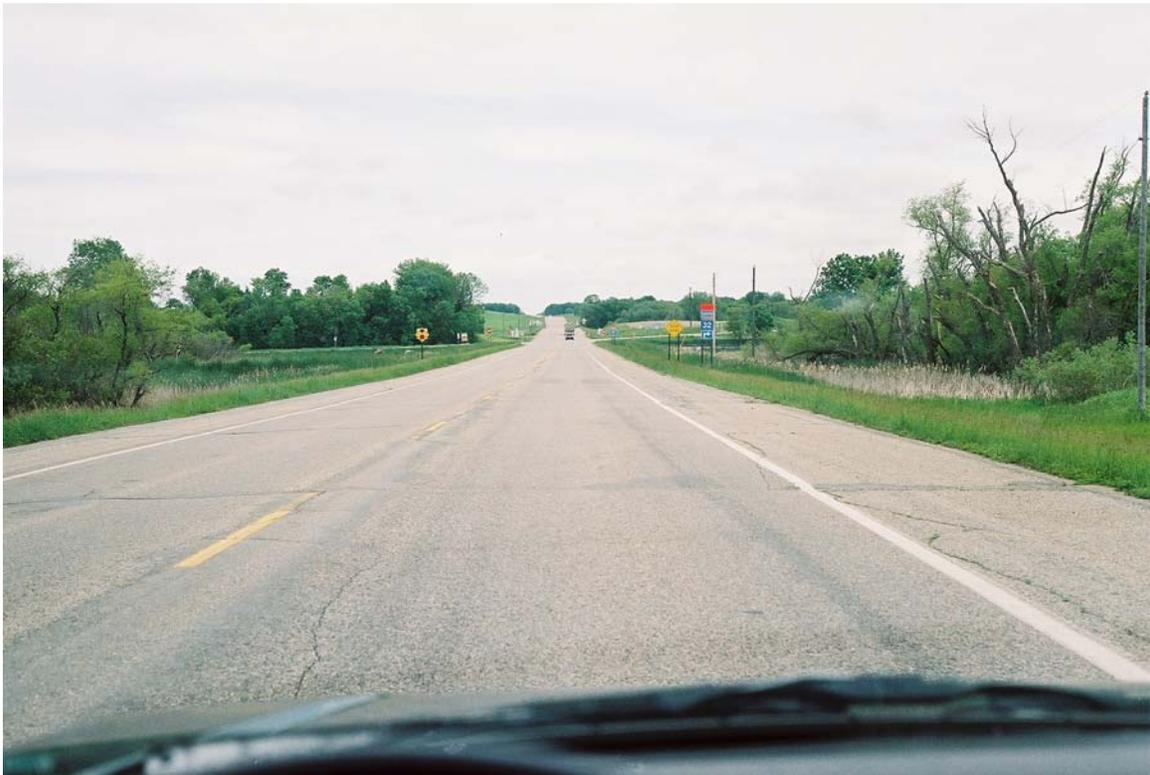
Condition: **Rumble Strips (wheel)** on Minor Road.

On West Side (looking East): to North—trees partial obscure traffic on major road; to South—trees obscure traffic on major road.

Photograph #378 (Reel #17, 24) (from West looking East): first rumble strips and warning sign in view.

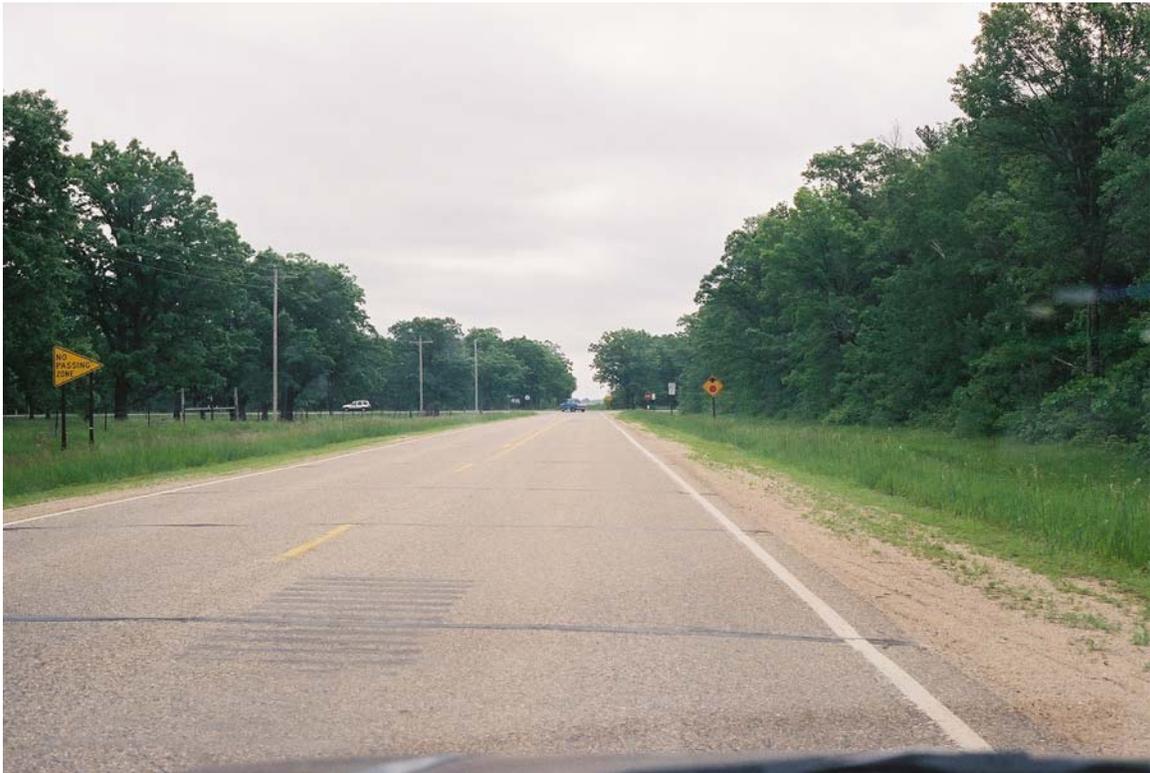
Condition: **Rumble Strips (only *half wheel*)** on Minor Road.

On West Side (looking East): to North—clear view of traffic on major road; to South—
trees obscure traffic on major road.

Photograph #380 (Reel #19, 14A) (from West looking East): first *half* rumble strip and warning sign in view.

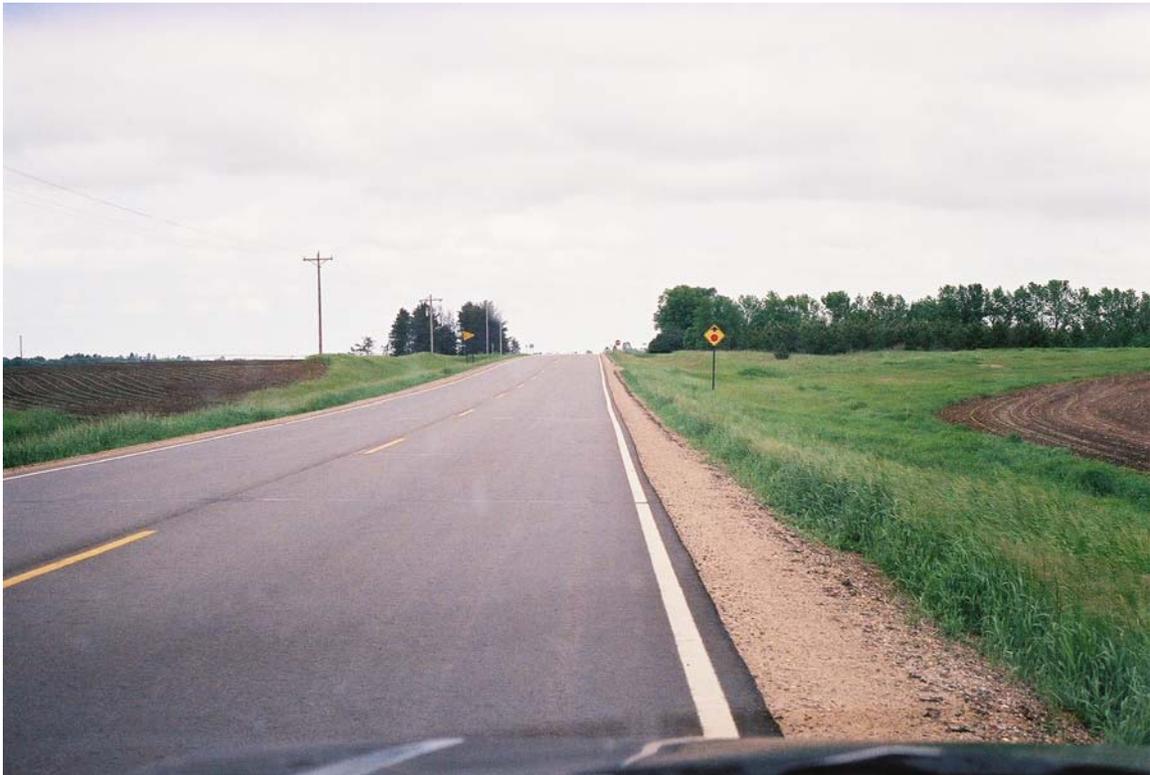
Condition: *No Rumble Strips* on Minor Road.

On South Side (looking North): to East—trees obscure traffic on major road; to West—
clear view of traffic on major road.

Photograph #382 (Reel #19, 16A) (from West looking East): warning sign in view.

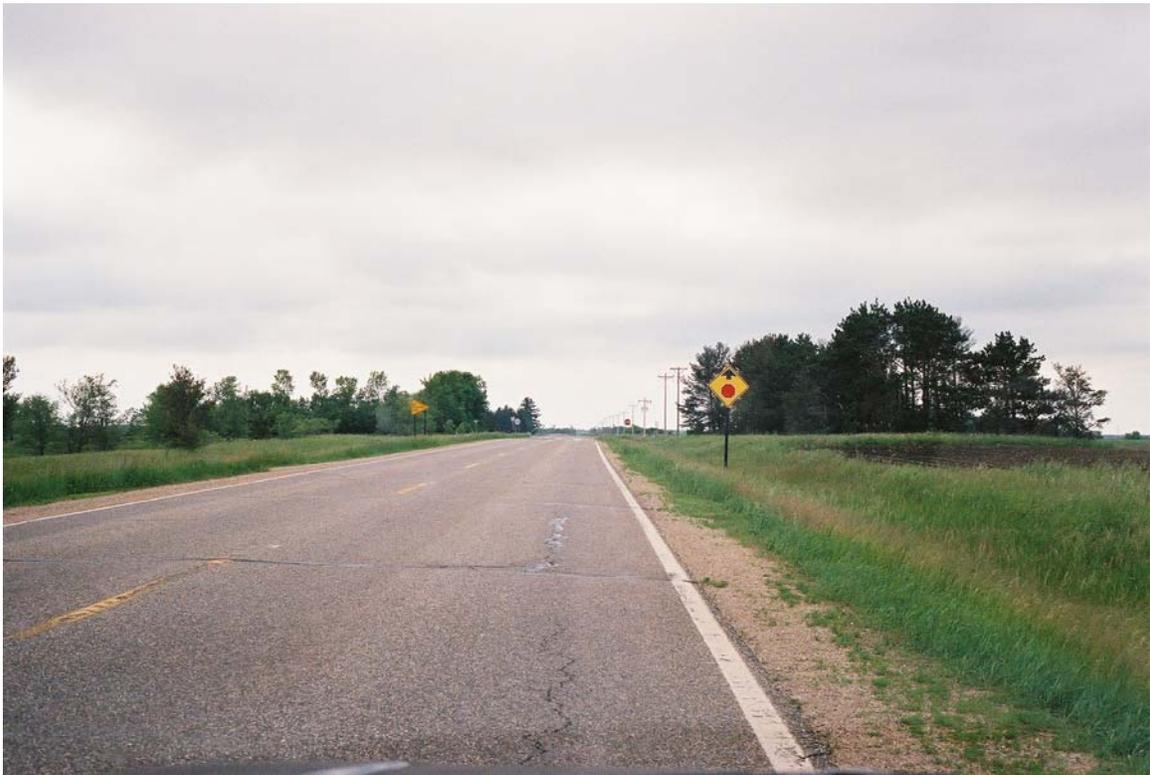
Condition: *No Rumble Strips* on Minor Road.

On North Side (looking South): to East—trees obscure traffic on major road; to West—further away from intersection on major road, there is clear view of traffic, while nearer to the intersection on the major road trees obscure view of traffic.

Photograph #383 (Reel #19, 17A) (from North looking South): warning sign in view.

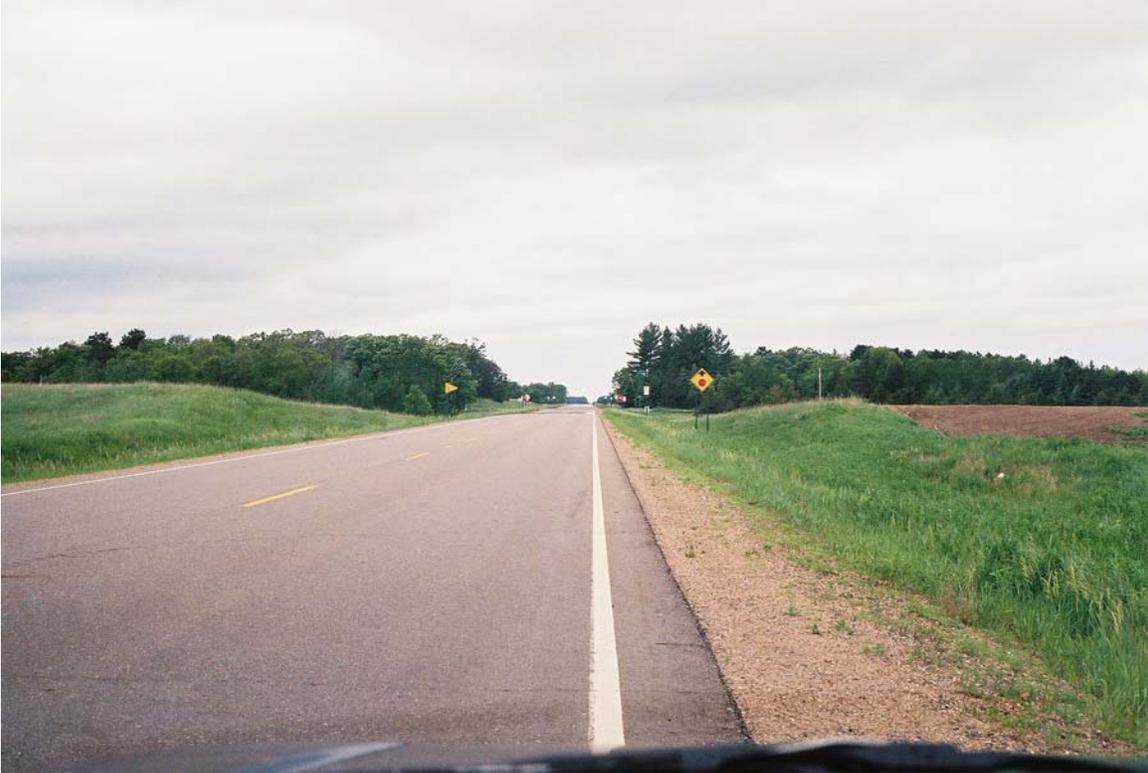
Condition: *No Rumble Strips* on Minor Road.

On East Side (looking West): on both sides—trees obscure traffic on major road.

Photograph #384 (Reel #19, 18A) (from East looking West): warning sign in view.

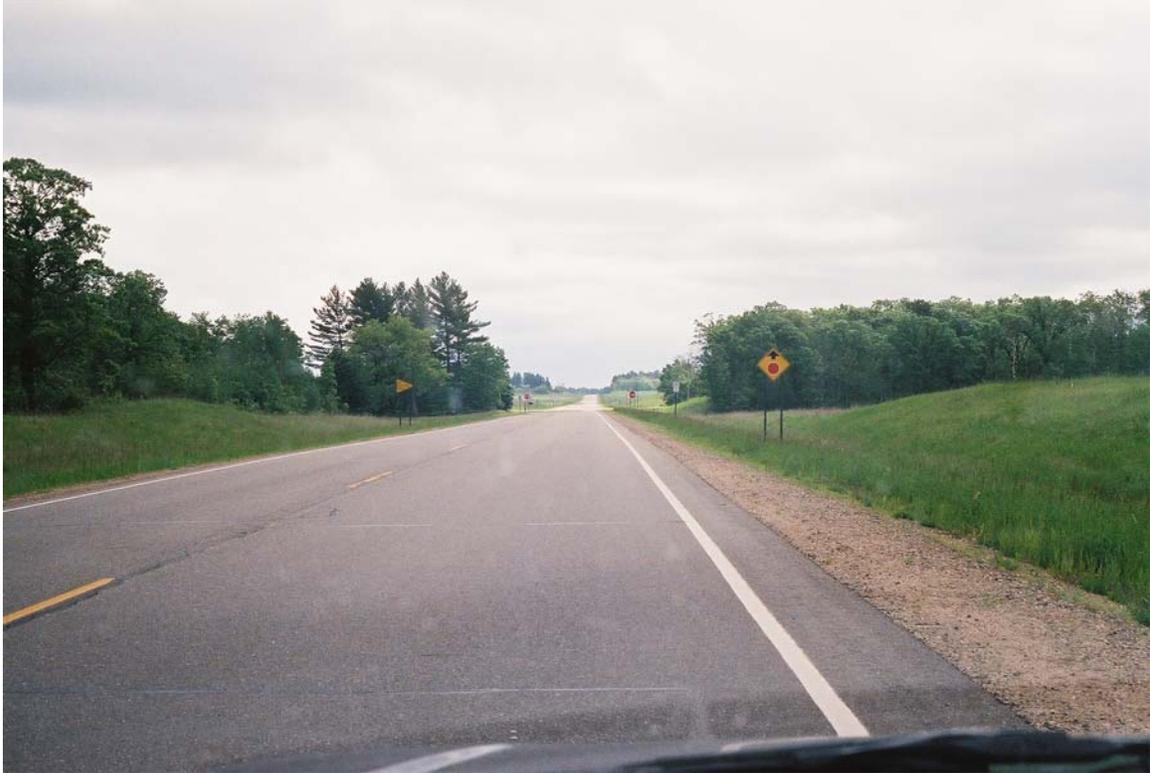
Condition: *No Rumble Strips* on Minor Road.

On West Side (looking East): on both sides—trees obscure traffic on major road.

Photograph #385 (Reel #19, 19A) (from East looking West): warning sign in view.

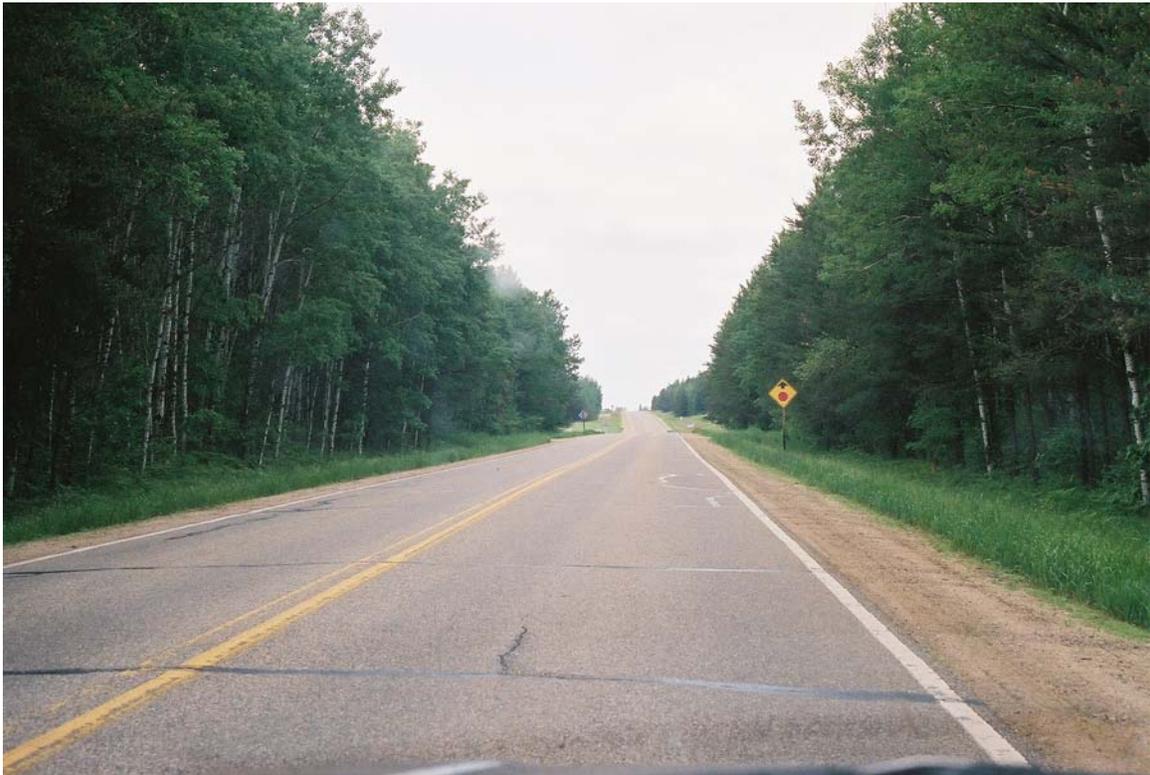
Condition: *No Rumble Strips* on Minor Road.

On South Side (looking North): rise obscures intersection; on both sides—trees and rise obscure traffic on major road.

Photograph #386 (Reel #19, 20A) (from South looking North): warning sign in view.

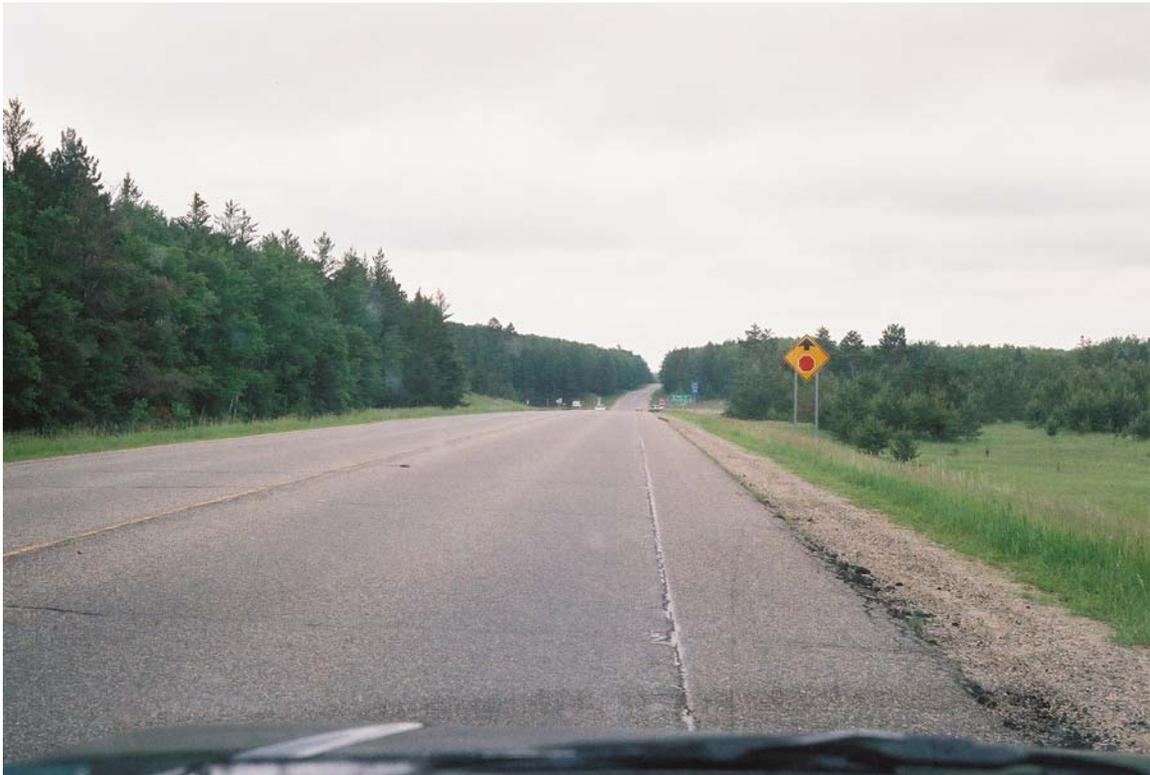
Condition: *No Rumble Strips* on Minor Road.

On North Side (looking South): rise obscures intersection; on both sides—trees and rise obscure traffic on major road.

Photograph #387 (Reel #19, 21A) (from South looking North): warning sign in view.

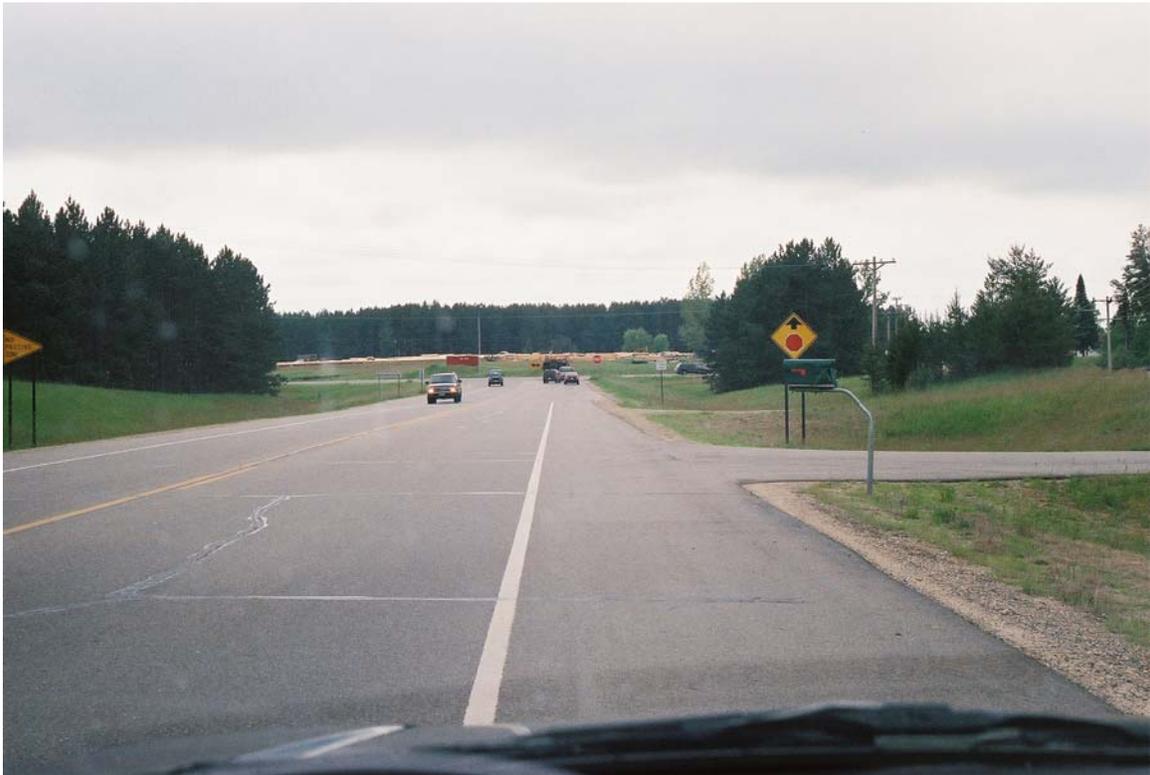
Condition: *T-junction No Rumble Strips* on Minor Road.

On North Side (looking South): on both sides—trees obscure traffic on major road.

Photograph #388 (Reel #19, 22A) (from North looking South): warning sign in view.
