2006-42

Final Report

Stopping Behavior at Real-World
Stop-Controlled Intersections
with and without In-Lane Rumble Strips

**Center for Human Factors Systems Research and Design
University of Minnesota**

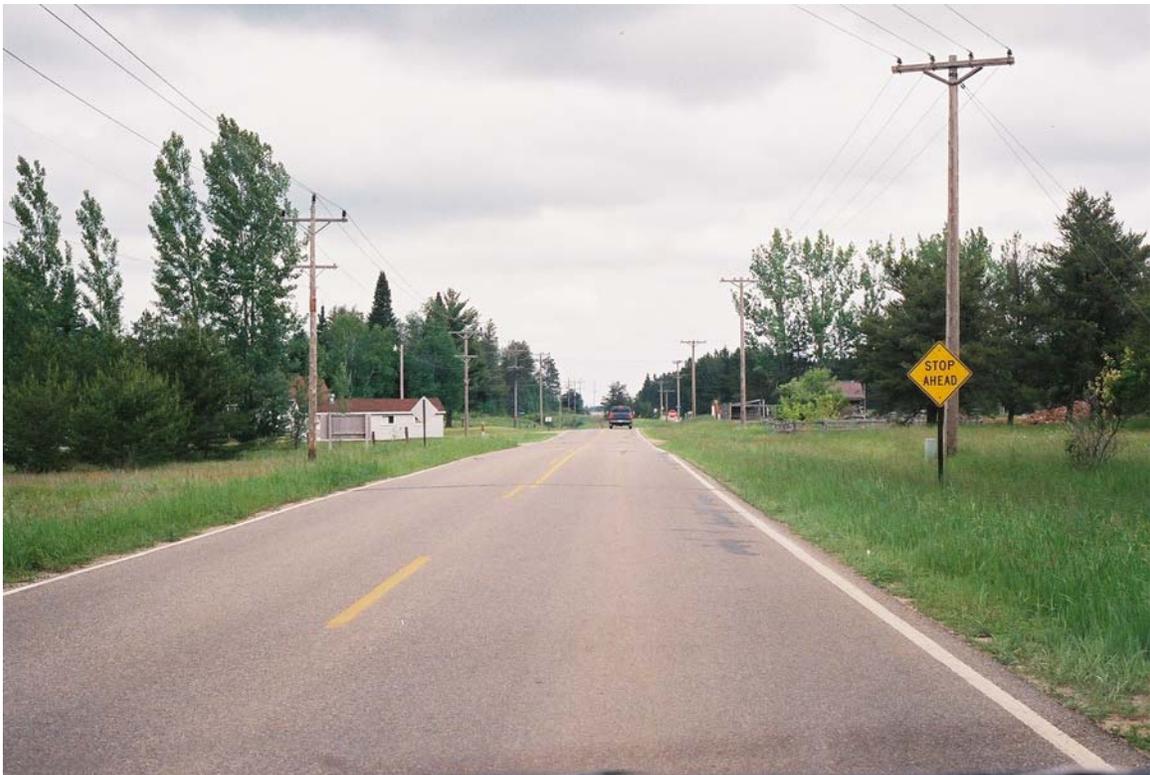
Condition: *T-junction No Rumble Strips* on Minor Road.

On South Side (looking North): on both sides—trees and buildings obscure traffic on major road.

Photograph #389 (Reel #19, 23A) (from North looking South): warning sign in view.

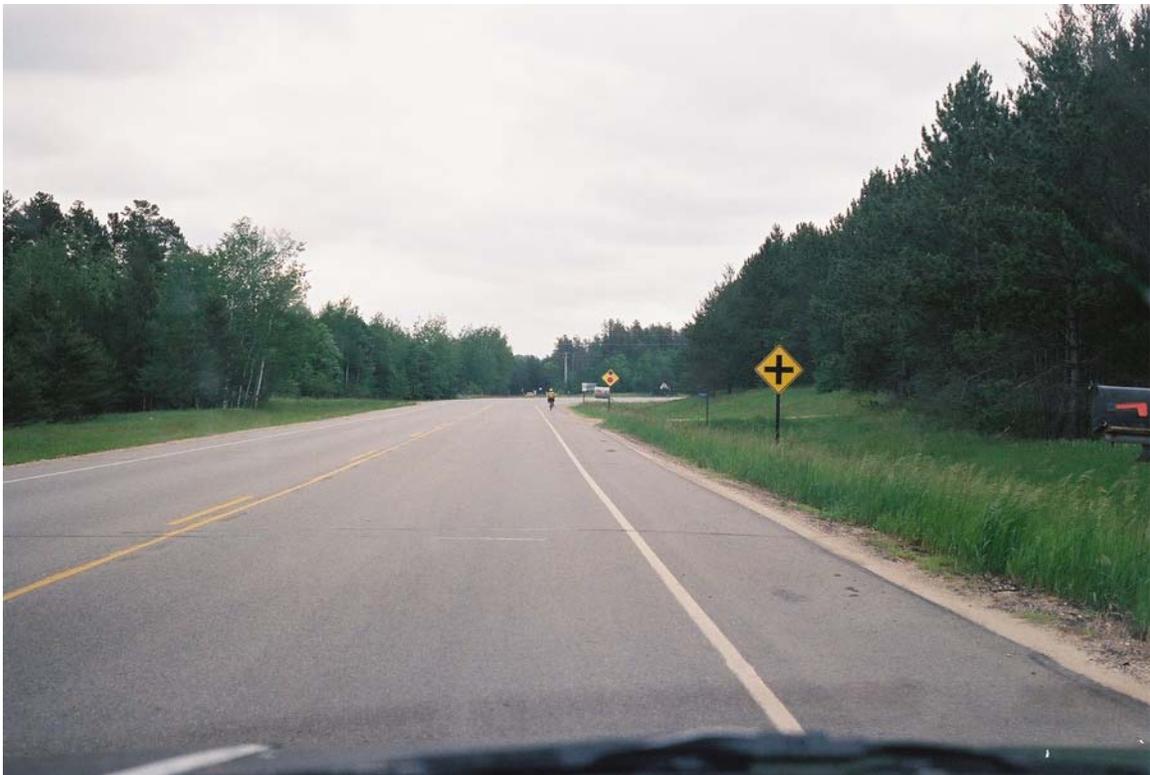
Condition: *No Rumble Strips* on Minor Road.

On West Side (looking East): intersection obscured by trees and curve; on both sides—curve and trees obscure traffic on major road.

Photograph #390 (Reel #19, 24A) (from West looking East): two warning signs—one indicating road crossing ahead, the other stop sign ahead—in view.

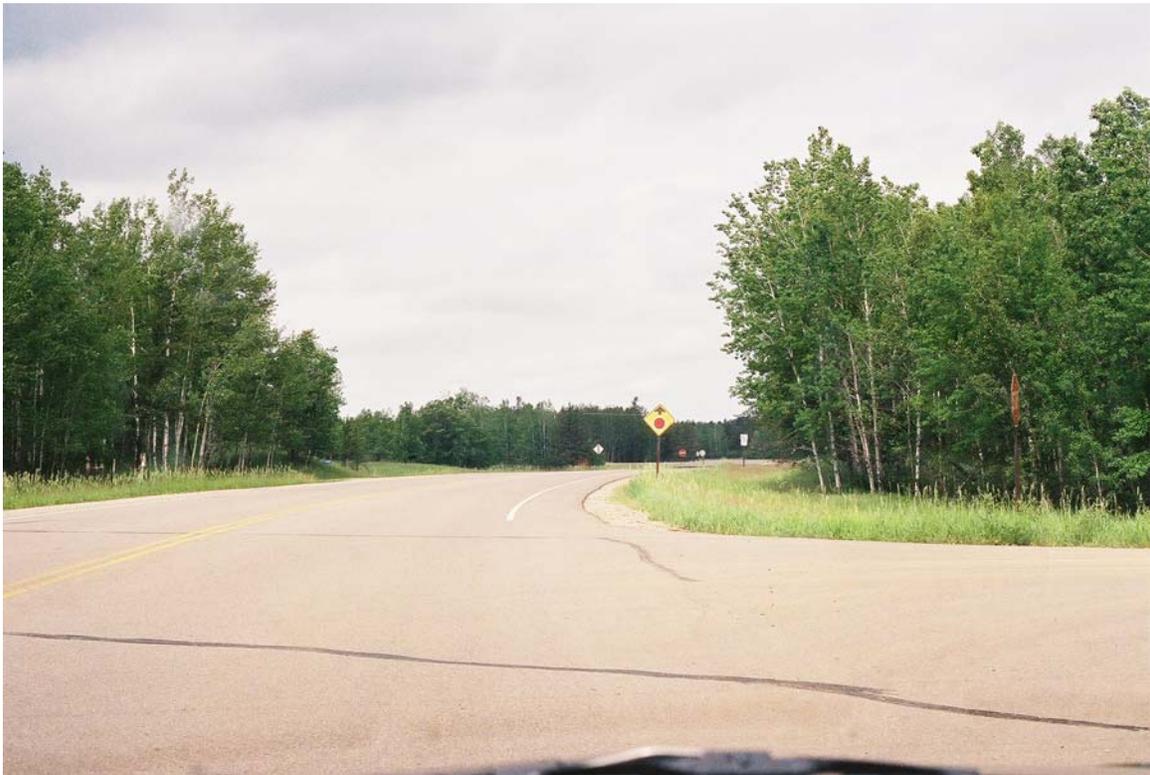
Condition: *No Rumble Strips* on Minor Road.

On East Side (looking West): on both sides—trees obscure traffic on major road.

Photograph #392 (Reel #20, 2A) (from East looking West): warning sign in view.

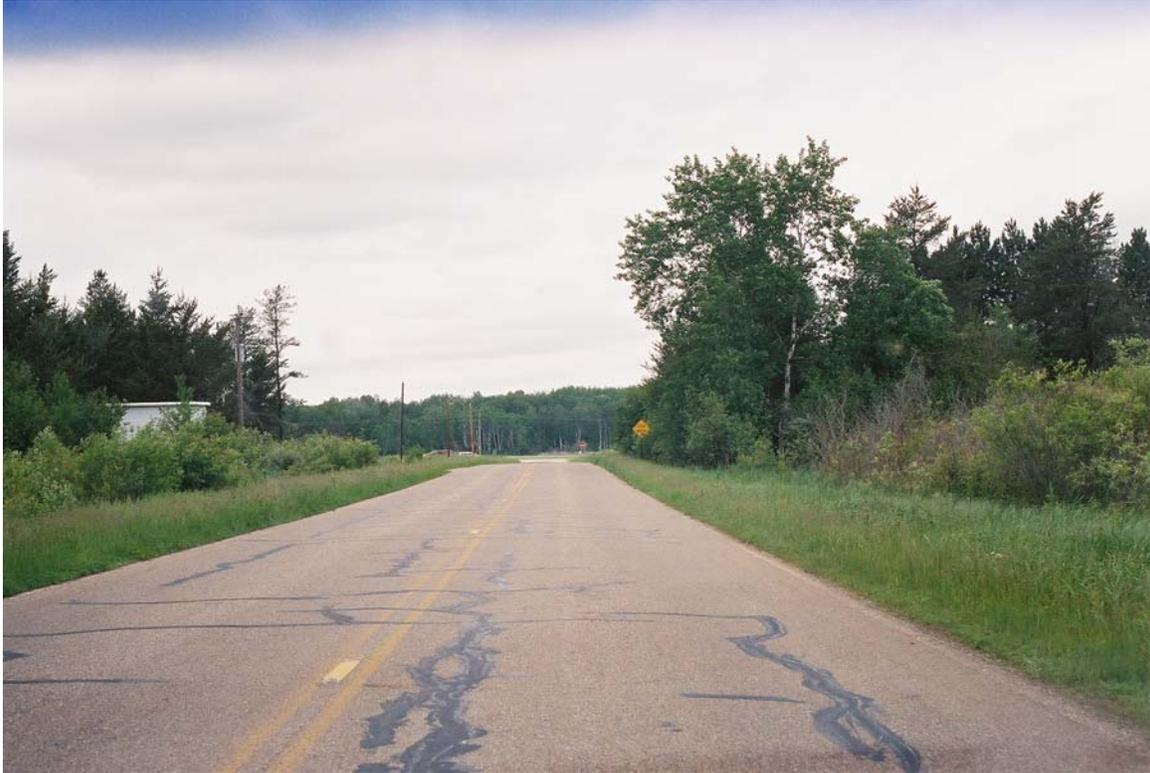
Condition: *T-junction No Rumble Strips* on Minor Road.

On East Side (looking West): on both sides—trees obscure traffic on major road.

Photograph #394 (Reel #20, 4A) (from East looking West): warning sign in view.

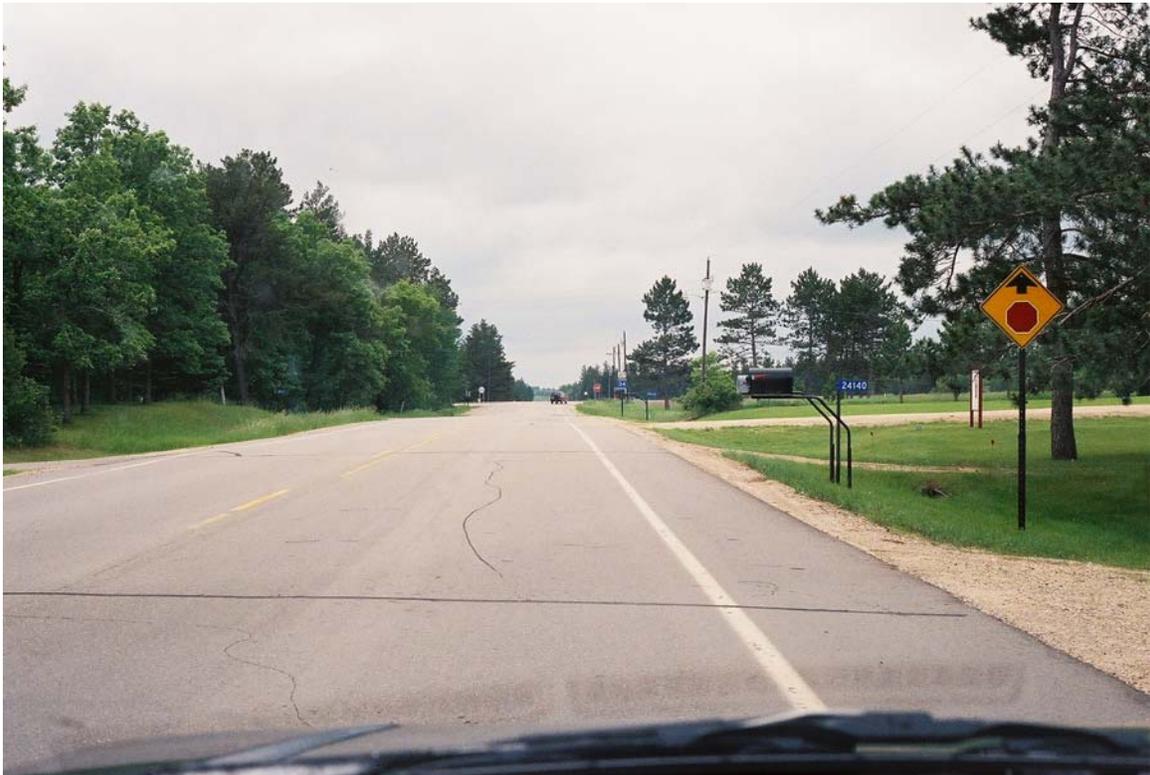
On North Side (looking South): to East—trees obscure traffic on major road; to West—trees and building obscure traffic on major road.

Photograph #395 (Reel #20, 5A) (from North looking South): warning sign in view.

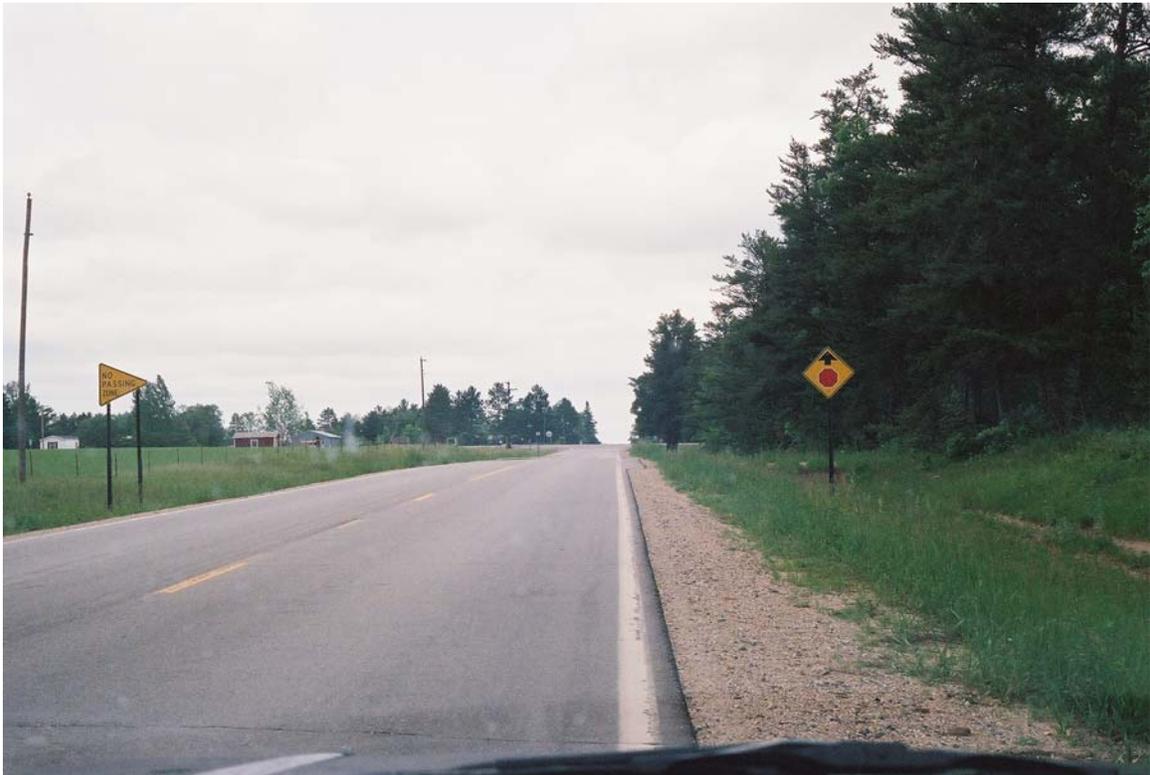
On South Side (looking North): to East—trees obscure traffic on major road; to West—buildings partially obscure traffic on major road.

Photograph #396 (Reel #20, 6A) (from South looking North): warning sign in view.

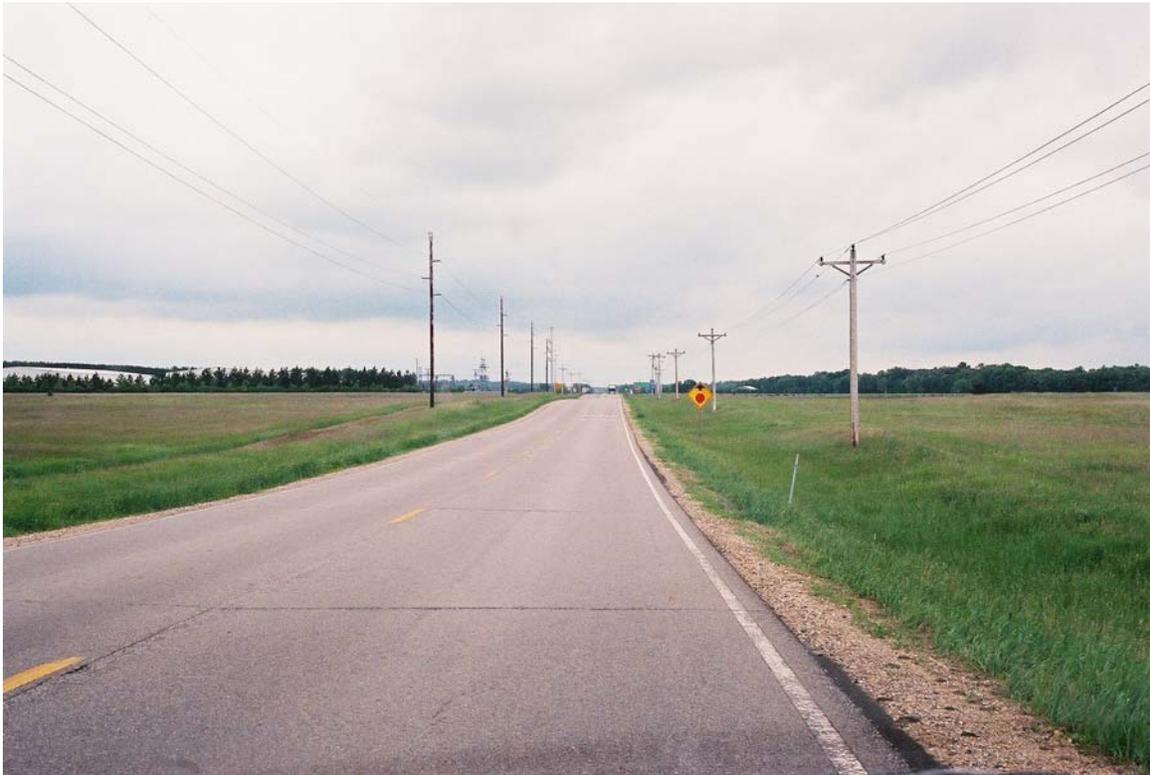
On North Side (looking South): to East—clear view of traffic on major road; to West—trees obscure traffic on major road.

Photograph #397 (Reel #20, 7A) (from North looking South): warning sign in view; also STOP AHEAD on road.

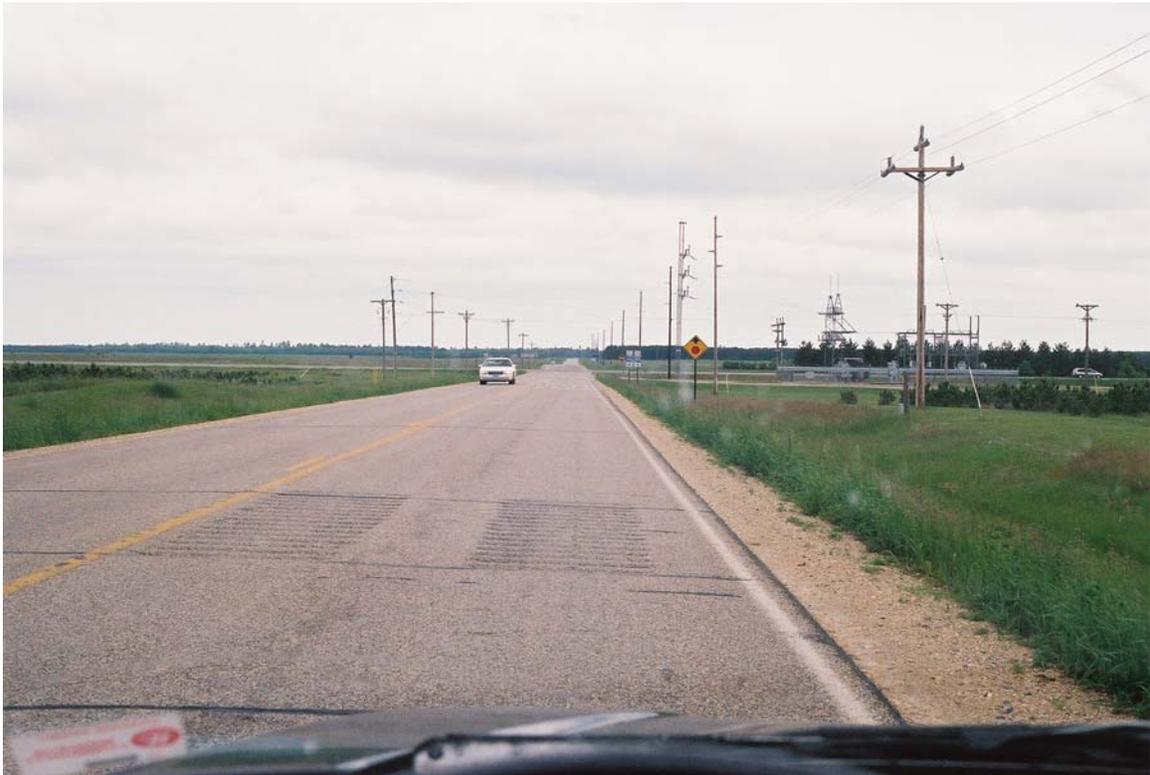
On South Side (looking North): to East—clear view of traffic on major road; to West—power plant partially obscures traffic on major road.

Photograph #399 (Reel #20, 9A) (from South looking North): first rumble strips and warning sign in view.

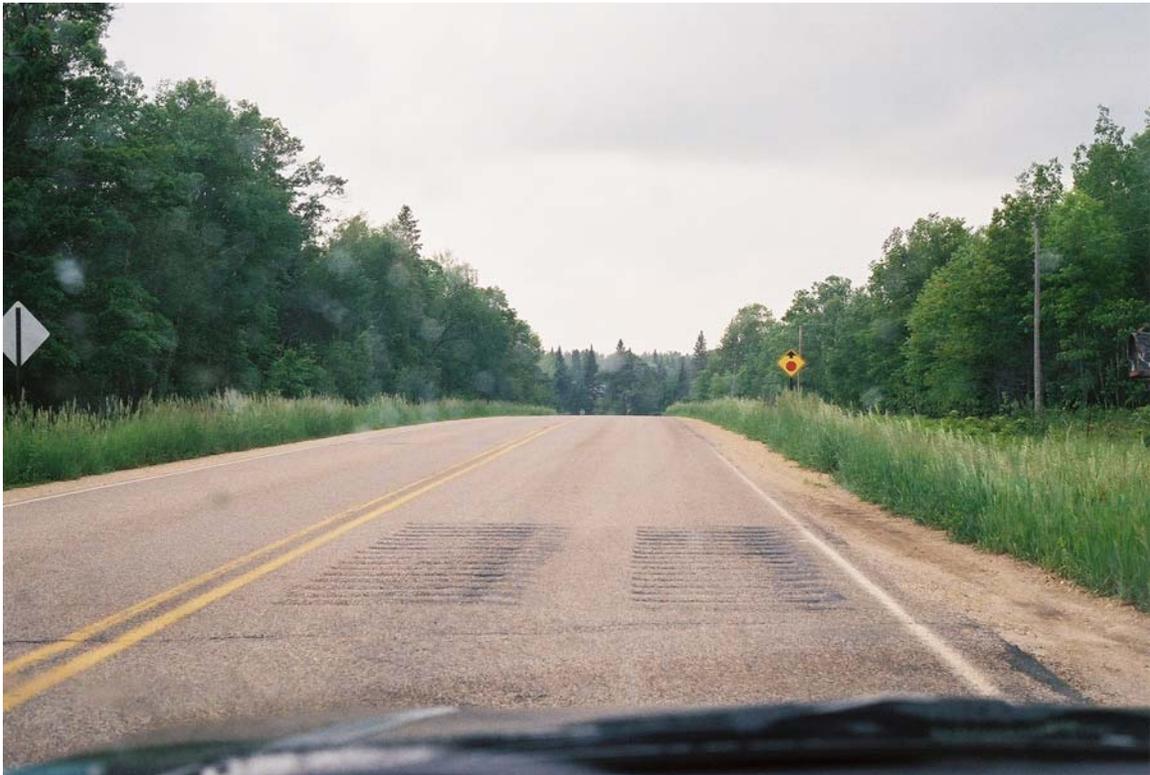
On North Side (looking South): rise obscures intersection; on both sides—rise and trees obscure traffic on major road.

Photograph #401 (Reel #20, 11A) (from North looking South): first rumble strips and warning sign in view.

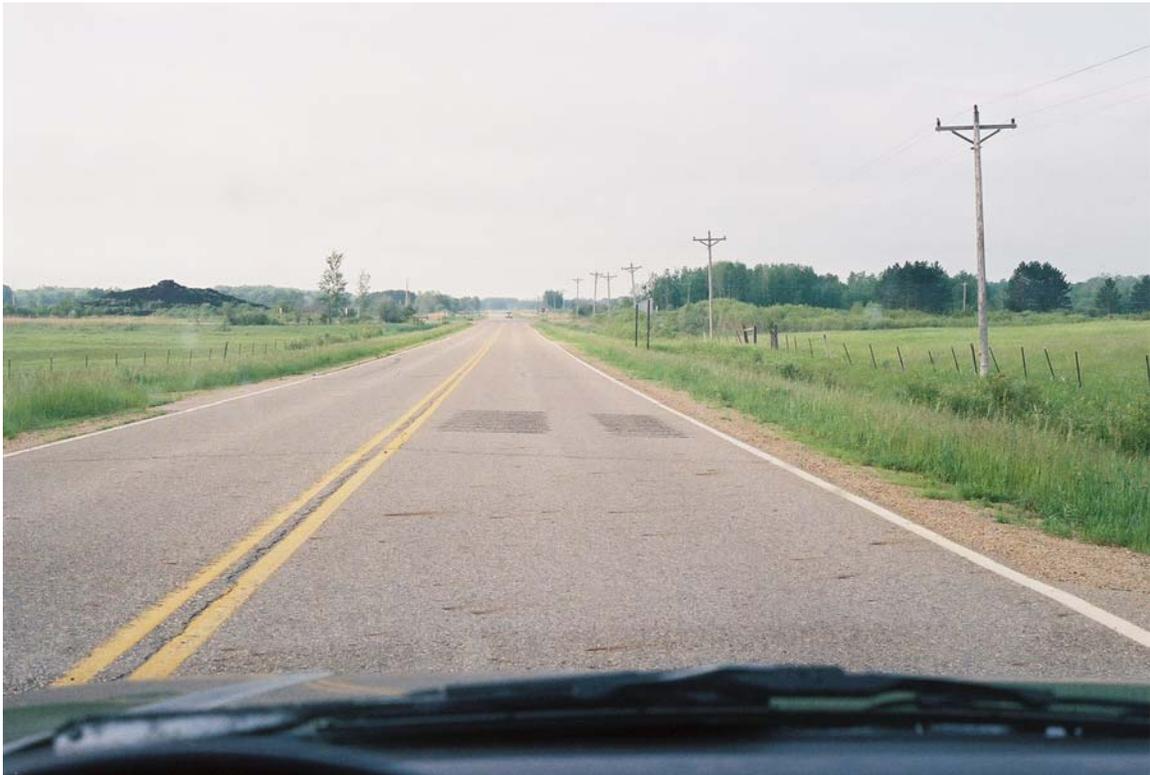
On North Side (looking South): to East—trees partially obscure traffic on major road; to West—trees obscure traffic on major road.

Photograph #403 (Reel #19, 2A) (from North looking South): first rumble strips in view, but there is *no warning sign*.

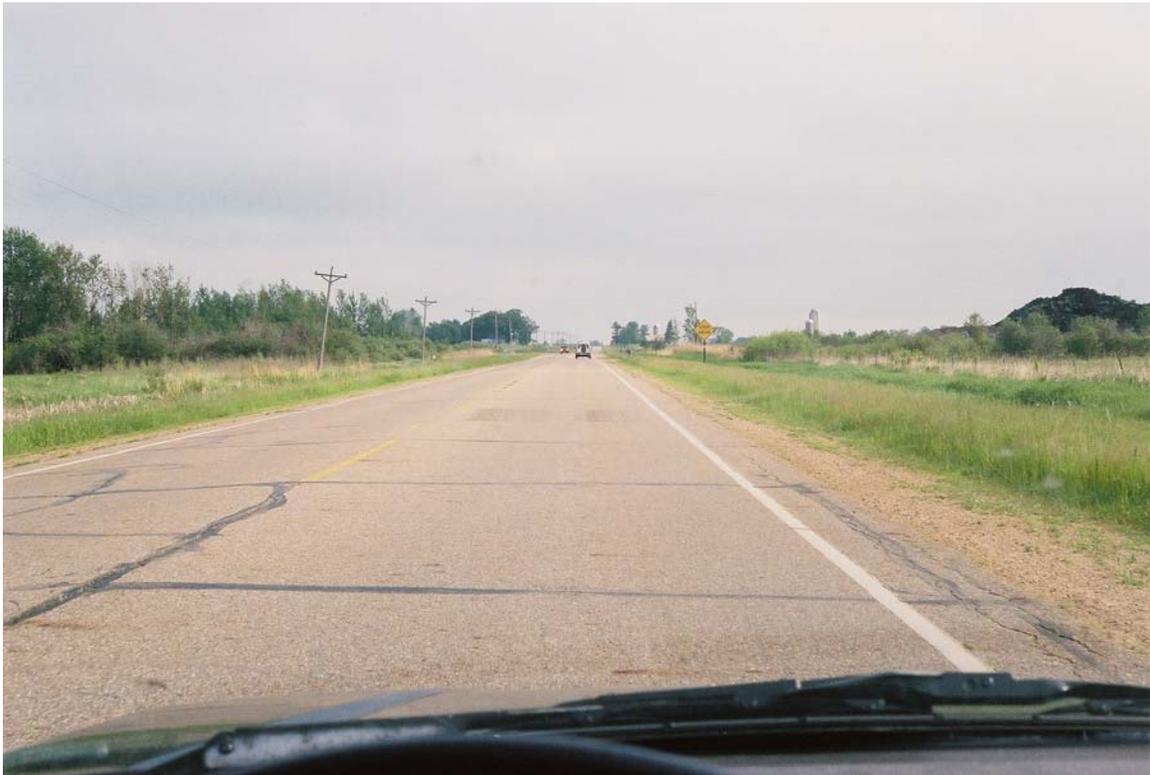
On North Side (looking South): to East—trees partially obscure traffic on major road; to West—trees obscure traffic on major road.

Photograph #404 (Reel #19, 4A) (from North looking South): first rumble strips and warning sign in view.

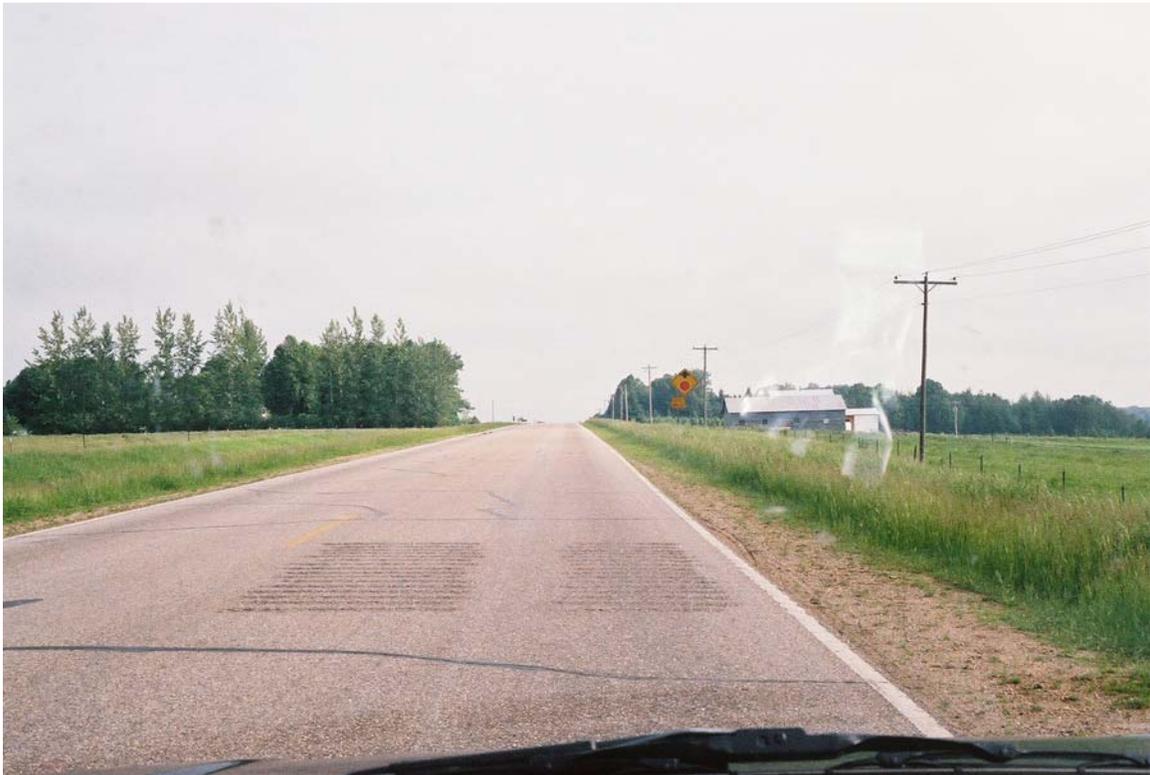
On South Side (looking North): to East—building partially obscures traffic on major road; to West—trees obscure traffic on major road.

Photograph #407 (Reel #19, 6A) (from South looking North): first rumble strips and warning sign in view.

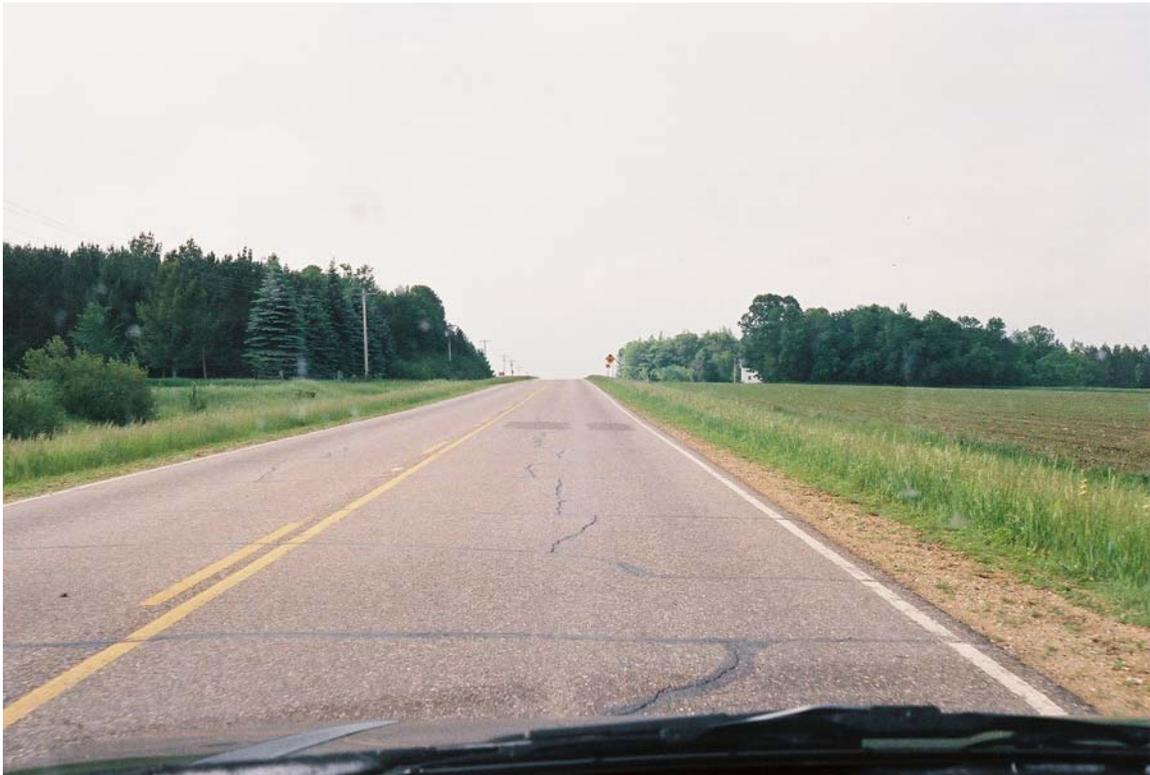
On North Side (looking South): rise obscures intersection; on both sides—rise and trees obscure traffic on major road.

Photograph #409 (Reel #19, 8A) (from North looking South): first rumble strips and warning sign in view.

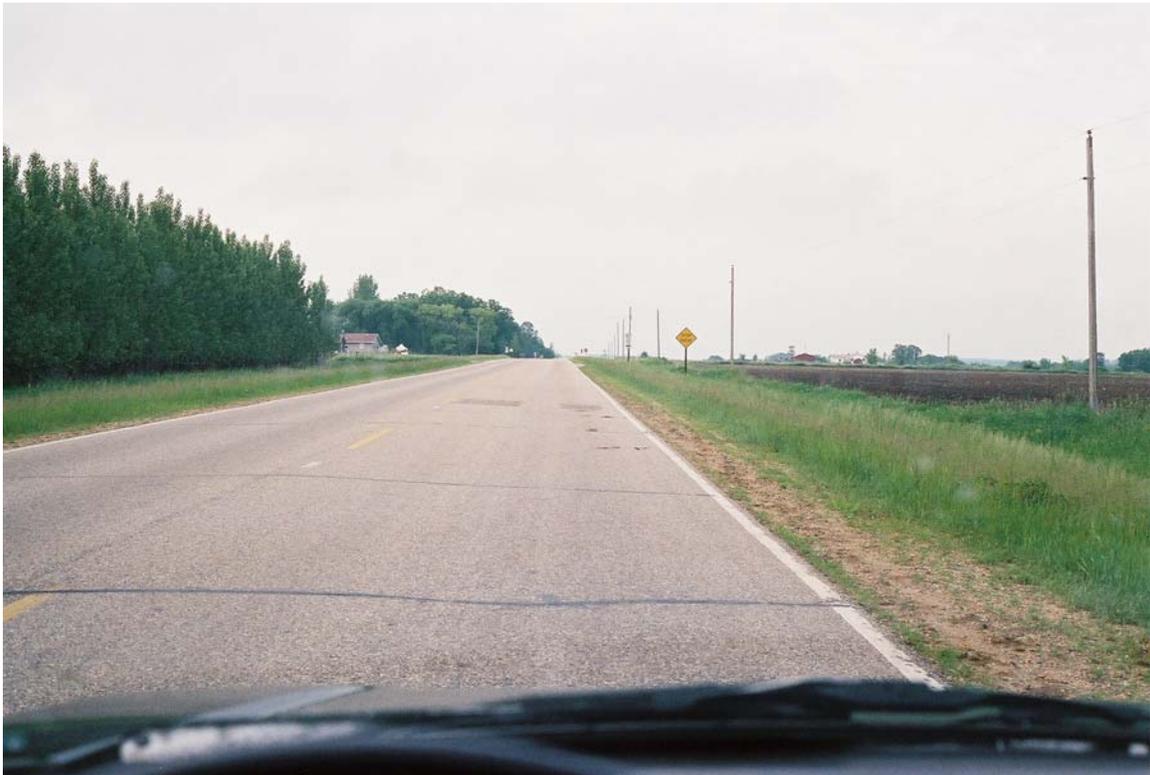
On North Side (looking South): to East—trees obscure traffic on major road; to West—clear view of traffic on major road.

Photograph #411 (Reel #19, 10A) (from North looking South): first rumble strips and warning sign in view.

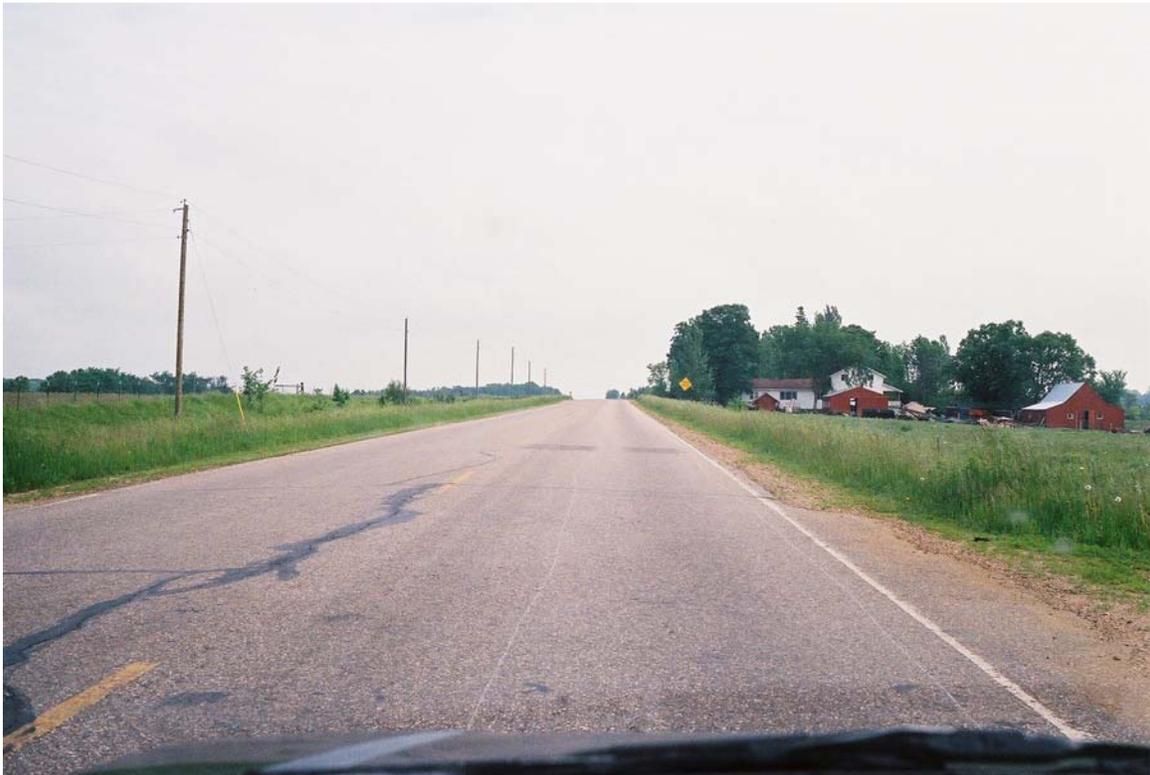
On South Side (looking North): to East—trees and buildings obscure traffic on major road; to West—rise obscures traffic on major road.

Photograph #413 (Reel #19, 12A) (from South looking North): first rumble strips and warning sign in view.

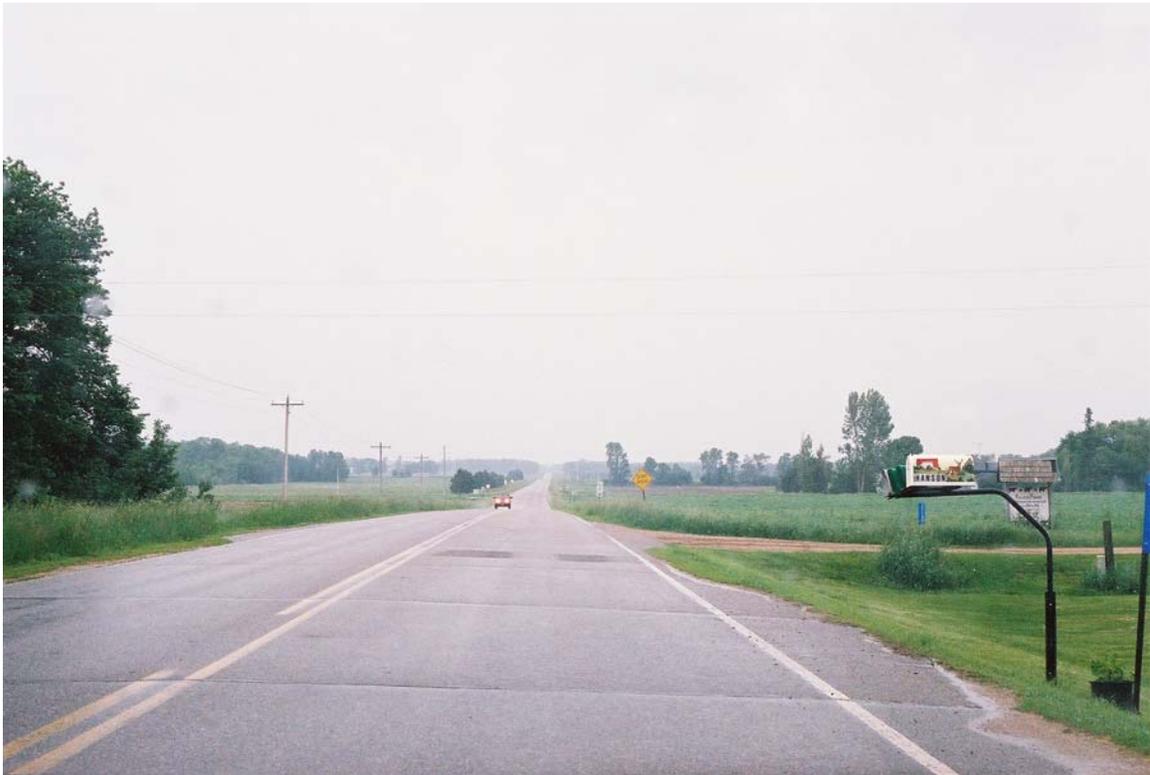
On North Side (looking South): on both sides—rise obscures traffic on major road—but by second rumble strips there is clear view of traffic.

Photograph #415 (Reel #20, 13A) (from North looking South): first rumble strips and warning sign in view.

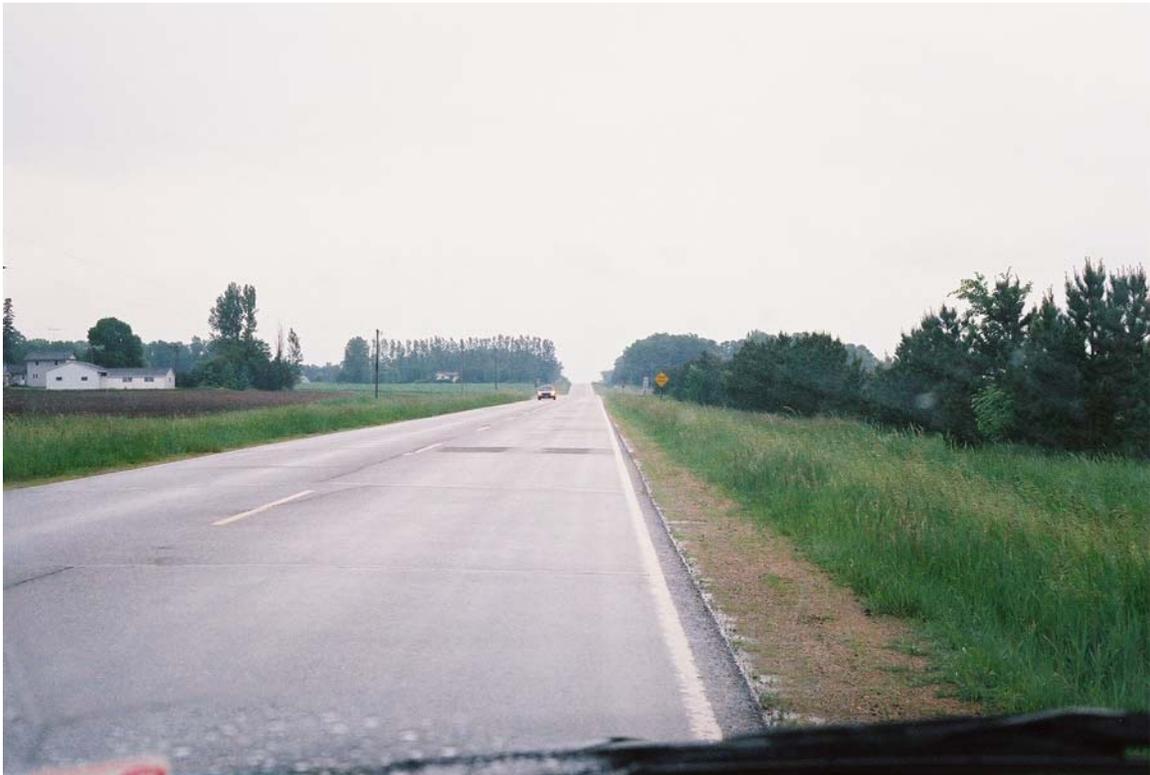
On South Side (looking North): to East—trees obscure traffic on major road; to West—buildings and trees obscure traffic on major road.

Photograph #417 (Reel #20, 15A) (from South looking North): first rumble strips and warning sign in view.

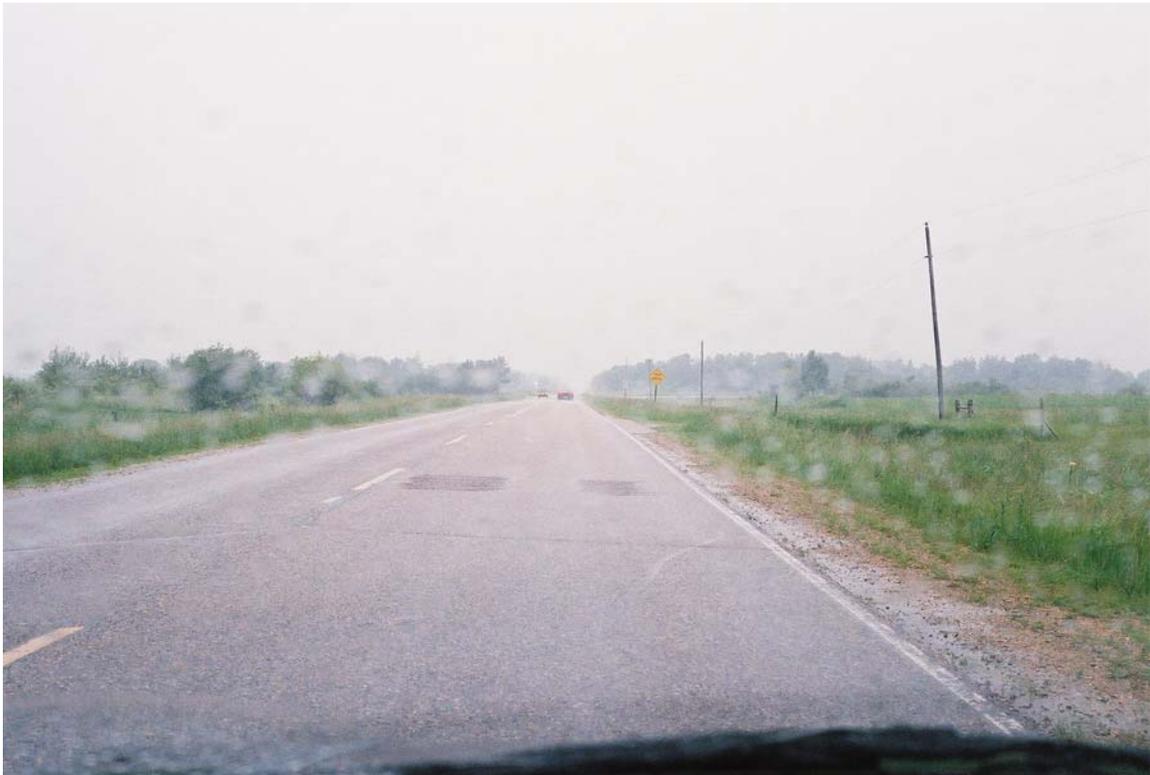
On North Side (looking South): on both sides—trees obscure traffic on major road by foliage.

Photograph #419 (Reel #20, 17A) (from North looking South): first rumble strips and warning sign in view.

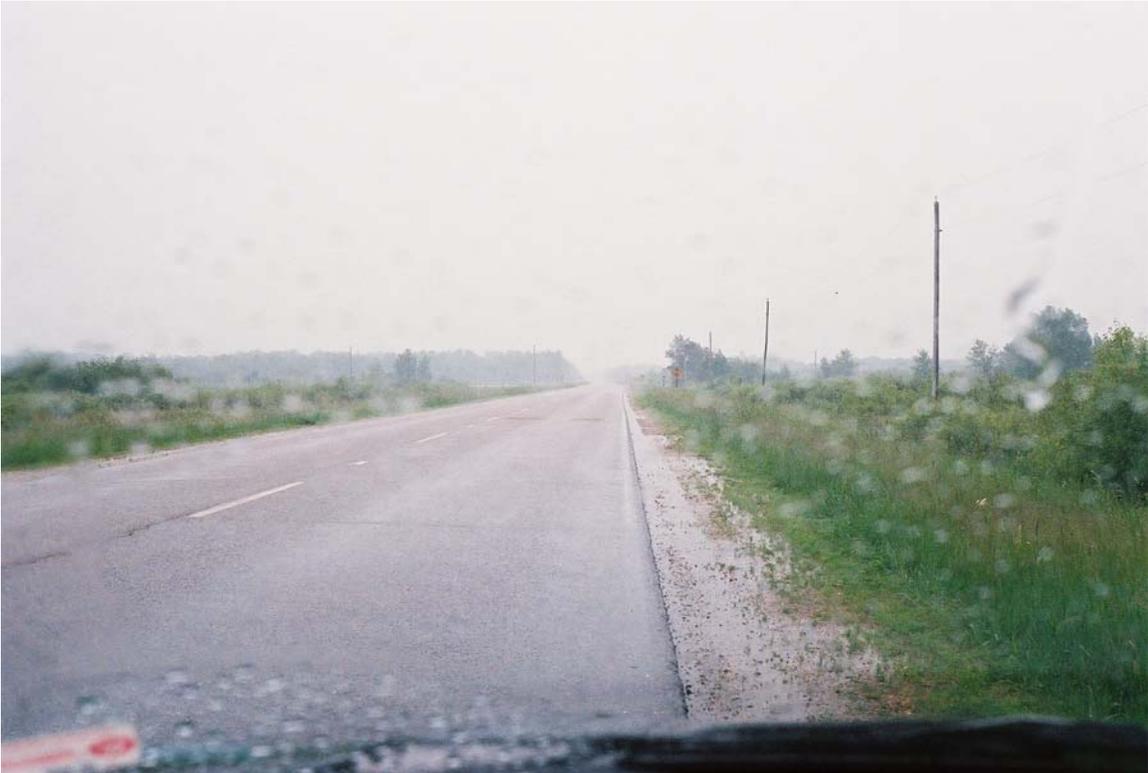
On South Side (looking North): to East—trees obscure traffic on major road; to West—
trees partially obscure traffic on major road.

Photograph #421 (Reel #20, 19A) (from South looking North): first rumble strips and warning sign in view.

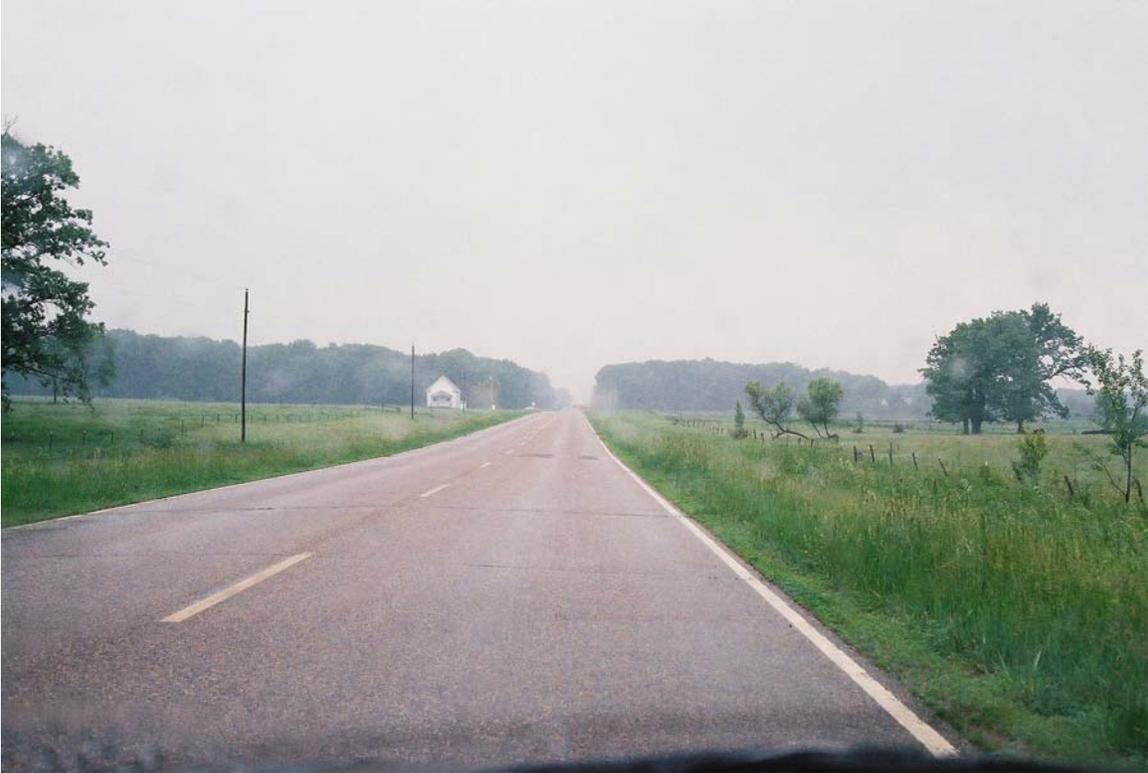
On South Side (looking North): on both sides—clear view of traffic on major road.

Photograph #423 (Reel #20, 21A) (from South looking North): first rumble strips in view, but *no warning sign*.

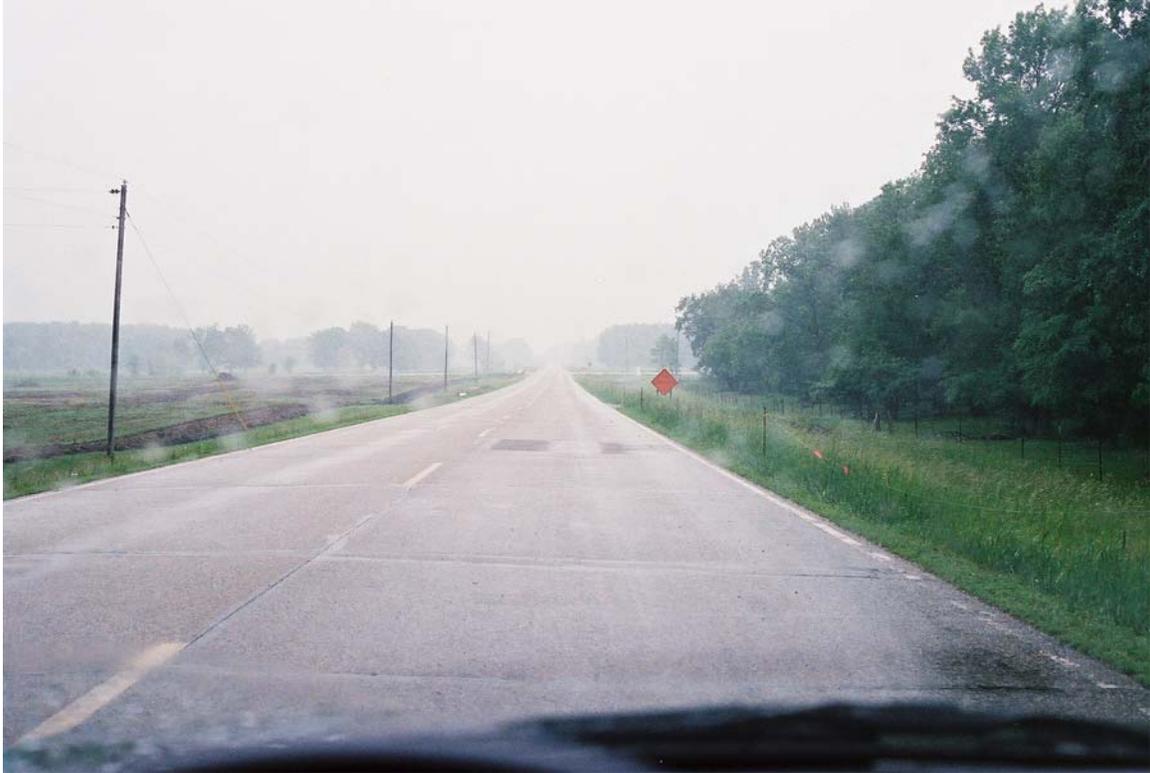
On North Side (looking South): to East—clear; to West—obscured by trees.

Photograph #426 (Reel #20, 24A) (from North looking South): first rumble strips in view, but *no warning sign* [Note; there is a “No Shoulder” sign in view.]

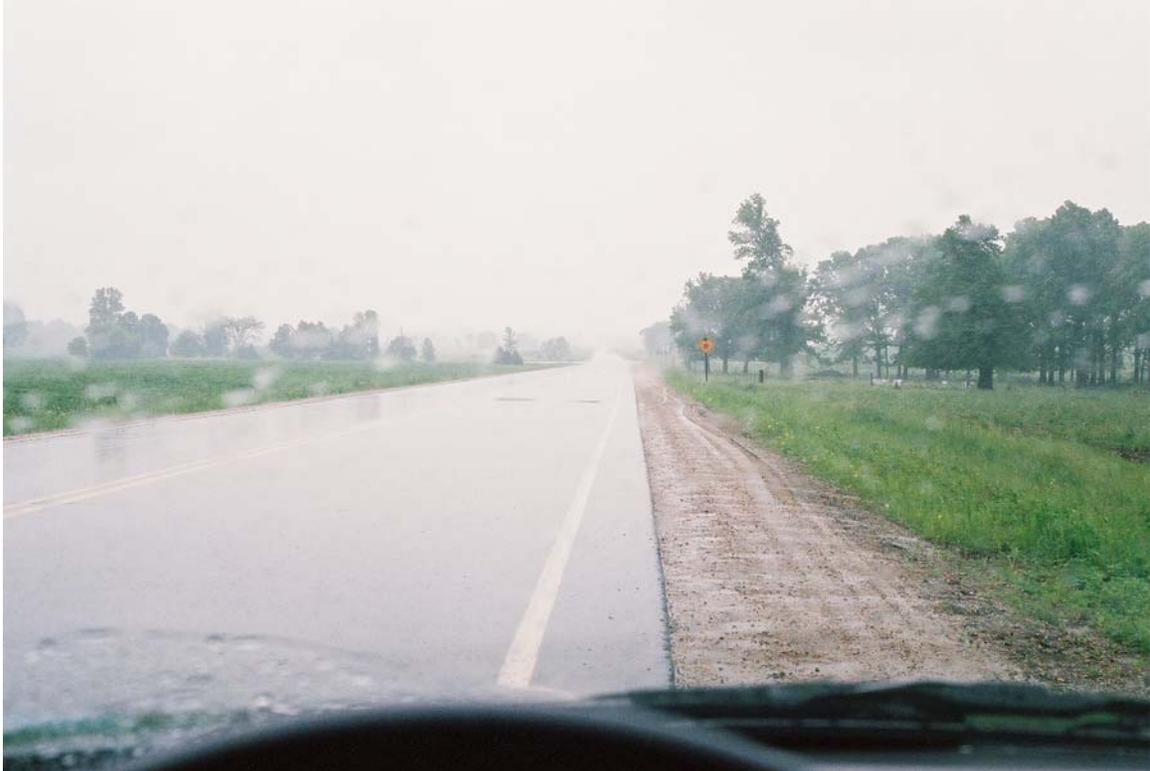
On South Side (looking North): to East—partially obscured by trees; to West—clear.

Photograph #428 (Reel #21, 3) (from South looking North): first rumble strips and warning sign in view.

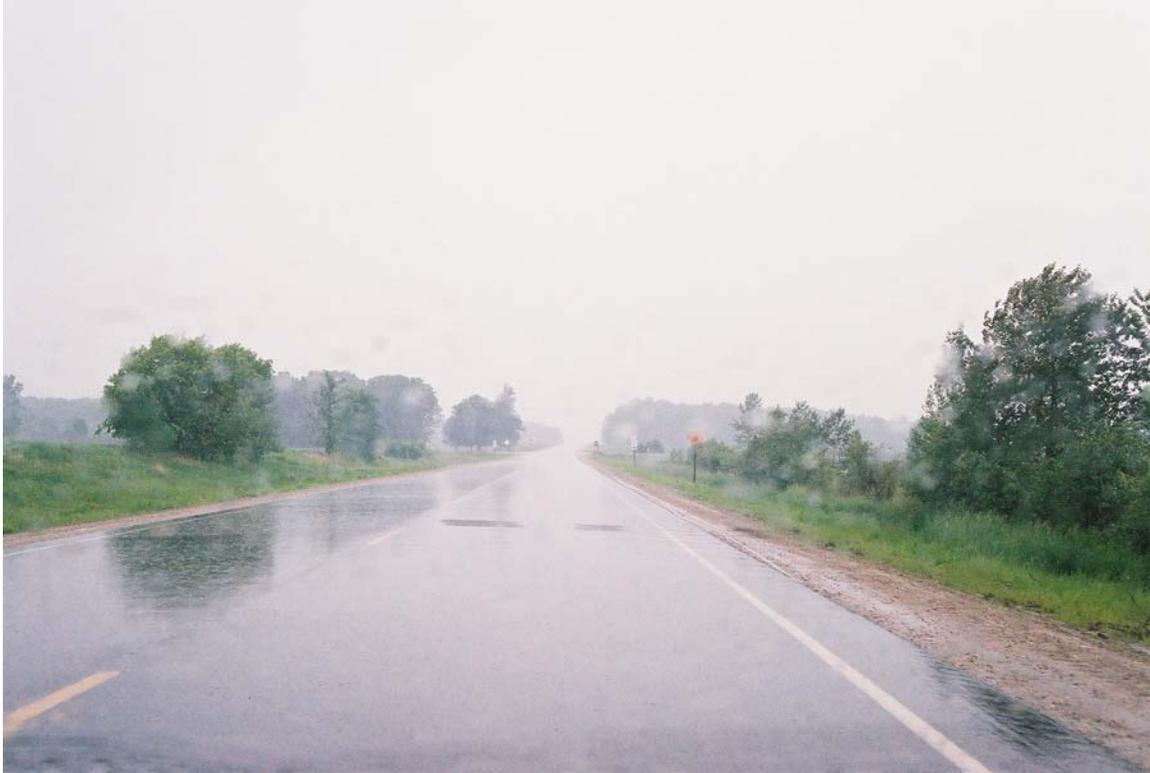
On North Side (looking South): on both sides—trees partially obscure traffic on major road.

Photograph #430 (Reel #21, 5) (from North looking South): first rumble strips and warning sign in view.

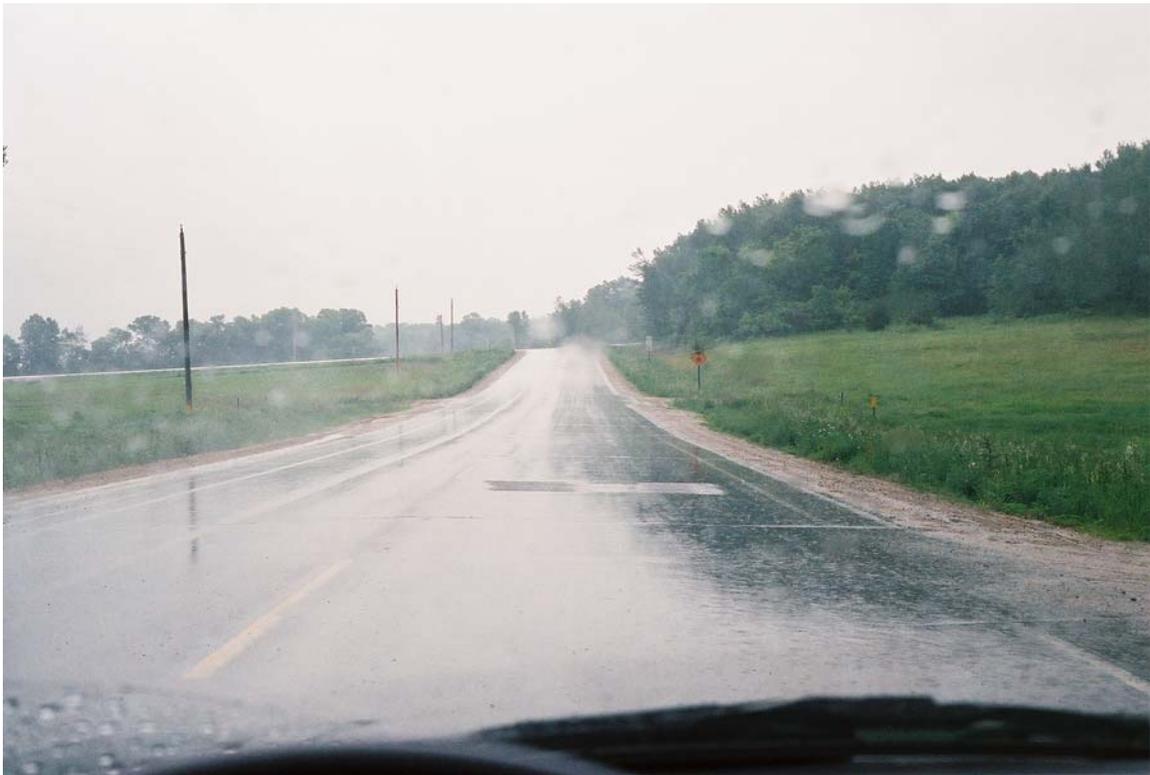
On West Side (looking East): to North—clear view of traffic on major road; to South—trees obscure traffic on major road.

Photograph #432 (Reel #21, 7) (from West looking East): first rumble strips and warning sign in view.
