2006-42

Final Report

Stopping Behavior at Real-World
Stop-Controlled Intersections
with and without In-Lane Rumble Strips

**Center for Human Factors Systems Research and Design
University of Minnesota**

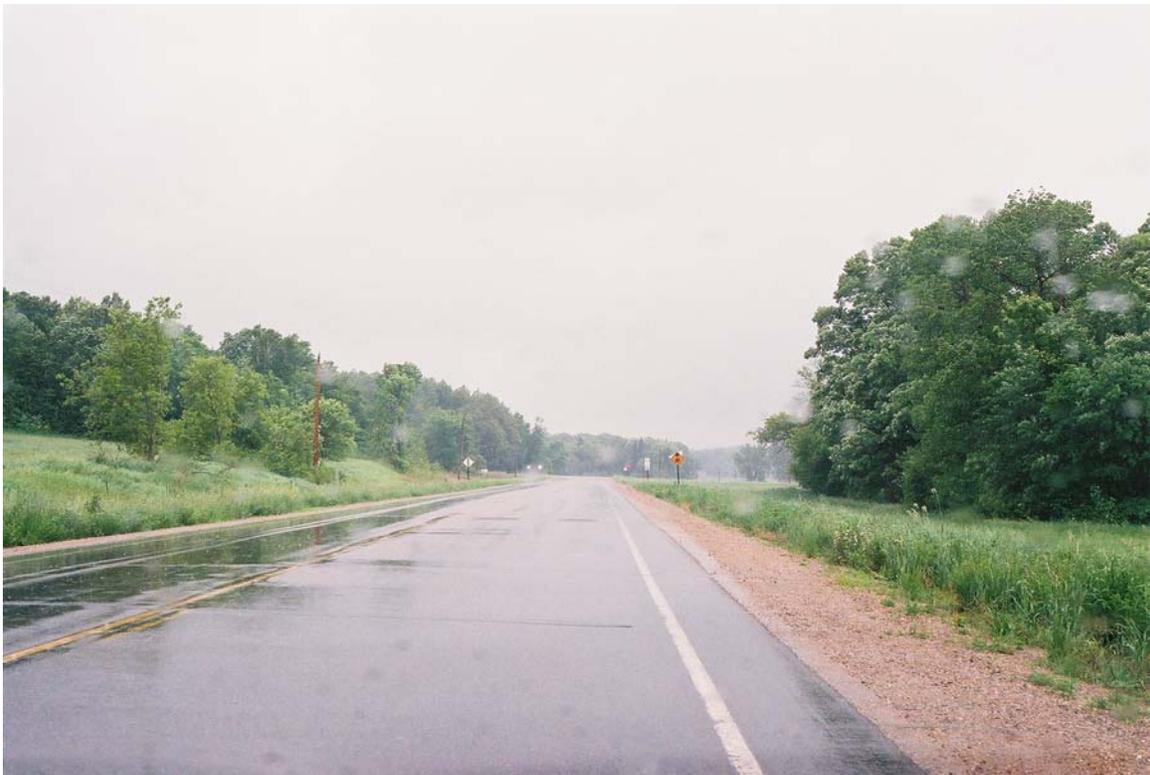
On East Side (looking West): to North—trees obscure traffic on major road at 1st rumble strips but there is a clear view of traffic by 2nd rumble strips; to South—trees obscure traffic on major road.

Photograph #434 (Reel #21, 9) (from East looking West): first rumble strips and warning sign in view.

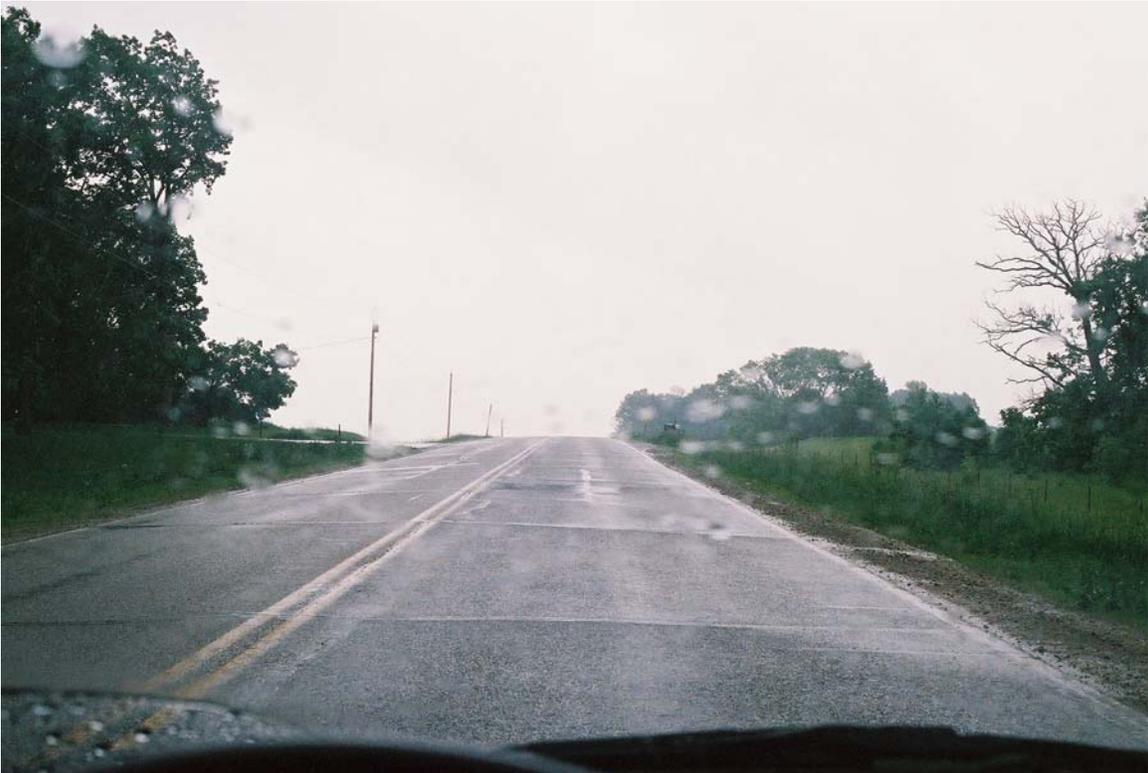
On West Side (looking East): rise obscures intersection; on both sides—trees obscure traffic on major road.

Photograph #436 (Reel #21, 11) (from West looking East): first rumble strips in view, *but no yellow warning sign*. [Note: unusually, warning sign is placed close to second rumble strips.]

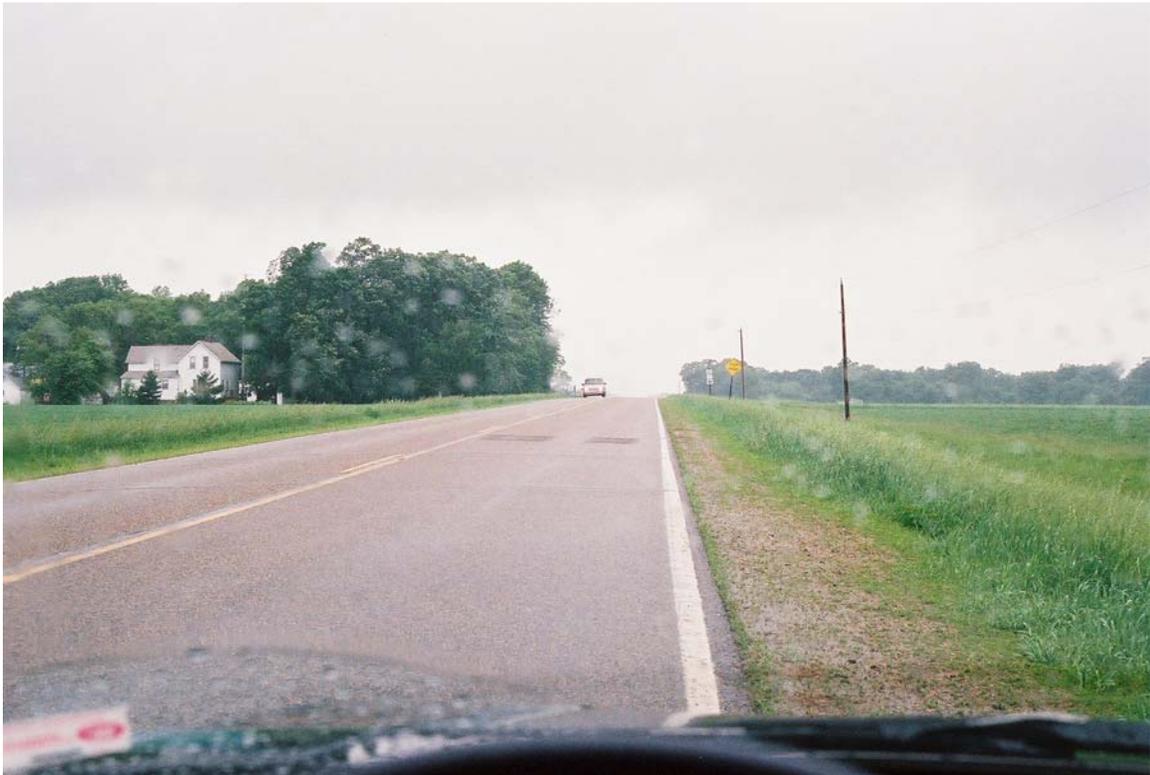
On East Side (looking West): rise partially obscures intersection; to North—clear view of traffic on major road; to South—trees and building obscure traffic on major road.

Photograph #438 (Reel #21, 13) (from East looking West): first rumble strips and warning sign in view.

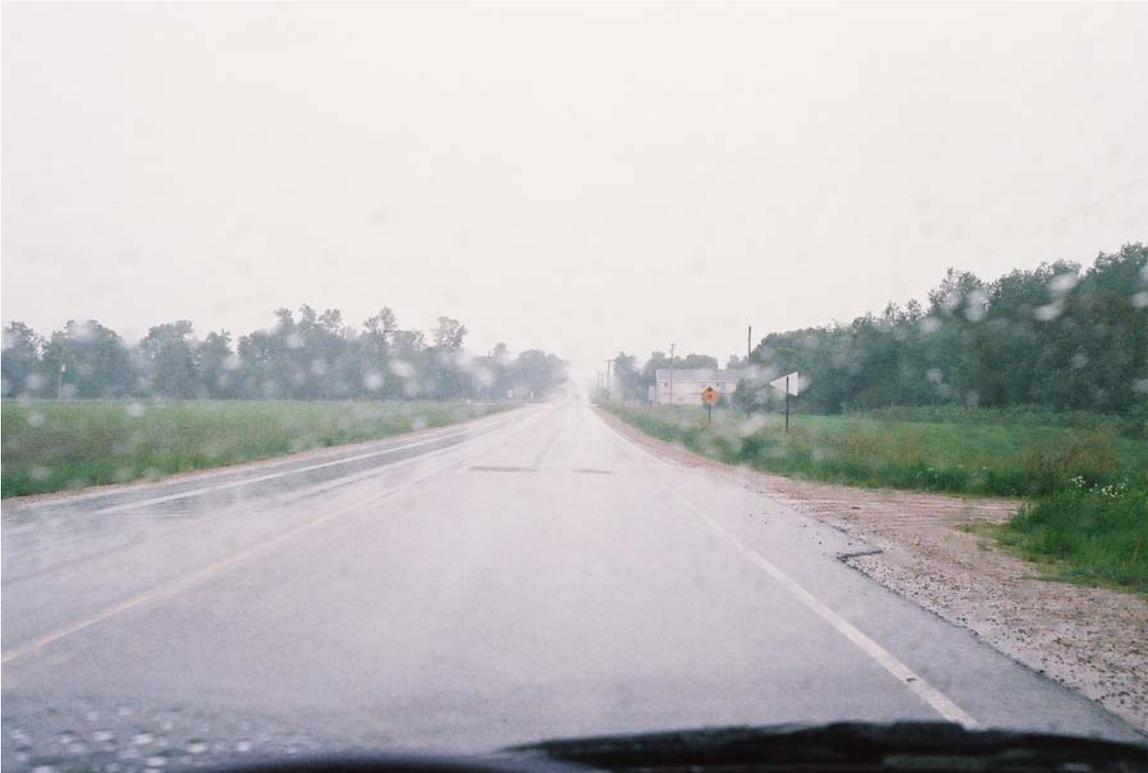
On North Side (looking South): to East—clear view of traffic on major road (runs in front of trees); to West—trees and buildings obscure traffic on major road.

Photograph #440 (Reel #21, 15) (from North looking South): first rumble strips and warning sign in view (in rain)

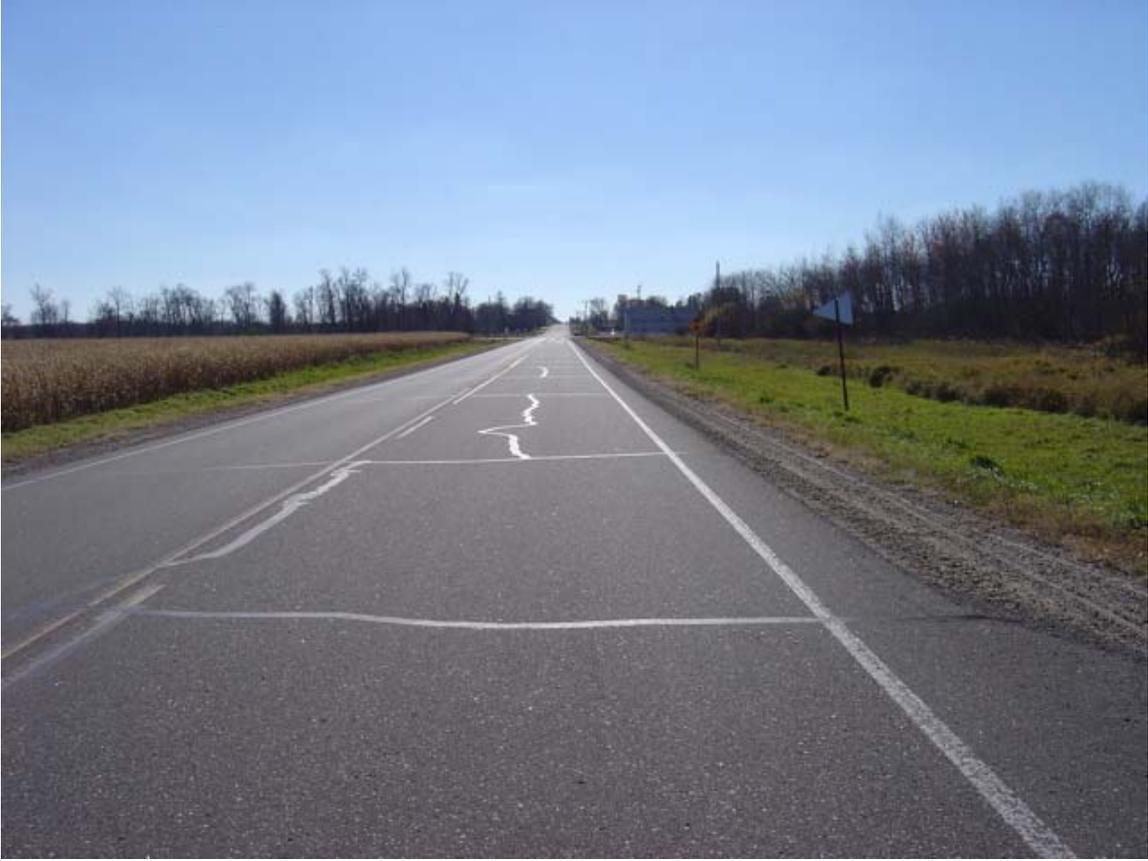
Same intersection—No rain (Photograph: DCS00615—from North looking South): first rumble strips and warning sign in view (in rain)

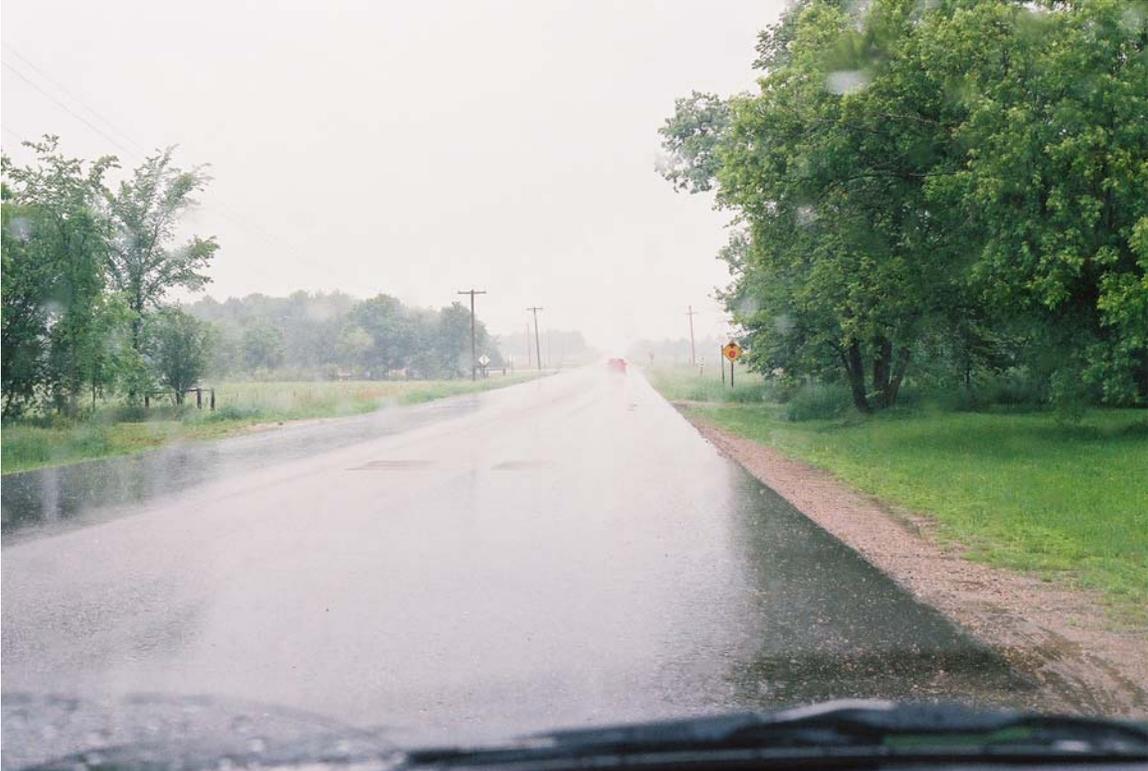
On South Side (looking North): on both sides—trees obscure traffic on major road.

Photograph #442 (Reel #21, 17) (from South looking North): first rumble strips and warning sign in view.

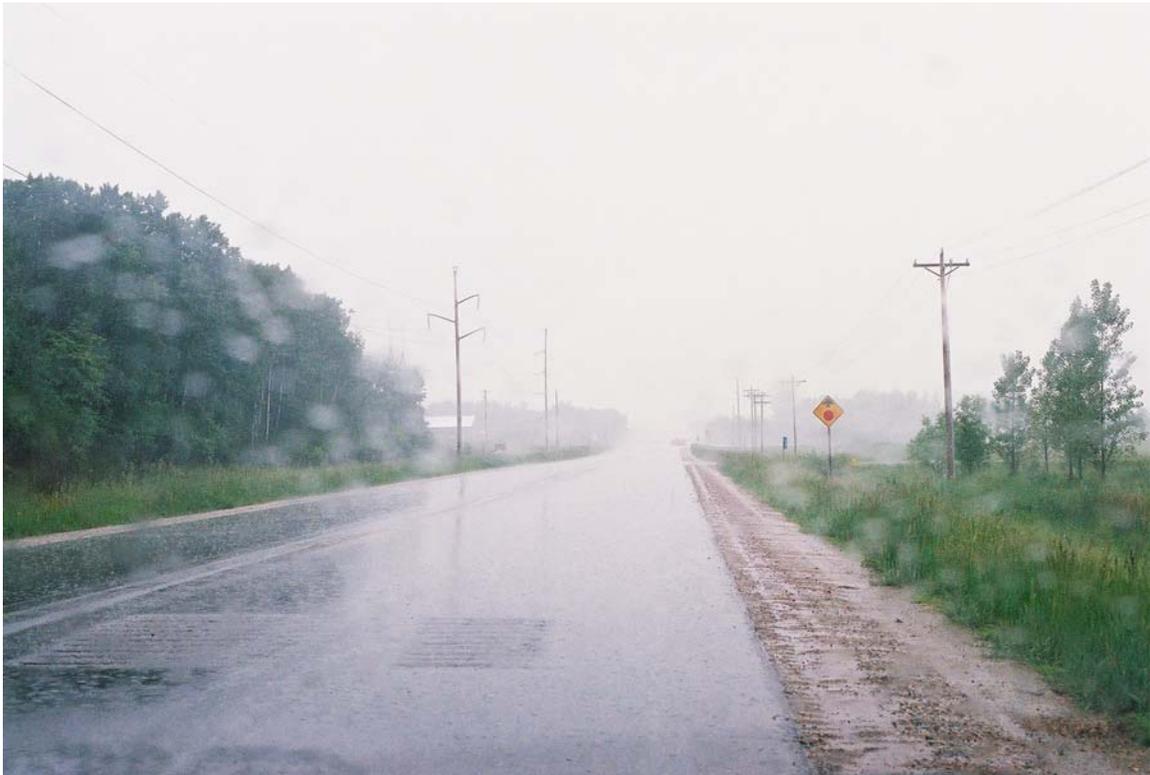
On South Side (looking North): to East—trees obscure traffic on major road; to West—trees partially obscure traffic on major road at 1st rumble strips, but there is a clear view of traffic by 2nd rumble strips.

Photograph #444 (Reel #21, 19) (from North looking South): first rumble strips and warning sign in view.

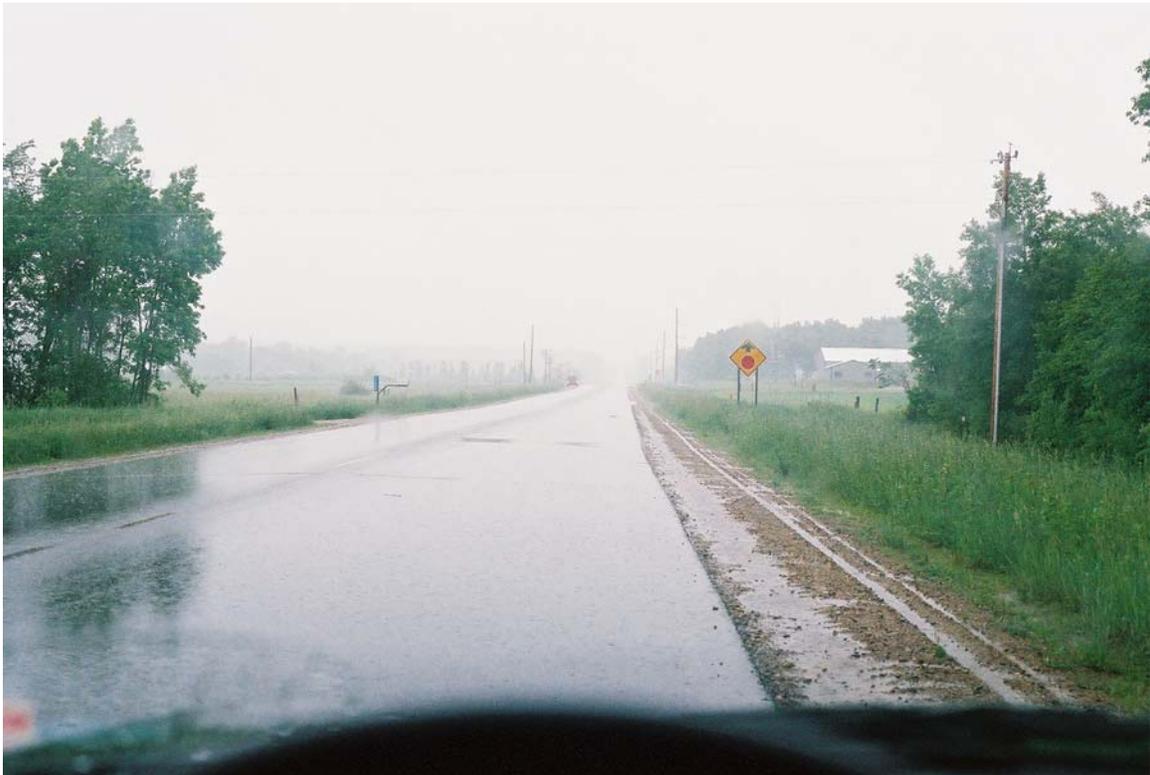
On South Side (looking North): to East—power plant, building, and trees obscure traffic on major road; to West—clear view of traffic on major road.

Photograph #446 (Reel #21, 21) (from South looking North): first rumble strips and warning sign in view.

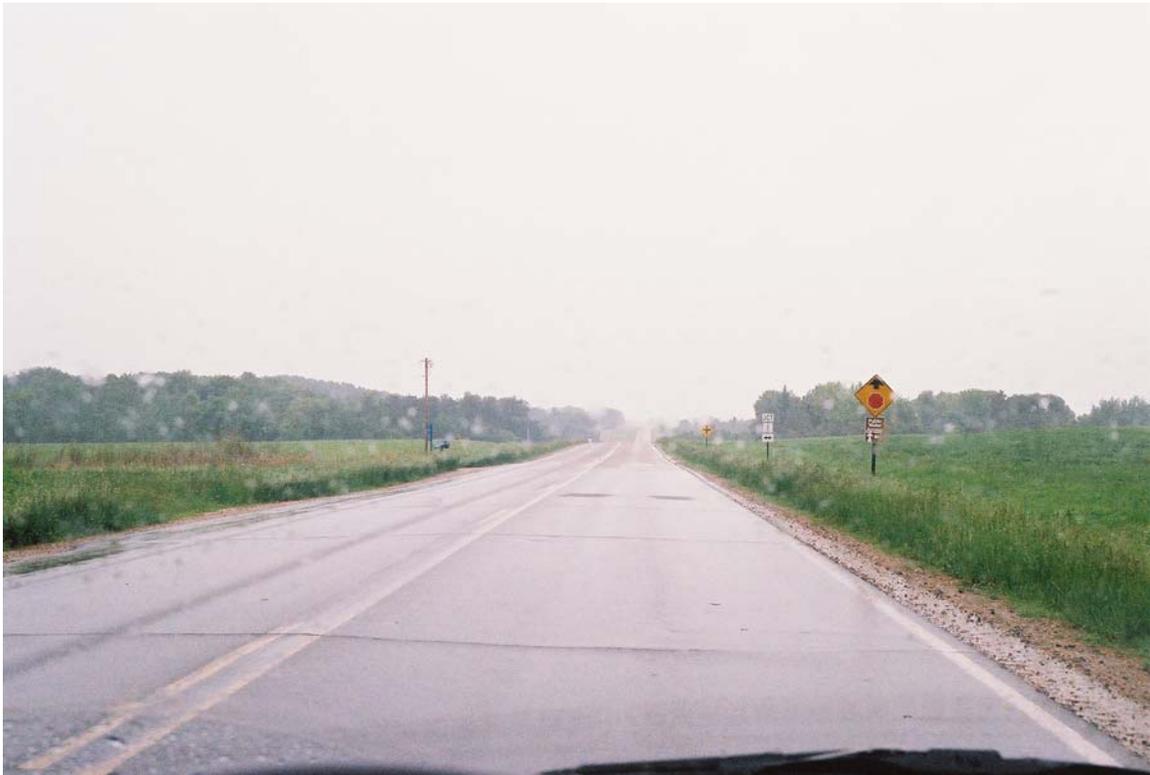
On North Side (looking South): rise obscures intersection; on both sides—rise obscures traffic on major road.

Photograph #448 (Reel #21, 23) (from North looking South): first rumble strips and warning sign in view.

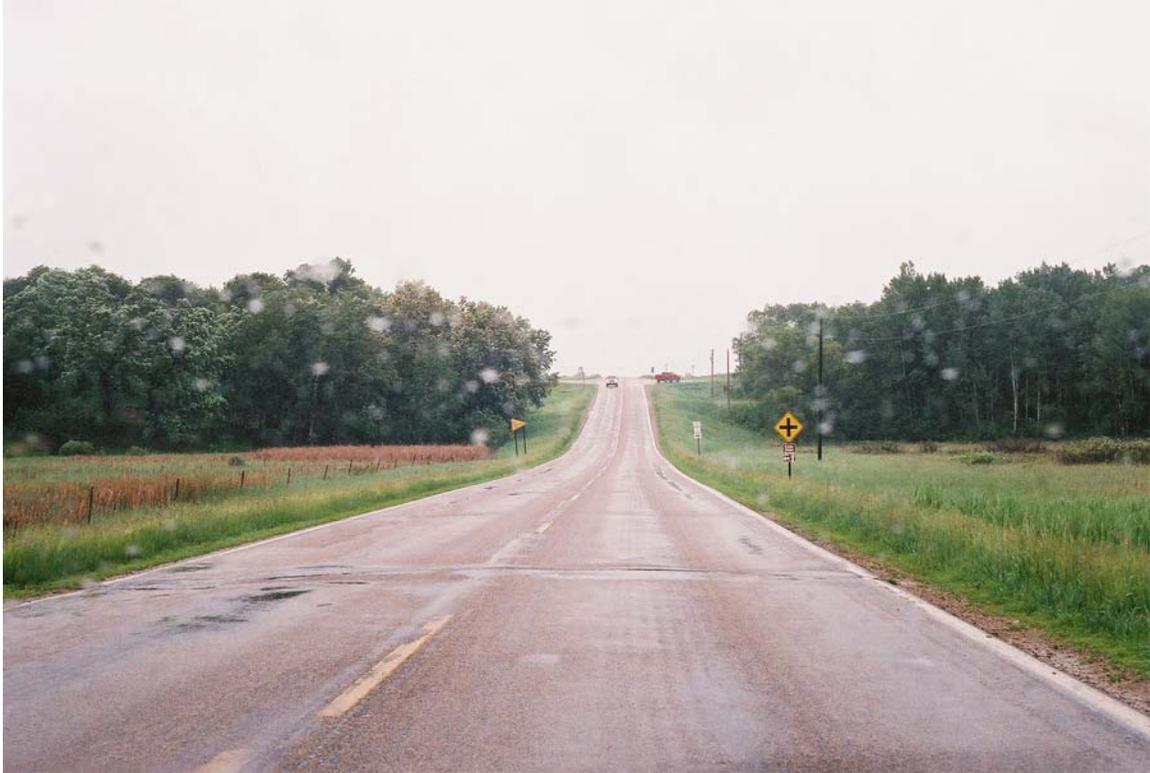
On South Side (looking North): on both sides—trees obscure traffic on major road.

Photograph #450 (Reel #21, 25) (from South looking North): “Road crossing” warning sign in view. [Note; unusually, there is no stop ahead warning sign.]

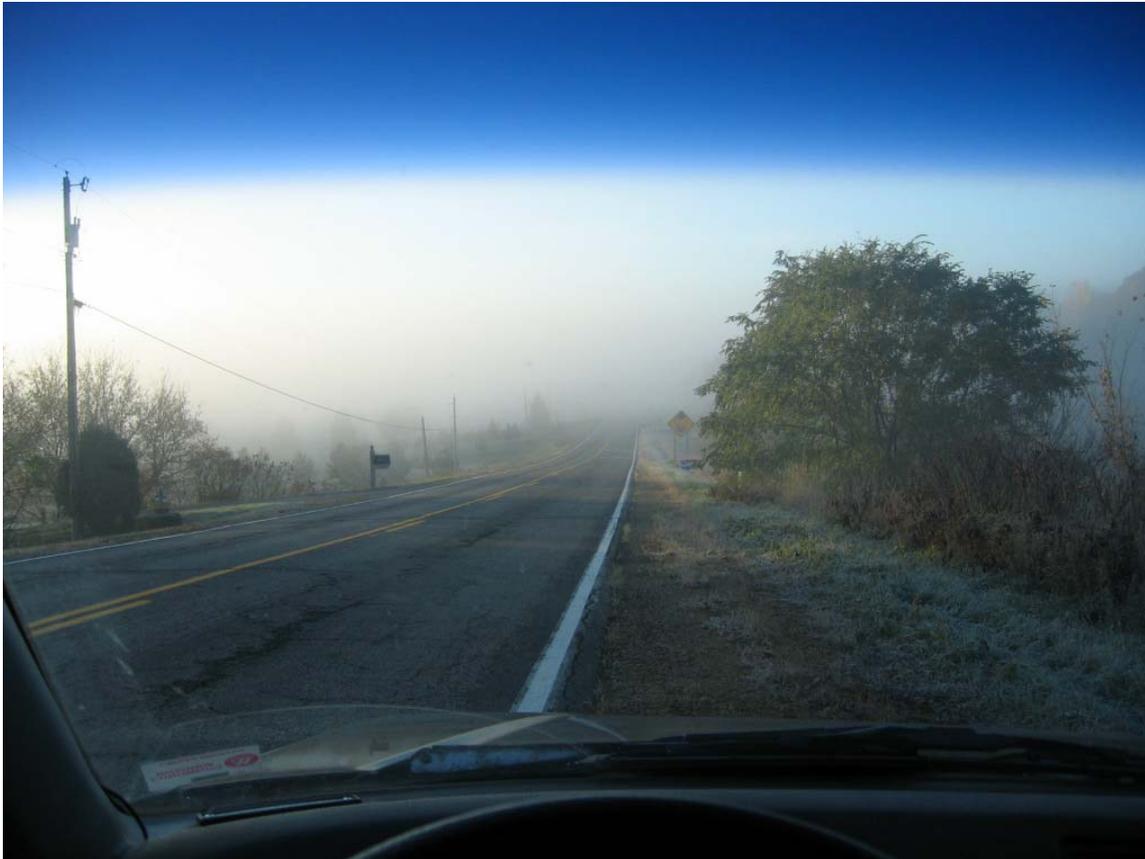
On North Side (looking South): on both sides—traffic on major road obscured by trees.

Photograph #451 (Reel E1, 1) (from North, looking South): warning sign in view; and STOP AHEAD on road.

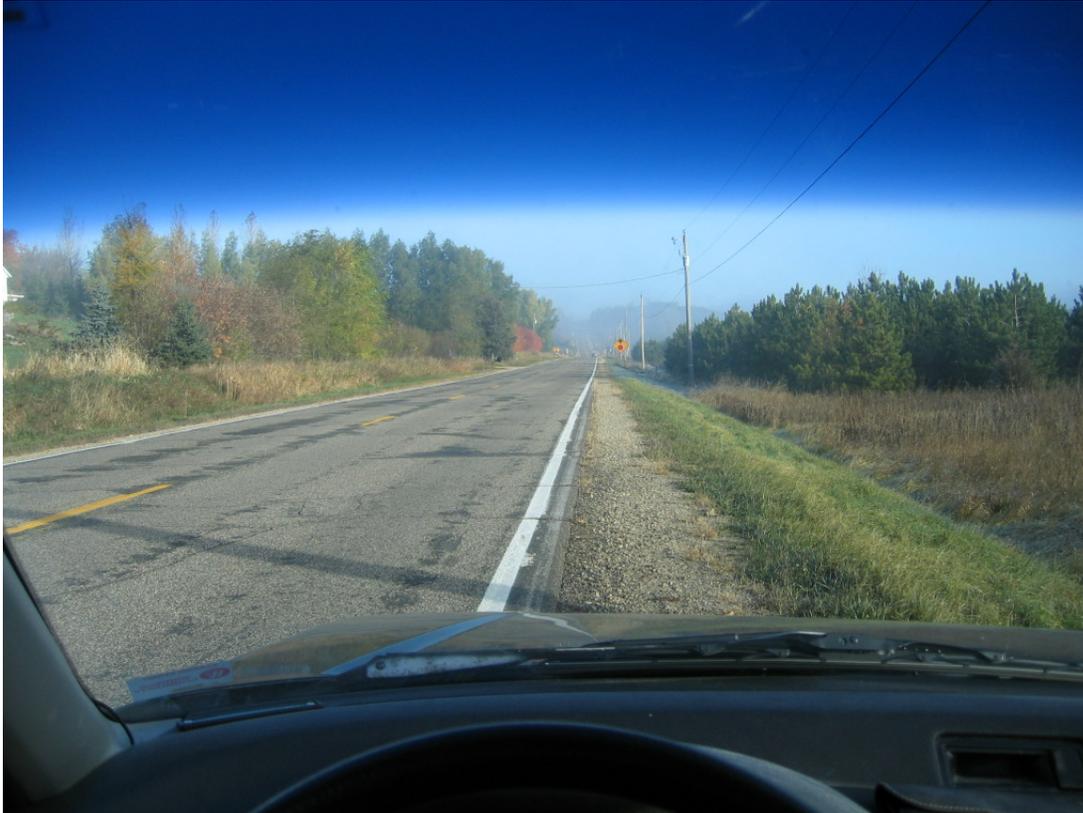
On South Side (looking North): on both sides—trees obscure traffic on major road.

Photograph #470 (Reel E1, 19) (from South, looking North): warning sign in view; and, STOP AHEAD on road (but barely visible).

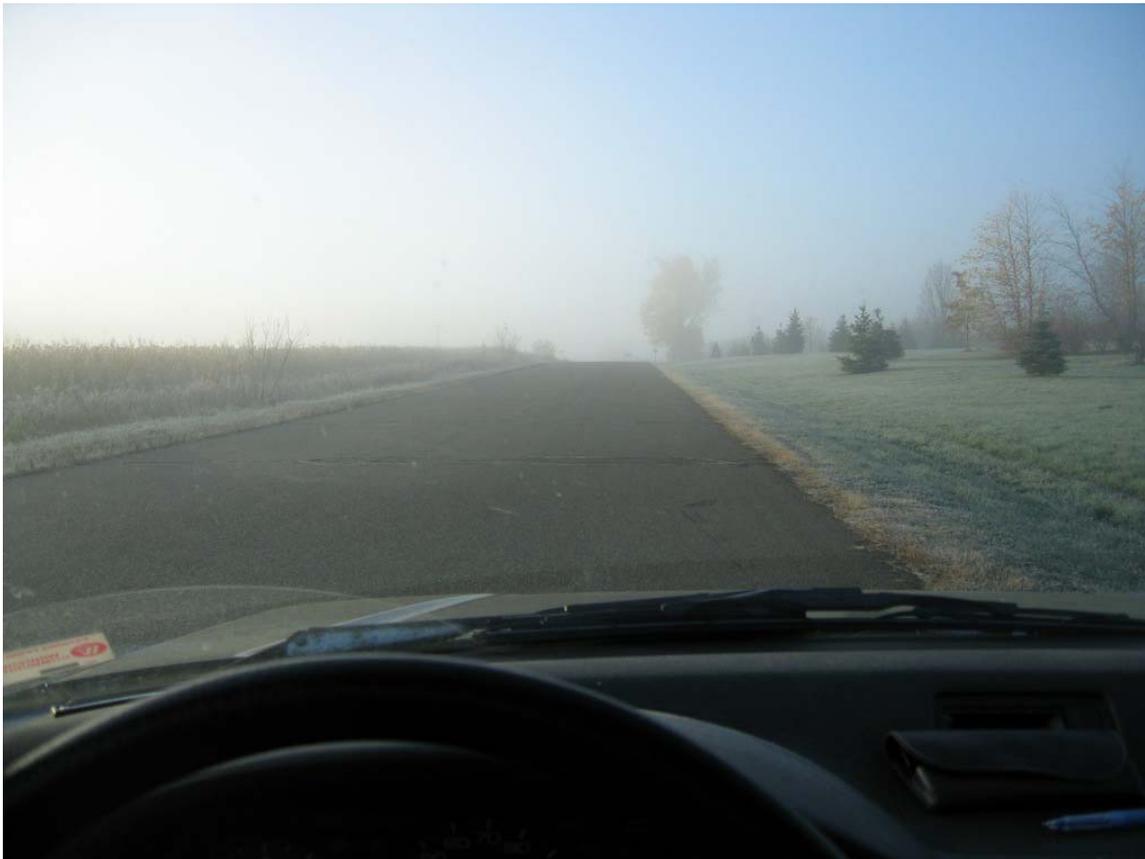
On North Side (looking South): to West—traffic on major road obscured by rise; to East—traffic on major road obscured by rise and trees.

Photograph #453 (Reel E1, 2) (from North, looking South): *no* warning sign—Stop sign and T-junction sign (just) visible at intersection.

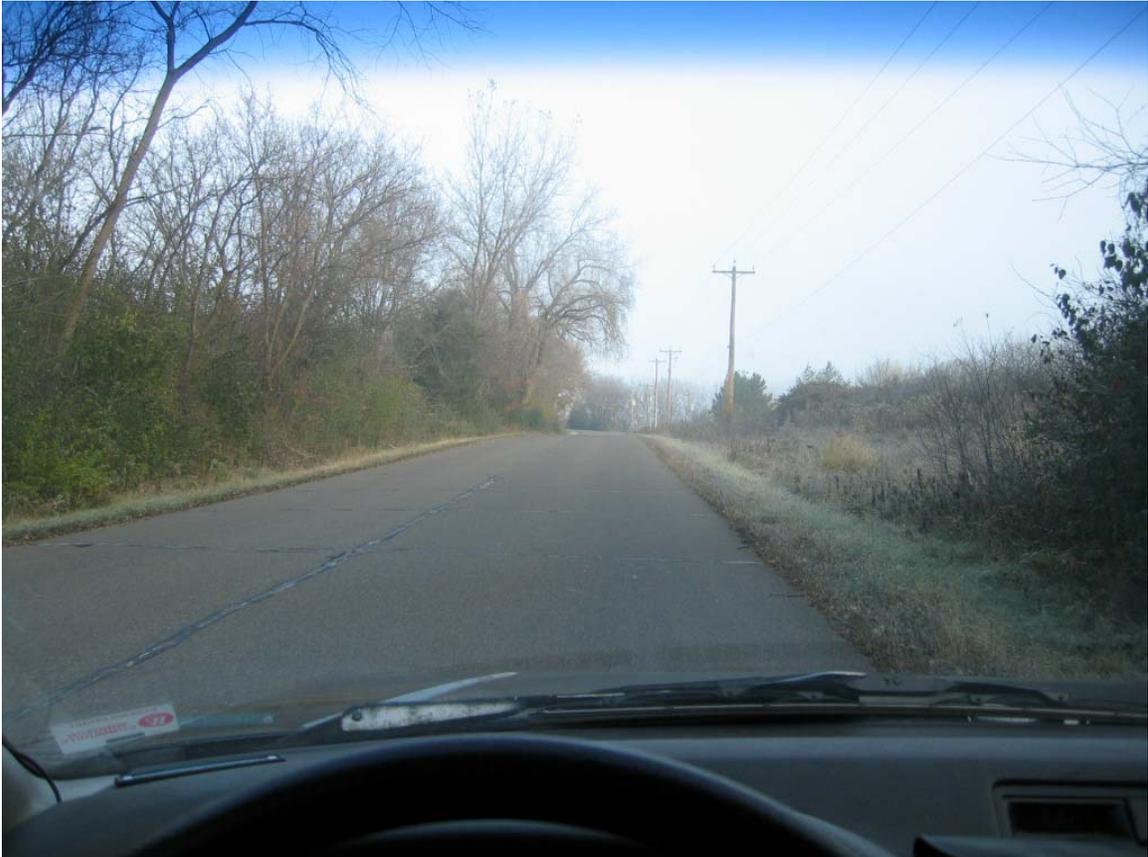
On South Side (looking North): to West—traffic on major road obscured by rise; to East—traffic on major road obscured by rise and trees.

Photograph #454 (Reel E1, 3) (from South, looking North): *no* warning sign—Stop sign barely visible at intersection.

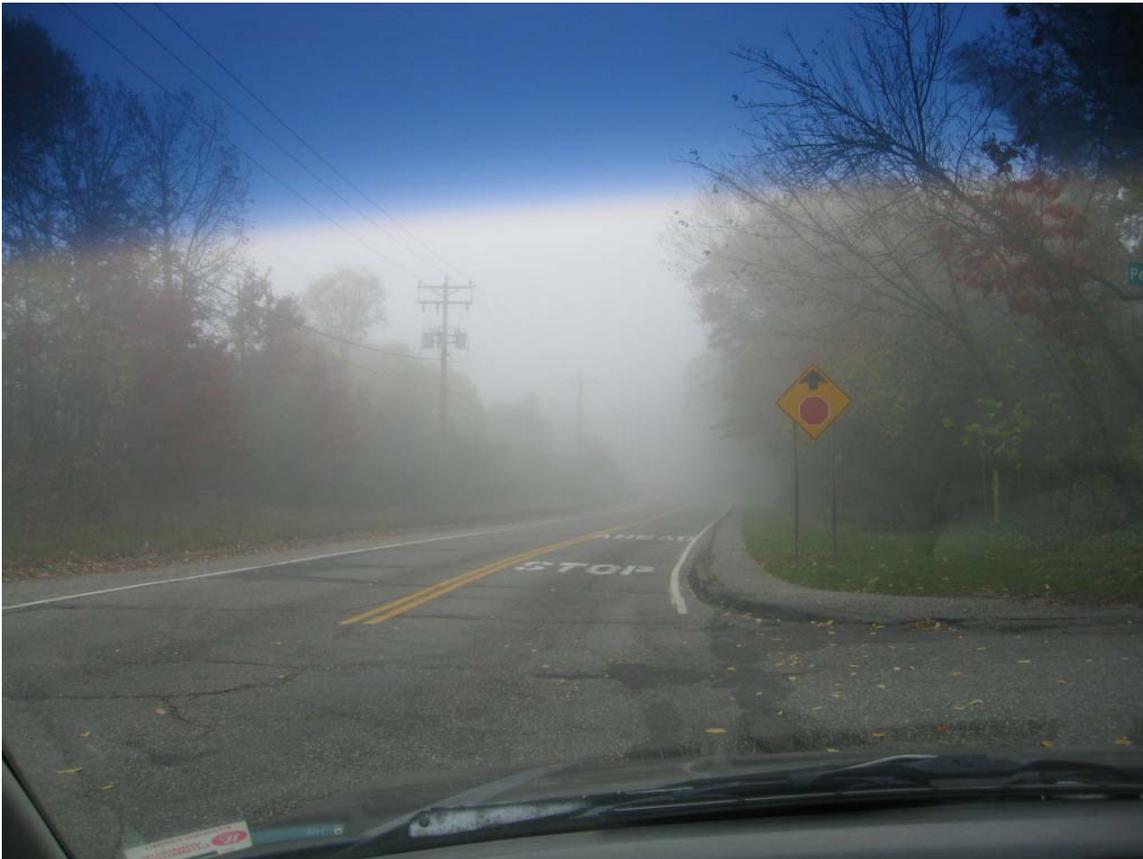
On East Side (looking West): on both sides—traffic on major road obscured by trees.

Photograph #455 (Reel E1, 4) (from East, looking West): warning sign in view; and, STOP AHEAD on road (also, side road visible to right—i.e., South).

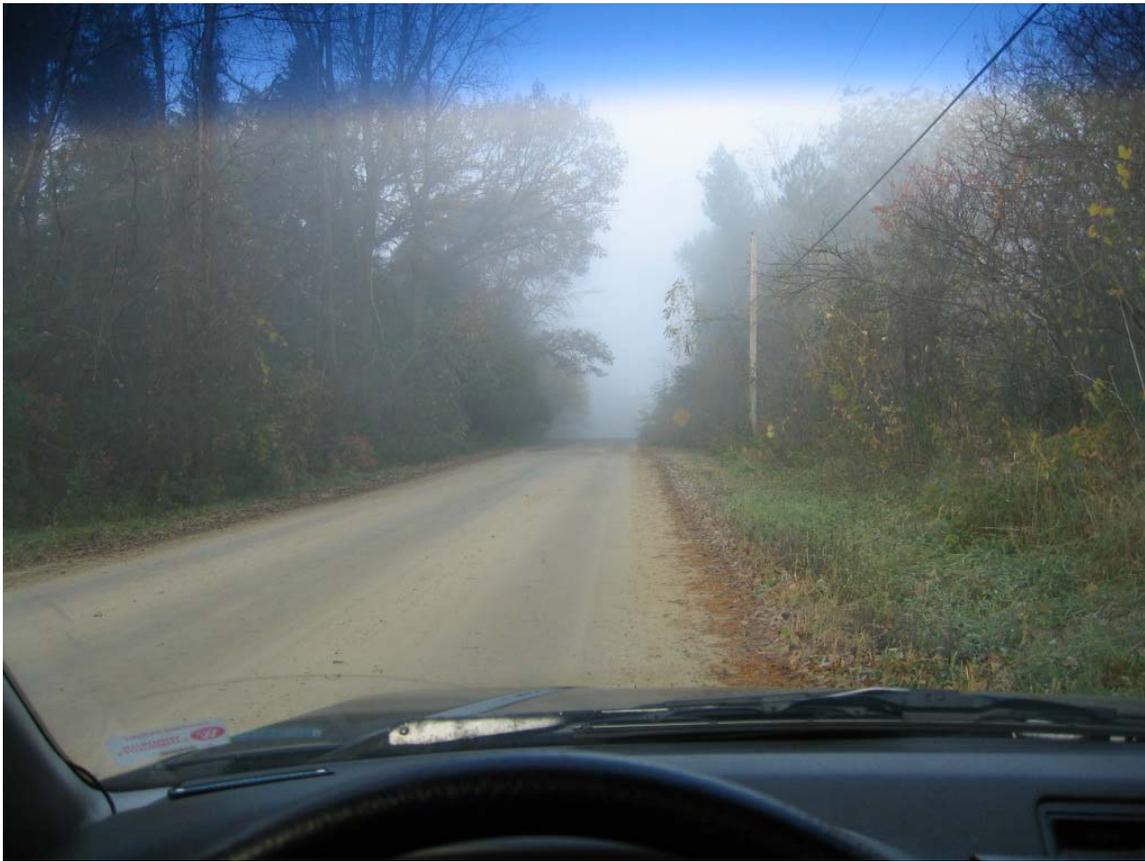
On East Side (looking West): on both sides—traffic on major road obscured by vertical rise.

Photograph #456 (Reel E1, 5) (from East, looking West): warning sign in view; and, STOP AHEAD on road surface.

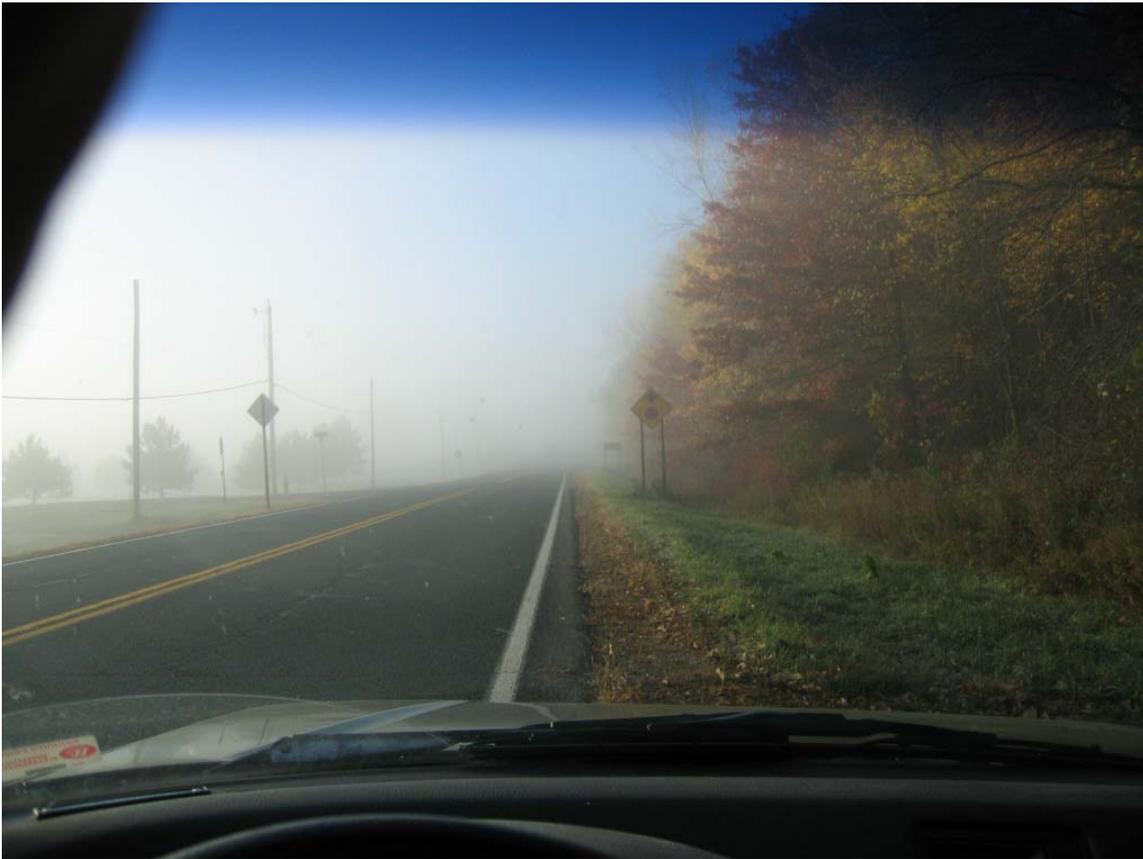
On North Side (looking South): to East—traffic on major road obscured by trees; to West—traffic on major road partially obscured by trees (& fog).

Photograph #459 (Reel E1, 8) (from North, looking South): warning sign in view.

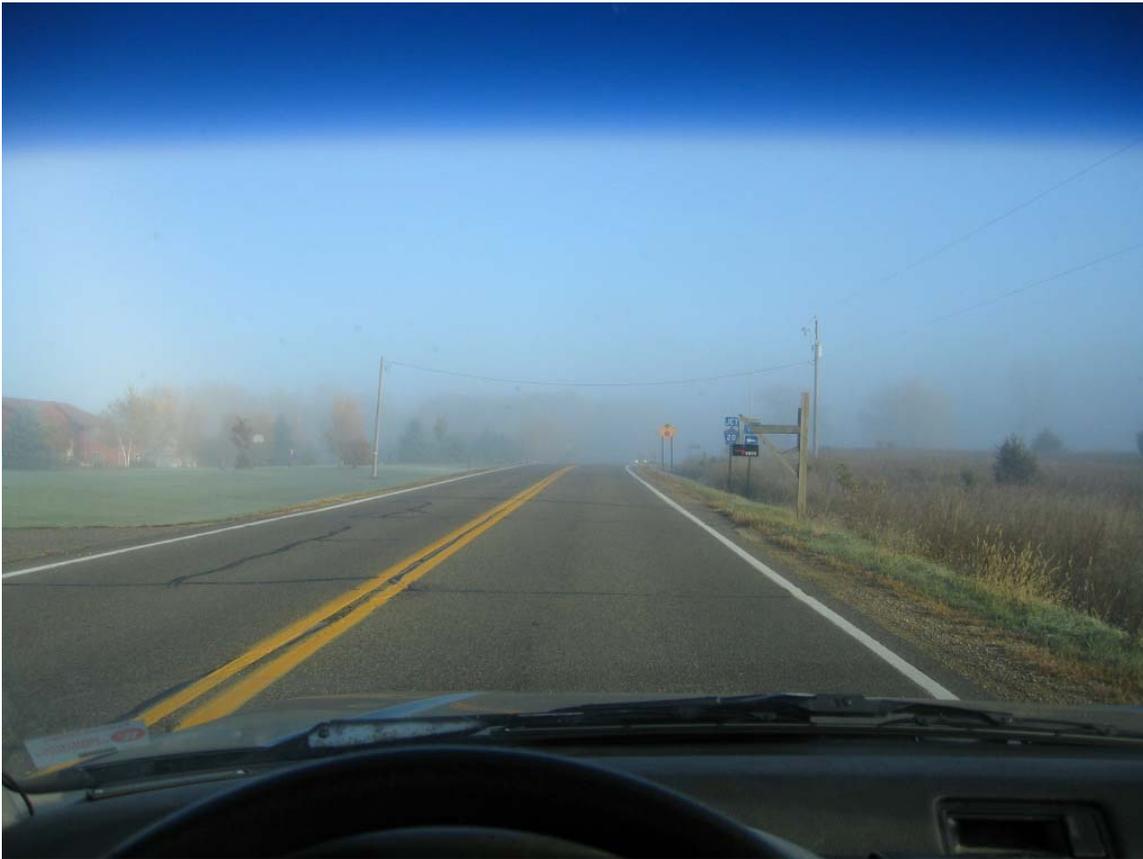
On South Side (looking North): on both sides—traffic on major road obscured by rise and trees.

Photograph #460 (Reel E1, 9) (from South, looking North): warning sign in view.

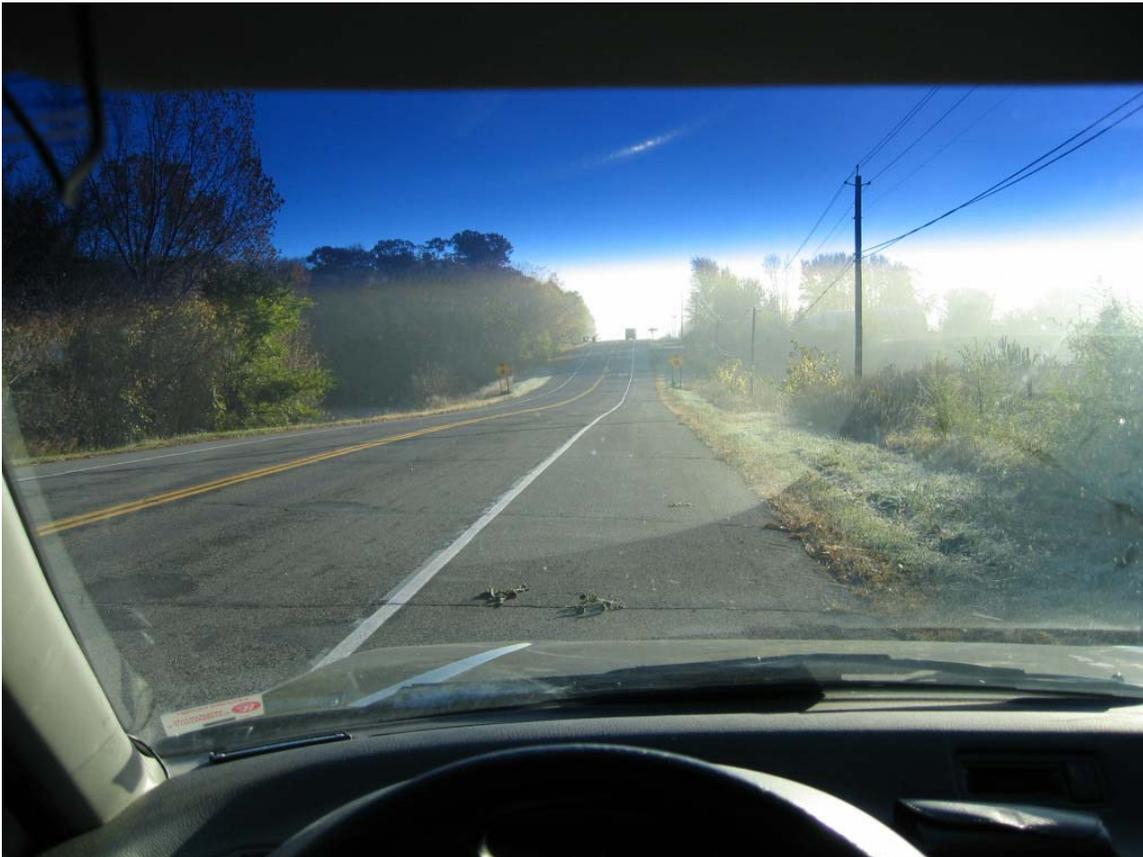
On West Side (looking East): on both sides—traffic on major road obscured by vertical rise.

Photograph #462 (Reel E1, 11) (from West, looking East): warning sign in view; and, STOP AHEAD on road.

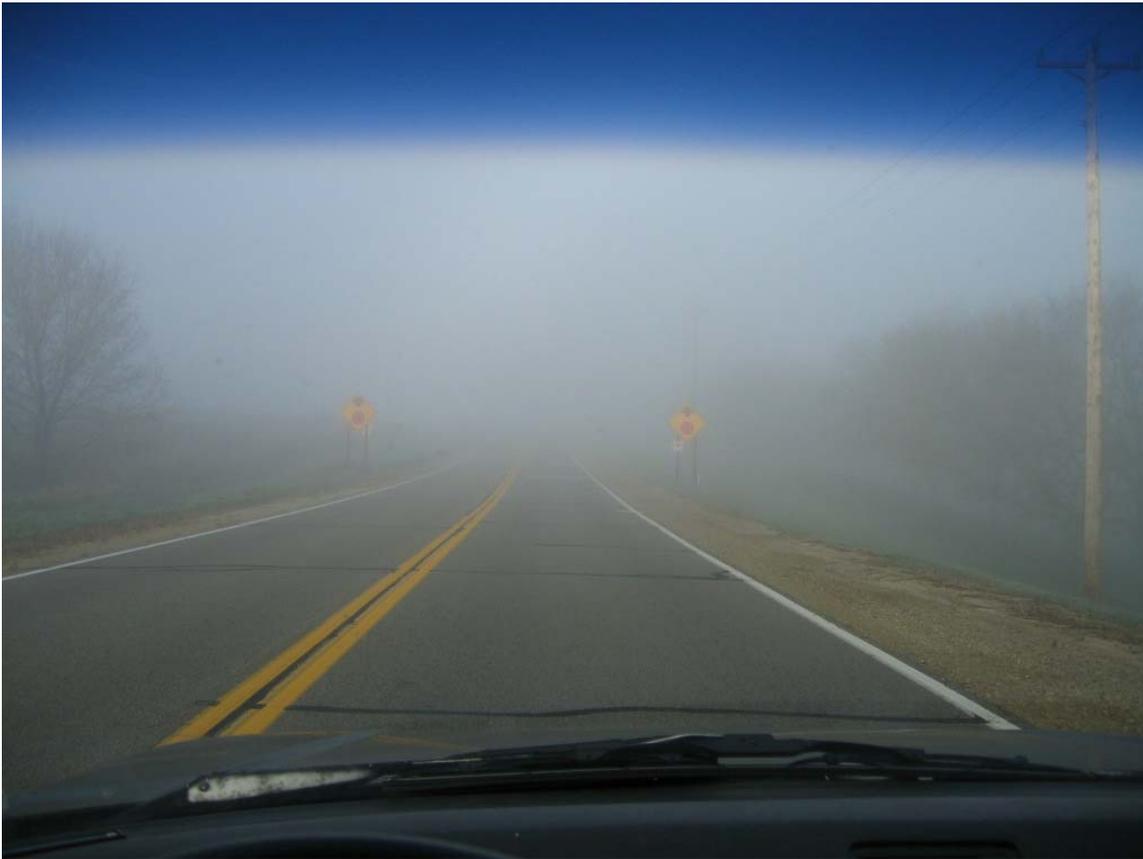
On East Side (looking West): on both sides—traffic on major road obscured by rise/trees/fog.

Photograph #463 (Reel E1, 12) (from West, looking East): warning sign in view; and, STOP AHEAD on road.

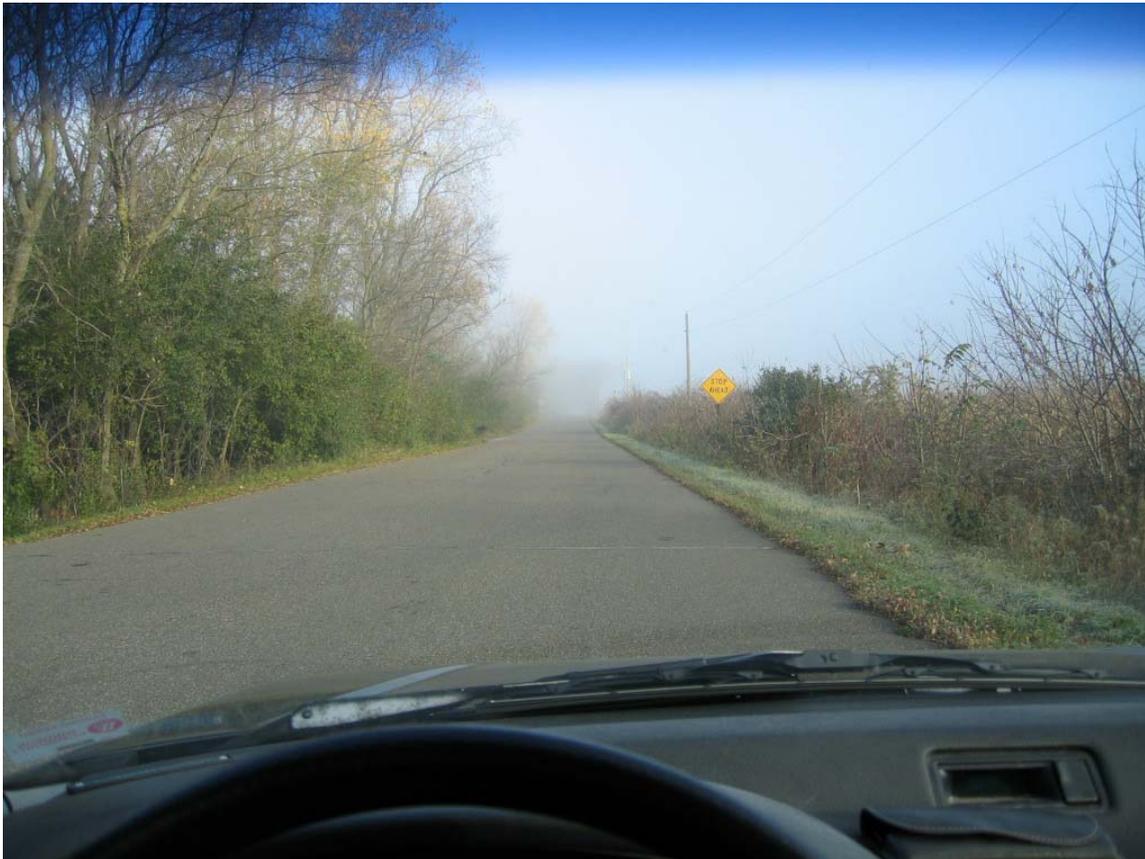
Intersection #148 (North Side)

On South Side (looking North): on both sides—traffic on major road obscured by trees
(with more trees to West).

Photograph #465 (Reel E1, 14) (from South, looking North): warning sign in view.

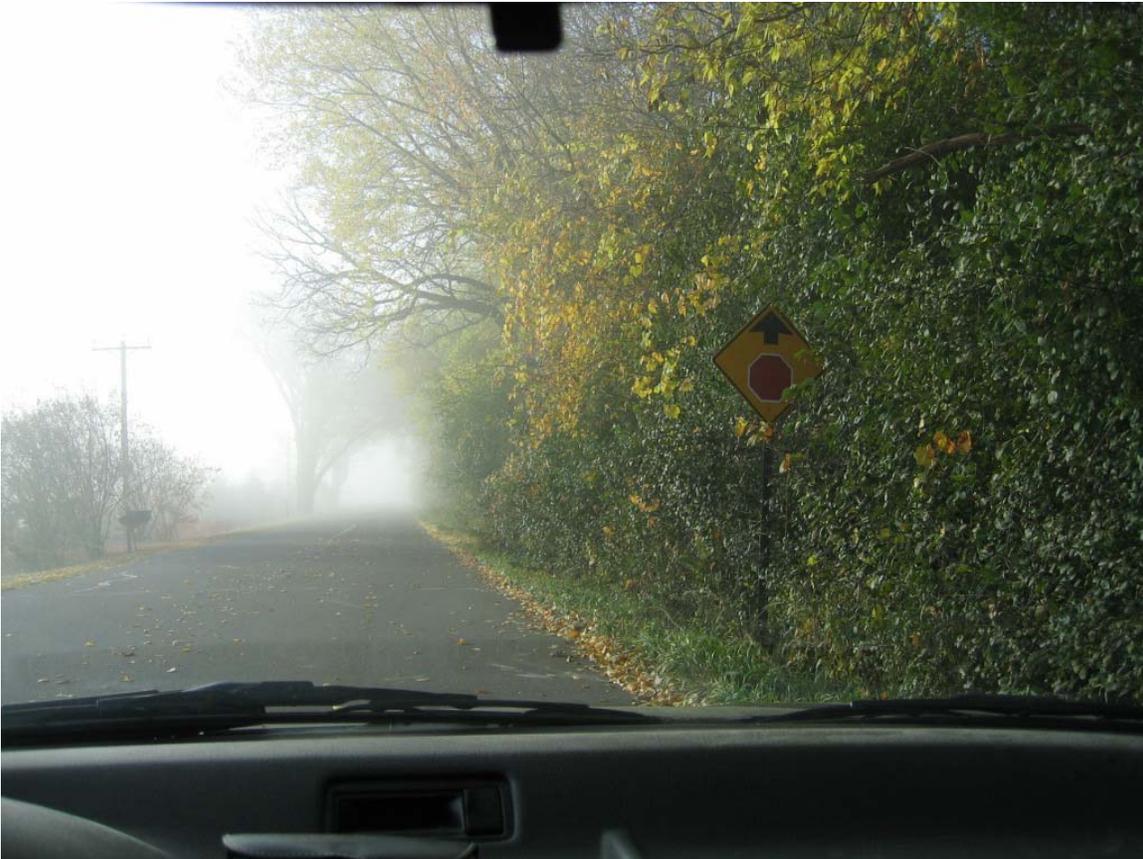
Intersection #149 (West Side)

On North Side (looking South): on both sides—traffic on major road obscured by trees
(with more trees to West).

Photograph #467 (Reel E1, 16) (from North, looking South): warning sign in view.

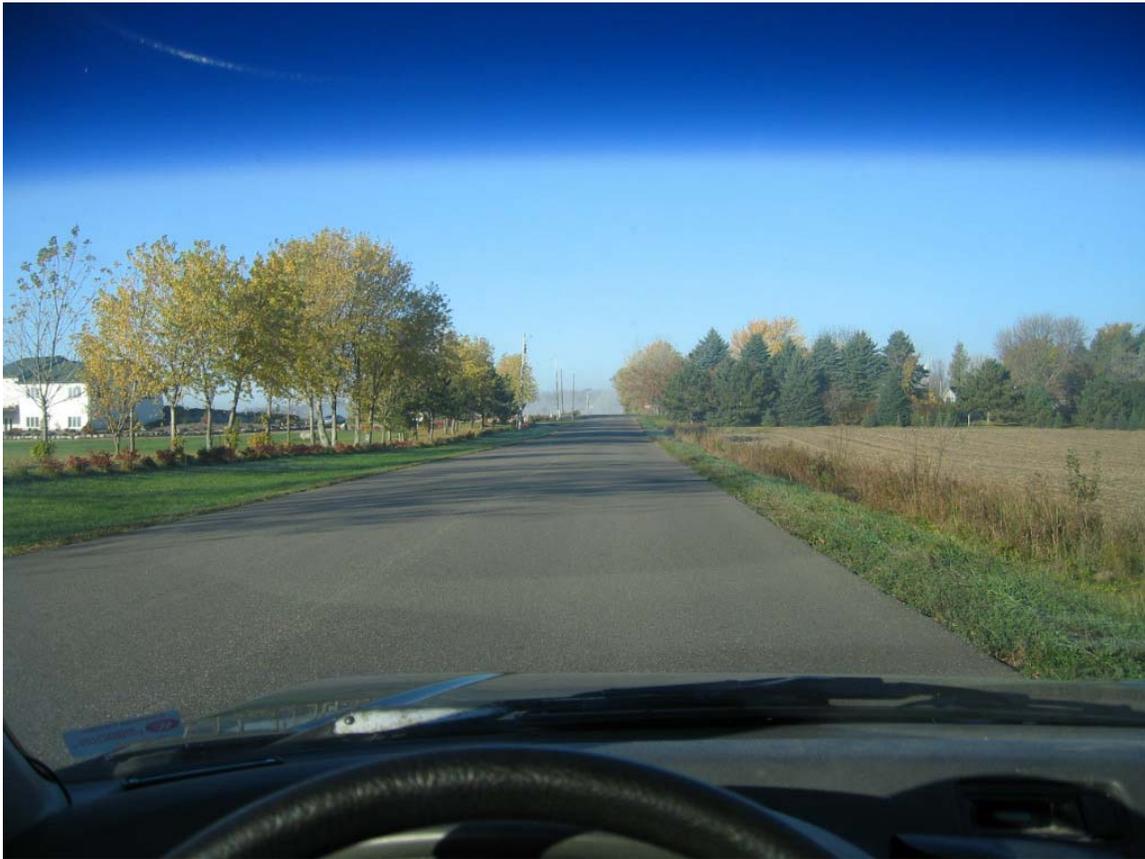
On West Side (looking East): on both sides—traffic on major road obscured by trees.

Photograph #469 (Reel E1, 18) (from West, looking East): *no* warning sign on this approach—Stop sign in view.
