2006-42

Final Report

Stopping Behavior at Real-World
Stop-Controlled Intersections
with and without In-Lane Rumble Strips

**Center for Human Factors Systems Research and Design
University of Minnesota**

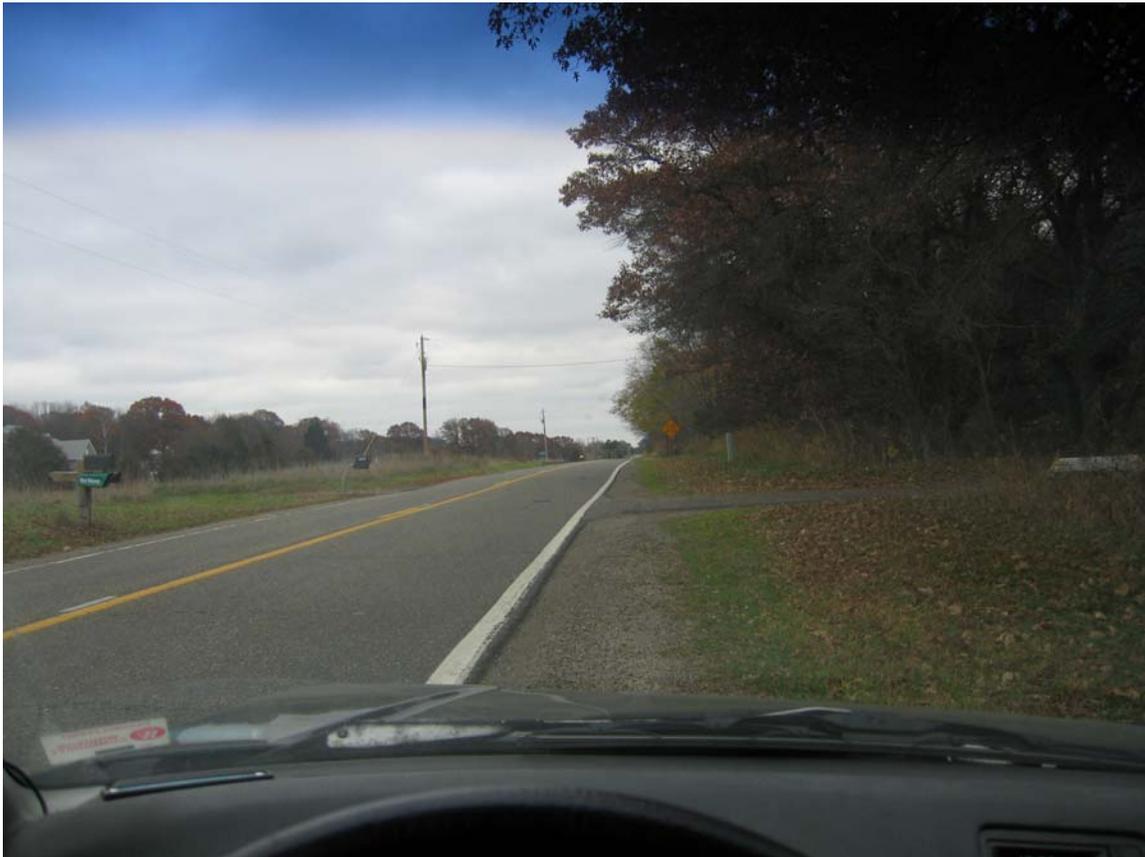
On West Side (looking East): rise obscures intersection; on both sides—rise and trees obscure traffic on cross road.

Photograph #470 (Reel #E1, 19) (from North, looking South): *no rumble strip*; warning sign in view (just *before* crest of vertical curve).

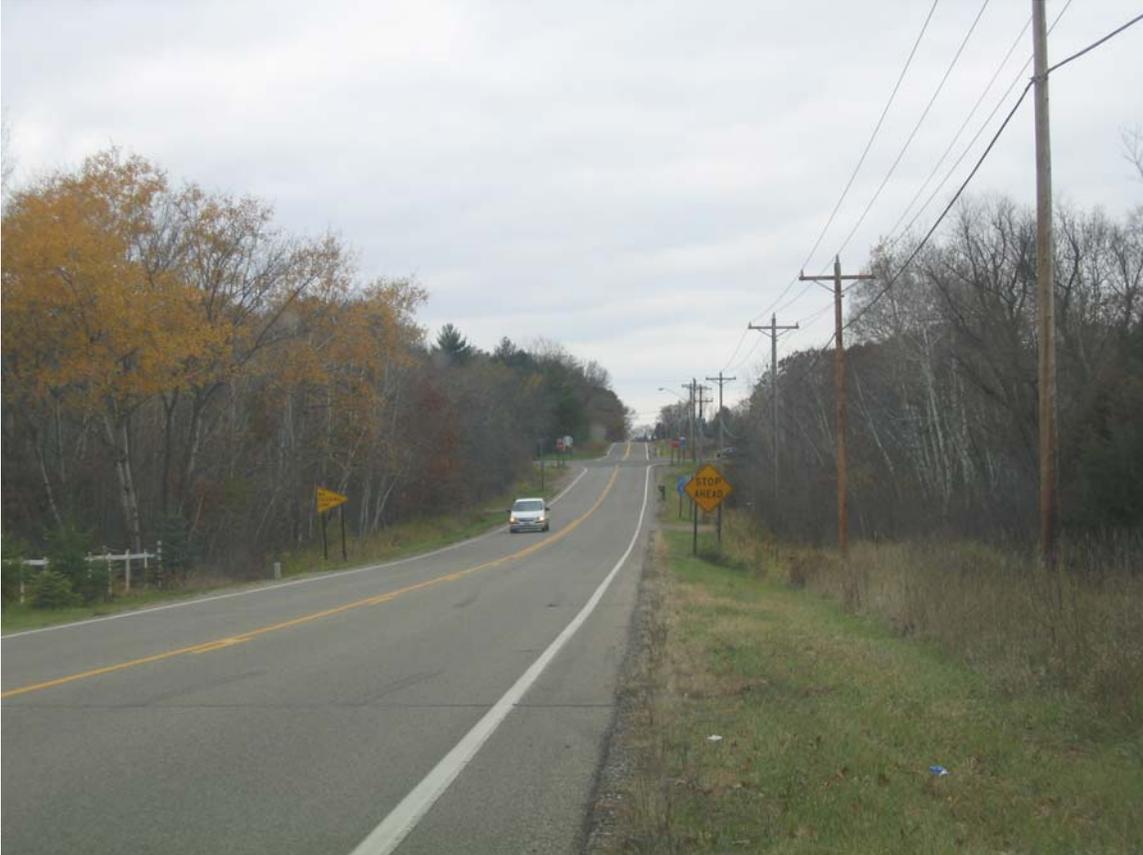
Intersection #150 (East Side)
Anoka Co. (Map Page 41)
4-way stop
Condition: *No Rumble Strips*

On East Side (looking West): on both sides—trees obscure traffic on cross road.

Photograph #472 (Reel #E1, 22) (from North, looking South): *no rumble strip*; warning sign in view.

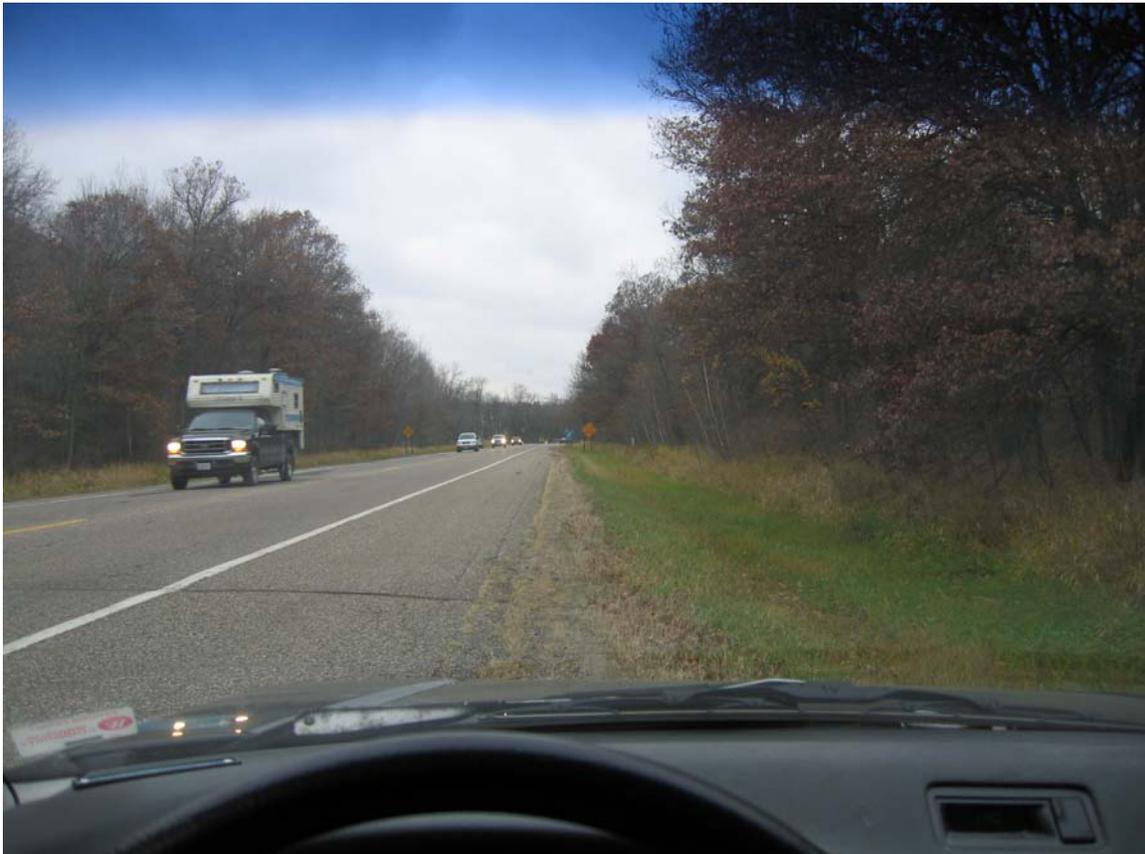
Intersection #151 (East Side)
Anoka Co. (Map Page 41)
Condition: *No Rumble Strips*
T-junction

On East Side (looking West): on both sides—trees obscure traffic on major road.

Photograph #473 (Reel #E1, 24) (from North, looking South): *no rumble strip*; warning sign in view.

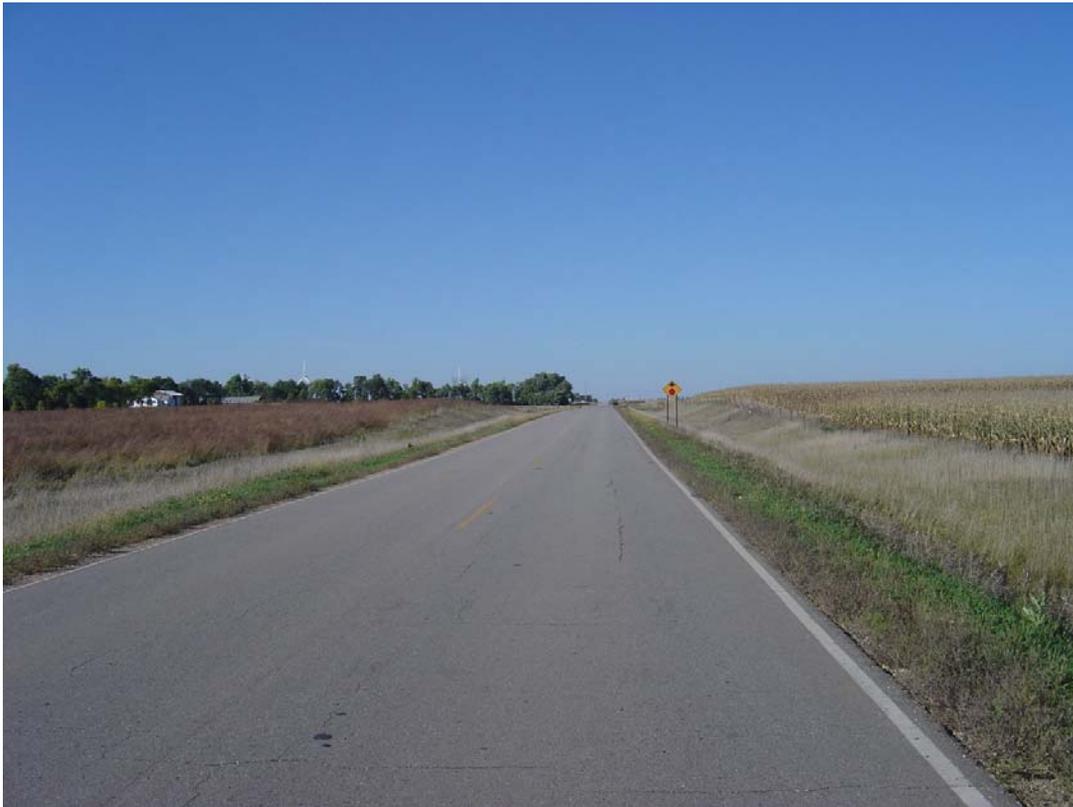
Obscure Both: *With Rumble Strips*

“Obscure Both”—*With Rumble Strips*:
Pipestone County #26: SR-30 & CR-13
(1st rumble strip visible)

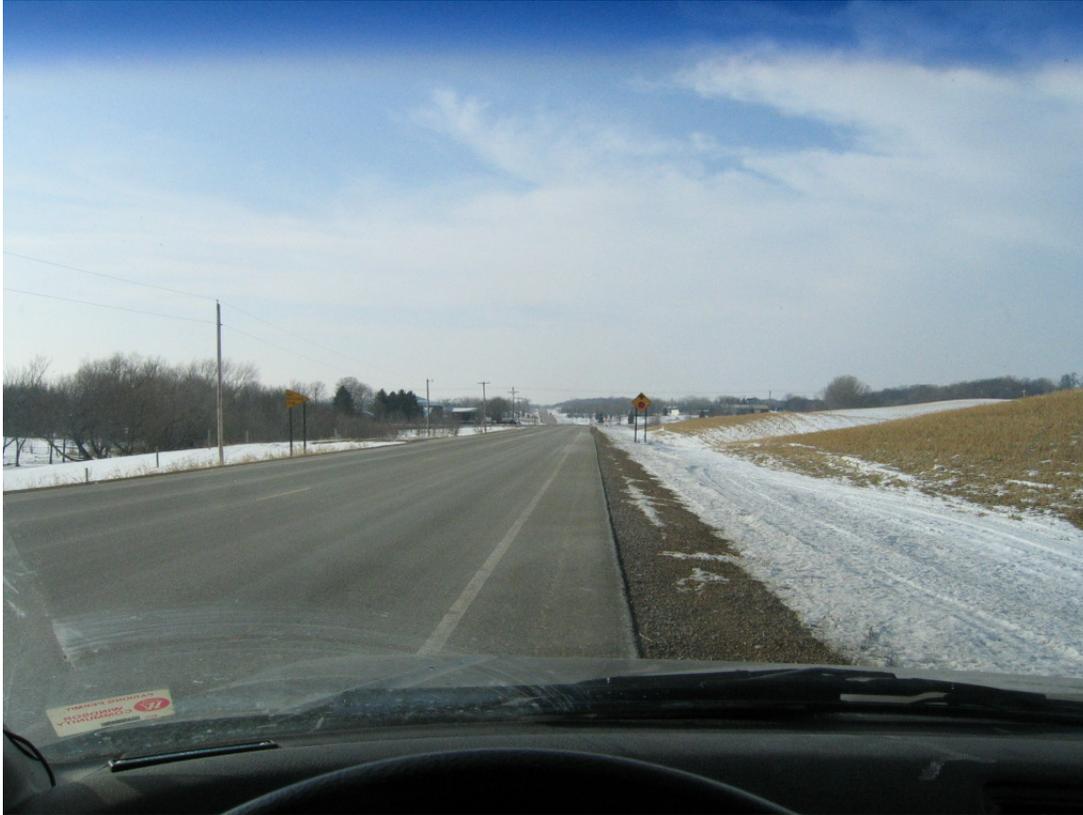
Obscure Both: *Without Rumble Strips*

“Obscure Both”—*Without Rumble Strips*:
Scott County #141: CR-27 & CR-62/240th
(from approximately where 1st rumble strip would be located)

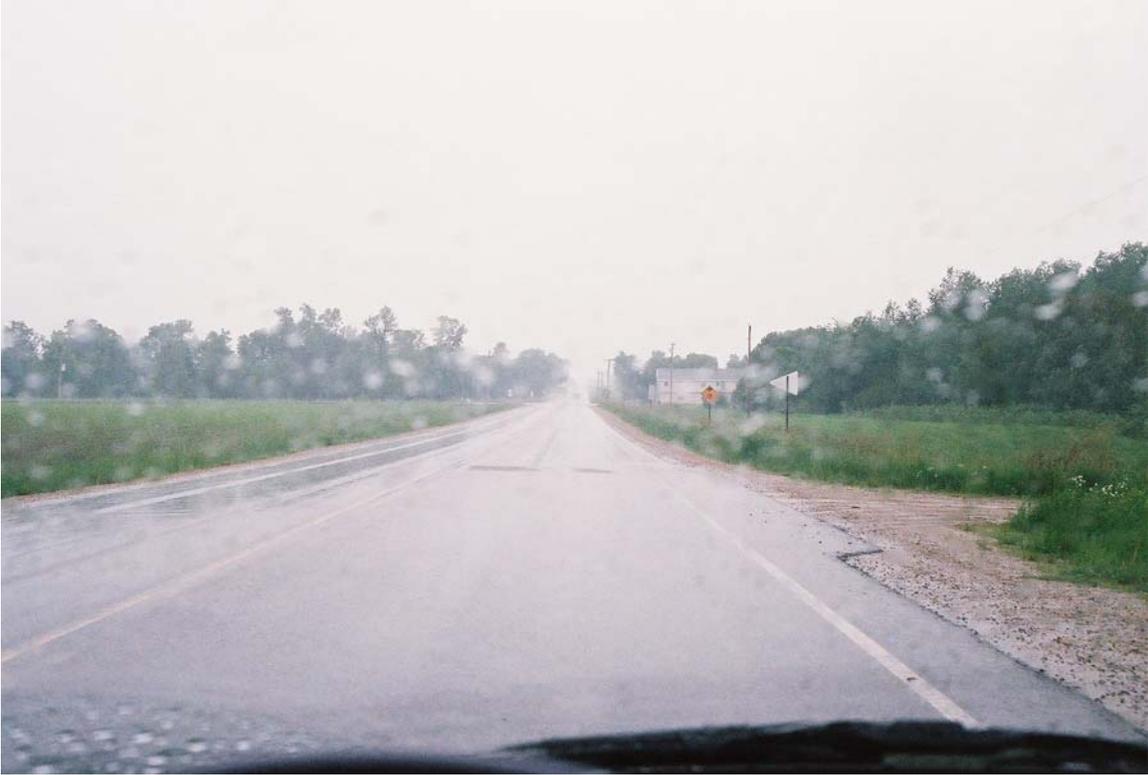
Obscure/Visible: *With Rumble Strips* (Photograph 1—in rain)

“Obscure/Visible”—*With Rumble Strips*:
Todd County #138: CR10 & CR 11
(1st rumble strip visible)
(in rain)

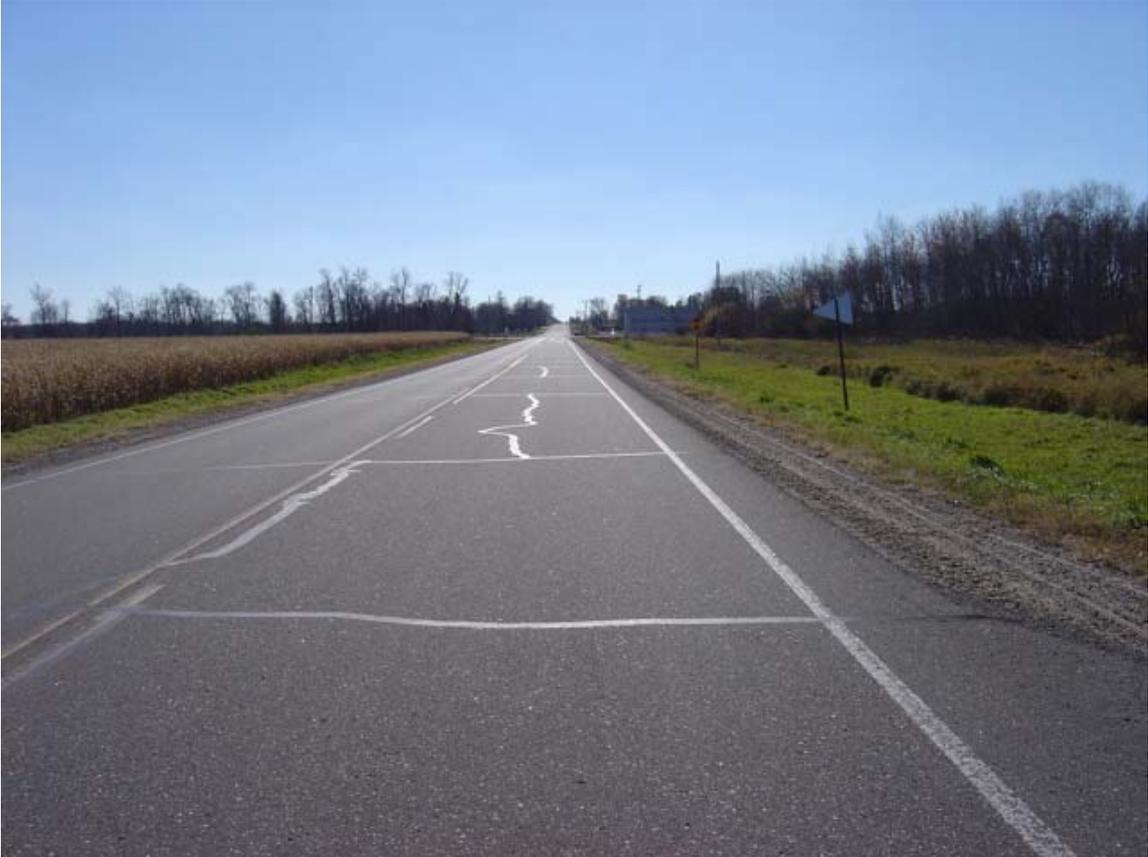
Obscure/Visible: *With Rumble Strips* (Photograph 2—*no rain*)

“Obscure/Visible”—*With Rumble Strips*:
Todd County #138: CR10 & CR 11
(1st rumble strip visible)
(*no rain*)

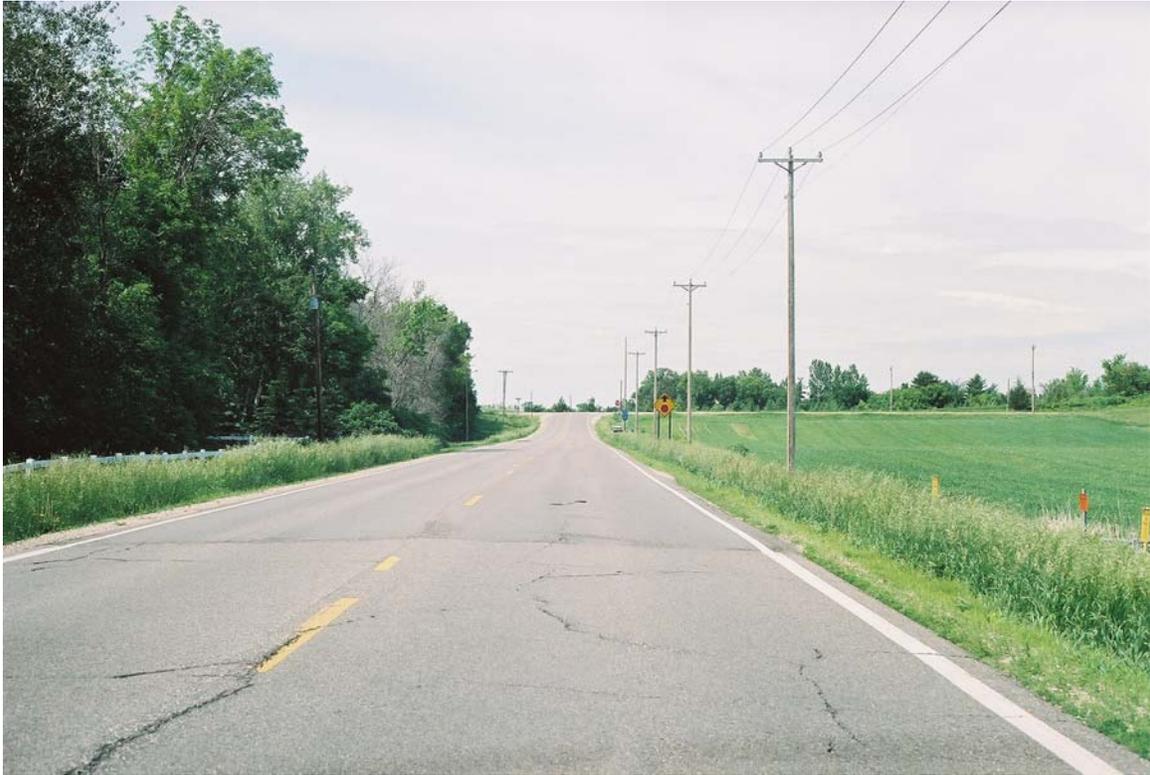
Obscure/Visible: *Without Rumble Strips*

“Obscure/Visible”—*Without Rumble Strips*:
Wright County #106: CR-37 & CR-15
(from approximately where 1st rumble strip would be located)

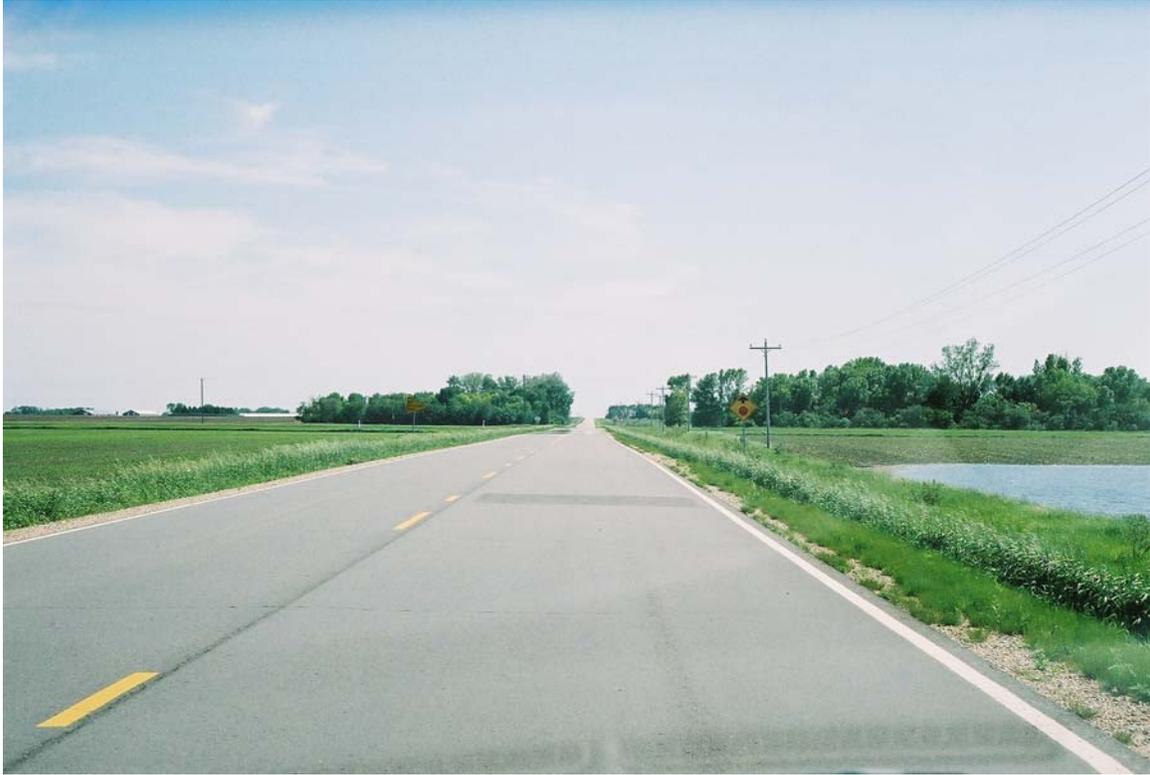
Visible Both: *With Rumble Strips*

“Visible Both”—*With Rumble Strips*:
Kandiyohi County #101: SR-7 & CR-44
(1st rumble strip visible):

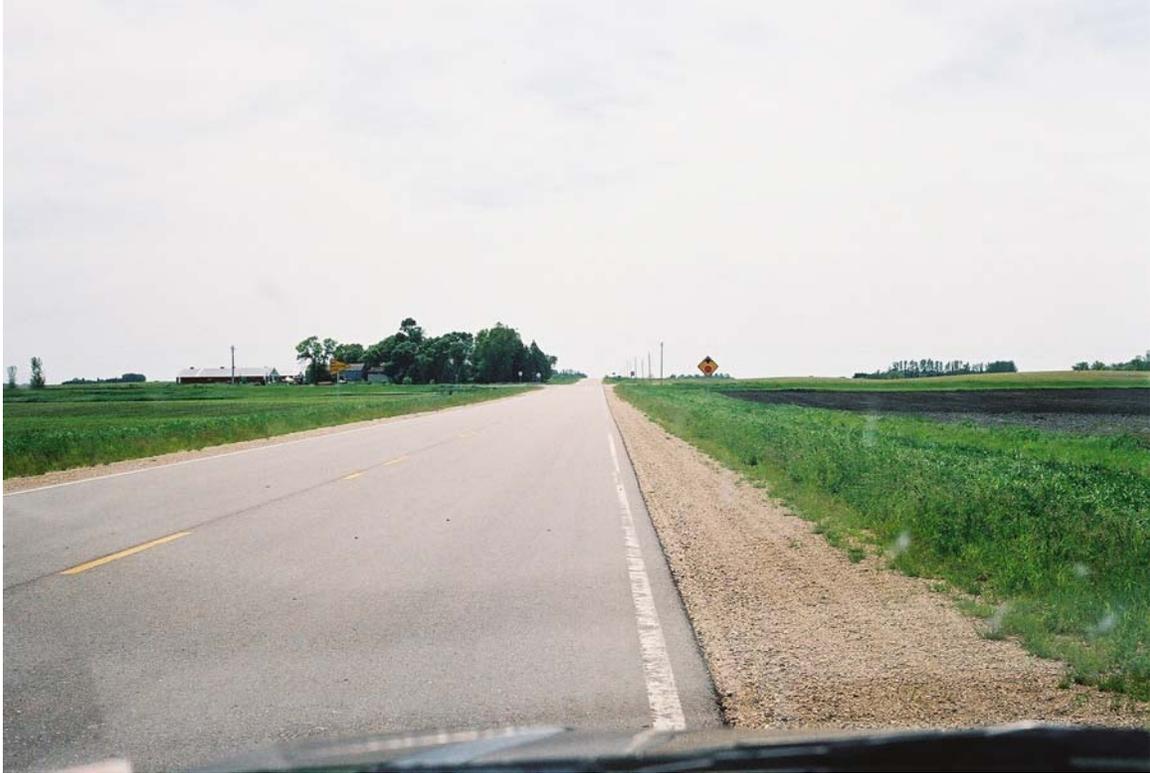
Visible Both: *Without Rumble Strips*

“Visible Both”—*Without Rumble Strips*:
Kandiyohi County #97: SR-40 & CR-1
(from approximately where 1st rumble strip would be located):

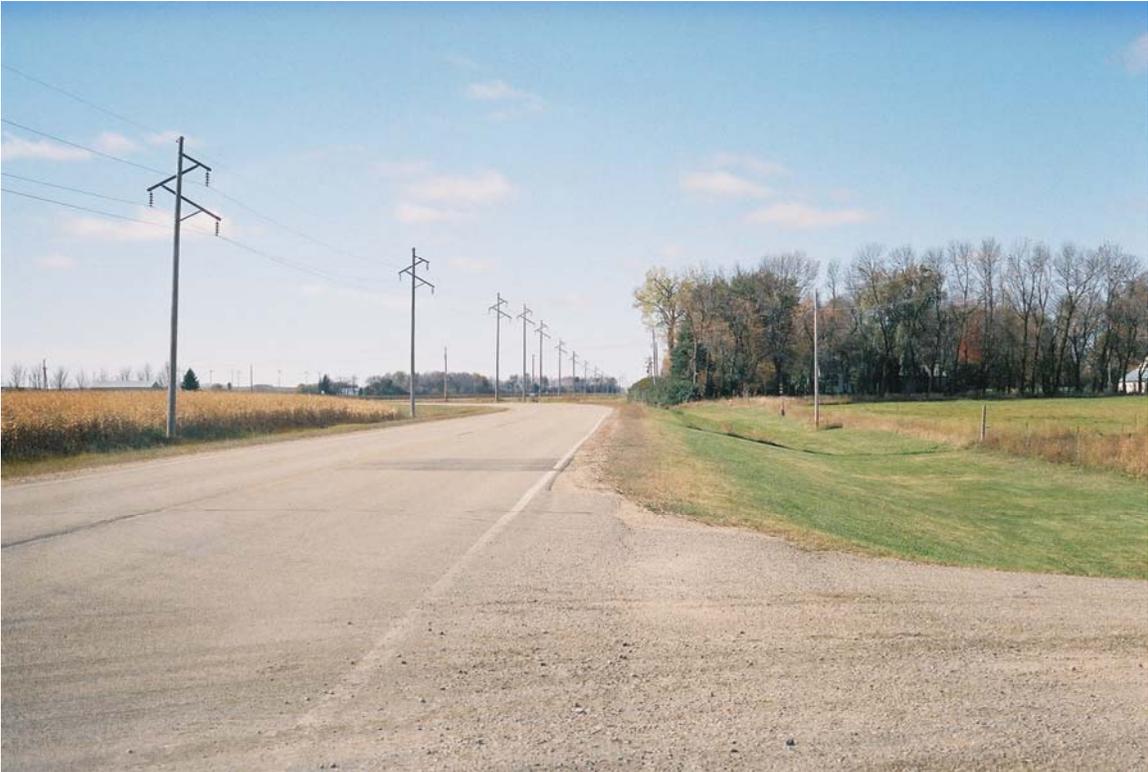
Horizontal Curve: *With Rumble Strips*

“Horizontal Curve”—*With Rumble Strips*:
Lincoln County #7: US-75 & CR-13
(1st rumble strip visible)

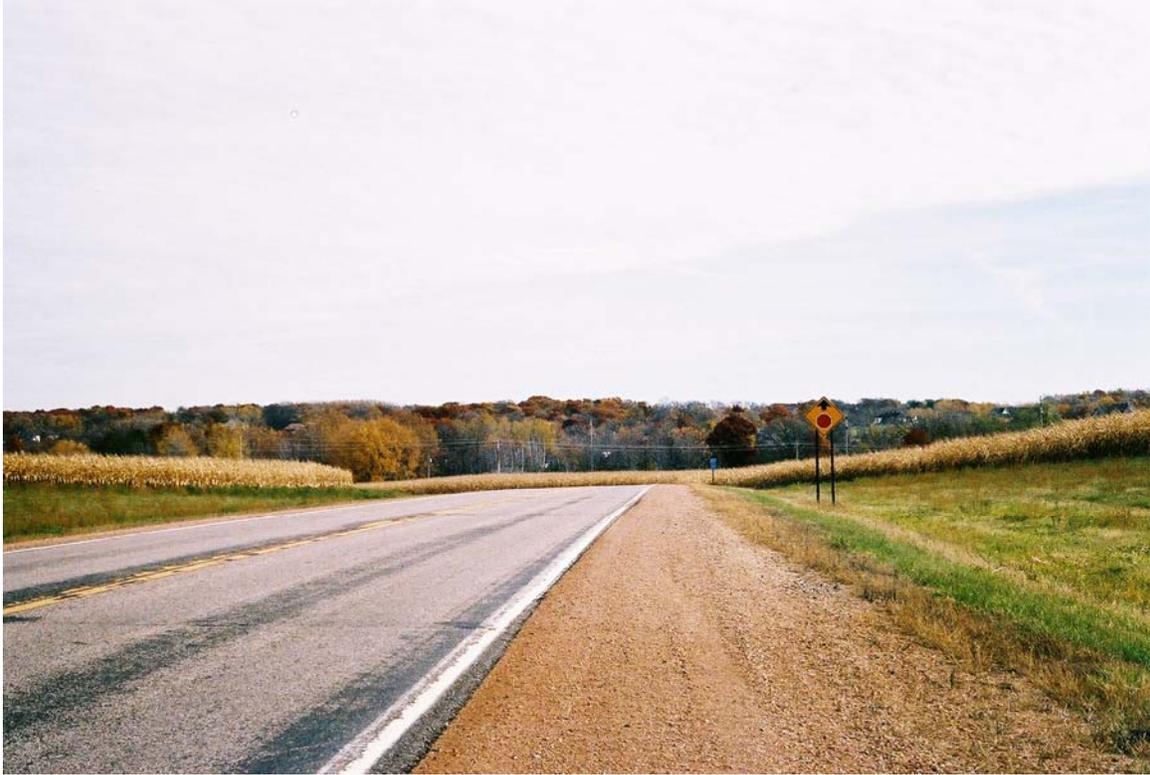
Horizontal Curve: *Without Rumble Strips*

“Horizontal Curve”—*Without Rumble Strips*:
Scott County #56: Credit River Boulevard/CR-12 & Natchez Avenue/Vernon Avenue
(from approximately where 1st rumble strip would be located)

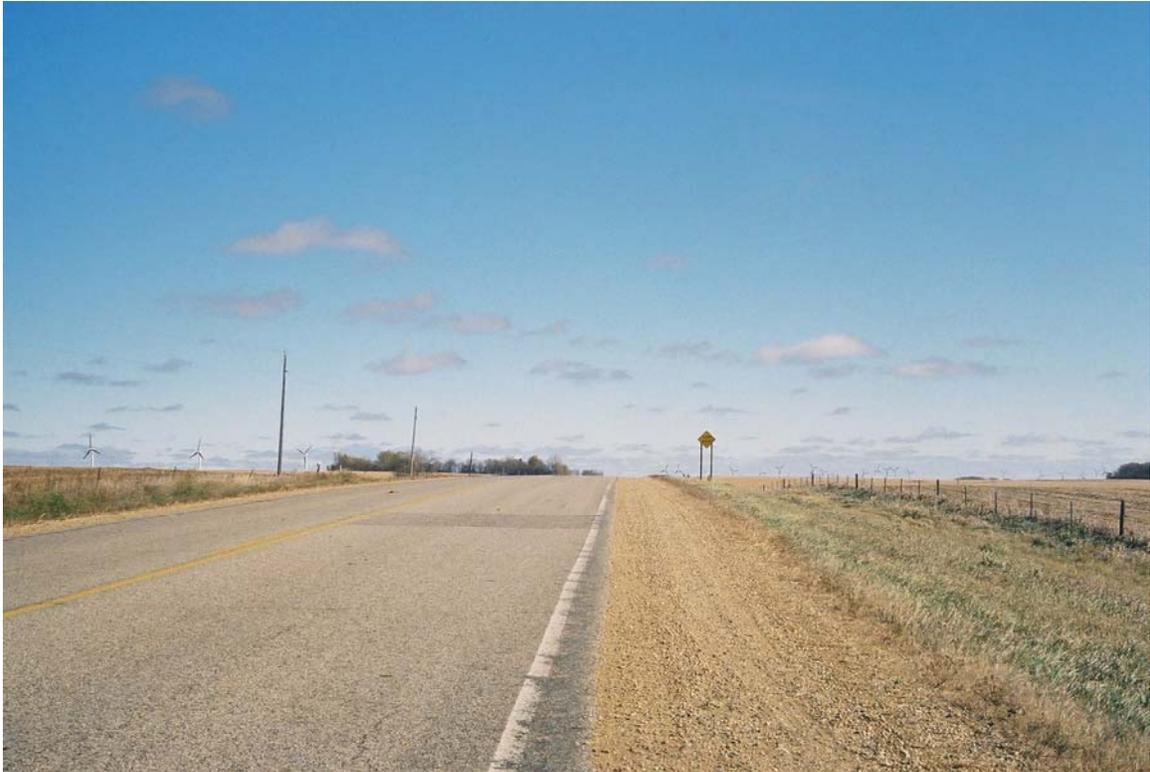
Vertical Curve: *With Rumble Strips*

“Vertical Curve”—*With Rumble Strips*:
Lincoln County #9: CR-1 & CR-13
(1st rumble strip visible)

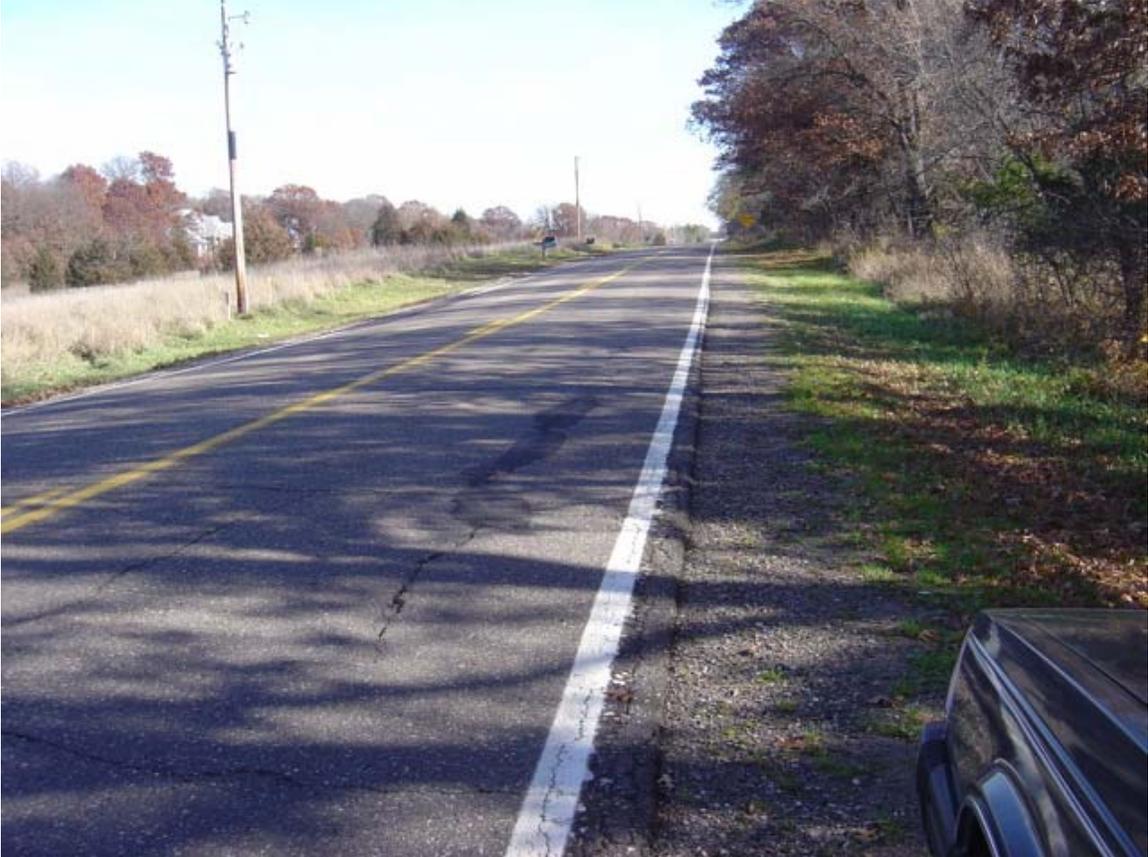
Vertical Curve: *Without Rumble Strips*

“Vertical Curve”—Without Rumble Strips:
Anoka County #150: CR-9 & CR-58
(from approximately where 1st rumble strip would be located)
