## TECHNICAL SUMMARY

# Developing Flexural Vibration Inspection Techniques for Wooden Bridges

*This Technical Summary pertains to the LRRB-produced Report 2009-40, “Development of Flexural Vibration Inspection Techniques to Rapidly Assess the Structural Health of Rural Bridge Systems: Phase II,” published December 2009. The full report can be accessed at <http://www.lrrb.org/PDF/200940.pdf>.*

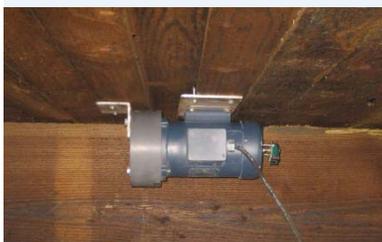
Electric motors with offset weights are used to create vibrations in the wooden bridge deck that are detected with sensors elsewhere on the deck.

The testing procedure utilized a one-half horsepower DC motor rotating an unbalanced disc attached at the center of the bridge span to vibrate the deck. Accelerometers attached at midspan measured the amplitude of vibration of the deck over a range of frequencies as the revolutions per minute of the motor increased.

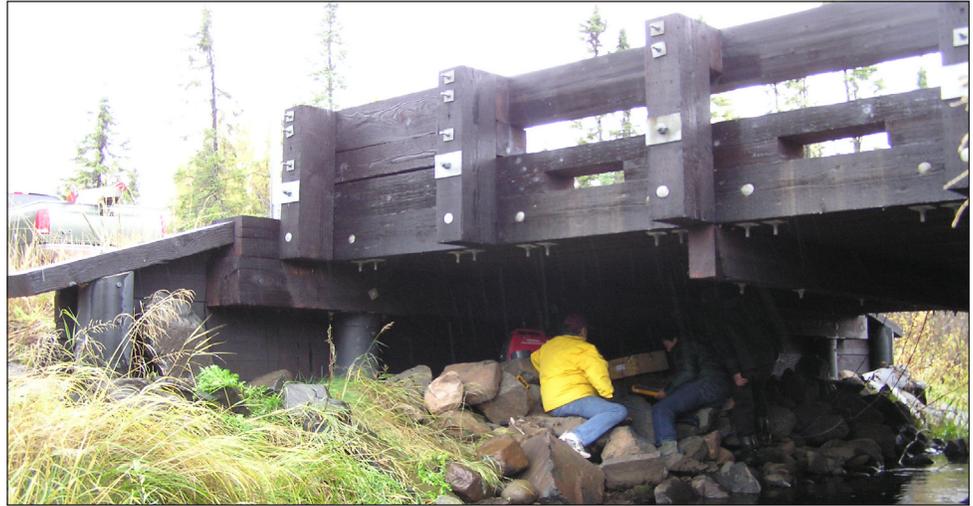
Researchers examined the potential for using vibration testing to assess the structural health of dowel-laminated bridge systems—wooden bridges constructed with laminated timbers held together transversely by metal dowels and supported by a spreader beam.
