TECHNICAL SUMMARY

Developing Flexural Vibration Inspection Techniques for Wooden Bridges

This Technical Summary pertains to the LRRB-produced Report 2009-40, “Development of Flexural Vibration Inspection Techniques to Rapidly Assess the Structural Health of Rural Bridge Systems: Phase II,” published December 2009. The full report can be accessed at <http://www.lrrb.org/PDF/200940.pdf>.

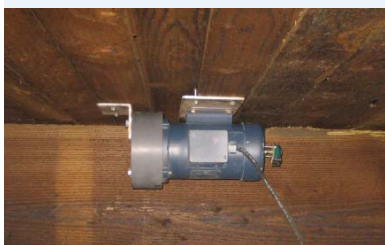
Electric motors with offset weights are used to create vibrations in the wooden bridge deck that are detected with sensors elsewhere on the deck.

The testing procedure utilized a one-half horsepower DC motor rotating an unbalanced disc attached at the center of the bridge span to vibrate the deck. Accelerometers attached at midspan measured the amplitude of vibration of the deck over a range of frequencies as the revolutions per minute of the motor increased.

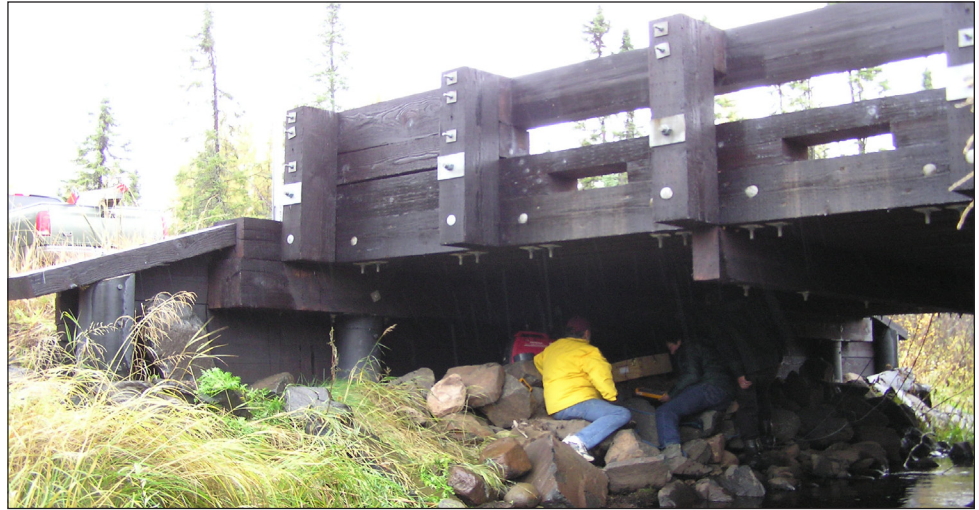
Researchers examined the potential for using vibration testing to assess the structural health of dowel-laminated bridge systems—wooden bridges constructed with laminated timbers held together transversely by metal dowels and supported by a spreader beam.
