# Performance Assessment of Oversized Culverts to Accommodate Fish Passage

Minnesota  
Department of  
Transportation

Research Project  
Final Report 2011-19

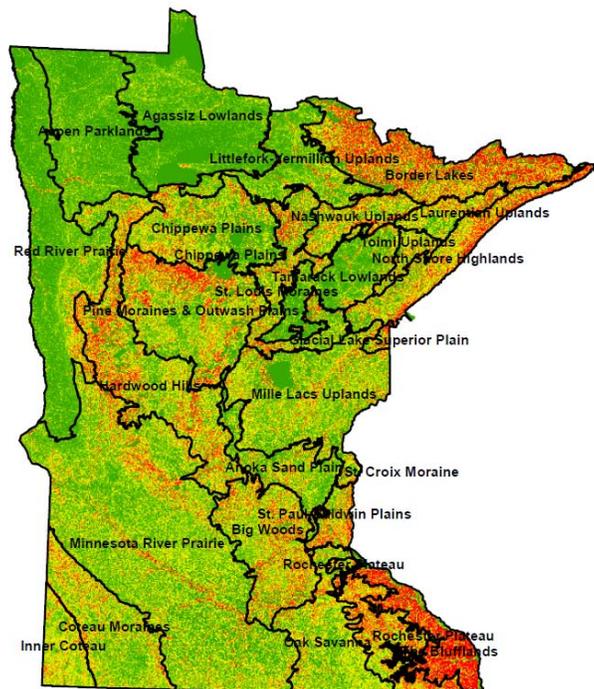
**Figure 3.1. Map of Minnesota showing the slope gradient in each ecoregion. The slope increases as the colors change from green to red.**

Figure 3.1 shows the diversity of landscapes in Minnesota and how slopes are distributed within each ecoregion. Each ecoregion of the state, with the exception of the Red River Valley, has a range of low to steep slopes with geomorphic features unique to that region. Because of this diversity in landscapes a decision was made to select a small number of sites in a number of ecoregions to cover the main landscape features in the state.

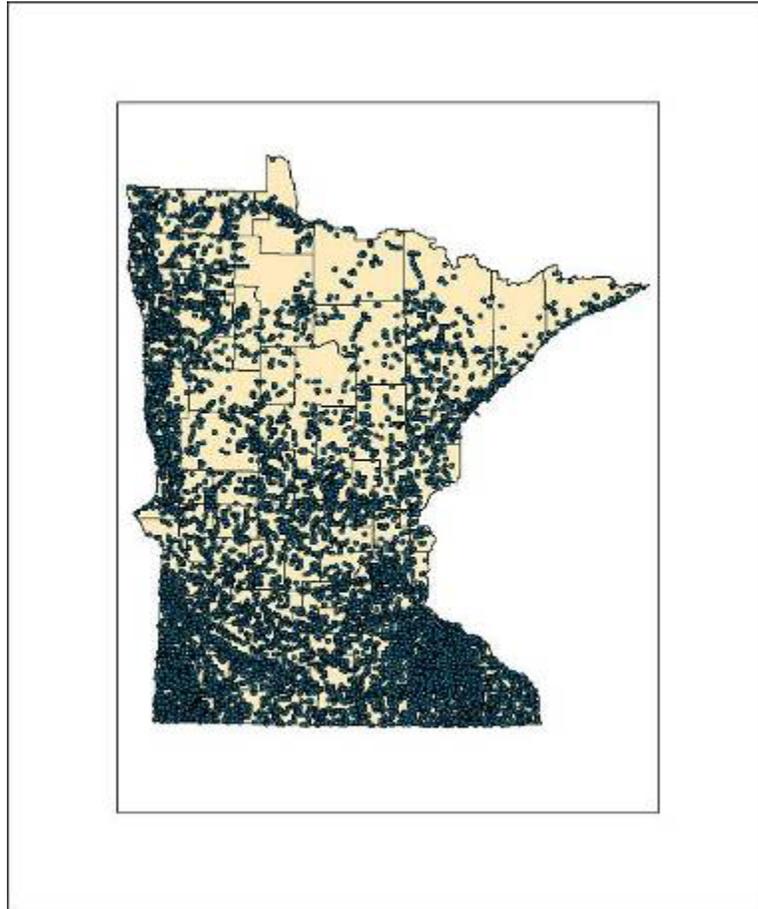
**Figure 3.2. Map of Minnesota showing the locations of culverts on public waters.**

The distribution of culverts was also considered in the selection process. The southern half of Minnesota has the highest density of culverts, especially focused in the southwest and southeast (Figure 3.2). These areas of the state have two things in common; a large number of streams and high road density. The Red River Valley region and the strip of road infrastructure along the North Shore also have high concentrations of culverts.

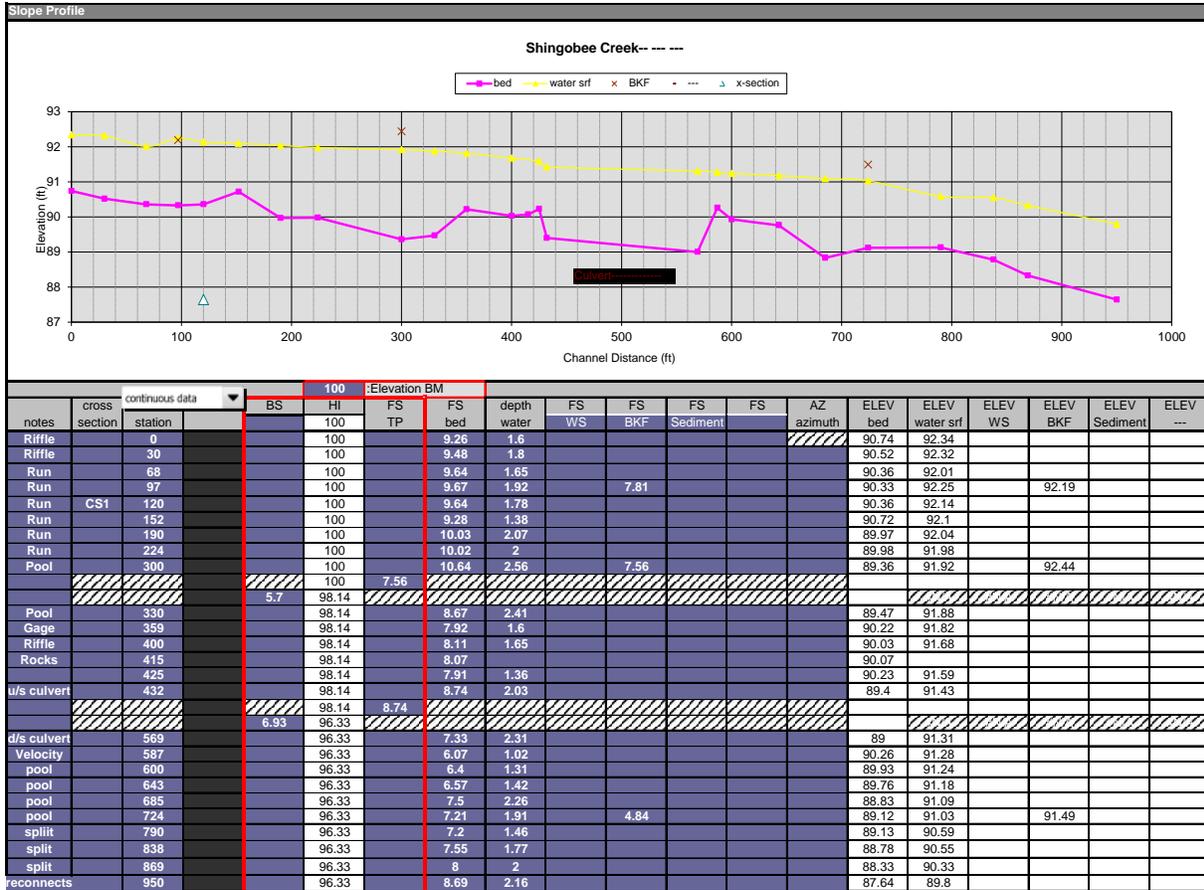
Figure 4.2. Screenshot including table and line graph. Line graph shows the longitudinal profile of the channel bottom upstream and downstream of the culvert at Shingobee Creek.

Data was tabulated and plotted using software developed by Mecklenburg in 1999 [17]. It includes tabs for cross-sections, longitudinal profiles, bed materials and a summary. Each culvert site has its own spreadsheet. An example of each tab is given below (Figure 4.1, Figure 4.2, and

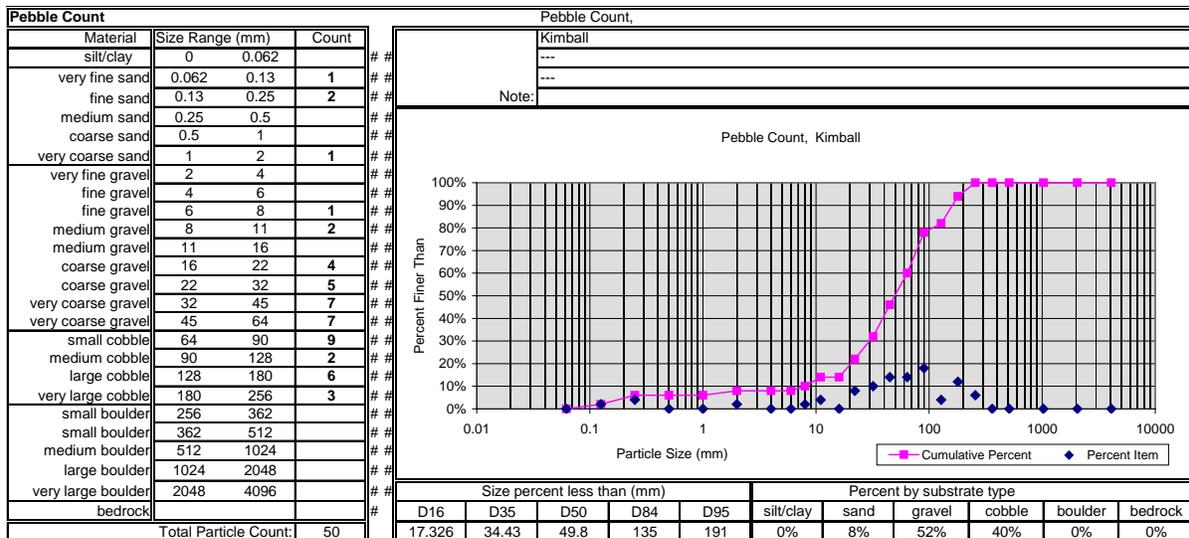
Figure 4.3. Screenshot showing table and line graph. Line graph shows the particle distribution of channel sediments at Kimball Creek.

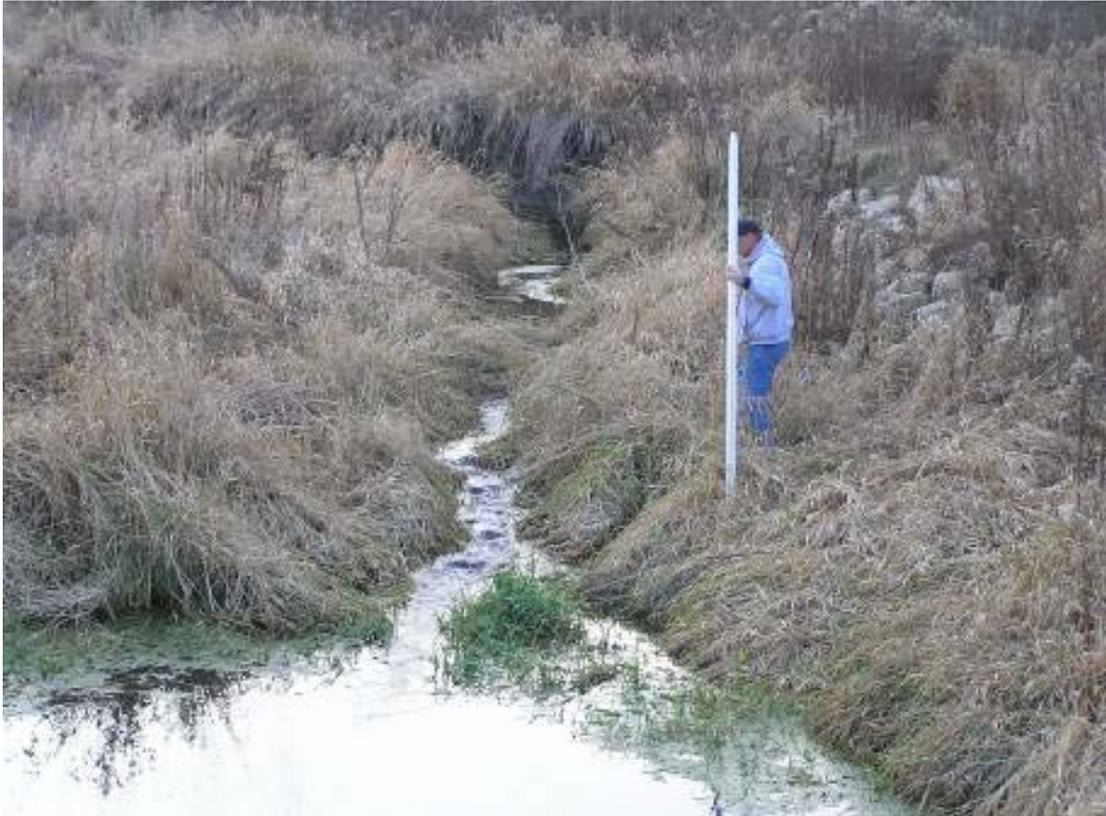
**Figure 5.1. Photograph of rip-rap placed at upstream end of the pool to prevent the formation of a head cut developing from the recessed culvert installation.**

The need to protect this elevation drop created during installation of the recessed culvert was well represented in the field. The field surveys documented head cutting mitigation efforts at all but two of the recessed study sites. No evidence of head cuts moving upstream from a recessed culvert installation was observed at any of the seventeen study sites where rock had been put in place. At the two sites where no rock had been placed no head cuts had developed at the time of

the survey. All mitigation study sites featured some form of rock weir or immobile rip-rap placed in the channel to serve as grade control and protect against the possibility of a head cut. Two different configurations were observed. At culvert sites with pools both upstream and downstream of the culvert, rock is placed where the channel enters the upstream pool and where the channel exits the downstream pool (Figure 5.1). At sites where the stream channel flows directly into the culvert, the rock is placed just upstream of the culvert entrance (Figure 5.2).

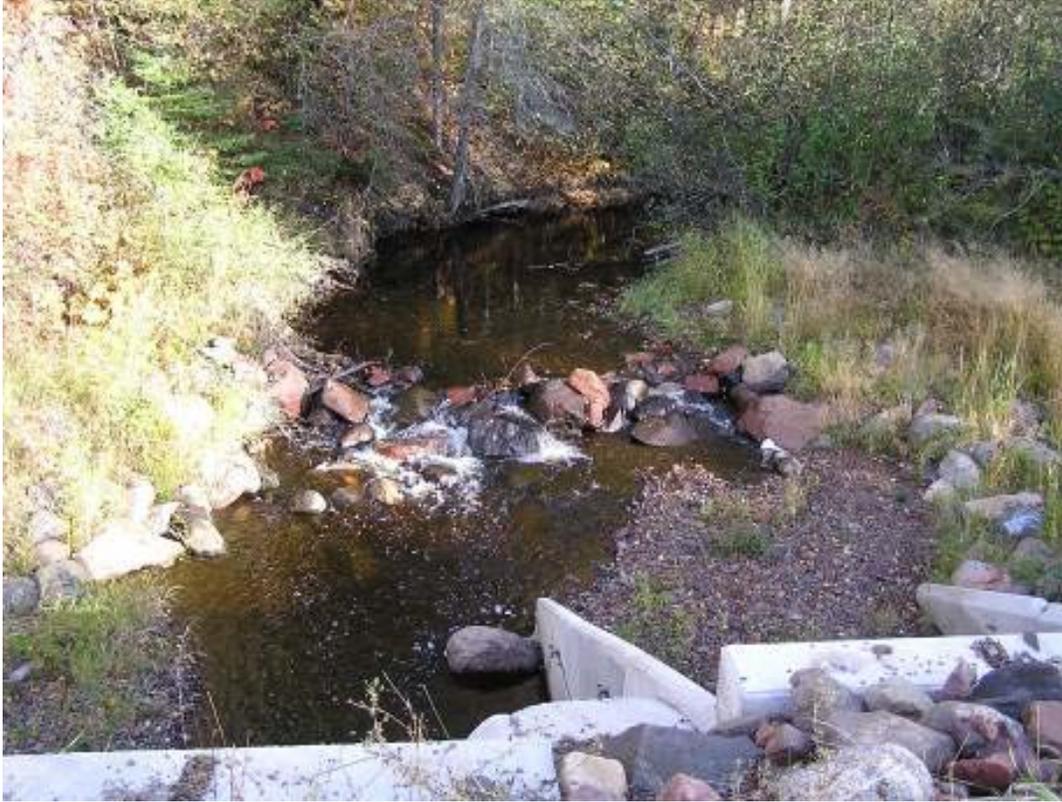
**Figure 5.2. Photograph of rock placed in the channel immediately above the culvert to protect against head cut development.**

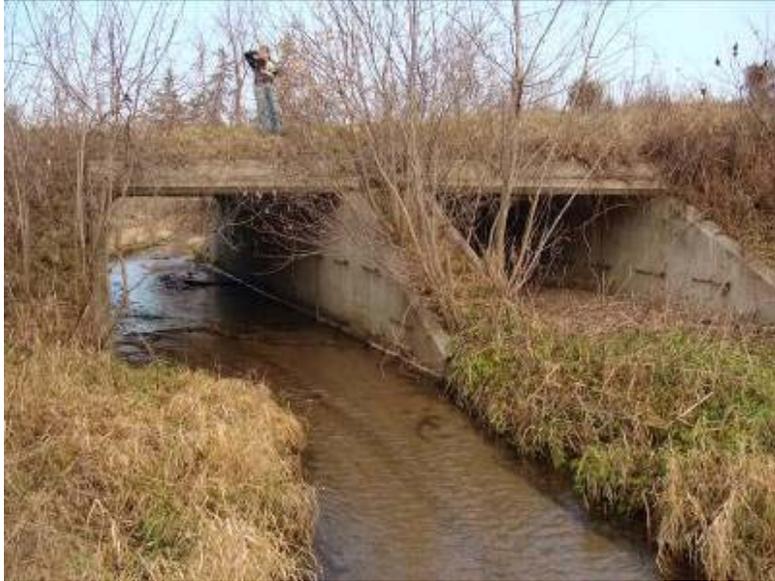
**Figure 5.3. Photograph showing a highly mobile sand bed at Gorman Creek. Note the side culvert filled in with sediment (Goodhue County).**

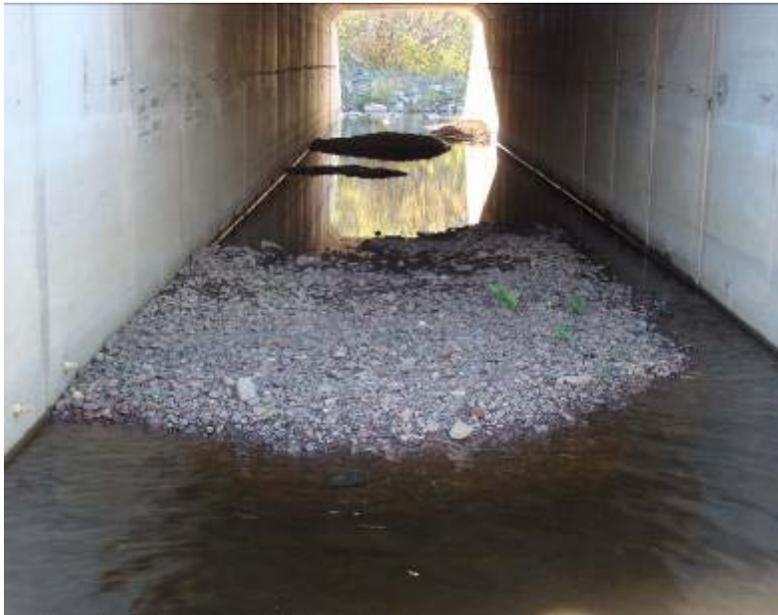
**Figure 5.4. Photograph showing gravel and small cobble accumulating in the side barrel at Beaver River site (St. Louis County).**

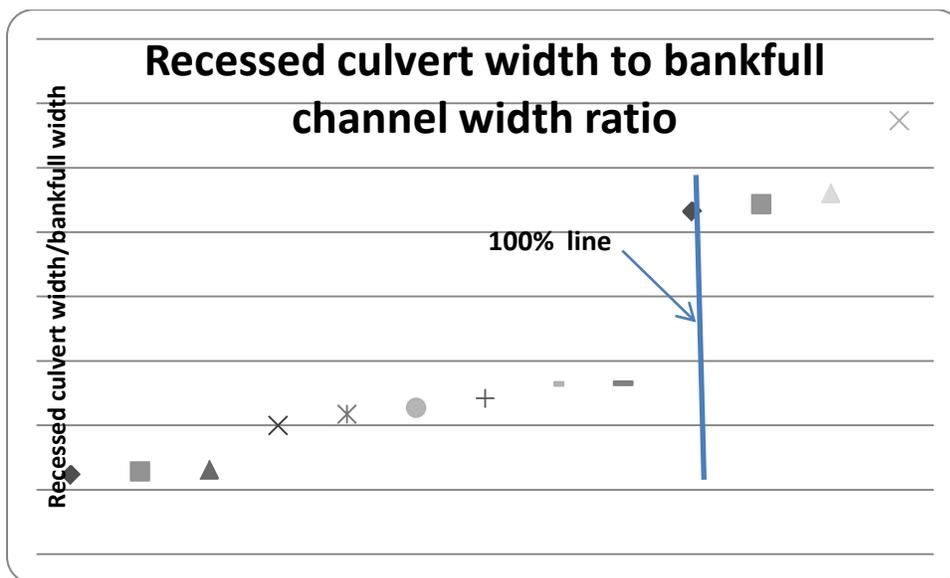
Figure 5.5. Graph showing the ratio of recessed culvert width and the bankfull channel width for the thirteen recessed culvert sites. The graph shows that at nine sites recessed culvert width was less than bankfull width.

Figure 5.5 shows the ratio of the recessed culvert width compared to the bankfull channel width for the thirteen sites with recessed culverts. At nine of the thirteen sites the recessed culvert width is less than the bankfull width, including five of the six sites with no sediment in the recessed culvert. Of the six sites that had no sediment accumulated in the recessed barrel two were single barrel culverts and the remaining four were double barrel culverts. The single barreled culverts had ratios of 0.40 and 0.52 which suggests the culverts are undersized and sediment accumulation could be a problem because of higher culvert velocities compared to the channel. The four double barrel culverts had sediment accumulated in the side barrels which suggests enough sediment is moving downstream to accumulate in the recessed barrel. However, it may be accumulated in the side barrels to a depth that forces more flow through the recessed barrel which may explain why no sediment had accumulated in the recessed barrel.

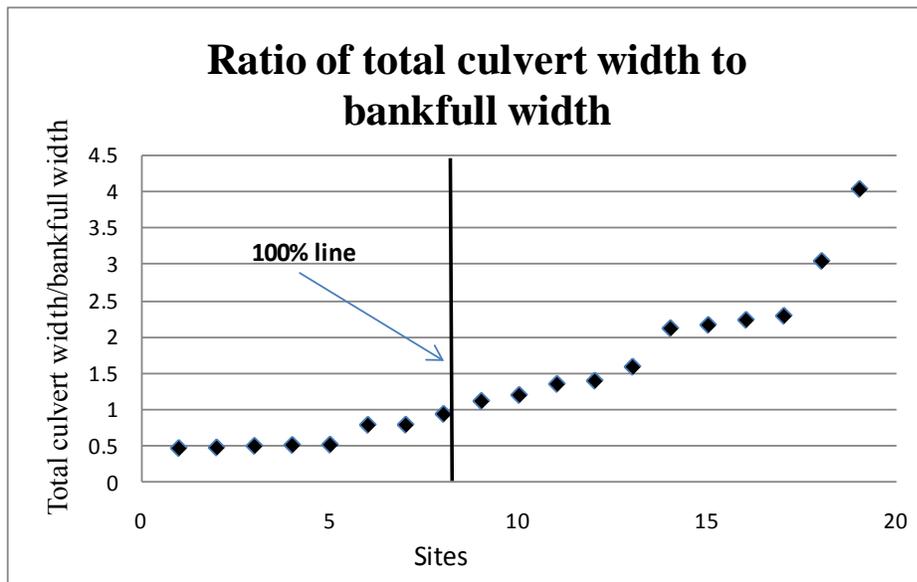
**Figure 5.6. Graph of the ratio of total culvert width compared to the bankfull channel width. Eight of the sites had a total culvert width that was less than the bankfull channel width.**

Figure 5.6 shows the ratio of total culvert width (all barrels) to the bankfull channel width for all 19 sites. Eight of the 19 sites have a total culvert width less than the channel width.

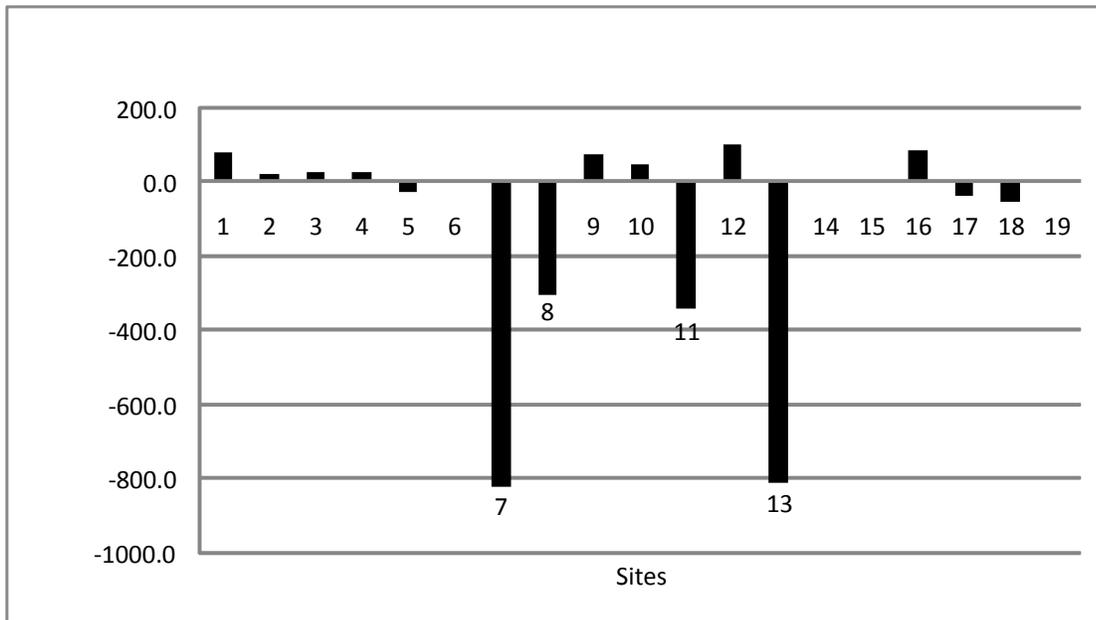
**Figure 5.7. Graph comparing the upstream channel slope to the downstream channel slope. Four sites have greater downstream slope as compared to upstream slope.**

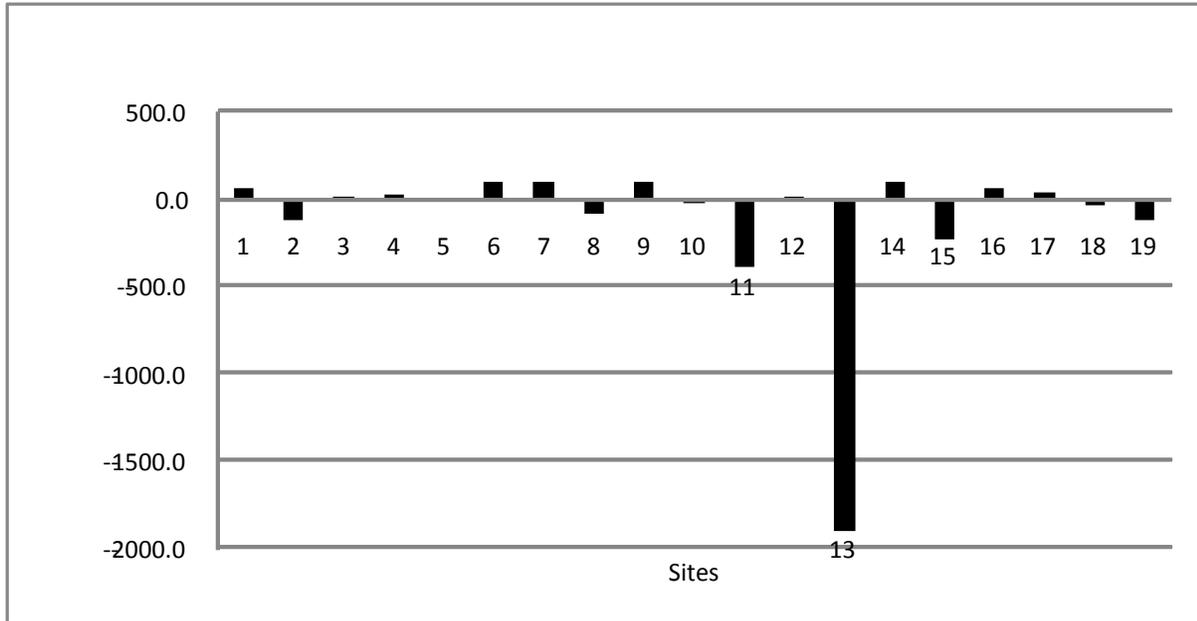
**Figure 5.8. Graph showing the culvert slope compared to the upstream channel slope. Five culvert sites have greater culvert slope than upstream channel slope.**

Figure 5.8 compares the upstream slope to the culvert slope. Six sites have culvert slopes that are greater than the upstream slopes. Steeper culvert slopes can result in higher culvert velocities as compared to channel velocities. However, in this data set there is no correlation between higher culvert slope and a lack of accumulated sediments in the recessed culvert. Nor was there a correlation between the practice of recessing culverts and the difference in slope between upstream and downstream segments.
