Pavement Marking Compatibility with Chip Seal and Micro Surfacing

Minnesota
Department of
Transportation

October 2011

Research Project
Final Report 2011-24

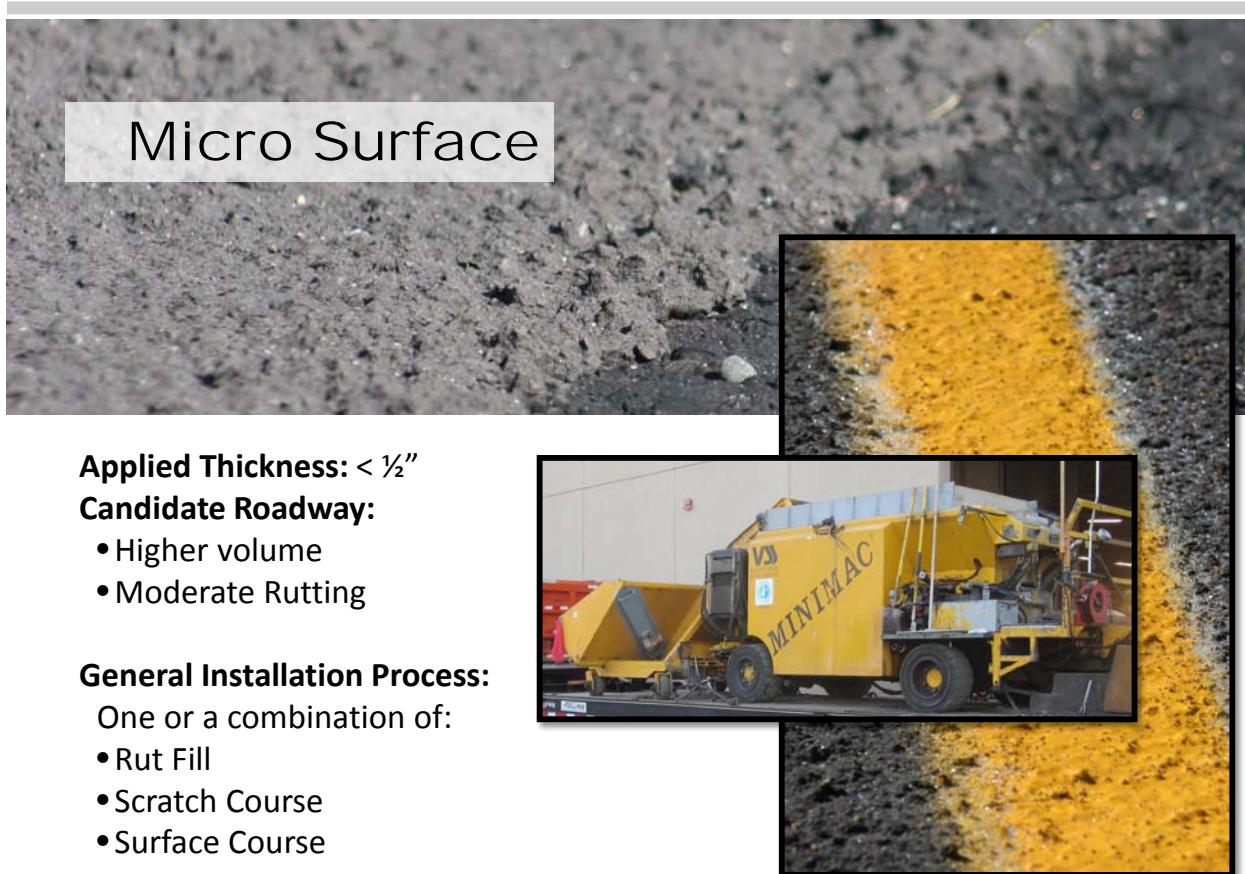
Figure 3. Typical Micro Surface Treatment

Micro Surface – The LRRB report on Preventive Maintenance Best Practices report (3) describes micro surface treatments as follows: “Micro-surface treatments can be defined as a mixture of fine aggregate, asphalt emulsion and mineral filler such as Portland cement; this treatment uses a chemically controlled curing process which typically allows traffic to use the roadway within one hour, as opposed to slurry seals which use a thermally controlled curing process. Furthermore the additional mix stability, resulting from the latexes, makes this treatment ideal for higher volume roads, where a chip seal would be impractical. This treatment is applied as in slurry form and placed by a slurry box that uses a screed to control the surface elevation. A micro-surface can be applied in relatively thick layers, which makes it ideal for filling in ruts, and correcting other deformations. The main disadvantage of this treatment when compared to a seal coat or other surface treatments is its relatively high unit cost. Micro-surfacing also can be used to restore friction to an otherwise sound pavement surface.” Figure 3 shows a typical MnDOT seal coat surface treatment and application information.

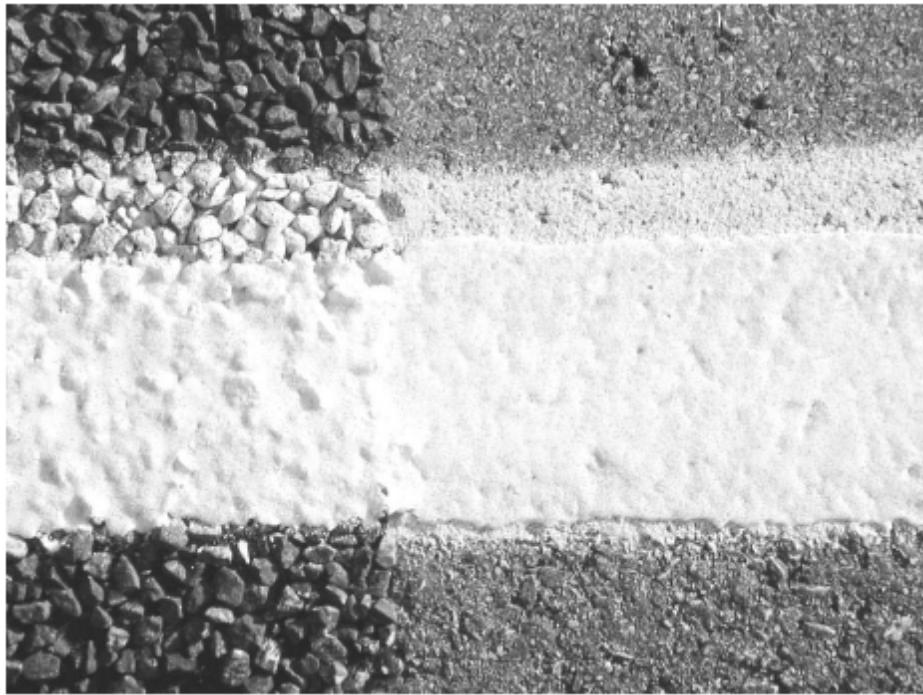
Figure 4. Thermoplastic Marking on Seal Coat (left) vs. HMAC (right) (4)

Findings: **Yes**, although based on a small sample size, after 14 days the smooth surface had higher levels of retroreflectivity than the seal coat surface (using the same marking materials), see Figure 4. The evaluation also found that the markings placed on the HMAC surface had greater uniformity in retroreflectivity readings.

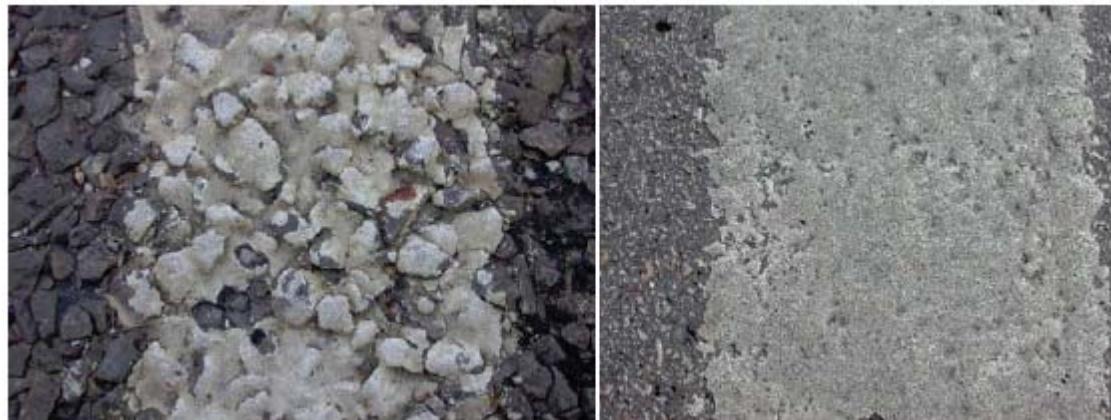
Figure 5. Thermoplastic after Two Years (Seal Coat on Left vs. HMAC on Right) (4)

Findings: Yes, both initially and after eight months, the smooth surface had higher levels of retroreflectivity than the seal coat surface, see Figure 5. The evaluation also found that after eight months the retroreflectivity levels for the markings on seal coat surfaces had degraded by 36 to 55 percent of initial levels while in contrast the HMAC thermoplastic markings had lost only 0 to 7 percent of their initial values. Another finding showed that the difference in directional retroreflectivity for yellow centerline markings were significantly less on HMAC versus seal coat surfaces which indicated a better binder/bead coverage for markings on HMAC surfaces and again the HMAC markings had better uniformity in retroreflectivity readings.

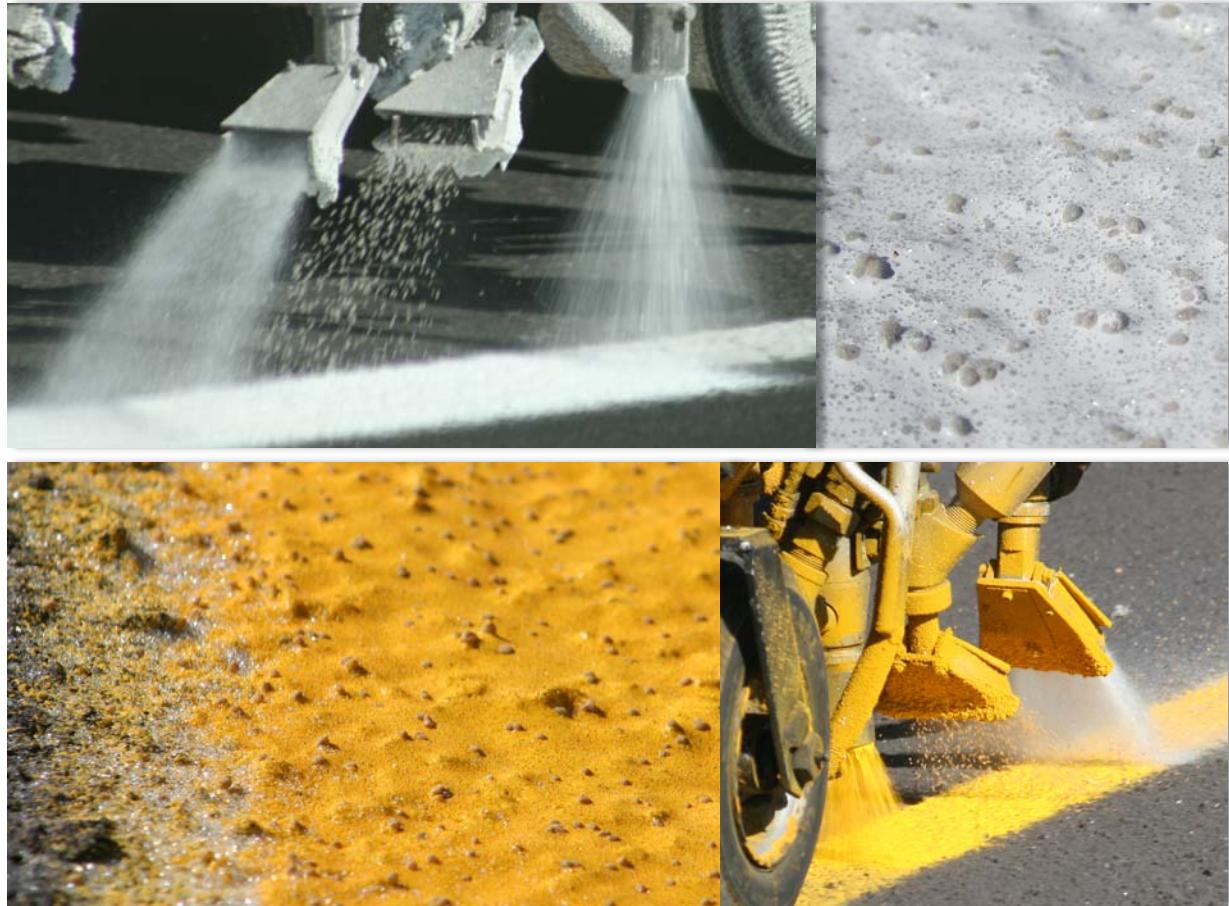
Figure 11. I-94 Micro Surface Project Permanent Marking Placement

The permanent pavement markings were placed in September of 2010. As shown in Figure 10, these new 4" wide markings were offset from the temporary markings by approximately 2 inches (edge lines only) to observe differences in wear over time and to consider the difference in adhesion of the permanent marking when placed over a primer coating (the temporary marking) versus over the micro surface alone.

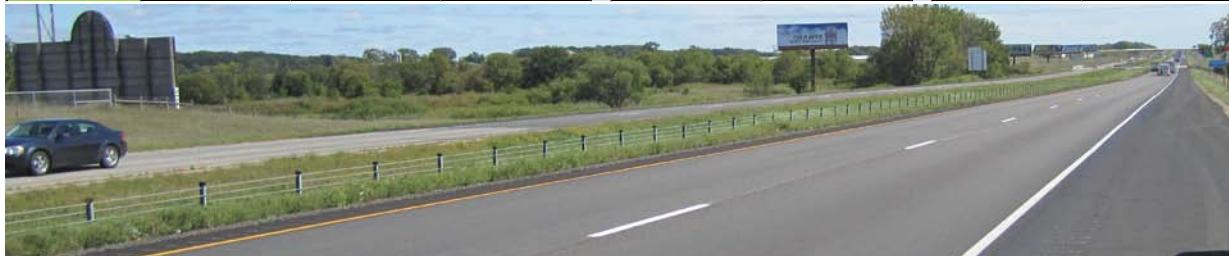
Figure 12. I-94 Pavement Marking Performance

Location		Roadway		Pavement Marking		Retroreflectivity (mcd)	
Highway	Ref. Pt.	Surface	Year	Striping	Year	Left Edge (Yellow)	Right Edge (White)
94	131 Ramp	Microsurface	2010	All Weather	2010	272	324
	132	Microsurface	2010	All Weather	2010		368
	133.95	Microsurface	2010	All Weather	2010	299	
	134.04	Microsurface	2010	All Weather	2010	398	434

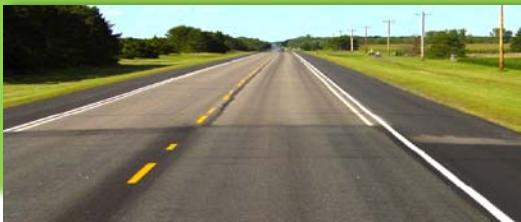
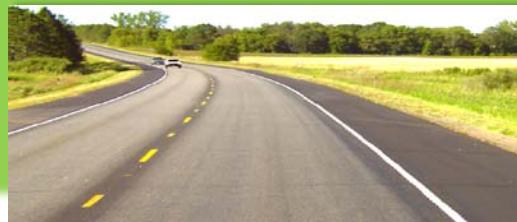
Figure 13. Highway 25 Pavement Marking Performance

Location		Roadway		Pavement Marking		Retroreflectivity (mcd)		
Highway	Ref. Pt.	Surface	Year	Striping	Year	Left Edge	Center	Right Edge
25	81.999	Seal Coat	2010	All Weather	2010	192	152	320
	82.868	Seal Coat	2009	Epoxy	2009	320	164	301
	82.868	Seal Coat	2009	All Weather	2010	348	190	420
	93	Seal Coat	2010	All Weather	2010	354	163	186

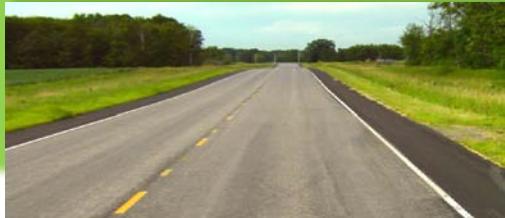
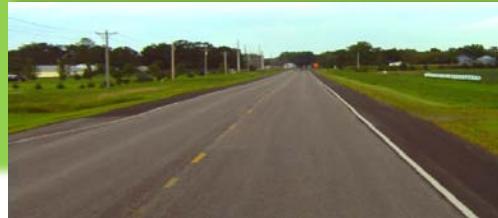
Figure 14. Highway 47 Pavement Marking Performance

- @ 60.000 AWP performance after one year: Given the lower volume, the AWP performed adequately over the winter. The large difference between edge line readings (left at 112 and right at 473 mcd) has been explained by noting that the right edge line markings are on smooth pavement where the left edge line marking is on a seal coat surface.
- @ 67.000 AWP performance after one year: Very similar performance to what was found at reference point 60. The yellow center line marking did not perform well (87 mcd) over the one year period.

Location		Roadway		Pavement Marking		Retroreflectivity (mcd)		
Highway	Ref. Pt.	Surface	Year	Striping	Year	Left Edge	Center	Right Edge
47	60	Seal Coat	2009	All Weather	2009	112	135	473
	67	Seal Coat	2009	All Weather	2009	133	87	325

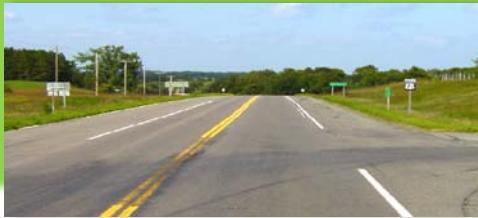
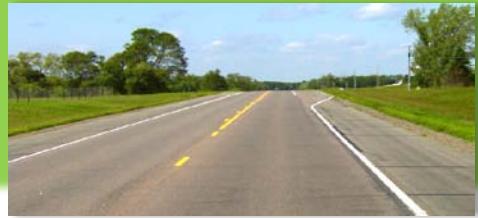
Figure 15. Highway 71 Pavement Marking Performance

- @ 169.99 This section provides a comparison where AWP was used initially over a seal coat in 2008. After one year, all but one segment was repainted using epoxy. Staff felt, from a night time driving perspective, that they were able to get 2 years out of the AWP segment, however, the right edge line measured 59 mcd only. The one year old epoxy performance was marginal (105/116 mcd), however, it might not perform over another winter.
- @ 172.00 This section shows much better performance for the epoxy after one year compared to the previous segment when looking at the right edge line. The performance of the left edge line is marginal.
- @ 174.00 Same results as at reference post 172.00, good performance over the one year period for the right edge line and marginal for the left edge line.

Location		Roadway		Pavement Marking		Retroreflectivity (mcd)		
Highway	Ref. Pt.	Surface	Year	Striping	Year	Left Edge	Center	Right Edge
71	169.99	Seal Coat	2008	All Weather	2008			59
	169.99	Seal Coat	2008	Epoxy	2009		105	116
	172	Seal Coat	2008	Epoxy	2009	163	127	223
	174	Seal Coat	2008	Epoxy	2009	130	125	263

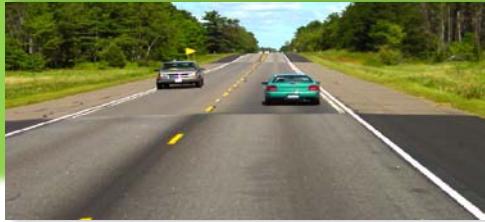
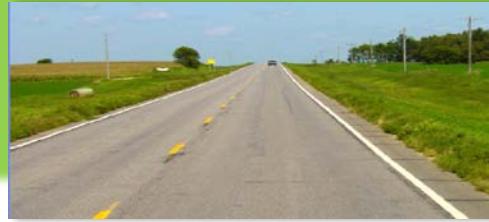
Figure 16. Highways 65 and 4 Pavement Marking Performance

- @ 163.00 Latex paint was applied and at the end of the summer and is still providing excellent retroreflectivity. This emphasizes the impact of traffic on both durability and retroreflectivity.

Location		Roadway		Pavement Marking		Retroreflectivity (mcd)		
Highway	Ref. Pt.	Surface	Year	Striping	Year	Left Edge	Center	Right Edge
65	47	Seal Coat	2009	All Weather	2009	244		
4	163	Seal Coat	2007	Latex	2010	325	227	263

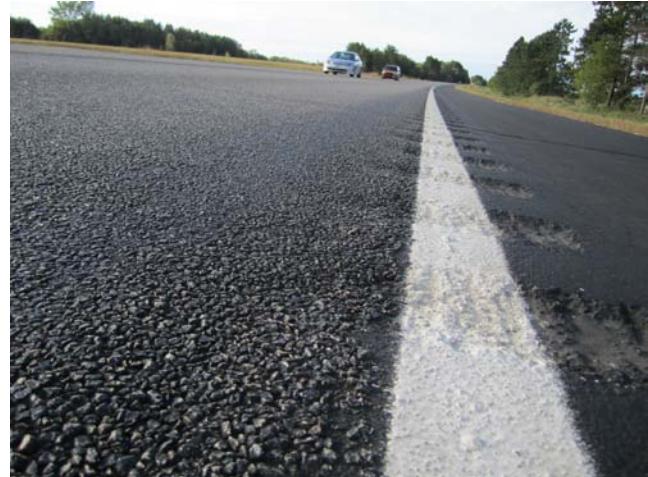
Figure 17. Rumble Stripe Placement Outside of Seal Coat

- Figure 17 shows an example where the seal coat surface stops prior to the location of the edge line rumble stripe. This provides vertical protection for the marking from snow plow blades and the smoother surface allows for better retroreflectivity.

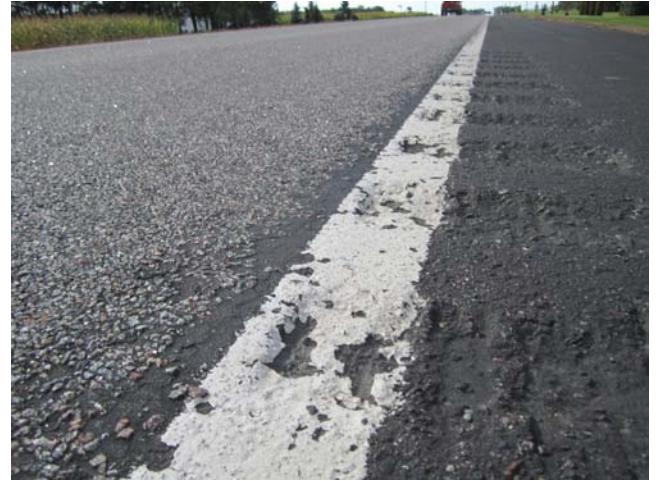
Figure 18. Rumble Stripe Damage

- Figure 18 shows an example of rumble stripe damage which was not caused by snow plows. As shown, there are large pieces of marking material missing in the bottom “trough” of the rumble. Whether this was a reaction to the extra fog sealant in the bottom of the rumble or caused by the freezing/thawing of water is unknown but should be further investigated.

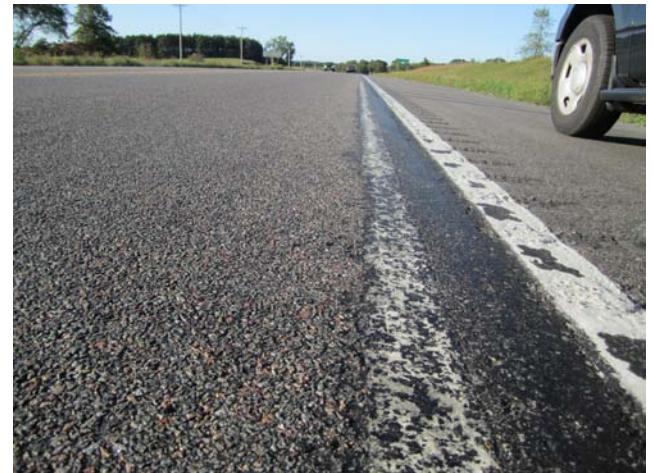
Figure 19. Adherence to Existing Markings

- Micro or seal coat surfaces placed over existing pavement markings do not adhere to the old stripe very well. Fog sealants are typically used as a primer over the old stripe to improve adhesion. This is a particular problem when the existing edge line has been moved out to create a rumble stripe as shown in Figure 19 (where both stripes are visible).

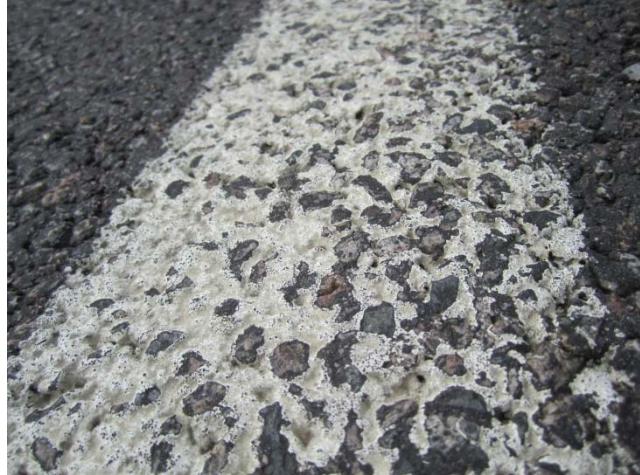
Figure 21. Aggregate Adhesion

- In some cases, pavement markings appear to suffer adhesion related issues where there are flat exposed aggregates as shown in Figure 21.

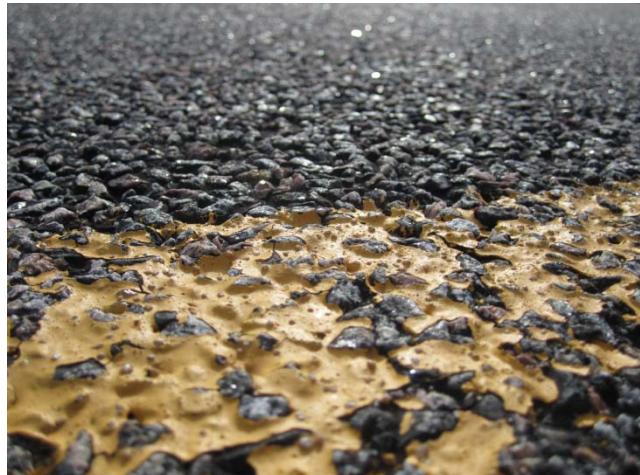
Figure 22. Aggregate Size and Marking Damage

- In some cases, the size of the aggregate appears to “break” up the mono-layer of marking material which causes rapid deterioration as shown in Figure 22.

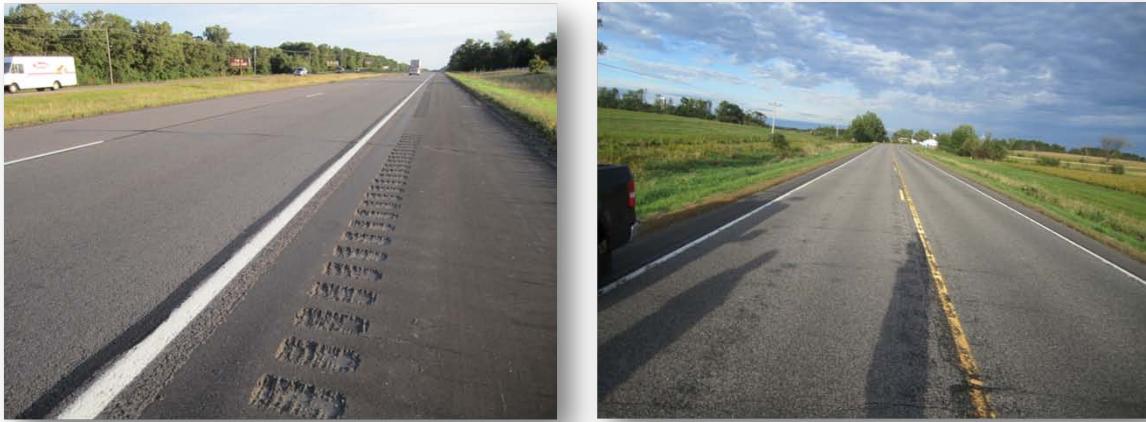
Figure 23. Example Roadway Characteristics

The field trial will be conducted on both four-lane divided and two-lane roadways and will include both yellow (yellow edge and centerline) and white (white edge and skip) pavement markings on both micro surface and seal coat roadways. Example test sections are shown in Figure 23 below.
