Vehicle Speed Impacts of Occasional Hazard (Playground) Warning Signs

Minnesota
Department of
Transportation

John Hourdos, Principal Investigator
Department of Civil Engineering
University of Minnesota

Research Project
Final Report 2012-06

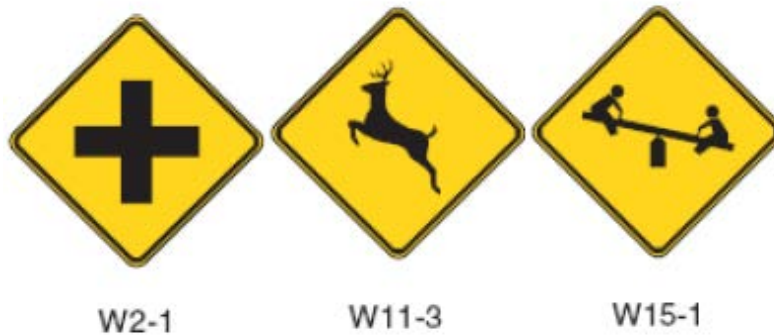
Figure 1.1. Examples of Occasional Hazard Warning Signs

Warning signs are installed along roadways to provide information to vehicle drivers about hazards that may impact their decision-making. In general, these signs are located and designed to elicit one or more driver responses (e.g., more awareness, speed reduction). They are also sometimes supplemented with advisory speed limit signs. Some hazards identified by warning signs are relatively static (e.g., the existence of a horizontal curve), whereas other warning signs are installed for hazards that may occur on a more sporadic basis. These occasional hazard warning signs can be used to raise awareness of the potential for hazards at particular locations (e.g., playground or intersection ahead) or along an entire roadway segment (e.g., deer crossing). Examples of occasional hazard warning signs include the non-standard “children-at-play” sign and the Manual on Uniform Traffic Control Devices (MUTCD) [1] compliant signs shown in Figure 1.1.

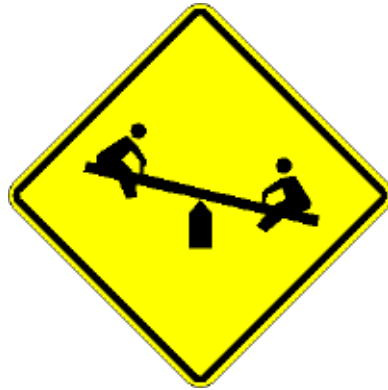
Figure 2.1. Occasional Hazard (Playground) Warning Sign (I)

This chapter provides a summary of studies, documented and completed, that are relevant to this research project. Several research projects have considered the potential impacts of occasional hazard warning signs. However, none of publications found during the literature search focused on the vehicle speed impacts of the OHPW sign (See Figure 2.1).

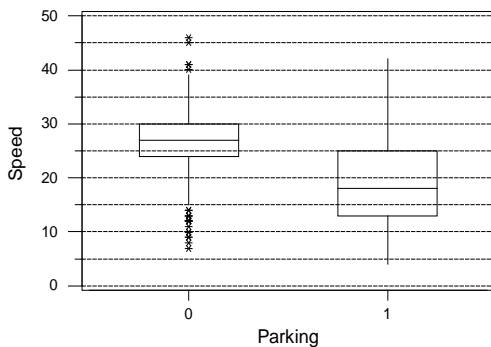
Figure 4.9. Boxplot Summarizing the Distribution of Vehicle Speeds without On-Street Parking (=0) and with On-Street Parking (=1) at the Chicago Avenue South Study Site
