## TECHNICAL SUMMARY

# Effects of Agricultural Equipment on Pavement Performance

This Technical Summary pertains to the LRRB-produced Report 2012-08, "Effects of Implements of Husbandry (Farm Equipment) on Pavement Performance," published April 2012. The full report can be accessed at <a href="http://www.dot.state.mn.us/research/documents/201208.pdf">http://www.dot.state.mn.us/research/documents/201208.pdf</a>. Information about the ongoing pooled fund study TPF-5(148) can be found at <a href="http://www.pooledfund.org/Details/Study/375">http://www.pooledfund.org/Details/Study/375</a>.

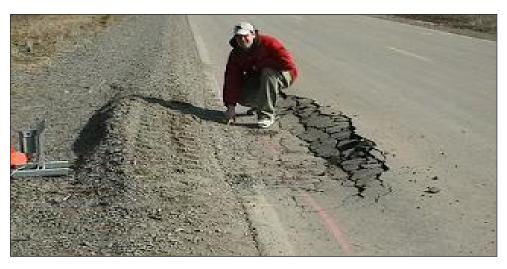
Failures on test sections like this one in March of 2009 show how heavy agricultural equipment driven near the edge of a rural pavement can cause structural failure.

- Pavement thickness was critical to resisting failure. The thinner asphalt sections suffered extensive cracking, severe rutting and failure in spring and fall of 2009. The thinner concrete pavement suffered several corner breaks.
