Stripping of Hot-Mix Asphalt Pavements under Chip Seals

Minnesota
Department of
Transportation

April 2013

Research Project
Final Report 2013-08

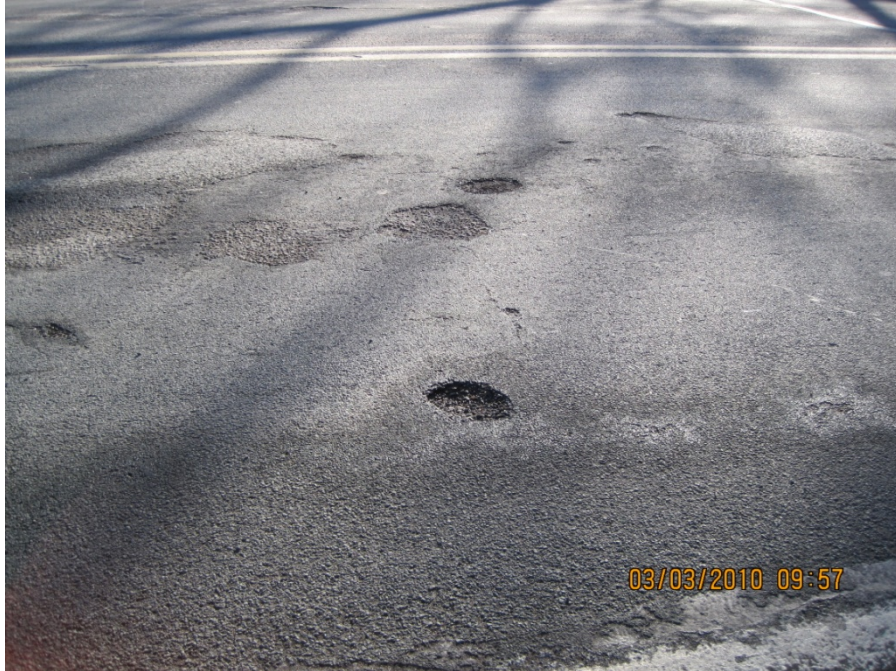
Figure 1: Stripping of asphalt pavement under chip seal.

For more than twenty years, Cities have experienced pavement deterioration of the upper 0.5 to 1.0 inch of HMA pavements under chip seals. The distress causing this is stripping of the asphalt layer directly beneath the chip seal (Figures 1 and 2). This distress starts as a small blister and becomes enlarged to the size of a small pothole; at which time the chip seal delaminates off of the asphalt pavement.

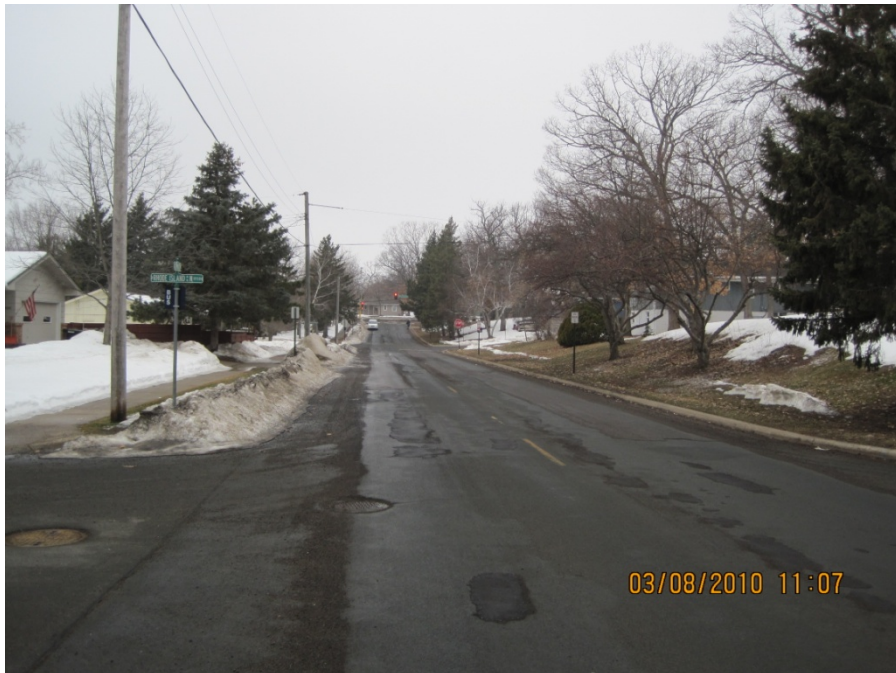
Figure 2: Asphalt deterioration under chip seal.

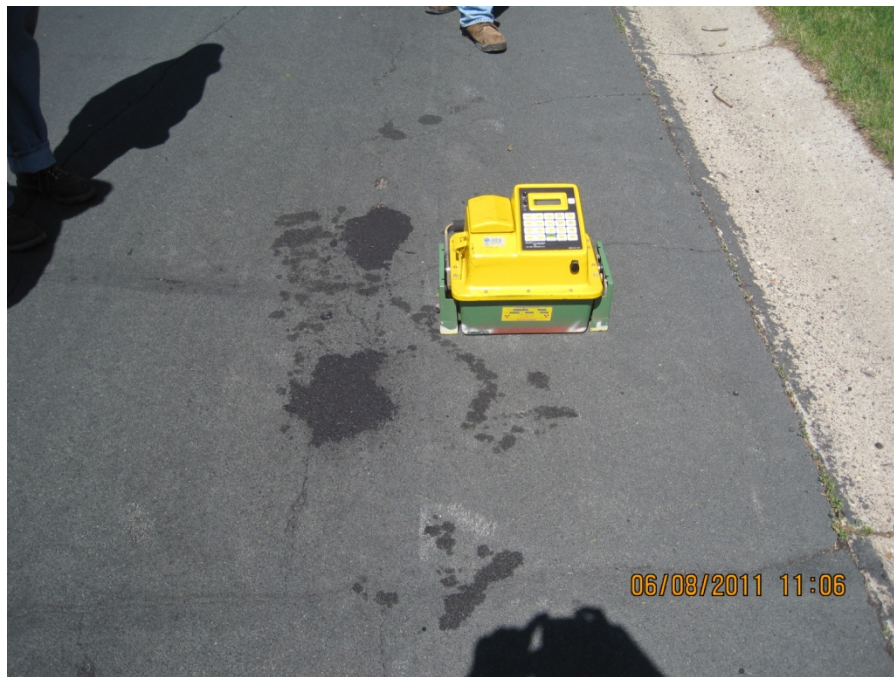
Figure 3: Nuclear density tester.

areas of not stripping to areas suffering from stripping. One street had weight from 145 lbs. per cubic foot in areas of the street with no issues to a low of 117.3 lbs. per cubic foot in areas suffering from stripping. For field evaluation of streets the nuclear density tester is the fastest and easiest to use of method tested. After discuss with experts from around the country it is recommend to not chip seal a street if the variability in density varies more than 6 lbs. per cubic foot as measured with nuclear density tester. (See appendix E)

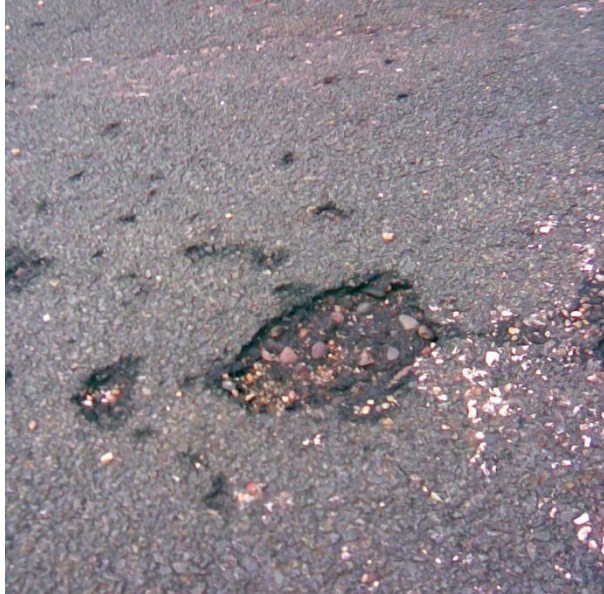
Figure 1. Early stage of HMA deterioration under a chip seal (251 Reid).

Introduction: In recent years, Mn/DOT has received reports of stripping, or deterioration, of the upper ½ to 1 inch of hot mixed asphalt (HMA) pavements under chip seal surface treatments. This distress (Figure 4) usually starts out as a small blister and develops to small potholes, at which point the chip seal delaminates from the pavement. These distresses can become an expensive maintenance problem. These distresses could also impede the deployment of cost saving preventive maintenance (PM) treatments if the treatments are viewed as the cause of the distresses.

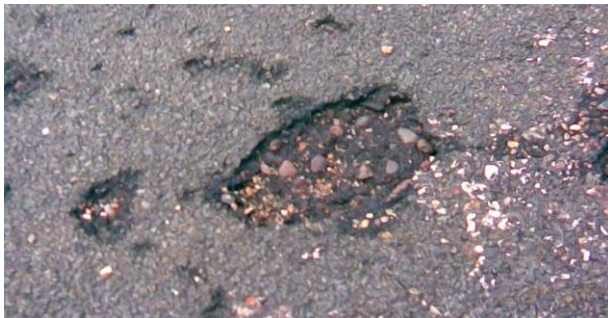
Figure 1.1. Early stage of HMA deterioration under a chip seal (251 Reid).

This problem has been observed for more than twenty years; however recently, Mn/DOT has received increased reports of stripping of the upper ½ to 1 inch of hot mixed asphalt (HMA) pavements under chip seal surface treatments. This stripping distress (Figure 1.1) usually starts out as a small blister and develops to small potholes, at which point the chip seal delaminates from the pavement. These stripping distresses can become an expensive maintenance problem.

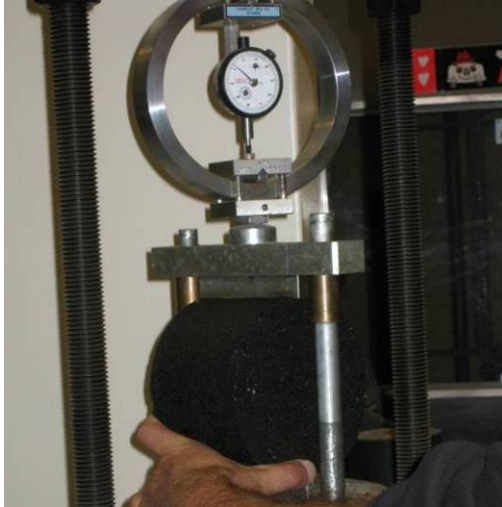
Figure 2.4. Lottman Testing

The moisture sensitivity was ascertained by performing modified Lottman tests in accordance with ASTM D 4867, Mn/DOT modified (See Appendix A). The moisture sensitivity was gauged by comparing splitting tensile test (Figure 2.4) results of control, or non-moisture conditioned specimens (dry strength) against those of moisture conditioned specimens (wet strength). The ratio of the wet strength to the dry strength represents the tensile strength ratio, or TSR. The generally accepted minimum threshold value for TSR is 70%.

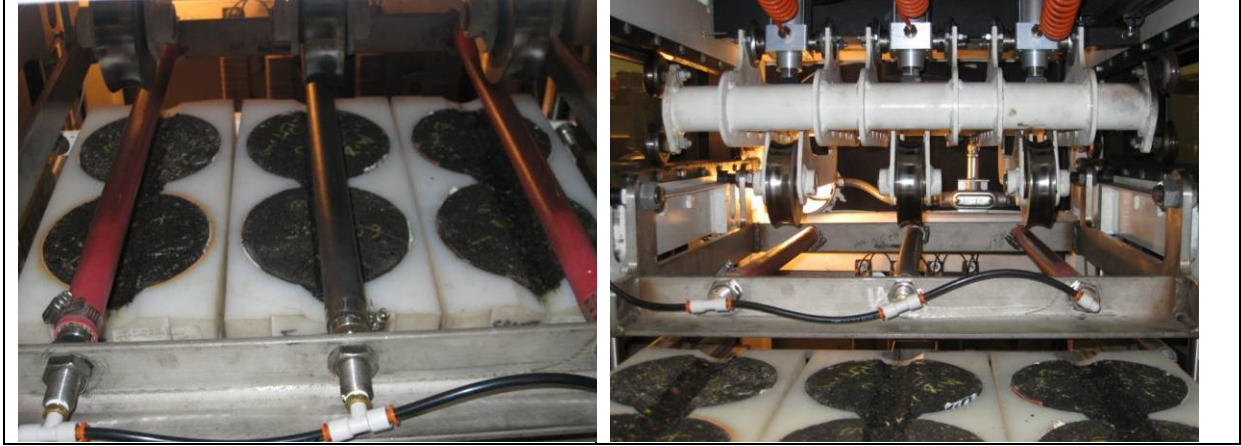
The asphalt pavement analyzer (APA) device, as shown in Figure 2.8, was used to experimentally evaluate the mixture’s susceptibility to rutting. The “dry” test consisted of applying 8,000 cycles of 100 lbf strokes to the lab-compacted gyratory specimens at 137 °F (58°C), which is approximately equivalent to 1,000,000 ESALS. The “wet” test consisted of applying a number of cycles until the mixture reached a set rutting value while immersed in water. A mixture’s susceptibility to rutting is typically dependant upon the binder (content and stiffness) as well as the gradation of the mixture and air void content. Higher rut depths indicate a softer mixture where lower rut depths indicate a stiffer mixture; typical level three mixtures evaluated by Mn/DOT have rut depths between 6 – 10mm.

Figure 2.8. Asphalt Pavement Analyzer (APA), or Rut Tester

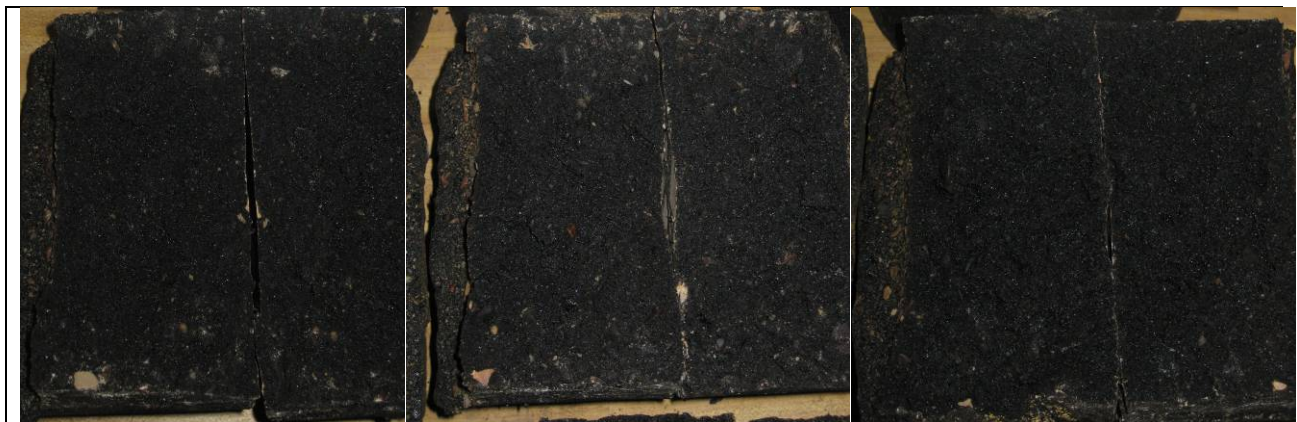
The mixtures with the higher air void contents rutted at a faster rate than those with smaller air void contents. The greatest difference in rutting rates between ‘wet’ and ‘dry’ testing conditions were at the 10% and 7% air void contents; the mixture with 14% air void content showed little difference. After testing in the wet condition the specimens were broken open and examined for any visual evidence of stripping (Figure 2.11); there was no visual evidence of stripping among any of the test specimens, although there did appear to be some evidence of stripping where the hose interfaced with the mixture surface.

Figure 2.11. Visual Examination of APA ‘wet’ specimens

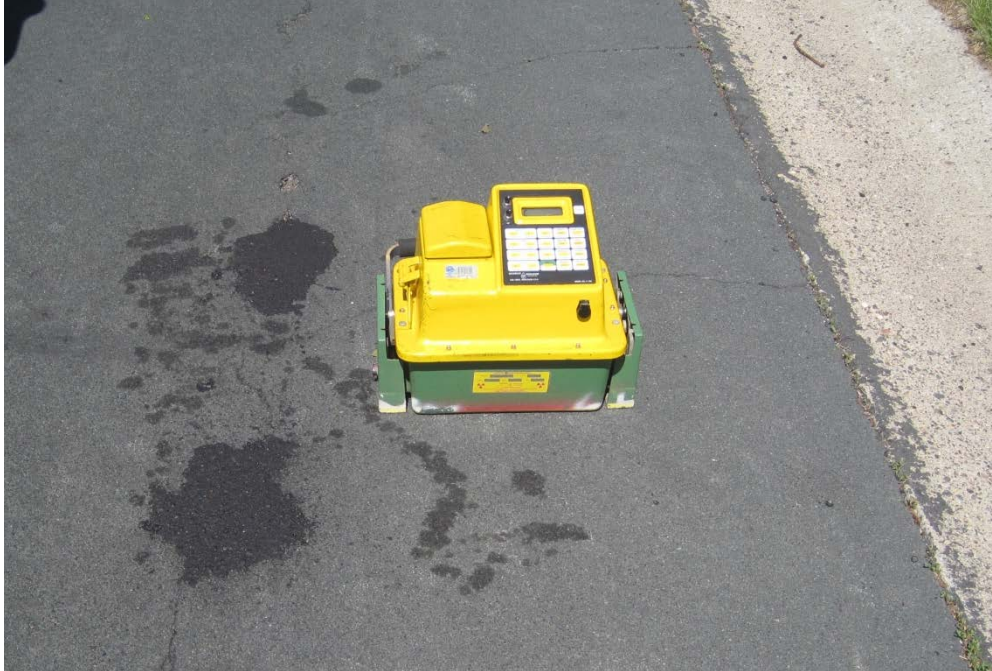
Figure 14 Nuclear Density Gauge

First a visual review with City Street Department personnel was conducted. Based on this review, areas were selected for further evaluation. On the streets that had previously received a chip seal, the following methods were used for evaluation. A nuclear density gauge was used to perform a nuclear density test (NDT). The gauge was placed on pavement close to the area of stripping ensuring uniform contact from gauge and the street. Two (2) readings were taken at 90° to each other (Figure 1). Then the gauge was placed as close to the stripped area as possible that showed no sign of damage. Two (2) more tests were performed similarly as previously described. This process continued until the complete paving pass had been tested. Then cores were cut at same location as the NDT readings (Figure 2)

Field testing: Based on ease of use and quick results, the nuclear density gauge is the best test method to used test and evaluates a large number of locations. The negative to this method of evaluation is the gauge requires a trained and licensed operator and has special storage requirements. The NCAT Field Permeameter tester is a slow test taking over 20 minutes to complete on test location in field. The result can vary from operator to operator. Some pavement surfaces are more difficult to seal the tester to which can give false readings. One interesting observation was that in areas of stripping under chip seal, we had difficulty in obtaining cores. The action of the core barrel and water in many cases completely destroyed the remaining pavement. Areas close to site of destroyed cores had air voids up to 11% this leads us to believe that areas with worst stripping have even higher voids. See figure 4 & 5 below.

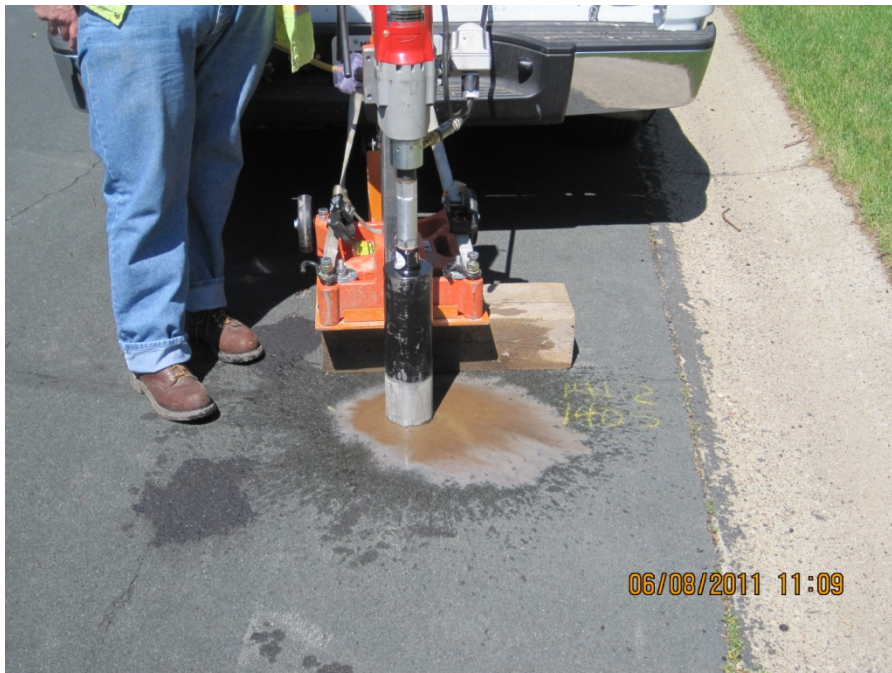
Figure 15 Coring at NI location

The cores were then taken to the MnDOT Materials Lab. The chip seal was sliced off the samples, then air voids (ASTM T269, T166 & T209) and permeability were measured using the Flexible Wall Permeameter ASTM PS 129-01.

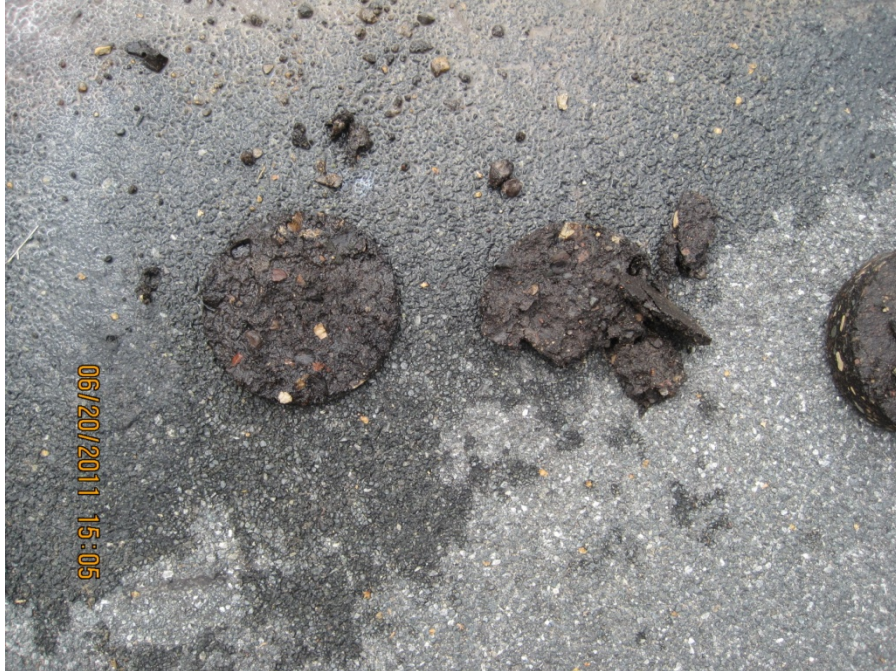
Figure 17 Destroyed cores

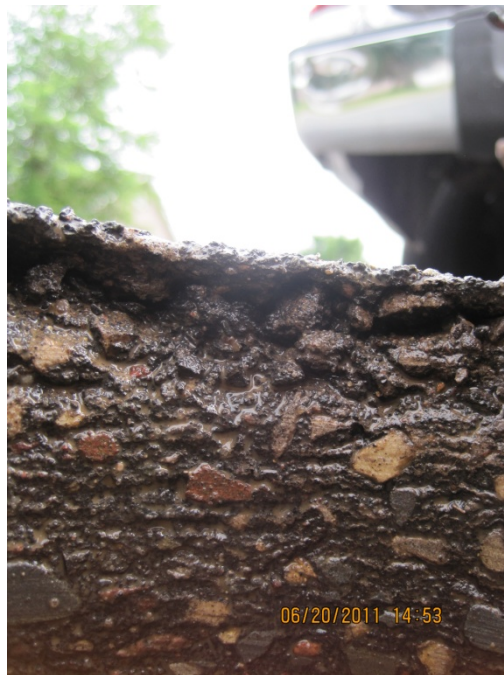
Figure 18 Pavement in area of stripping

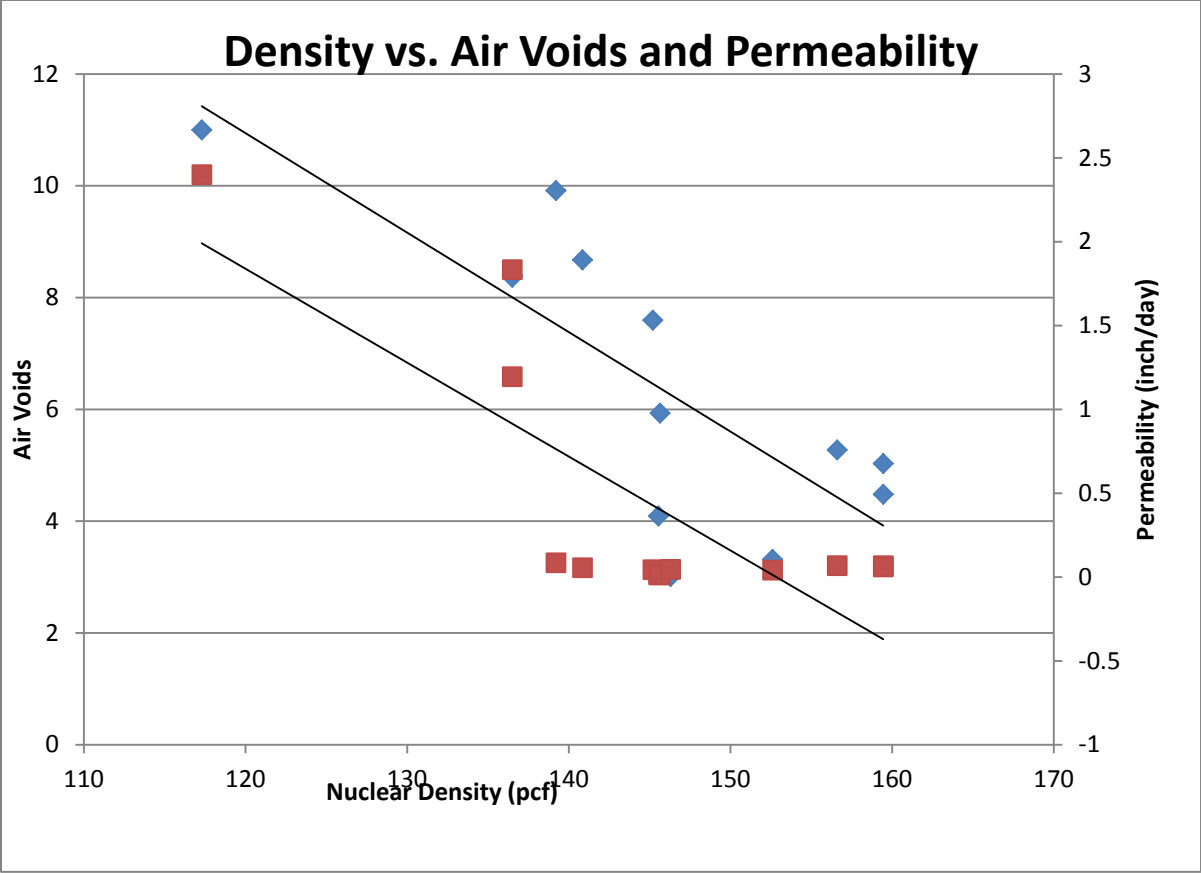
Figure 6 is graph of some of the data obtained for field samples. Base on the information gathered both NDI and Lab permeability correlate and are acceptable tools to determine variability in density.

Figure 19 Graph comparing Density vs. Air Voids & Permeability
