Strength and Stability of Prestressed Concrete Through-Girder Pedestrian Bridges Subjected to Vehicular Impact

Technical Report Documentation Page

Final Report

Prepared by:
Eray Baran
Arturo E. Schultz
Catherine W. French

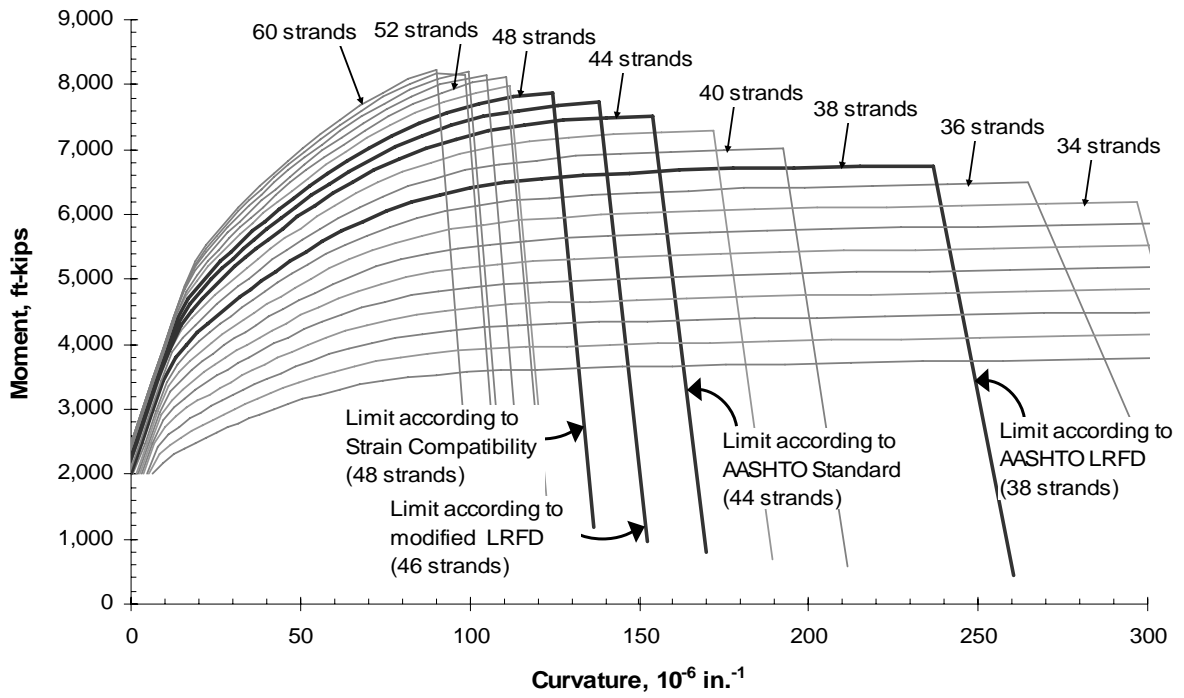
Fig. 2.8. Moment-curvature relations for Mn/DOT Type 63 section.

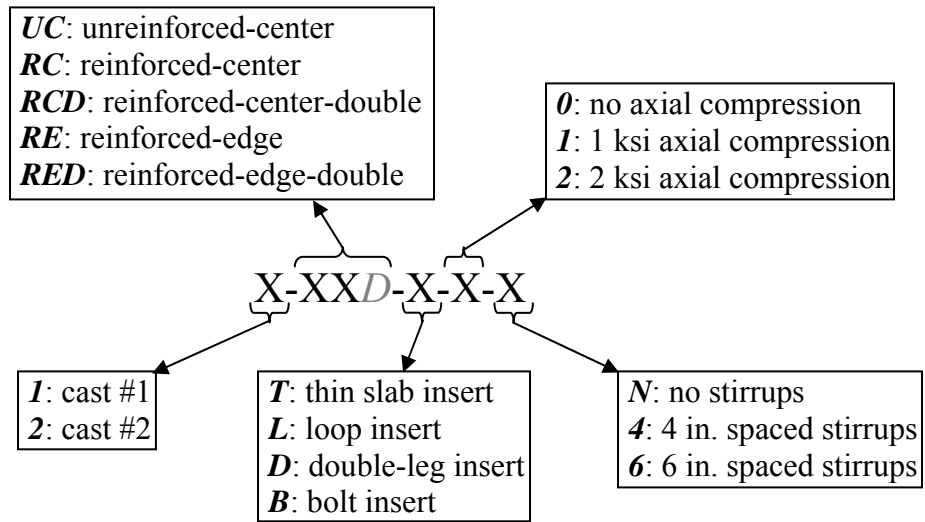
Fig. 3.1. Designation used to identify pull-out specimens.

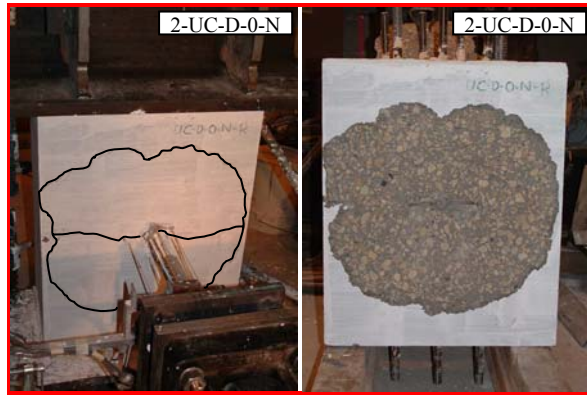
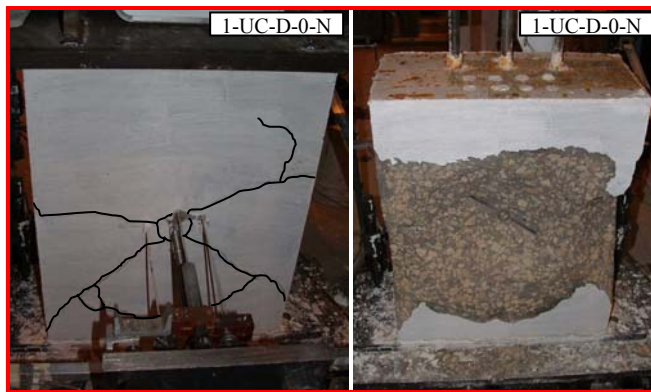
Fig. 3.11. Concrete cone breakout failures in unreinforced pull-out test specimens: (a) concrete breakout; (b) concrete breakout with radial cracking.

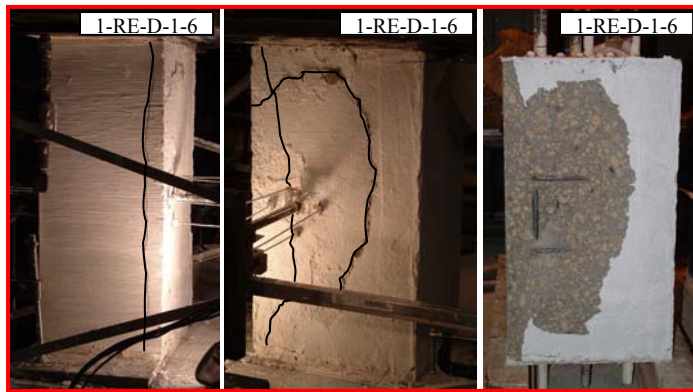
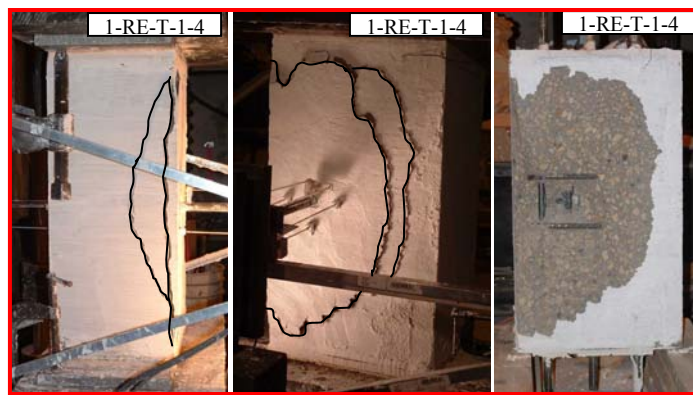
Fig. 3.13. Concrete cone breakout failures in edge-insert pull-out test specimens: (a) very shallow breakout; (b) regular cone breakout.

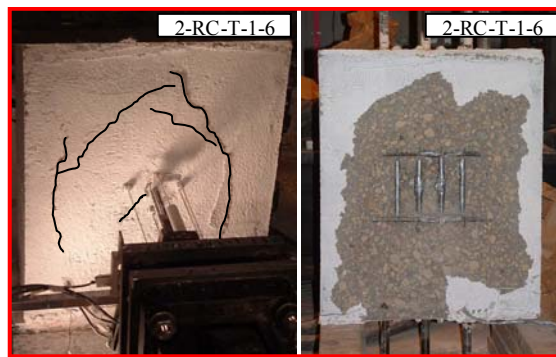
Fig. 3.19. Crack pattern of pull-out test specimens with thin-slab inserts: (a) 2-RC-T-1-6; (b) 2-RCD-T-1-6.

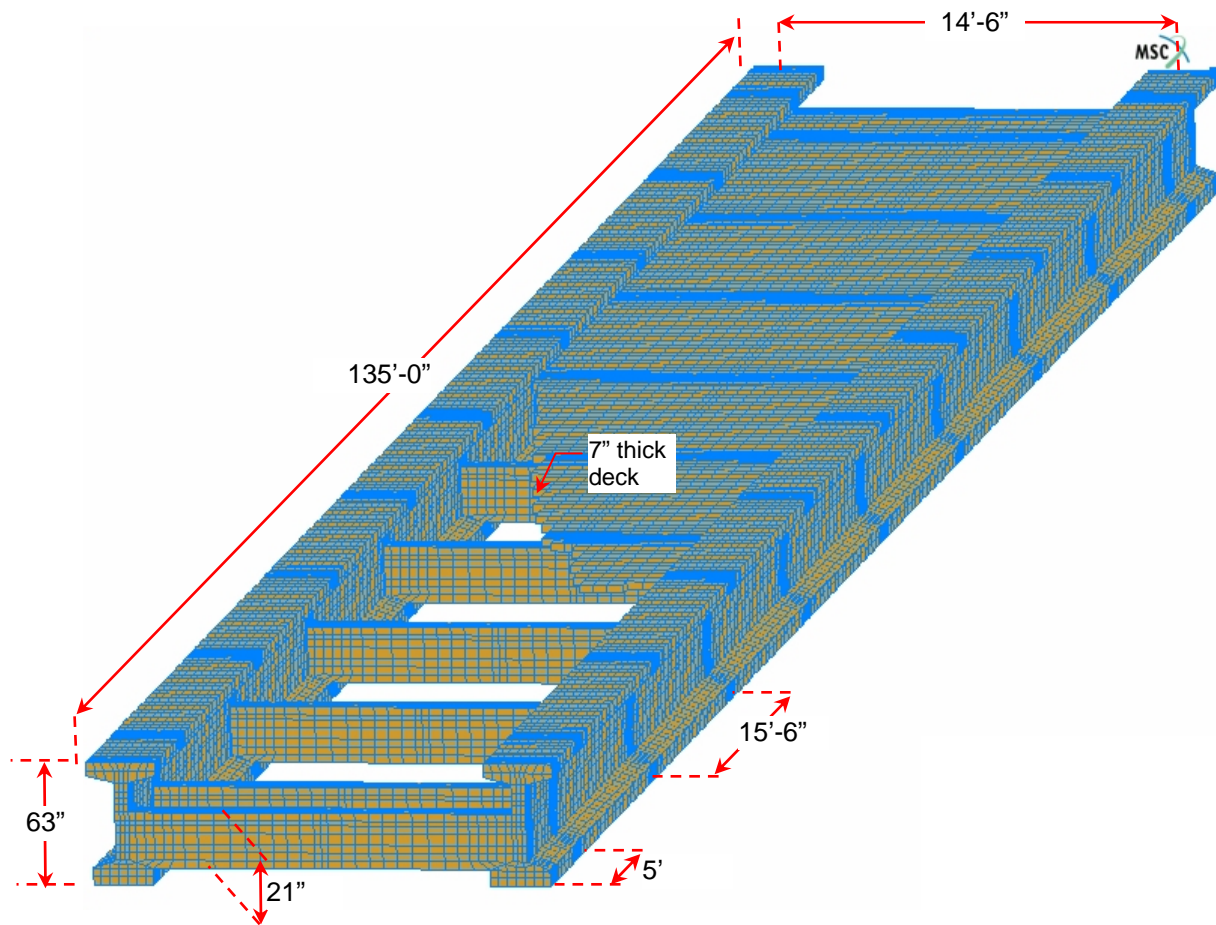
Fig. 4.1. Dimensions used in full-bridge finite element model.

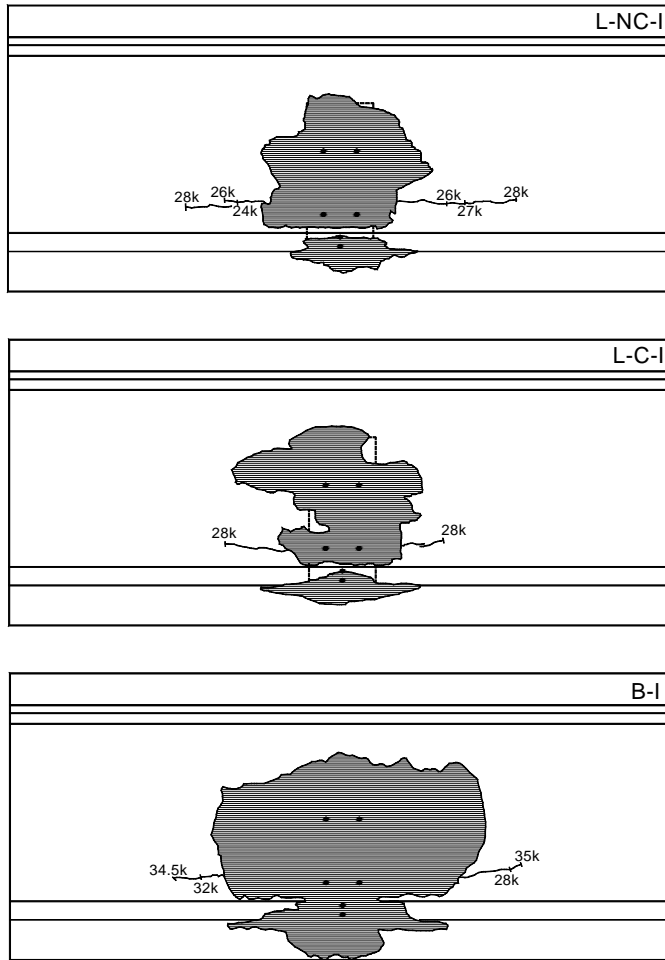
Fig. 4.17. Concrete breakout and cracking pattern in inclined loading specimens.

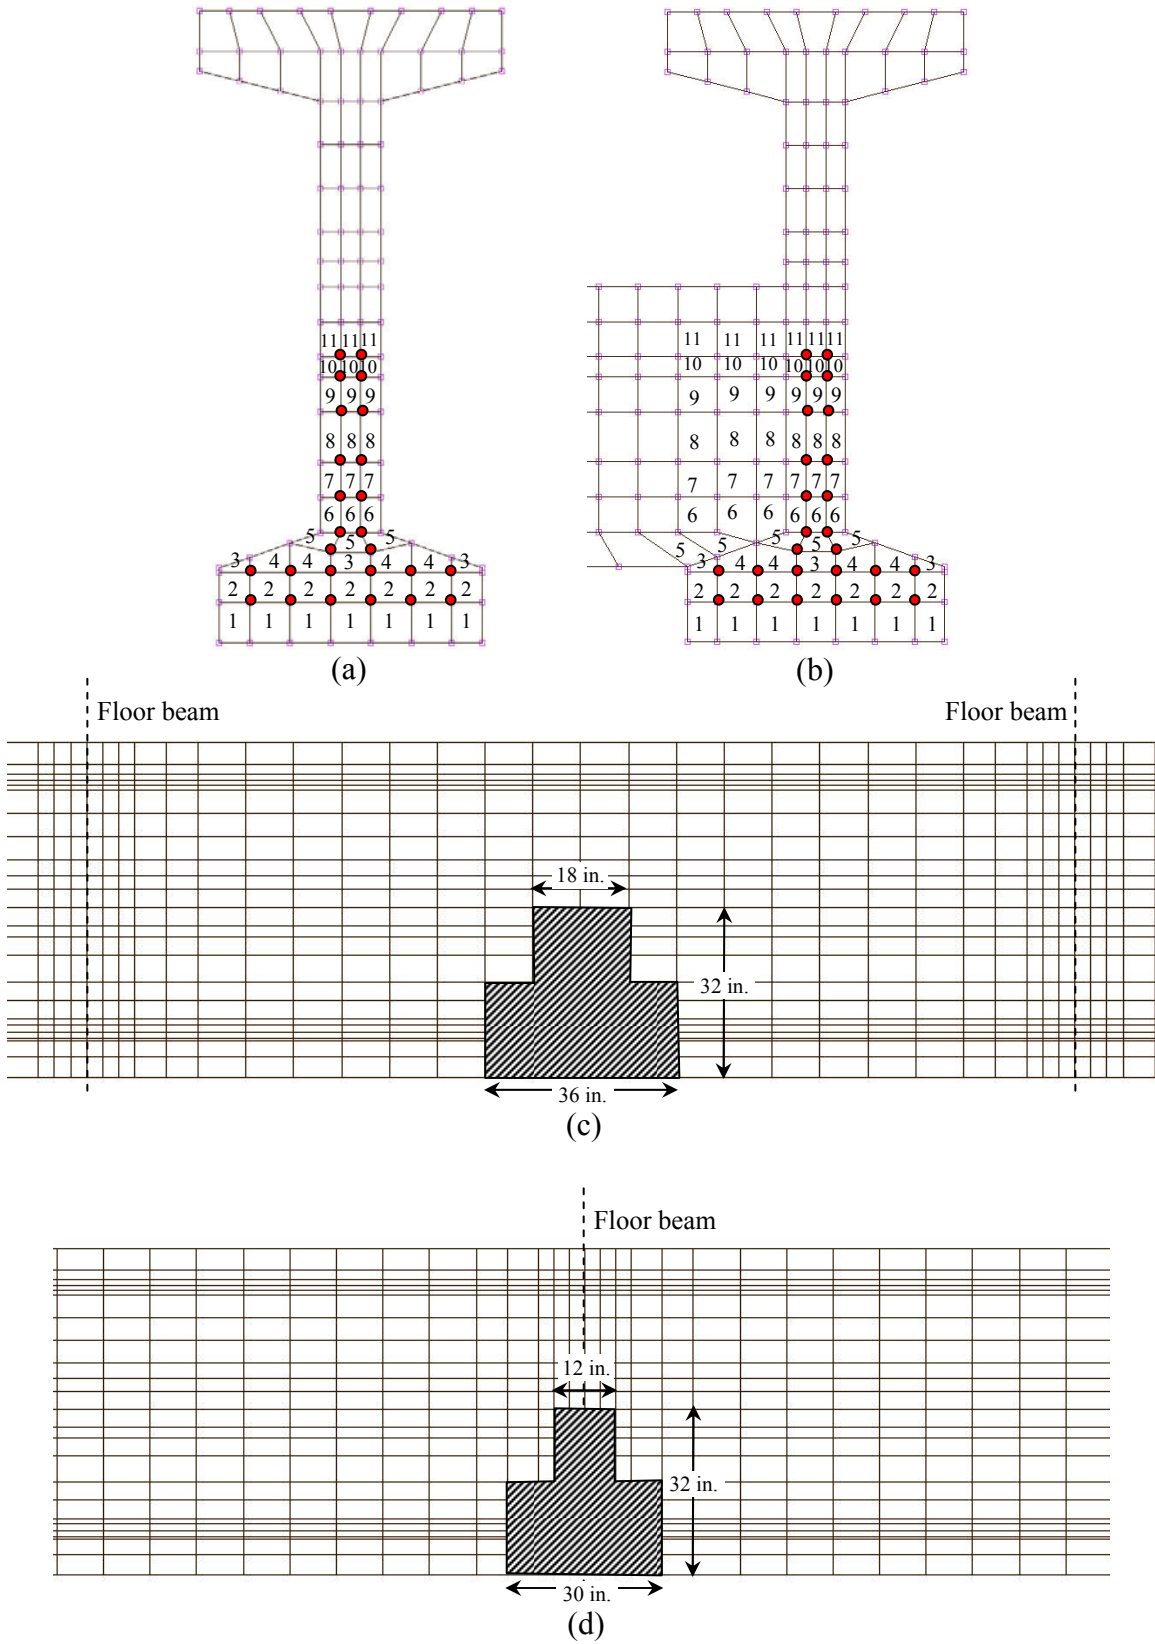
Fig. 6.31. Element removal procedure: (a) between floor beams; (b) at floor beam locations; (c) between floor beams side view, (d) at floor beam locations side view.

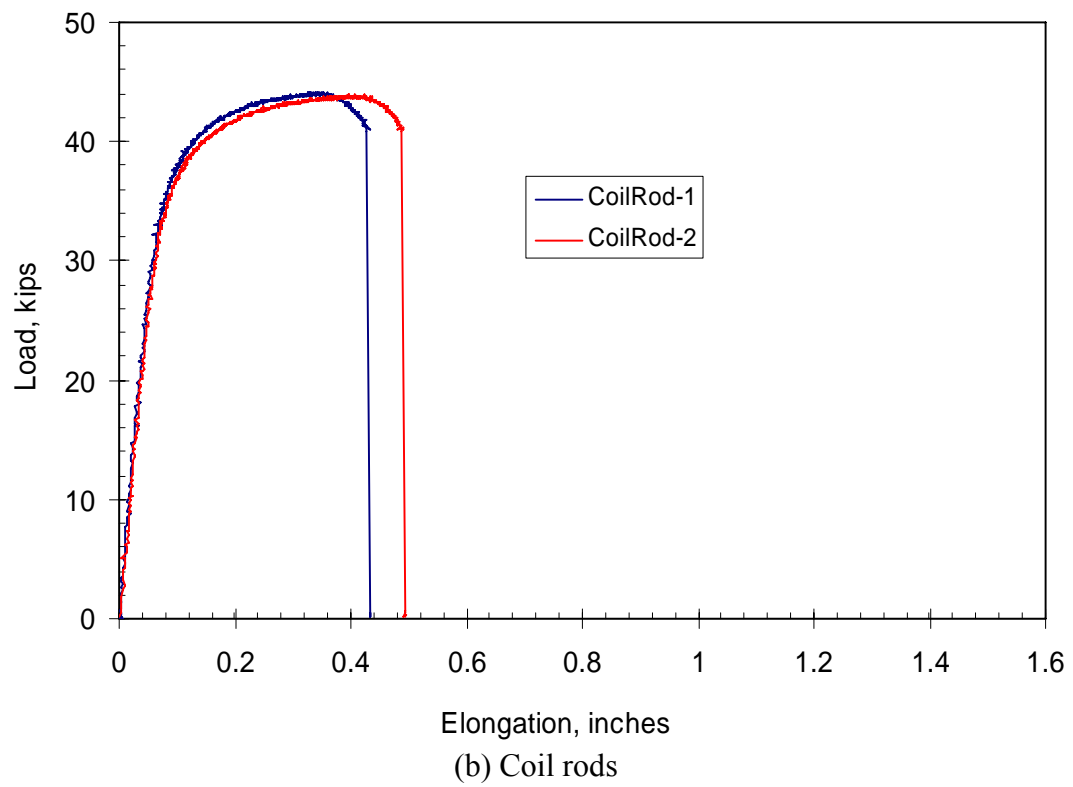
Fig. C.2. Load-elongation behavior of connection rods.
