Investigation of Winter Pavement Tenting

1. Report No. MN/RC 2008-03	2.	3. Recipients Accession No.	
4. Title and Subtitle Investigation of Winter Pavement Tenting		5. Report Date January 2008

Final Report

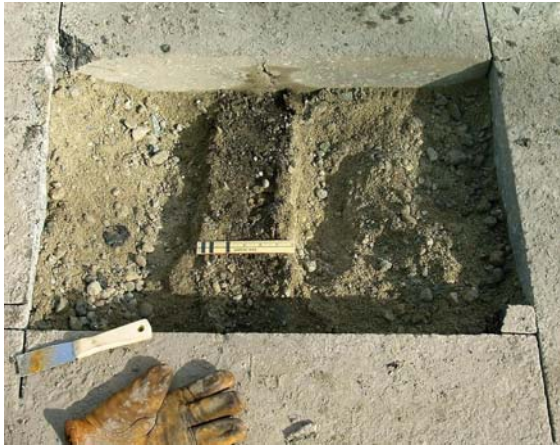
Figure 9 Frozen lens at top of test pit No. 1, located at the outer edge of the lane.

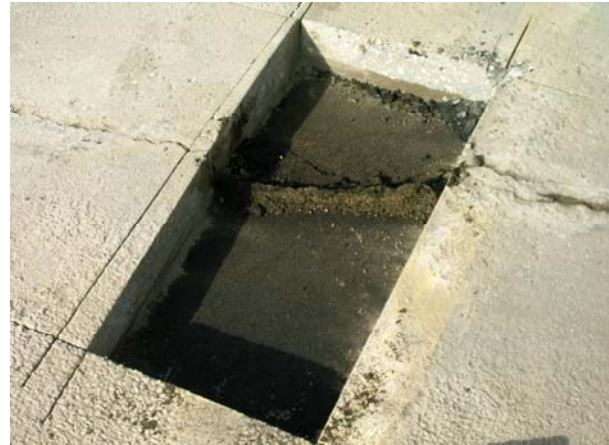
Figure 10 Ridge of fine material in the upper HMA layer of test pit No. 2, located at the centerline.

After HMA block removal, a ridge of fine, silty material was found just below the location of the tented cracks in each pit. The pit 1 ridge rested directly on the base, and was less pronounced than the ridge found between HMA layers in pit 2. It is hypothesized that in these cases the fines originated from degraded crack seal. Part of the pit 1 ridge may have been assimilated into the aggregate base.

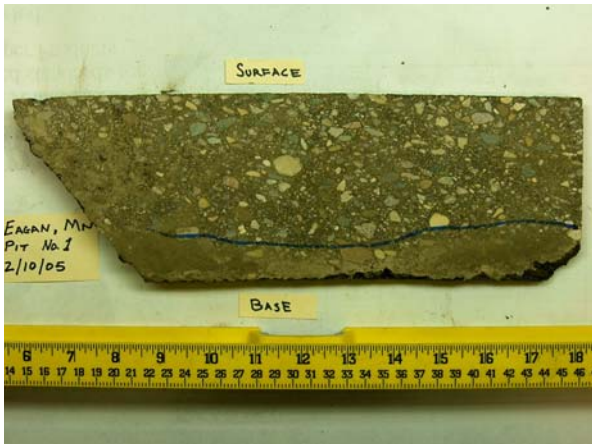
Figure 13 Eagan pit No. 1 with moist regions highlighted.

Inspection of the HMA blocks showed that some moisture was present along the crack edges and the bottom surface. Since the cutting operation used no lubrication, it was apparent that an amount of water had been present in the cracks, between HMA layers, and also in the base material.

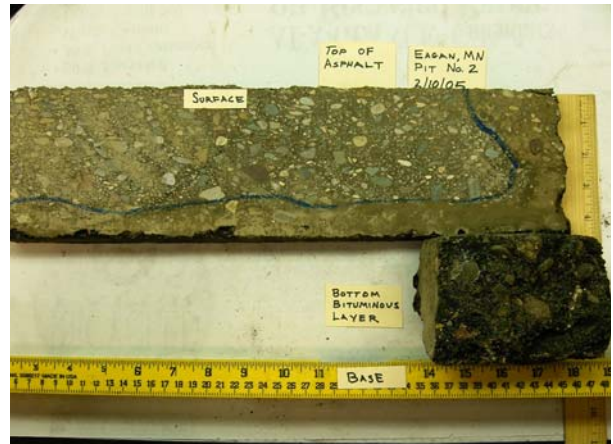
Figure 14 Eagan pit No. 2 with moist regions highlighted.

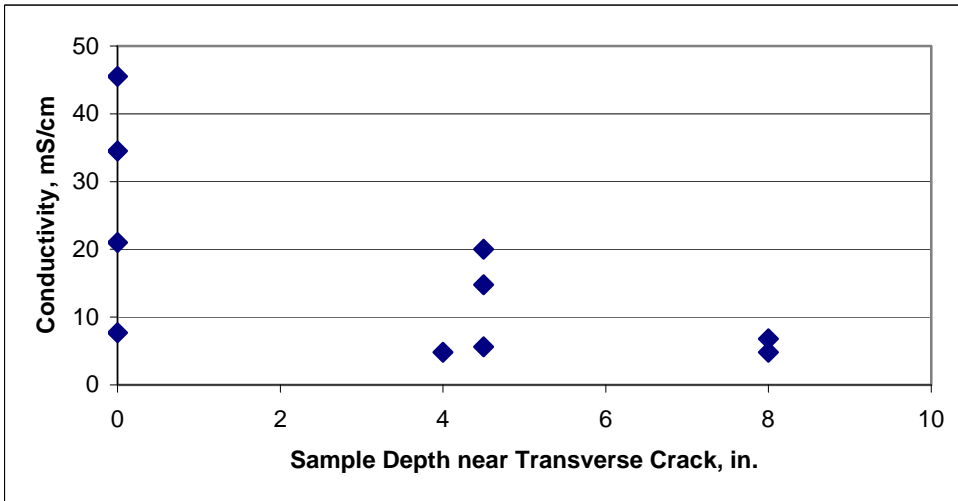
Figure 21 Conductivity vs. depth data at pit No.'s 1 and 2.

Figures 20 and 21 show differences in deicing chemical concentration occurring throughout the base structure. The figures use samples obtained at various depths and distances from the transverse crack. Figure 20 shows the conductivity conditions (with respect to depth and horizontal distance from the transverse crack) that occurred during excavation of test pit D1. Figure 21 shows various conductivity measurements obtained at test pits No. 1 and 2, and plots them with respect to depth. Figures 20 and 21 show that it is possible to see how differences in deicing chemical concentration occur throughout the base structure using samples obtained at various depths and distances from the transverse crack.

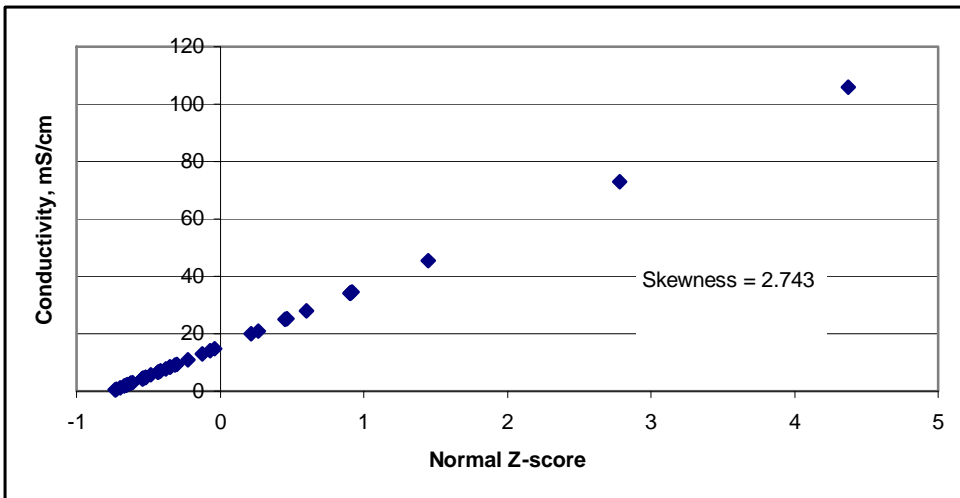
Figure 40 Normal skewness of conductivity values from subject roads.

Figure 39 is a plot of the data set of conductivity values. Figure 40 shows conductivity versus the standard normal z-score. It is apparent that the data is skewed to the positive, and the skewness was calculated to be approximately 2.7. Adjusting to a log-normal distribution in Figure 41 improves the skewness to approximately -0.27, with the resulting log average equal to approximately $\exp(0.88)$ mS/cm = 7.6 mS/cm. This value may be more representative of the center of the overall data set.
