RESEARCH SERVICES SECTION

TECHNICAL SUMMARY

Effects of Centerline Rumble Strips on Motorcycles

This Technical Summary pertains to Report 2008-07, “Effects of Center-Line Rumble Strips on Non-Conventional Vehicles,” published January 2008. The full report can be accessed at <http://www.lrrb.org/PDF/200807.pdf>.

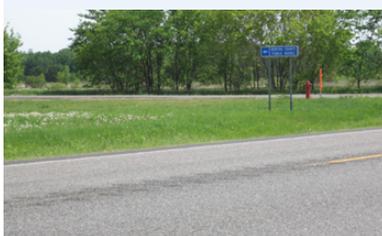
At 4 inches wide, 3 inches long and 2 inches deep, centerline rumble strips are not easy to spot.

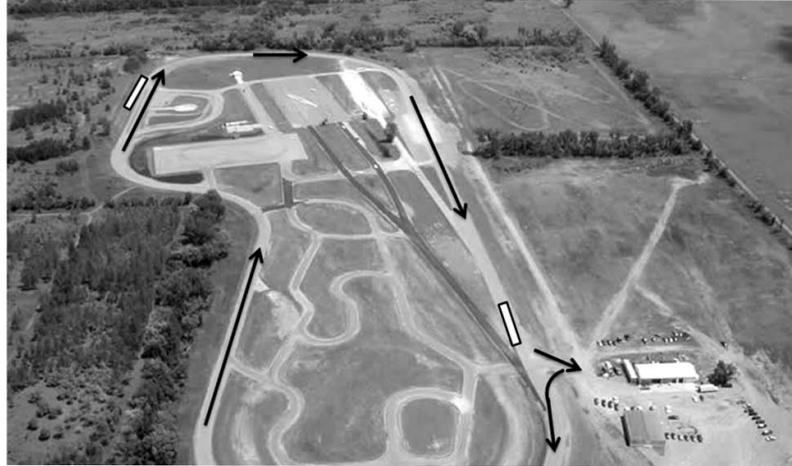
Investigators observed motorcyclists circuit a 1-mile course with rumble strips, marked here by rectangles.

Closed-course examination showed no steering, braking or throttle adjustments during strip crossing. Postride interviews confirmed these observations, and no rider expressed difficulty or concern with crossing rumble strips. Half of the riders noticed the strips before crossing, but no rider described the strips as a hazard either on the closed course or on public roads, though eight found them a nuisance when passing another vehicle.
