Development of Flexural Vibration Inspection Techniques to Rapidly Assess the Structural Health of Rural Bridge Systems: Phase II

Technical Report Documentation Page

Final Report

December 2009

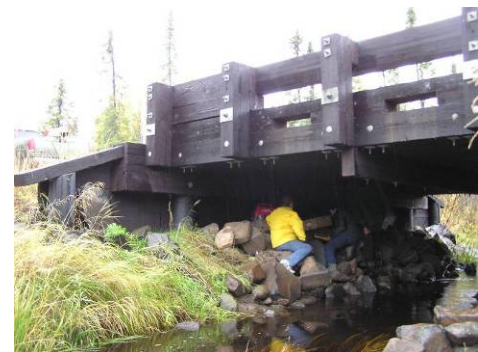
Figure 1.1. Dowel laminated timber bridge near Brimson, Minnesota.

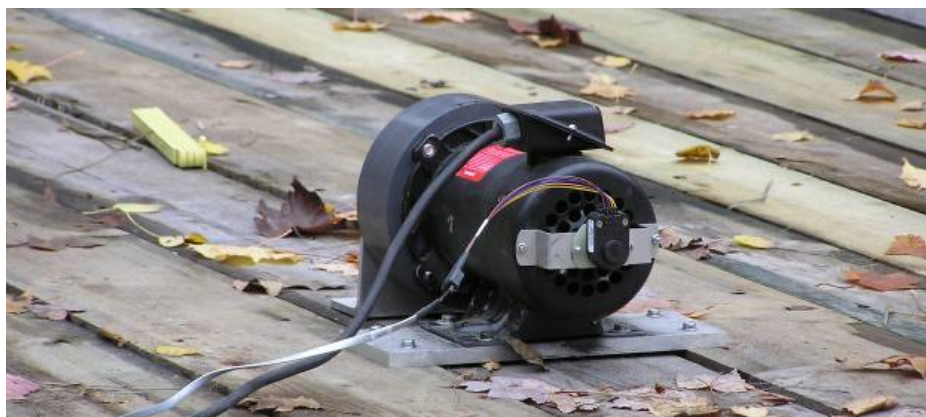
Figure 2.1. Rotating motor used to excite the timber bridge.

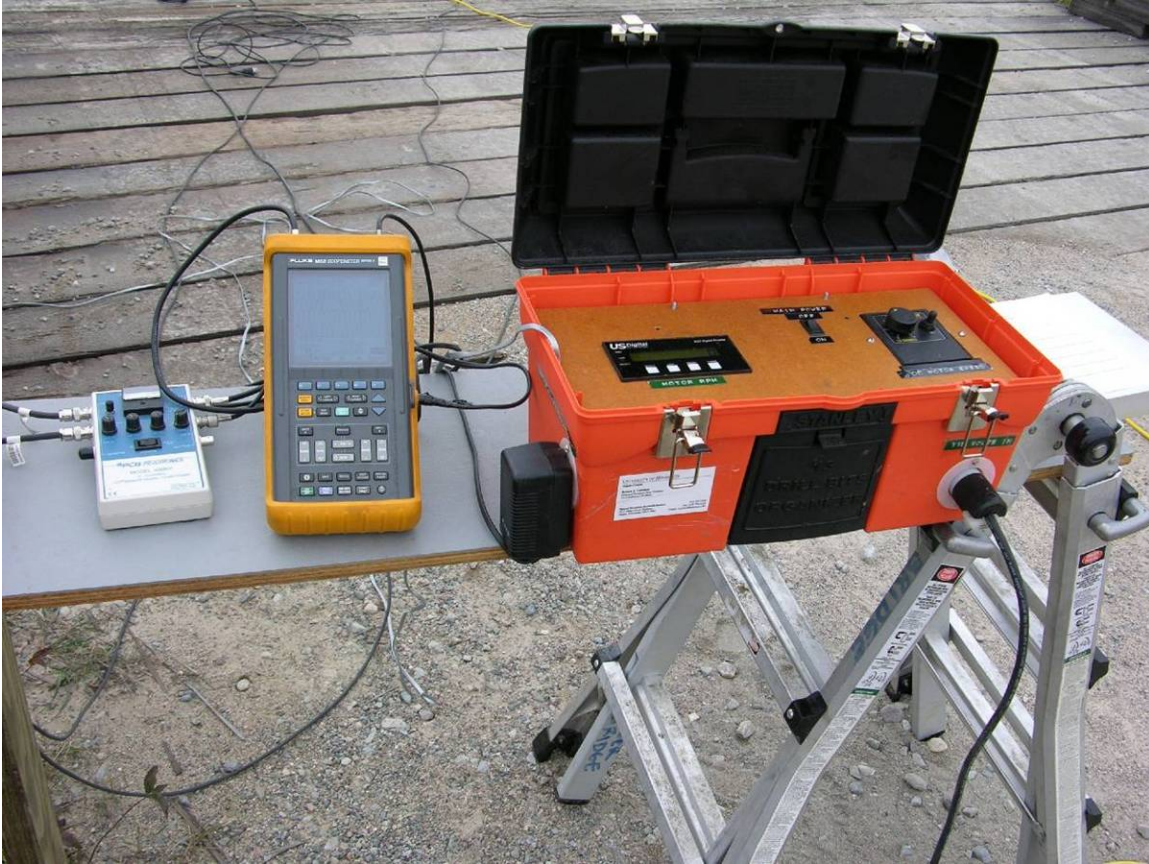
Figure 2.2. Testing system used to control motor and acquire vibration response.

resistance plastic case for portability and ease. The computer selected was a Toshiba Satellite laptop. This unit had more computing power and speed than other systems evaluated. The proposal had suggested purchase of a “ruggedized” laptop. Several manufacturers of “ruggedized” laptops were evaluated, however, the computer processing speed was very limiting and the costs excessive. As an alternative, a 3 year extended warranty was purchased for the Toshiba, which would cover any damage from weather, impact or other on-site problems.

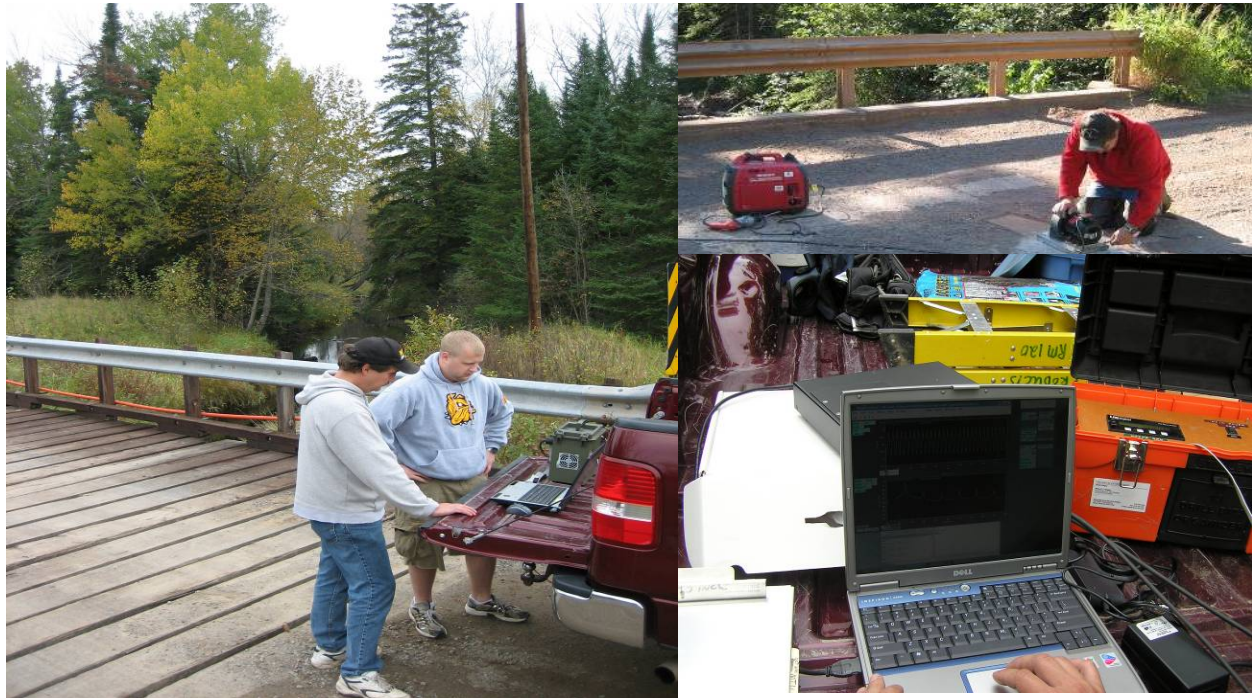
Figure 2.3. Images from the automated bridge vibration system developed in this project.

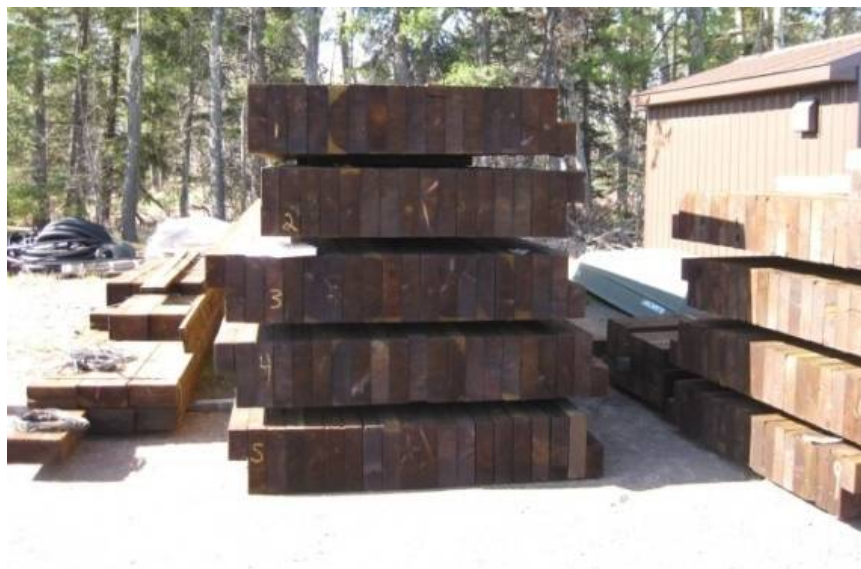
Figure 3.1. Bridge sections to be used as the new superstructure for St. Louis County Bridge 53.

The bridge sections that were to be used for the new Bridge 53 were numbered so the data collected during testing would be clearly identified and to minimize potential testing error through misidentification. There were two different types of cross sections for the bridge members. Sections 1 and 2 had a shiplap type joint on one edge on their cross section and were the outside sections of the bridge deck. Sections 2, 3 and 4 had a shiplap joint on each outer edge and would be the inner sections of the bridge. The numbered sections and their different cross sections can be seen in Figure 3.1. Dimension measurements for the length, width, and depth of each section were collected.

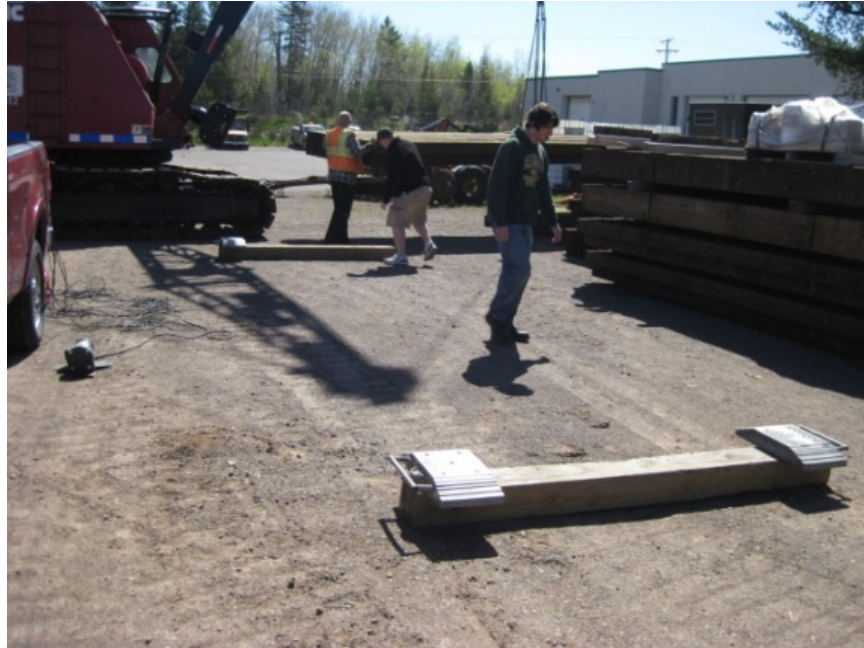
Figure 3.3. Scales were placed on each corner of two beams. The sections were then set on the scales using a crane to get a weight estimate.

Each bridge section was weighed. As known from the theoretical model shown in Equation (3), bridge weight is needed in predicting the structure stiffness when using the vibration response method, which was used in this research and is outlined later in this chapter. In order for the sections to be weighed, a crane was used to transport the sections from their original position onto two wooden beams. This process can be seen in Figure 3.2. The purpose of the beams was to elevate the sections so they were only in contact with the beams and not the ground. They were spaced apart so that when the sections were set on them there was little to no overhang of the section over the beam. Scales were placed on each corner of both beams for a total of four scales as seen in Figure 3.3. When the section was set onto the beams, the weight measurement for each scale was recorded and the four measurements were then added together to get an estimate of the overall weight of the section.

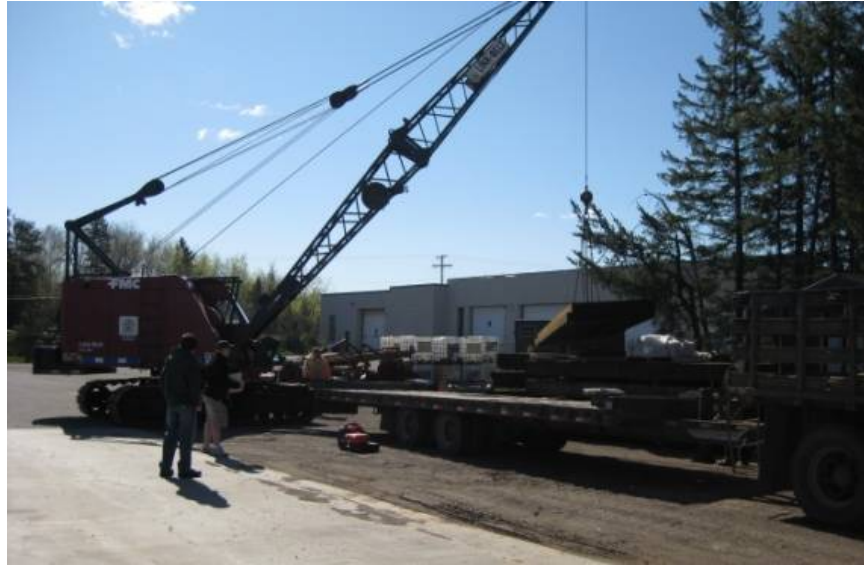
Figure 3.4. The first two tests of the first section were conducted on a trailer. Due to poor signal quality, this technique was abandoned for the remaining testing.

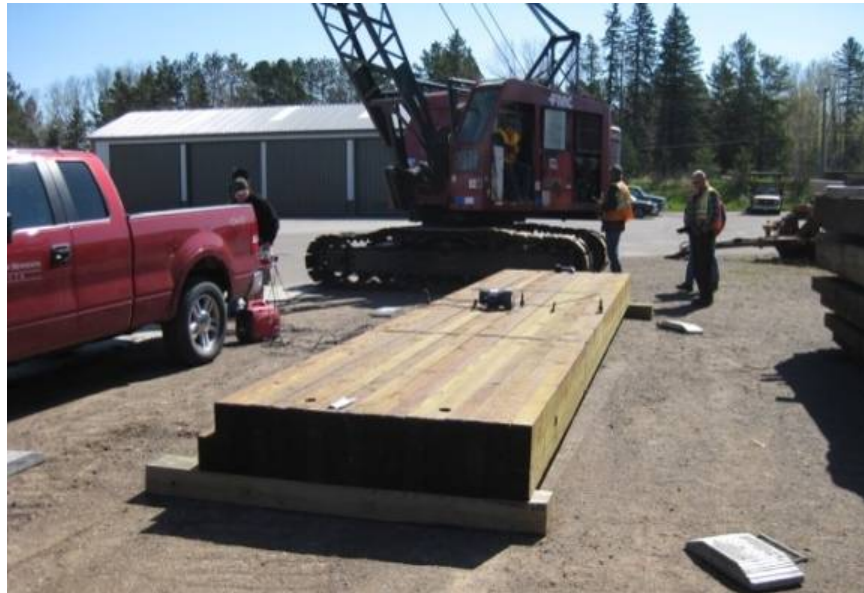
Figure 3.5. The sections were placed on two beams so that they were elevated above the ground for vibration testing.

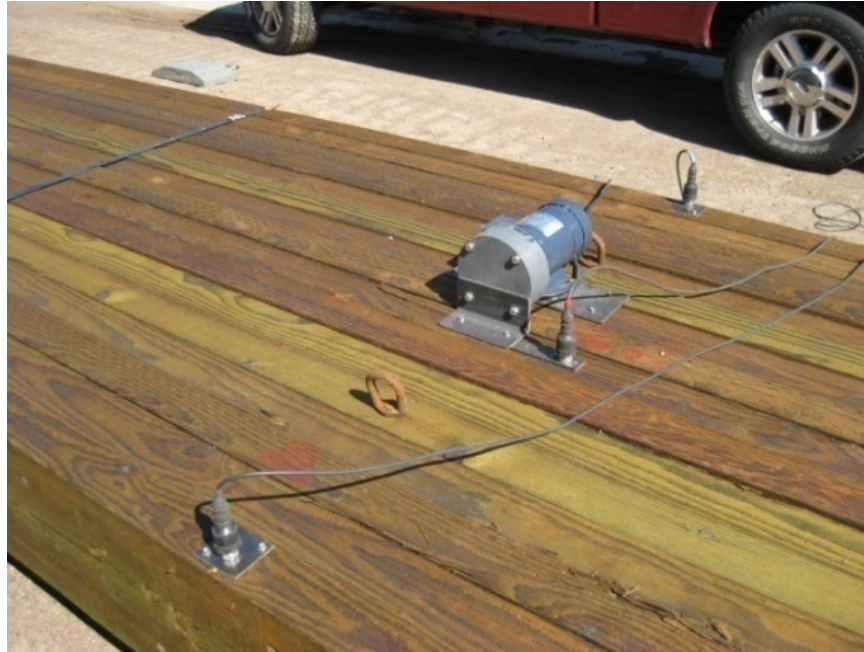
Figure 3.6. General test setup used for vibration testing of each section.

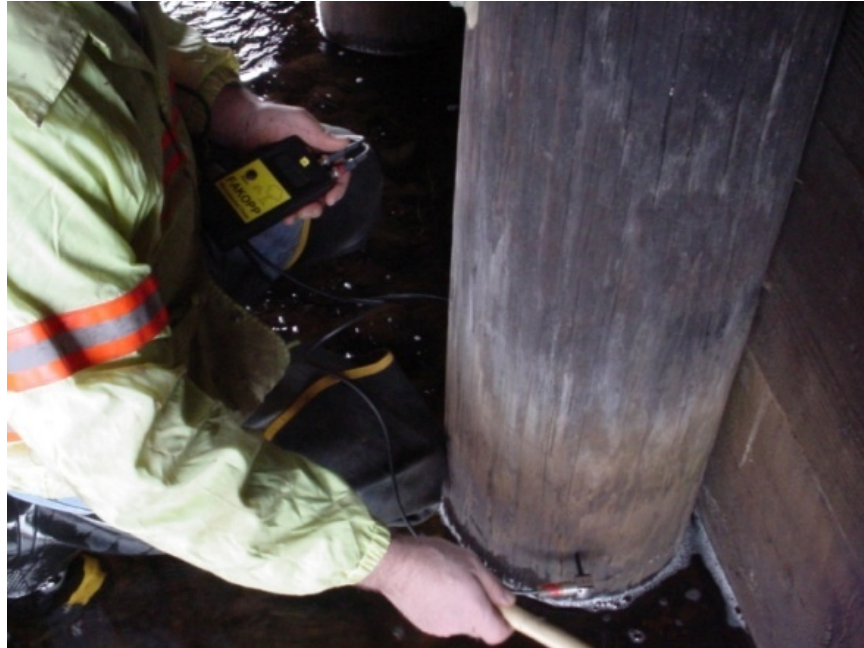
Figure 3.8. Fakopp microsecond timer being used on a timber pile.

An example of the stress wave concept for detecting decay for a circular piling is shown in Figure 3.8. First, a stress wave is induced by striking the specimen with an impact device instrumented with an accelerometer that emits a start signal to a timer. A second accelerometer, which is held in contact with the other side of the specimen, receives the leading edge of the propagating stress wave and sends a stop signal to the timer. The elapsed time for the stress wave to propagate between the accelerometers is displayed on the timer. There are several commercially available stress wave timing units. These units will yield comparable results if they are calibrated and operated according to the manufacturer's recommendations. The use of stress wave velocity to detect wood decay in timber bridges and other structures is limited only by access to the structural members under consideration. It is especially useful on thick timbers 89 mm (3.5 in.) where hammer sounding is not effective. A detailed explanation of the use of stress wave timing and interpretation of the testing is detailed in publications prepared by Brashaw et al (2005).

A commercial Fakopp Microsecond Timer was used to determine the stress wave time across the pile top and 2 feet below the pile top. The Fakopp is very accurate at determining the presence of decay at the testing location and is useful in mapping the decay locations. Table 3.1 shows the stress wave transmission times perpendicular to the grain for several species at various degradation levels for the species present in timber bridges. The substructure species for bridge 53 was determined to be southern yellow pine.

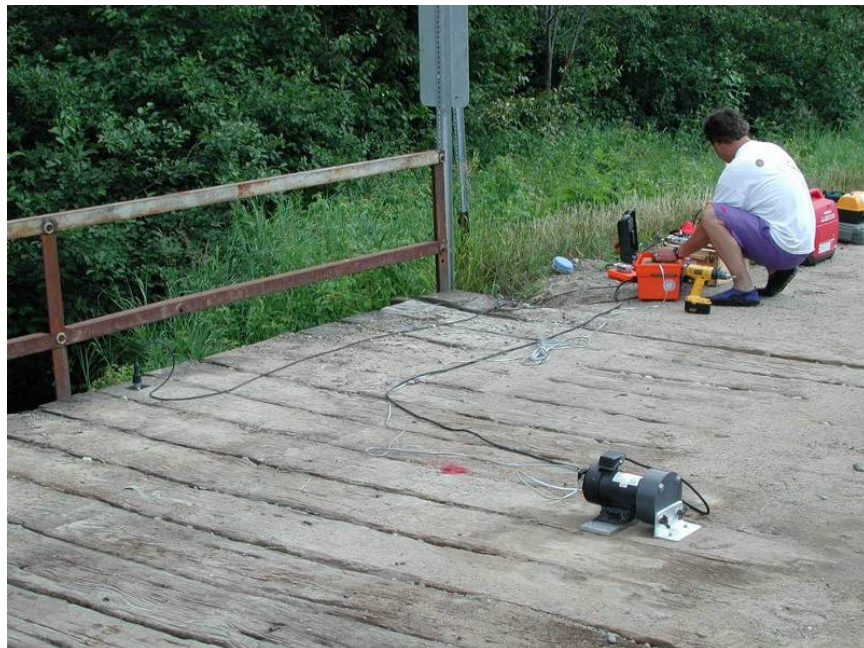
Figure 3.9. General test setup for vibration testing.

Once all of the tests have been completed, the data is reviewed briefly and photographs are taken before leaving the test site. The typical test setup for vibrational testing on a bridge superstructure can be seen in Figure 3.9.

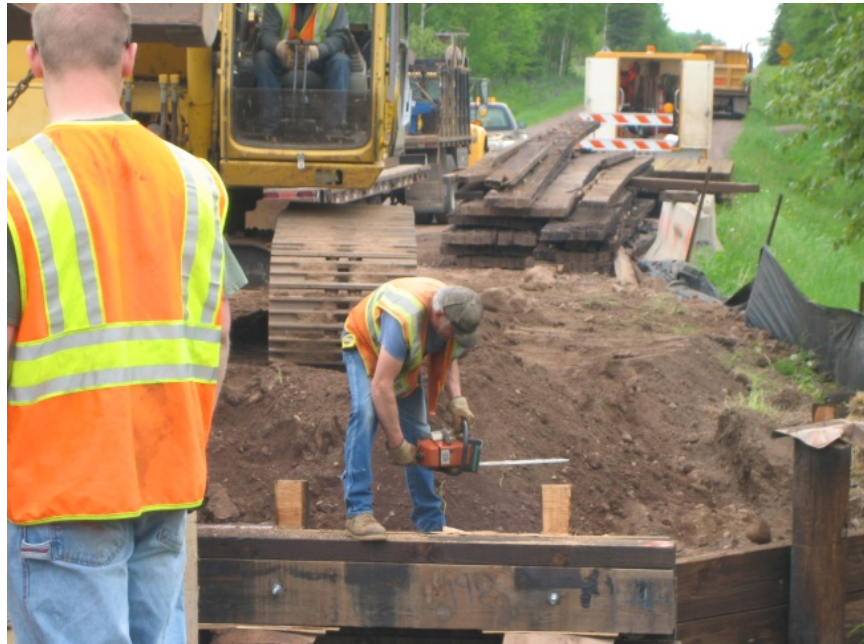
Figure 3.12. Some stays were trimmed with a chainsaw so sections could fit. Copper naphthenate was used to treat the newly exposed surfaces.

Some of the stays that hold the sections in place had to be trimmed with a chainsaw in order for the sections to fit onto the pile cap. Every stay that was cut was treated with copper naphthenate to protect the wood from decay. The procedure can be seen in Figures 3.11 and 3.12.

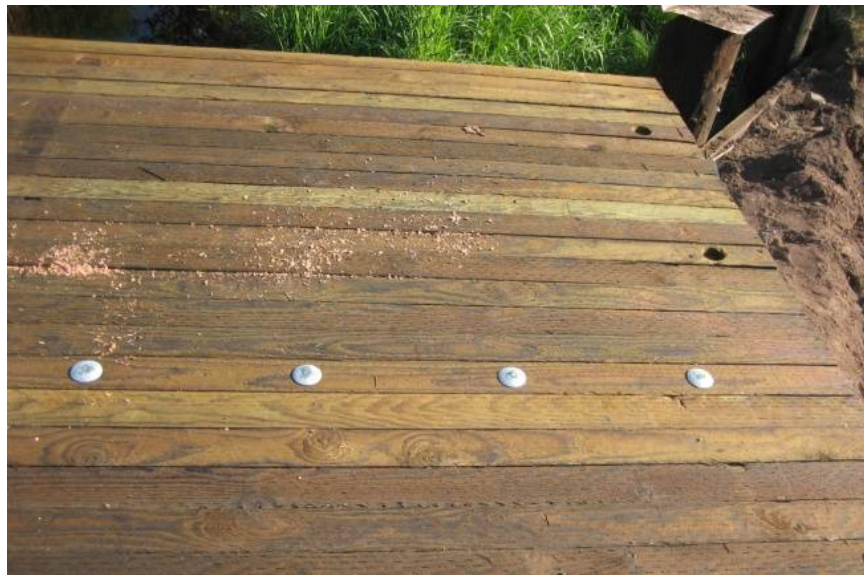
Figure 3.14. Lap joints were pinned together with carriage bolts once sections were set into place.

As soon as the cut stays were treated, the sections could be set into place as seen in Figure 3.13. Once the sections were all in place, the lap joints were pinned with carriage bolts. This can be seen in Figure 3.14. The sections were then bolted to the pile cap and all of the dirt that had been removed was back filled. Figure 3.15 shows the bridge with one side completely back filled and the other side in the process of being back filled.

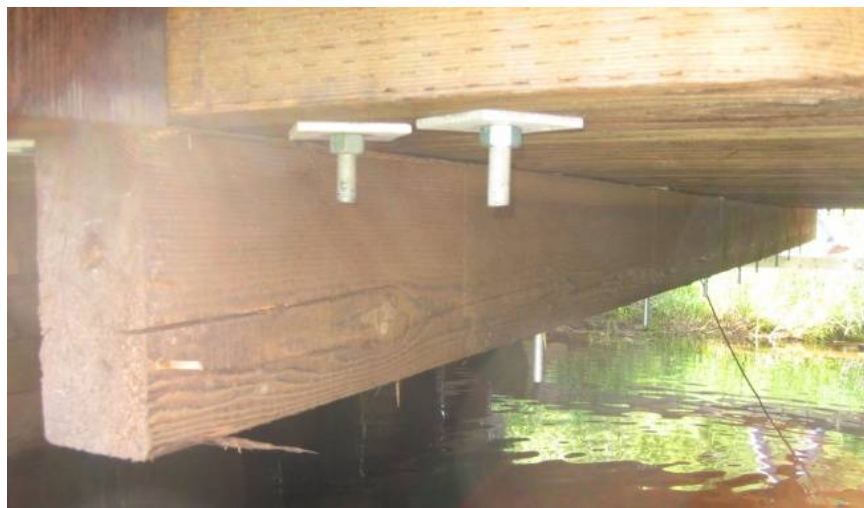
Figure 3.16. Spreader beam mounted below the bridge deck.

Once all of the dirt was back filled, the spreader beam was mounted below the deck, but it was not bolted tight. The curbs and guard rails were then installed. Figure 3.16 shows the spreader beam mounted below the deck and Figures 3.17 and 3.18 show the curb and guard rail being installed on one side of the bridge. After the guard rails were installed, the spreader beam was bolted tight, additional dirt work was completed, and the bridge deck was paved with bituminous asphalt. Construction of the bridge was then complete. Vibration testing was conducted during each phase of bridge construction as noted in the following dated sections.

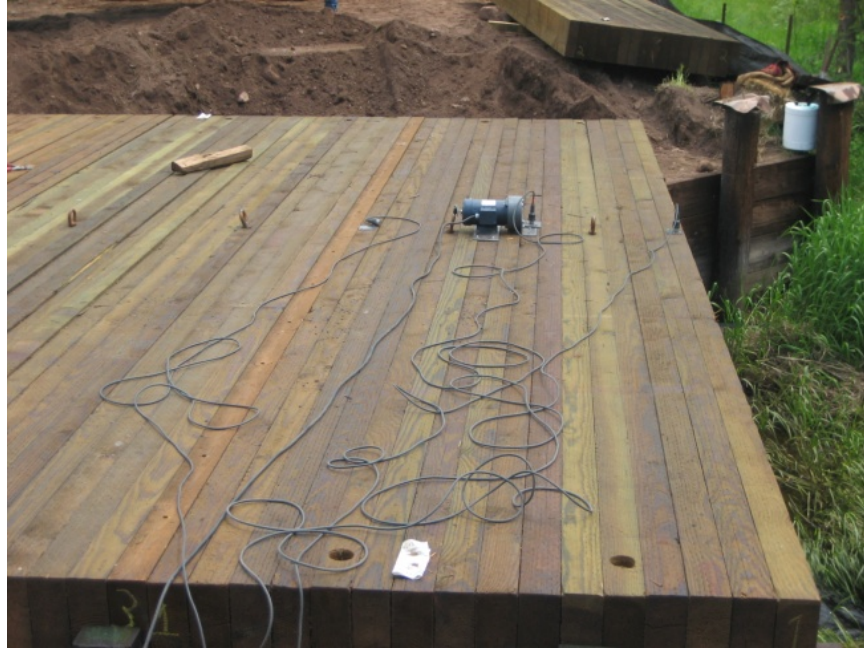
Figure 3.20. The first tests were conducted with the motor in the center of the first section oriented parallel to the laminations.

6/19/2008 Vibration testing was conducted after the first three sections had been set and were only resting on the pile cap as seen in Figure 3.19. The first series of tests were performed with the motor parallel to the laminations at the center of panel 1. The setup is shown in Figure 3.20. Test 9 was conducted with the motor in the center of panels 1 and 3, but perpendicular to the laminations. The lap joints for the three sections were then pinned and test 10 was run with the motor still in the center of panels 1 and 3, but with the motor shaft rotating parallel to the laminations as shown in Figure 3.21.

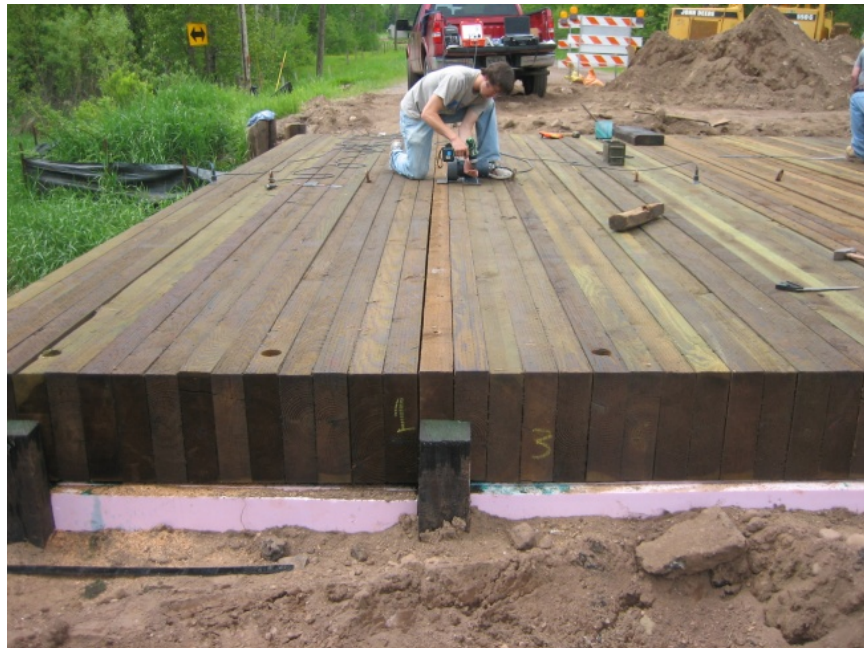
Figure 3.21. Motor being mounted parallel to the laminations in the center of sections 1 and 3.

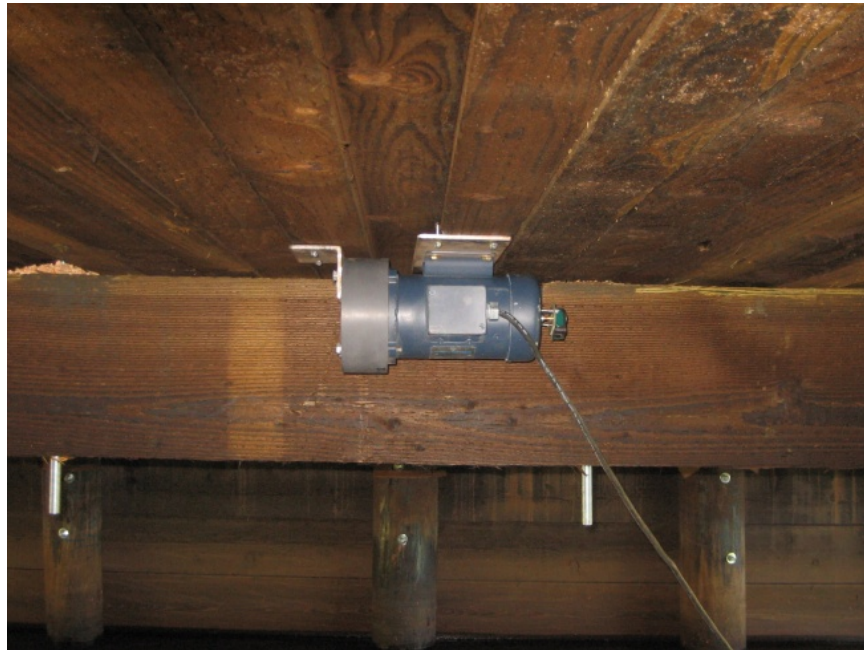
Figure 3.25. Vibration testing with motor mounted below the bridge deck.

6/26/2008 The upstream rail was now secure as seen in Figure 3.18, but the downstream rail was not. The spreader beam was still not bolted. Three tests were conducted with the motor mounted on top of the bridge. Three additional tests were run with the motor mounted underneath the bridge and the accelerometers mounted on top. Figure 3.25 shows the motor mounted underneath the bridge deck. For the tests with the motor mounted on the bottom, the deck was clear of materials and the downstream railing was being installed.

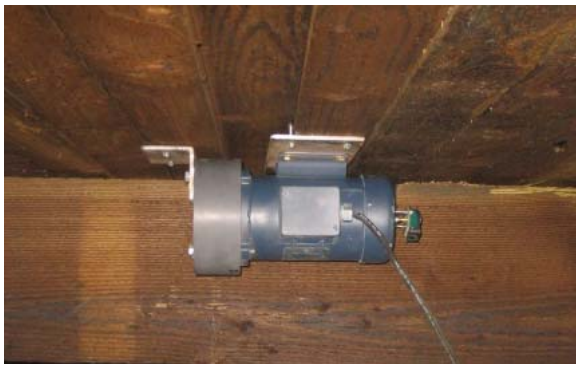
Figure 4.2. General motor attachment on underside of bridge deck for conducting vibration testing.

The typical test setup for the motor attached midspan under the bridge is shown in Figure 4.2. The in testing computer interface that controls the testing and acquires data is shown Figure 4.3 and the data collection accelerometers are shown as attached in Figure 4.4.

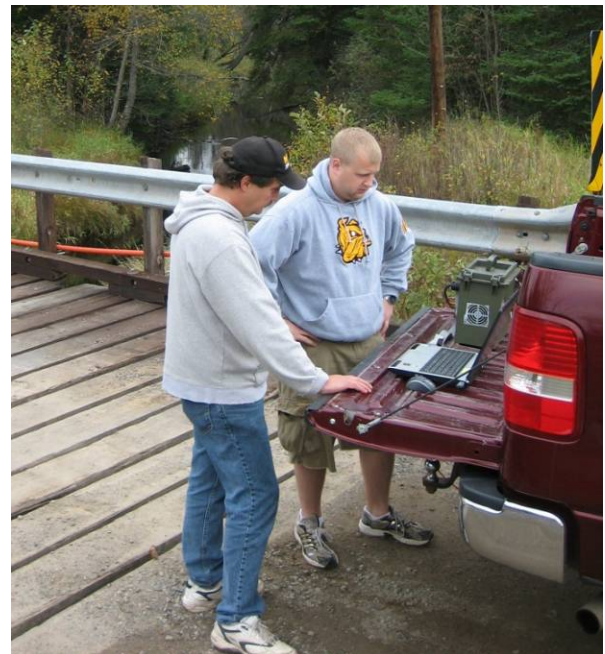
Figure 4.3. Computer controlled interface to control vibration testing and collect vibration characteristics.
