Investigation and Assessment of Colored Concrete Pavement

Minnesota
Department of
Transportation

August 2014

Research Project
Final Report 2014-26

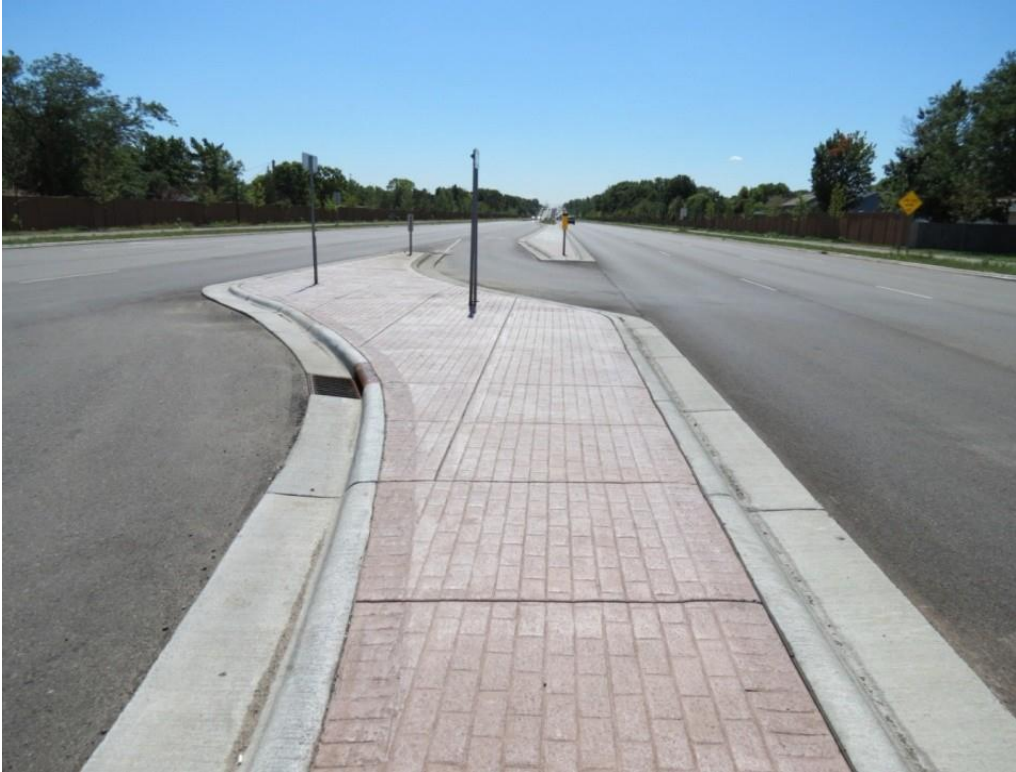
Figure 2.1 Apple Valley – Median on Cedar Avenue near 162nd Street W

Stamped colored concrete was used in the medians at the intersection of Cedar Avenue and 162nd Street West. Figure 2.1 shows the newer colored concrete in excellent condition. Colored concrete was also used in the sidewalks along Cedar Avenue near 153rd Street West, as well as along 153rd Street West. Figures 2.2 and 2.3 show these locations. These projects were newly constructed in 2012.

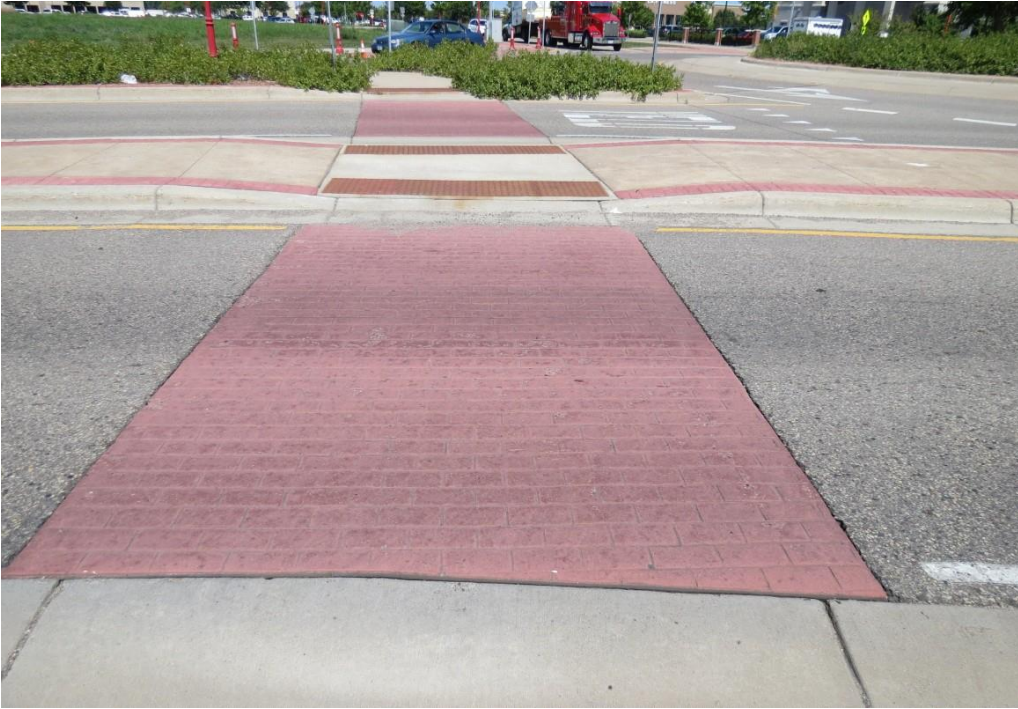
Figure 2.4 Apple Valley – Crosswalk on Founders Lane

Colored concrete was used in the medians, sidewalks and crosswalks on Founders Lane near Galaxie Avenue in Apple Valley. See Figures 2.4 and 2.5. Constructed in 2009, the overall condition of most structures was very good. There was some cracking in several sidewalk panels, possibly due to thermal restraint from nearby structures (light posts?).

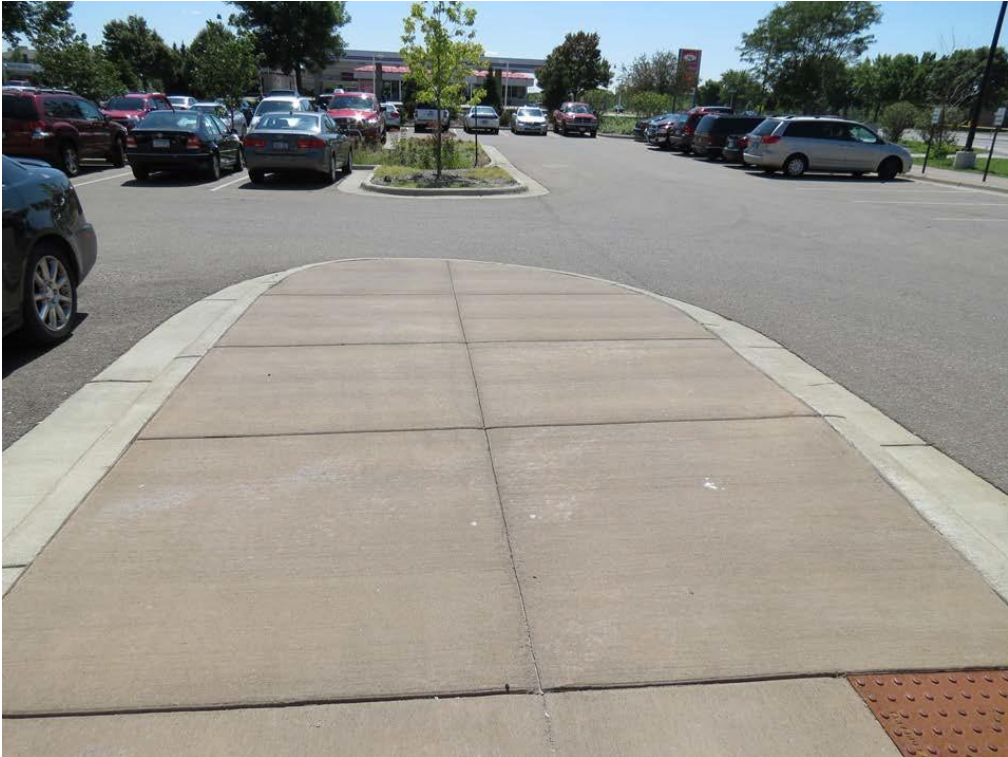
Figure 2.6 Sidewalk/median around Apple Valley Transit Center

Colored concrete was used in the sidewalks and medians around the Apple Valley Transit Center. These sidewalks were constructed in 2009. Figures 2.6 and 2.7 show that most joints are still intact and free of deterioration, however some mid-panel cracks are present.

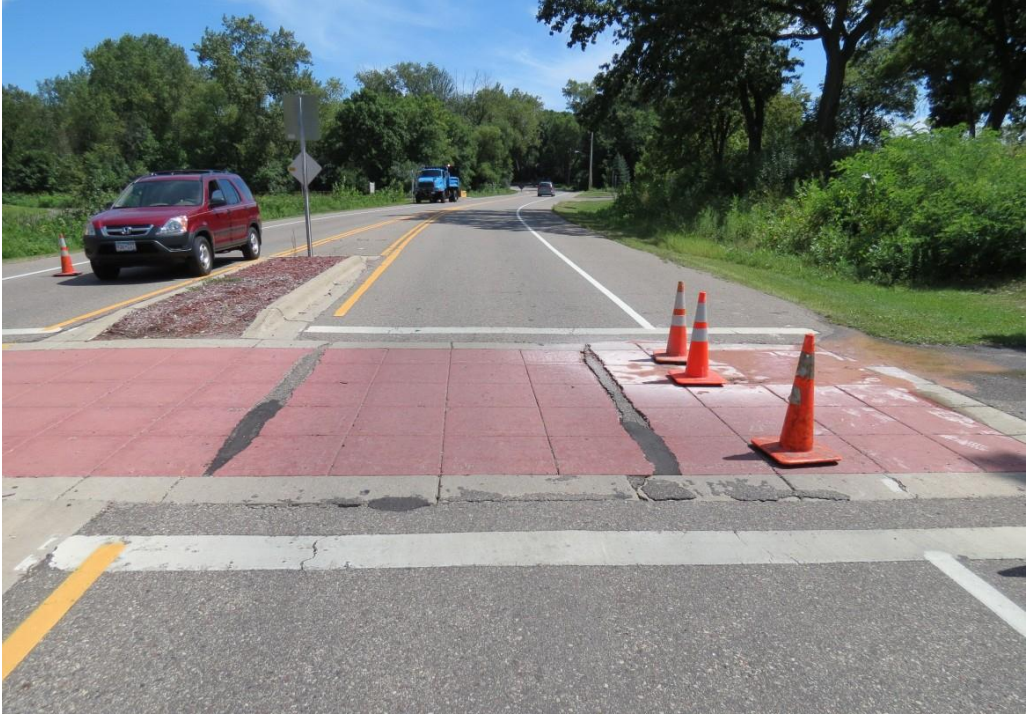
A colored concrete crosswalk was constructed across Lake Johanna Blvd (on the north side of Lake Johanna) in 1999. As of 2012, significant joint deterioration is occurring near both wheel paths of the eastbound lane, as well as one wheel path of the westbound lane. Figures 2.8 and 2.9 show the distress.

Figure 2.8 Arden Hills – Eastbound Lake Johanna Blvd in Tony Schmidt Park

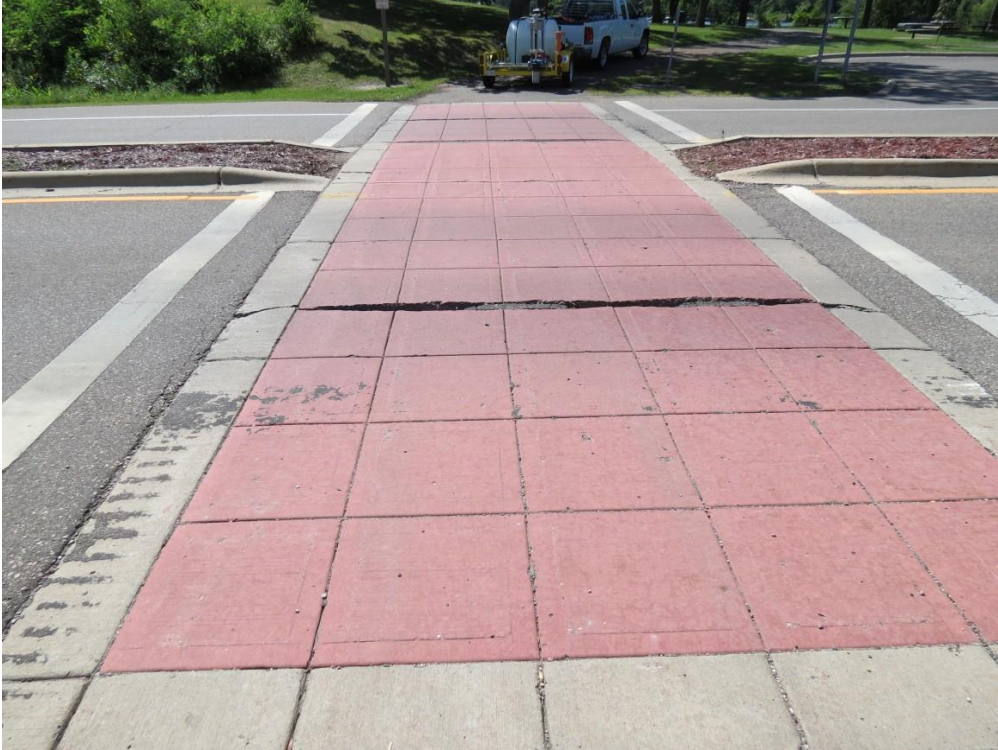
Figure 2.9 Arden Hills – Westbound Lake Johanna Blvd in Tony Schmidt Park

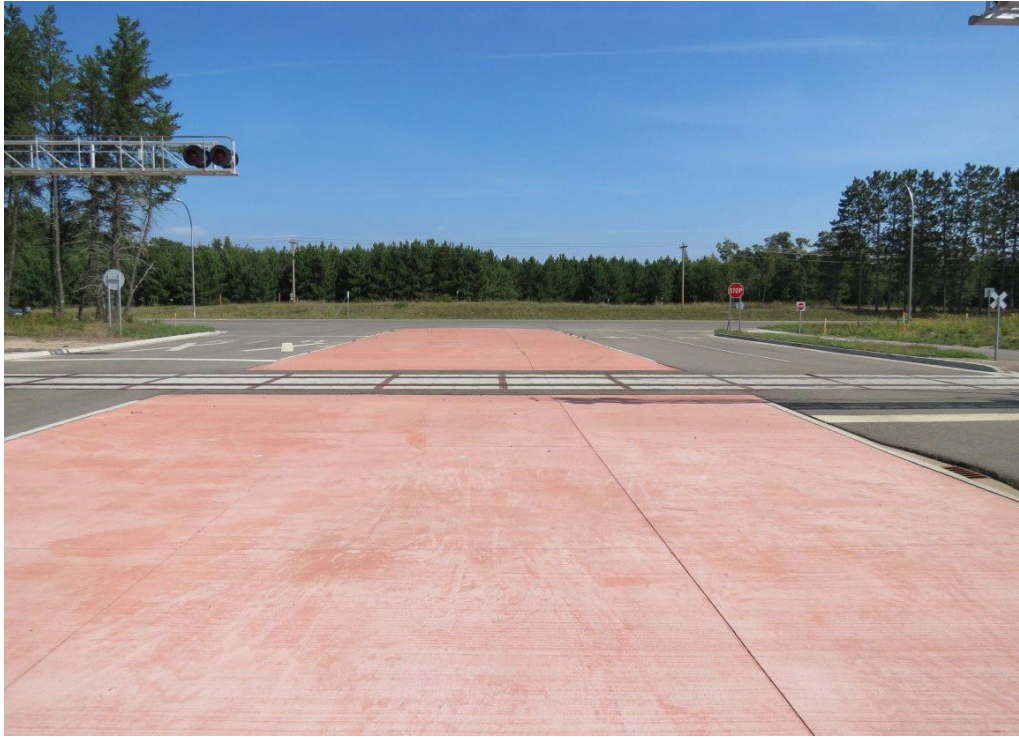
Colored concrete was used in a large median straddling a railroad crossing near the intersection of Timberwood Drive and TH210. Constructed in 2010, Figures 2.10 and 2.11 show that its overall condition was still very good in 2012.

Figure 2.10 Baxter - Median near railroad crossing on Timberwood Drive and TH210

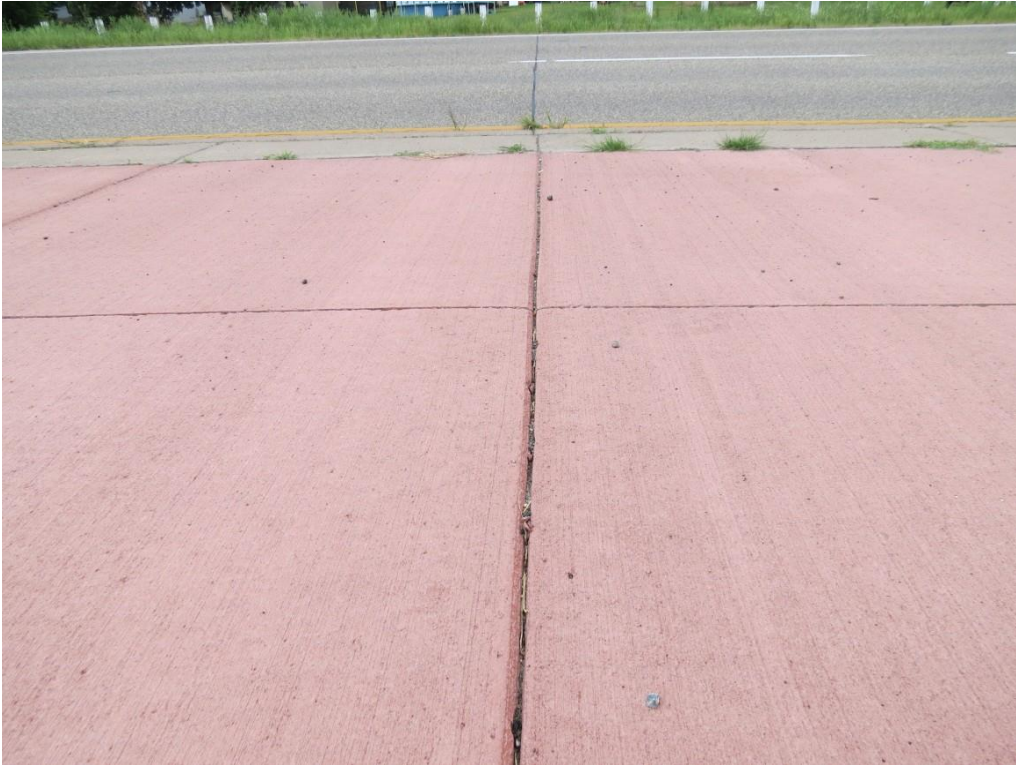
Colored concrete resides in the median along Radisson Road, south of the intersection with County Rd 14 in Blaine. Constructed in 2011, the joints in the median are in excellent condition, except one location where a joint in the surrounding plain PCC likely caused distress in the colored concrete. See Figures 2.12 and 2.13.

Figure 2.12 Blaine – Joints in median on Radisson Road

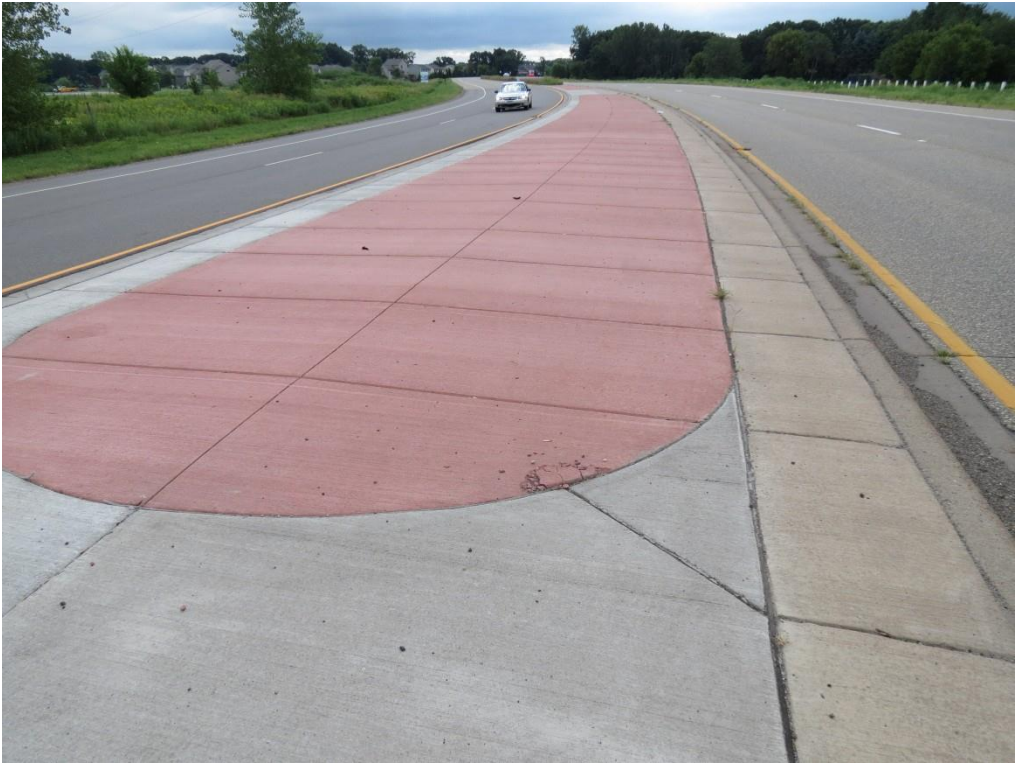
Figure 2.13 Blaine – Distress in median on Radisson Road

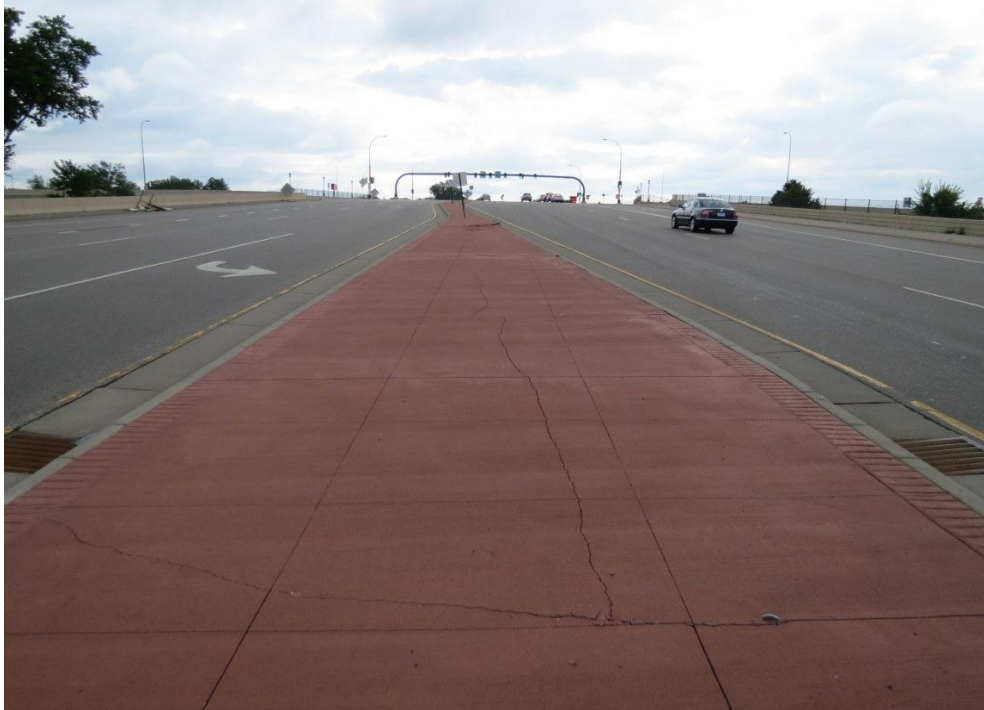
Colored sidewalks, boulevards, and medians were constructed along County Road 14, west of TH65, in 2008-2009. The overall condition of the joints in 2012 was good; however panel cracking was prevalent throughout the project. See Figures 2.14 and 2.15. In one of the large medians, a sizeable area buckled. This is shown in Figures 2.16 and 2.17. It appeared that significant thermal stresses had been causing cracking throughout the area. Figure 2.18 shows that there was also spalling at the edge of the sidewalk, adjacent to a curb. Overall it appears there is a lot of expansion pressure throughout the median. Some cracks radiated from structures like light poles and manholes.

Figure 2.15 Blaine – Cracking of median within County Rd 14

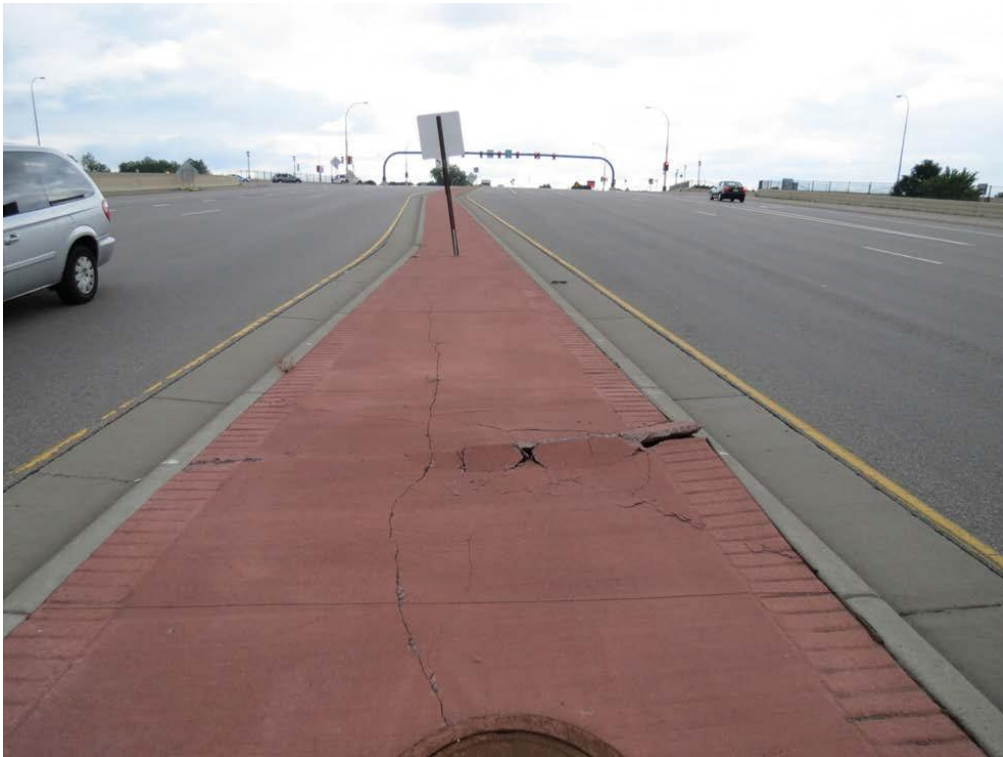
Figure 2.16 Blaine – Buckling in median within County Rd 14

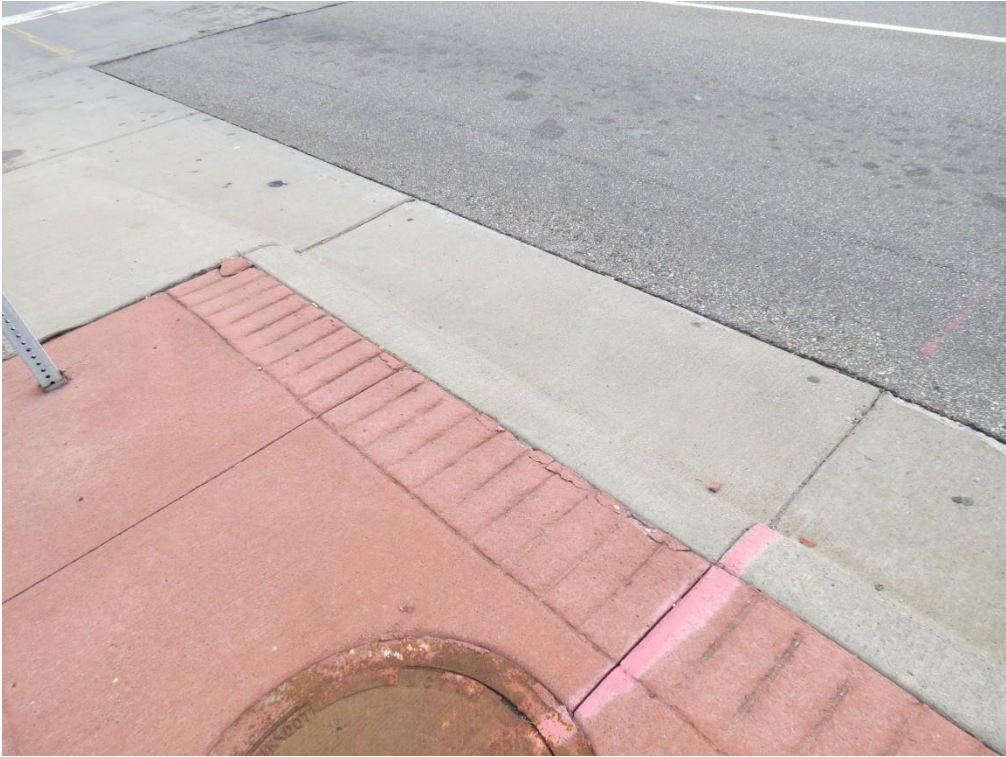
Figure 2.18 Blaine – Edge spalling of median within County Rd 14

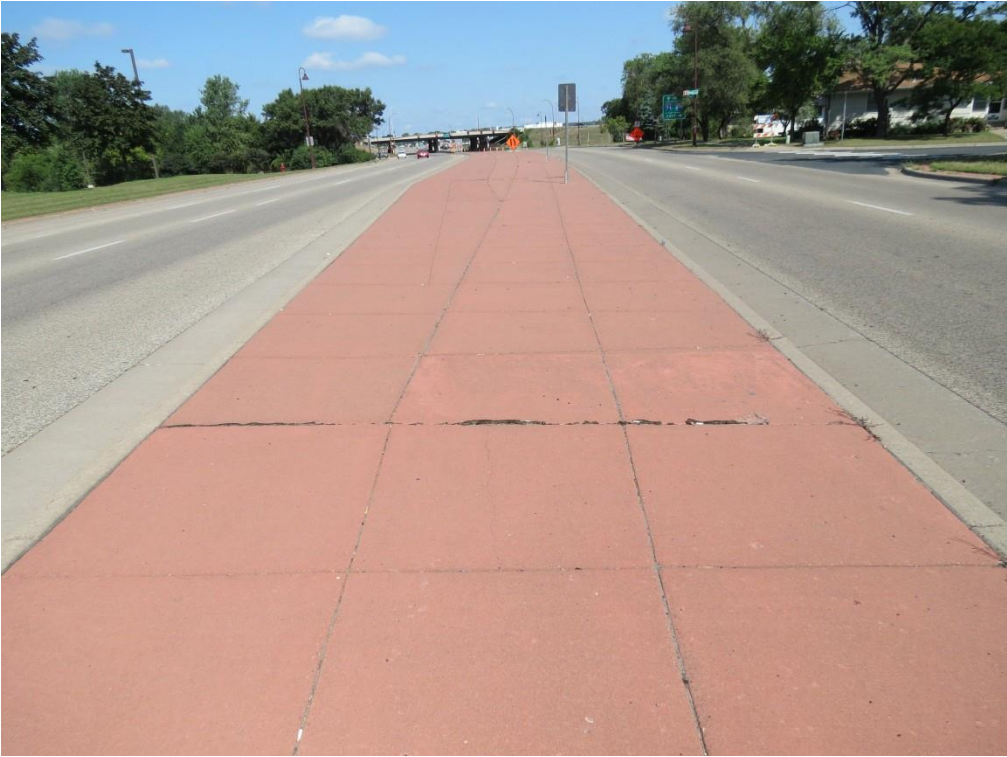
Colored sidewalks, boulevards, and medians were constructed along Brooklyn Boulevard, south of TH694. The year of construction could not be determined, but it did appear to be at least several years old. Figures 2.19 and 2.20 show that the joints are in good condition, however there was evidence of high compressive forces pushing joint isolation material upward during periods of high temperatures.

Figure 2.20 Brooklyn Center – Joint isolation material being squeezed from the joints in median during periods of high temperatures

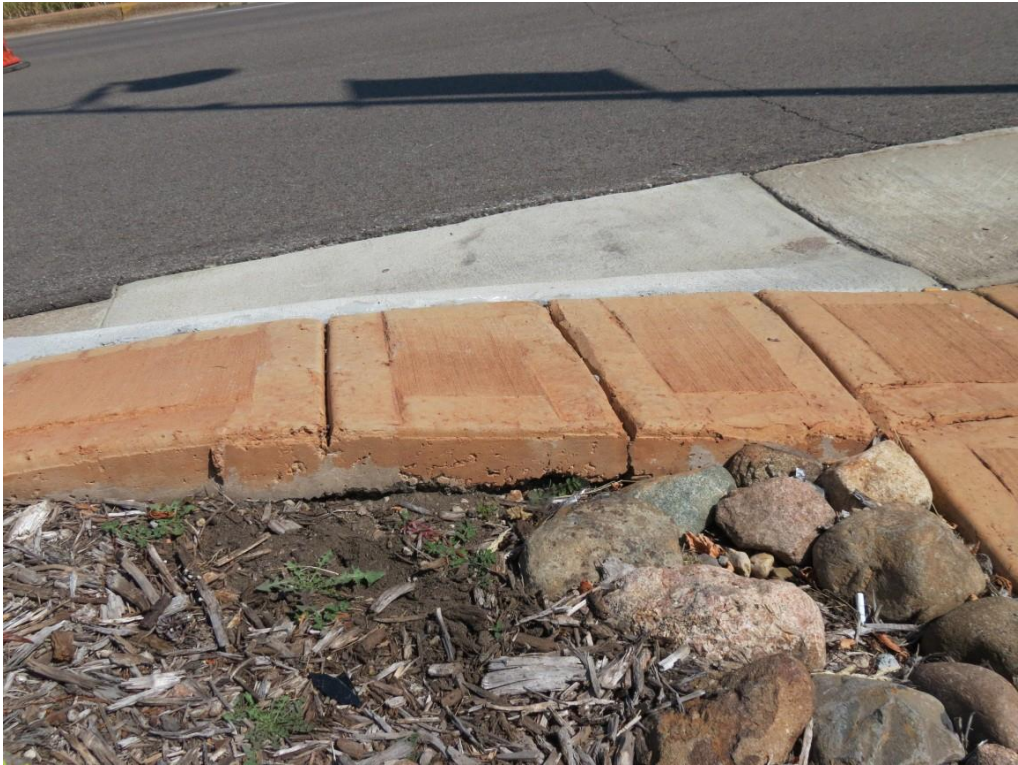
Colored concrete was used in the medians and sidewalks along Bass Lake Road near TH100. The concrete was stamped in large rectangular patterns. Other than some poor consolidation in some locations, overall conditions appear to be very good on this project. Figures 2.21 and 2.22 show examples of the colored concrete located within this project.

Figure 2.22 Brooklyn Center – Poor consolidation of boulevard along Bass Lake Road

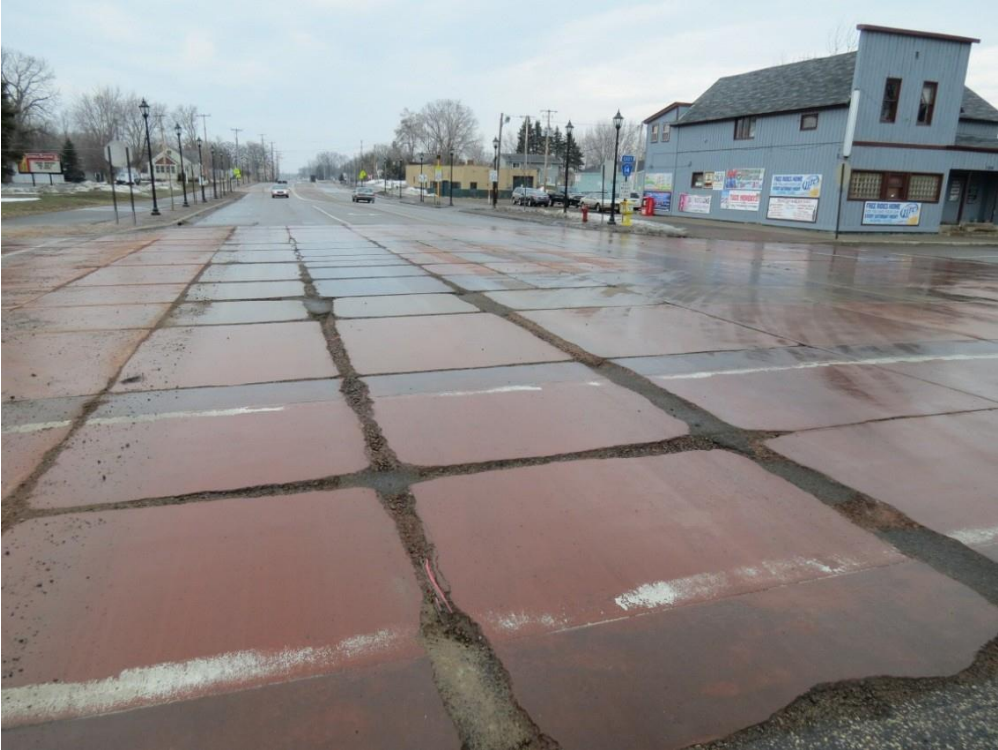
In 2008, two multi-colored concrete intersections were constructed on County Road 14 (Main Street) in downtown Centerville, MN. Significant joint distress began to appear in 2011, particularly in the westbound lanes. Figures 2.23 and 2.24 clearly show the early and significant joint deterioration. Owing to its severity, it was decided that these intersections would be one of the four main focus areas in this study. A number of core samples were extracted for a detailed examination and determination of the potential causes of the distress. Findings from the detailed investigation of this location will be discussed in Chapter 4.

Figure 2.23 Centerville – Joint deterioration on County Road 14 at intersection with Centerville Road

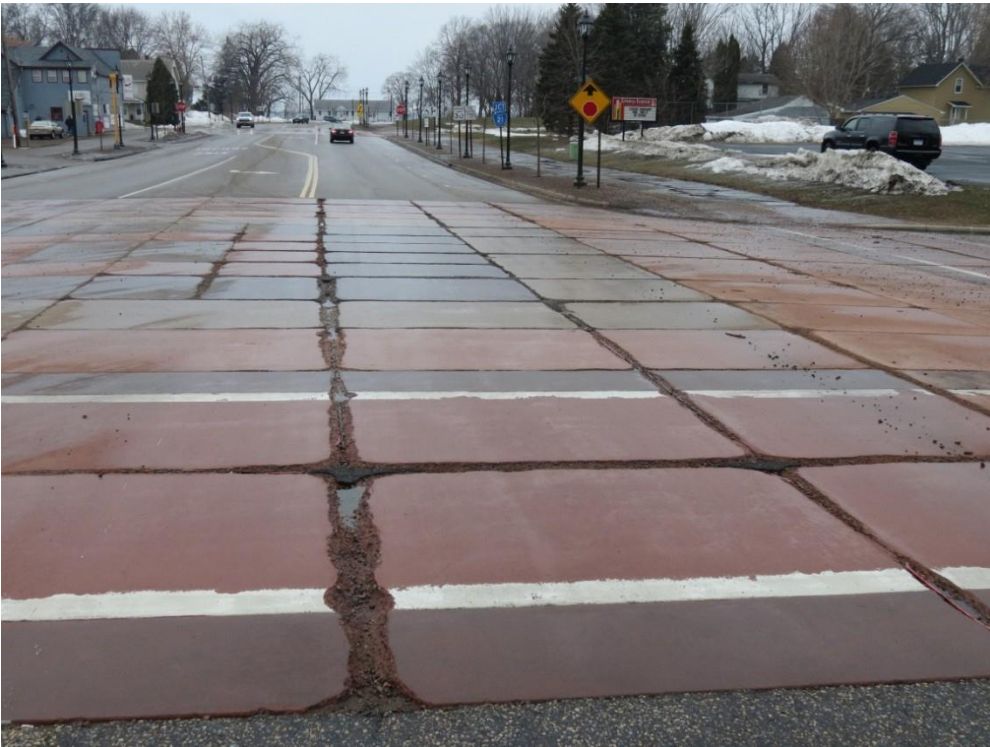
Figure 2.24 Centerville – Joint deterioration on County Road 14 at intersection with Progress Road

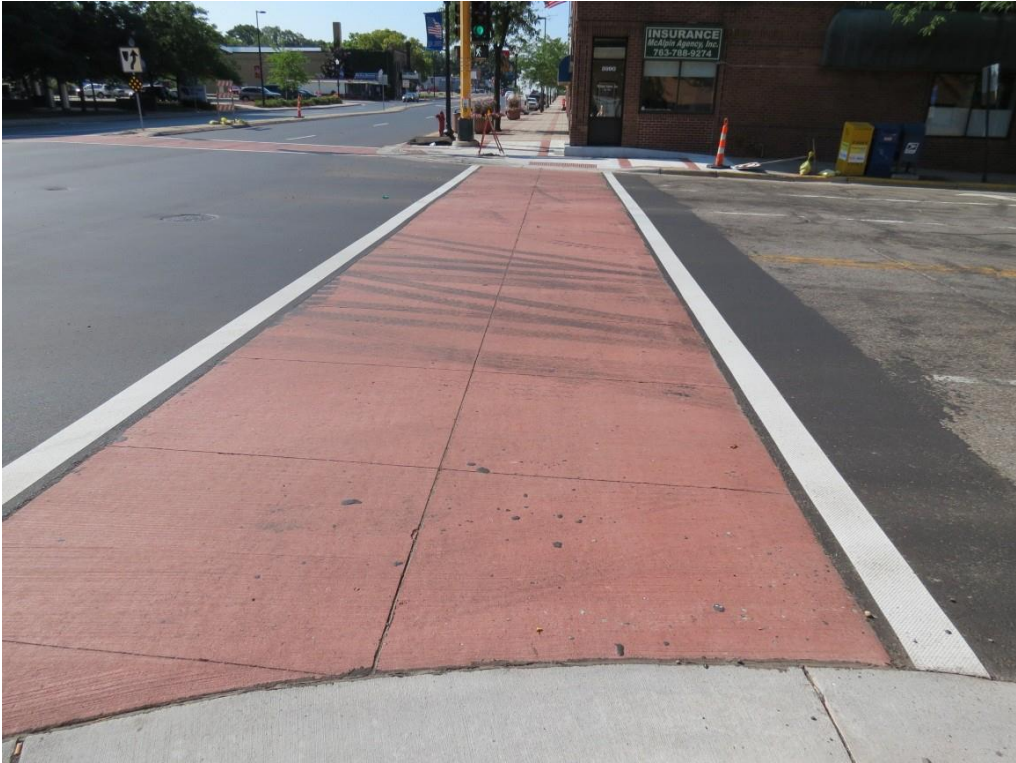
Colored concrete was used in crosswalks, sidewalks, and boulevards near the intersection of Central Avenue and 40th Avenue NE. See Figures 2.25 and 2.26. Construction took place in 2012. Limited joint spalling from sawing was the only distress observed.

Figure 2.25 Columbia Heights – Crosswalk in intersection of Central Avenue and 40th St NE

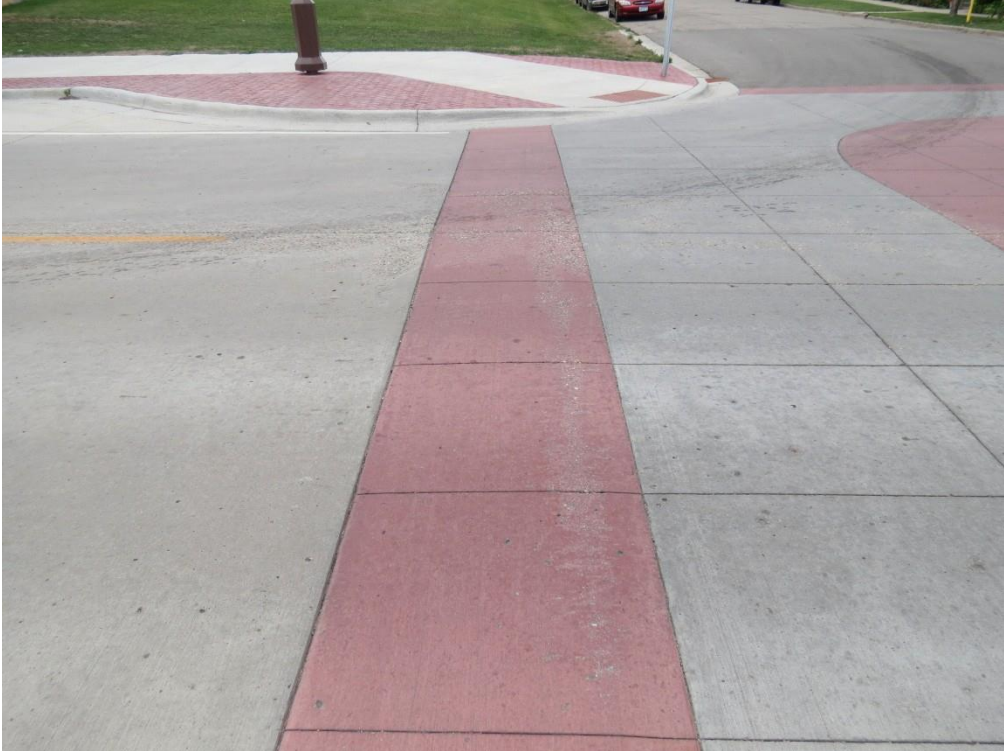
Colored concrete was used in an intersection and between the sidewalk and curb along Washington Avenue. The intersection was constructed in 2010 and shows no noticeable deterioration along the joints. See Figures 2.27 and 2.28. Several areas showed evidence of surface scraping, likely due to snow plow damage.

Figure 2.28 Detroit Lakes – Scraped surface, likely due to snow plow damage

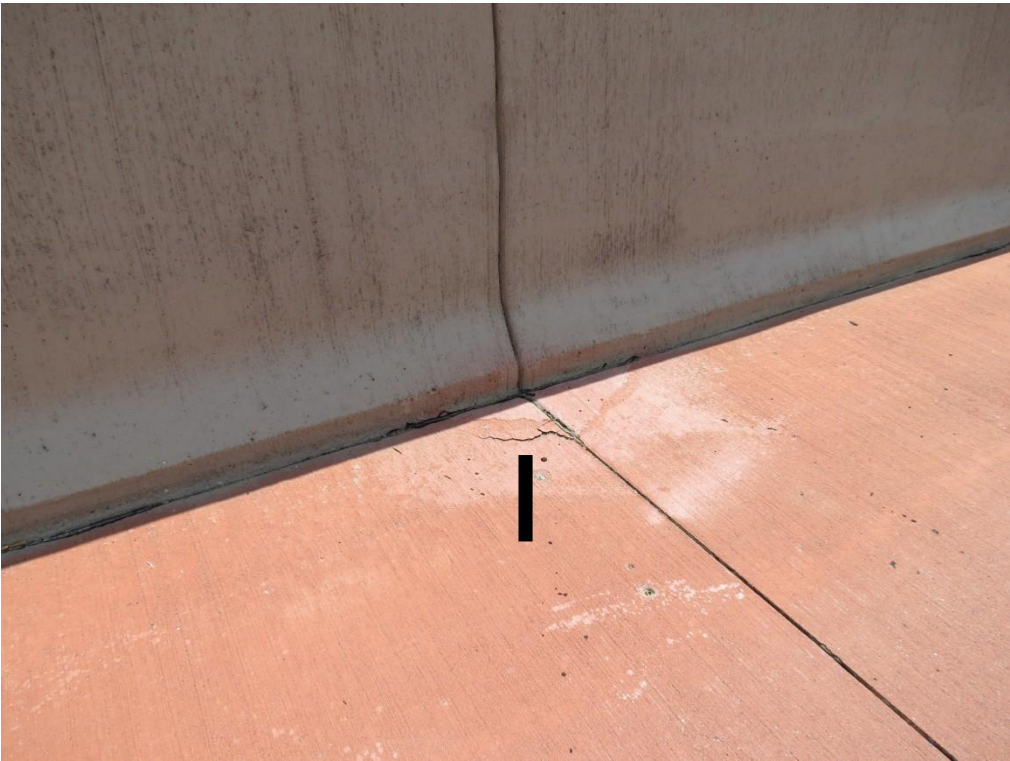
Colored concrete was used in the bus lanes running through the 46th Street Metro Transit Station on I35W. Constructed in 2010, this project only exhibits some minor joint surface spalling near the Jersey barriers. Thermal expansion/restraint may be the cause for this cracking. See Figures 2.29 and 2.30.

Figure 2.30 Minneapolis – Cracking, likely due to thermal expansion/restraint

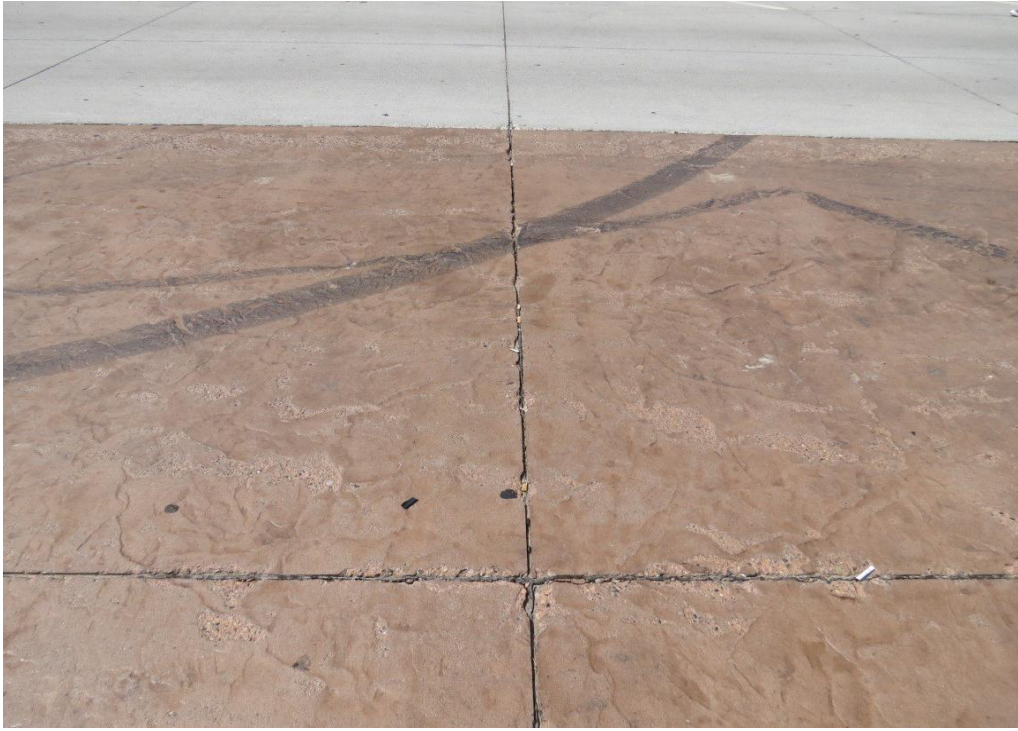
Constructed in 2010, many different colored concretes were used in the crosswalks, parking areas, and sidewalks along Main Avenue. The concrete was stamped with a textured pattern. Noticeable damage to the joints and surface texture was noted in the central parking areas running down the center of the street. See Figure 2.31. This damage was likely caused by snow removal equipment. Multiple large cracks were observed in the sidewalks, likely due to differences in thermal expansion rates between neighboring materials of different color. See Figure 2.32.

Figure 2.31 Park Rapids – Sculpted colored concrete joint damage, likely due to snow removal equipment

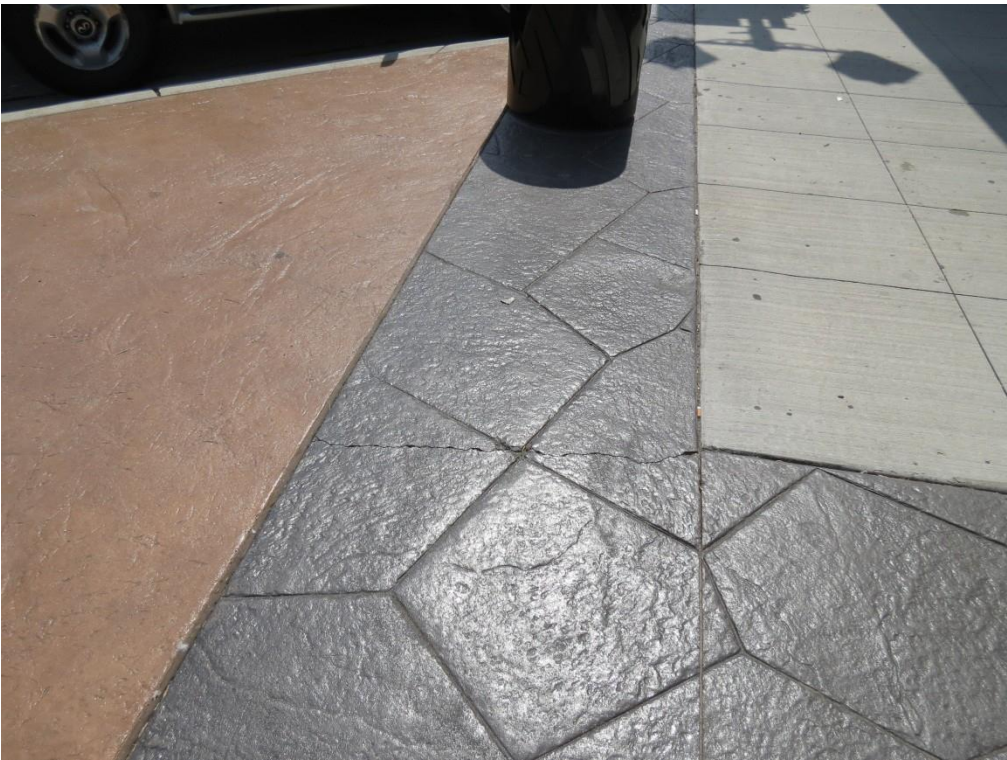
Figure 2.32 Park Rapids – Crack in sidewalk, likely due to different thermal expansion/contraction rates

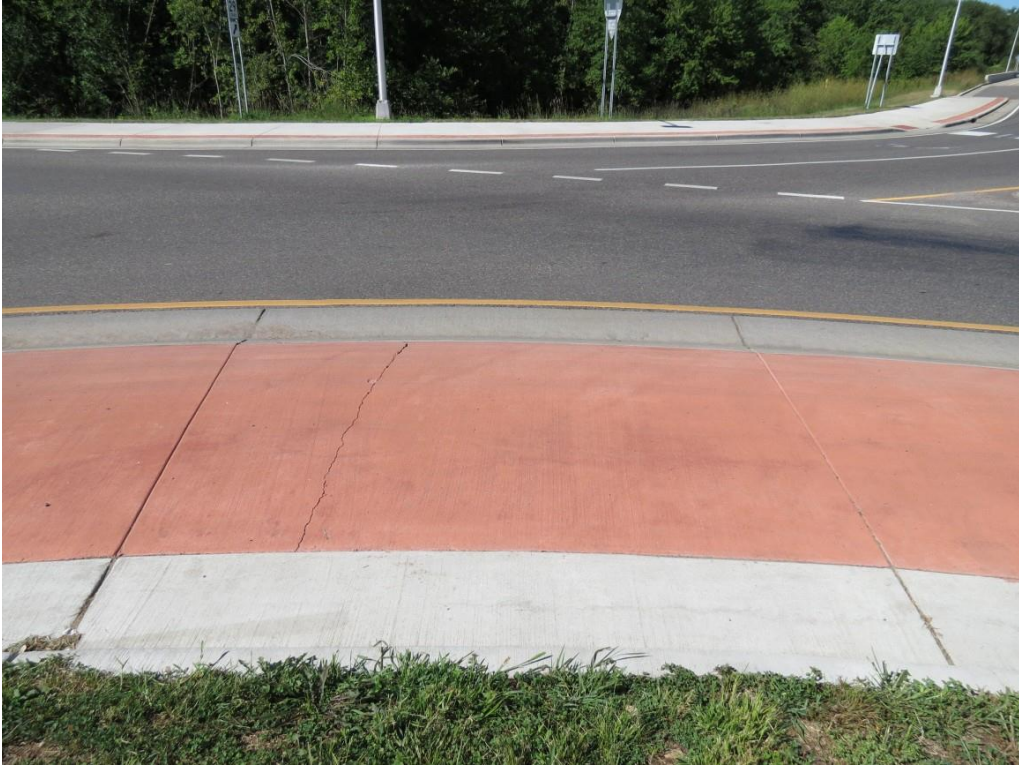
Colored concrete was used in a truck apron of a roundabout and boulevard strips behind the curb near the TH95 roundabout. Constructed in 2010, no deterioration was noticeable at the joints in the roundabout apron, however several cracks have formed across the full width of the panels. See Figure 2.33. Figure 2.34 show that cracking at the end of the boulevard strips in the sidewalk may indicate differing thermal expansive rates between the darker and lighter colored concretes.

Figure 2.33 Princeton – Crack in apron of TH95 roundabout

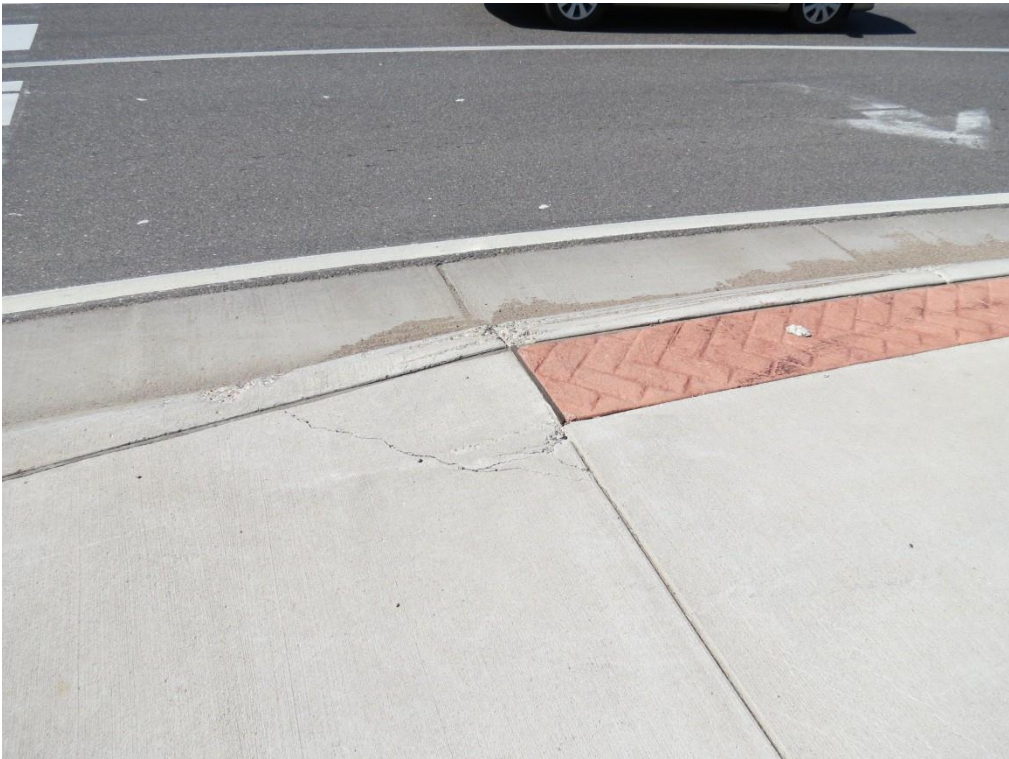
Figure 2.34 Princeton – Crack at end of colored concrete boulevard strip

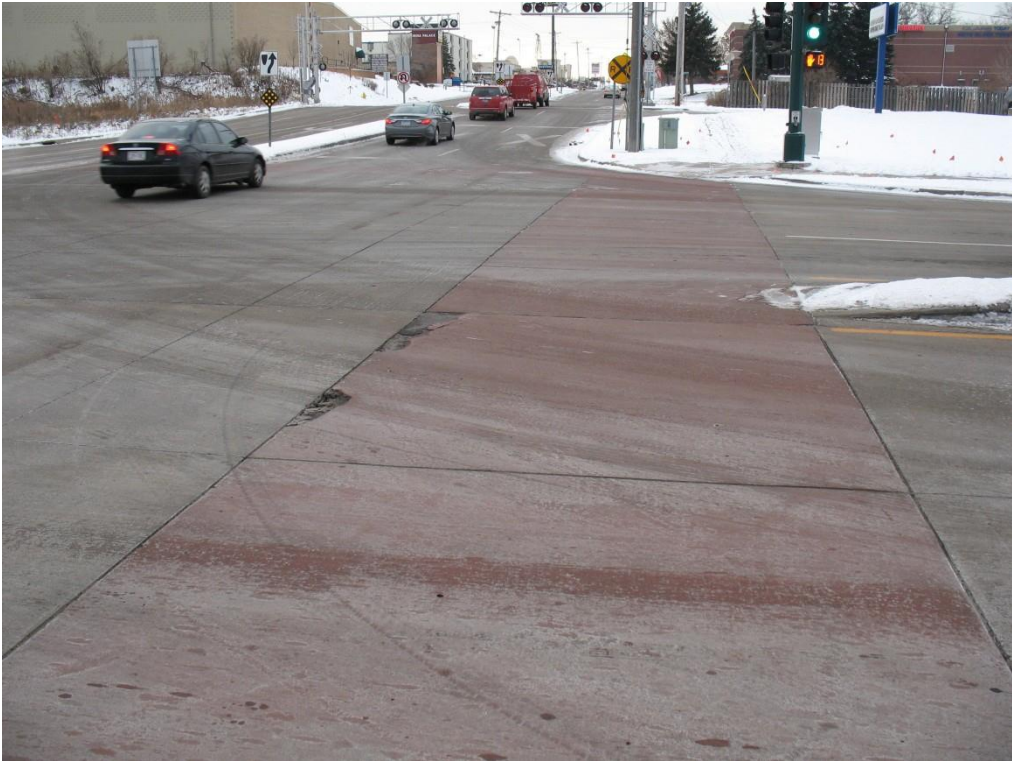
Colored concrete crosswalks, sidewalks and gutter lines were installed in 2001 along Larpenteur Avenue West, including the intersection with Fernwood Street. At this location, moderate to severe deterioration was observed in several areas of the colored concrete crosswalks. Joint deterioration was also occurring. Figures 2.36 and 2.37 show these distresses. Some minor joint deterioration was also occurring in some of the gutter-line joints. See Figure 2.38.

Figure 2.36 Roseville – Distressed areas in crosswalk panels at intersection of Larpenteur Avenue W and Fernwood Street

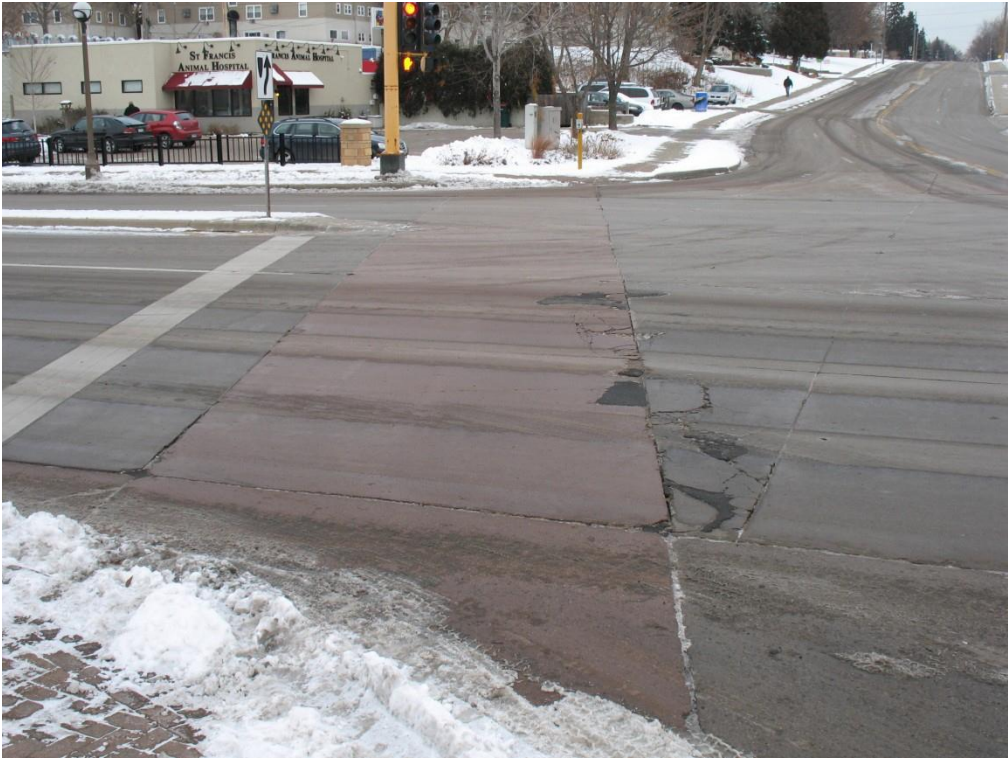
Figure 2.37 Roseville – Distressed joints in crosswalk panels at intersection of Larpenteur Avenue W and Fernwood Street

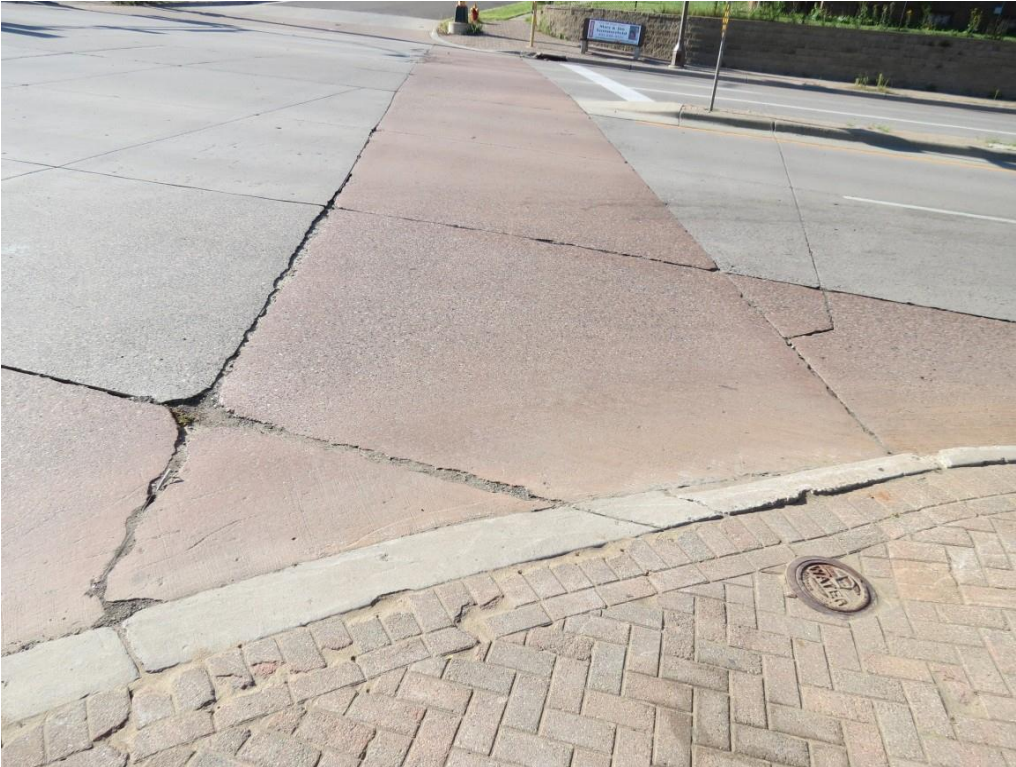
Figure 2.38 Roseville – Minor joint distress in colored concrete gutterline along Larpenteur Avenue W

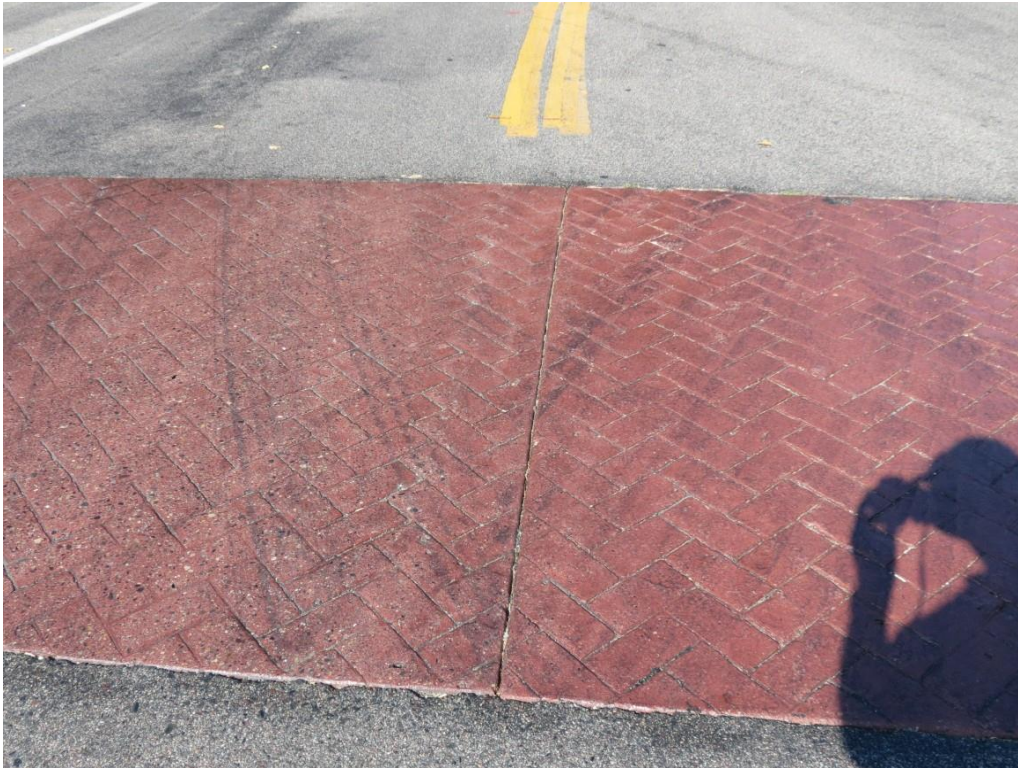
Colored concrete crosswalks were installed in 2001 in four locations along Josephine Road. A stamped brick pattern was used. Overall condition of the panels and joints was very good. See Figures 2.39 and 2.40. Gray colored sidewalks were also installed at the intersection with Lexington Avenue. Some joint deterioration was observed in these areas. See Figure 2.41.

Figure 2.40 Roseville – Colored concrete crosswalk in good condition across Josephine Road near Fernwood Street N
