Investigation and Assessment of Colored Concrete Pavement

Minnesota
Department of
Transportation

August 2014

Research Project
Final Report 2014-26

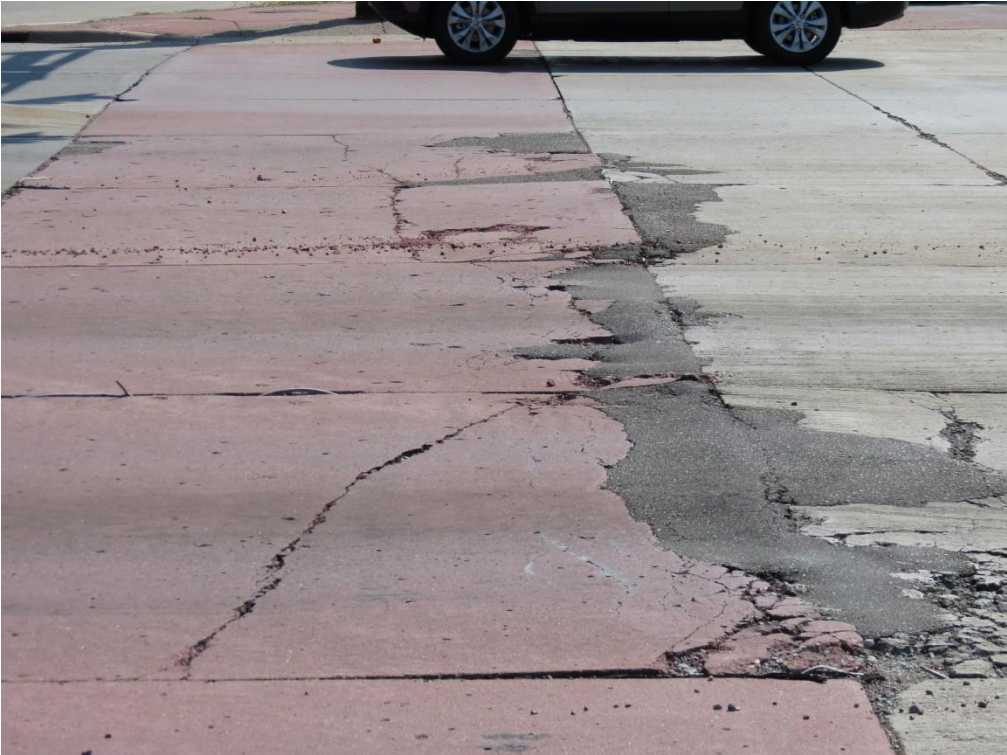
Colored concrete crosswalks were installed from 1997 to 2000 at the intersections along County Highway 96 West. Significant panel and joint deterioration was observed in several intersections, including Hodgson Road, Village Center Drive, McMenemy Street, Greenhaven Drive, and Centerville Road. Figures 2.46 to 2.49 show some of the distresses observed. Due to the variety and severity of the joint distress in the intersection with Greenhaven Drive, this became the fourth focus area in this study. Several cores were taken over and near the distressed joints in the crosswalks. Results from the analysis of the core samples will be discussed in Chapter 4.

Figure 2.47 Vadnais Heights – Severe panel distress in crosswalk at intersection of County Highway 96 West and Village Center Drive

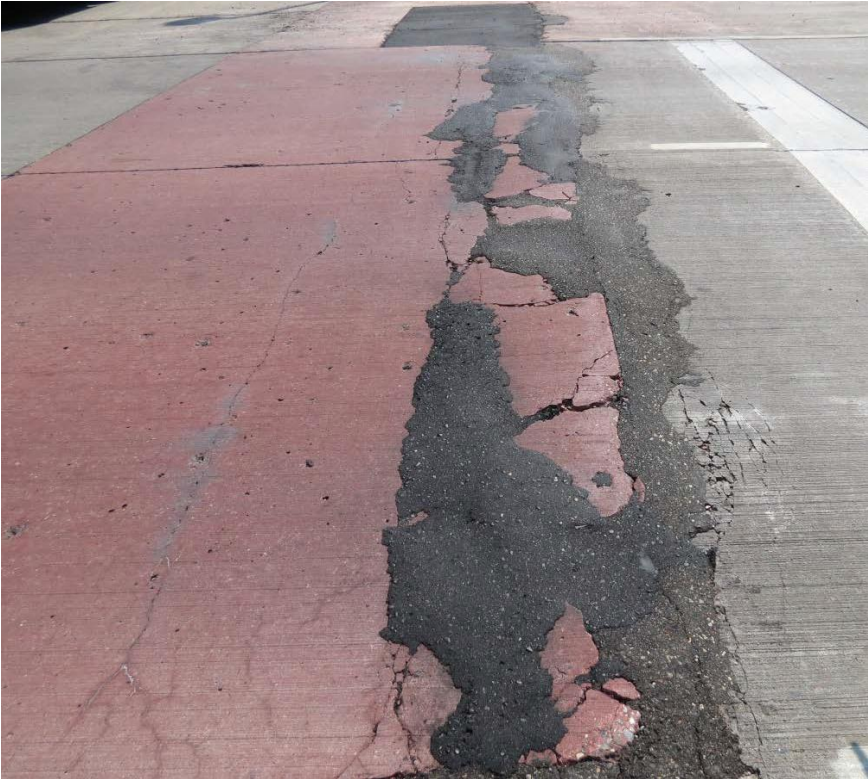
Figure 2.48 Vadnais Heights – Extensive joint distress in crosswalk at intersection of County Highway 96 West and McMenemy Street

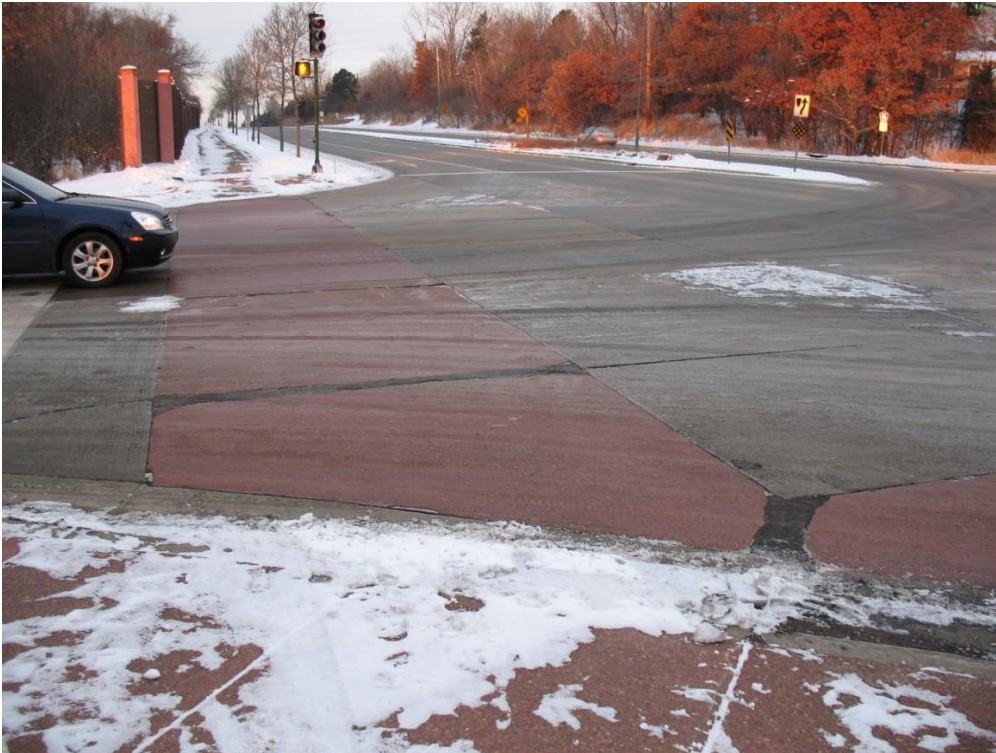
Figure 2.49 Vadnais Heights – Extensive joint distress in crosswalk at intersection of County Highway 96 West and Greenhaven Drive

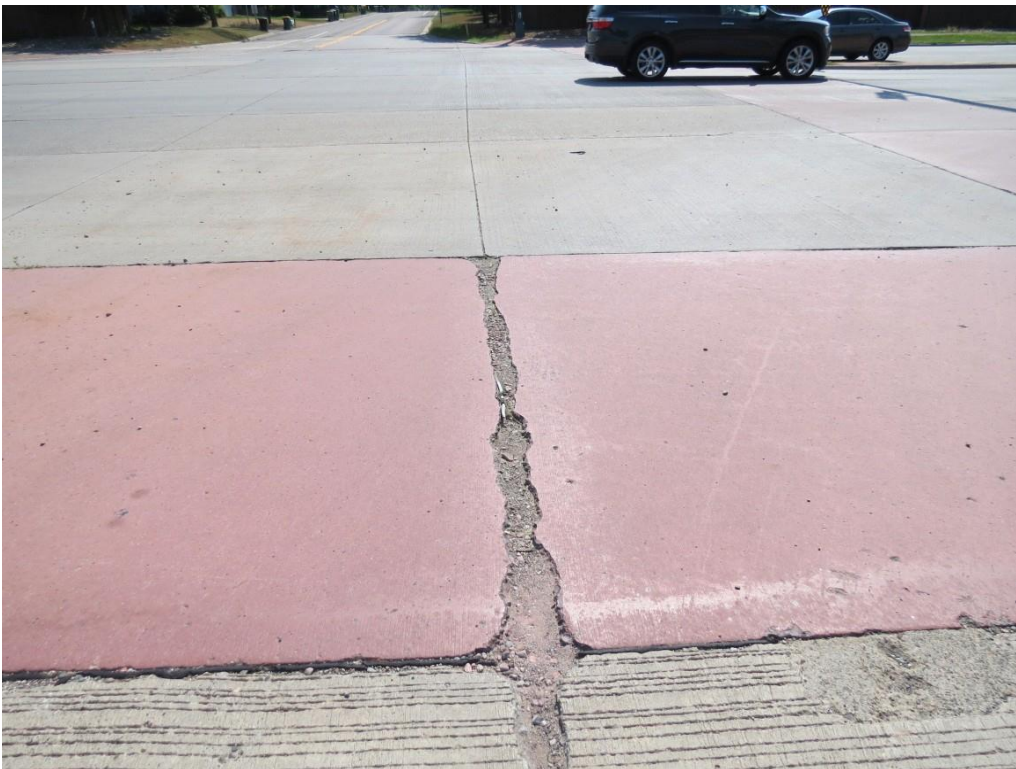
Colored concrete was used in the crosswalks of the intersection of Phalen Blvd and Payne Avenue. Constructed in 2003, the concrete was stamped in a brick pattern. Overall condition was fair, with some joint distress observed, but more prevalent was the noticeable wearing of the surface of the pavement. Figures 2.50 and 2.51 show the general conditions.

Figure 2.50 St. Paul – Joint distress in crosswalk at intersection of Phalen Boulevard and Payne Avenue

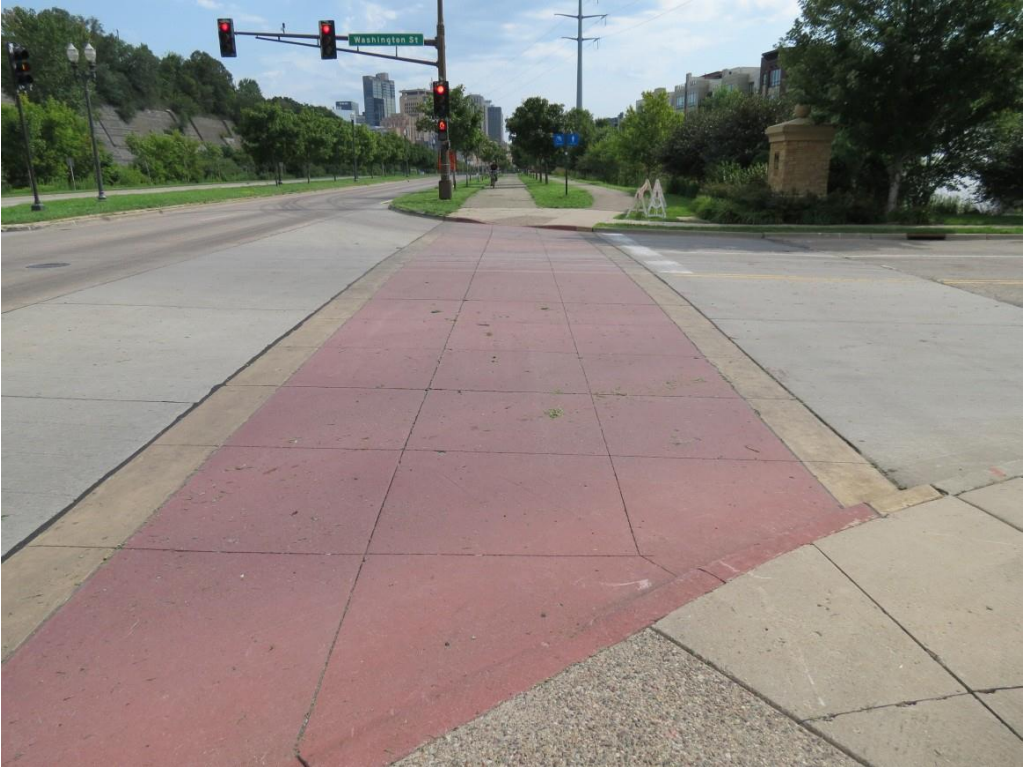
Colored concrete was used in 1998 to construct three different intersections along Shepard Road in St Paul: at Washington Street, at Old Chestnut Street, and at Ontario Street. The overall condition of the crosswalks at the intersection with Washington Street was good, with only some limited joint deterioration starting to appear. See Figures 2.52 and 2.53.

Figure 2.53 St. Paul – Joint distress in crosswalk at intersection of Shepard Road and Washington Street

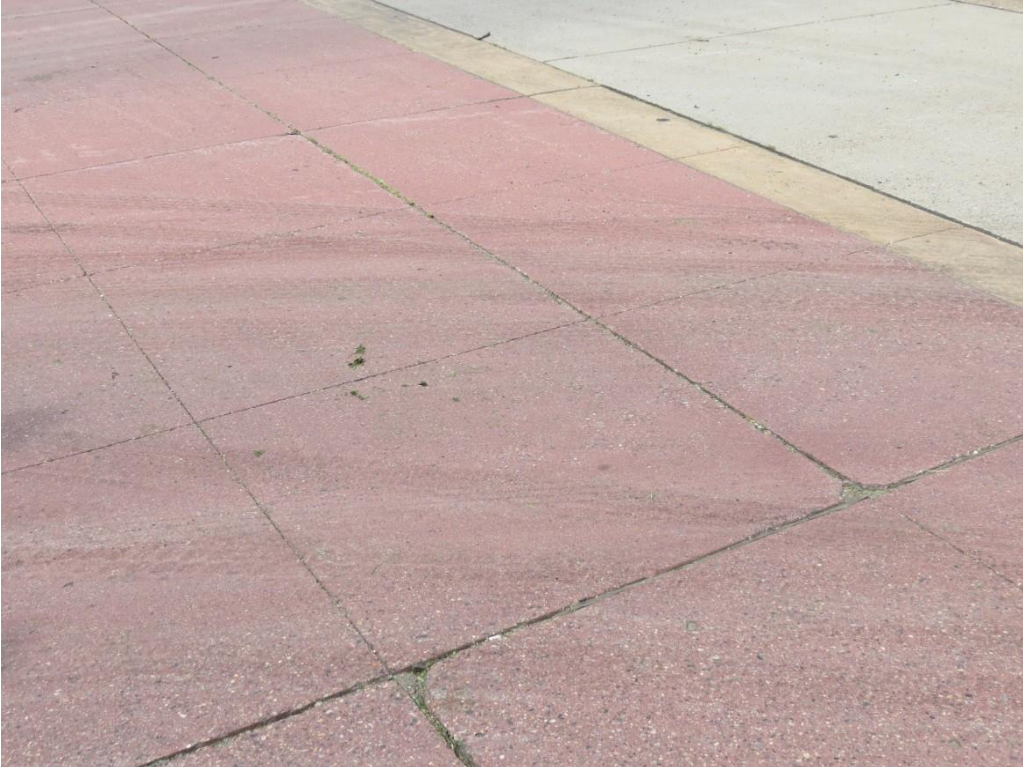
constructed using colored concrete. Severe joint deterioration was found in multiple locations at this site. One large crack across multiple panels was also identified. See Figures 2.54 and 2.55. The colored concrete at the intersection of Ontario Street was in good condition, with some signs of joint deterioration starting to appear. See Figures 2.56 and 2.57.

Figure 2.54 St. Paul – Joint distress in crosswalk at intersection of Shepard Road and Old Chestnut Street

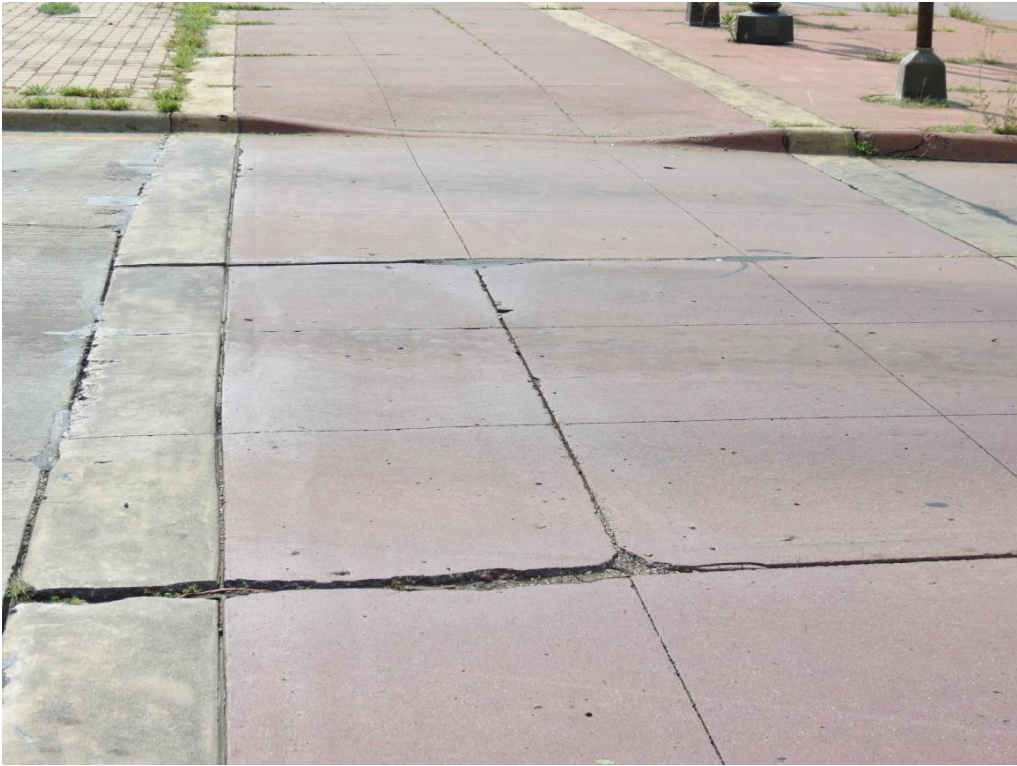
Figure 2.55 St. Paul – Joint distress in crosswalk at intersection of Shepard Road and Old Chestnut Street

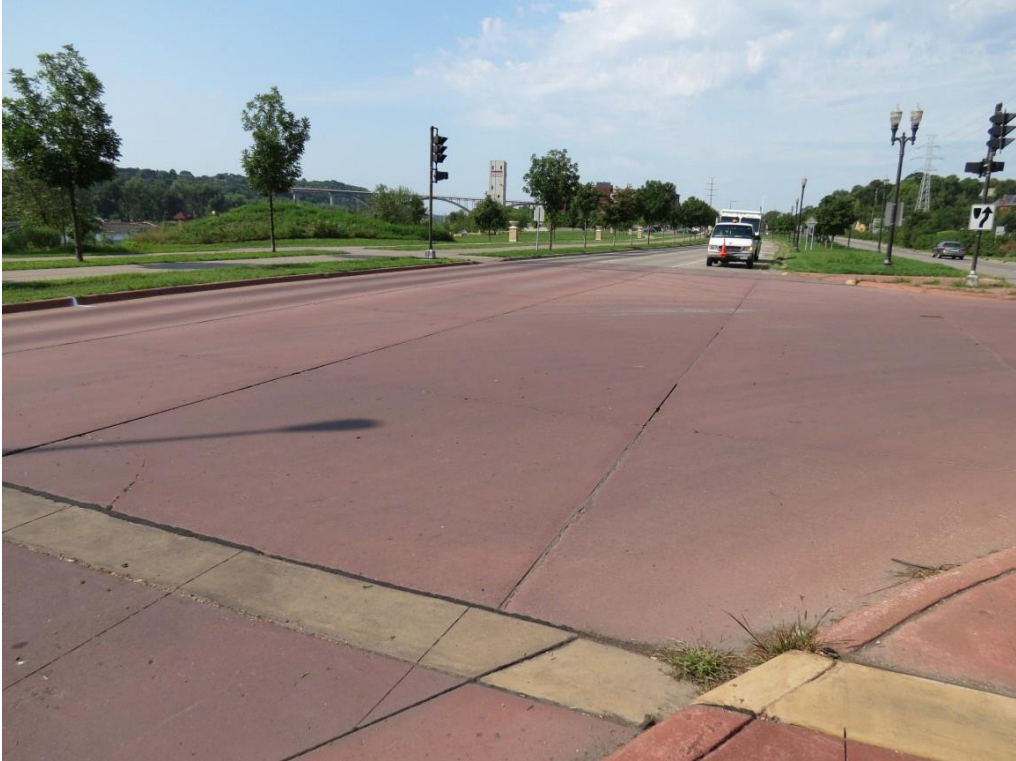
Colored concrete was used across the entire intersection of 7th Street West and West 5th Street in downtown St. Paul. Constructed in 1987, it is apparent by the wide asphalt patches along most of the joints that severe joint deterioration has occurred. Figures 2.58 and 2.59 show the extent of the distress. It is important to note that the center portion of most of the panels appear to be in good condition.

Figure 2.58 St. Paul – Widespread joint distress at intersection of 7th Street West and West 5th Street

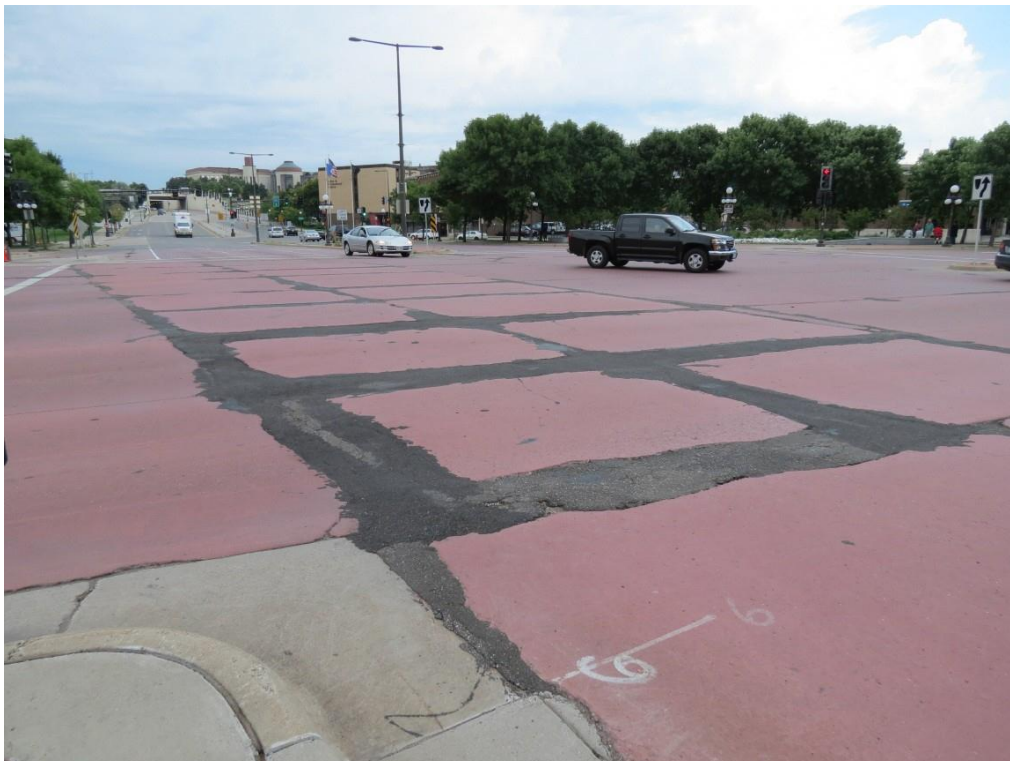
Figure 2.59 St. Paul – Widespread joint distress at intersection of 7th Street West and West 5th Street

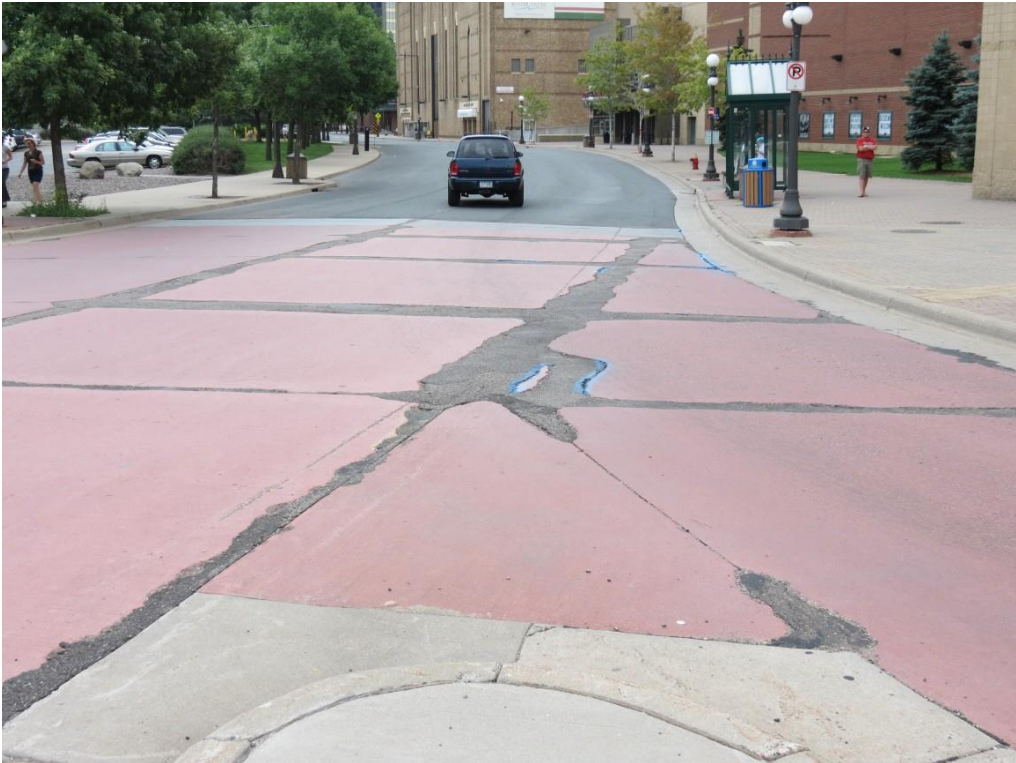
Colored concrete crosswalks and sidewalks were placed in 2012 at the intersection of Main Street North and Commercial Street in downtown Stillwater. Numerous cracks, extending across many panels, were identified in multiple locations. See Figures 2.60 and 2.61. Because the colored concrete is confined within borders of plain concrete, the cracking may be due to differences in their rate of thermal expansion.

Figure 2.60 Stillwater – Panel cracking in new colored concrete crosswalk at intersection of Main Street North and Commercial Street

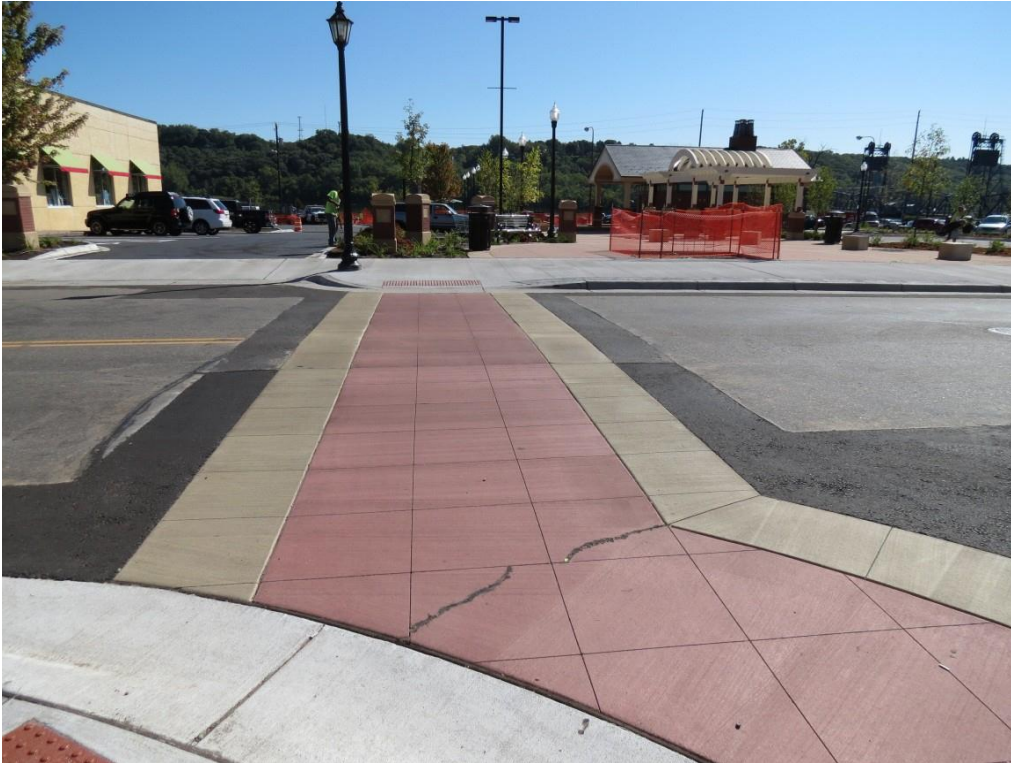
Figure 2.61 Stillwater – Panel cracking in new colored concrete crosswalk at intersection of Main Street North and Commercial Street

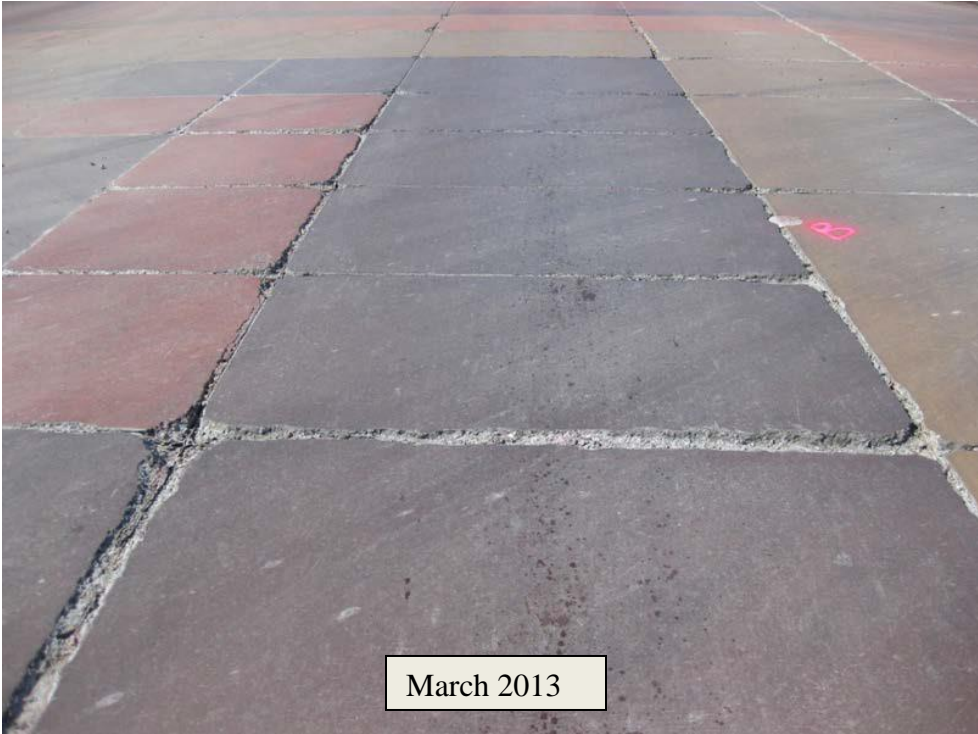
Figure 4.1 Typical joint deterioration occurring in colored concrete intersection of County Highway 14 (Main Street) and Progress Road in Centerville, MN

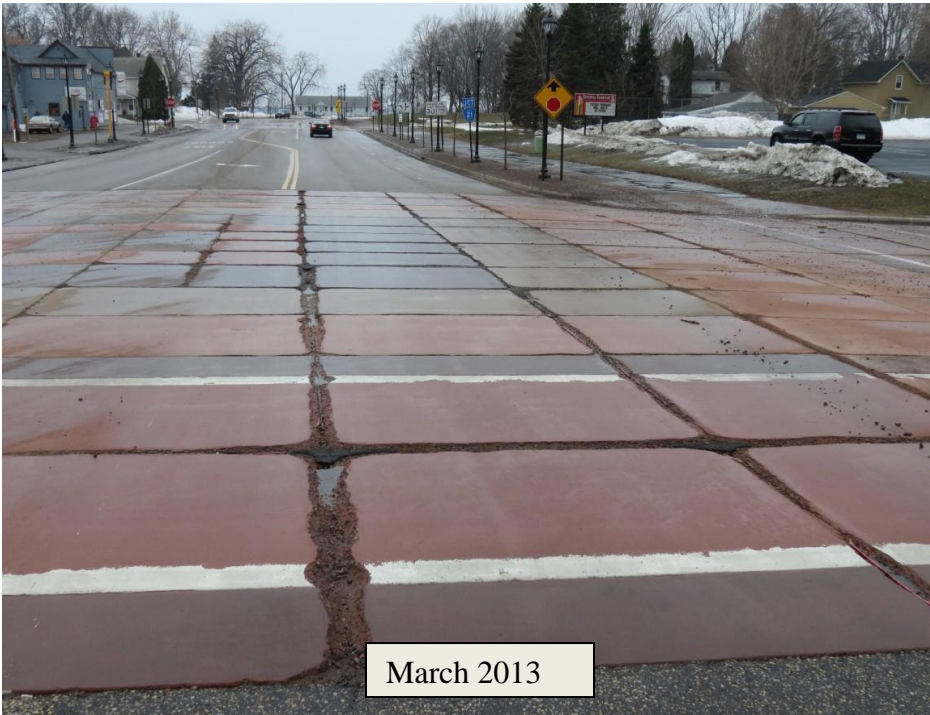
Figure 4.2 Typical joint deterioration occurring in colored concrete intersection of County Highway 14 (Main Street) and Progress Road in Centerville, MN

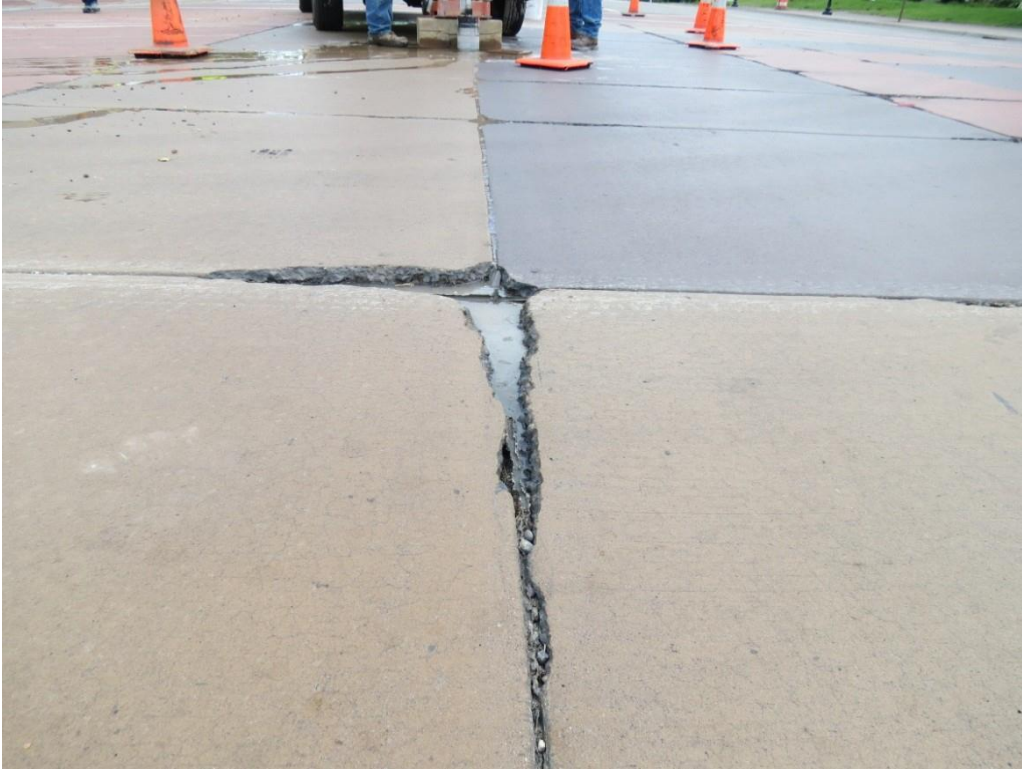
Figure 4.4 Standing water in joints from coring operation

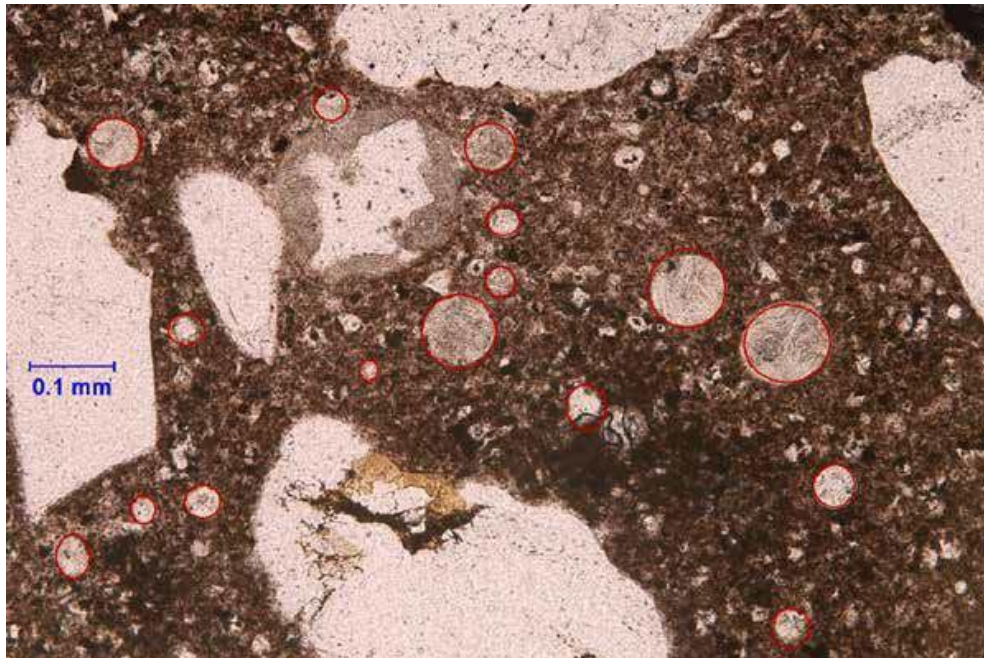
Figure 4.9 Centerville – Voids in Core 14A filled with secondary ettringite crystals (circled in red)

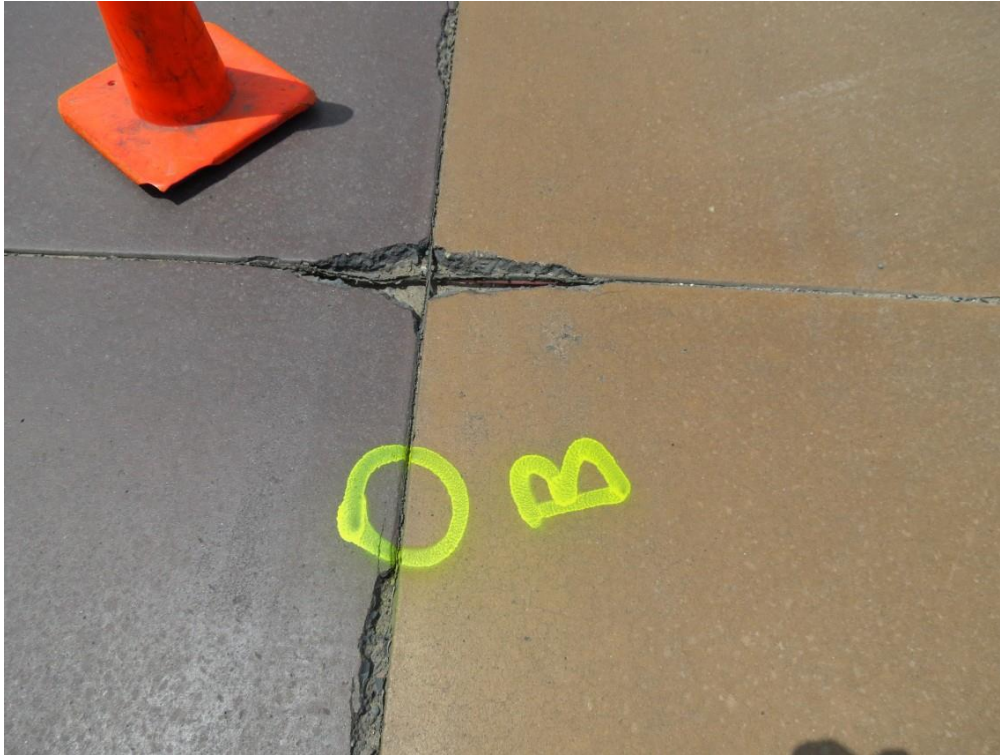
Figure 4.10 Centerville - Core location 14B, June 2012

Core sample 14B was taken several panels away, in the same longitudinal joint as Core sample A. This time the core sample straddled panels with different colors: dark red and tan. Figure 4.10 shows the location where the core sample was taken in June 2012. Figure 4.11 shows the same location in May 2013.

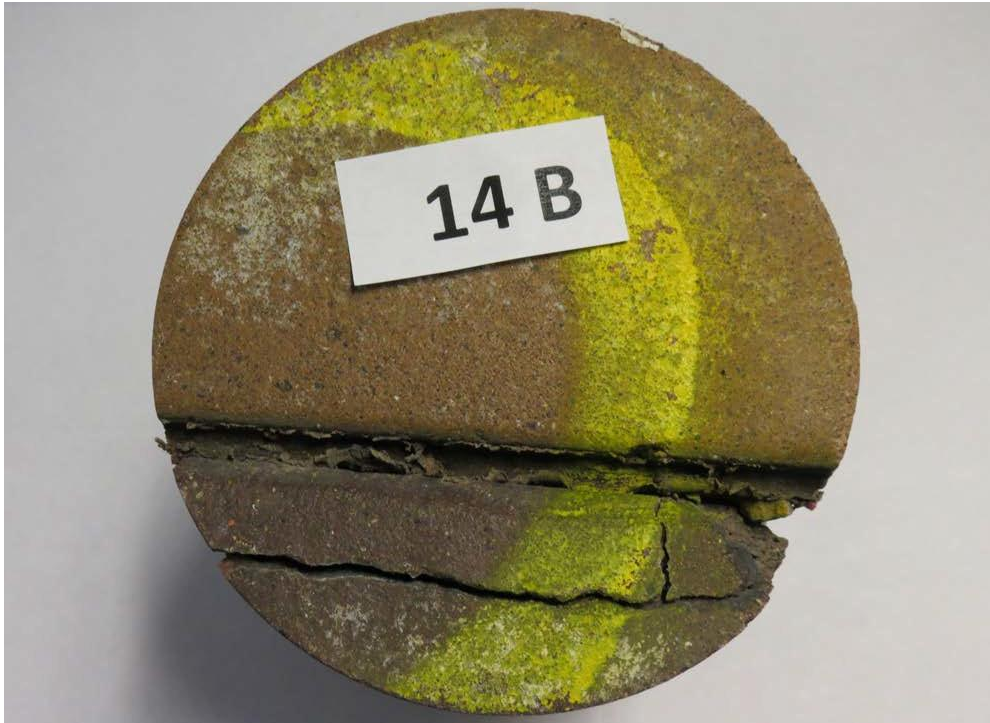
- of the joint.
- Despite the joint sealant material continuing to be firmly attached to one side of the joint, the deterioration has rendered the other side to be ineffective. The crack parallel to the joint is likely allowing an increased amount of moisture into the joint, thus accelerating the deterioration.

Figure 4.13 Centerville- Top of Core 14B, showing parallel crack that formed above the region of deterioration.

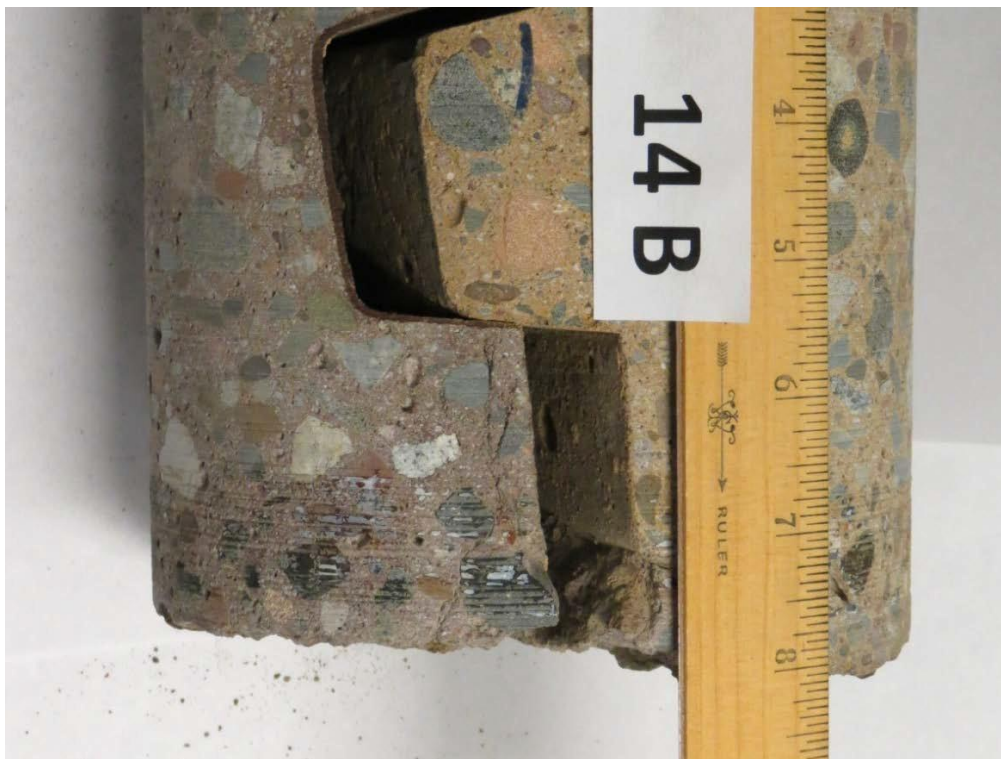
Figure 4.14 Centerville - Core 14B showing vertical cracks in darker colored side of joint near bottom of pavement

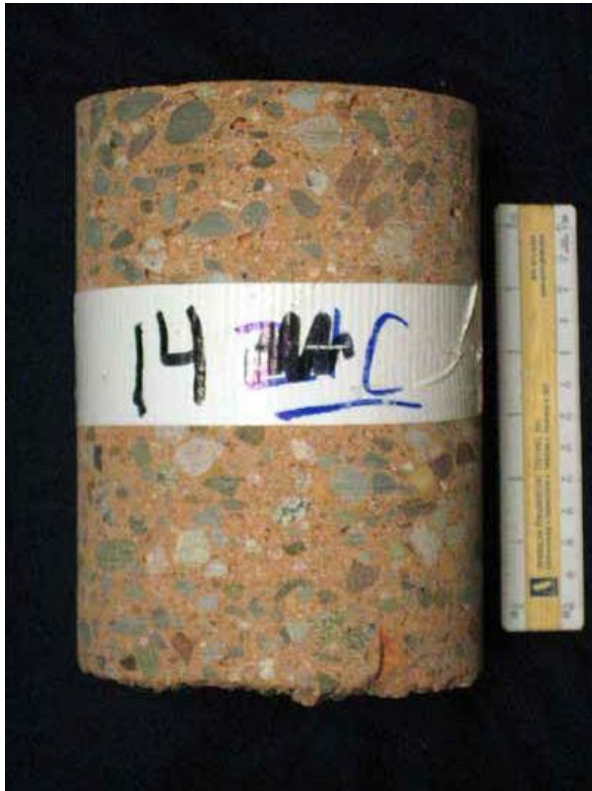
Core sample 14C was taken in the middle of a panel in the westbound travel lane of County Highway 14. Figure 4.15 shows the location where the core sample was taken. As with the surface, the lower portion of the core appeared to be in very good condition. Figure 4.16 shows the condition of the pavement throughout its depth.

Figure 4.16 Centerville - Core 14C showing good condition throughout depth

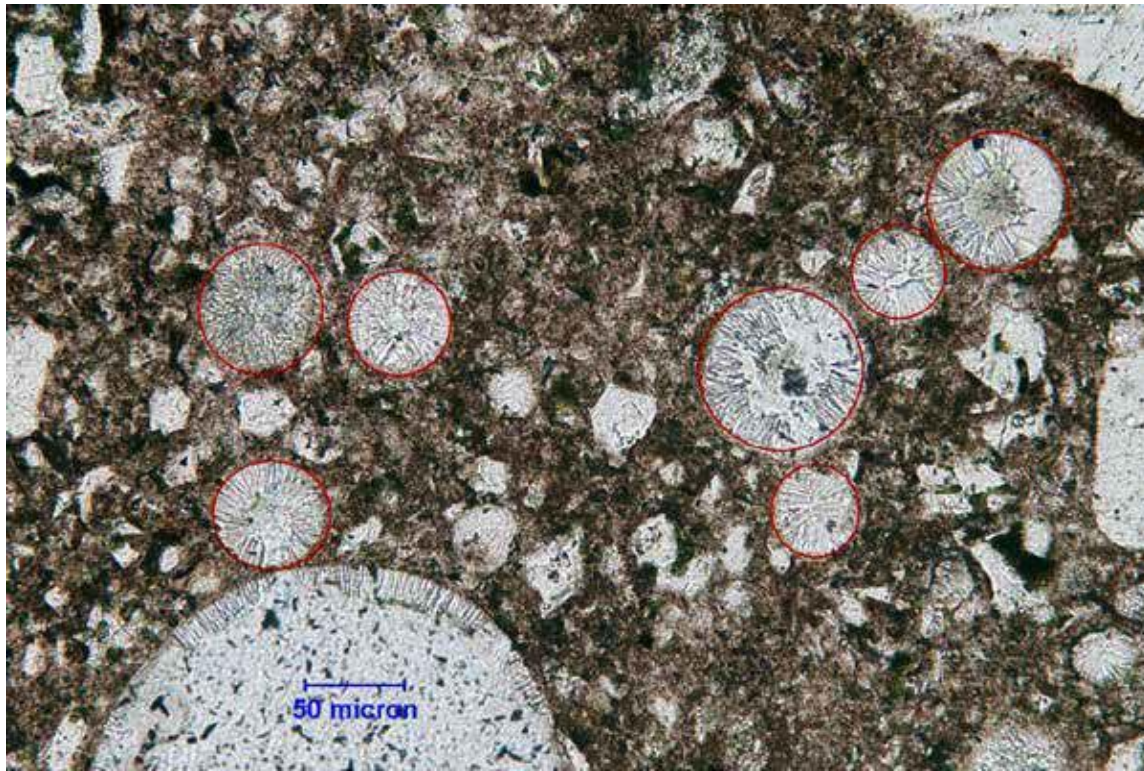
- Closer examination of the surface revealed several fine, sub-vertical, drying shrinkage microcracks that proceed to a maximum depth of 15mm.
- A close-up examination of the smallest air voids revealed that they were partially to completely filled with secondary ettringite crystals, thus reducing the capacity of freeze-thaw resistance of the paste. Figure 4.17 shows the filled voids.

- The water-to-cementitious ratio throughout the core sample was estimated to be between 0.44 and 0.49. This exceeds the general recommended maximum of 0.45 for freeze-thaw resistant concrete [10]. Higher water-to-cementitious ratio mixes correlate

Figure 4.17 Centerville – Voids in Core 14C mostly filled with secondary ettringite crystals (circled in red)

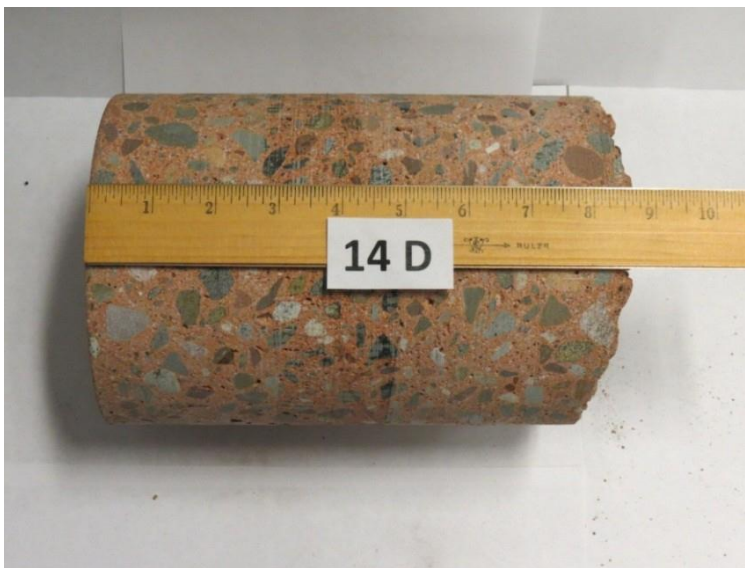
- The average measured core length was 8.25 inches.
- Examination of the core shows that its overall condition was very good. See Figure 4.19.
- Consolidation of the mix and distribution of the visible air voids appeared to be adequate. Without further analysis, comments on the internal condition of the core are not justified.
- The surface appeared to have a lightly broomed texture.

Figure 4.19 Centerville - Core 14D showing good condition throughout depth

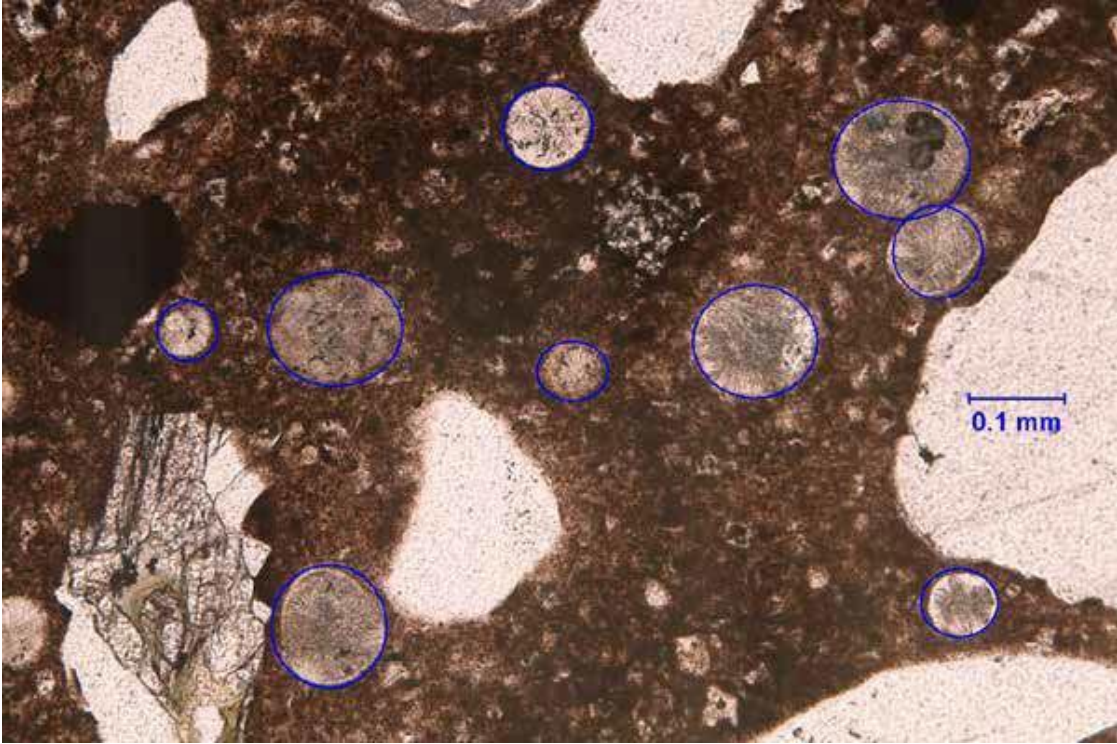
Figure 4.23 Centerville – Voids in Core 14E mostly filled with secondary ettringite crystals (circled in blue)

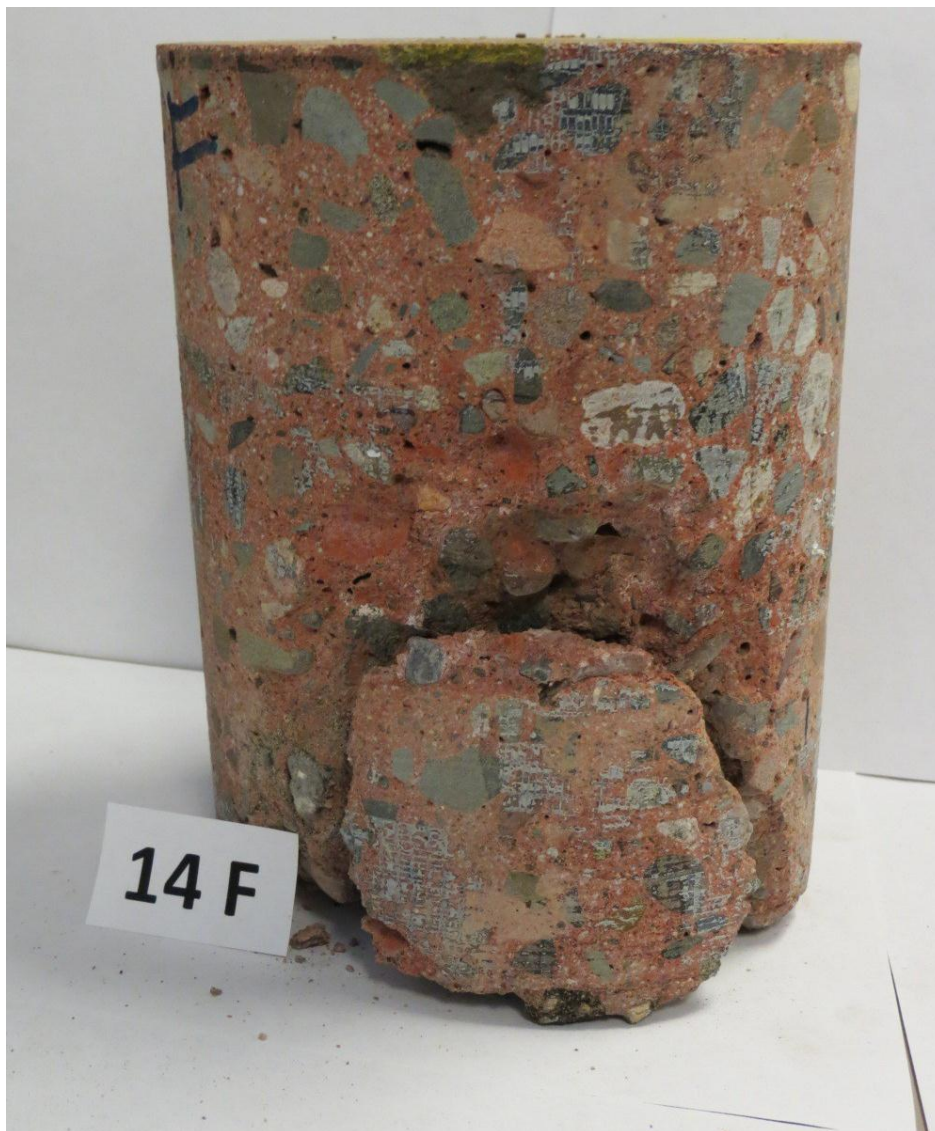
Figure 4.25 Centerville - Core sample 14F

- The average measured core length was 7.75 inches.
- The surface showed no distress, and has a very lightly broomed texture.
- Examination of the core shows that it intersected the bottom portion of a neighboring joint. See Figure 4.25. There seemed to be the possibility that deterioration was occurring in the joint just above the portion extracted with the core sample. See Figure 4.26.
- The presence of several medium to large air voids suggests that the consolidation of the mix was fair to good.
- Without further analysis, comments on the internal condition of the core are not justified.

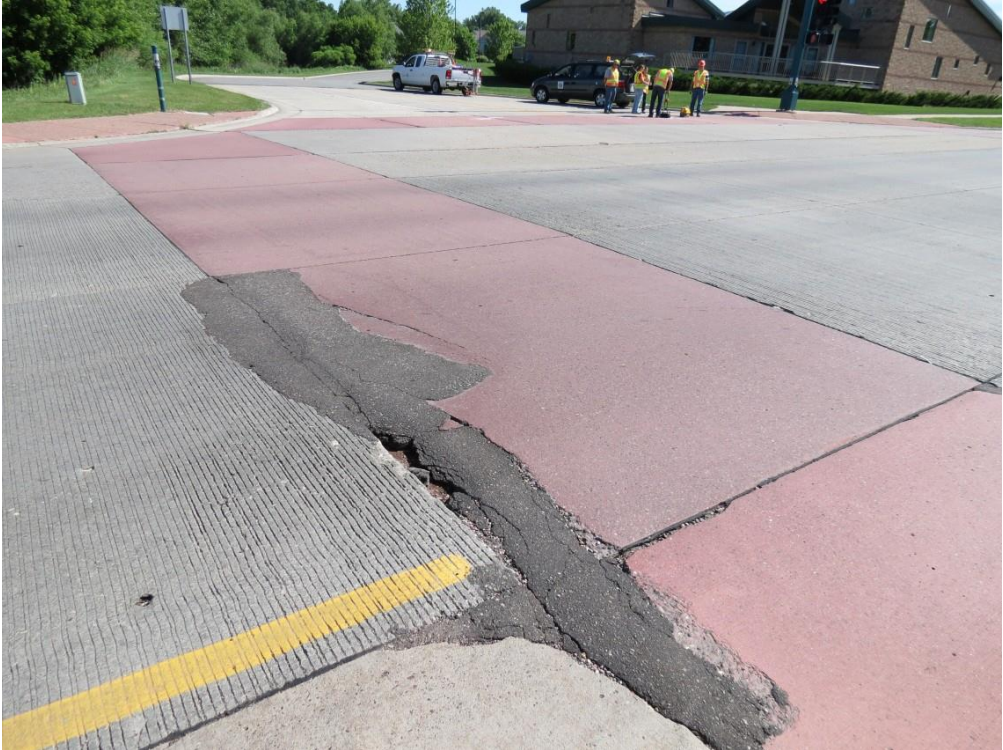
Figure 4.29 Joint and panel deterioration occurring in colored concrete crosswalks at intersection of County Highway 96 and Greenhaven Drive in Vadnais Heights, MN

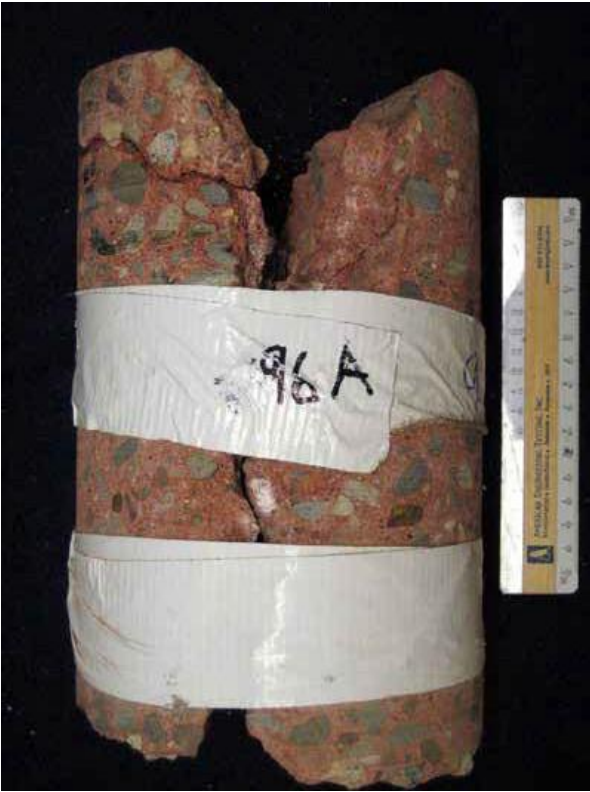
Core sample 96A was taken directly over a severally distressed joint in the northern crosswalk spanning Greenhaven Drive. The coring location is shown in Figure 4.31. The sample showed significant deterioration both near the top and bottom of the joint. See Figure 4.32.

Figure 4.32 Vadnais Heights - Core sample 96A showing significant deterioration in top and bottom regions of joint

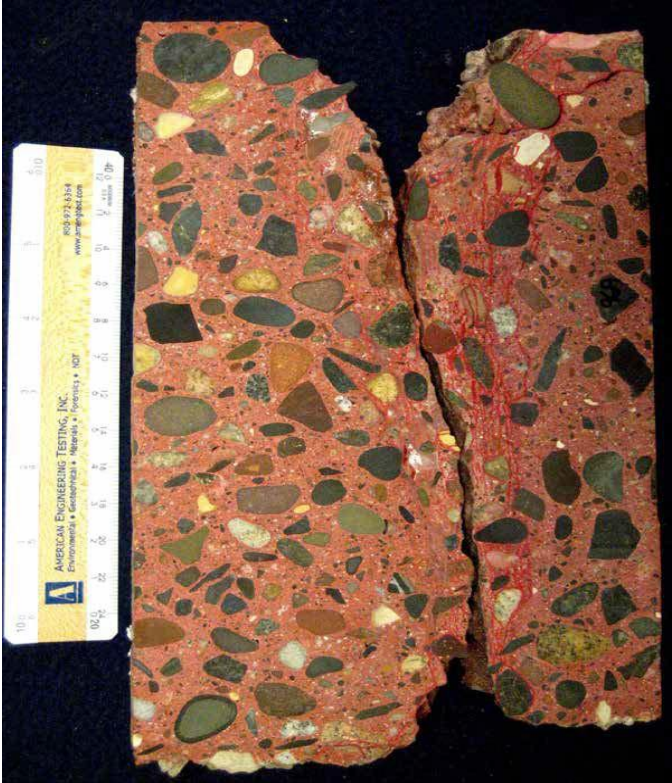
- Closer examination of the joint revealed vertical micro and macro-cracking extending from the top to the bottom of the core sample. These cracks are highlighted in Figure 4.34. The cracks were prevalent in both the paste and around aggregate particles.

Figure 4.34 Vadnais Heights - Core sample 96A showing significant material loss near the top and bottom of the joint. Vertical cracking is also extensive parallel to the joint, highlighted by red ink.

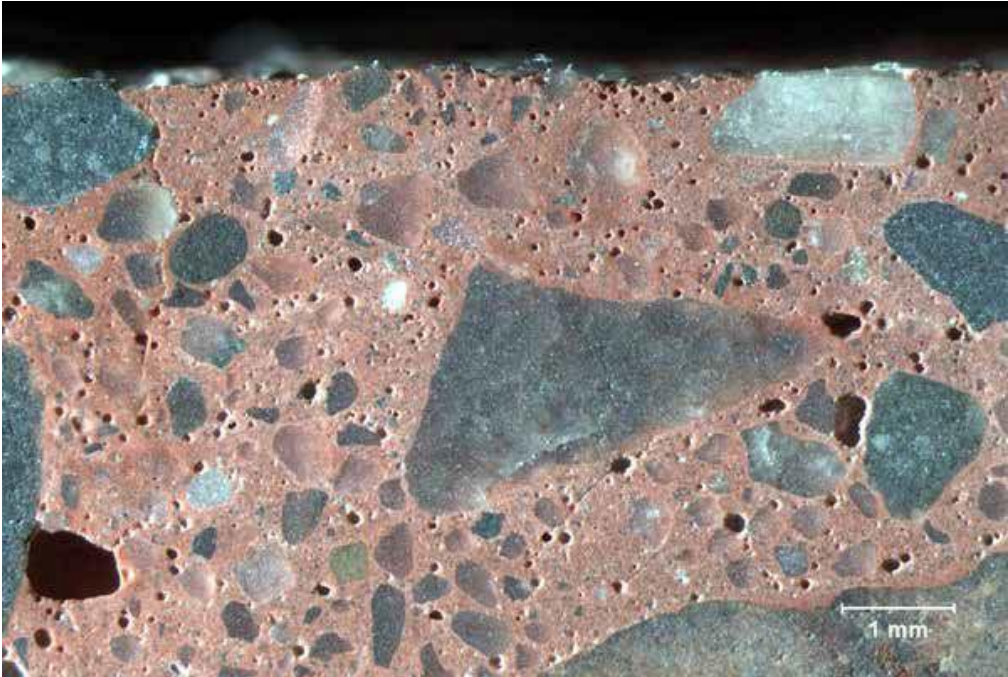
- A close-up examination of the air voids near the top of the sample revealed they were clean and unfilled. In contrast, air voids near the joints and bottom of the sample were observed to be completely filled with secondary ettringite crystals, thus rendering the voids unable to aid in freeze-thaw resistance of the paste. Figures 4.35 and 4.36 show the air voids in the two different regions.

Figure 4.35 Vadnais Heights - Core sample 96A showing unfilled air voids near top of pavement

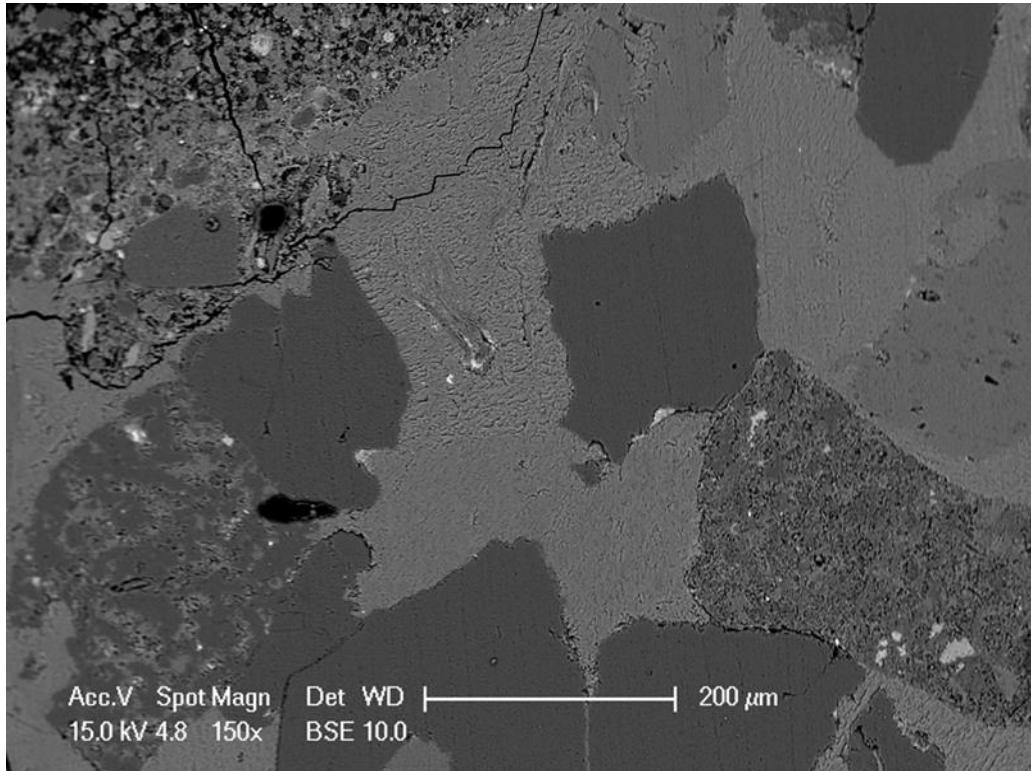
- In Figure 4.37, the majority of the non-quartz particles in the image are highly altered cement paste or aggregate, with small inclusions of ettringite, magnesium oxides (likely dehydrated magnesium hydroxide), and other phases. The cause for this behavior is likely due to chemical attack from deicers or other weathering forces (e.g., freeze-thaw cycling).

Figure 4.37 Vadnais Heights – Portion of core sample 96A, showing backscattered electron image of chemically altered cement paste and aggregate near the joint
