Investigation and Assessment of Colored Concrete Pavement

Minnesota
Department of
Transportation

August 2014

Research Project
Final Report 2014-26

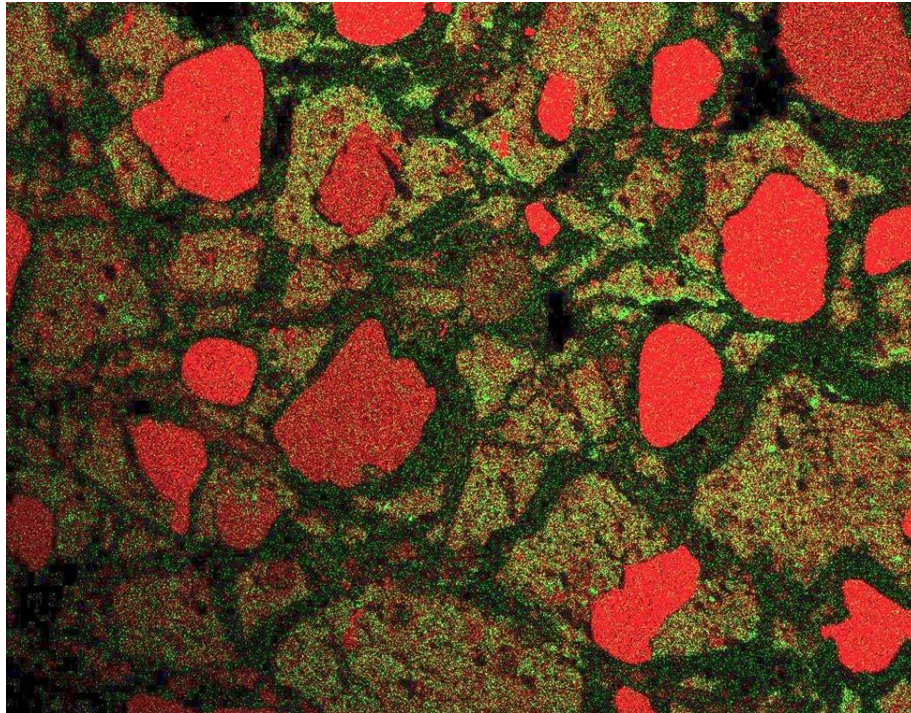
- In Figure 4.38, the EDX image highlights the sand grains (red) and also shows a broad, low concentration distribution of magnesium (green), likely associated with magnesium chloride deicing chemicals.

Figure 4.38 Vadnais Heights – Portion of core sample 96A, showing EDX image indicating presence of magnesium (green colors) throughout specimen

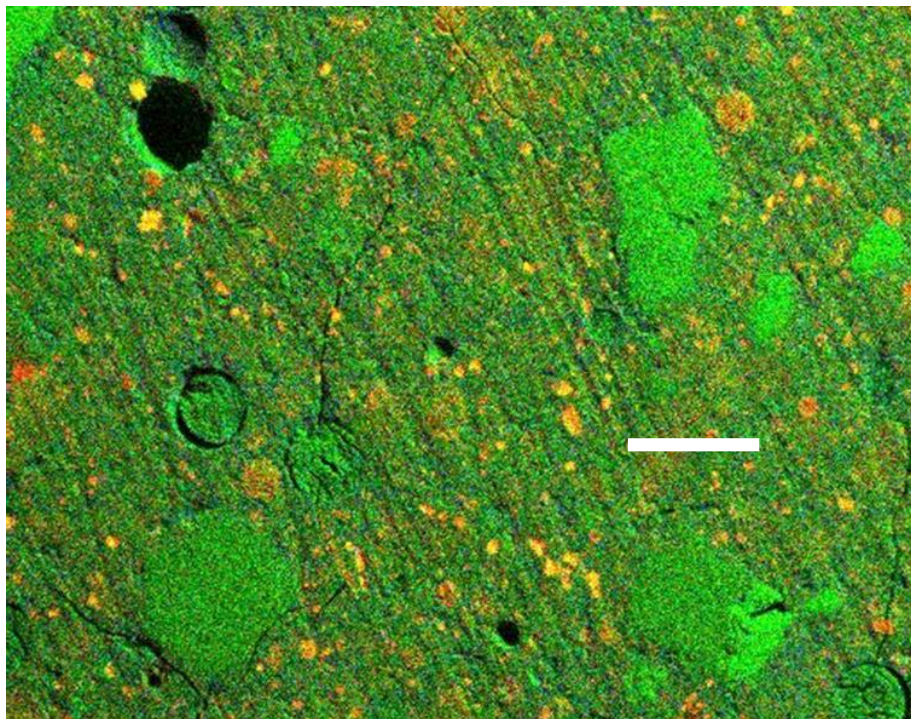
- Magnesium-bearing solutions are moving through the concrete and magnesium is depositing in voids as either an oxide or hydroxide. See Figure 4.39.
- Alkali-rich fine aggregate feldspar particles are reacting with magnesium solutions (blue) moving through the concrete. See Figure 4.40. Also note that most of the aggregate particles are lined by the iron-based pigment particles (green).

Figure 4.39 Vadnais Heights – Portion of core sample 96A, showing EDX image with magnesium oxide (yellow) filling voids

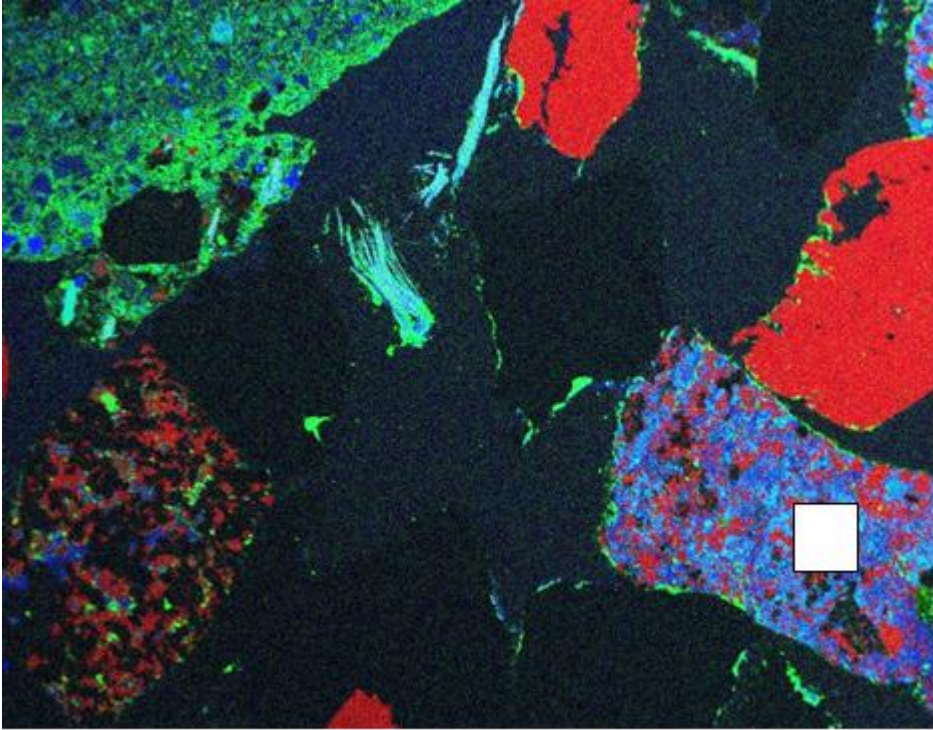
Figure 4.40 Vadnais Heights – Portion of core sample 96A, showing EDX image with magnesium (blue) infiltrating feldspar particle (marked “A” in lower right). The iron-based color pigment is indicated in green.

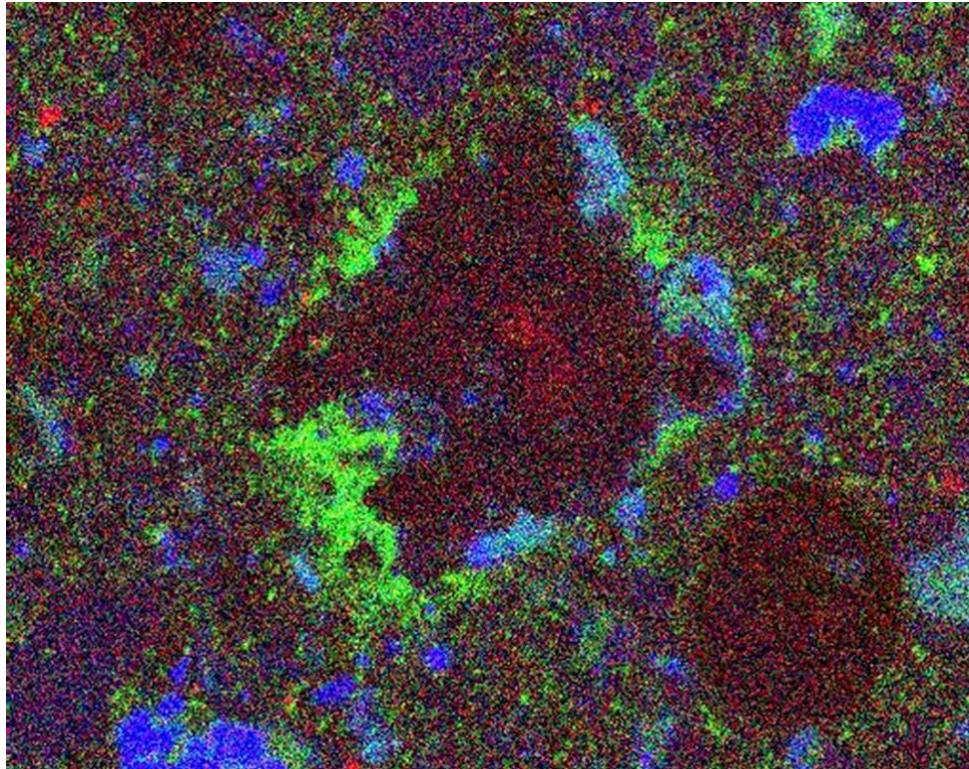
- with concentrated iron-based pigment. See Figure 4.41.
- Due to the single sample and small specimen size, the research team was not yet comfortable identifying the exact mechanism of the chemical attack.

Figure 4.41 Vadnais Heights – Portion of core sample 96A, showing EDX image with magnesium (blue) and iron-based pigment (green) coinciding throughout the paste

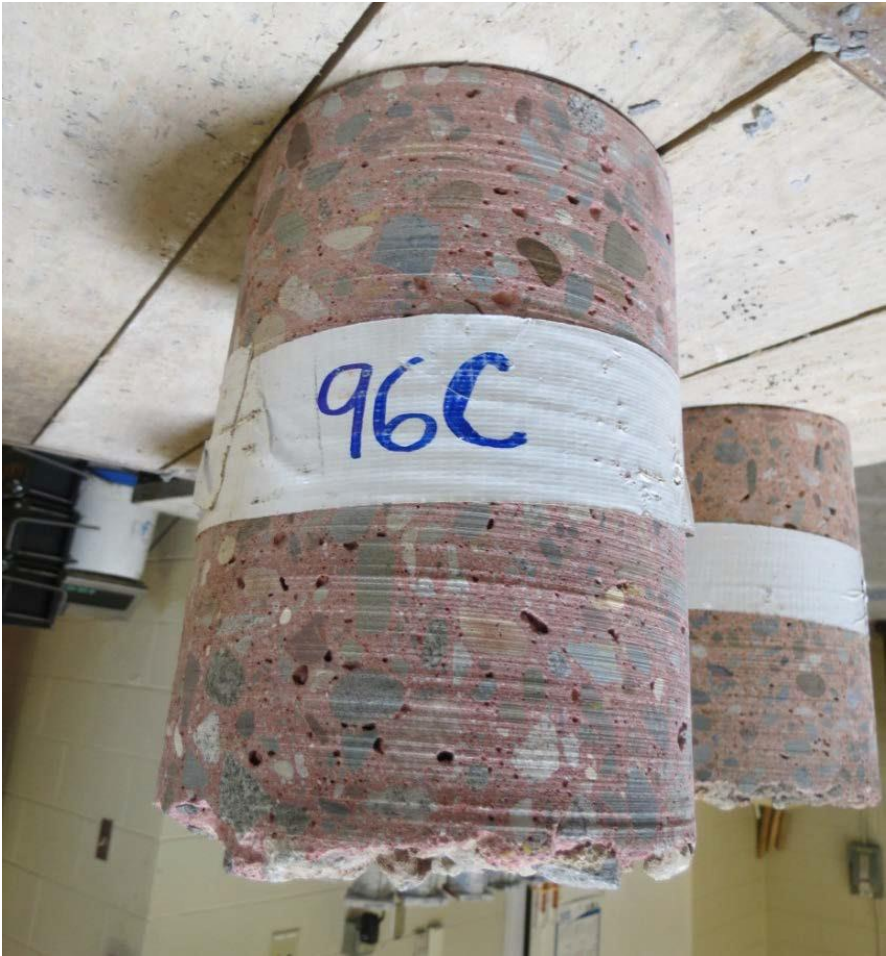
Figure 4.44 Vadnais Heights - Core sample C

Core sample 96C was taken in the middle of a panel in the crosswalk. The coring location is shown in Figure 4.43. The sample did not show any visible distress. See Figure 4.44.

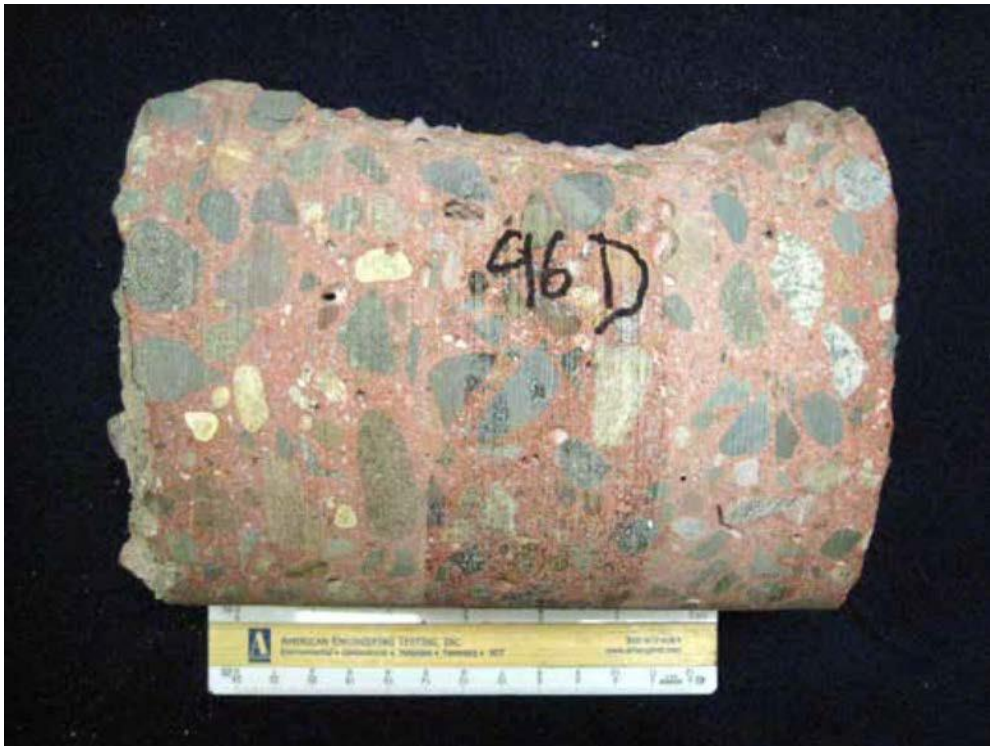
Core sample 96D was taken immediately adjacent to a severely distressed joint in the northern crosswalk spanning Greenhaven Drive. The coring location is shown in Figure 4.47. Figure 4.48 shows that the core sample had a significant amount of material missing at the mid-depth of the joint. Cracking along the joint face was evident, as shown in Figure 4.49.

Figure 4.48 Vadnais Heights - Core sample 96D (top of sample on right)

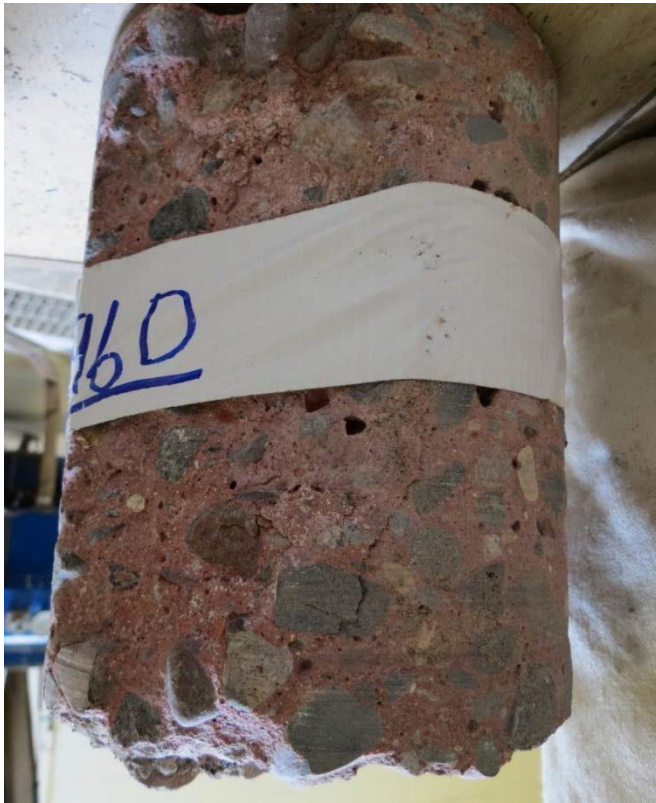
Figure 4.49 Vadnais Heights - Core sample 96D. Note cracking near joint face

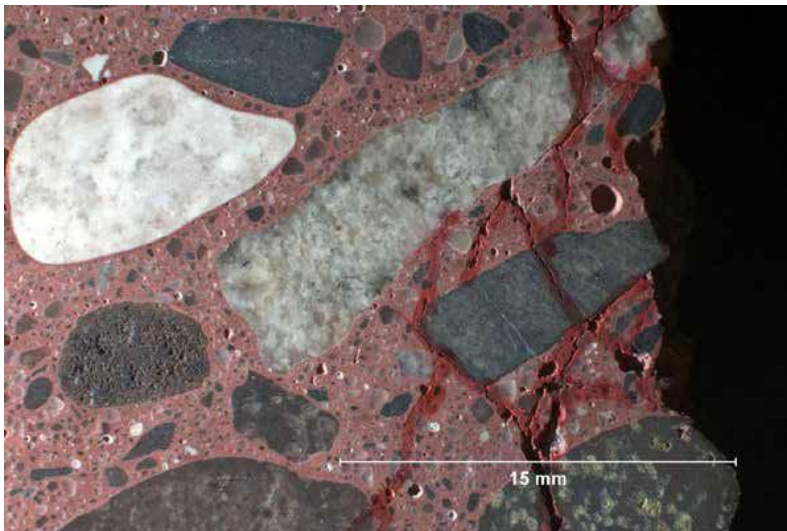
- The paste portion was deemed to be relatively hard, however the paste- to-aggregate bond strength was rated as “fair to poor.”
- Closer examination of the sample near the pavement surface revealed numerous vertical microcracks within 25 mm of the joint crack. See Figure 4.50.

Figure 4.50 Vadnais Heights - Core sample 96D. Note microcracking near joint face (highlighted in red ink)

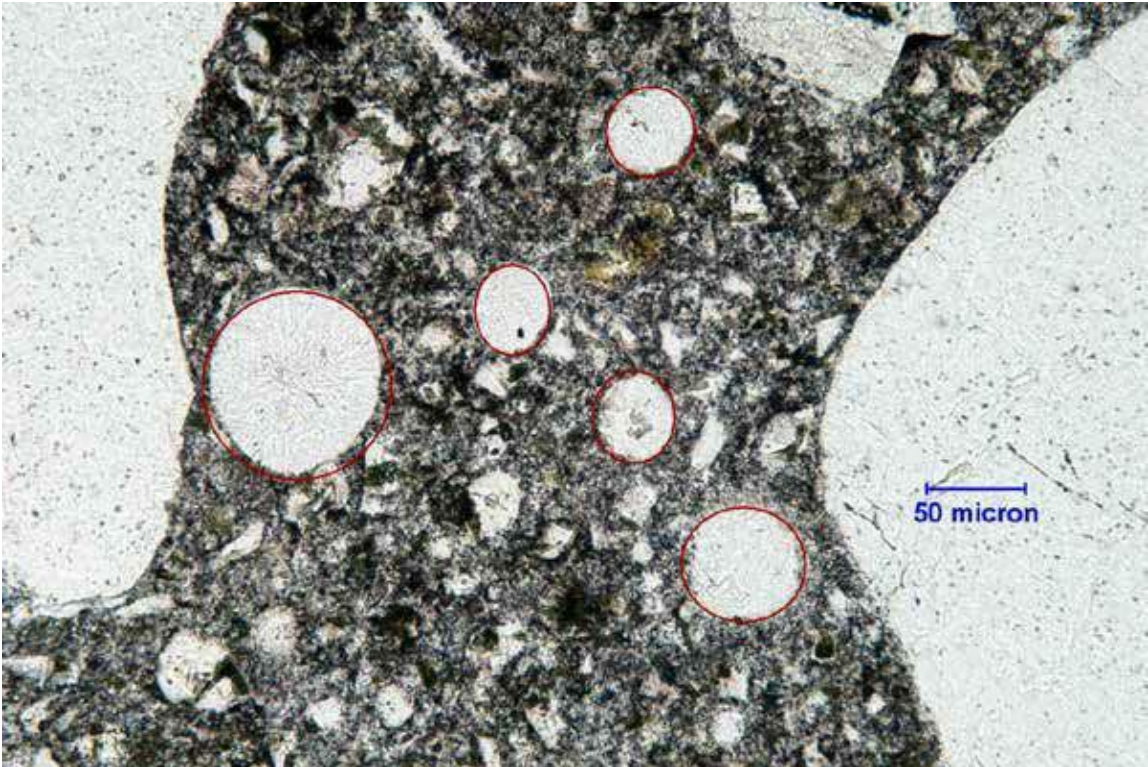
- A close-up examination of the air voids, throughout all but the top 5mm of the sample, revealed that most of the finest entrained air voids were filled with secondary ettringite crystals, thus rendering the voids unable to aid in freeze-thaw resistance of the paste. See Figure 4.51.

Figure 4.51 Vadnais Heights - Core sample 96D showing air voids (under polarized light) throughout the pavement filled with secondary ettringite (circled in red)

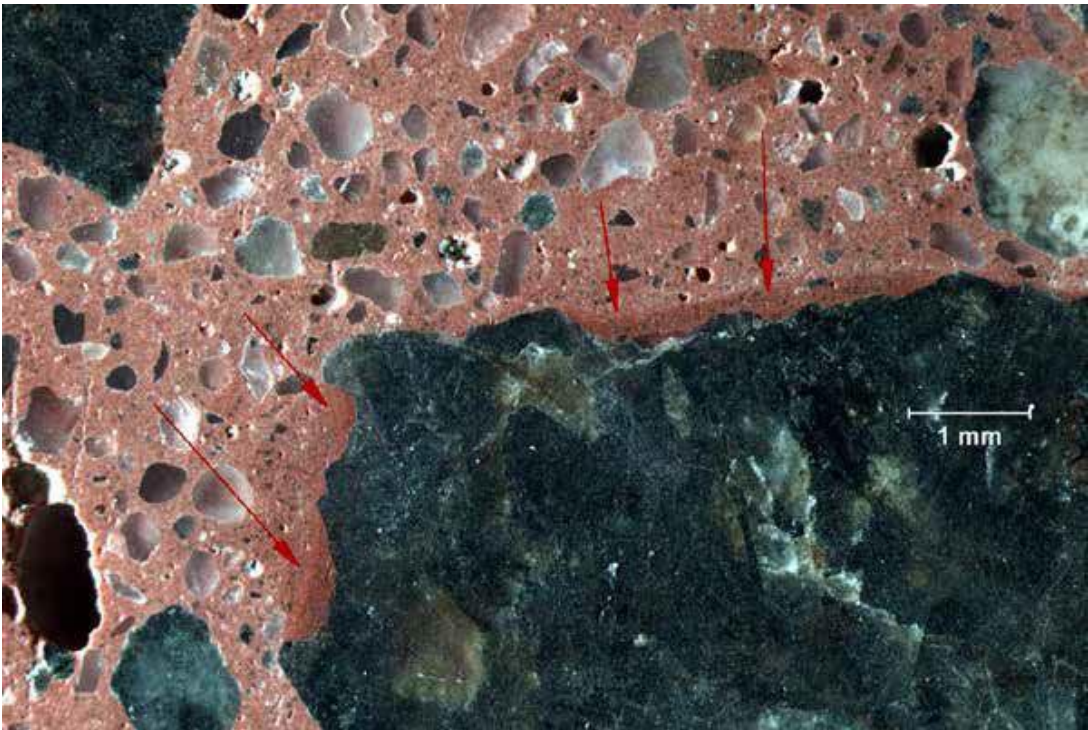
- Distinct, darker colored, denser paste of lower w/cm was observed in many concave coarse aggregate notches. This suggests that multiple additions of water during batching. See Figure 4.52.

Figure 4.52 Vadnais Heights - Core sample 96D showing darker, low w/cm paste, indicating multiple additions of water during batching

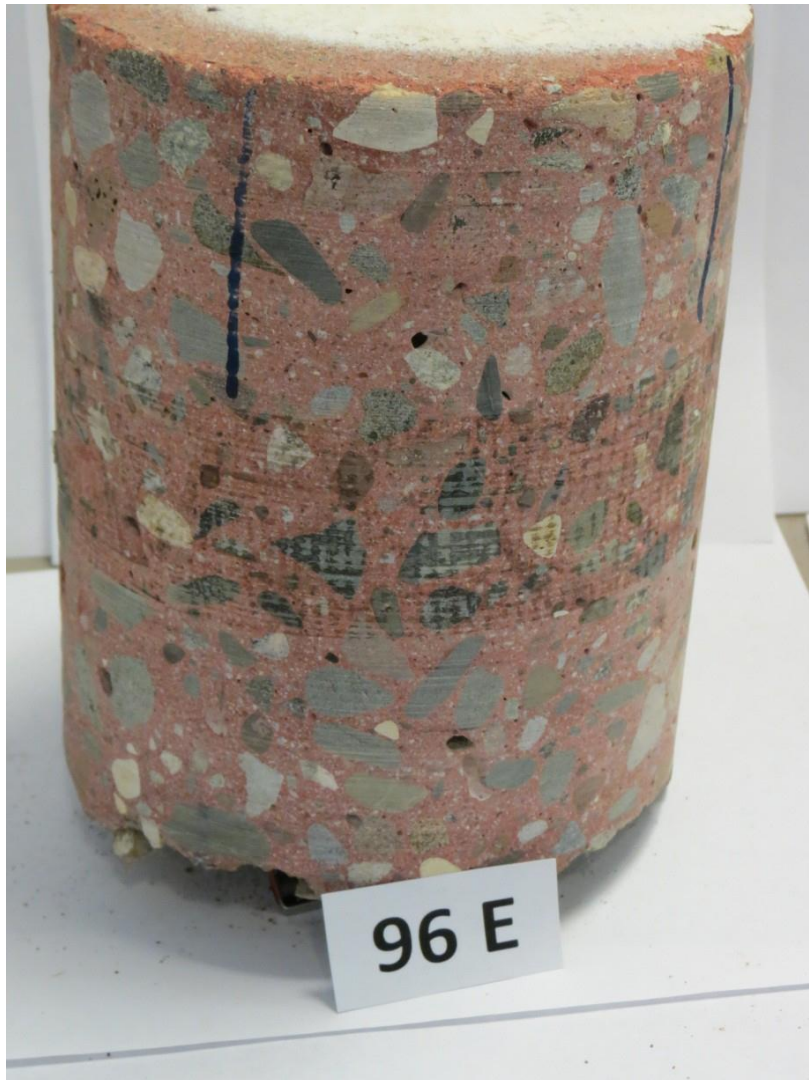
Figure 4.53 Vadnais Heights - Core 96E

- The average measured core length was 7.25 inches.
- The sides of the core sample appear to be in good condition, with no visible cracks or signs of distress. See Figure 4.53.

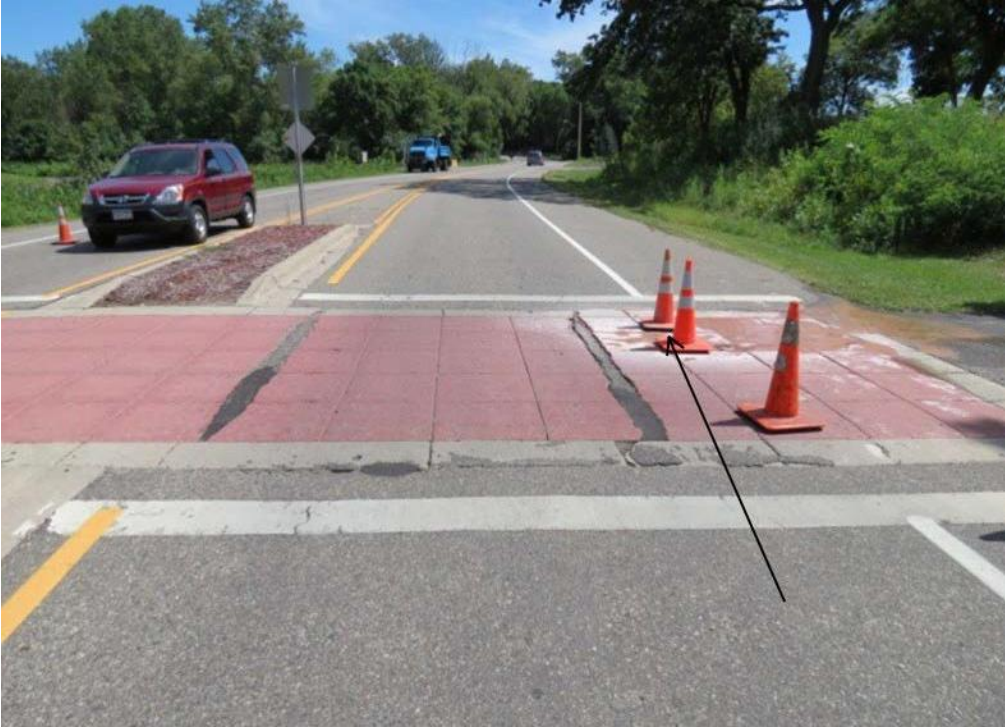
Figure 4.54 Crosswalk on eastbound lane of Lake Johanna Boulevard in Arden Hills. Due to access limitations, core samples were taken from a neighboring joint line.

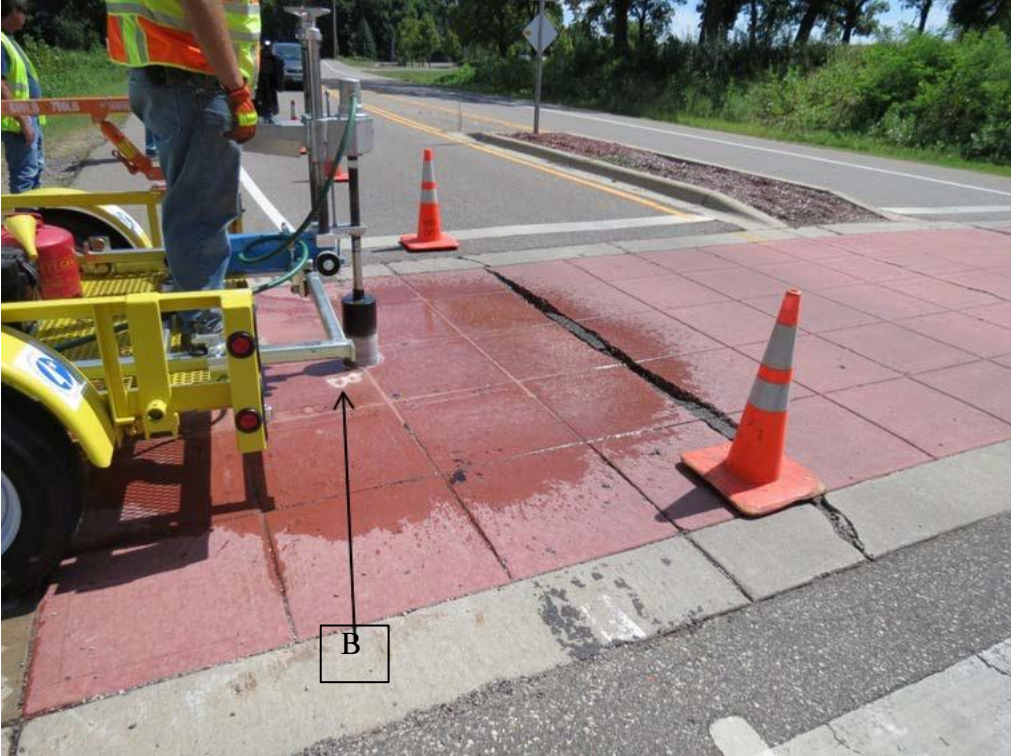
Figure 4.55 Crosswalk on westbound lane of Lake Johanna Blvd. in Arden Hills. Due to access limitations, core samples were taken from a neighboring joint line.

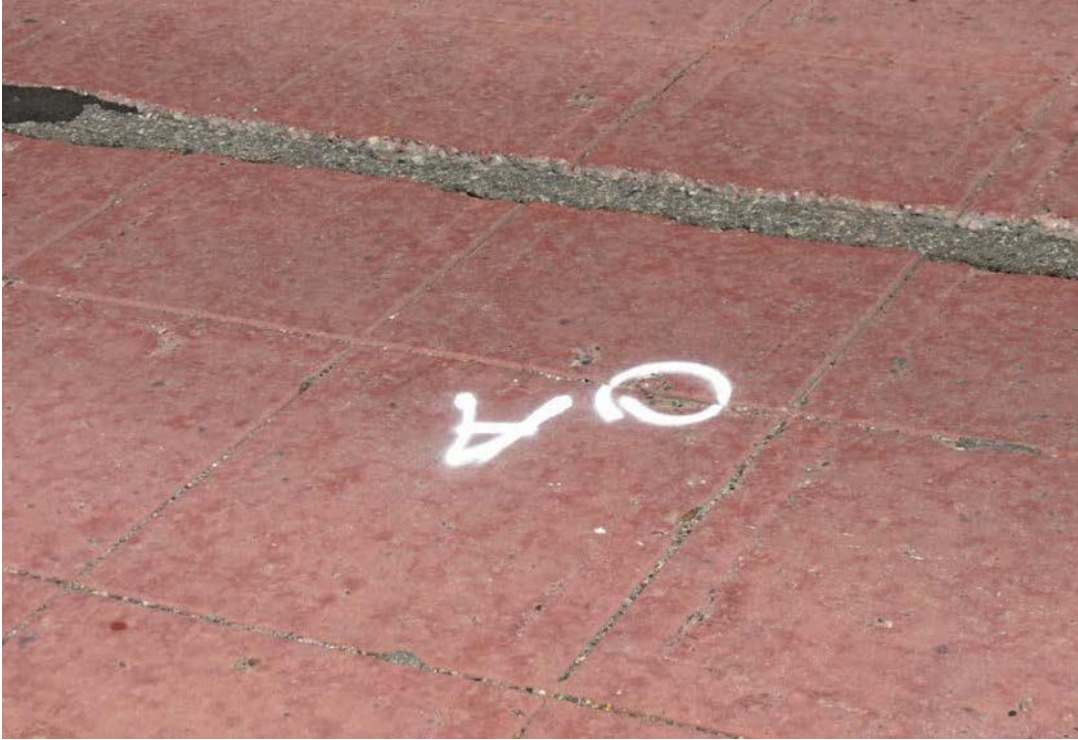
Figure 4.56 Arden Hills - Core location LJEB-A

coring location is shown in Figure 4.56. As shown in Figure 4.57, the only visible “distress” was the short vertical crack created during the tooling of the decorative joint.

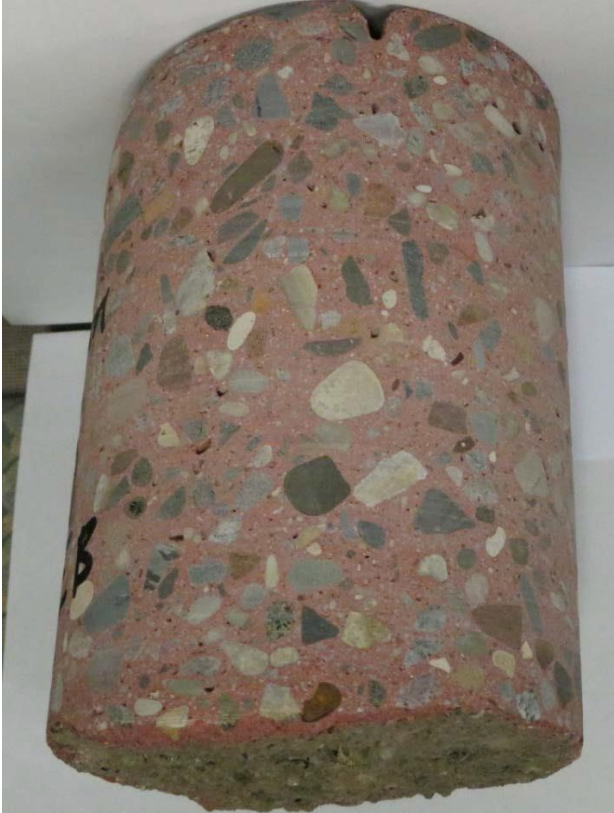
Figure 4.57 Arden Hills - Core sample LJEB-A

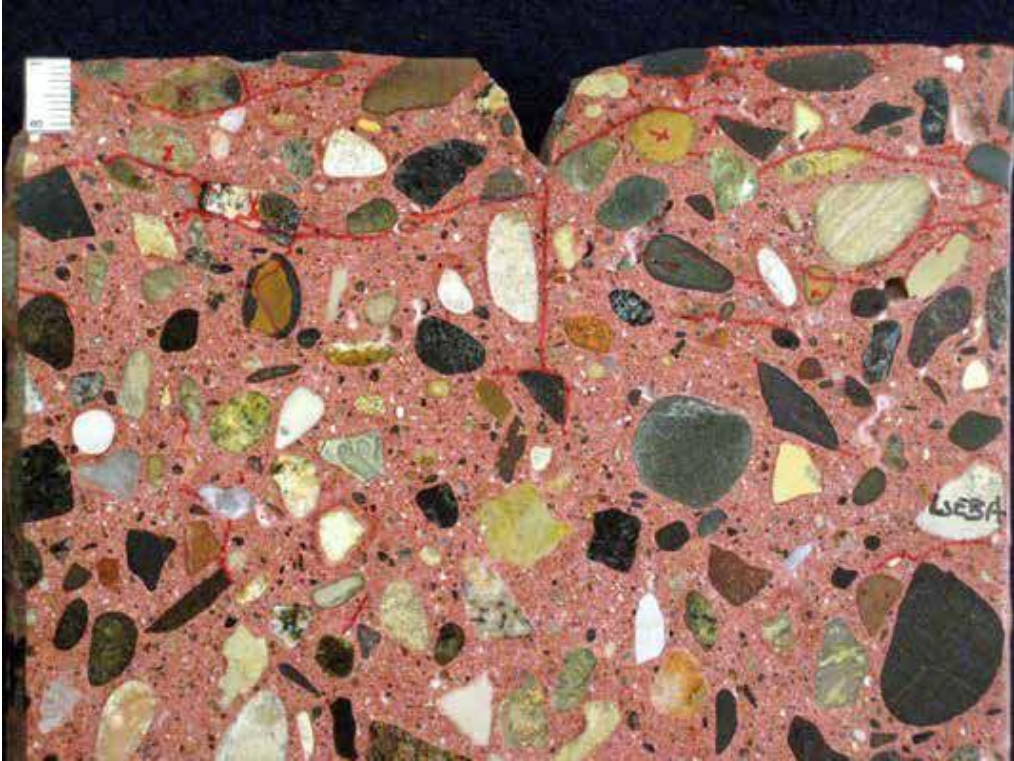
- Alkali-silica reaction (ASR) induced microcracking was found in both fine and coarse aggregates, particularly within the upper portion of the core sample. This is shown in Figures 4.59 and 4.60.

Figure 4.59 Arden Hills - Core sample LJEB-A showing vertical and horizontal ASR-induced cracks (highlighted in red ink)

Given the prevalent microcracking near the surface of the concrete, it is expected that the crosswalk will continue to deteriorate, especially in the areas of high loads and moisture contents (joints). Since the distress is currently close to the surface, it may be reasonable to do partial or full-depth joint repairs to extend the service life of this crosswalk. It might also be beneficial to apply a liquid sealant material to slow the ingress of water and reduce the growth of ettringite and ASR gel.

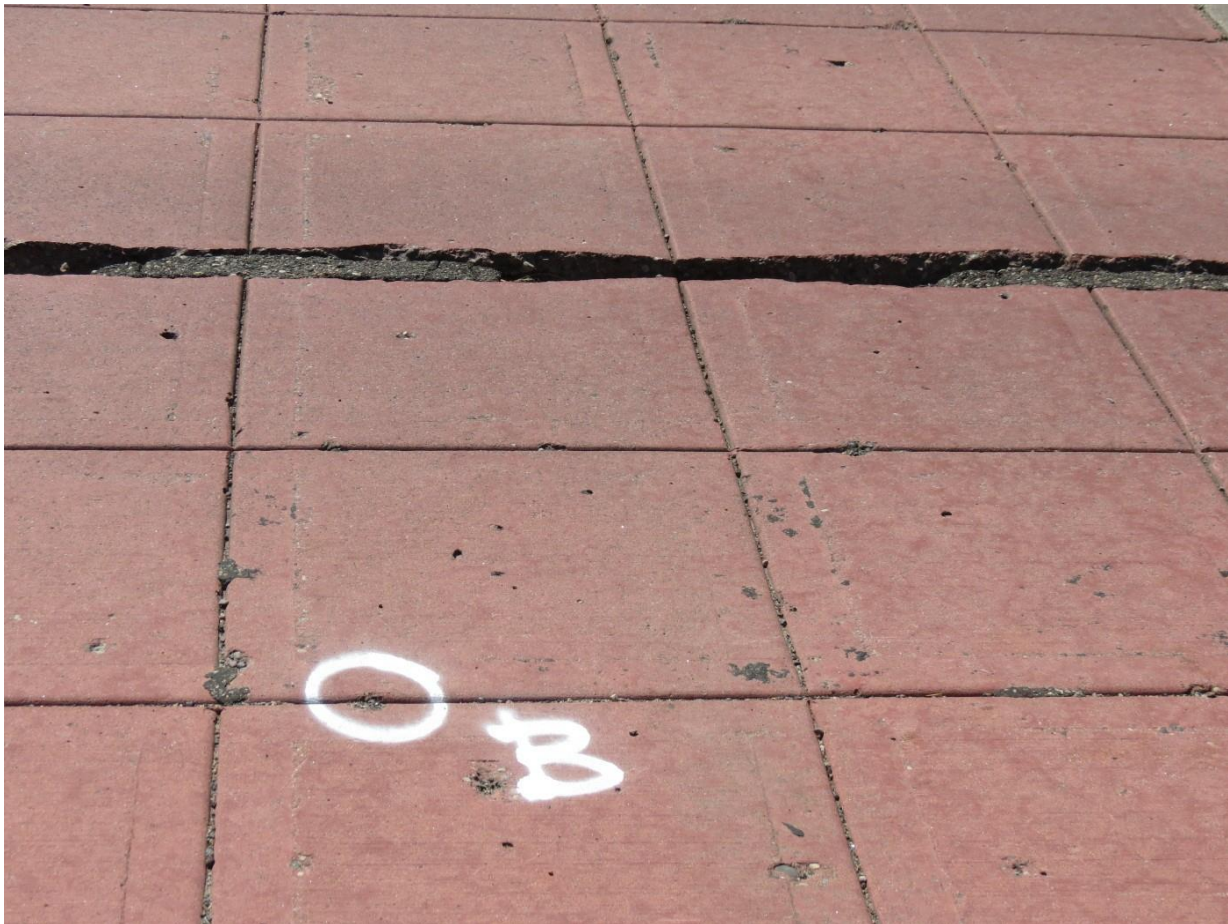
Figure 4.61 Arden Hills - Core location LJWB-B

Core sample LJWB-B was taken at approximately the center of a panel, over a formed decorative longitudinal joint, parallel to a distressed longitudinal contraction (sawed) joint. The coring location is shown in Figure 4.61. As shown in Figure 4.62, the only visible “distress” was the short vertical crack created during the tooling of the decorative joint.

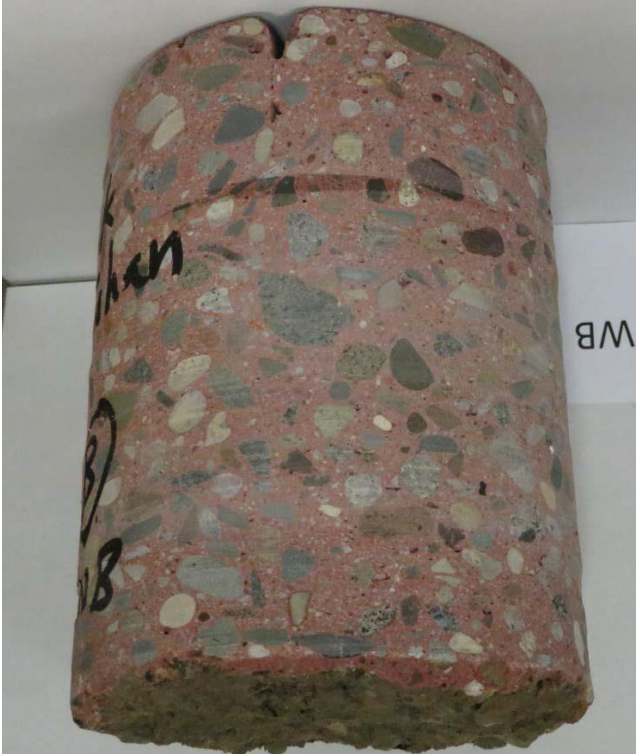
Figure 4.62 Arden Hills - Core sample LJWB-B

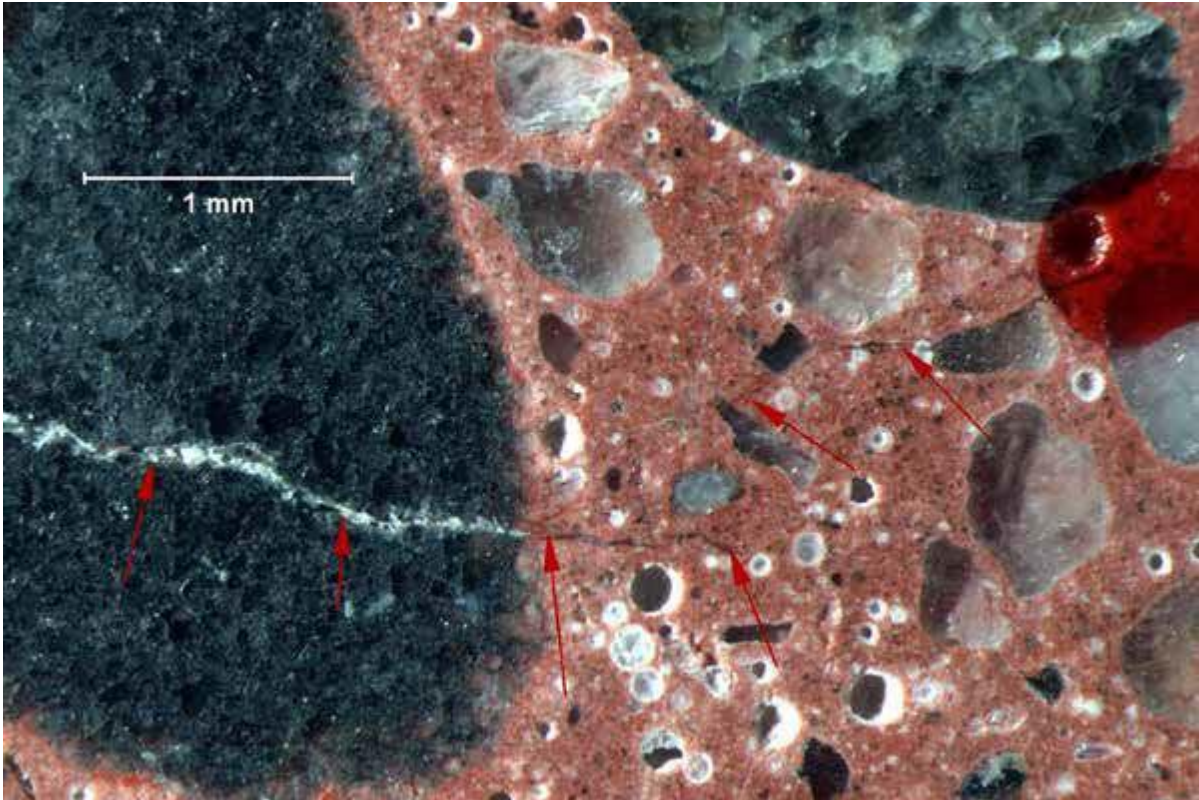
- A close-up examination of the air voids throughout the sample revealed that most of the entrained air voids were filled with secondary ettringite crystals, thus rendering the voids unable to aid in freeze-thaw resistance of the paste. Many larger air voids are also lined with secondary ettringite crystals.
- Alkali-silica reaction (ASR) induced microcracking was found in both fine and coarse aggregates, particularly within the upper portion of the core sample. This is shown in Figures 4.63 through 4.65.
- Refer to Appendix A for additional results of the petrographic analyses.

Figure 4.64 Arden Hills - Core sample LJWB-B showing clear ASR gel product within microcracks traversing both the paste and a greywacke coarse aggregate particle. Also note air voids filled with secondary ettringite.

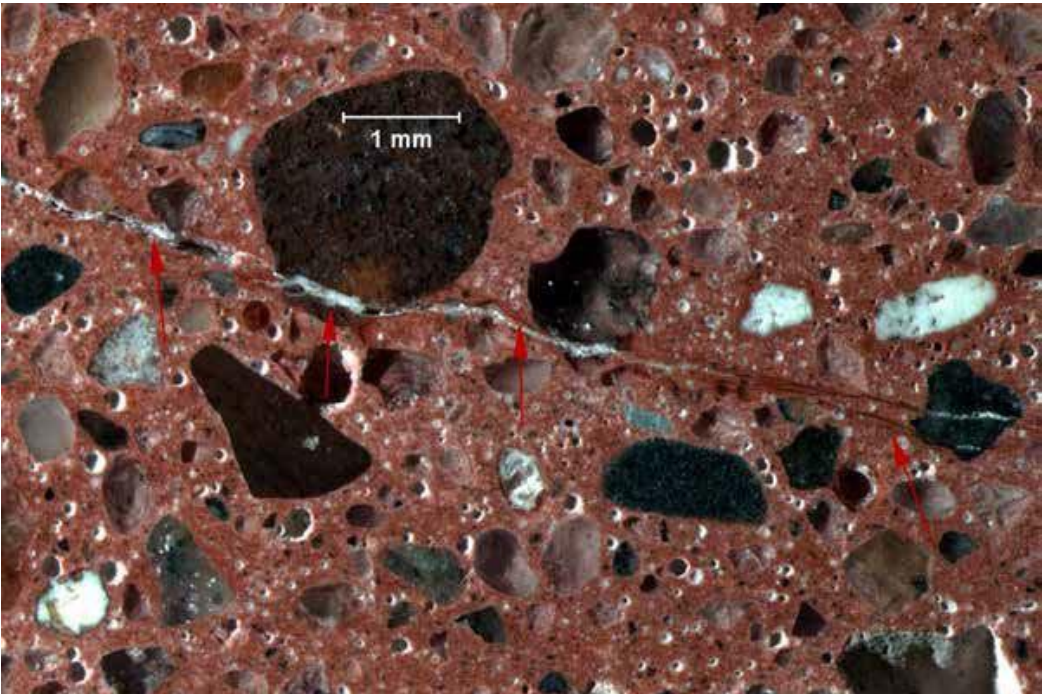
Figure 4.65 Arden Hills - Core sample LJWB-B showing white to clear ASR gel mostly filling microcracking proceeding through three reactive fine aggregates

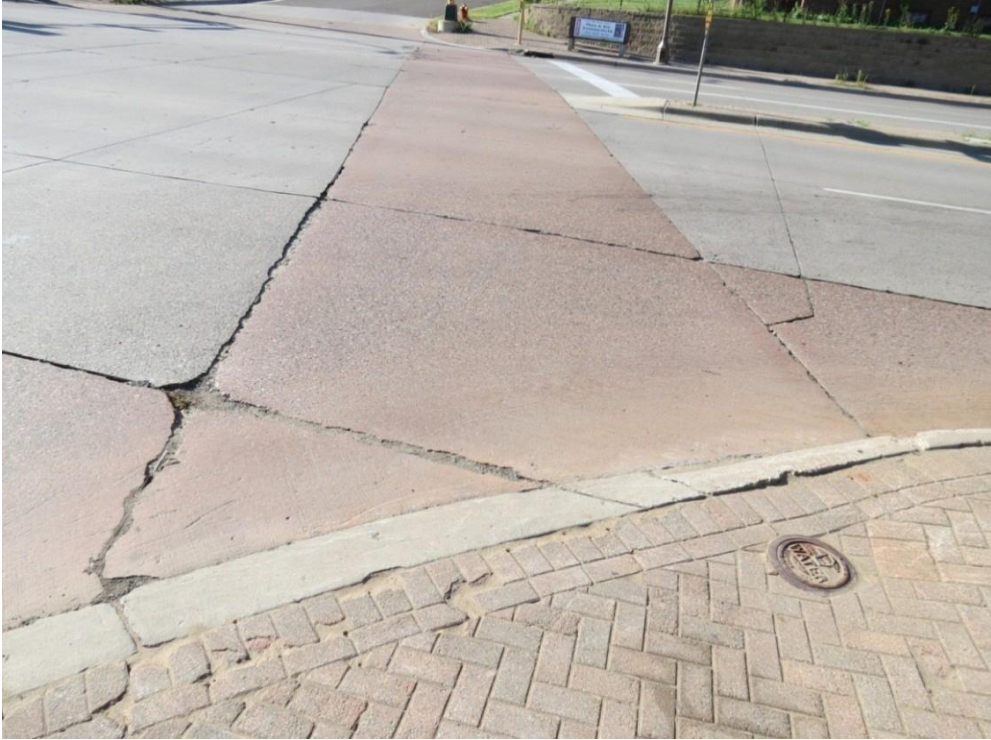
Constructed in 2001, the colored crosswalks within the intersection of Larpenteur Avenue and Fernwood Street in Roseville are showing significant joint and panel distress. Figures 4.66 and 4.67 show the condition of the crosswalks. A total of four core samples were taken on August 17th, 2012, from both distressed and sound joints and panels. Figure 4.68 shows the coring locations. Three of the samples were subjected to a detailed petrographic analysis. One sample was further investigated using the SEM and EDX techniques.

Figure 4.66 Distressed joints in crosswalks at intersection of Larpenteur Avenue and N Fernwood Street

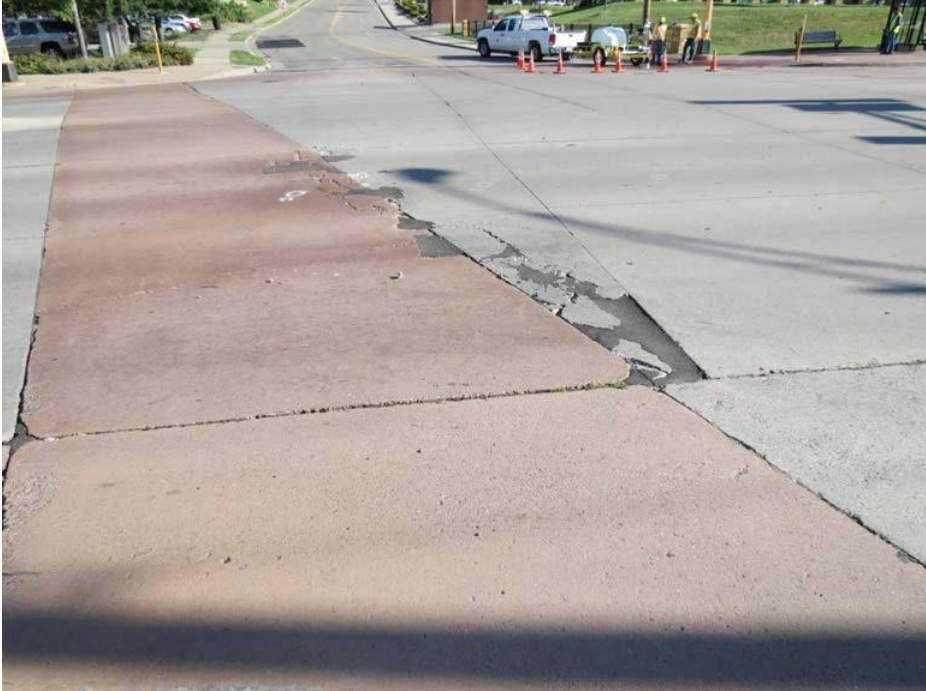
Figure 4.67 Distressed joints and panels in crosswalk at intersection of Larpenteur Avenue and N Fernwood Street

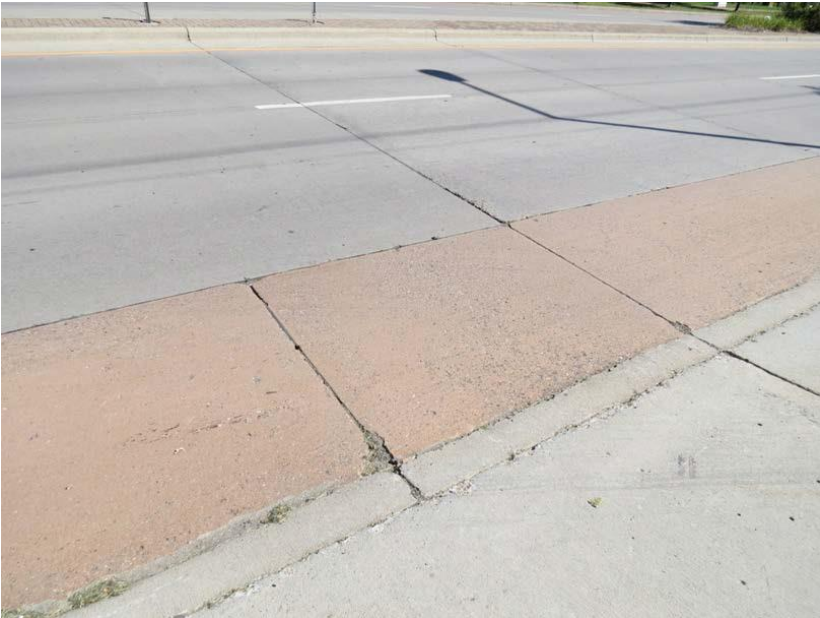
The predominant distresses observed in the crosswalks include both joint deterioration and significant cracking near the edge of panels. Figure 4.69 shows that minor distress was also observed in the joints of the parking lane along Larpenteur Avenue.

Figure 4.69 Distressed joints in parking lane along Larpenteur Avenue near Fernwood Street

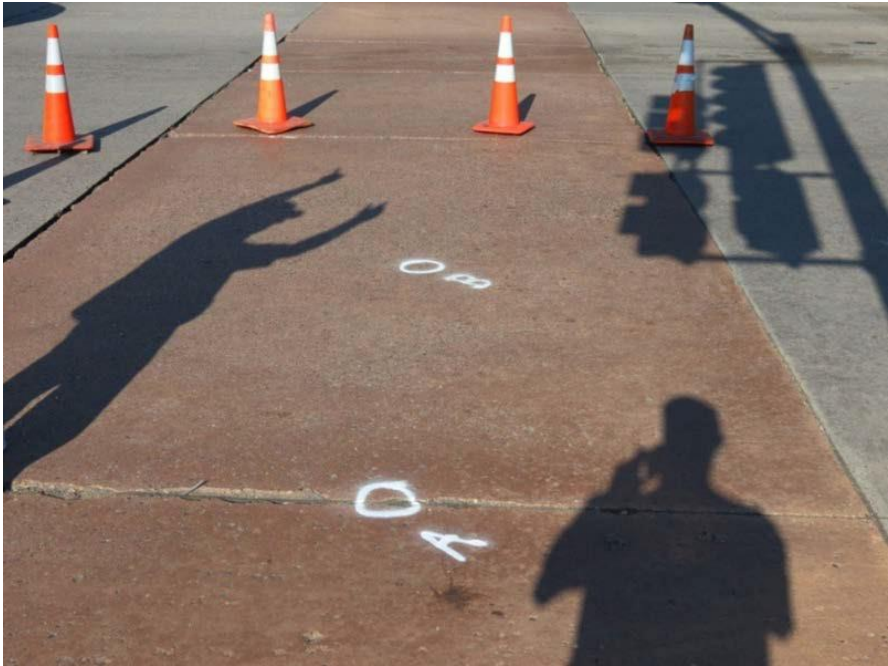
Figure 4.70 Roseville - Core locations L&F-A and L&F-B

Core sample L&F-A was taken over a distressed joint in the northern crosswalk spanning North Fernwood Street. Figure 4.70 shows the core location. The sample showed severe deterioration within the joint, both near the top and bottom of the pavement. Also, horizontal cracking was occurring near the bottom of the pavement. See Figures 4.71 to 4.72.

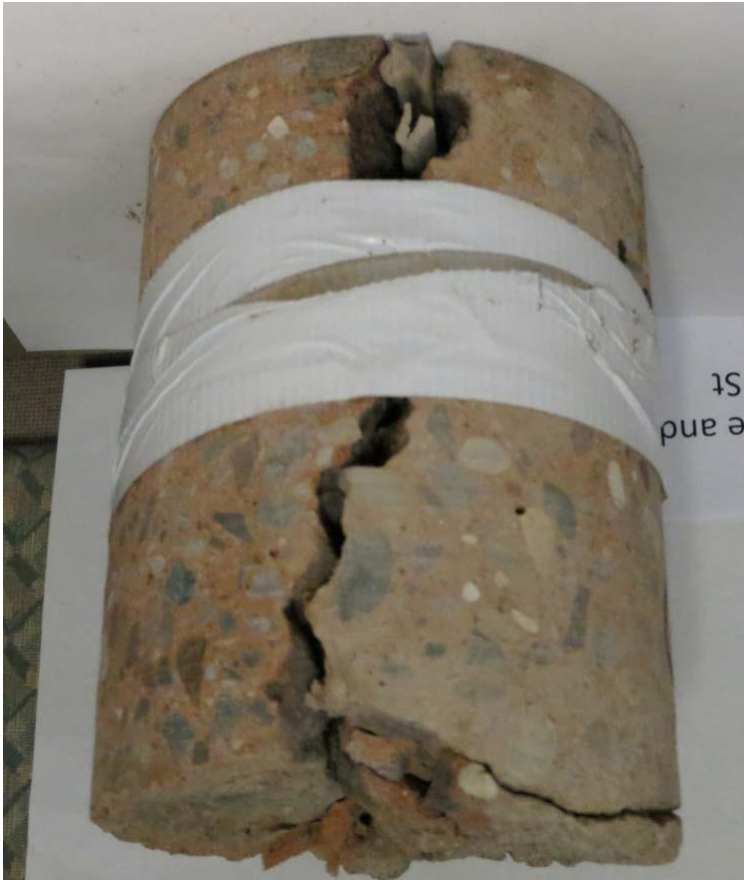
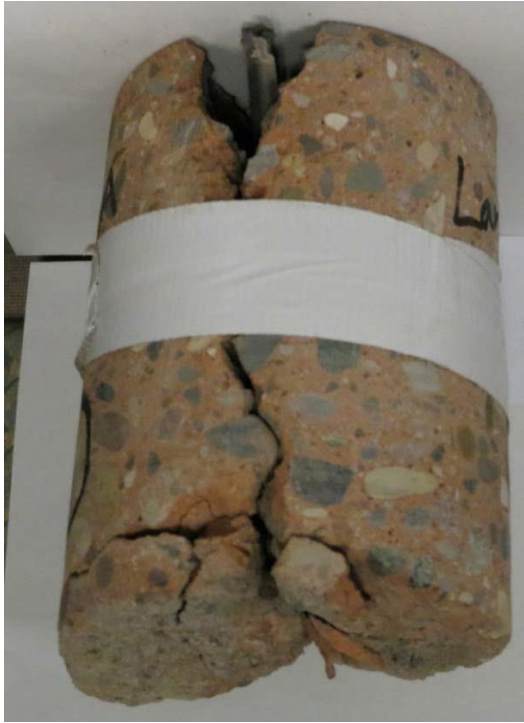
Figure 4.71 Roseville - Core sample L&F-A showing distresses at both top and bottom of joint

Figure 4.72 Roseville - Core sample L&F-A showing distresses at both top and bottom of joint (side opposite that shown in Figure 4.71)

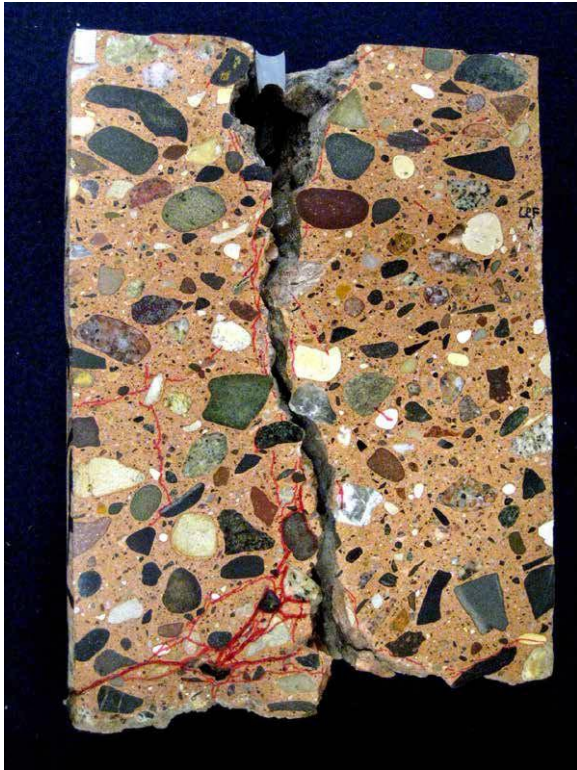
- Vertical microcracking is prevalent along the faces of the joint, while horizontal microcracks occur both at mid-depth and near the bottom of the sample. See Figure 4.74.

Figure 4.74 Roseville - Core sample L&F-A showing vertical and horizontal microcracking (highlighted in red ink)

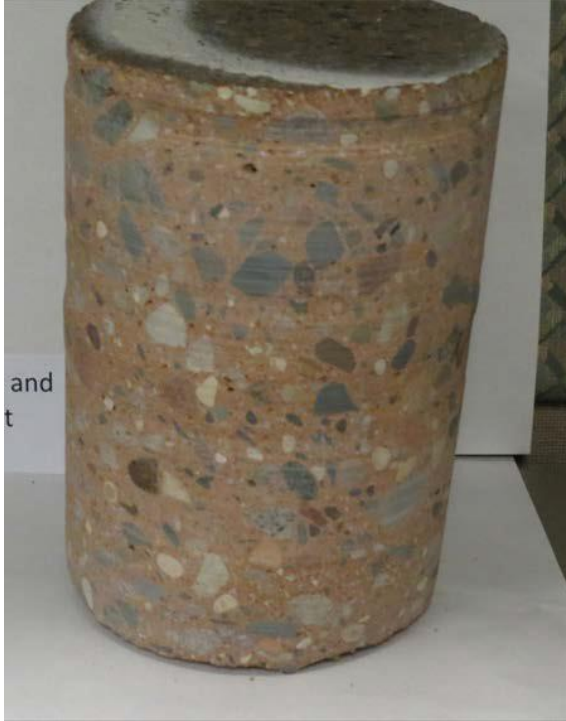
Core sample L&F-B was taken in the middle of a panel in the same crosswalk as Core sample L&F-A. Figure 4.70 shows the core location. As with the surface, the lower portion of the core appeared to be in very good condition. See Figure 4.75.

Figure 4.75 Roseville - Core sample L&F-B

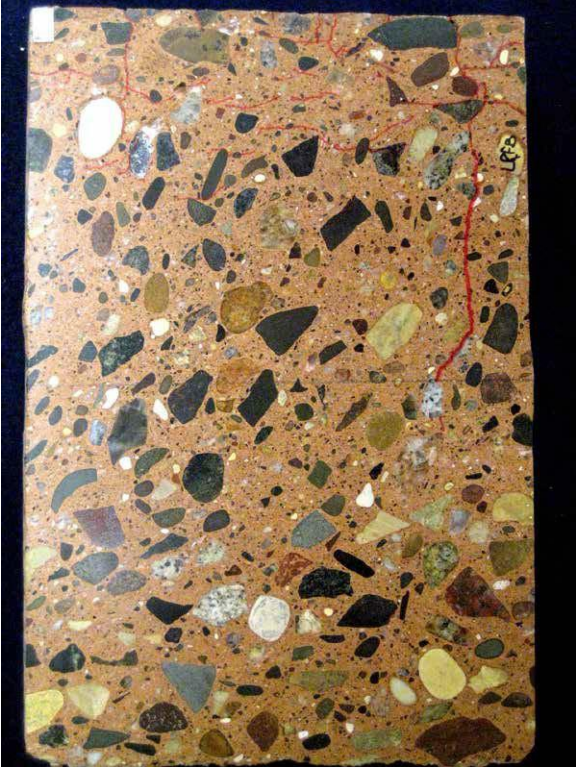
- Alkali-silica reaction (ASR) induced microcracking was found in both fine and coarse aggregates, as well as the paste, particularly within 60 mm from the surface. This is

Figure 4.76 Roseville - Core sample L&F-B showing vertical and horizontal ASR-induced cracks (highlighted in red ink)

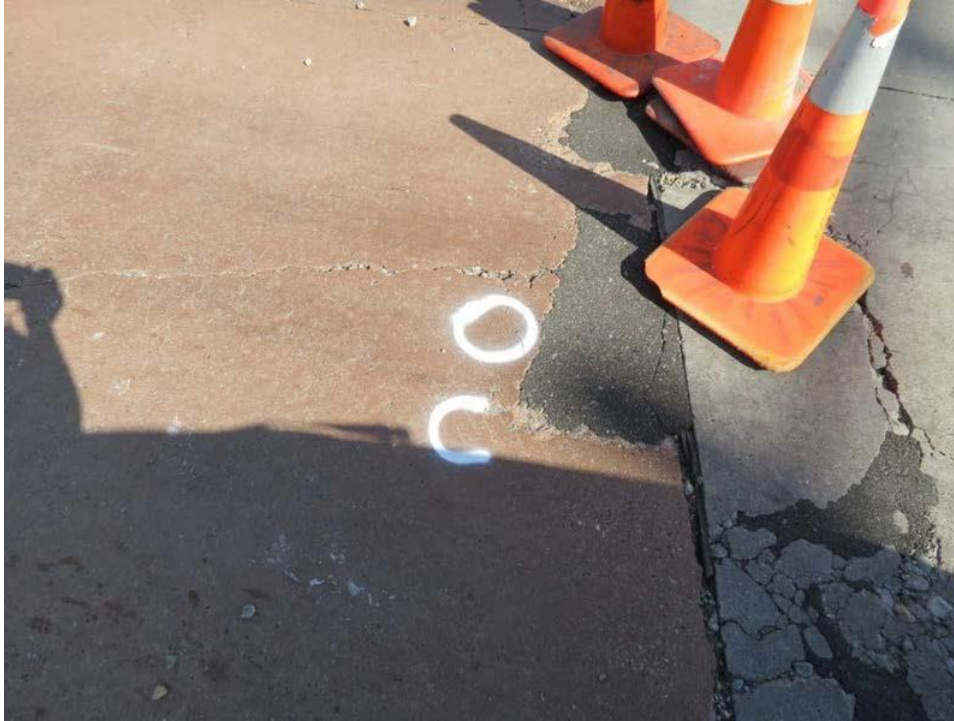
Figure 4.78 Roseville - Core location L&F-C

Core sample L&F-C was taken in the middle of a panel, near some longitudinal cracking and other significant cracking along a transverse joint. Figure 4.78 shows the core location. Extensive delamination was observed in the core sample. See Figures 4.79 and 4.80.
