Investigation and Assessment of Colored Concrete Pavement

Minnesota
Department of
Transportation

August 2014

Research Project
Final Report 2014-26

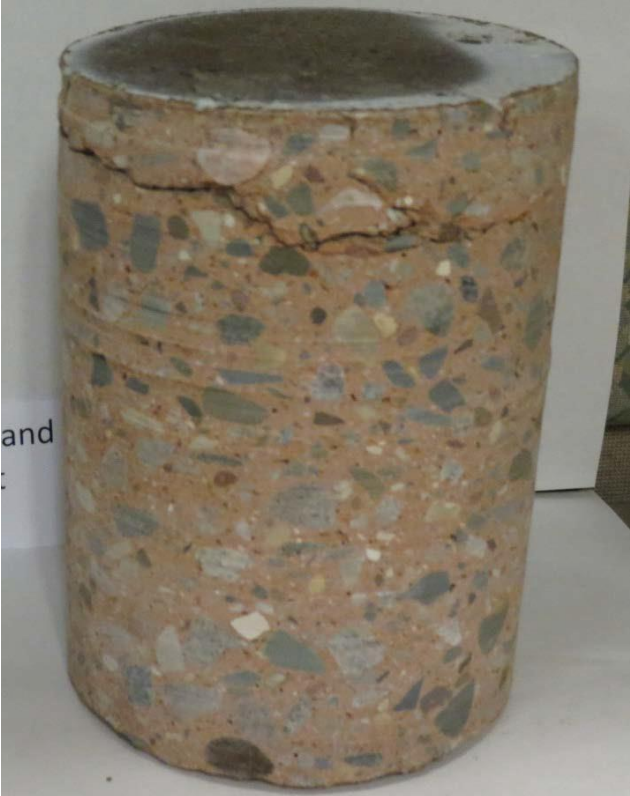
Core sample L&F-C was taken in the middle of a panel, near some longitudinal cracking and other significant cracking along a transverse joint. Figure 4.78 shows the core location. Extensive delamination was observed in the core sample. See Figures 4.79 and 4.80.

Figure 4.79 Roseville - Core sample L&F-C showing horizontal delamination crack

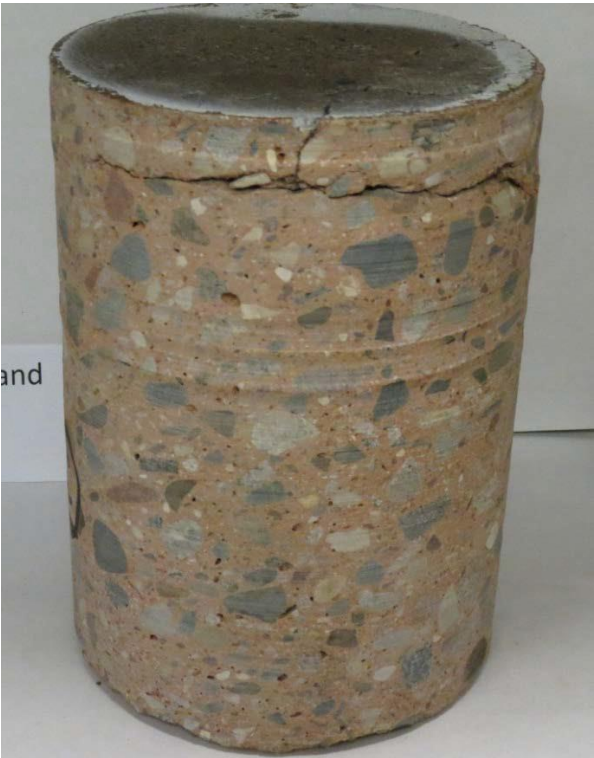
Figure 4.80 Roseville - Core sample L&F- C showing vertical crack up from horizontal delamination crack

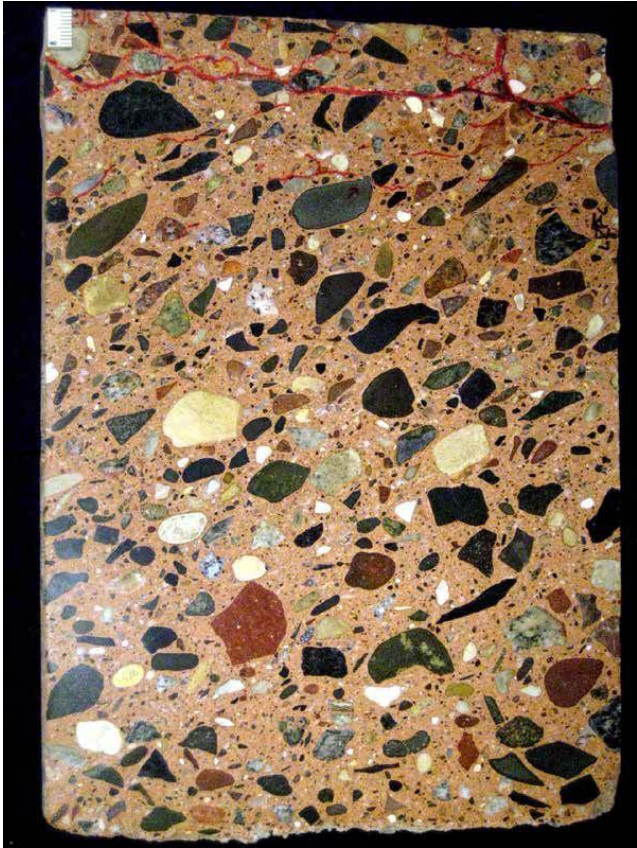
- Alkali-silica reaction (ASR) induced microcracking was found in both fine and coarse aggregates, as well as the paste, particularly within 50 mm from the surface. This is

Figure 4.81 Roseville - Core sample L&F-C showing vertical and horizontal ASR-induced cracks (highlighted in red ink)

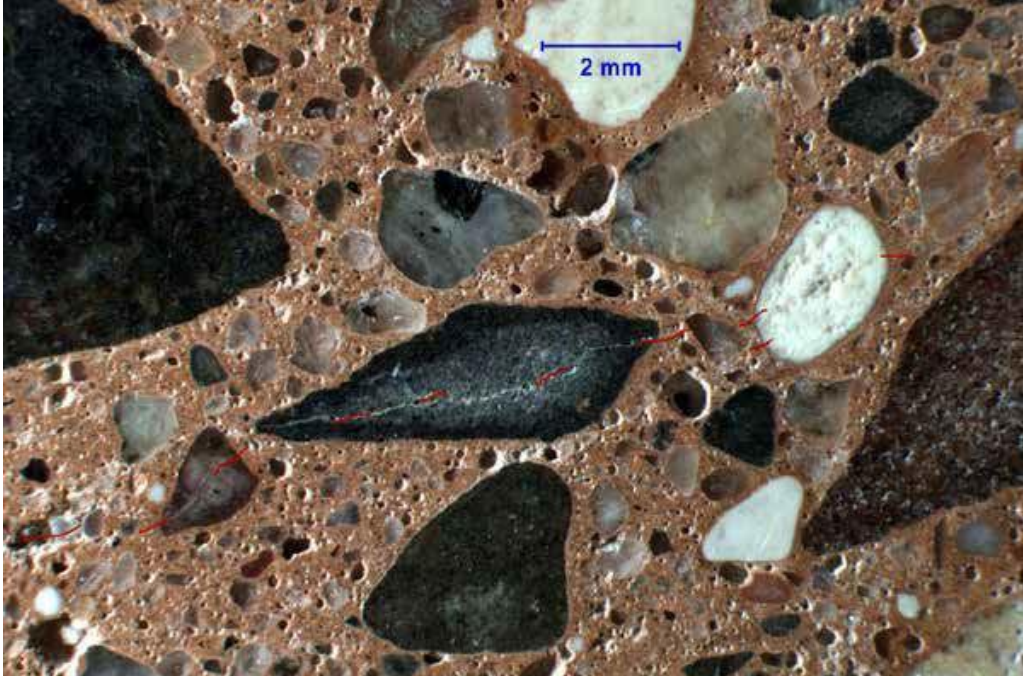
Figure 4.82 Roseville - Core sample L&F-C showing ASR gel product (highlighted in red ink) within microcracks traversing the paste, fine and coarse aggregate particles

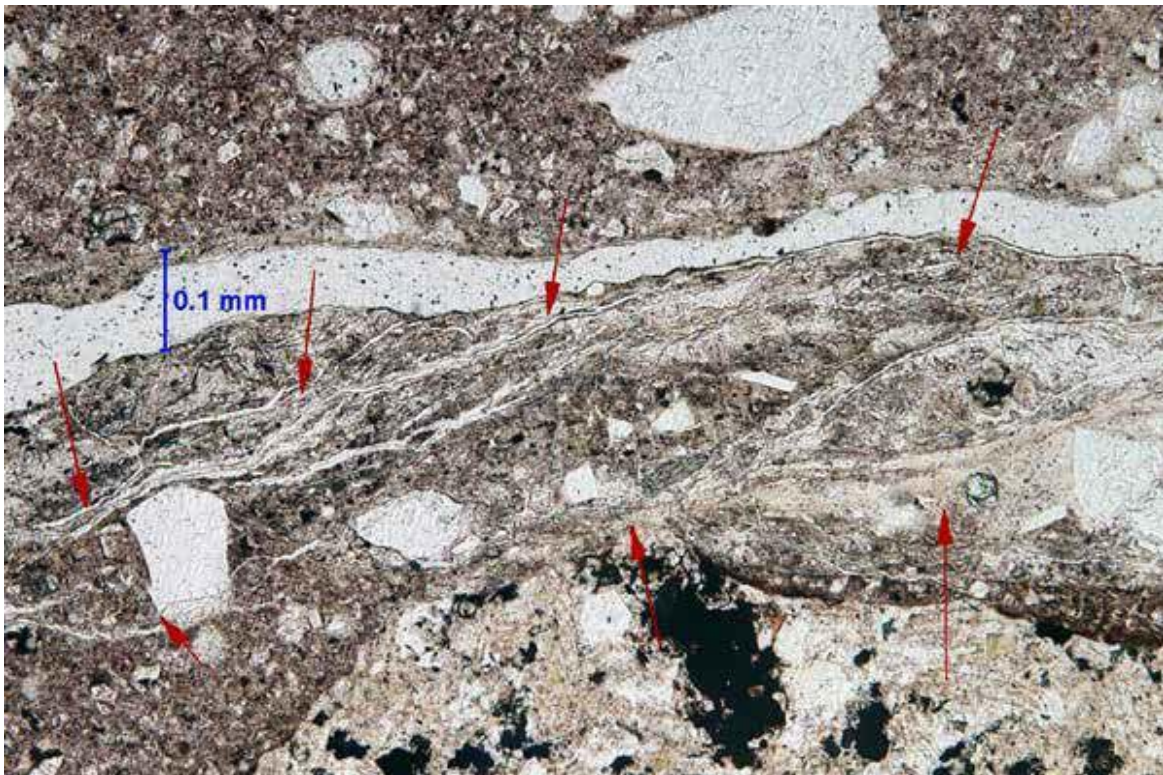
- shown in Figures 4.81 and 4.82. Figure 4.83 shows the prevalence of the ASR gel.
• The surface texture was described as smooth and worn.

Figure 4.83 Roseville - Core sample L&F-C: Close-up view of clear ASR-gel product filling microcracks proceeding from an adjacent reactive aggregate particle (thin section under plane polarized light)

Given the prevalent delamination near the surface of the concrete, it is expected that the crosswalks in this intersection will continue to deteriorate, especially in the areas of high loads and moisture contents (joints). Since the distress is currently close to the surface, it may be reasonable to do partial or full-depth repairs to extend their service lives. It might also be beneficial to apply a liquid sealant material to slow the ingress of water and reduce the growth of the ASR gel.

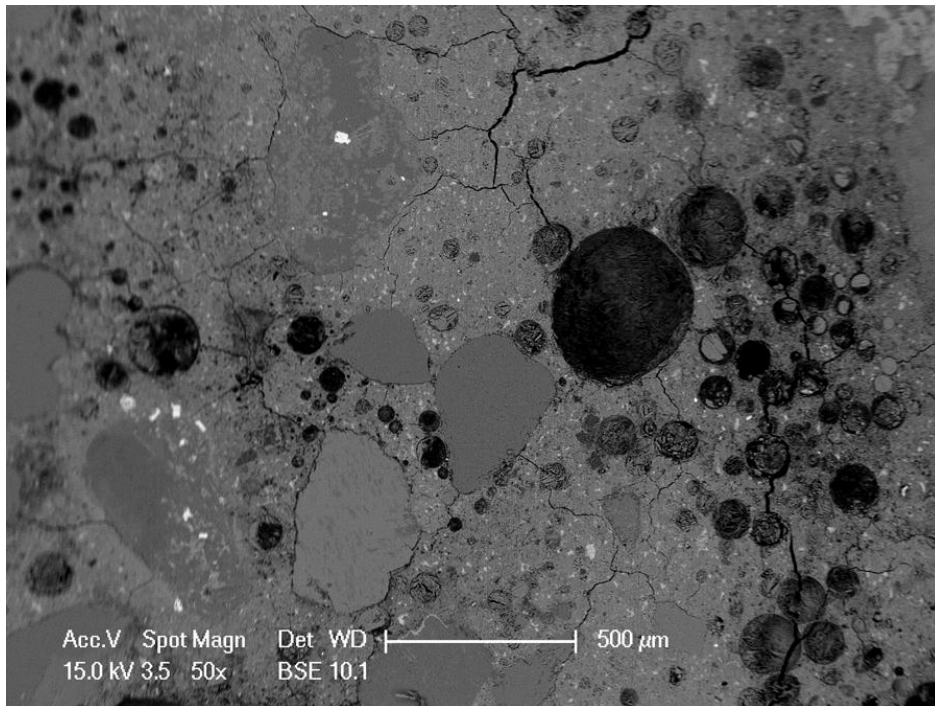
- There appears to be a high amount of larger entrained air voids, and they are often clustered. There also appears to be altered cement paste. See Figure 4.84. The altered paste was determined to generally have lower calcium contents, which is often consistent with calcium hydroxide being leached from the paste during the presence of deicers.

Figure 4.84 Roseville – Portion of core sample L&F-C: Backscattered electron image showing the cement paste matrix near the joint surface. Regions of the cement paste appear to be altered. Note the clustering of air voids

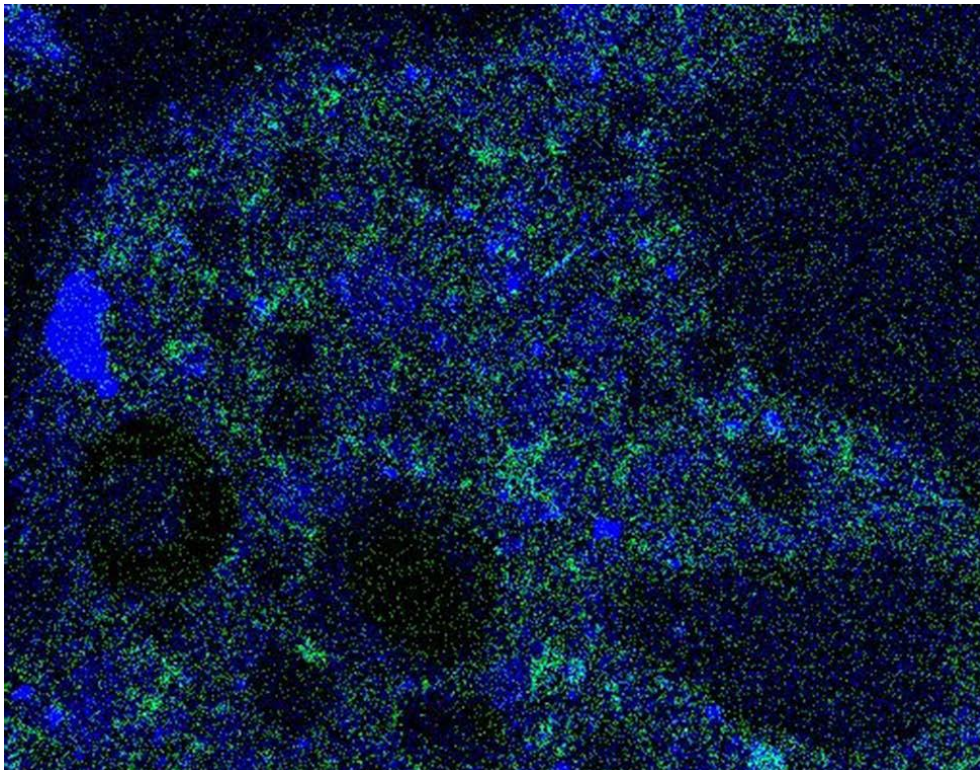
Figure 4.85 Vadnais Heights – Portion of core sample L&F-C, showing EDX image with magnesium (blue) and iron-based pigment (green) coinciding throughout the paste

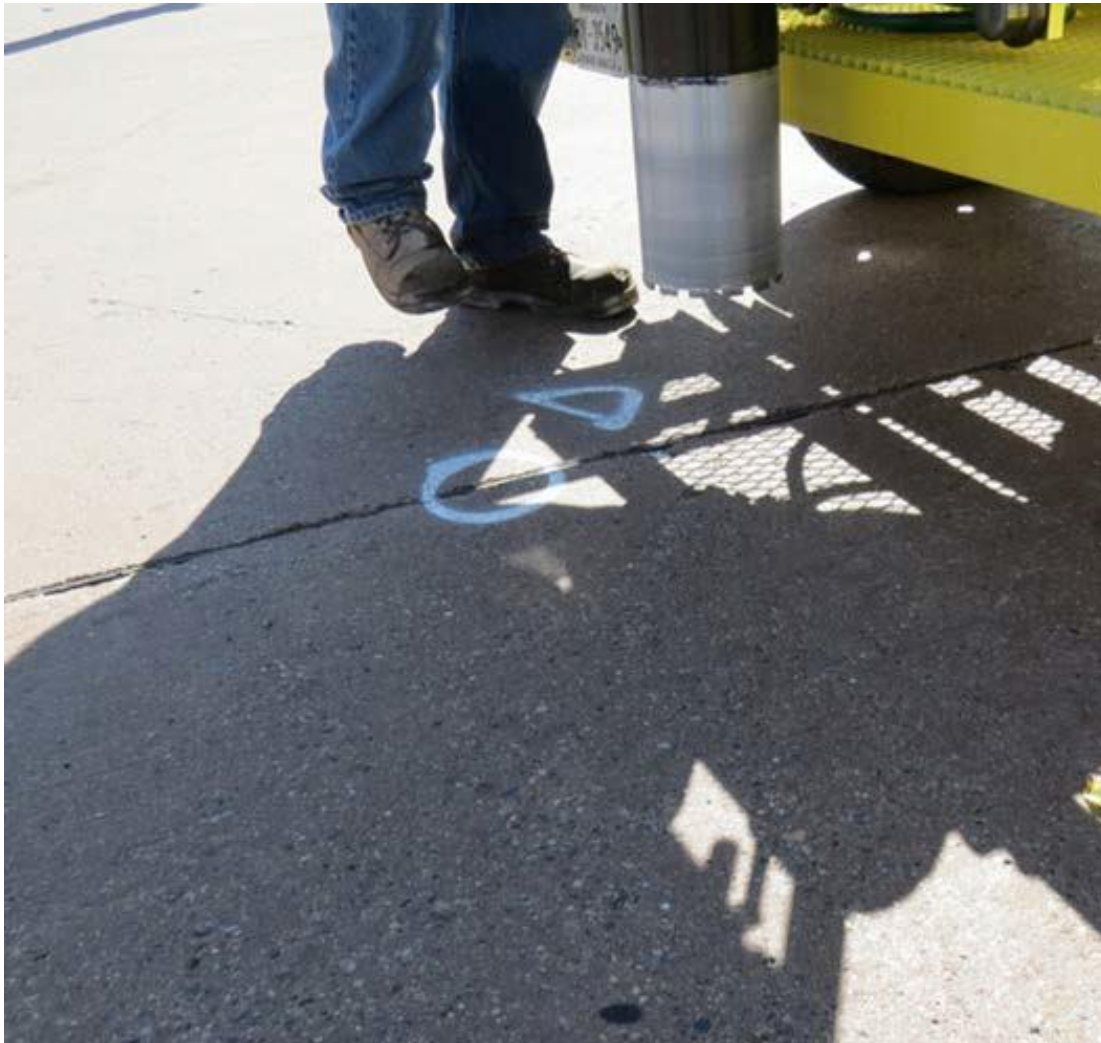
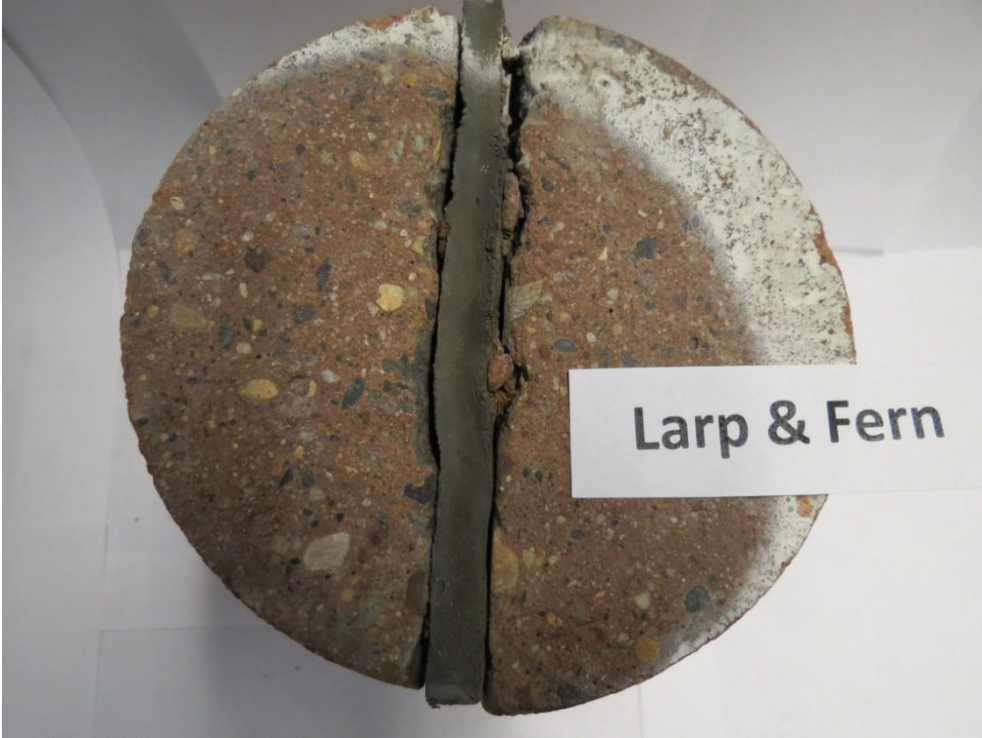
Core sample L&F-D was taken over a longitudinal joint (that appeared to be in good condition) in the southern crosswalk spanning North Fernwood Street. Figures 4.86 and 4.87 show the coring location and condition of the joint at the surface. The sample showed good joint performance, with only slight widening of the joint near the bottom of the pavement. Internal aggregate interlock remains good. See Figures 4.88 to 4.89.

Figure 4.86 Roseville - Core location L&F-D

Figure 4.87 Roseville - Core sample L&F-D (top view)

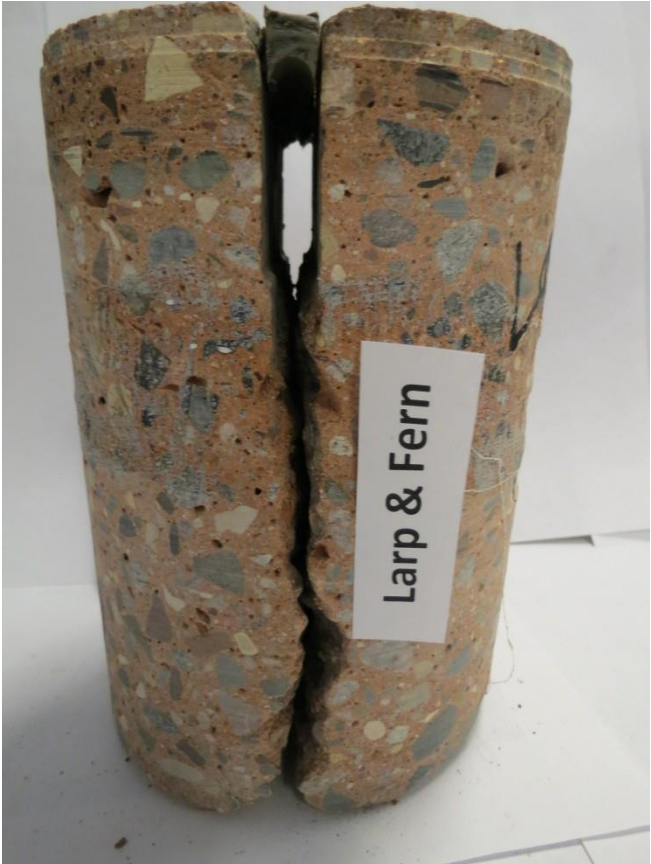
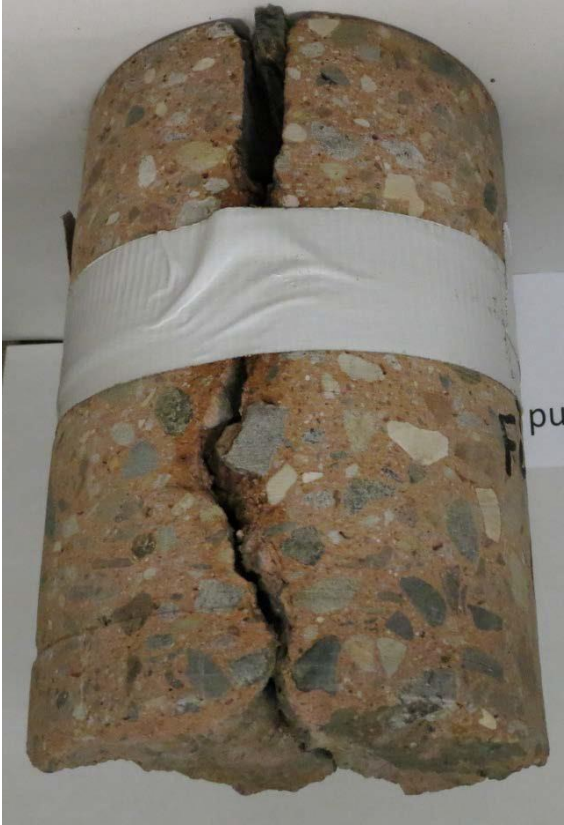
- The average measured core length was 8.75 inches.
- The sides of the core sample appear to be in good condition, with no visible cracks or signs of distress.
- The silicone joint seal was poorly bonded to one side of the joint reservoir.

Figure 4.88 Roseville - Core sample L&F-D

Figure 4.89 Roseville - Core sample L&F-D

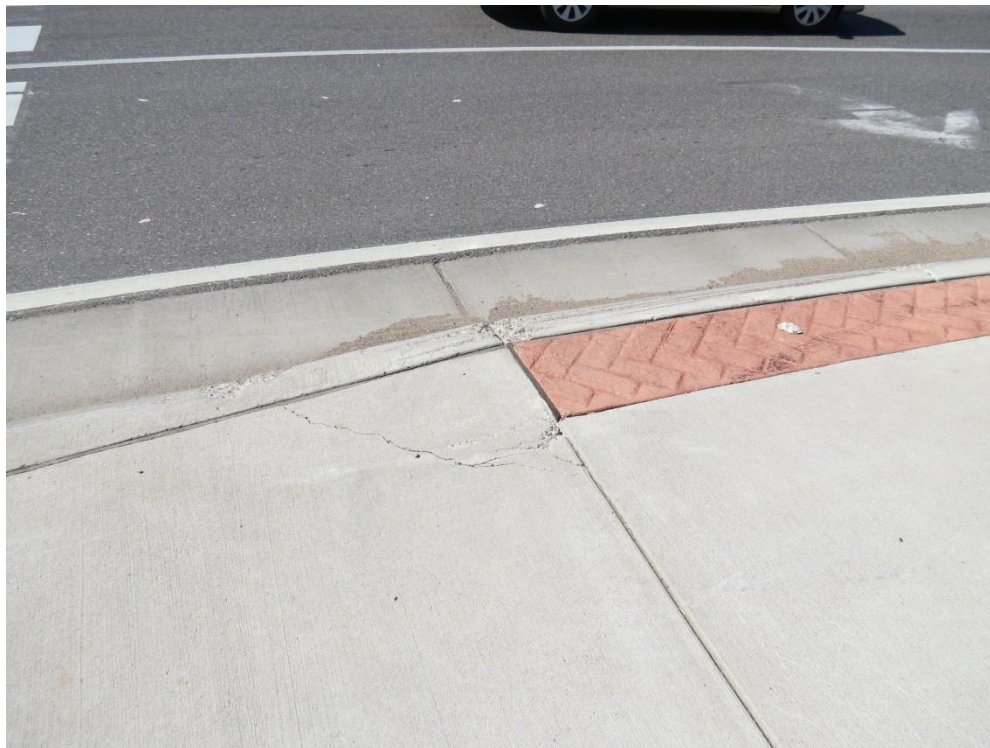
Figure 6.2 Crack in sidewalk, likely produced by expansion of neighboring colored concrete strip

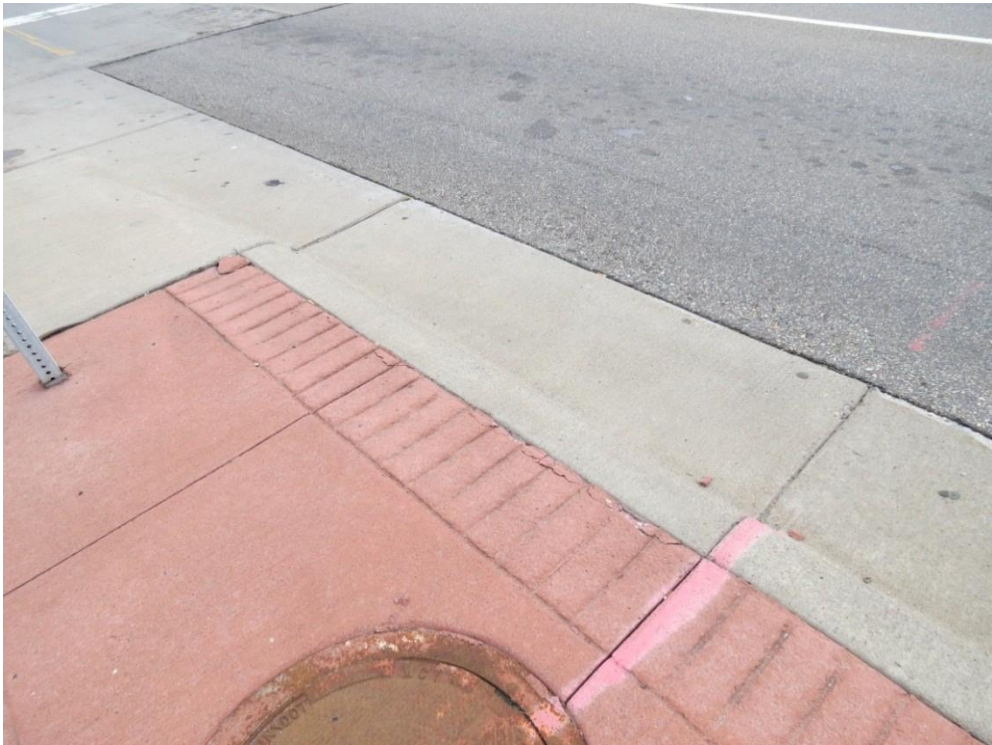
Figure 6.6 Expansion of slab near surface, due to temperature gradients, may lead to surface spalling near the edge of panels

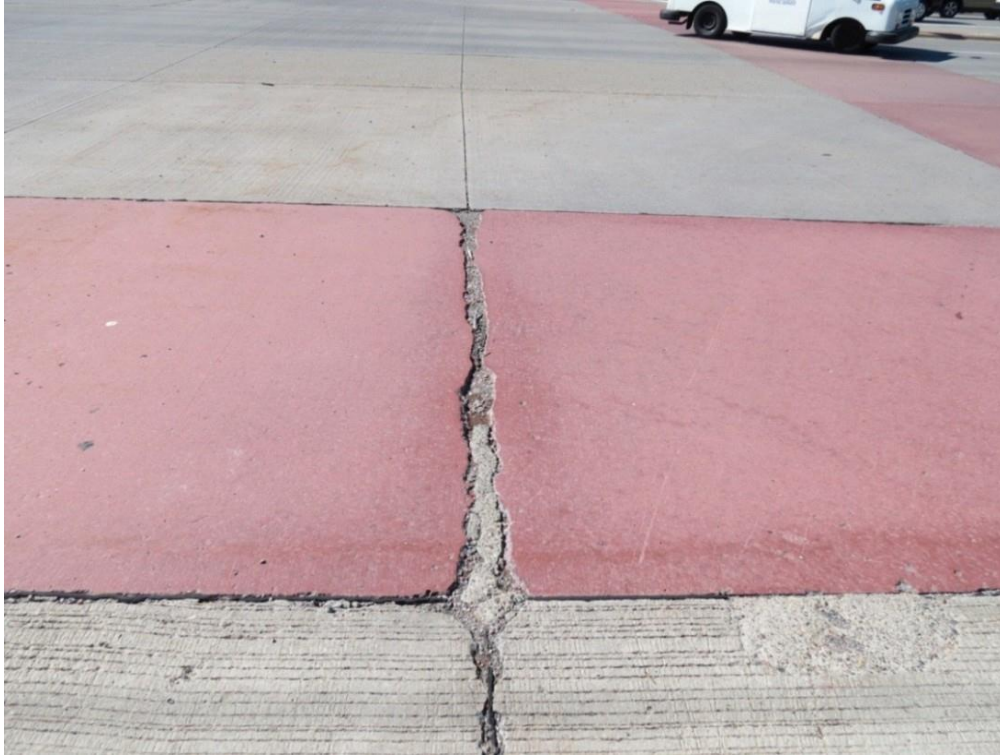
Figure 8.1 Example of joint distress in older pavement. Suitability for repair must be determined via core samples or other test methods.

One of the primary reasons for this study was the observation of significant early age joint deterioration in a number of projects containing colored concrete pavements, sidewalks, and medians. See Figures 8.1 and 8.2 for examples. The repair or rehabilitation techniques available for this type of distress depend on the type of deterioration in the joints. Standard techniques used for the repair of normal (non-colored) concrete can often be considered, except if color matching is important to the owner.

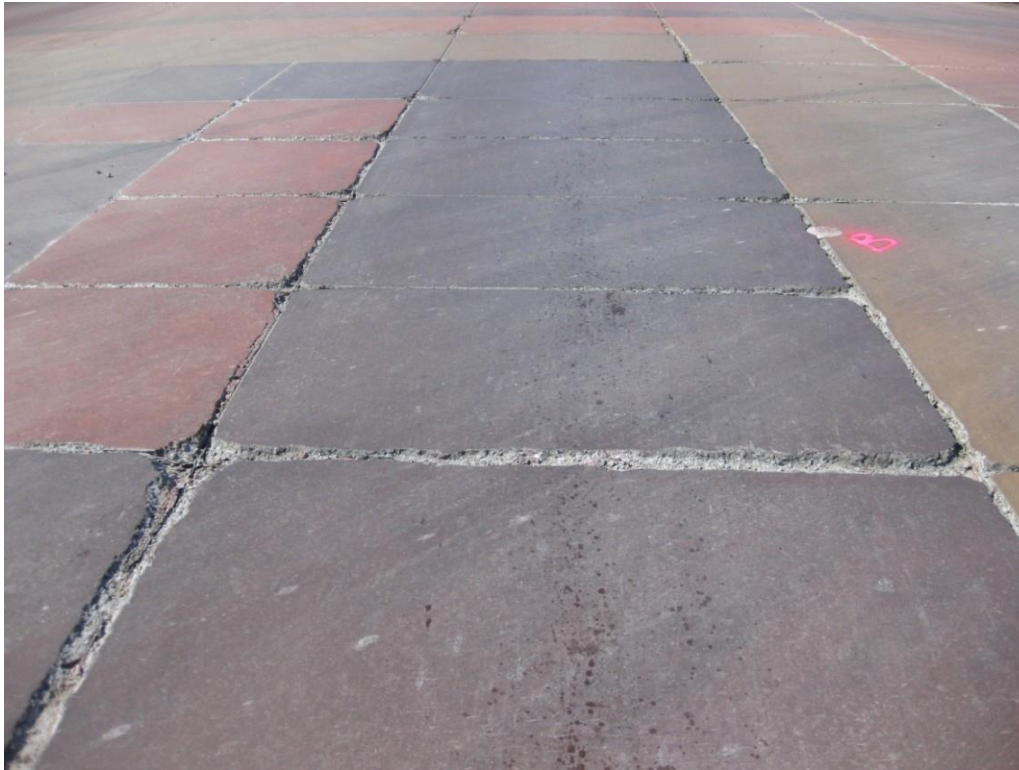
Figure 8.2 Example of joint distress in newer pavement. Suitability for repair must be determined via core samples or other test methods.

It is important to note that if the distress is expansive in nature (i.e. ASR), or it has been developing rapidly, often the only viable repair solution is to remove and replace the entire slab.

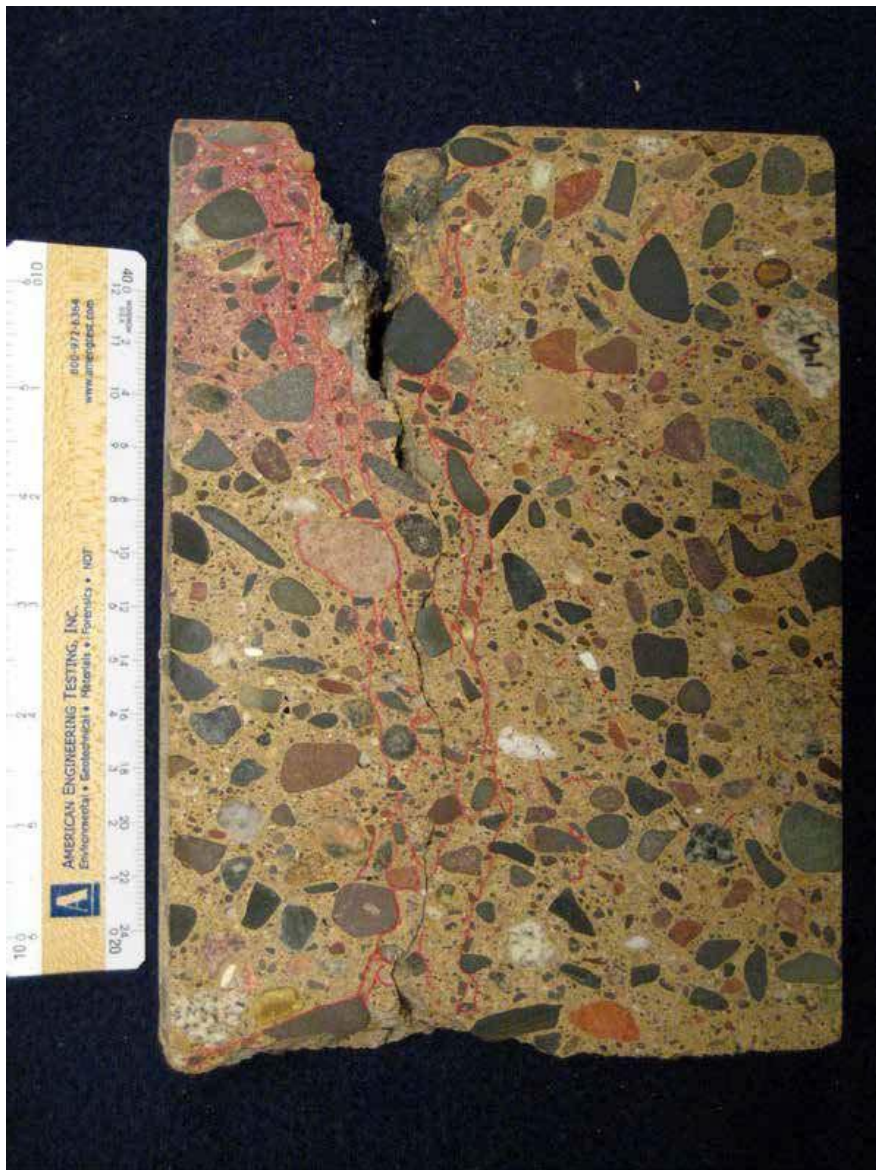
As noted previously, most of the joint deterioration observed during this study extended the full depth of the joint. Figure 8.3 shows one such example. If the underlying cause of the distress is high permeability within the existing colored concrete, establishing new joints may not prevent the continuing formation of distress within the slabs.

Figure 8.3. Core sample showing deterioration along the entire length of the joint. The red lines highlight microcracking near the joint face.

If deemed appropriate, standard full-depth concrete repair techniques, referred to as Type C3D repairs in MnDOT's concrete pavement rehabilitation guidelines[14,15], can be used. The repair material can be colored with pigment to match the existing slabs (within reason). Alternatively, non-colored patch material can be placed and left as is, or the repair and surrounding areas can be blended together using a stain, dye or colored surface treatment.

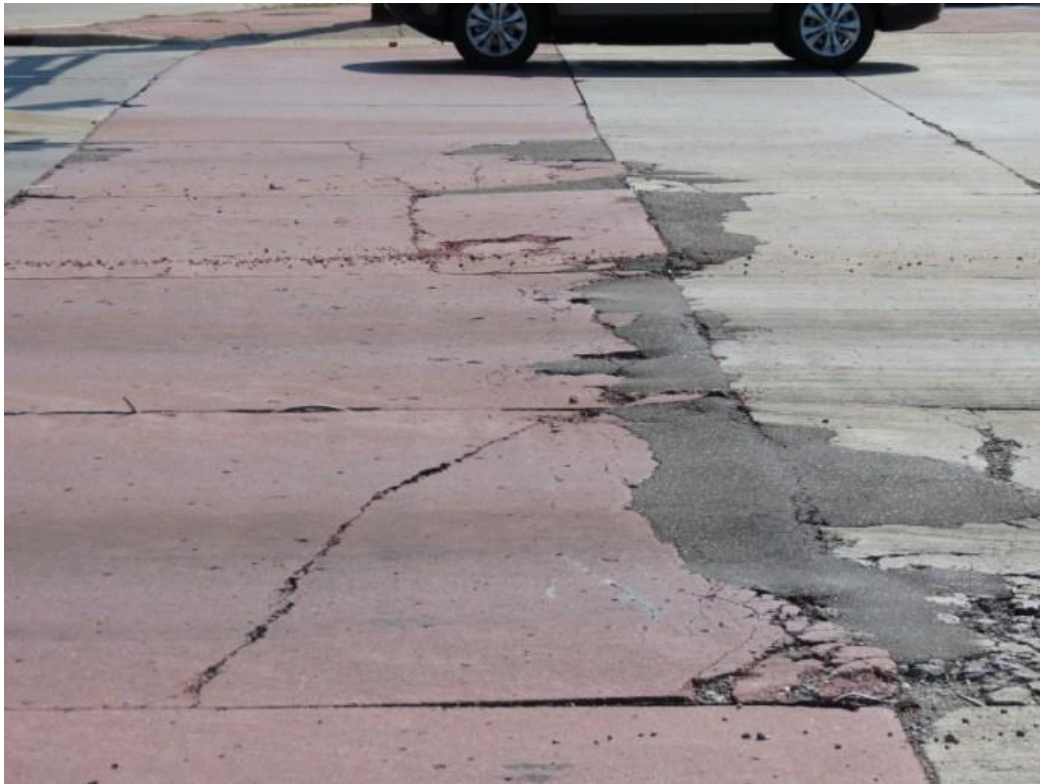
Several cases were found in this study that demonstrated the need for full-depth slab replacement. Figures 8.4 through 8.6 show three such examples. The slabs in the Figure 8.4 project are too deteriorated internally to support most types of repair. The extensive thermal stress cracking and buckling shown in Figure 8.5 also requires full-depth slab replacement. In this situation, additional

Figure 8.4 Deterioration of the slabs is too extensive, therefore requiring full slab replacement.

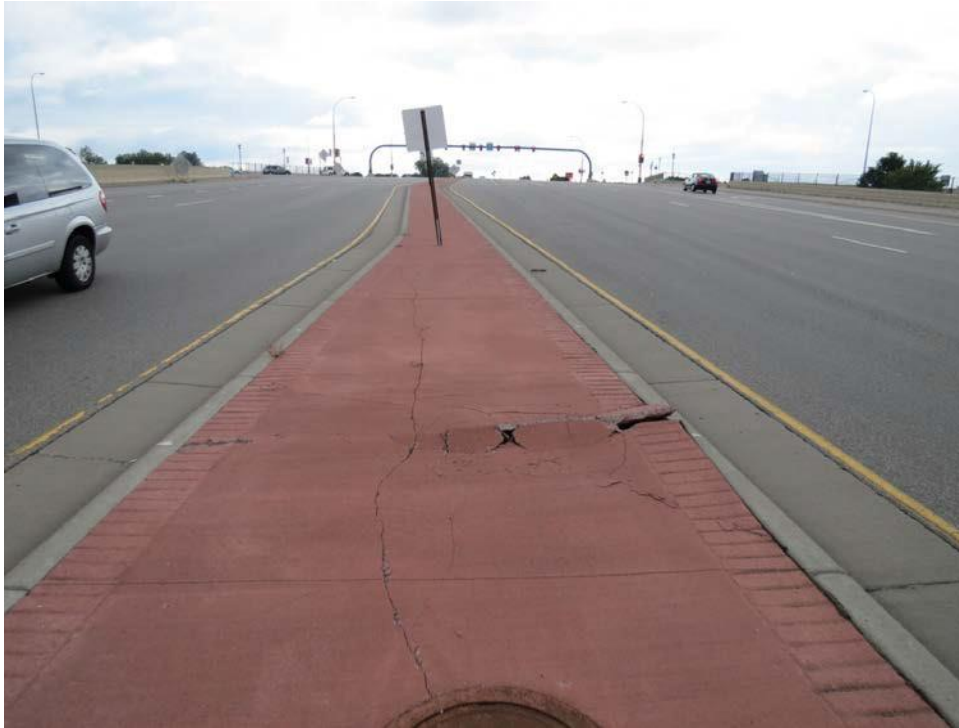
consideration must be given to provide adequate stress relief, due to the differing thermal expansion rates of the darker colored concrete, the standard concrete curbs, and structures such as manholes. The rapid acceleration in joint deterioration in the colored concrete intersection shown in Figure 8.6 would also be a suitable candidate for full-depth slab removal. As identified in Figure 8.3, when a concrete system is inherently too porous due to a high water- to-cementitious ratio, and the air system has been compromised by secondary ettringite, it is unlikely partial or full-depth joint repairs, or penetrating sealant materials, could effectively slow the rate of deterioration. Full-depth slab replacement can be done using standard MnDOT Type D repair guidelines [14,15]. The replacement concrete can be colored with pigment to match neighboring slabs (within reason). Alternatively, non-colored patch material can be placed and left as is, or the repair and surrounding areas can be blended together using a stain, dye or colored surface treatment.

Figure 8.5 Cracking and buckling of colored concrete median. This type of distress requires a full-depth slab replacement.

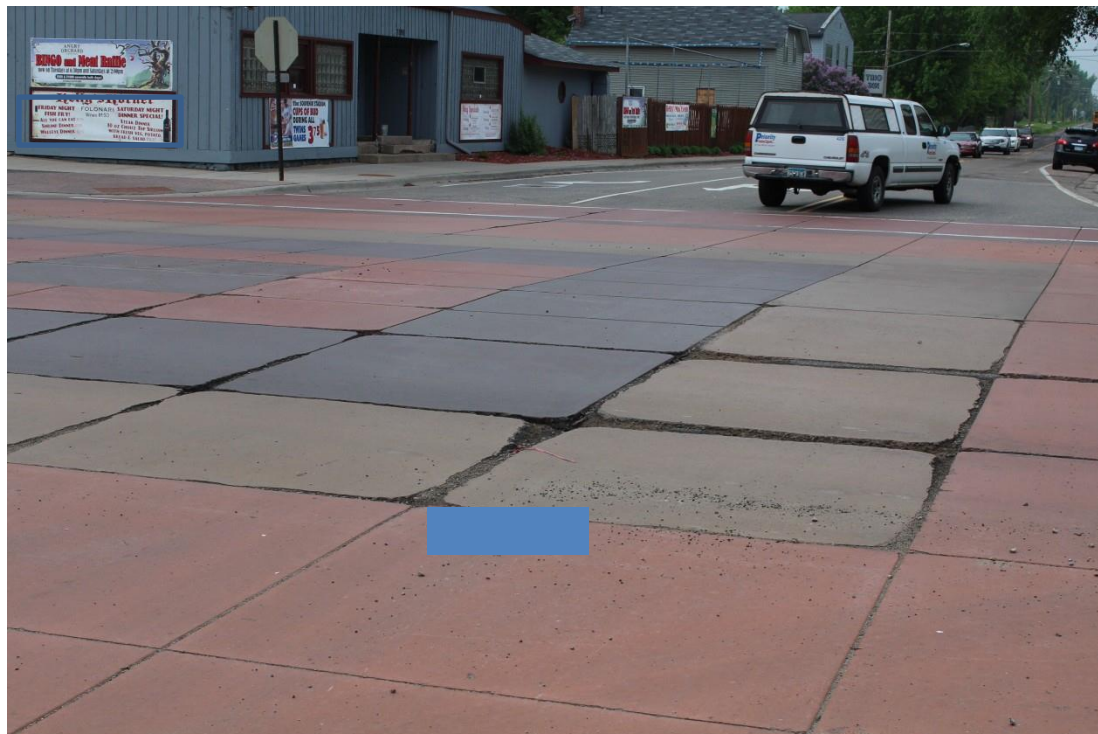
Figure 8.6 Accelerated joint deterioration occurring throughout intersection. The potential for continuing distress at new joint faces (created during repair process) necessitates full-depth slab replacement.

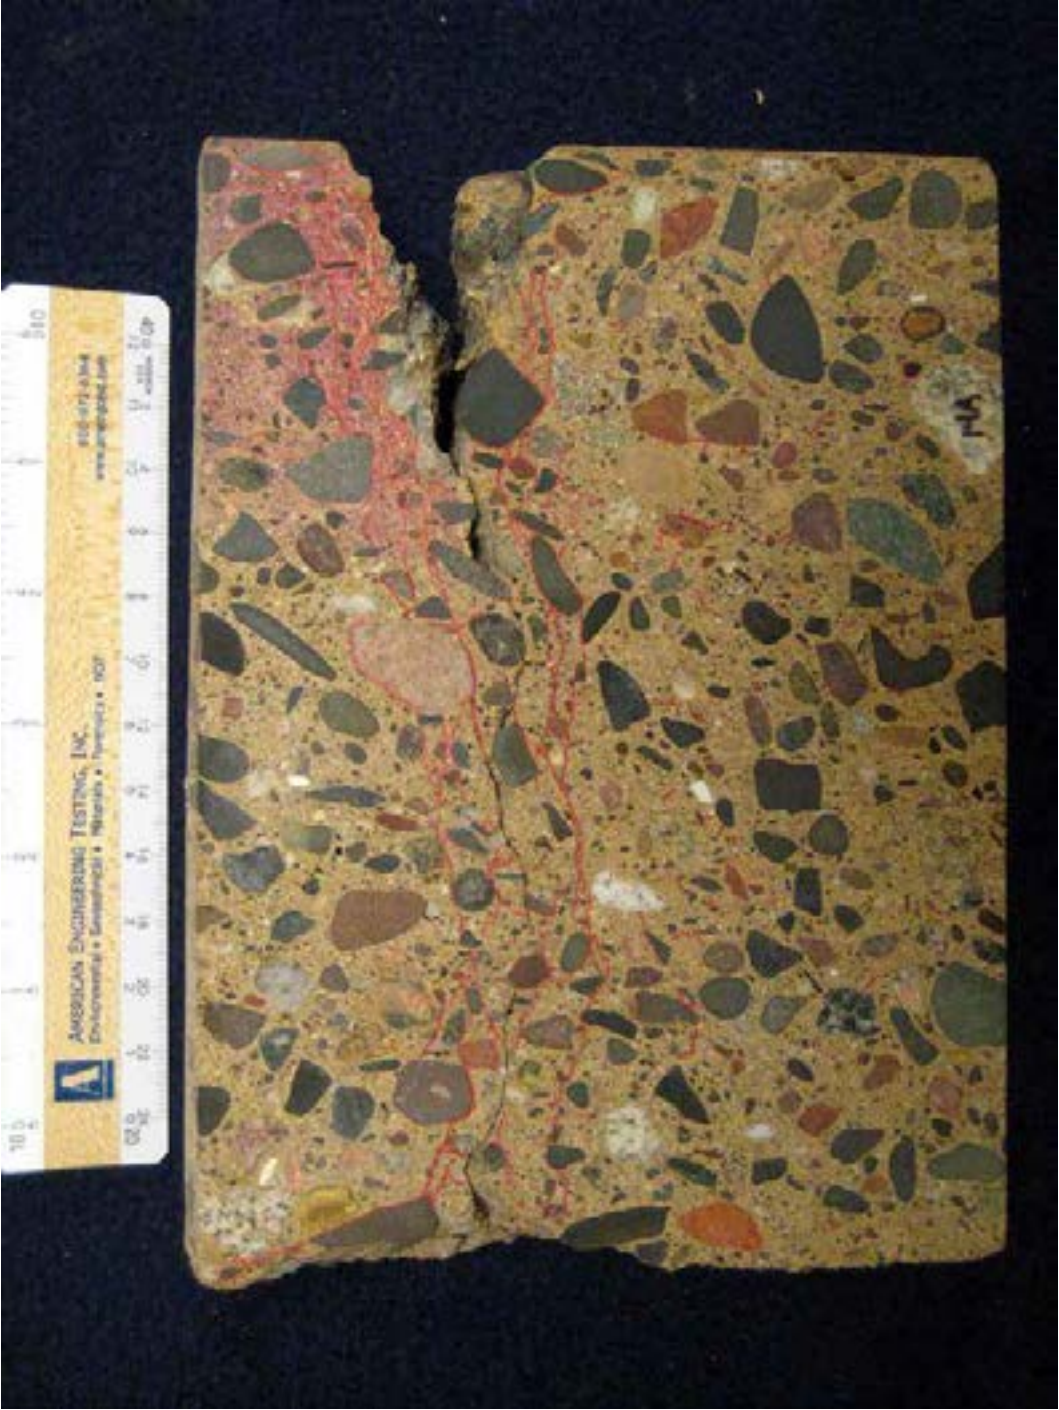
14A DESCRIPTION: Sliver spalling and severe incipient distress (sub-vertical micro and macro cracking) in the concrete paste directly adjacent to the "activated", tooled and sawcut control joint crack; mapped in red ink in sawcut and lapped cross sectore.

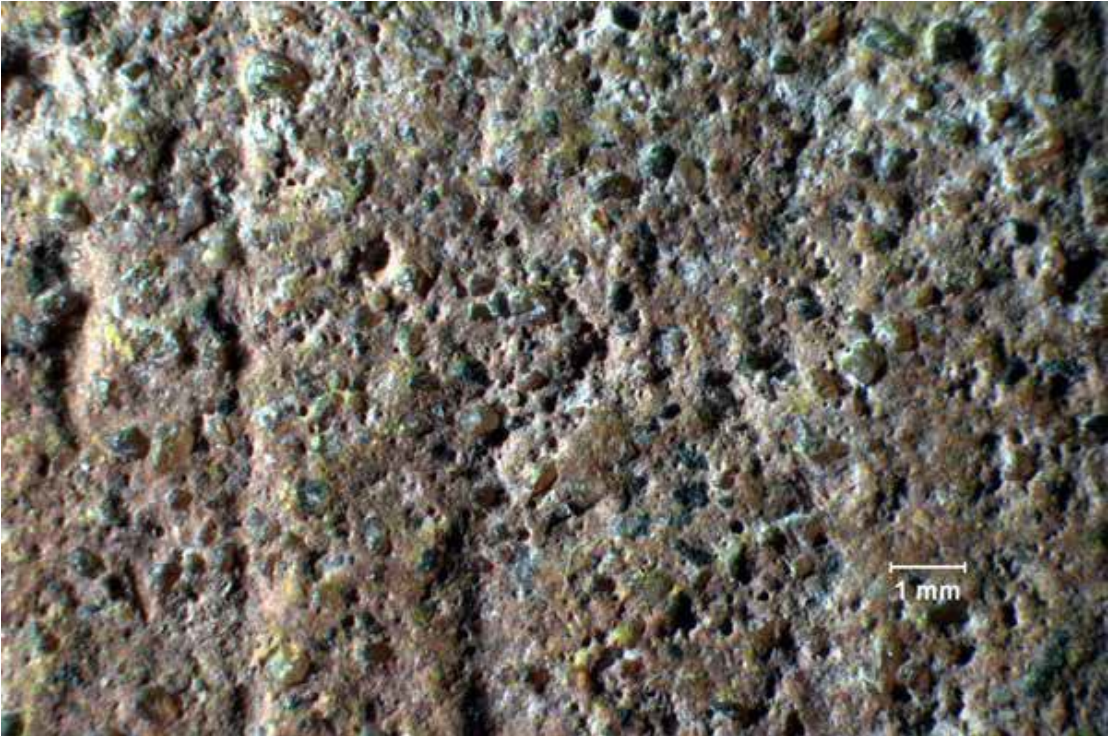
14A DESCRIPTION: Close up. MAG: 5x

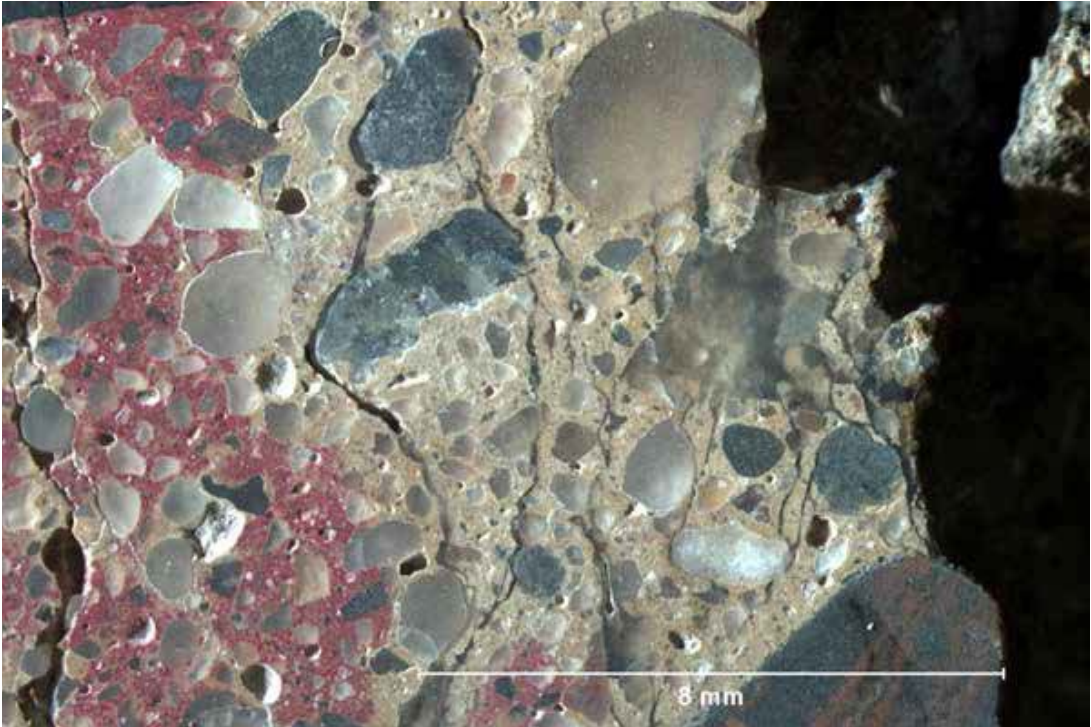
14A DESCRIPTION: Severely microcracked paste adjacent to the distressed joint plane. Microcracking is filled with epoxy required for preparation of the sawcut and lapped cross section. Note lack of open air entrainment. MAG: 10x

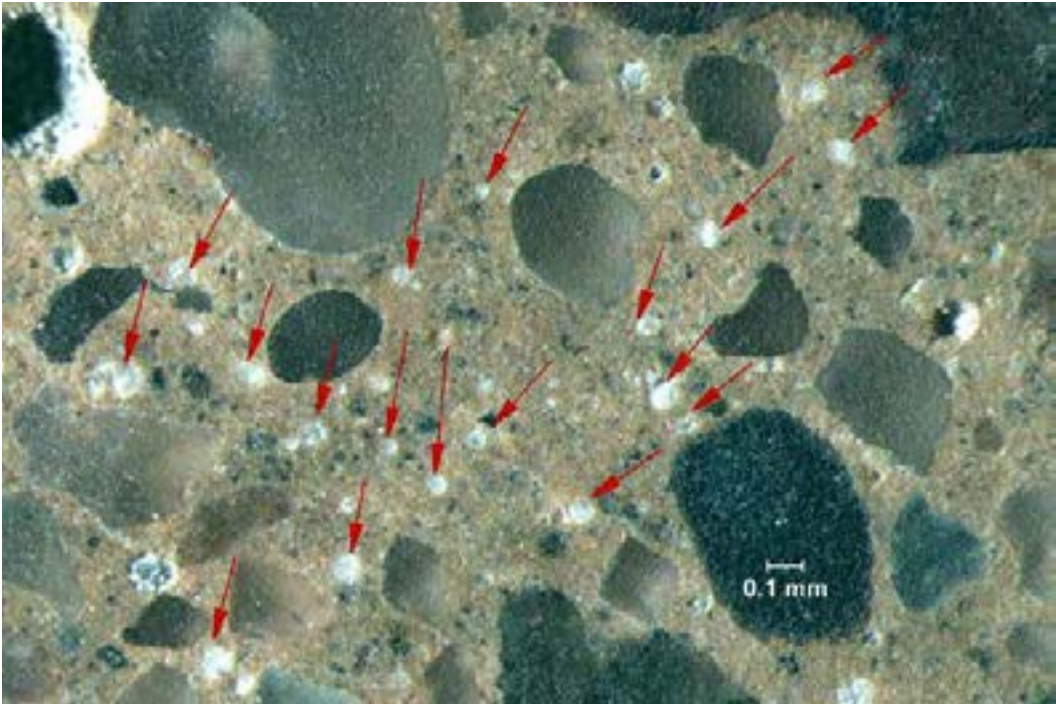
14A DESCRIPTION: Ettringite-filled air voids at 130mm depth from the top surface and at least 3mm depth from the distressed joint plane. MAG: 50x

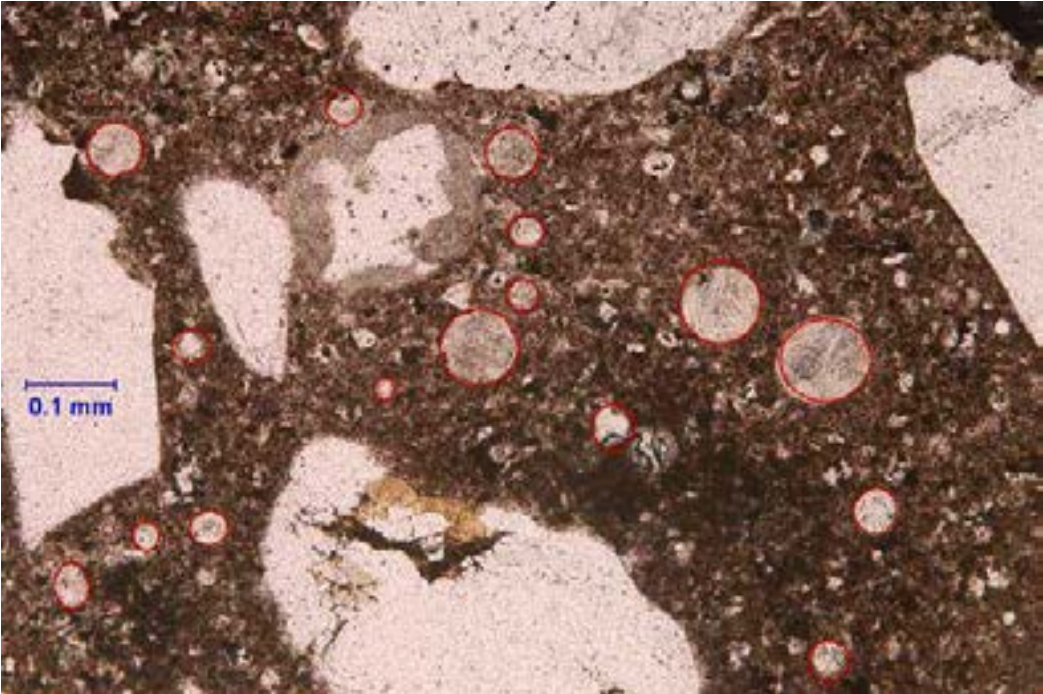
14A DESCRIPTION: Ettringite-filled entrained sized air void spaces in the pigmented paste (outlined in red); in thin section of concrete under plane polarized light. MAG: 100x

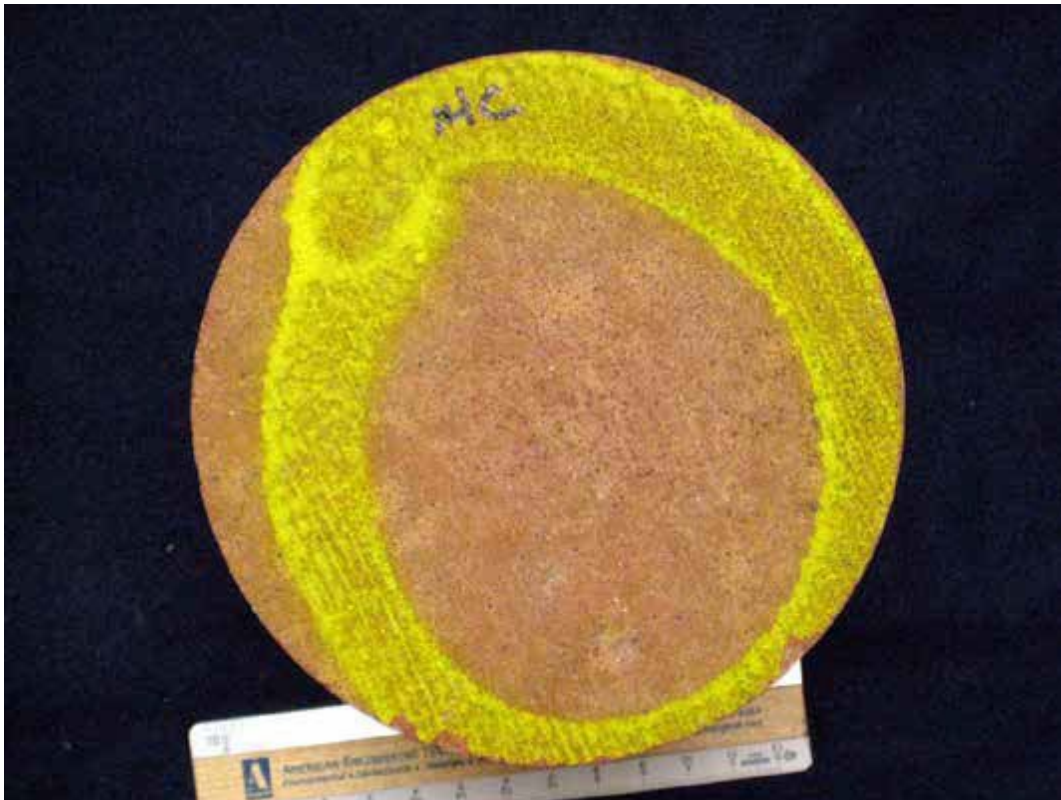
14C DESCRIPTION: Lightly textured and mortar eroded top surface of the core sample as received.

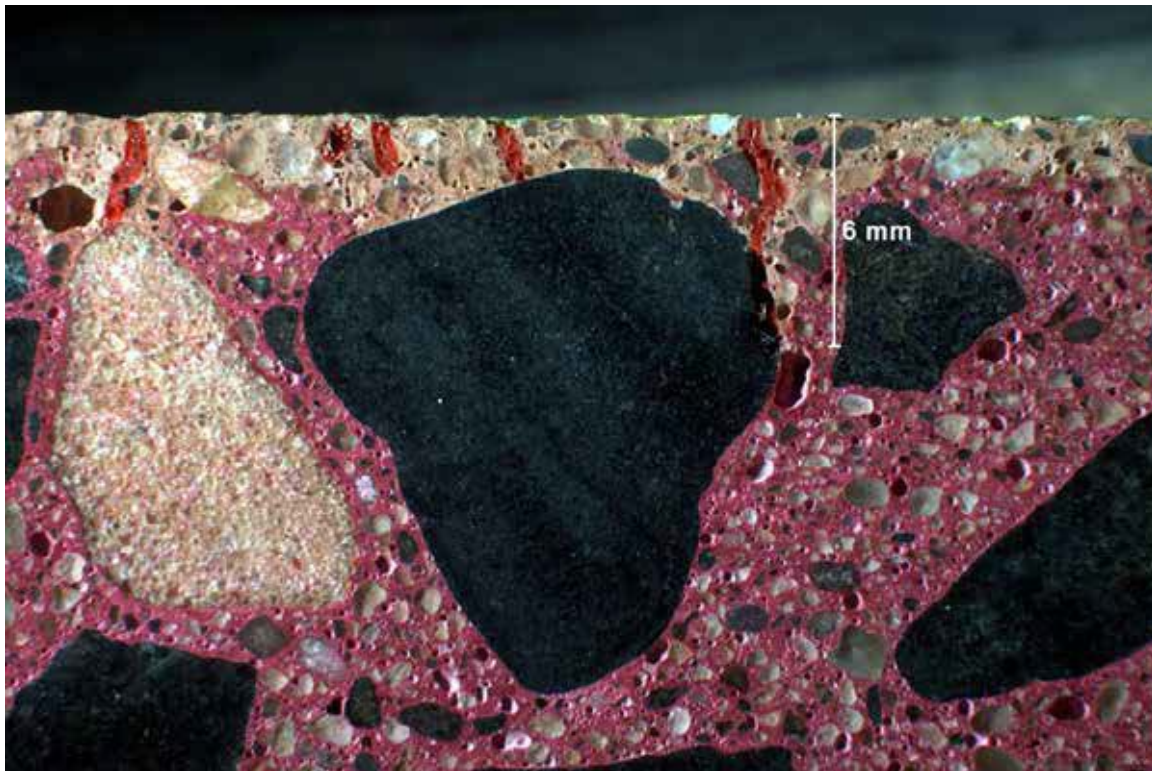
14C DESCRIPTION: Carbonation (unstained) ranged from 1mm up to 6mm depth from the top surface along sub-vertical drying shrinkage microcracks mapped in red ink. MAG: 5x
