Investigation and Assessment of Colored Concrete Pavement

Minnesota
Department of
Transportation

August 2014

Research Project
Final Report 2014-26

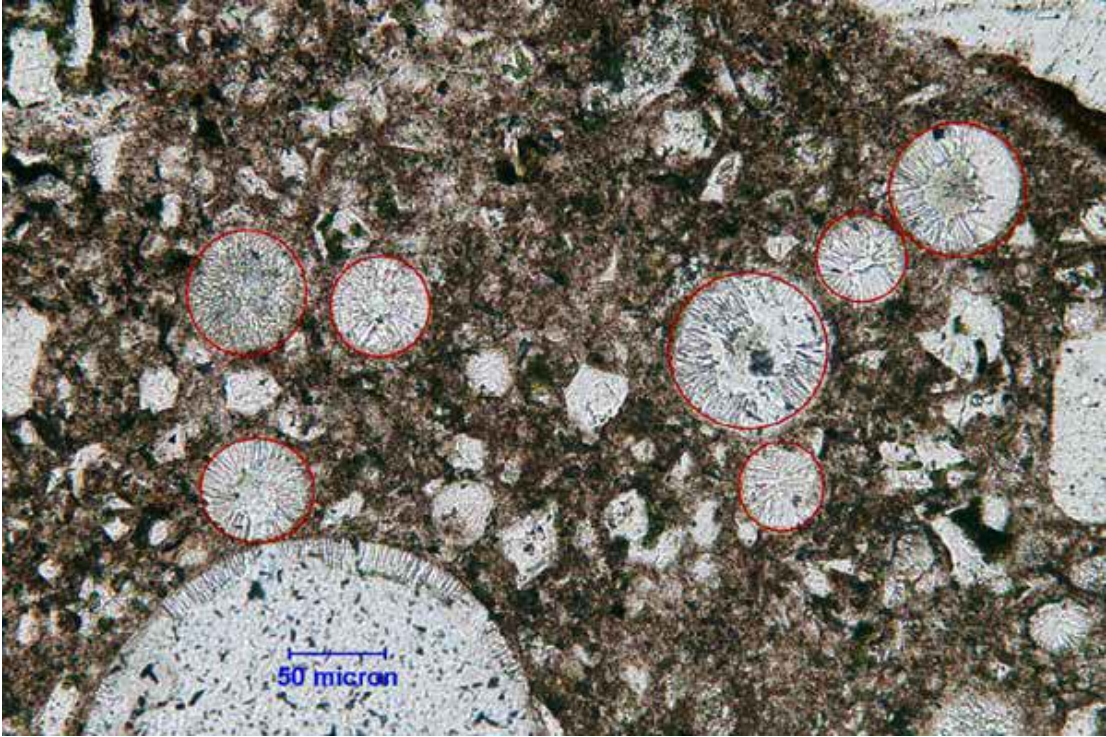
14C DESCRIPTION: Ettringite-filled or lined entrained sized air voidspaces in the pigmented paste (outlined in red); in thinsection of concrete under plane polarized light. MAG: 200x

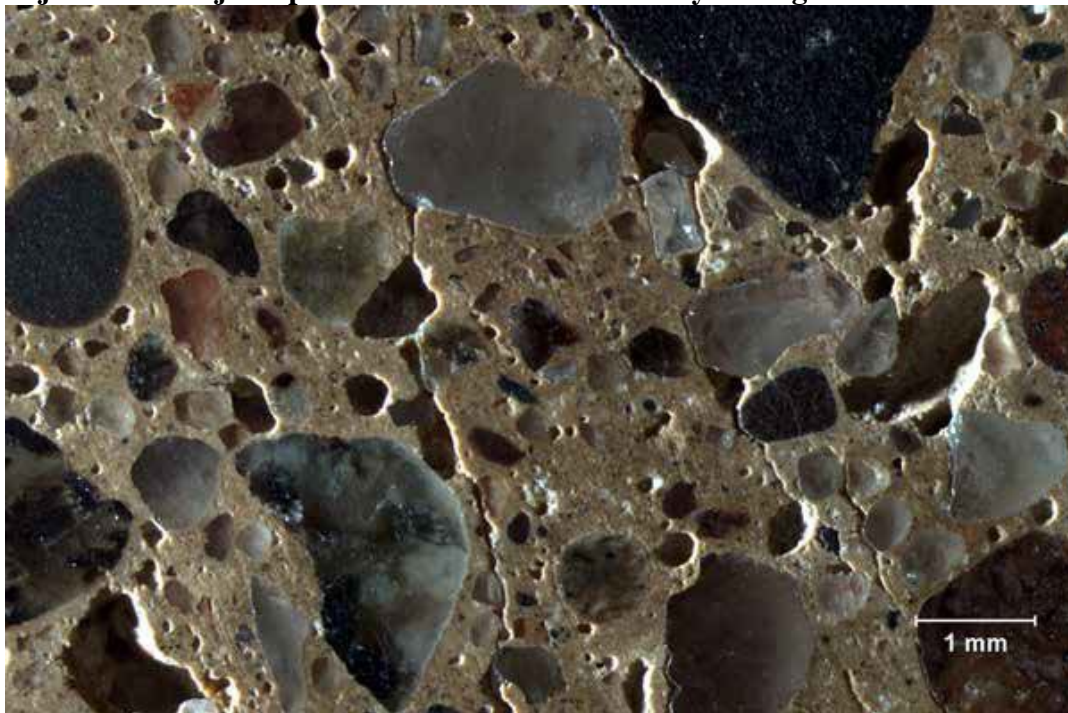
14E DESCRIPTION: Most fine entrained-sized air void spaces within the distressed paste adjacent to the joint plane are filled with secondary ettringite. MAG: 15x

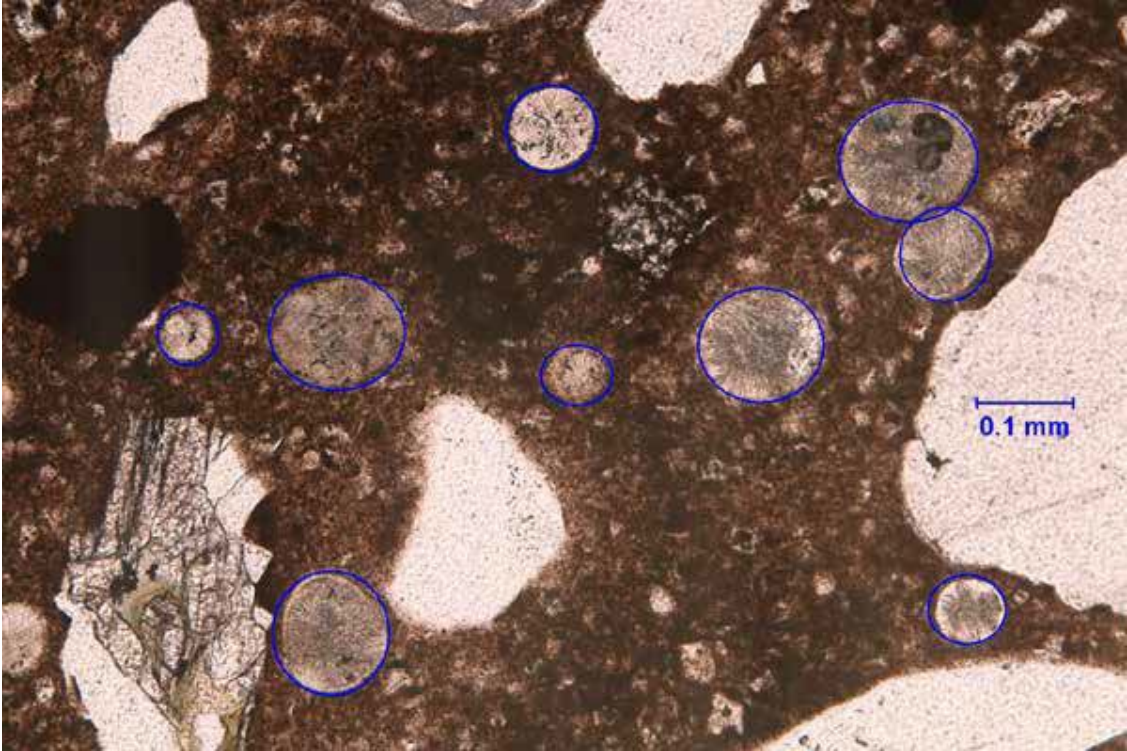
14E DESCRIPTION: Ettringite-filled entrained sized air voidspaces in the pigmented paste (outlined in blue); in thin section of concrete under plane polarized light. MAG: 10x

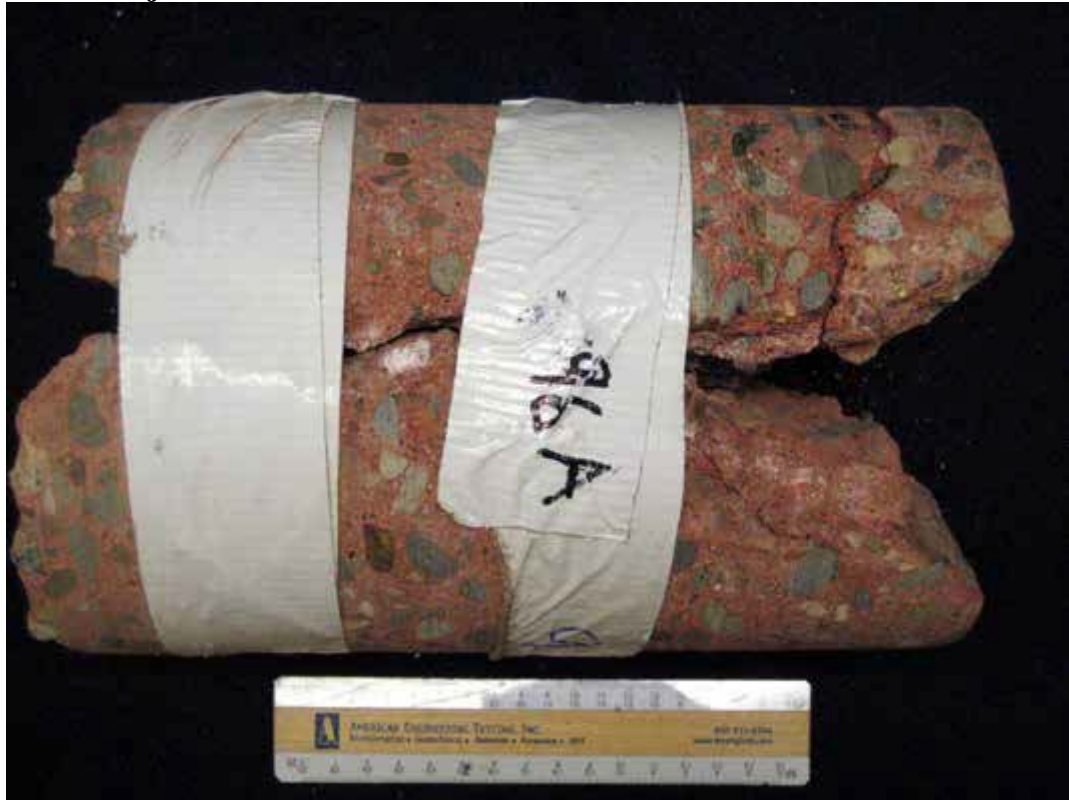
96A DESCRIPTION: Core sample as received. Top surface is right. Note severely distressed joint.

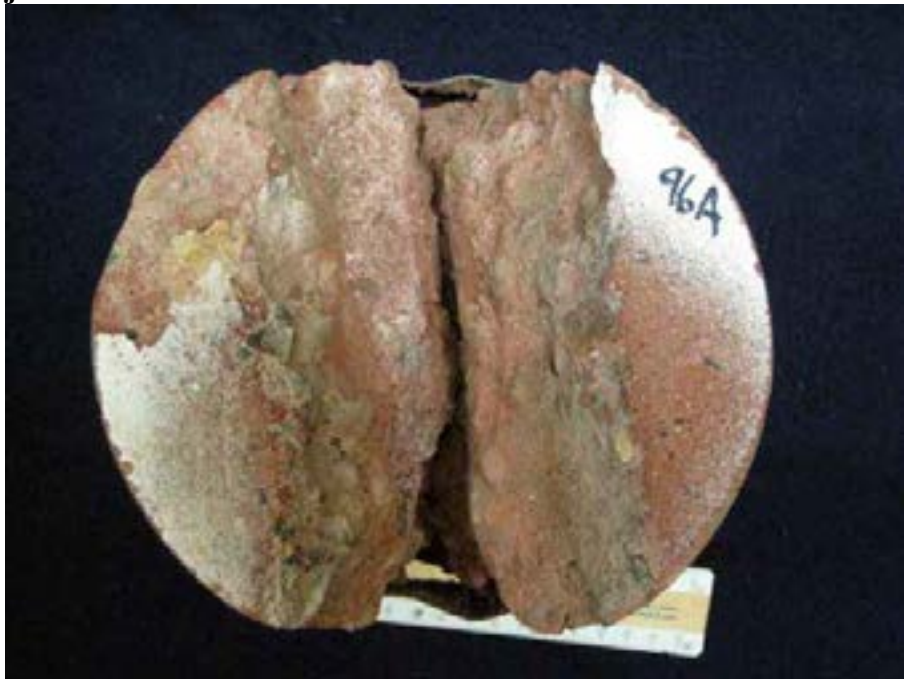
96A DESCRIPTION: Top surface of the core sample as received. Note severely distressed joint.

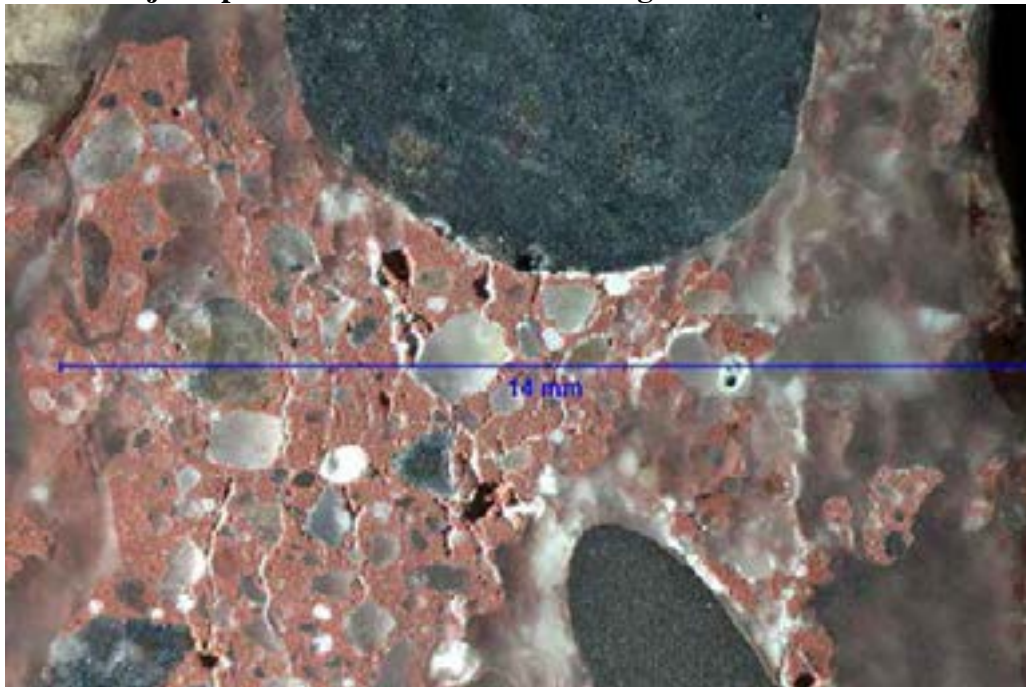
96A DESCRIPTION: Concentrated, sub-vertical microcracking within 14mm of the distressed joint plane is filled with white ettringite. MAG: 10x

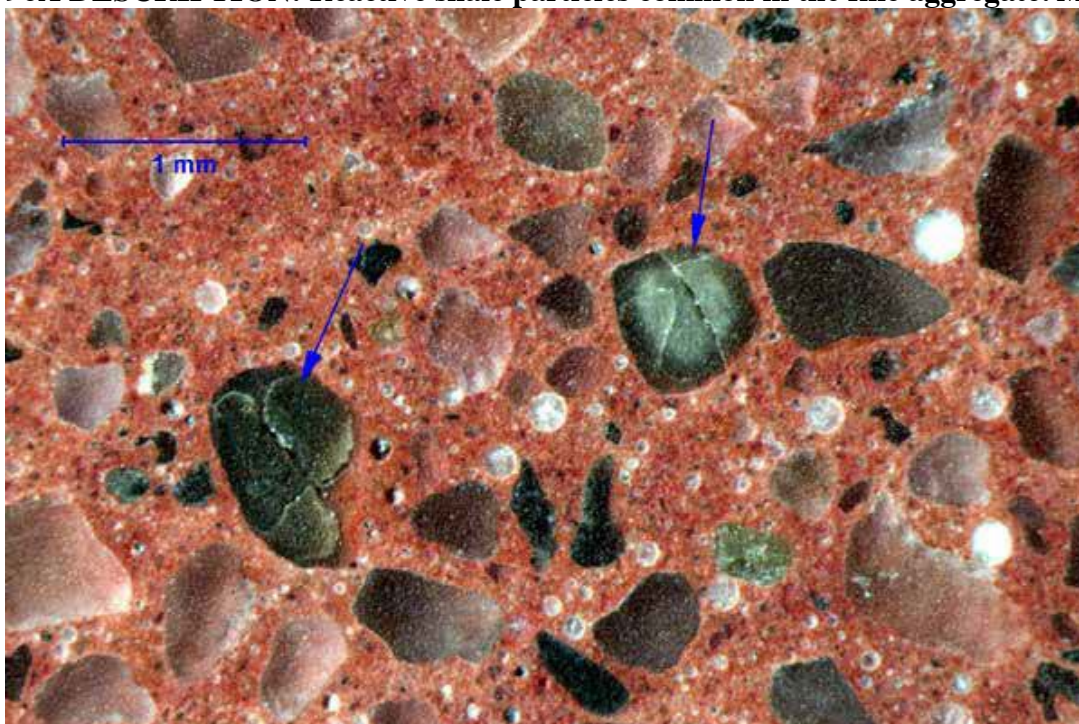
96A DESCRIPTION: Reactive shale particles common in the fine aggregate. MAG: 30x

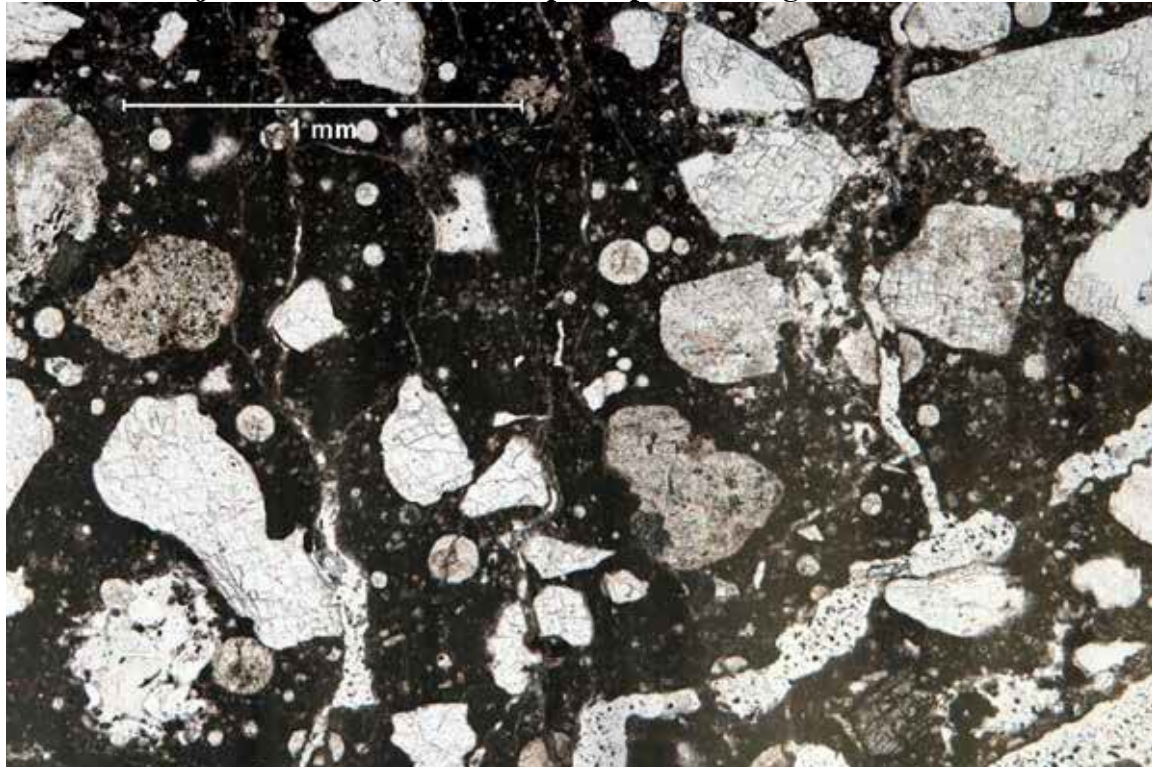
96A DESCRIPTION: Fine sub-vertical microcracking in the paste, in thin section of concrete adjacent to the joint; under plane polarized light. MAG: 40x

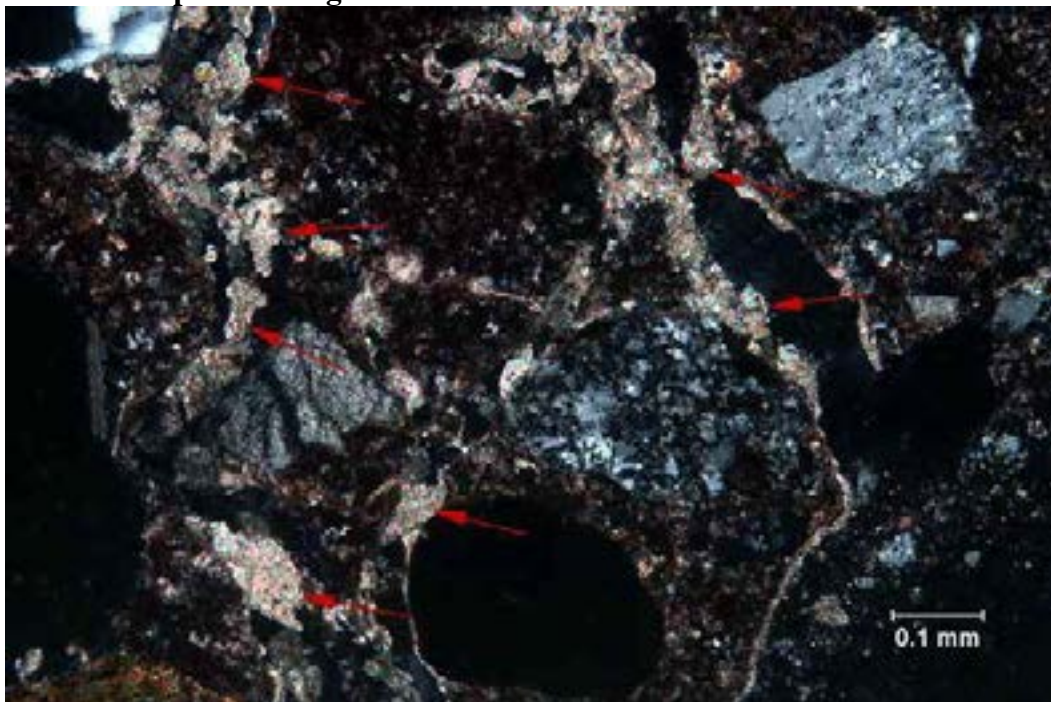
96A DESCRIPTION: Brightly colored secondary calcite in microcracking within the outer 7mm of the concrete directly adjacent to the distressed joint plane; in thin section under cross polarized light. MAG: 100x

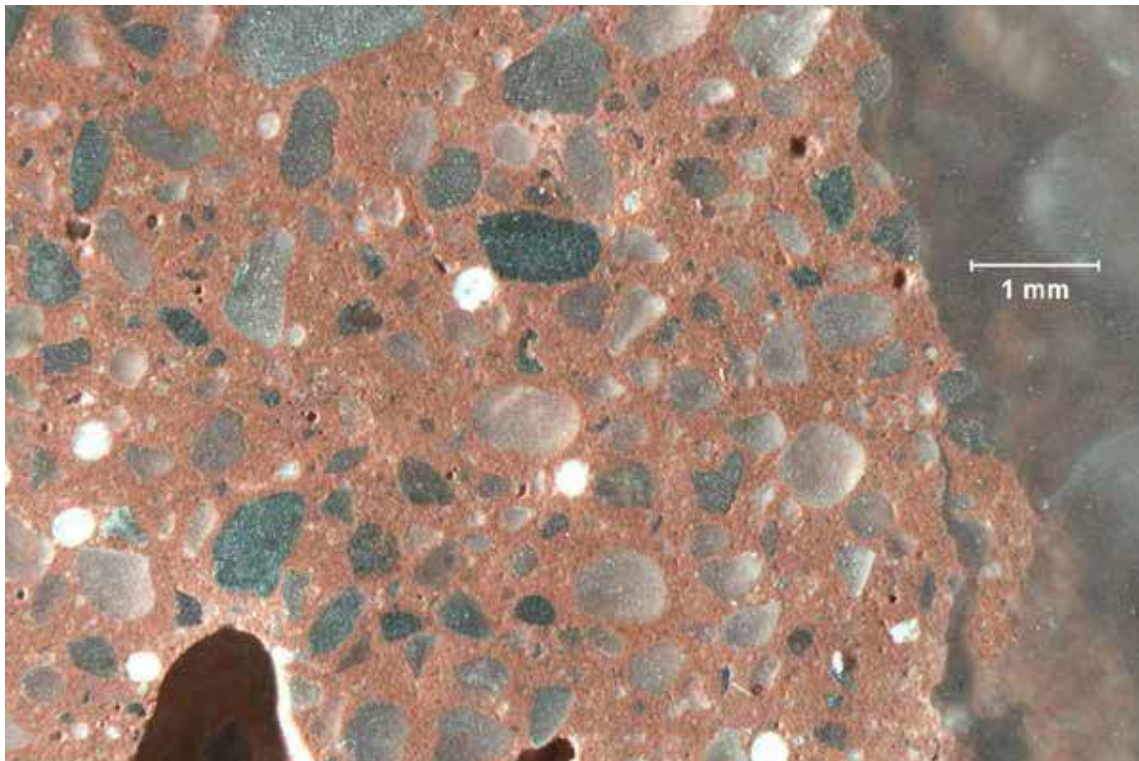
96A DESCRIPTION: The concrete at +165mm depth and directly adjacent to the joint exhibits little un-filled air entrainment. **MAG: 15x**

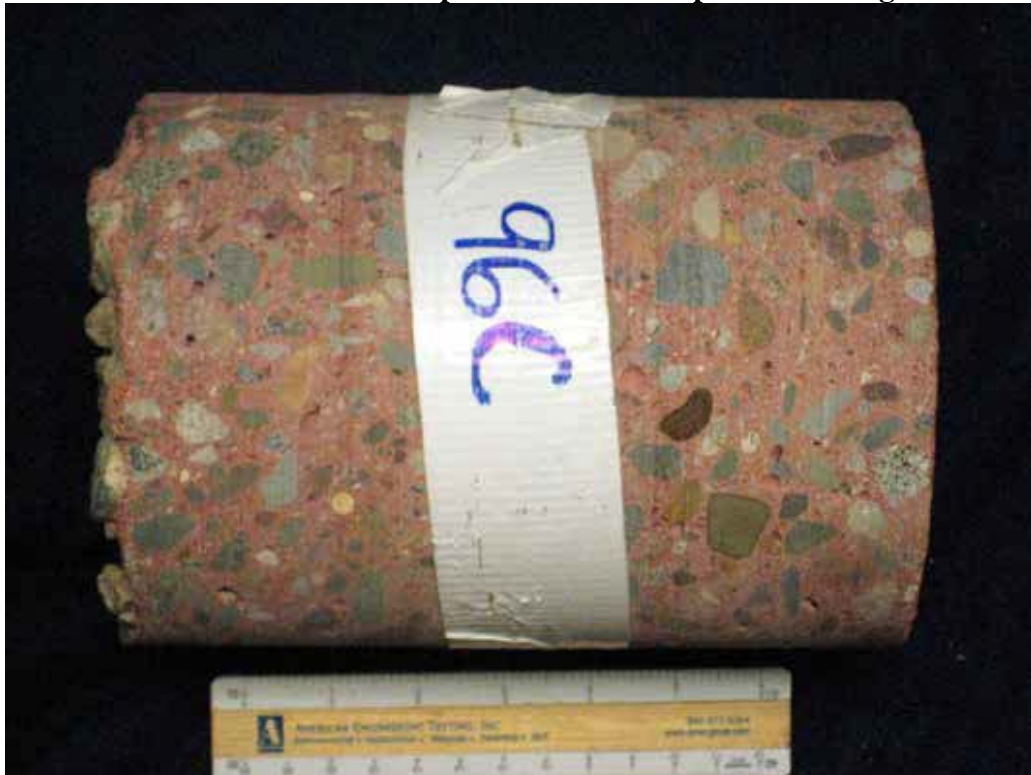
96C DESCRIPTION: Lightly textured and mortar eroded top surface of the core sample as received.

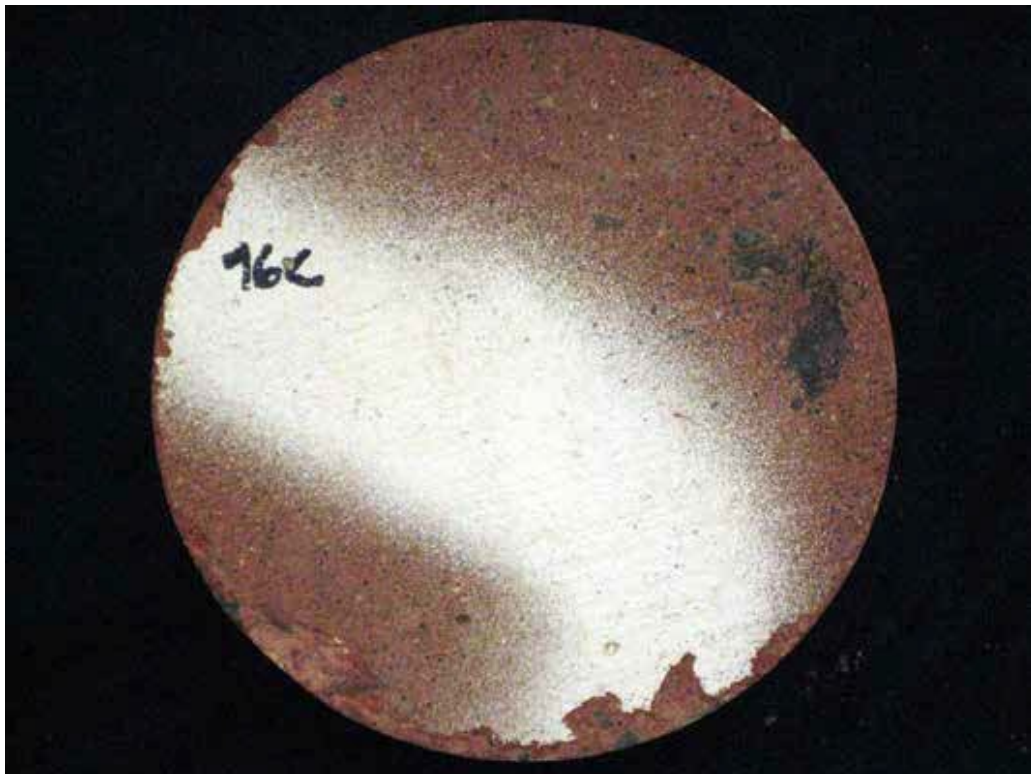
96C DESCRIPTION: Sawcut and lapped cross section of 151mm diameter, undistressed, mid-panel concrete core.

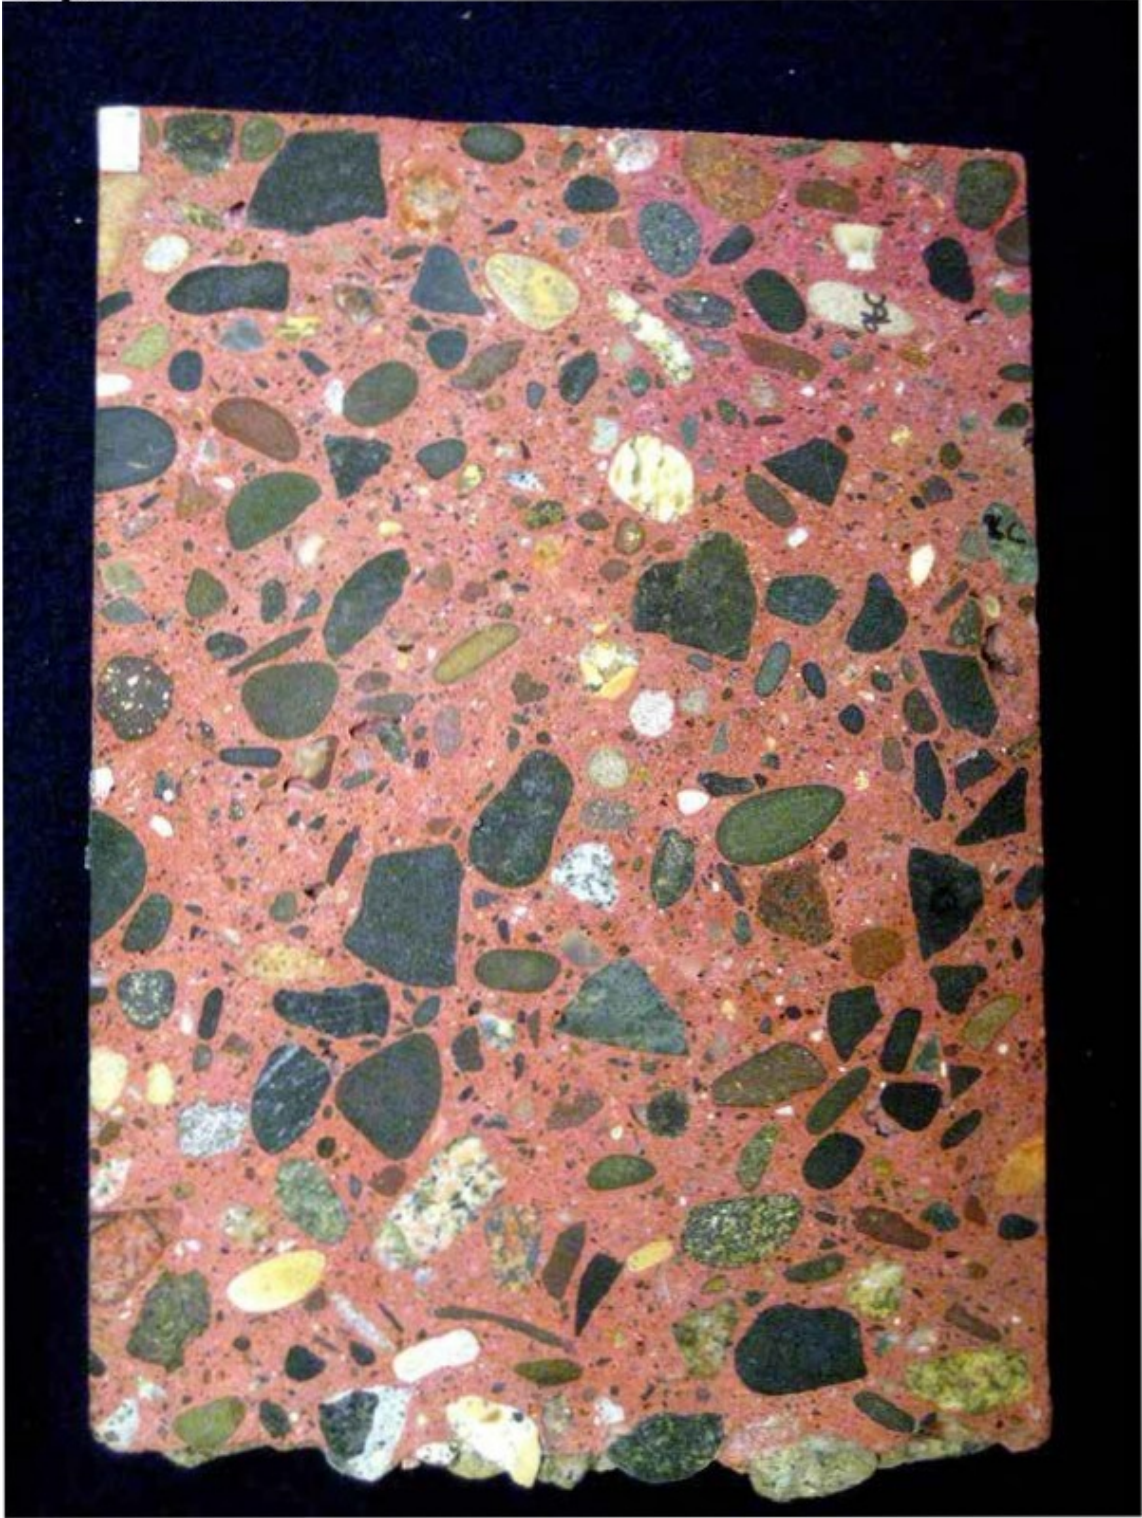
96C DESCRIPTION: Carbonation ranged from negligible up to 12mm depth, intermittently, along sub-vertical drying shrinkage microcracks mapped in red ink. MAG: 5x

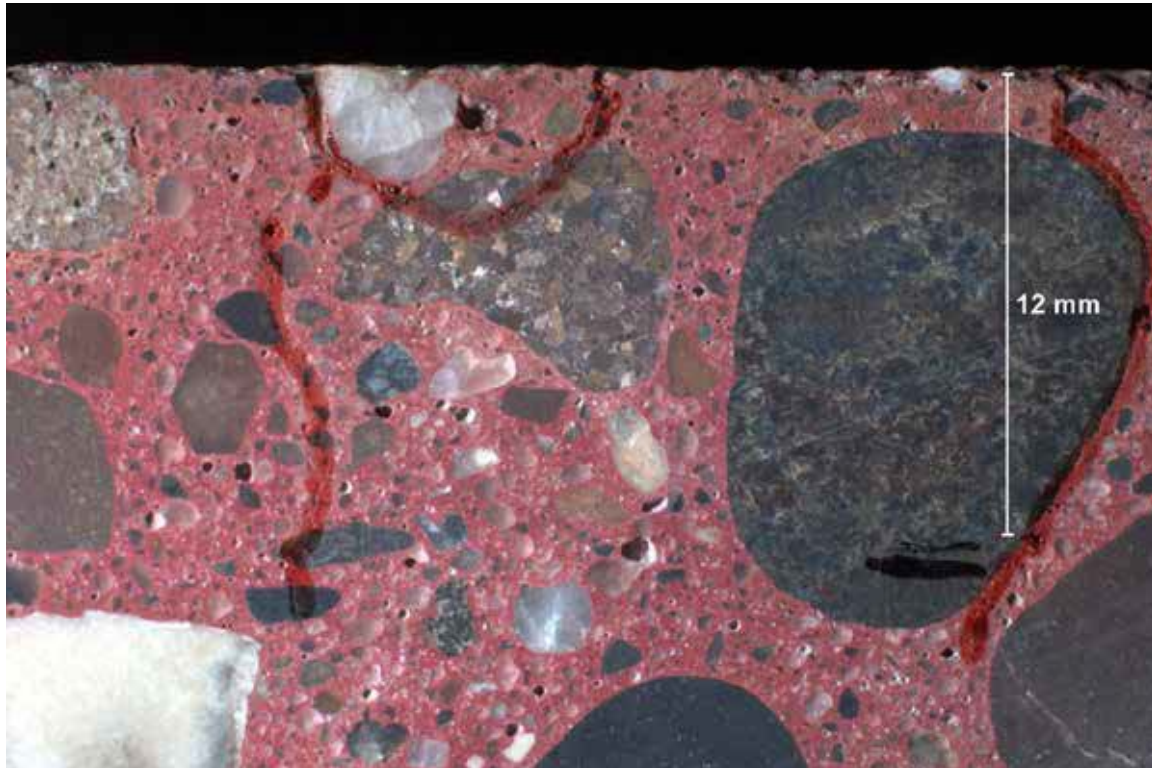
96C DESCRIPTION: The top surface of the concrete exhibits mortar erosion exposing many fine aggregates. MAG: 5x

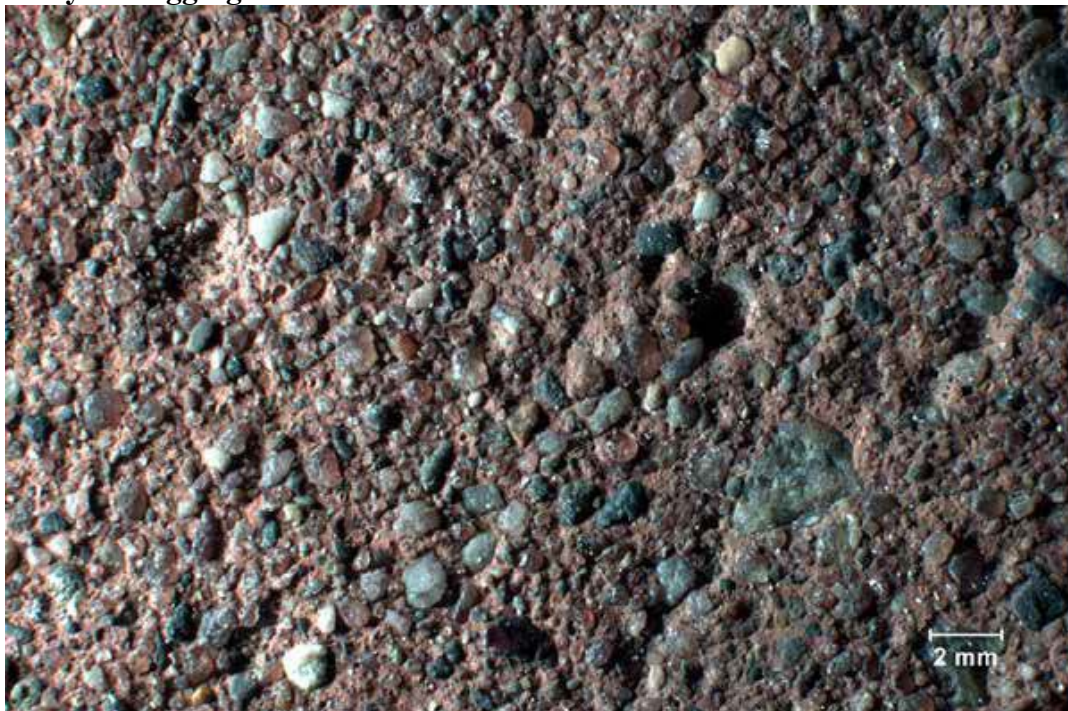
96C DESCRIPTION: Overall hardened air content proximate to the top surface of the core. **MAG: 15x**

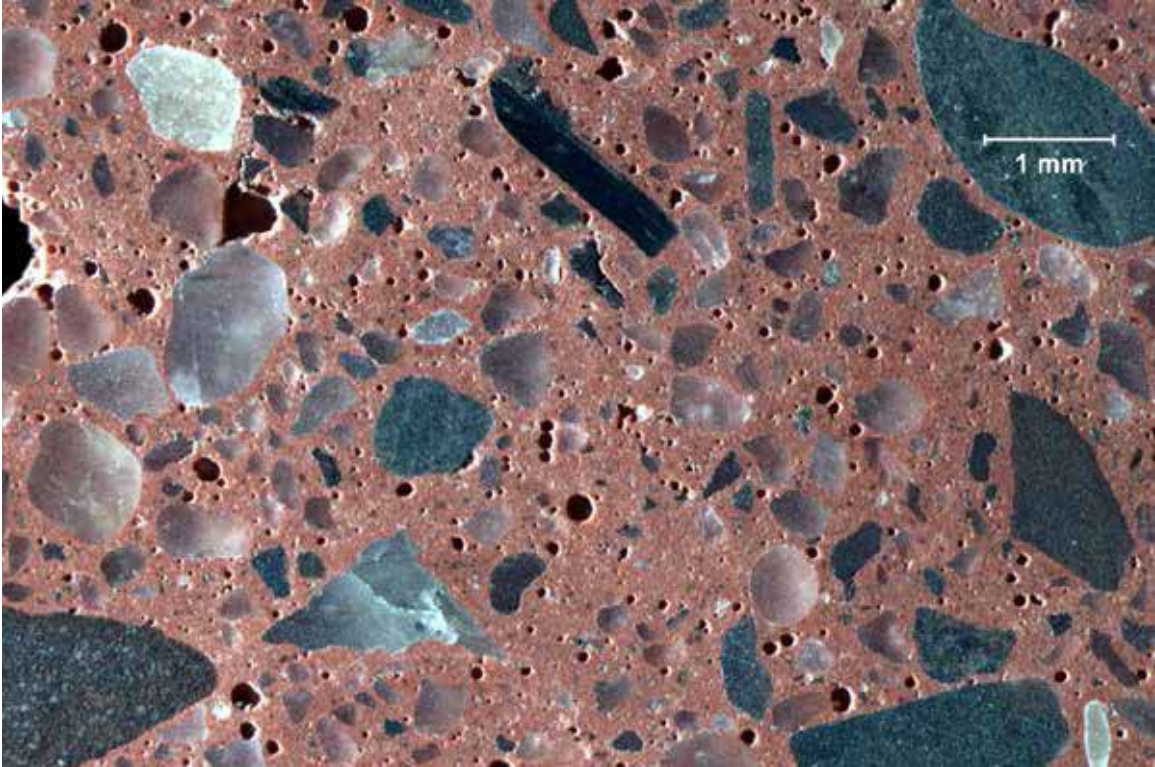
96C DESCRIPTION: Ettringite-filled voidspaces below 17mm depth in the core. **MAG: 50x**

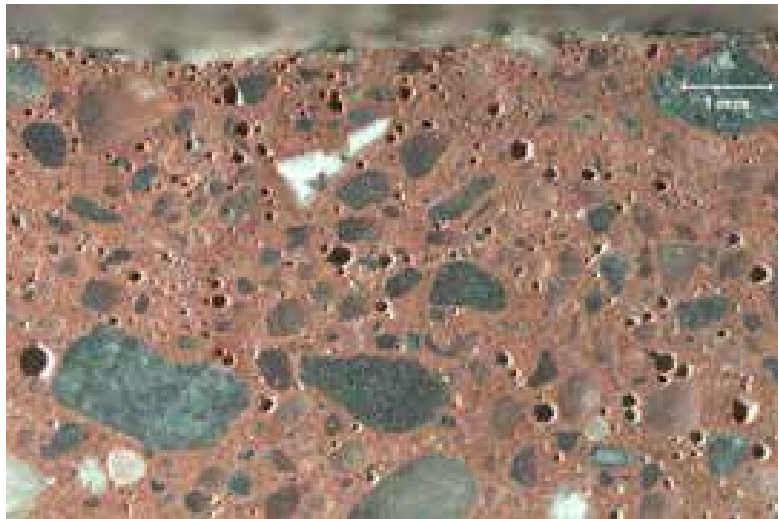
4. &General Physical Conditions: The concrete core was apparently taken directly adjacent to a distressed, sawcut pavement joint. The joint is characterized by evidence of a sawcut, locatable only by a single, vertically-truncated, sawcut aggregate particle protruding from the distressed cement paste, to 12mm (1/2") depth from the top surface plane. The remaining evidence of the sawcut joint was vertically scaled/spalled away; with the subsequent distressed joint plane comprising a vertical face along the entire depth of the core. Up to approximately 19mm (3/4") of the total core diameter has vertically scaled/spalled off along the joint crack. Several of the aggregate particles on the face of the joint crack appear to have fractured along the joint crack while a few relatively "clean" and un-distressed aggregate particles protrude from the cement paste along the joint crack. Numerous sub-vertical microcracks (incipient scaling/spalling) were observed within 25mm of the joint crack. The microcracks pass through several coarse aggregate particles. The top approximately 20mm of the joint plane is characterized by a light brownish gray, somewhat "dirty" surface with some debris lining the joint plane. Below 20mm depth the joint plane appears clean with some white secondary deposits or "mats" of ettringite lining the joint plane to a depth of 170mm. The coarse aggregate appeared sound. No evidence of ASR associated with the coarse aggregate was observed. A few alkali-silica "reacted" shale fine aggregate particles were present in the core. The "reacted" shale particles exhibit internal cracking that propagates shallowly into the paste.

96D DESCRIPTION: Core sample as received. Top surface is right. Note distressed joint profile.

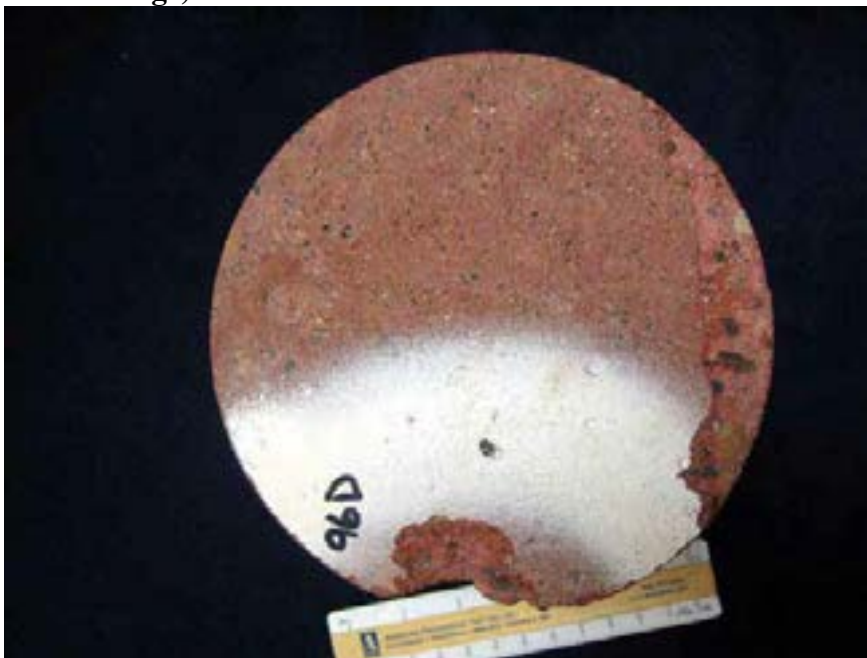
96D DESCRIPTION: Saw cut and lapped cross section of 200mm long concrete core taken directly adjacent to a distressed control joint (R).

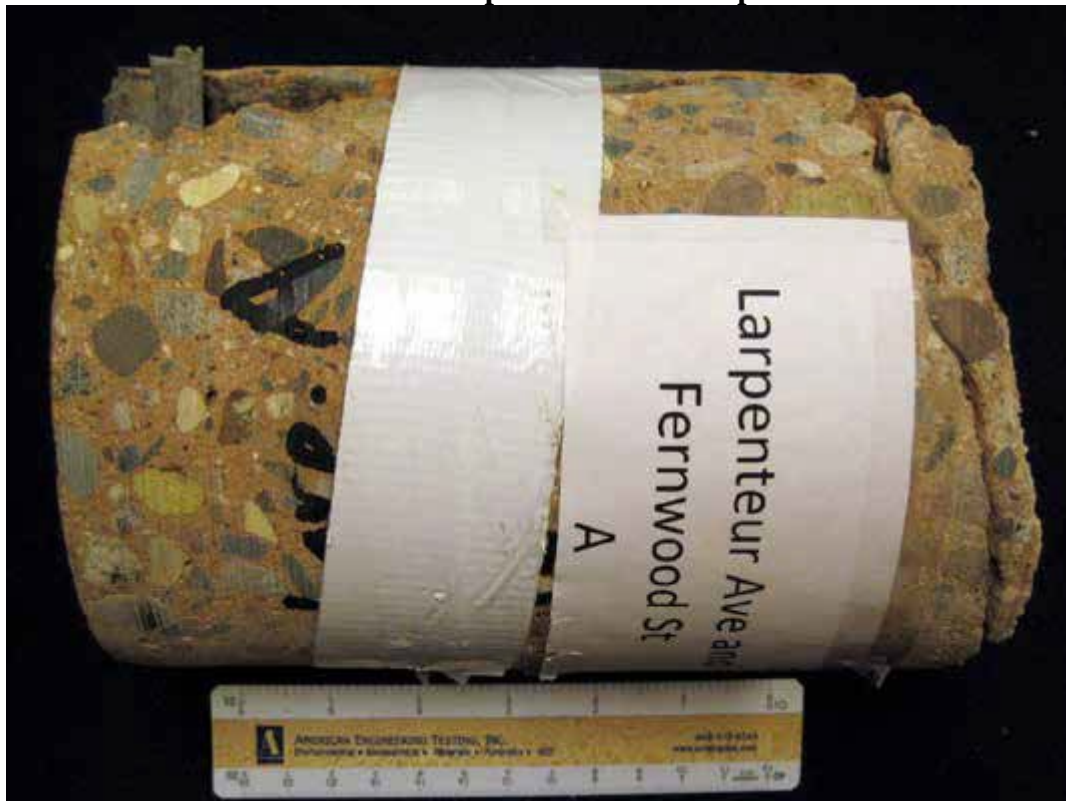
L&F A DESCRIPTION: Top surface of the core sample as received. Note sealed and raveled joint.

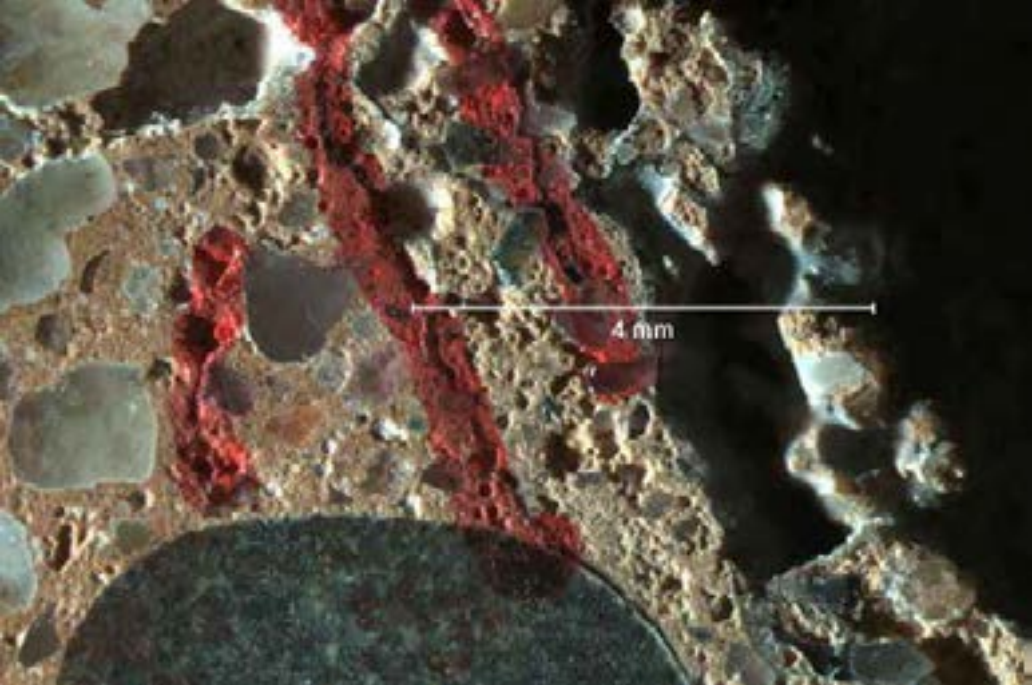
L&F A DESCRIPTION: Softer paste characterizing the outer 4mm of distressed concrete directly adjacent to the spalled joint surface at 15mm depth from the top surface plane. MAG: 10x

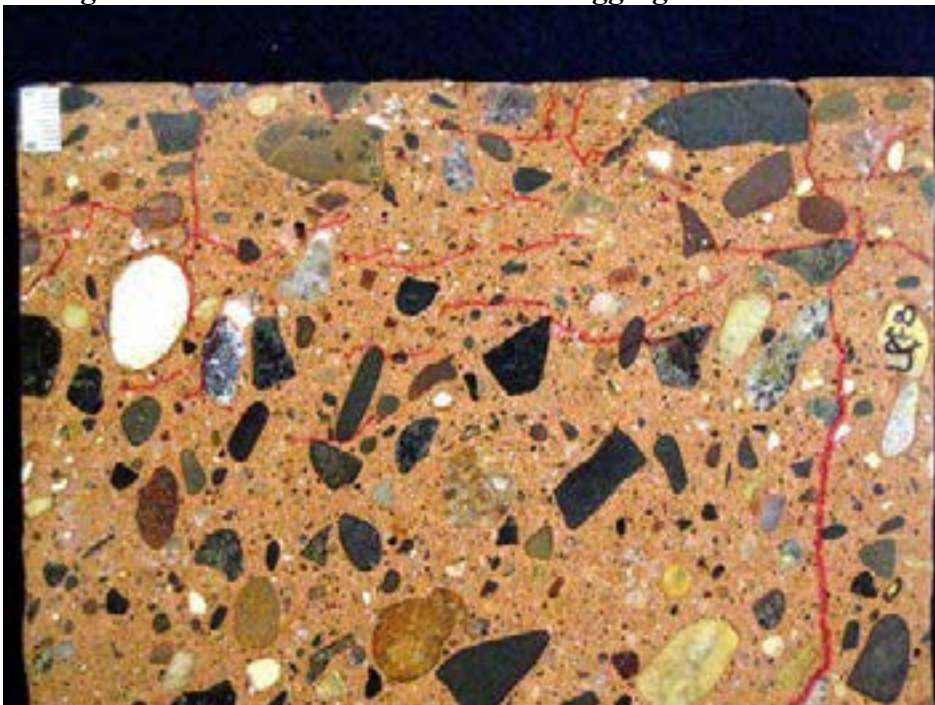
L&F B DESCRIPTION: Alkali-silica reaction (ASR) induced microcracking is mapped in red ink. The subhorizontally oriented cracking is confined to the top 60mm and proceeds through several coarse and dozens of fine aggregates.

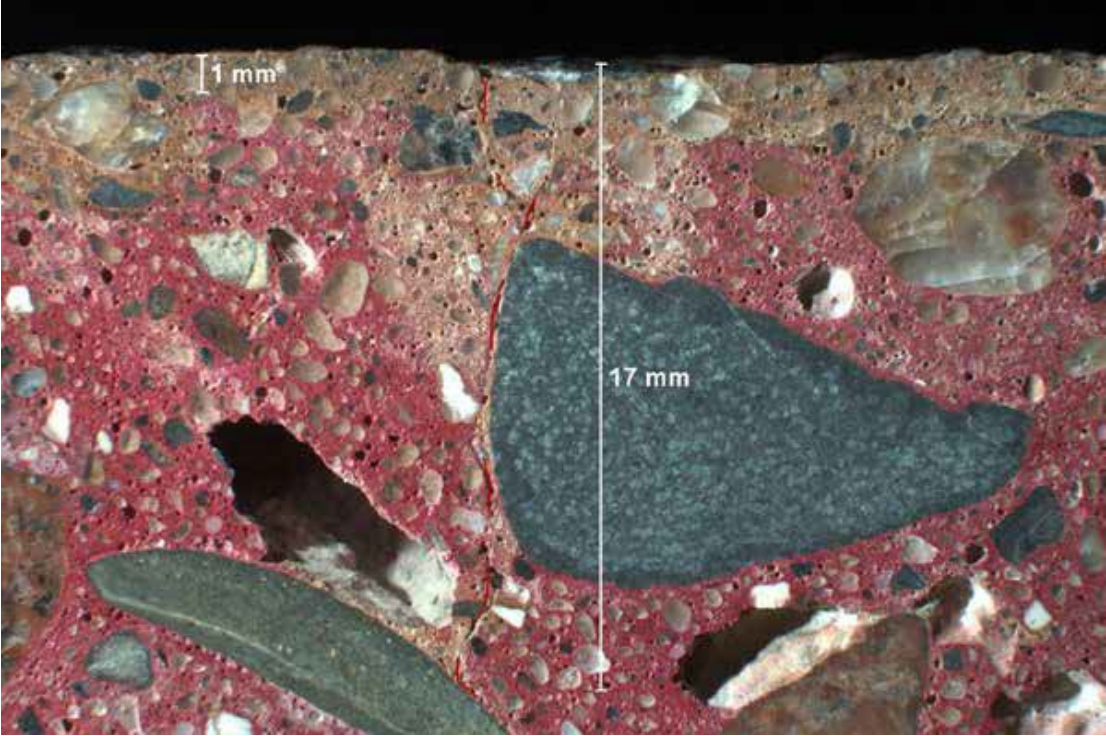
L&F B DESCRIPTION: Carbonation (unstained paste) ranged from 1mm up to 17mm depth (in this image) from the top surface of the concrete. MAG: 5x

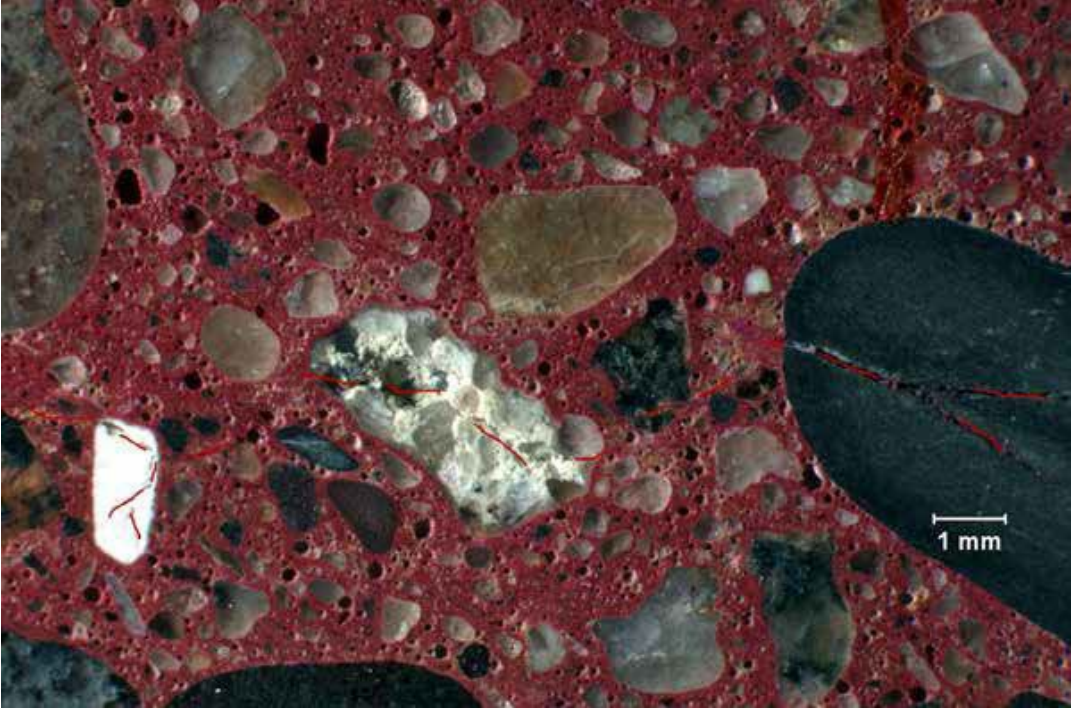
L&F B DESCRIPTION: Alkali-silica reaction (ASR) induced sub-horizontal microcracking (mapped in red dashed line) proceeds through three coarse and fine aggregates at approx. 25mm depth in the core. MAG: 5x

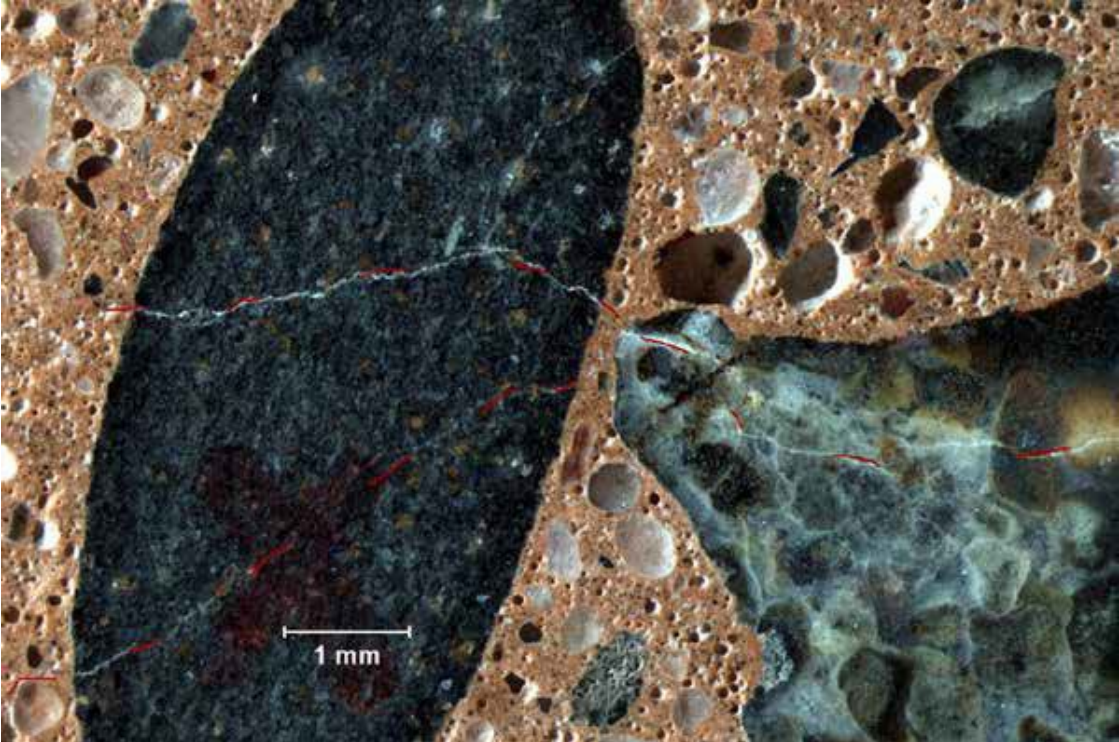
L&F B DESCRIPTION: Alkali-silica reaction (ASR) induced sub-horizontal microcracking (mapped in red dashed line) proceeds through two coarse aggregates at approx. 40mm depth in the core. MAG: 15x

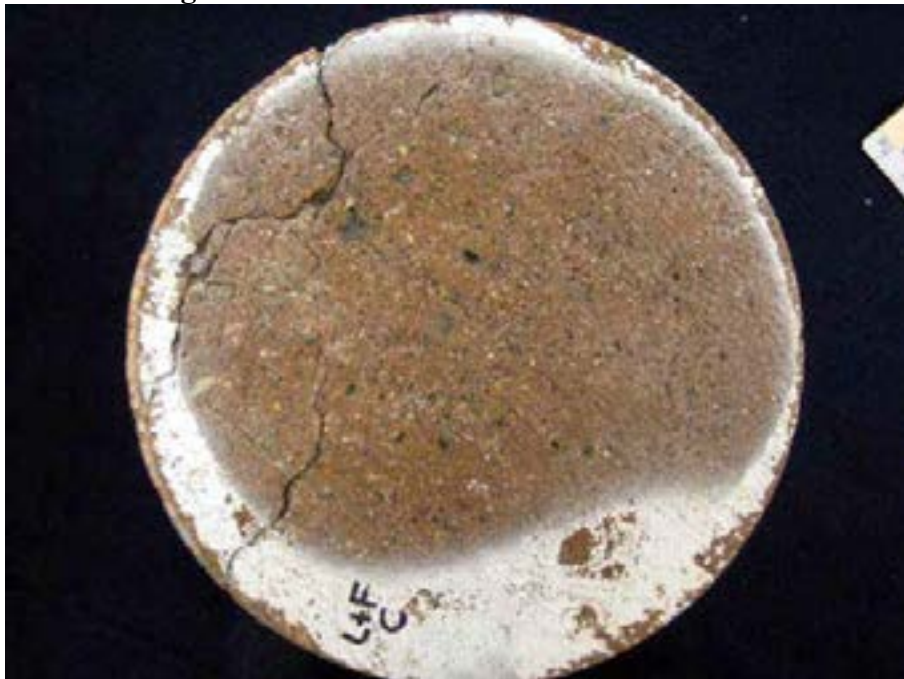
L&F C DESCRIPTION: Traffic-worn top surface of the core sample as received. Note cracking.

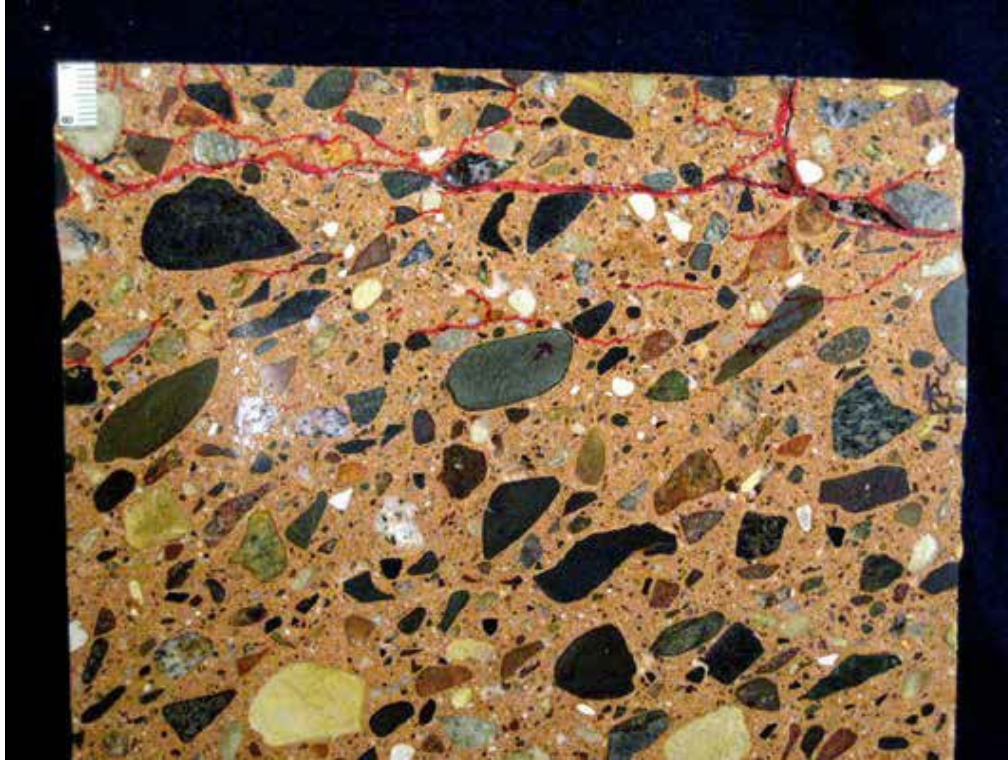
L&F C DESCRIPTION: Alkali-silica reaction (ASR) induced microcracking is mapped in red ink. The sub-horizontally oriented cracking is confined to the top 50mm and proceeds through several coarse and dozens of fine aggregates.

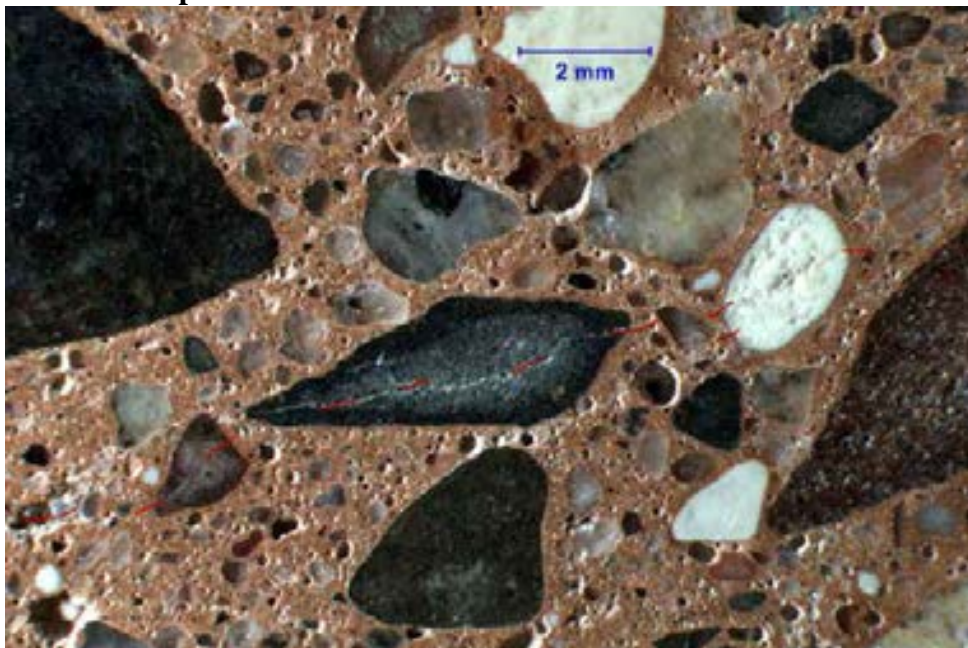
L&F C DESCRIPTION: Alkali-silica reaction (ASR) induced sub-horizontal microcracking (mapped in red dashed line) proceeds through coarse and fine aggregates within the top 50mm of the core. MAG: 10x
