Investigation and Assessment of Colored Concrete Pavement

Minnesota
Department of
Transportation

August 2014

Research Project
Final Report 2014-26

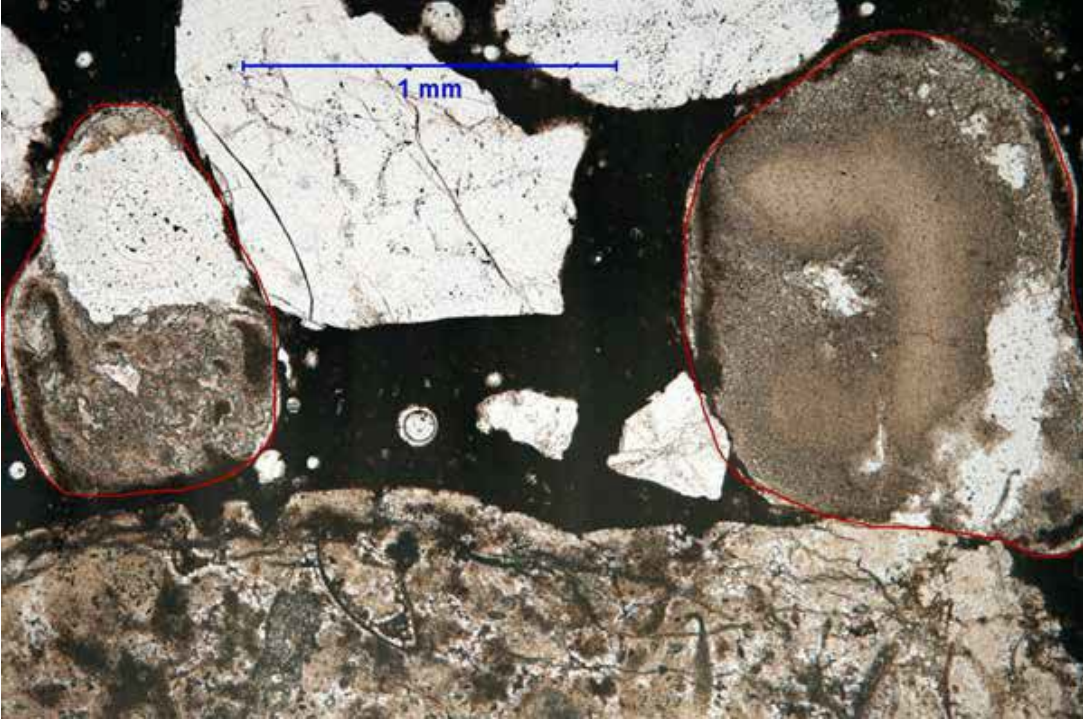
L&F C DESCRIPTION: ASR-gel filled voidspaces (outlined in red) directly adjacent to a reactive chert aggregate particle (bottom); in thin section of concrete under plane polarized light. MAG: 40x

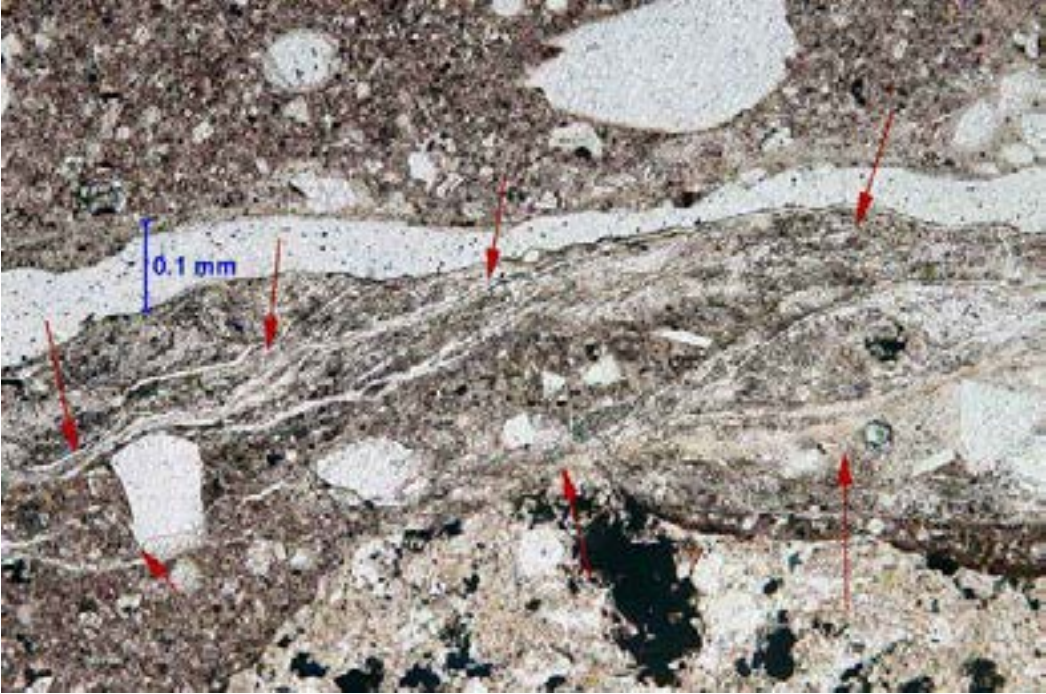
L&F C DESCRIPTION: Clear ASR-gel product fills a swarm of sub-horizontal microcracking proceeding from an adjacent reactive aggregate particle within the top 50mm of the core; in thin section under plane polarized light. MAG: 100x

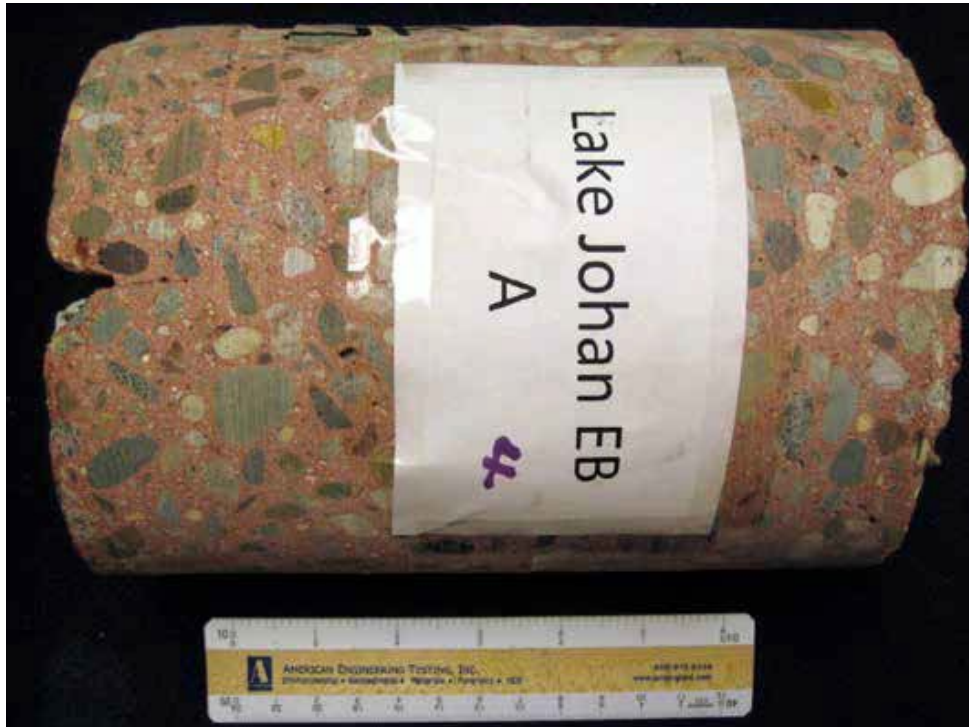
LJ EB A DESCRIPTION: Core sample as received. Top surface is left. Note un-activated joint.

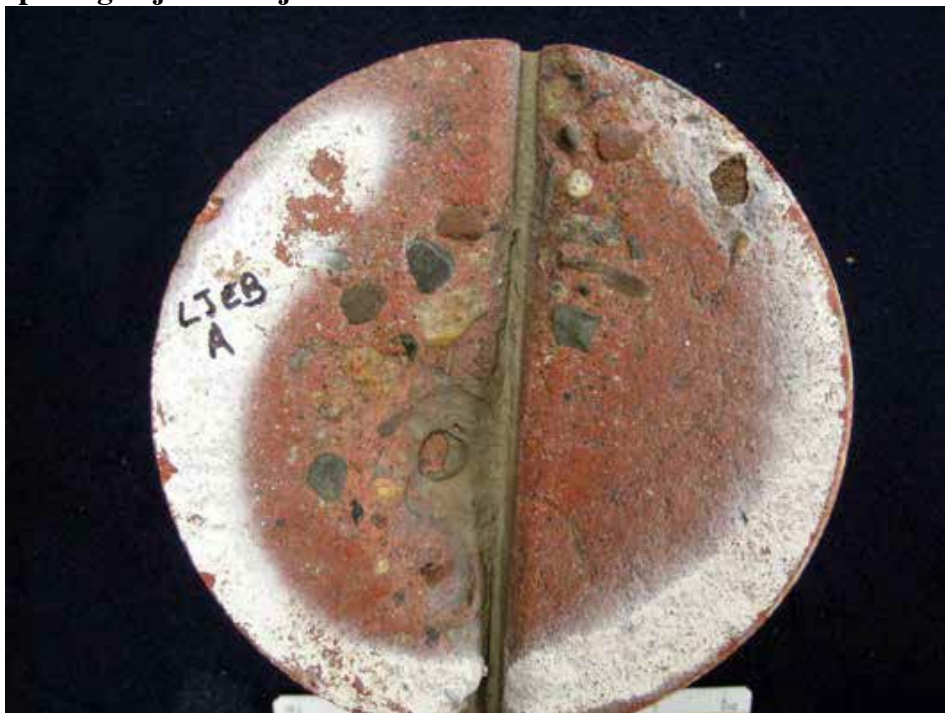
LJ EB A DESCRIPTION: Traffic-worn top surface of the core sample as received. Note spalling adjacent to joint.

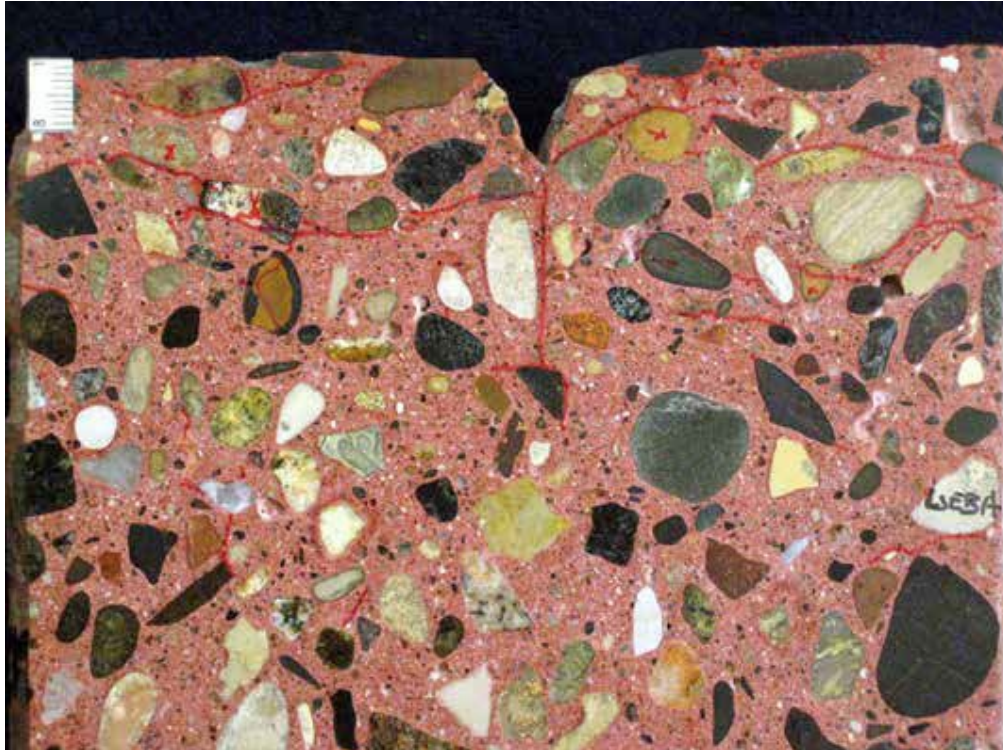
LJ EB A DESCRIPTION: ASR induced microcracking is mapped in red ink. The sub-horizontally oriented cracking is confined to the top 76mm and proceeds through several coarse and dozens of fine aggregates. Note un-activated, tooled, control joint.

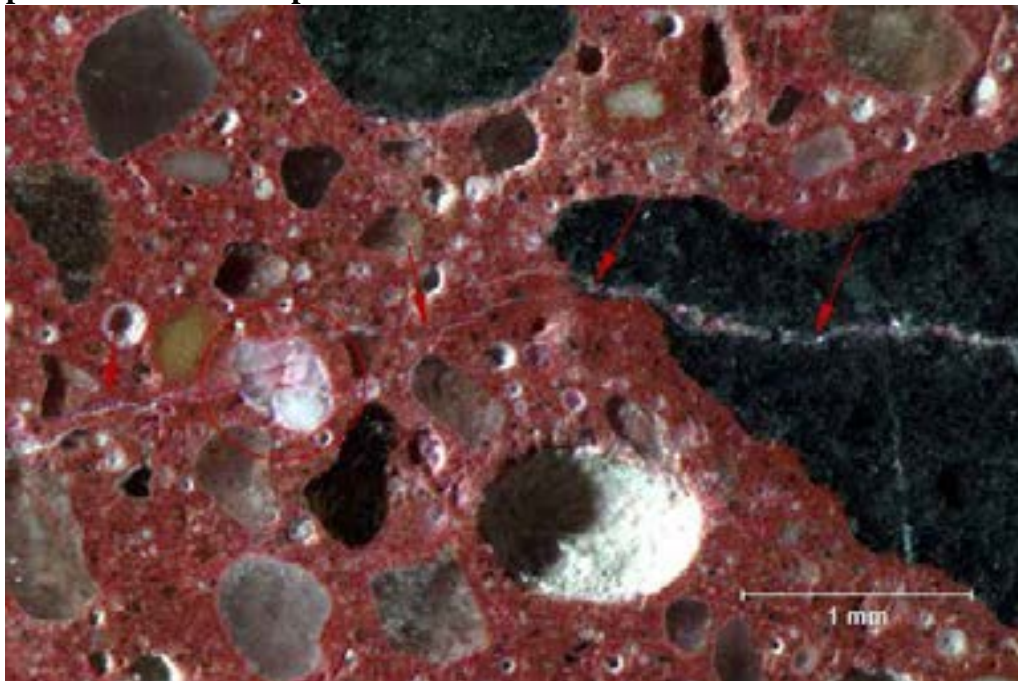
LJ EB A DESCRIPTION: Clear ASR-gel product fills a swarm of sub-horizontal microcracking within and proceeding from a reactive greywacke coarse aggregate particle within the top 76mm of the core. MAG: 30x

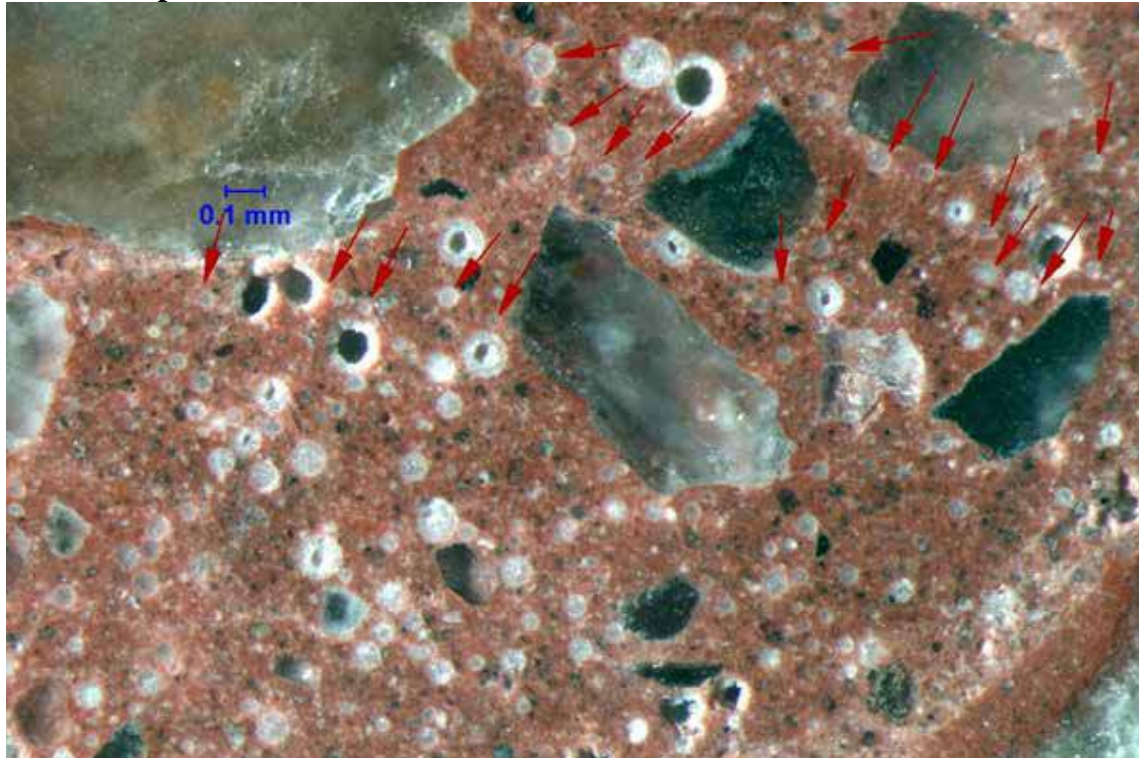
LJ EB A DESCRIPTION: Ettringite-filled entrained sized air voids in the concrete paste at 60mm depth in the core. MAG: 50x

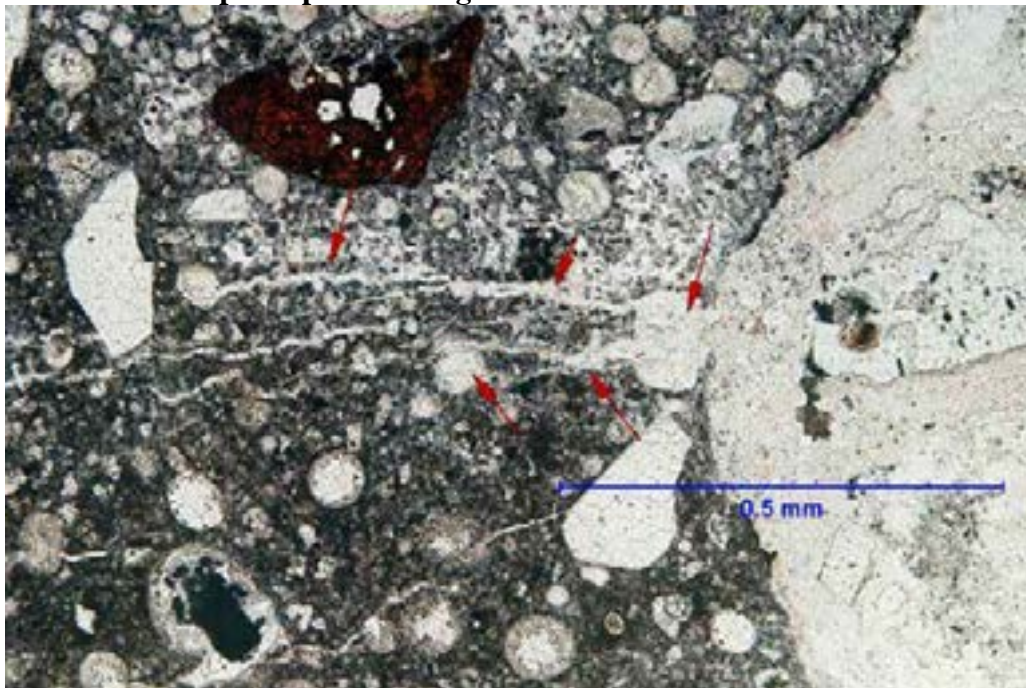
LJ EB A DESCRIPTION: Clear ASR-gel product fills a swarm of sub-horizontal microcracking proceeding from a reactive chert fine aggregate particle; in thin section of concrete under plane polarized light. MAG: 100x

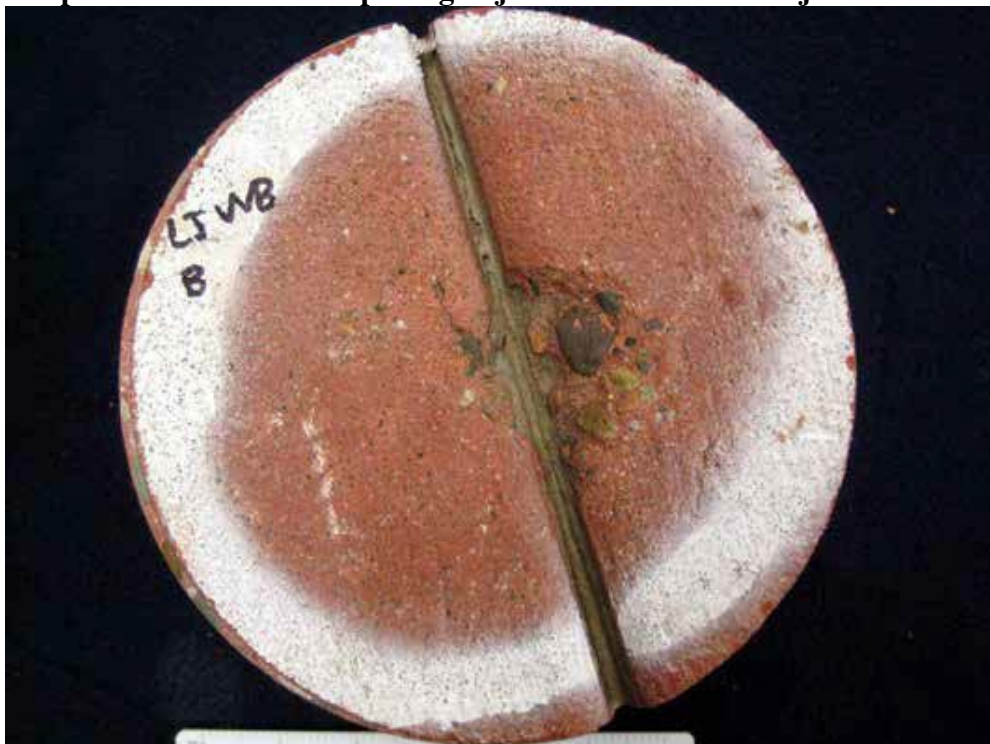
and fine aggregate particles. The cracking occurs generally in a sub-horizontal orientation and between 10mm and 58mm depth in the core. Clear to white ASR gel was observed partially lining to filling voidspaces and microcracks adjacent to the reactive particles and bisected by the microcracking.

LJ WB B DESCRIPTION: Sawcut and lapped cross section of 151mm diameter concrete core. Note sub-horizontal microcracking in the top approx. 60mm of the core.

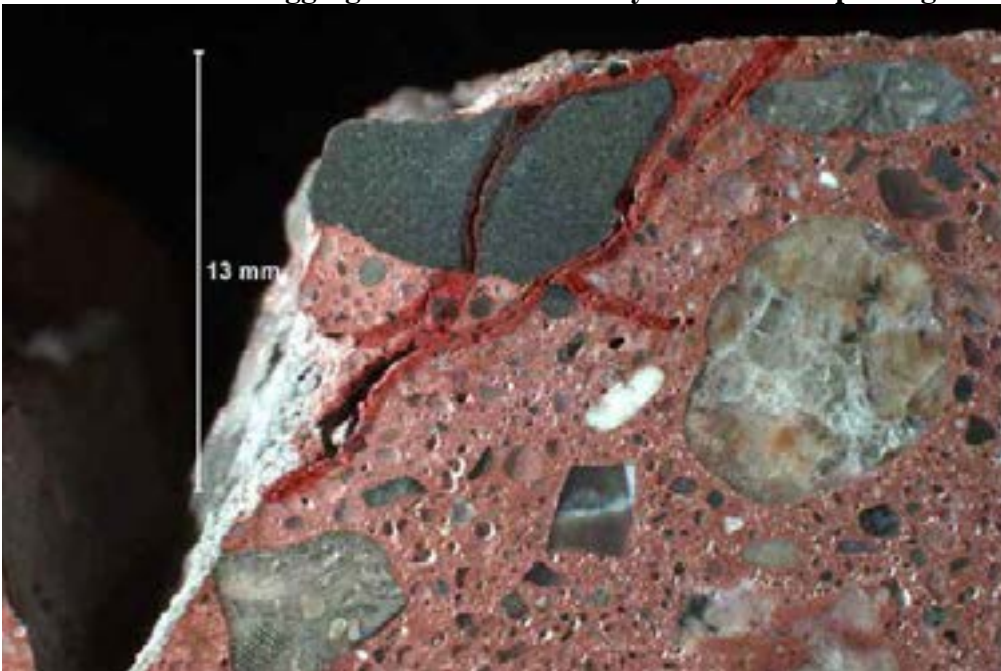
LJ WB B DESCRIPTION: White to clear ASR gel mostly fills sub-horizontally oriented

microcracking proceeding through three reactive fine aggregates. MAG: 15x

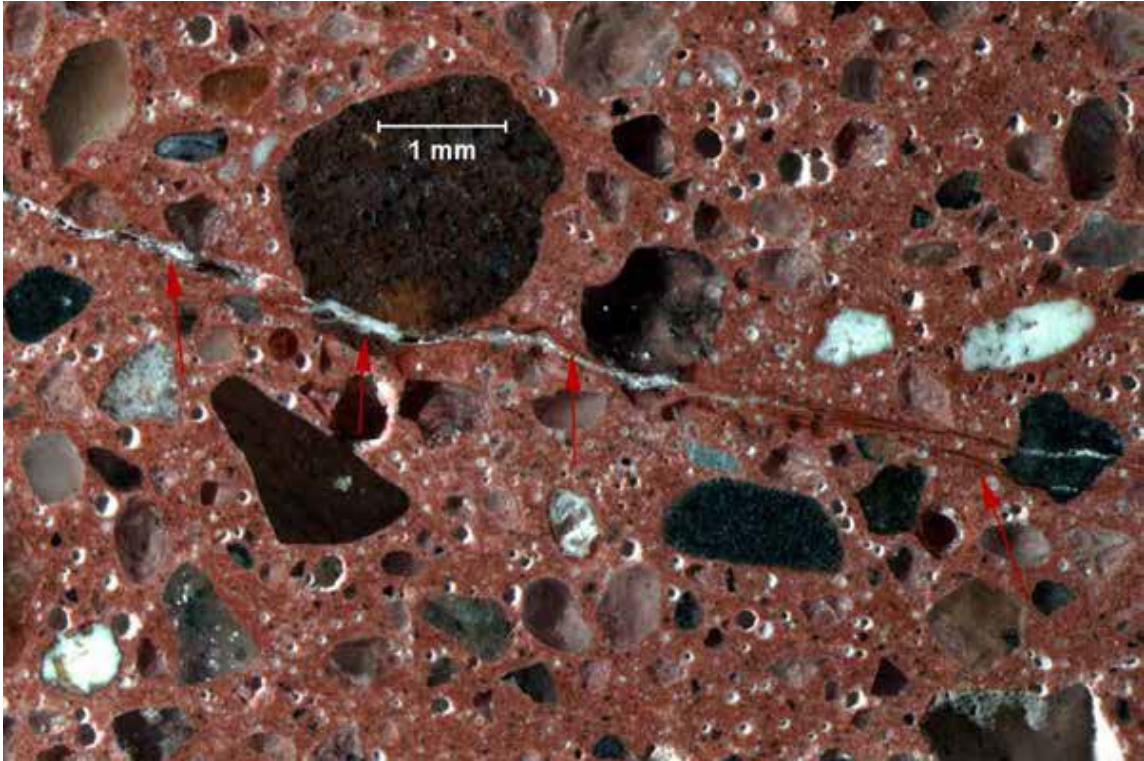
LJ WB B DESCRIPTION: White to clear ASR gel mostly fills sub-horizontally oriented microcracking proceeding through a graywacke coarse aggregate. MAG: 30x

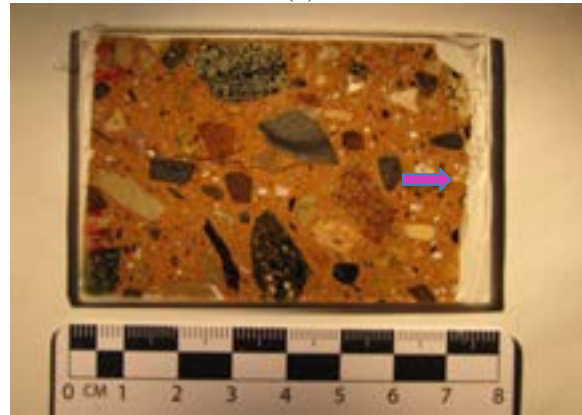
Figure 3. Specimens prepared for analysis in the SEM. (a) 96A, (b) Larpenteur & Fernwood A, (c) 96D, and (d) Larpenteur & Fernwood C. Magenta arrow indicates location of the joint showing deterioration.

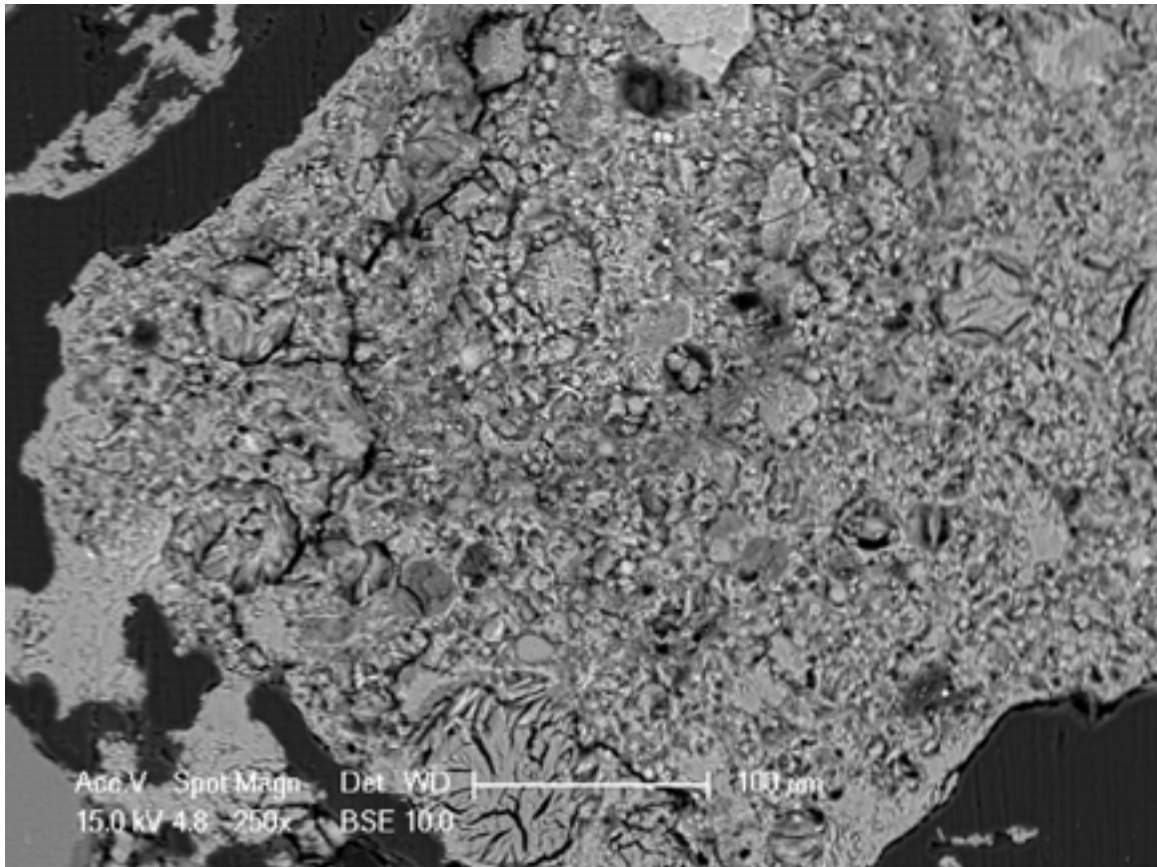
Figure 11 shows grain A from Figure 4, and Figure 12 shows the x-ray intensity maps associated with this same area. Figure 13 shows ettringite phases as purple regions and the calcite rim on the particle is clearly seen (blue rim). Figure 14 shows a number of orange phases that are combinations of magnesium and oxygen, more rich in magnesium. These are magnesium oxide phases but likely were originally magnesium hydroxide (brucite). In Figure 15 ettringite phases stand out clearly as cyan inclusions. Figure 16 shows the distribution of potassium, magnesium and iron in the aggregate fraction. The distribution is not uniform and in the case of magnesium does not seem to be associated with specific sub-particle phases, indicating the magnesium is likely from external sources and is migrating into the particle. As will be discussed, there is a particular felsic fine aggregate that appears to be susceptible to chemical attack in the concrete studied.

Figure 11. Backscattered electron image of grain A shown in Figure 6.

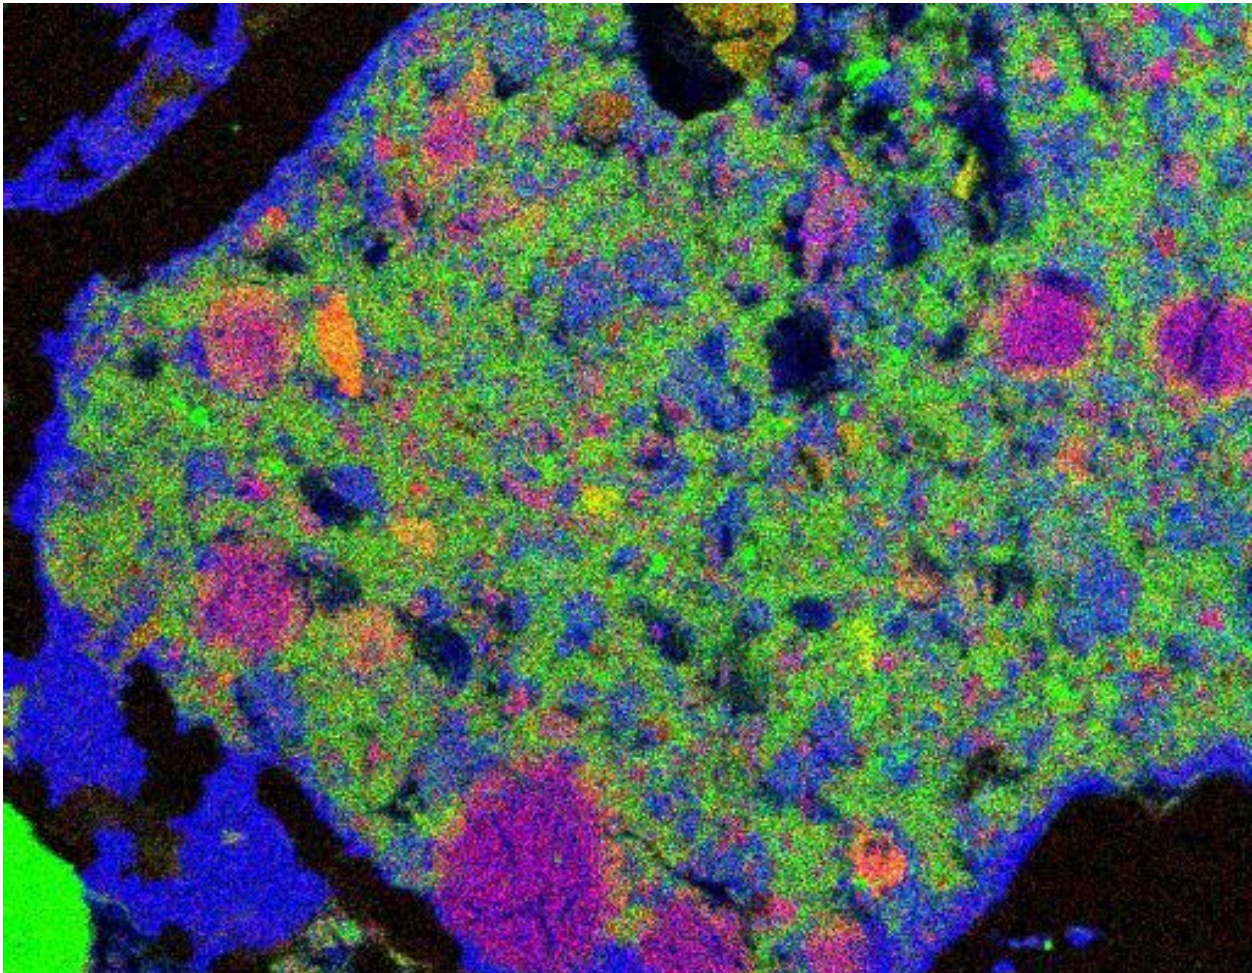
Figure 13. Combined x-ray intensity maps from the area shown in Figure 11 where maps for aluminum (red color), silicon, (green color) and calcium (blue color) are combined to show discrete and coincident locations of elements. Other colors result from the addition of colors as shown in the key at the top of the image. Shades of color (e.g., shades of purple) indicate varying rations of the elements combined to form that color.

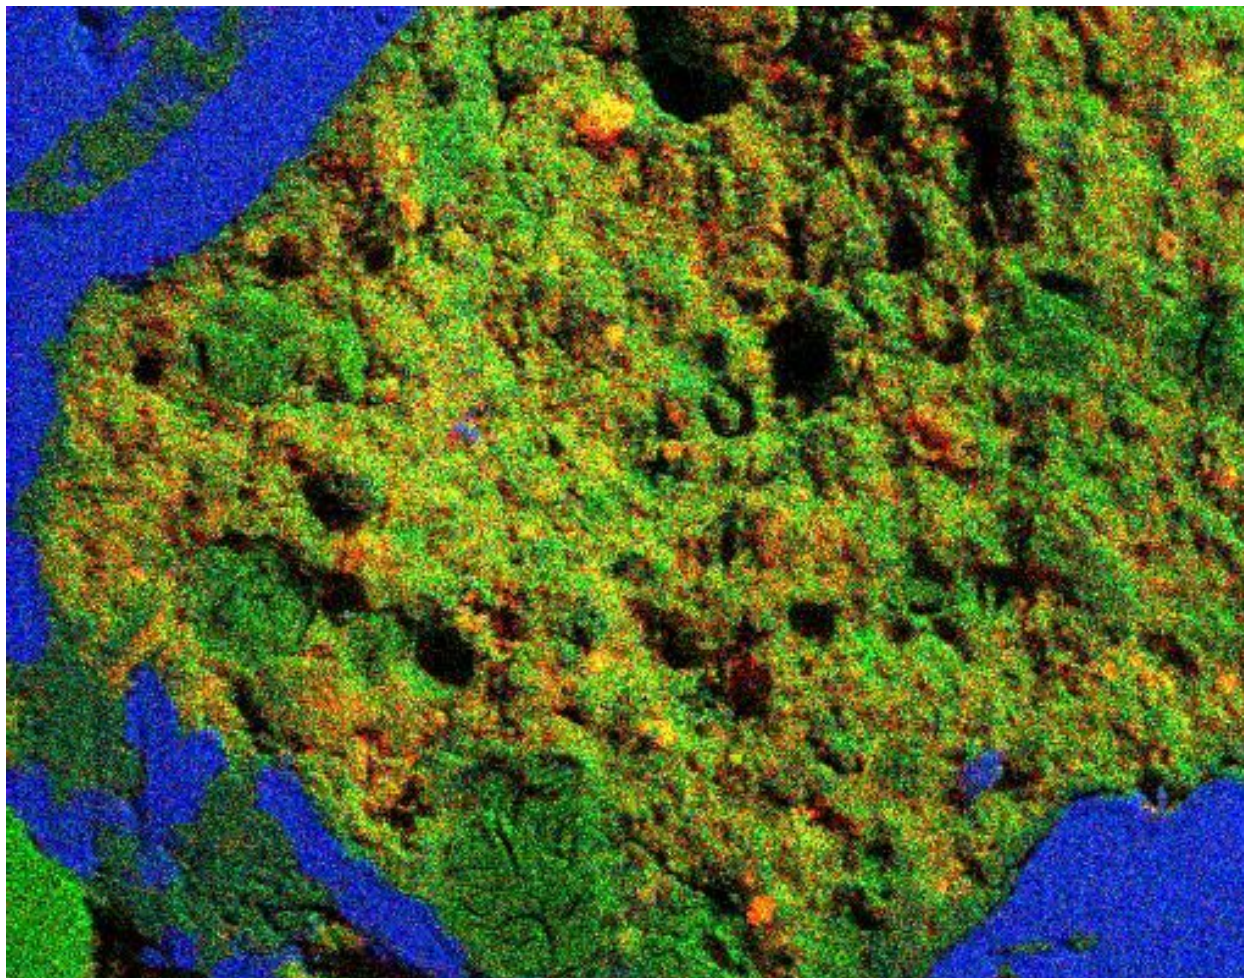
Figure 14. Combined x-ray intensity maps from the area shown in Figure 11 where maps for magnesium (red color), oxygen, (green color) and carbon (blue color) are combined to show discrete and coincident locations of elements. Other colors result from the addition of colors as shown in the key at the top of the image. Shades of color (e.g., shades of yellow) indicate varying ratios of the elements combined to form that color.

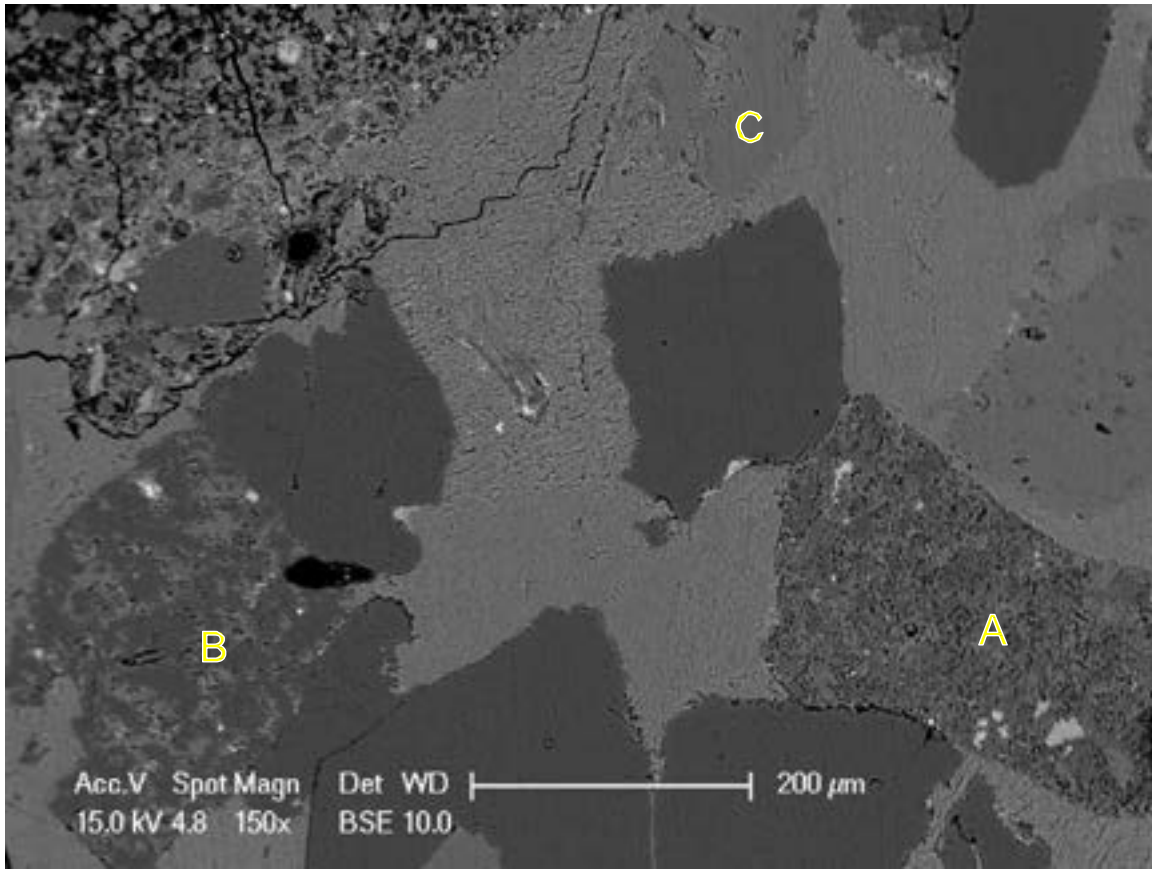
Figure 17 shows a region of the specimen adjacent to the joint (i.e., the joint is seen in the upper left-hand corner of the micrograph) but primarily includes concrete adjacent to the joint. Figure 18 presents the x-ray intensity maps gathered from this area while Figure 19 through Figure 23 show combinations of these maps in greater detail.

Figure 19 shows the combined aluminum, silicon, and calcium x-ray intensity maps. Prominent is the calcium rich matrix (blue color), which again represents the calcite matrix replacing cement. In Figure 17 the texture of the calcite can be seen and it clearly shows different regions of texture indicating successive layers of deposit. In the center of the micrograph is a feature (resembling a “squid” in appearance) that is also seen in the x-ray intensity maps that is aluminum and silicon bearing (Figure 19), and magnesium and iron bearing (Figure 20). The iron and magnesium are noted as it appears these elements may have been trapped as part of the deposition. The source of the magnesium is likely the deicers while the source of the iron appears to be the coloring added to the concrete. The iron coloring appears to be mobile as it is seen lining the interfaces around the aggregates in Figure 20 (i.e., thin green layer seen around aggregates) after the paste has undergone dissolution and re-precipitation as calcite. Also, as will be discussed further, there seems to be a coincidental occurrence of magnesium and iron in a number of locations observed.

Referring to the aggregate labeled as A in Figure 17, note in the lower right corner of the particle is a large yellow phase and 3-4 smaller yellow phases distributed throughout the grain. These yellow phases are apatite ($\text{Ca}_5(\text{PO}_4)_3\text{F}$). Example analyses are presented below in Table 1.

Figure 17. Backscattered electron image of chemically altered cement paste. Massive calcium carbonate forms the matrix around aggregates. Specimen prepared from core sample 96A.

It is recommended that a more detailed analysis of the fine aggregate used in this concrete be conducted. Observations here should be confirmed by examining the natural aggregate. Laboratory leaching tests of the aggregate should be conducted to determine if leaching of alkalis and the general process of dissolution can be identified. Additionally, MnDOT may want to consider developing a “salt soundness” test for evaluating aggregates, particularly if the laboratory testing indicates aggregate dissolution in the presence of deicers (or water) is in fact occurring.

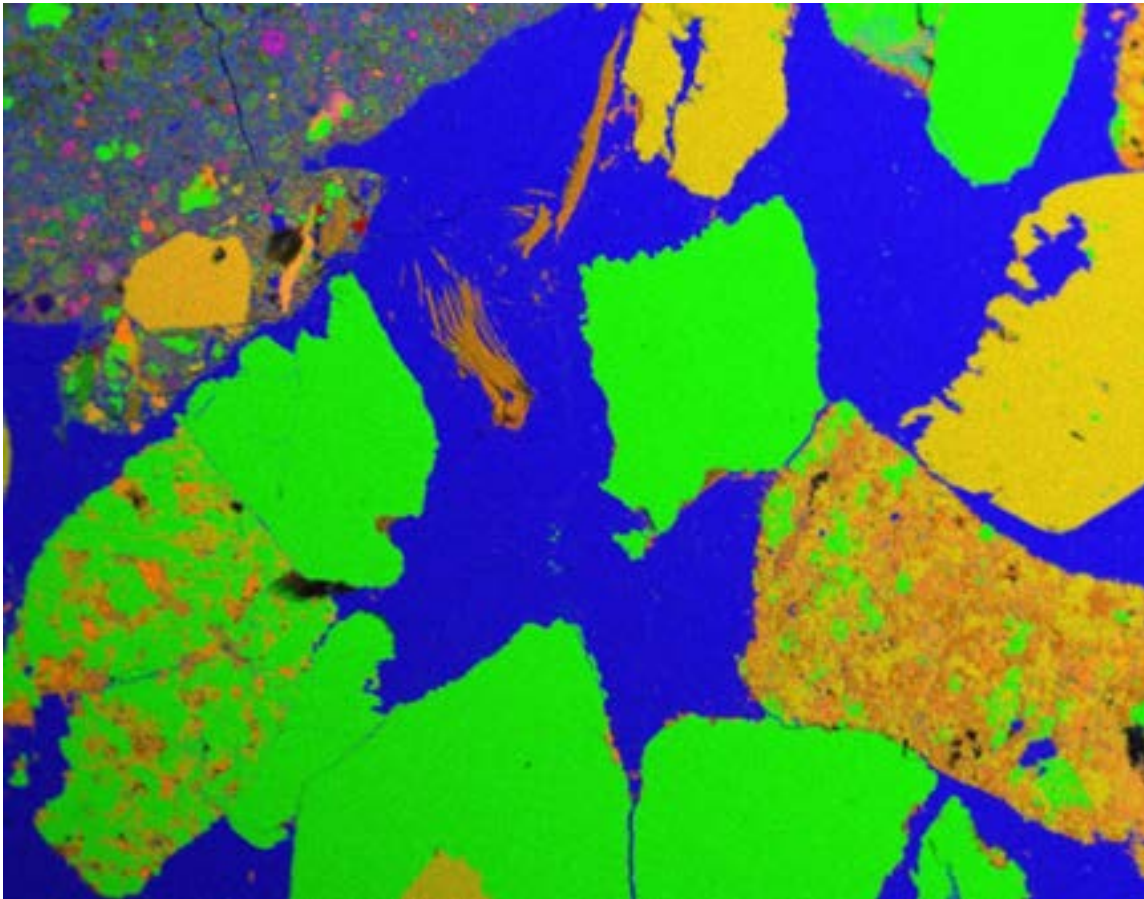
Figure 19. Combined x-ray intensity maps from the area shown in Figure 17 where maps for aluminum (red color), silicon, (green color) and calcium (blue color) are combined to show discrete and coincident locations of elements. Other colors result from the addition of colors as shown in the key at the top of the image. Shades of color (e.g., shades of purple) indicate varying rations of the elements combined to form that color.

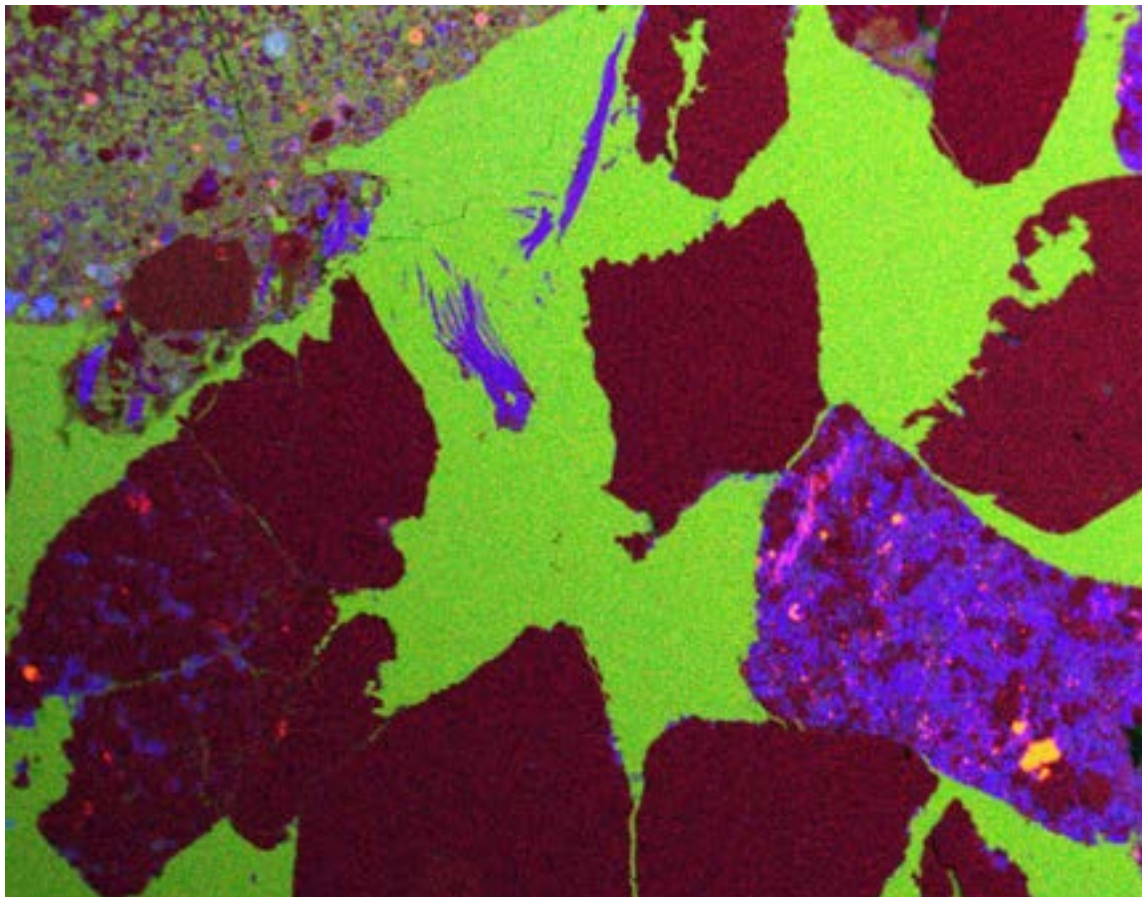
Figure 21 shows the combined phosphorous, calcium, and magnesium x-ray intensity maps. Of particular interest in this x-ray map is the coincidental occurrence of phosphorous with calcium, and separately with magnesium. Figure 22 shows the distribution of magnesium and iron. A cyan color indicates the coincidence of magnesium and iron, which is common. Figure 23 is included primarily to show the carbon x-ray intensity map to confirm the matrix is carbonate.

Figure 21. Combined x-ray intensity maps from the area shown in Figure 17 where maps for phosphorous (red color), calcium, (green color) and magnesium (blue color) are combined to show discrete and coincident locations of elements. Other colors result from the addition of colors as shown in the key at the top of the image. Shades of color (e.g., shades of purple) indicate varying rations of the elements combined to form that color.

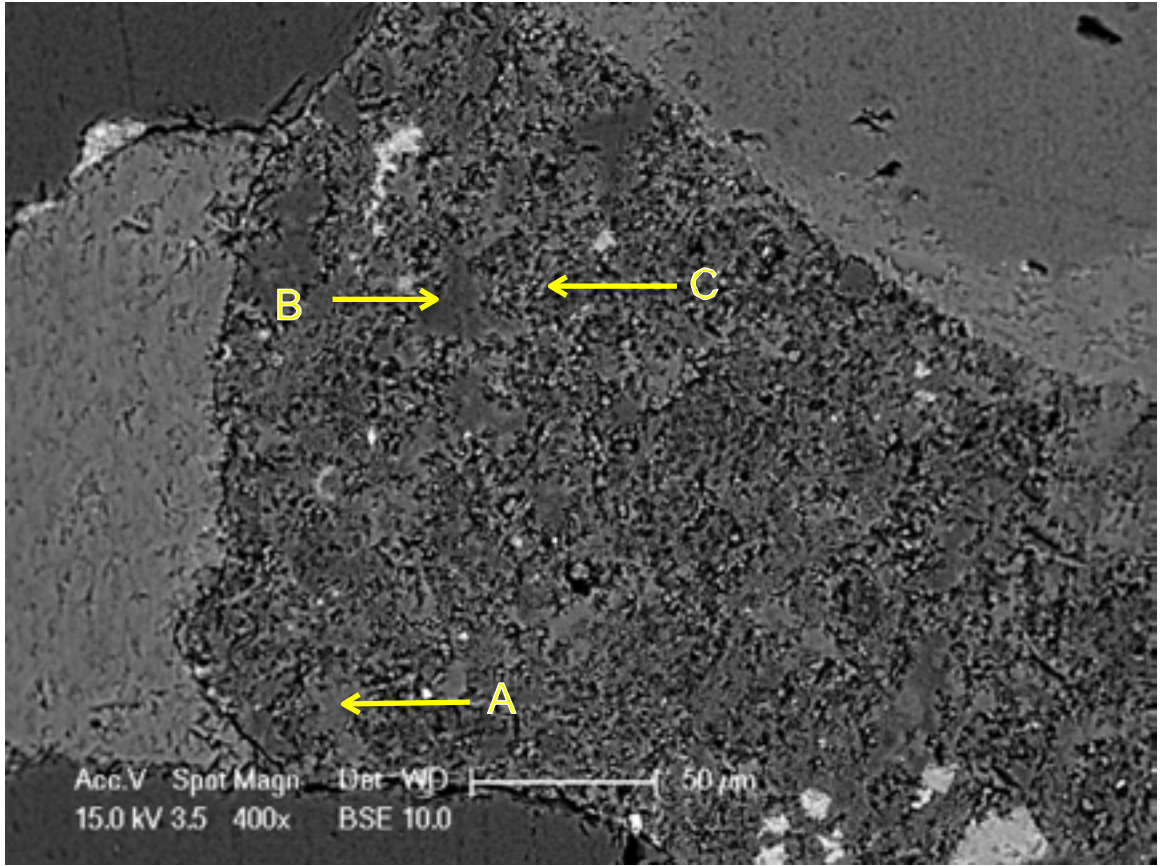
Table 2. Analyses from grain A in Figure 24.

Figure 24. Backscattered electron image of grain A shown in Figure 17. Areas marked A, B, and C represent analyses shown in Table 2.

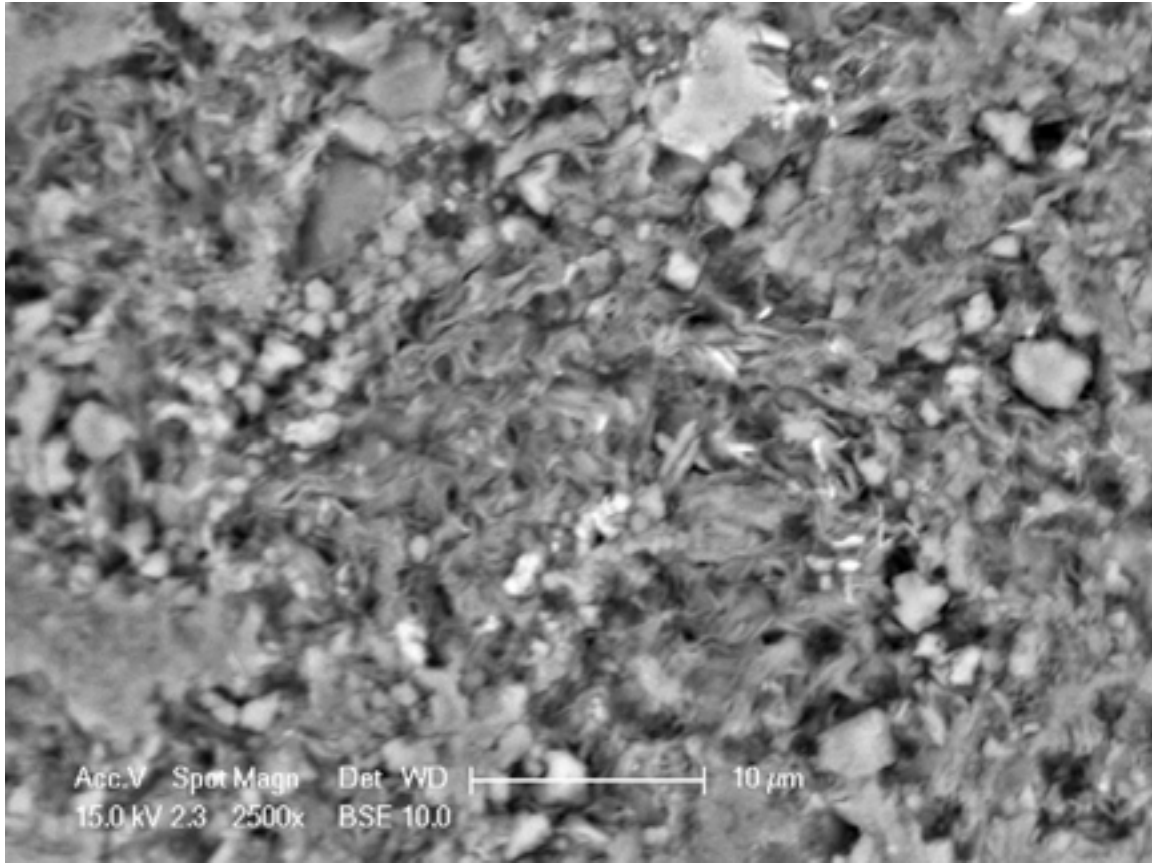
Figure 25. Backscattered electron image of area C shown in Figure 24.

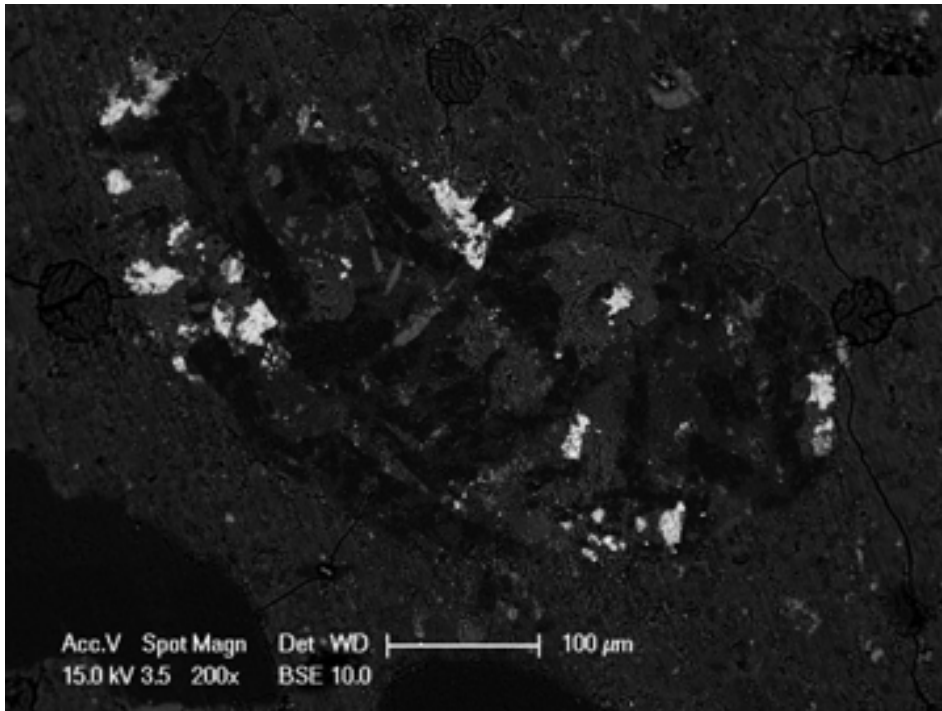
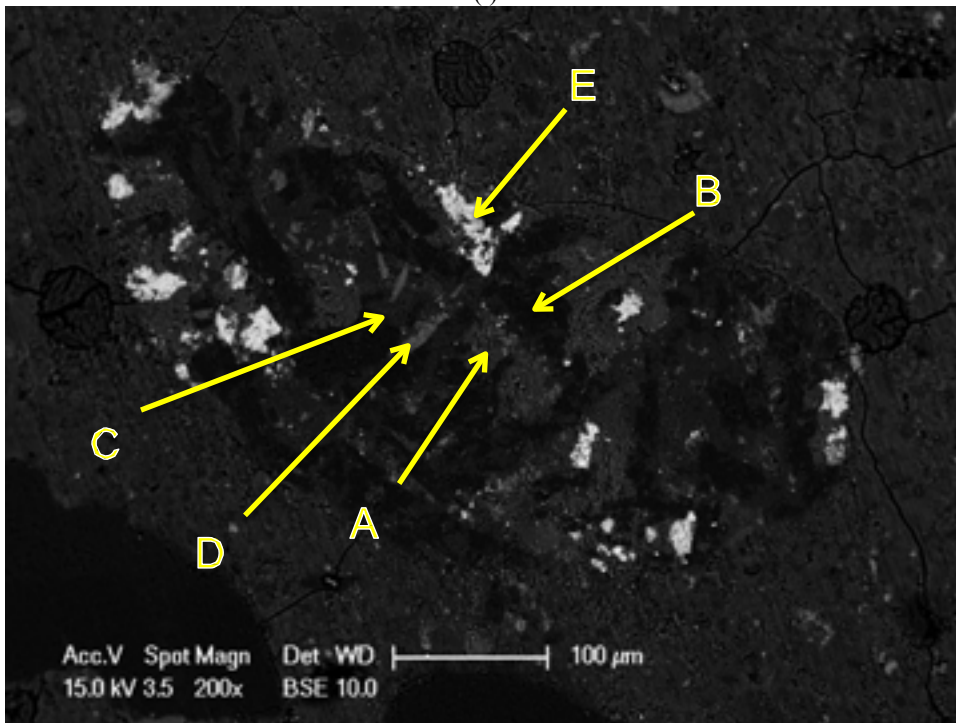
Table 3. Analyses from grain shown in Figure 26.

Figure 26. Backscattered electron image of unreacted apatite-bearing feldspar. Both images (i) and (ii) are the same. Micrograph (ii) is labeled to identify analysis areas for results shown in Table 3.

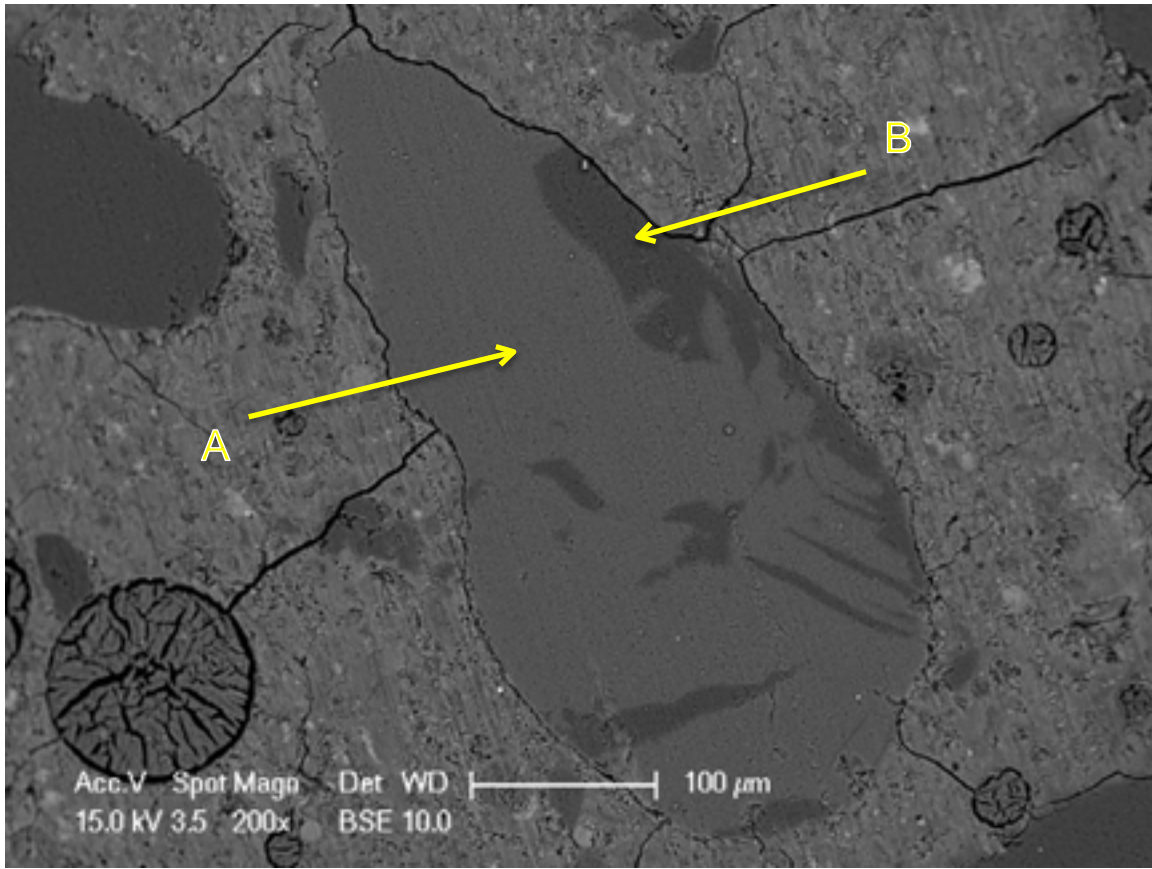
Table 4. Analyses from common felsic grains in the fine aggregate, as shown in Figure 27.

Figure 27. Example of other felsic aggregate type. Analysis areas A and B correspond to results presented in Table 4. Specimen prepared from core sample 96A.

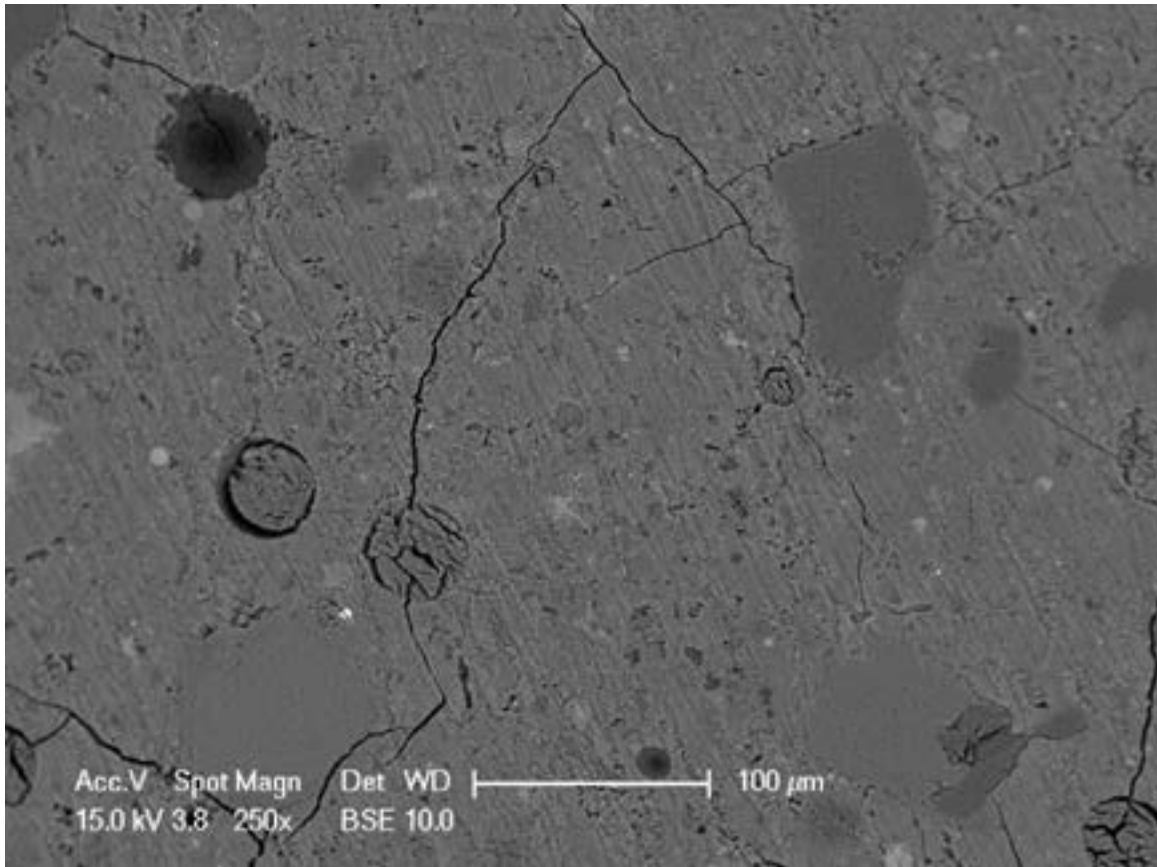
Figure 28. Backscattered electron image of cement paste away from the joint. Specimen prepared from core sample 96A.
