Investigation and Assessment of Colored Concrete Pavement

Minnesota
Department of
Transportation

August 2014

Research Project
Final Report 2014-26

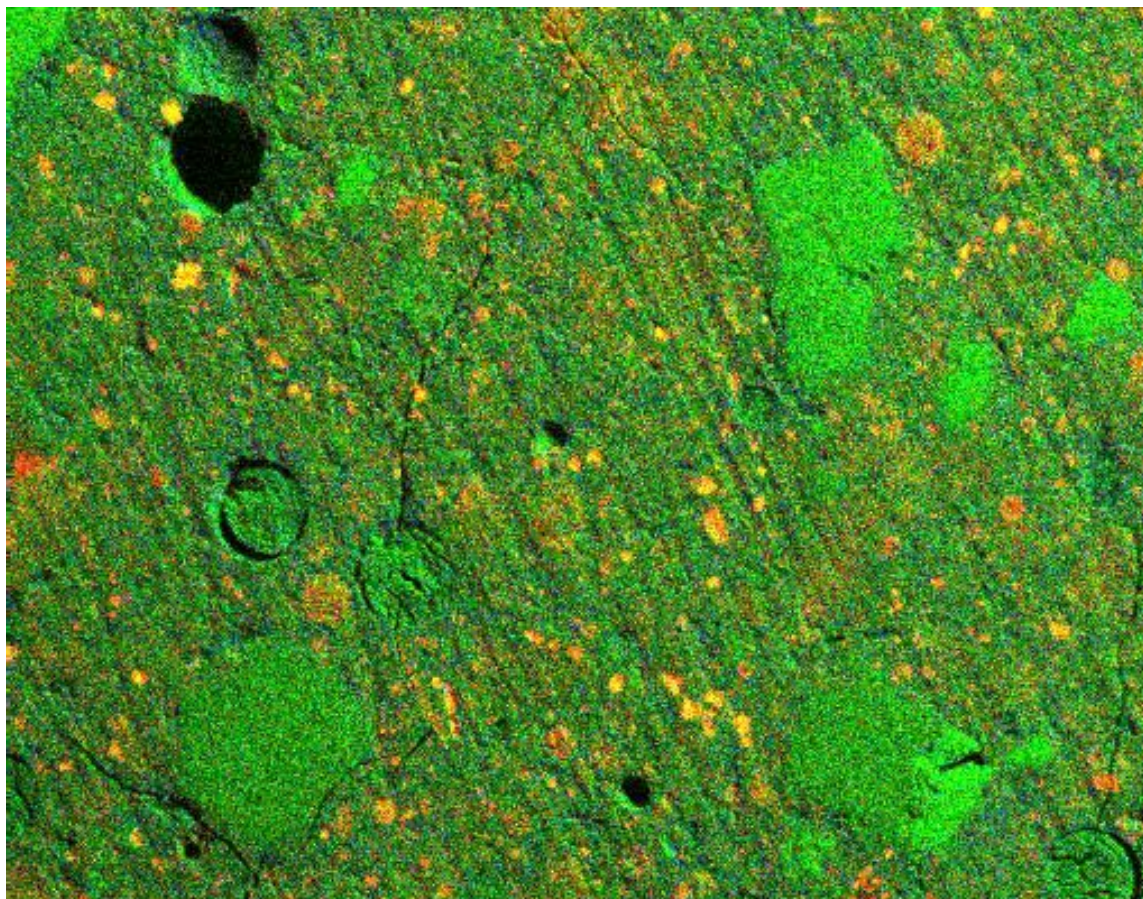
Figure 31 shows the matrix is oxide, not carbonate. Also seen in Figure 31 are orange inclusions that are mixtures of magnesium and oxygen (i.e., magnesium oxide). Magnesium oxide inclusions are common throughout the concrete, from the joint inward. This would indicate that magnesium-bearing solutions are moving through the concrete and magnesium is depositing in voids as either an oxide or hydroxide. Evidence of both were found with magnesium oxide being much more common. Presumably hydroxide phases would oxidize or dehydrate over time, or carbonate. All three forms of magnesium are seen in the voids of the specimen. Figure 32 shows the relationship between aluminum, sulfur, and calcium. Primarily ettringite phases are highlighted (green or cyan). Figure 33 illustrates a common observation of iron and magnesium in coincidence (represented by a cyan or blue-green color).

Figure 31. Combined x-ray intensity maps from the area shown in Figure 28 where maps for magnesium (red color), oxygen, (green color) and carbon (blue color) are combined to show discrete and coincident locations of elements. Other colors result from the addition of colors as shown in the key at the top of the image. Shades of color (e.g., shades of yellow/orange) indicate varying ratios of the elements combined to form that color.

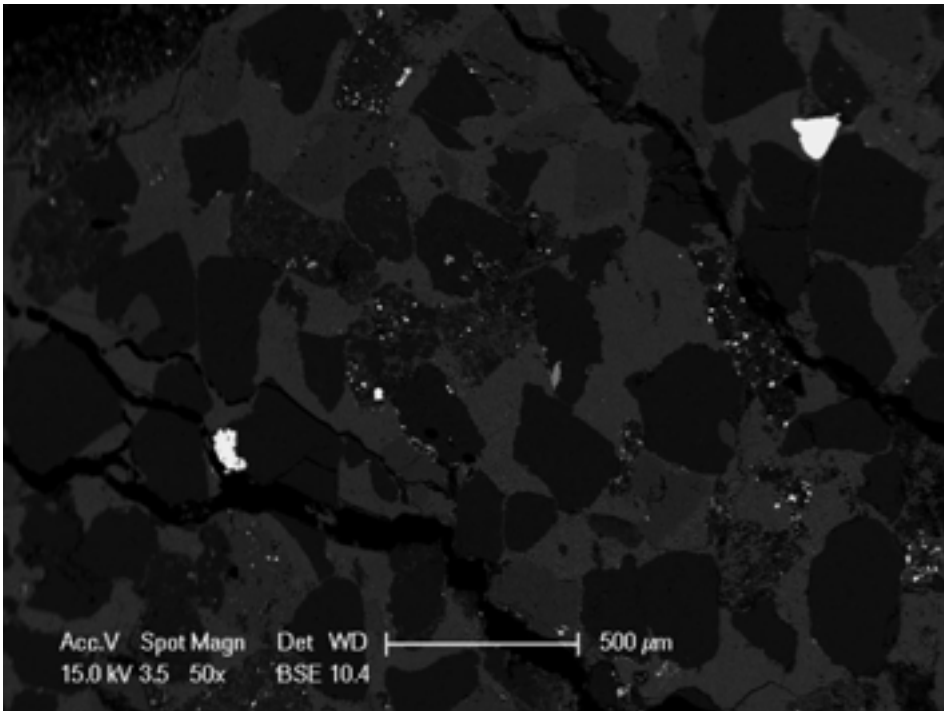
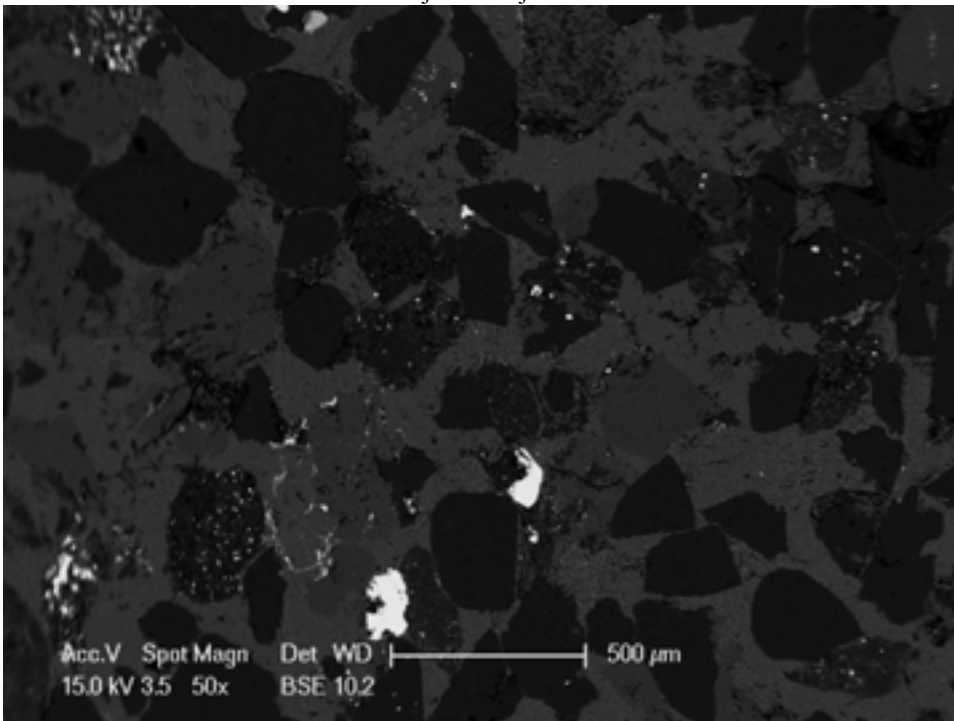
Figure 41. Backscattered electron images of cement paste showing porous aggregate. Specimen prepared from core sample 96A.

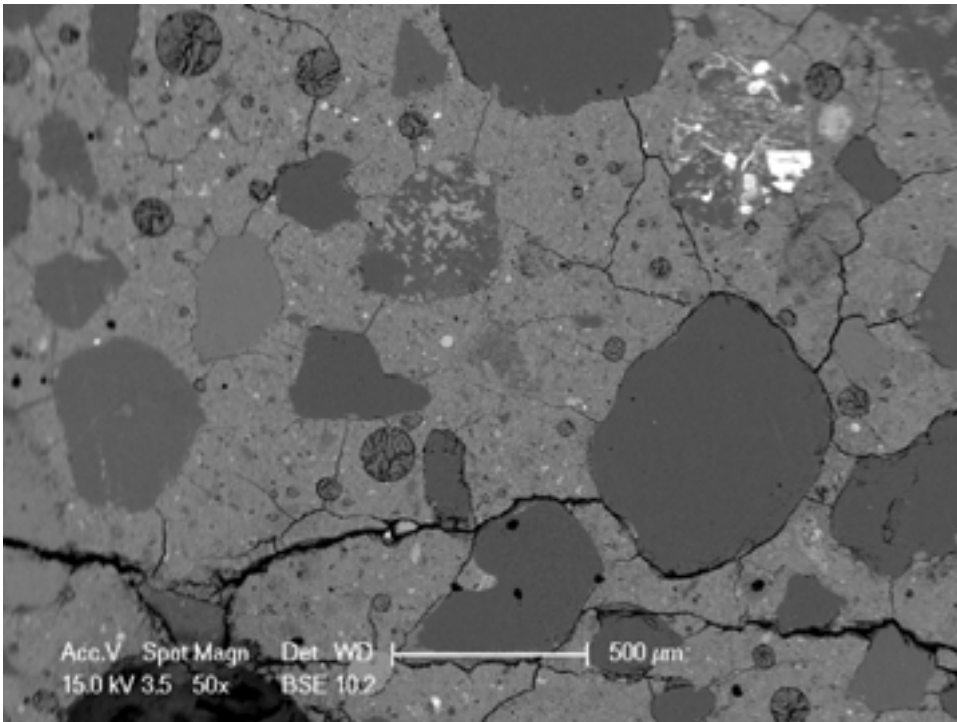
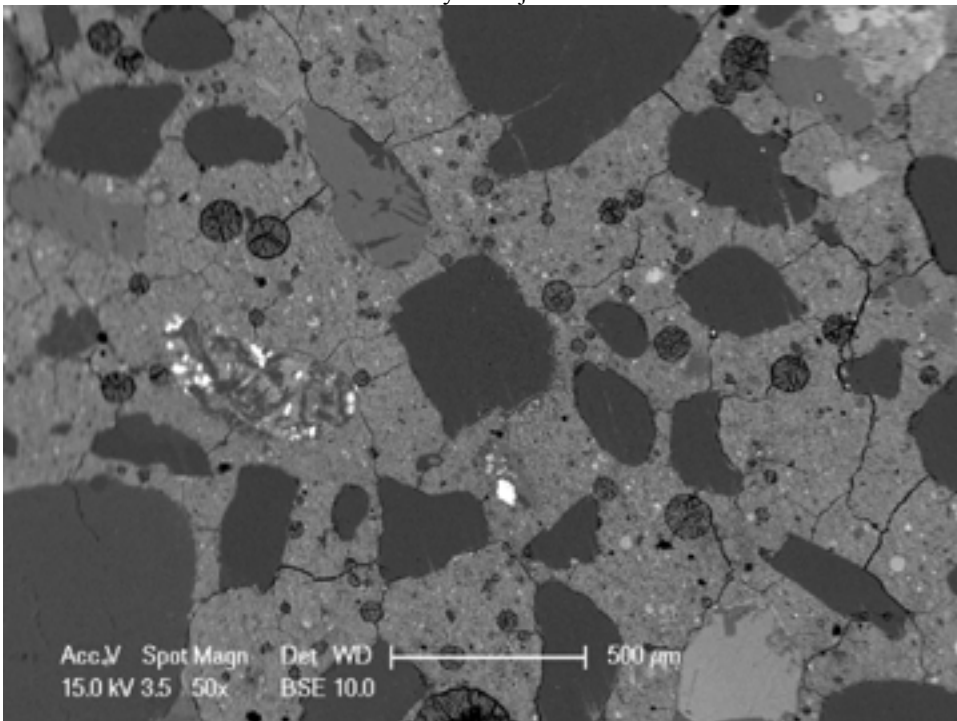
Figure 42. Backscattered electron images of cement paste showing aggregate without porosity. Specimen prepared from core sample 96A.

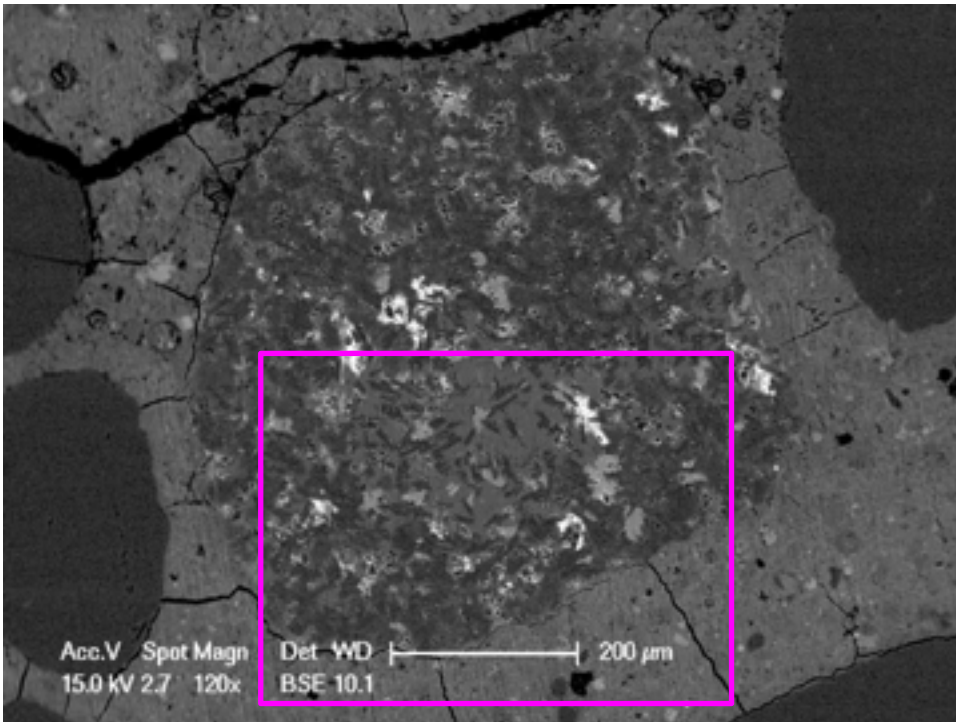
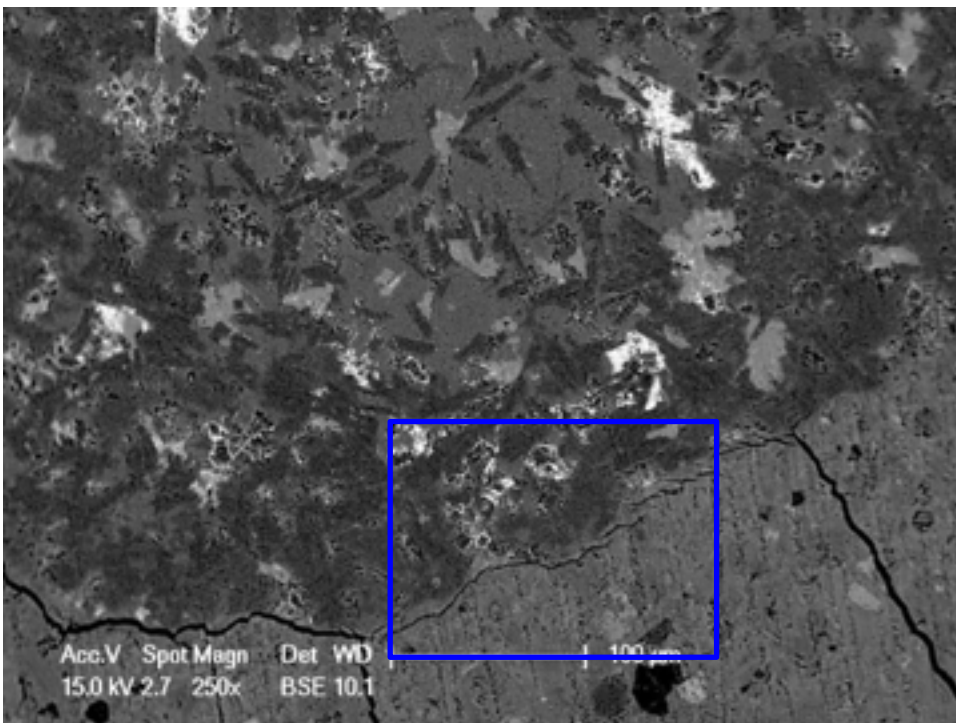
Figure 43. Backscattered electron image of aggregate particle that has undergone partial dissolution. Micrograph (b) is the area outlined in magenta in micrograph (a). Figure 49 is the area outlined in blue in micrograph (b). Specimen prepared from core sample 96A.

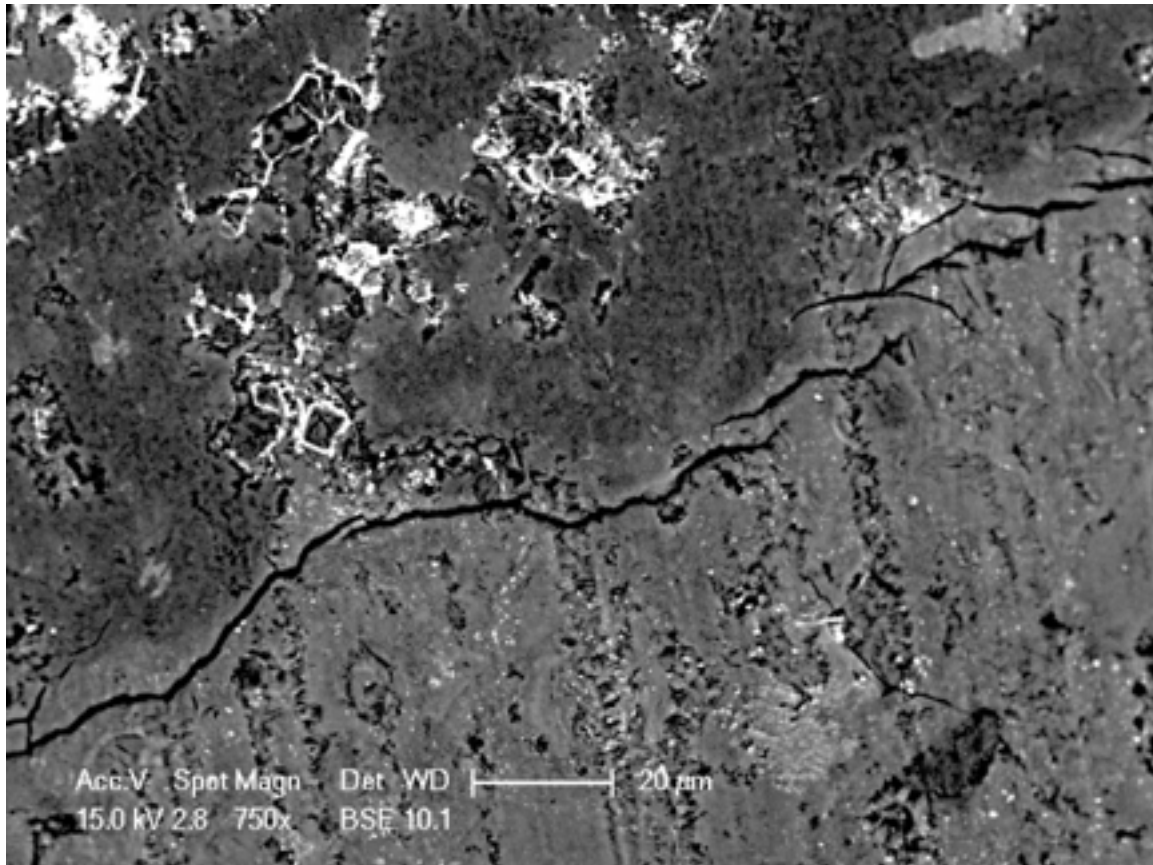
Figure 49 is a closer examination of this same aggregate. Note the bright iron phases forming box like perimeters around the magnesium phases. Figure 51 shows the distribution of major elements and again shows the silica rich phases. Figure 52 shows the relationship between the silica phase, sodium, and alkali. At the higher magnification some potassium bearing phases are seen but clearly, there are phases where the potassium has been depleted. Figure 53 shows the magnesium rich phases and the coincidence of oxygen (i.e., magnesium oxide). Figure 54 shows clearly the iron rimming the magnesium phase. It is not clear if the occurrence of potassium in the region of magnesium and iron is a transient of the dissolution process. In other words, if the interaction of magnesium and iron is leading to the dissolution of potassium bearing phases, perhaps this is a remnant of a partially completed dissolution. Finally, Figure 55 shows the occurrence of phosphorus, the apatite phase, and its proximity to the magnesium rich phase. One hypothesis is the apatite is going into solution and the magnesium/iron combination is re-precipitating in the void space created in that dissolution.

Figure 49. Backscattered electron image of aggregate particle that has undergone partial dissolution. Area shown is the area outlined in blue in Figure 43(b).

It is recommended that a more detailed analysis of the fine aggregate used in this concrete be conducted. Observations here should be confirmed by examining the natural aggregate. Laboratory leaching tests of the aggregate should be conducted to determine if leaching of alkalis and the general process of dissolution can be identified. Additionally, MnDOT may want to consider developing a “salt soundness” test for evaluating aggregates, particularly if the laboratory testing indicates aggregate dissolution in the presence of deicers (or water) is in fact occurring.

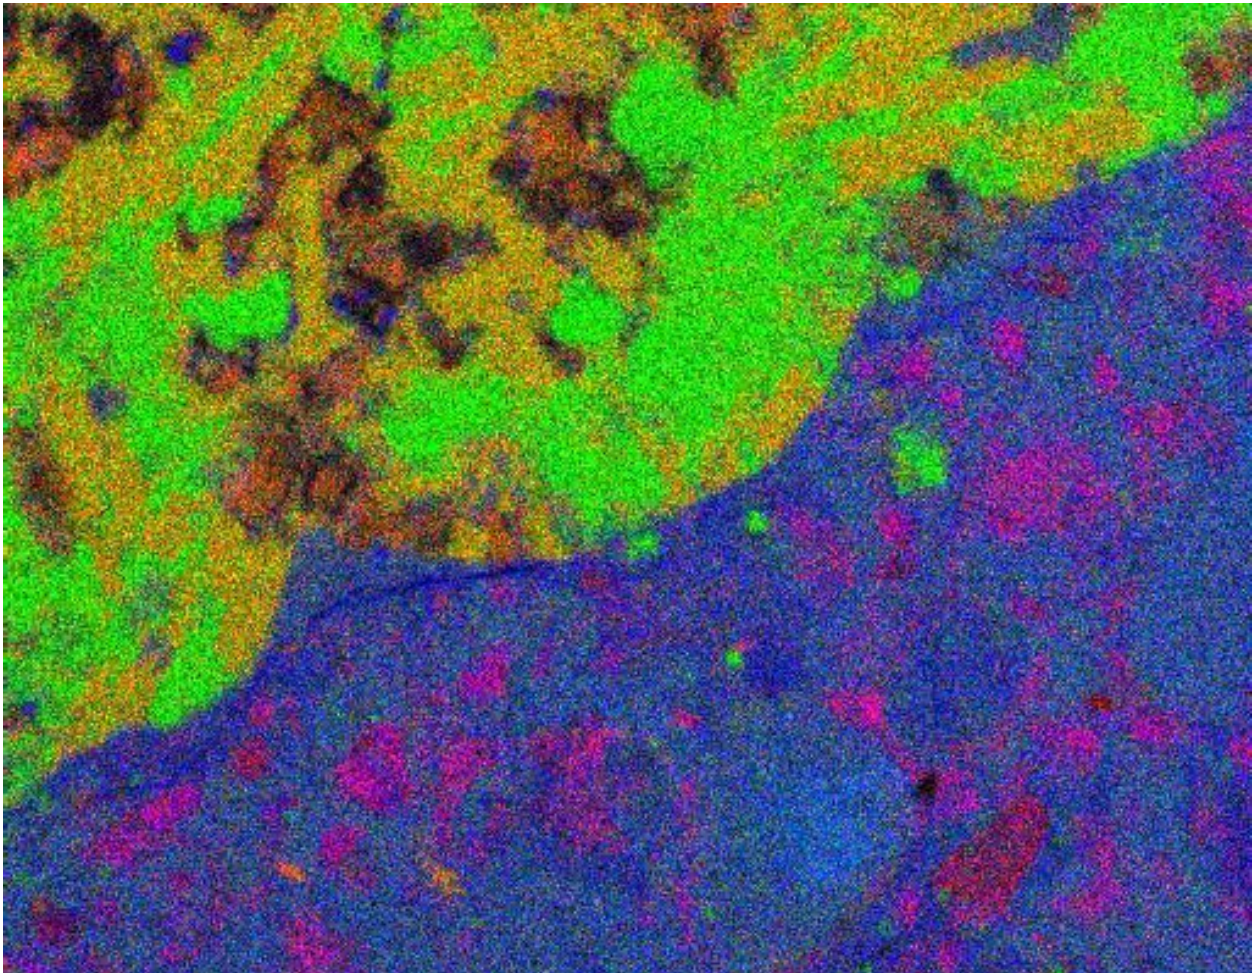
Figure 51. Combined x-ray intensity maps from the area shown in Figure 49 where maps for aluminum (red color), silicon, (green color) and calcium (blue color) are combined to show discrete and coincident locations of elements. Other colors result from the addition of colors as shown in the key at the top of the image. Shades of color (e.g., shades of purple) indicate varying ratios of the elements combined to form that color.

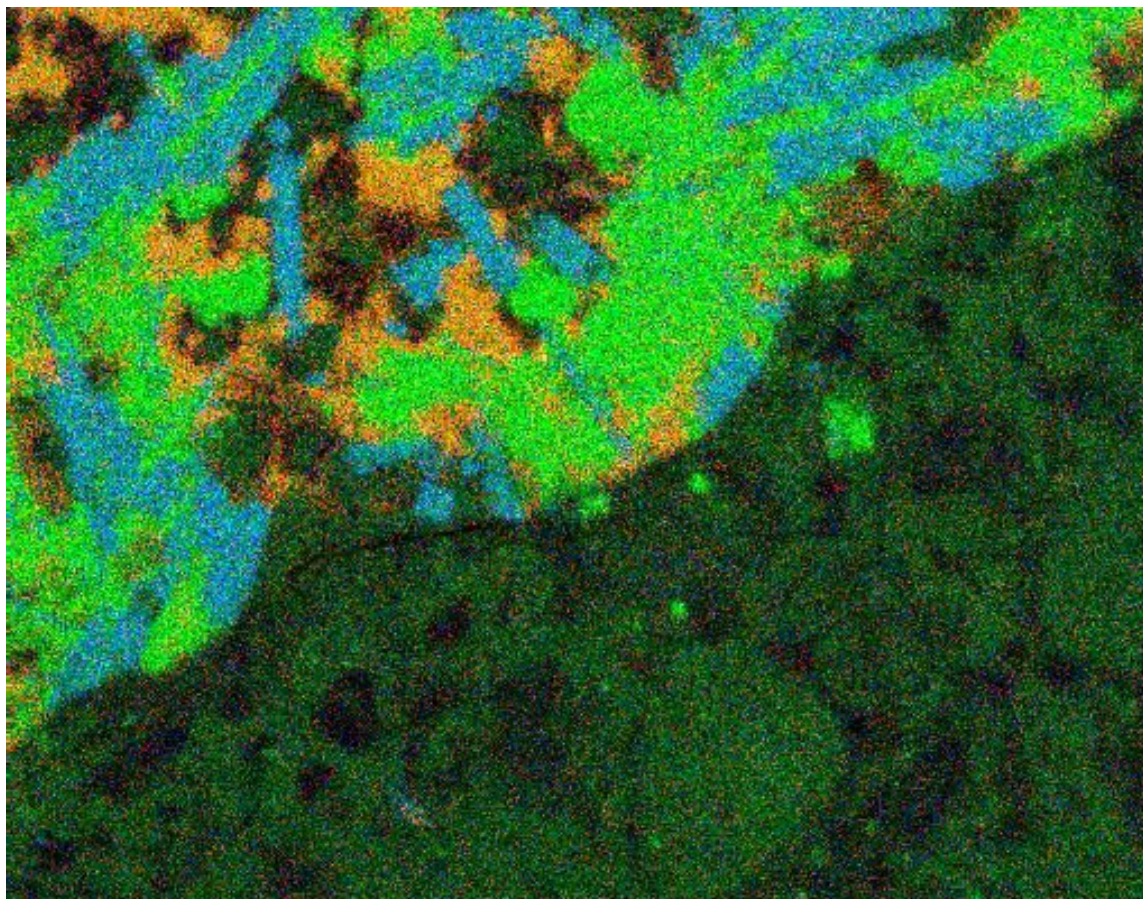
Figure 52. Combined x-ray intensity maps from the area shown in Figure 49 where maps for potassium (red color), silicon, (green color), sodium (blue color), and iron (magenta) are combined to show discrete and coincident locations of elements. Other colors result from the addition of colors as shown in the key at the top of the image. Shades of color (e.g., shades of yellow/orange or cyan) indicate varying ratios of the elements combined to form that color.

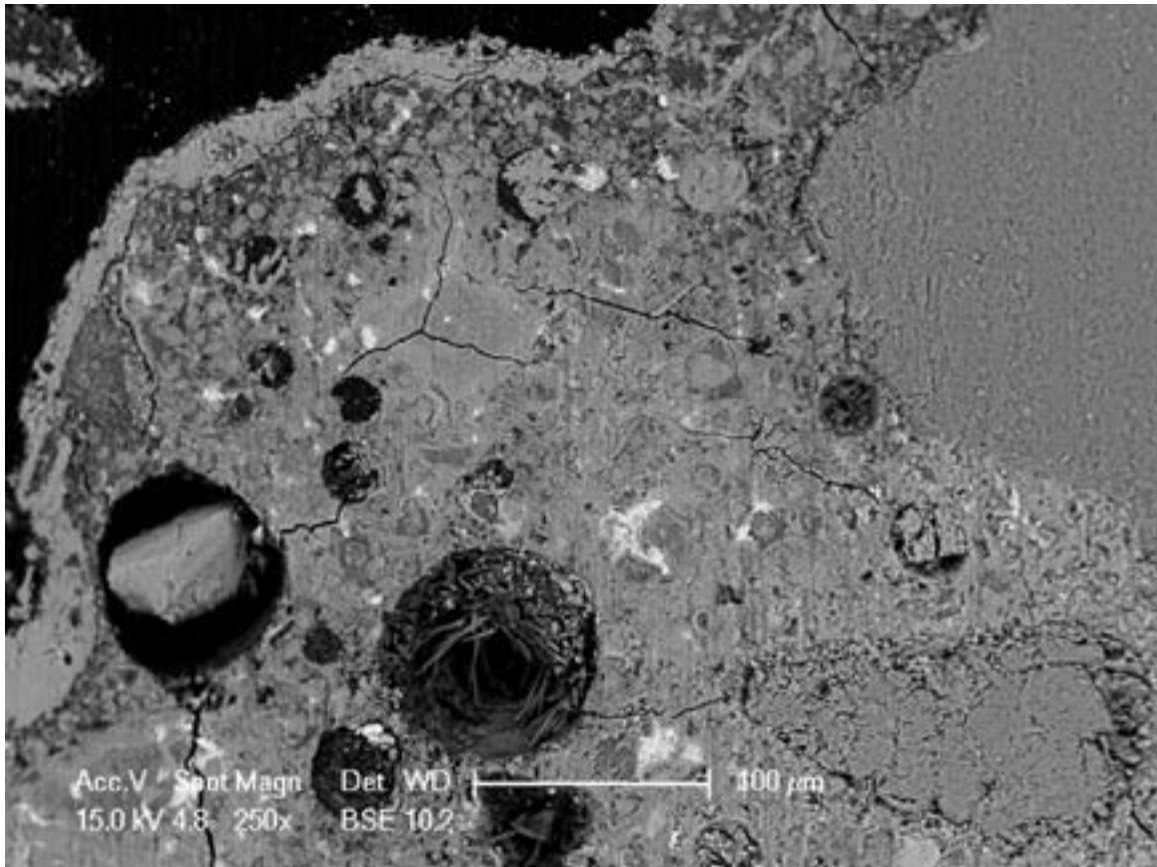
The concrete from this site appeared to be less affected, though it was distressed. As seen in Figure 56, the paste is more intact as compared to site 96A. Figure 57 through Figure 62 present the x-ray intensity maps associated with the area shown in Figure 56. Figure 58 indicates there is a layer of calcite at the joint, as seen in 96A, but the paste is not converted to calcite. Aggregates do not show signs of dissolution. Figure 59 indicates the paste is not significantly carbonated and magnesium oxide inclusions are noted. Figure 60 shows some ettringite but much of the infilling seen in this concrete was Friedel's Salt rather than ettringite. The areas in this x-ray map that are cyan or blue-green are ettringite. The blue-only inclusions are Friedel's Salt. Figure 61 indicates no appreciable level of phosphorus, in contrast to site 96A. Figure 62 shows the coincidence of magnesium and iron and as seen in the 96A concrete, there is a noticeable coincidence between these two elements. However, this trend is not as strong in this concrete as was seen in the 96A concrete. Another area near the surface was examined and the micrograph of that area is shown in Figure 63. The x-ray intensity maps for the area shown in Figure 63 are presented in Figure 64 through Figure 69. Overall, the areas presented are similar and no obvious deterioration mechanism is apparent other than the paste dissolution indicated by the calcite layer at the joint.

Figure 56. Backscattered electron image of showing the joint surface and cement paste matrix near the joint surface. Specimen prepared from core sample L&F C.

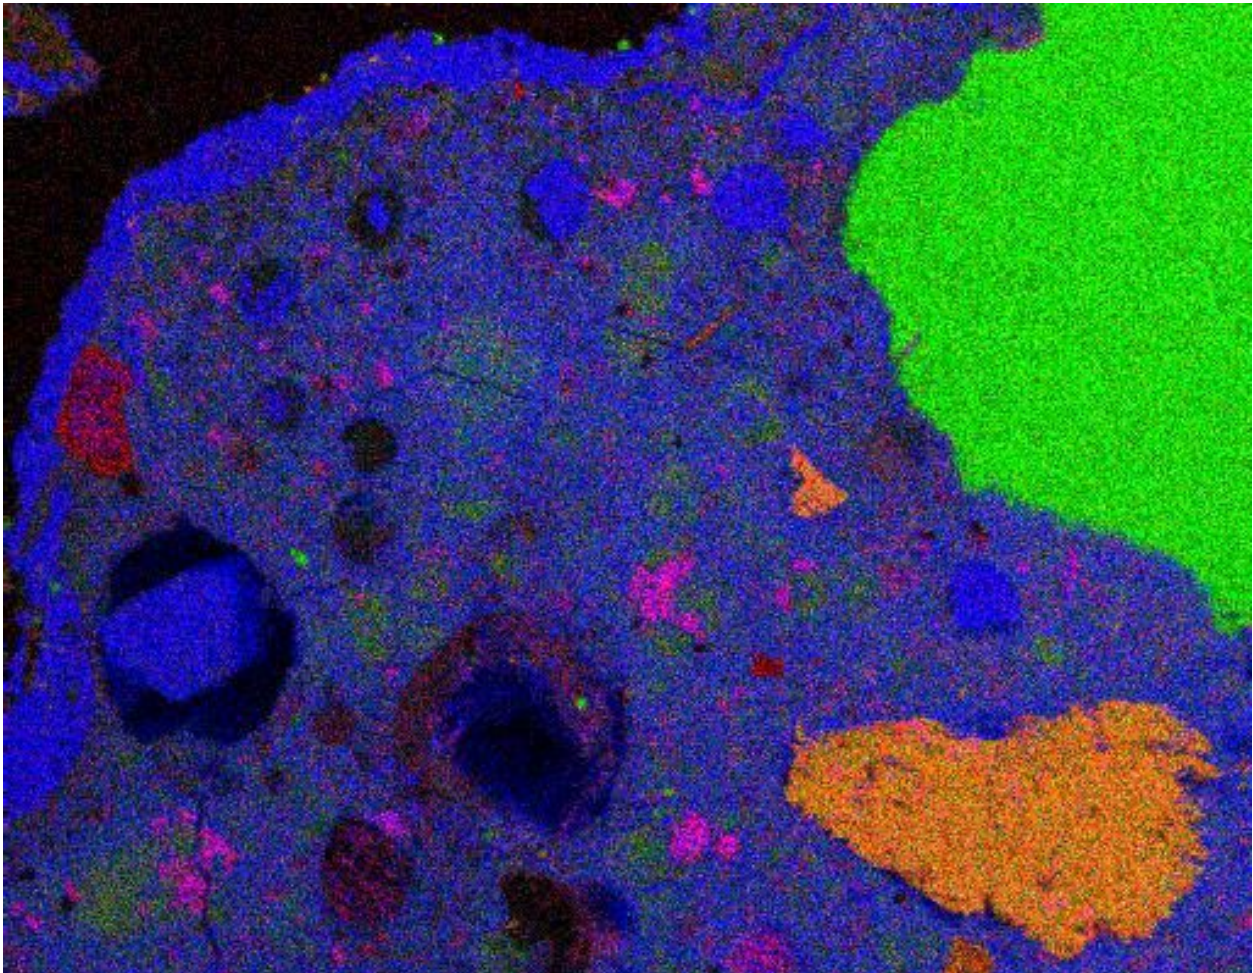
Figure 58. Combined x-ray intensity maps from the area shown in Figure 56 where maps for aluminum (red color), silicon, (green color) and calcium (blue color) are combined to show discrete and coincident locations of elements. Other colors result from the addition of colors as shown in the key at the top of the image. Shades of color (e.g., shades of purple) indicate varying ratios of the elements combined to form that color.

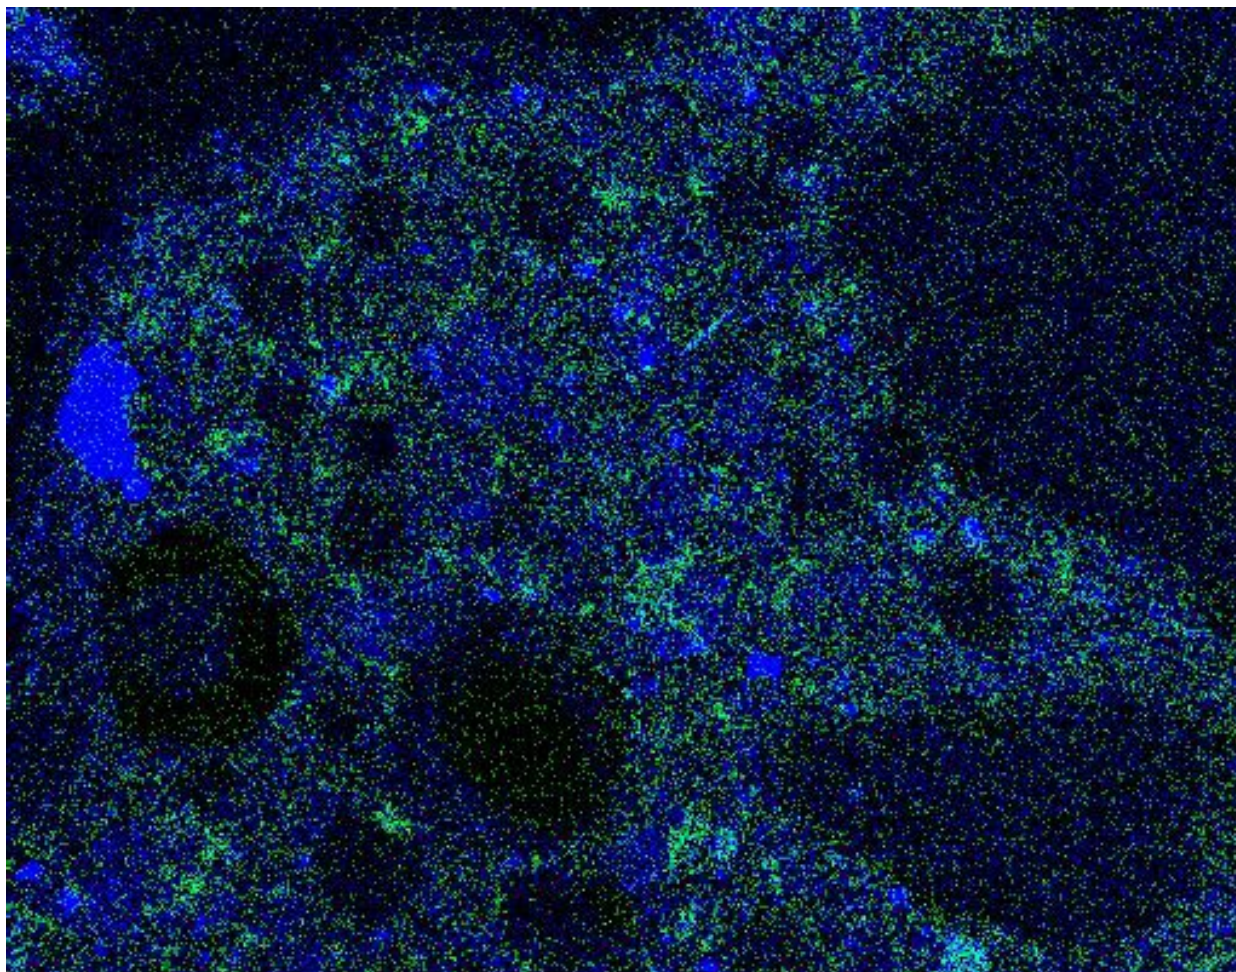
- Figure 62 shows the repeated coincidence of magnesium and iron-based pigment in the L&F-C core sample, however the trend of these minerals grouping together was not as strong as in the 96A core sample.

Figure 62. Combined x-ray intensity maps from the area shown in Figure 56 where maps for iron (green color) and magnesium (blue color) are combined to show discrete and coincident locations of elements. Other colors result from the addition of colors as shown in the key at the top of the image. Shades of color (e.g., cyan) indicate varying ratios of the elements combined to form that color.

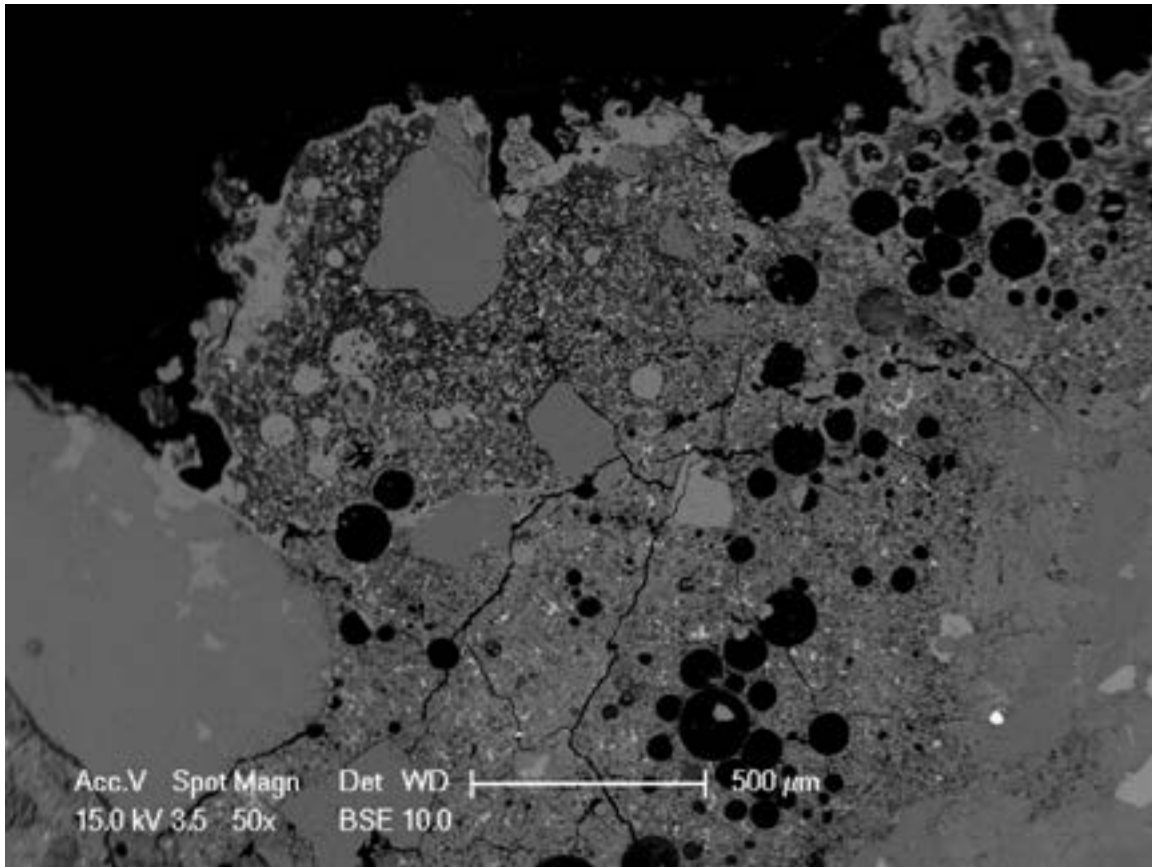
The fine aggregate used in the L&F site appears similar to that used in 96A. The most striking difference between the two sites, other than the degree of damage, is the L&F site appears to have a much higher amount of larger entrained air voids. This can be seen in Figure 70 and the other micrographs in Figure 70 through Figure 75.

Figure 70. Backscattered electron image showing the joint surface and cement paste matrix near the joint surface. Specimen prepared from core sample L&F C.

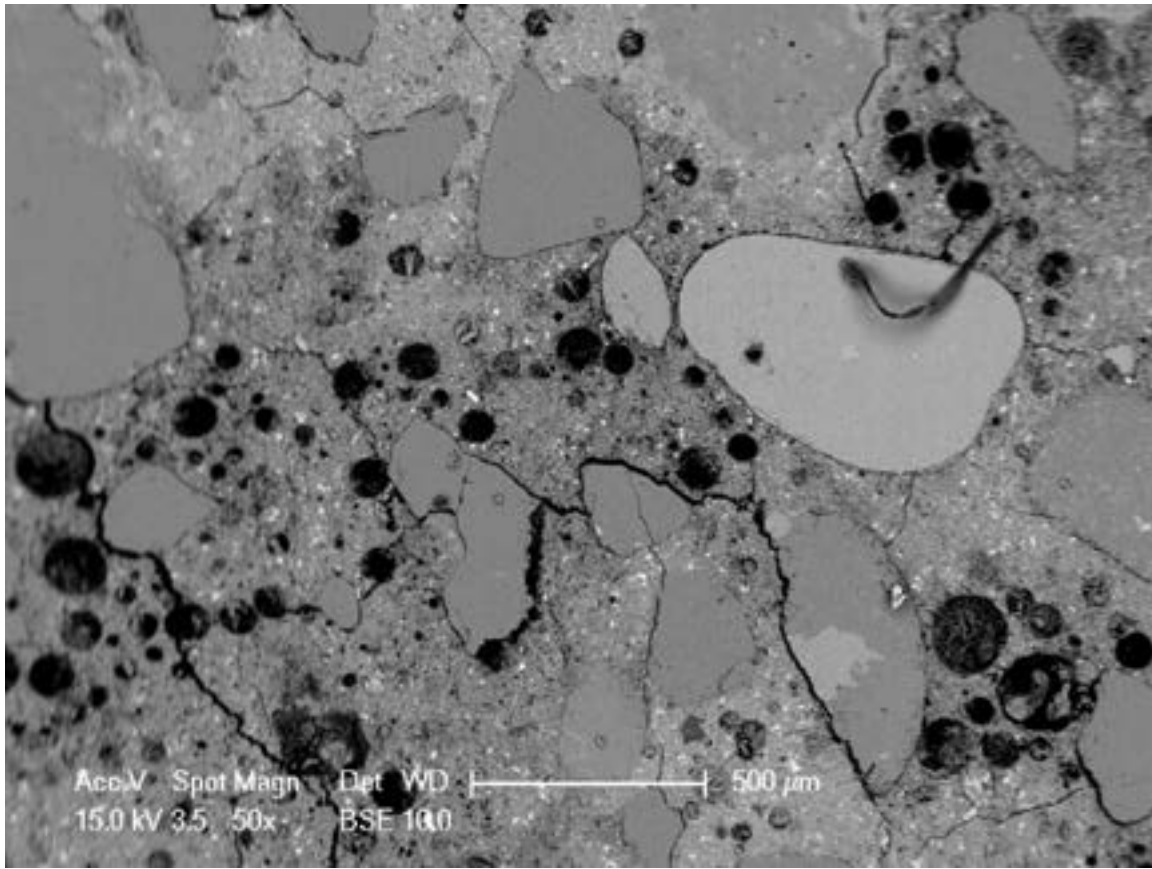
One observation was the cement paste in the L&F specimen appeared altered in regions. Figure 71 through Figure 73 show this observation. The alteration appears as a decrease in paste density, a more grainy appearance, as compared to the more dense paste, as seen away from the joint and shown in Figure 75. The areas of alteration seem to correspond with clusters of air voids, although this trend is not universal.

Figure 71. Backscattered electron image showing the cement paste matrix near the joint surface. Regions of the cement paste, as shown here, appear to be altered. Specimen prepared from core sample L F C.

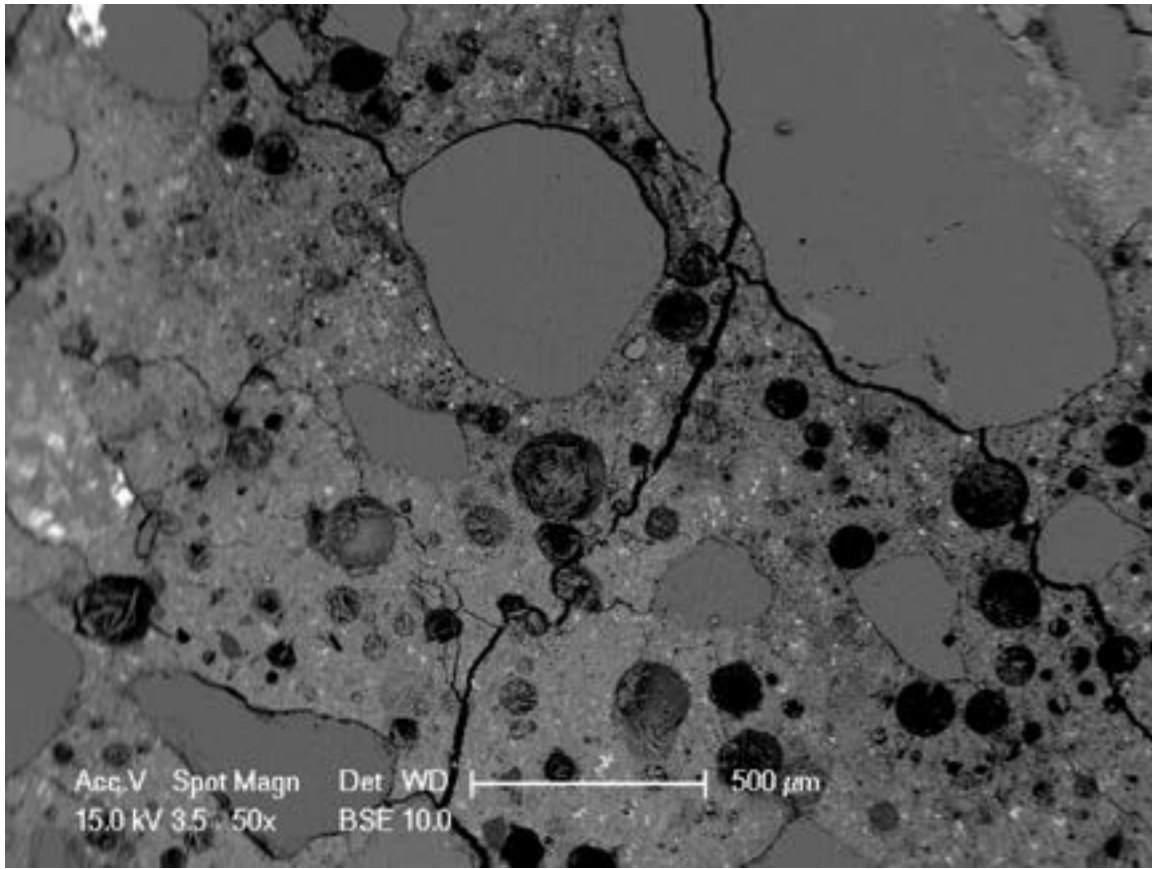
Figure 72. Backscattered electron image showing the cement paste matrix near the joint surface. Regions of the cement paste, as shown here, appear to be altered. Specimen prepared from core sample L F C.

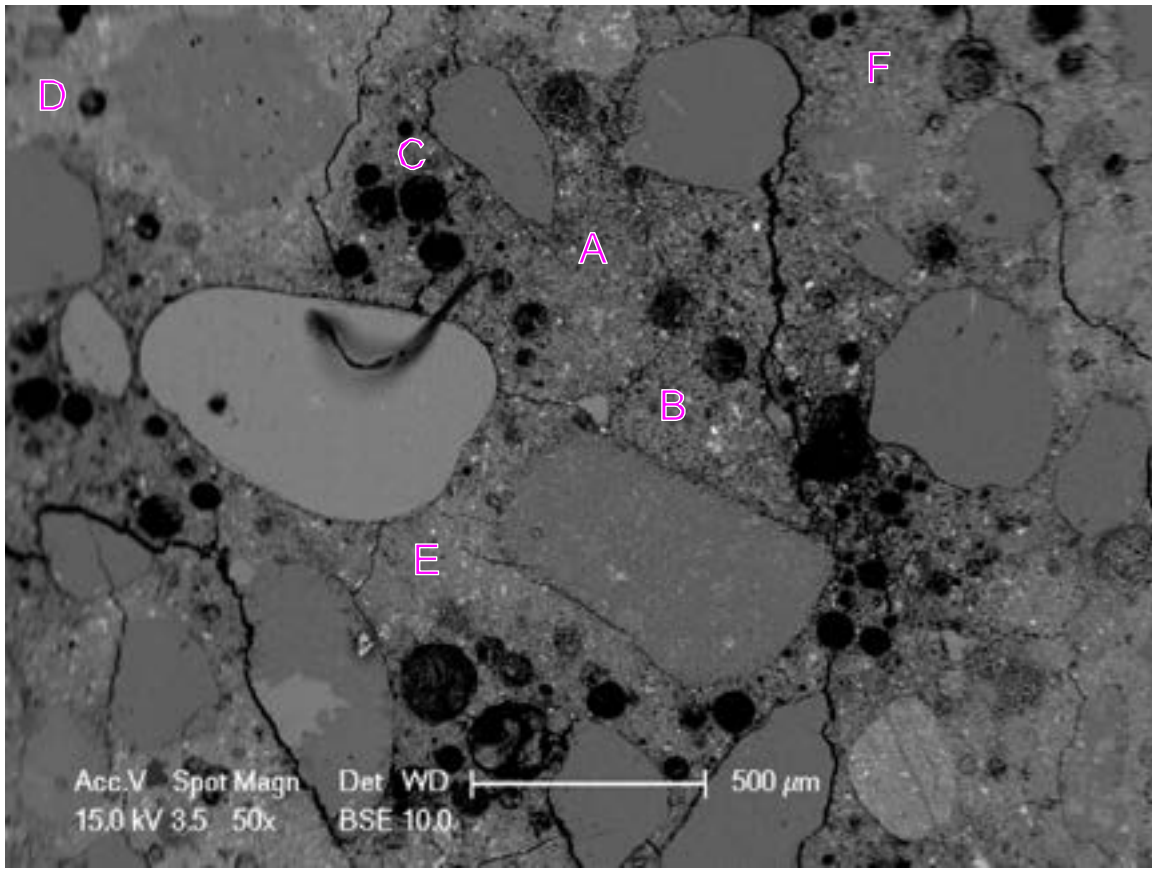
Figure 73. Backscattered electron image showing the cement paste matrix near the joint surface. Regions of the cement paste, as shown here, appear to be altered. Specimen prepared from core sample L F C.

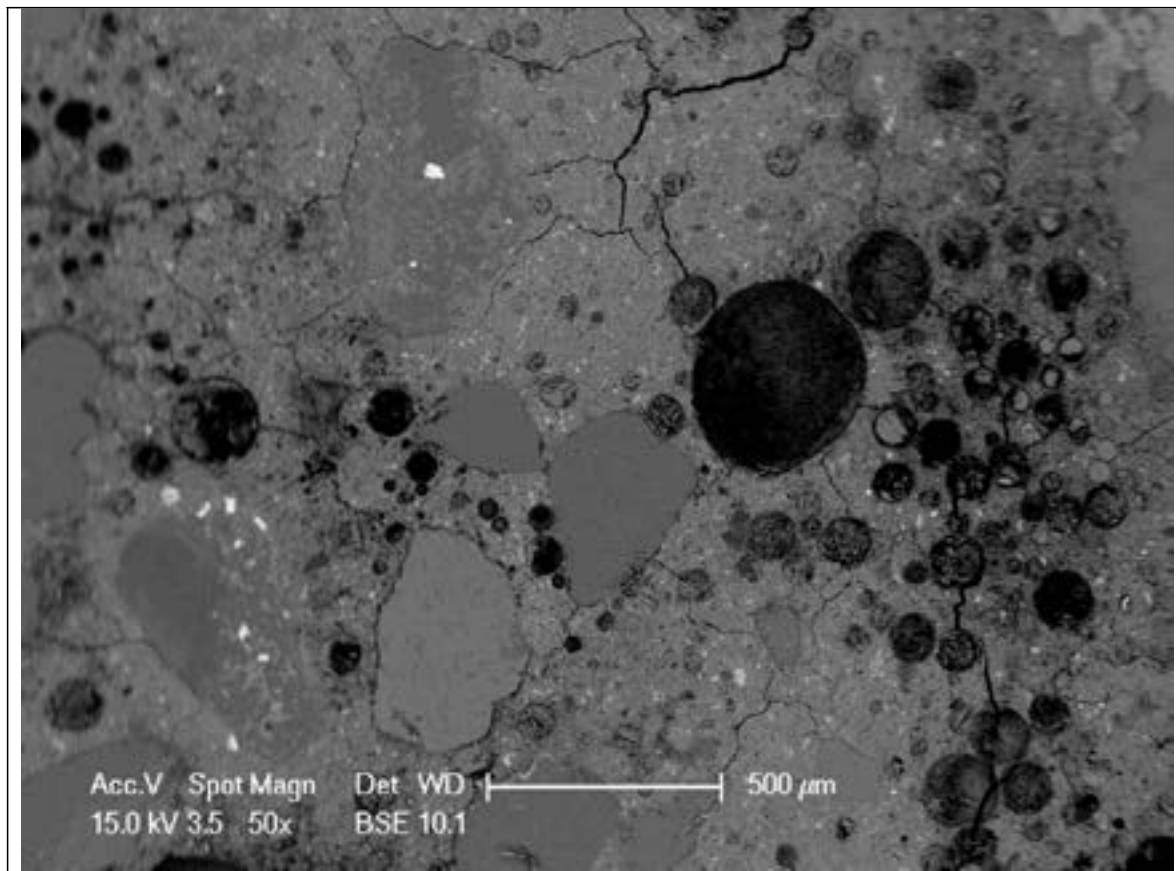
Figure 74. Backscattered electron image showing the cement paste matrix near the joint surface. Regions of the cement paste, as shown here, appear to be altered. Note the clustering of air voids. Specimen prepared from core sample L F C.

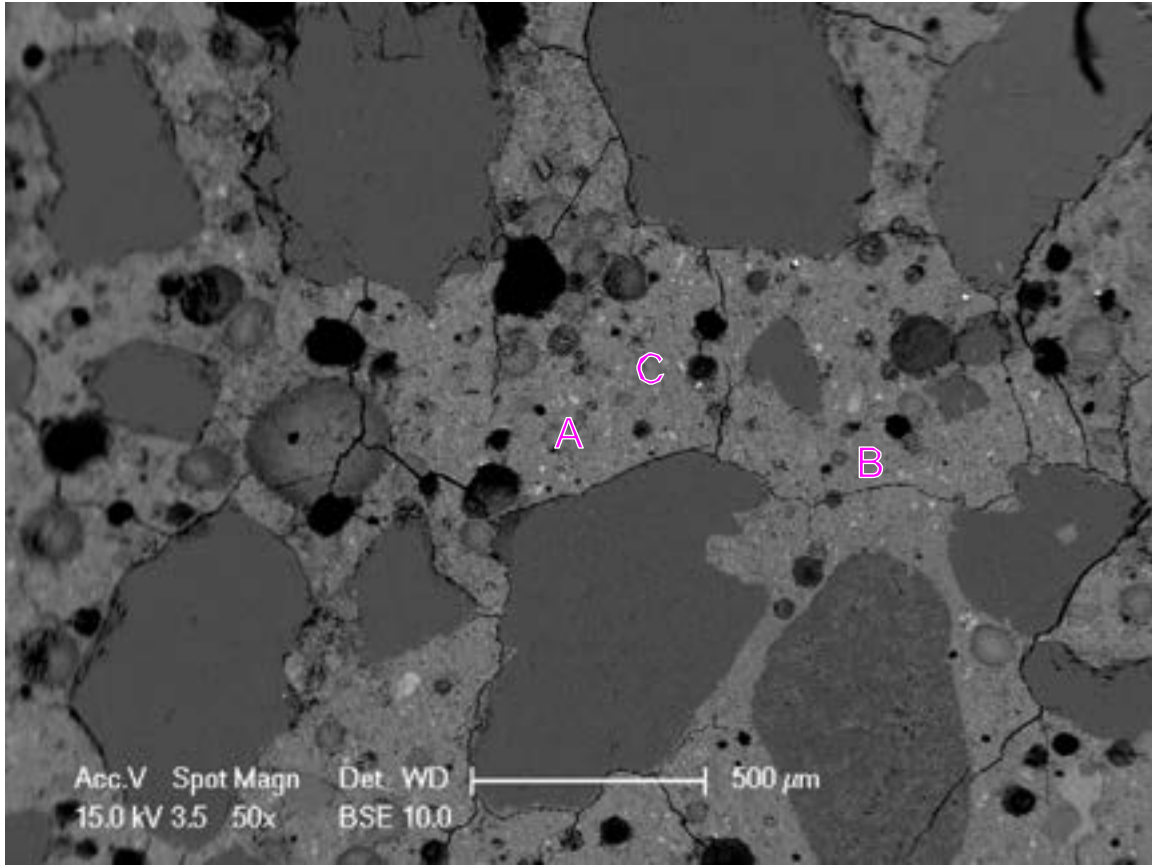
Figure 75. Backscattered electron image showing the cement paste matrix away from the joint surface. Regions of the cement paste, as shown here, do not appear to be altered. Specimen prepared from core sample L F C.

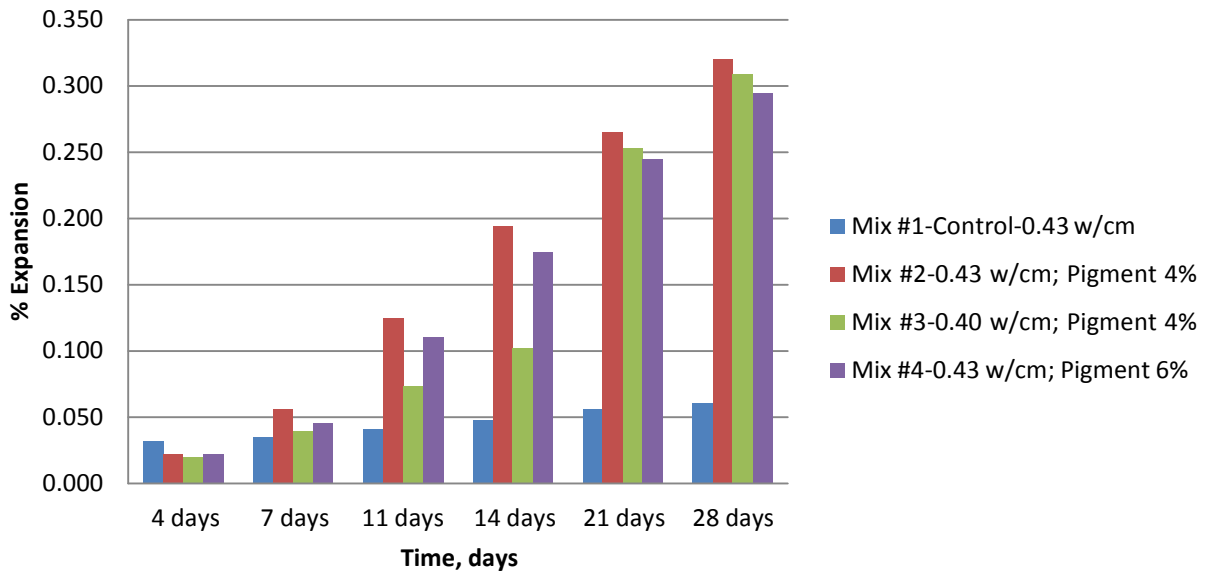
Figure C-1 Plot of results from Table C-3 (ASTM C1567)

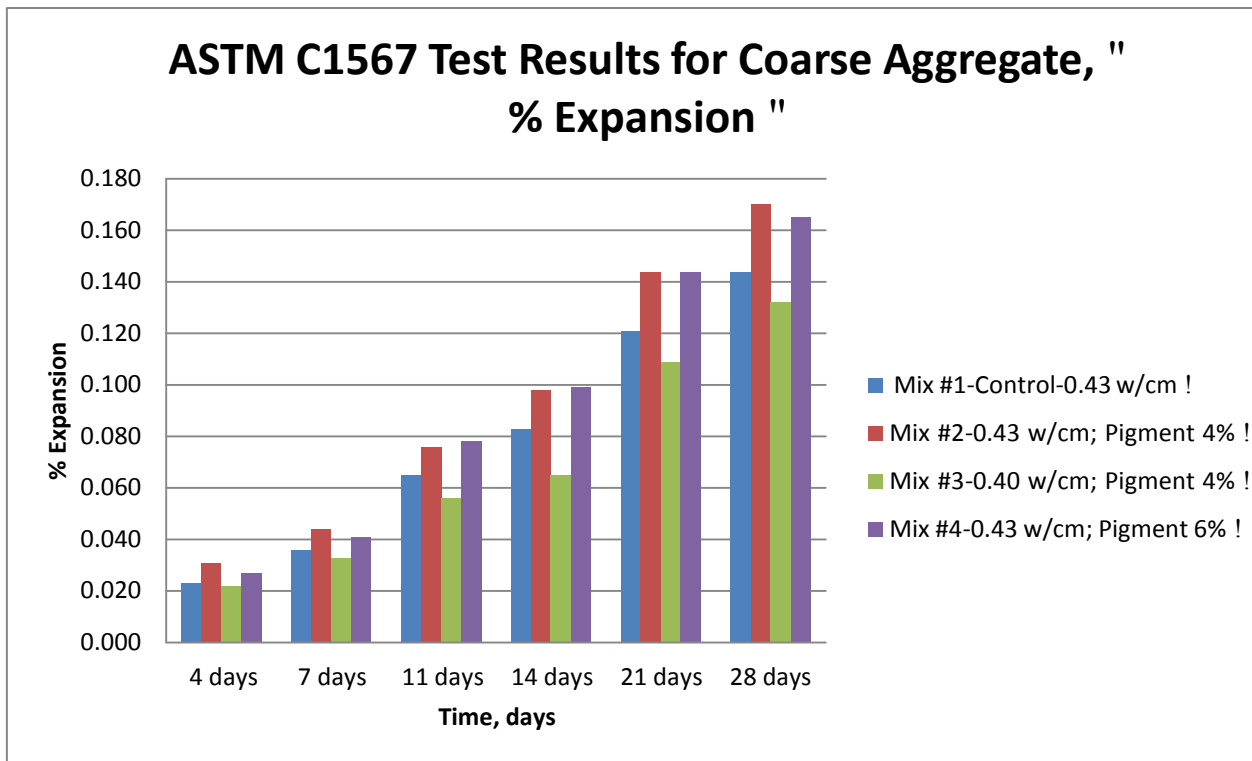
Figure C-2 Plot of results from Table C-5 (ASTM C1567)
