# Aggregate Road Surface Rejuvenation

Charles Jahren, Principal Investigator  
Department of Civil, Construction, and Environmental Engineering  
Construction Management and Technology, Institute for Transportation  
Iowa State University

**April 2015**

Research Project  
Final Report 2015-04

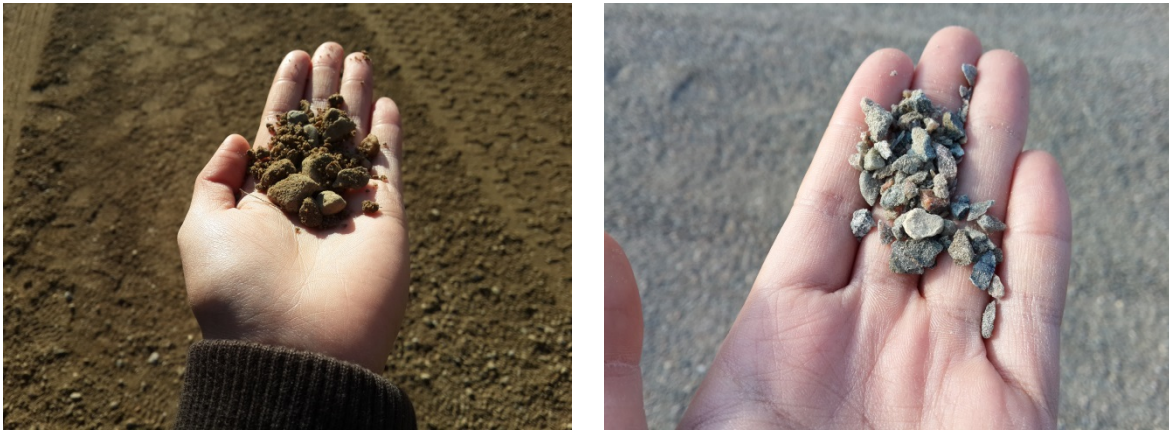
**Figure 29. Beltrami County Angularity Comparison between Standard Class 1 (left) and Crusher Dust (right)**

Figure 29 shows angularity of surfacing aggregate after construction. The interlock mechanism provided by angular aggregate helps to stabilize the surfacing aggregate. A coarse angularity test was performed as part of this investigation. The proportion of angular aggregate on experimental sections surpassed that on the others by more than 25%.

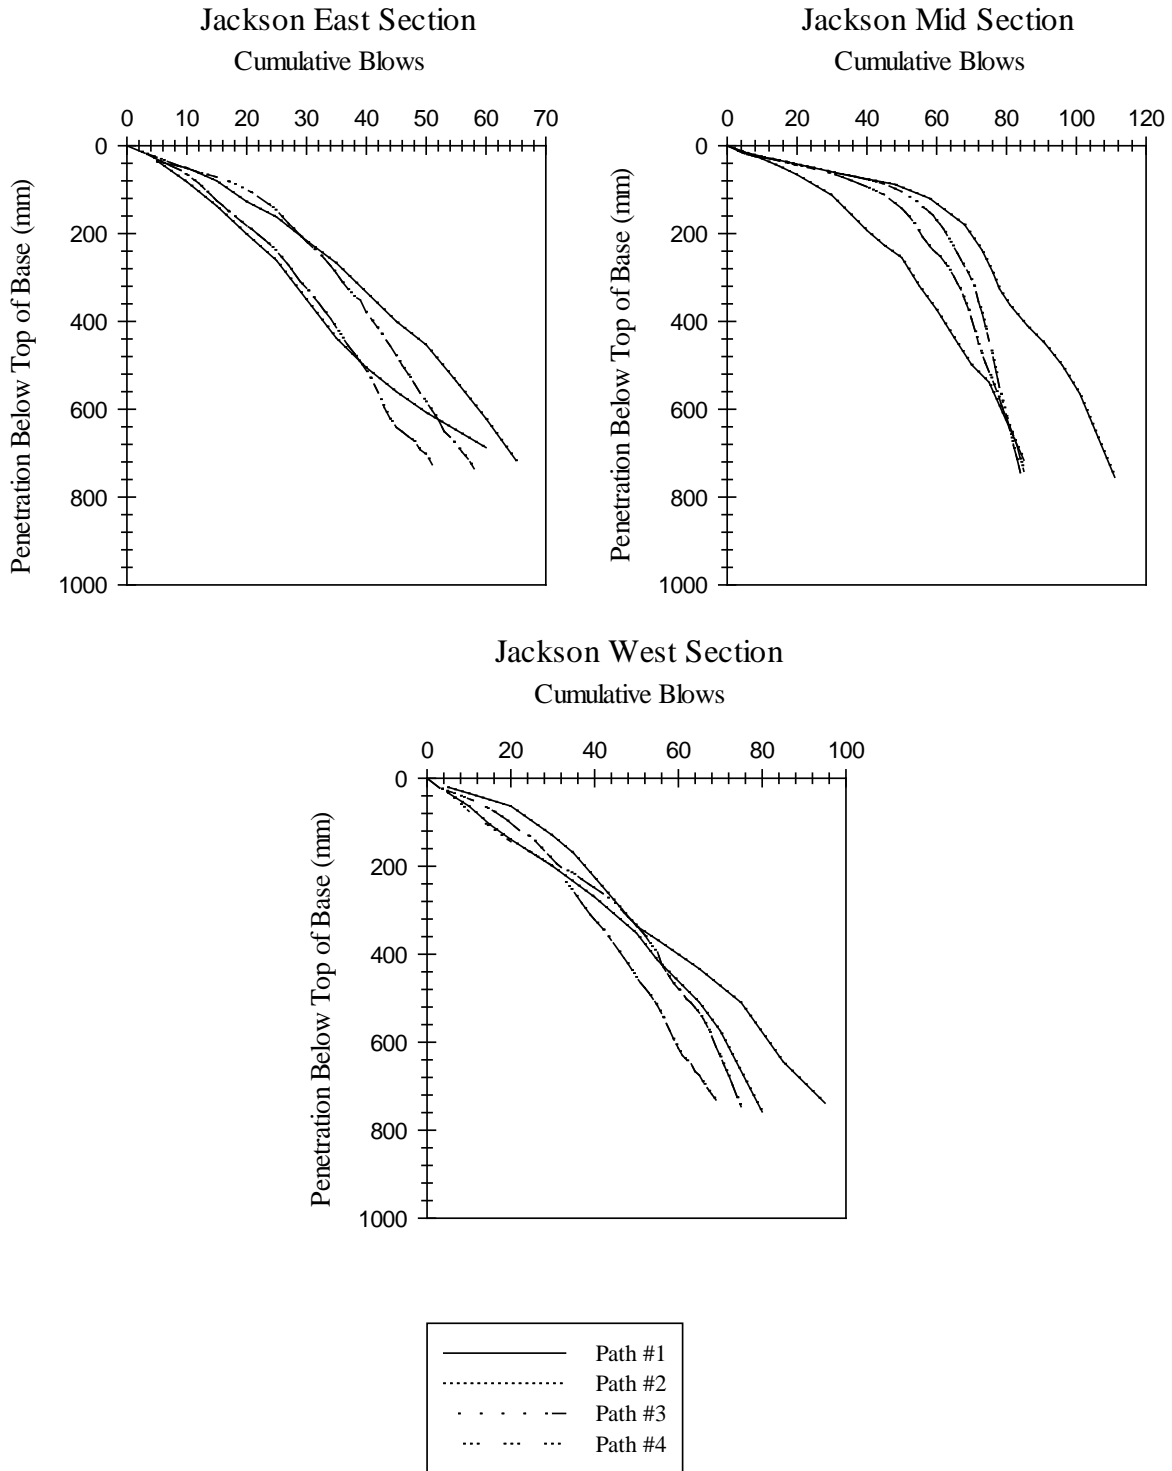
**Figure 32. DCP Test showing Cumulative Depth against Cumulative Blows for Jackson County**

Figure 32 reveals that the surface and subgrade materials are rather consistent with regard to stability since the penetration rate (PR) does not change, except for in the Middle/Second Test Section. From the plot for the Middle/Second Section, a pronounced downturn is seen at about 120 mm (4.7 in.) from the surface, suggesting heterogeneity of the subgrade material.

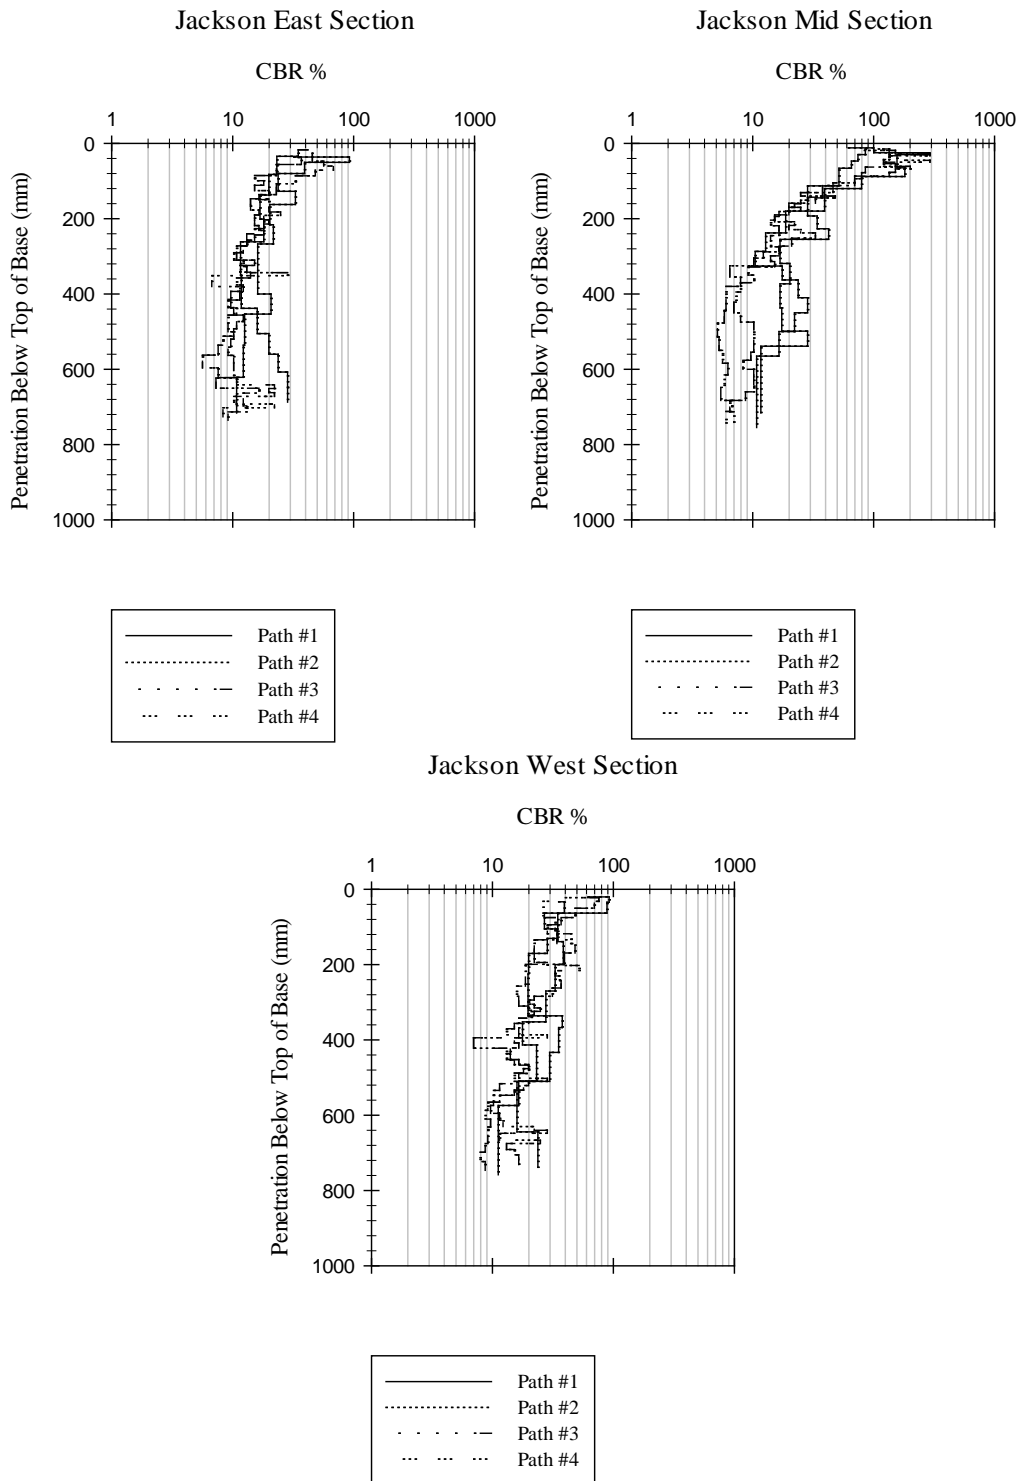
**Figure 33. DCP Test Cumulative Depth against CBR Percentage for Jackson County**

The California Bearing Ratio (CBR) appears to be comparable between the West/First (control) and East/Third (experimental) Test Sections (Figure 33), indicating that the stiffness of these

road sections are similar. However, according to some measurements, the CBR increases to 300 percent within the wearing surface in the Middle/Second Test Section, indicating a greater stiffness in this part of the road section.

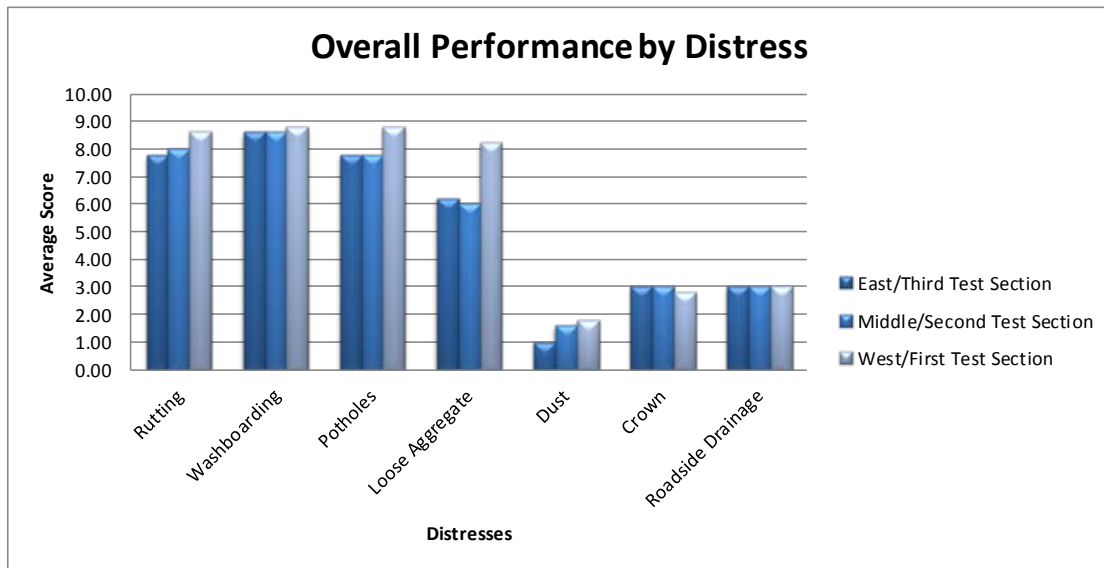
**Figure 35. Jackson County Pavement Condition Ratings by Distress Type**

For the above three distresses, the conditions were comparable since they lie within the same severity level. For the distress of loose aggregate, however, the West/First Section outperformed the other two sections. The West/First Section fell in the Good category in terms of condition of loose aggregate. The other two sections were rated as Fair. In addition, for dust emission, the East/Third Section was rated as Medium, lower than the control (West/First) and other experimental (Middle/Second) sections. This could be significant given that dust loss is the major source of material loss.

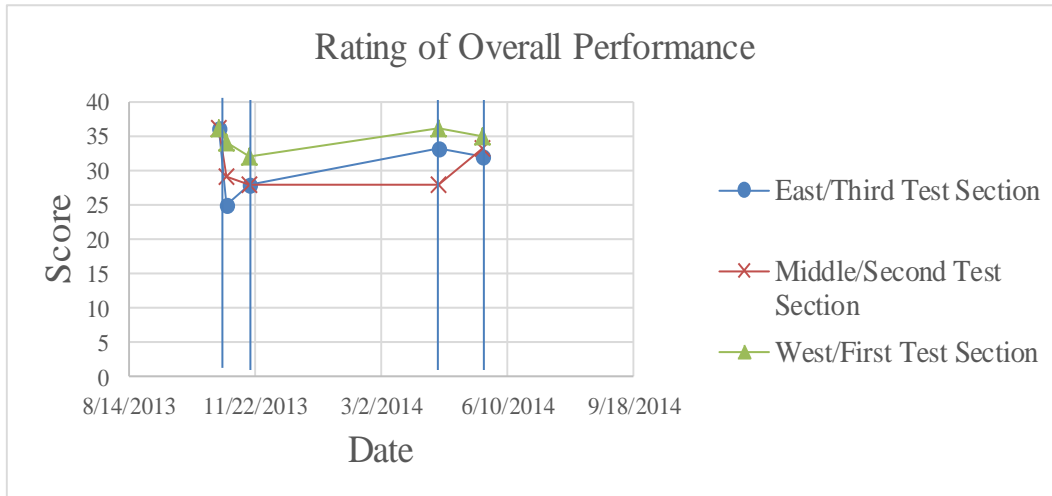
**Figure 36. Jackson County Overall Performance Ratings by Date**

The overall performance ratings also indicated that, throughout the observation period, the control (West/First) section outperformed the other two sections, as shown in Figure 35. The darker solid vertical lines indicate dates of maintenance activities.

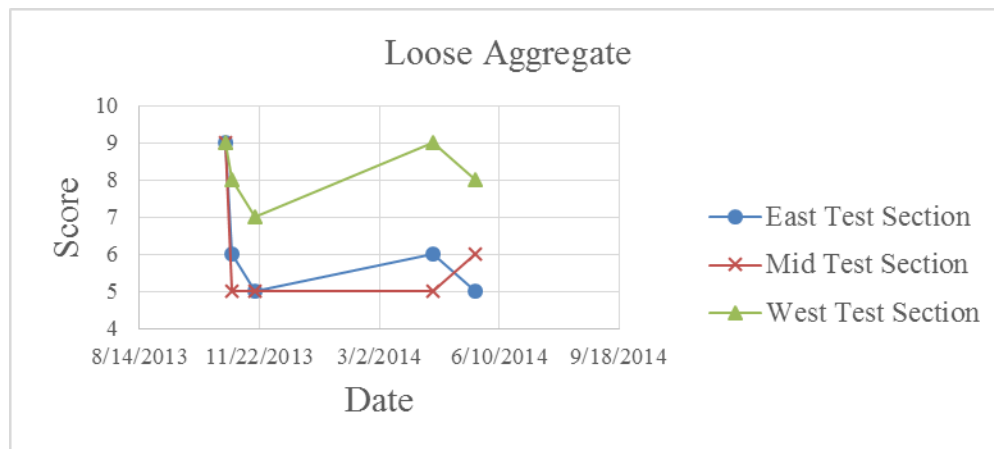
**Figure 37. Jackson County Loose Aggregate Ratings by Date**

Necessary maintenance activities were carried out during the observation period. Ratings were obtained before the maintenance activities. Figure 37 shows that the two experimental sections (the Middle/Second and East/Third Test Sections) suffered from loose aggregate soon after construction and that the problem remained since then.

Segregation that resulted generated a large amount of loose aggregate, which compromised the performance of the experimental sections.

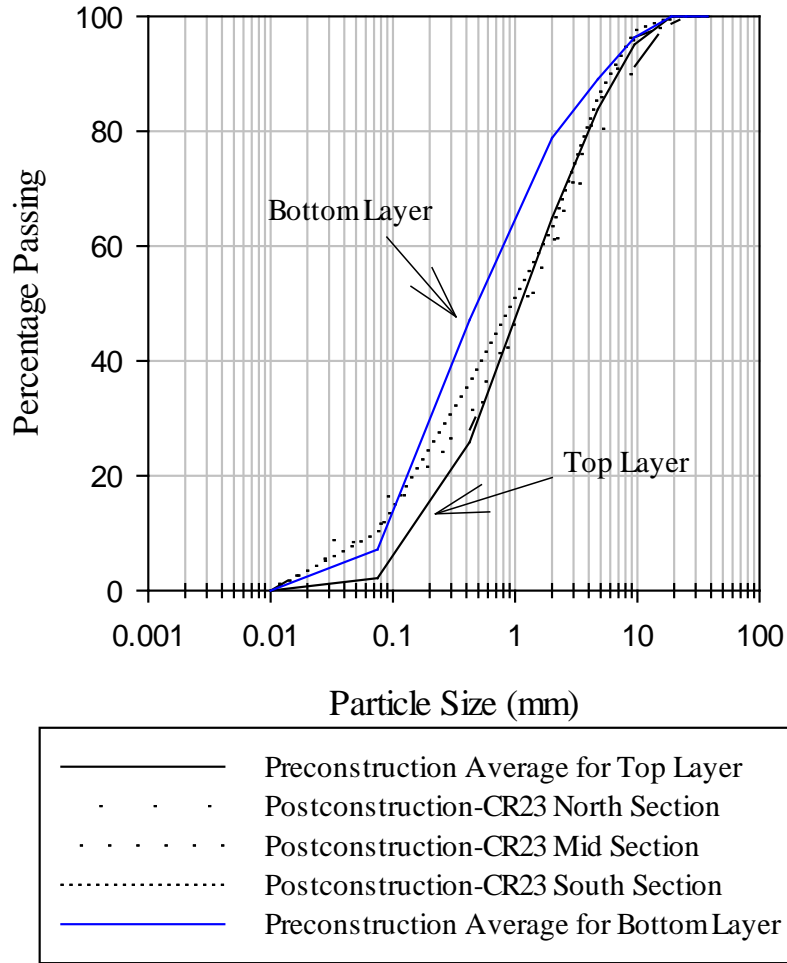
**Figure 39. PSD of Material for Beltrami County CR 23**

The addition of crusher dust on Beltrami County CR 23 successfully boosted the fine content of the in situ loose aggregate on the surface (see Figure 39). The North/First (control) Section had the highest fine content among the three sections.

The two solid lines represent the preconstruction PSD curve for the top and bottom layers of material, as indicated. Detailed material properties are summarized in Table 9.

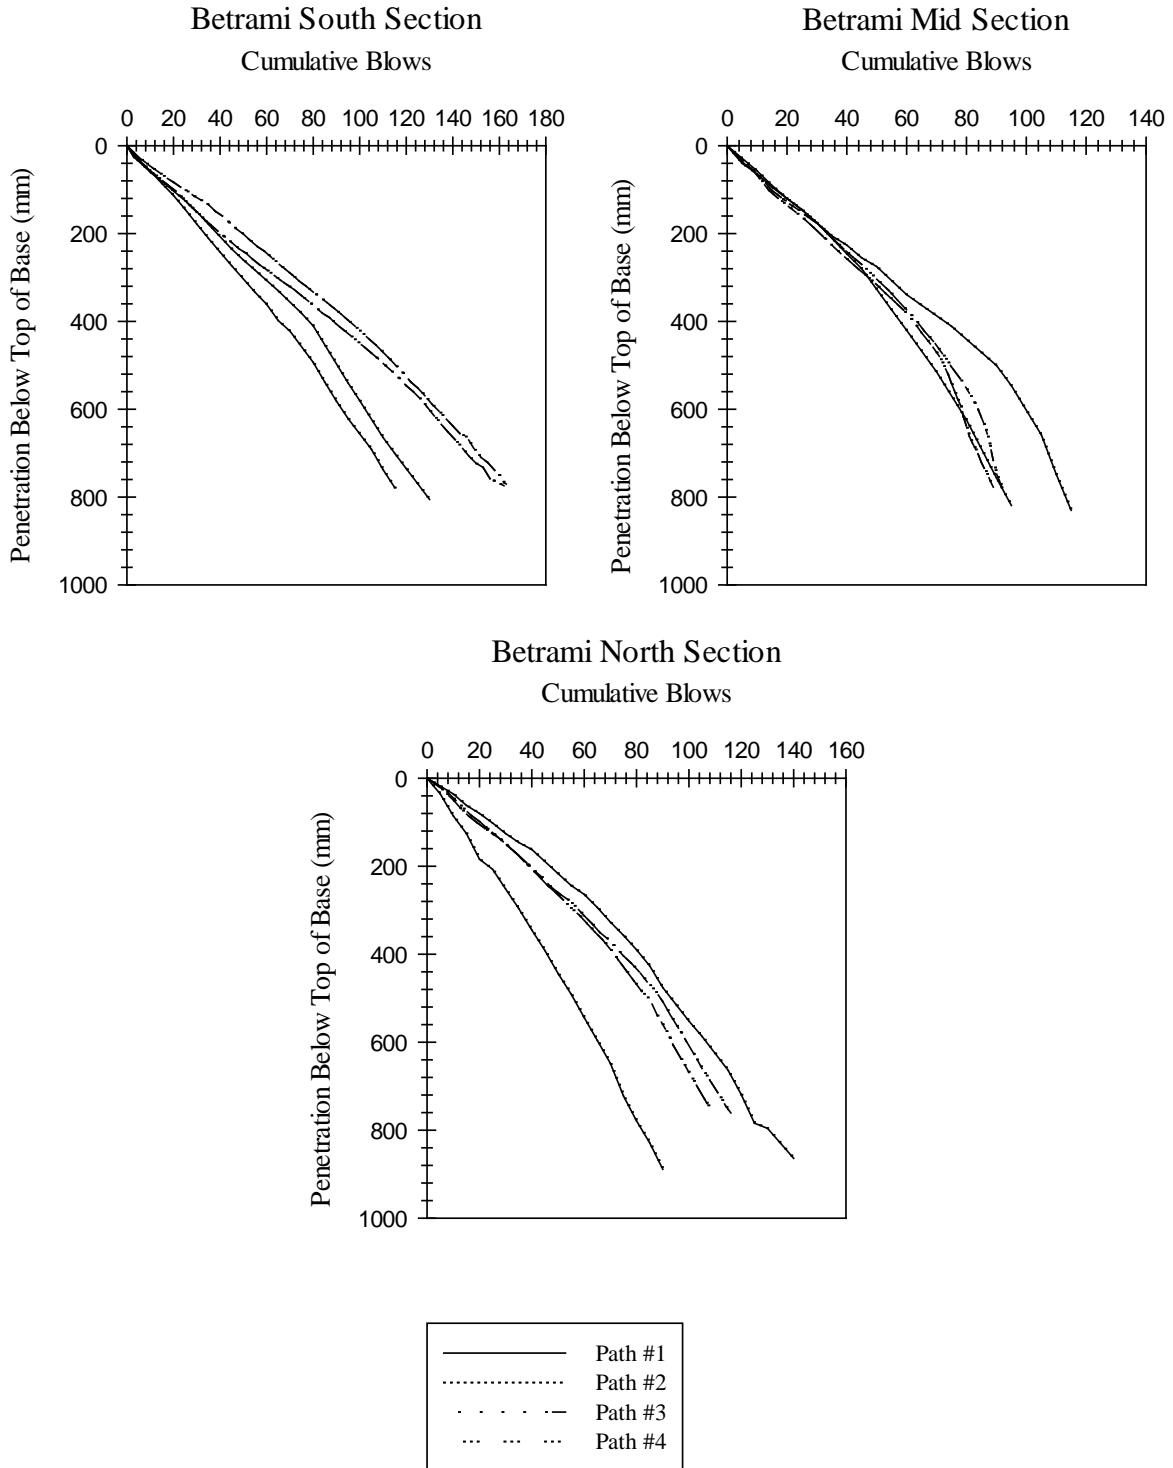
**Figure 40. DCP Test showing Cumulative Depth against Cumulative Blows for Beltrami County**

From the penetration-cumulative blows plotted in Figure 40, it is apparent that the various layers of road surface and subgrade material are consistent with regard to stability because the penetration per blow is relatively constant.

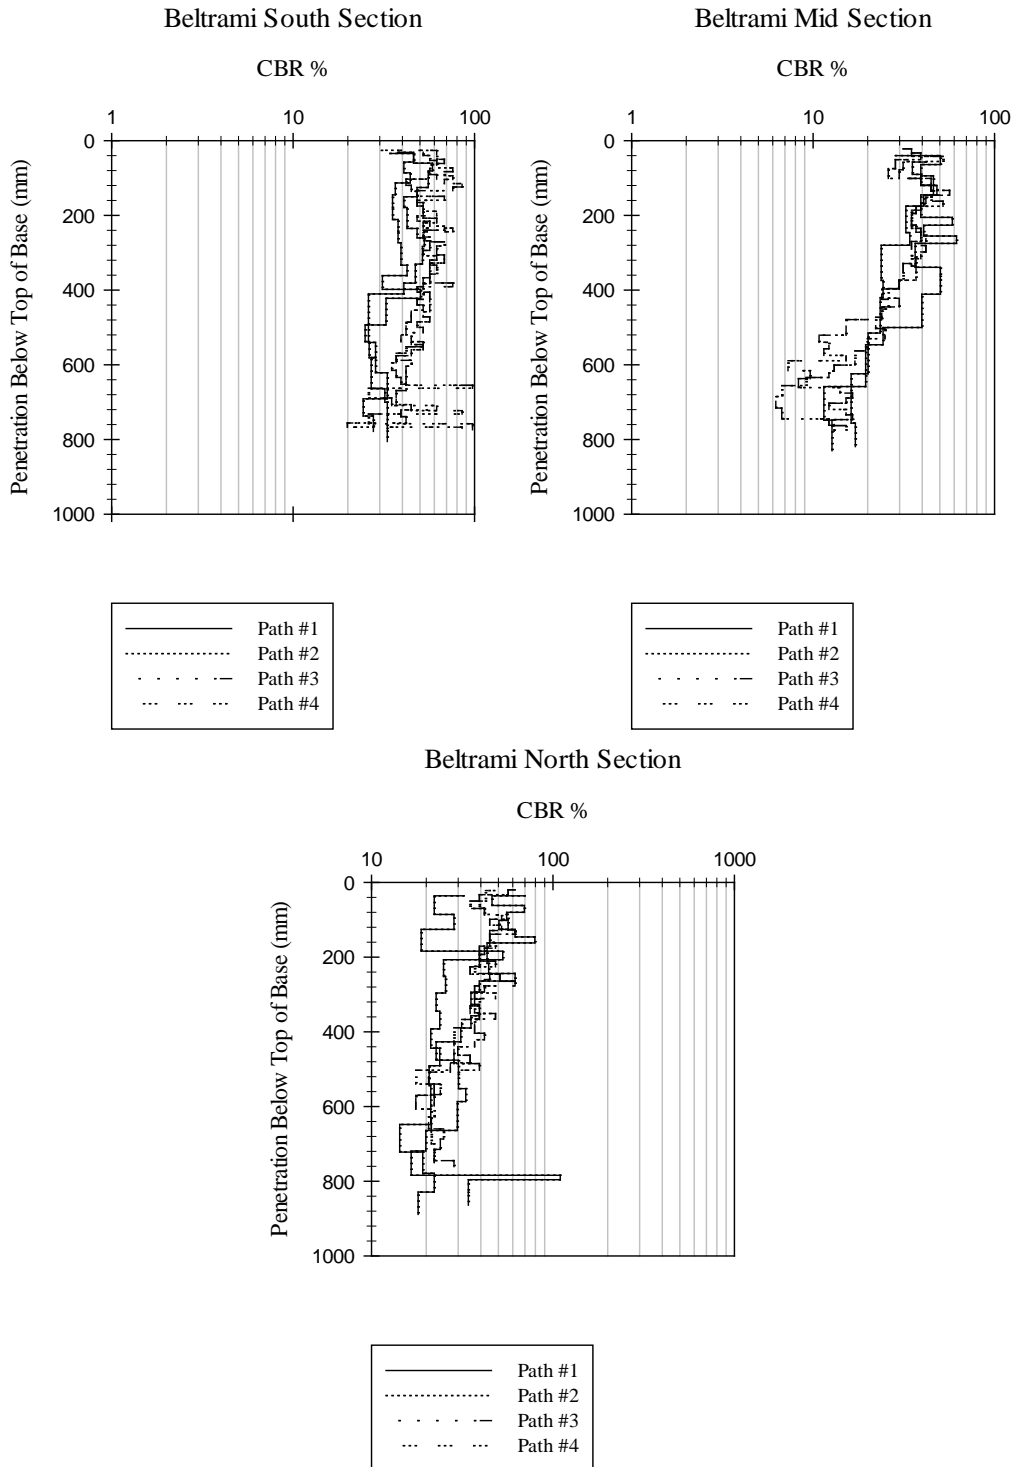
**Figure 41. DCP Test showing Cumulative Depth against CBR Percent for Beltrami County**

Figure 41 shows CBR values for the each section along the depth of the pavement. The CBR value for the top 200 mm (7.87 in.) has an average value of 46.18 for the North/First Section, 40.26 for the Middle/Second Section, and 50.26 for the South/Third Section.

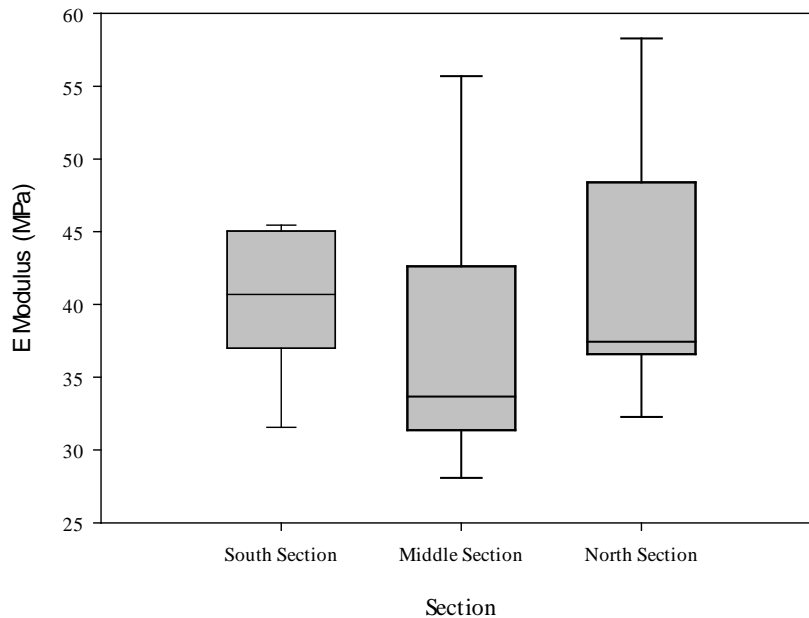
**Figure 42. Beltrami County LWD Readings (Test Date: 6/22/2014)**

LWD data show comparable stiffness across test sections, as Figure 42 shows that data in the range between the 25th and 75th percentile overlap.

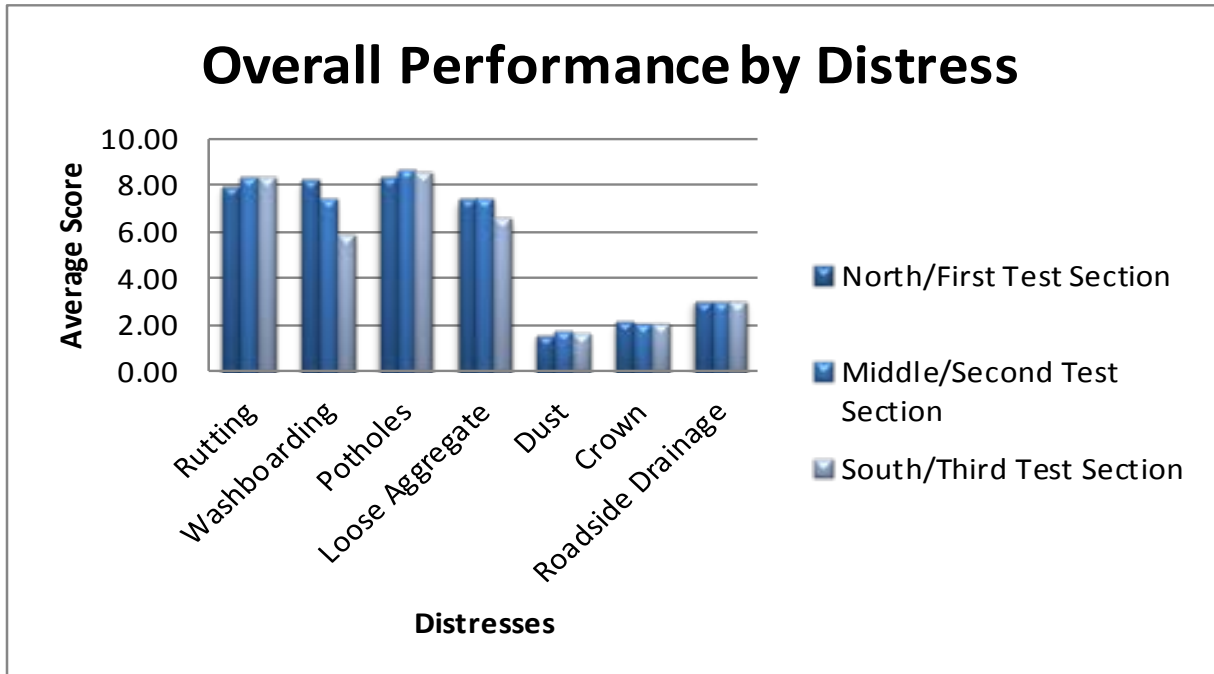
**Figure 43. Beltrami County Pavement Condition Ratings by Distress Type**

The South/Third Test Section was rated Fair for the distress of washboarding, which reflects the lasting distress that was observed in this section (see Figure 43). A Fair level of washboarding suggests that 10 to 25 percent of the roadway appears to suffer from corrugations that are generally 1 to 2 inches deep and vehicle control could be compromised.

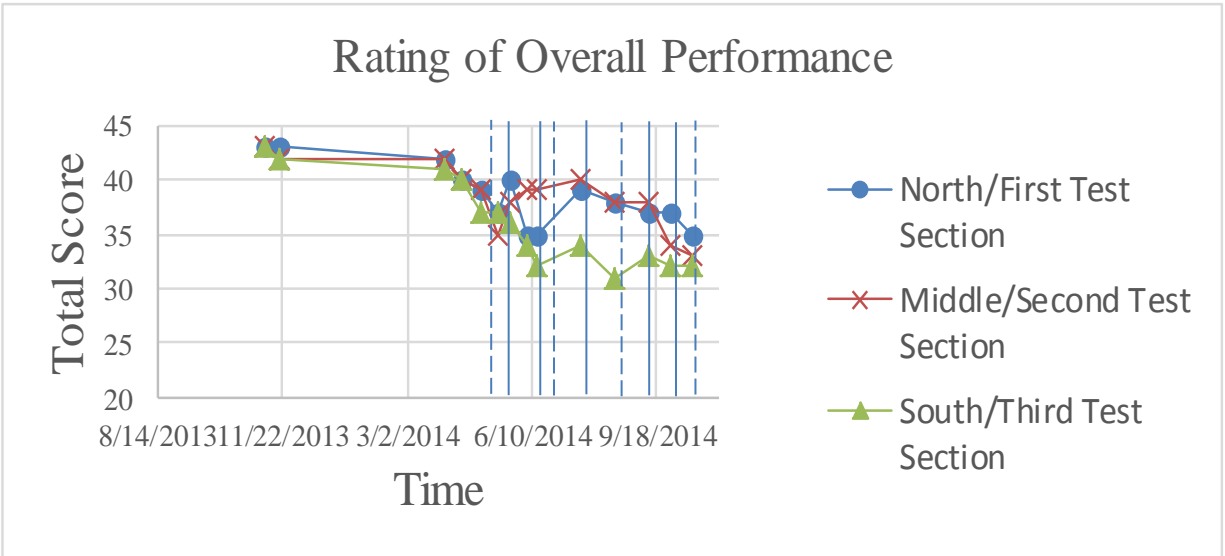
**Figure 44. Beltrami County Overall Performance Ratings by Date**

Considering that the scores assigned to the distresses of dust, crown, and roadside drainage were very close, if not exactly the same, between test sections, the overall performance according to the rating would be highly dependent on the other distress ratings. Figure 44 shows that the Middle/Second Test Section performed generally as well as the North/First (control) Section, including during the dryer part of the summer starting in June. In most cases, the Middle/Second Section performed better than the South/Third Section.

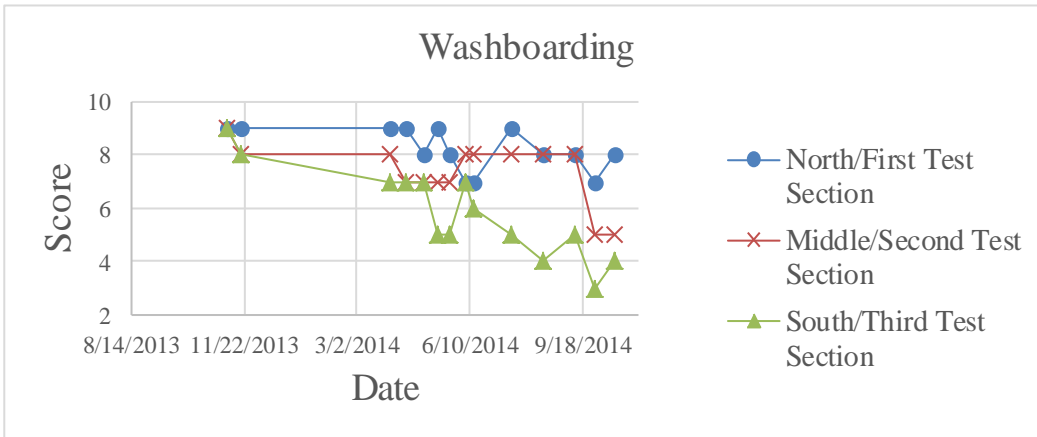
**Figure 45. Beltrami County Washboarding Ratings by Date**

The South/Third Section remained at the lowest score level for the majority of the observation period, even though it received more frequent maintenance. The South/Third Section started to deteriorate noticeably beginning in late May 2014 as it was entering into a dryer summer season. The deterioration is most pronounced in terms of washboarding, as shown in Figure 45.

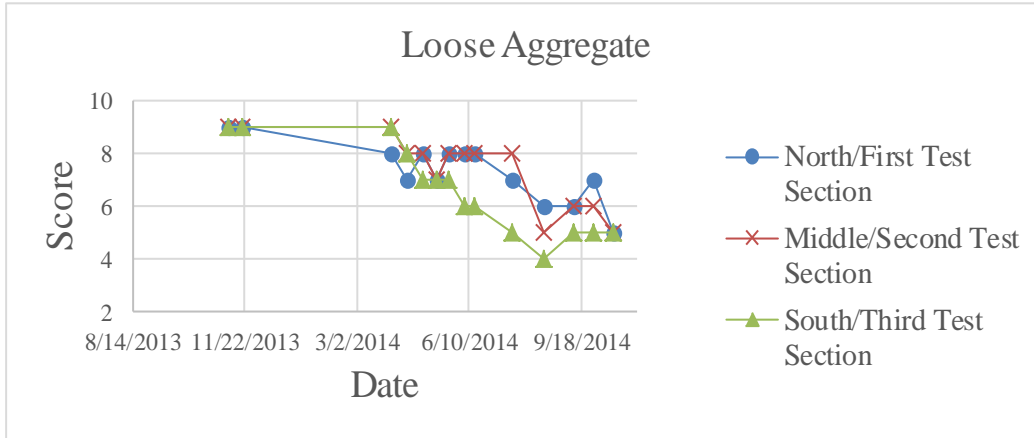
**Figure 46. Beltrami County Loose Aggregate Ratings by Date**

Loose aggregate issues started to occur in May as well, and were the worst for the South/Third Section, as shown in Figure 46.

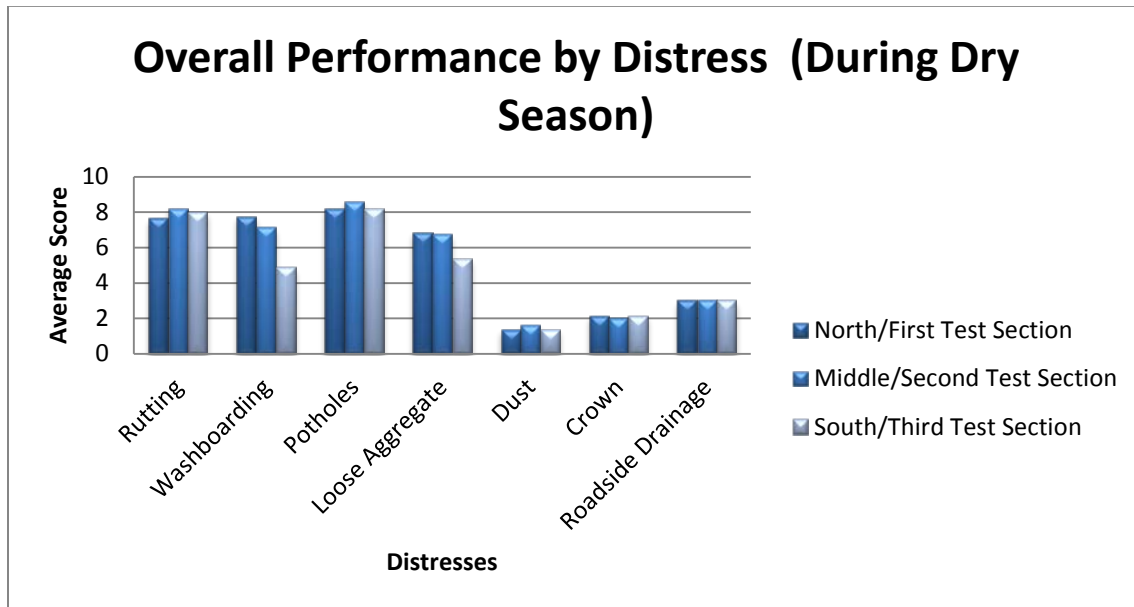
**Figure 47. Beltrami County Overall Ratings by Distress Type during Dry Season**

It is of interest to reveal how all the sections were performing during the dry season, after late May in this case. Figure 47 shows that the ratings for washboarding and loose aggregate for the South/Third Section dropped substantially versus those shown in Figure 43, while the ratings for both the North/First (control) Section and Middle/Second Section exhibit a noticeably less substantial drop.

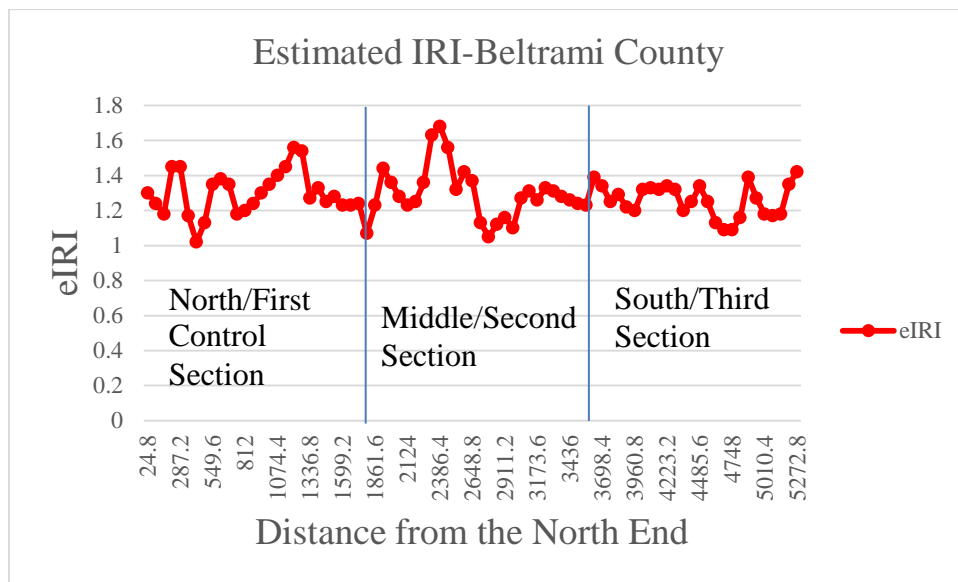
**Figure 48. Beltrami County CR 23 Estimated IRI Values**

Roadroid generated estimated IRI (eIRI) as shown in Figure 48.

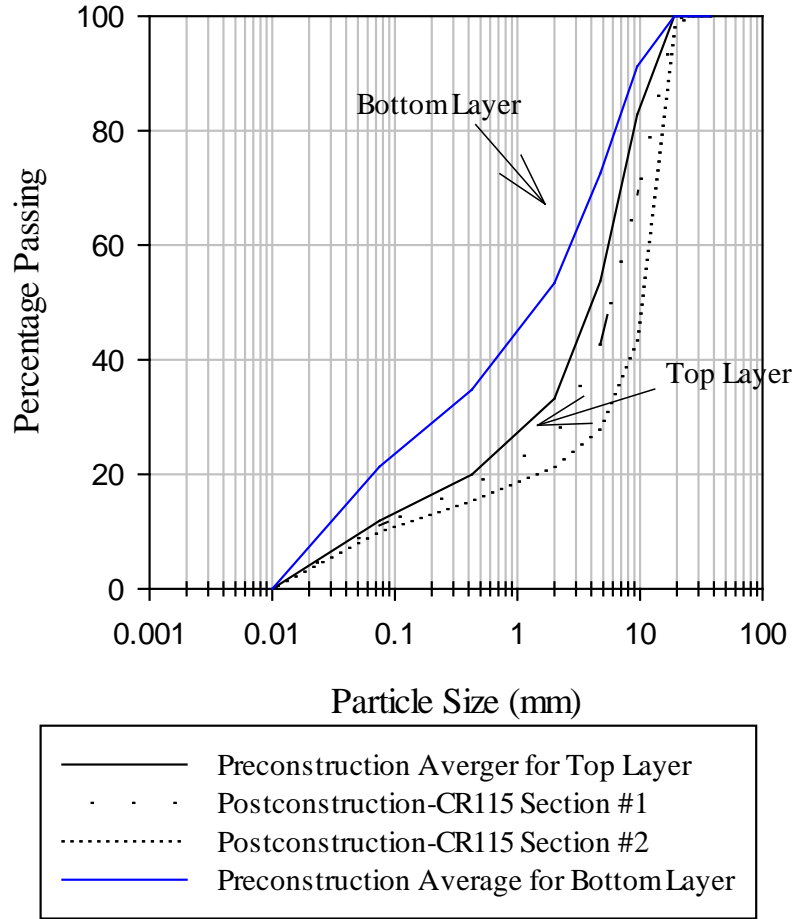
**Figure 52. PSD of Material for Olmsted County CR 115 South**

PSD plots for Olmsted County CR 115 South and North are shown in Figure 52 and Figure 53, respectively.

The two solid lines represent the preconstruction PSD curve for the top and bottom layers of material, as indicated. It is interesting to note that the resulting gradation of the newly placed material was coarser than that of the top material. All material was determined to be non-plastic as shown in Table 10.

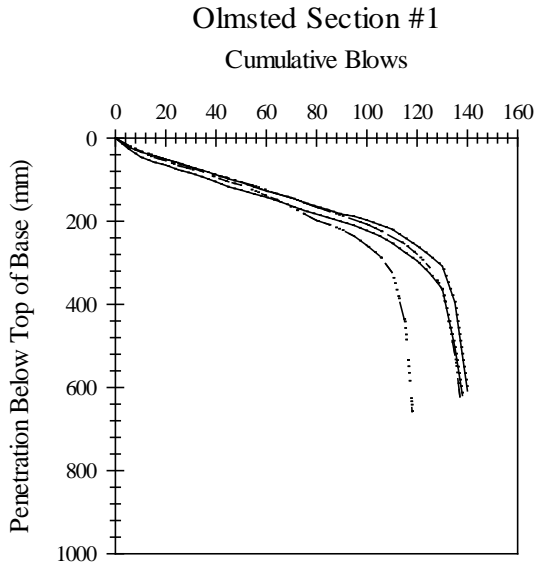
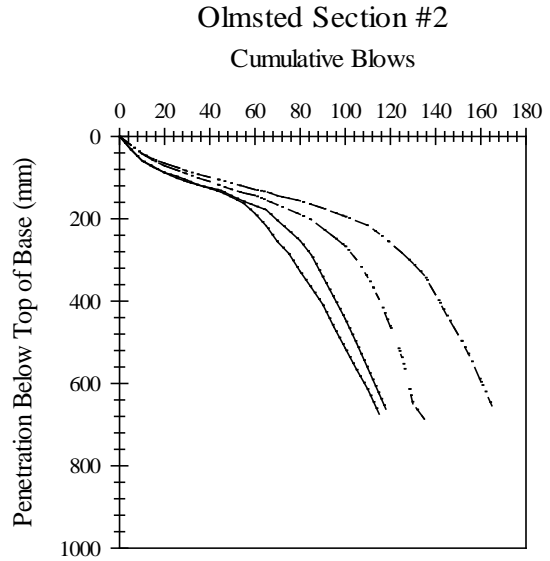
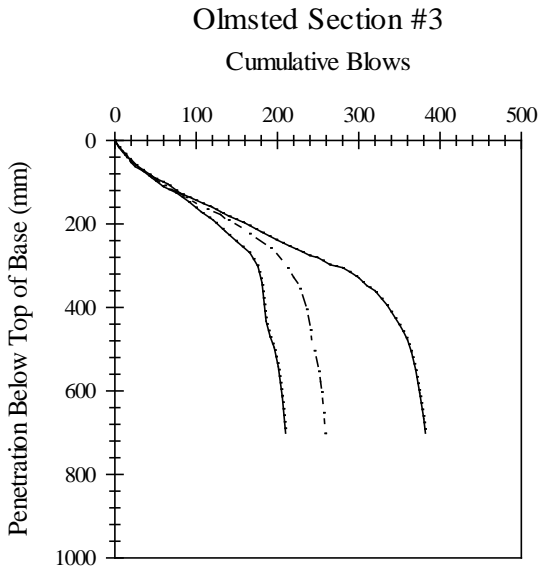
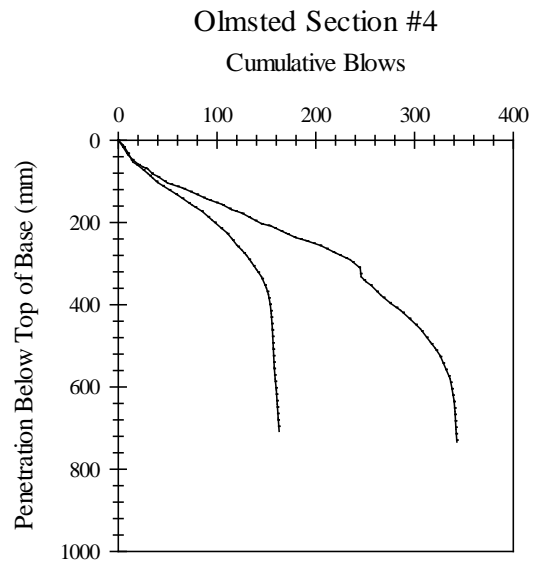
**Figure 54. Cumulative Depth against Cumulative Blows for Olmsted County (Test Date: 6/20/2014)**

Figure 54 shows a clear indication of the location of the interface between the crushed rock layer and the subgrade layer. The crushed rock of the test sections had various depths ranging from 200 mm (7.9 in.) to 300 mm (11.8 in.).

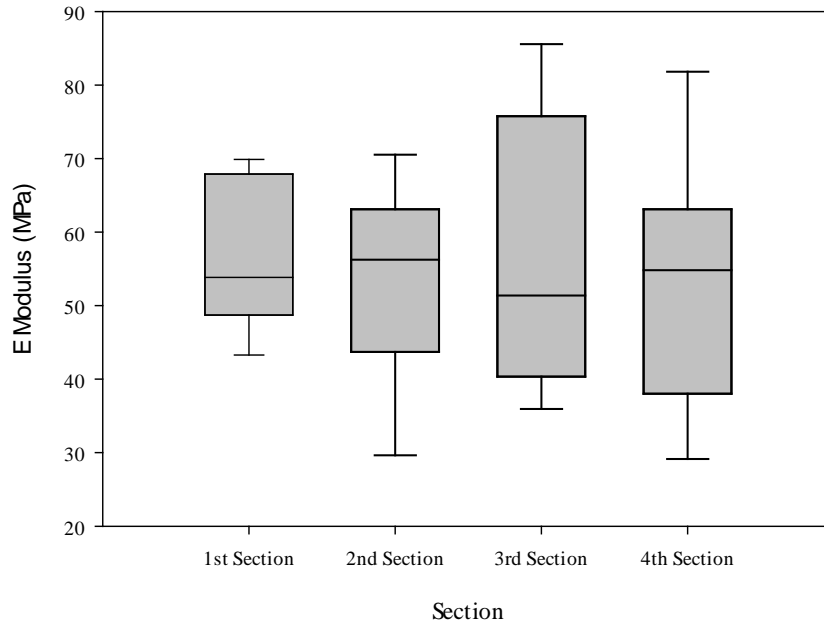
**Figure 56. Olmsted County LWD Readings**

Figure 56 shows comparable LWD readings. In other words, no noticeable difference was found in the stiffness of the road surfacing materials for the four test sections.

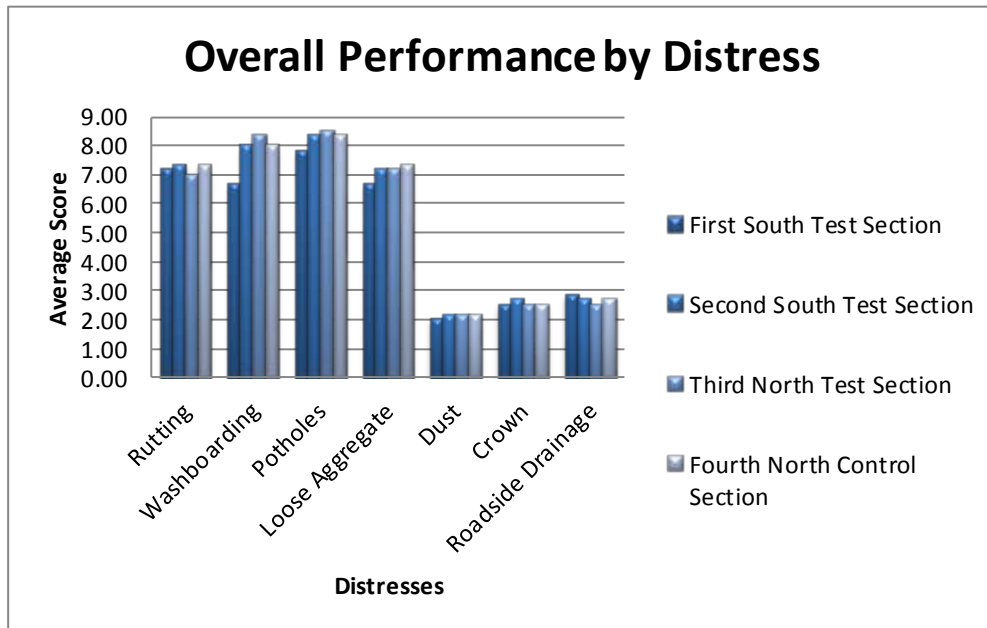
**Figure 57. Olmsted County Pavement Condition Ratings by Distress Type**

All four test sections were considered to be performing reasonably well, except that the First South (experimental) Section received a rating of Fair with respect to loose aggregate, while the other sections were rated Good. In addition, the First South Section had more severe corrugation

compared to the other sections, probably due to its proximity to an intersection. Figure 57 shows the rating results by distress.

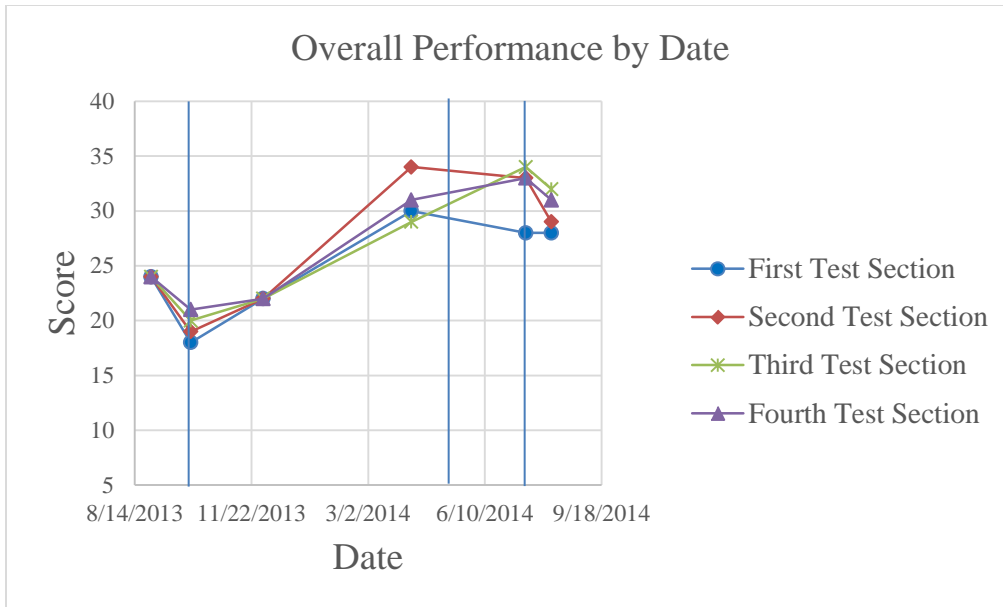
**Figure 58. Olmsted County Overall Performance Ratings by Date**

Considering that nearly identical scores were given to dust, crown, and roadside drainage distresses for all four sections, differences in the overall rating must be due to differences in the other distress ratings. Figure 58 shows the rating outcomes by date.

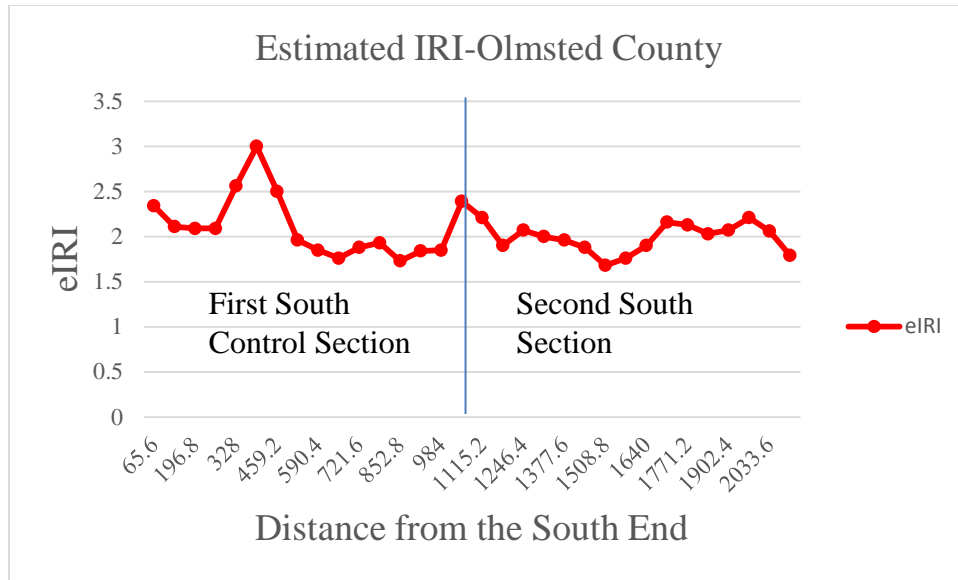
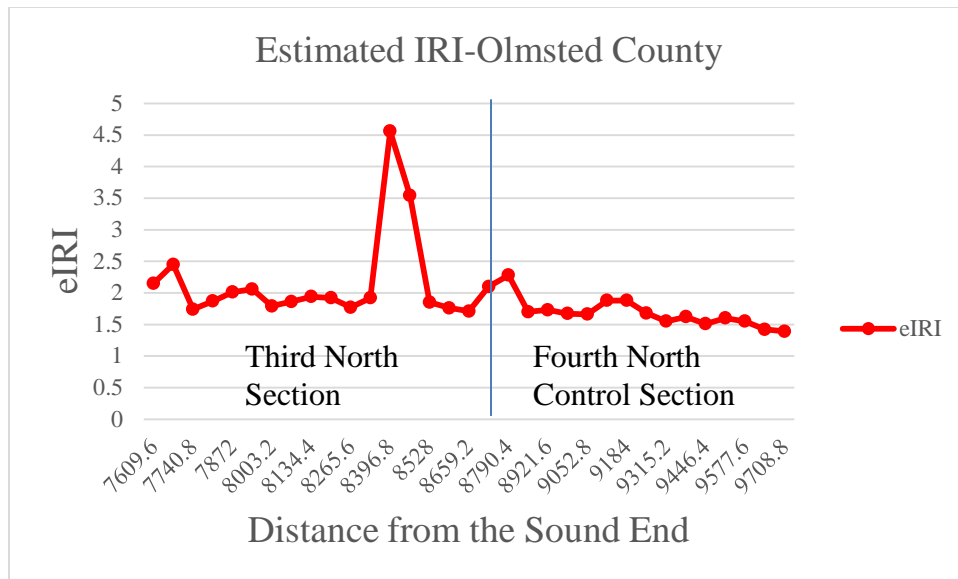
**Figure 59. Olmsted County CR 115 Estimated IRI Values**

There were spikes in the roughness measurements for the First South (experimental) Section and the Third North (experimental) Section for a short time (see Figure 59). Otherwise, all four sections had stable estimated IRI values. Generally, the surfaces provided a good riding surface, as the average estimated IRI value for each section was lower than 2.2.

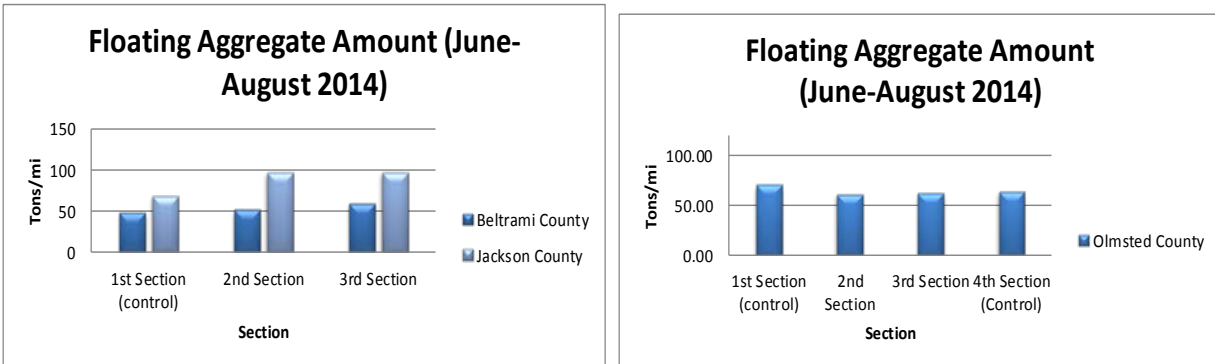
**Figure 62. Postconstruction Floating Aggregate Results**

The amounts of floating aggregate and gravel loss after construction estimated for each test section are presented in Figure 62 through Figure 64.
