# Construction Report for a Thin Unbonded Concrete Overlay on Minnesota TH 53

Minnesota  
Department of  
Transportation

Research Project  
Interim Report #2010-23

## **Interim Report**

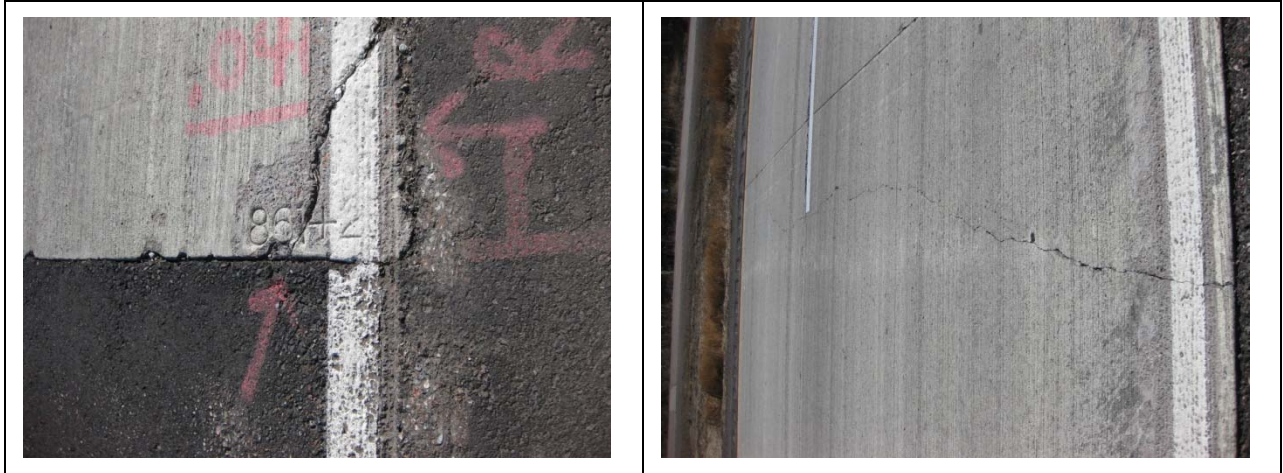
Figure A.1. Distress No. 1 [Left] & No. 2 [Right], April 2009

Based on the random occurrence of the transverse cracks through the panels, it is deduced they were likely caused by late sawing of the joints. It seems that paving the thin concrete overlay progressed much faster than the capabilities of the sawing equipment on site. The higher surface to thickness ratio of the overlay also presented additional challenges in timing the saw cuts. The skewed nature of some of the cracks (Figure 4.3, rightmost photo) leads one to believe they are more reflective in nature. In addition to transverse cracking through the panels, the fall 2009 survey also revealed the presence of other distresses, notably joint spalling, which was again most likely caused by improper timing (early) of the joint sawing. It should be noted that no mid panel cracks have appeared in the overlay section with 6-foot by 6-foot panels.
