Concrete Bridge Deck Crack Sealant Evaluation and Implementation

Minnesota
Department of
Transportation

Matthew S. Oman, Principal Investigator
Braun Intertec Corporation

Research Project
Final Report 2014-34

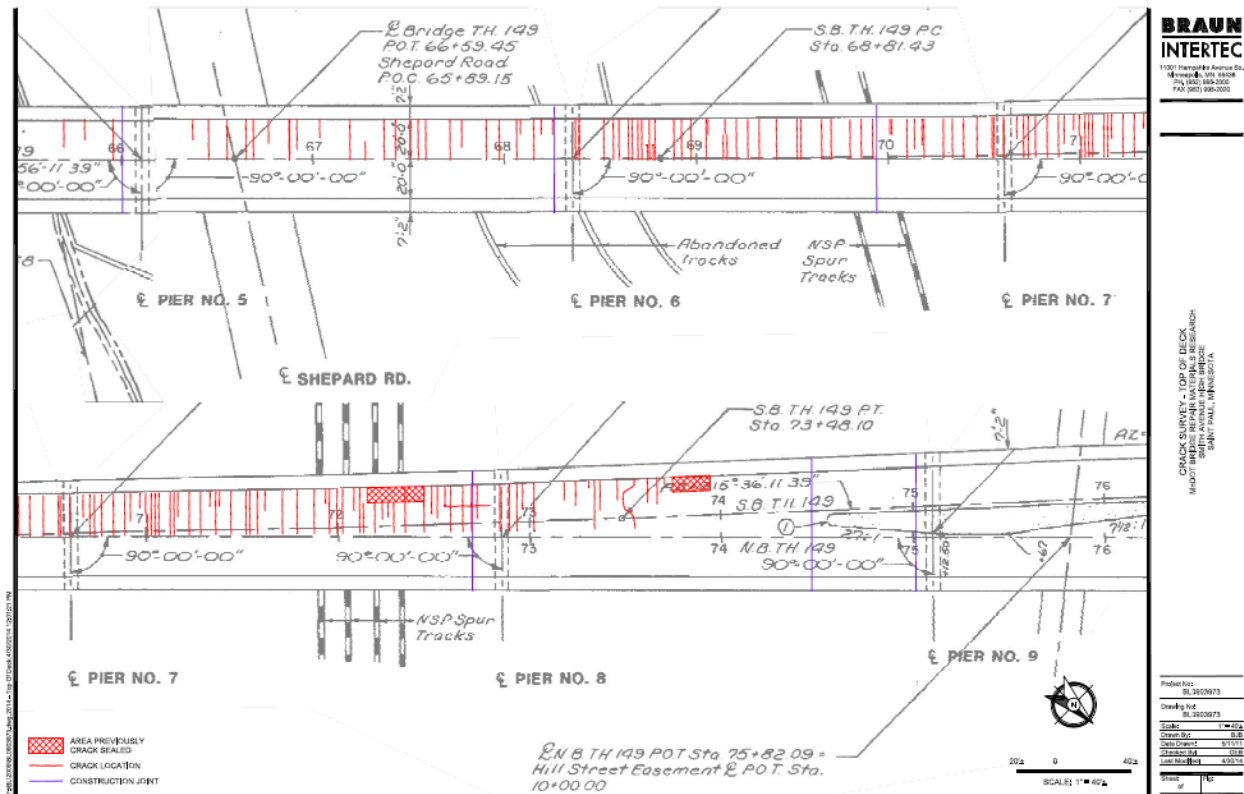
Figure 2. Plan View of the Bridge Area Surveyed (top cracks indicated).

Visible cracks in the southbound lane and shoulder were documented. A total of 48 cracks were observed between Piers 5 and 6, 44 between Piers 6 and 7, and 48 between Piers 7 and 8. Crack

widths were estimated with a crack comparator and ranged from 0.016 to 0.040 inches (16 to 40 mils).

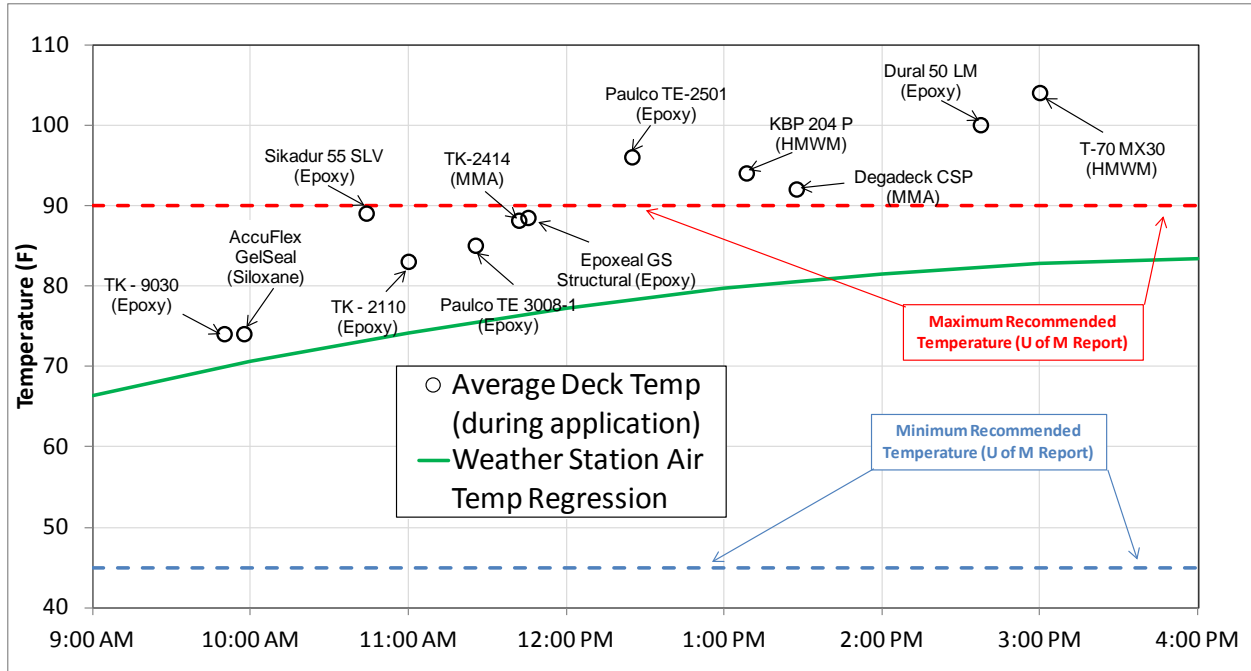
Figure 4. Air and Deck Temperatures During Product Application.

In the U of M report, it is unclear whether the temperature range recommendation applies to air temperatures or deck temperatures. Note that the air temperature during application remained below the recommended upper limit, whereas the measured deck temperatures exceeded this recommendation.

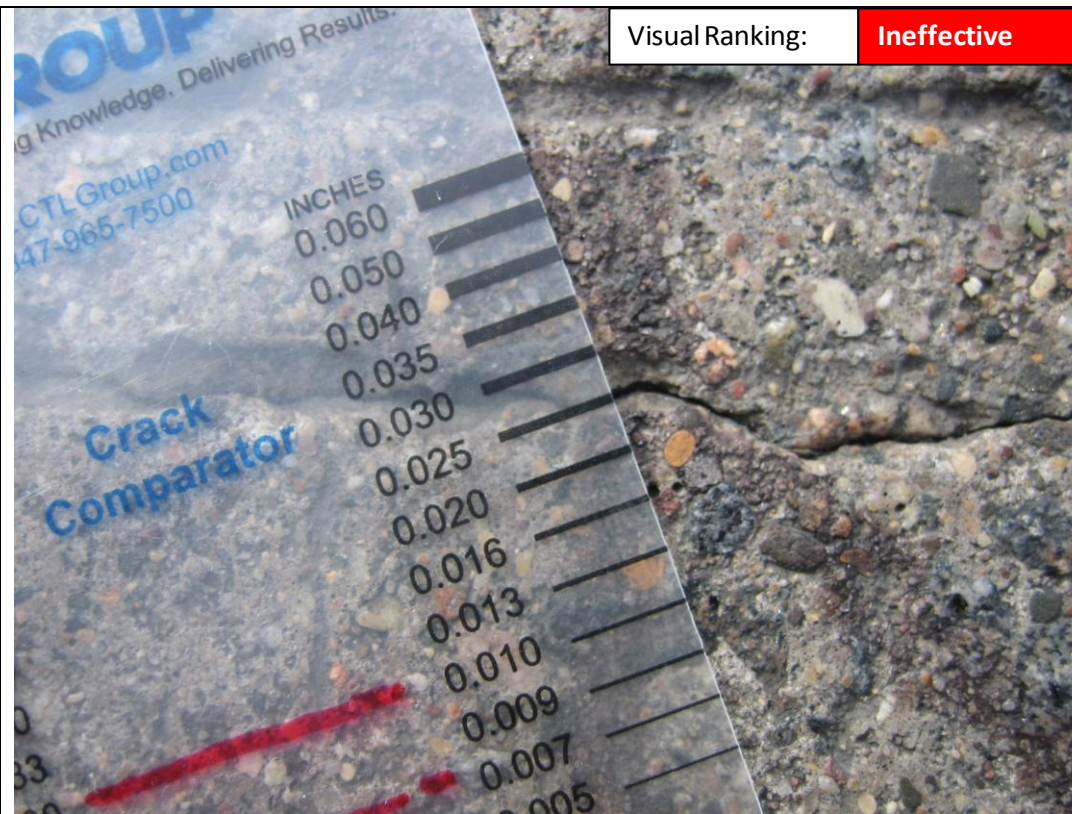
Photograph #: 1
 Test Information: Test Section 1, Test 1A - Accuflex Coatings Gel-Seal (Silicate)
 Surface Prep & Application: Air Hose, Pretreat, Flood, Sand Coat: No
 Date: May 11, 2012
BRAUN INTERTEC

The cause of the increase in permeability in the Accuflex Gel-Seal test section is unknown. It is understood that the Gel-Seal product is a silicate-based sealer that reacts with calcium hydroxide in the concrete and produces calcium-silicate-hydrate within the crack to function as a sealer. Perhaps a significant amount of calcium hydroxide was not present to initiate this reaction. Regardless of the cause, it appears that the Accuflex Gel-Seal section behaved like some of the control sections over this performance period. However, determination of the cause for this reduced performance is beyond the scope of this work.

Visual Ranking: **Ineffective**

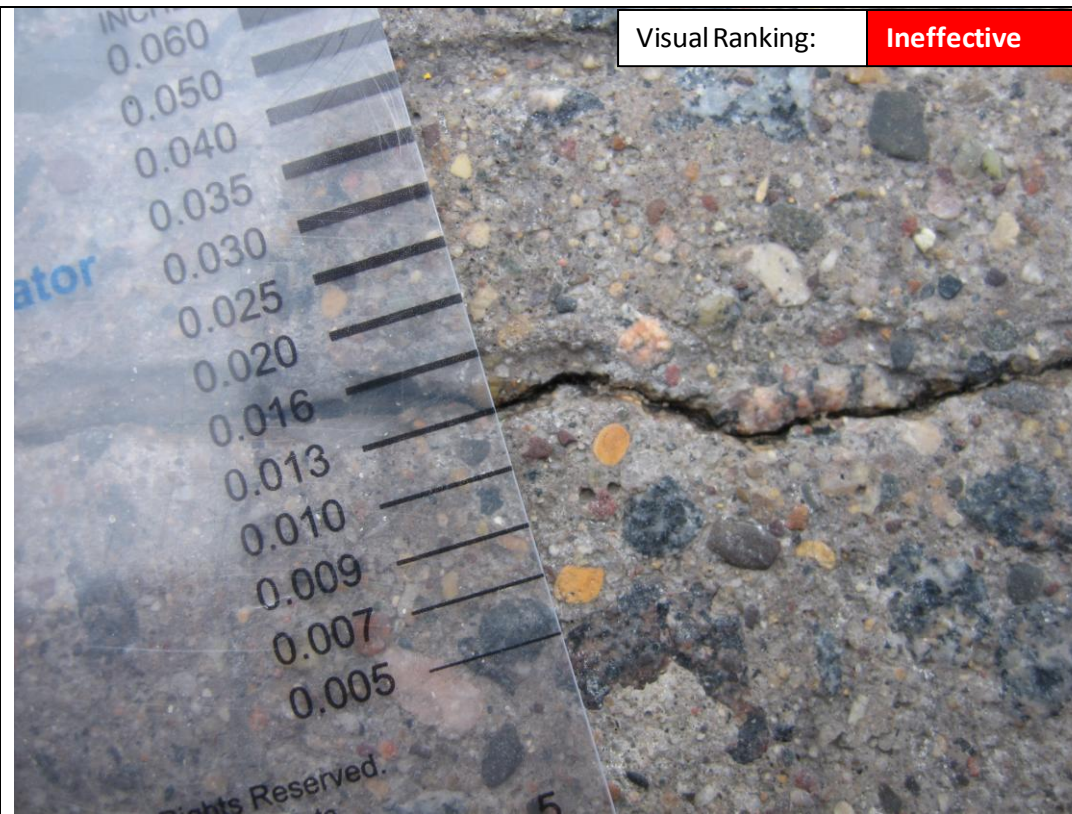
Photograph #: 2
 Test Information: Test Section 1, Test 1A - Accuflex Coatings Gel-Seal (Silicate)
 Surface Prep & Application: Air Hose, Pretreat, Flood, Sand Coat: No
 Date: April 30, 2013
BRAUN INTERTEC

Visual Ranking: **Ineffective**

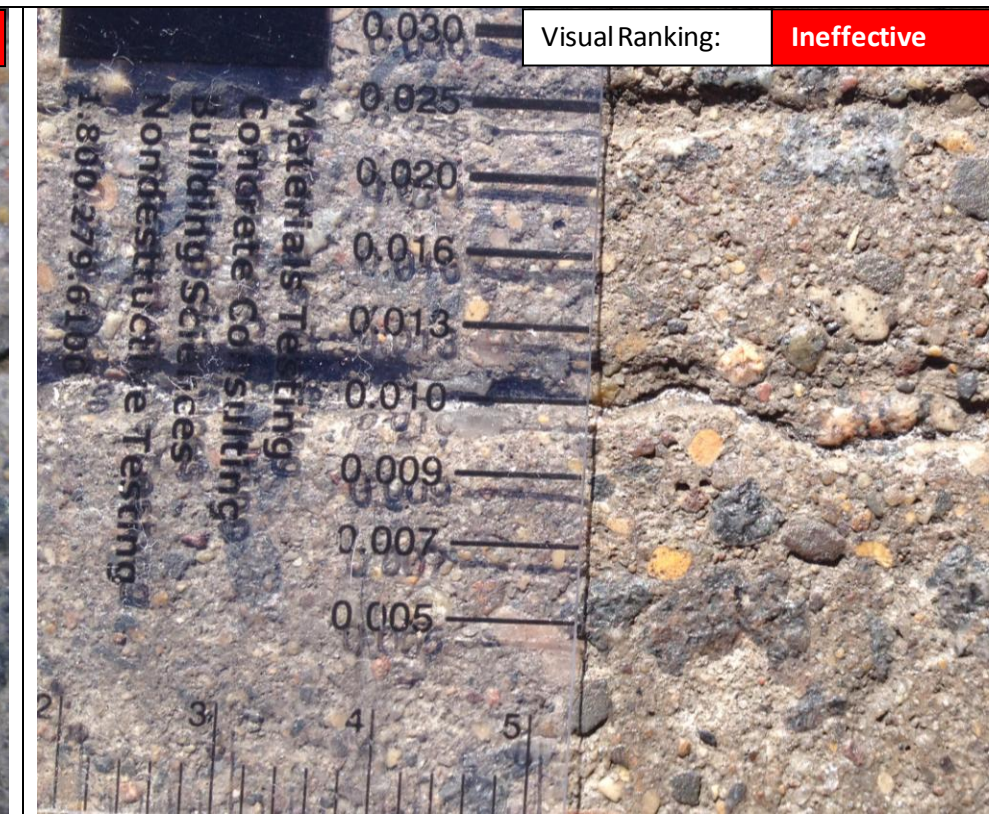
Photograph #: 3
 Test Information: Test Section 1, Test 1A - Accuflex Coatings Gel-Seal (Silicate)
 Surface Prep & Application: Air Hose, Pretreat, Flood, Sand Coat: No
 Date: April 8, 2014
BRAUN INTERTEC

Visual Ranking: **Ineffective**

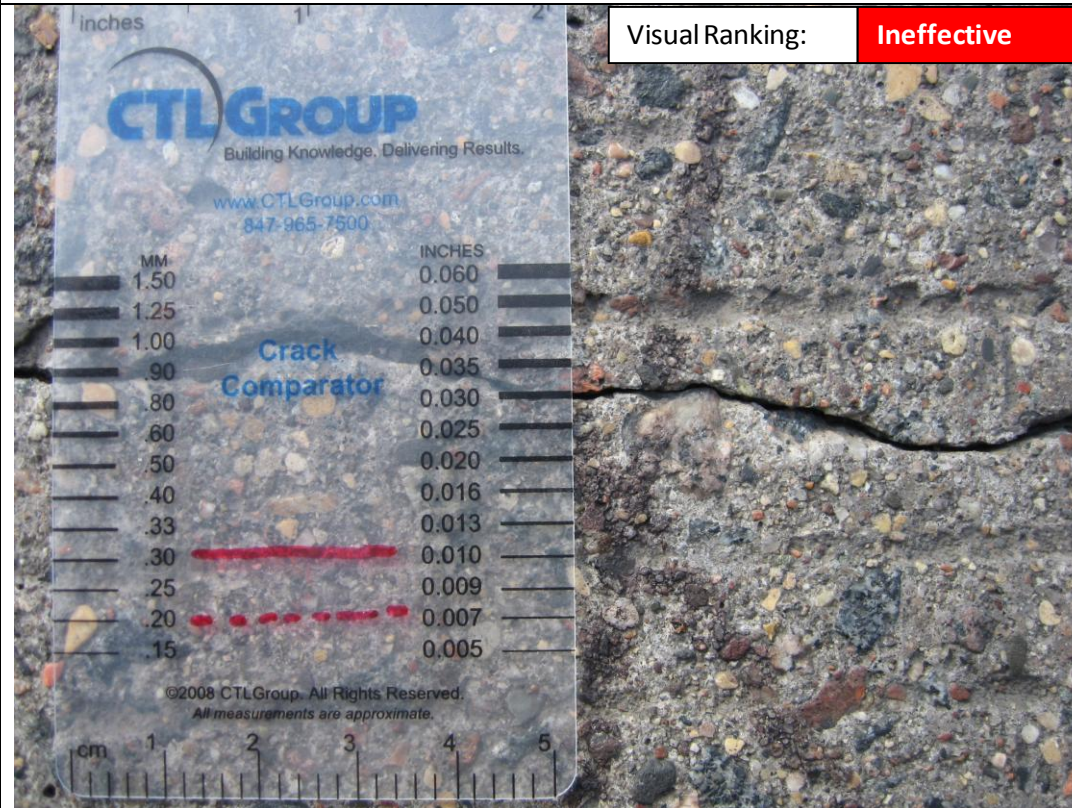
Photograph #: 4
 Test Information: Test Section 1, Test 2A - Accuflex Coatings Gel-Seal (Silicate)
 Surface Prep & Application: Air Hose, Pretreat, Flood, Sand Coat: No
 Date: May 11, 2012
BRAUN INTERTEC

Visual Ranking: **Ineffective**

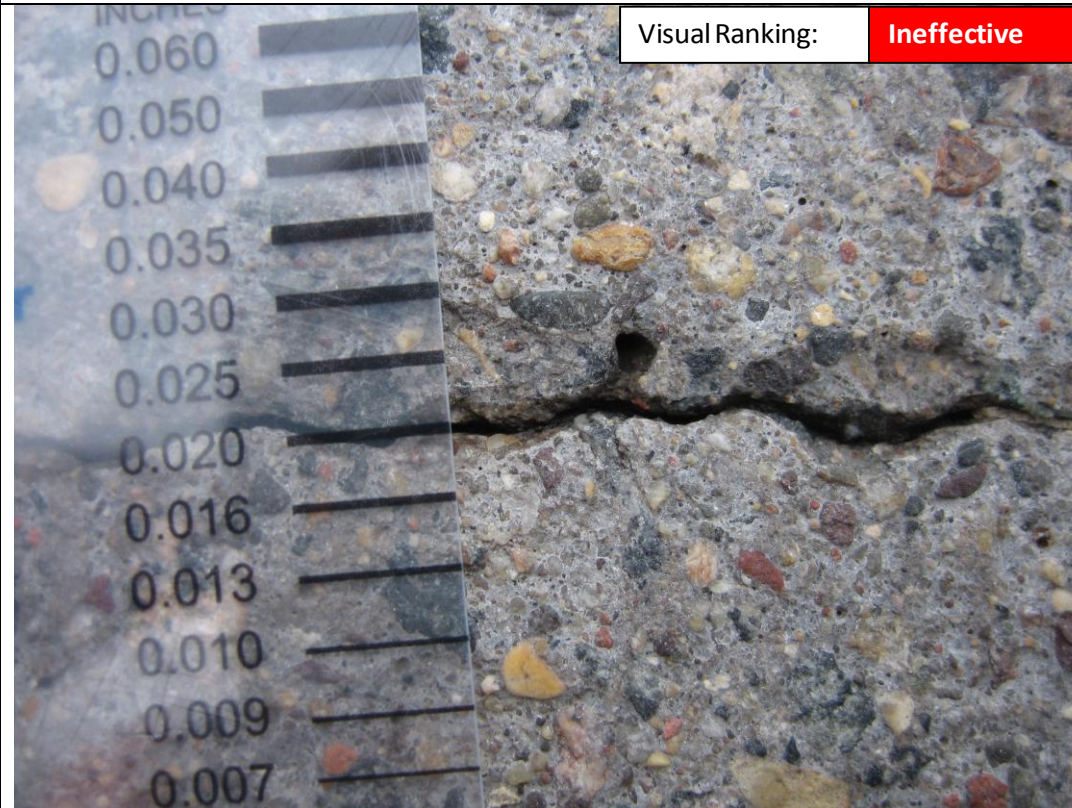
Photograph #: 5
 Test Information: Test Section 1, Test 2A - Accuflex Coatings Gel-Seal (Silicate)
 Surface Prep & Application: Air Hose, Pretreat, Flood, Sand Coat: No
 Date: April 30, 2013
BRAUN INTERTEC

Visual Ranking: **Ineffective**

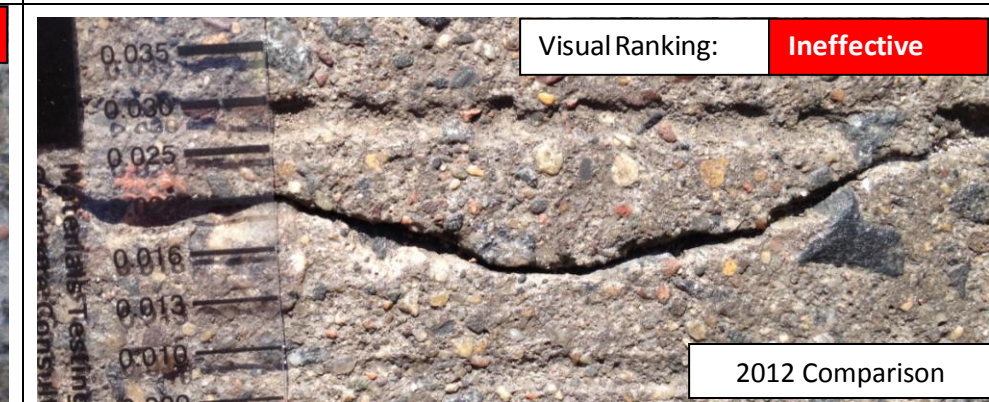
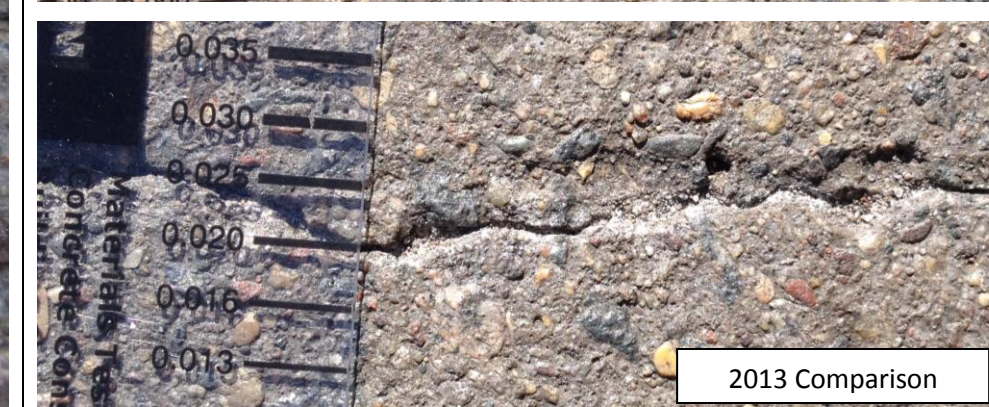
Photograph #: 6
 Test Information: Test Section 1, Test 2A - Accuflex Coatings Gel-Seal (Silicate)
 Surface Prep & Application: Air Hose, Pretreat, Flood, Sand Coat: No
 Date: April 8, 2014
BRAUN INTERTEC

Visual Ranking: **Ineffective**

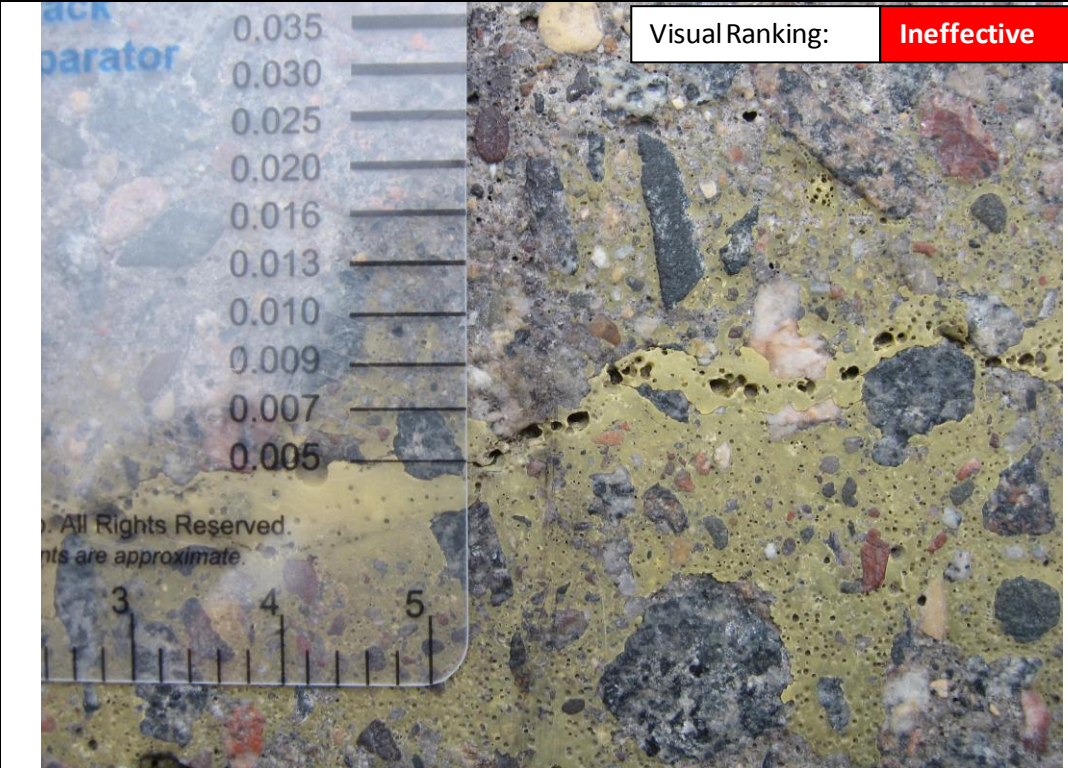
Photograph #: 17
 Test Information: Test Section 3, Test 8A - TK Products TK-9030 (Epoxy)
 Surface Prep & Application: Air Hose, Bottle, Sand Coat: No
 Date: April 30, 2013

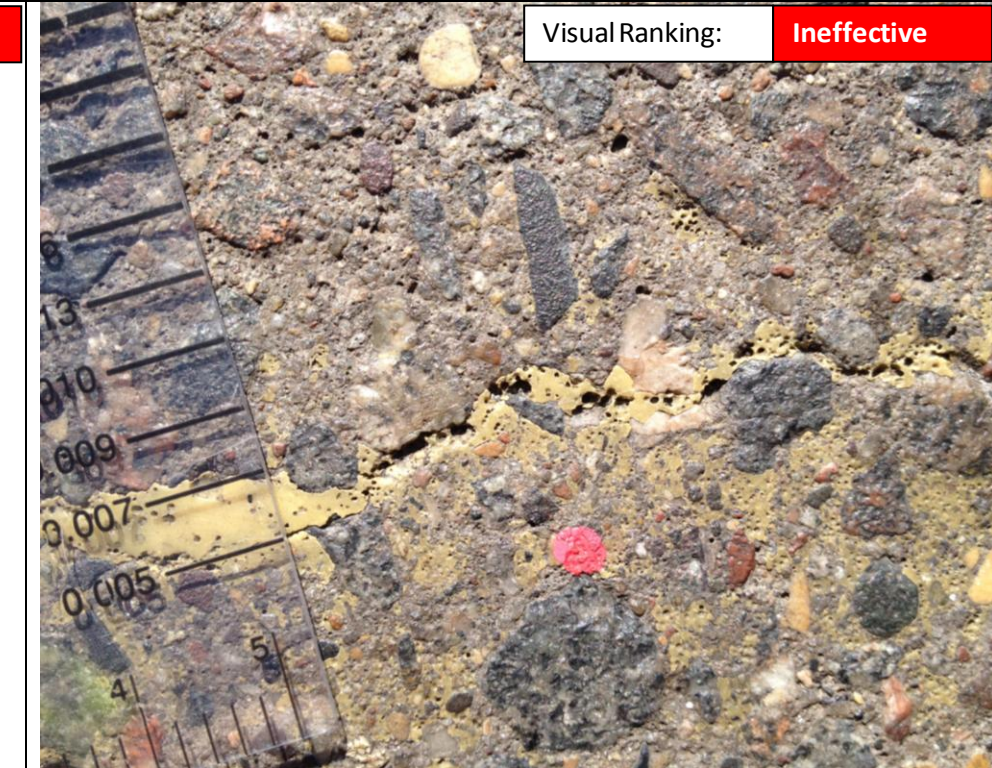
Photograph #: 18
 Test Information: Test Section 3, Test 8A - TK Products TK-9030 (Epoxy)
 Surface Prep & Application: Air Hose, Bottle, Sand Coat: No
 Date: April 8, 2014

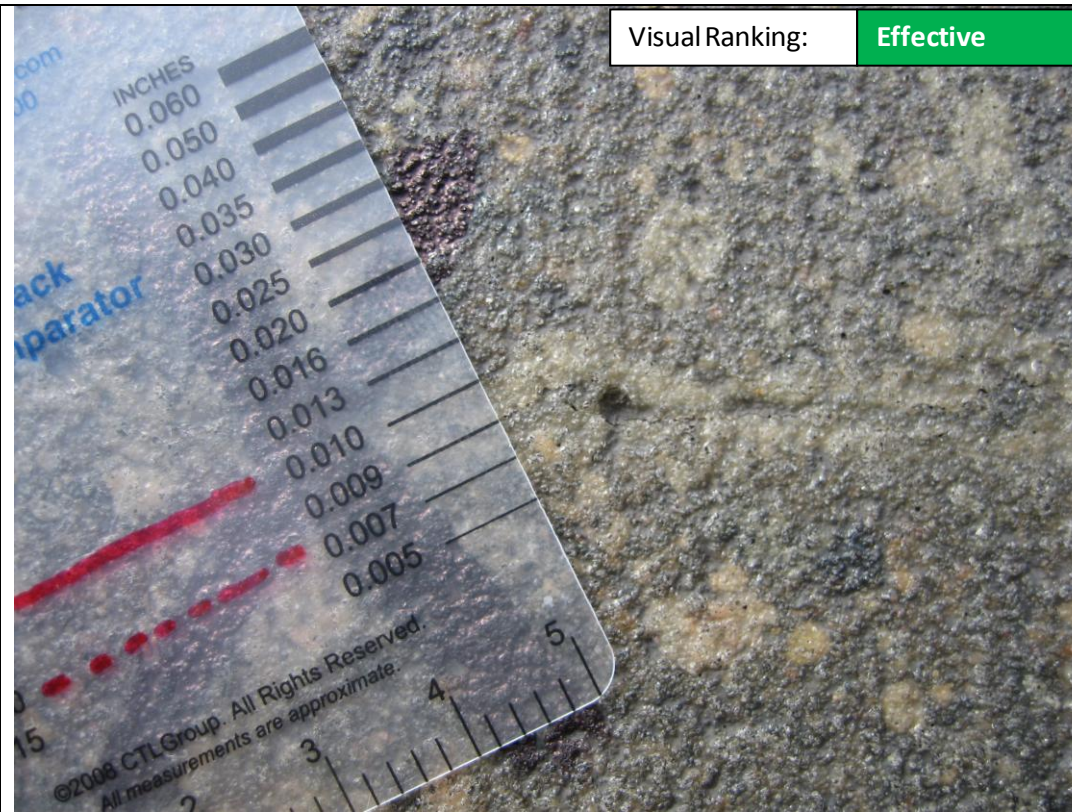
Visual Ranking: **Effective**

Photograph #: 19
Test Information: Test Section 4, Test 9A - TK Products TK-2110 (Epoxy)
Surface Prep & Application: Air Hose, Flood, Sand Coat: Yes
Date: May 11, 2012
Project BL-09-03973
BRAUN INTERTEC

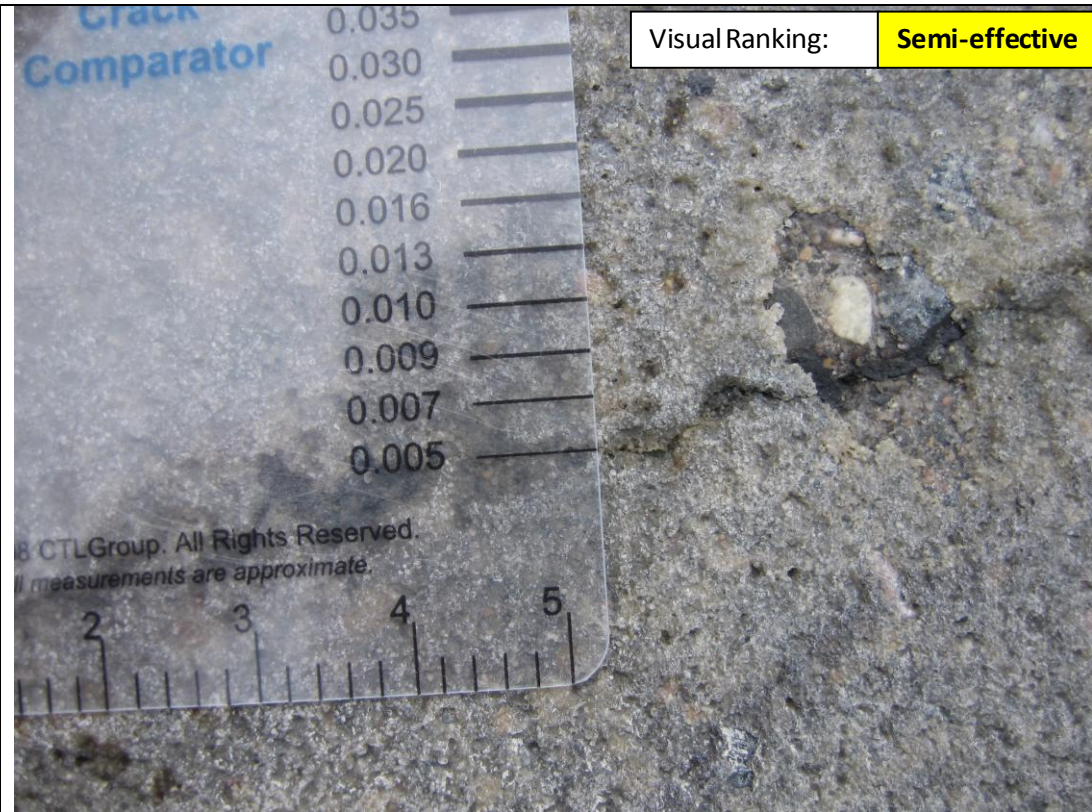
Visual Ranking: **Semi-effective**

Photograph #: 20
Test Information: Test Section 4, Test 9A - TK Products TK-2110 (Epoxy)
Surface Prep & Application: Air Hose, Flood, Sand Coat: Yes
Date: April 30, 2013
Project BL-09-03973
BRAUN INTERTEC

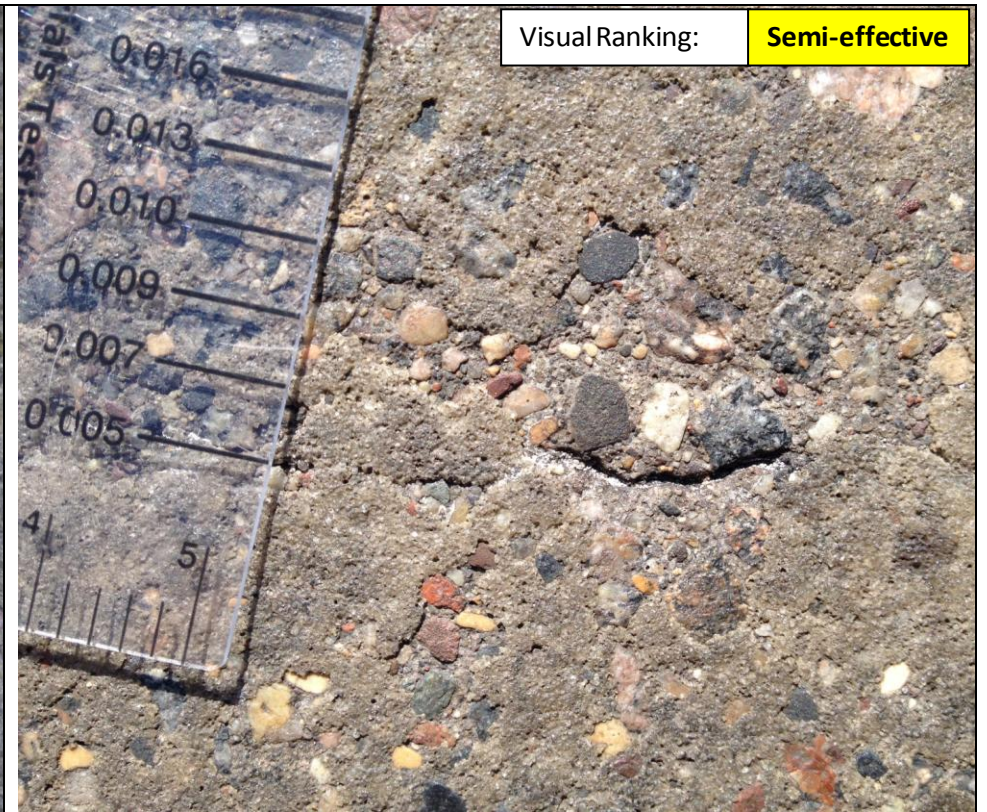
Visual Ranking: **Semi-effective**

Photograph #: 21
Test Information: Test Section 4, Test 9A - TK Products TK-2110 (Epoxy)
Surface Prep & Application: Air Hose, Flood, Sand Coat: Yes
Date: April 8, 2014
Project BL-09-03973
BRAUN INTERTEC

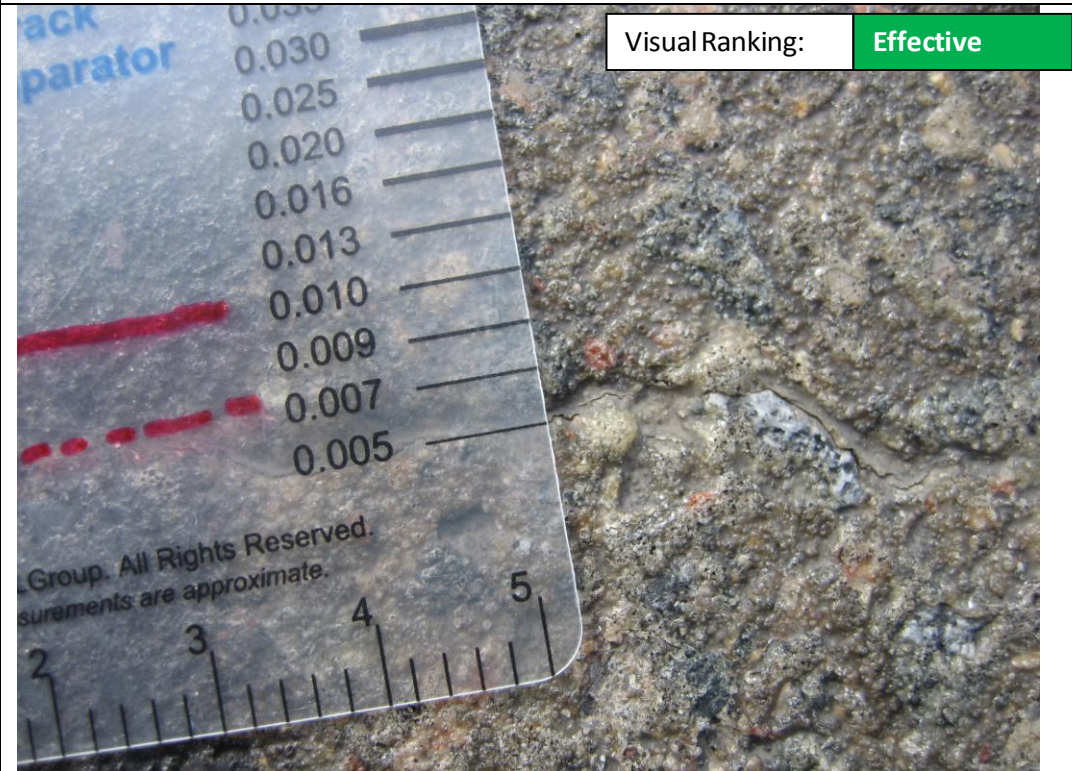
Visual Ranking: **Effective**

Photograph #: 22
Test Information: Test Section 4, Test 10B - TK Products TK-2110 (Epoxy)
Surface Prep & Application: Sand Blast, Flood, Sand Coat: Yes
Date: May 11, 2012
Project BL-09-03973
BRAUN INTERTEC

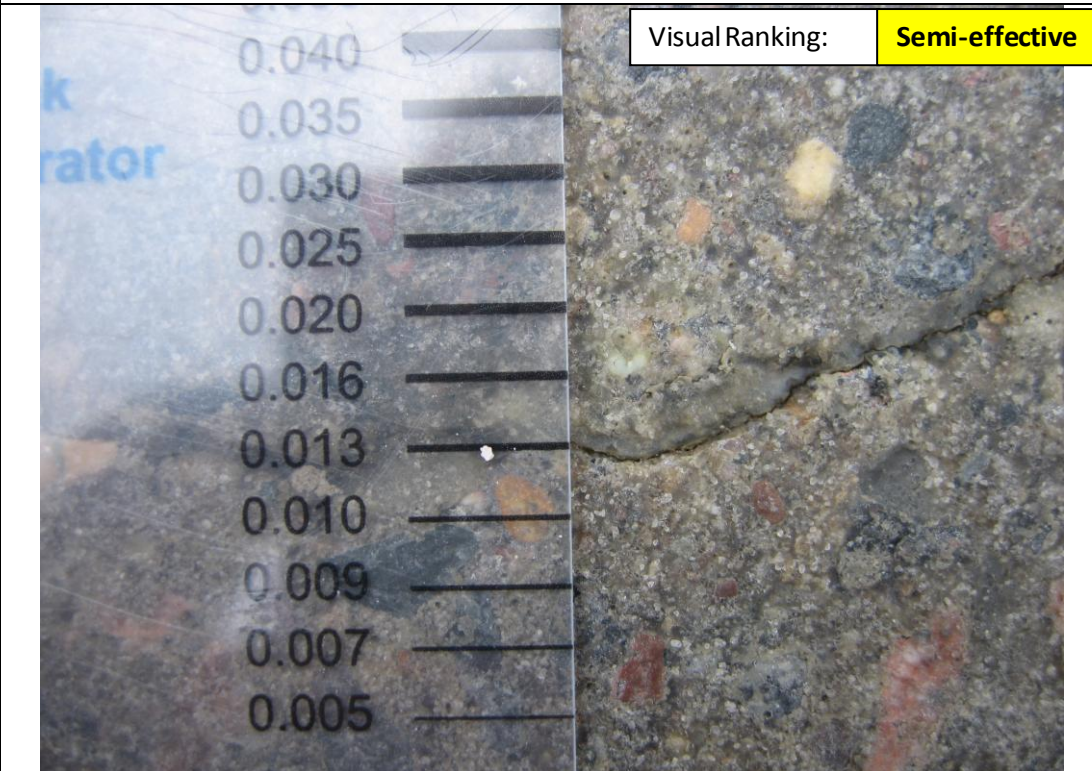
Visual Ranking: **Semi-effective**

Photograph #: 23
Test Information: Test Section 4, Test 10B - TK Products TK-2110 (Epoxy)
Surface Prep & Application: Sand Blast, Flood, Sand Coat: Yes
Date: April 30, 2013
Project BL-09-03973
BRAUN INTERTEC

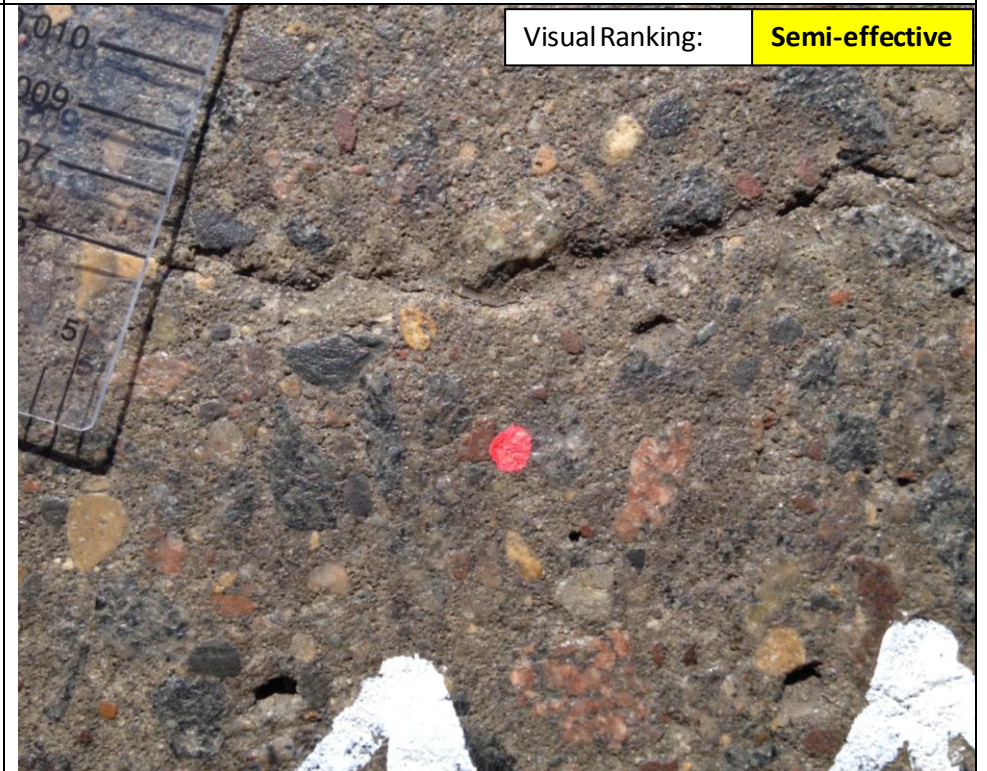
Visual Ranking: **Semi-effective**

Photograph #: 24
Test Information: Test Section 4, Test 10B - TK Products TK-2110 (Epoxy)
Surface Prep & Application: Sand Blast, Flood, Sand Coat: Yes
Date: April 8, 2014
Project BL-09-03973
BRAUN INTERTEC

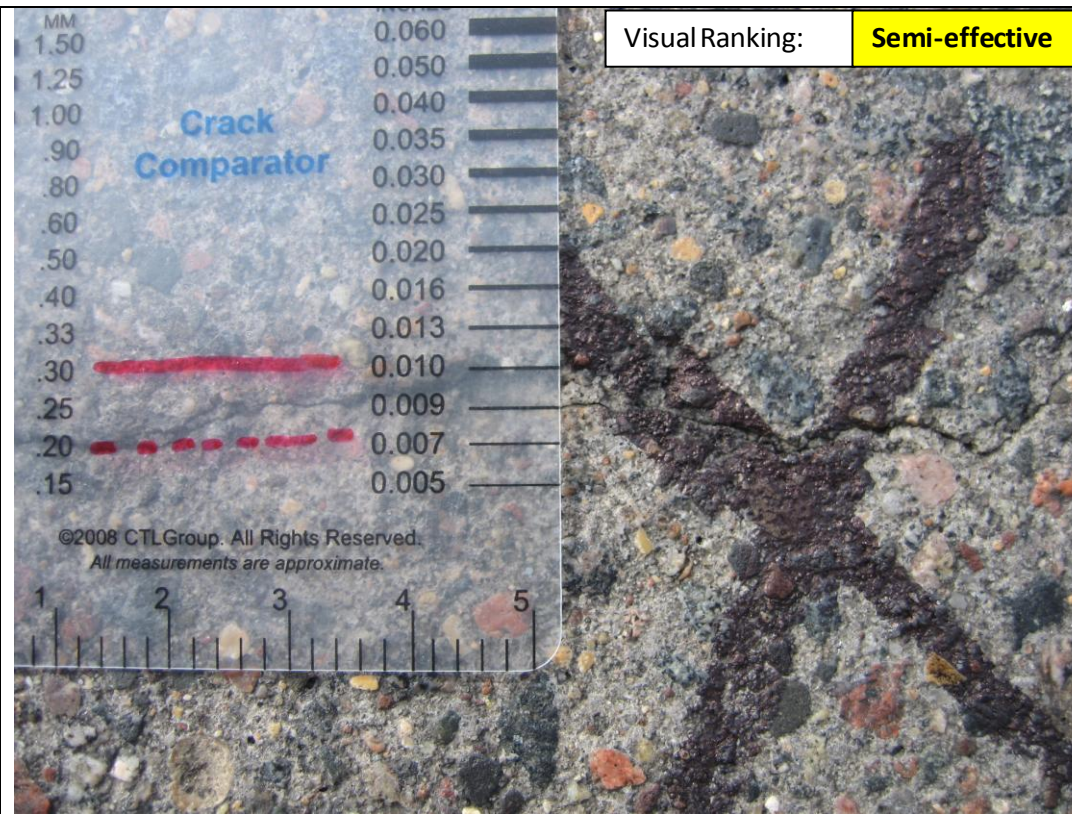
Visual Ranking: **Semi-effective**

Photograph #: 25
 Test Information: Test Section 5, Test 11A - TK Products TK-2414 (MMA)
 Surface Prep & Application: Sand Blast, Flood, Sand Coat: Yes
 Date: May 11, 2012
 Project BL-09-03973
BRAUN INTERTEC

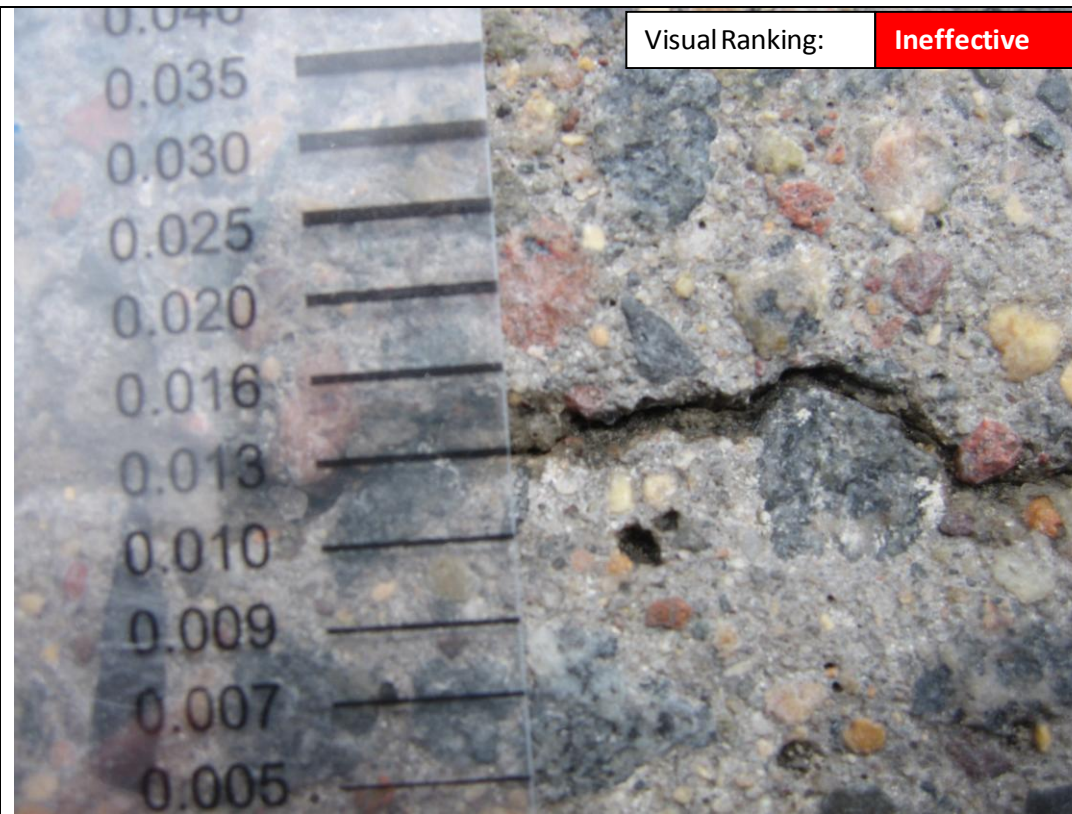
Visual Ranking: **Ineffective**

Photograph #: 26
 Test Information: Test Section 5, Test 11A - TK Products TK-2414 (MMA)
 Surface Prep & Application: Sand Blast, Flood, Sand Coat: Yes
 Date: April 30, 2013
 Project BL-09-03973
BRAUN INTERTEC

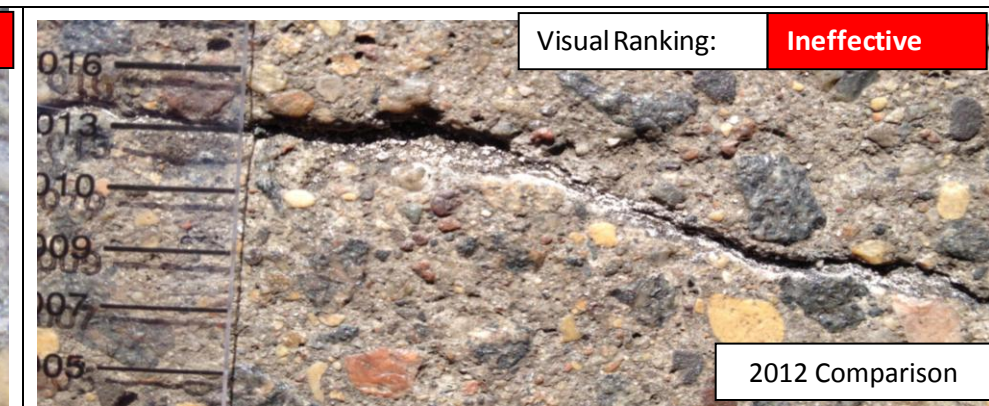
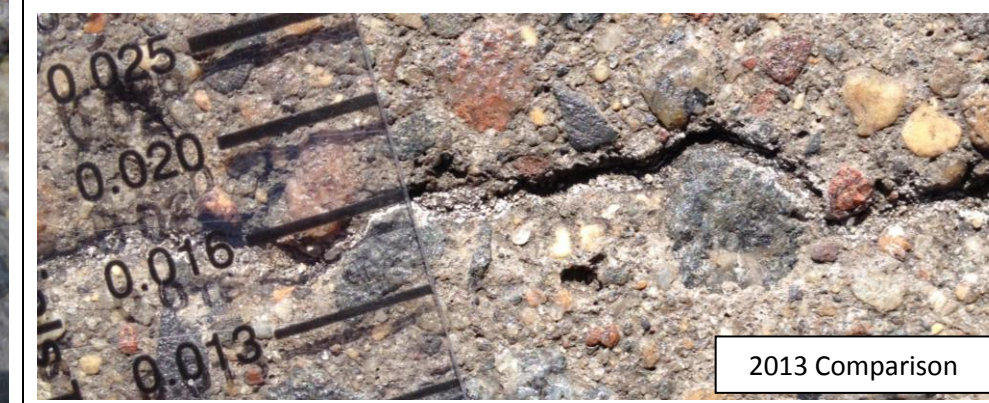
Visual Ranking: **Ineffective**

Photograph #: 27
 Test Information: Test Section 5, Test 11A - TK Products TK-2414 (MMA)
 Surface Prep & Application: Sand Blast, Flood, Sand Coat: Yes
 Date: April 8, 2014
 Project BL-09-03973
BRAUN INTERTEC

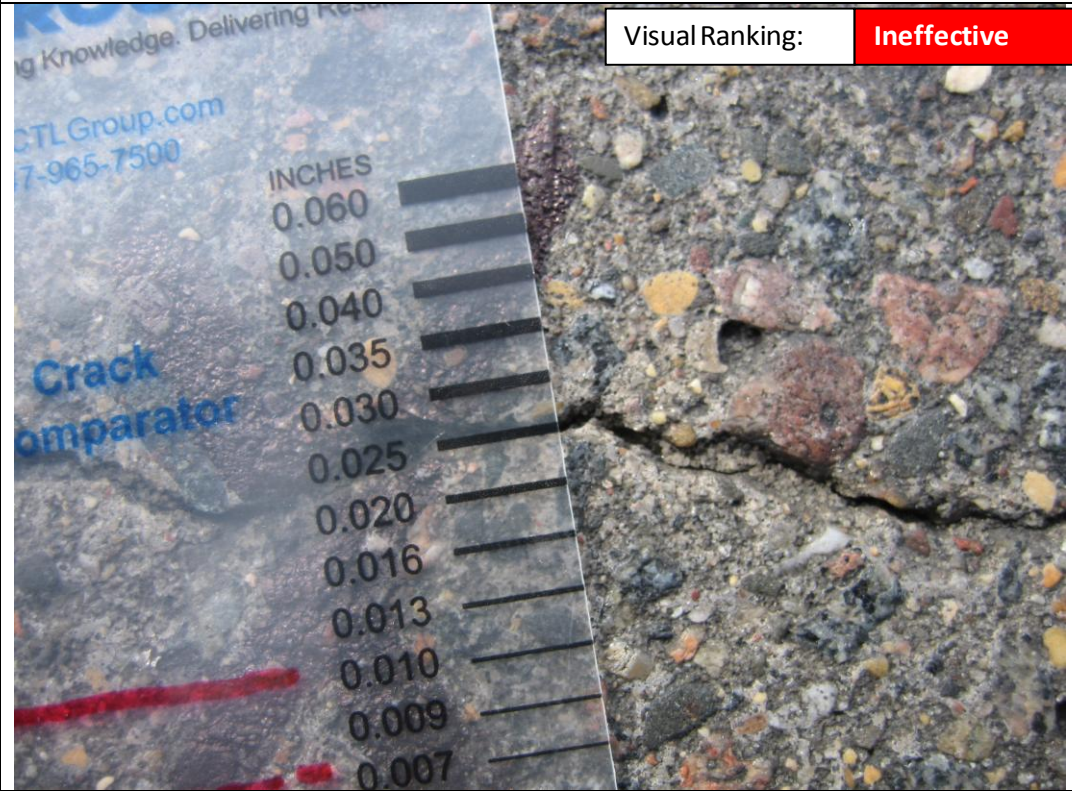
Visual Ranking: **Ineffective**

Photograph #: 28
 Test Information: Test Section 5, Test 12A - TK Products TK-2414 (MMA)
 Surface Prep & Application: Air Hose, Flood, Sand Coat: Yes
 Date: May 11, 2012
 Project BL-09-03973
BRAUN INTERTEC

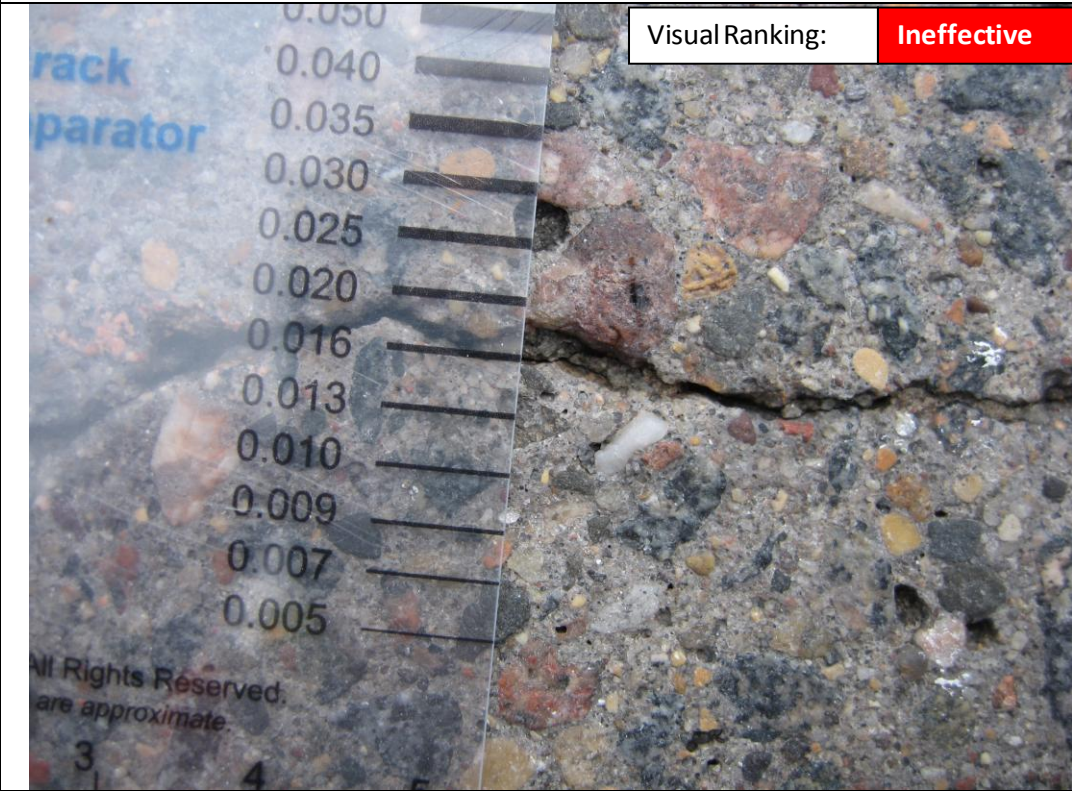
Visual Ranking: **Ineffective**

Photograph #: 29
 Test Information: Test Section 5, Test 12A - TK Products TK-2414 (MMA)
 Surface Prep & Application: Air Hose, Flood, Sand Coat: Yes
 Date: April 30, 2013
 Project BL-09-03973
BRAUN INTERTEC

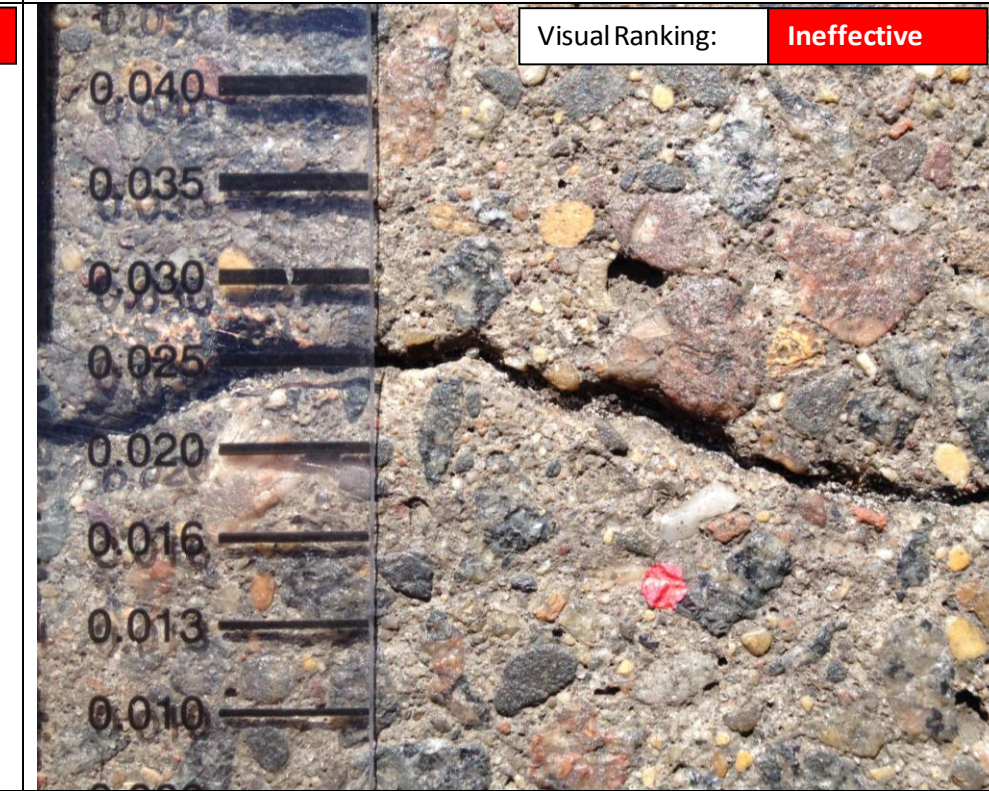
Visual Ranking: **Ineffective**

Photograph #: 30
 Test Information: Test Section 5, Test 12A - TK Products TK-2414 (MMA)
 Surface Prep & Application: Air Hose, Flood, Sand Coat: Yes
 Date: April 8, 2014
 Project BL-09-03973
BRAUN INTERTEC

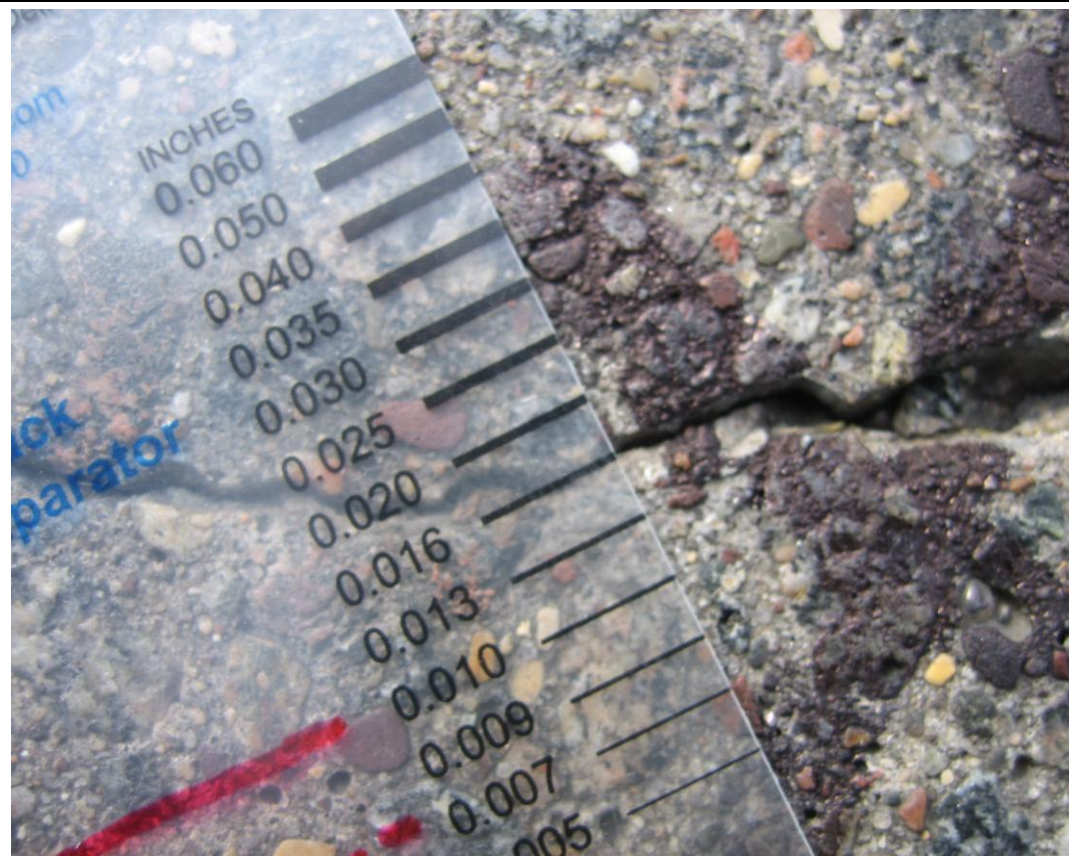
Photograph #: 31
 Test Information: Test Section 6, Test 12B - CONTROL
 Surface Prep & Application: CONTROL
 Date: May 11, 2012

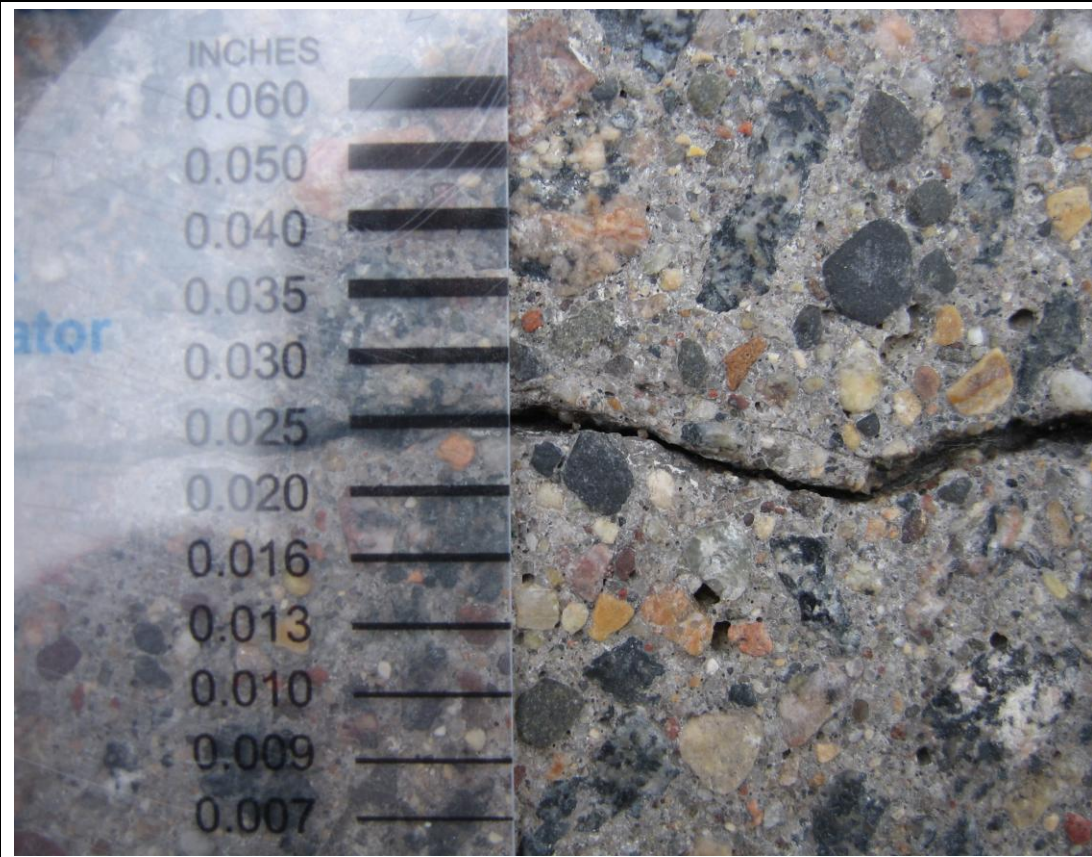
Photograph #: 32
 Test Information: Test Section 6, Test 12B - CONTROL
 Surface Prep & Application: CONTROL
 Date: April 30, 2013

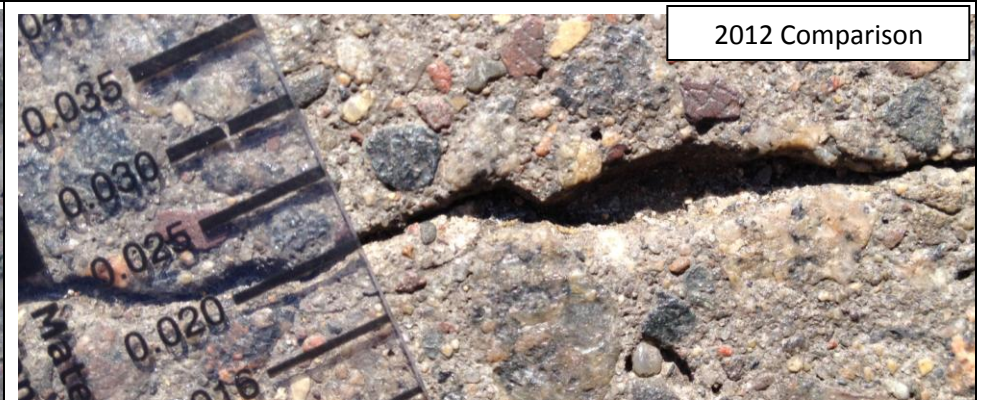
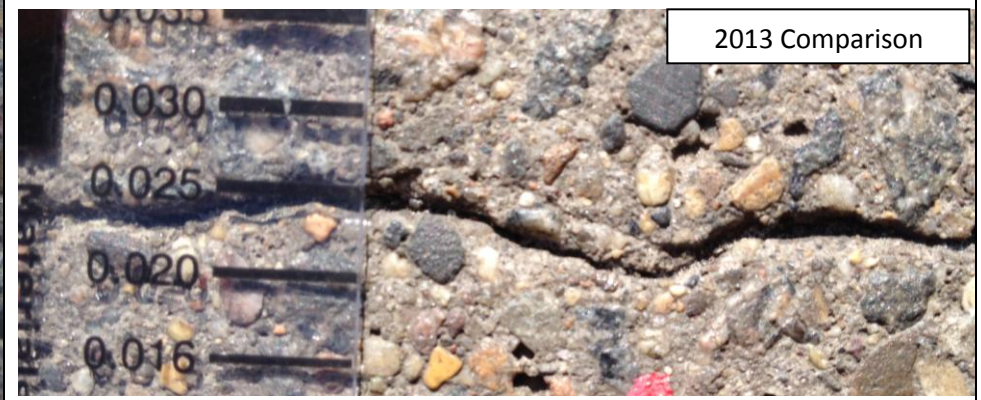
Photograph #: 33
 Test Information: Test Section 6, Test 12B - CONTROL
 Surface Prep & Application: CONTROL
 Date: April 8, 2014
