Concrete Bridge Deck Crack Sealant Evaluation and Implementation

Minnesota
Department of
Transportation

Matthew S. Oman, Principal Investigator
Braun Intertec Corporation

Research Project
Final Report 2014-34

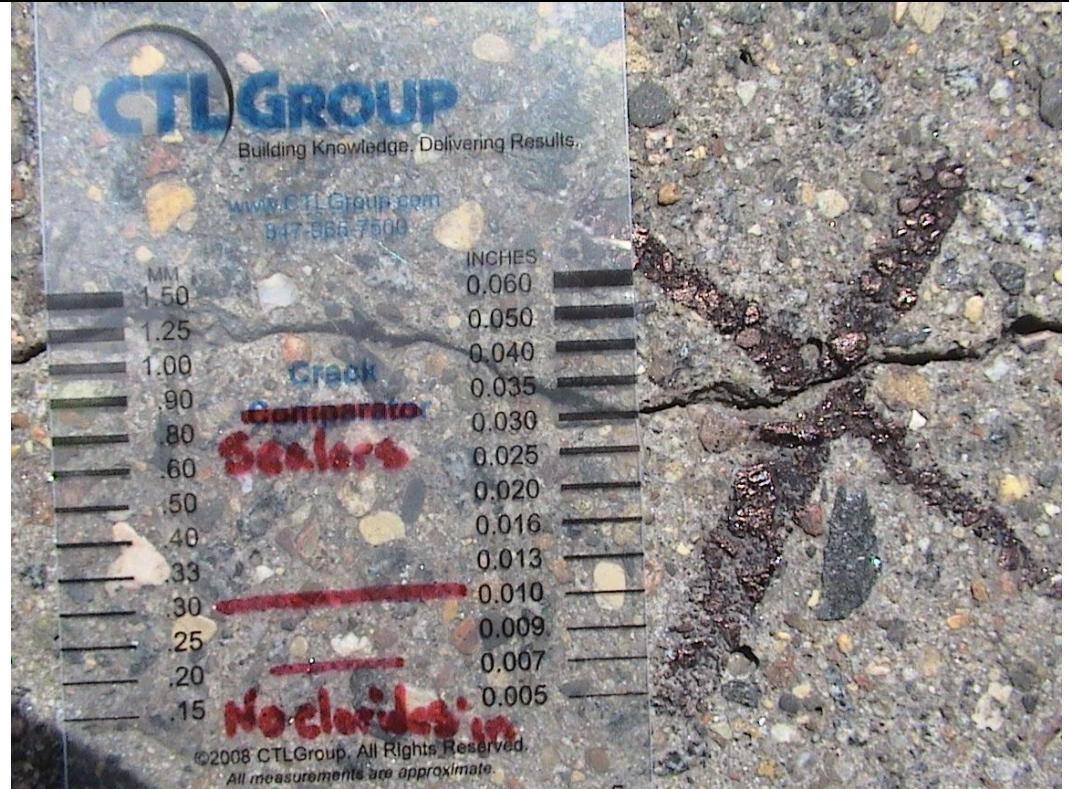
Photograph #: 34
 Test Information: Test Section 6, Test 15A - CONTROL
 Surface Prep & Application: CONTROL
 Date: May 11, 2012

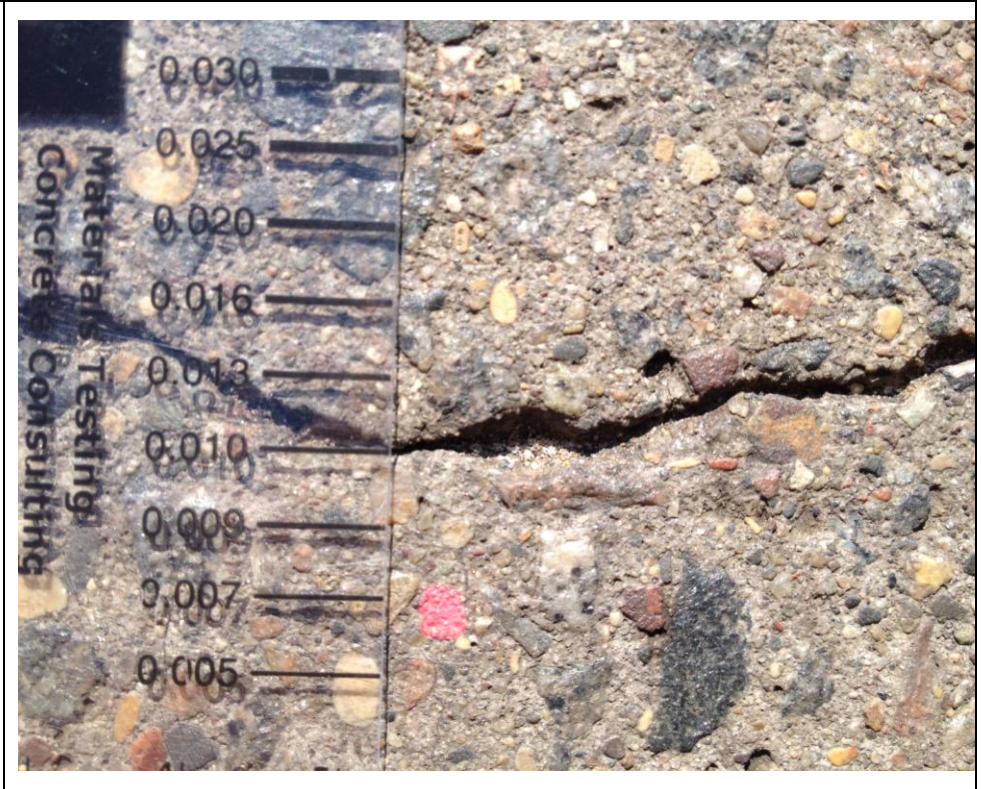
Photograph #: 36
 Test Information: Test Section 6, Test 15A - CONTROL
 Surface Prep & Application: CONTROL
 Date: April 8, 2014

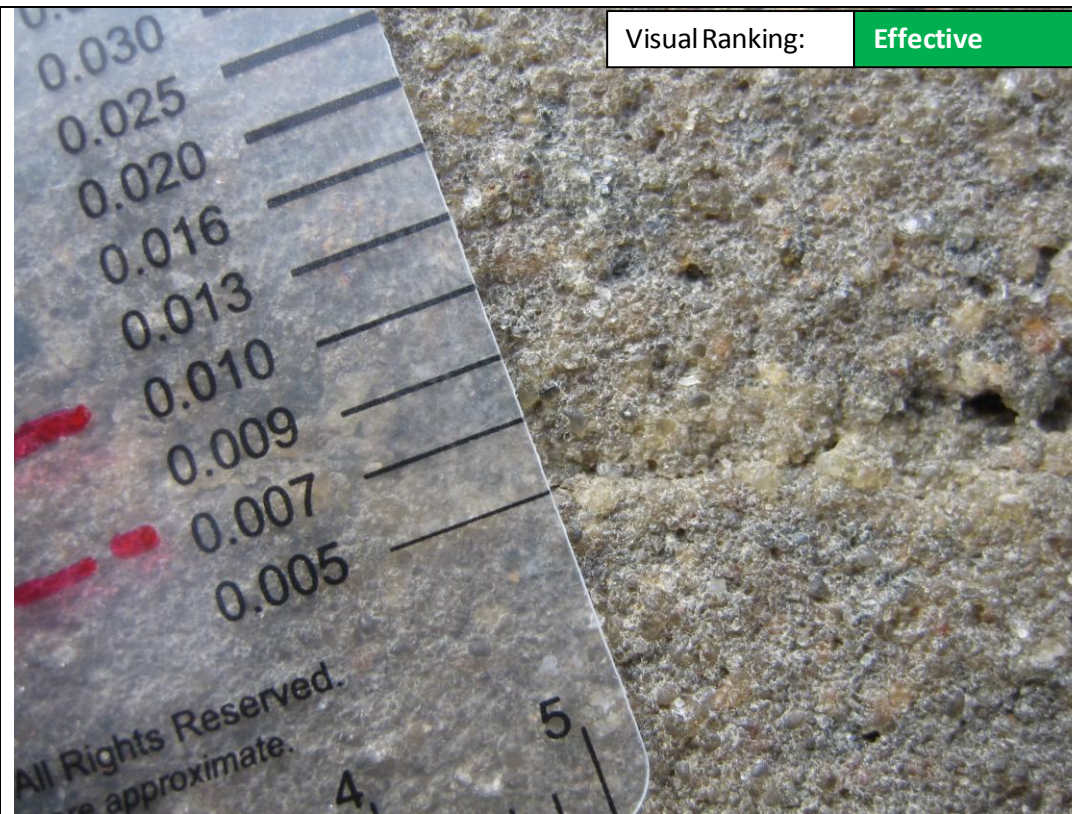
Photograph #: 37
 Test Information: Test Section 7, Test 17A - BASF Epoxeal GS Structural (Epoxy)
 Surface Prep & Application: Air Hose, Flood (cracks), Sand Coat: Yes
 Date: May 11, 2012

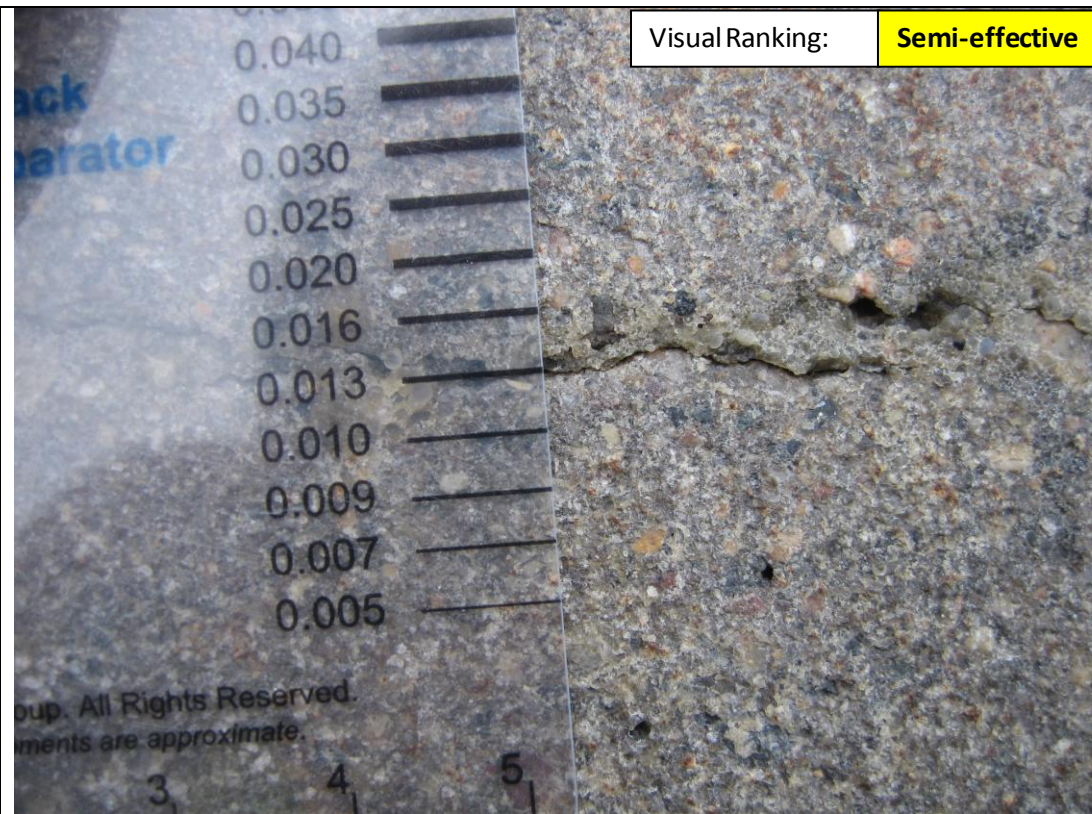
Photograph #: 38
 Test Information: Test Section 7, Test 17A - BASF Epoxeal GS Structural (Epoxy)
 Surface Prep & Application: Air Hose, Flood (cracks), Sand Coat: Yes
 Date: April 30, 2013

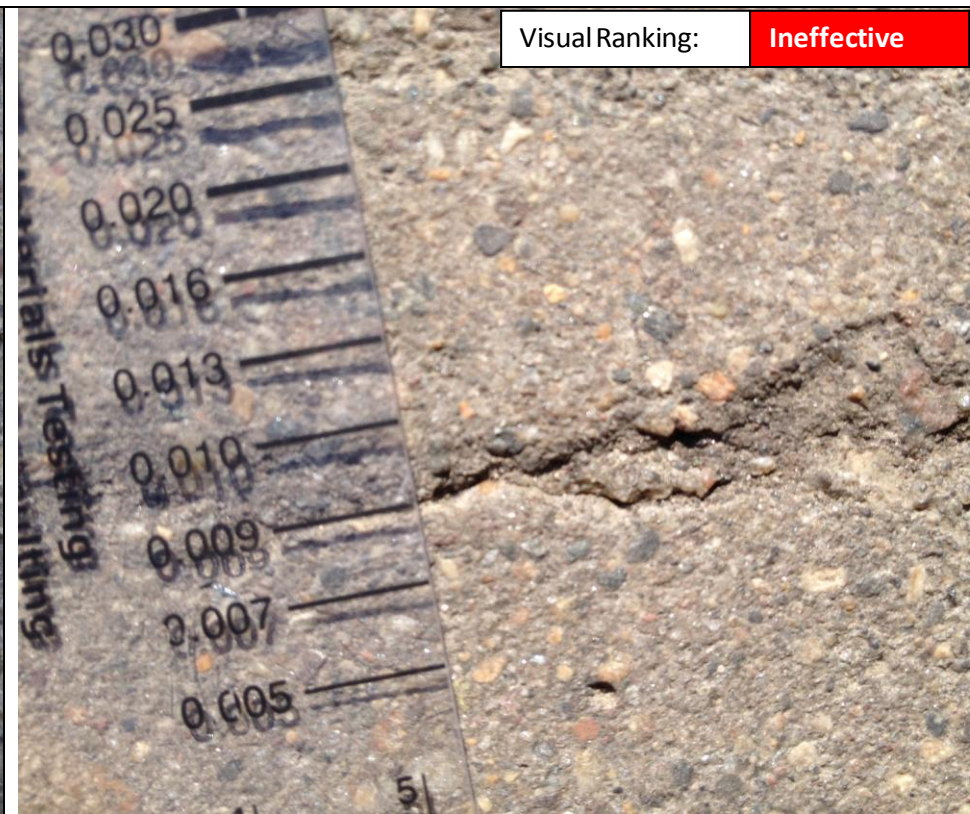
Photograph #: 39
 Test Information: Test Section 7, Test 17A - BASF Epoxeal GS Structural (Epoxy)
 Surface Prep & Application: Air Hose, Flood (cracks), Sand Coat: Yes
 Date: April 8, 2014

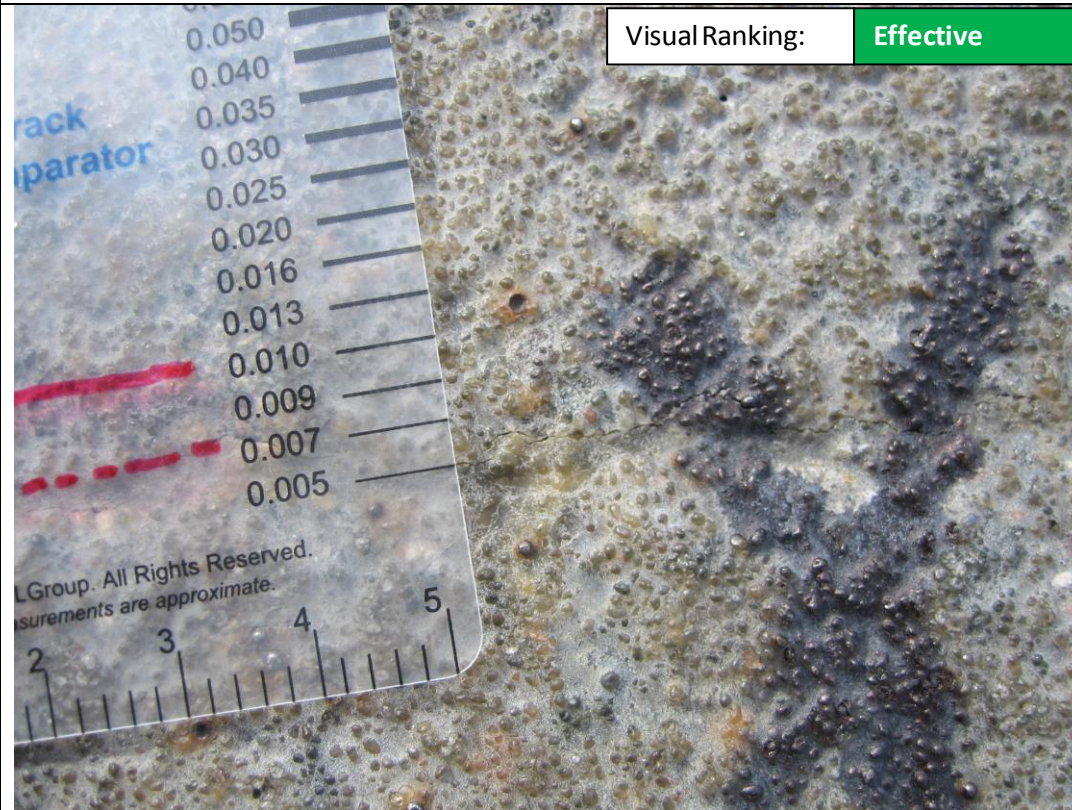
Photograph #: 40
 Test Information: Test Section 7, Test 19A - BASF Epoxeal GS Structural (Epoxy)
 Surface Prep & Application: Shot Blast, Flood (cracks), Sand Coat: Yes
 Date: May 11, 2012

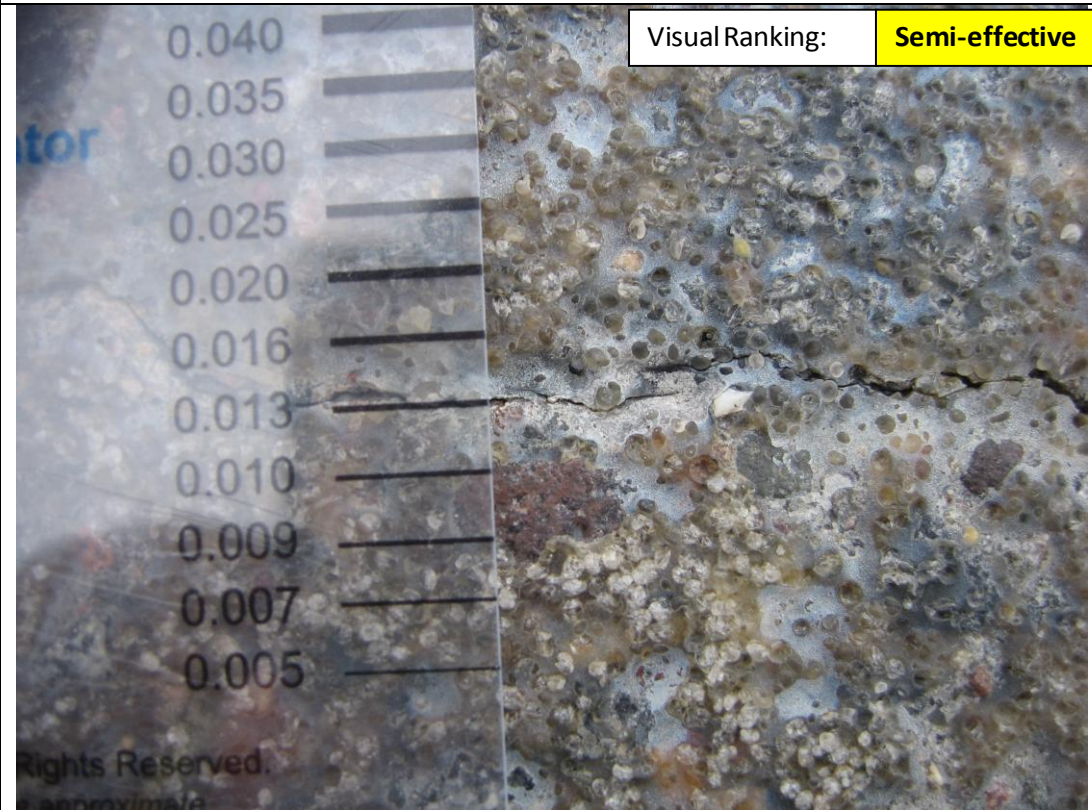
Photograph #: 41
 Test Information: Test Section 7, Test 19A - BASF Epoxeal GS Structural (Epoxy)
 Surface Prep & Application: Shot Blast, Flood (cracks), Sand Coat: Yes
 Date: April 30, 2013

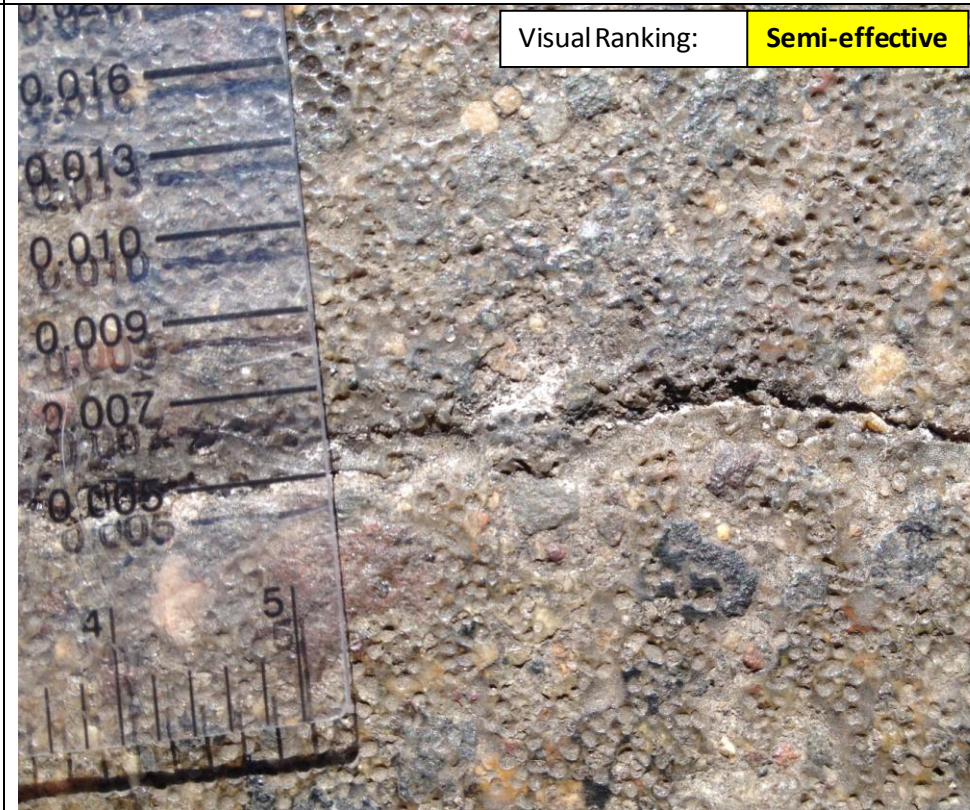
Photograph #: 42
 Test Information: Test Section 7, Test 19A - BASF Epoxeal GS Structural (Epoxy)
 Surface Prep & Application: Shot Blast, Flood (cracks), Sand Coat: Yes
 Date: April 8, 2014

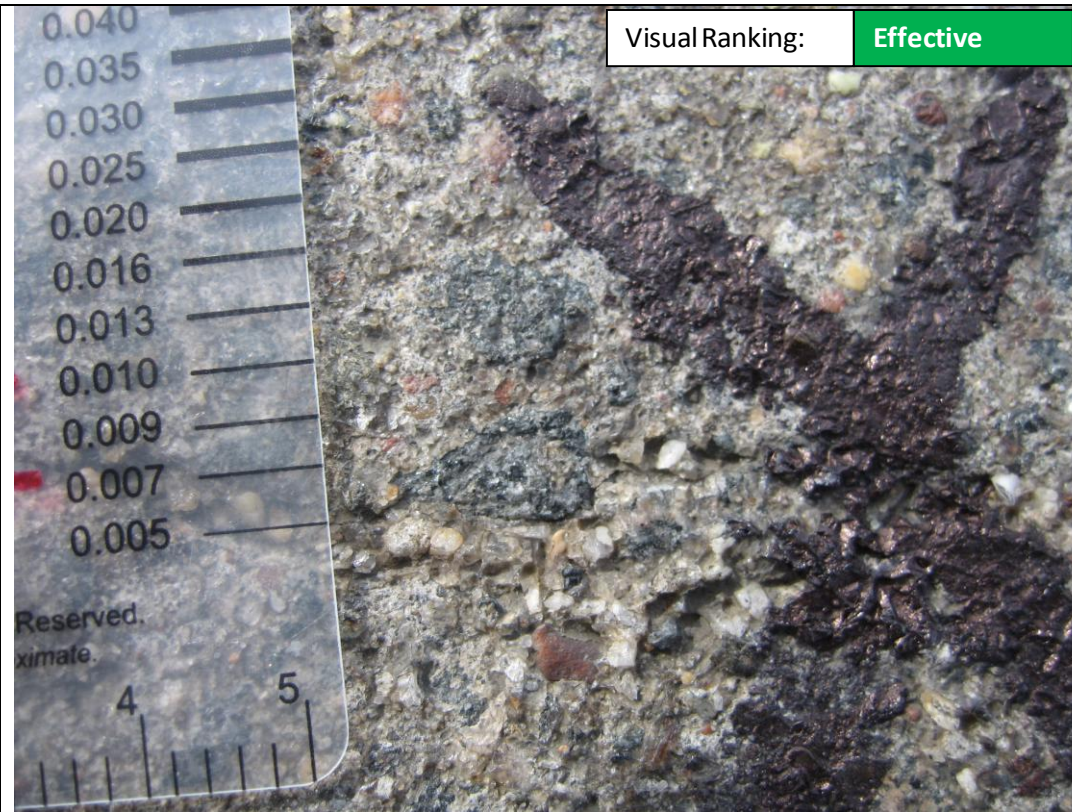
Photograph #: 43
 Test Information: Test Section 8, Test 18A - Kwik Bond KBP 204 P (HMWM)
 Surface Prep & Application: Shot Blast, Flood, Sand Coat: Yes
 Date: May 11, 2012
 Project BL-09-03973
BRAUN INTERTEC

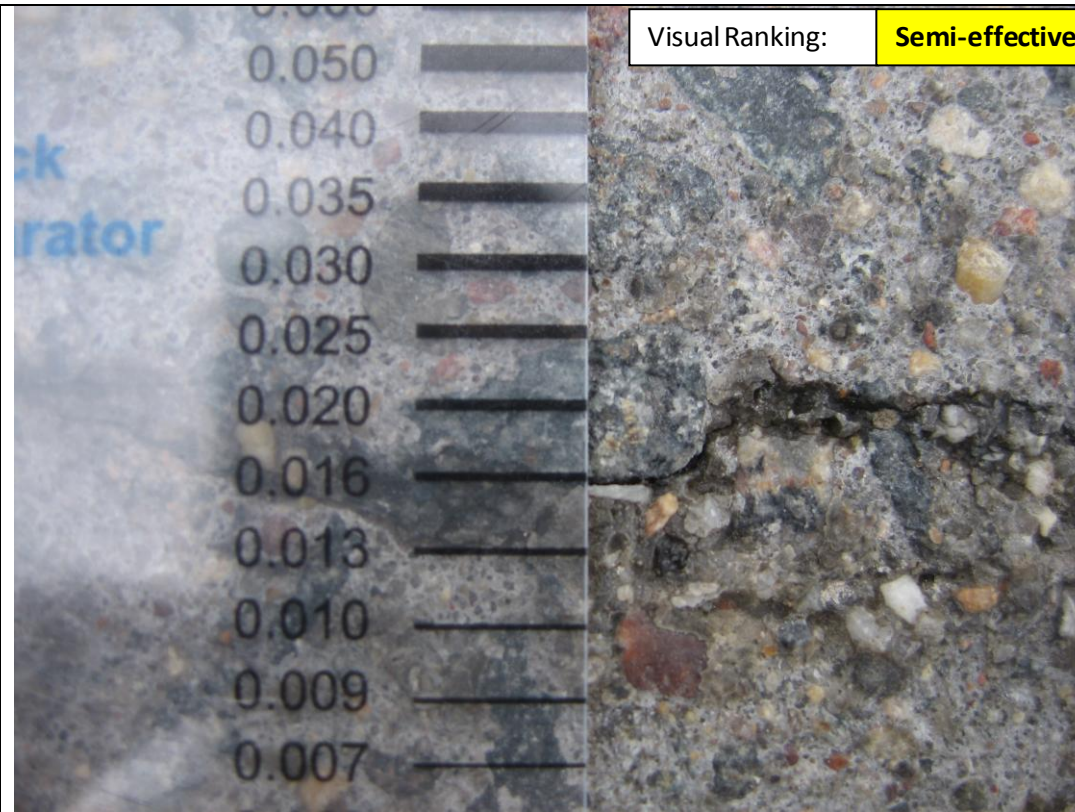
Photograph #: 44
 Test Information: Test Section 8, Test 18A - Kwik Bond KBP 204 P (HMWM)
 Surface Prep & Application: Shot Blast, Flood, Sand Coat: Yes
 Date: April 30, 2013
 Project BL-09-03973
BRAUN INTERTEC

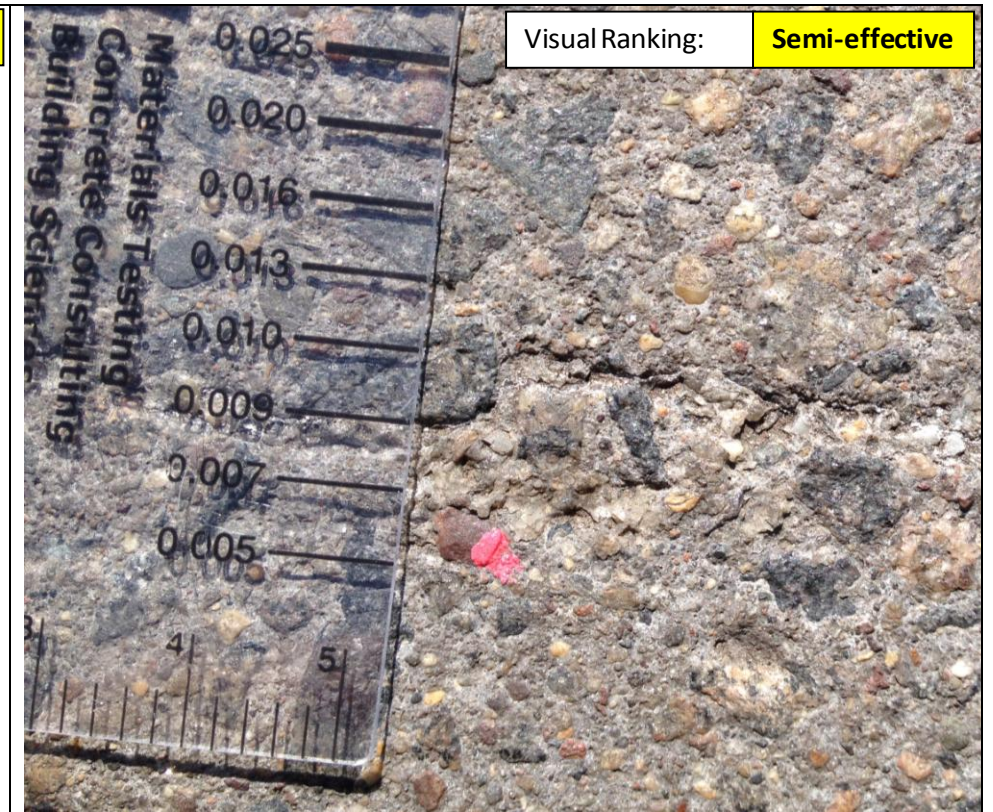
Photograph #: 45
 Test Information: Test Section 8, Test 18A - Kwik Bond KBP 204 P (HMWM)
 Surface Prep & Application: Shot Blast, Flood, Sand Coat: Yes
 Date: April 8, 2014
 Project BL-09-03973
BRAUN INTERTEC

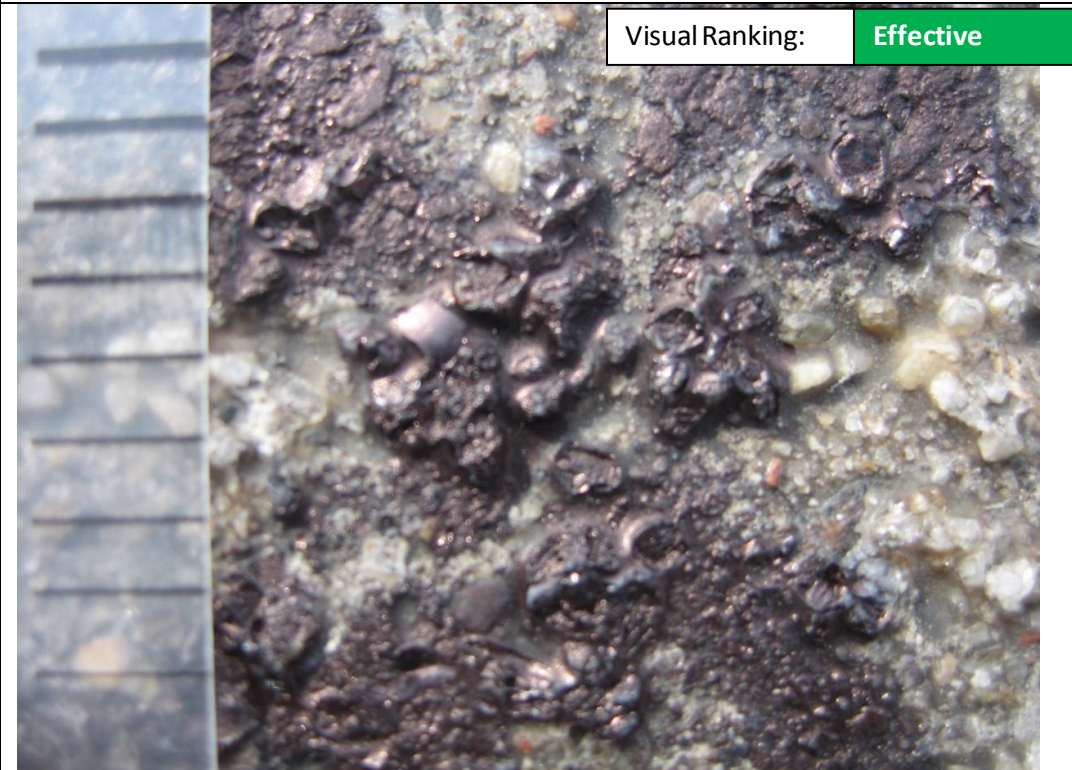
Photograph #: 46
 Test Information: Test Section 8, Test 20A - Kwik Bond KBP 204 P (HMWM)
 Surface Prep & Application: Air Hose, Flood, Sand Coat: Yes
 Date: May 11, 2012
 Project BL-09-03973
BRAUN INTERTEC

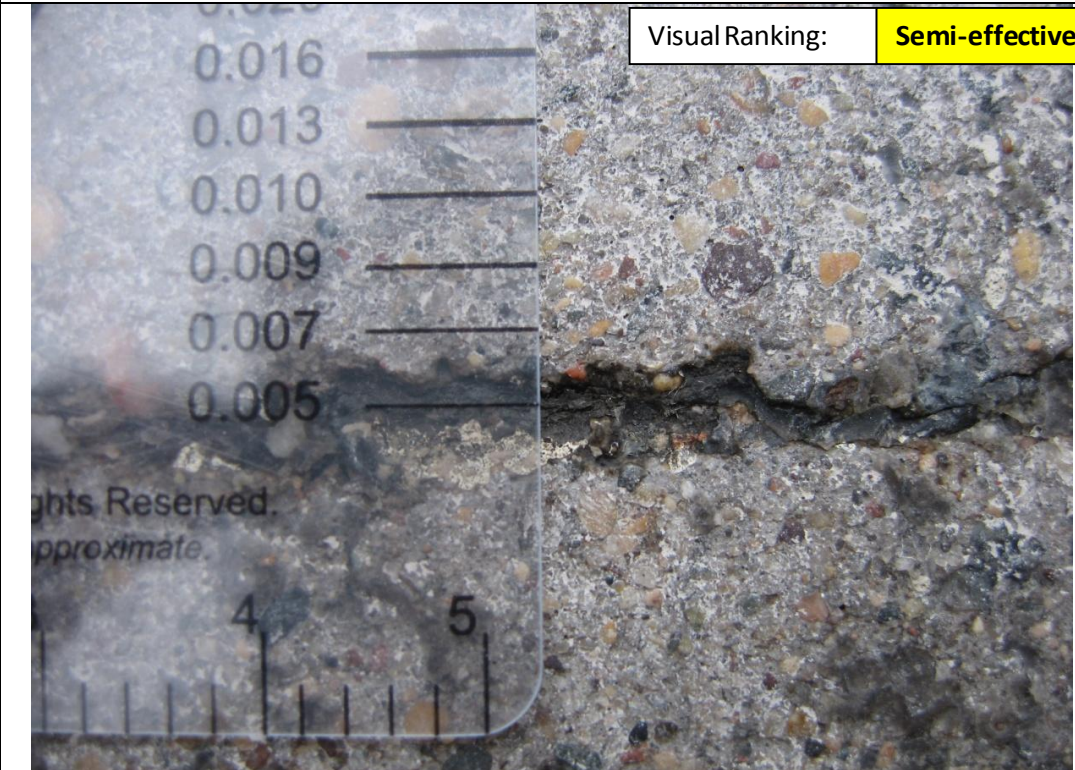
Photograph #: 47
 Test Information: Test Section 8, Test 20A - Kwik Bond KBP 204 P (HMWM)
 Surface Prep & Application: Air Hose, Flood, Sand Coat: Yes
 Date: April 30, 2013
 Project BL-09-03973
BRAUN INTERTEC

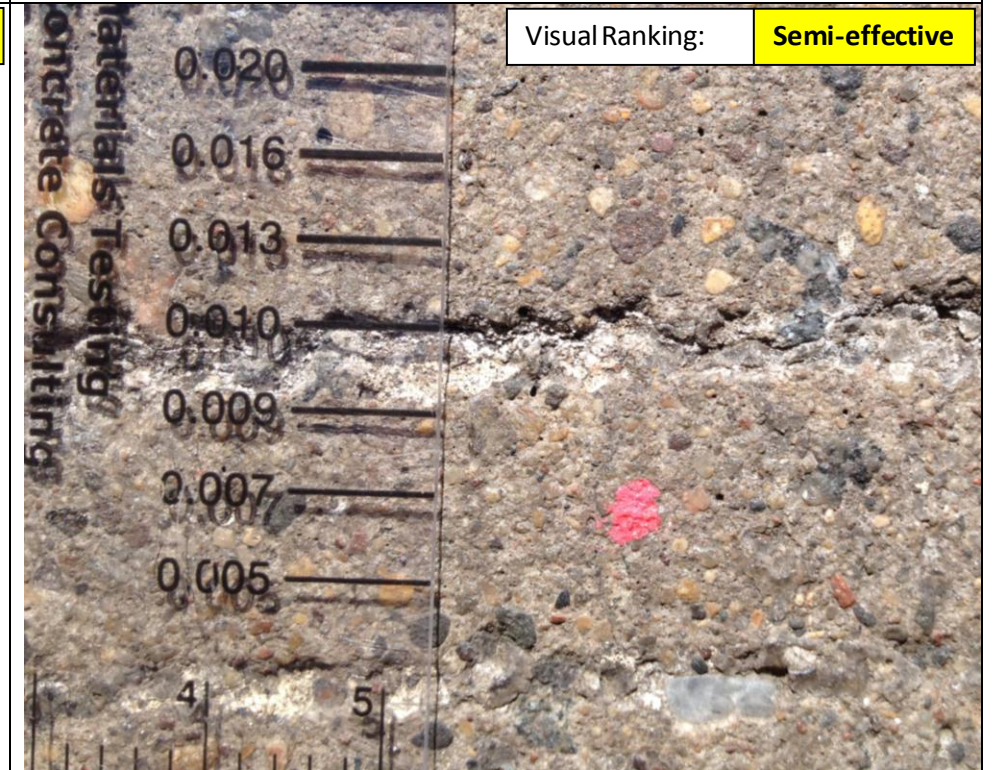
Photograph #: 48
 Test Information: Test Section 8, Test 20A - Kwik Bond KBP 204 P (HMWM)
 Surface Prep & Application: Air Hose, Flood, Sand Coat: Yes
 Date: April 8, 2014
 Project BL-09-03973
BRAUN INTERTEC

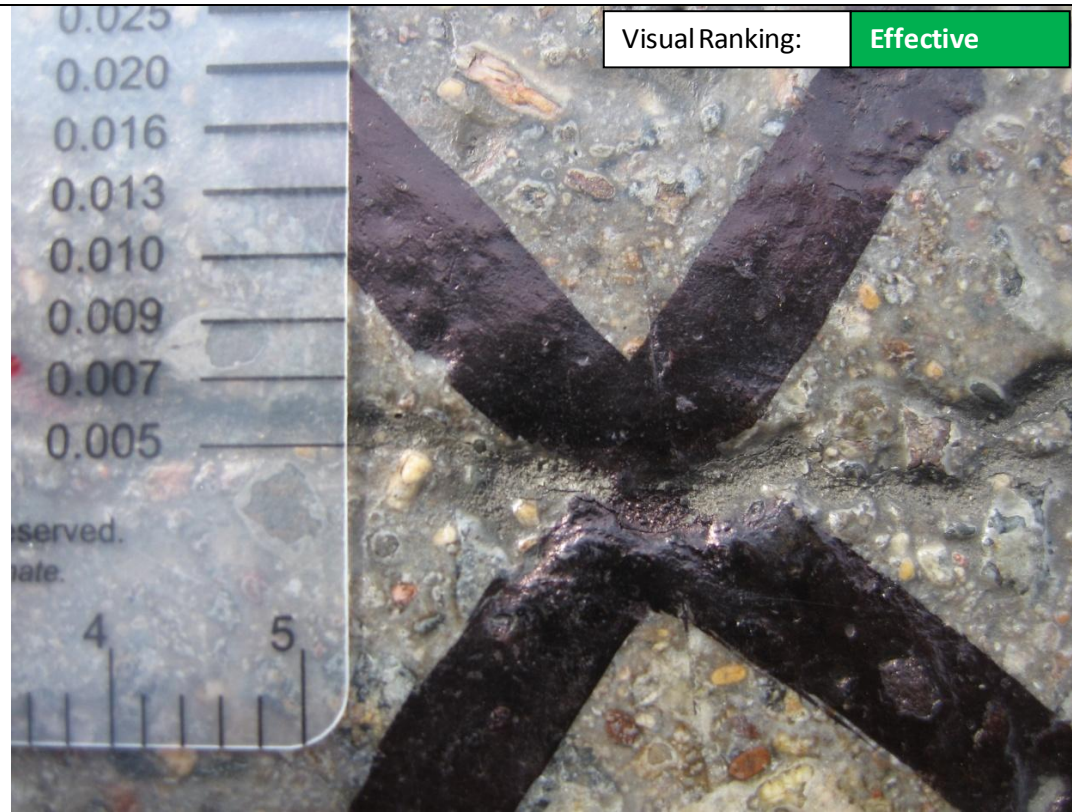
Photograph #: 49
 Test Information: Test Section 9, Test 21A - BASF Degadeck Crack Sealer Plus (MMA)
 Surface Prep & Application: Air Hose, Pretreat, Flood, Sand Coat: Yes
 Date: May 11, 2012

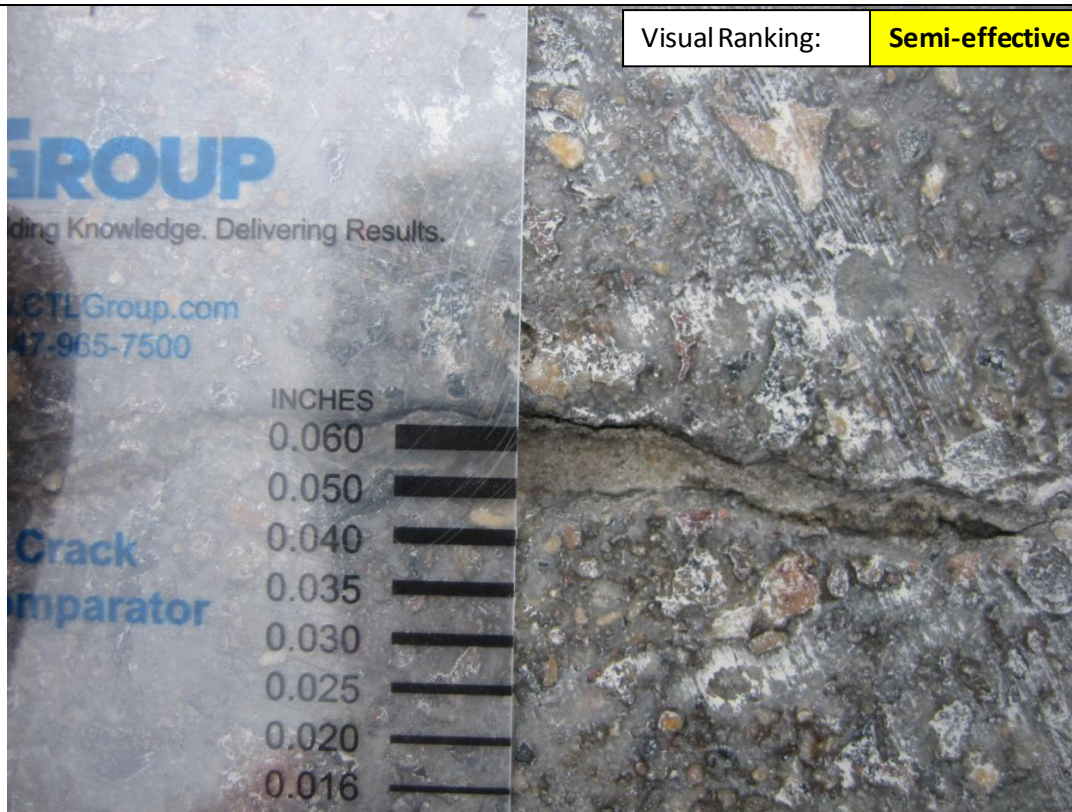
Photograph #: 50
 Test Information: Test Section 9, Test 21A - BASF Degadeck Crack Sealer Plus (MMA)
 Surface Prep & Application: Air Hose, Pretreat, Flood, Sand Coat: Yes
 Date: April 30, 2013

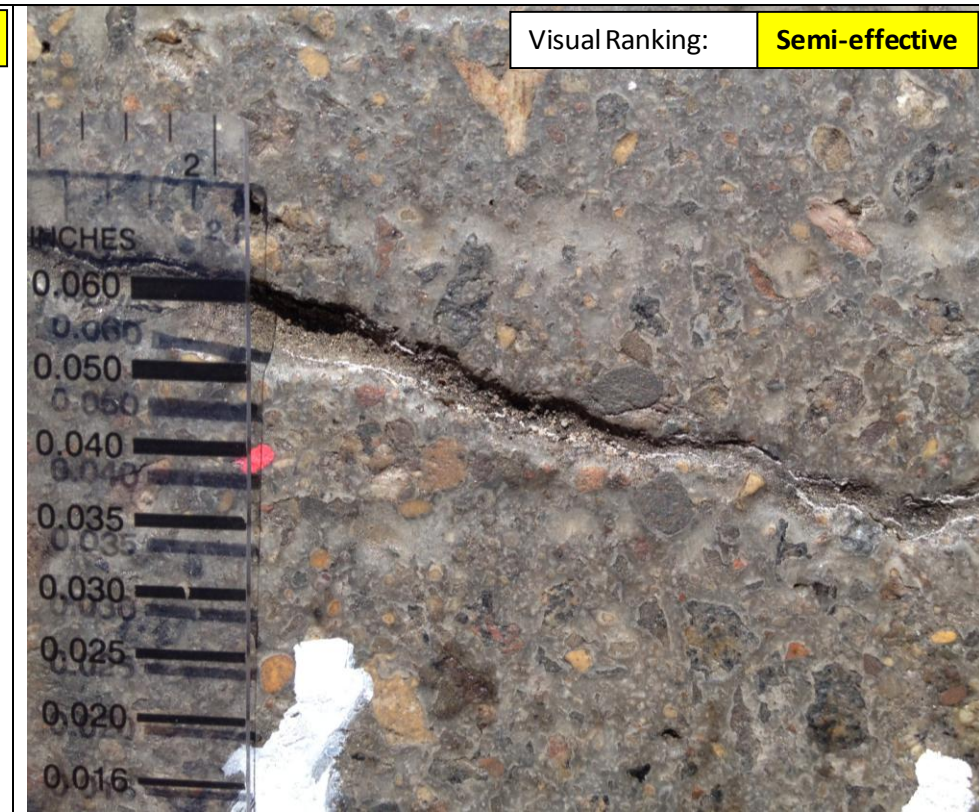
Photograph #: 51
 Test Information: Test Section 9, Test 21A - BASF Degadeck Crack Sealer Plus (MMA)
 Surface Prep & Application: Air Hose, Pretreat, Flood, Sand Coat: Yes
 Date: April 8, 2014

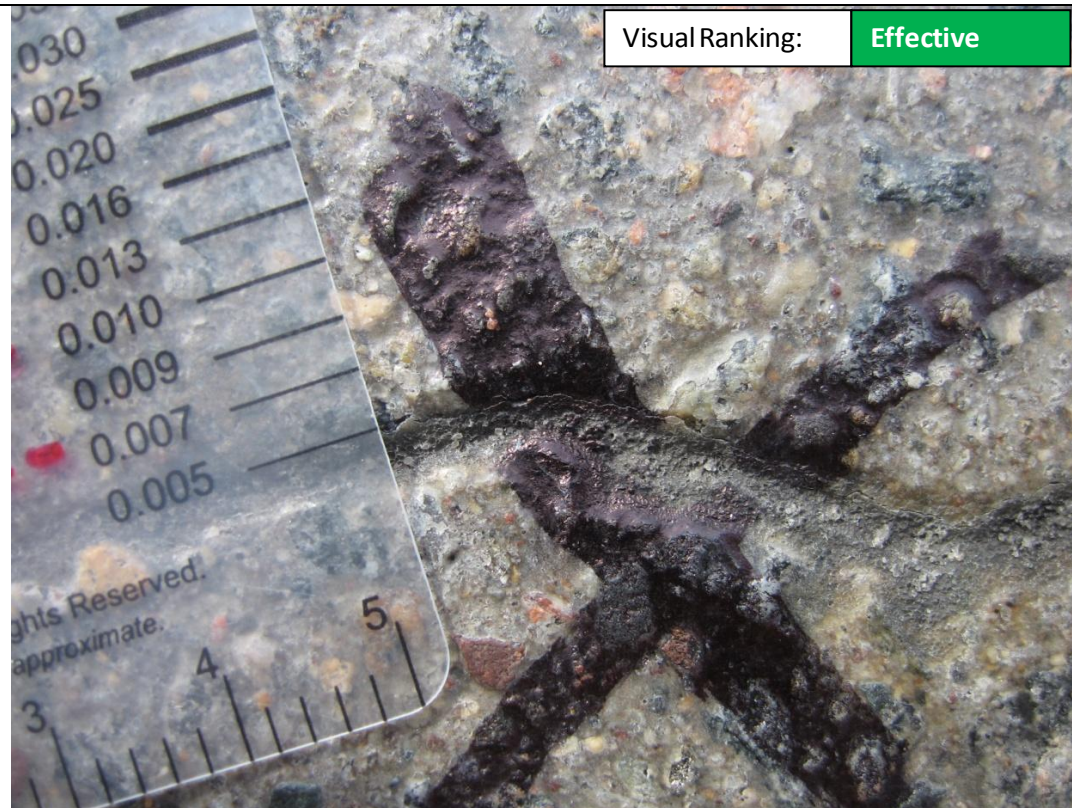
Photograph #: 52
 Test Information: Test Section 9, Test 21B - BASF Degadeck Crack Sealer Plus (MMA)
 Surface Prep & Application: Shot Blast, Pretreat, Flood, Sand Coat: Yes
 Date: May 11, 2012

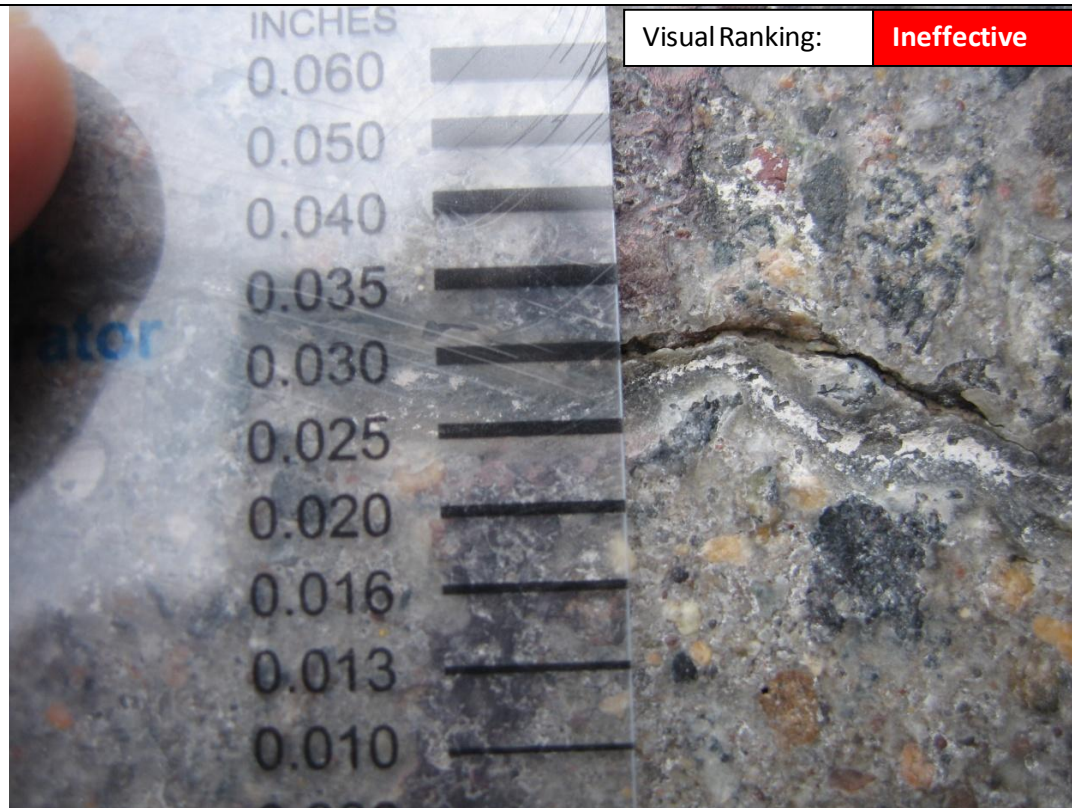
Photograph #: 53
 Test Information: Test Section 9, Test 21B - BASF Degadeck Crack Sealer Plus (MMA)
 Surface Prep & Application: Shot Blast, Pretreat, Flood, Sand Coat: Yes
 Date: April 30, 2013

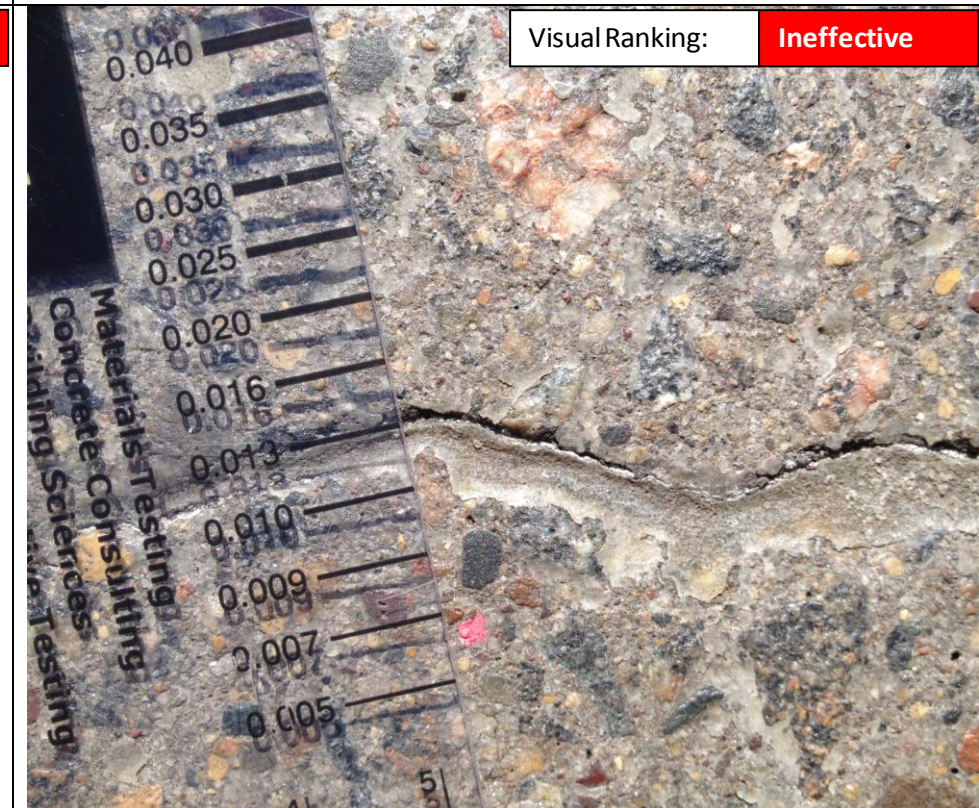
Photograph #: 54
 Test Information: Test Section 9, Test 21B - BASF Degadeck Crack Sealer Plus (MMA)
 Surface Prep & Application: Shot Blast, Pretreat, Flood, Sand Coat: Yes
 Date: April 8, 2014

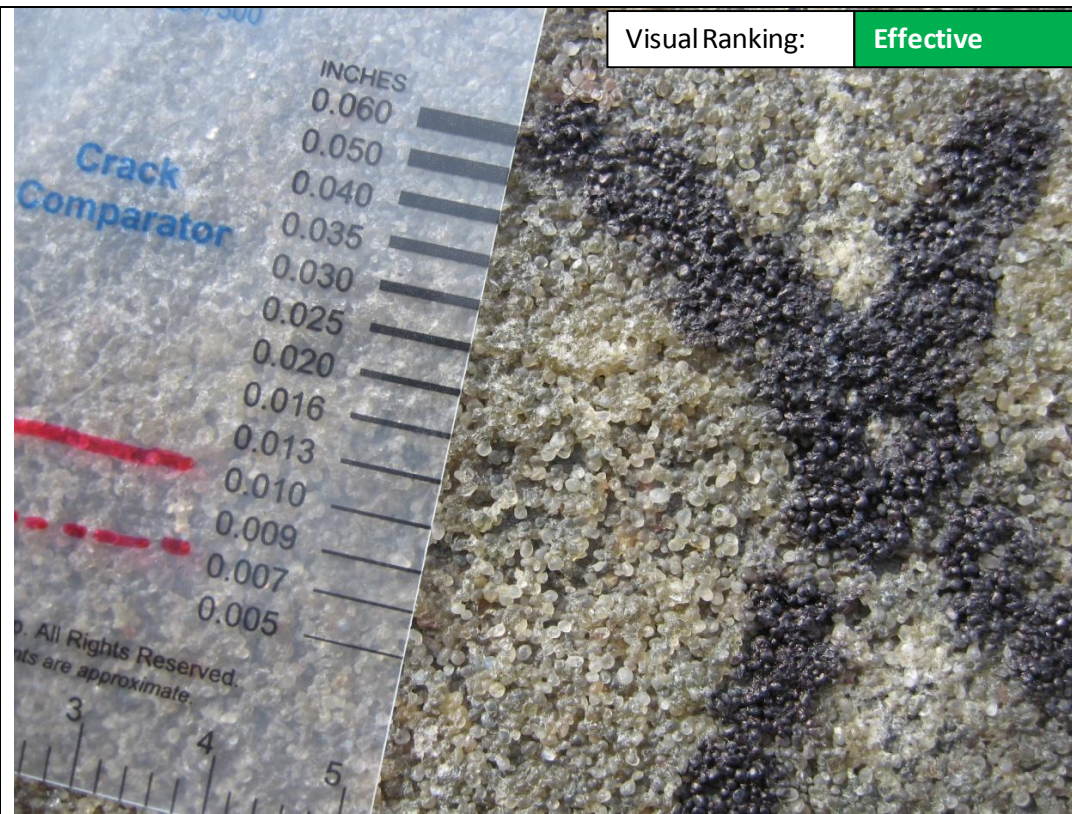
Photograph #: 55
 Test Information: Test Section 10, Test 22A - Sika Corp Sikadur 55 SLV (Epoxy)
 Surface Prep & Application: Air Hose, Route, Pump (squeegee), Sand Coat: Yes
 Date: May 11, 2012
 Project BL-09-03973
BRAUN INTERTEC

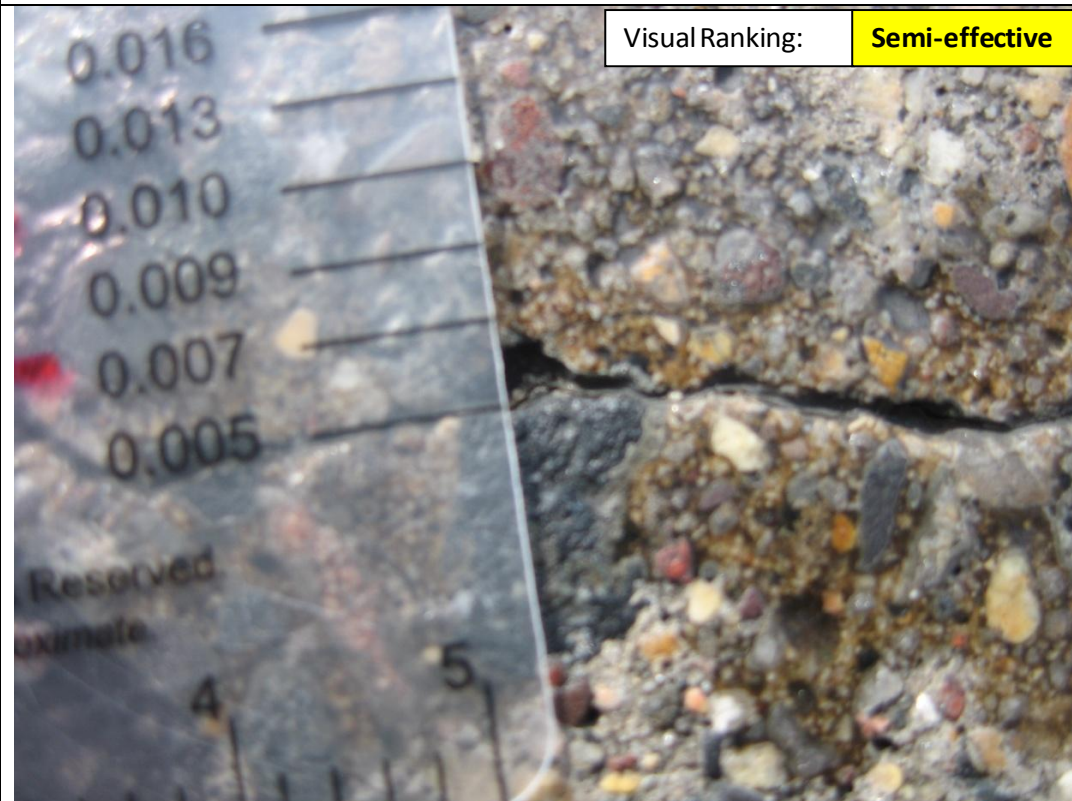
Visual Ranking:

Semi-effective

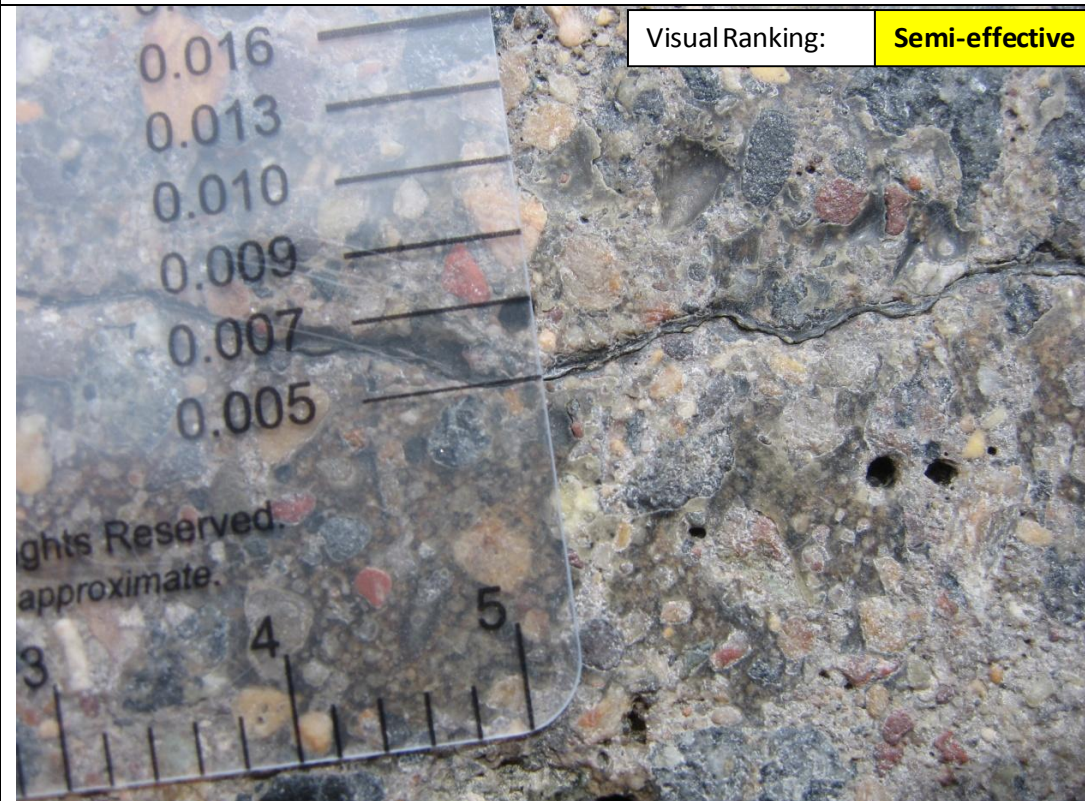
Visual Ranking:

Semi-effective

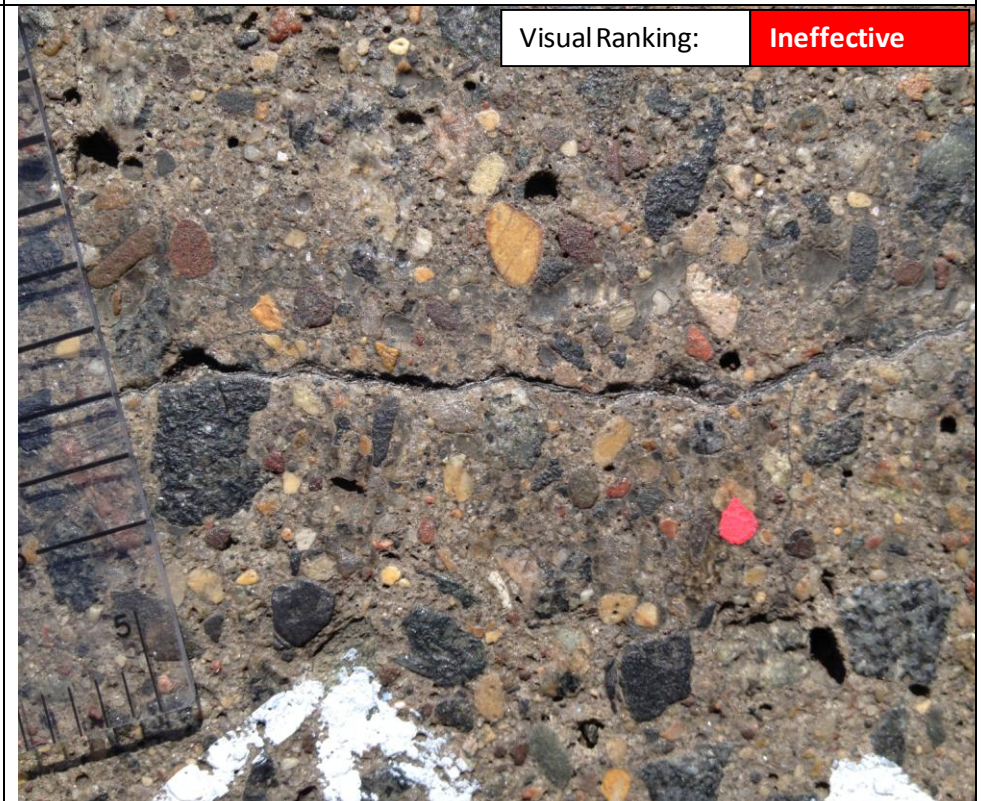
Visual Ranking:

Ineffective

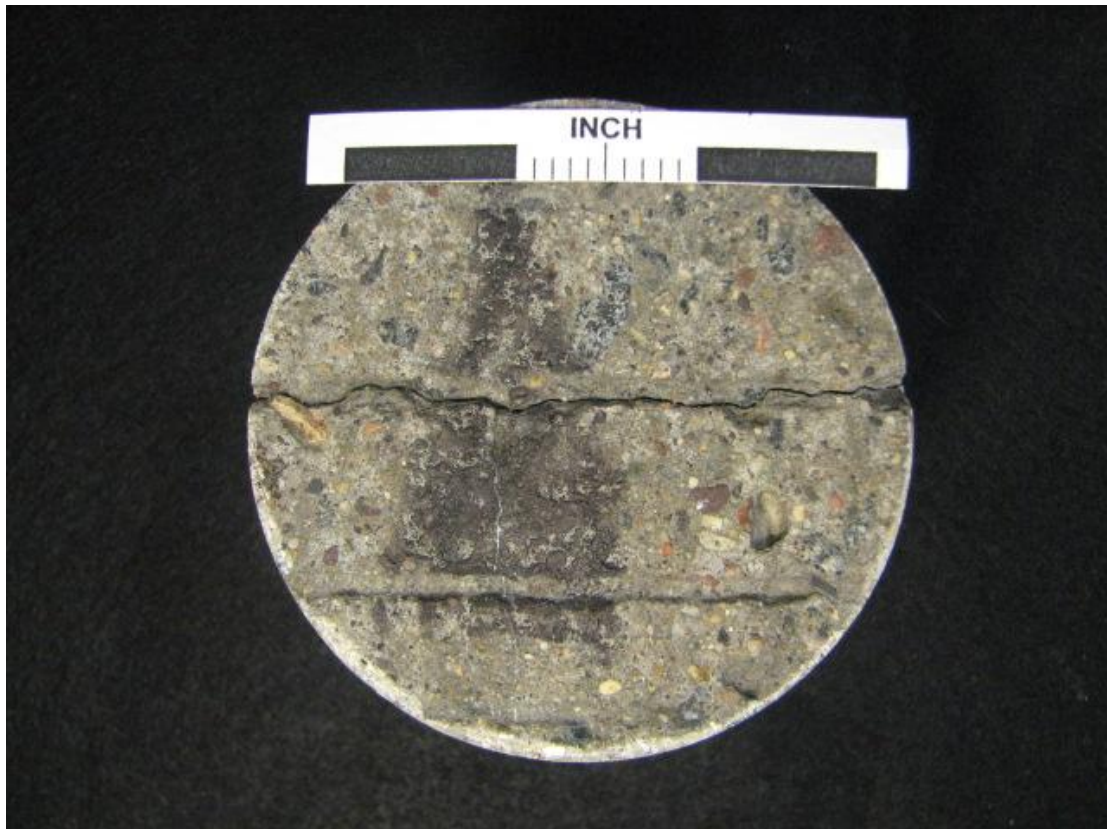
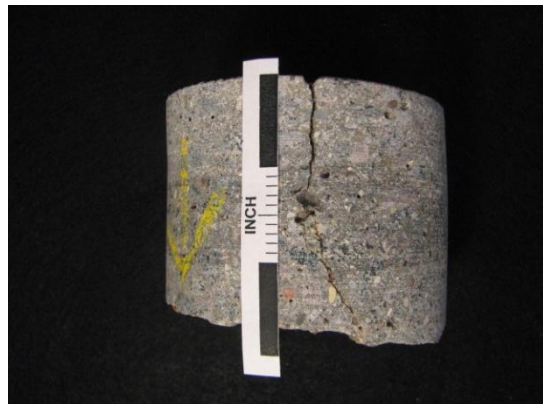
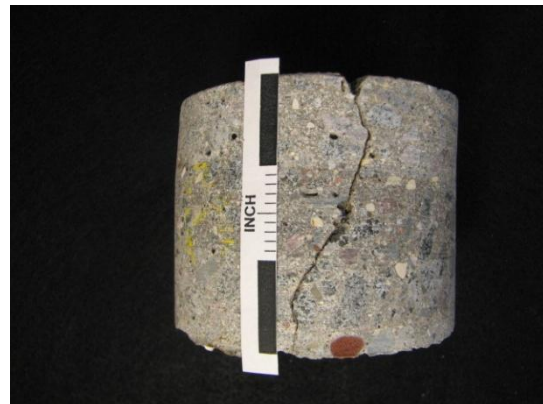
Core #: 1A
Subject: Test Section 1, Test 1A - Accuflex Coatings, Gel Seal
Location: Smith Avenue High Bridge
Notes: Top photo is the top surface of the core. The direction of traffic flow is towards the top of photo. Bottom two photos are the left and right side of the core when viewed in the direction of traffic flow.
