Concrete Bridge Deck Crack Sealant Evaluation and Implementation

Minnesota
Department of
Transportation

Matthew S. Oman, Principal Investigator
Braun Intertec Corporation

Research Project
Final Report 2014-34

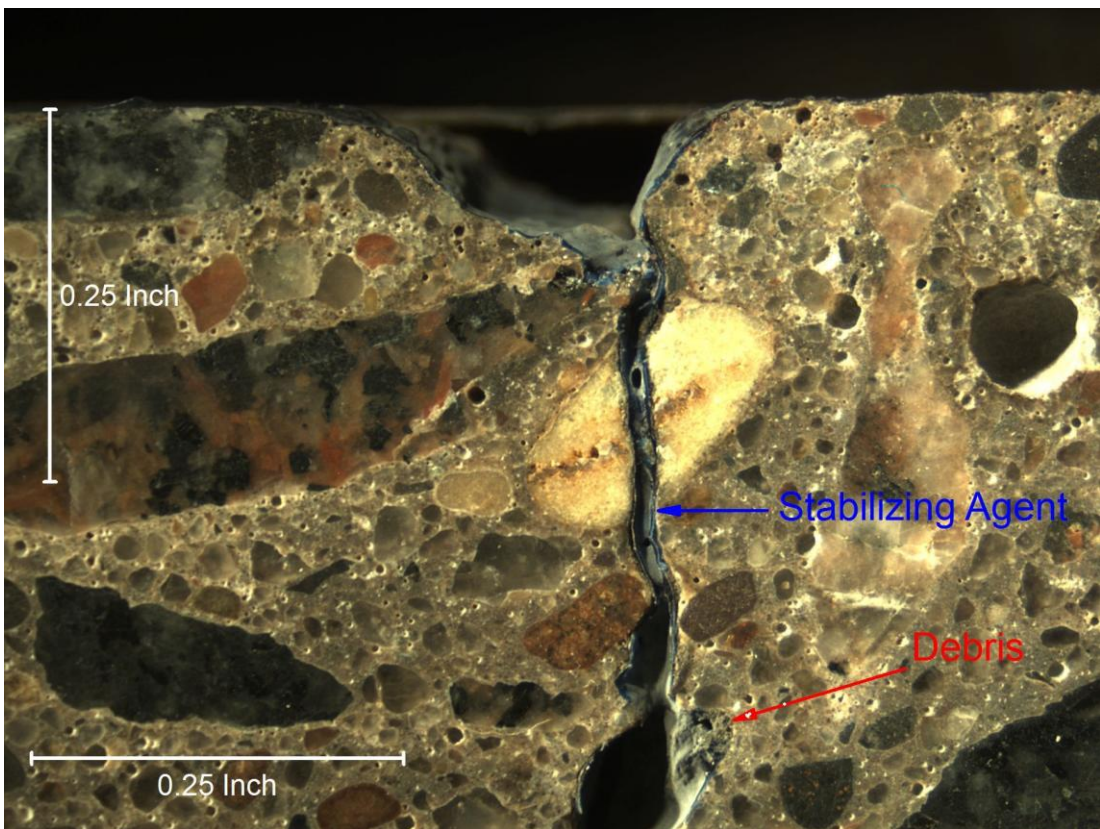
Core #: 1A
Subject: Test Section 1, Test 2A - Accuflex Coatings, Gel Seal
Comments: Depth of Maximum Penetration is 0.000 in.

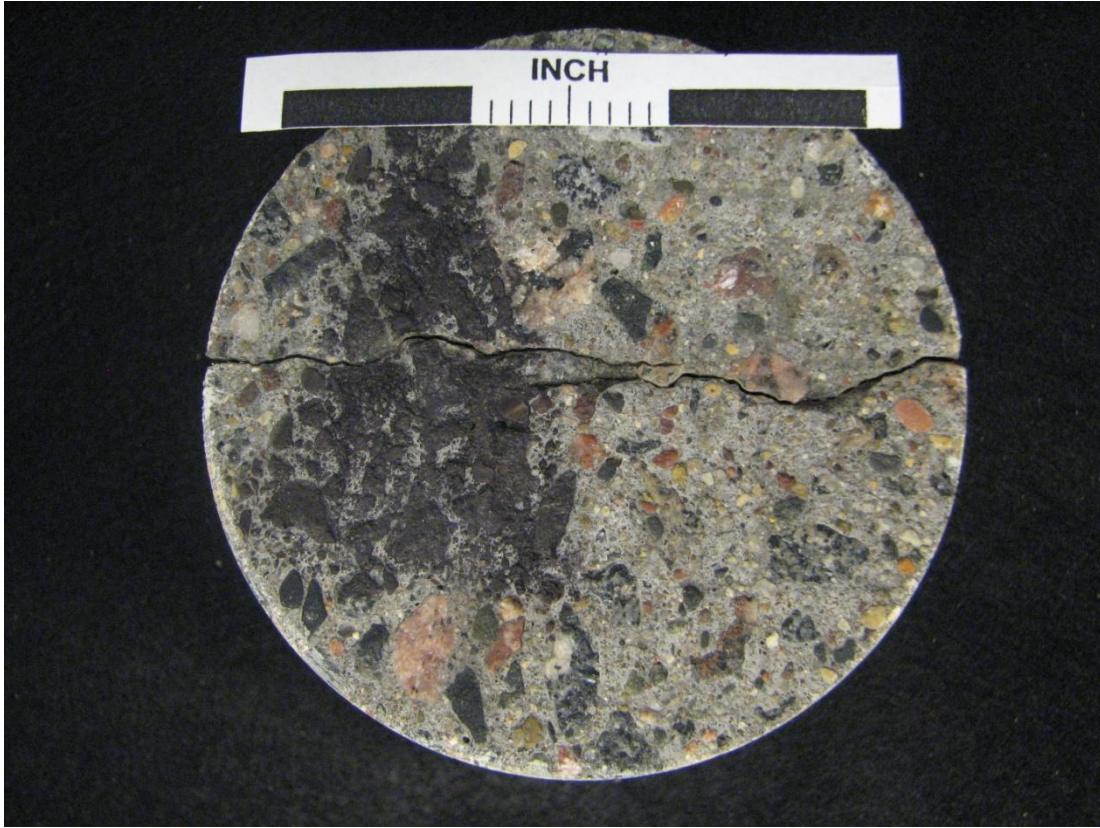
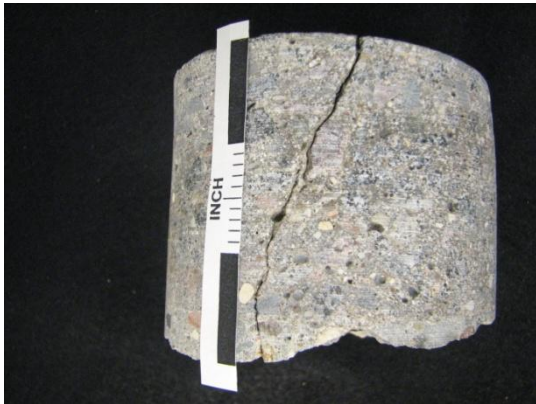
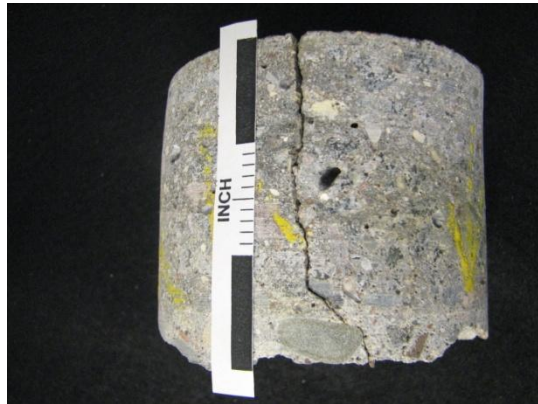
Core #: 2A
Subject: Test Section 1, Test 2A - Accuflex Coatings, Gel Seal
Location: Smith Avenue High Bridge
Notes: Top photo is the top surface of the core. The direction of traffic flow is towards the top of photo. Bottom two photos are the left and right side of the core when viewed in the direction of traffic flow.

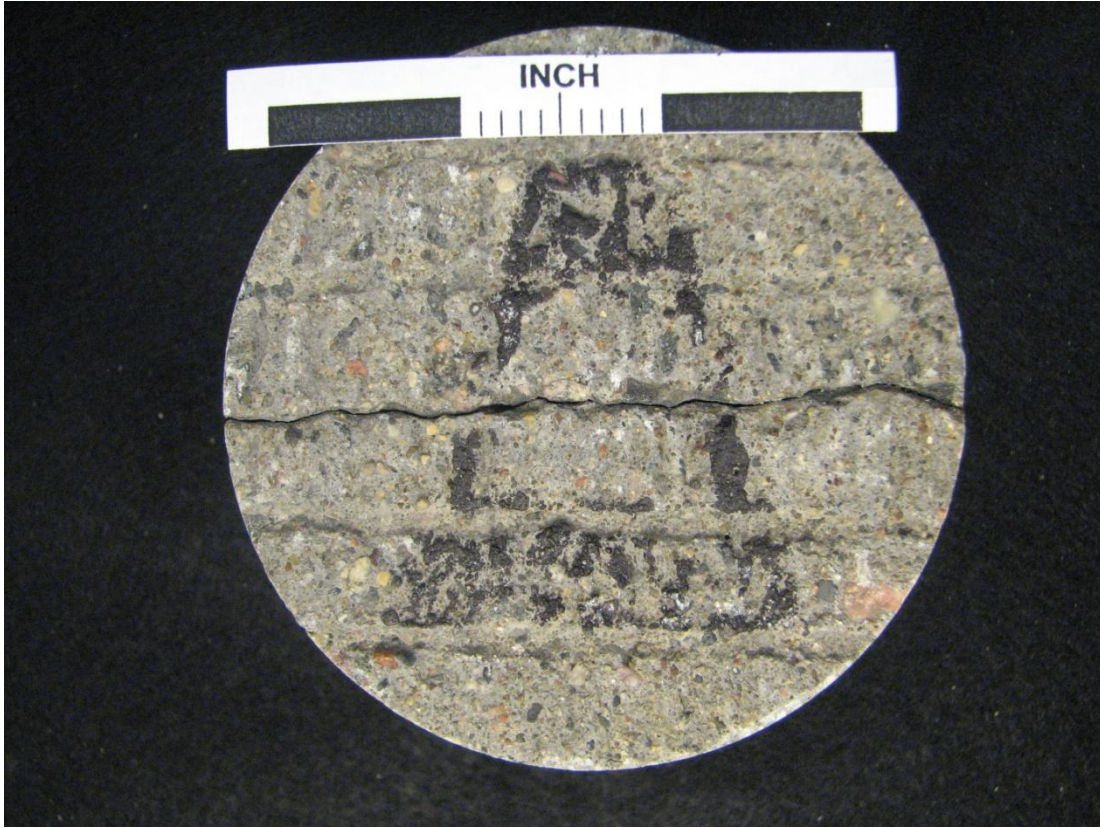
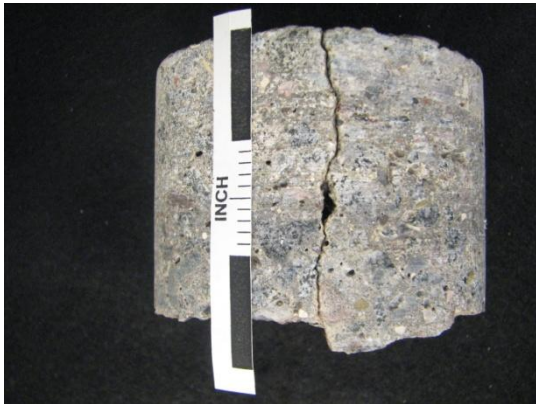
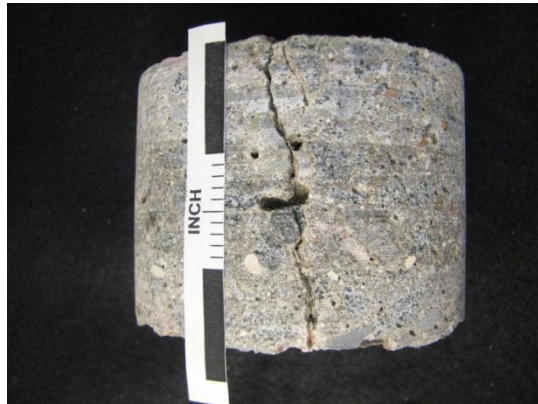
Core #:	4B	Project BL-09-03973
Subject:	Test Section 2, Test 4B – Control	
Location:	Smith Avenue High Bridge	
Notes:	Top photo is the top surface of the core. The direction of traffic flow is towards the top of photo. Bottom two photos are the left and right side of the core when viewed in the direction of traffic flow.

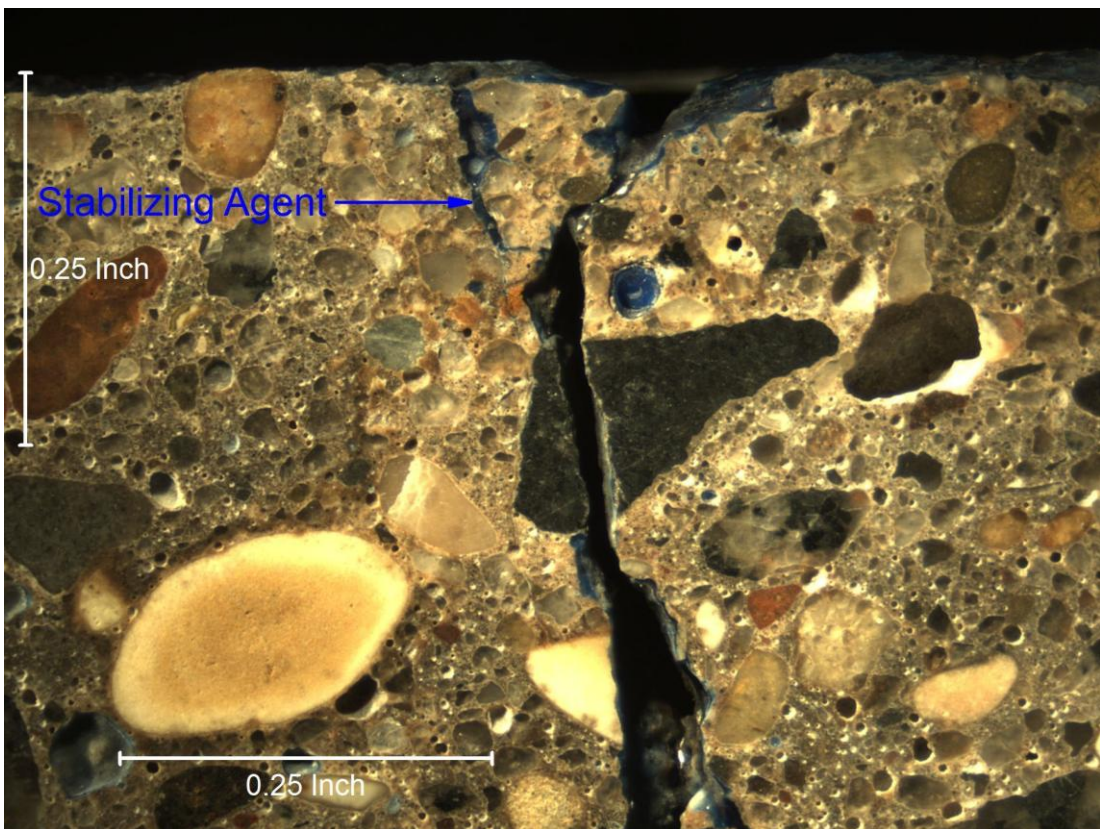
Core #: 4B
Subject: Test Section 2, Test 4B – Control
Comments: Depth of Maximum Penetration is 0.000 in.

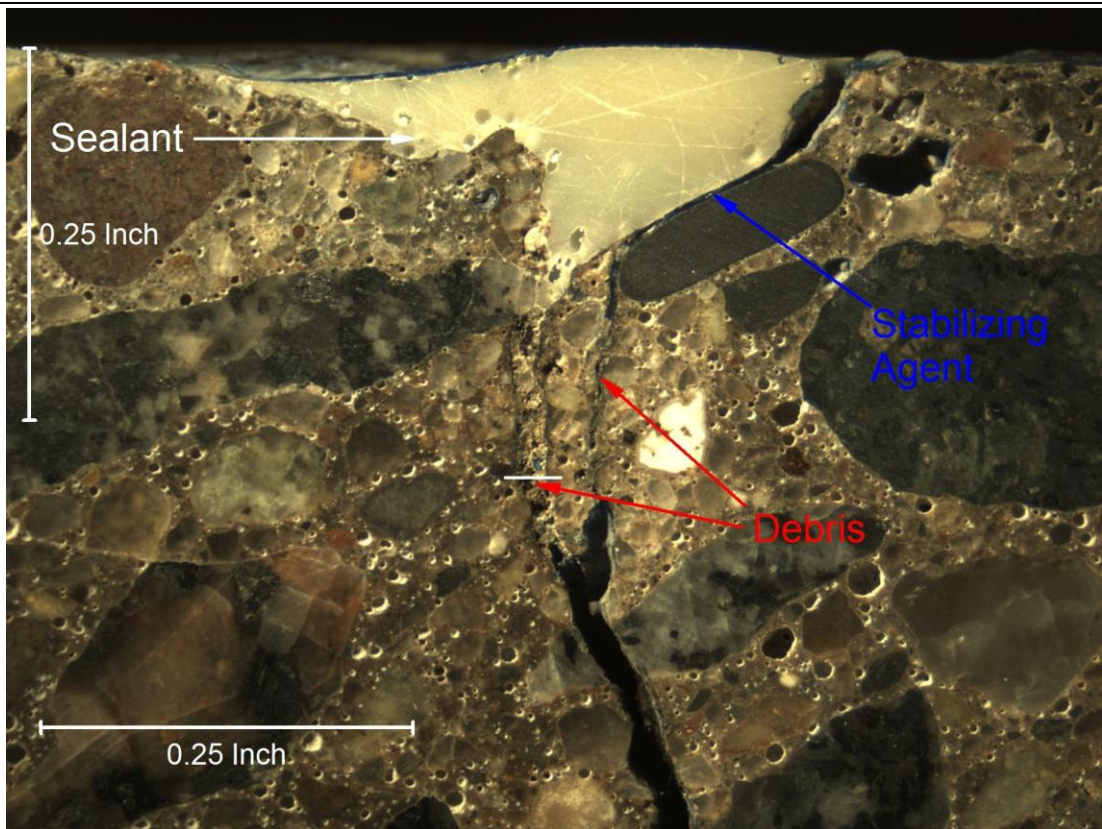
Core #: 7B
 Subject: Test Section 3, Test 7B - TK-9030
 Comments: Depth of Maximum Penetration is 0.302 in. White horizontal line marks the approx. depth of sealant.

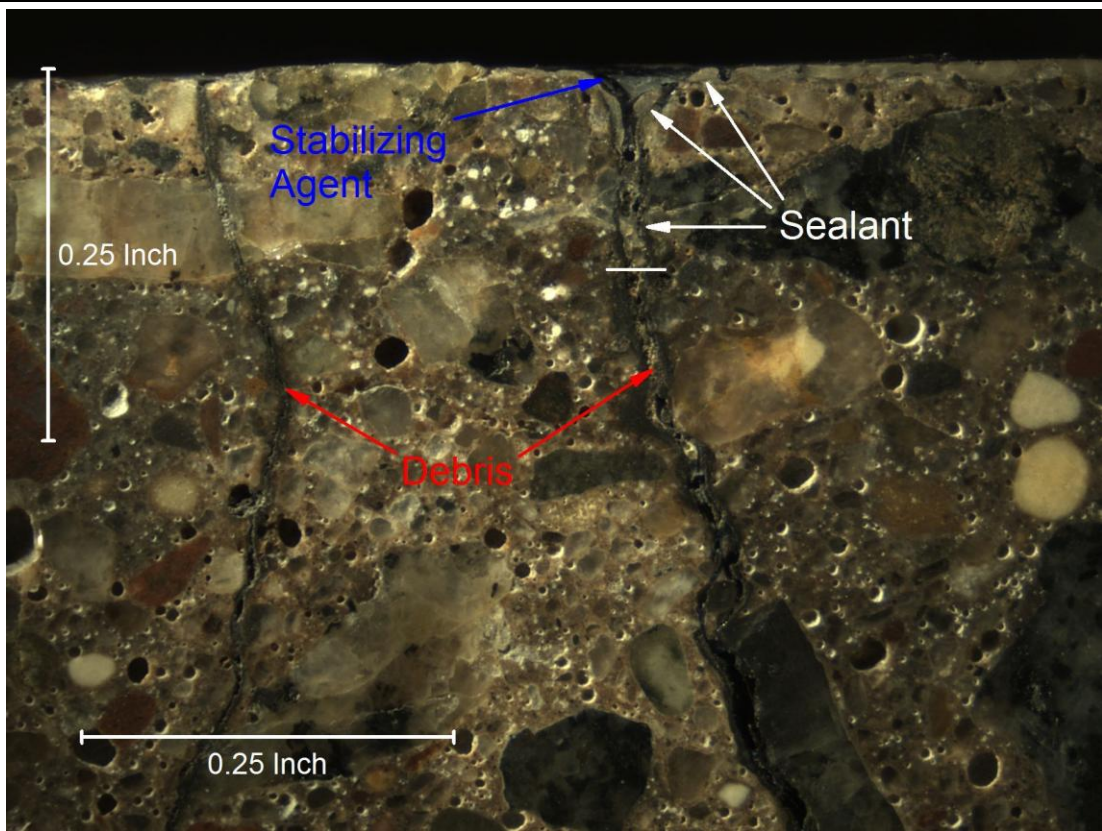
Core #: 8A Project BL-09-03973
 Subject: Test Section 3, Test 8A - TK-9030
 Comments: Depth of Maximum Penetration is 0.136 in. White horizontal line marks the approx. depth of sealant.

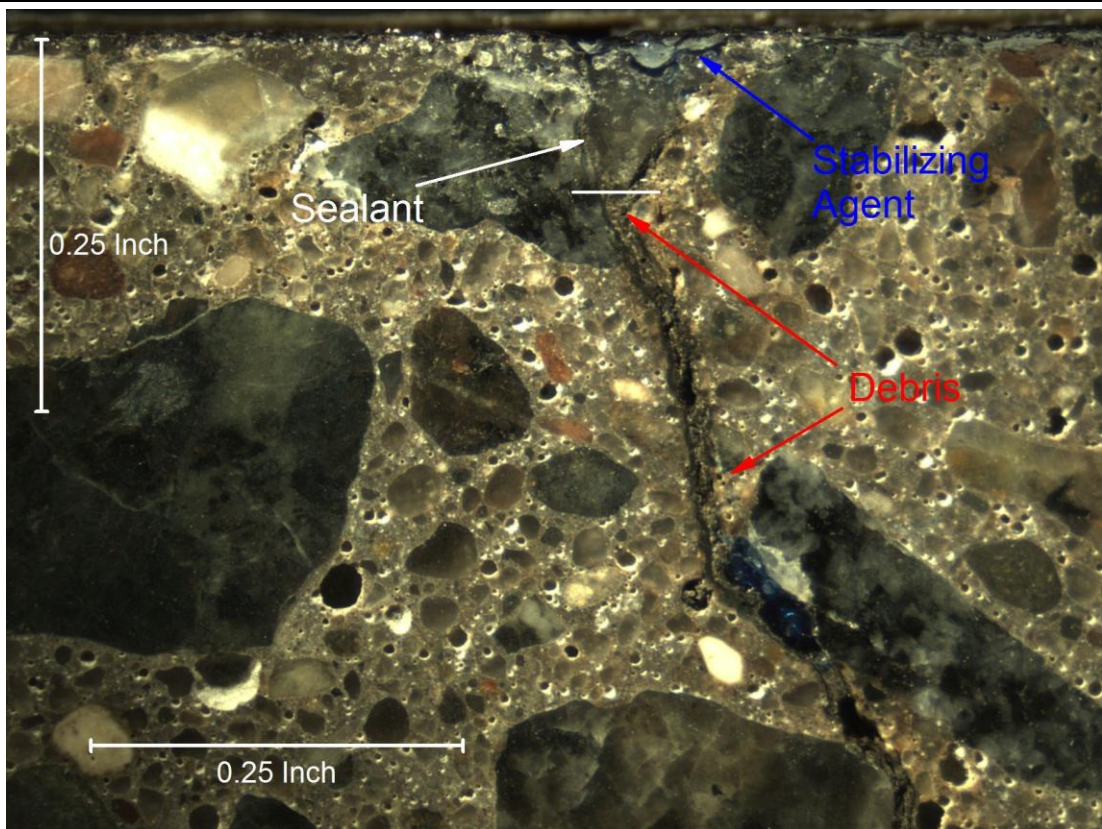
Core #: 9A
 Subject: Test Section 4, Test 9A - TK-2110
 Comments: Depth of Maximum Penetration is 0.118 in. White horizontal line marks the approx. depth of sealant.

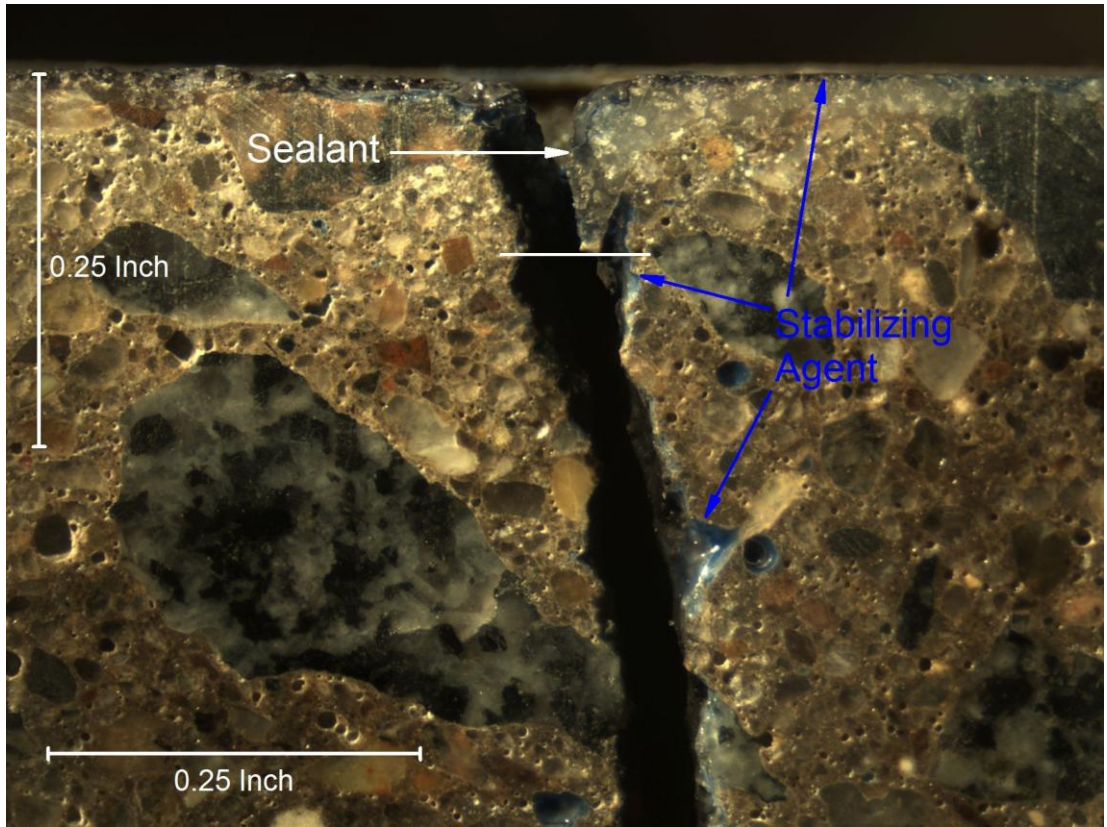
Core #:	10B	Project BL-09-03973
Subject:	Test Section 4, Test 10B - TK-2110	BRAUN INTERTEC
Comments:	Depth of Maximum Penetration is 0.122 in. White horizontal line marks the approx. depth of sealant.

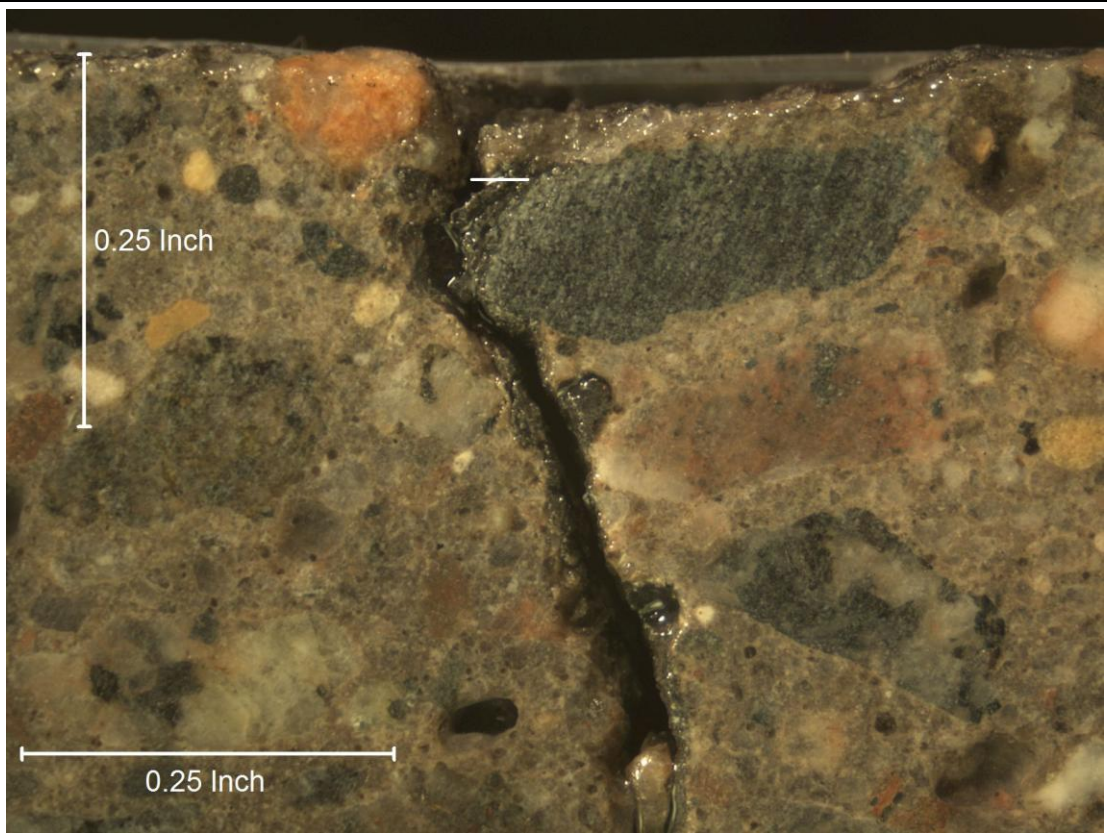
Core #:	11A	Project BL-09-03973
Subject:	Test Section 5, Test 11A - TK-2414

Notes:	Depth of Maximum Penetration is 0.088 in. White horizontal line marks the approx. depth of sealant.

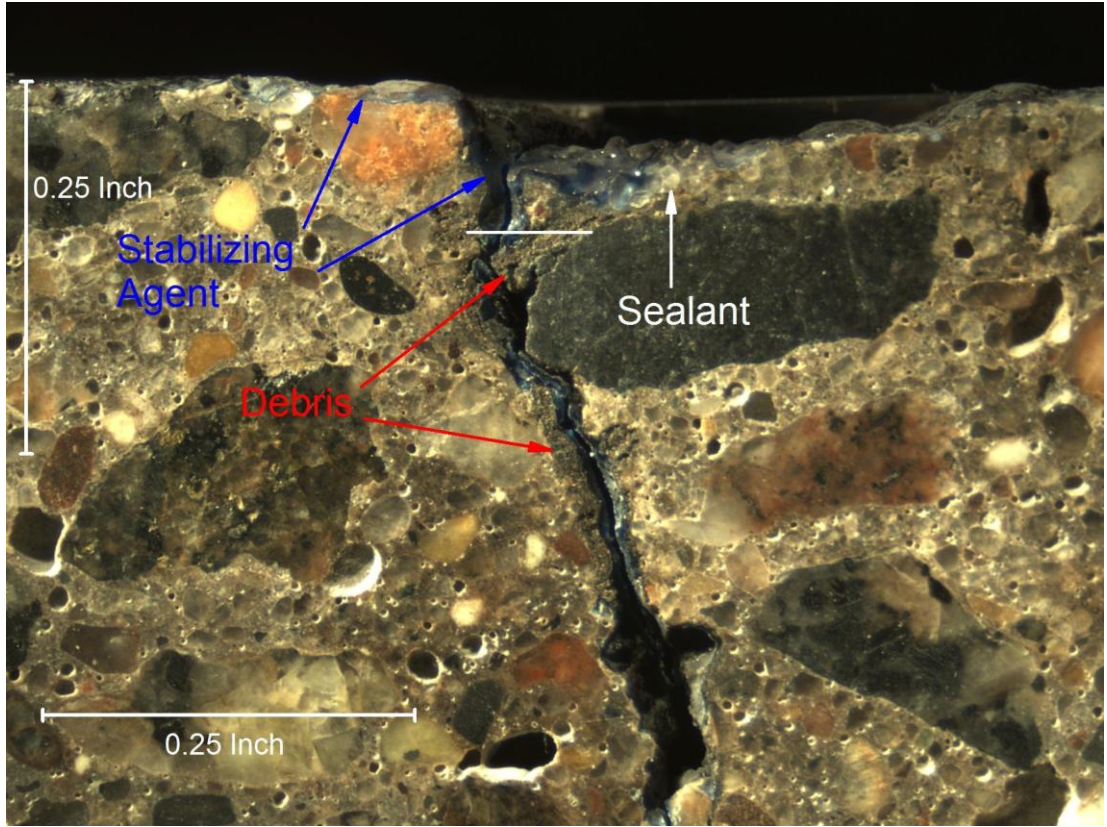
Core #:	11A	Project BL-09-03973
Subject:	Test Section 5, Test 11A - TK-2414

Comments:	Depth of Maximum Penetration is 0.094 in. White horizontal line marks the approx. depth of sealant.

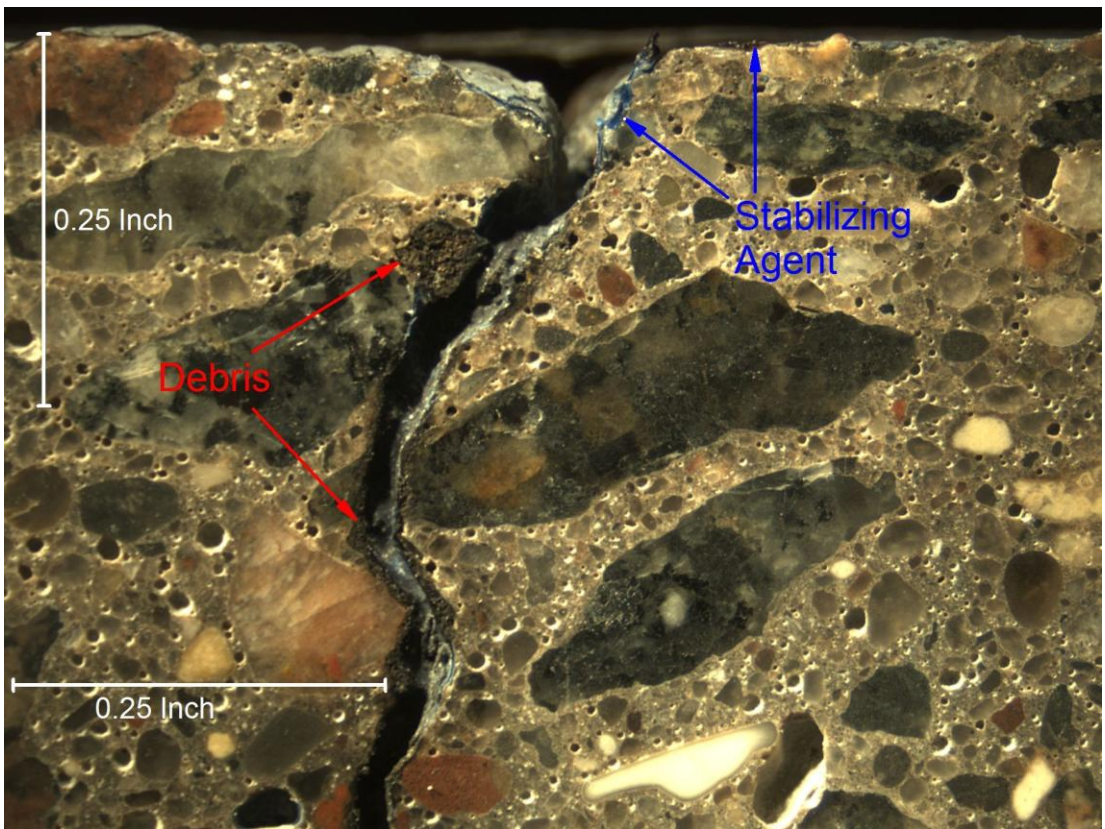
Core #: 12A
Subject: Test Section 5, Test 12A - TK-2414
Comments: Depth of Maximum Penetration is 0.000 in.

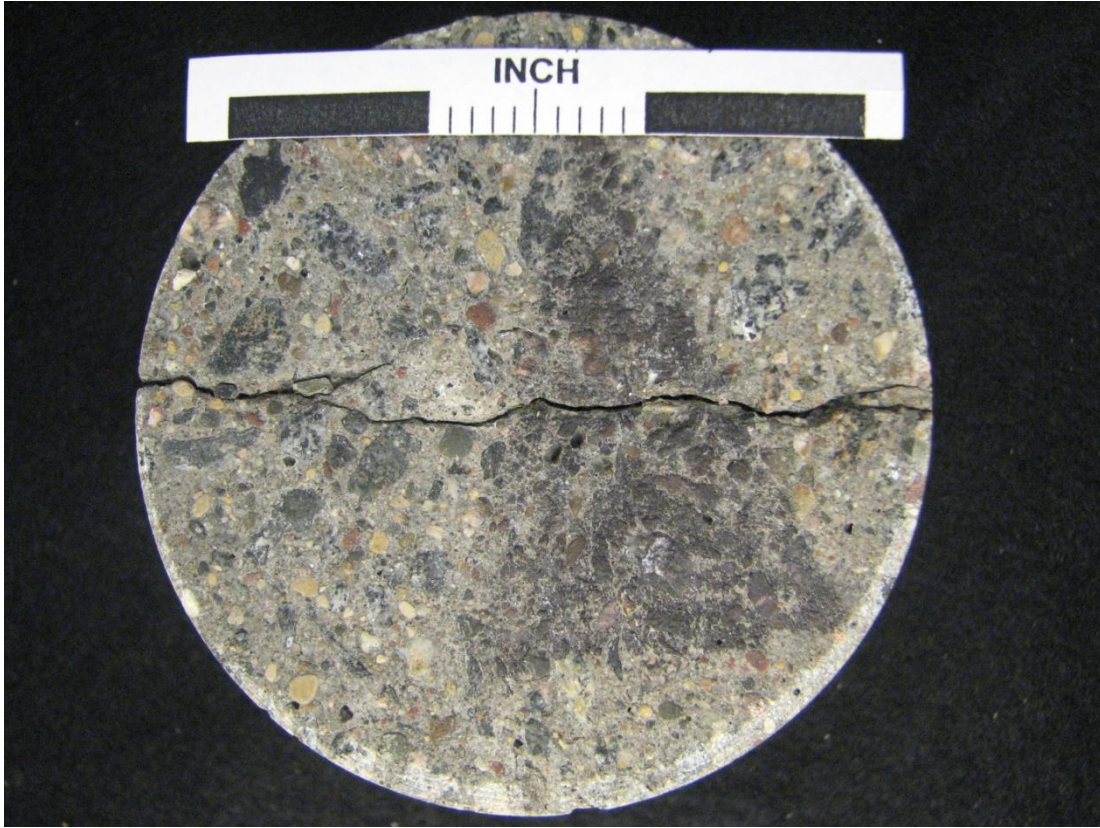
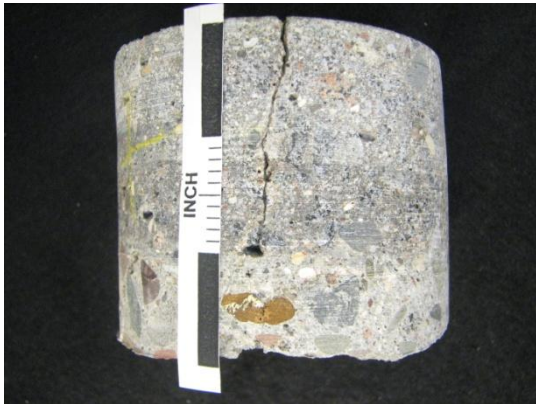
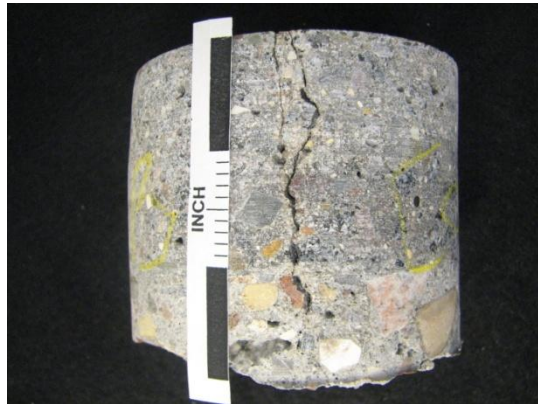
Core #:	12B	Project BL-09-03973
Subject:	Test Section 6, Test 12B - Control	
Location:	Smith Avenue High Bridge	
Notes:	Top photo is the top surface of the core. The direction of traffic flow is towards the top of photo. Bottom two photos are the left and right side of the core when viewed in the direction of traffic flow.

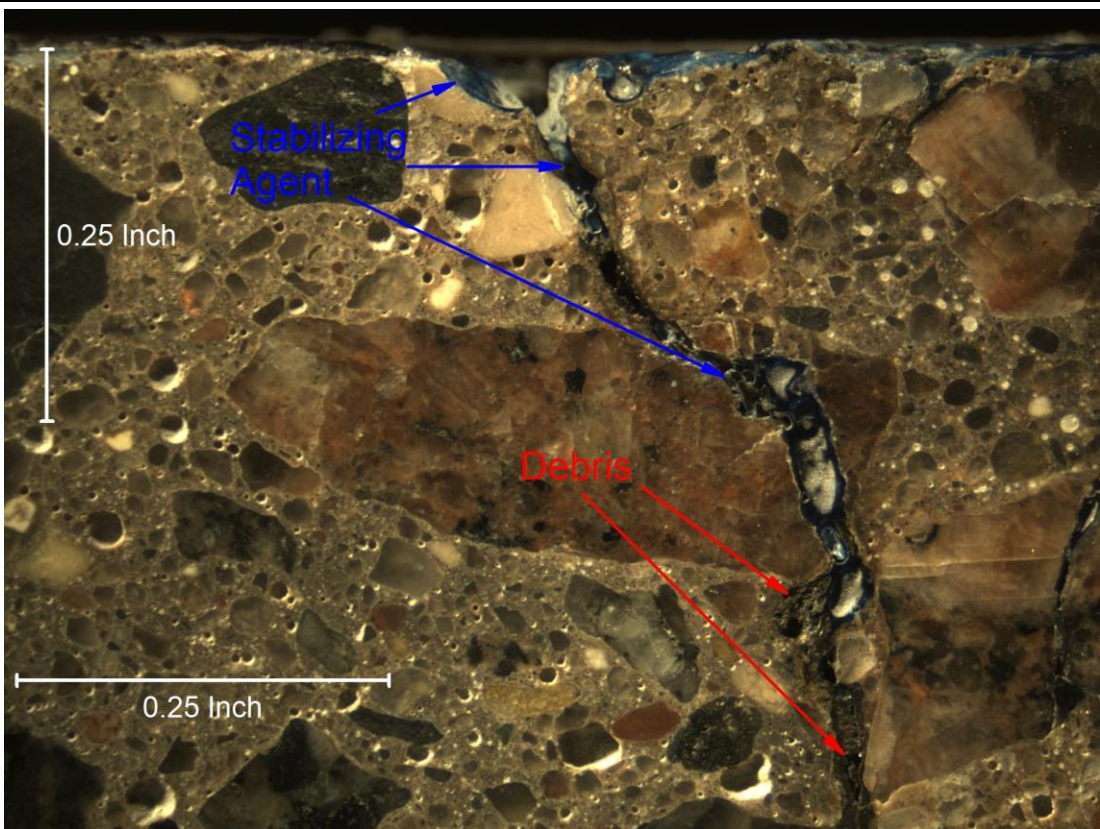
Core #: 12B
Subject: Test Section 6, Test 12B - Control
Comments: Depth of Maximum Penetration is 0.000 in.

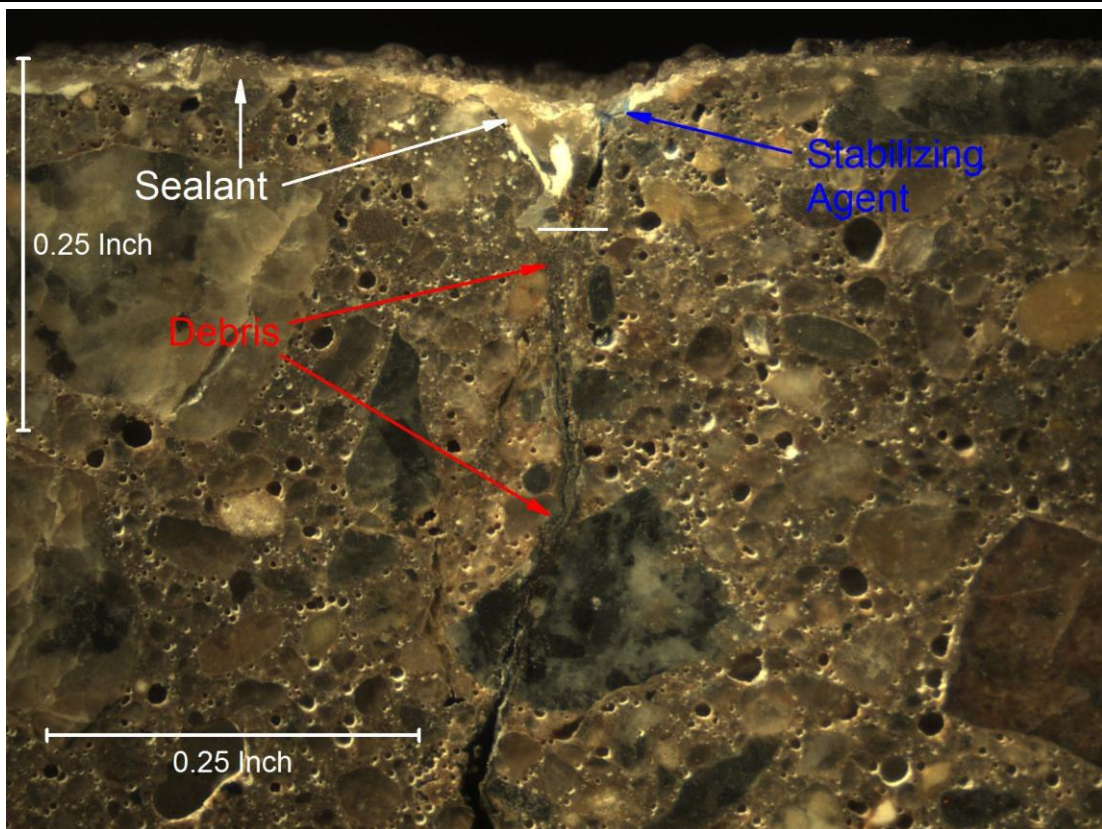
Core #: 17A
 Subject: Test Section 7, Test 17A –Epoxyal GS Structural
 Comments: Depth of Maximum Penetration is 0.121 in. White horizontal line marks the approx. depth of sealant.

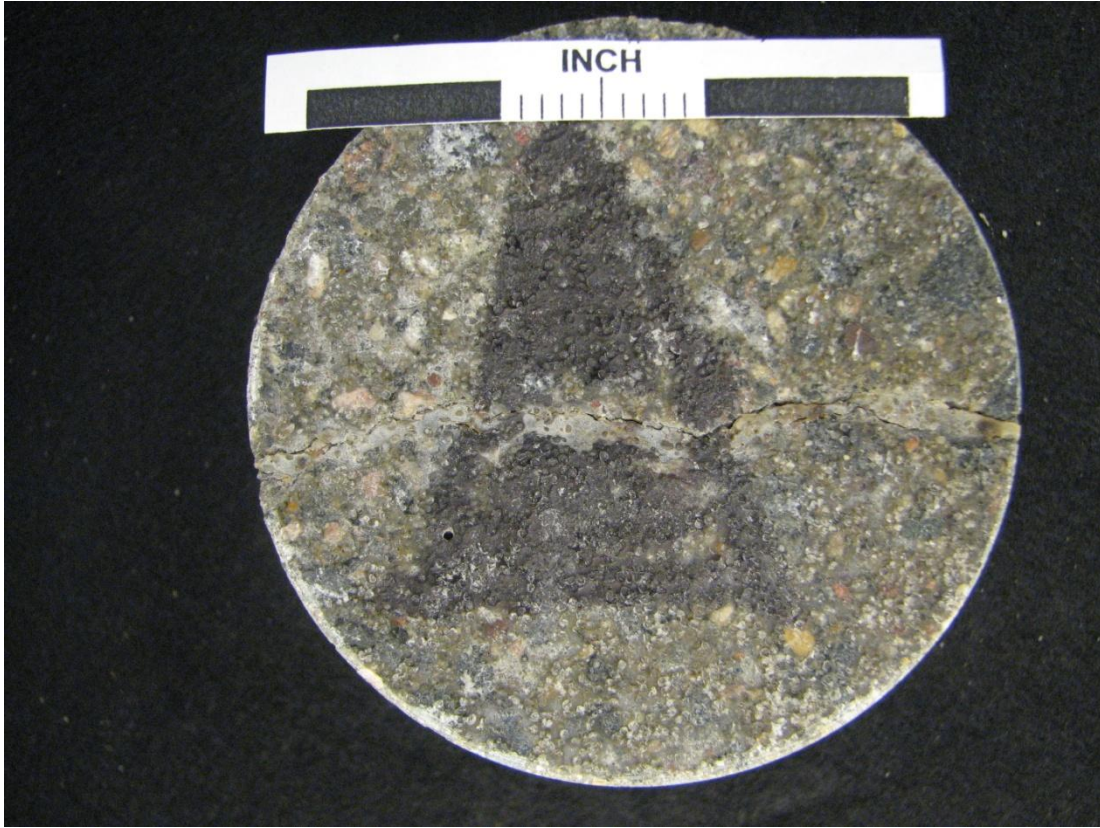
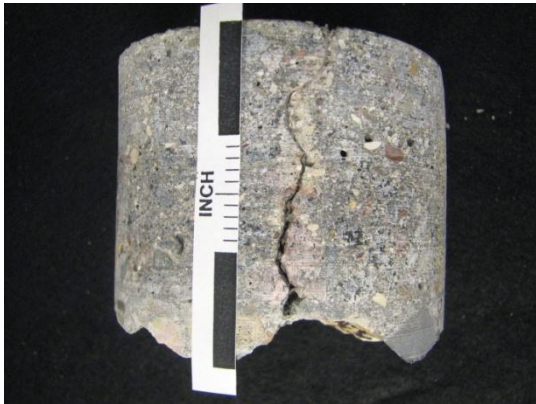
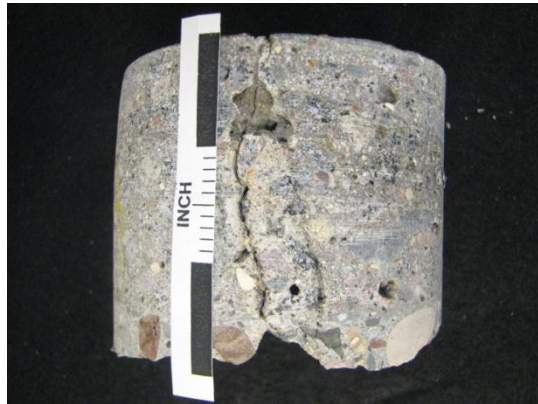
Core #: 19A

Subject: Test Section 7, Test 19A –Epoxyal GS Structural

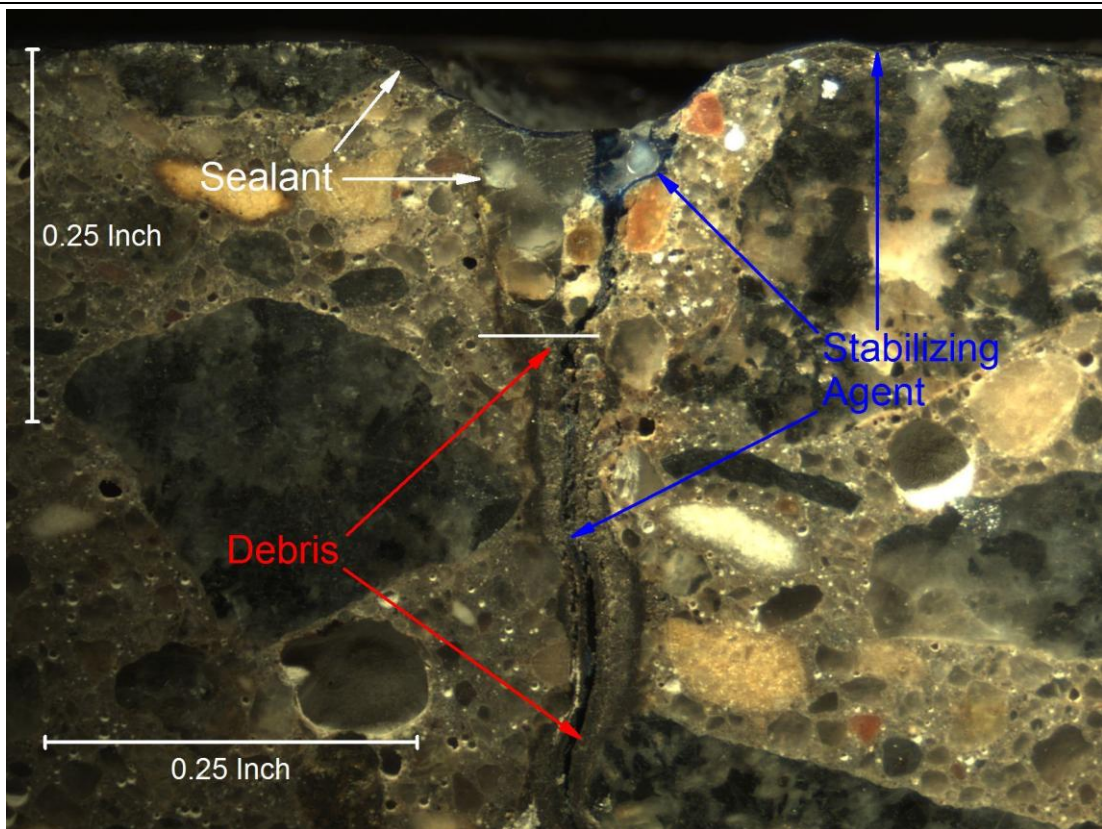
Core #: 19A
 Subject: Test Section 7, Test 19A –Epoxy GS Structural
 Comments: Depth of Maximum Penetration is 0.211 in. White horizontal line marks the approx. depth of sealant.

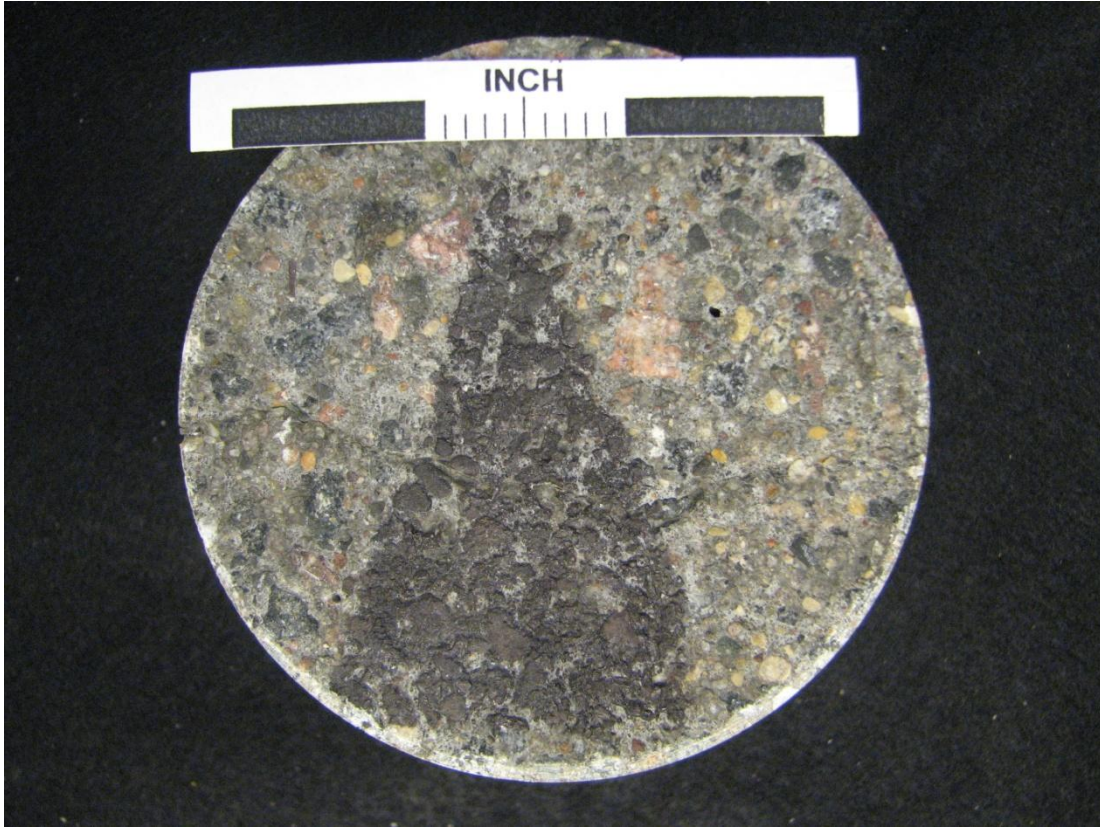
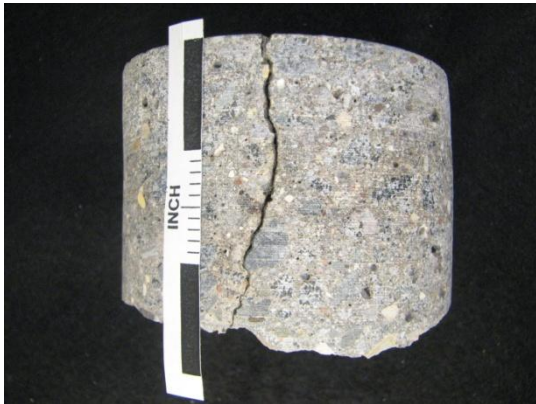
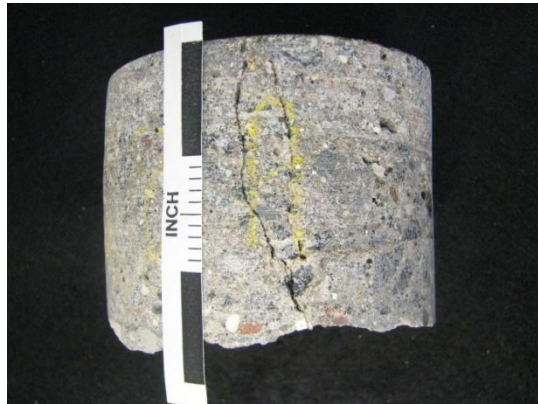
Core #:	18A	Project BL-09-03973
Subject:	Test Section 8, Test 18A – Kwik Bond KBP 204	
Location:	Smith Avenue High Bridge	
Notes:	Top photo is the top surface of the core. The direction of traffic flow is towards the top of photo. Bottom two photos are the left and right side of the core when viewed in the direction of traffic flow.

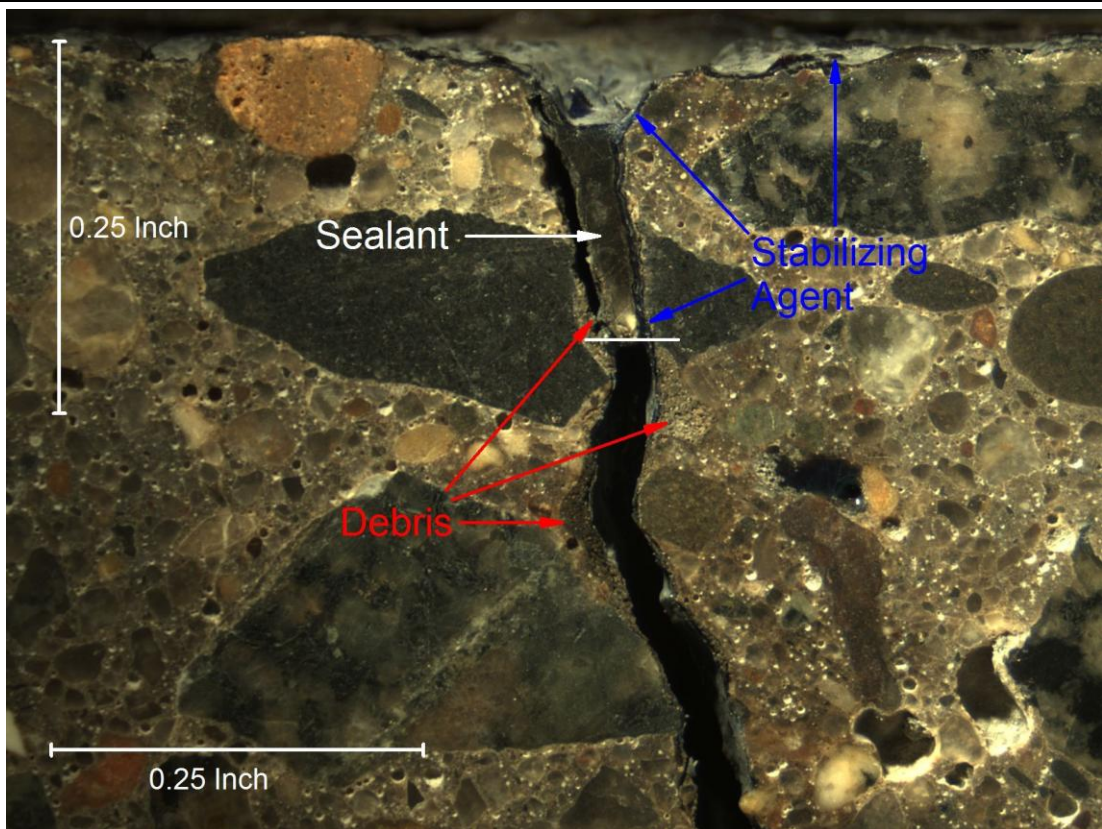
Core #: 18A
 Subject: Test Section 8, Test 18A – Kwik Bond KBP 204
 Comments: Depth of Maximum Penetration is 0.204 in. White horizontal line marks the approx. depth of sealant.

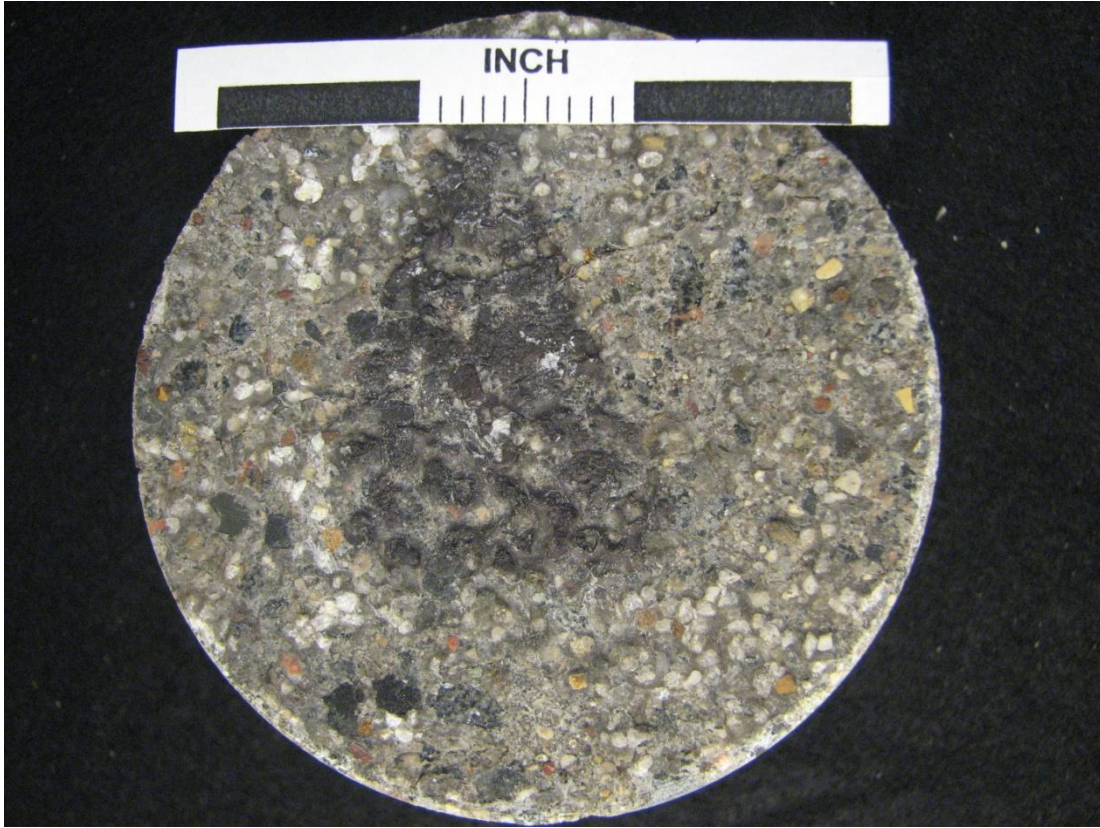
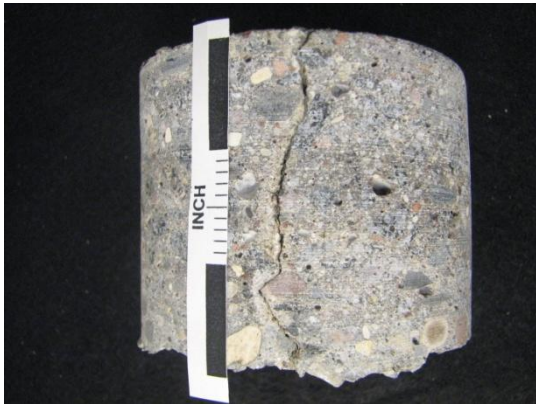
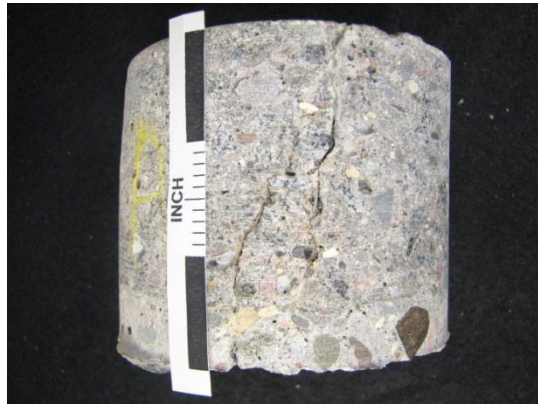
Core #: 20A

Subject: Test Section 8, Test 20A – Kwik Bond KBP 204

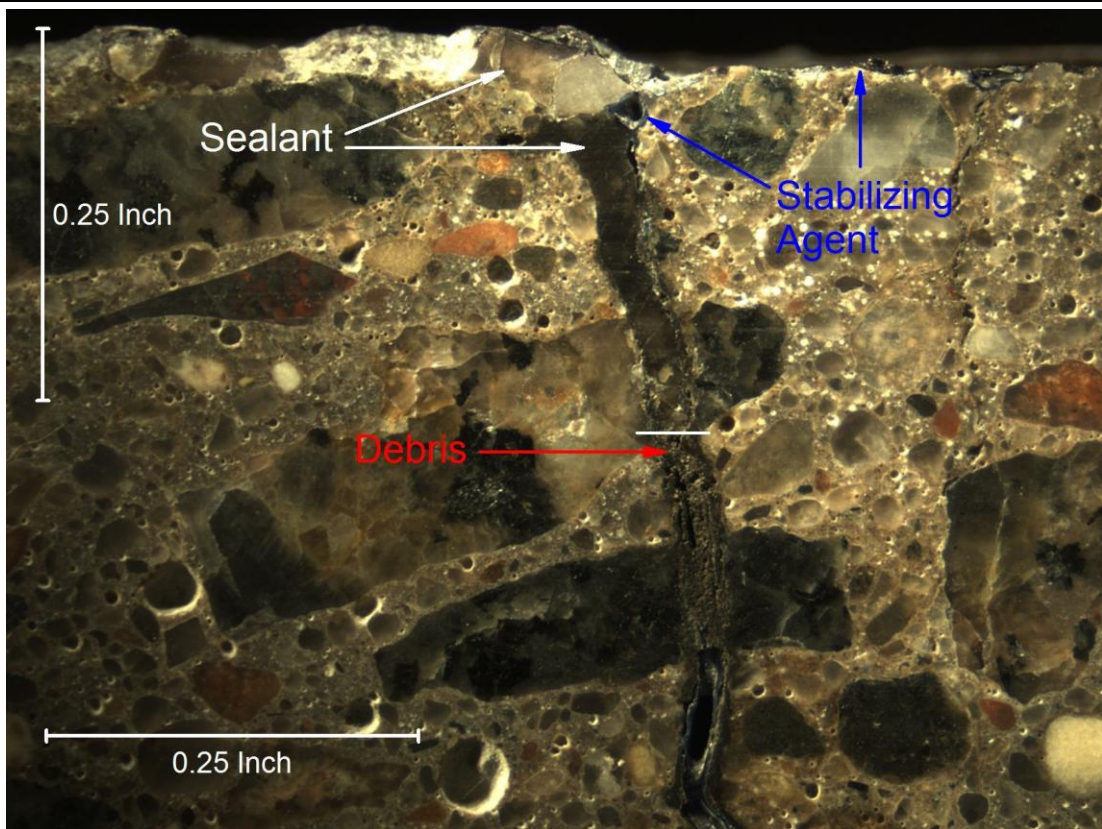
Core #: 20A
 Subject: Test Section 8, Test 20A – Kwik Bond KBP 204
 Comments: Depth of Maximum Penetration is 0.266 in. White horizontal line marks the approx. depth of sealant.
