Concrete Bridge Deck Crack Sealant Evaluation and Implementation

Minnesota
Department of
Transportation

Matthew S. Oman, Principal Investigator
Braun Intertec Corporation

Research Project
Final Report 2014-34

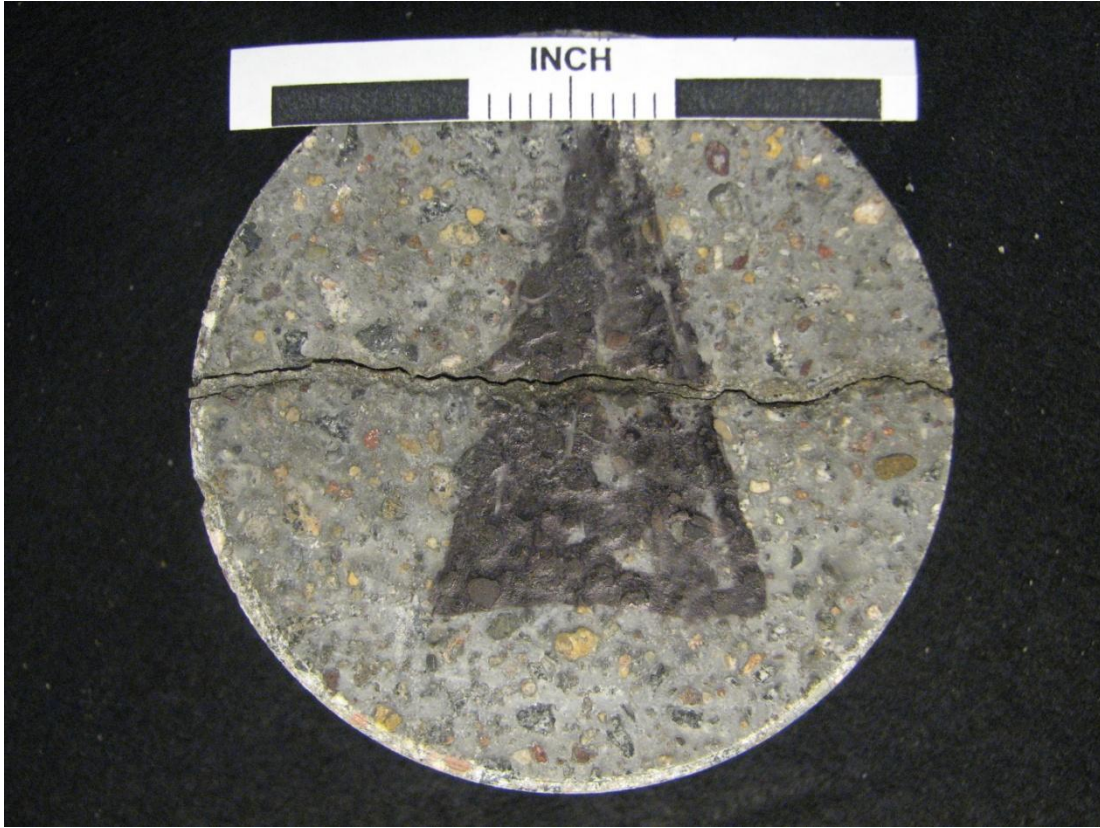
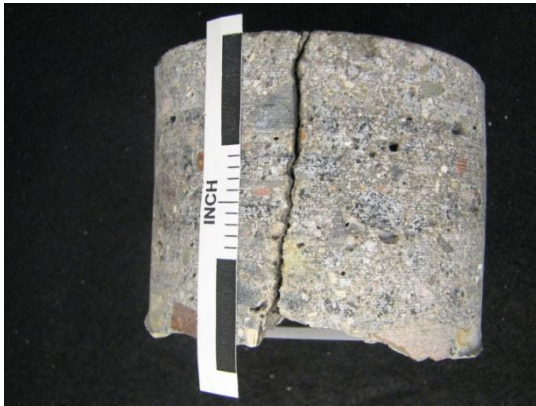
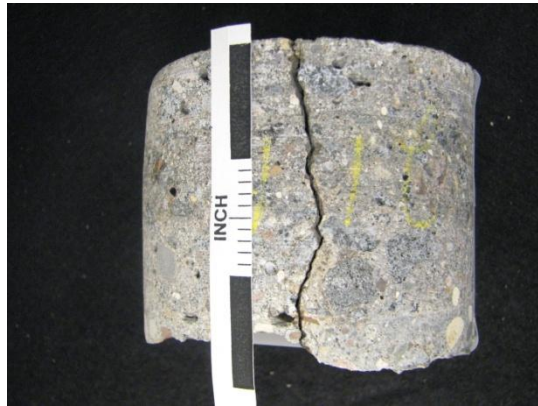
Core #: 21A
Subject: Test Section 9, Test 21A – Degadeck Crack Sealer Plus
Location: Smith Avenue High Bridge
Notes: Top photo is the top surface of the core. The direction of traffic flow is towards the top of photo. Bottom two photos are the left and right side of the core when viewed in the direction of traffic flow.

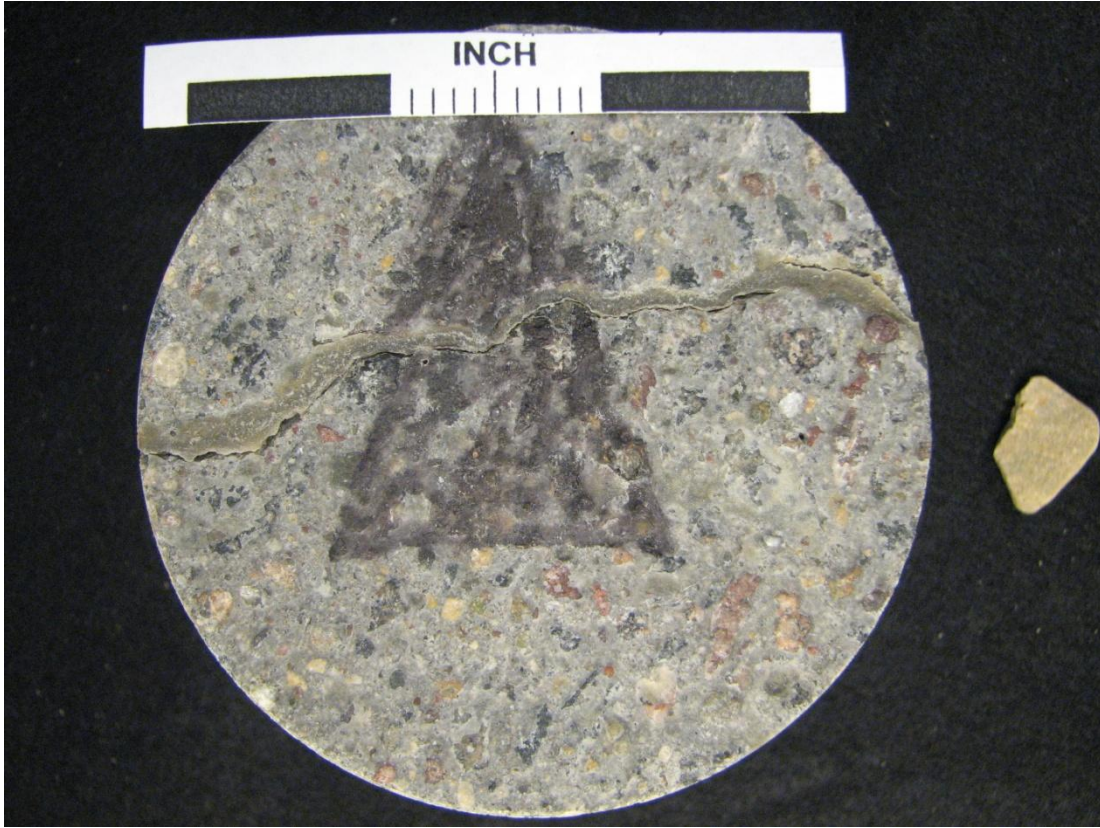
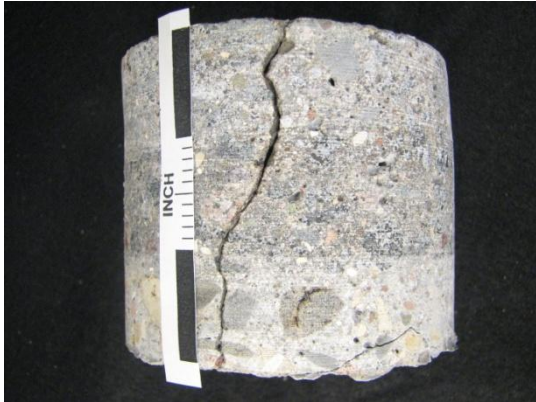
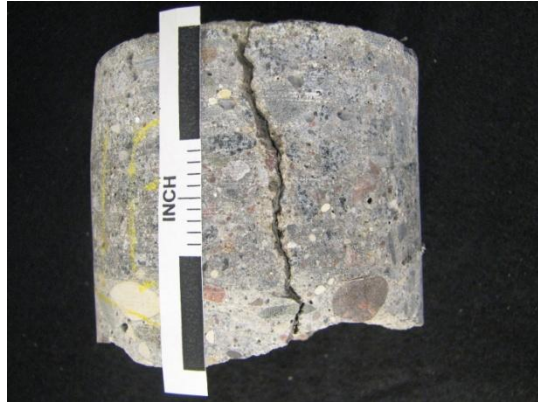
Core #: 21B

Subject: Test Section 9, Test 21B – Degadeck Crack Sealer Plus

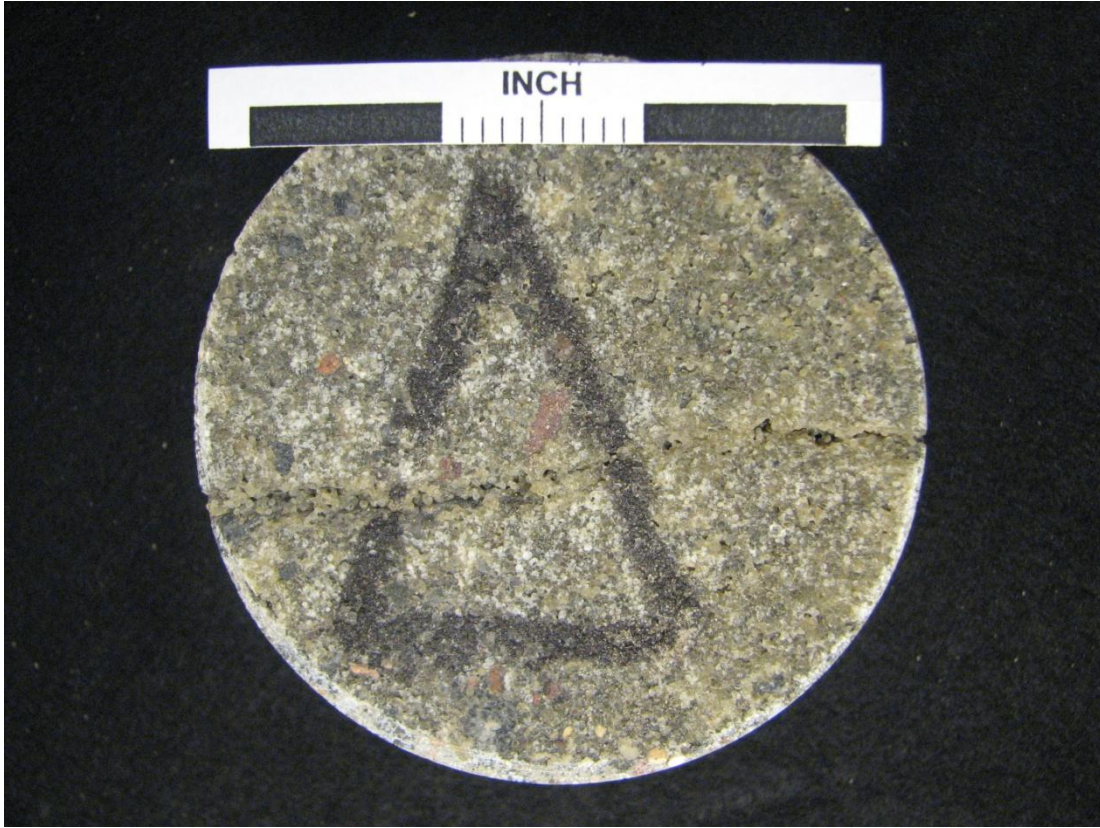
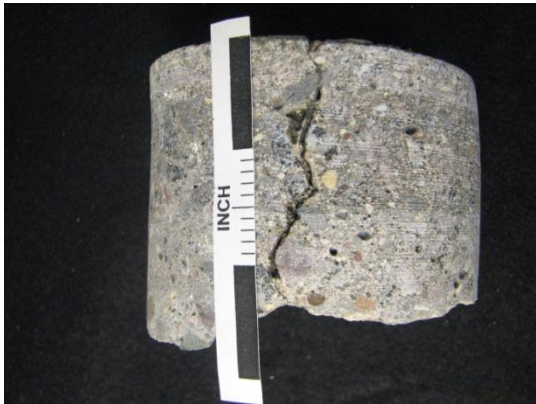
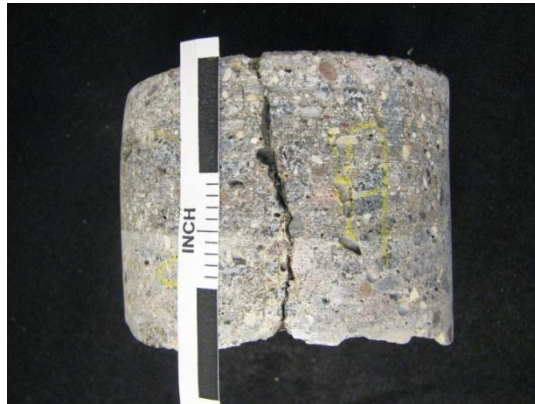
Core #: 22A

Subject: Test Section 10, Test 22A – Sikadur 55 SLV

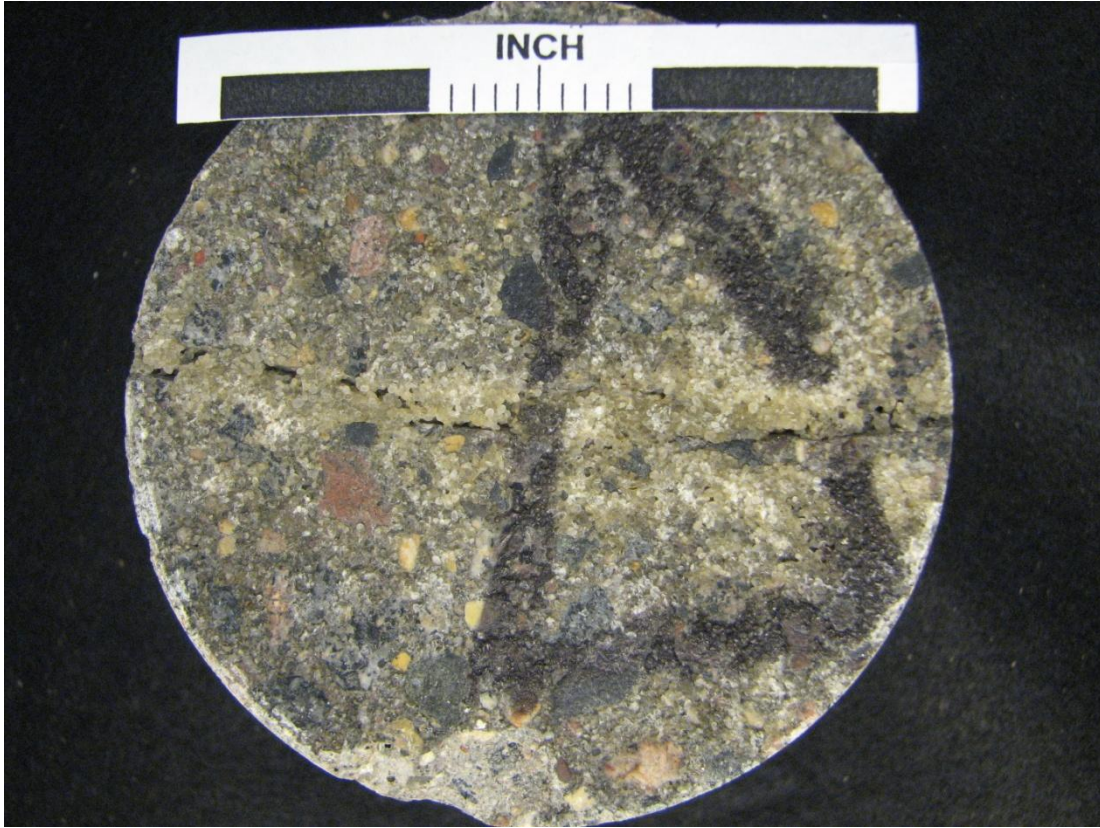
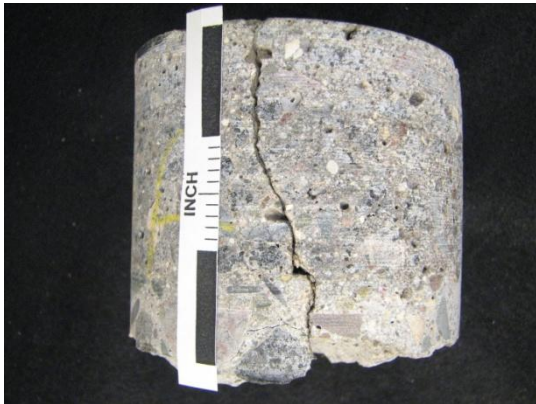
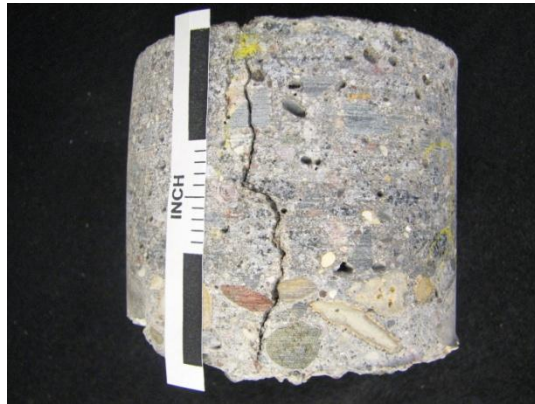
Core #:	23A	Project BL-09-03973
Subject:	Test Section 10, Test 23A – Sikadur 55 SLV	
Location:	Smith Avenue High Bridge	
Notes:	Top photo is the top surface of the core. The direction of traffic flow is towards the top of photo. Bottom two photos are the left and right side of the core when viewed in the direction of traffic flow.

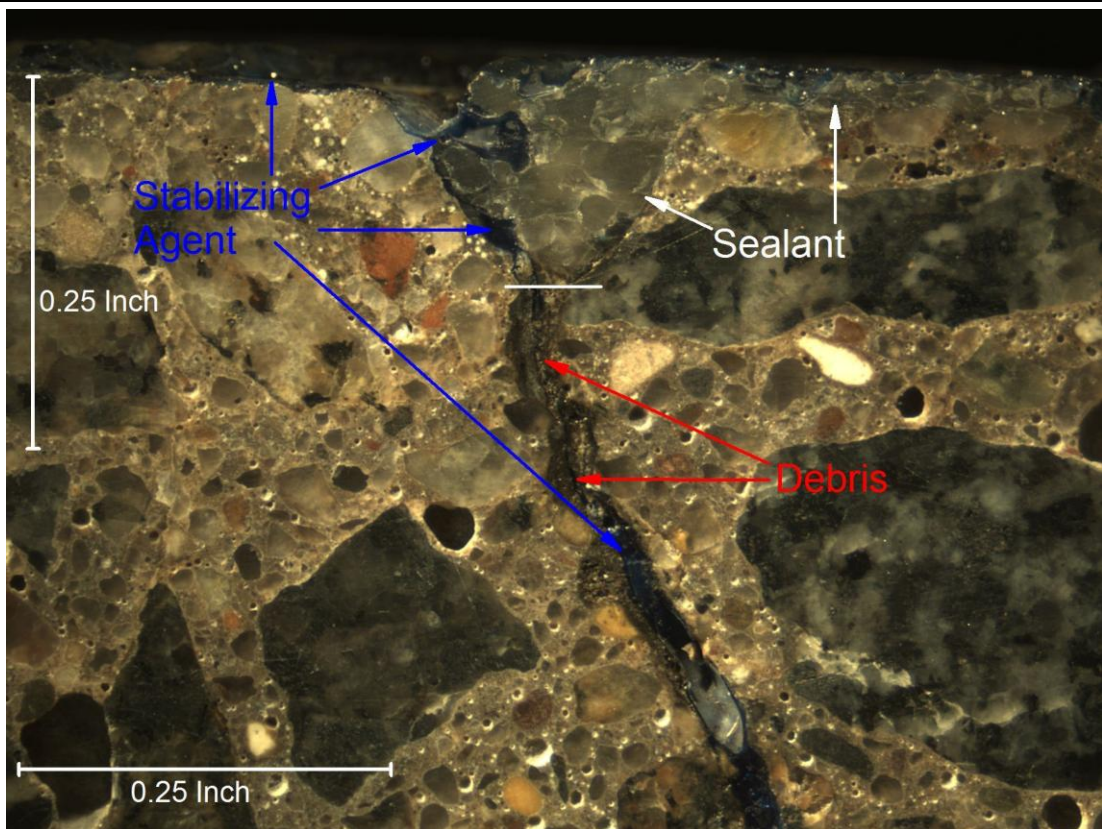
Core #: 23A
 Subject: Test Section 10, Test 23A – Sikadur 55 SLV
 Comments: Depth of Maximum Penetration is 0.135 in. White horizontal line marks the approx. depth of sealant.

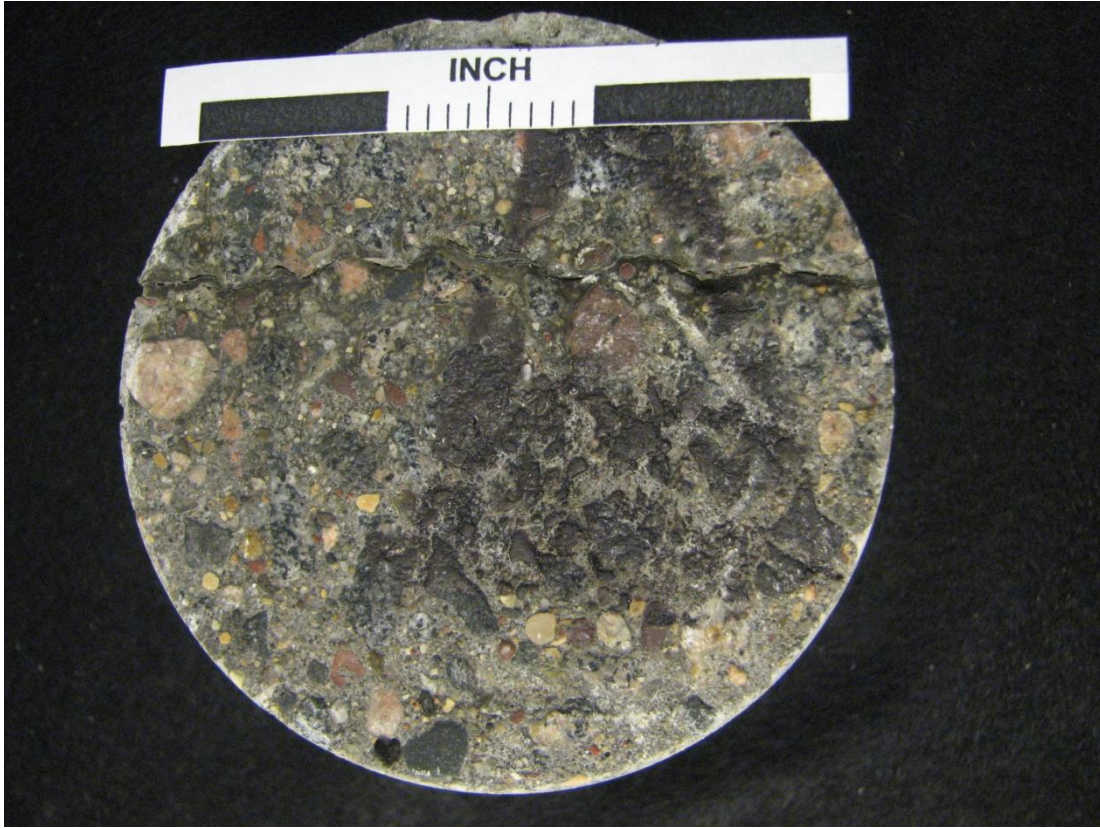
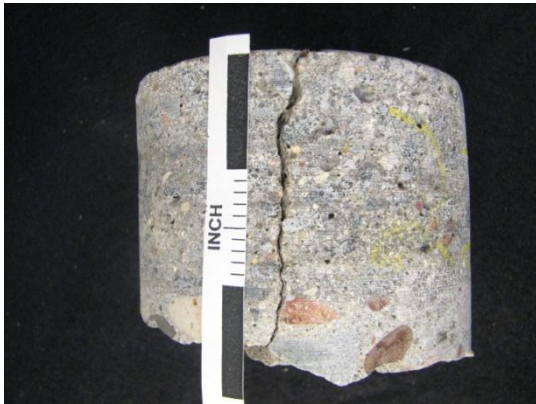
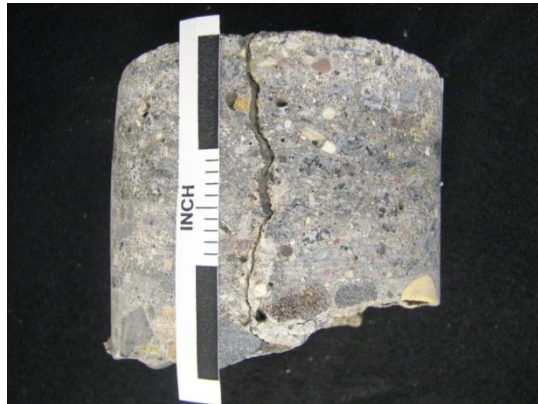
Core #: 22B
Subject: Test Section 11, Test 22B, Paulco TE-3008-1
Location: Smith Avenue High Bridge

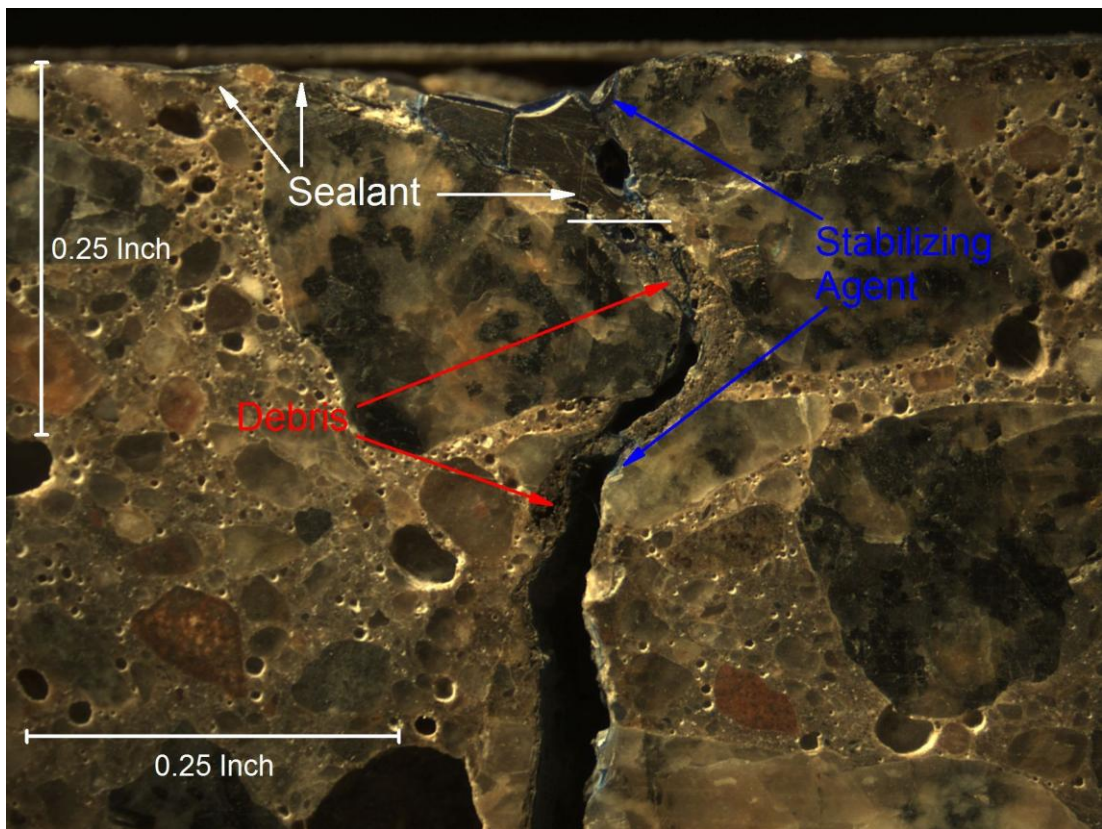
Core #: 22B
 Subject: Test Section 11, Test 22B, Paulco TE-3008-1
 Comments: Depth of Maximum Penetration is 0.113 in. White horizontal line marks the approx. depth of sealant.

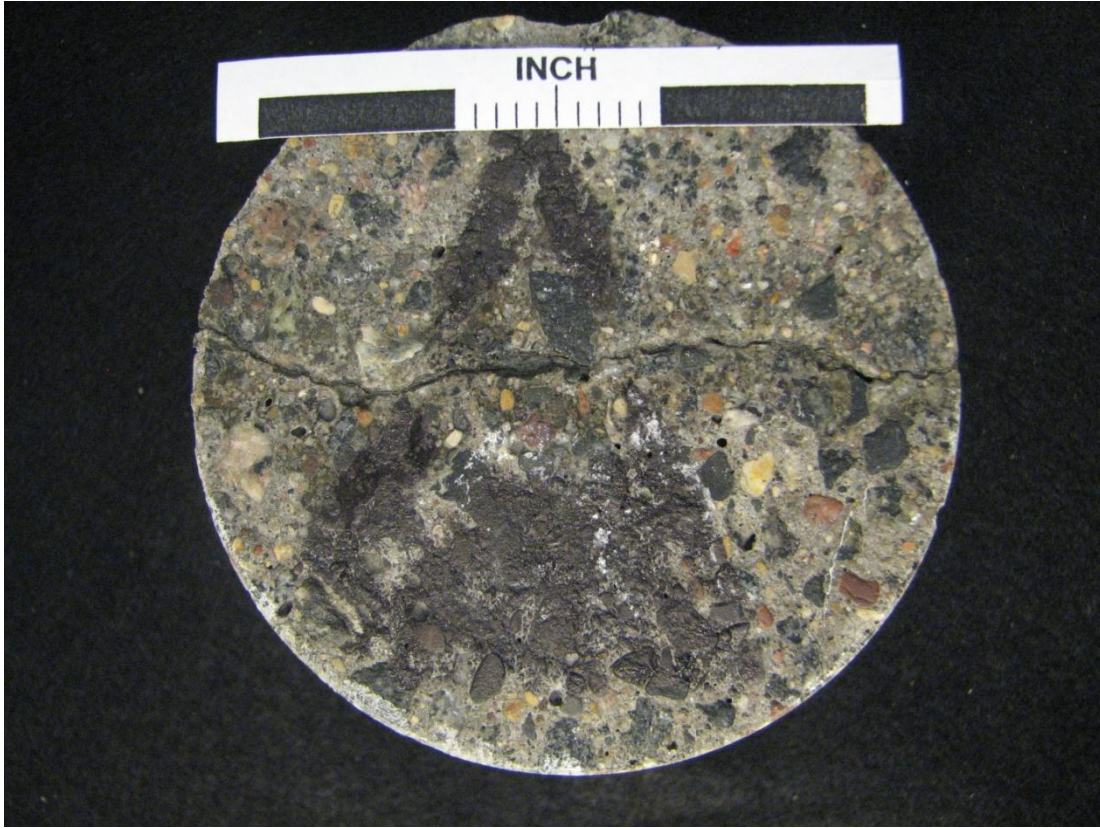
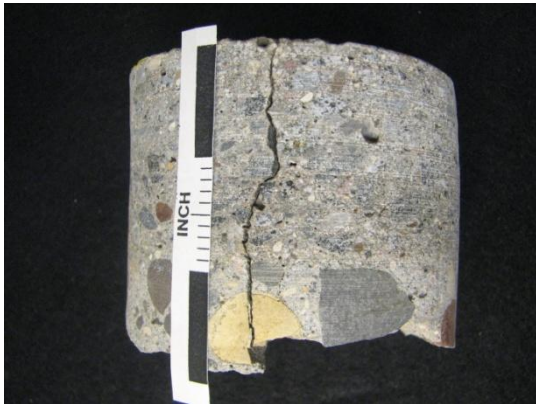
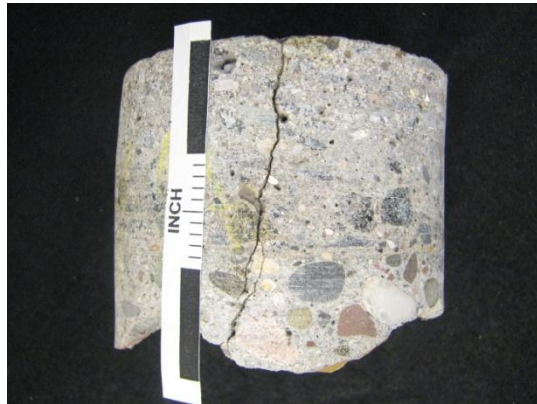
Core #: 34A

Subject: Test Section 11, Test 34A, Paulco TE-3008-1

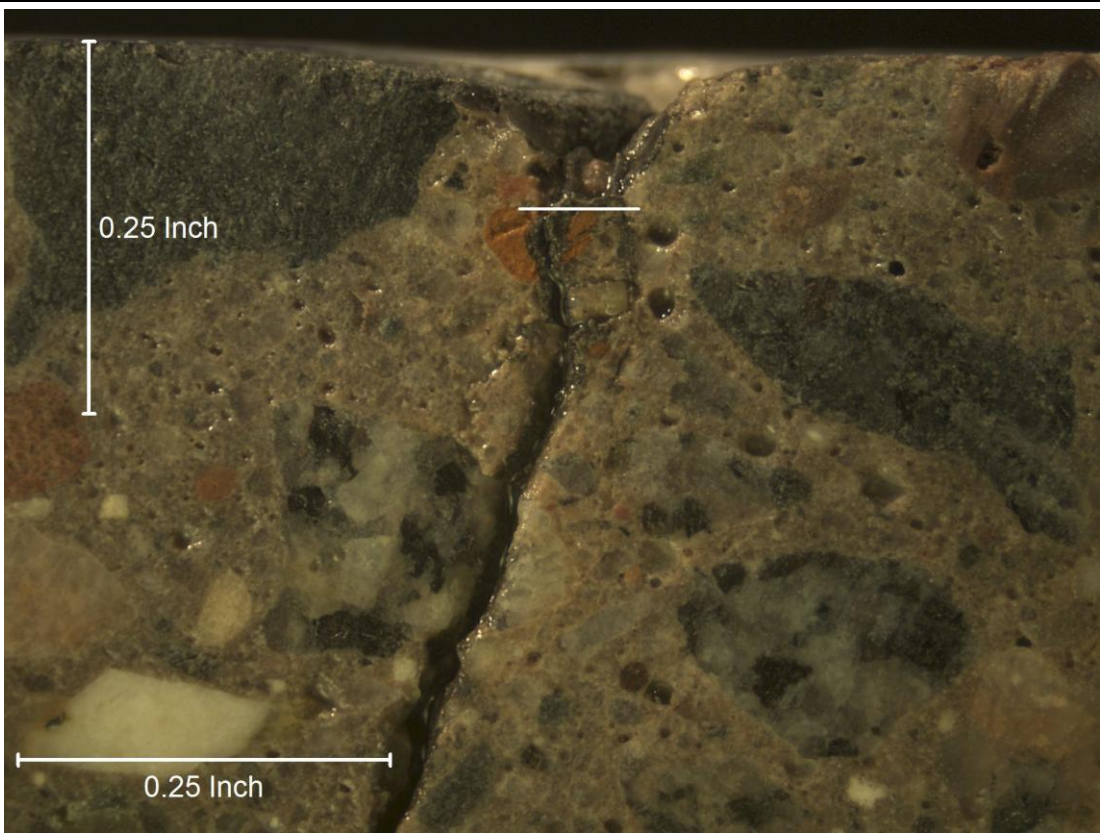
Core #: 34A
 Subject: Test Section 11, Test 34A, Paulco TE-3008-1
 Notes: Depth of Maximum Penetration is 0.111 in. White horizontal line marks the approx. depth of sealant.

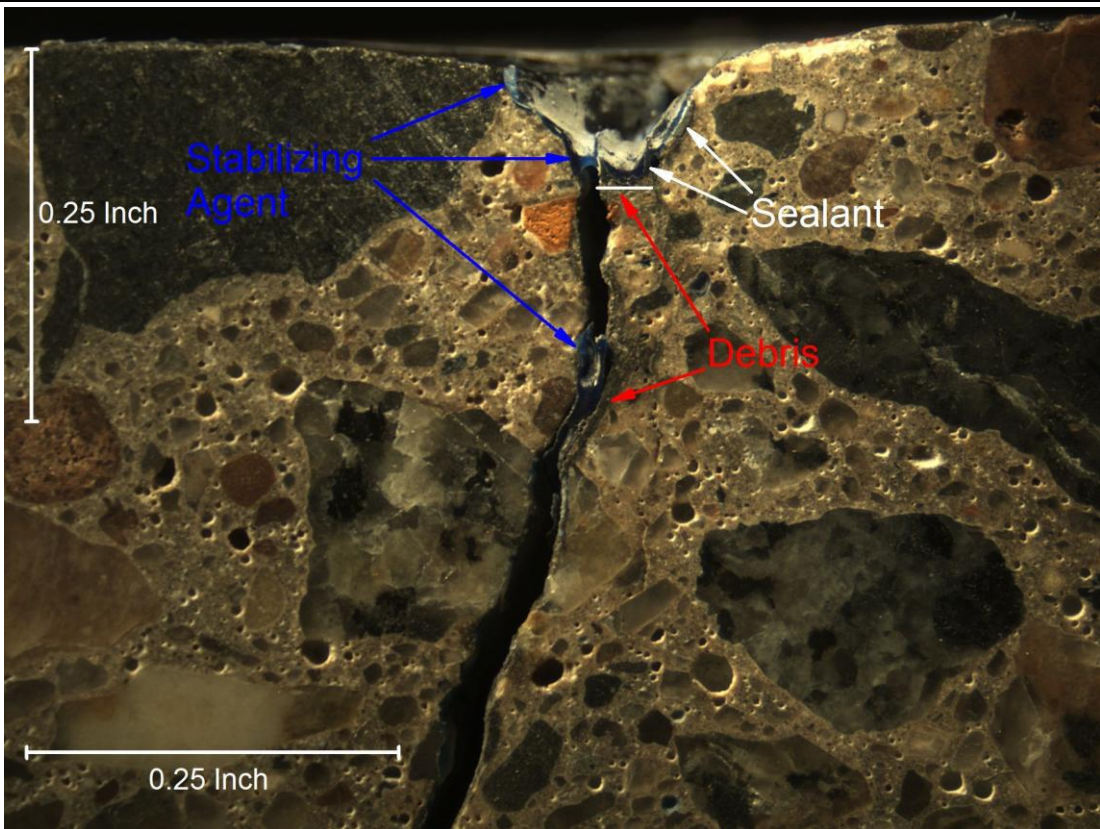
Core #: 34A
 Subject: Test Section 11, Test 34A, Paulco TE-3008-1
 Comments: Depth of Maximum Penetration is 0.113 in. White horizontal line marks the approx. depth of sealant.

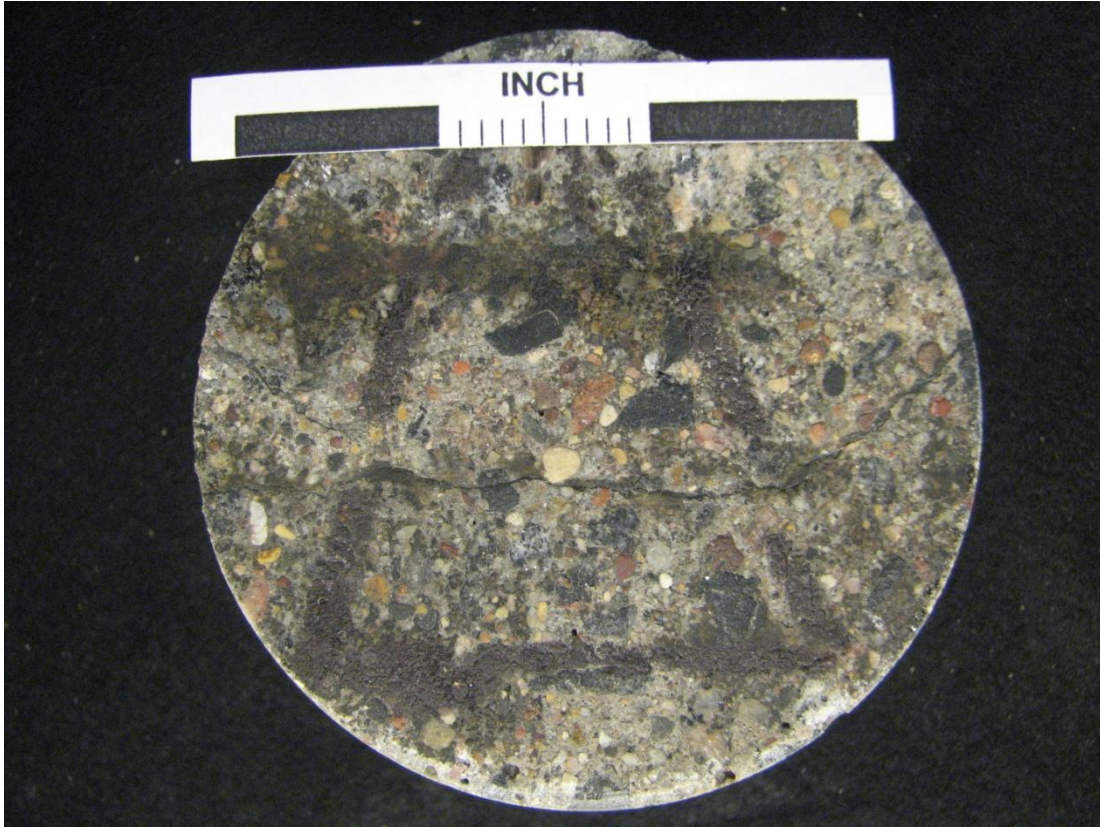
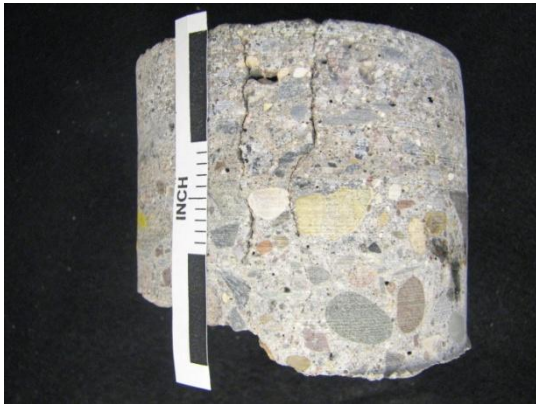
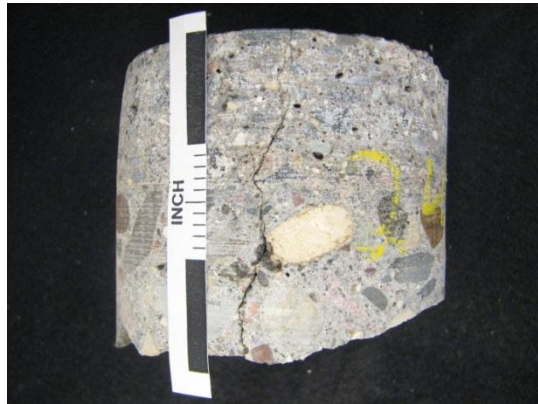
Core #:	24A	Project BL-09-03973
Subject:	Test Section 12, Test 24A – Paulco TE-2501	
Location:	Smith Avenue High Bridge	
Notes:	Top photo is the top surface of the core. The direction of traffic flow is towards the top of photo. Bottom two photos are the left and right side of the core when viewed in the direction of traffic flow.

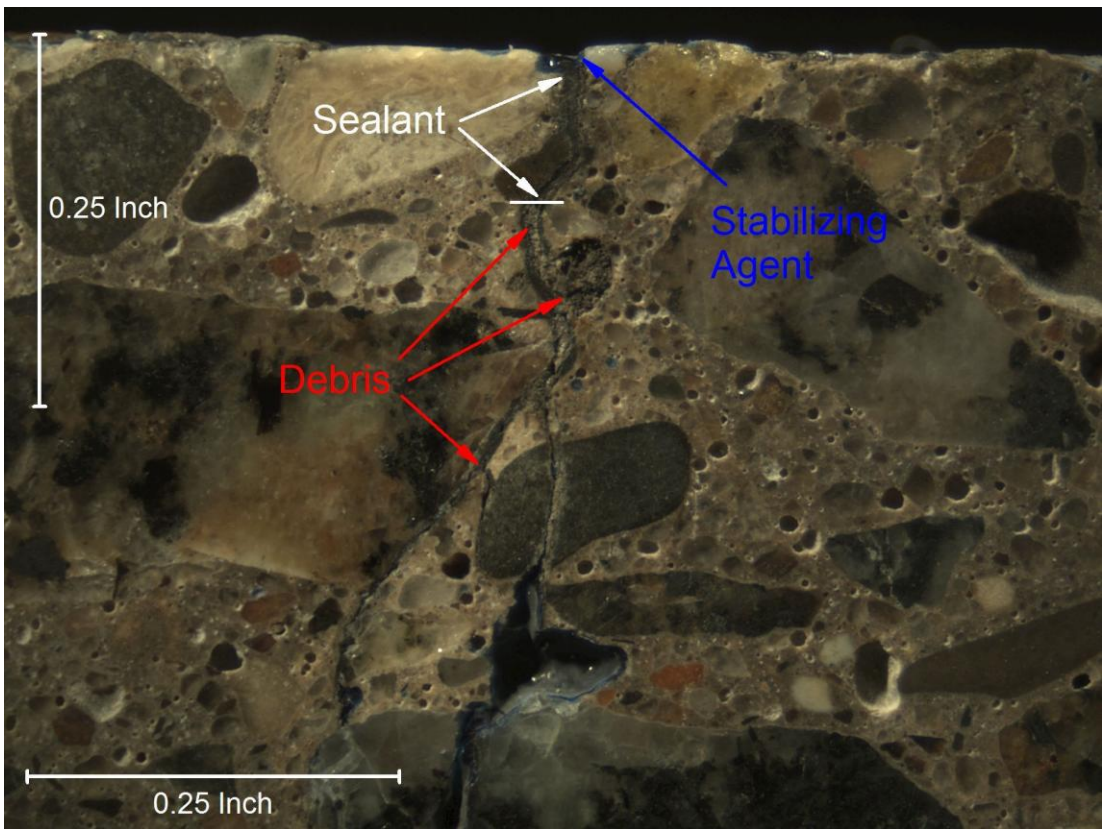
Core #: 24A
 Subject: Test Section 12, Test 24A – Paulco TE-2501
 Comments: Depth of Maximum Penetration is 0.108 in. White horizontal line marks the approx. depth of sealant.

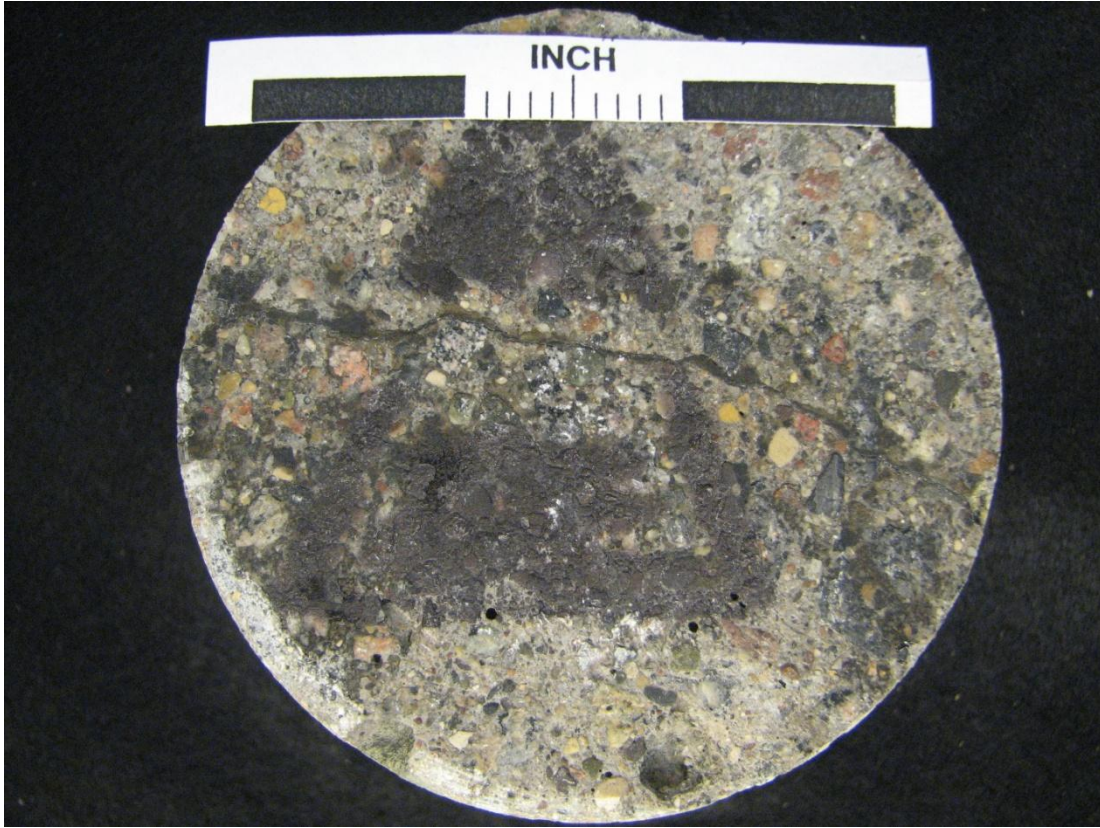
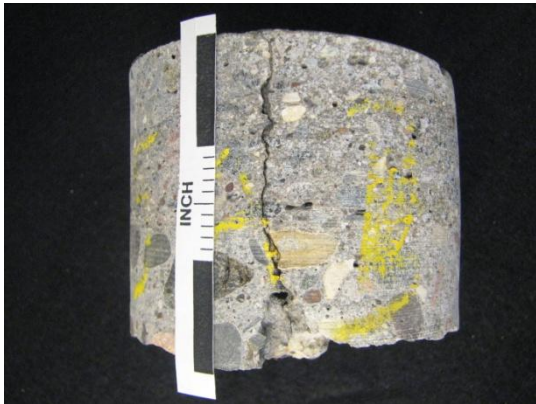
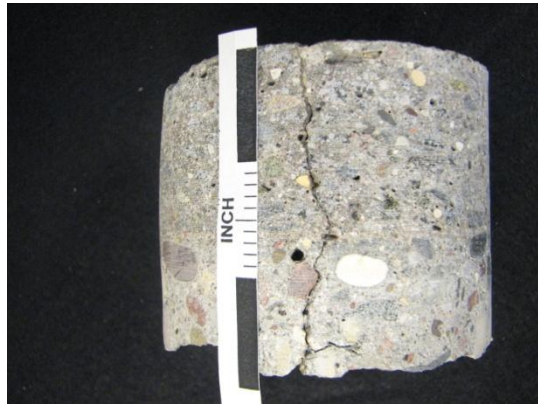
Core #: 35A

Subject: Test Section 12, Test 35A – Paulco TE-2501

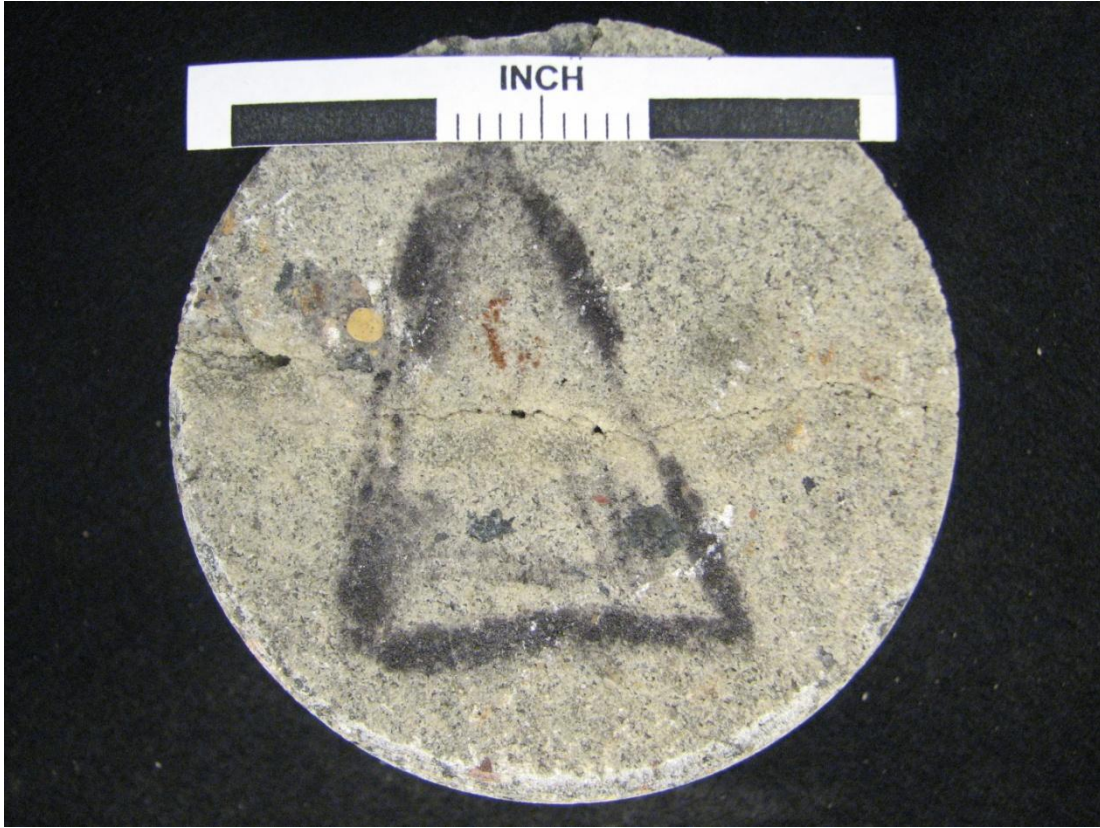
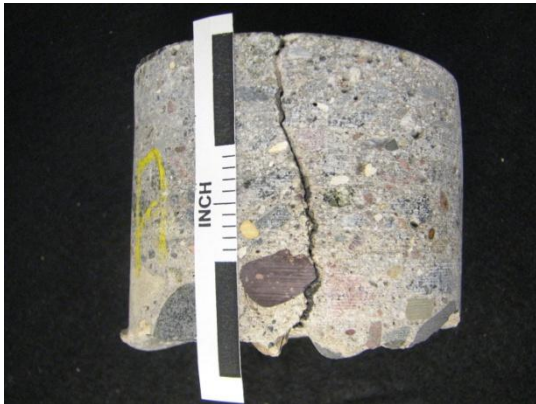
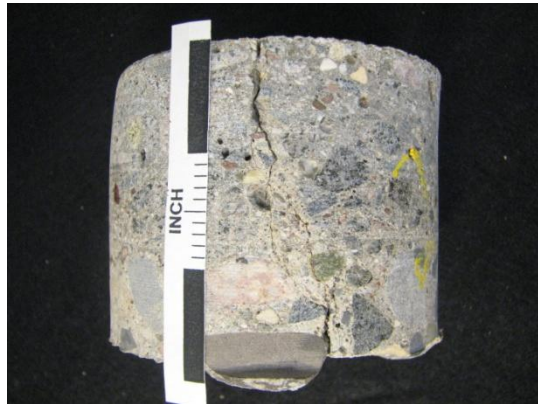
Core #: 25A

Subject: Test Section 13, Test 25A – Euclid, Dural 50 LM

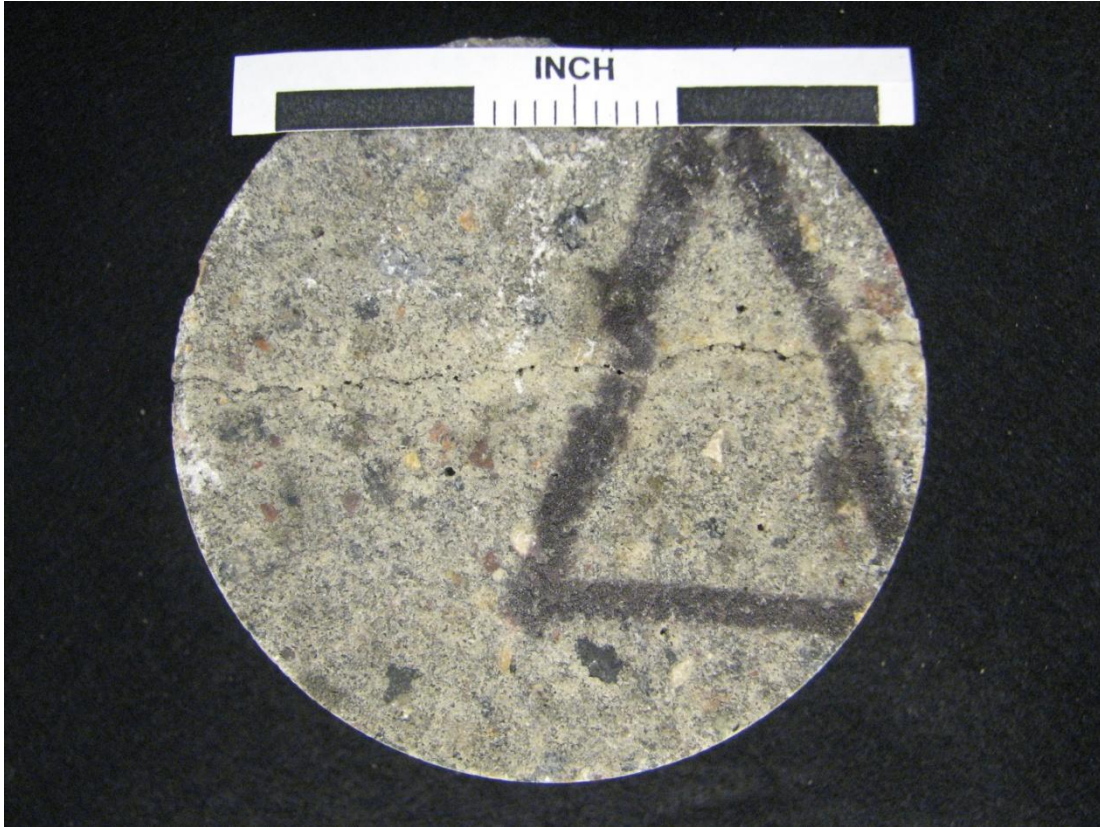
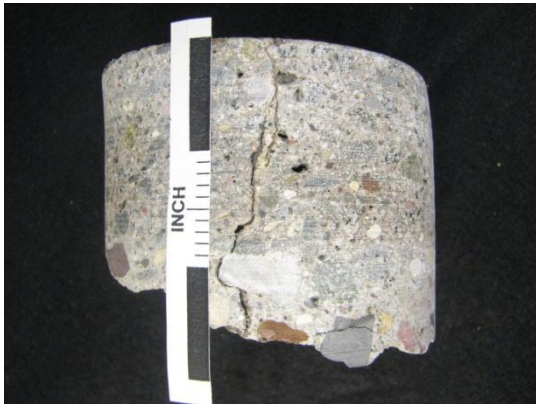
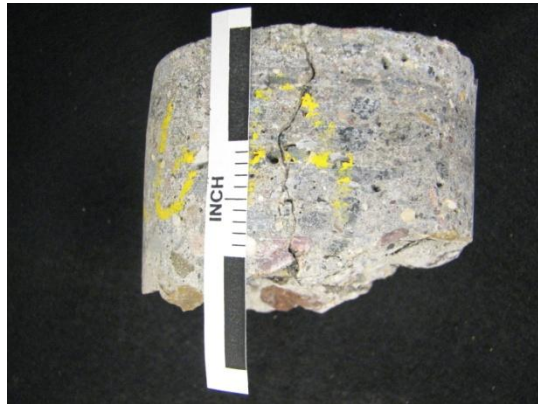
Core #: 26A

Subject: Test Section 13, Test 26A – Euclid, Dural 50 LM

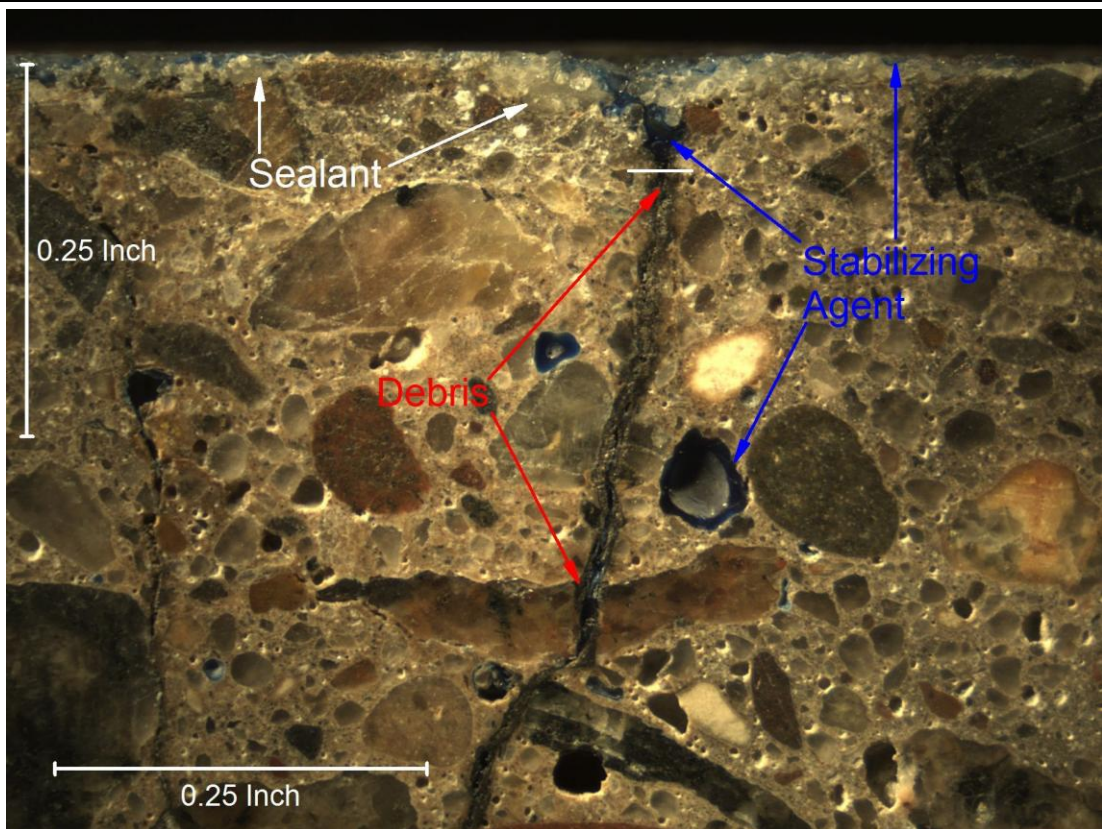
Core #: 26A
 Subject: Test Section 13, Test 26A – Euclid, Dural 50 LM
 Comments: Depth of Maximum Penetration is 0.066 in. White horizontal line marks the approx. depth of sealant.

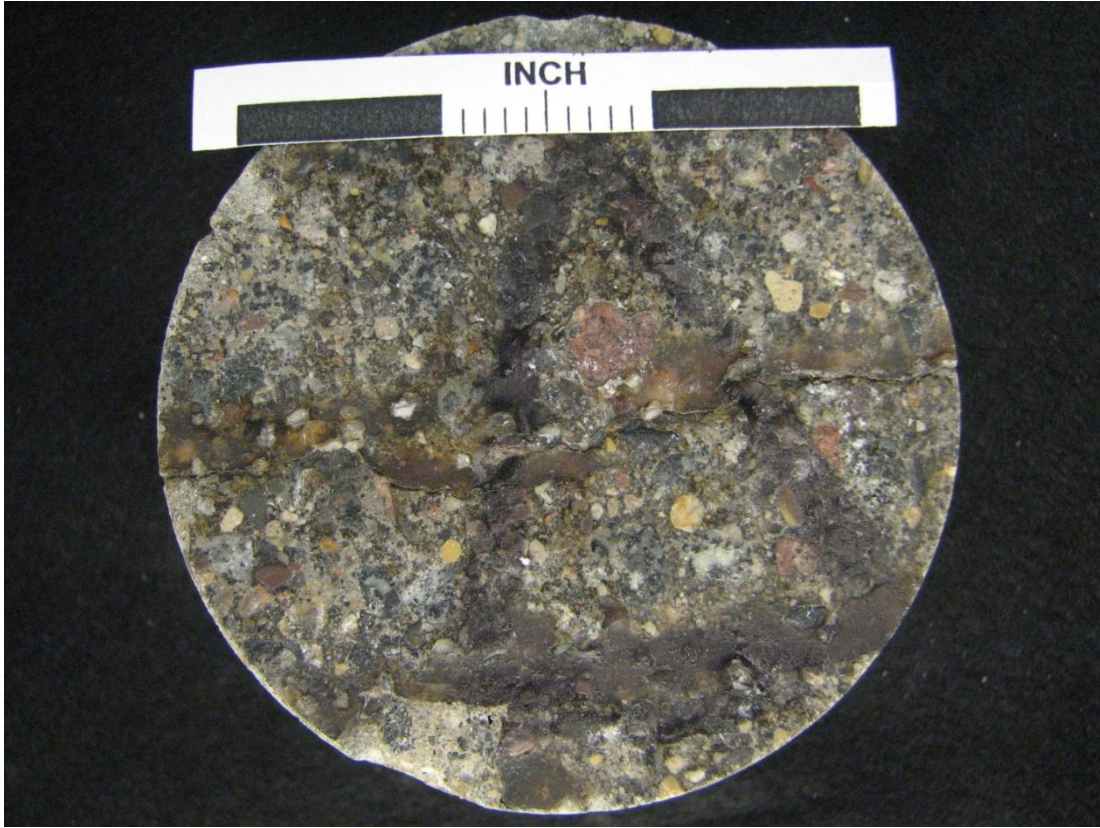
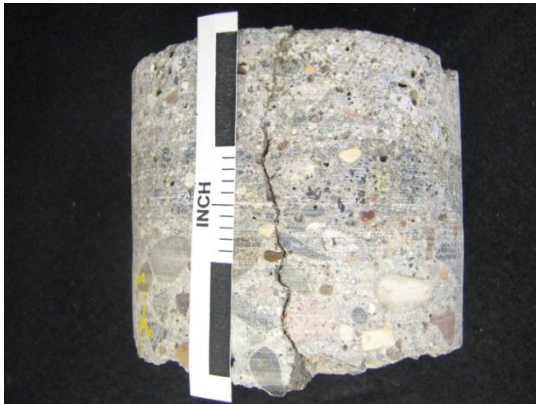
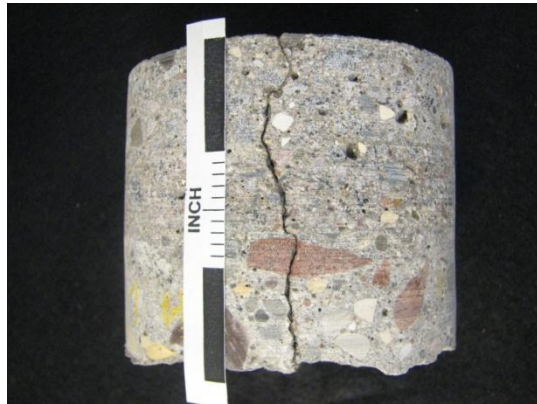
Core #: 27A
Subject: Test Section 14, Test 27A – Transpo T-70, MX-30
Location: Smith Avenue High Bridge
Notes: Top photo is the top surface of the core. The direction of traffic flow is towards the top of photo. Bottom two photos are the left and right side of the core when viewed in the direction of traffic flow.

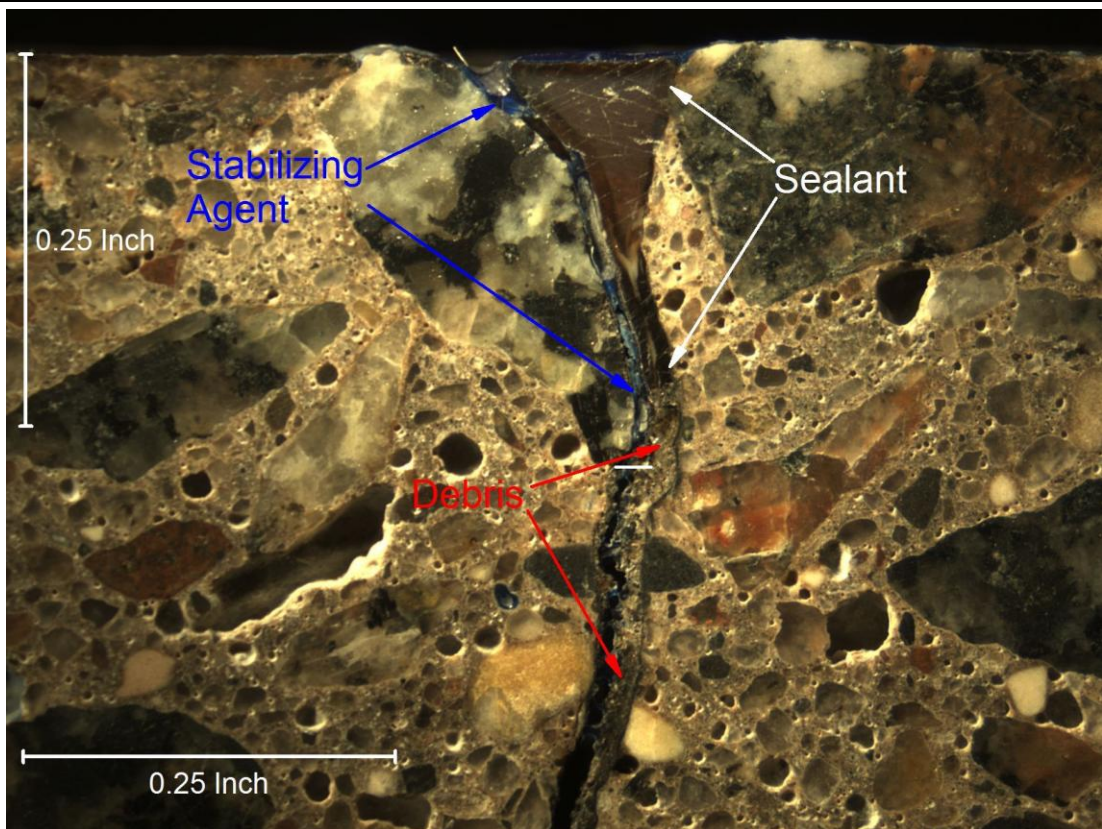
Core #: 27A
 Subject: Test Section 14, Test 27A – Transpo T-70, MX-30
 Comments: Depth of Maximum Penetration is 0.299 in. White horizontal line marks the approx. depth of sealant.
