Concrete Bridge Deck Crack Sealant Evaluation and Implementation

Minnesota
Department of
Transportation

Matthew S. Oman, Principal Investigator
Braun Intertec Corporation

Research Project
Final Report 2014-34

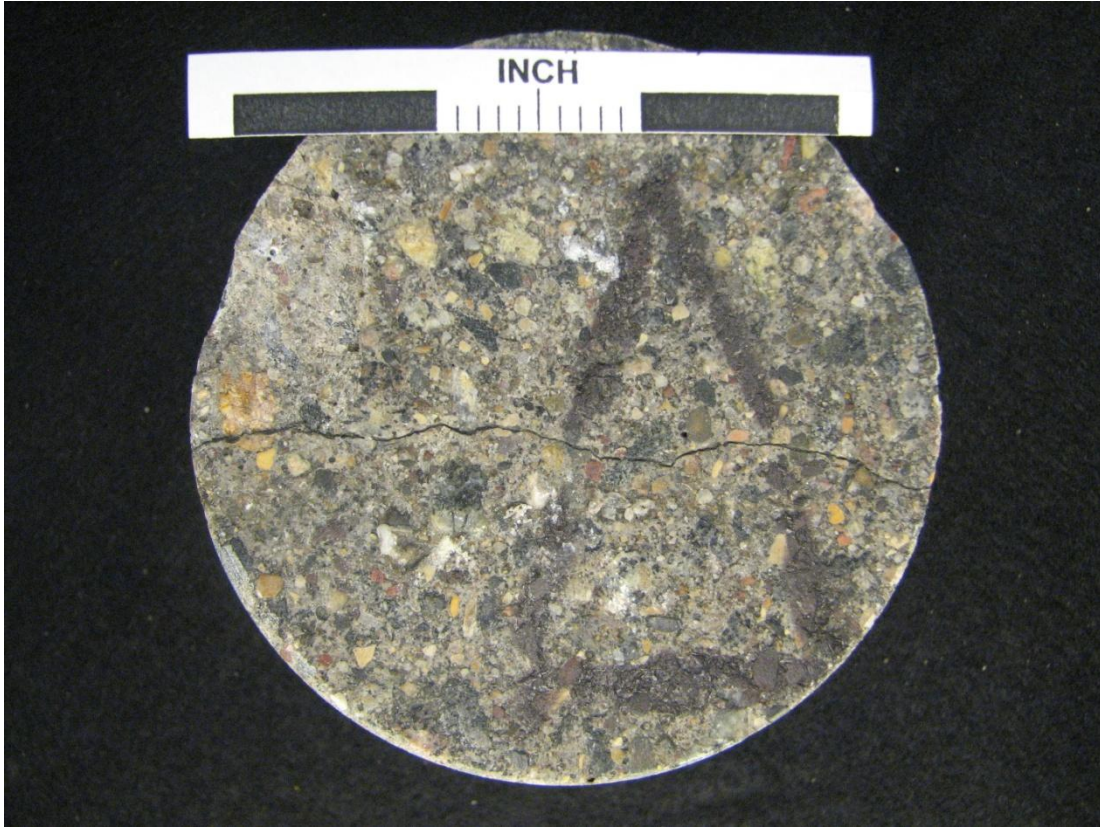
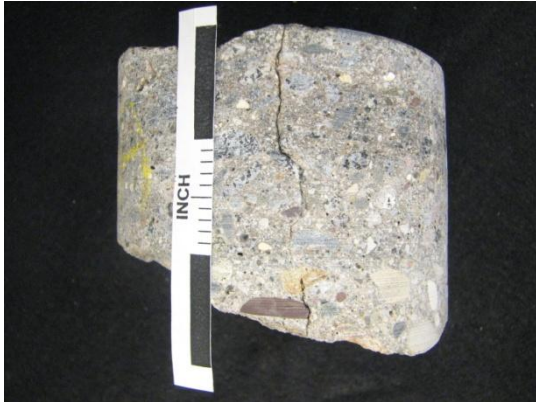
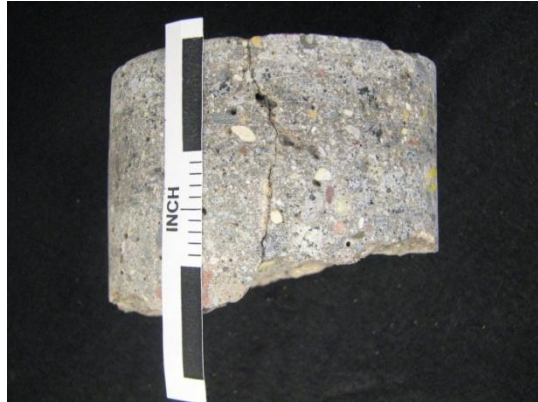
Core #: 28A
Subject: Test Section 14, Test 28A – Transpo T-70, MX-30
Location: Smith Avenue High Bridge
Notes: Top photo is the top surface of the core. The direction of traffic flow is towards the top of photo. Bottom two photos are the left and right side of the core when viewed in the direction of traffic flow.

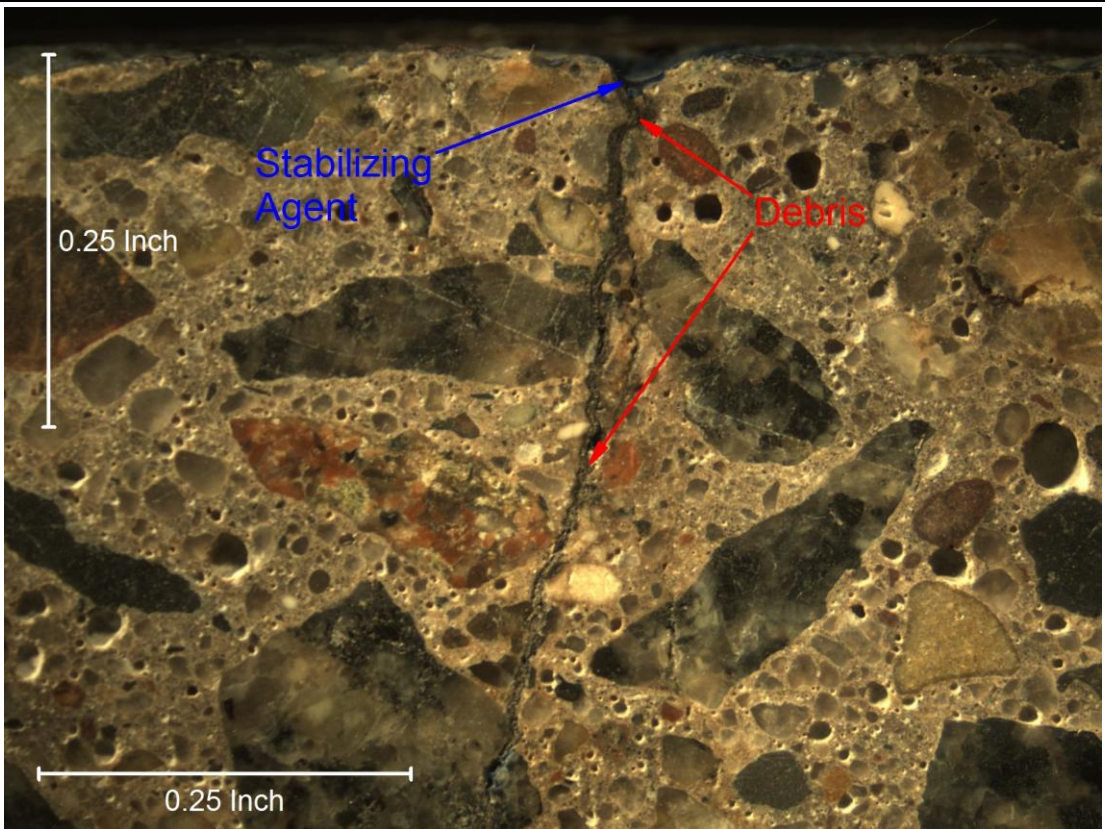
Core #: 28A
Subject: Test Section 14, Test 28A – Transpo T-70, MX-30
Comments: Depth of Maximum Penetration is 0.000 in.
