Minnesota
Department of
Transportation

Scour Monitoring Technology Implementation

September 2014

Research Project
Final Report 2014-37

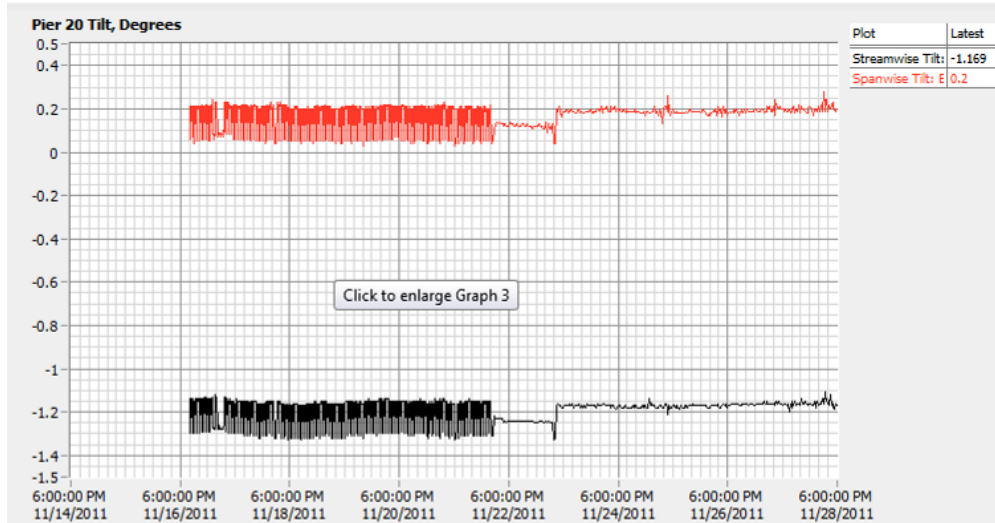
Figure 18: Bridge 5900 - Pier 20 Tilt Signals Before and After Programming Fix

The second issue was the noise on both the tilt sensor and the voltage reading. The noise was likely due to the cellular modem operation. This can be seen in Figure 18 where the signal is more noisy prior to the 11/22 reprogramming. The programming fix was to make these readings at times when the cellular modem was turned off. This may be due to poor wiring and could likely be resolved by rewiring making sure to remove any stray connections.

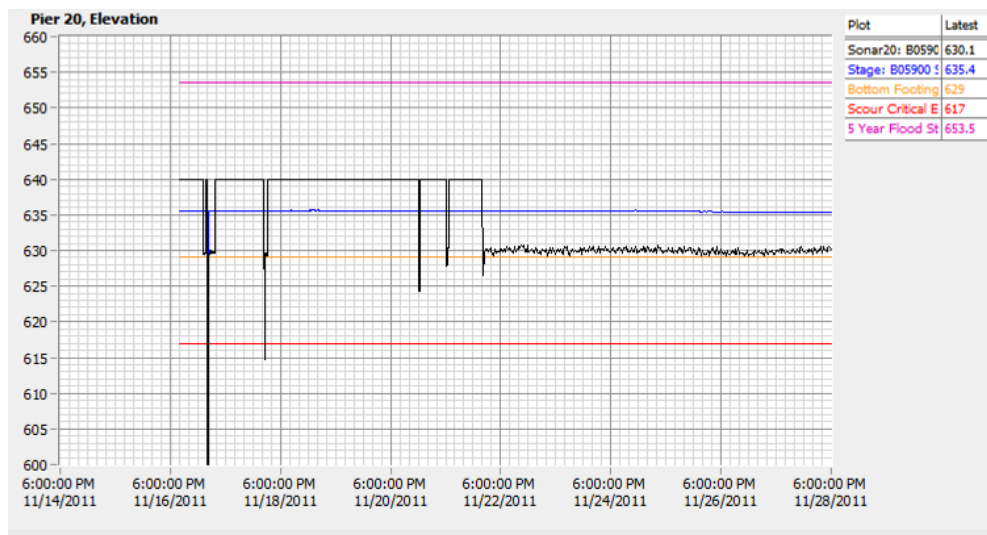
Figure 19: Bridge 5900 - Pier 20 Sonar Signal Before and After Programming Fix

The biggest issue to resolve was the incorrect wiring issues on the Bridge 5900 Master Station. The issue was the sonar and cellular modems appeared to be powered together rather than individually. Both are powered off when the modem is not turned on. The programming fix made the sonar readings while the cellular modem was turned on and powered up. This can be seen in Figure 19 which shows that sonar readings are correct and stable after the 11/22 reprogramming. Prior to this, the readings were typically 640 ft because the elevation offset in the program and the output is 0 while the sensor is powered down. The correct readings prior to the reprogramming relate to time when the sonar and cellular modem happened to be powered on simultaneously.

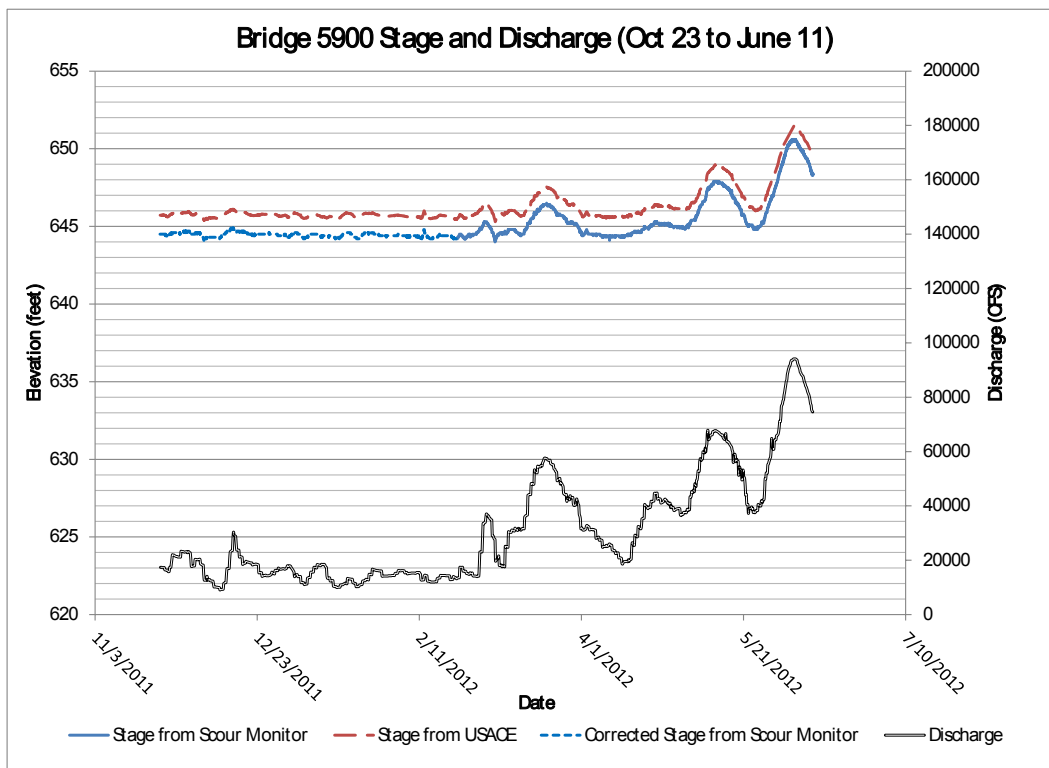
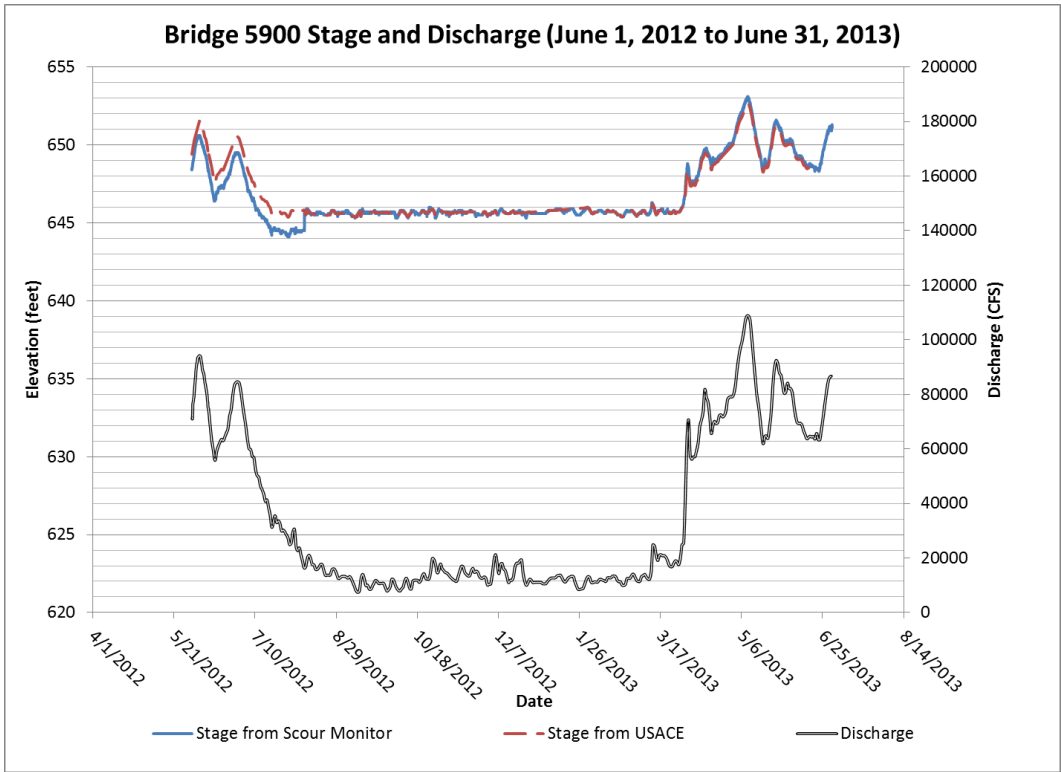
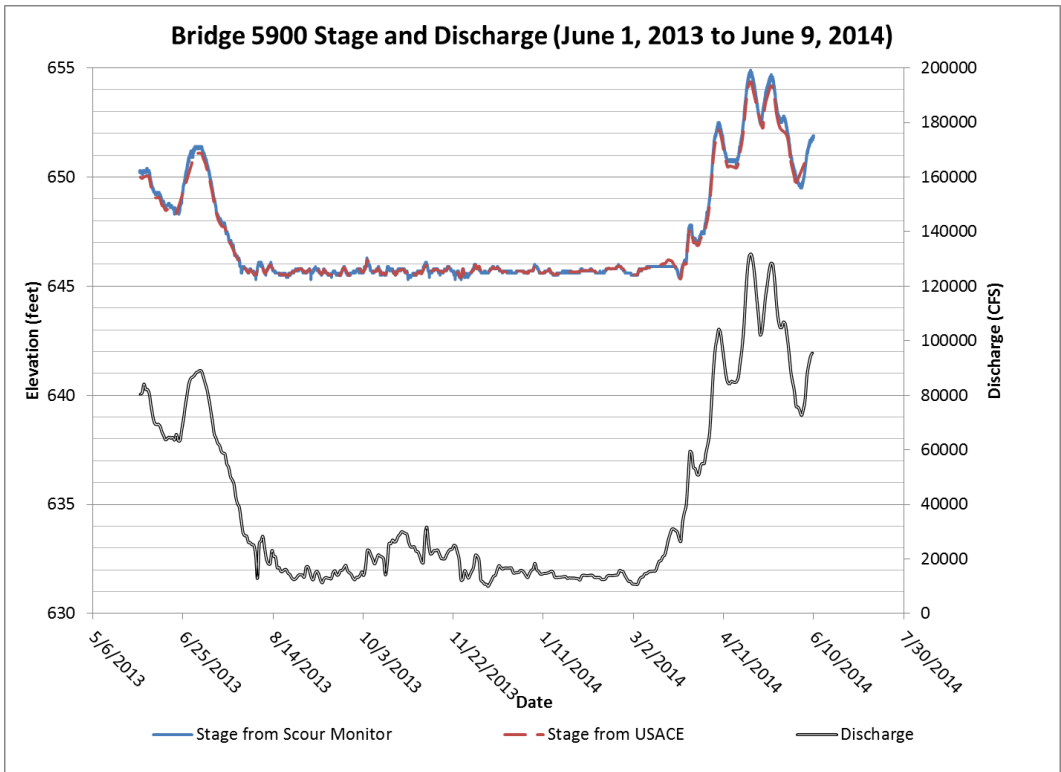
Figure 27, Figure 28, and Figure 29 show the discharge and stage from a local USACE monitoring station and from the scour monitoring equipment. The stage sensor on the Bridge 5900 system is a pressure sensor located a few inches from the front edge of the Pier 19. The USACE gauge is located on the Minnesota side of the river approximately 700 ft downstream of the bridge and uses MSL 1912 as a datum.

- The programmed sensor elevation is 640 and the actual is 640.75 ft based on NGVD 1929.
- Bridge 5900 is likely built with the NGVD 1929 datum and USACE report with the MSL 1912 datum. The 1929 datum is 0.5 ft below the 1912 datum near Winona.

The system was reprogrammed with a stage sensor elevation of 641.25 ft to use the MSL 1912 datum.

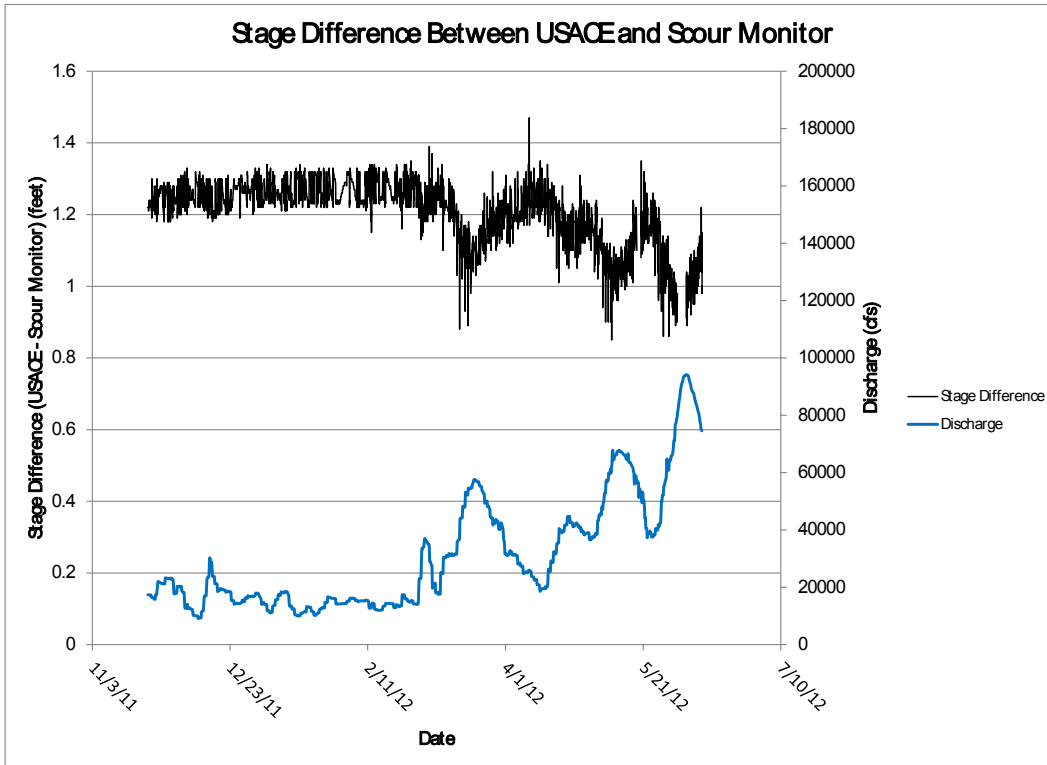
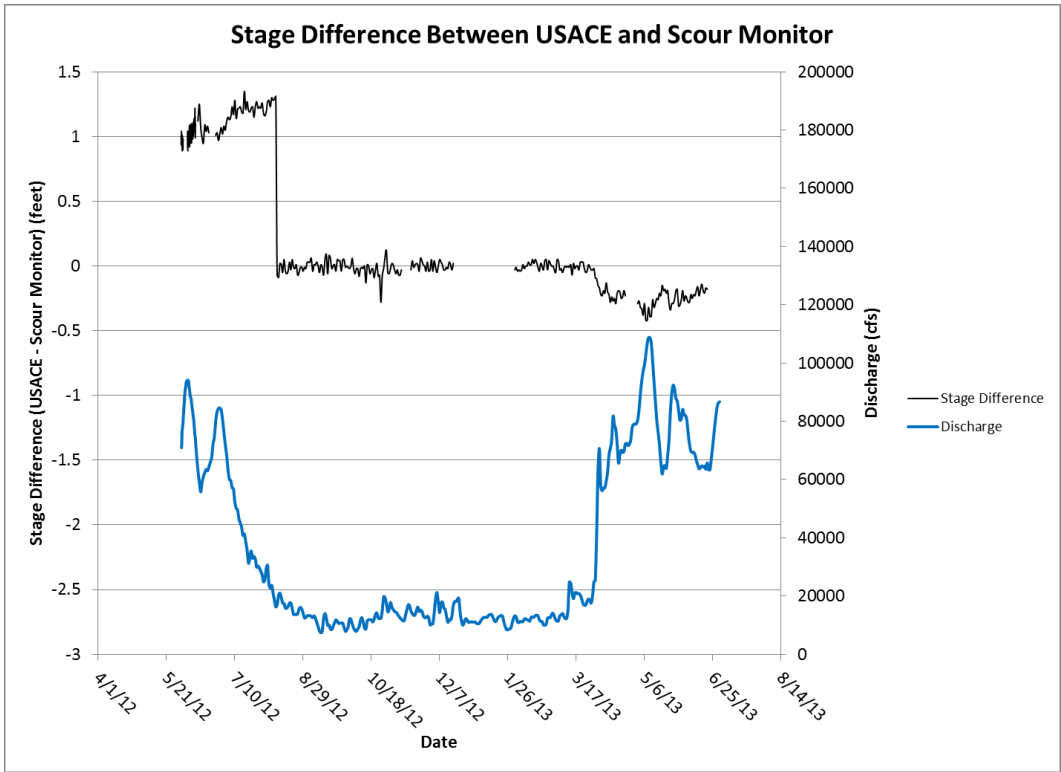
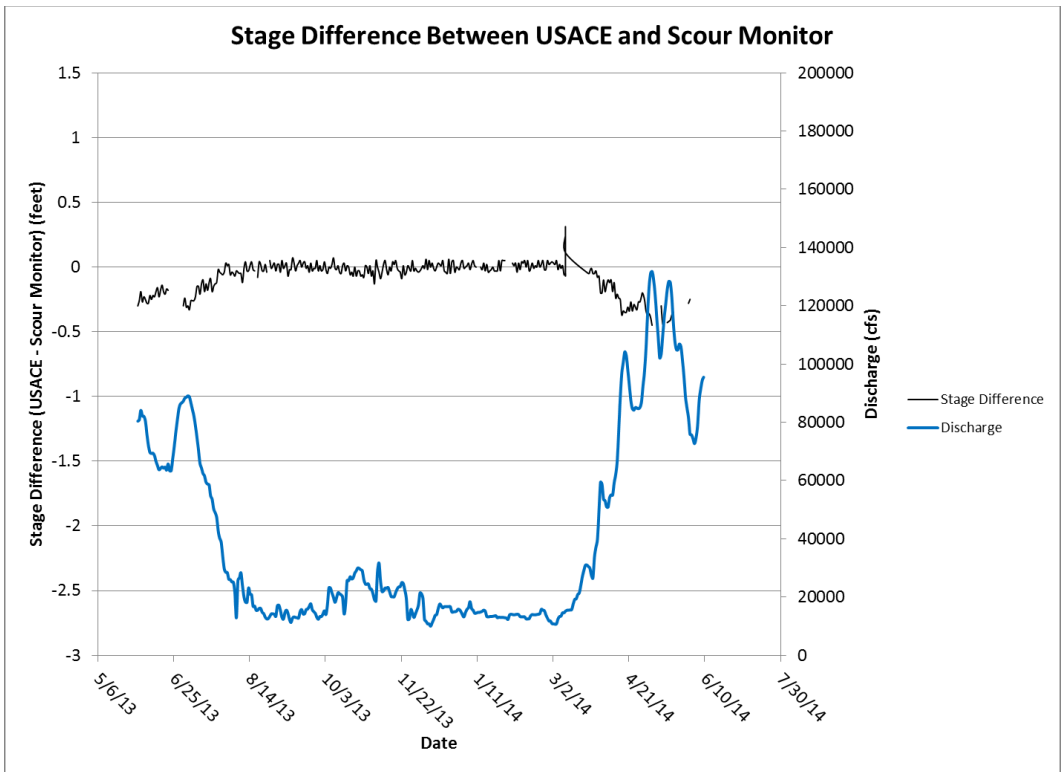
Figure 30, Figure 31, and Figure 32 show the stage difference between the stages recorded by the scour monitoring equipment and the USACE stage sensor and also shows

the river discharge. At higher discharges, the stage deviates because of slightly higher water surface elevations at the upstream profile of the pier where the stage measurement is taken.

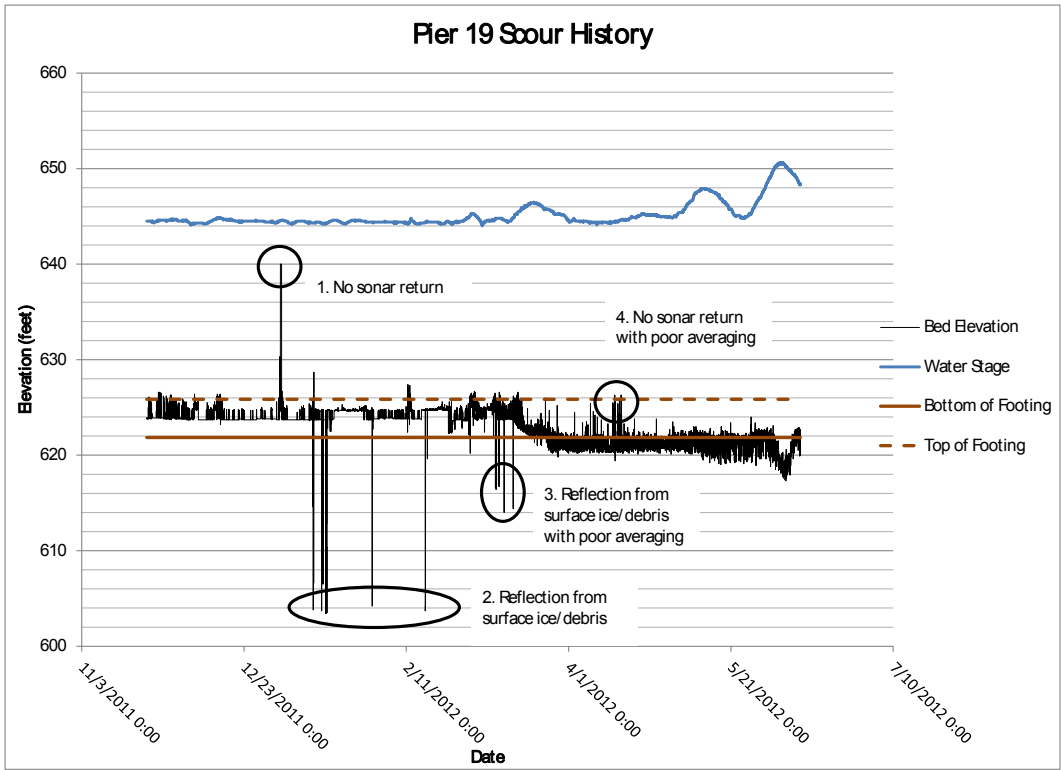
Figure 34: Pier 19 Scour History - Administration 2011-2012

Figure 34 shows the scour around Pier 19 from Oct 23 to June 11. There are a few false spikes in the dataset along with some significant scour events that occurred.

The major false readings during 2011-2012 administration, highlighted as 1 through 4 in Figure 34 are due to one of the following three items.

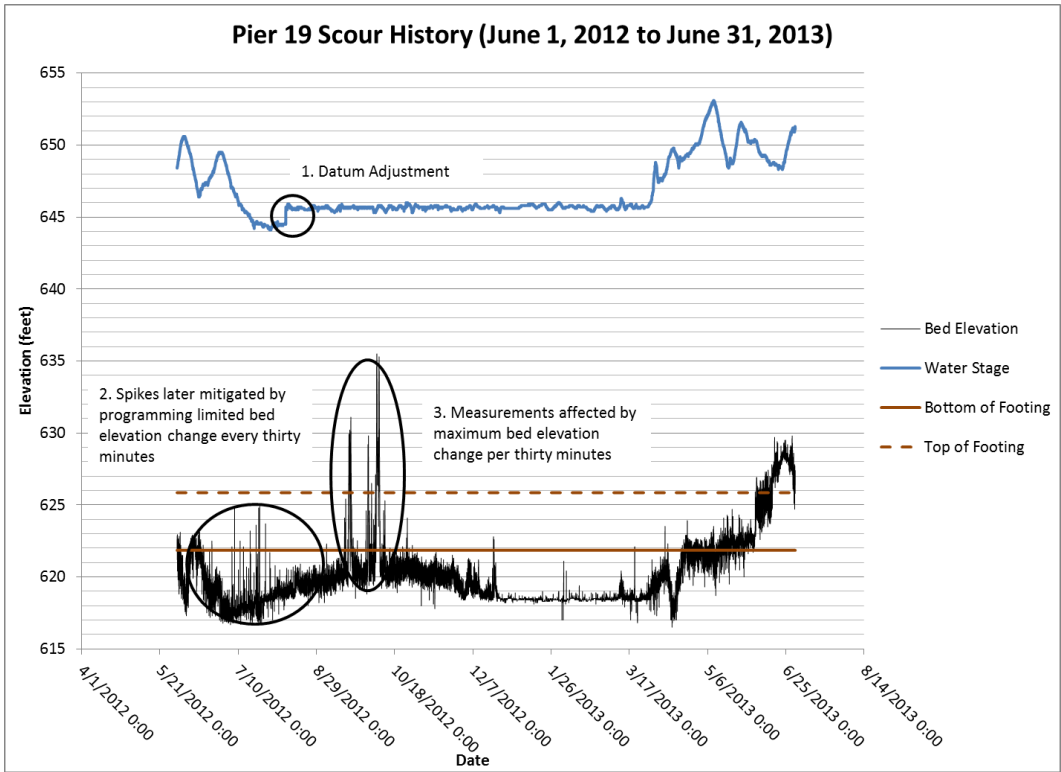
Figure 35: Pier 19 Scour History - Administration 2012-2013

Figure 35 shows the scour around Pier 19 from 6/1/2012 to 6/30/2013. The spikes in the data set abruptly stop after the 8/9/2012 reprogramming. The resulting bed elevation shows a smoother bed elevation time series dataset, but the artifacts due to the maximum inter sample bed elevation change are also noticeable.

The spikes from 7/6/2012 to 8/5/2012, indicated by circle 2 in Figure 35, are likely due to no sonar returns on some, but not all of the eight readings that are used to calculate the reported bed elevation. From the magnitude of the spikes, about one to three of the eight samples averaged appear to have been samples with no sonar return. The spikes were mitigated by the 8/9/2012 reprogramming.

The spikes from 9/16/2012 to 10/11/2012, indicated by circle 3 in the Figure 35, are due to an abrupt, but constant change in elevation as read by the sonar. These readings are heavily affected by limited maximum change in bed elevation allowed in reprogramming. This is evident by the step change of one foot every sample period over the course of about ten sample periods, or five hours for the largest spike. The cause of these spikes is unknown due to the fact that reprogramming limiting the change in bed elevation between samples.

Bed degradation and aggradation from 6/1/2012 to 6/10/2012 corresponds with a spring runoff peak. This event lowered the local bed from the elevation of the bottom of the footing (622 ft) to 618 ft and then quickly refilled back to the bottom footing elevation. The discharge of this peak was 92,000 cfs and was the greatest peak on the Spring 2012 runoff hydrograph.

The last Spring 2012 peak occurred on 6/30/2012. This event caused an abrupt degradation followed by a very slow aggradation which occurred from 6/11/2012 to 8/16/2012. The bed elevation dropped from 622 ft to 617 ft, then aggraded back to 620 ft. The tail of the hydrograph ends approximately at approximately 8/2012 at a discharge of 10,000 cfs.

Degradation started again 10/28/2012 due a series of small peaks from 10/17/2012 to 12/23/2012. The local bed elevation on 12/23/2013 was 618.5 ft and this was maintained until Spring 2013 runoff events.

Spring 2013 runoff events brought initial aggradation before degrading to 618 ft at the second peak of the hydrograph on 4/13/2013. From this point, the bed aggraded to 629 ft on 6/23/2012 although two higher peaks than the 4/13/2013 peak occurred during this time. A possible reason for this aggradation could be operation of the downstream dam.

To reduce spikes in sonar data, reprogramming on 8/9/2012 caused the maximum change in bed elevation to be one foot if the sonar reads an elevation change of two feet or greater over its 30 minute sample period. . This causes some artifacts to be present in the data when there is an abrupt change in bed elevation. The current programing calculates sonar distance by taking ten readings, removing the minimum and maximum, and averaging the remaining eight samples. Most erroneous readings are due to no sonar return and false returns from the sonar return taking an additional ping from the surface due to ice or other debris. To remedy this, we propose the following pseudocode.

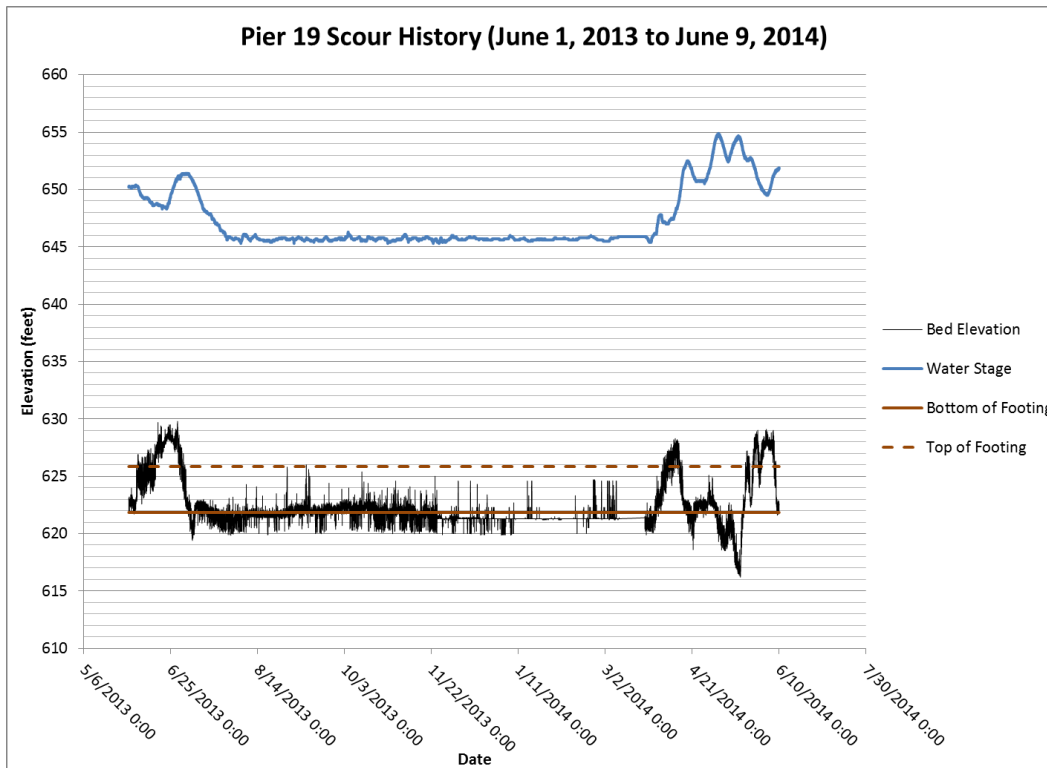
Figure 36: Pier 19 Scour History - Administration 2013-2014

Figure 36 shows the scour around Pier 19 from 6/1/2013 to 6/9/2014. The bed elevation stayed around the elevation of the bottom of the footing with the exception of the Spring 2014 runoff event. The initial Spring hydrograph caused aggradation which was quickly eroded during the rising limb of the first peak which occurred on 4/18/2014. The local bed elevation eroded to the elevation of the bottom of the footing. The peaks occurring on 5/6/2014 and 5/18/2014 generally caused degradation during the rising limb and aggradation during the falling limb. The lowest local bed elevation was occurred during the slightly lower discharge 5/18/2014 peak. This elevation was 616.5 ft and was the lowest recorded local bed elevation during the 3-year monitoring period.

The 2014 Spring runoff caused initial local aggradation from 621 ft to 627 ft. This local maximum bed elevation occurred a few days after the 4/2/2014 peak of 59,400 cfs. The bed elevation again quickly degraded back to 621 ft over nine days. This minimum bed elevation correlates in time to the 4/19/2014 peak of 103,000 cfs. The 5/16/2014 peak of 132,000 cfs caused the bed to degrade from 622.5 ft to a minimum bed elevation of 620 ft. The bed was starting to aggrade until the rising limb of the 5/18/2014 peak caused it to degrade. During the 5/18/20014 peak of 128,000 cfs, the local bed degraded to a level of 616.5 ft and then quickly aggraded to an elevation of 626 ft. Since this aggradation, some minor changes to local bed elevation have occurred. As of 6/9/2014, the local bed elevation has settled at 622.5 ft, the approximate elevation of the bottom of the footing.

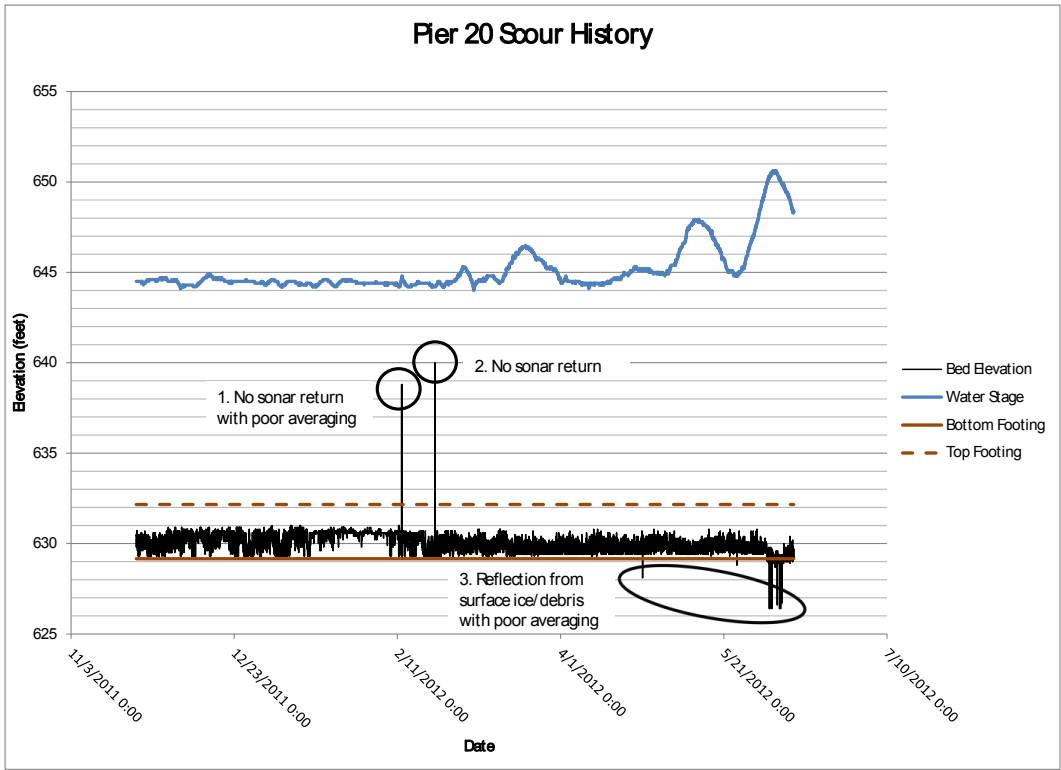
Figure 37: Pier 20 Scour History – Administration 2011-2012

During 2011-2012 administration, the false readings at Pier 20 were likely due to the same causes as with Pier 19. Refer back to Section 6.1.2.1 for a description of these causes.

Overall during 2011-2012 administration, the bed at pier 20 was very constant with few fluctuations during the time frame shown in Figure 37. Over the entire period the bed varied by less than +/- 1 foot. Also, with the exception of the 6/2/2012 event, the data set appears to hit a minimum of 629.6 ft. This is about 0.4 ft above the bottom of the footing and likely has to do with the scour at the front edge of the pier stopping at the bottom of the footing. This same discontinuity in the progression of scour was found at Pier 19. During the 6/2/2012 scour event, the scour did increase until 80,000 cfs. At this point, the scour lowered the bed elevation by about 6 inches, but quickly refilled as the discharge fell back down.

Similar programming modifications as pier 19 are recommended. See Section 6.1.2.3

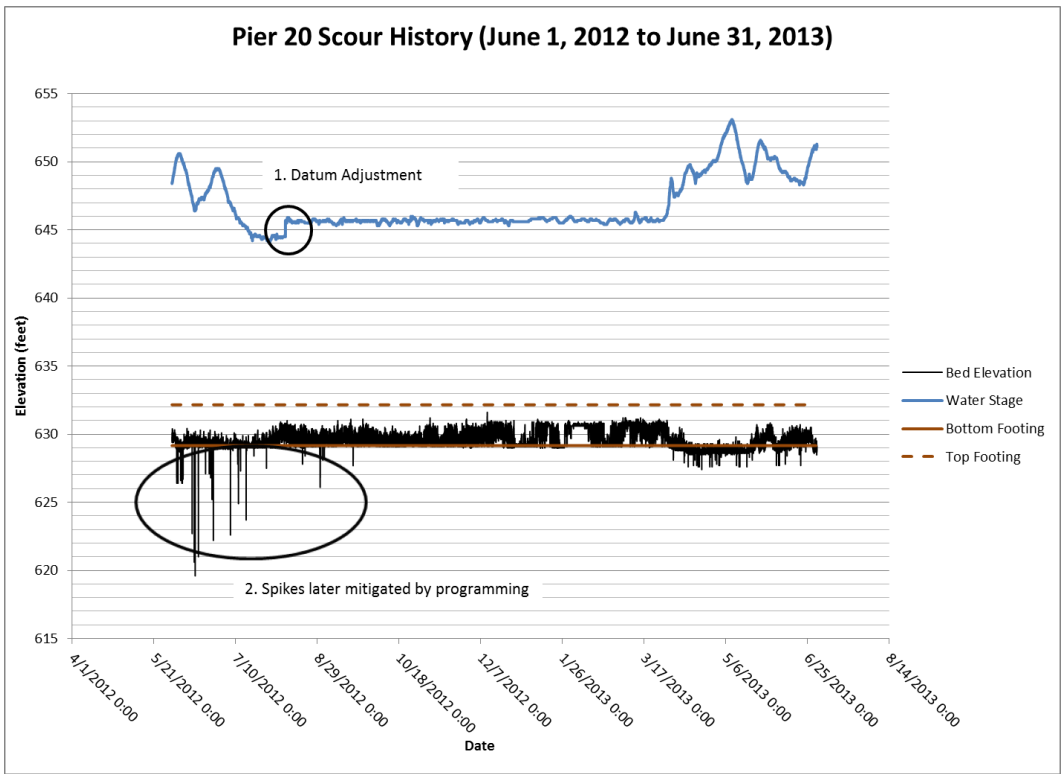
Figure 38: Pier 20 Scour History – Administration 2012-2013

The spike on 2/22/2012, indicated by circle 2 in Figure 38 is likely due to no sonar return affecting all of the 8 readings used to calculate the reported bed elevation.

Overall, the bed was very constant with few fluctuations during the time frame shown in Figure 37. As with the 2011-2012 yearly administration report, the bed during 2012-2013 varied by approximately +/- 1 foot. Over the current year examined, the minimum bed elevation encountered was 628.5 ft. This elevation was maintained for approximately one month during the spring 2013 runoff. The maximum bed elevation was 630.5 ft. This was the same maximum bed elevation from the previous year and likely corresponds to the bed elevation not affected by local scour.

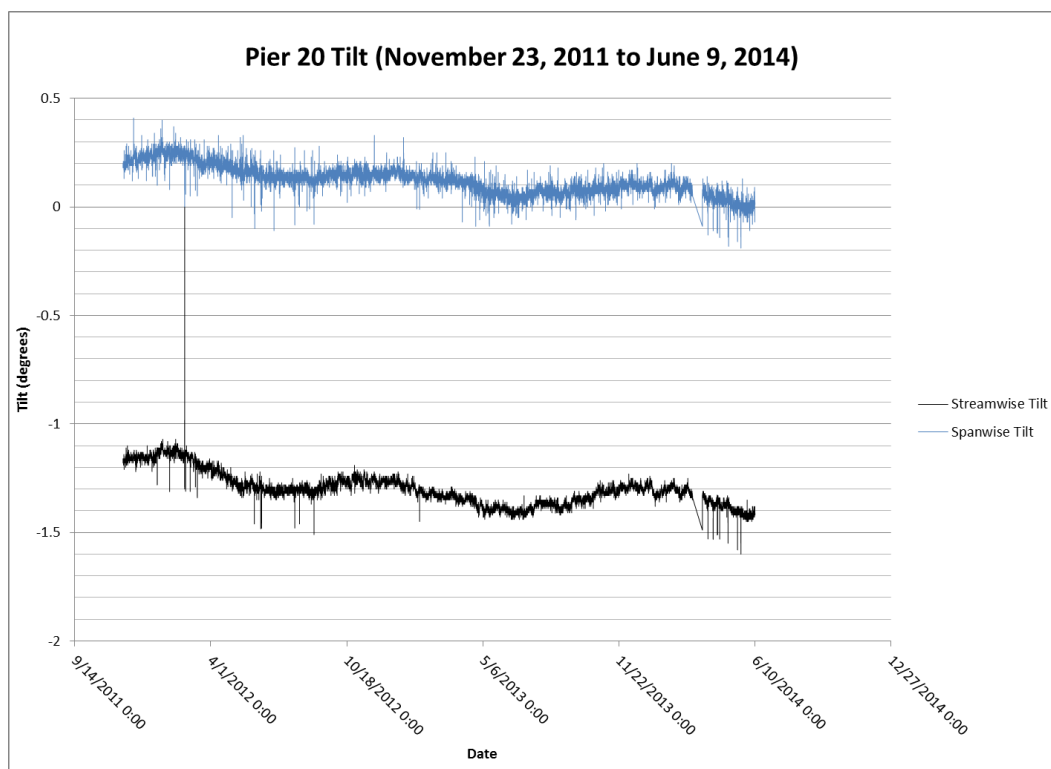
Figure 40: Pier 20 Tilt History for Entire Monitoring Period

Figure 40 shows the tilt history of entire monitored period from 11/23/2011 to 6/9/2014. Frequency analysis shows both signals have dominant frequencies around 24 hours likely correlated to daily heating (day) and cooling (night) of the bridge structure.

- Slightly reduced, but continued sensor drift, about $-0.05^\circ/\text{year}$, for both streamwise and spanwise tilt
- Maximum tilt in winter, minimum tilt in later summer for both stream wise and spanwise tilt.
- Spanwise tilt sensor appears to have more spikes than the stream wise tilt sensor.

There appears to be no significant abrupt changes in tilt. It is not possible to conclude if the tilt reading were related to actual pier movement or sensor drift.

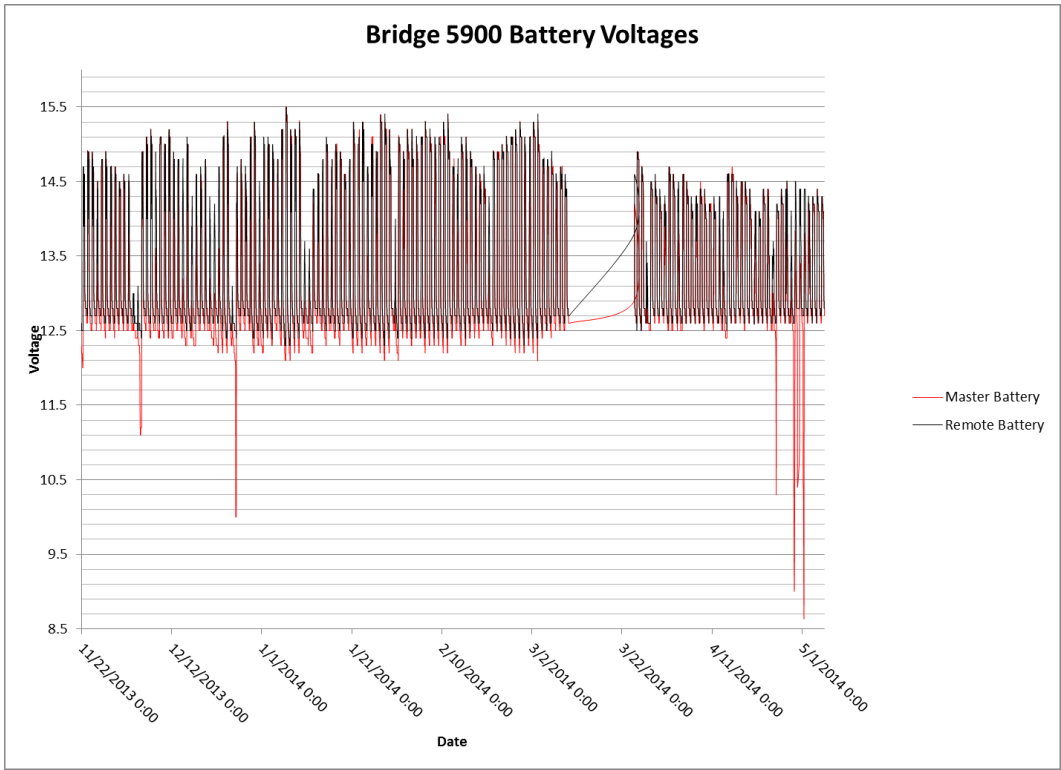
Figure 42: Bridge 5900 Voltages

During 2013-2014 administration, the storage capacity on the Master Station battery was diminished and the battery required replacement. Figure 41 shows the initial issue occurring on 12/5/2013 with voltages dropping to 11.1 Volts. Starting on 4/29/2013, a series of days with low solar radiation caused the voltage to drop to 8.7 Volts at which point, the datalogger stopped operating. The datalogger came back online by itself once the battery was recharged via the solar panel. Figure 43 shows the degraded battery storage capacity. At 12.5 Volts, the battery abruptly loses voltage which is indicative of reduced battery Amp-hours. The other batteries likely also have reduced Amp-hours and should also be replaced.

The gap in reported voltage shown in Figure 41 is due to a communication error with a Gmail server during the weekly update email. The time of the last reported data was 6:00 AM and the weekly message was due to be sent at 6:25 AM. This communication error caused the program to stall and no data was collected from 3/10 to 3/24. ETI likely restarted the program to remove the error. The portion of the code that sends the email has been removed until the operating system is updated, which according to Campbell Scientific, should resolve the Gmail communication issue.

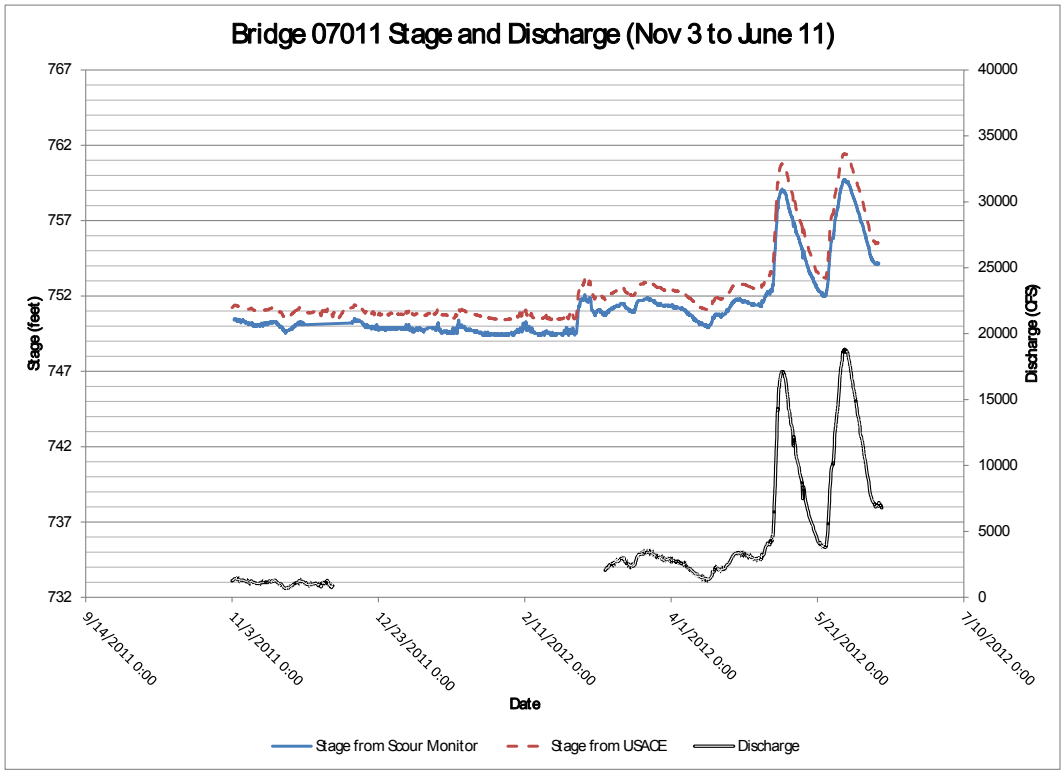
Figure 44: Bridge 07011 Stage and Discharge –Administration 2011-2012

Figure 44, Figure 45, and Figure 46 show the stage and discharge from a local USACE monitoring station and from the scour monitoring equipment for each administration period. The radar stage sensor on the Bridge 07011 system is located on the downstream side of the bridge about 20 ft west of Pier 4. The USACE gauge is located on the east side of the river approximately 1.5 miles upstream of the bridge and uses NGVD 1929 as a datum for elevation. The stage as measured by the scour monitor is consistently 1 ± 0.1 ft below the reported USACE levels when discharges are below 4500 cfs. This agrees well with the reported bed slopes given in flood profiles. Figure 47, Figure 48, and Figure 49 show the difference between local staging station and the stage recorded by the scour monitoring equipment. At larger discharges, the difference increases up to two feet. This is likely due to reduced water surface elevation at the bridge caused by the increase in local velocity head. The time when the scour monitoring station was not operational is shown by the gap in the Figure 44. The USACE stage curve shows that no meaningful data was lost during this time.

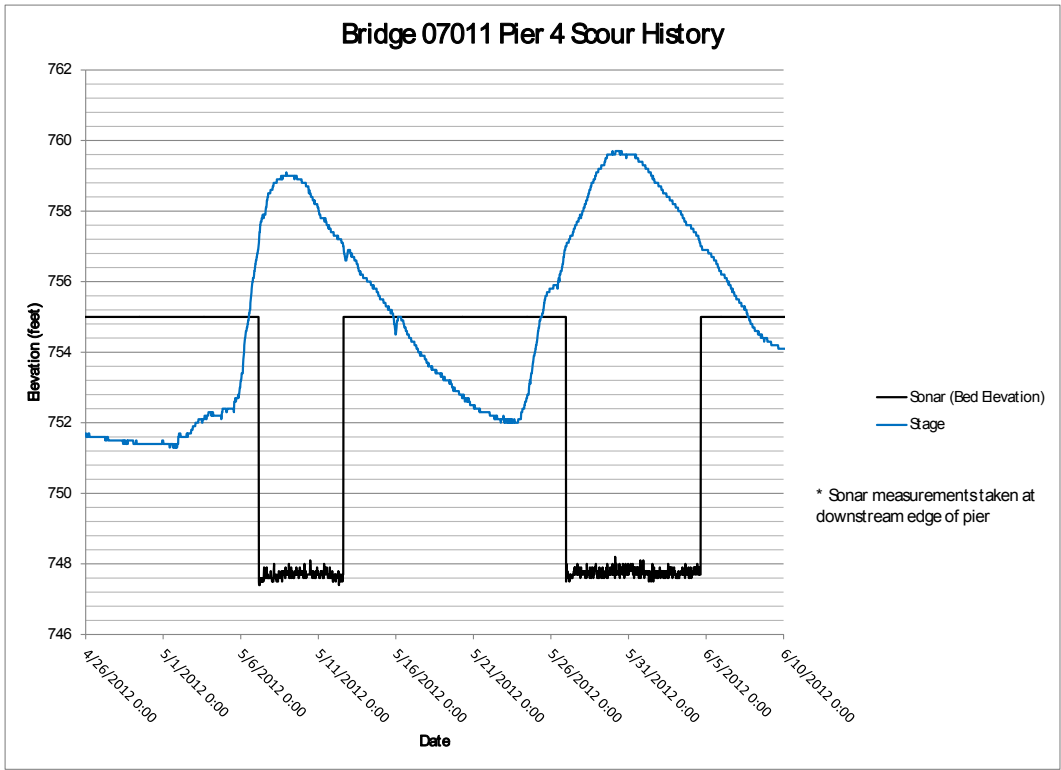
Figure 50: Pier 4 Downstream Bed Elevation – Administration 2011-2012

The sonar is mounted on the downstream side of the bridge at an elevation of 755 ft and the stage needs to reach 757 ft for the sonar to operate. The bed elevation for all events during the monitored period ranged from 747 to 748 ft. This is far above the scour critical elevation of 733 ft.

Figure 50 shows the two events that activated the sonar on Pier 4 during 2011-2012 Administration.

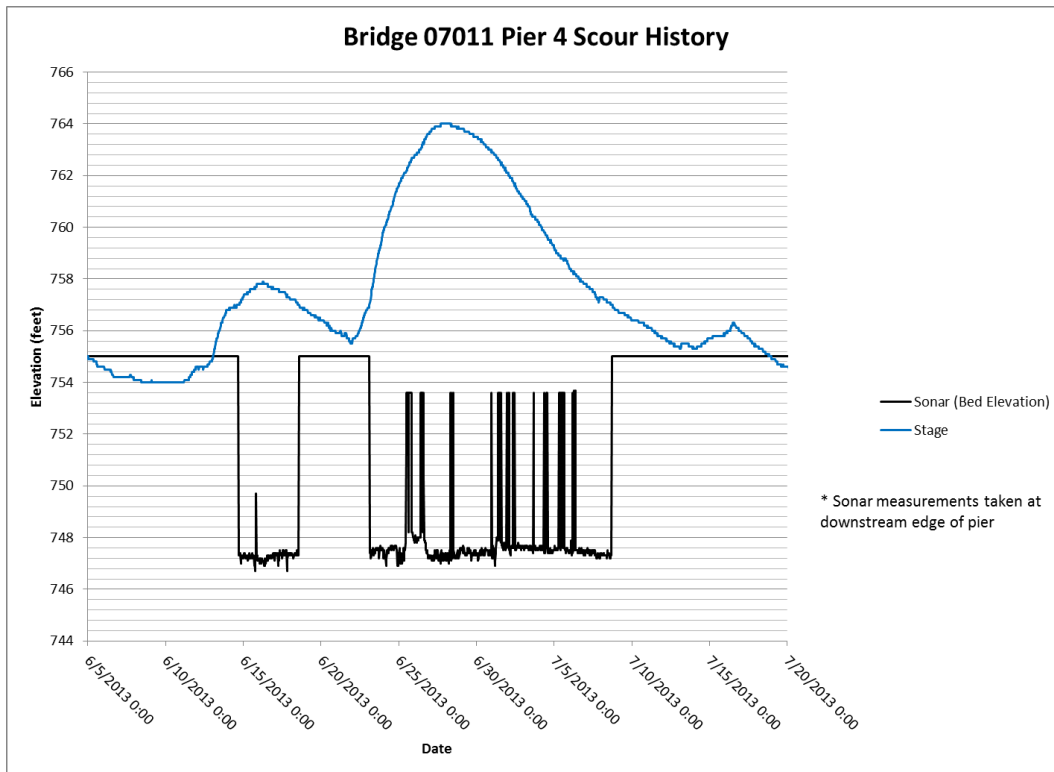
Figure 51: Pier 4 Downstream Bed Elevation – Administration 2012-2013

Figure 50 shows the two events that activated the sonar on Pier 4 during 2012-2013 Administration.

The specification sheet indicates the minimum range for the instrument is 0.4 meters or 1.3 ft. This correlates well with a reported bed elevation of 753.6 ft with the sonar datum set at 755 ft.

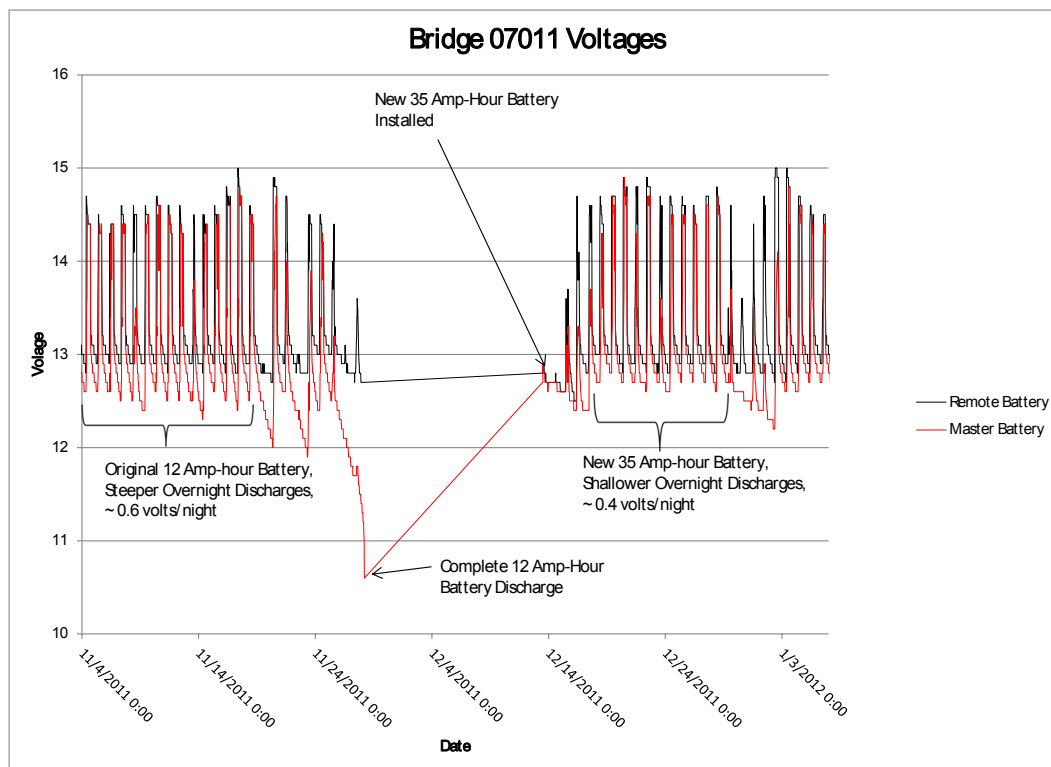
Figure 53: Bridge 07011 Voltages

The initial 12 Amp-hour battery installed on the Master Station of Bridge 07011 was undersized to deal with the continuous operation of the wireless float-out receiver. This receiver needs to operate continuously to ensure the float-out signal is captured before it floats downstream. This issue manifested itself on 11/28/2011 when the master voltage dropped to 10.6 volts and the datalogger quit operating. This occurred after 2.5 days of little solar charging. The 12 Amp-hour battery was replaced with a 35 Amp-hour battery on 12/13/2011 by a District Signal Technician and the system worked well for more than a year. Similar consecutive non-charging days are found in the voltage data and the lowest master battery voltage since the replacement was 12 volts.

Figure 53 shows the comparison of overnight discharge before and after the master battery voltage was replaced. The remote battery voltage is also shown for reference.

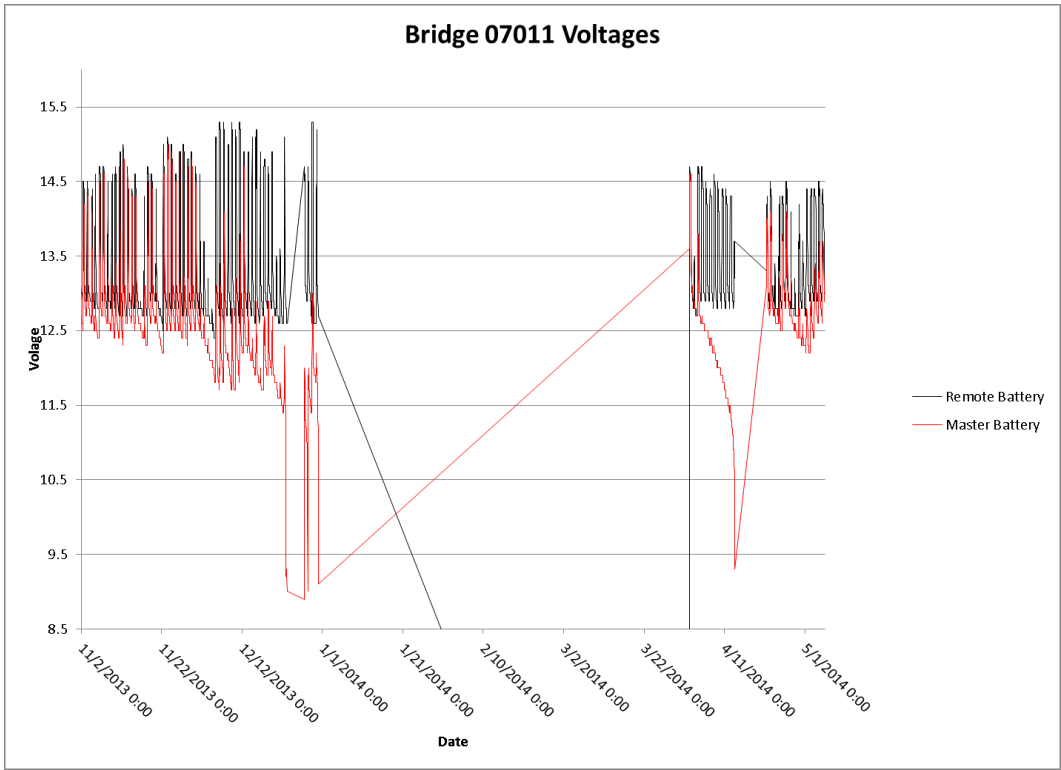
Figure 54: Bridge 07011 Voltages

Figure 53 shows the lowest battery voltages encountered during 2013-2014 maintenance.

Although it worked well for over a year, the 35 Amp-hour battery installed during 2011-2012 maintenance was unable to store enough energy in December 2013 and the system went offline on 12/31/2013. This was preceded by an outage from 12/23/2013 to 12/27/2013 when the battery voltage dropped too low to operate the datalogger. For this event, the datalogger restarted automatically after the solar panel recharged the battery.
