Development and Integration of Advanced Timber Bridge Inspection Techniques for NBIS

Brian Brashaw, Principal Investigator
Natural Resources Research Institute
University of Minnesota Duluth

Research Project
Final Report 2015-01

**BRIDGE # 69529
CSAH 52 over DITCH**

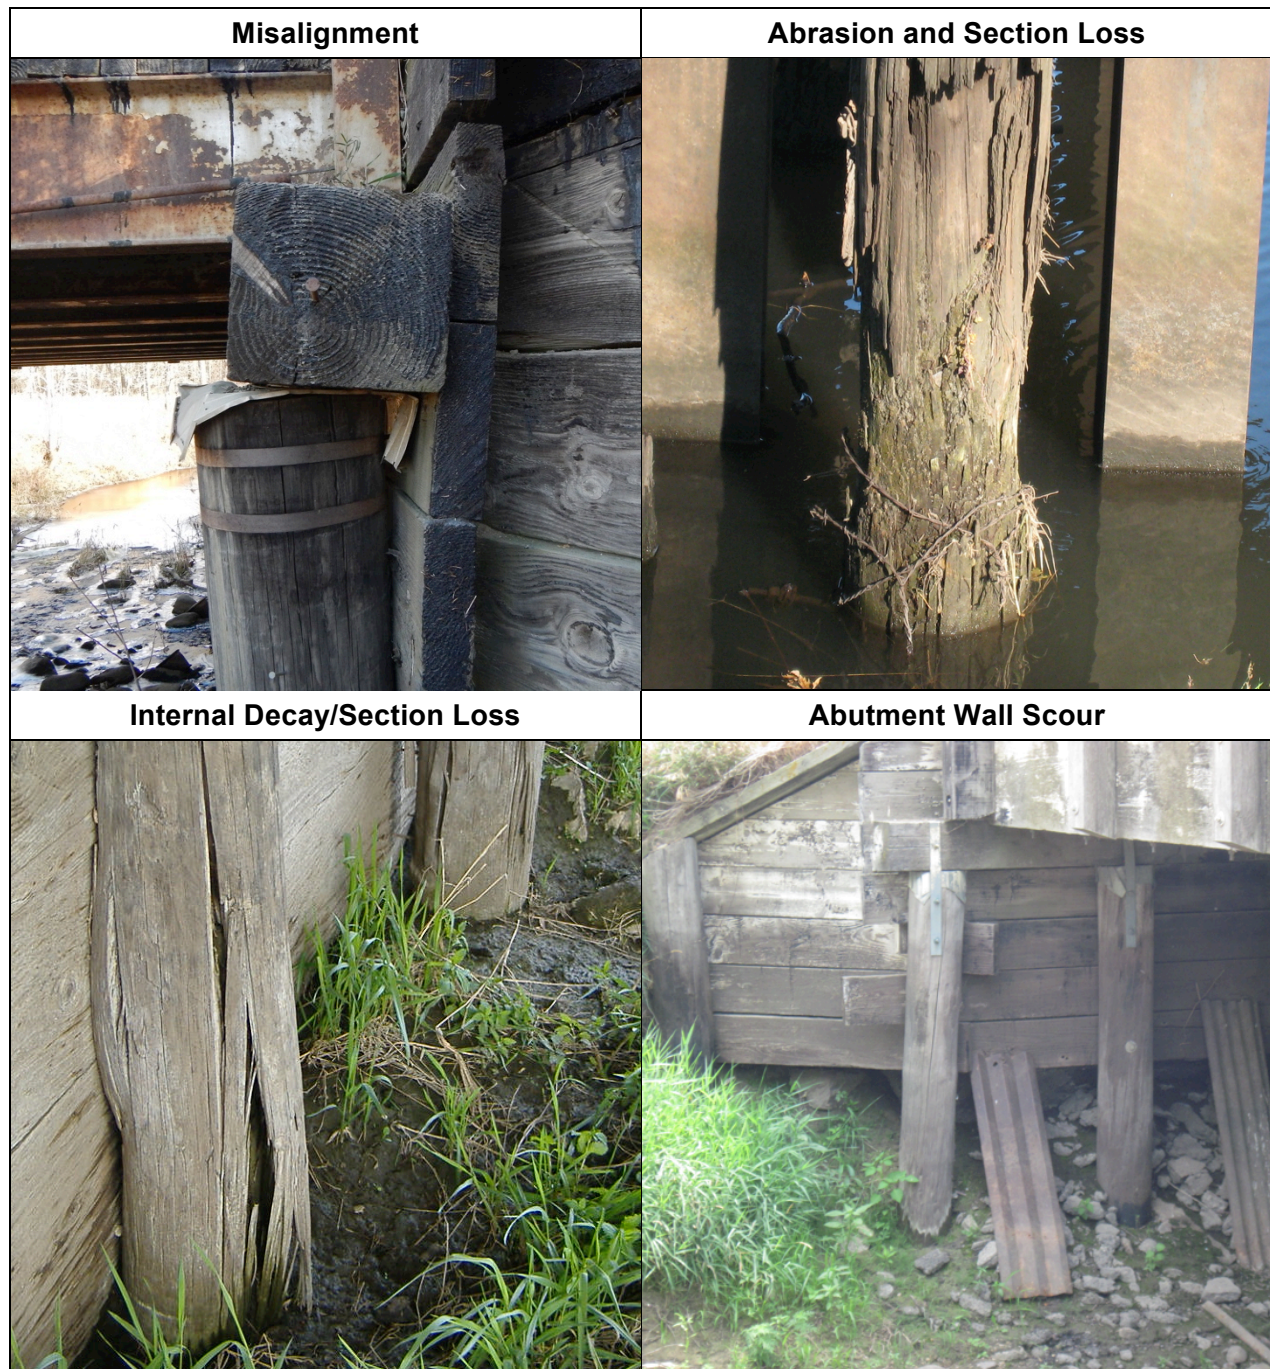
Figure 7.6. Examples of deterioration of timber substructure elements.

The use of inspection equipment can provide additional information to the definitions provided by AASHTO and MnDOT. Special attention should be focused on the steel connections, and looking for evidence of decay in timber adjacent to the connections. A pick hammer can be used to assess surface quality and possible decay. Feeler gages and awls may be used to assess the extent of cracks, checks, splits and delamination. A moisture meter can establish high levels of moisture. It is important to assess the presence of decay using hammer picks, stress wave timers and resistance microdrills to determine the actual cross-section and location of both sound and deteriorated material. Chapter 5 provided detailed information about the use of stress wave timers for identifying areas of decay. **Table 5.1** should be consulted when assessing the collected data. Chapter 6 provides detailed information about interpreting resistance drill data from a variety of different resistance drill models. **Table 6.1** should be consulted when assessing the collected data. **Figure 7.6 and 7.7** shows examples of damage to timber substructure elements.

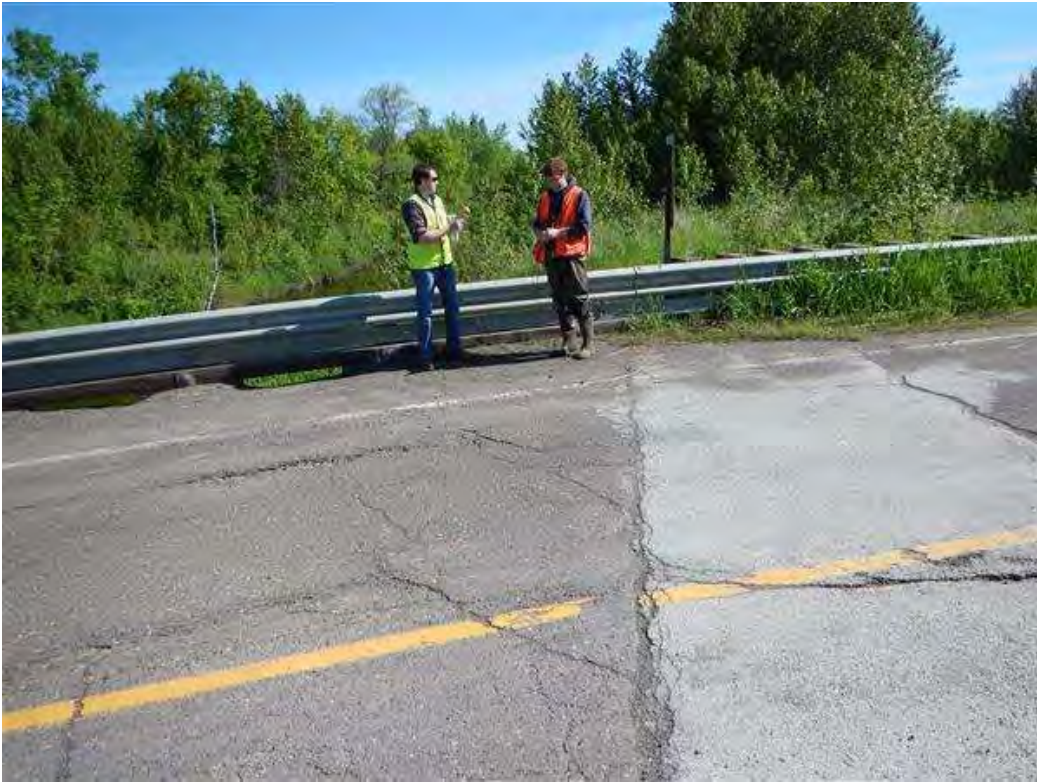
Notes: [2013] Significant deterioration evidenced as cracking and potholing in bituminous wear layer in transverse direction at both bridge abutments and at the piers. There are also longitudinal cracking present, most likely at joints for deck panels. Water infiltration is occurring at these locations, as evidenced by visual staining of the underside and water dripping through the deck. Hammer sounding and pick inspection did not identify any decay present. One area that sounded affected was drilled with Resistance drill. No decay noted using drill in these locations. Water infiltration through deck is also causing high moisture and cracking in pier 1 and pier 2 caps. This moisture is then leading to severe corrosion of CIP plates.

Photo 3 - Bituminous east end before abutment

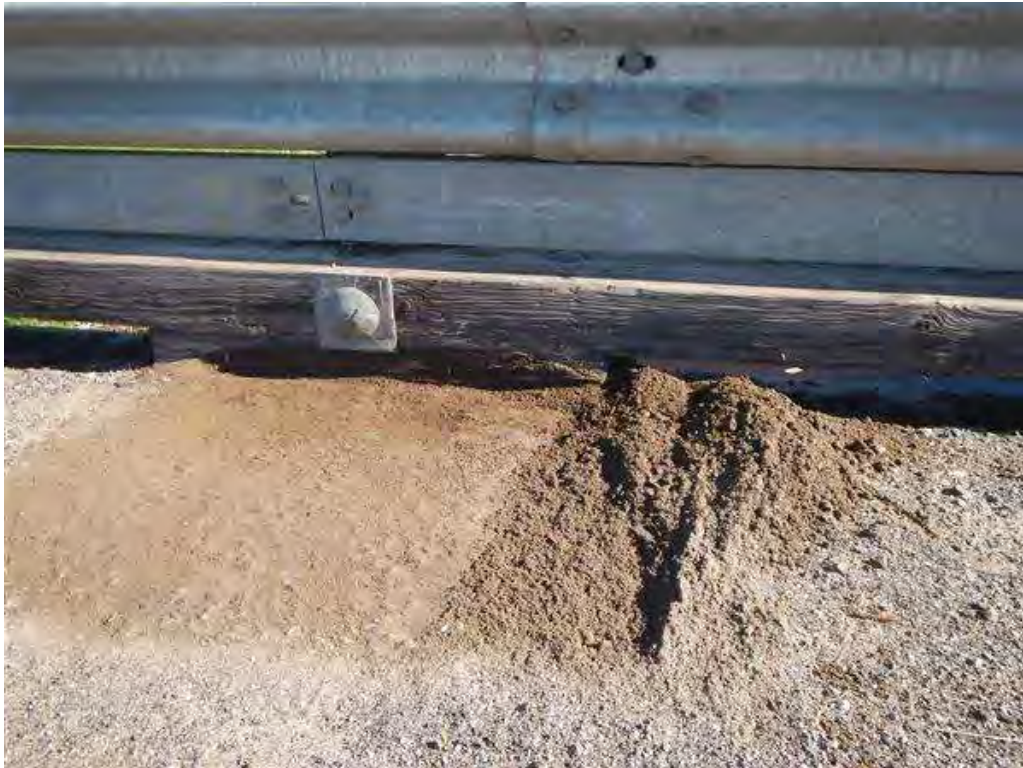
Photo 4 - N. deck-scupper 3" sand on deck

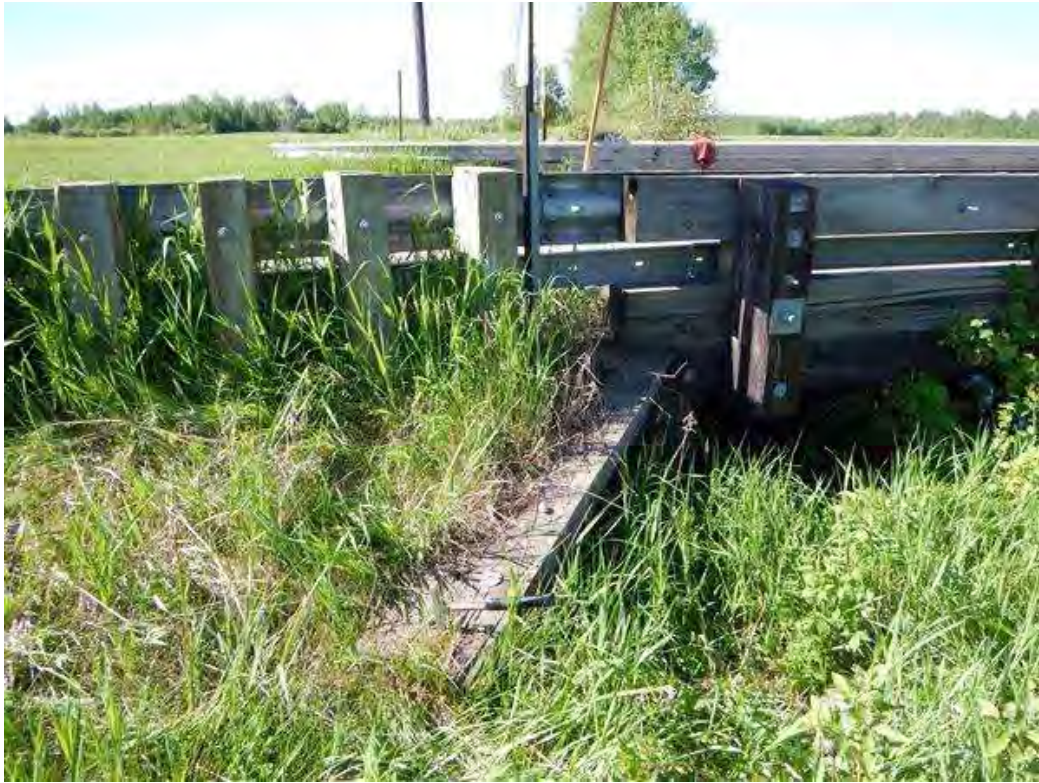
Notes: [2013] NW cap showed severe decay in pile. NE cap 50% decayed as it was almost fully covered by vegetation. SW Wing pile showed decay.

Photo 17 - Wing wall with significant vegetation
