# Evaluation of the SafeLane™ Overlay System for Crash Reduction on Bridge Deck Surfaces

Minnesota  
Department of  
Transportation

Research Project  
Final Report #2010-13

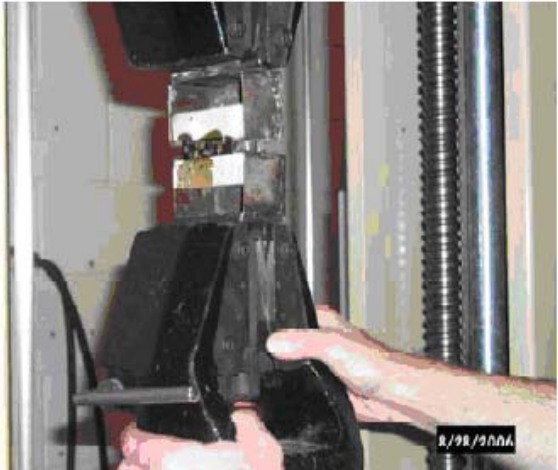
Figure 3.2. Pull out machine employed.

The test specimen was placed in the standard housing and the grip of the bond pull out machine (Fig. 3.2) and pulled out at a loading rate equivalent to a deformation rate of 0.1 inch/min until the maximum load was attained.

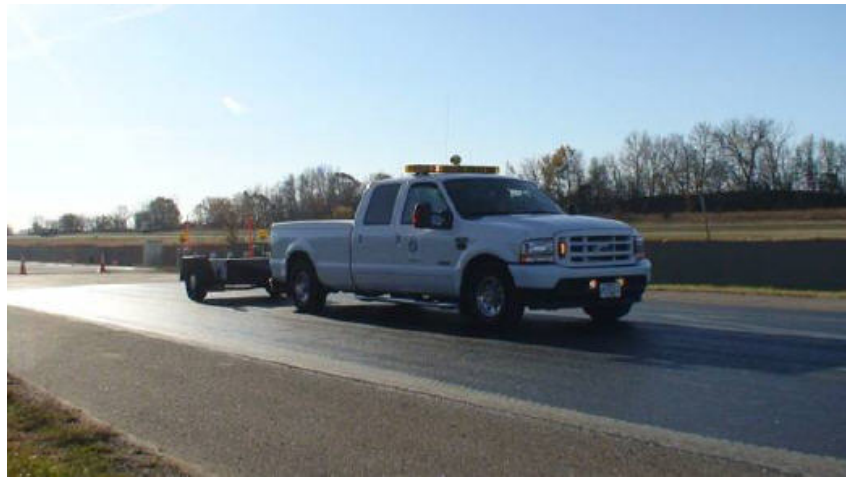
Figure 5.2. KJ Law (Dynatest) skid trailer.

Skid tests were performed on the overlay installed at the Hibbing site using the KJ Law skid trailer (Figure 6.1) over the course of three years. The results are plotted in Figure 6.2.

The data taken shortly after installation (9/06) is a minimum estimate provided by the operator. The traction was so good that the skid trailer would not skid for either tire type (ribbed vs smooth). This excellent initial performance degraded rather significantly after the first winter,

Using the data from Figure 6.2, exponential decay functions were fit to the data. A least squares fit to the ribbed tire data yielded a correlation coefficient of 0.9908, while that for the smooth tire data gave a value of 0.9640. In each case the regression equation was used to predict the time a value of 15 would be expected for a smooth tire, and likewise a value of 25 for a ribbed tire, giving a value of 3.6 years for the ribbed tire data, and a value of 5.0 years for the smooth tire data. Unfortunately, either of these predictions suggests an unacceptably short service life for the overlay system.
