Minnesota
Department of
Transportation

Acoustic Emission Monitoring of a Fracture-Critical Bridge

March 2014

Research Project
Final Report 2014-15

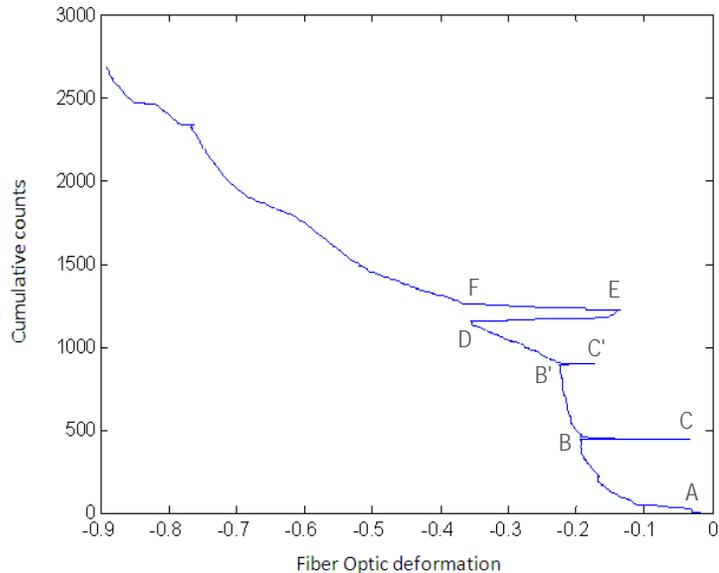
Figure 5.8: Acoustic emissions vs. fiber optic gauge deformation (inches) for third beam test

Figure 5.8 shows the cumulative acoustic emission activity vs. the total shortening of the fiber optic gauge (in inches). The total deformation of the fiber optic gauge installed on a member that is loaded in the linear, elastic range, is proportional to strain, therefore stress and load. Thus, the fiber optic gauge reading can be used to construct a plot that is analogous to the cumulative (acoustic) emission vs. load plot in Fig. 5.7.

The first unloading and reloading (A-B-C-B in Fig. 5.8) occurred at approximately 500 acoustic emission counts, and the beam behaved as expected. That is, further acoustic emission activity did not begin until the previous deformation was reached (point B in Fig. 5.8). However, the epoxy seal between notched and support beams broke after the second reloading (B'-C'-B' in Fig. 5.8). The loss of contact along the epoxied surfaces resulted in fewer acoustic emission sensors being effective, and, therefore, a reduction in cumulative acoustic emission activity. The reduced acoustic emission activity (at approximately 1,000 counts) produced a flatter rather than a steeper slope beyond B' in Fig. 5.8. Nevertheless, there is a clear example of the Felicity effect in the third unloading (D-E-F in Fig. 5.8).

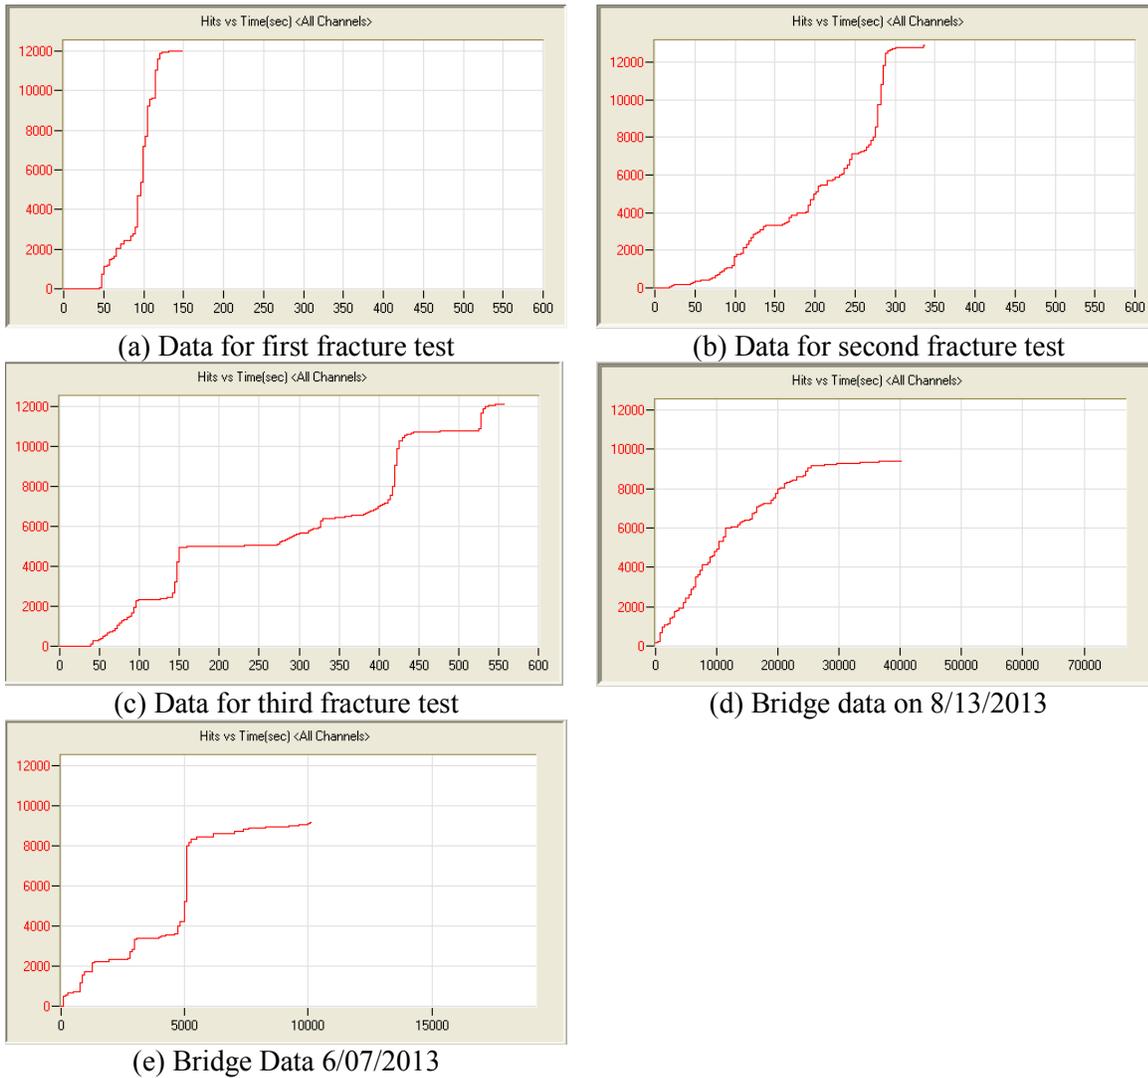
Figure 6.1: Hits vs. time (sec)

One of the observations that is evident in the hits vs. time graphs can be seen by comparing Figures 6.1(a)-(c) for the fracture tests with Figures 6.1(d)-(e) for the bridge data. For example, the number of hits in Figure 6.1(a) rises from 0 to 12,000 hits in less than 2 minutes. The 2nd test shows a similar trend due to fracture, with a sudden rise from 8,000 to 12,000 hits in a short period of time. The fracture caused a sudden increase in the number of hits over time, a pattern previously observed during the first two tests.

When analyzing the bridge data in Figure 6.1(d), the typical pattern found in the graph of hits vs. time is a steady accumulation of hits during the day. The number of hits recorded did not reach the 12,000 hits in 11 hours, while the fracture tests exceeded that amount in a few minutes. Moreover, there are none of the sudden increases, marked by large increases in slope, in the hits vs. time relation that were observed for the fracture tests. Therefore, the behavior on the August 13th data does not resemble that of the fracture tests.

Figure 6.1(e) shows that on June 7, an unusual type of event caused a sudden increase in the number of hits over time. This type of behavior is very similar to what is observed from the fracture tests. However, as a result of these measurements, the authors accompanied a bridge inspector from MnDOT's Metro Division to inspect the Cedar Avenue Bridge, and no evidence of any cracking distress was found. Thus, further evidence is required before a hits vs. time relation alone is used to conclude that a cracking event has occurred in the bridge.

In general, when assessing hits vs. time plots, normal behavior (i.e., when cracking is not occurring) is consistent with (1) a steady increase of hits vs. time, and (2) no sudden increases occurring in short periods of time.

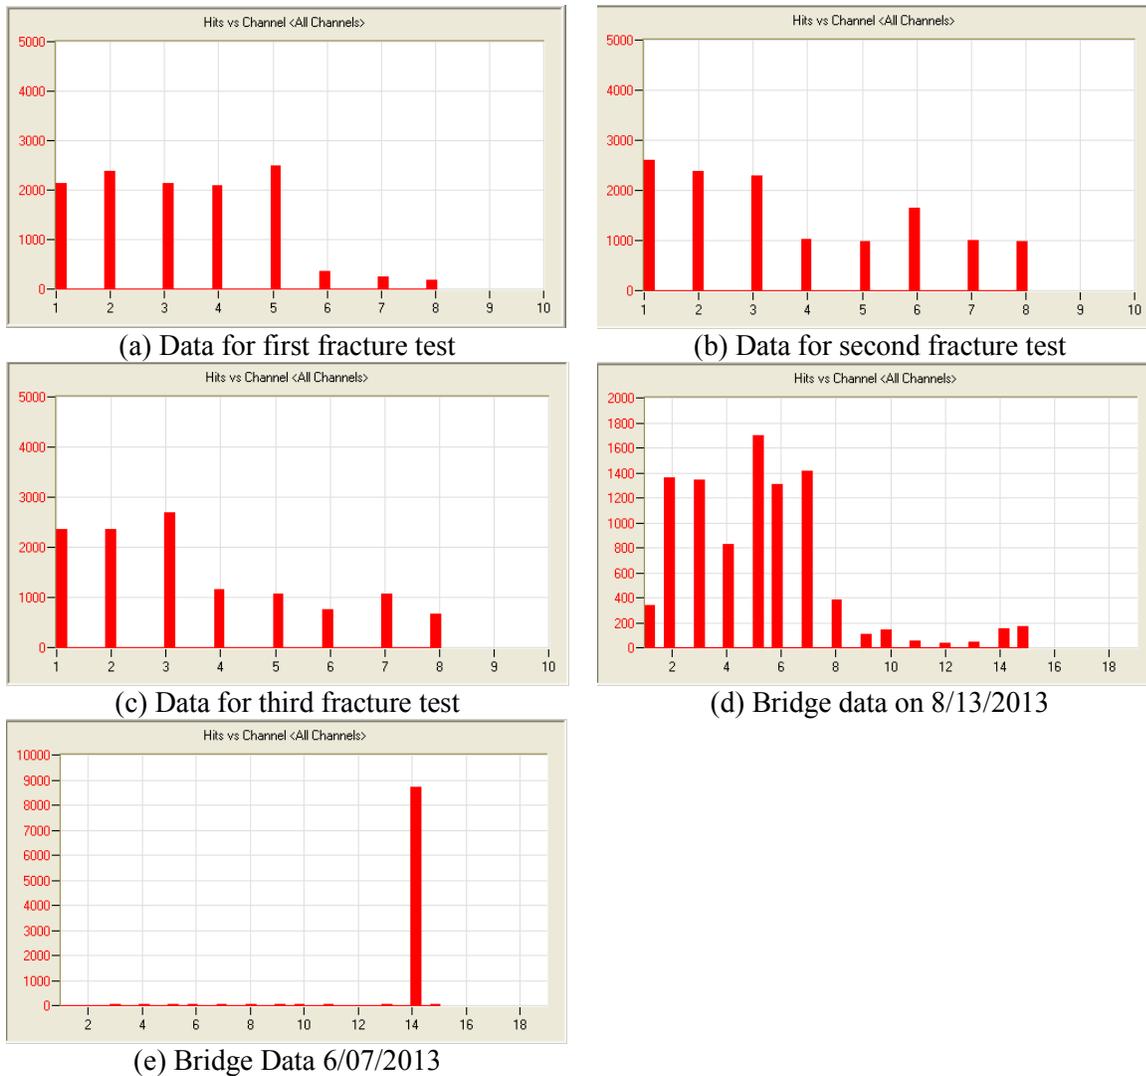
Figure 6.2: Hits vs. channel

The plots shown in Figure 6.2 illustrate the number of hits recorded by each sensor. Figures 6.2(a) – 6.2(c) show that sensors closest to the fracture in the tests reached 2000 hits in less than 5 minutes, while the bridge data sensors in August 13, 2013 (Fig. 6.2(d)) did not reach this mark in more than 11 hours. A different situation occurs by observing Figure 6.2(e), which shows that all relevant acoustic hits were captured by a single sensor (No. 14). This figure provides clear evidence of unusual or anomalous behavior occurred during June 7, 2013. Typical activity in the bridge would show graphs similar to Figure 6.2(d), which have AE hits spread over several different sensors. This observation was noticeable enough to distinguish it from all the different data files that have been analyzed during July and August. It appears that an unusual AE event occurred, but it is still unclear its source. Possible effects include abnormal electrical activity, as AE monitoring systems are subject to disruption from electrical grounding in steel bridges (Ono 2011), or a temporarily malfunctioning AE sensor.

In general, when assessing hits vs. channel plots, normal behavior is consistent with (1) the hits being distributed over several sensors, and (2) the number of hits per sensor not exceeding some threshold value, say 200 hits per hour.

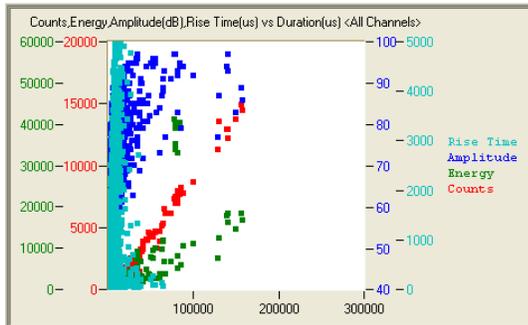
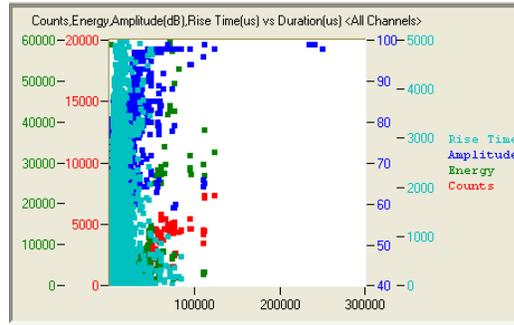
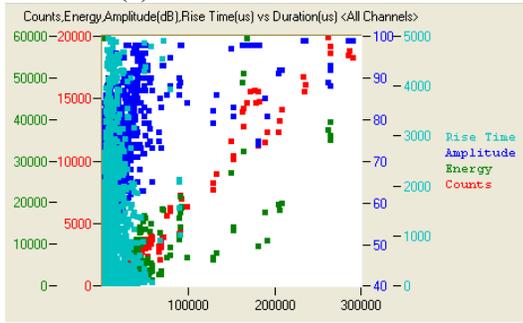
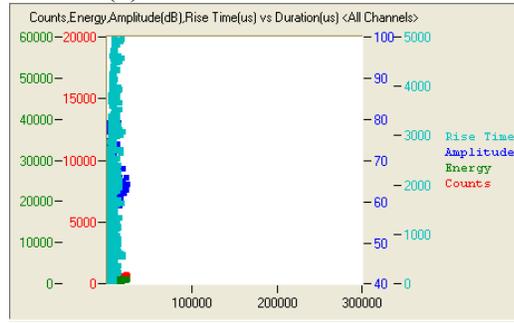
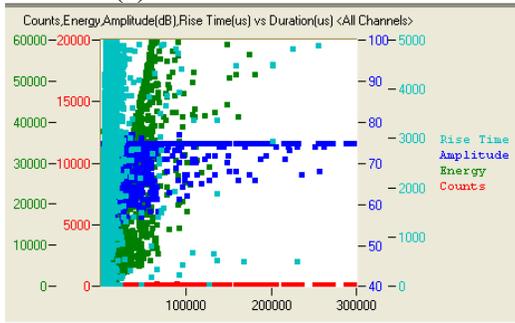
Figure 6.5: Counts, energy, amplitude (dB) and rise time (μs) vs. duration (μs)

When fracture occurs, durations increase in relation to amplitude (dB), energy and counts (Fig. 6.5(a) – (c)). The difference between fracture and ‘normal’ bridge behavior is dramatic (Fig. 6.5(d)). For the latter, the four parameters are clustered to the left of the duration (μs) axis. The independent variable, duration, is defined as the elapsed time from the 1st threshold crossing of the AE to the last. This variable depends on the magnitude of the AE event, and it is valuable to recognize that crack formation and propagation lengthens duration. On a normal day (Fig. 6.5(d)), the number of acoustic emissions crossing the threshold should be low and thus explains why the data is clustered to the left. During fracture, the number of acoustic emissions crossing the threshold extends over a longer period of time.

In evaluating AE data, it is worthwhile to observe if the data is clustered. If the data is not clustered, the data should be evaluated to determine if there is a spread of the data towards the right, and if the energy and amplitude increase significantly. These would be suggestive of fracture. There is also a maximum duration threshold, on the order of 50,000 μs , that can be used to distinguish between cracking and non-cracking events.

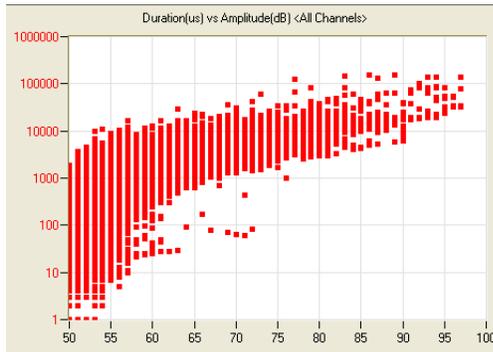
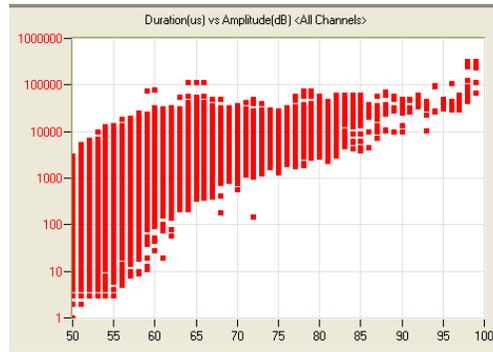
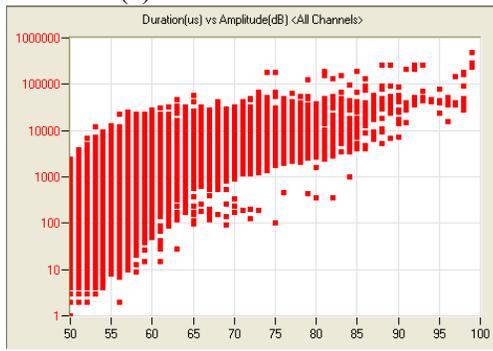
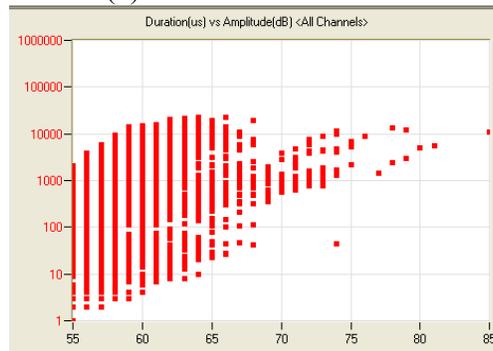
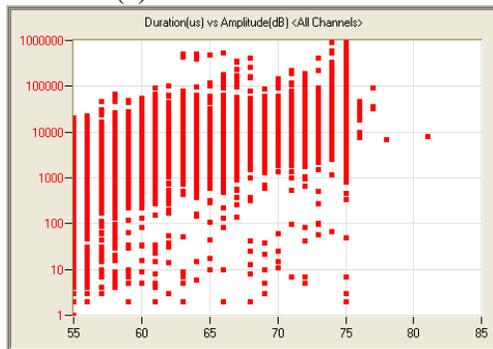
Figure 6.6: Duration (μs) vs. amplitude (dB)

Figure 6.6 shows the relationship between duration and amplitude for the five AE data sets. During normal activity, the amplitude rarely reaches values above 80 dB, and most of the activity occurs in the 50 to 70 dB range. The duration appears to fall within 0 to 10,000 μs , and it remains high for larger amplitudes. Duration is the elapsed time from the first threshold crossing to the last. The fracture tests, as well as the anomalous data recorded on June 7, 2013, reveal that as the amplitude increases, the duration of threshold crossing increases. More importantly, the durations increase to values exceeding 100,000 μs , which is ten times as large as the maximum

duration for ‘normal’ activity. The amplitude also increases to at least 95 dB, which is considerably larger than the largest values observed during ‘normal’ activity.

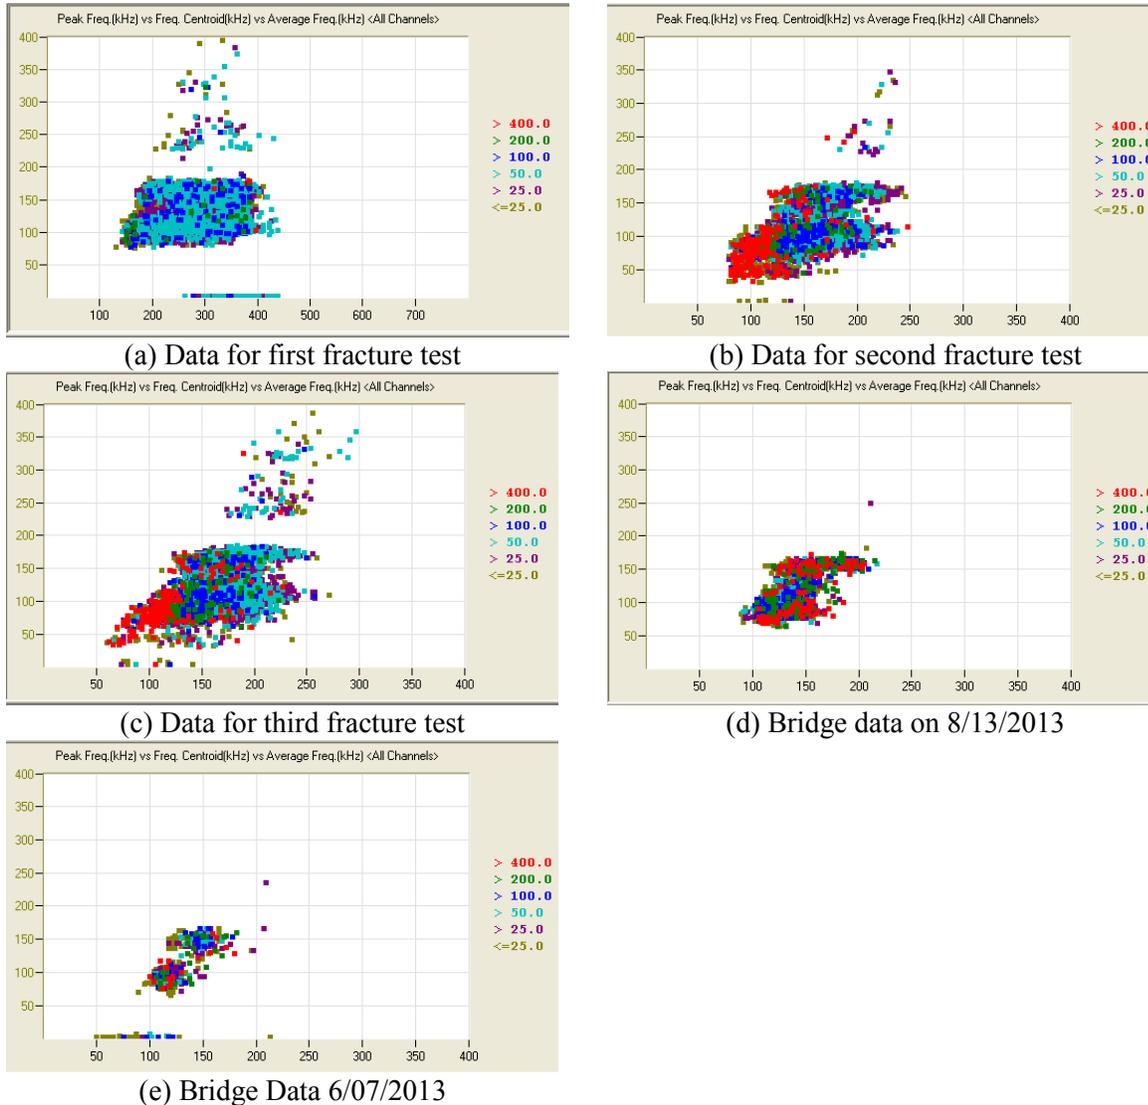
Figure 6.7: Peak frequency (kHz) vs. frequency centroid (kHz) vs. average frequency (kHz)

Figures (32-26) show the peak frequency (kHz) and frequency centroid (kHz) vs. the average frequency (kHz). The color scale shows frequency centroid magnitude, while the values on the x and y axes show average and peak frequencies. These plots provide only one clear trend: Normal and anomalous data (Fig. 6.7(d) and (e)) exhibit few peak frequencies in excess of 200 kHz, whereas the fracture data (Fig. 6.7(a) – (c)) have ample data between 200 and 400 kHz.

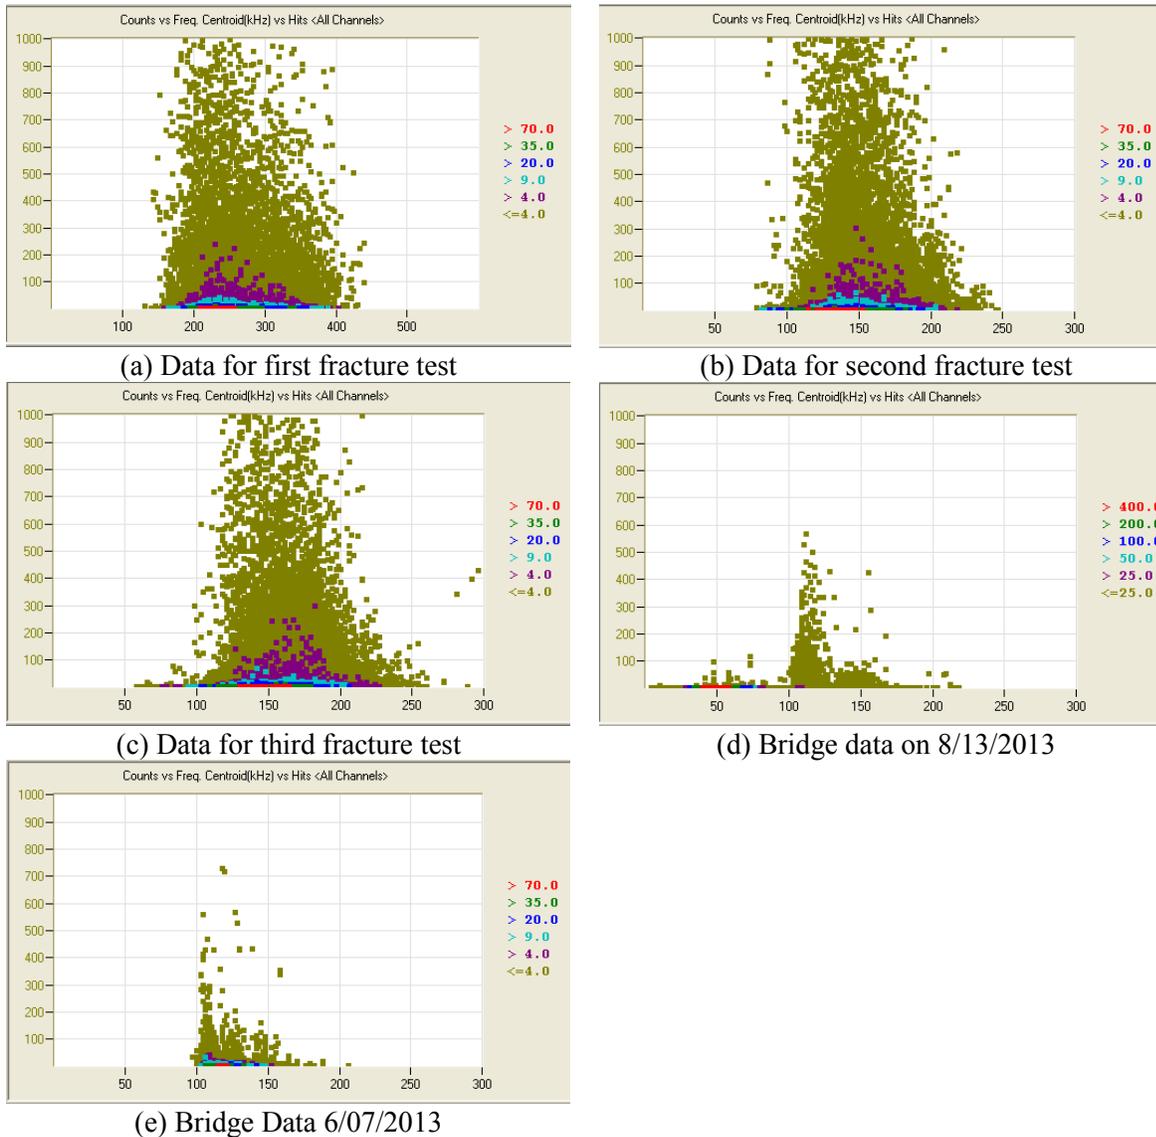
Figure 6.9: Counts vs. frequency centroid (kHz) vs. hits

Figure 6.9 shows the plots for counts vs. frequency centroid (kHz) vs. hits. The count axis is located at the left side of the graph, while frequency centroid is defined by a color scale. Counts are defined when there is a threshold crossing pulse and depend on the magnitude of the AE event. The number of hits is the independent variable. The graphs for all fracture tests look

very similar, but they differ from what is observed for the bridge data under ‘normal’ conditions. Aside from number of counts, both bridge data sets show little differences in Fig. 6.9, and thus these parameters are not strong indicators to discriminate anomalous activity from fracture.

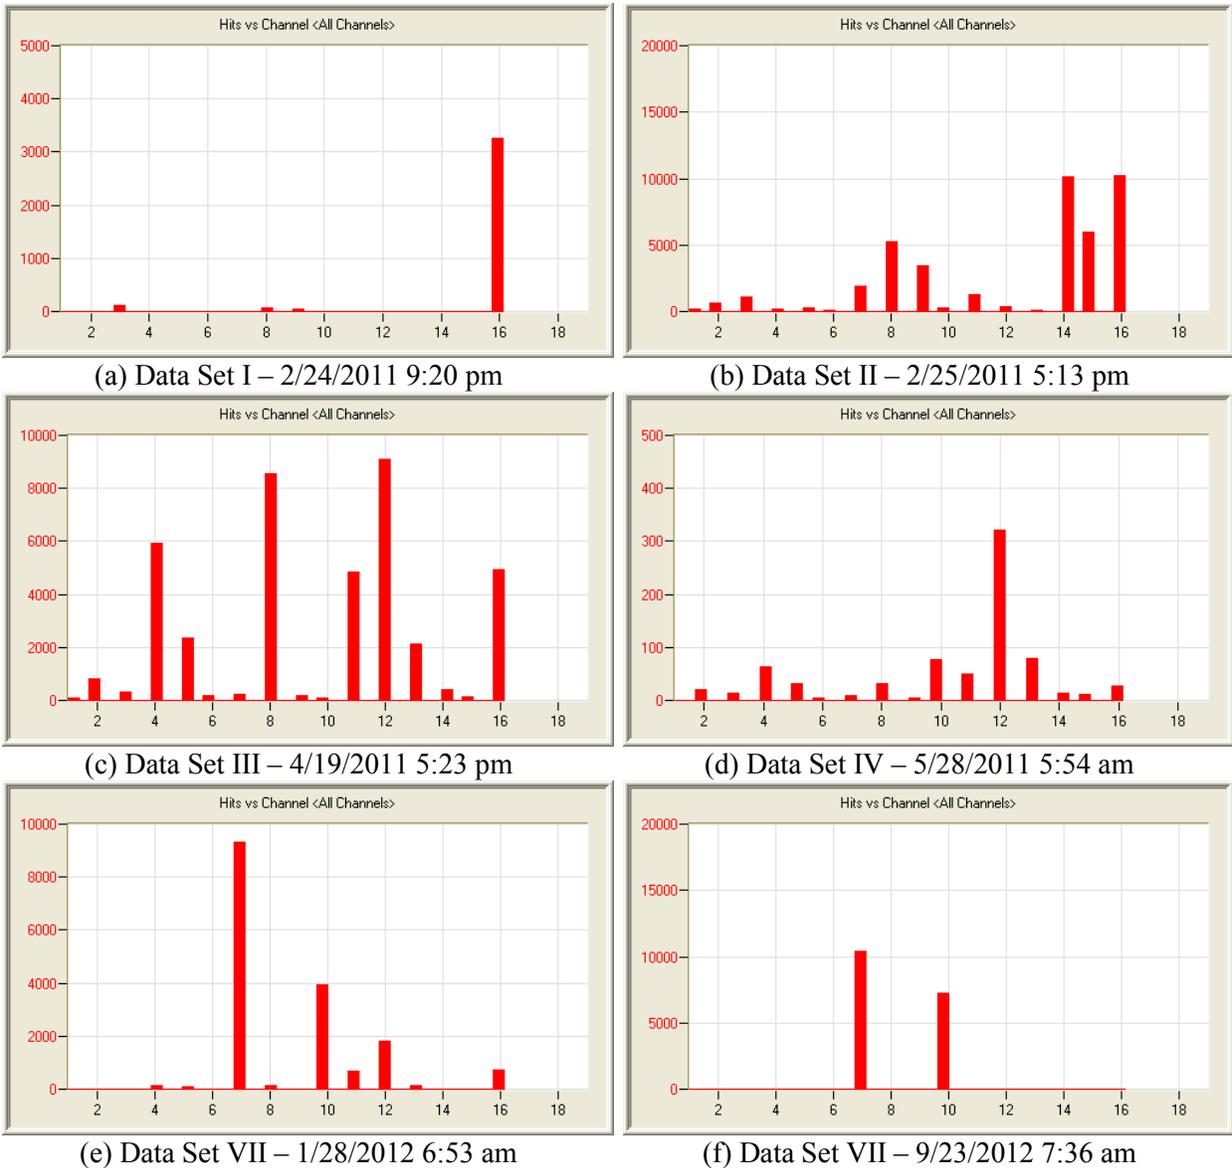
Figure 7.2: Hits vs. channel

Figure 7.2 shows that most recorded events were distributed over many sensors (Fig. 7.2(b) – 7.2(e)). But, in a few cases like Fig. 7.2(a) and 7.2(f), the hits were concentrated over a few sensors. The latter are often associated with small files i.e., files with a relatively low number of hits (less than 2000). Furthermore, section 7.3.3 indicates that cases like Fig. 7.2(a) and 7.2(f) are typical for files with for low amplitudes (i.e., less than 70 dB) and are, therefore, considered to be unimportant non-AE events.

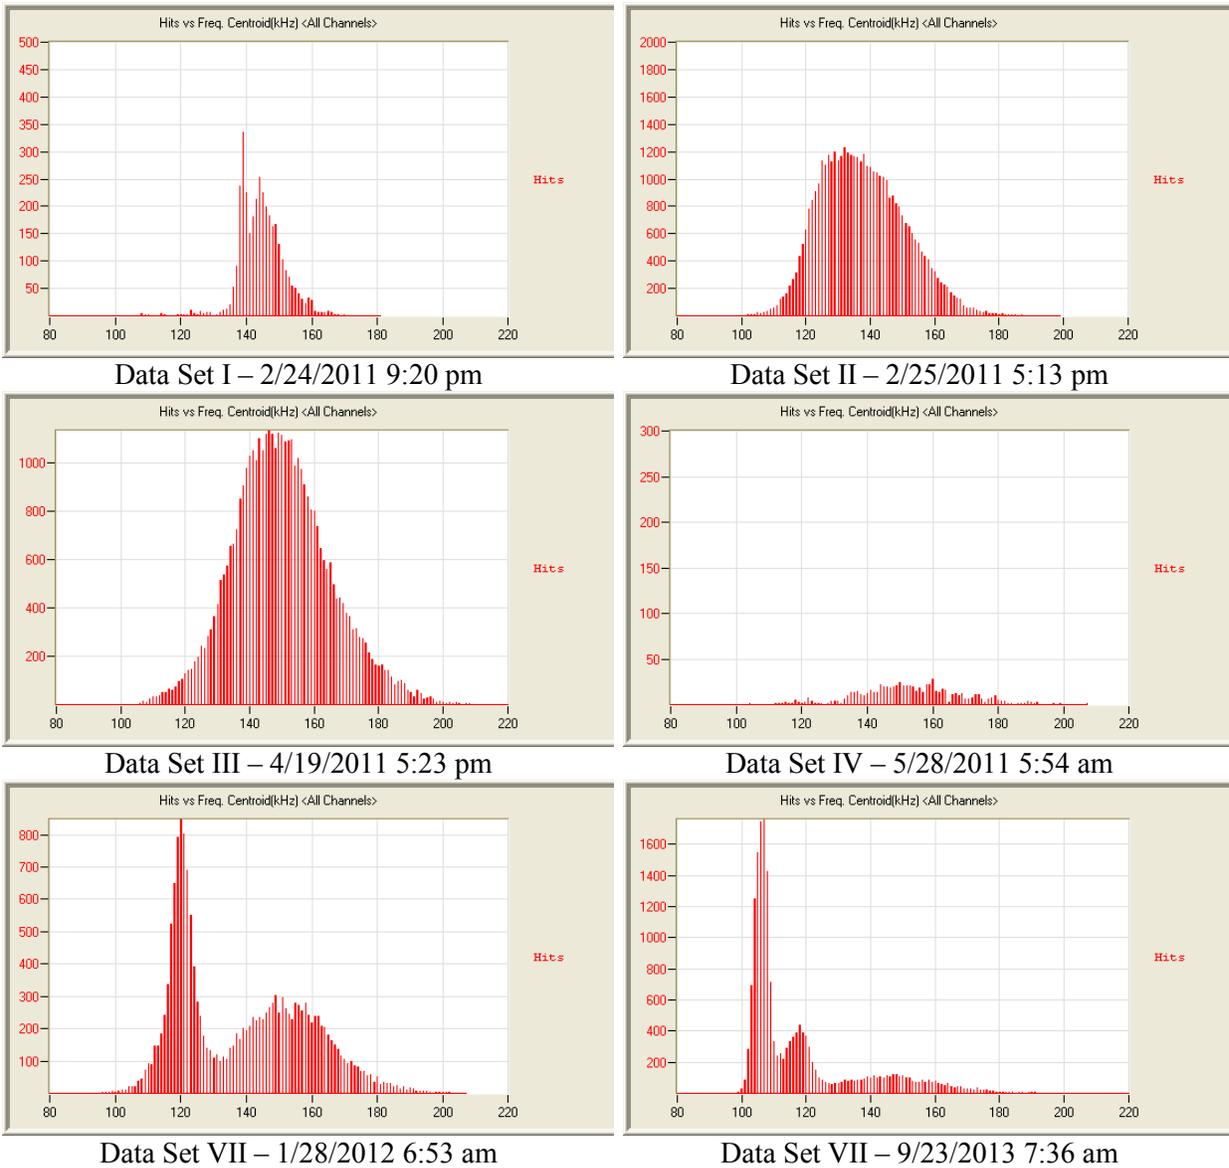
Figure 7.4: Hits vs. frequency centroid (kHz)

The frequency centroid is the centroid (i.e., similar to center of “mass”) of the power spectrum for an AE signal, and the higher the frequency centroid, the faster the energy delivery rate. Large frequency centroids are often associated with fracture events, and for the first fracture test described in Chapters 5 and 6, the peak frequency centroid (i.e., the frequency centroid
