Final Report

Forensic Investigation Report  
For MnROAD Ultrathin Whitetopping  
Test Cells 93, 94 and 95

| 7. Author(s)<br><b>Thomas R. Burnham</b> | | 8. Performing Organization Report No.<br><b>T9PR2004</b> | |

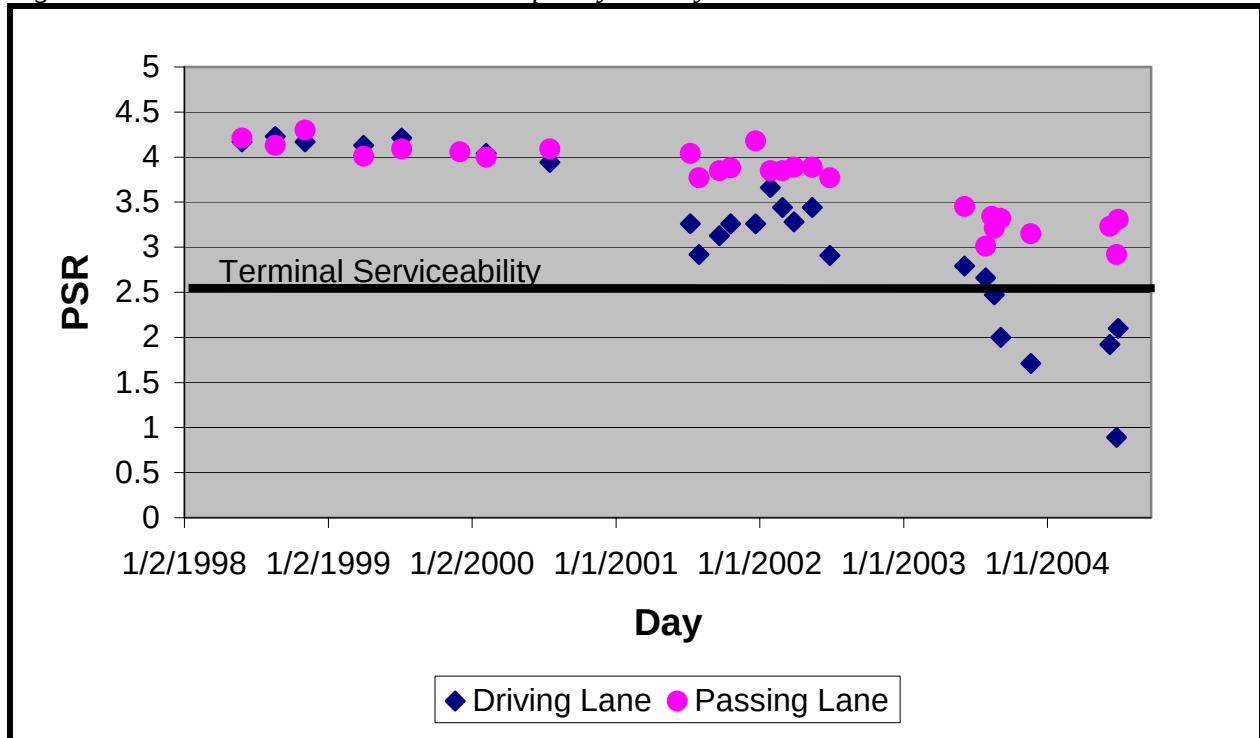
Figure 2.1. MnROAD Test Cell 93 ride quality history.

As shown in Figures 2.1-2.3, by the spring of 2004, the driving lane of test cells 93, 94, and 95 had all reached values far below 2.5. The cause of the low PSR numbers was predominantly due to the increasing amount of asphalt patching being placed on the distressed UTW surface. Cell 94 in particular was experiencing punchout type distress in the corners of the interior panels near the wheelpaths. See Photo 2.1 for an example.

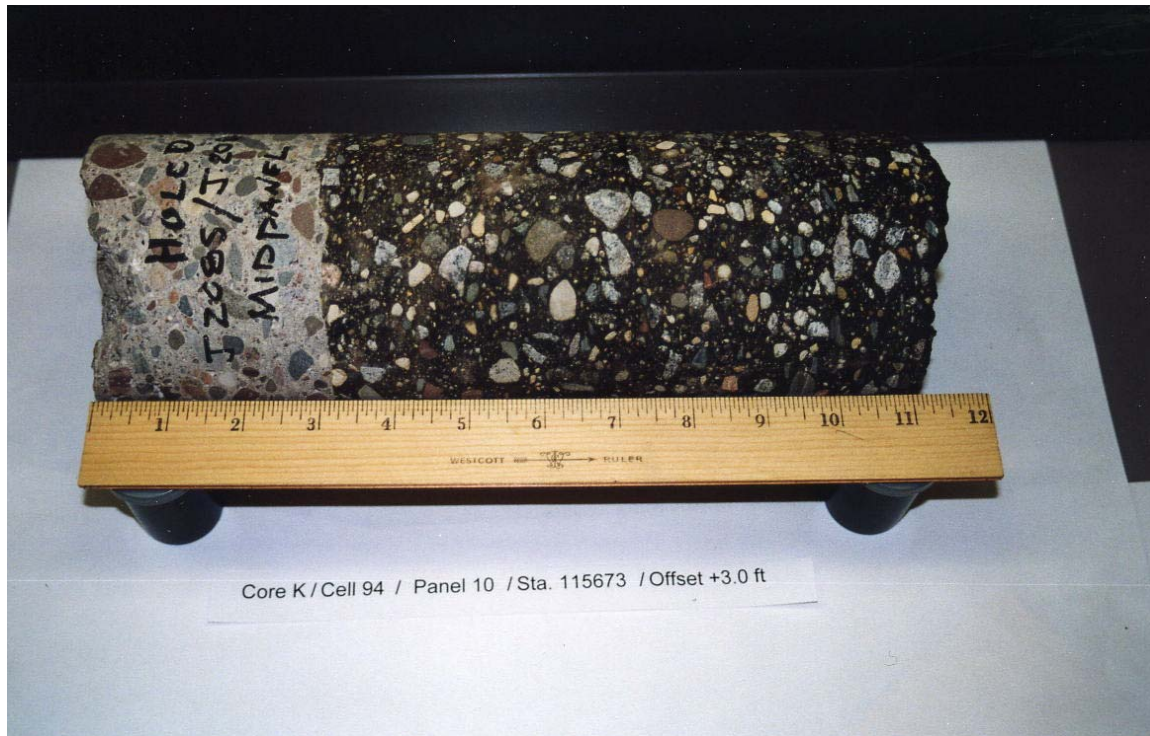
Photo 3.1. Core sample showing bonded layers of HMA and UTW.

Near the center of panels, bond between the layers was usually found to be intact. Photos 3.1 and 3.13 show core samples with complete bond after 7 years of service.

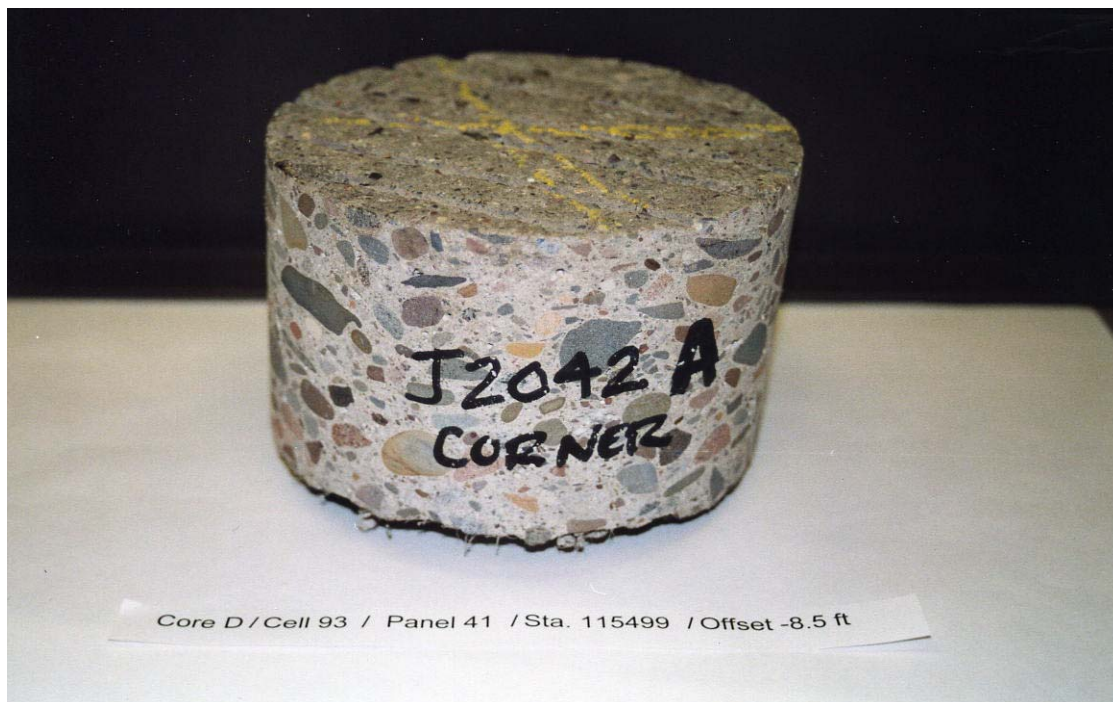
Photo 3.2. Core sample showing unbonded UTW.

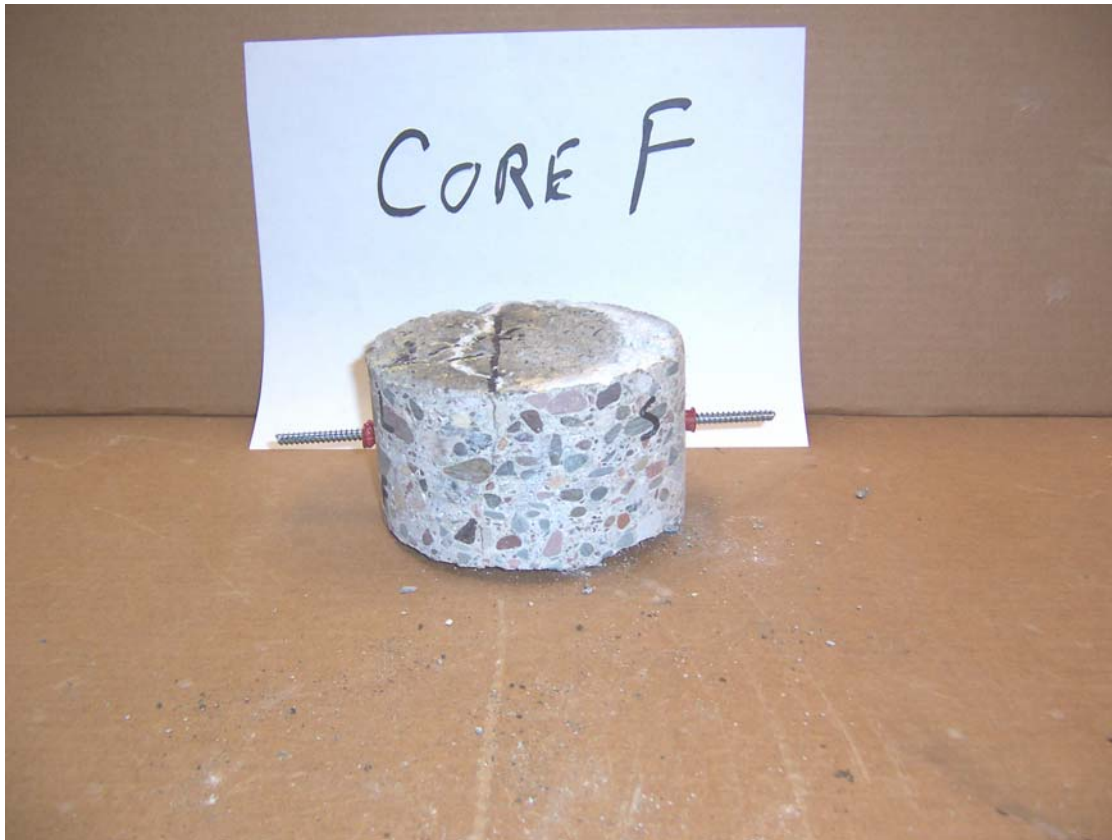
*Photo 3.3. Steel anchor screws installed into core before testing.*

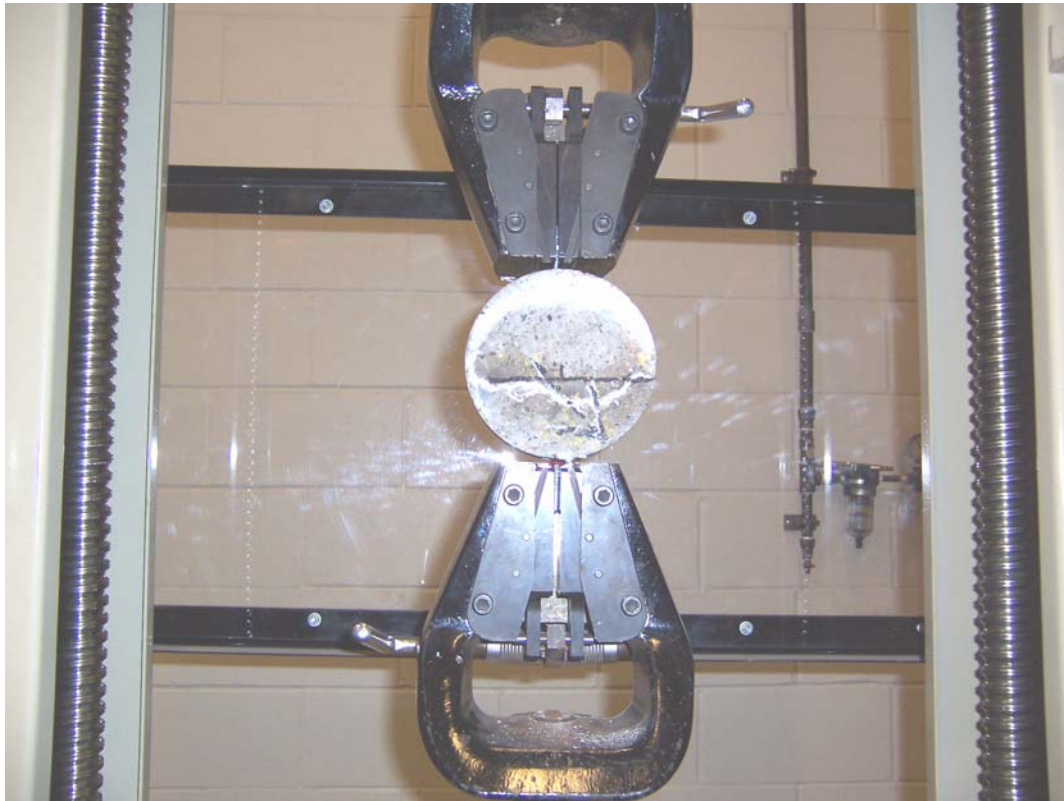
*Photo 3.4. Core sample during testing in universal testing machine.*

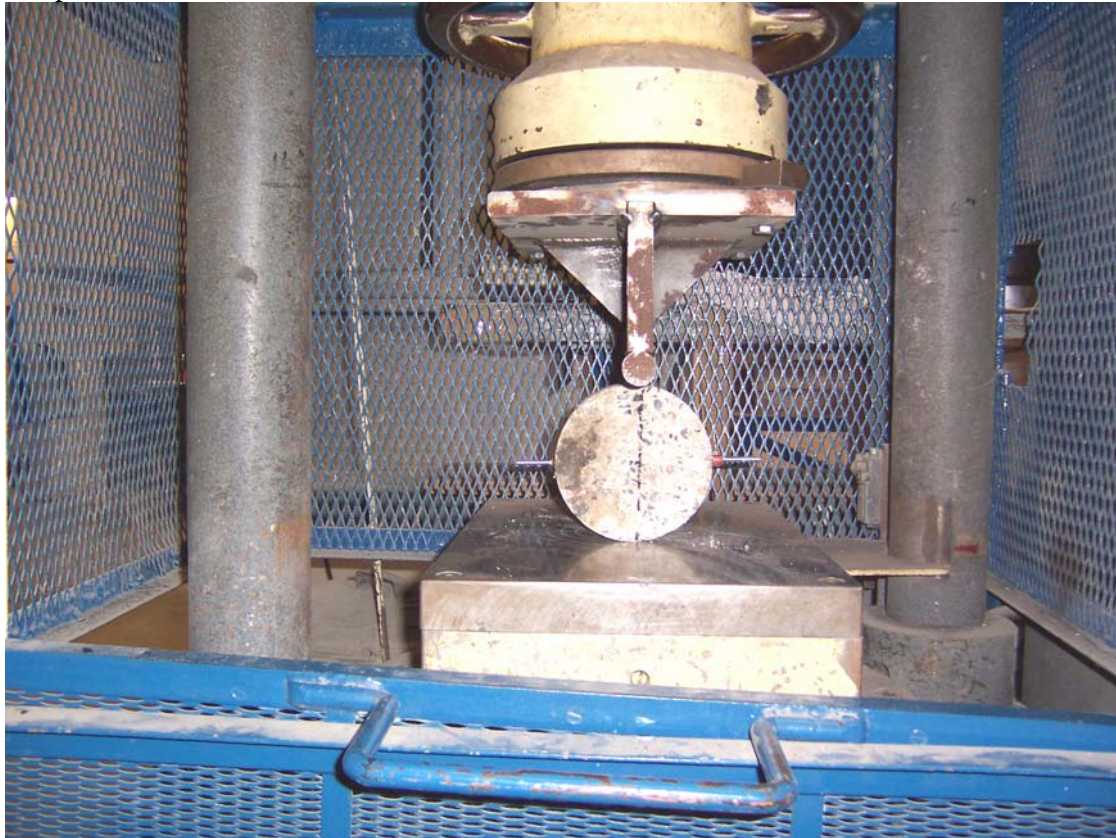
*Photo 3.6 Split tensile testing equipment used to test strength of fibers across crack in core samples.*

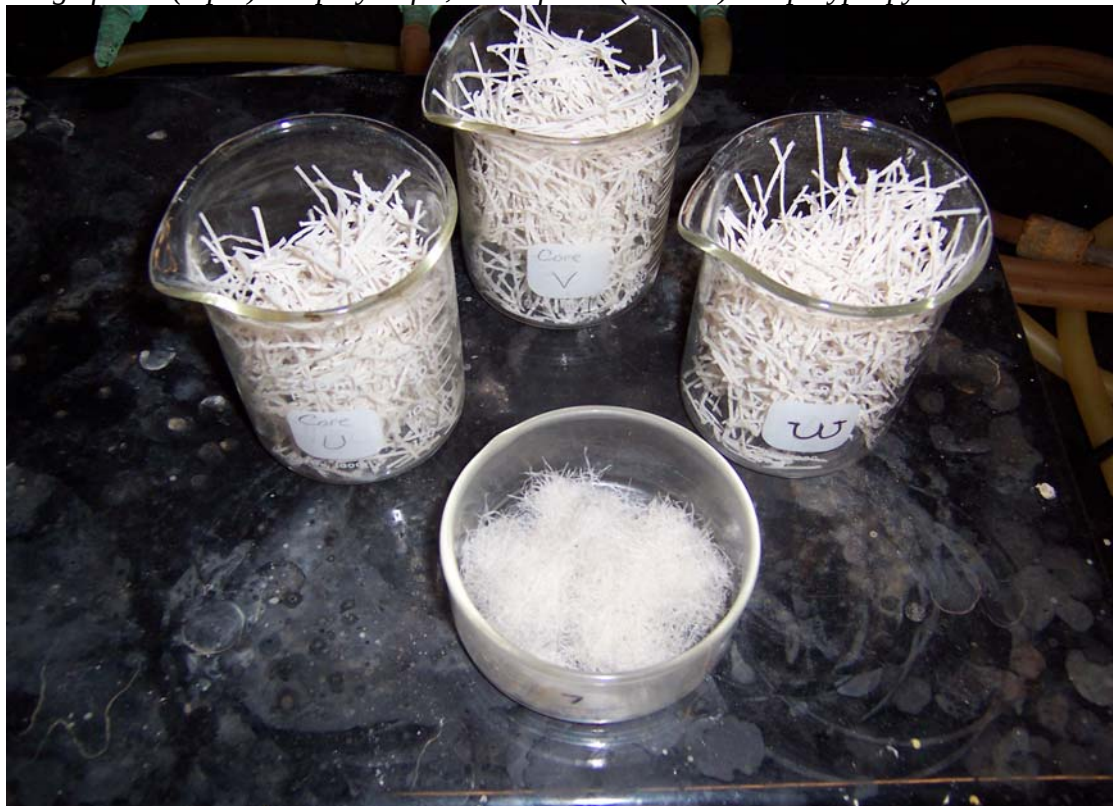
The third laboratory investigation determined the amount of fibers actually found in the concrete mix placed in the whitetopping test cells. The determination was made using two techniques. For the larger polyolefin fibers, a concrete sample was crushed to pass through a No. 4 (4.75 mm) sieve. The fibers were then hand picked out of the sample and weighed. For the smaller polypropylene fibers, the concrete was again crushed, but was then subject to several increasing concentrations of hydrochloric acid to dissolve the cement paste. A series of screens was then used to separate out the fibers to be weighed. Photo 3.8 shows the fibers after removal from the core samples.

*Photo 3.8 Fibers removed from core samples.  
Large fibers (top 3) are polyolefin, small fibers (bottom) are polypropylene.*

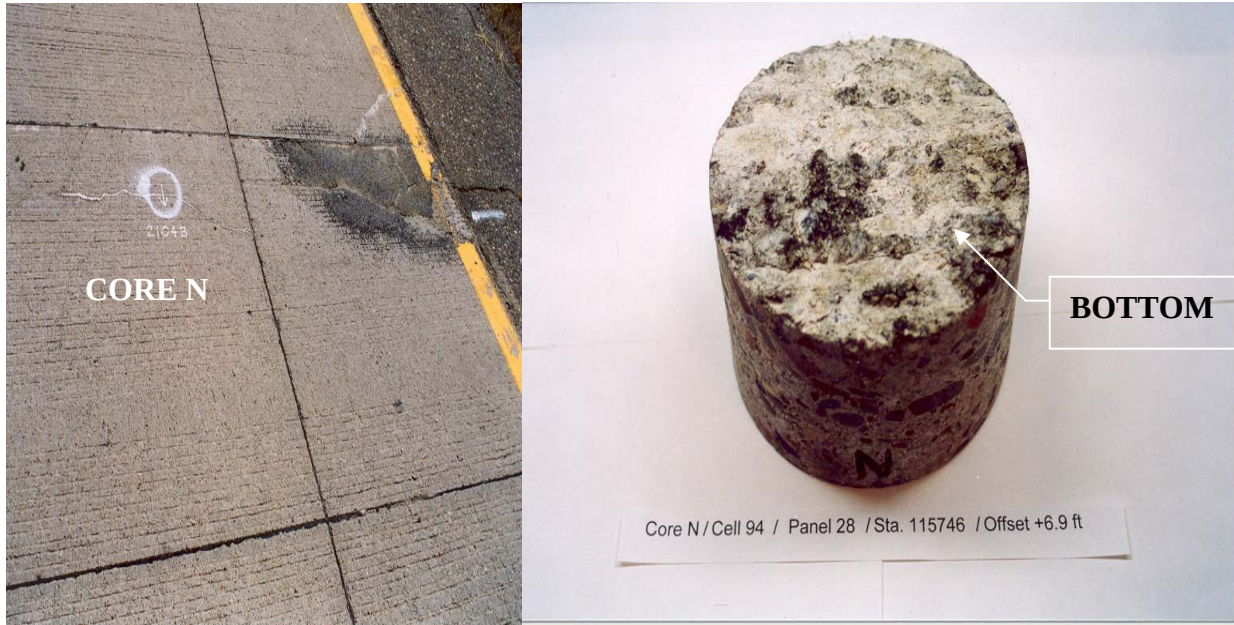
Photo 3.10 Core sample “N” showing no bond between UTW and HMA. Core shown upside down.

Reflective cracks appeared in all three of the UTW cells, although were more prevalent in the 3 inch (76 mm) thick test cells 94 and 95. The distress maps in Appendix A indicate the locations of the major thermal cracks that were present before the UTW test cells were placed. Photos 3.10 and 3.17 show examples of reflective cracking through the UTW. Not every major thermal crack reflected through the UTW. Photo 3.18 shows an example without reflective cracking in test cell 95.

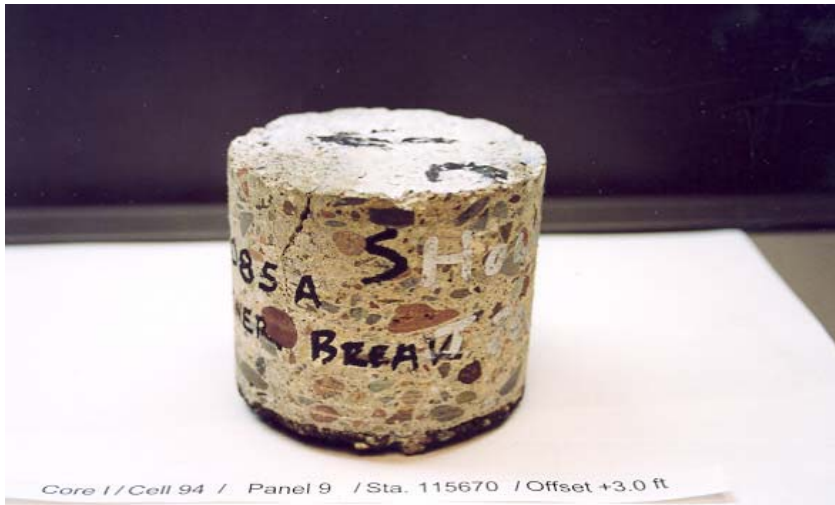
FC "I", Cell 94  
1-12-2005/E-19

| Cell | Field Core ID | Date | Roll ID | Photo number | Description | Direction of photo |
|---|---|---|---|---|---|---|
| 94 | | 1/12/2005 | E | 19 | Core "I". South side of core. Shows partial-depth top-down crack in UTW. | |

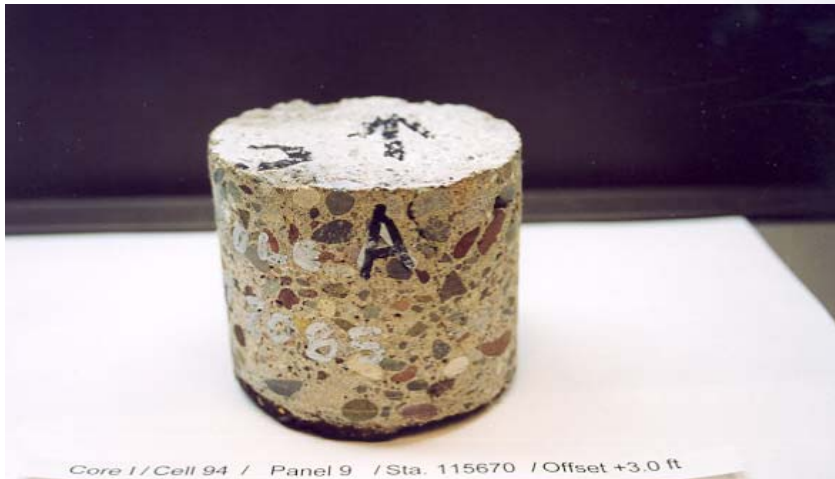
FC "I", Cell 94  
1-12-2005/E-18

| Cell | Field Core ID | Date | Roll ID | Photo number | Description | Direction of photo |
|---|---|---|---|---|---|---|
| 94 | | 1/12/2005 | E | 18 | Core "I". Approach side of core. Shows partial-depth top-down crack in UTW. | |

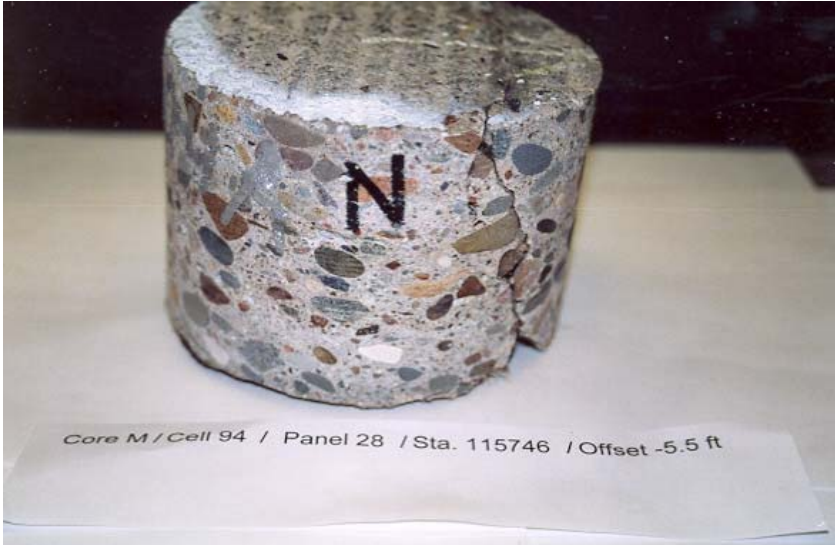
**FC "M", Cell 94  
1-12-2005/C-14**

| Cell | Field Core ID | Date | Roll ID | Photo number | Description | Direction of photo |
|---|---|---|---|---|---|---|
| 94 | | 1/12/2005 | C | 14 | Core "M". Bottom of core. Close-up view of crack. (inverted core in photo) | |

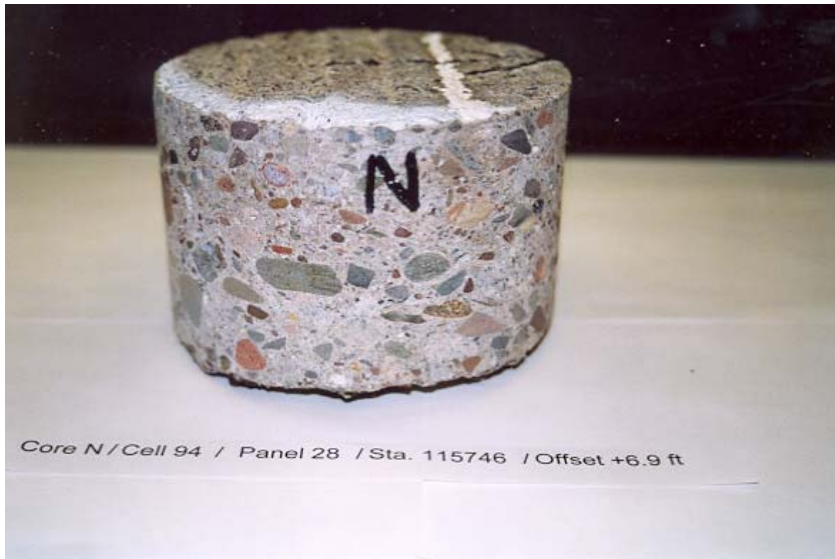
**FC "N", Cell 94  
1-12-2005/A-5**

| Cell | Field Core ID | Date | Roll ID | Photo number | Description | Direction of photo |
|---|---|---|---|---|---|---|
| 94 | | 1/12/2005 | A | 5 | Core "N". South side of core. Beginning of top-down crack. | |

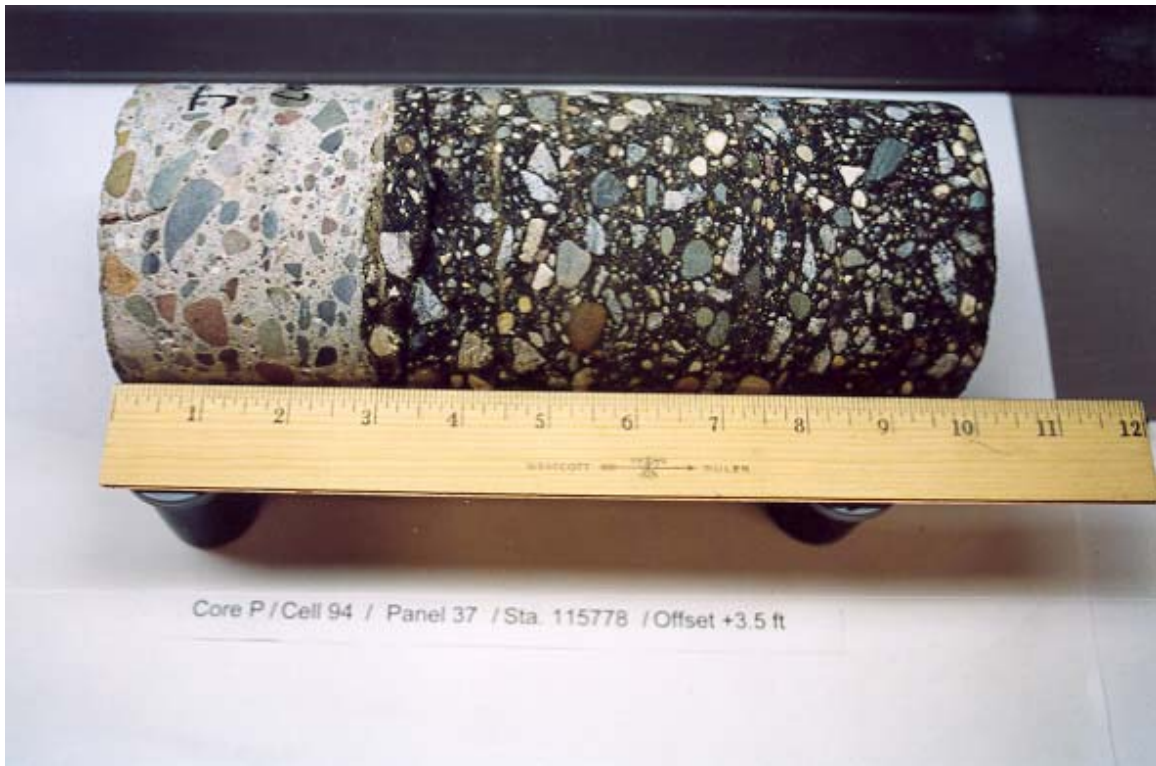
FC "P", Cell 94

| Cell | Field Core ID | Date | Roll ID | Photo number | Description | Direction of photo |
|---|---|---|---|---|---|---|
| 94 | | 1/12/2005 | E | 8 | Core "P". Shows partial-depth top-down crack in UTW. | |

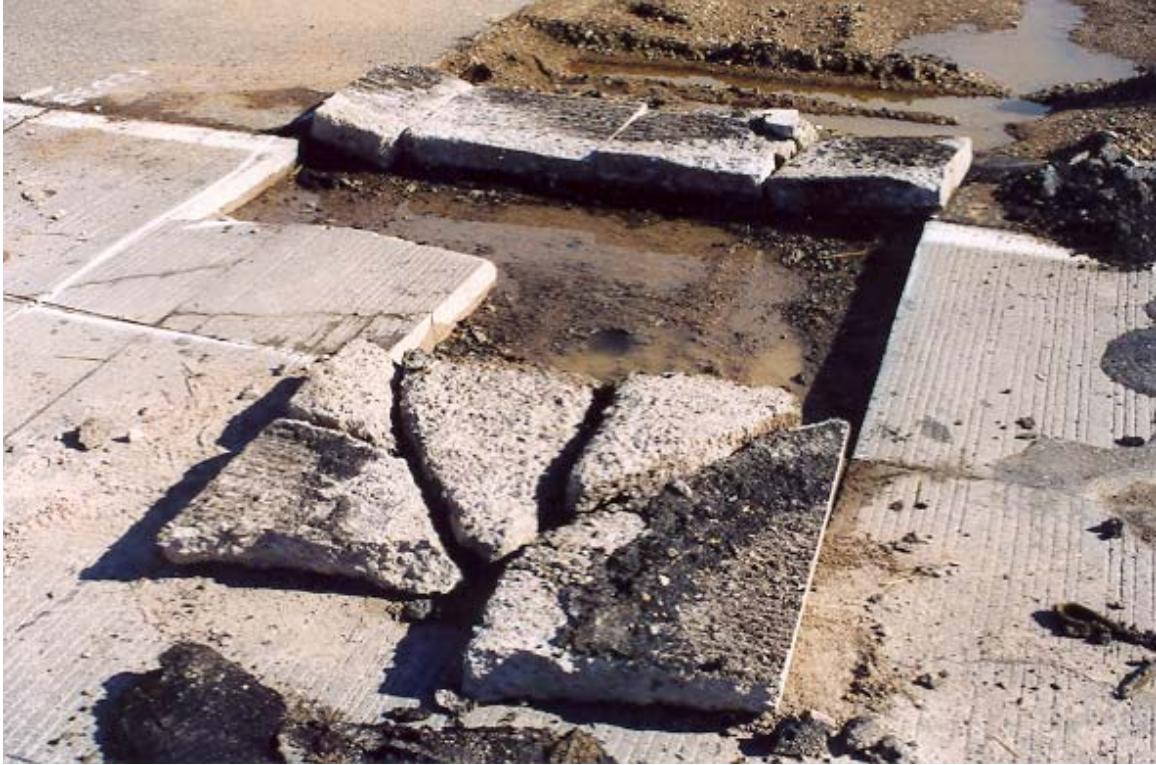
**9-02-2004/C-24**

| Cell | Field Core ID | Date | Roll ID | Photo number | Description | Direction of photo |
|---|---|---|---|---|---|---|
| 94 | | 9/2/2004 | C | 24 | Early corner cracking on inside wheelpath of driving lane. (in repair area) | Southeast |

**Cell 94 Early corner cracking on inside wheelpath of driving lane.**

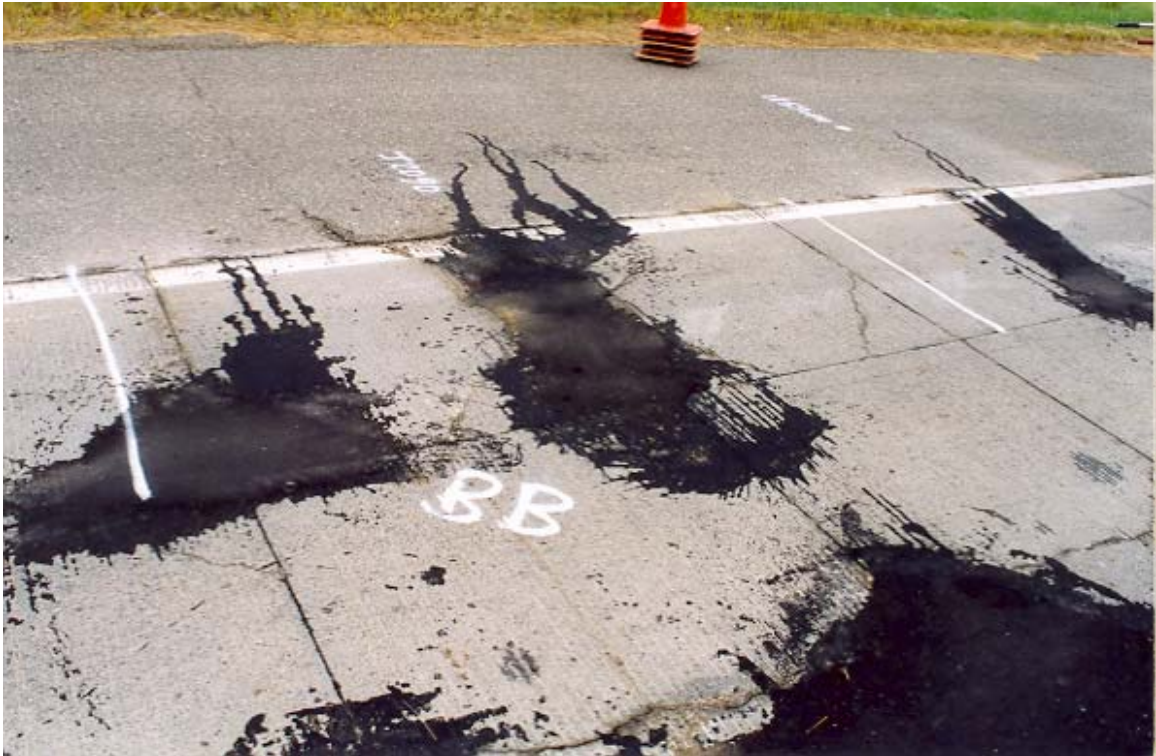
**FA "A", Cell 93 Remaining portions of slab still bonded to HMA. 8-25-2004/B-33**
