2008-47

## Corrosion Protection Performance of Epoxy-Coated Reinforcing Bars

## **Final Report**

**September 2008**

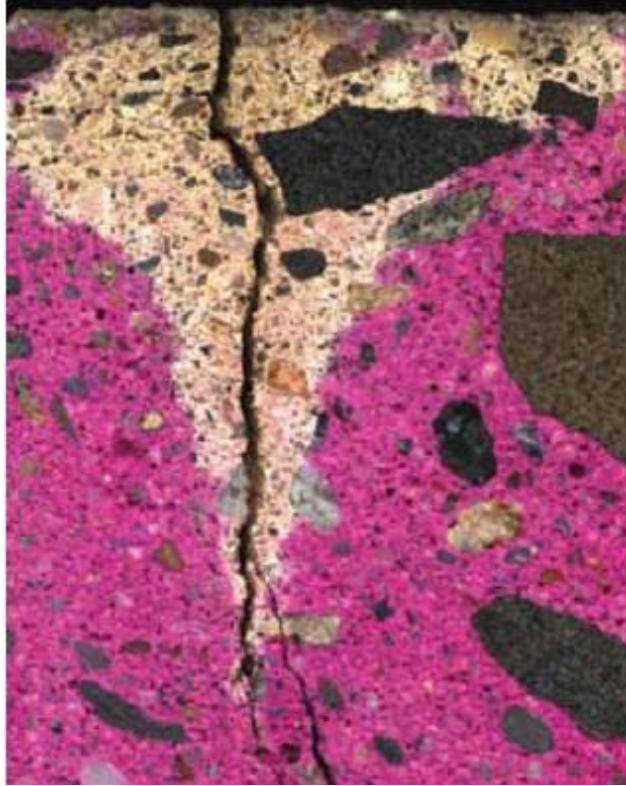
*Figure 2.3 Example of concrete carbonation (clear surface) in a vertical crack [46].*

Figure 2.3 shows an example of concrete carbonation in a vertical crack, the clear (light gray) surface indicates that carbon dioxide has penetrated. The red surface indicated no carbonation. This is explained in more detail in section 5.4.

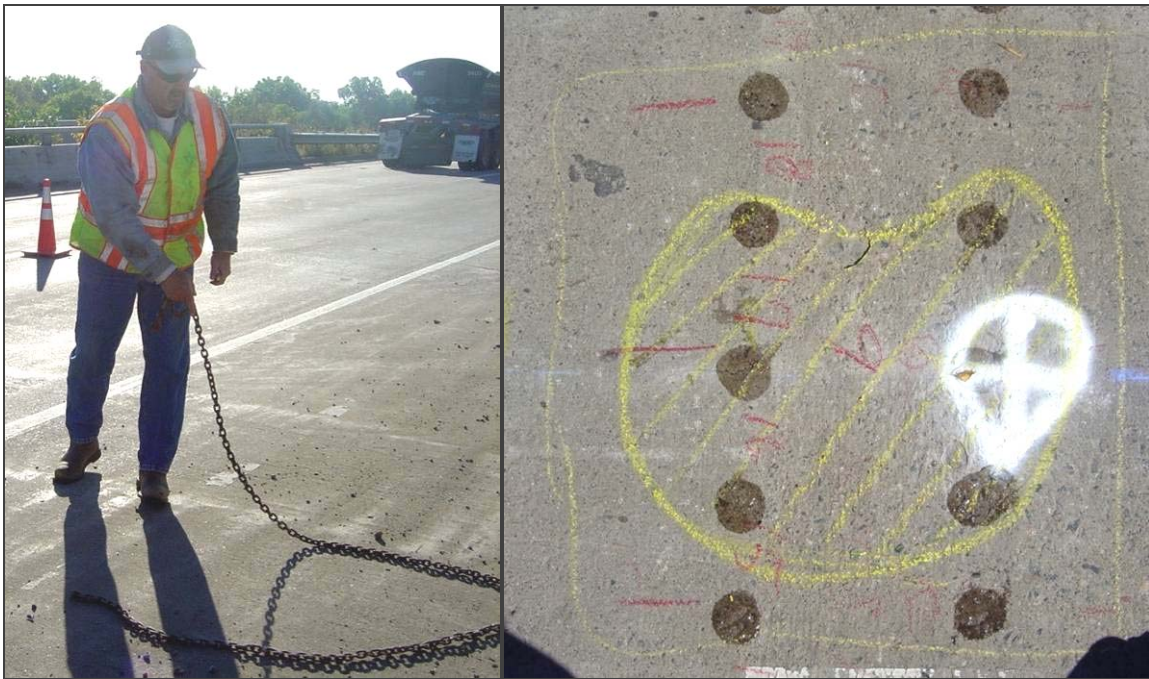
*Figure 4.1 Chain-drag survey.*

Figure 4.1 shows a Mn/DOT crew member dragging the chain across a deck surface; at the right the figure shows the preliminary evaluation of delaminated area by hollow sound using chain drag (outer yellow square) and the final evaluation of delaminated area (shaded area) by hollow sound using hammer tapping.

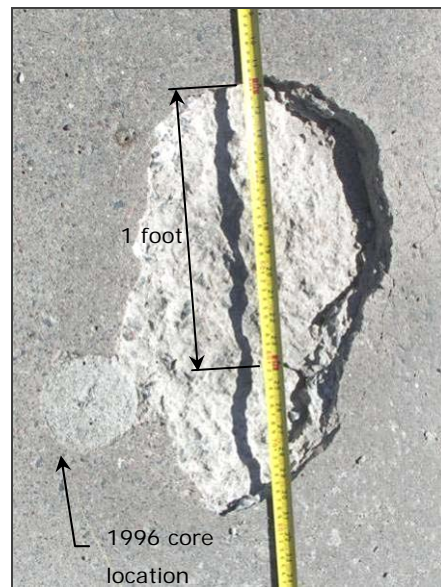
Visual inspection was performed in the shoulder and the right lane (lane 1). The deck showed light cracking mainly in the longitudinal direction, and few discontinuous cracks in the transverse direction. The total crack length in the area inspected was 220 ft, corresponding to a frequency of 0.062 ft/ft<sup>2</sup>. Crack widths ranged from 0.016 in. (0.4 mm) in the South span, to 0.080 in. (2.0 mm) in the transverse cracks next to the Pier No. 1. The right lane also had an open spalled area of about 1 sq. ft. (0.09 m<sup>2</sup>) next to the joint above Pier No. 2 on the North span of the bridge; this spall is presented in Figure 6.1. Figure 6.2 shows the crack layout of the surveyed deck (right lane and shoulder). There was no evidence of rebar corrosion at the bottom of the deck.

*Figure 6.1 Spalled area in bridge 19015.*

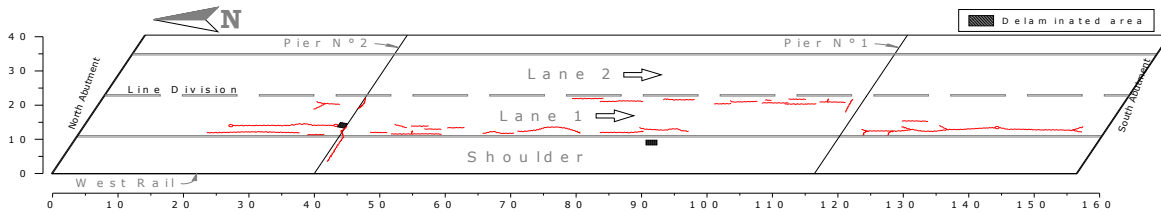
**Figure 6.2** Crack layout, spalled and delaminated areas on bridge 19015.

This survey was conducted by Mn/DOT personnel and it was performed in the right lane and the shoulder along the whole bridge length. The survey yielded three delaminated areas totaling 39 sq. ft., representing about 1.1% of the inspected area. Most of the delaminated area was adjacent to the joint above Pier No. 2 and the spall shown in Figure 6.1. Additionally, 4 and 6 sq. ft. delaminated areas were found on the right lane (lane 1) and the shoulder respectively. Details of the survey method are presented in section 4.2.2.

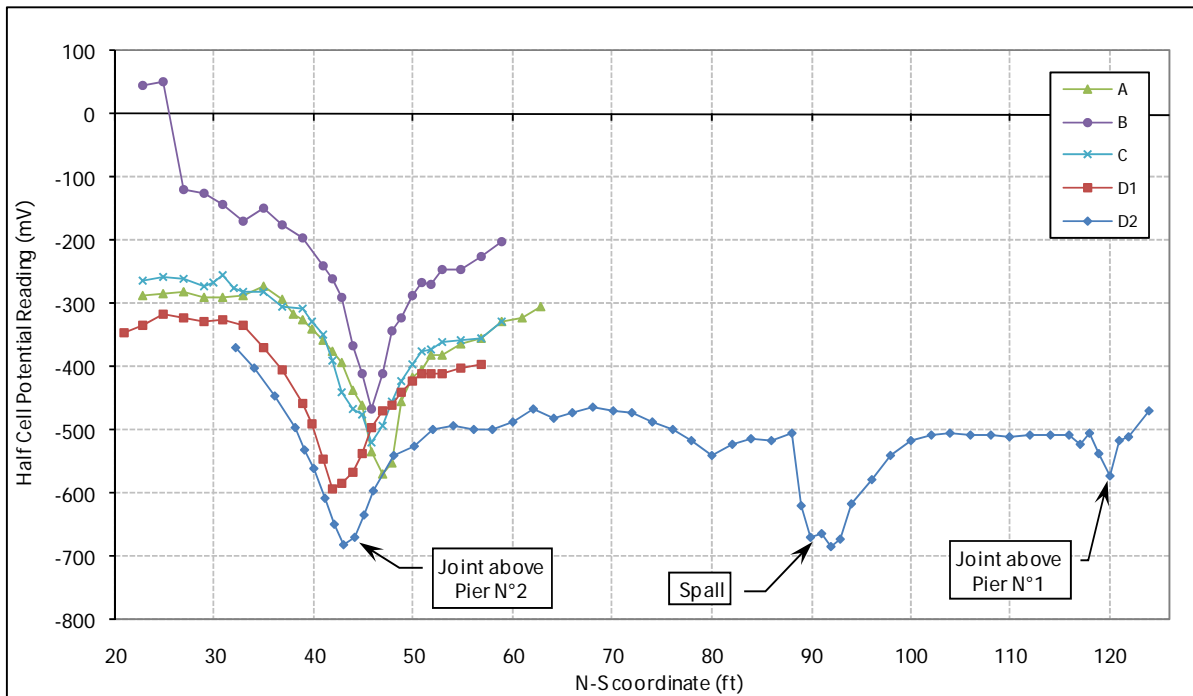
Along grid line D, two measurements were taken using two different connections to the bar. These readings are shown as D1 and D2 in Figure 6.4. Half-cell potential readings along grid line D on the shoulder showed much lower voltage readings (less than -350 mV) than along any of the other gridlines in the longitudinal direction. In addition, the chain drag deck survey showed areas of delamination on the shoulder. For this reason, half-cell potential measurements were continued into the second span of the bridge up to pier No. 1 as shown in Figure 6.3. As discussed in section 2.5.2, values of half cell potential readings lower than -350 mV indicate 90% probability of corrosion activity in the bars [50]. These absolute values, however, may vary significantly for epoxy-coated reinforcement depending on the concentration of oxygen and chloride, and on the electrical resistance of the concrete. Therefore, more important is the difference in the potential readings along a grid line, where the more negative the potential readings, the higher the level of corrosion activity.

**Figure 6.4** Half-cell potential readings along grid line A, B, C, D1, and D2 in bridge 19015.

All the readings clearly show a drastic drop in potential readings of -250 mV or more at various locations along the grid lines. Not coincidentally, this drop in voltage occurred at the joints above the piers that allow the ingress of deicing salts to the bars. A similar drop in potential readings can be seen along grid line D2, 90 ft from the north end of the deck. This location coincided with one of the delaminated areas detected during chain drag survey of the deck. The survey lines located in the wheel paths of the vehicles (lines A and C), show readings lower than line B located in between, this situation might be indicating that traffic is producing an effect in the half-cell potential readings.

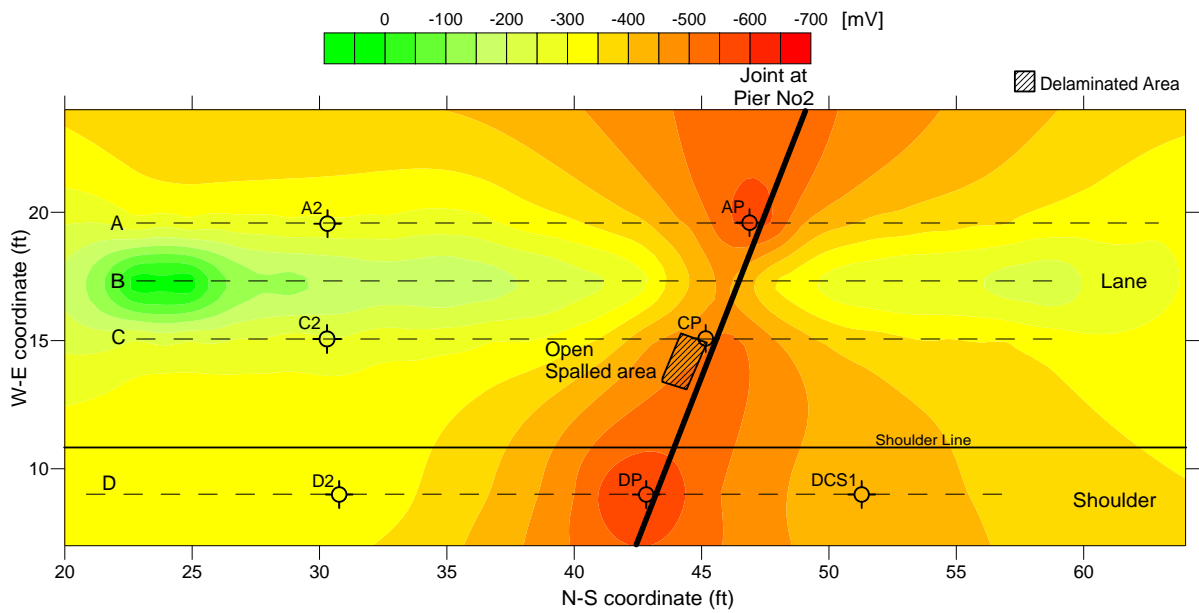
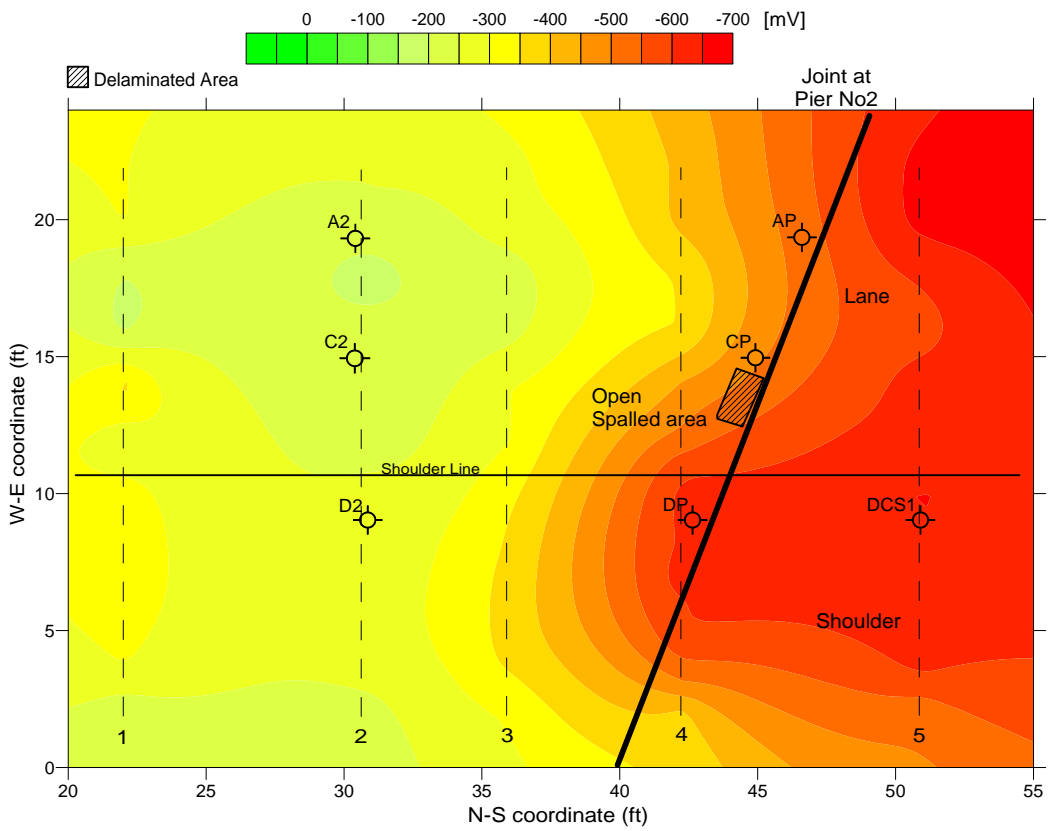
To provide a global idea about how the HCP readings are distributed on the deck and to easily identify high and low readings on the deck, the half-cell potential results along the longitudinal and transversal gridlines are presented in the contour plots shown in Figure 6.6 and Figure 6.7. The delaminated areas identified by the chain drag survey are also displayed. Although the two set of gridlines correspond to measurements in different rebars, both indicate that the area along the joint over pier No. 2 show the highest corrosion activity. Both figures show the significant effect of the saw cut at Pier No. 2.

**Figure 6.6** Contour map of HCP along longitudinal survey lines, bridge 19015.

**Figure 6.7** Contour map of HCP along transverse survey lines, bridge 19015.

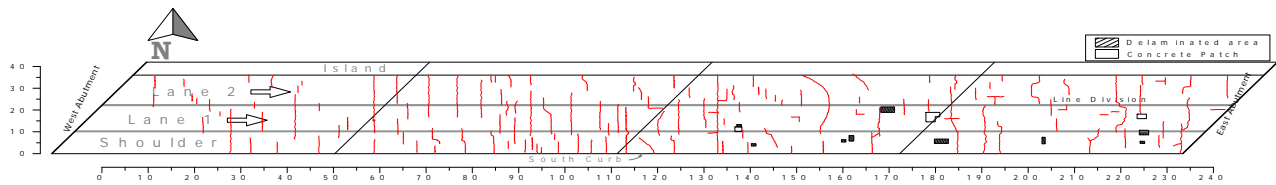
Visual inspection was performed in the shoulder and both eastbound lanes (lane 1 and lane 2). The deck had extensive cracking mainly along the transverse direction as shown in Figure 6.16. These cracks were sealed in the summer 2006, and as a result, it was not possible to measure any of the crack widths. The total crack length in the area inspected was 1134 ft, corresponding to a frequency of 0.129 ft/ft<sup>2</sup>. The deck also had a number of spalled and delaminated regions that had been already patched, mostly in the westbound lanes. There is also evidence of rebar corrosion at the bottom of the deck as shown in Figure 6.17. This corrosion evidence was observed in transverse cracks that coincide with the top of the deck. Figure 6.18 shows the crack layout of the entire bridge 27062 deck.

**Figure 6.18** Crack Layout, Spalled and/or delaminated areas on bridge 27062.

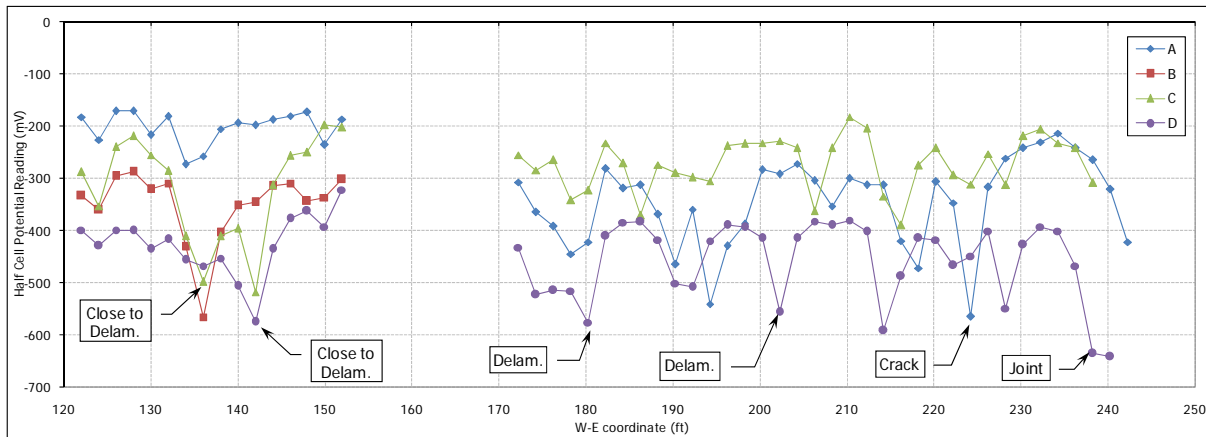
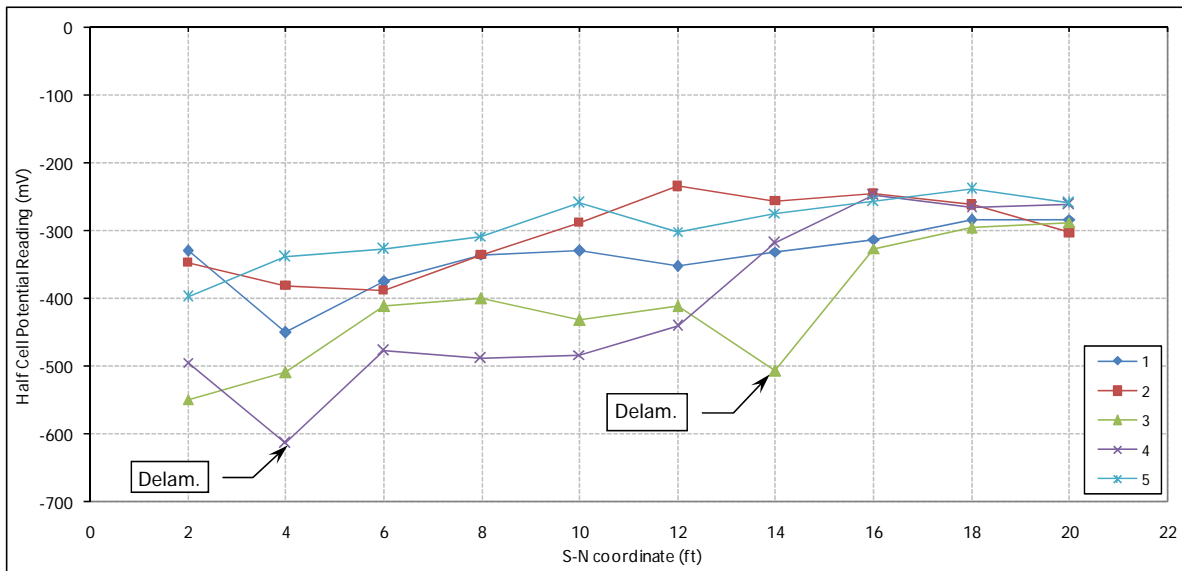
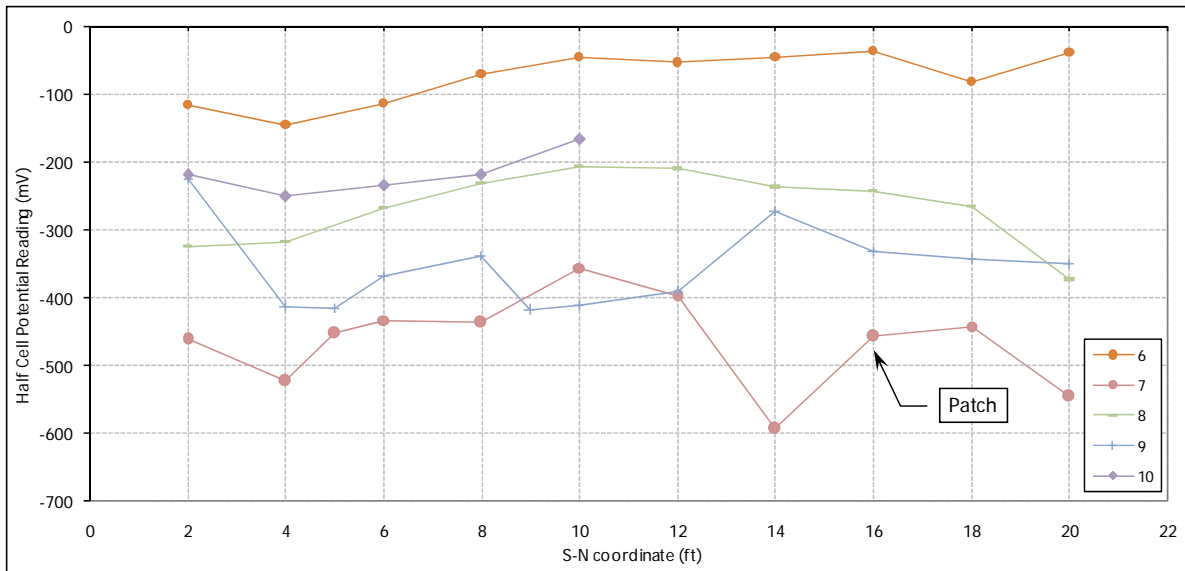
Results of the obtained half-cell potential readings along longitudinal and transversal grid lines are summarized in Figure 6.20, Figure 6.21, and Figure 6.22. Not surprisingly, the lowest voltage readings (-500mV or lower) indicating corrosion activity, correlate well with the presence of patches and delaminated areas, although this correlation does not apply to every single defect. Line D shows relative lower readings than other survey lines where most of the new delaminations detected are located in the shoulder. Corrosion activity was also found at crack locations and the joints.

triangles in the Figure 6.22) also shows a match between low reading and delamination. On the other hand, line 6 was selected in a healthy region of the deck and the readings are all above -150mV as shown in Figure 6.22.

**Figure 6.20** Half-cell potential readings along grid line A, B, C and D in bridge 27062.

**Figure 6.21** Half-cell potential readings along grid line 1 to 5 in bridge 27062.

**Figure 6.22** Half-cell potential readings along grid line 6 to 10 in bridge 27062.

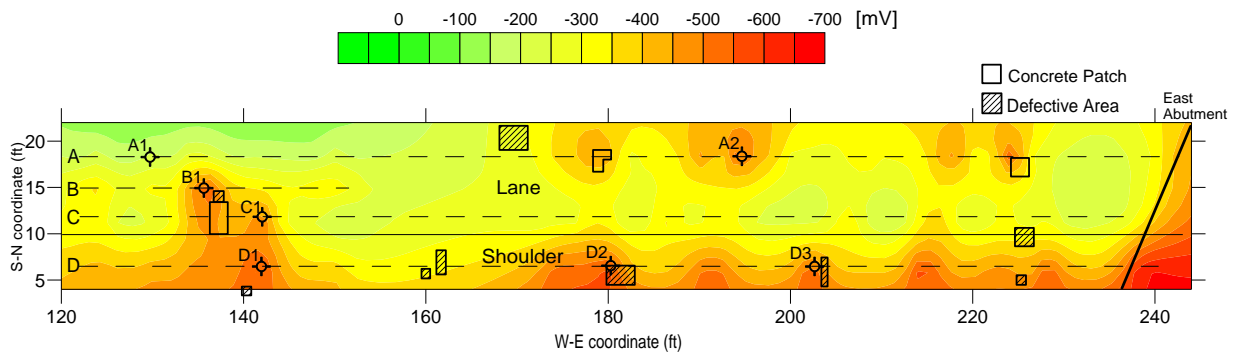
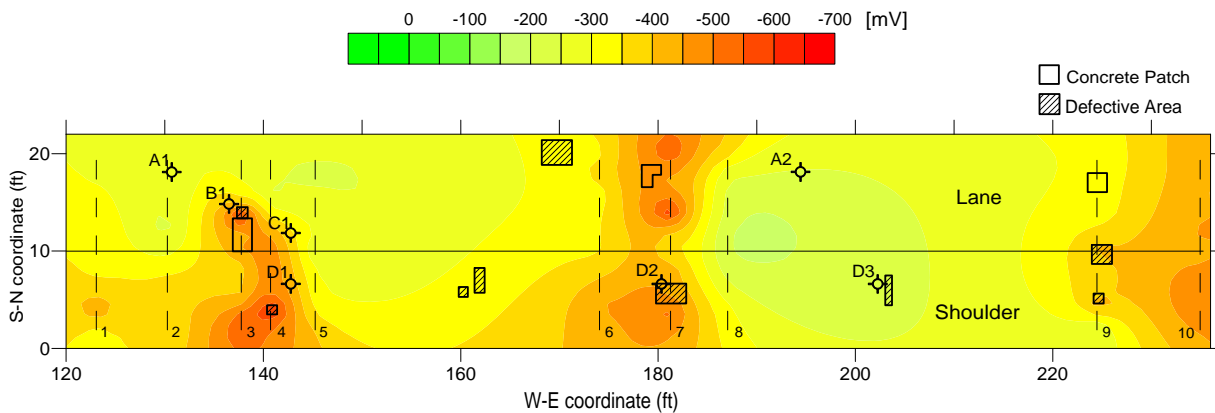
**Figure 6.23** Contour map of HCP readings in the longitudinal survey lines, bridge 27062.

**Figure 6.24** Contour map of HCP readings in the transverse survey lines, bridge 27062.

The figures show how lower HCP readings are located and concentrated close to deck patches, delamination areas, cracks and joints. Therefore, these results suggest that HCP can be a valuable tool to identify corrosion activity in decks with ECR.

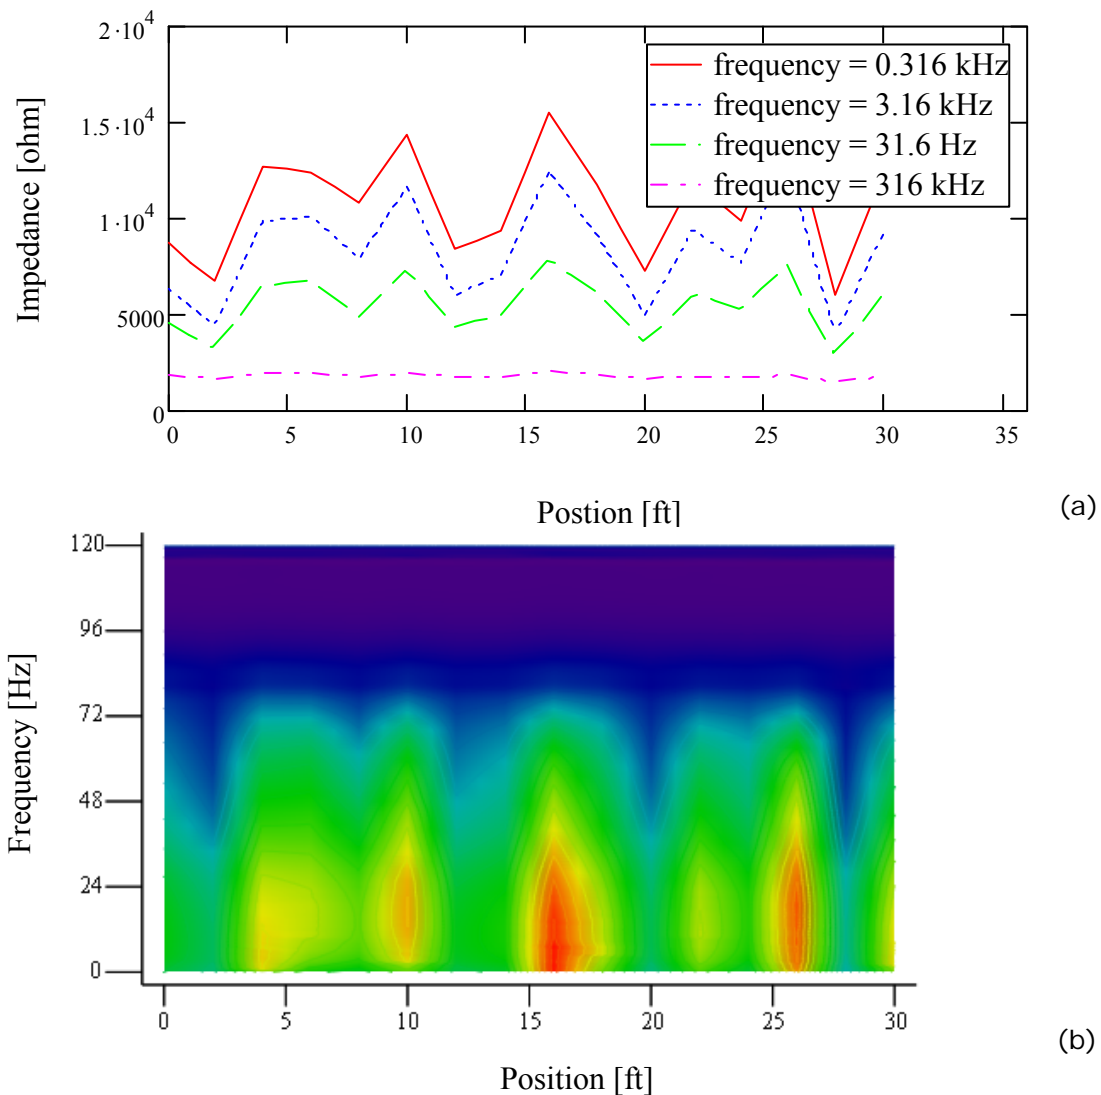
**Figure 6.25** Electrical impedance spectroscopy along longitudinal line A bridge 27062. (a) Impedance magnitude at four frequencies and (b) Contour plot of impedance amplitude versus frequency and measurement position along the survey line.

Figure 6.25 shows no sudden drops in electrical impedance along survey line A indicating that the bar has the same electrical properties through its length. These data coincide with half-cell potential data along line A where there is no indication of corrosion. That is no-corrosion activity on a rebar that seem to have healthy epoxy coating as indicated by the electrical impedance spectroscopy readings.

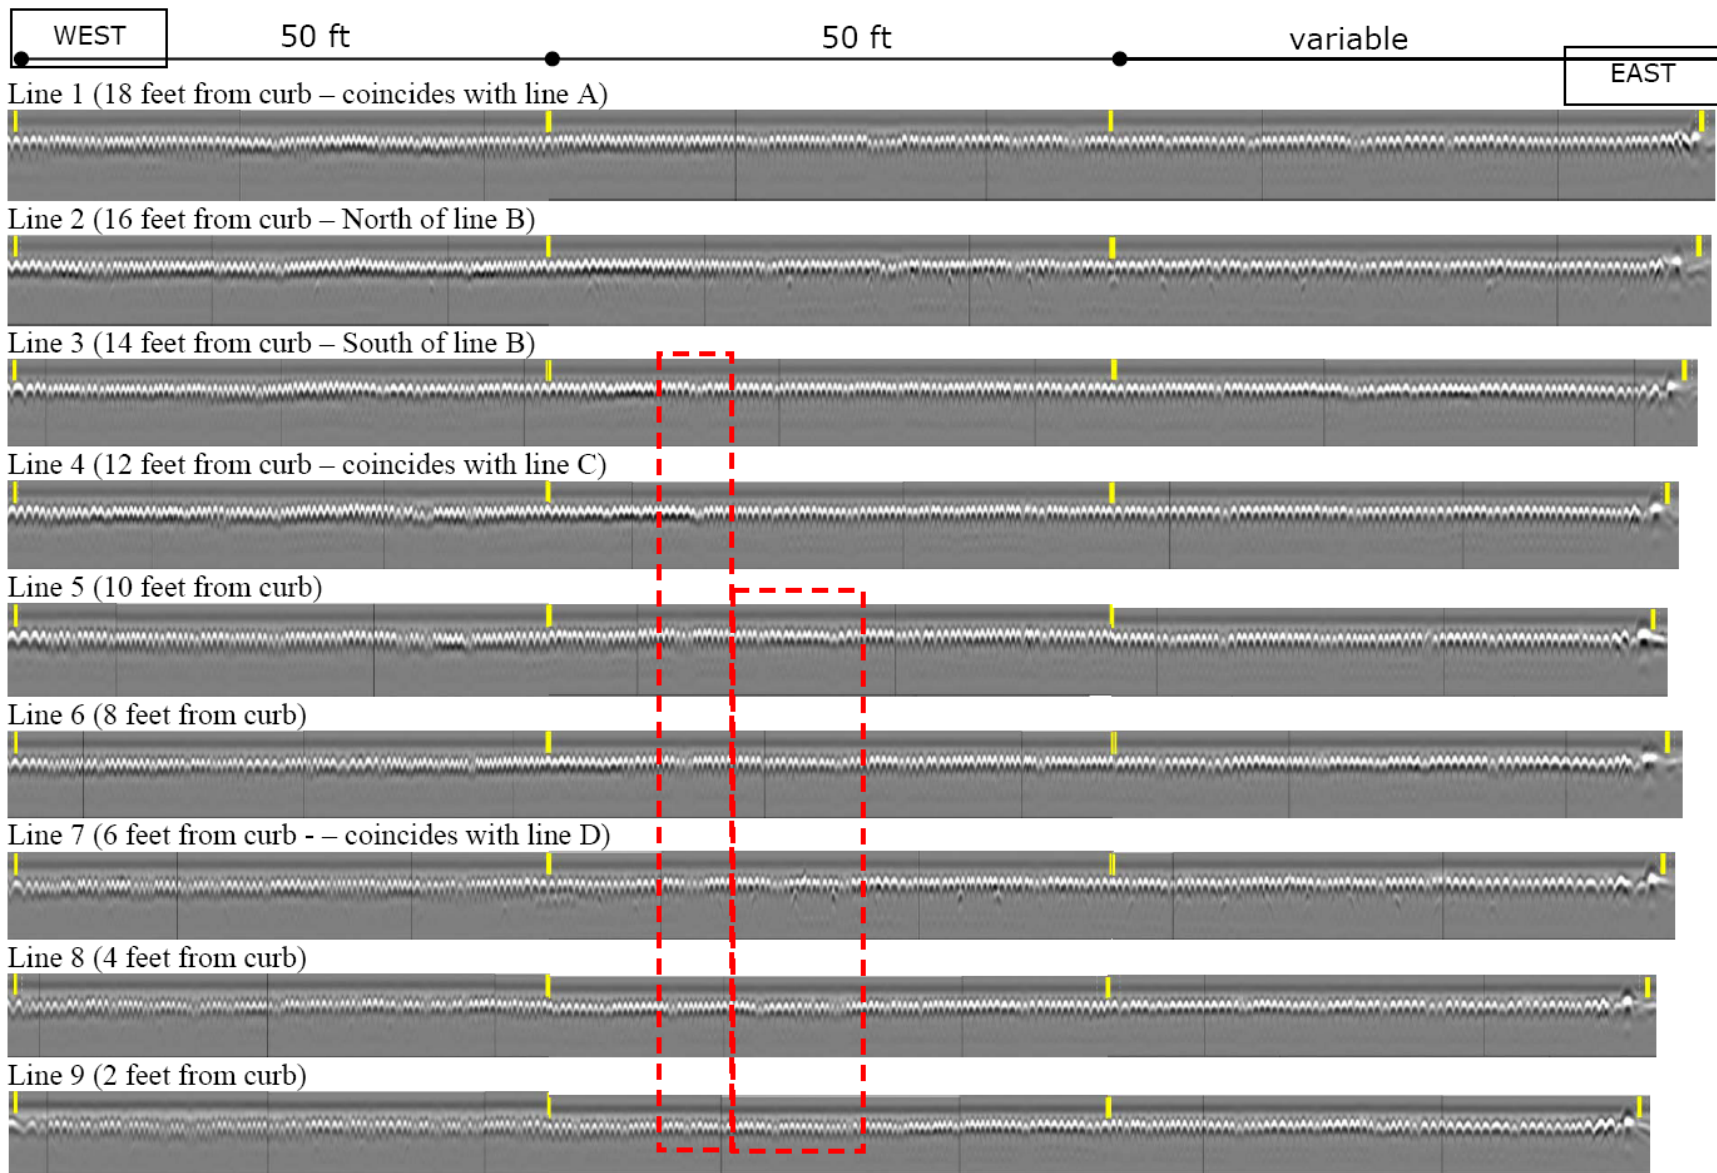
A reduction in the EM signal amplitude is an indication of high material attenuation. In the case of bridge deck that is related to the presence of moisture and  $\text{Cl}^-$  content. For example, the GPR survey consistently shows (dashed boxes in Figure 6.27) a sudden drop in amplitude and velocity (weaker signals and longer EM waves travel time at 60-70 ft coordinate). These signatures coincide with most negative half-cell potential measurements as shown in Figure 6.24. That is, high volumetric water and  $\text{Cl}^-$  content contribute to the corrosion environment. The problem with this interpretation is that the GPR survey show many other areas with similar signatures that do not correspond to half cell potential response. This is a clear indication of the complexity and interplay of many complex parameters including the quality of the epoxy coating in the rebars.

**Figure 6.27** GPR results along survey lines in bridge 27062.

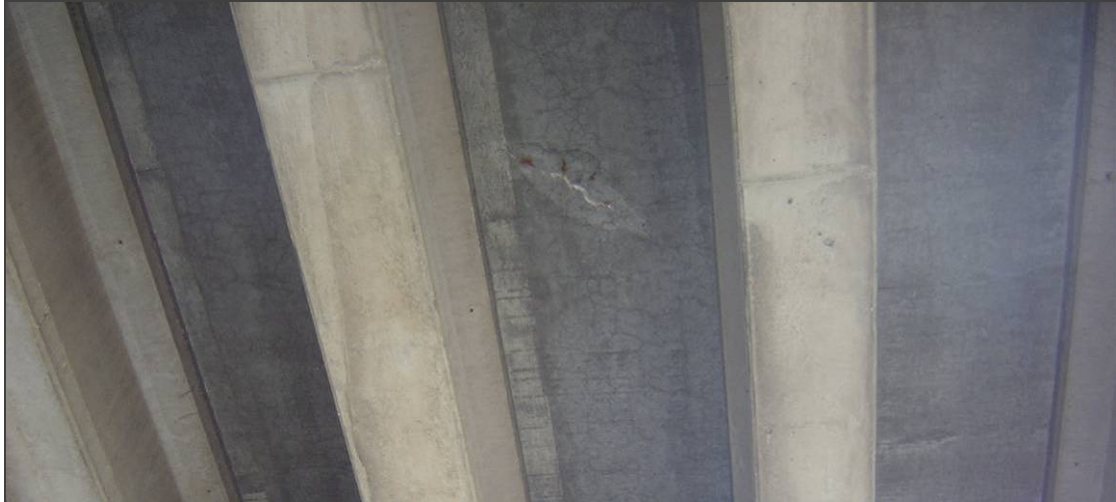
Visual inspection was performed only in the eastbound lane (lane 1). The deck showed minor longitudinal and transverse cracking as shown in Figure 6.31 and Figure 6.33. The total crack length in the area inspected was 263 ft, corresponding to a frequency of 0.038 ft/ft<sup>2</sup>. Crack widths ranged from 0.008 in. (0.2 mm) near the east abutment, to 0.080 in. (2.0 mm) in the longitudinal direction next to the delaminated area in the west abutment. There was also evidence of some efflorescence and light rust staining from the black bars of the bottom reinforcing mat. This efflorescence evidence was observed in a small area on the underside of the deck as shown in Figure 6.32.

**Figure 6.32** Evidence of efflorescence and rust staining on the underside of the deck of bridge 27812.

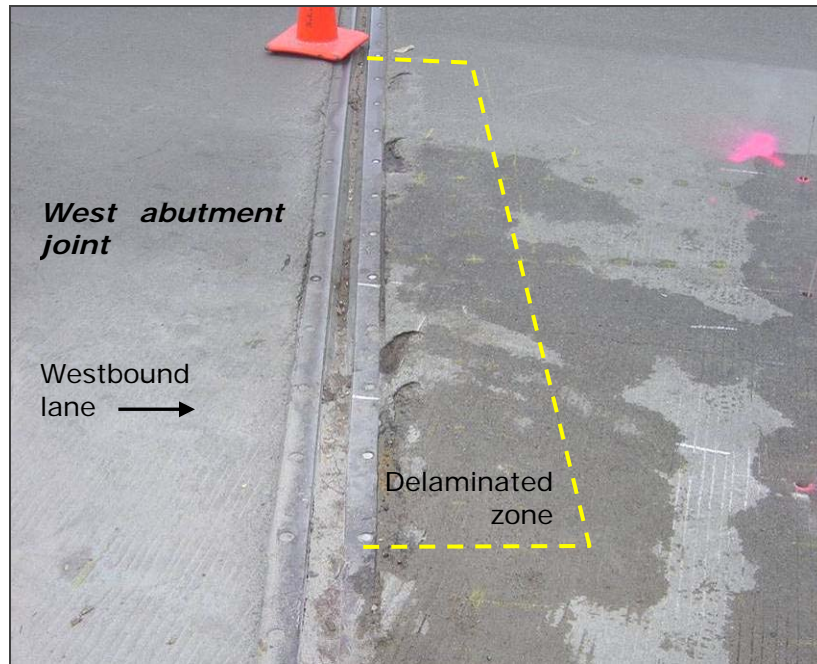
*Figure 6.34 Delaminated area detected in bridge 27812.*

This survey was conducted by Mn/DOT personnel and it was performed in only half the width of the right lane along the whole bridge length of the eastbound direction. In this bridge one delaminated area of 20 sq. ft. (2x10 ft) was detected, 0.3% of the inspected area. The delaminated area was located in the East side of the West abutment as shown in Figure 6.34.

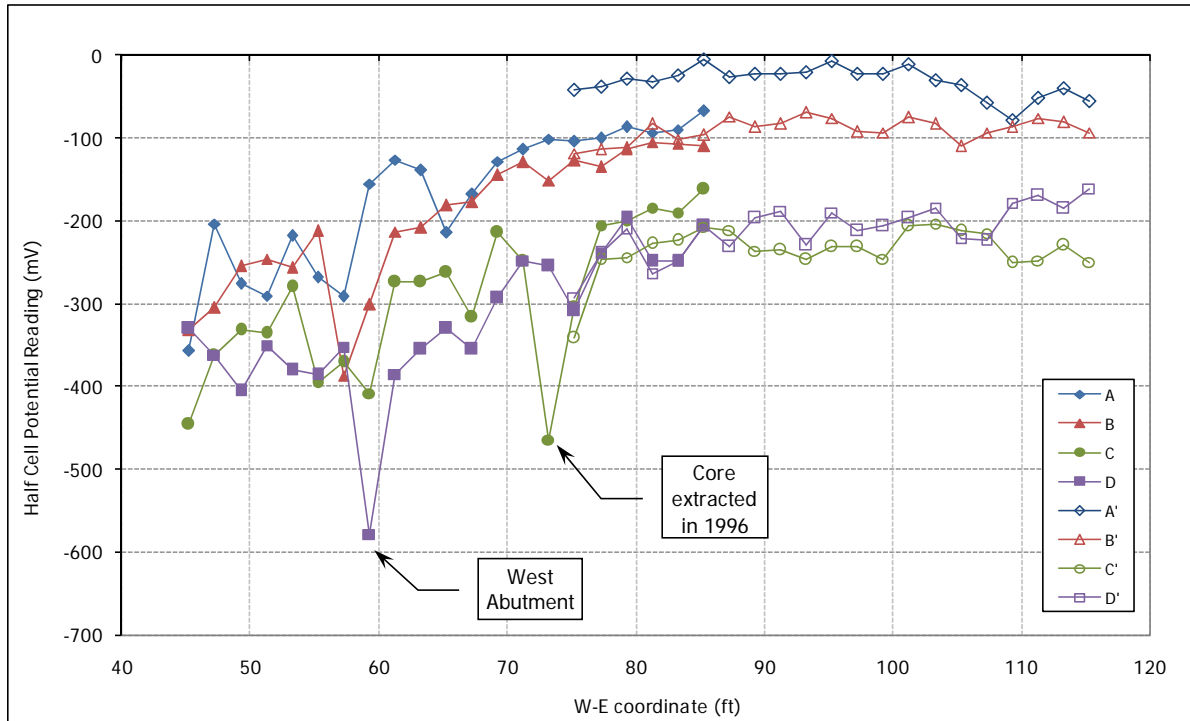
**Figure 6.36** Half-cell potential readings along grid line A, B, C and D in bridge 27812.

Figure 6.36 and Figure 6.37 show the half cell potential readings in the longitudinal and transverse directions, respectively. In the longitudinal direction, the data show potential readings that are above the value corresponding to a 90% probability of corrosion activity (-350mV) and are nearly constant along the gridline except at few locations. In general, it can be observed that the longitudinal readings are lower when they are close to the west abutment (left in Figure 6.36) and the potential increases gradually with the distance from abutment. These results suggest that corrosion activity is concentrated primarily near the joint abutment.

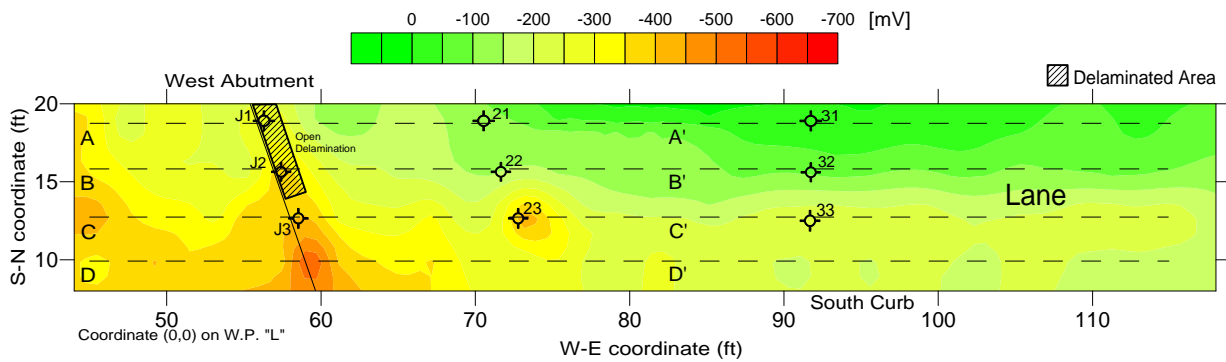
**Figure 6.38** Contour map of HCP readings in the longitudinal survey lines, bridge 27812.

To have a global idea about how the HCP readings are distributed on the deck and to easily identify high and low readings on the deck, the half-cell potential results along the longitudinal and transversal gridlines are presented in the contour plots shown in Figure 6.38 and Figure 6.39. The delaminated areas identified by the chain drag survey are also displayed.

The figures show the good condition of the deck and the concentration of low HCP readings close to the west abutment. The extrapolation to the left of the west abutment joint in Figure 6.39 can not be considered as a prediction of the condition of the deck.

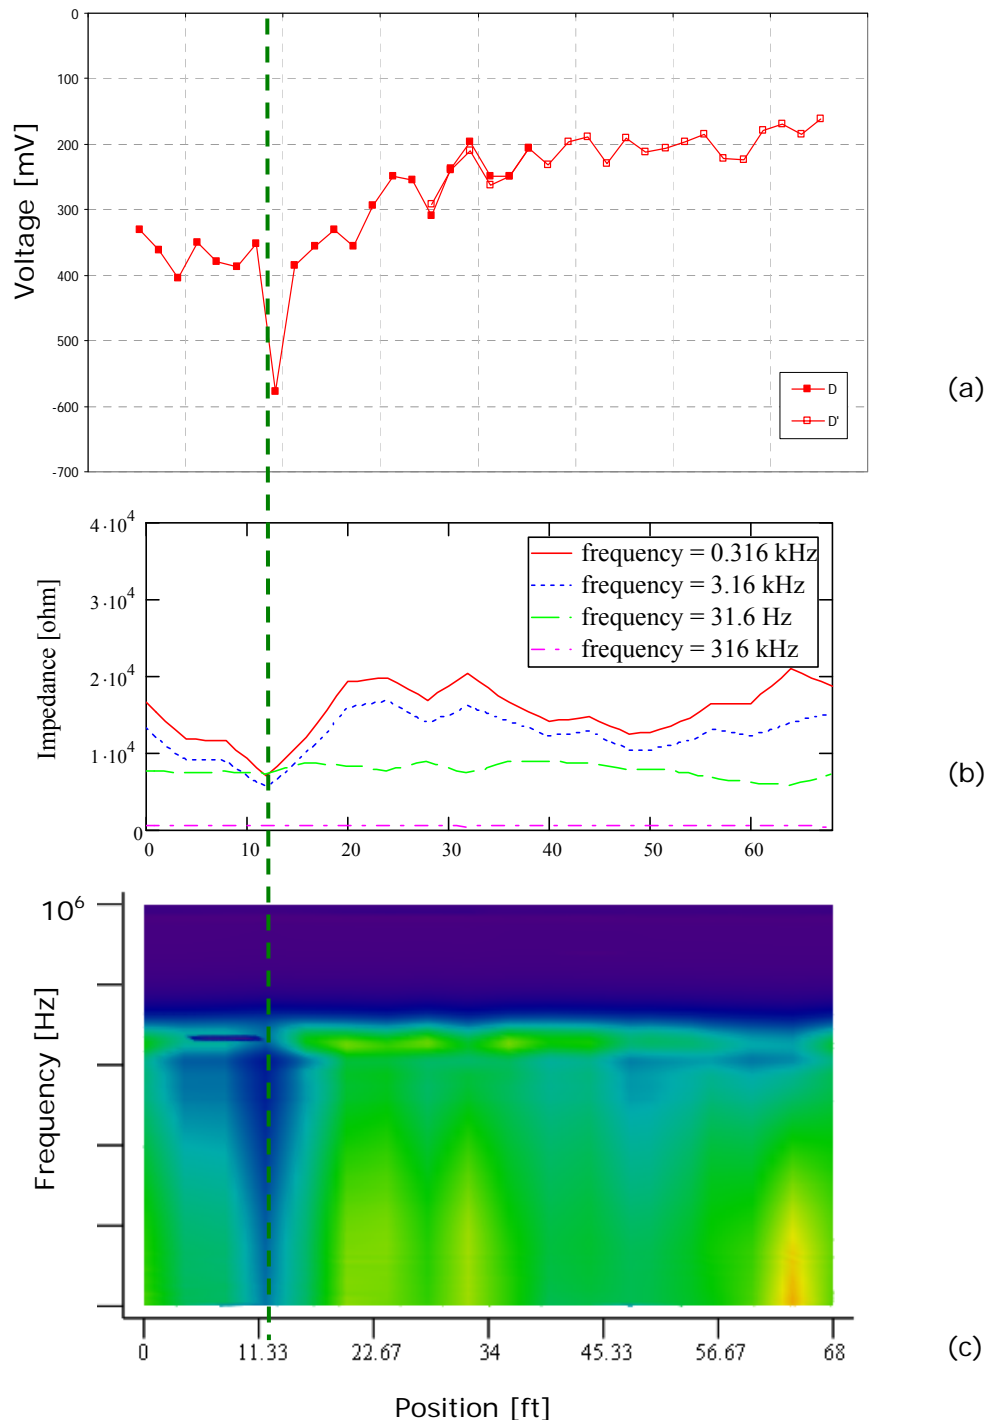
**Figure 6.40** Electrical impedance spectroscopy versus half-cell potential measurement along line D-D' in Bridge 27812. (a) half-cell potential measurements, (b) four-frequency impedance measurement, and (c) contour plots of impedance magnitude versus frequency and positions along the survey line.

Impedance spectroscopy data were collected only along the half-cell potential longitudinal gridlines A-A', C-C' and D-D' and transversal gridlines "Joint", 1 and 2. The impedance spectroscopy results provide information about the quality of epoxy-coating of the rebars. That is, in areas with poor corrosion protection it is expected to have higher corrosion activity. For example, Figure 6.40 and Figure 6.41 show the correlation between corrosion activity and low impedance measurements. Areas with higher corrosion activity (low half potential measurements) coincide with a drop in electrical impedance measurements. Note that the impedance spectroscopy results on Figure 6.41 (Joint line) show low impedance at every single point. These results suggest that the epoxy coating has degraded, contributing to the corrosion activity found with the half cell potential measurements (see Figure 6.38 and Figure 6.39).

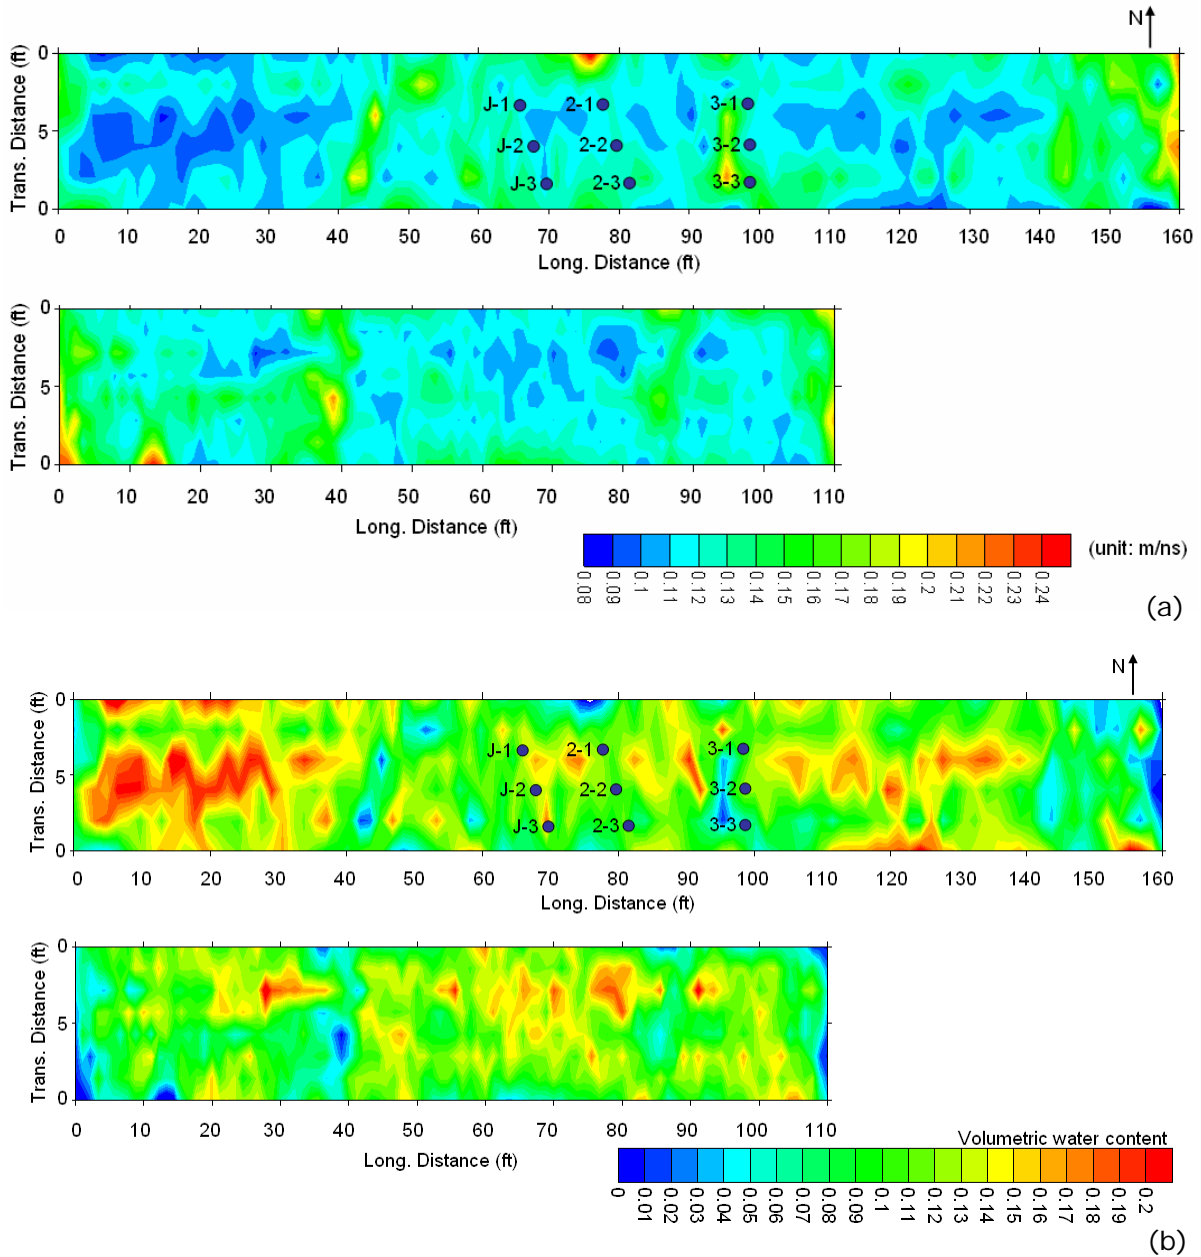
**Figure 6.43** Distribution of (a) electromagnetic wave velocity and (b) calculated volumetric water content.

Figure 6.42 presents the collected survey lines. The time analysis of these hyperbolas in the survey permits the evaluation of electromagnetic (ELM) wave velocity and volumetric water content distribution in the concrete (Figure 6.43) and the depth of each steel rebar (Figure 6.44). The mapping of ELM wave velocity provides an indication of the volumetric water content and salt content in the concrete. The evaluation of the ELM wave velocity also helps in the evaluation of deteriorated areas in the bridge deck. The results are compared against the mapping of cracks, patches and delaminated areas as these zones will tend to have concrete with greater water content. For example Figure 6.43 shows the area next to the joint (cores “J1”, “J2”, and “J3”) shows the highest water content. These data correlates well with the high corrosion activity documented with the half-cell potential measurements (Figure 6.38 and Figure 6.39) and the low coating quality as detected by the half-cell potential measurements (Figure 6.41)

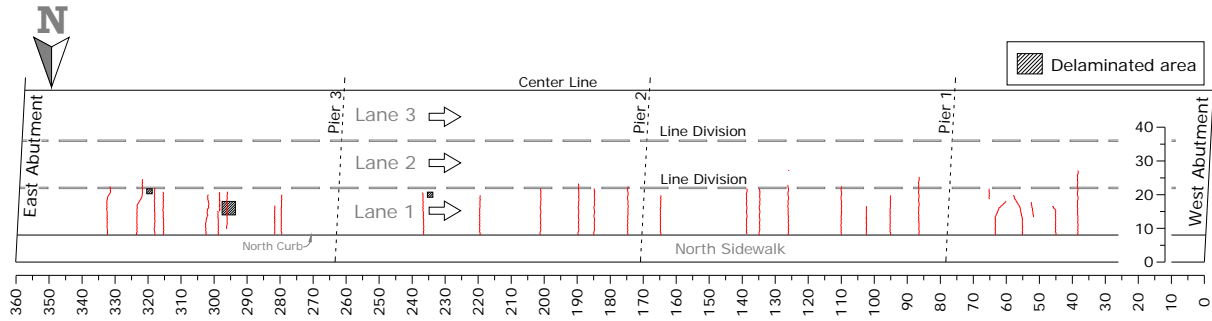
**Figure 6.45** Crack layout, spalled and/or delaminated areas on bridge 27815.

Visual inspection was performed only in the right lane (lane 1). This deck showed mostly transverse cracking (see Figure 6.45). The total crack length in the area inspected was 373 ft, corresponding to a frequency of 0.073 ft/ft<sup>2</sup>. Although the predominant crack width was 0.039 in. (1.0 mm), crack widths ranged from 0.008 in. (0.2 mm) in small cracks close to the north curb, to 0.080 in. (2.0 mm) in a transverse crack where core samples were extracted in the previous study (see Figure 6.46). Signs of efflorescence were observed on the underside of the deck along with several transverse cracks as shown in Figure 6.46. There was also evidence of rebar corrosion of the bottom mat in many sections of the deck, as indicated by light rust staining on the underside of the bridge as shown in Figure 6.47. This figure shows that despite the visual inspection was conducted only in the right lane, the cracks observed on the underside of the bridge are presented in the three lanes of the westbound.

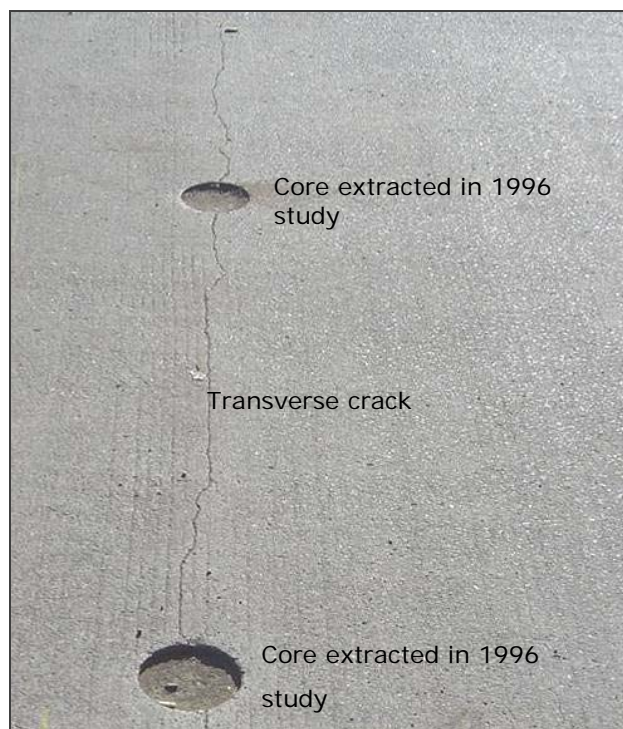
**Figure 6.46** Transverse crack in bridge 27815.

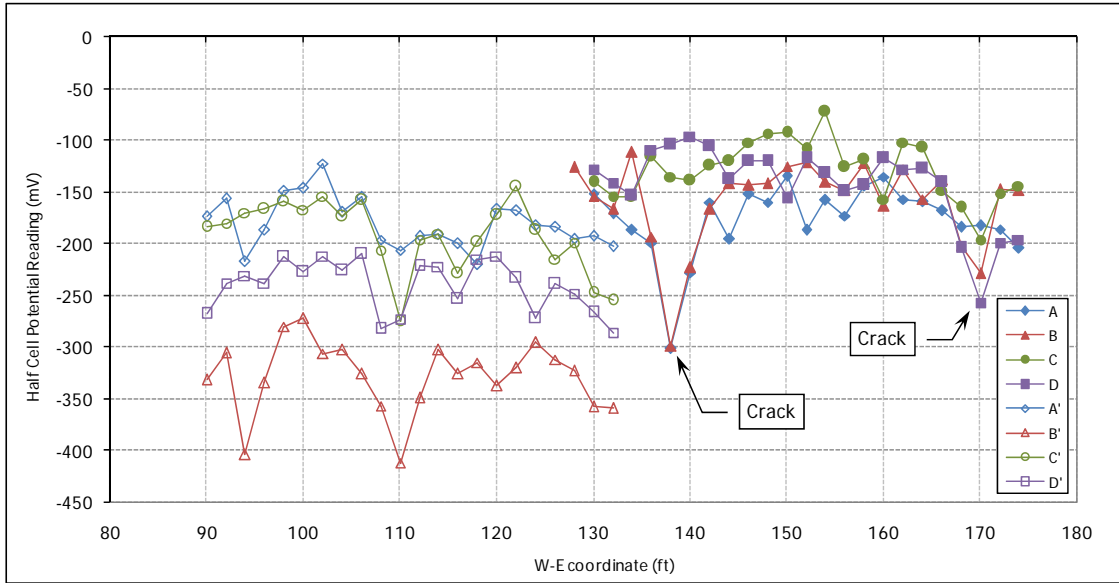
**Figure 6.49** Half-cell potential readings along grid line A, B, C and D in bridge 27815.

Figure 6.49 and Figure 6.50 show the half-cell potential readings in the longitudinal and transverse directions, respectively. The data show that the potentials are generally above the threshold value of -350 mV (corresponding to a 90% probability of corrosion activity in the bars), except along gridline B' in the longitudinal direction and along gridline 1 in the transverse direction. The data along gridline 1 were obtained next to a transverse crack and over an area reported to be delaminated by the chain drag survey. Overall, the half-cell potential measurements obtained in this bridge are less negative than the measurements from the other three bridges, which suggest low or no corrosion activity in the area surveyed.

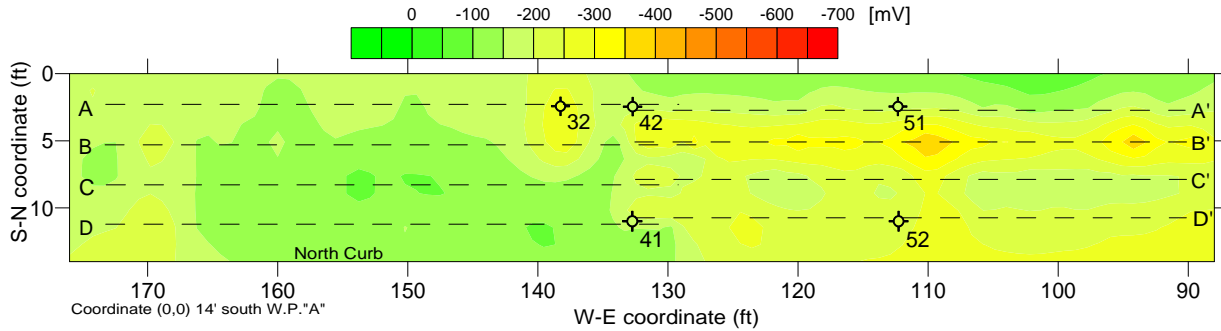
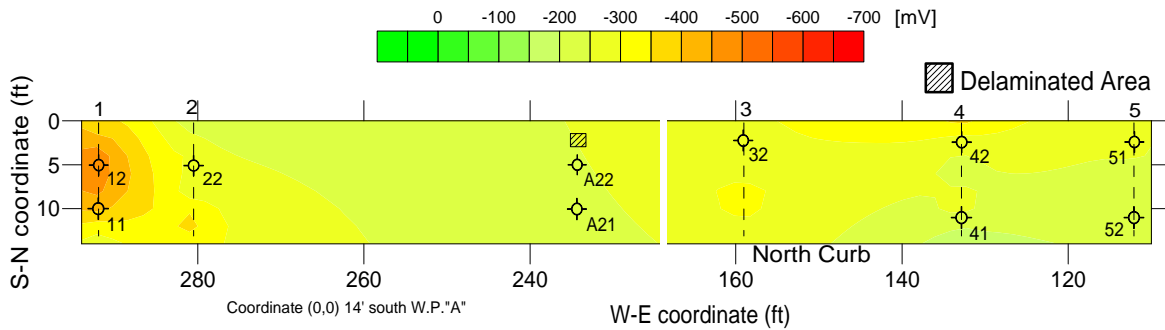
To have a global idea about how the HCP readings are distributed on the deck and to easily identify high and low readings on the deck, the half-cell potential results along the longitudinal and transversal gridlines are presented in the contour plots shown in Figures 6.51 and 6.52. The delaminated areas identified by the chain drag survey are also displayed. In this case, because the origin was located in the West abutment, the traffic runs from right to left in the figure. In Figure 6.52, due to the significant distance between transverse survey lines, which is more than 120 ft between line 3 and line 2, a split contour map is presented.

As shown in the figures, only few areas indicate corrosion activity (potentials of -350mV or higher). The interpolation cannot be considered as a prediction of the deck condition in most of the area studied.
