2008-47

## Corrosion Protection Performance of Epoxy-Coated Reinforcing Bars

## **Final Report**

**September 2008**

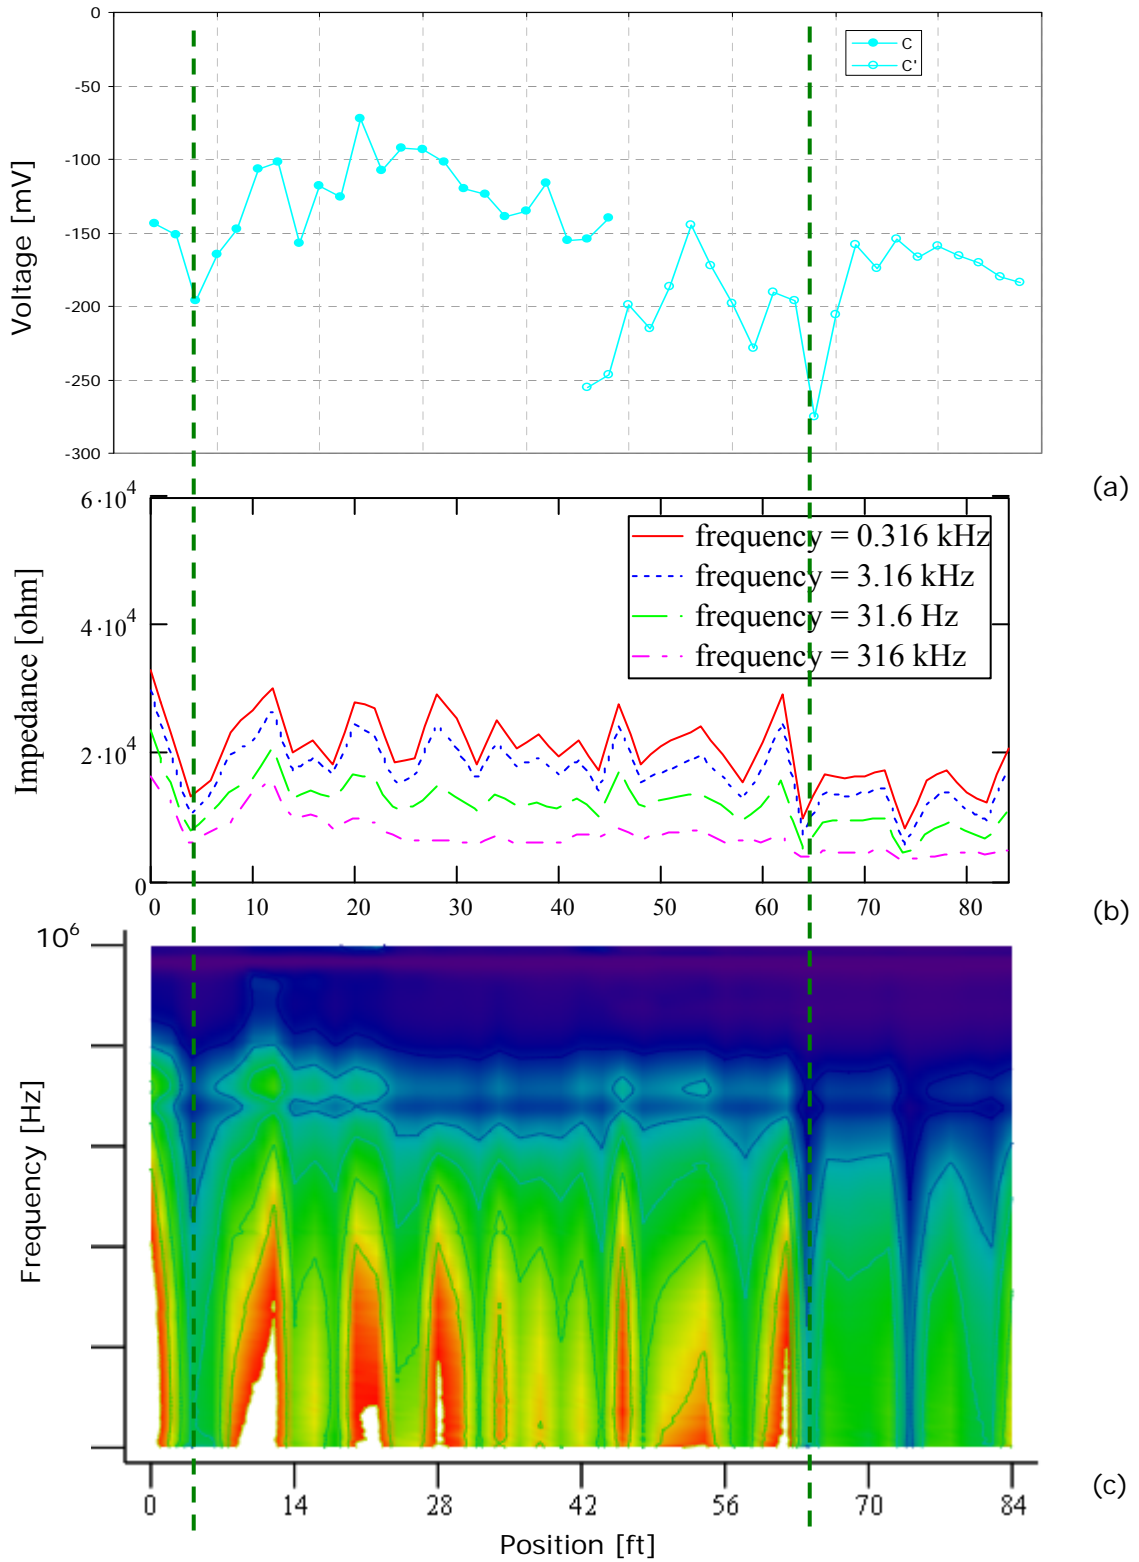
**Figure 6.53** Electrical impedance spectroscopy versus half-cell potential measurement along line C-C'. Bridge 27815: (a) half-cell potential measurements, (b) four-frequency impedance measurement, and (c) contour plots of impedance magnitude versus frequency and positions along the survey line.

Impedance spectroscopy data were collected only along the half-cell potential longitudinal gridlines C-C' and D-D' and transversal gridlines 3 and 4. The impedance spectroscopy results provide information about the quality of epoxy-coating of the rebars. That is, in areas with poor corrosion protection it is expected to have higher corrosion activity. For example, Figure 6.53 shows this correlation between corrosion activity and low impedance measurements. Areas with higher corrosion activity (very negative half cell potential measurements) coincide with a drop in electrical impedance measurements.

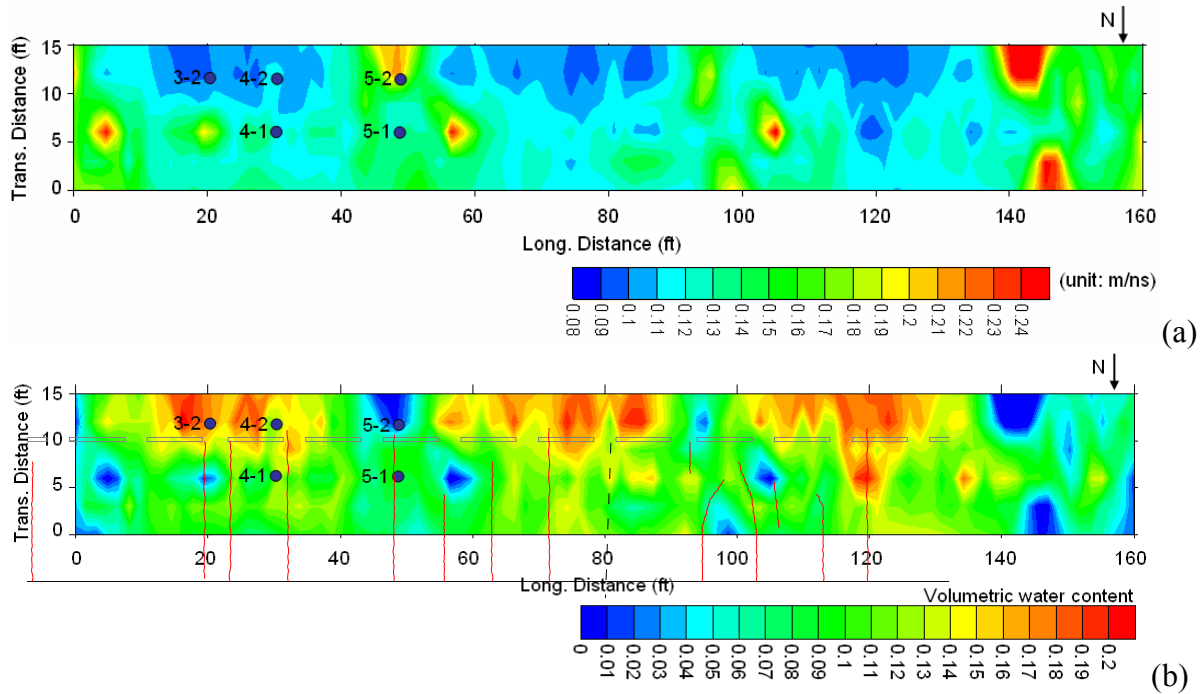
**Figure 6.55** Distribution of (a) electromagnetic wave velocity and (b) volumetric water content (overlapped with crack mapping) on Bridge 27815 as determined by the GPR survey.

Mn/DOT personnel ran a ground penetrating radar (GPR) survey along the west section of the westbound direction of the Bridge 27815. Six equally spaced longitudinal survey lines were collected. Figure 6.54 presents the collected survey lines. The time analysis of these hyperbolas permit the evaluation of electromagnetic (ELM) wave velocity and volumetric water content in the concrete (Figure 6.55) and the depth of each steel rebar. The mapping of ELM wave velocity provides an indication of the volumetric water content and salt content in the concrete. The results are compared against the mapping of cracks, patches and delaminated areas as these zones will tend to have concrete with greater water content.

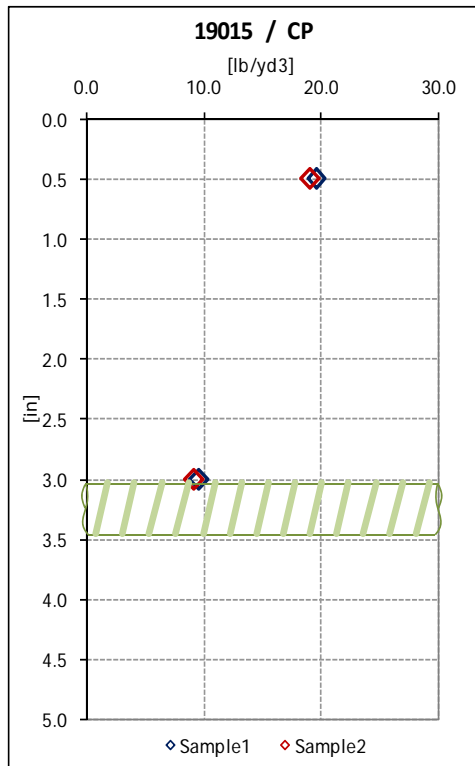
*Figure 7.2 Example of chloride content taken from a delaminated core at different depths.*

Figure 7.2 shows the chlorine ion content for cracked core “CP” of bridge 19015. Note that the chlorine ion concentration at the bar level (3 in) is much greater than that measured in uncracked cores at the same bar level (see Figure 7.1).

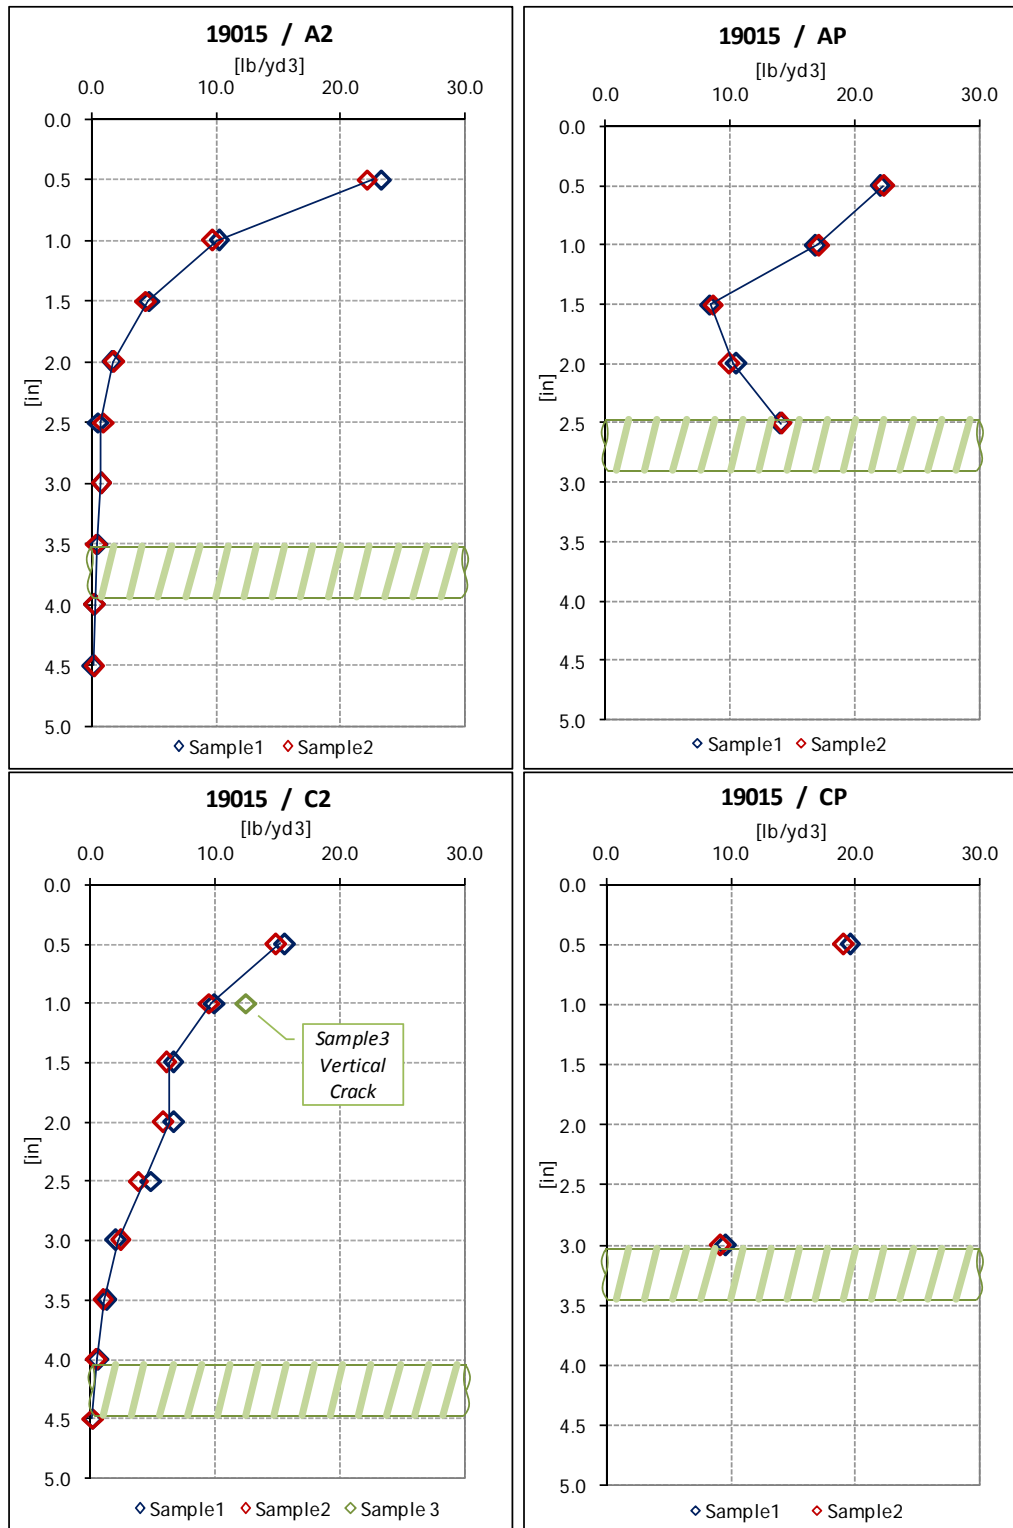
**Figure 7.3** Chloride ion content profile results for Bridge 19015, Cores “A2”, “AP”, “C2” and “CP”.

Figure 7.13 shows the values of chloride ion content at the bar level, grouped by the type of core, i.e., cracked and uncracked. This figure shows that at joints or near delaminated areas the chloride ion content in cores with cracks was much higher than in uncracked cores. Furthermore, the chloride ion content exceeds the reported value for corrosion initiation of 1.2 lb/cy for black steel [6] in nearly every cracked core. On the other hand, the chloride content in uncracked cores does not reach this threshold value, with the exception of the value in core “DCS1” from bridge 19015, which had a chloride ion content of about 5 lb/cy. However, the bar in this core was much closer to the surface with a bar cover of 2.5 in., which may explain the larger chloride ion content measured at the bar level. In fact, the chloride ion content is comparable to that at similar depths in other uncracked cores of the same deck (see Figure 7.3 and Figure 7.4).

It may be recalled that this model represents the chloride ion ingress into the concrete in healthy areas of the deck, *i.e.*, away from vertical cracks, joints or delaminated areas. Any of these defects will affect the one-dimensional diffusion phenomenon increasing the chloride ion content at lower depths (see for example core “AP” in Figure 7.3).

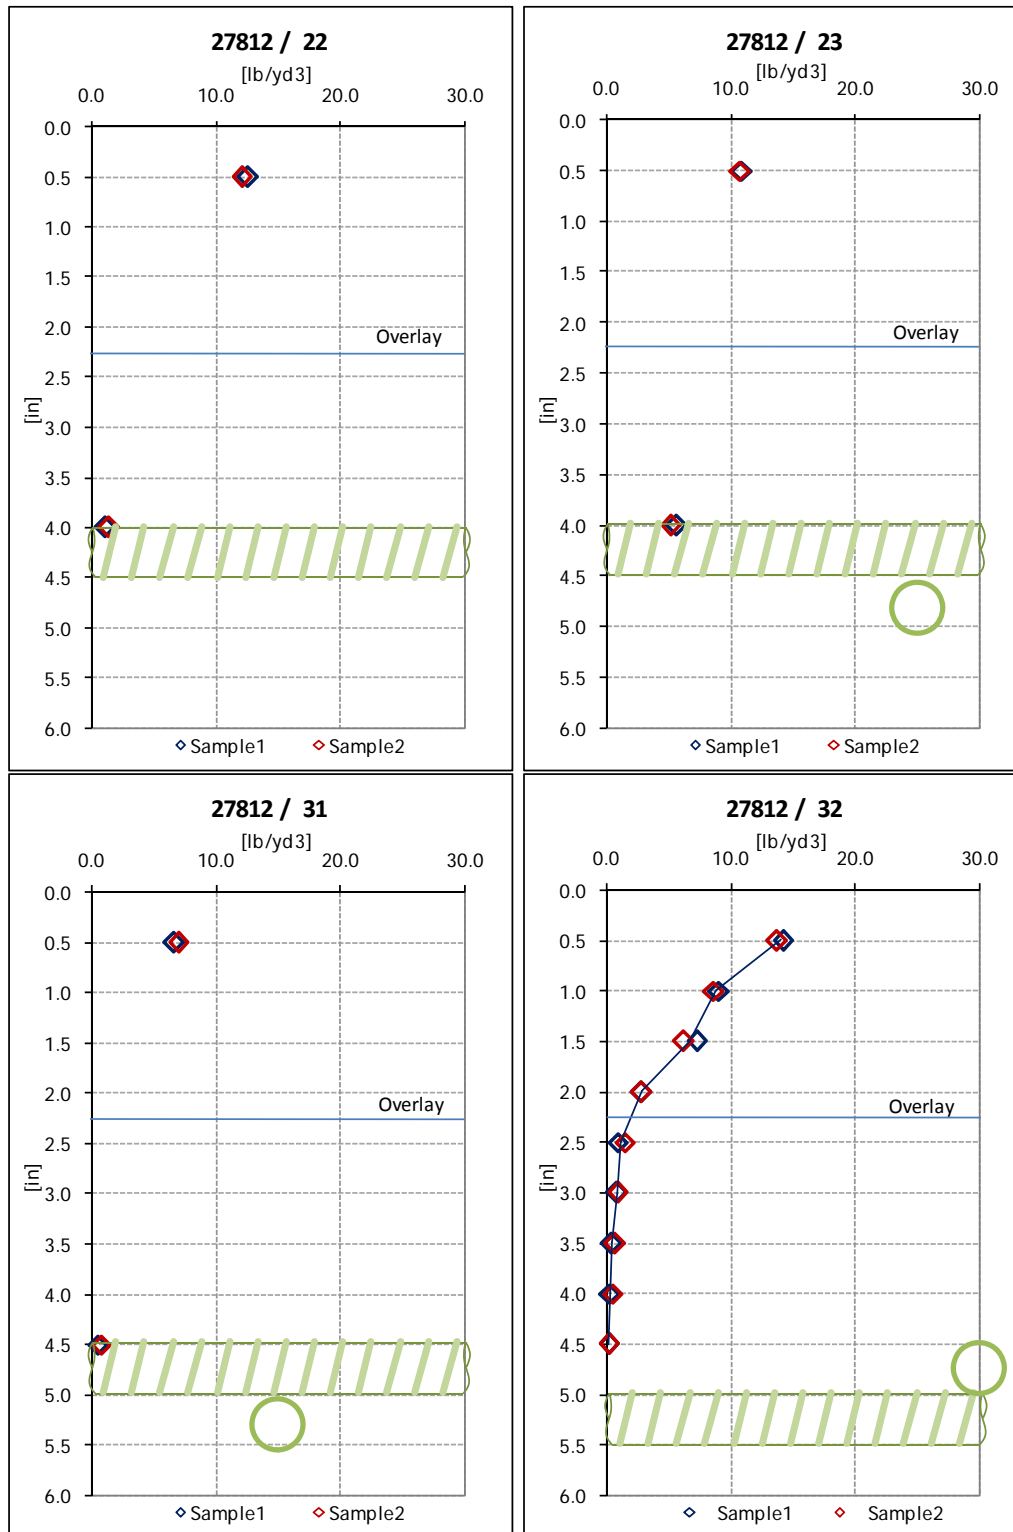
(3): Cores “31”, “32”, “33” and “J3” presented no cracks.

**Figure 7.7** Chloride ion content profile results for Bridge 27812, Cores “22”, “23”, “31” and “32”.

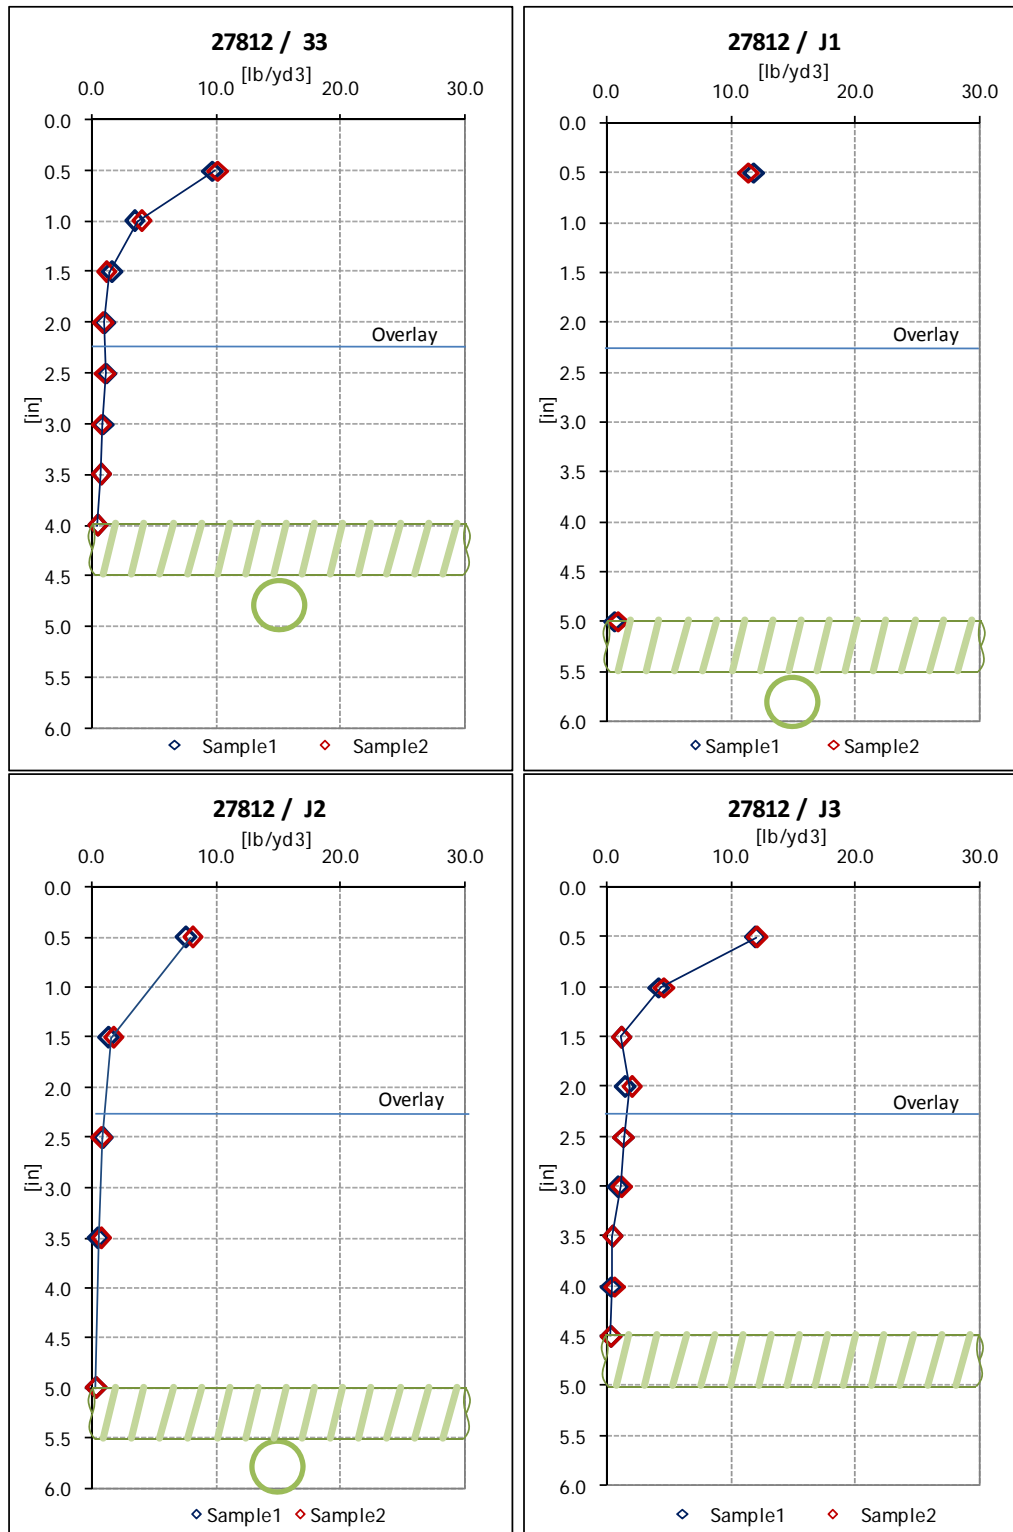
(4): Cores “J1”, “J2” and “J3” were adjacent to the west joint.

**Figure 7.8** Chloride ion content profile results for Bridge 27812, Cores “33”, “J1”, “J2” and “J3”.

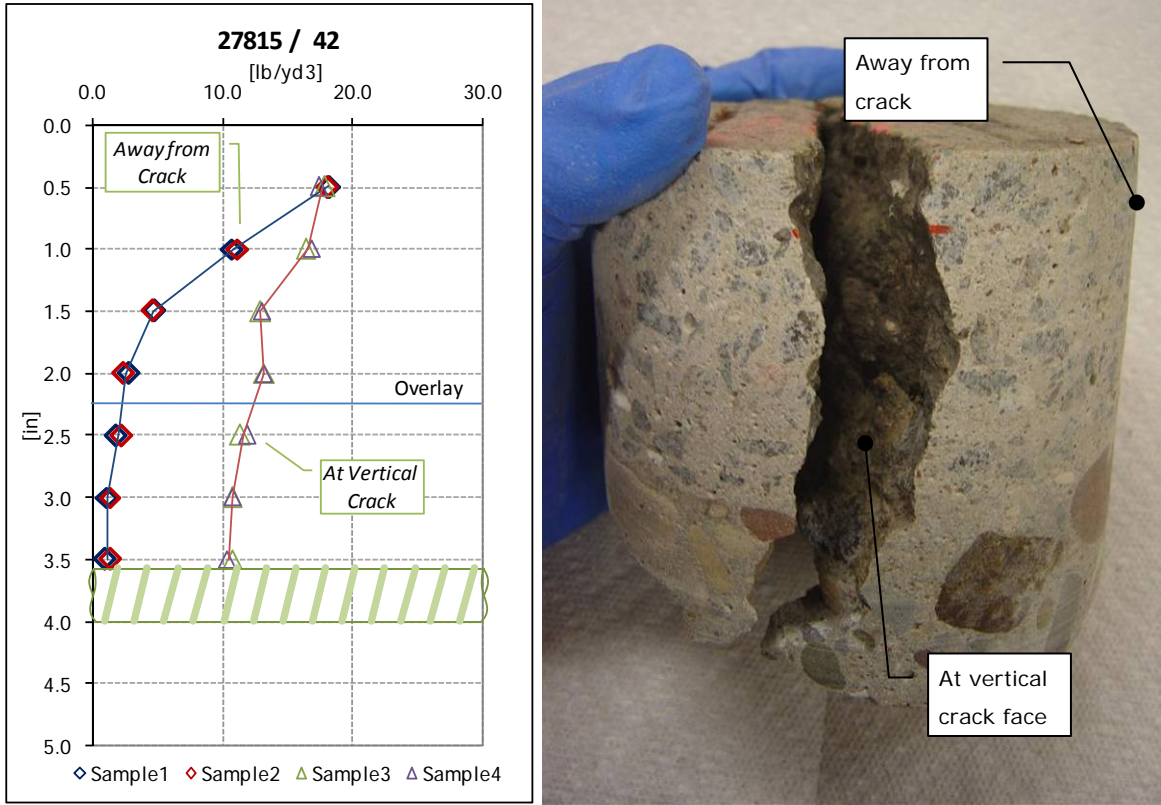
Cores “22”, “32”, “41”, “42”, “51” and “52” presented a vertical crack from the surface to the bar (see Figure 7.9). Thus, the values reported in the table show the chloride ion content away from the crack (left) and inside the crack (right). Near the surface, the measured chloride ion content varied between 9 and 19 lb/cy with an average value of 15 lb/cy. Again, the average chloride ion content was lower than that observed in the decks of bridges 19015 and 27062. At the bar level, the chloride ion content varied between 0.4 and 0.5 lb/cy in cores with no vertical crack (cores “11”, “12” and “A21”). The chloride ion content at the bar level in cores with vertical cracks (“22”, “32”, “41”, “42”, “51” and “52”) were much higher and varied between 7.4 and 13.4 lb/cy. These values are all above the threshold chloride ion content for corrosion initiation of epoxy coated bars, and are consistent with the rust observed on the surface of the bars.

**Figure 7.9** Example of chloride ion content at vertical crack and away from crack.

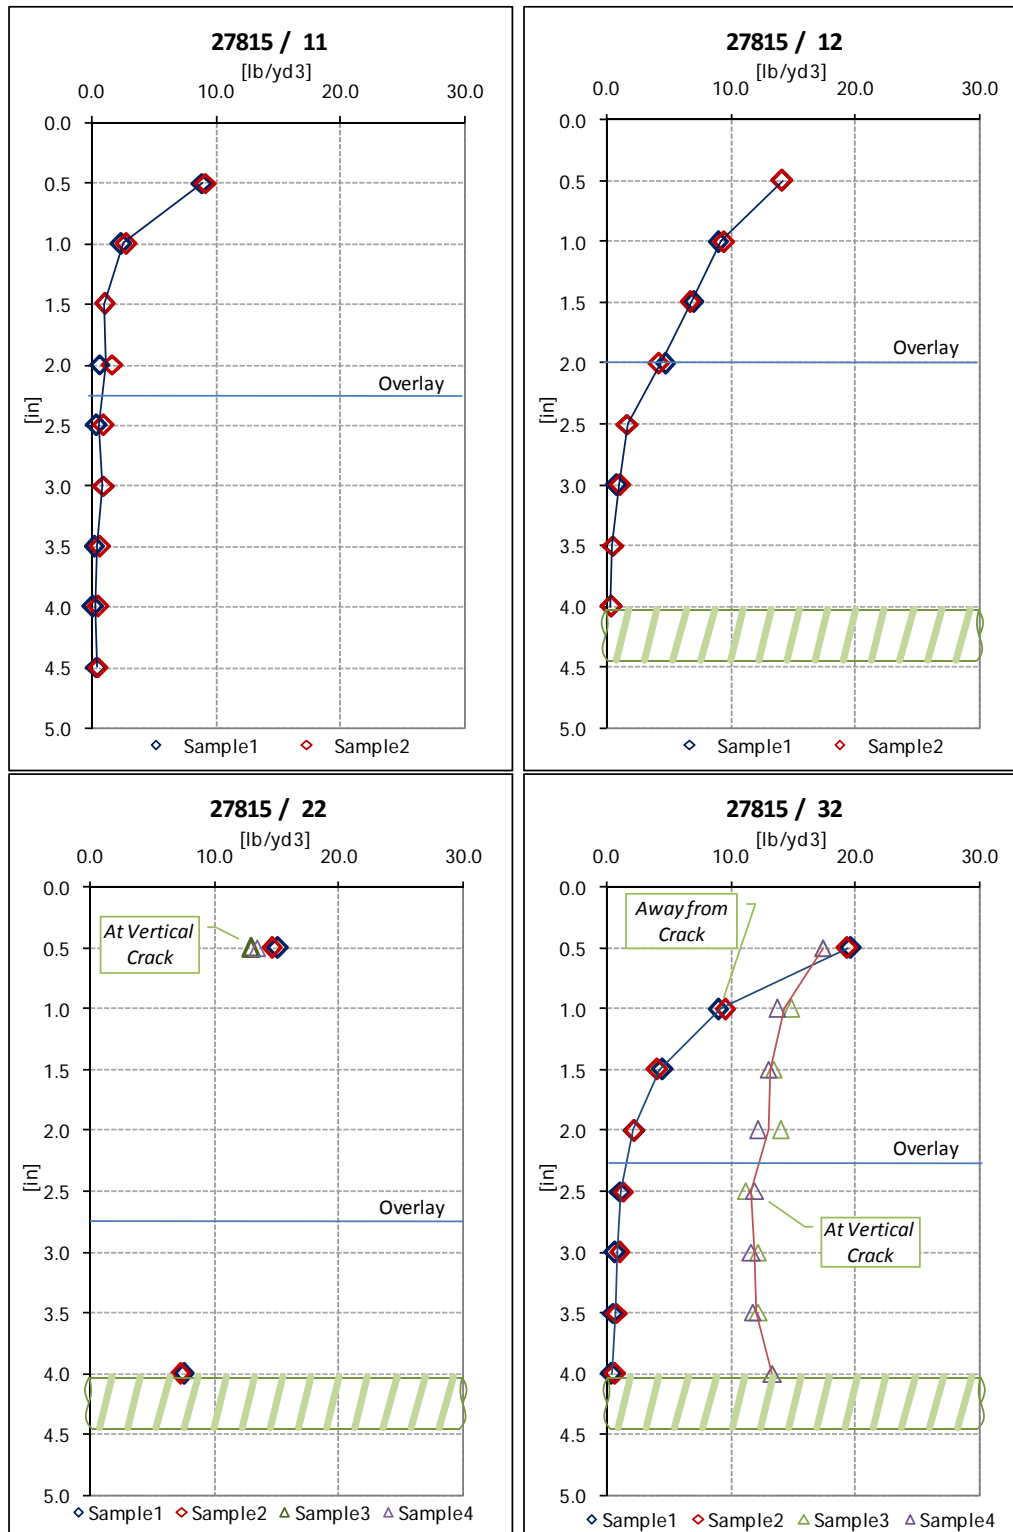
Figure 7.10 Chloride ion content profile results for Bridge 27815, Cores “11”, “12”, “22” and “32”.

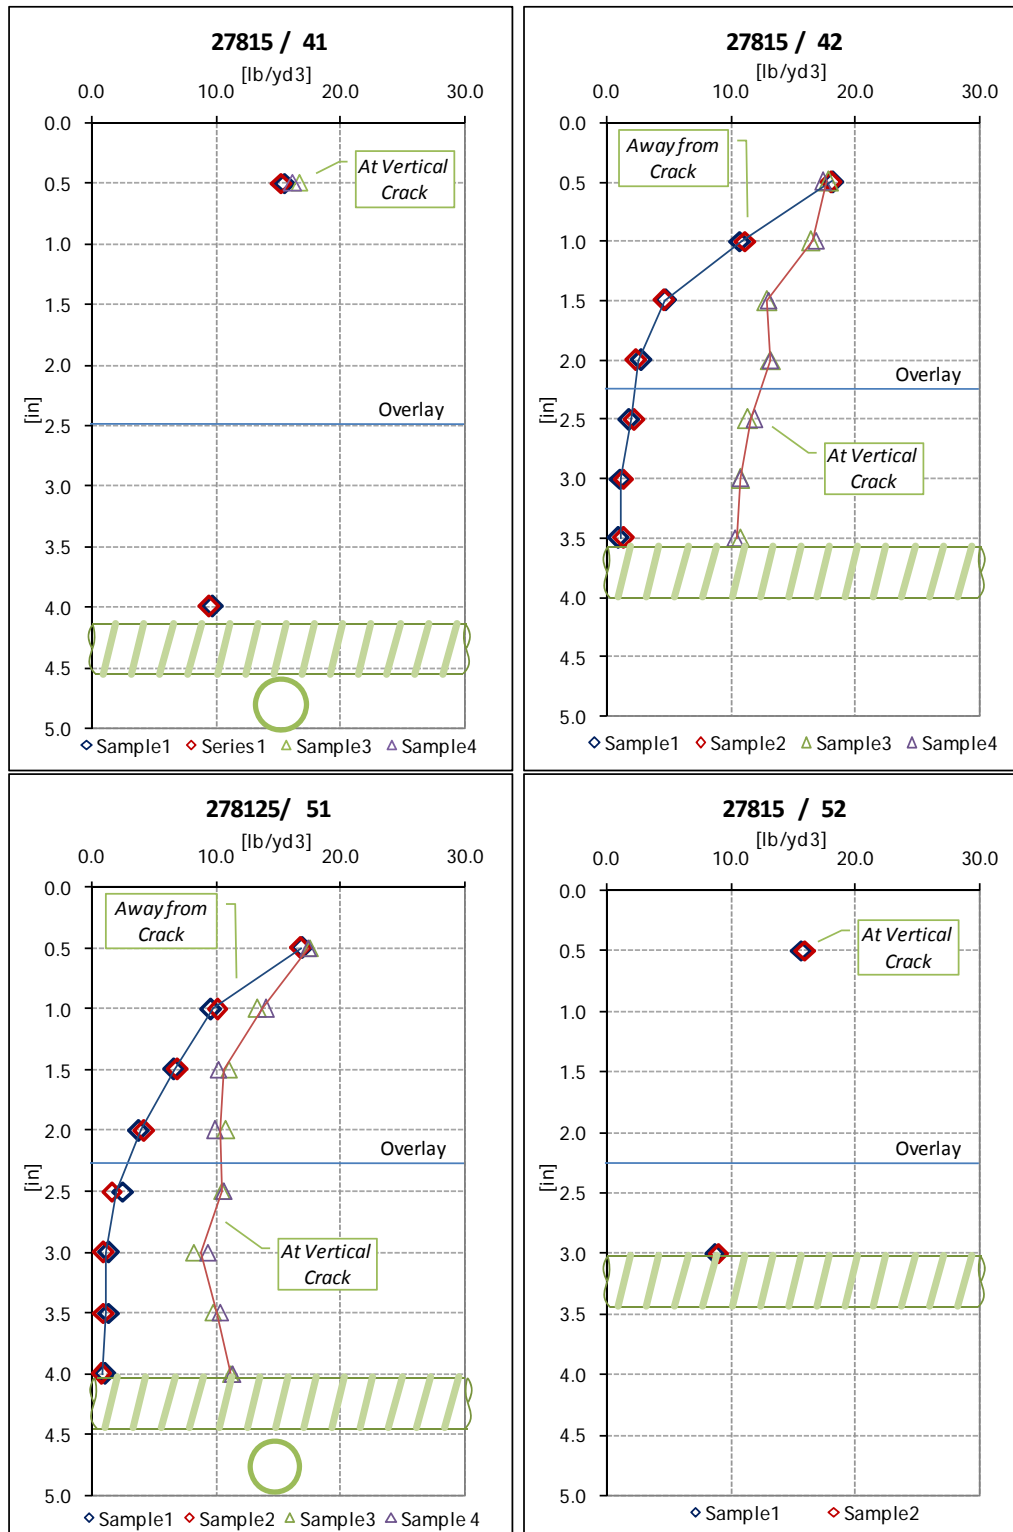
Figure 7.11 Chloride ion content profile results for Bridge 27815, Cores “41”, “42”, “51” and “52”.

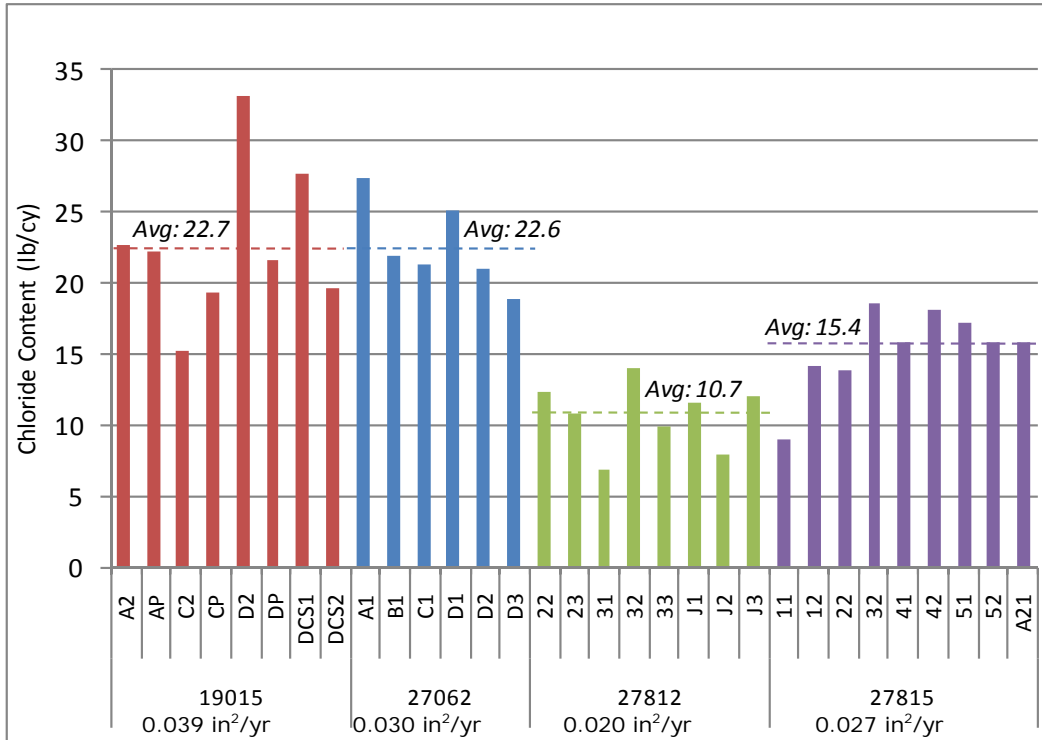
Table 7.31 and Figure 7.12 show that bridges 19015 and 27062 have much higher chloride concentrations on the surface than the other two decks. The standard deviation of these averages varied between 2 and 5 lb/cy.

**Figure 7.12 Chloride ion content at 0.5 in.**

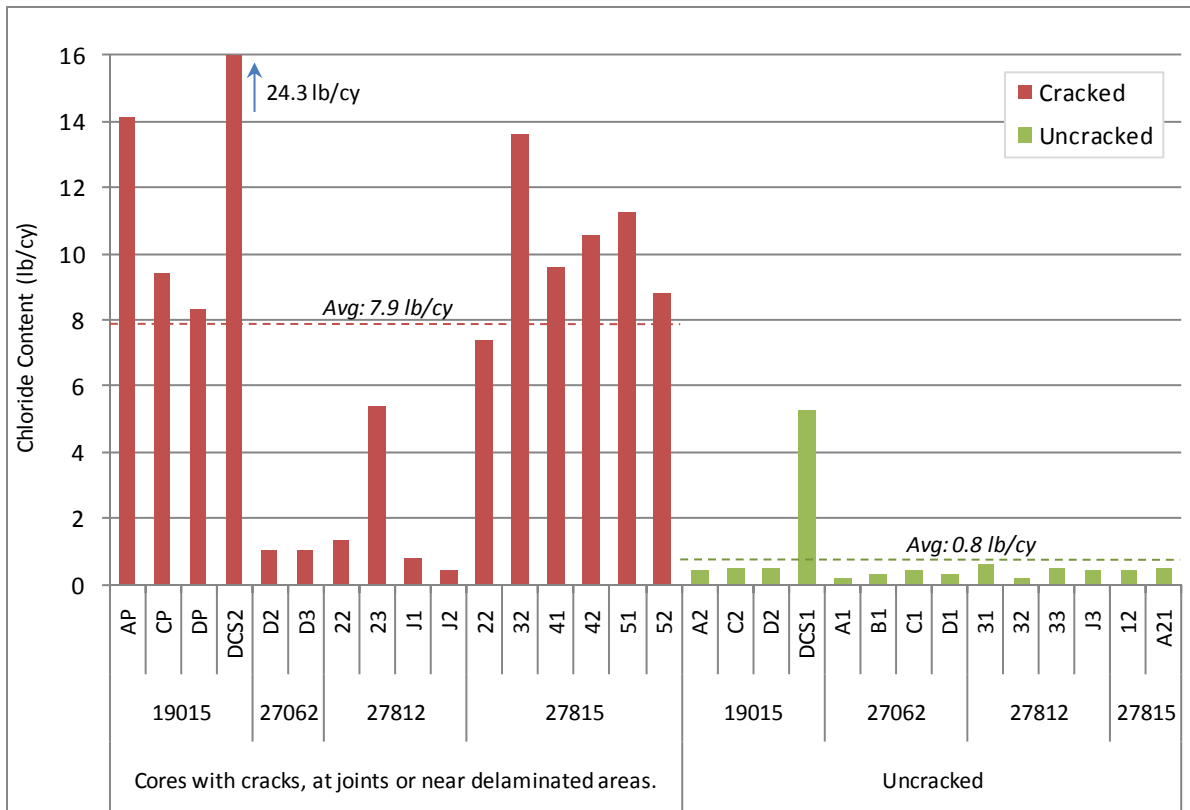
**Figure 7.13** Chloride ion content at the upper bar level for cracked and uncracked cores.

There was more corrosion activity on ECR segments extracted from cracked cores than in those bars taken from uncracked cores. In all cases, with chloride concentrations from 5.3 lb/cy, some visible level of corrosion was found. This suggests that cracks give both, chlorides and moisture, easy and direct access to ECR, which appears to accelerate the corrosion process.

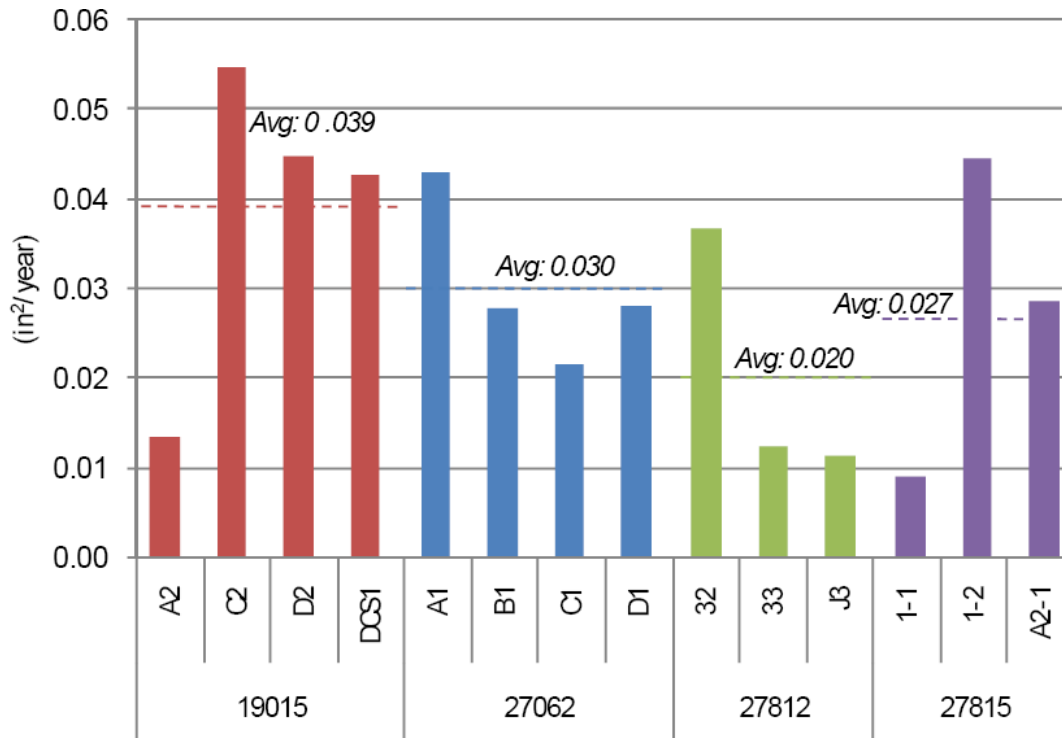
In Figure 7.14, the calculated chloride ion diffusion coefficients obtained from uncracked core specimens are compared. The data show that the average diffusion coefficient is smaller for decks with low slump, high density overlays (bridges 27812 and 27815) than for the other two decks (bridges 19015 and 27062). Note, however, that the scatter in the data is as large as the difference among the calculated averages.

**Figure 7.14** Calculated chloride ion diffusion coefficient in concrete for all four bridge decks.

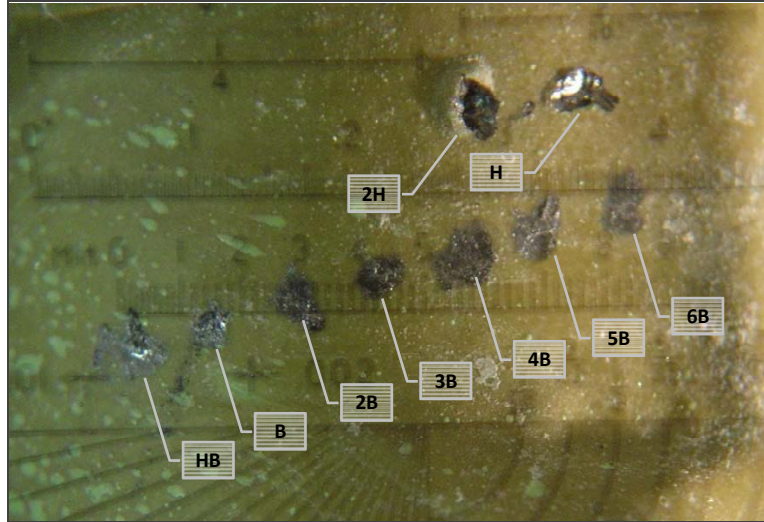
The purpose of this test was to evaluate the performance of protective coatings, and the test was conducted in both, corroded and non corroded bars. Figure 7.15 shows an example of the pencil hardness test where pencils from 6B (softest) to 2H were used. The figure presents different lead spots produced by the pencil, and only the last two (H and 2H) produced a clear damage to the coating. The hardness test showed to be very precise in terms of representing the coating resistance when the bar was in good condition. However, it was seen that coating disbondment and corrosion activity underneath the coating can greatly affect the hardness test results. The rust underneath the coating develops a soft millscale bed that helps the pencil lead to make coating damage easily than other coatings over steel in good condition.

*Figure 7.15 Example of pencil hardness test.*

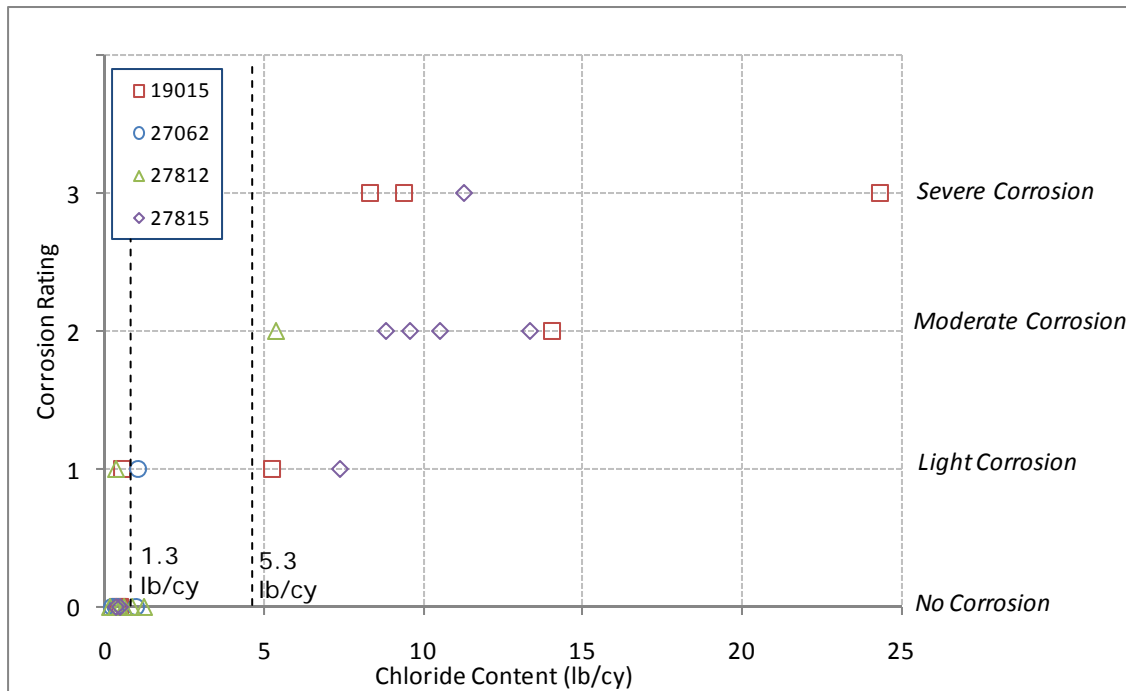
Figure 7.16 shows the corrosion condition of all (upper and lower) bars examined against the measured chloride ion content at the bar level. The figure shows that all of the bars without corrosion had a chloride ion content at the bar level of 1.3 lb/cy or less. On the other hand, all bars that exhibited some level of corrosion, had a bar level, chloride ion content of 5.3 lb/cy or larger. There were three exceptions to these observations: two upper bars that showed light corrosion, one from core “C2” of bridge 19015 and the other from core J3 in bridge 27812. These bars had bar level chloride ion contents of 0.5 and 0.4 lb/cy, respectively. There was also a lower bar from core “D2” in bridge 27062 that had a bar level, chloride ion content of 1.0 lb/cy. Two of these bars were extracted only a few feet away from a delaminated area. This observation suggests that the presence of corrosion in the bar may have been initiated elsewhere and it may not be related to the chloride ion content measured at the bar level. The third bar is not close to a delaminated area, joint or a crack, but the millscale brown stains can be seen only with a magnifier lens which means that the bar is in its very early stage of corrosion.

It should also be noted, however, that there were a few bars with very high chloride ion content values that showed no or light corrosion, such as the lower bars of cores “41” and “51” of bridge 27815 which had chloride ion contents of 9.6 and 11.3 lb/cy, respectively. Therefore, these results show that a high chloride ion content level is a necessary, but not sufficient condition to initiate corrosion of epoxy coated bars.

Although the data show considerable scatter, Figure 7.16 shows that the larger the chloride ion content, the more severe the level of corrosion of the bar, as might be expected.

**Figure 7.16** Relationship between chloride ion content and corrosion condition.

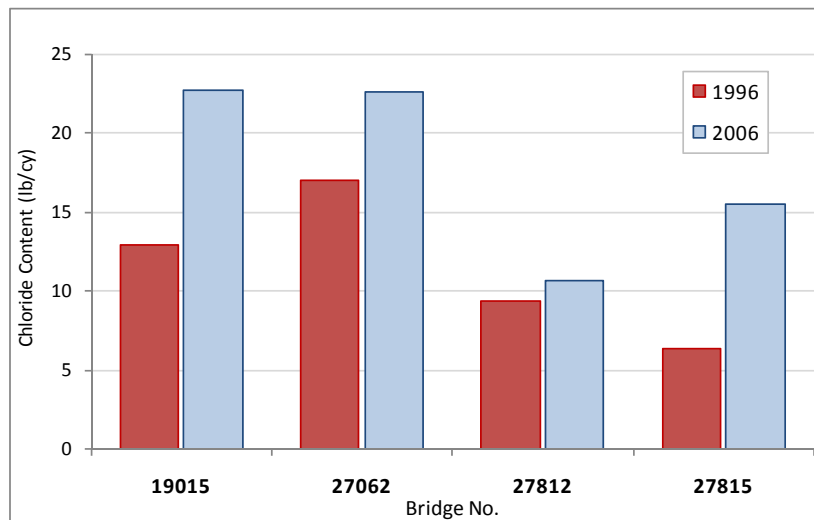
**Figure 8.1 Comparison of average measured chloride ion content at 0.5 in. below the surface in 1996 and in 2006.**

Table 8.3 and Figure 8.1 show that the chloride ion content has increased significantly in the last ten years in all bridges, but in particular in bridge 27815, which showed almost 2.5 times the chloride content detected in 1996. On the other hand, bridge 27812 showed a small variation remaining around 10 lb/cy. The larger increase in the near surface chloride ion content in bridge 27815 suggest that this deck may have been exposed to a larger salt rate application than the other decks.

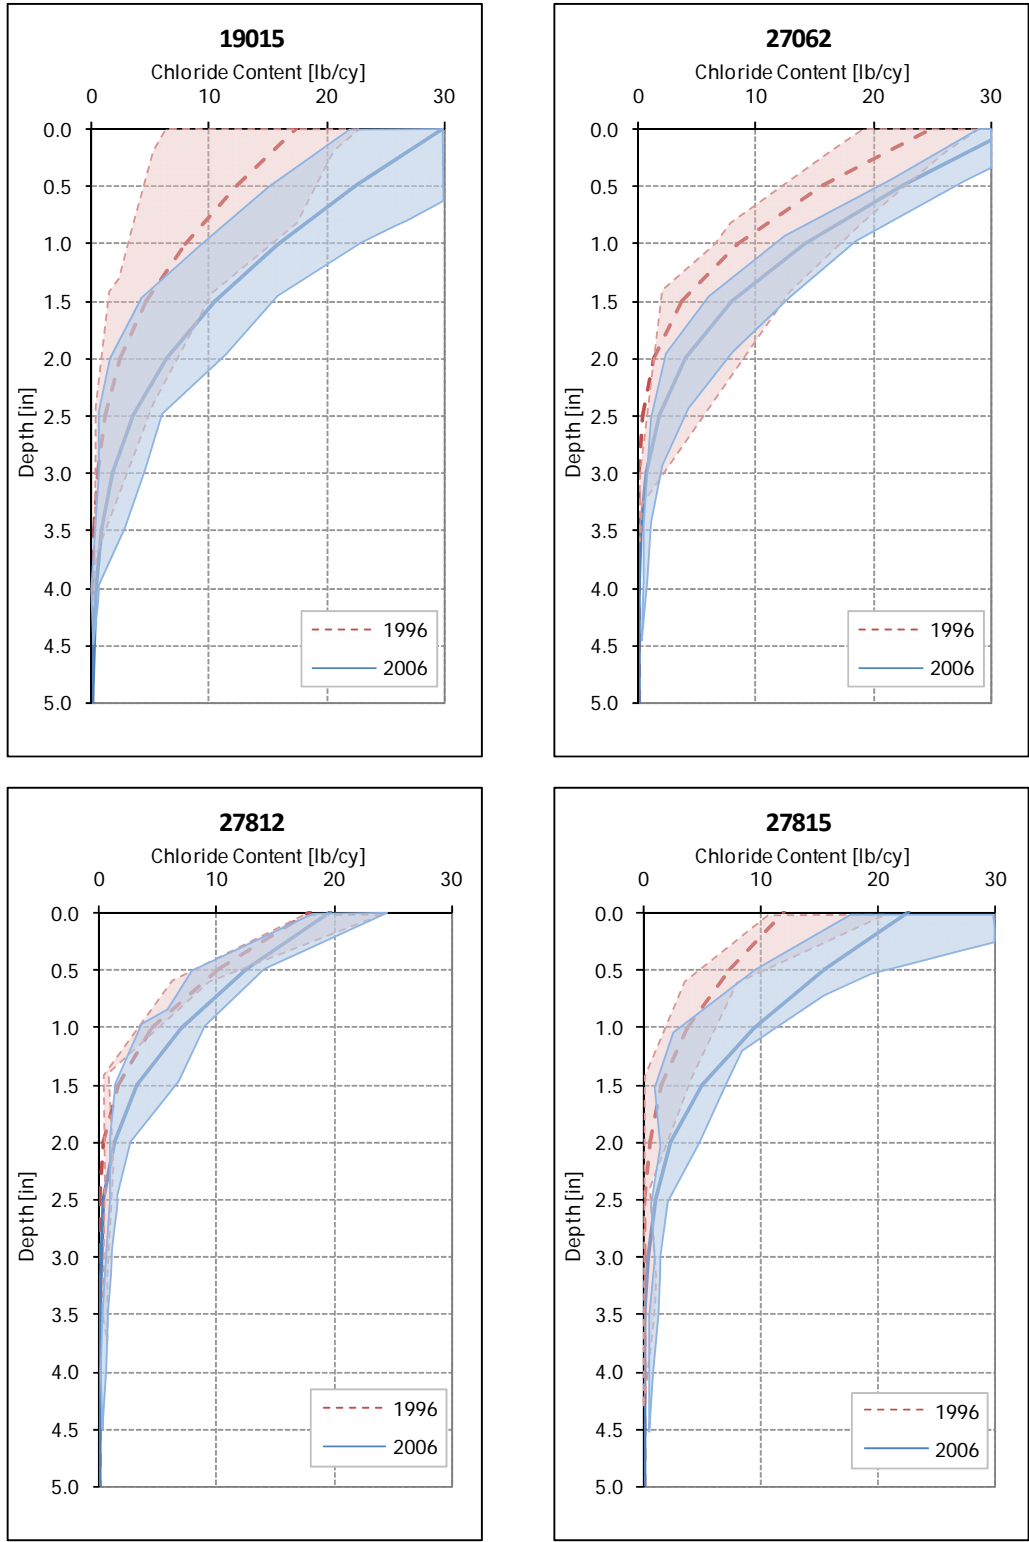
In Figure 8.2, the envelopes of minimum and maximum values of the chloride ion content measured in 1996 and 2006 are shown. The shaded areas show the range of values measured for the chloride ion content over the depth in 1996 (shown in light red) and in 2006 (shown in light blue). Also shown in the figure is the average chloride ion content over the depth in 1996 (light red dashed line) and in 2006 (light blue continuous line). These averages were calculated on the basis of the chloride ion content at the surface and the measured diffusion coefficient. These average values are also shown at 0.5 in. increments in Table 8.4. These data show a significant

*Figure 8.2 Envelope of chloride ion content profiles in 1996 and 2006.*

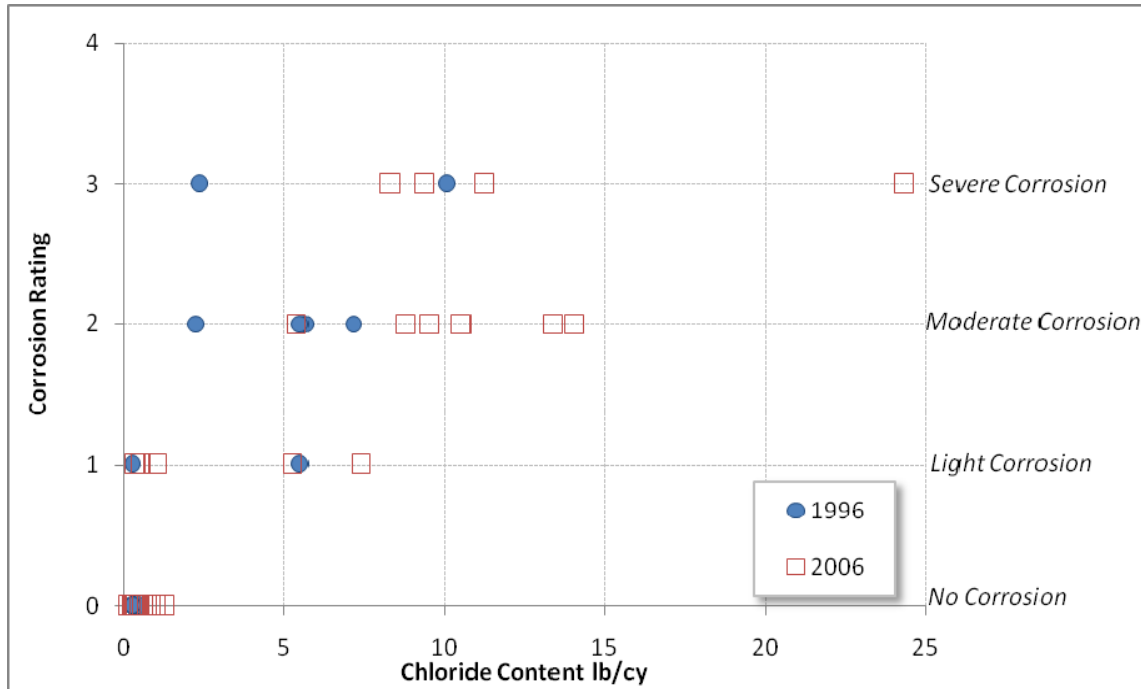
Figure 8.3 shows the corrosion condition of the extracted bars in both studies against the measured chloride ion content at the bar level. The figure shows that the chloride ion content at

the bar level has, on average, increased since 1996. This result is consistent with the increased chloride ion content measured at the surface of the decks (see Figure 8.1). Although the core location was non-randomly selected and the core area represents only a small fraction of the total bridge deck area, the fact that the present study detected more bars with light, moderate and severe corrosion than in 1996, is strong an indication that corrosion activity has increased in the last ten years.

**Figure 8.3** Relationship between chloride ion content at the bar level and corrosion condition of the bars.

It must be noted that the chloride ion concentration at the bar level in the majority of the bars that showed corrosion (light, moderate or severe) was about 5 lb/cy or greater. On the other hand, all bars without signs of corrosion had chloride ion concentrations at or below 1.3 lb/cy. There are, however, four exceptions to these results: one corroded bar from the 1996 WJE study that had a chloride ion content of 0.3 lb/cy and three corroded bars from the present study with chloride ion contents of 0.4 lb/cy, 0.5 lb/cy and 1.0 lb/cy. However, corrosion in two of these last bars is believed to have initiated elsewhere as discussed in section 7.8.6. On the other hand, the 1996 study showed two bars with moderate and severe corrosion where the chloride ion content was 2.3 and 2.4 lb/cy, respectively. These results suggest that corrosion may begin in ECRs at chloride ion contents between 1.3 lb/cy and 5.3 lb/cy.

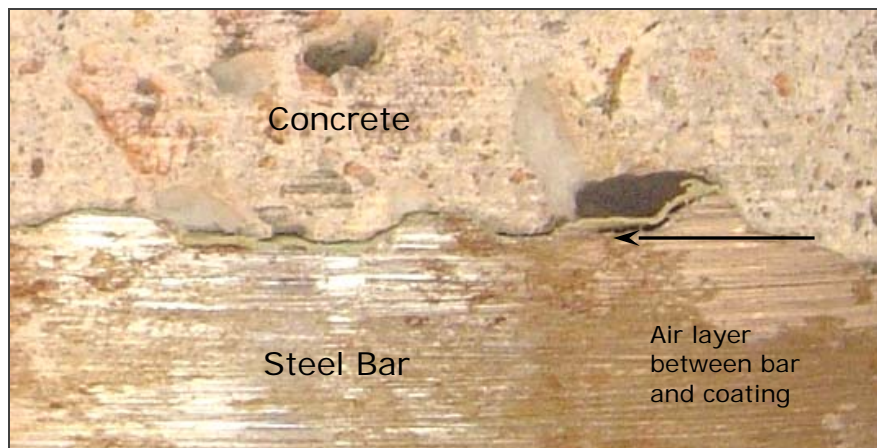
Poor adherence (rating 2) could be considered the limit after which coating disbondment develop a thin air layer between the steel and the coating (see Figure 8.4), and upon the arrival of chloride ions, corrosion underneath the coating could develop at a faster rate than with moderate or good adherence. However, the service life extension provided by coatings in various states of adhesion loss has not been studied in detail. Therefore, the level of protection provided by the epoxy coating with poor or moderate adherence is unknown at this time.

**Figure 8.4 Detail of coating disbondment in core.**
