2008-47

## Corrosion Protection Performance of Epoxy-Coated Reinforcing Bars

## **Final Report**

**September 2008**

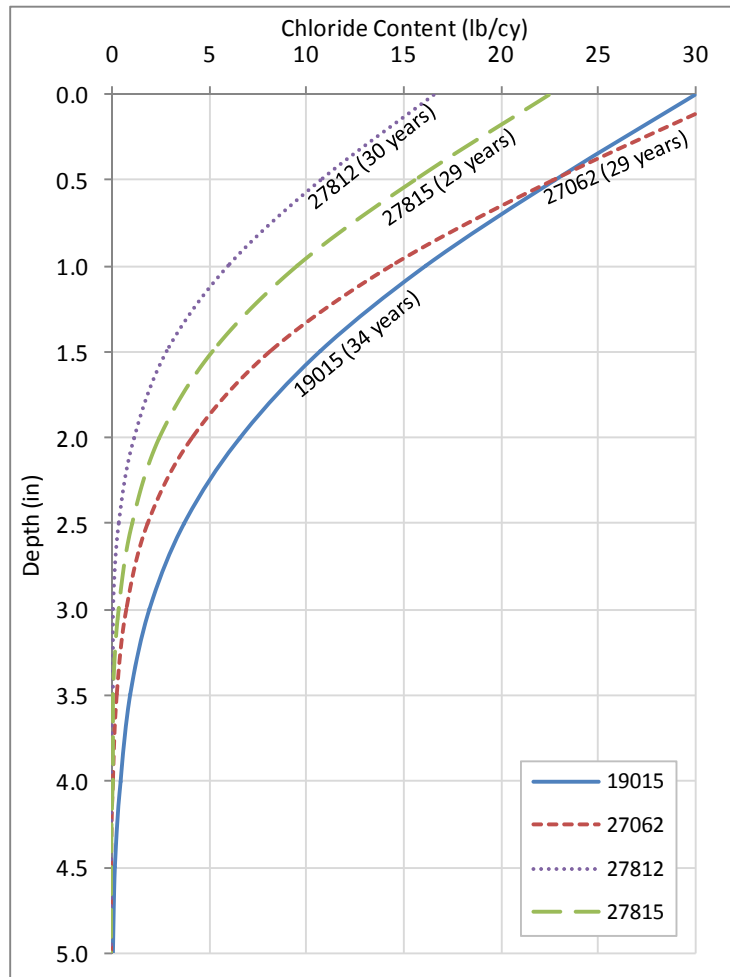
Once the chloride ion depth profile is estimated, the calculation of the chloride ion content at the bar level is a direct application of equation *D.2* (see appendix D). As an example, in Figure 8.5, the chloride ion content at 4 in. deep in 2006 has maximum value of 0.4 lb/cy. This content is well below the values observed for corrosion and suggests that no bar located at 4 in. deep from the surface and away from cracks or joints should have begun corroding in 2006, a result that is consistent with field observations from this and the 1996 study.

**Figure 8.5** Estimated chloride ion content profiles in 2006 for the decks studied.

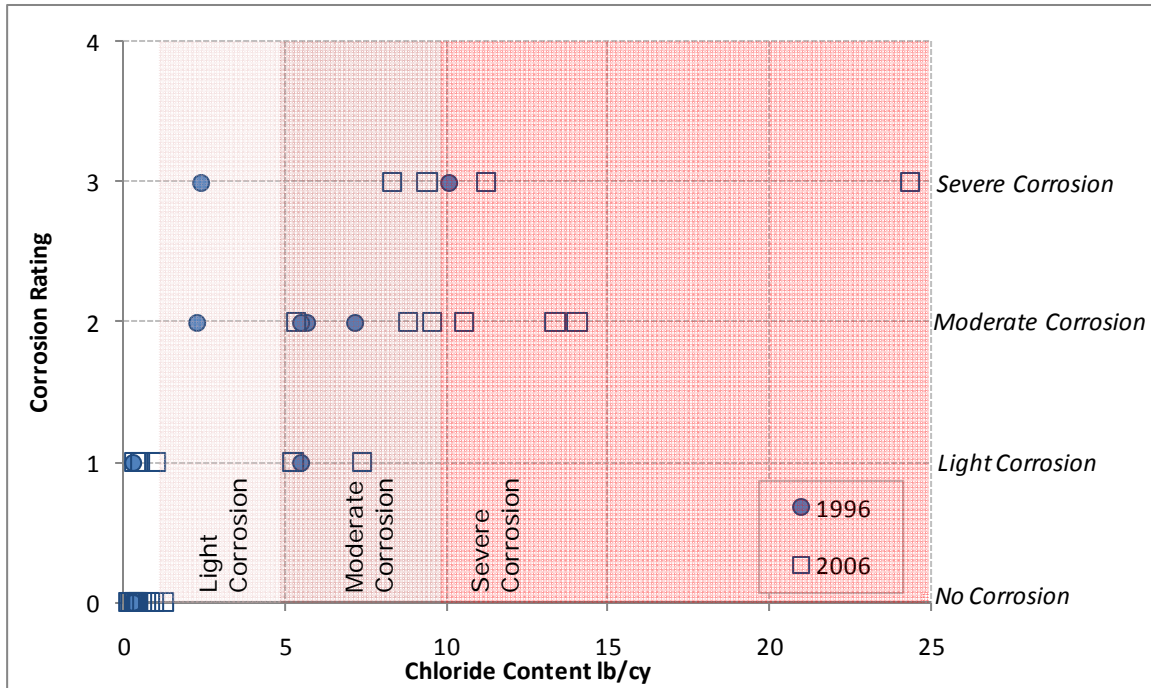
Figure 8.6 shows the data from the two studies (1996 and 2006) and the range of chloride ion content values defined above for each corrosion condition. These values are an approximation based on the data collected in this study; however, it is consistent with data from other studies.

**Figure 8.6** Regression of chloride ion content and corrosion condition.

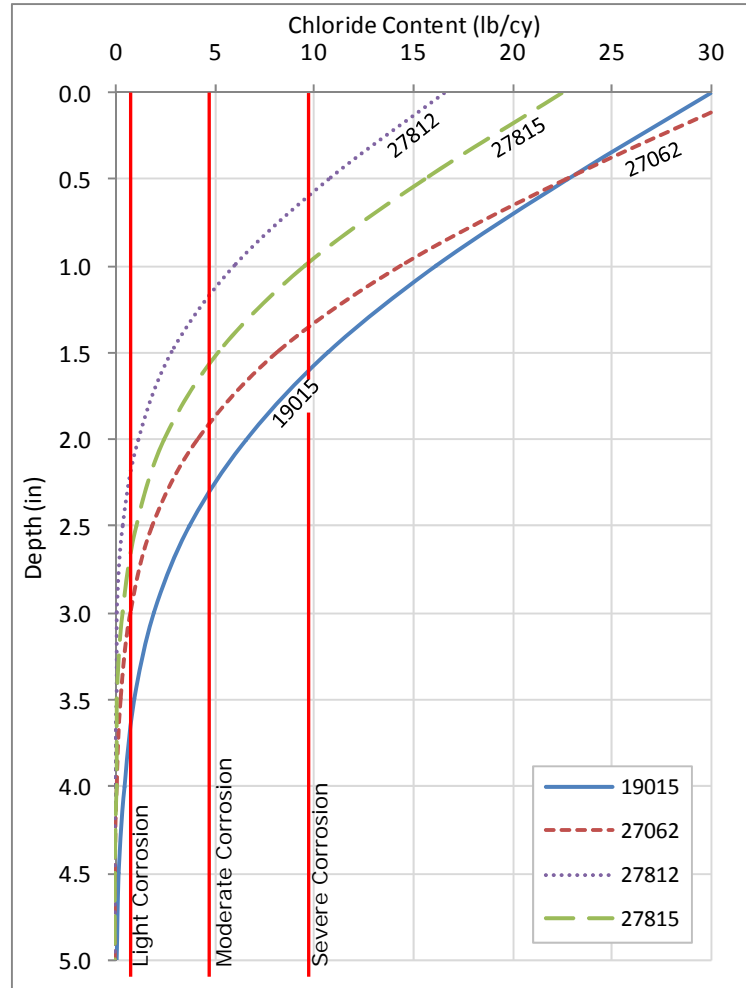
Using the lower limit of chloride ion content corresponding to a given corrosion condition in each range, and the average chloride ion profiles of each bridge, the relation between chloride ion concentrations and corrosion activity can be plotted. In Figure 8.7, the estimated chloride ion content profiles in 2006 and the chloride ion content thresholds levels defined above are shown for all four bridges studied. For example, in Fall 2006 the bars at a depth of cover of 3 in. in bridge 19015 would have begun to corrode. At a depth of cover of 2.5 in., the bars in bridge decks 19015, 27062 and 27815 would be above the lower limit of chloride content for light corrosion and at a depth of cover of 2 in. or less, the bars in all four bridges would be above that lower limit.

**Figure 8.7** Estimated chloride ion content profiles in 2006 and bar corrosion threshold levels for the bridges studied.

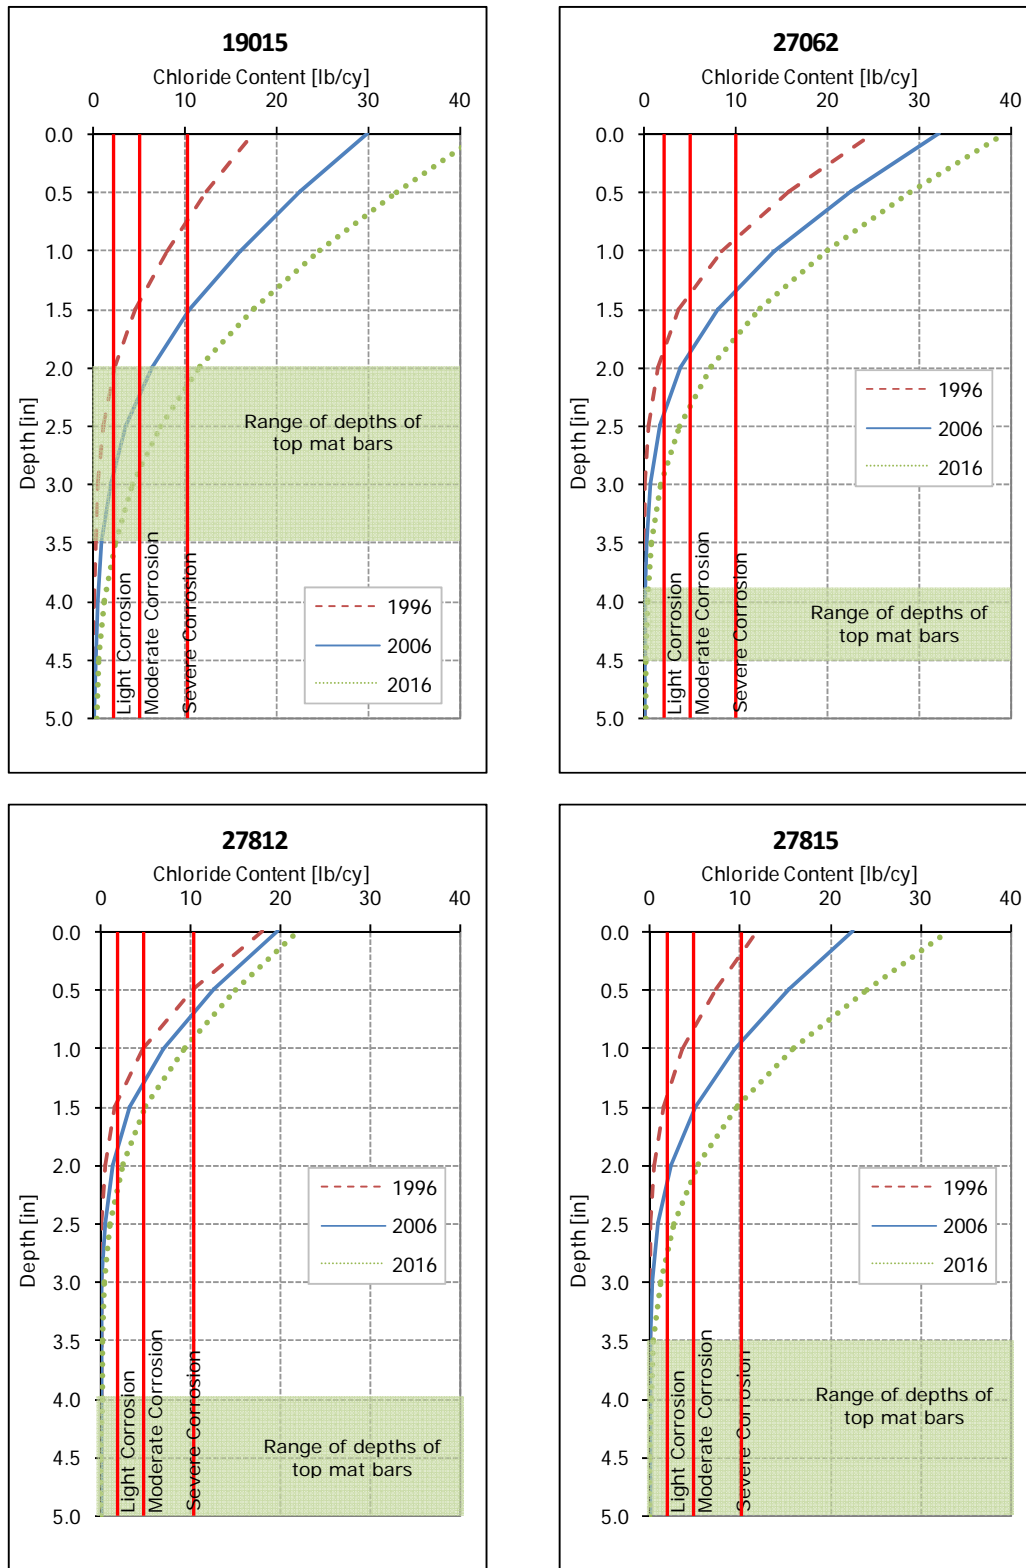
Figure 8.8 shows a comparison between chloride ion profiles from 1996, 2006 and the predicted curve for year 2016. The predicted profile was calculated assuming the same increment in chloride ion content observed in the period 1996-2006. The figure also shows the range of depths where the top mat bars were found. It can be observed that bars in bridges 27062, 27812 and 27815 show a very low probability of light corrosion by 2016. However, the bars in bridge 19015 show high probability of moderate to severe corrosion by 2016.

Note that at a depth of 3 in. in Bridge 19015, light corrosion will be expected at about 30 years of service (2003). However, at a depth of 2 in. (the minimum cover depth measured in this study), light corrosion is expected to occur only after 20 years of service. This means that, increasing the concrete cover by 1 in. can delay the onset of corrosion by about 10 years. These curves estimate the variation of chloride ion content in time and depth accordingly to the data obtained in this

**Figure 8.8** Example of chloride ion content profiles predicted for year 2016.

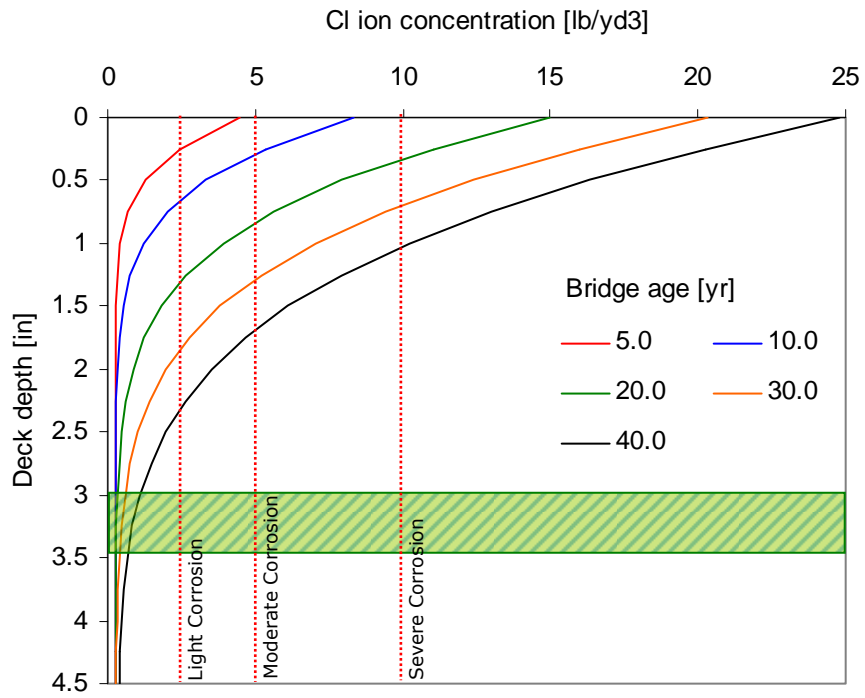
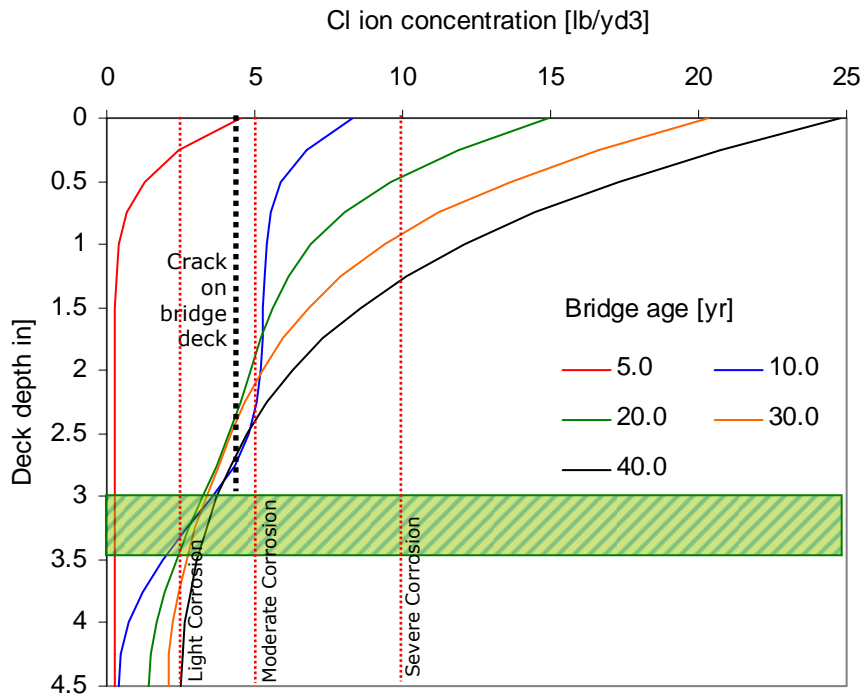
Figure 8.9a shows the theoretical chloride ion distribution versus depth for an uncracked bridge deck surface at 5, 10, 20, 30 and 40 years of service using a diffusion coefficient of  $0.039 \text{ in}^2/\text{yr}$ . For a 3 in. deep coated rebar, no corrosion would be expected to occur in 40 years of service in the uncracked deck. The chloride ion distribution for a cracked deck is shown in Figure 8.9b. For example, if at the fifth year a crack is formed, the surface chloride ion concentration will rapidly propagate along the face of the crack. Assuming that the concentration at the bar level is the same as that on the surface in that year, a new chloride content distribution will occur over the depth (see distribution at ten years – blue line). The chloride content at the bar level increases drastically and the bar is expected to show light to moderate corrosion shortly after the crack is formed. If the crack is sealed after one year, the chlorides at the bar level will gradually diffuse into the surrounding concrete areas and the chloride content distribution profiles will, in the long-term, become similar to those calculated for the uncracked deck (see profiles for 30 and 40 years in Figure 8.9b).

**Figure 8.9** Effect of a surface crack in year 5 (and sealed in year 6) on the chloride ion concentration distribution. (a) non-cracked bridge deck chloride ion distribution and (b) cracked bridge deck chloride ion distribution.

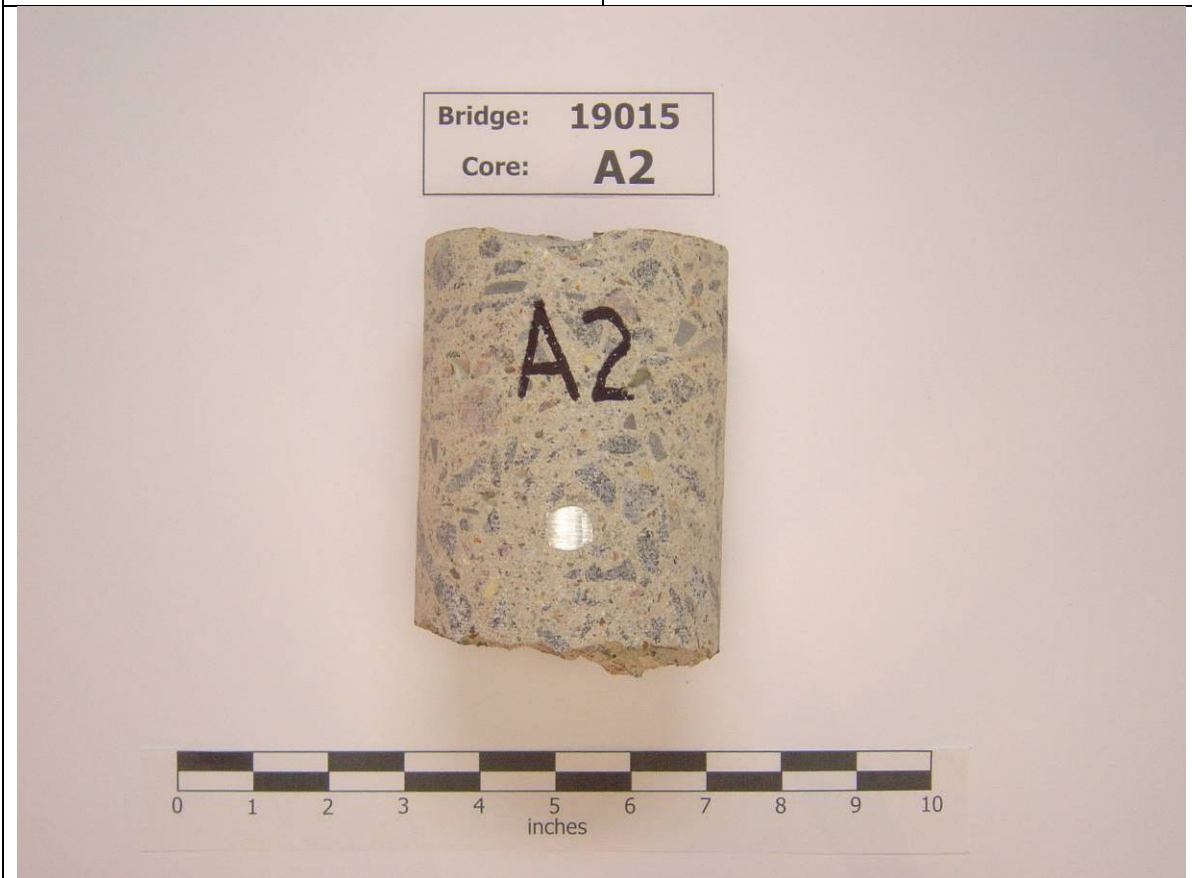
Core: A2

| Cracks:<br><b>None observed</b> | Corroded Bar:<br><b>No</b> | Delamination:<br><b>None</b> | Core diameter:<br><b>4"</b> |

- The chain drag survey indicated no signs of delamination at this location
- Half cell potential readings indicated a low probability of corrosion activity at this location
- Bar shows no evidence of corrosion

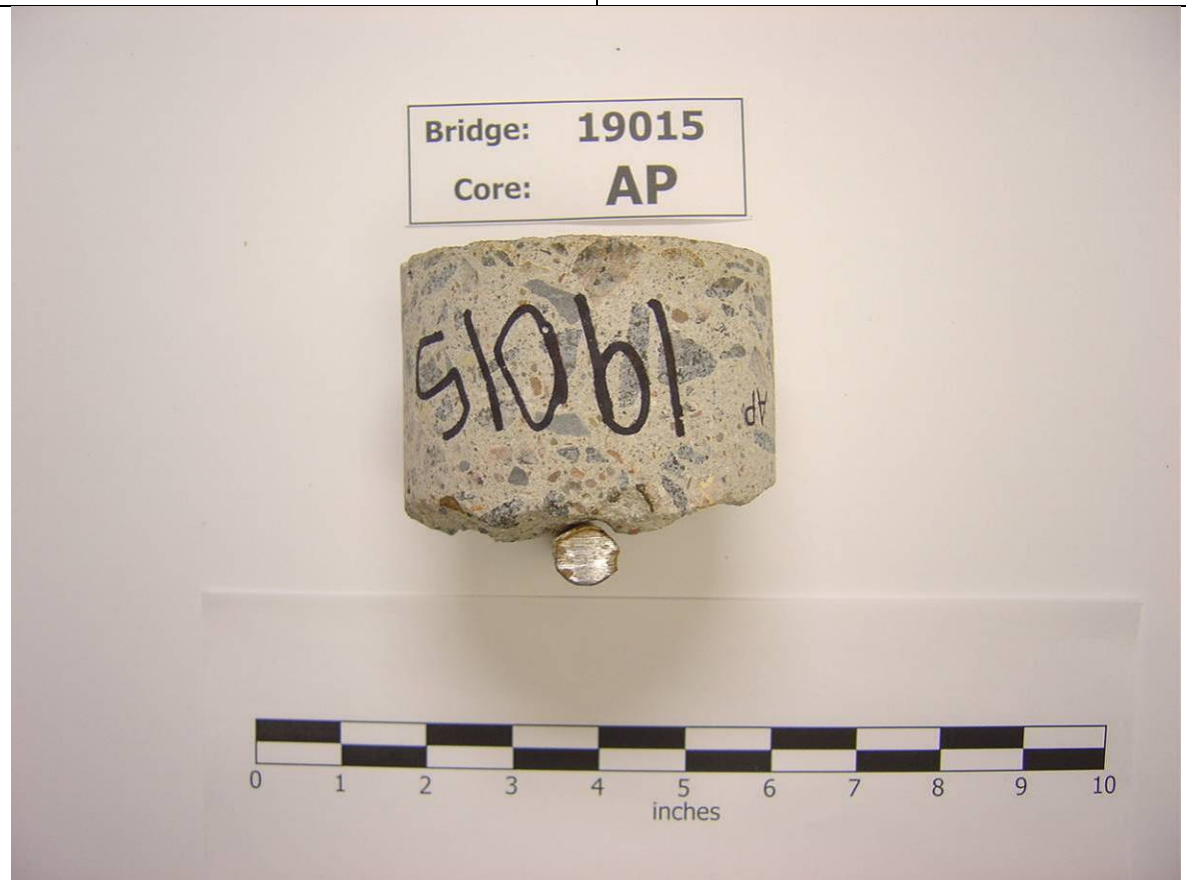
Core: AP

| Cracks:<br><b>None observed</b> | Corroded Bar:<br><b>Yes</b> | Delamination:<br><b>Yes</b> | Core diameter:<br><b>4"</b> |

- Cracks at bar level (possible delamination)
- The chain drag survey indicated no signs of delamination at this location
- Half cell potential readings indicated a high probability of corrosion activity at this location
- Bar shows evidence of corrosion

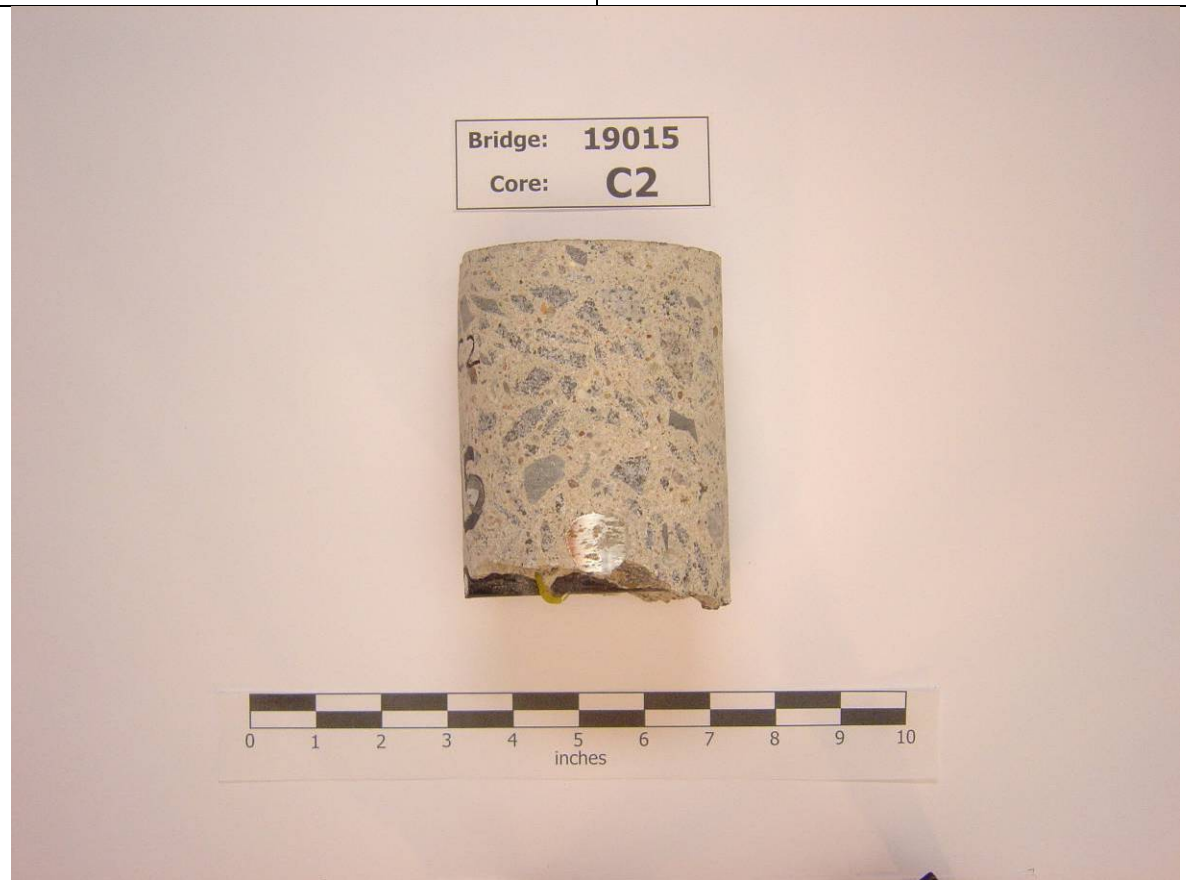
Core: C2

| Cracks:<br><b>None observed</b> | Corroded Bar:<br><b>Yes</b> | Delamination:<br><b>Yes</b> | Core diameter:<br><b>4"</b> |

- The chain drag survey indicated no signs of delamination at this location
- Half cell potential readings indicated a low probability of corrosion activity at this location
- Bar shows evidence of corrosion

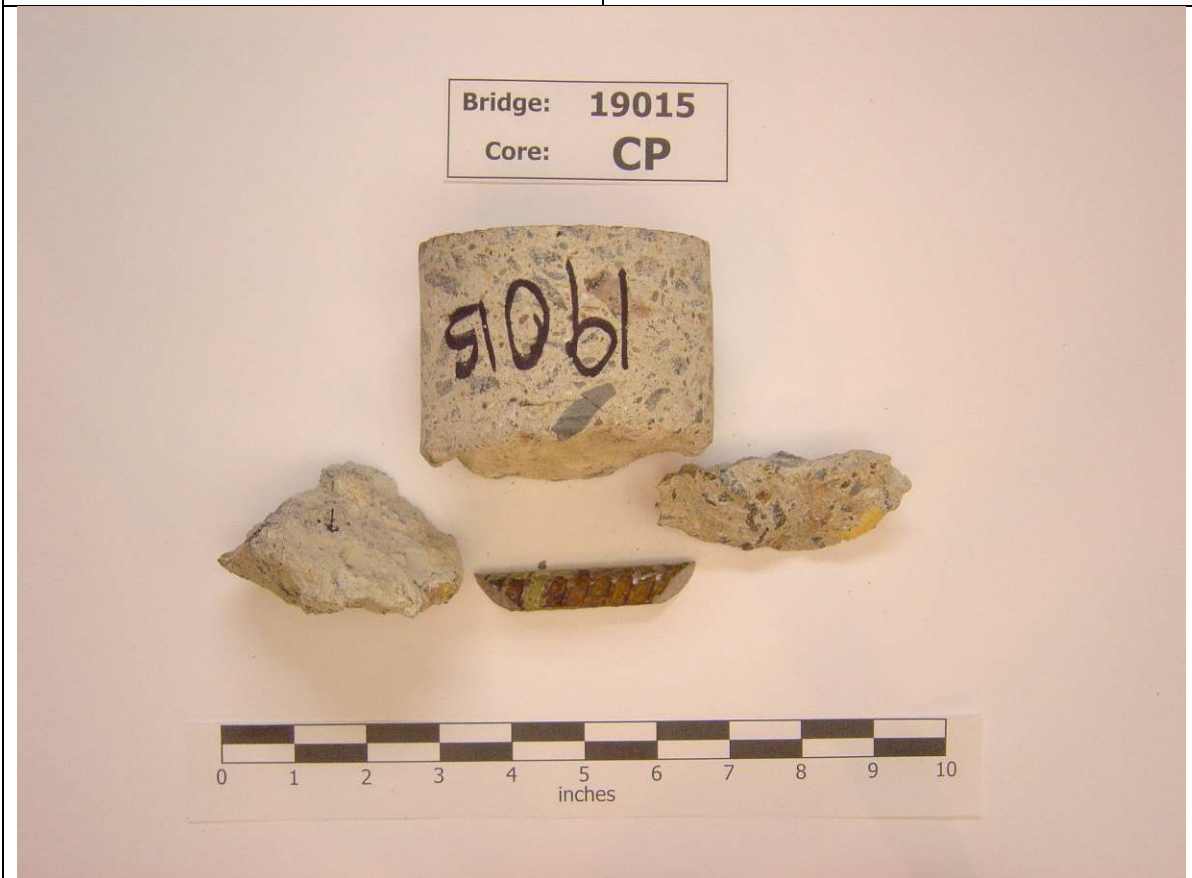
Core: CP

| Cracks:<br><b>Observed</b> | Corroded Bar:<br><b>Yes</b> | Delamination:<br><b>Yes</b> | Core diameter:<br><b>4"</b> |

- Cracks at bar level (possible delamination)
- The chain drag survey indicated a spall at this location
- Half cell potential readings indicated a high probability of corrosion activity at this location
- Bar shows evidence of corrosion

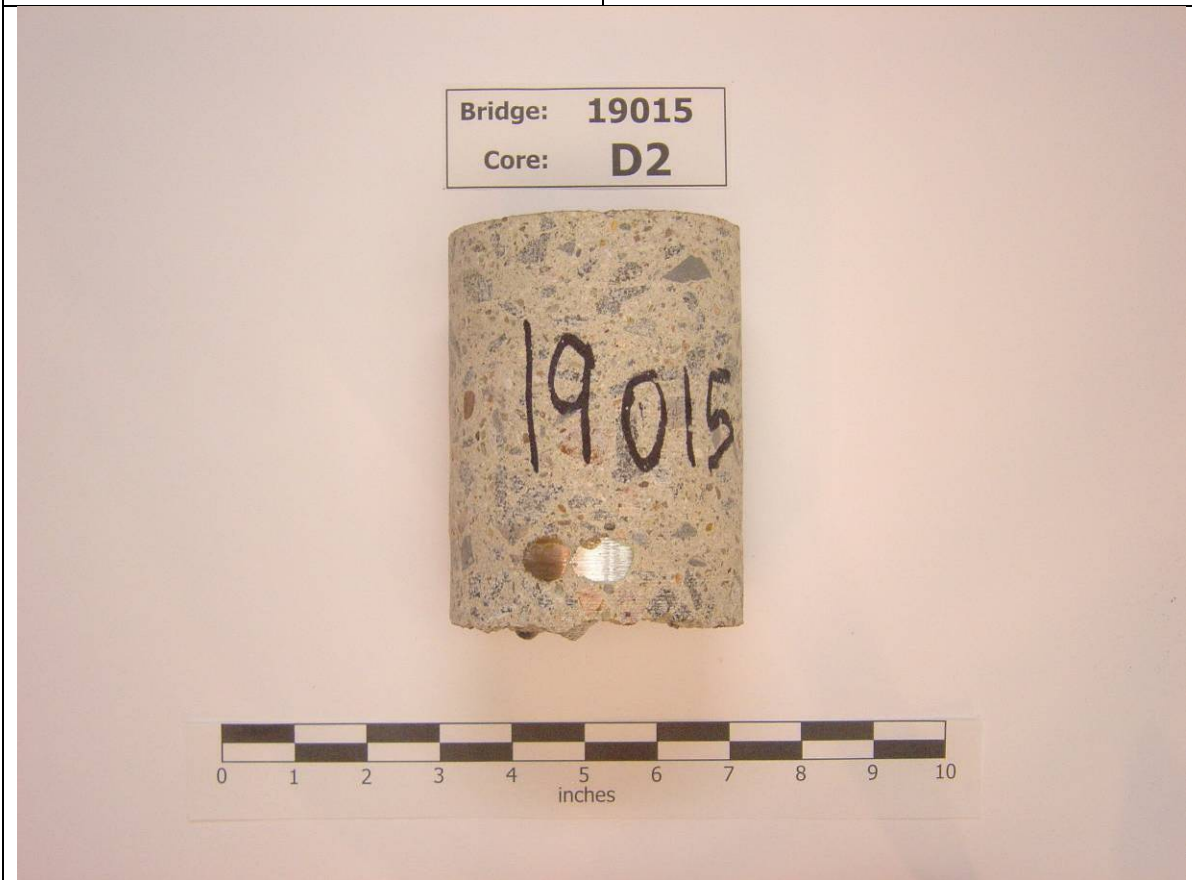
Core: **D2**

Cracks:  
**None observed**

Corroded Bar:  
**No**

- The chain drag survey indicated no signs of delamination at this location
- Half cell potential readings indicated a low probability of corrosion activity at this location
- Bar shows no evidence of corrosion

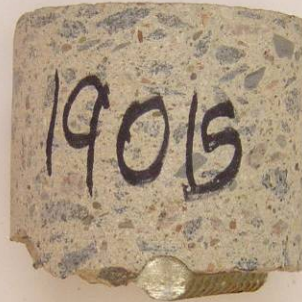
Bridge: **19015**  
Core: **DP**

Cracks:  
**None observed**

Corroded Bar:  
**Yes**

- The chain drag survey indicated no signs of delamination at this location
- Half cell potential readings indicated a high probability of corrosion activity at this location
- Bar shows evidence of corrosion

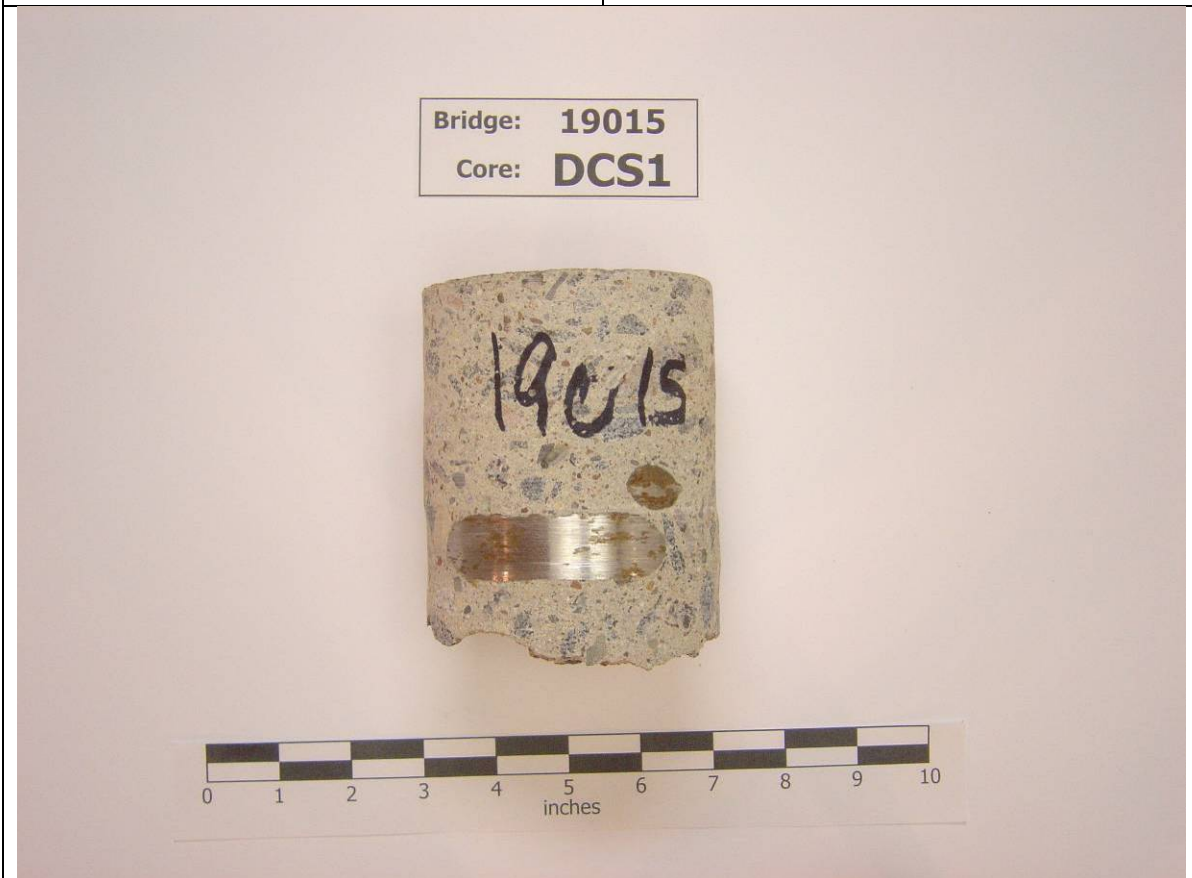
Core: **DCS1**

| Cracks:<br><b>None observed</b> | Corroded Bar:<br><b>Yes</b> | Delamination:<br><b>None</b> | Core diameter:<br><b>4"</b> |

- The chain drag survey indicated no signs of delamination at this location
- Half cell potential readings indicated a low probability of corrosion activity at this location
- Bar shows evidence of corrosion

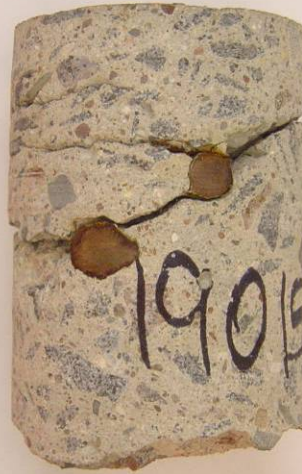
Bridge: 19015  
Core: DCS2

| Cracks:<br><b>Observed</b> | Corroded Bar:<br><b>Yes</b> | Delamination:<br><b>Yes</b> | Core diameter:<br><b>4"</b> |

- Delamination cracks at the bar level
- The chain drag survey indicated delamination at this location
- Half cell potential readings indicated a high probability of corrosion activity at this location
- Bar shows evidence of corrosion

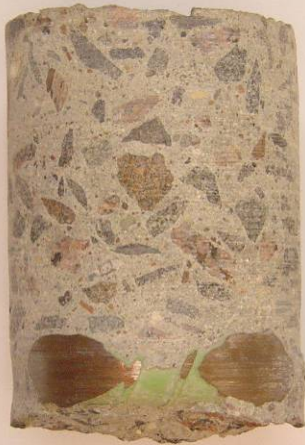
Bridge: 27062  
Core: A1

Cracks:  
**None observed**

Corroded Bar:  
**No**

- The chain drag survey indicated no signs of delamination at this location
- Half cell potential readings indicated a low probability of corrosion activity at this location
- Bar shows no evidence of corrosion

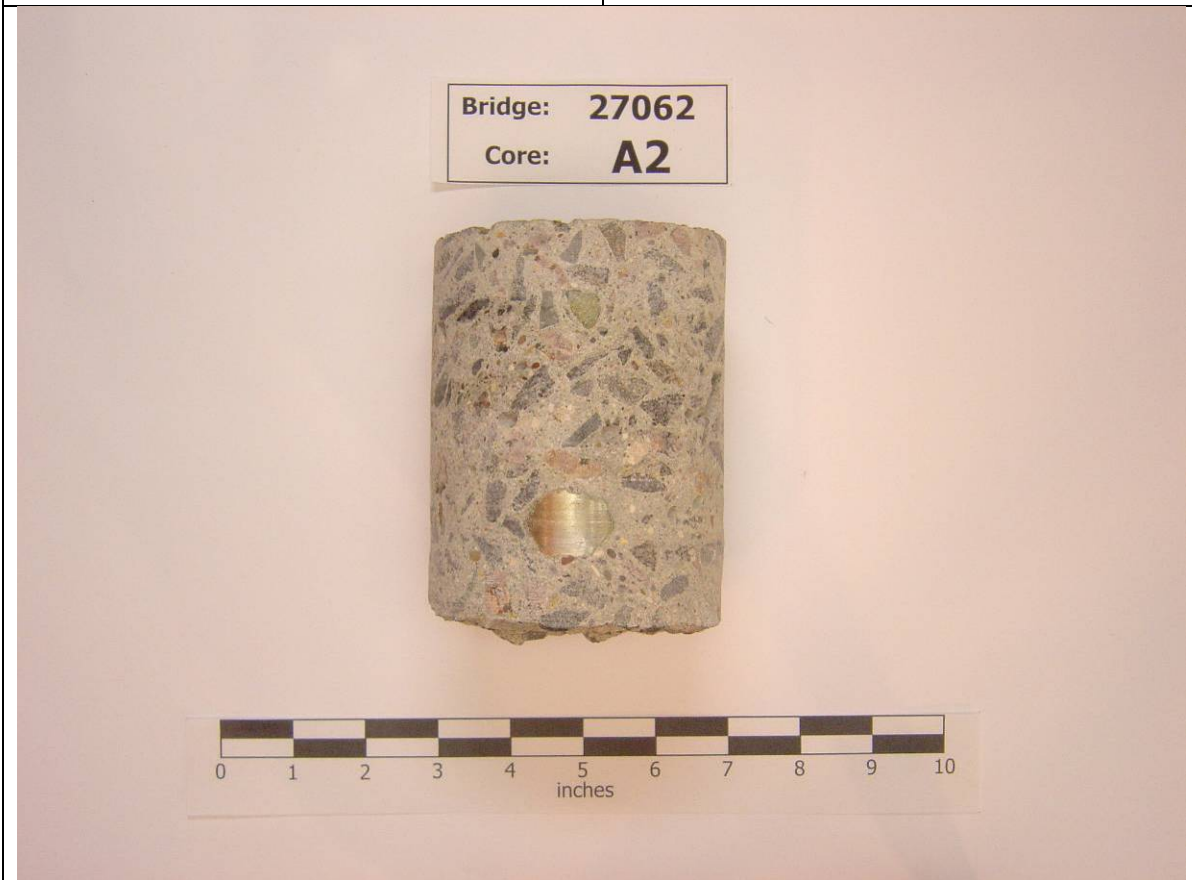
Core: A2

| Cracks:<br><b>None observed</b> | Corroded Bar:<br><b>No</b> | Delamination:<br><b>None</b> | Core diameter:<br><b>4"</b> |

- The chain drag survey indicated no signs of delamination at this location
- Half cell potential readings indicated a high probability of corrosion activity at this location
- Bar shows no evidence of corrosion

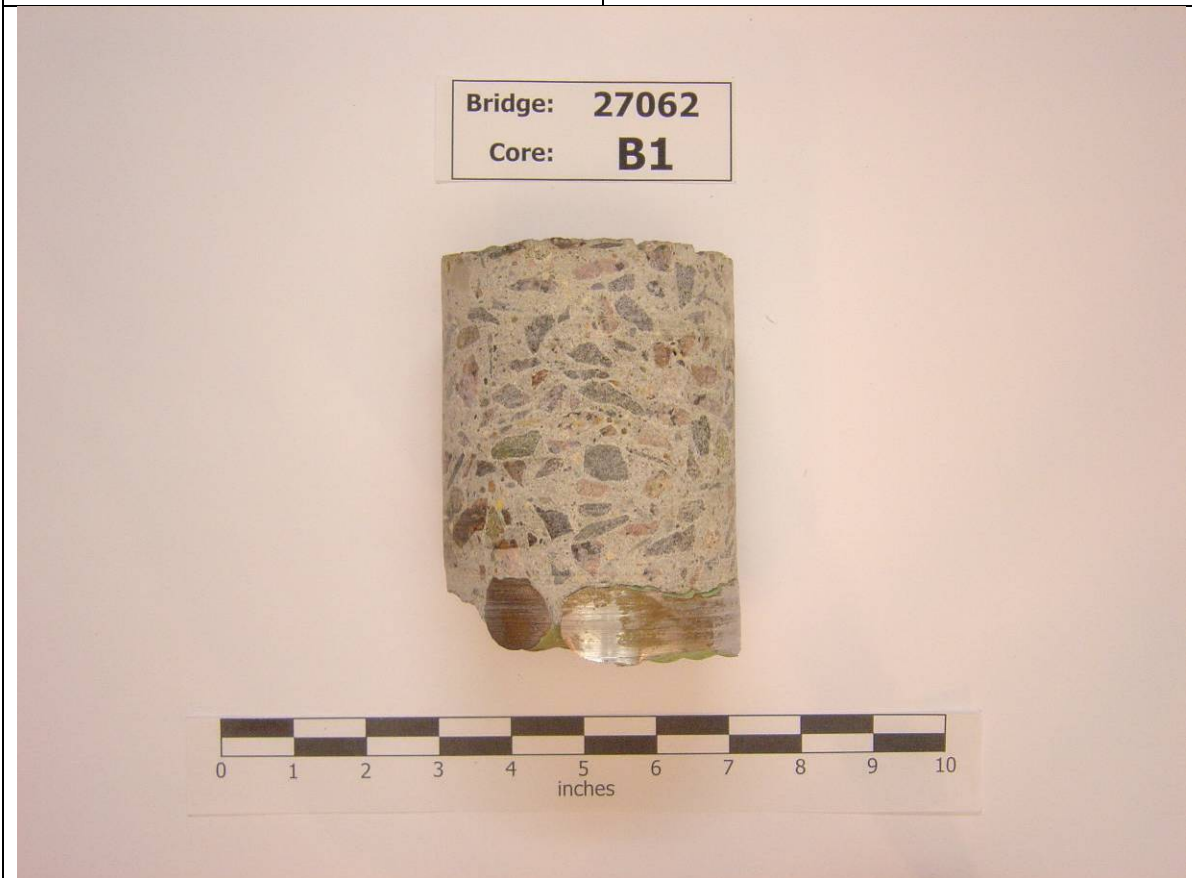
Core: B1

Cracks:  
**None observed**

Corroded Bar:  
**No**

- The chain drag survey indicated no signs of delamination at this location (Jose there is an inconsistency here)
- Half cell potential readings indicated a high probability of corrosion activity at this location
- Bar shows no evidence of corrosion

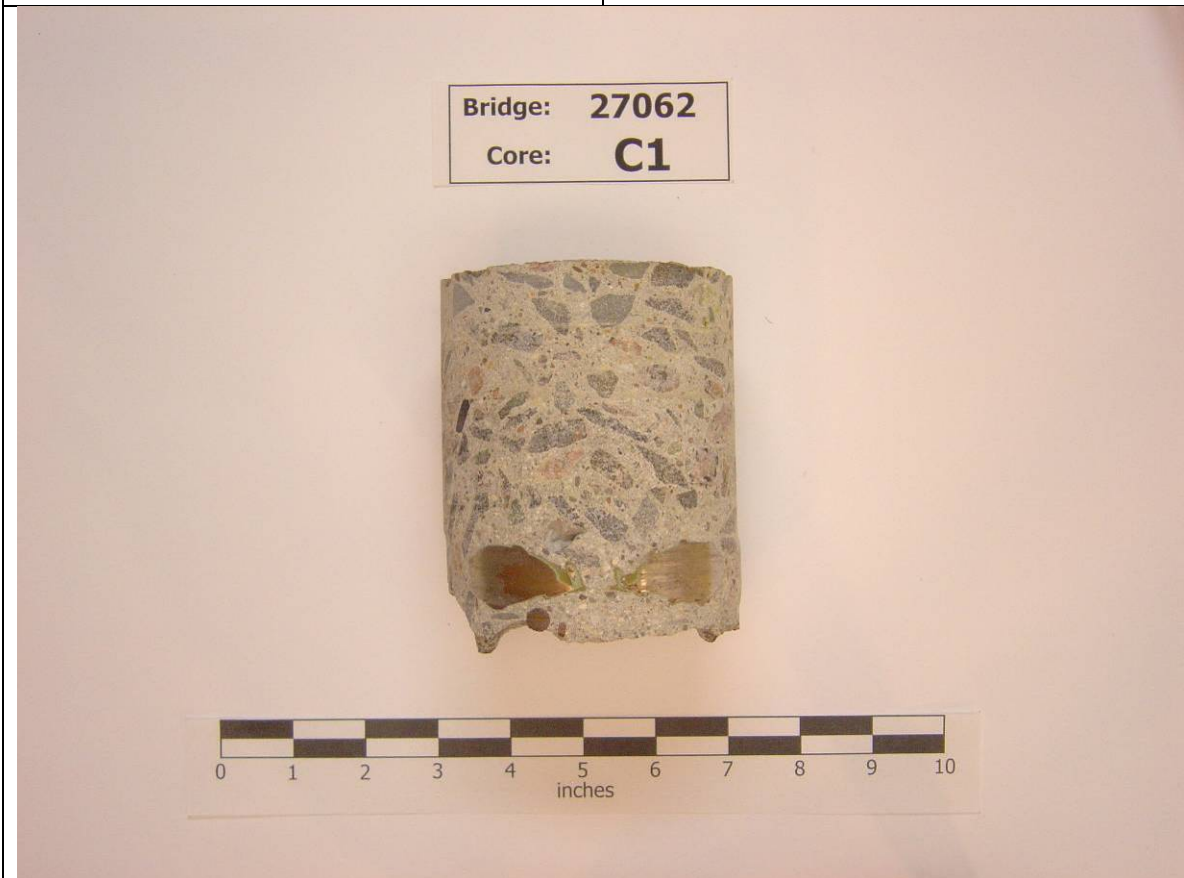
Core: C1

Cracks:  
**None observed**

Corroded Bar:  
**No**

- The chain drag survey indicated no signs of delamination at this location
- Half cell potential readings indicated a high probability of corrosion activity at this location
- Bar shows no evidence of corrosion

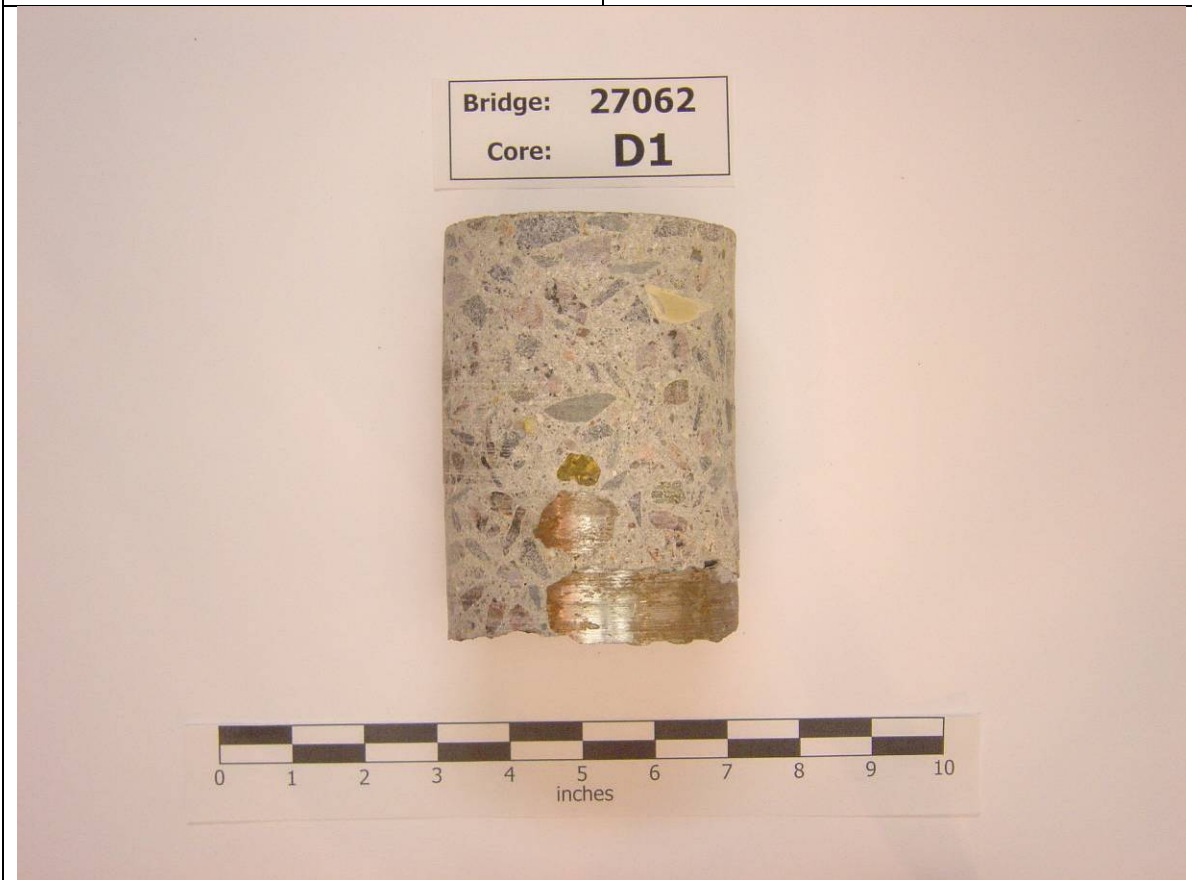
Core: D1

Cracks:  
**None observed**

Corroded Bar:  
**No**

- The chain drag survey indicated delamination 2' from this location
- Half cell potential readings indicated a high probability of corrosion activity at this location
- Bar shows no evidence of corrosion

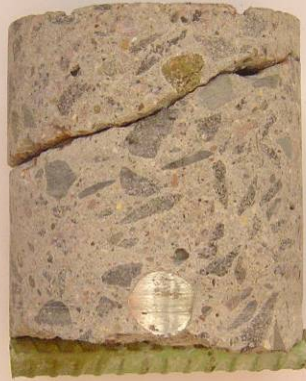
Bridge: 27062  
Core: D2

| Cracks:<br><b>Observed</b> | Corroded Bar:<br><b>Yes</b> | Delamination:<br><b>Yes</b> | Core diameter:<br><b>4"</b> |

- Diagonal crack from ½" to 2-½" below surface, delamination above rebar
- The chain drag survey indicated delamination at this location
- Half cell potential readings indicated a high probability of corrosion activity at this location
- Bar shows evidence of corrosion

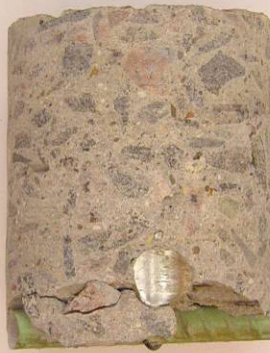
Bridge: 27062  
Core: D3

| Cracks:<br><b>Observed</b> | Corroded Bar:<br><b>No</b> | Delamination:<br><b>Yes</b> | Core diameter:<br><b>4"</b> |

- Cracks at bar level (possible delamination)
- The chain drag survey indicated delamination 1' from this location
- Half cell potential readings indicated a high probability of corrosion activity at this location

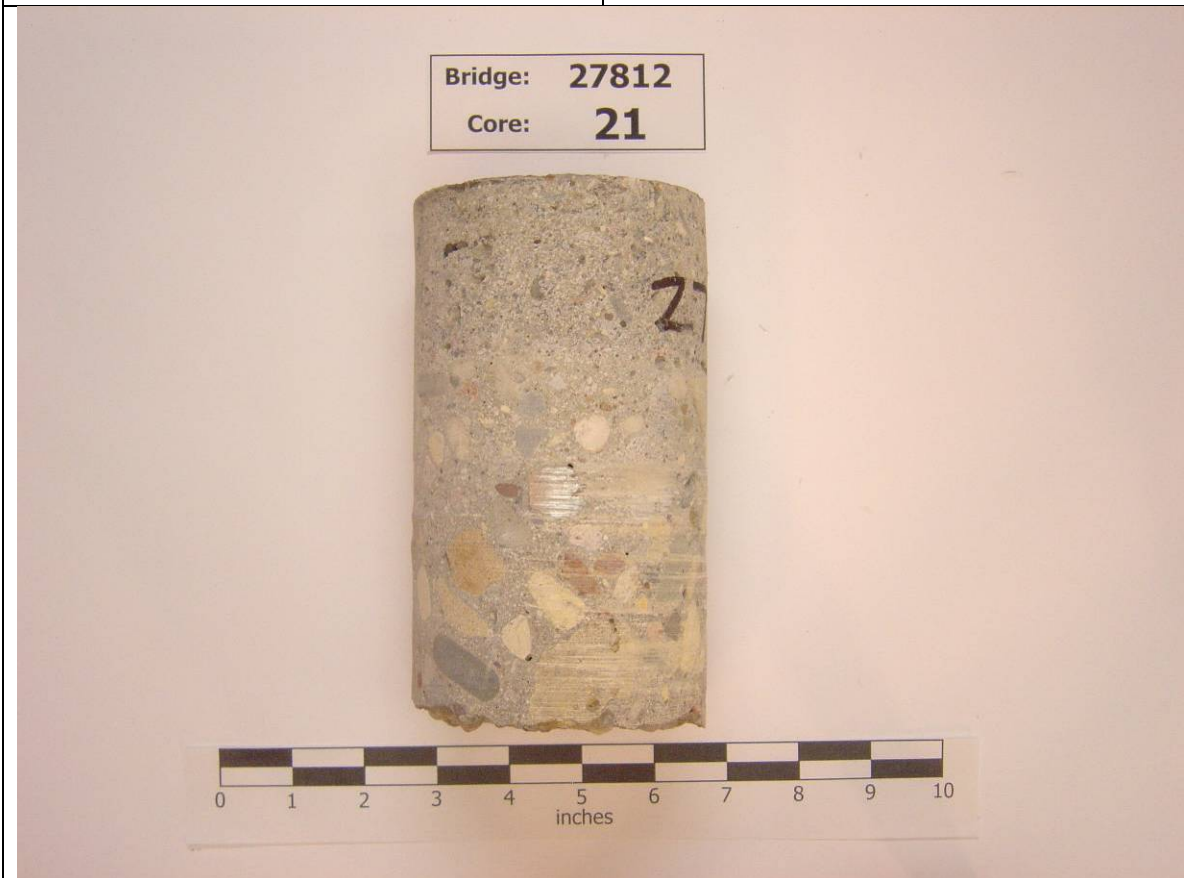
Core: 2-1

| Cracks:<br><b>None observed</b> | Corroded Bar:<br><b>No</b> | Delamination:<br><b>None</b> | Core diameter:<br><b>4"</b> |

- The chain drag survey indicated no signs of delamination at this location
- Half cell potential readings indicated a low probability of corrosion activity at this location
- Bar shows no evidence of corrosion

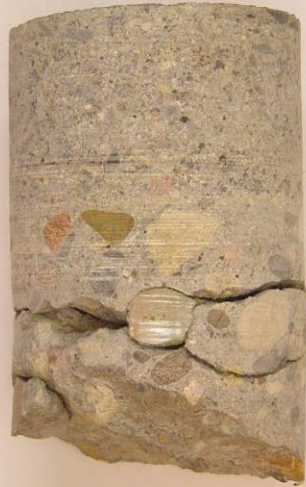
Core: 22

Cracks:  
**Observed**

Corroded Bar:  
**No**

- Delamination cracks at the bar level
- The chain drag survey indicated no signs of delamination at this location
- Half cell potential readings indicated that is likely to find corrosion activity at this location
- Bar shows no evidence of corrosion

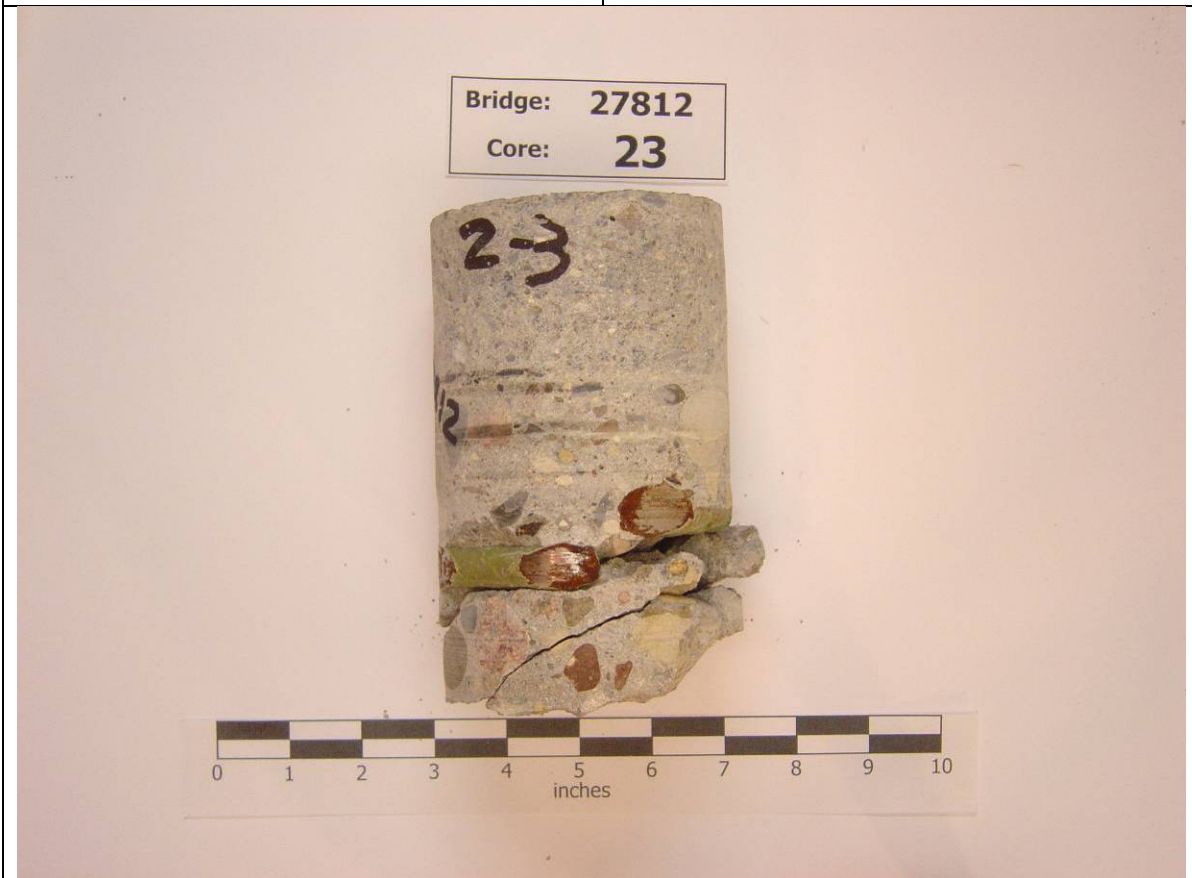
Core: 2-3

| Cracks:<br><b>Observed</b> | Corroded Bar:<br><b>Yes</b> | Delamination:<br><b>Yes</b> | Core diameter:<br><b>4"</b> |

- Delamination cracks at the bar level
- The chain drag survey indicated no signs of delamination at this location
- Half cell potential readings indicated a high probability of corrosion activity at this location
- Bar shows evidence of corrosion

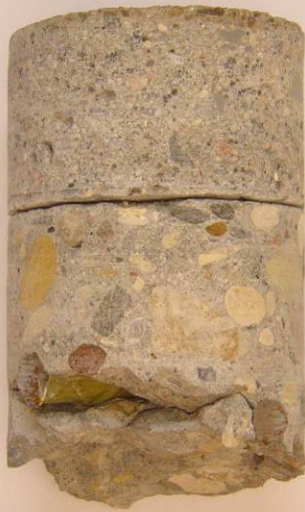
Core: 31

Cracks:  
**None observed**

Corroded Bar:  
**No**

- Horizontal crack 2" below surface (at overlay-deck interface)
- The chain drag survey indicated no signs of delamination at this location
- Half cell potential readings indicated a low probability of corrosion activity at this location
- Bar shows no evidence of corrosion

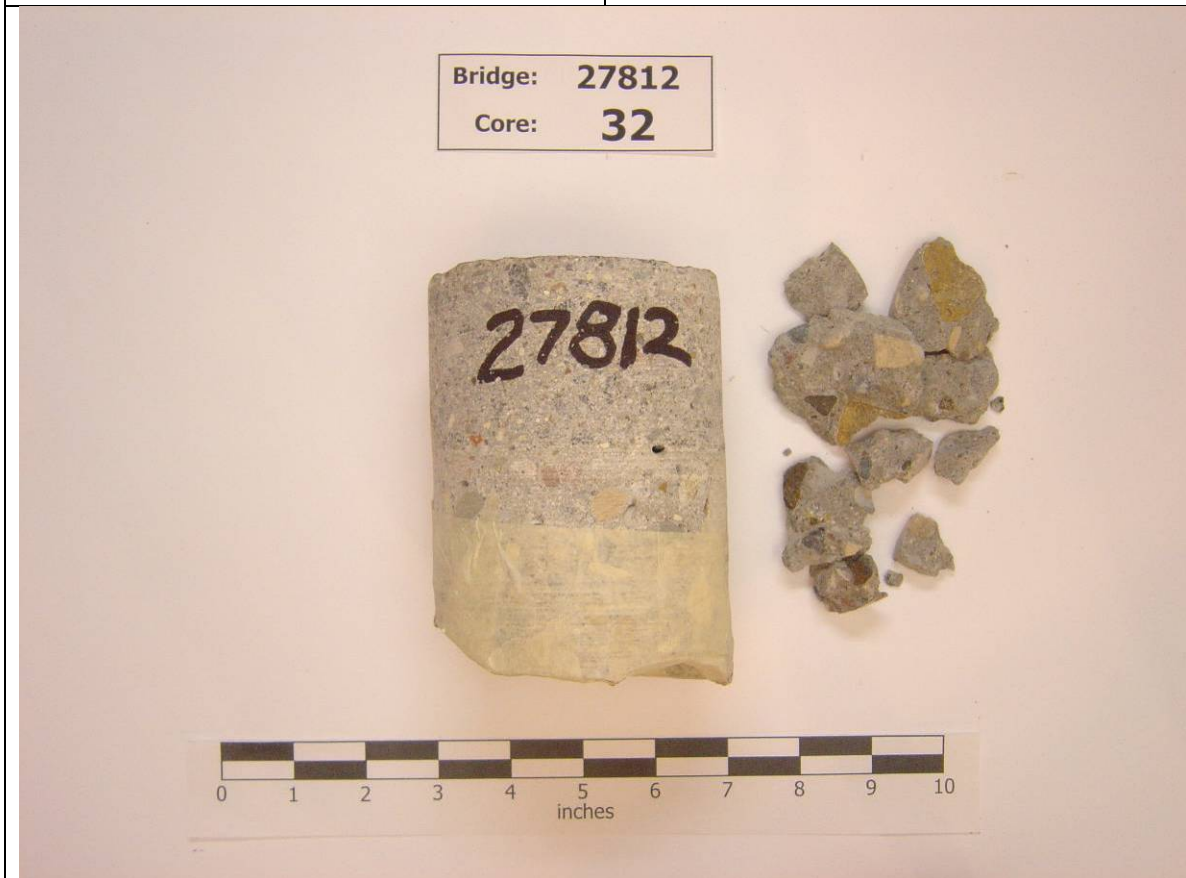
Core: 3-2

| Cracks:<br><b>Observed</b> | Corroded Bar:<br><b>No</b> | Delamination:<br><b>None</b> | Core diameter:<br><b>4"</b> |

- The chain drag survey indicated no signs of delamination at this location
- Half cell potential readings indicated a low probability of corrosion activity at this location
- Bar shows no evidence of corrosion
