2008-47

## Corrosion Protection Performance of Epoxy-Coated Reinforcing Bars

## **Final Report**

**September 2008**

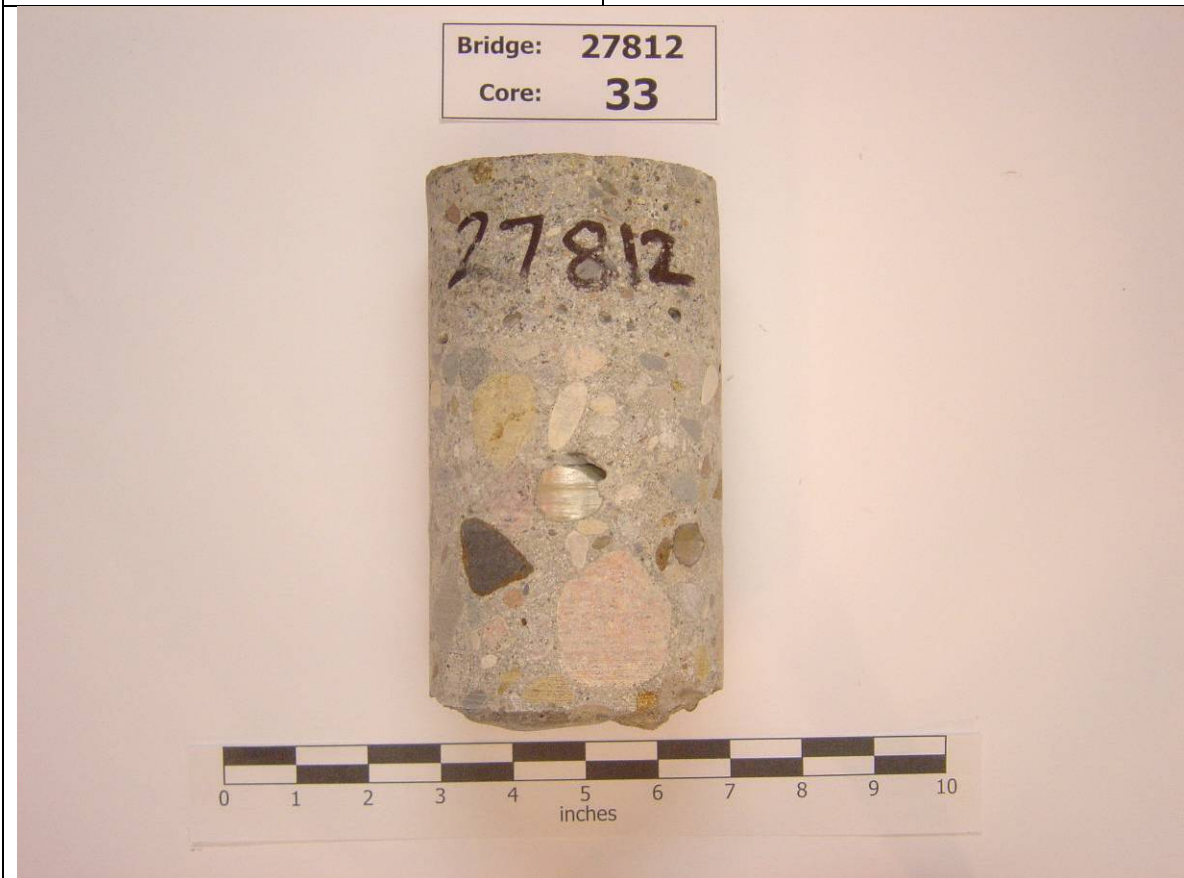
Core: 3-3

| Cracks:<br><b>None observed</b> | Corroded Bar:<br><b>No</b> | Delamination:<br><b>None</b> | Core diameter:<br><b>4"</b> |

- The chain drag survey indicated no signs of delamination at this location
- Half cell potential readings indicated a low probability of corrosion activity at this location
- Bar shows no evidence of corrosion

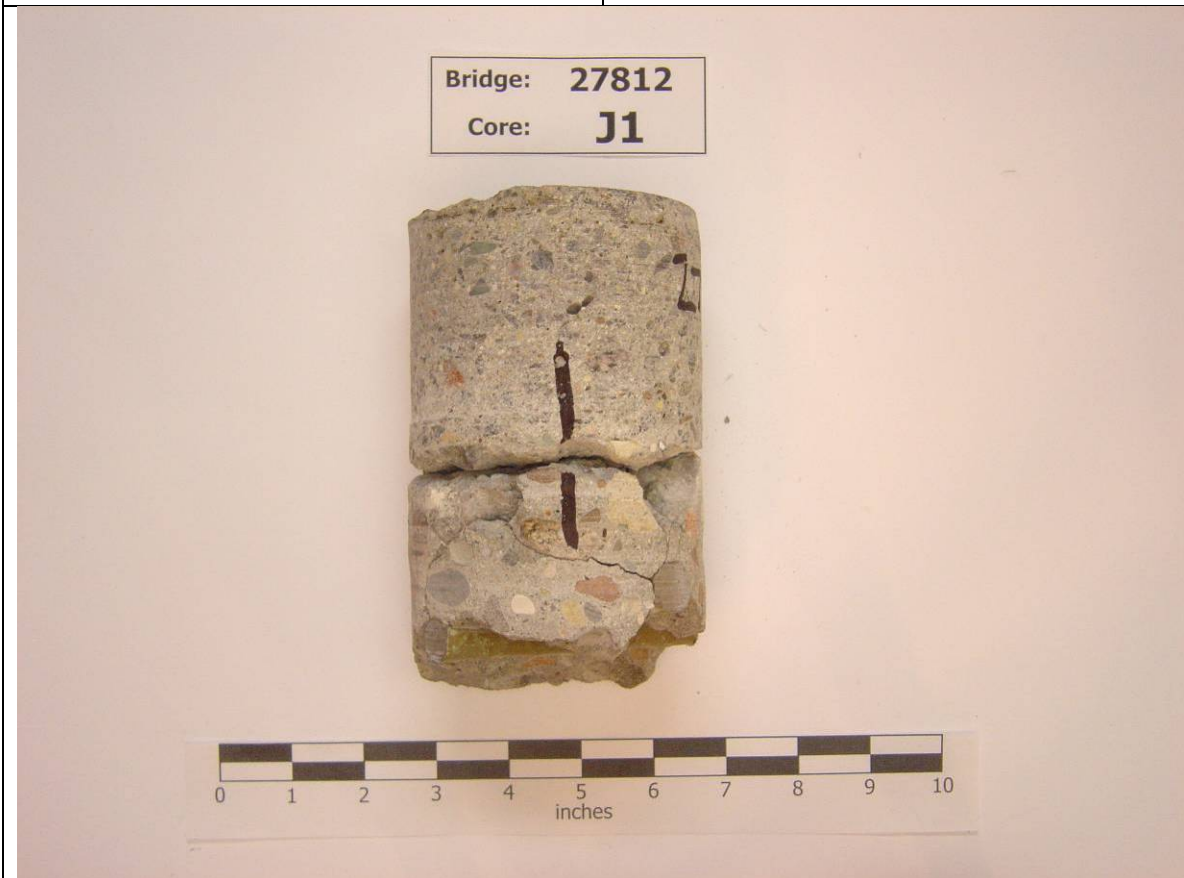
Core: J-1

| Cracks:<br><b>Observed</b> | Corroded Bar:<br><b>No</b> | Delamination:<br><b>Yes</b> | Core diameter:<br><b>4"</b> |

- Horizontal crack 4" below surface
- The chain drag survey indicated delamination at this location
- Half cell potential readings indicated a high probability of corrosion activity at this location
- Bar shows no evidence of corrosion

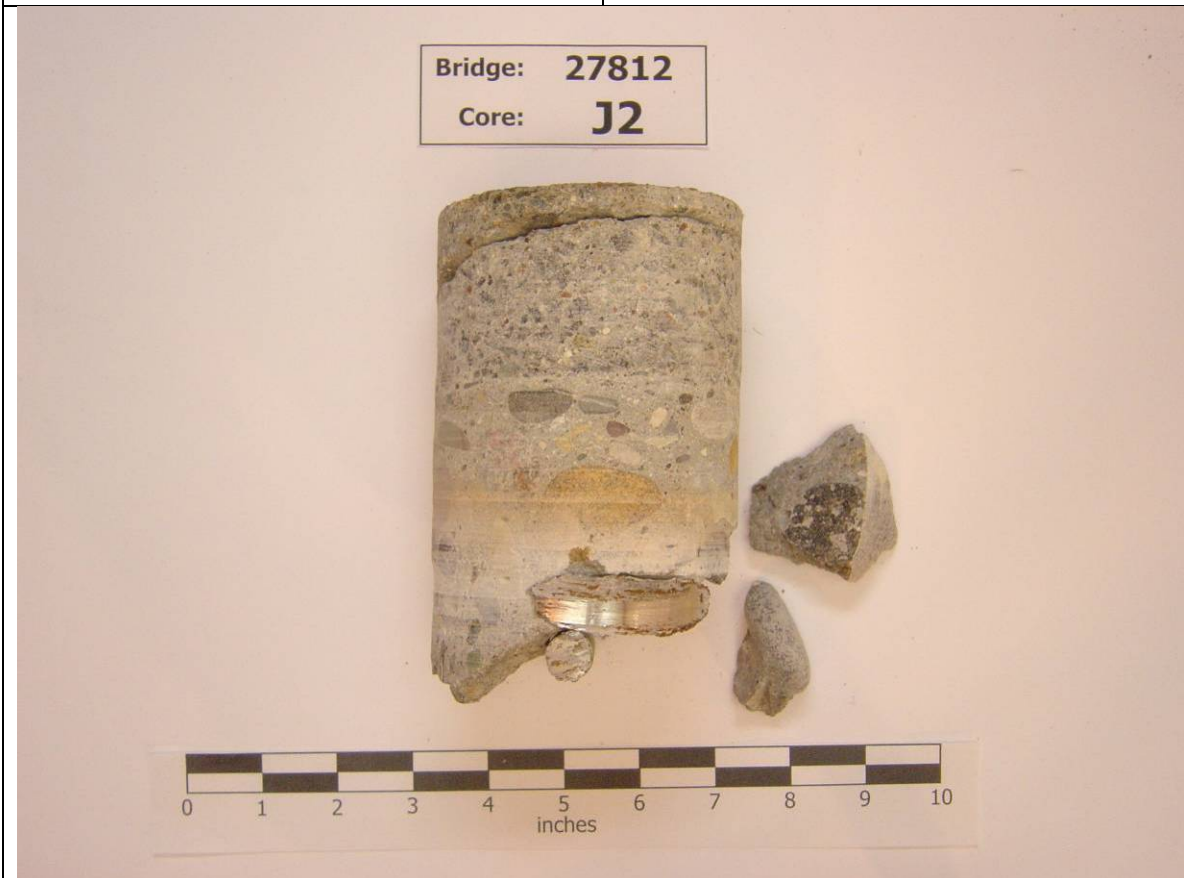
Core: J-2

| Cracks:<br><b>Observed</b> | Corroded Bar:<br><b>No</b> | Delamination:<br><b>Yes</b> | Core diameter:<br><b>4"</b> |

- Dipping crack ½" below surface
- Cracks at the bar level (possible delamination)
- The chain drag survey indicated delamination and spall at this location
- Half cell potential readings indicated a high probability of corrosion activity at this location
- Bar shows no evidence of corrosion

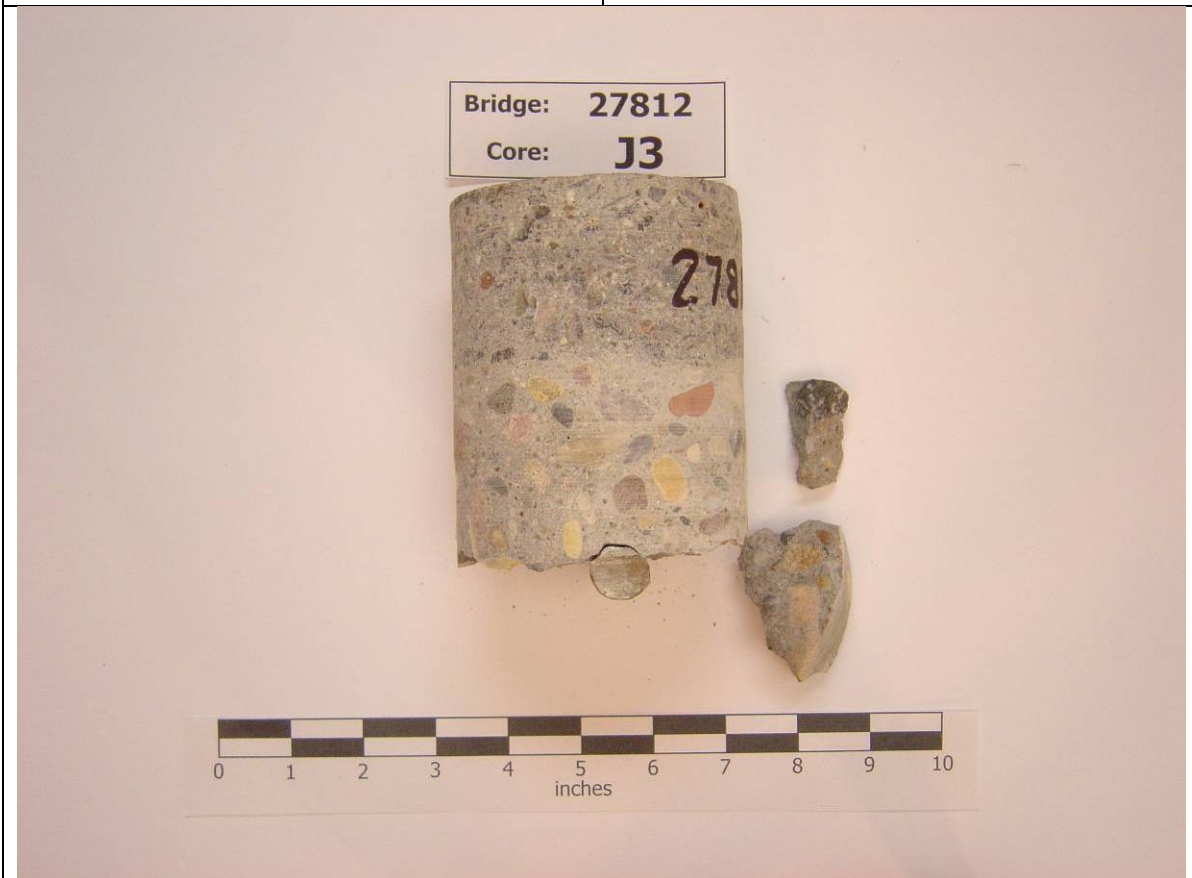
Core: J-3

| Cracks:<br><b>None observed</b> | Corroded Bar:<br><b>Yes</b> | Delamination:<br><b>Yes</b> | Core diameter:<br><b>4"</b> |

- Cracks at the bar level (possible delamination)
- The chain drag survey indicated delamination 1' from this location
- Half cell potential readings indicated a high probability of corrosion activity at this location
- Bar shows evidence of corrosion

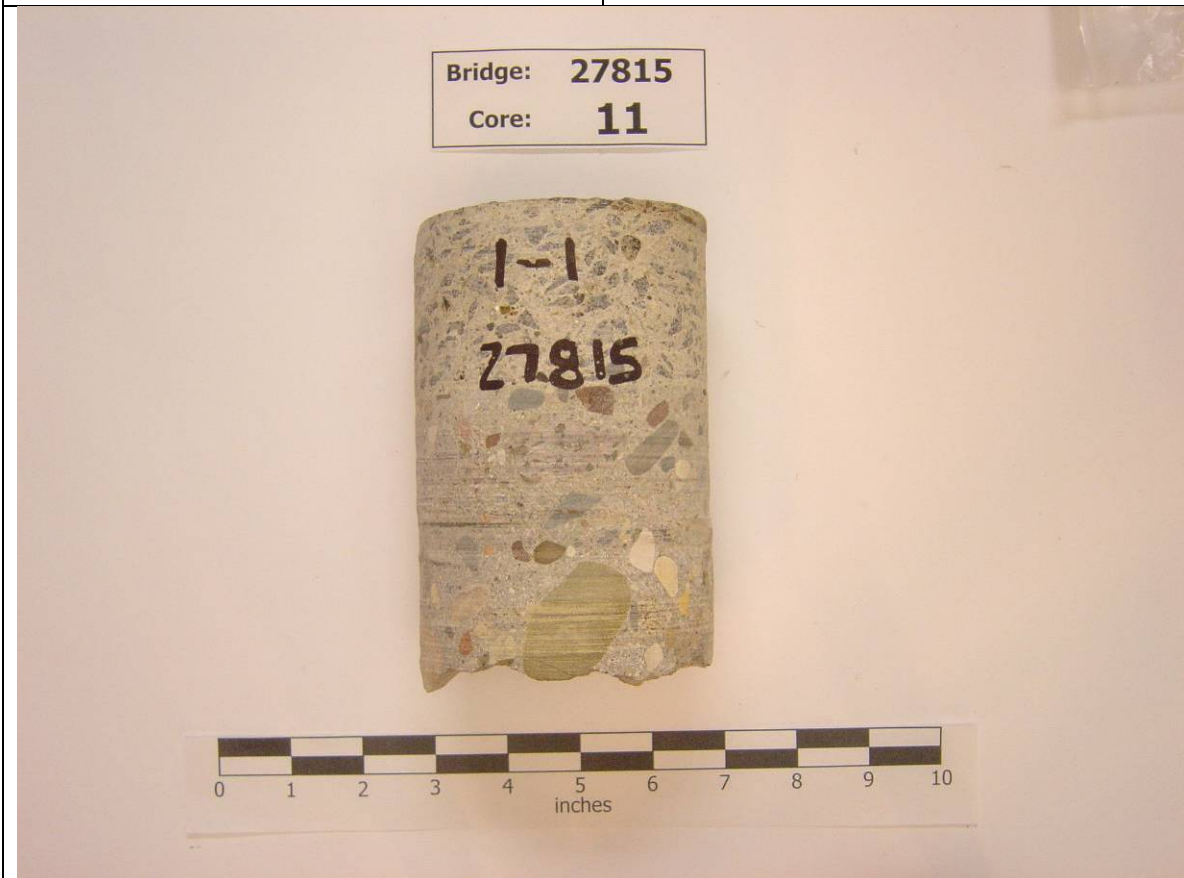
Core: 1-1

Cracks:  
**None observed**

Corroded Bar:  
**No**

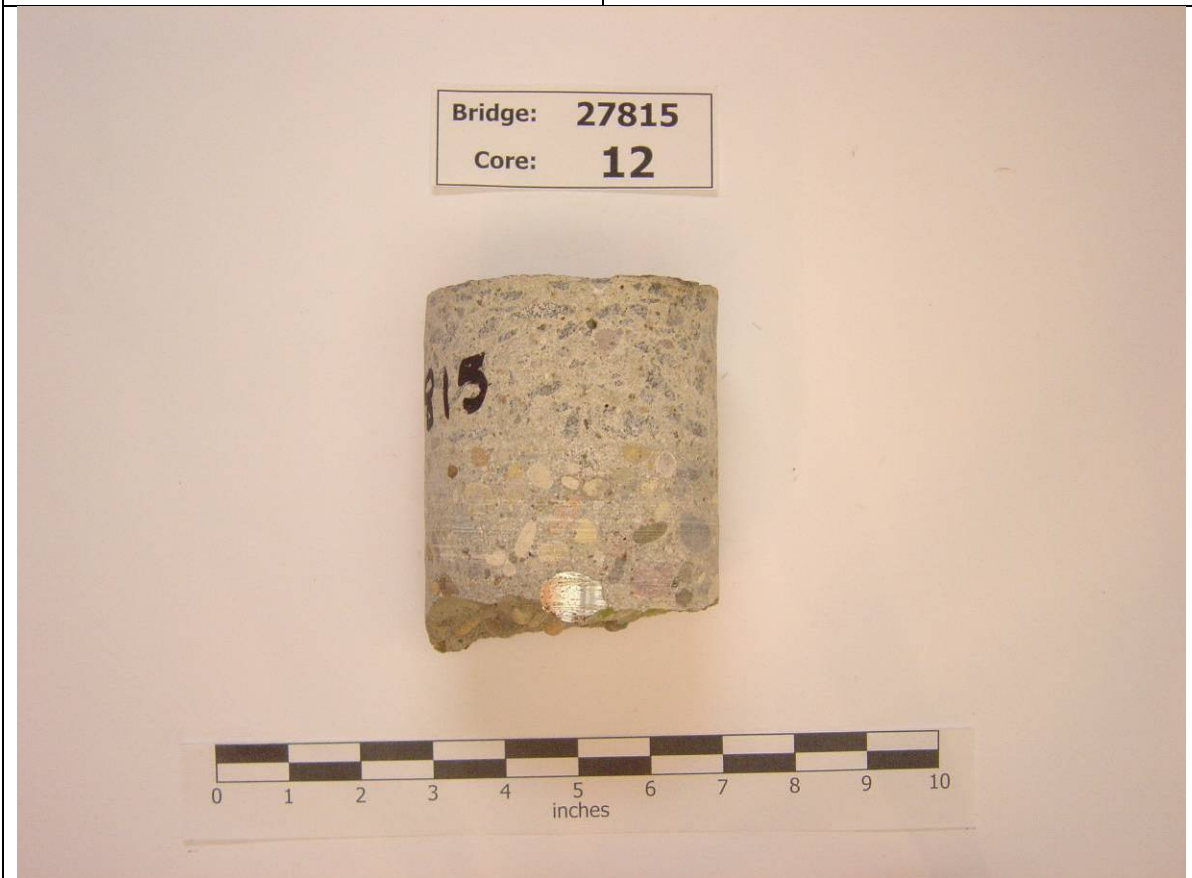
Core: 1-2

| Cracks:<br><b>None observed</b> | Corroded Bar:<br><b>No</b> | Delamination:<br><b>Yes</b> | Core diameter:<br><b>4"</b> |

- The chain drag survey indicated no signs of delamination at this location
- Half cell potential readings indicated a high probability of corrosion activity at this location
- Bar shows no evidence of corrosion

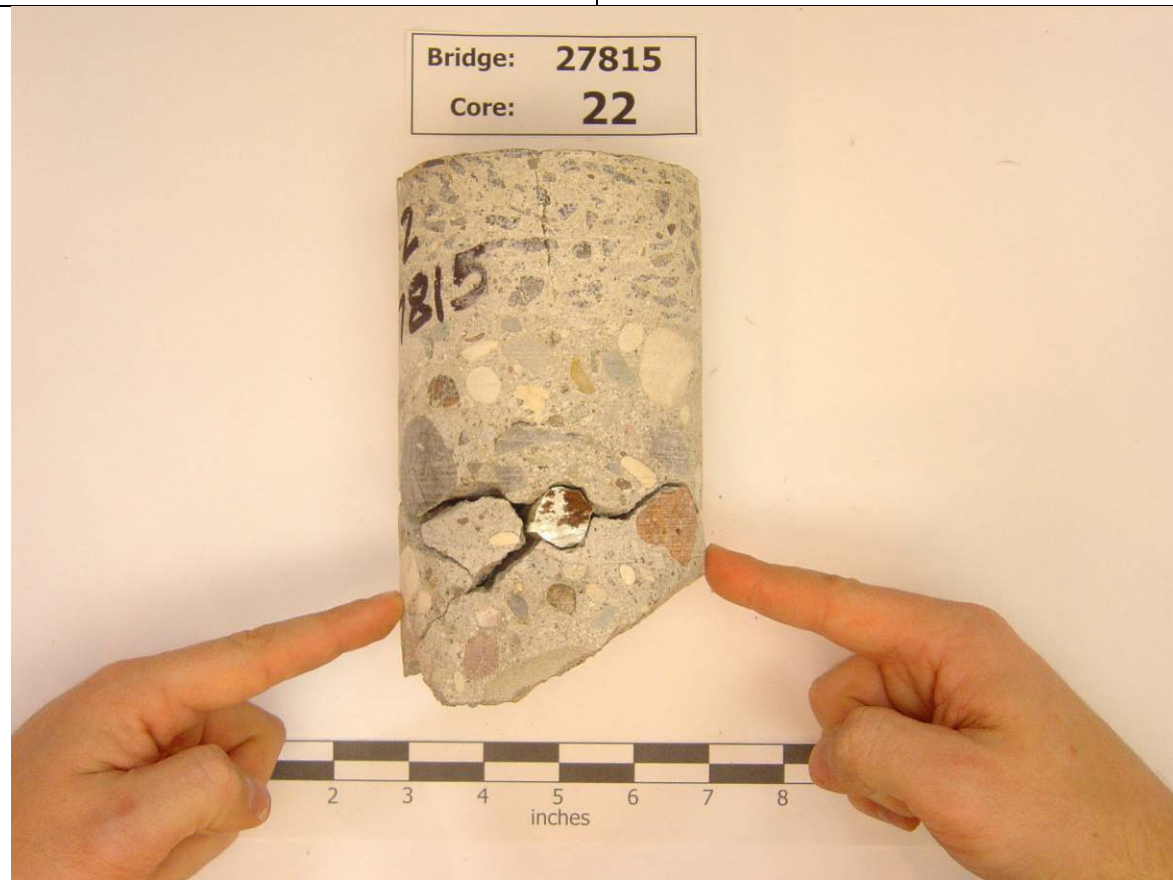
Core: 2-2

| Cracks:<br><b>Observed</b> | Corroded Bar:<br><b>Yes</b> | Delamination:<br><b>Yes</b> | Core diameter:<br><b>4"</b> |

- Vertical crack at center of core, 2" length from surface
- Delamination cracks at bar level
- The chain drag survey indicated no signs of delamination at this location
- Half cell potential readings indicated that is likely to find corrosion activity at this location
- Bar shows evidence of corrosion

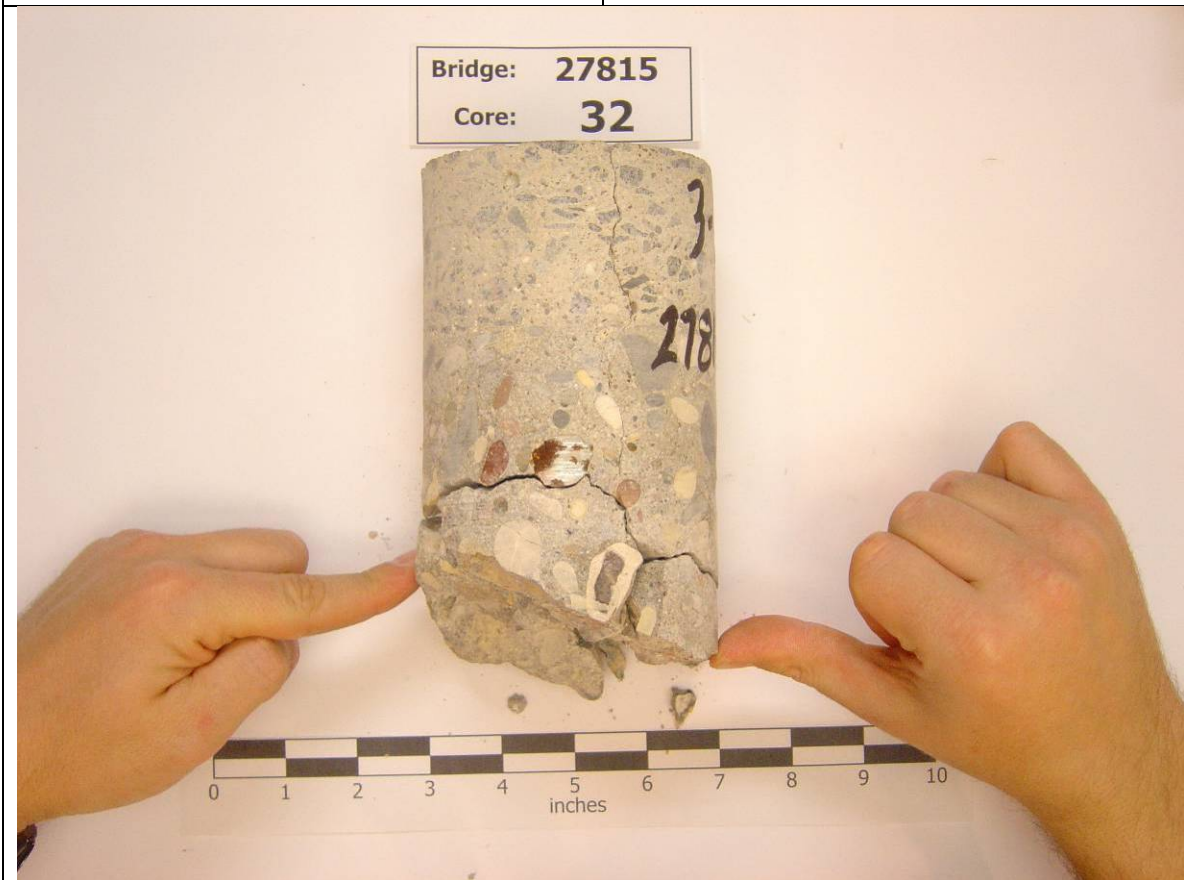
Core: 3-2

| Cracks:<br><b>Observed</b> | Corroded Bar:<br><b>Yes</b> | Delamination:<br><b>Yes</b> | Core diameter:<br><b>4"</b> |

- Delamination cracks at the bar level
- The chain drag survey indicated no signs of delamination at this location
- Half cell potential readings indicated that is likely to find corrosion activity at this location
- Bar shows evidence of corrosion

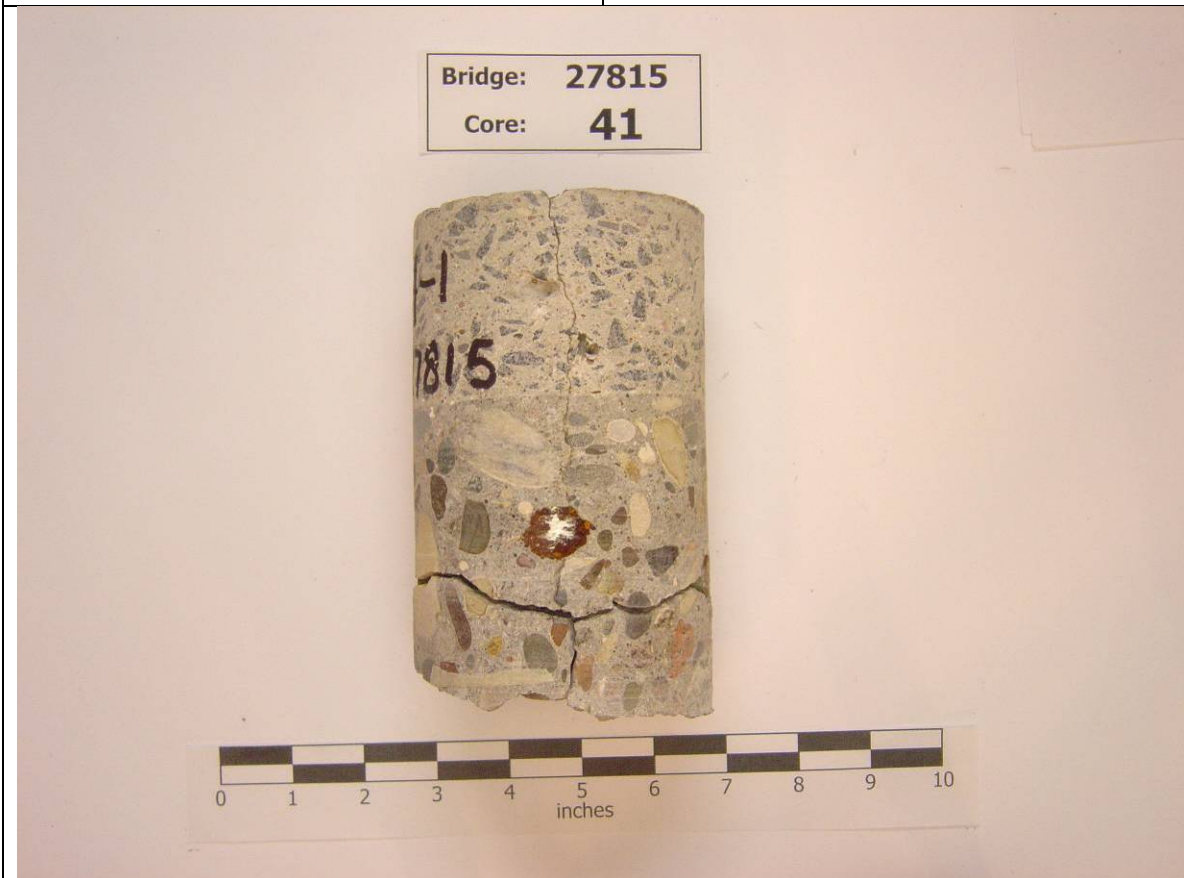
Core: 4-1

| Cracks:<br><b>Observed</b> | Corroded Bar:<br><b>Yes</b> | Delamination:<br><b>Yes</b> | Core diameter:<br><b>4"</b> |

- Vertical crack at center of core, from top to bottom
- Cracks below the bar
- The chain drag survey indicated no signs of delamination at this location
- Half cell potential readings indicated a high probability of corrosion activity at this location
- Bar shows evidence of corrosion

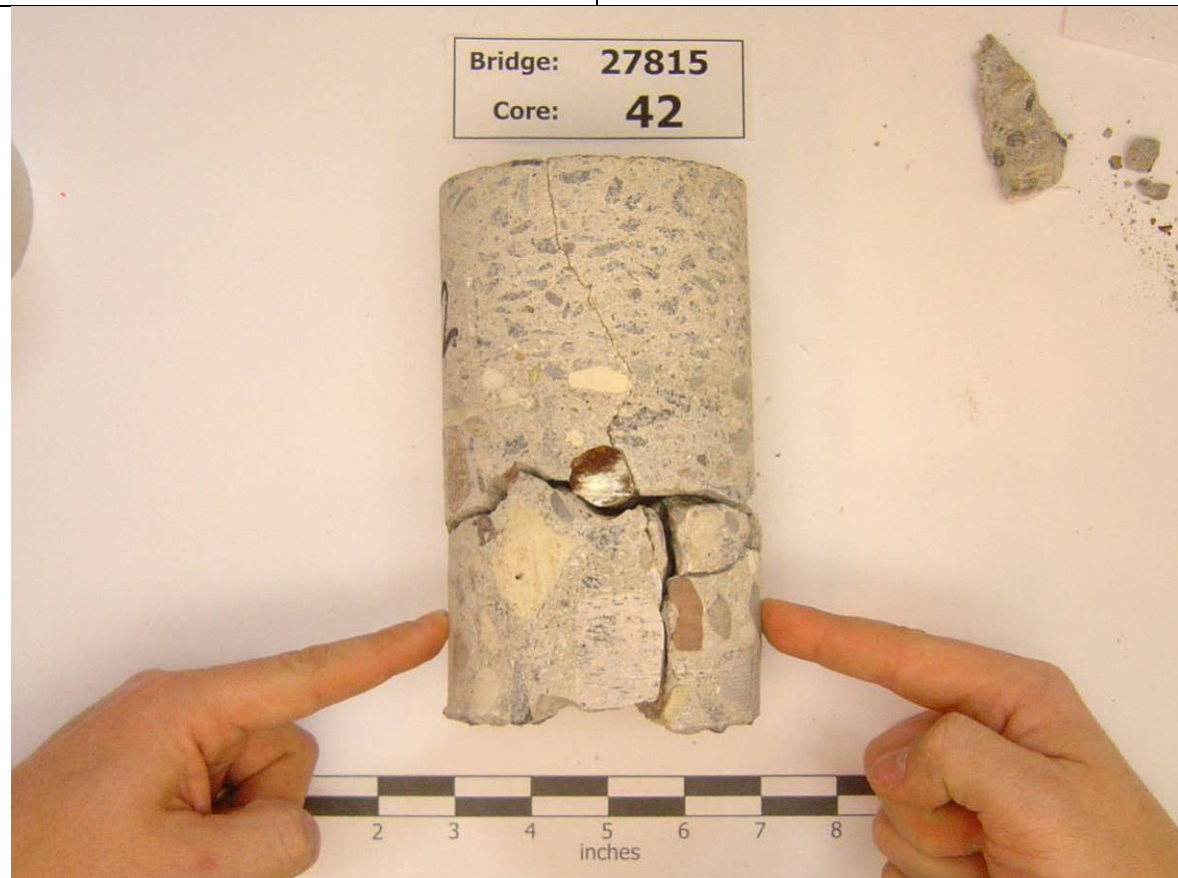
Core: 4-2

| Cracks:<br><b>Observed</b> | Corroded Bar:<br><b>Yes</b> | Delamination:<br><b>Yes</b> | Core diameter:<br><b>4"</b> |

- Vertical crack at center of core, from surface to bar level
- Delamination cracks at the bar level
- The chain drag survey indicated no signs of delamination at this location
- Half cell potential readings indicated that is likely to find corrosion activity at this location
- Bar shows evidence of corrosion

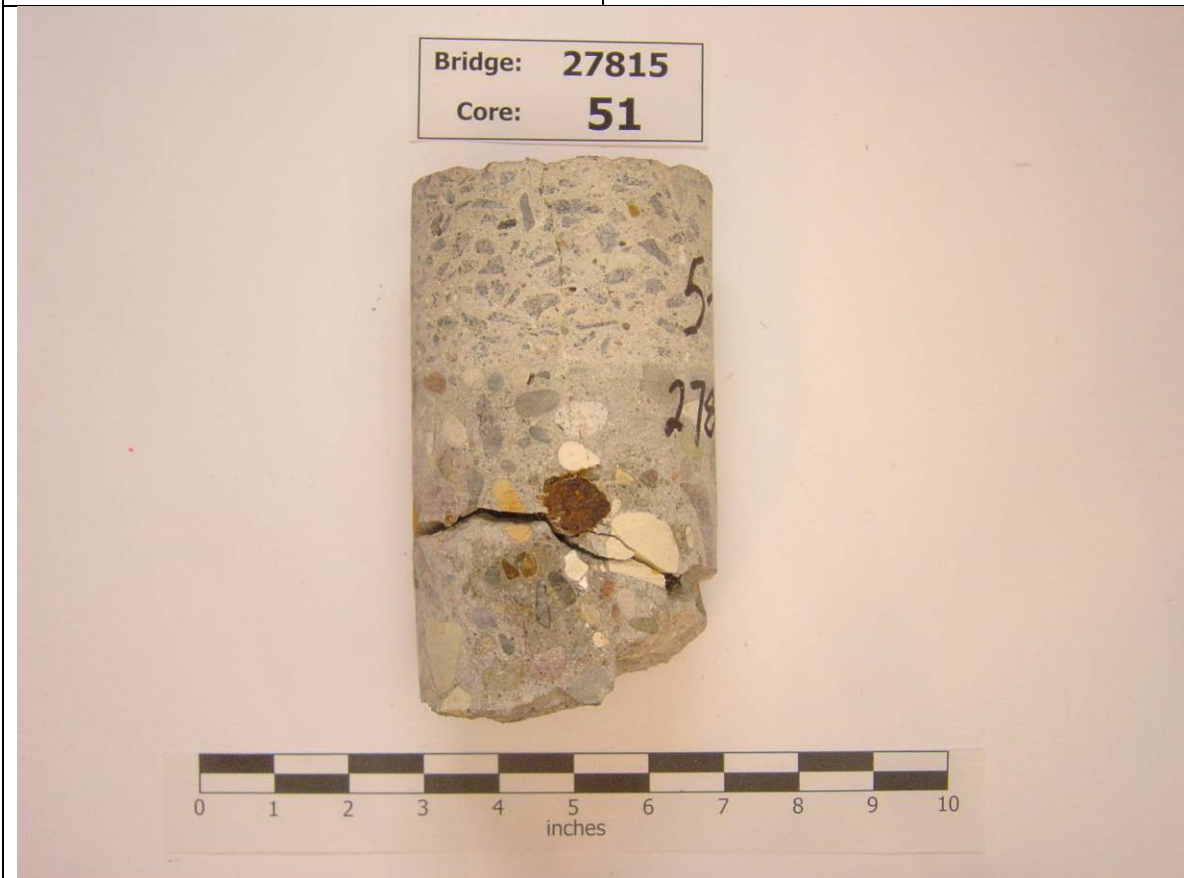
Core: 5-1

| Cracks:<br><b>Observed</b> | Corroded Bar:<br><b>Yes</b> | Delamination:<br><b>Yes</b> | Core diameter:<br><b>4"</b> |

- Vertical crack at center of core, from surface to bar level
- Delamination cracks at the bar level
- The chain drag survey indicated no signs of delamination at this location
- Half cell potential readings indicated a low probability of corrosion activity at this location
- Bar shows evidence of corrosion

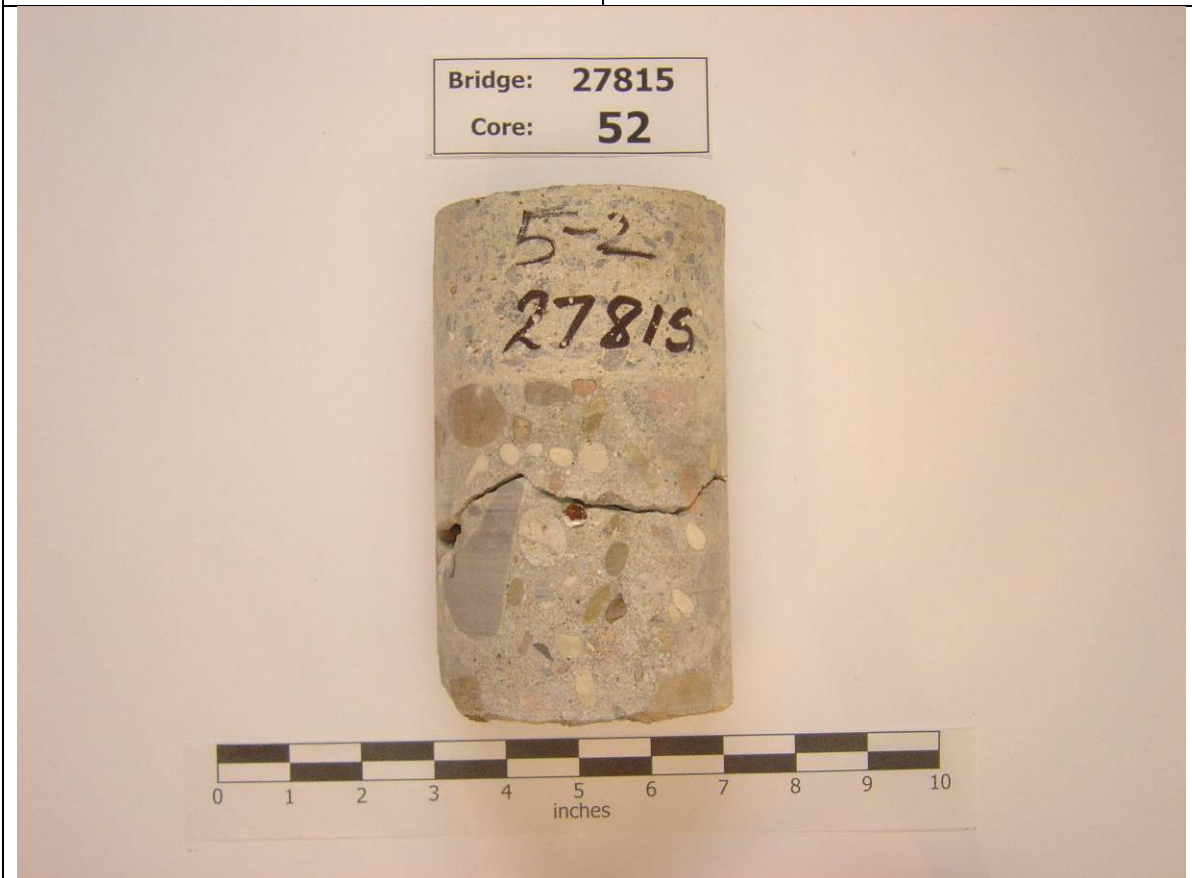
Core: 5-2

| Cracks:<br><b>Observed</b> | Corroded Bar:<br><b>Yes</b> | Delamination:<br><b>Yes</b> | Core diameter:<br><b>4"</b> |

- Cracks at the bar level (possible delamination)
- The chain drag survey indicated no signs of delamination at this location
- Half cell potential readings indicated a low probability of corrosion activity at this location
- Bar shows evidence of corrosion

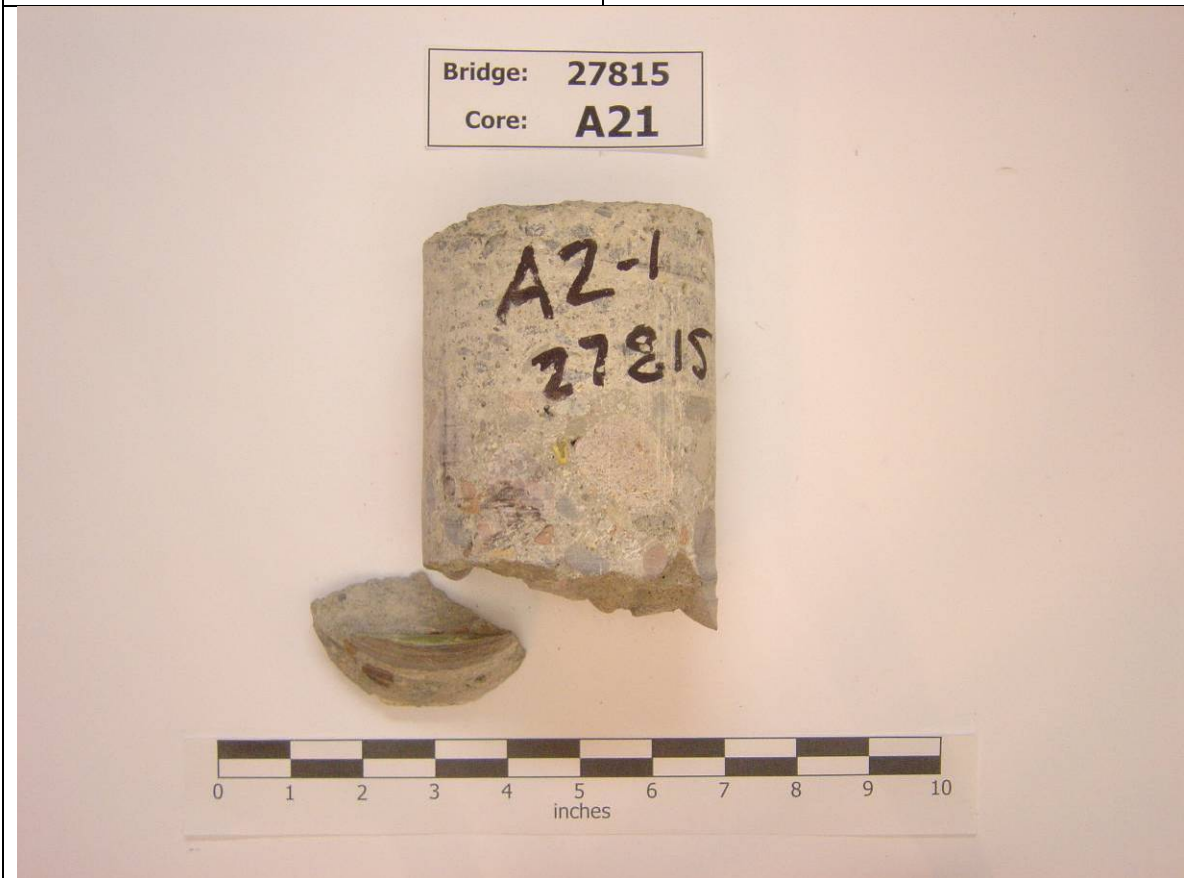
Core: A2-1

| Cracks:<br><b>Observed</b> | Corroded Bar:<br><b>No</b> | Delamination:<br><b>Yes</b> | Core diameter:<br><b>4"</b> |

- Delamination crack at bar level
- The chain drag survey indicated no signs of delamination at this location
- Half cell potential readings was not measured at this location
- Bar shows no evidence of corrosion

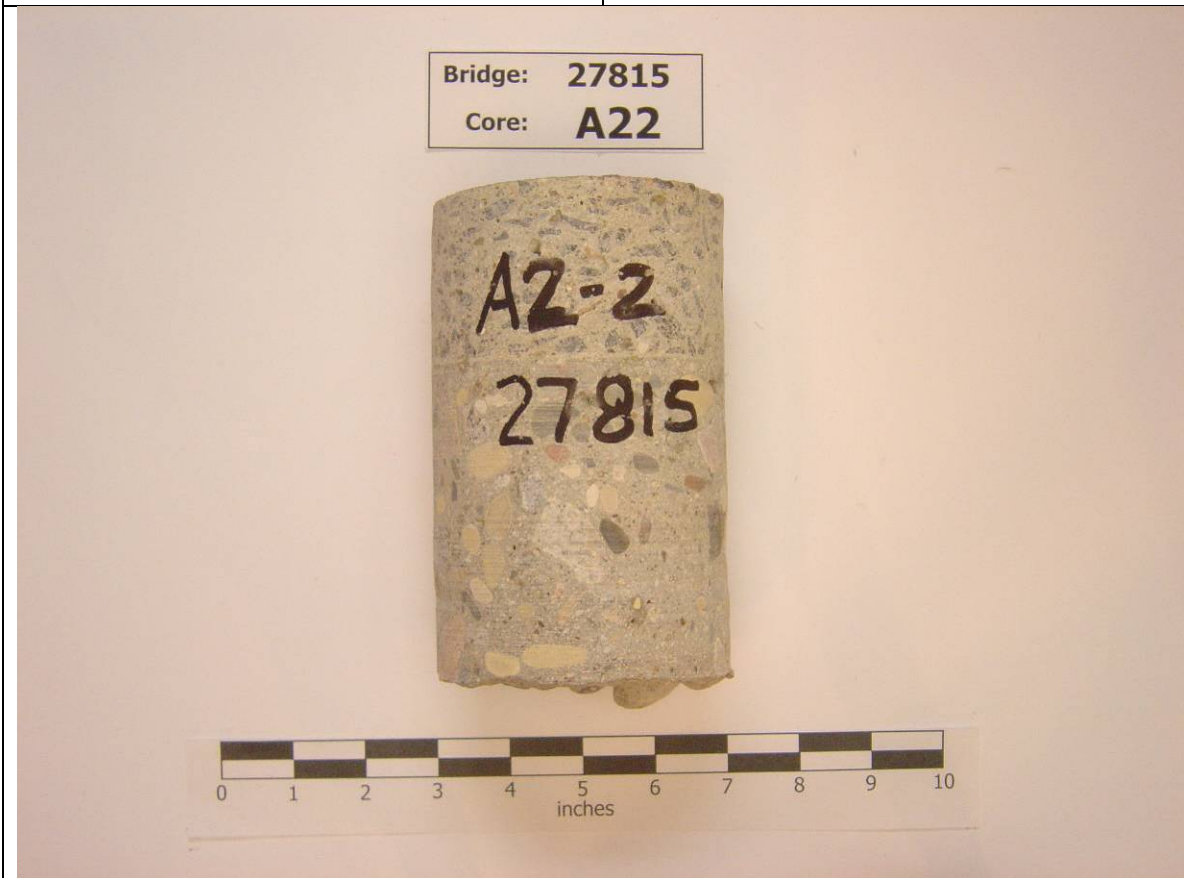
Core: A2-2

| Cracks:<br><b>None observed</b> | Corroded Bar:<br><b>No</b> | Delamination:<br><b>None</b> | Core diameter:<br><b>4"</b> |

- The chain drag survey indicated delamination area close to this location
- Half cell potential readings was not measured at this location
- Bar shows no evidence of corrosion
