# Predicting the Occurrence of Bumps in Overlays

Minnesota  
Department of  
Transportation

**August 2010**

Research Project  
Final Report 2010-31

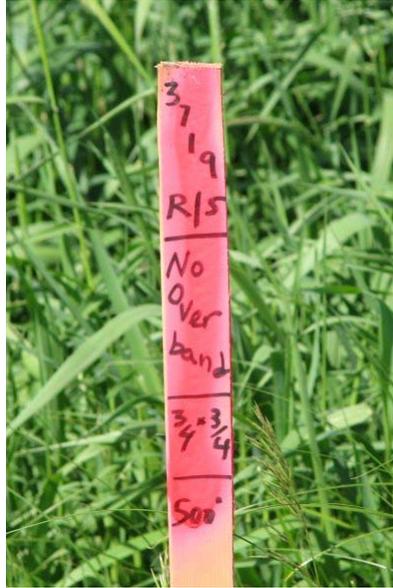
*Figure 5. Stake Marking Segment Beginning.*

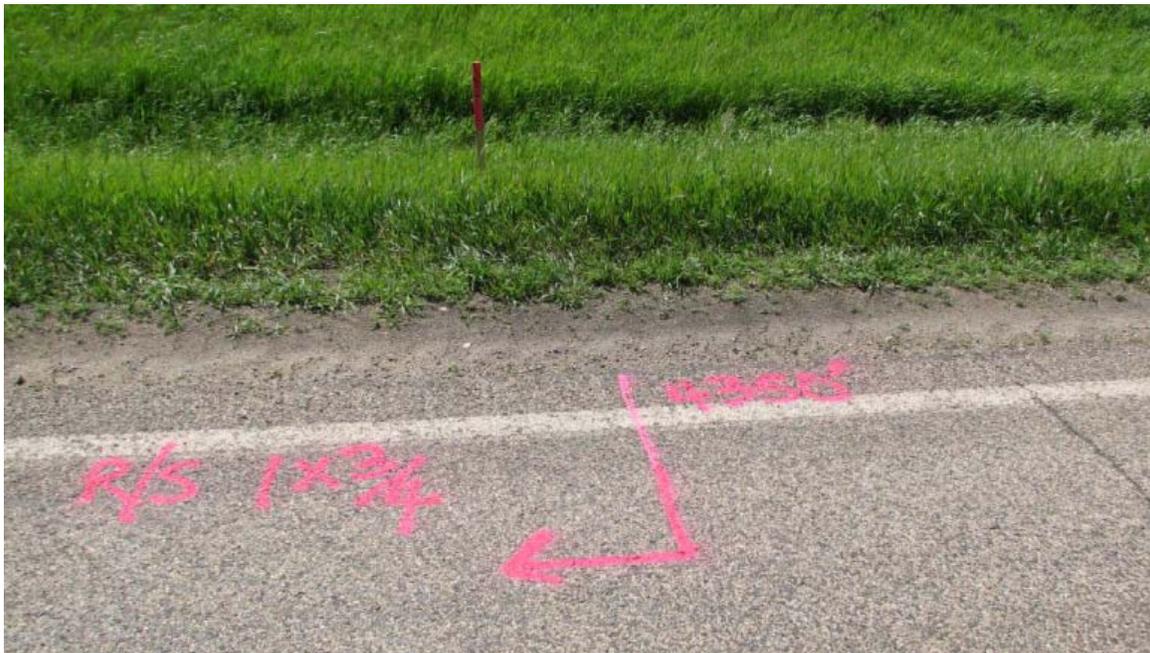
*Figure 6. Segment Markings on Roadway.*

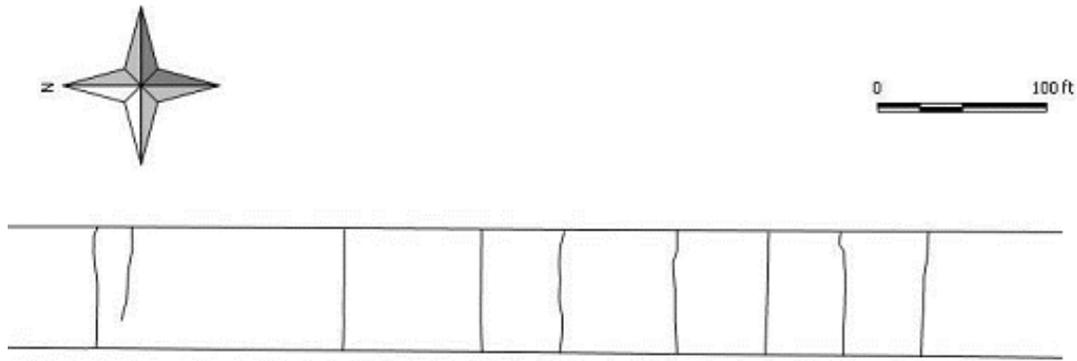
The location of individual cracks within each of the 19 segments was measured in two ways – a rough location by rolling measuring wheel and a precise location by high-resolution GPS. The precise crack survey, including the path of meandering cracks, was performed by the Jackson County Highway Department's GPS crew. A sample of the results of the precise crack location survey is shown in Figure 7.

Figure 7. Sample of GPS-Based Crack Survey on Jackson County CSAH 5.

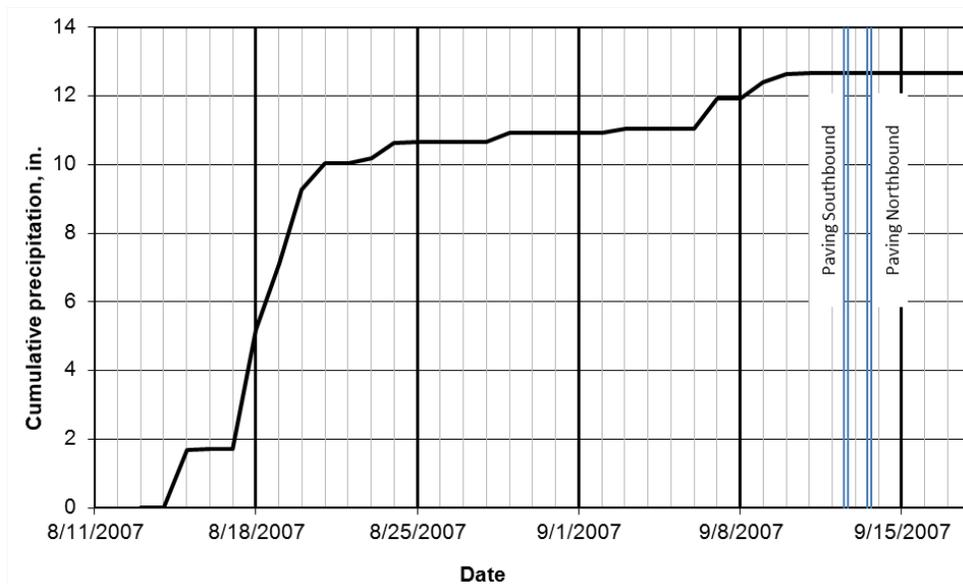
Since the presence of moisture has often been cited as a potential cause of bumps in overlays, the precipitation in the area of the test sites was obtained from the National Weather Service, for a period of 30 days prior to the construction. In just the seven days prior to paving, there was an accumulation of 1.6 inch of precipitation. This information is summarized in Figure 8.

Figure 8. Sealant Site, 30-Day Cumulative Precipitation.

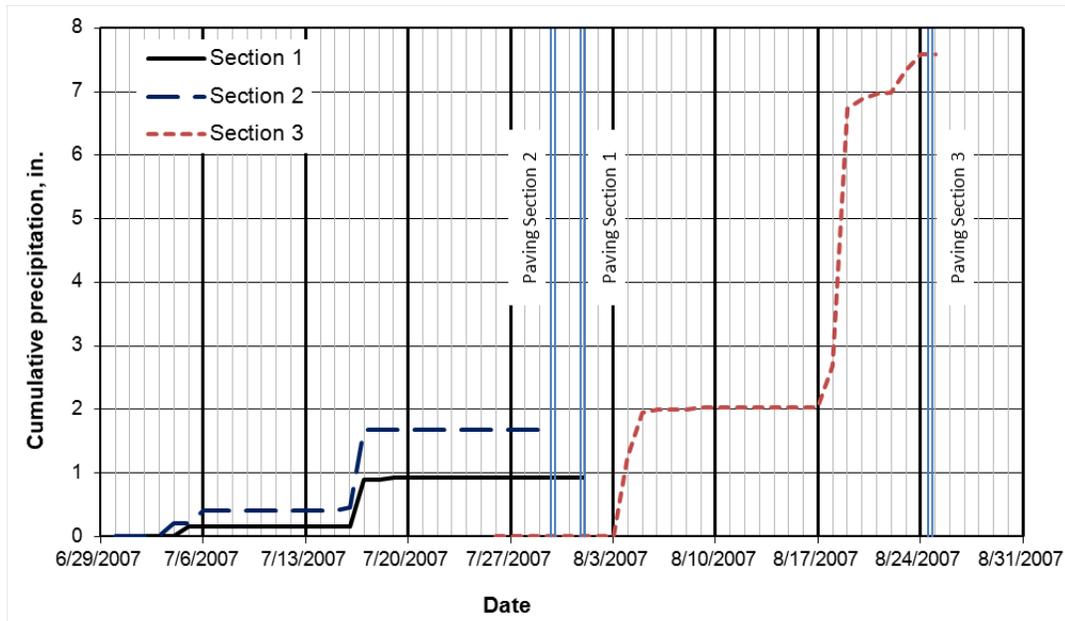
As with the sealant site, a graph of cumulative precipitation occurring during the 30 days leading up to paving on the methods site was developed. Dry conditions prevailed in the weeks leading up to paving of the Sections 1 and 2. In the seven days prior to paving Section 3 there was an

accumulation of 0.9 inch of precipitation with one day of drying weather. This information is summarized in Figure 10.

Figure 10. Precipitation Cumulative from 30 Days Prior to Paving.

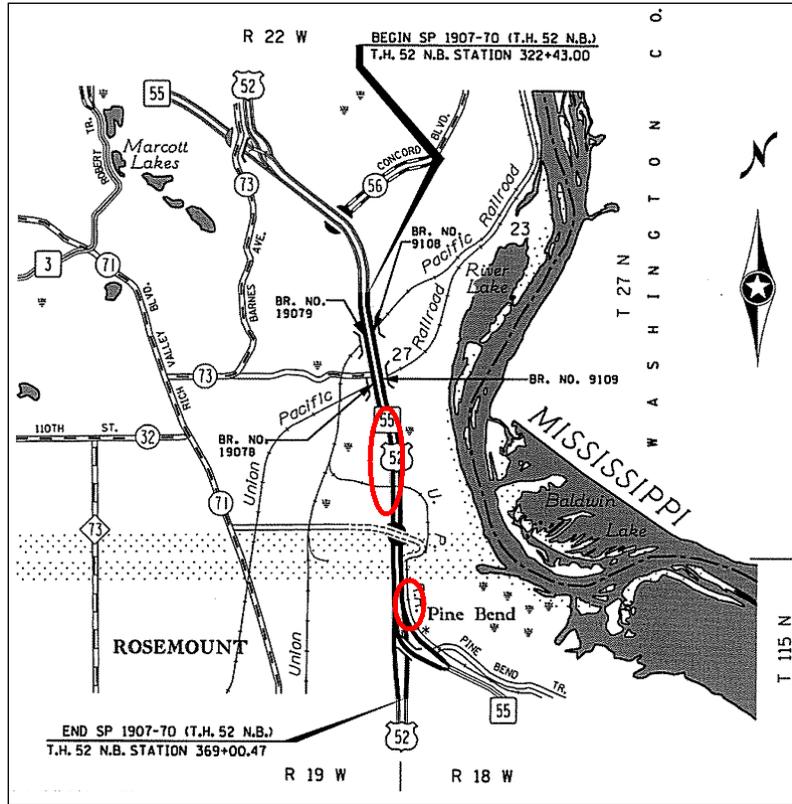
Construction began on US Highway 52 near Rosemount, MN in April, 2010. The design called for two 2-inch lifts of HMA over concrete. Observations were made on US 52 after bumps were reported to develop in the lower lift. Additional visits were also performed by personnel from the Mn/DOT Metro District and Bituminous Office. Figure 20 shows the project limits and the location of the field observations.

Figure 20. Bumps Observation Sites on US 52.

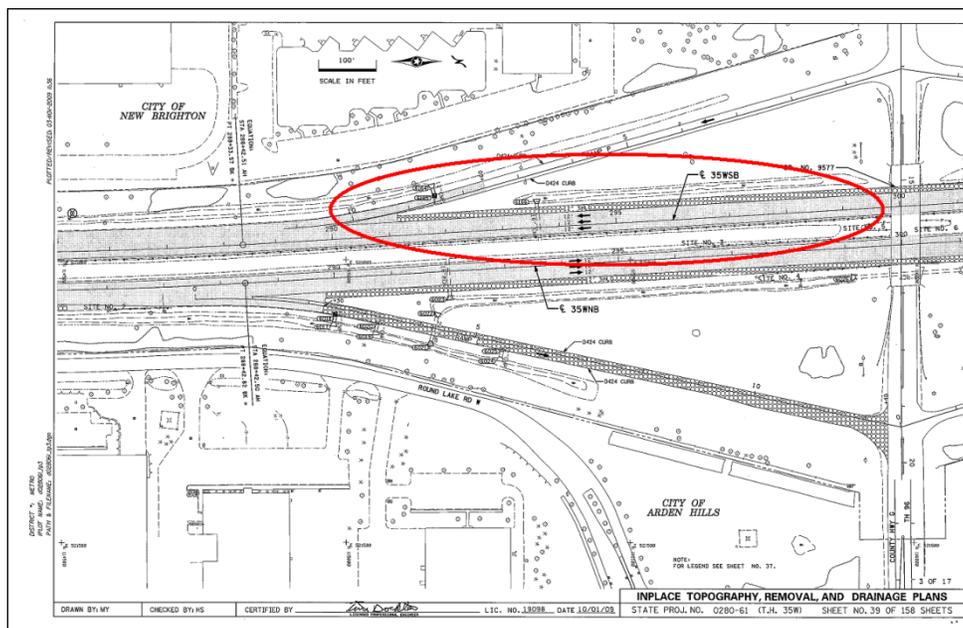
Construction began on I-35W near Arden Hills, MN in June 2010. The design called for removal of the existing 4-inch HMA down to the concrete surface followed by placing two 2-inch lifts of HMA. Observations were made on I-35W after bumps were reported to develop in the lower lift. Additional visits were also performed by personnel from the Mn/DOT Metro District and Bituminous Office. Figure 25 shows the location of the field observations, near mile 27.4 at the onramp from CSAH 96.

Figure 25. Roller Pattern Observation Site on I-35W.

Once the bump formations were detected on I-35W the paving contractor made alterations in the rolling patterns and choices of compaction equipment. The first seven configurations were unsuccessful in preventing the formation of bumps.

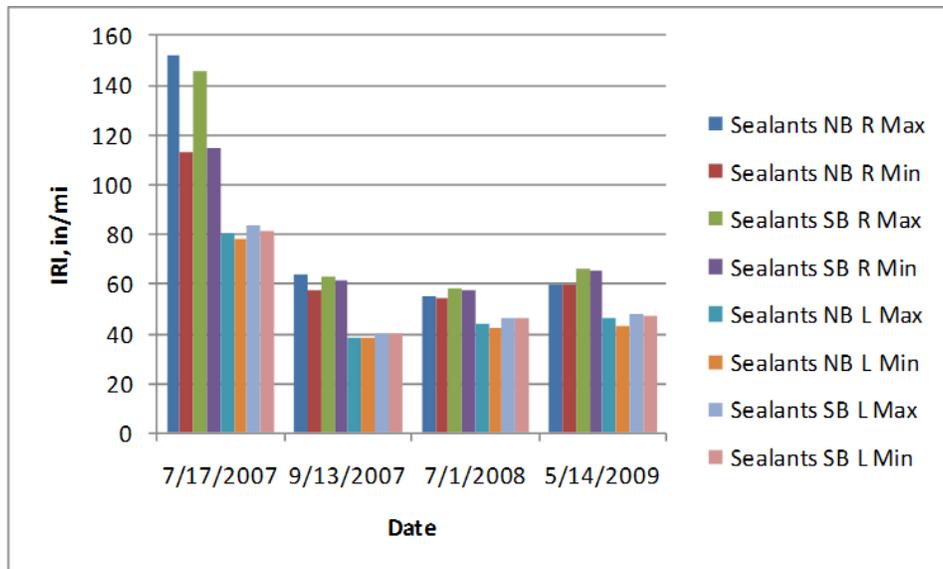
Figure 27 and Figure 28 compare the IRI collected over the full length of the site between July 2007 and May 2009. From the figures it is apparent that the IRI improves dramatically on all sections after construction of the HMA overlay. After one year it appears that the IRI of the right wheel paths may have improved slightly, perhaps due to the chip seal, while the left wheel paths show deterioration of at least 12 percent.

Figure 27. Smoothness Data for Sealant Site.

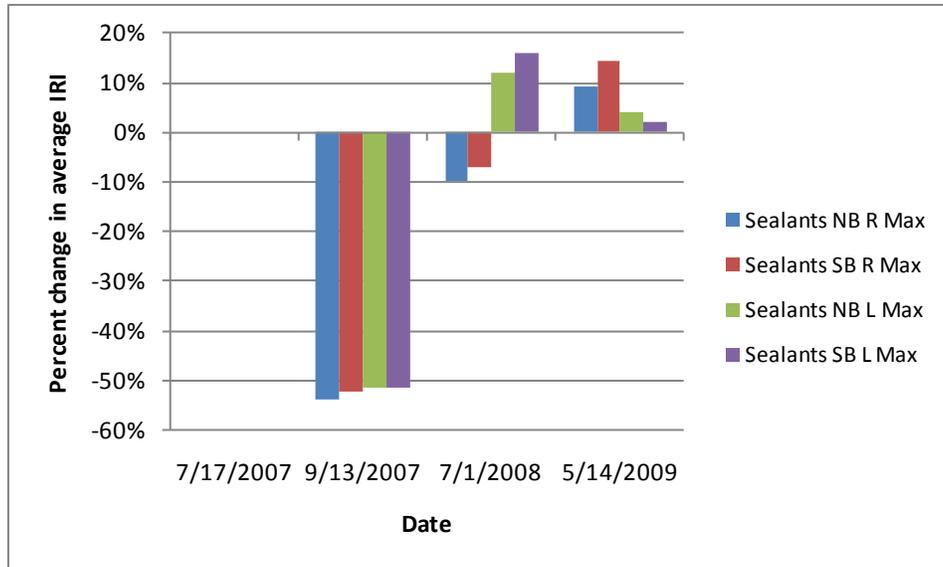
Figure 28. Percentage Change in Smoothness on Sealant Site.

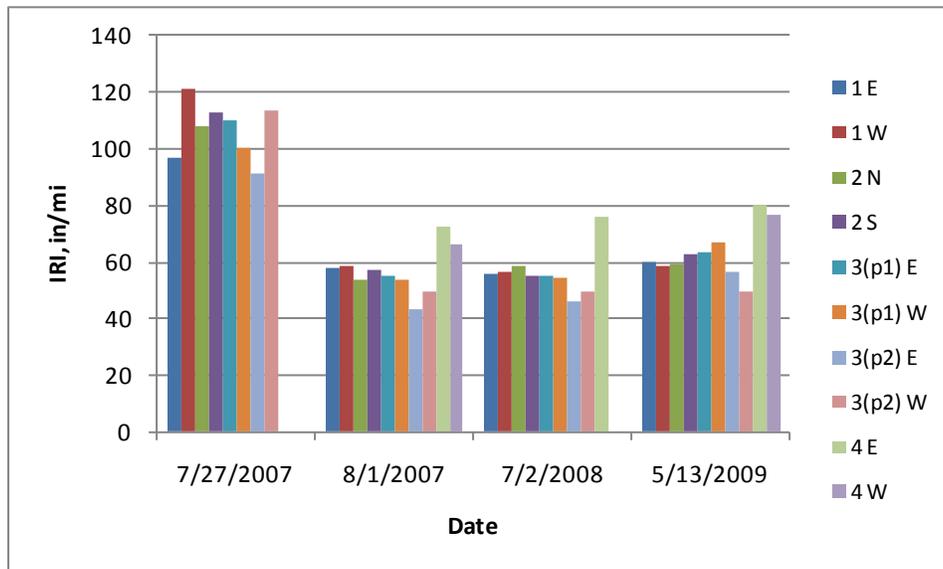
Figure 29 and Figure 30 compare the IRI collected over the full length of the construction materials sections between July 2007 and May 2009. From the figures it is apparent that the IRI improves dramatically on all sections after construction of the HMA overlay, as would be expected. These sections received maintenance crack filling, without routing, after the first winter of service. Collection of profile data occurred after crack filling.

Profile analysis results from 2008 were similar to the post-overlay condition in 2007. By 2009 the IRI of all sections showed deterioration, with an average increase in roughness of 10 percent.

Figure 29. Ride Condition Range for Methods Sites.

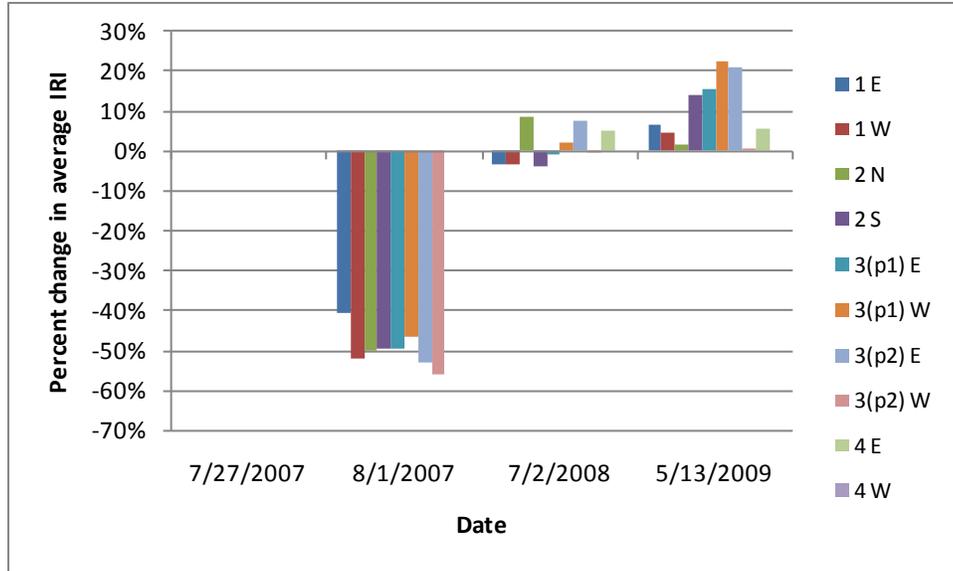
Figure 30. Percentage Change in Ride, Methods Sites.

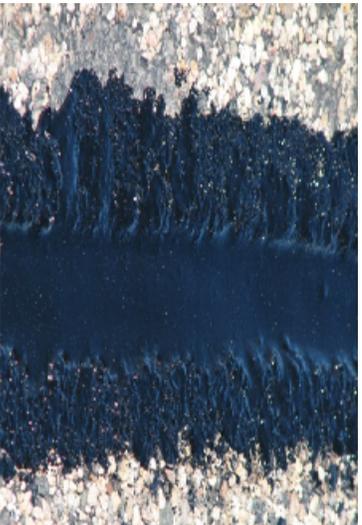
Wider and deeper routing operations can induce large volumes of sealant, essentially using more material than necessary, and increases the probability that bumps will form in a subsequent overlay.

### ▷ Minimize Sealant Reservoir Size
