Unmanned Aerial Vehicle Bridge Inspection Demonstration Project

Minnesota
Department of
Transportation

Barritt Lovelace, Principal Investigator
Collins Engineers, Inc.

Research Project
Final Report 2015-40

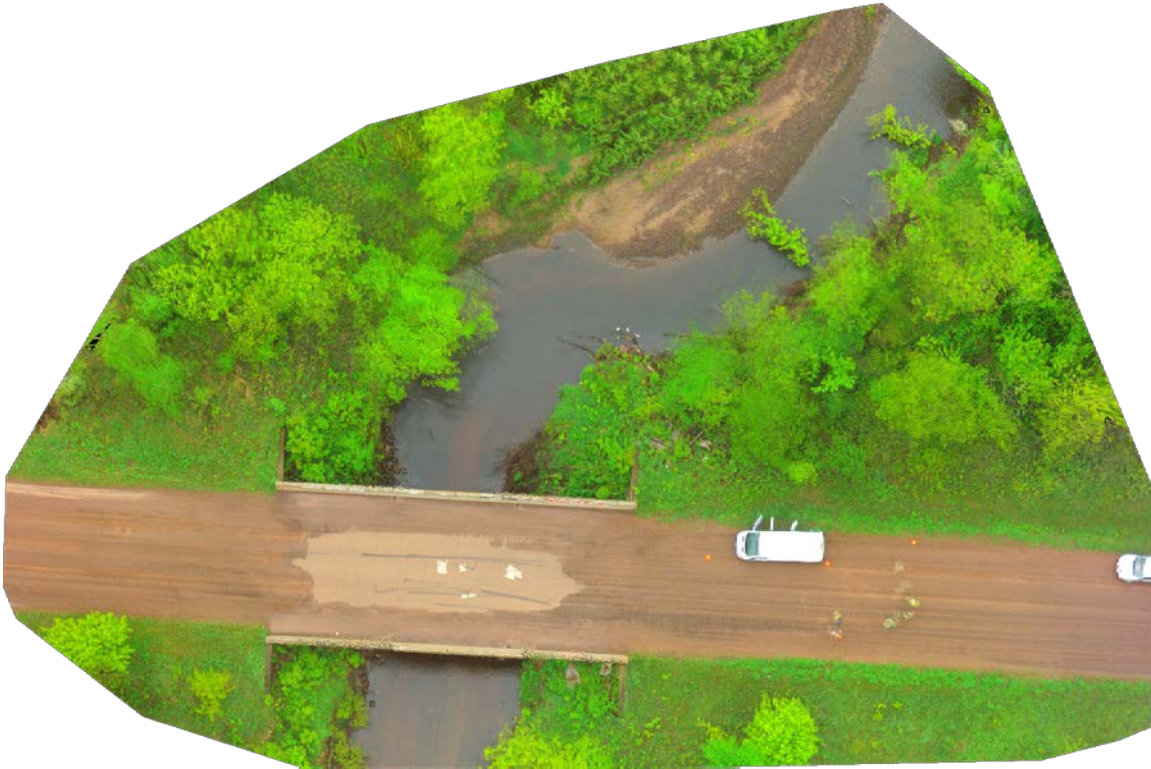
Figure 5-4 Bridge 13509 Orthographic Map.

Another highlight was the mapping function that was performed by the UAV of the immediate bridge area. The image below is a result of flying the site in a “lawn mower” pattern while taking overlying still photos and stitching a series of still photographs together using software. This flight was preprogrammed and flown autonomously.

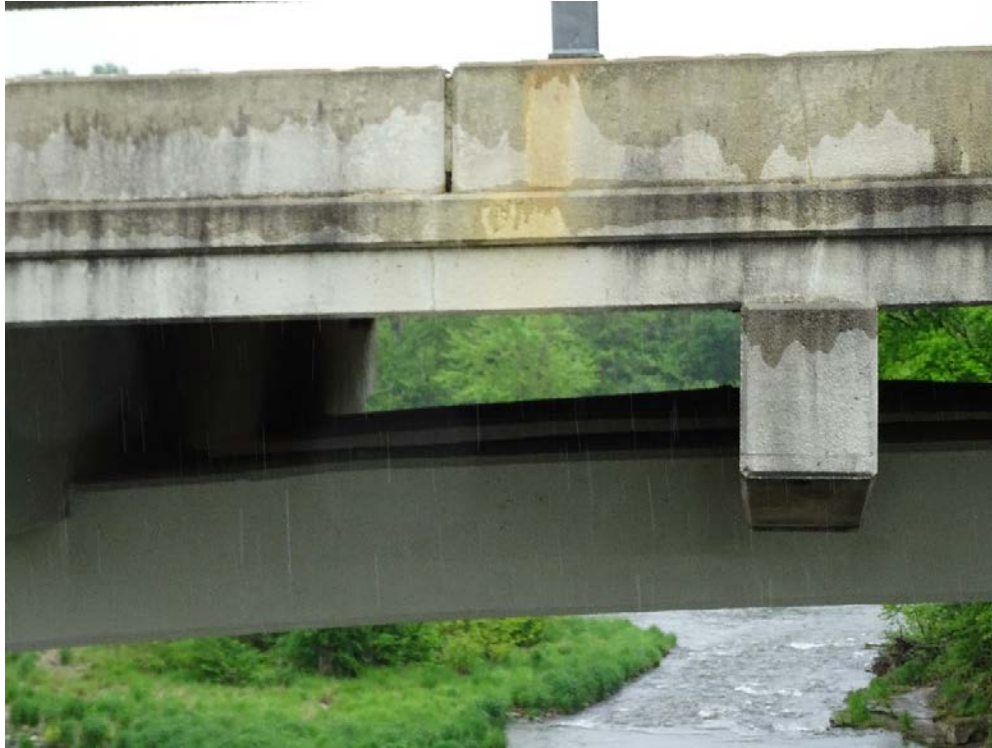
Figure 5-8 Photograph of Bridge 448 Detail Near Top of Arch.

The figures below show the level of detail obtained from the UAV for both a normal image and also an IR image.

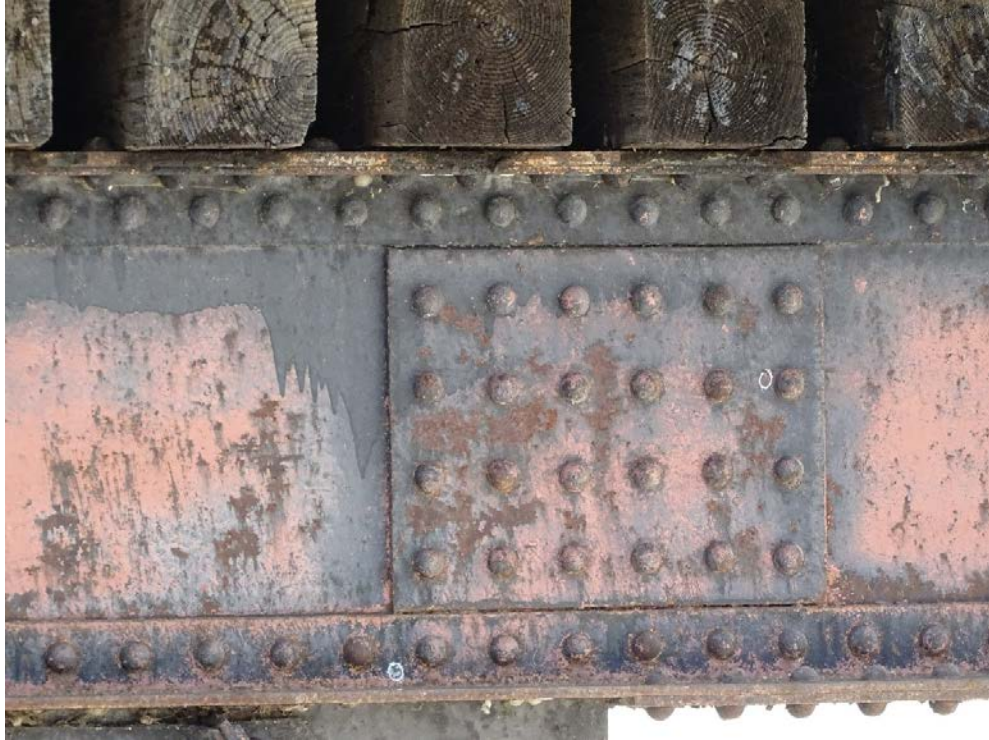
Figure 5-13 Photograph of Bridge 49553 Top Chord.

The figures below demonstrates the level of detail obtained from the UAV.

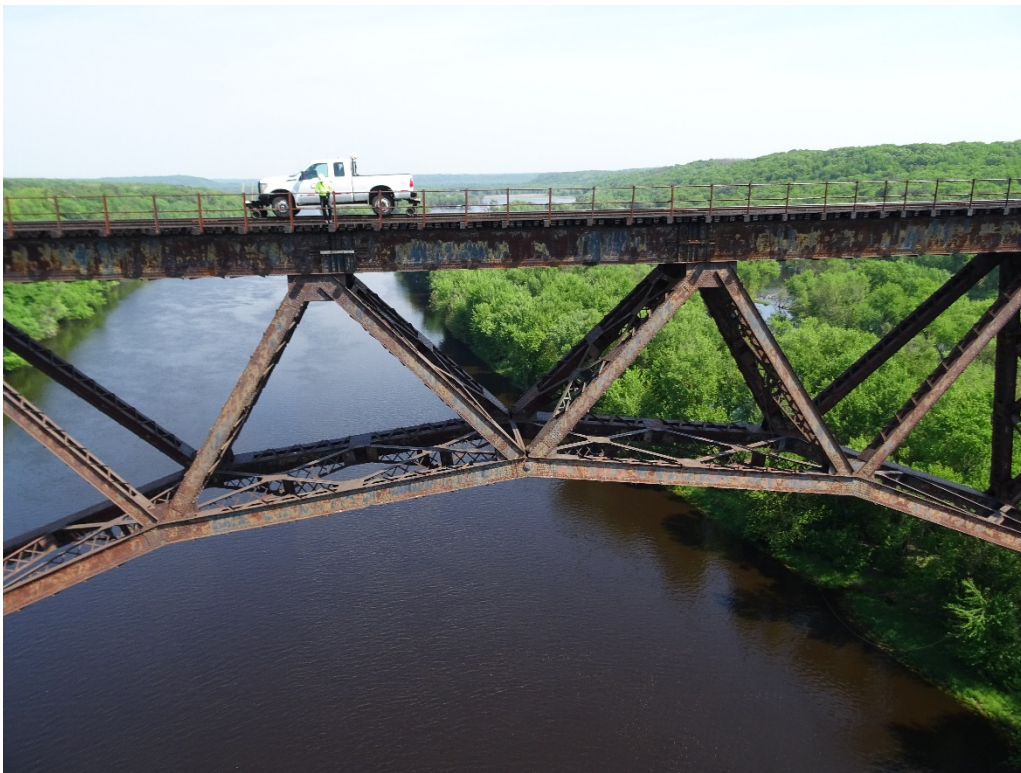
Figure 5-18 Photograph of Arcola Bridge Pin Detail Photo 1.

The figures below show the level of detail obtained from the UAV.

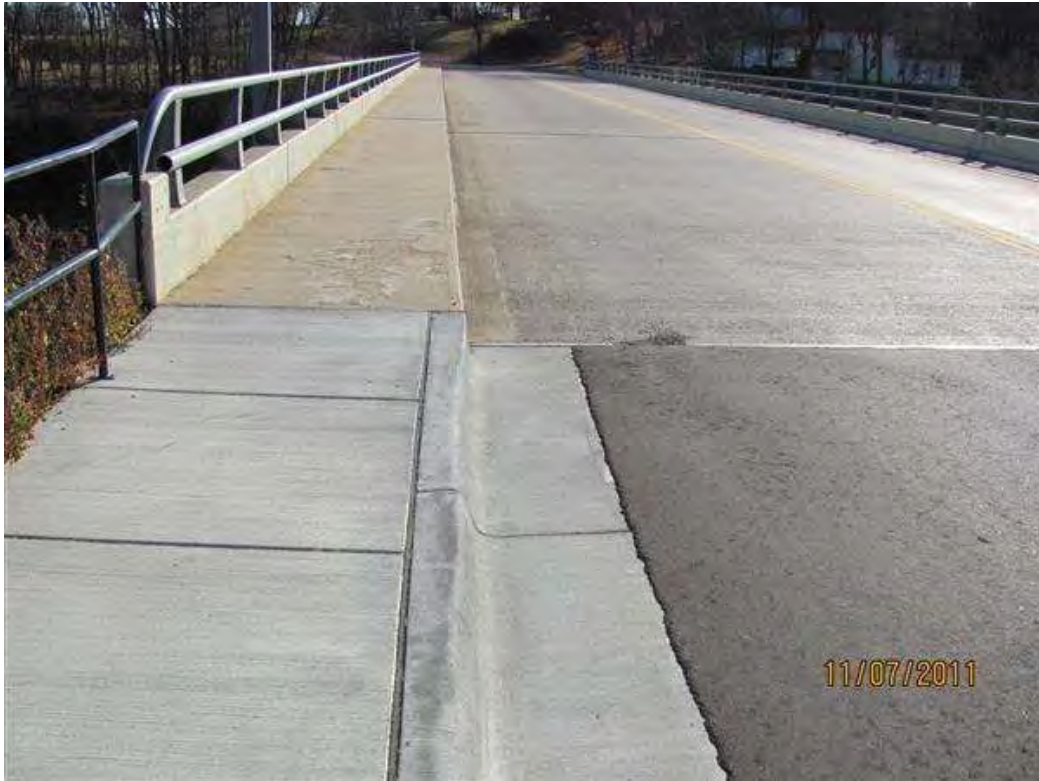
Photo 1 - New sidewalk and curbs at North abutment.

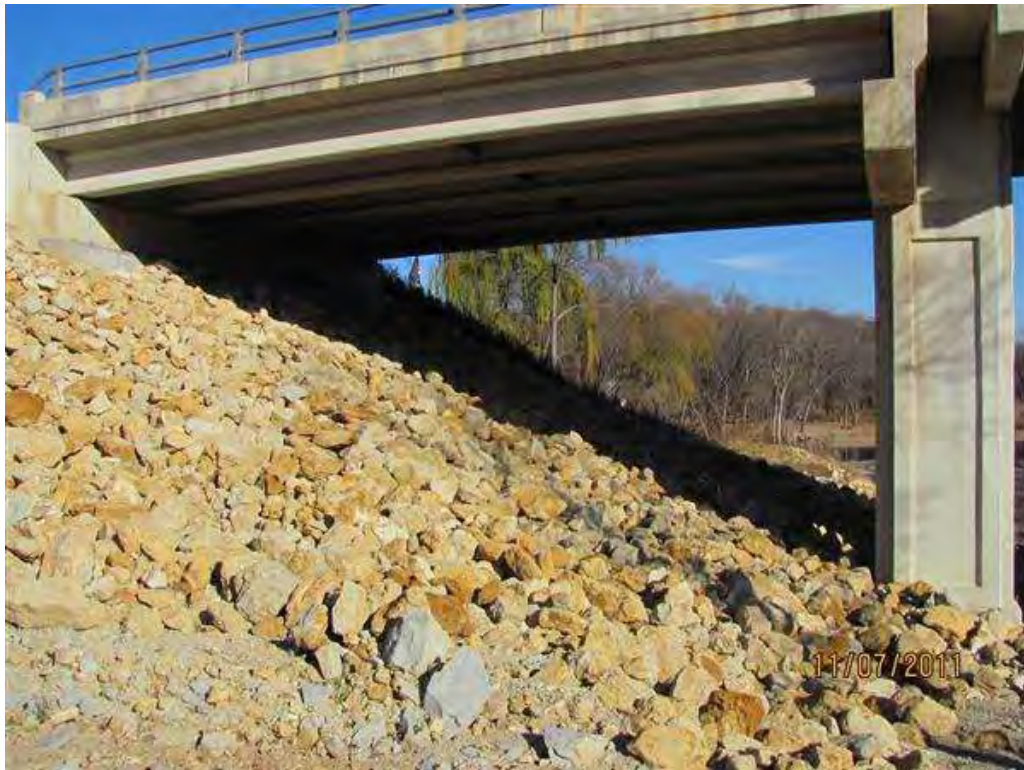
Photo 2 - New Rip rap at North abutment.

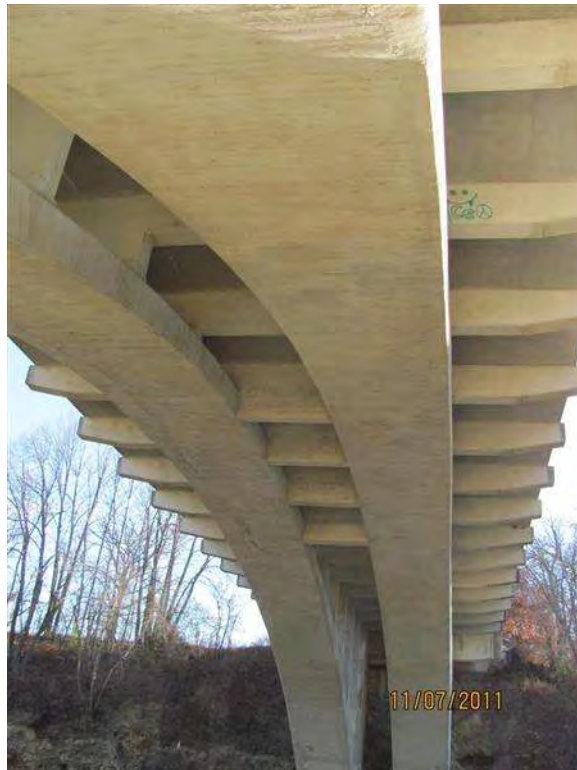
Photo 4 - Under side of archs

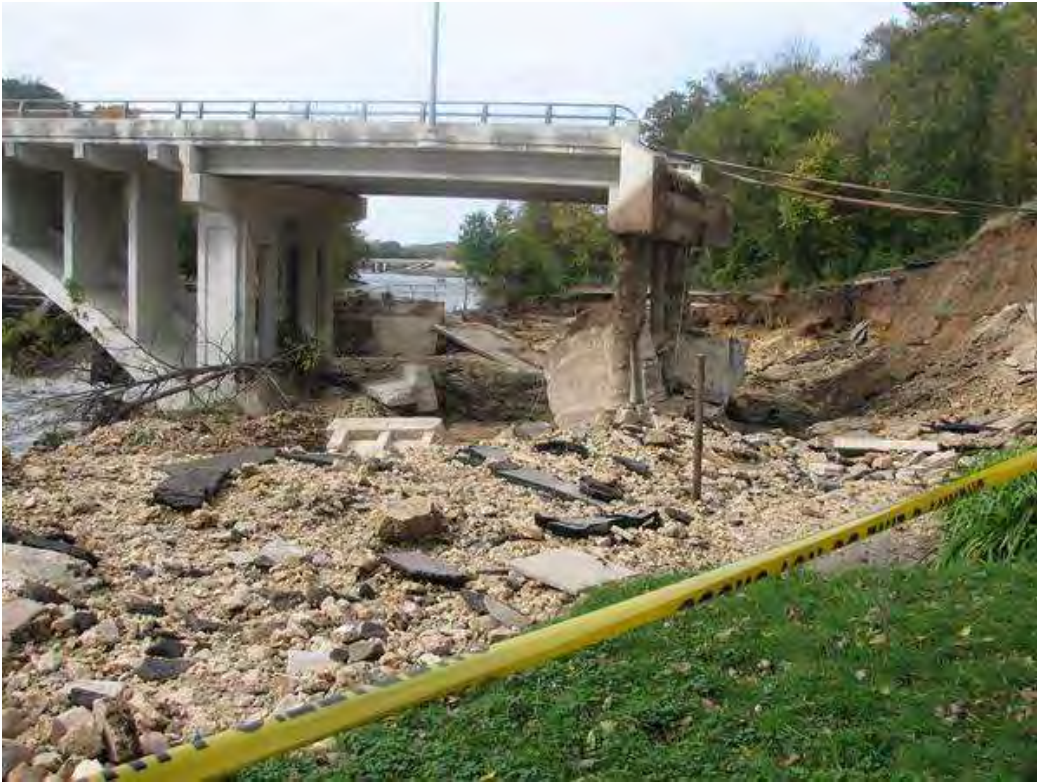
Photo 7 - 2010 Flood

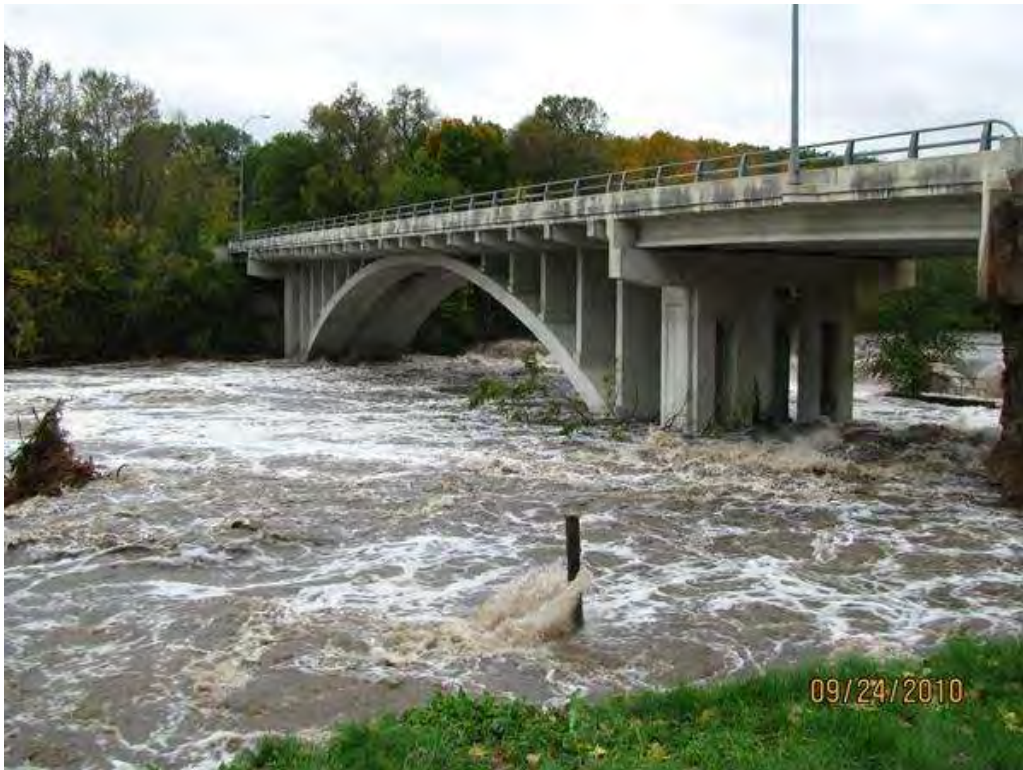
Photo 8 - 2010 Flood

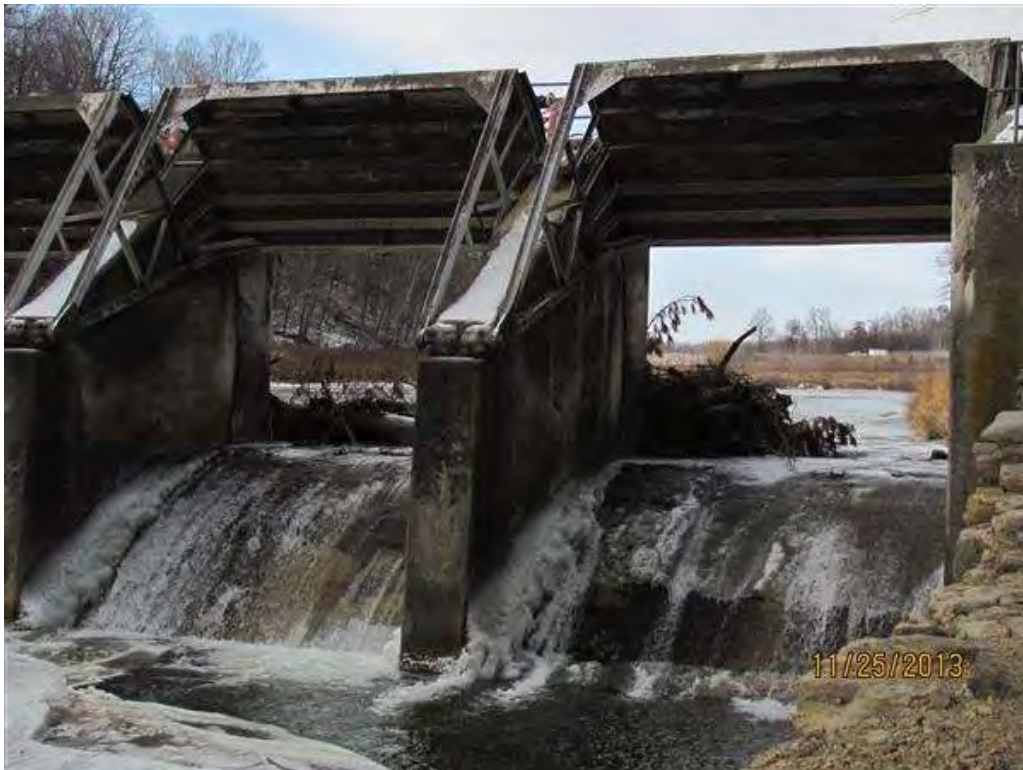
Photo 10 - Timber debris at dam.

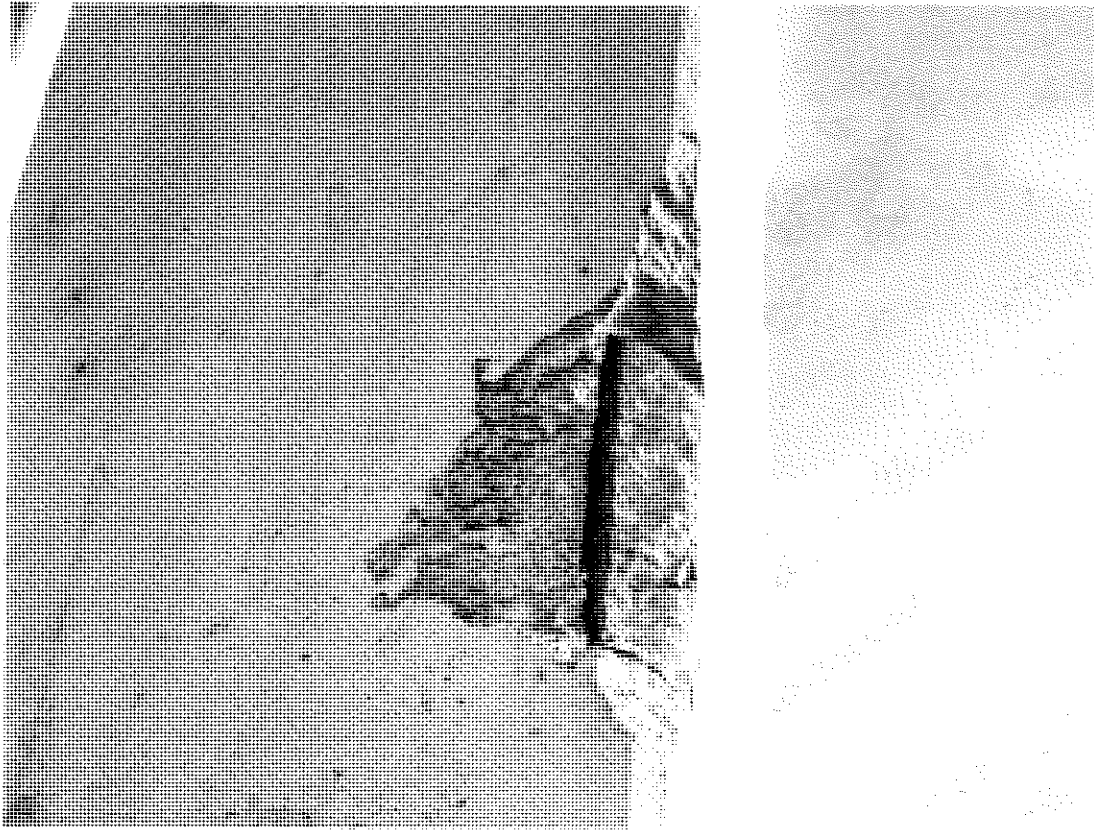
Column 2 southeast corner 15'8" up from the arch, there is a 3' long x 13" wide spall with exposed reinforcement (Photo 1). Southwest corner directly beneath the horizontal strut there is a 4' long x 11" wide spall with exposed reinforcement (Photo 2). Northwest corner 18'2" up from the arch, there is a 6' long x 22" wide spall with exposed reinforcement (Photo 3). Extending down from this spall is a vertical crack that is 38" long. Section loss to the exposed reinforcement at all of these spalls would be considered incidental at this time.

Photo 1 - East Arch Column 2 South End (54)

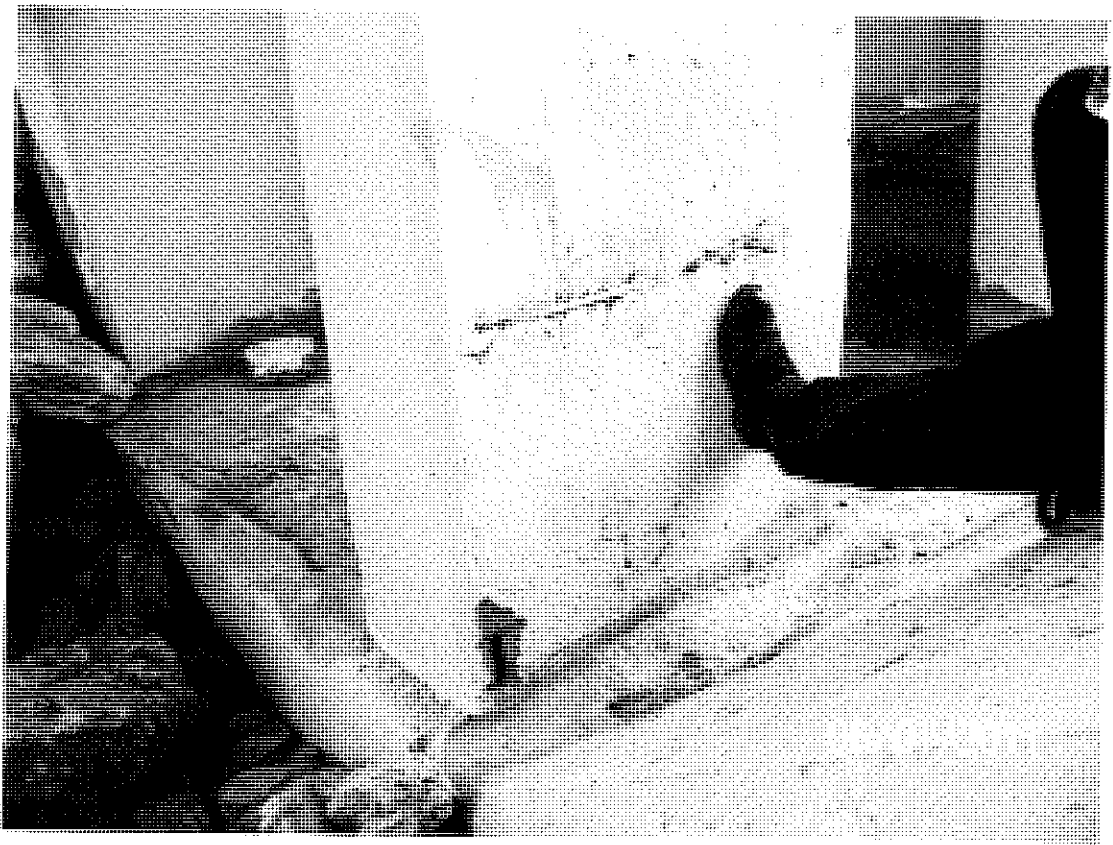
Column 1 south face of the column there is a horizontal spall with exposed reinforcement 24" up from the arch that is 24" long x 5" wide (Photo 4). Below the horizontal spall is a 3" x 6" vertical spall with exposed reinforcement (Photo 4). Directly below the horizontal strut southwest corner, there is a 6'2" long x 21" wide spall with exposed reinforcement (Photo 5). There are four additional horizontal spalls with exposed reinforcement on the south face of the column. The top spall is 2' x 2' in size, the next spall down is 15" x 5", the third spall is 13" x 5" and the fourth is 13" x 6" (Photo 5). On the southeast corner there is a 3'3" x 18" spall with exposed reinforcement 9'6" up from the arch (Photos 6 & 7). Section loss to the exposed reinforcement at all of these spalls would be considered incidental at this time.

Photo 4 - East Arch Column 1 North End

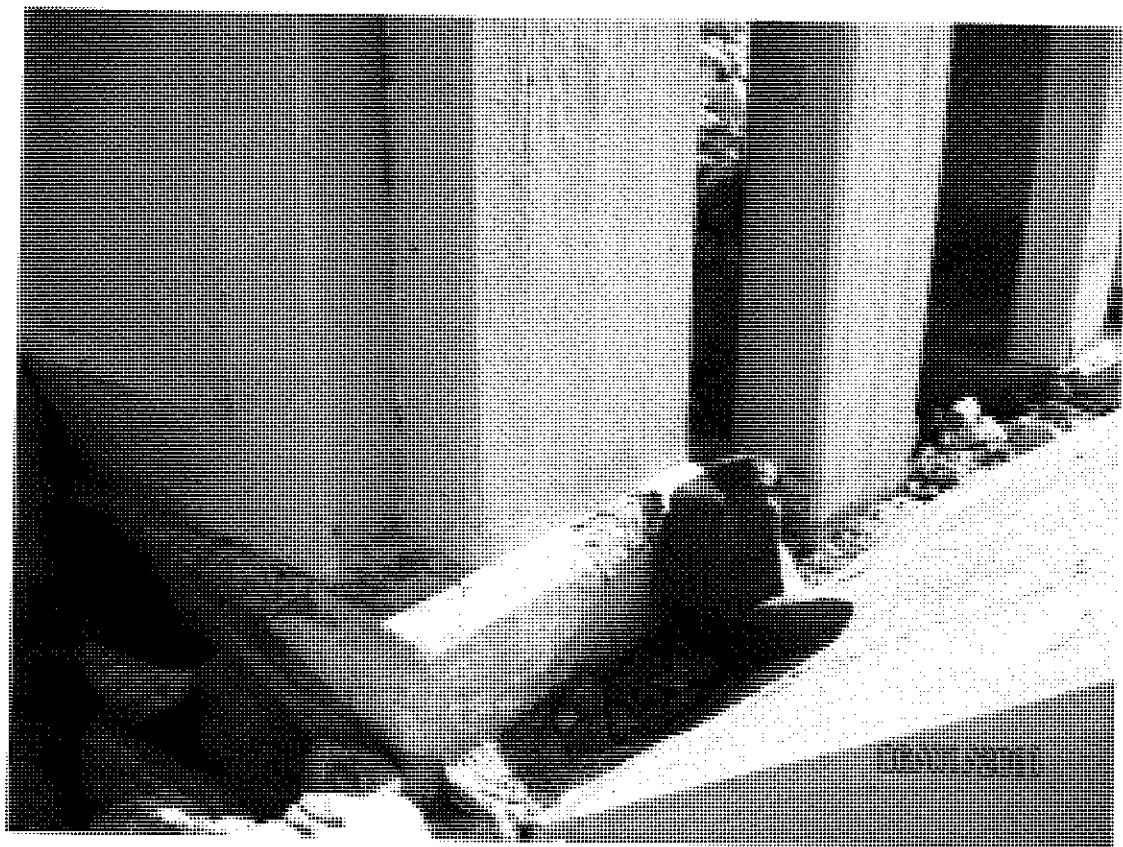
Column 1 at the bottom south side there is a 17" long x 10" wide x 4" deep spall (Photos 8 & 21). The entire south face of the column is cracked and has scattered delaminated areas. On the north side of the same column there is an 8" x 3" spall with exposed reinforcement.

Photo 8 - West Arch Column 1 North End

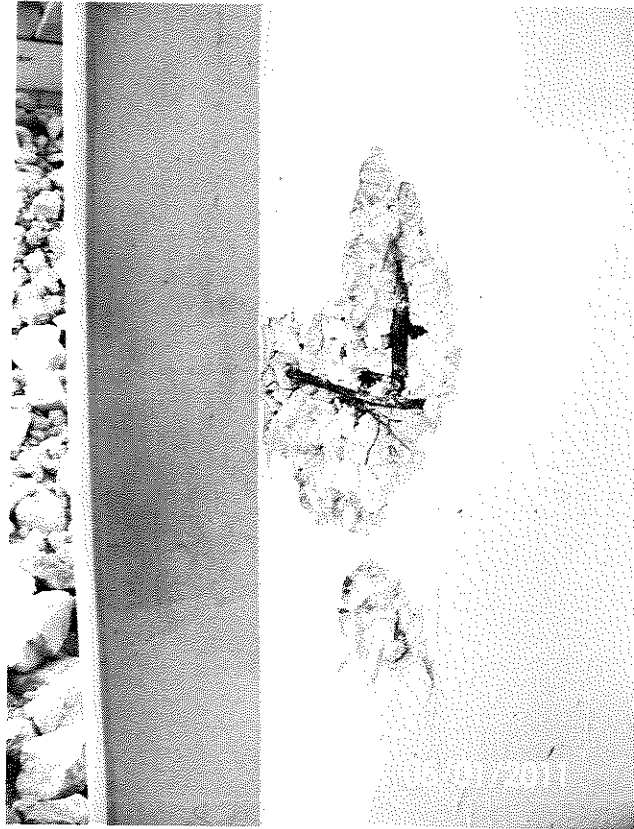
Column 3 has a 30" x 20" spall with exposed reinforcement along the southeast edge 10'6" up from the bottom of the column (Photo 9). There is a 50" x 16" spall with exposed reinforcement in the south face of the column directly below the horizontal strut (Photos 10 & 11).

Photo 9 - West Arch Column 3 North End

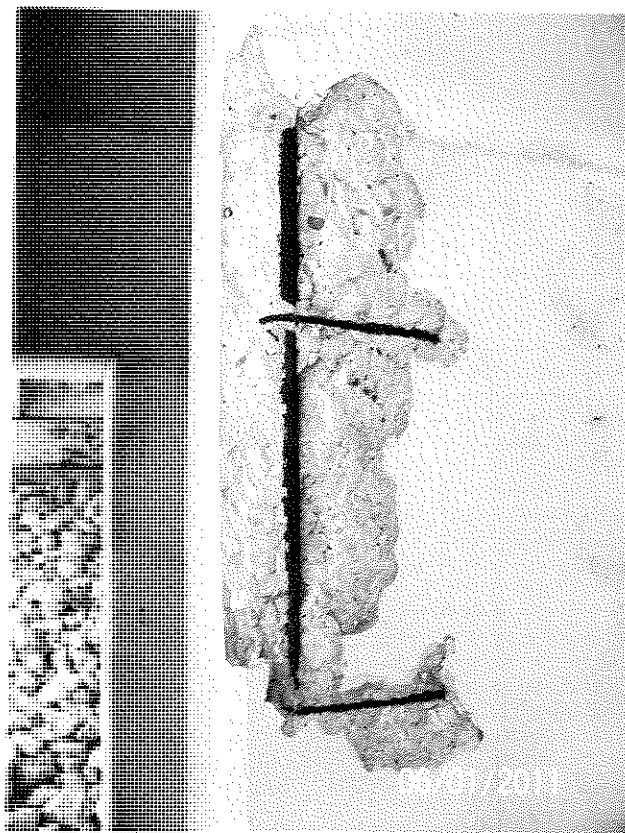
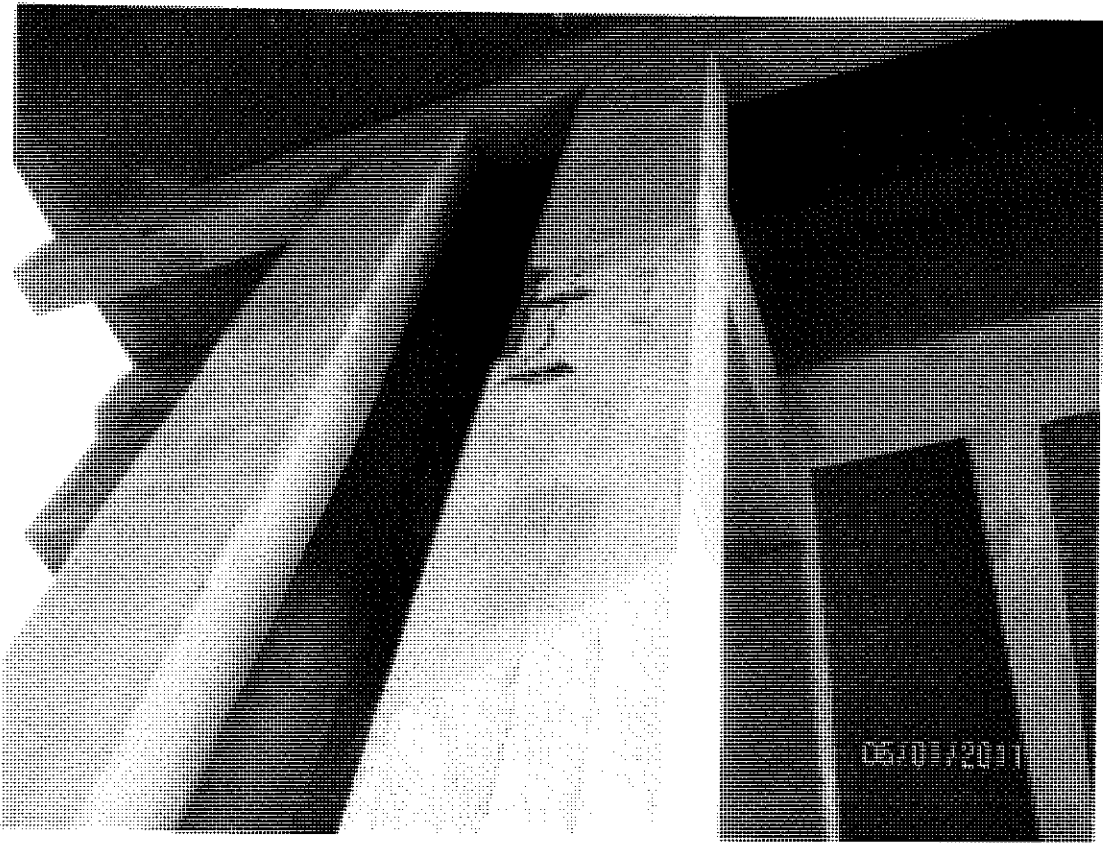
Photo 10 - West Arch Column 3 North End

Photo 11 - West Arch Column 3 North End

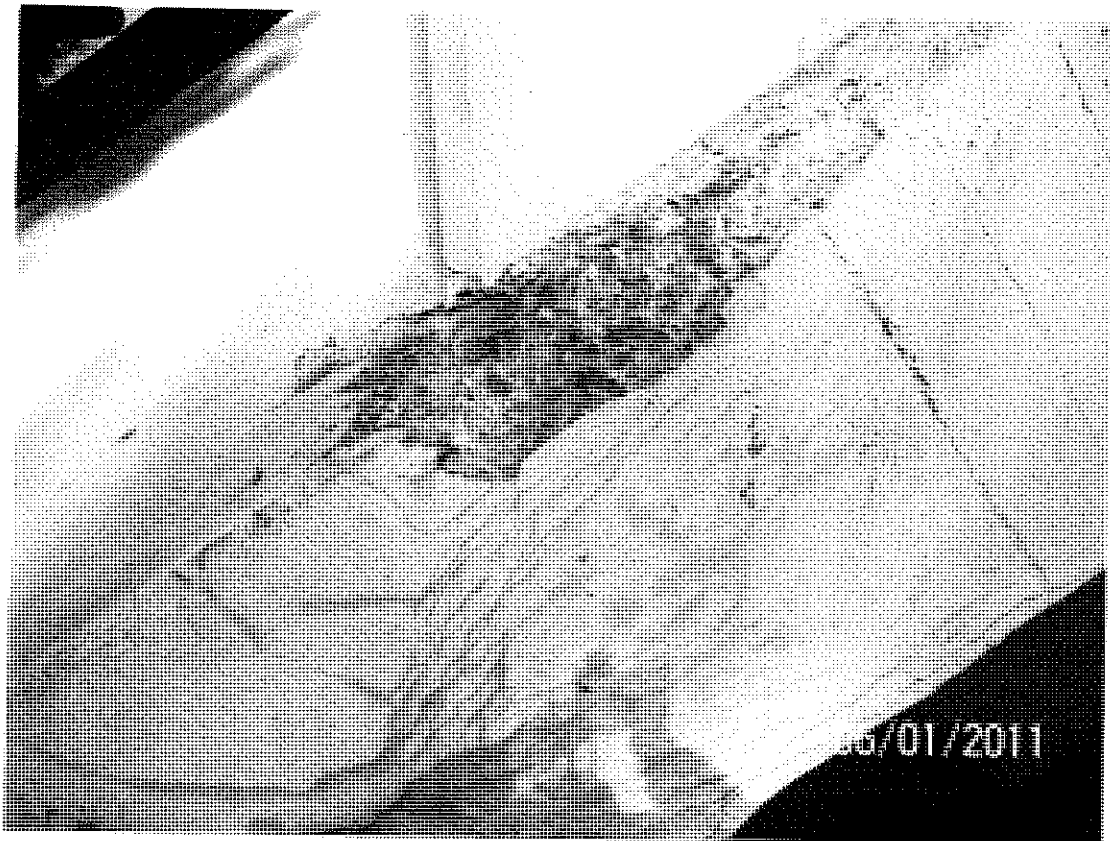
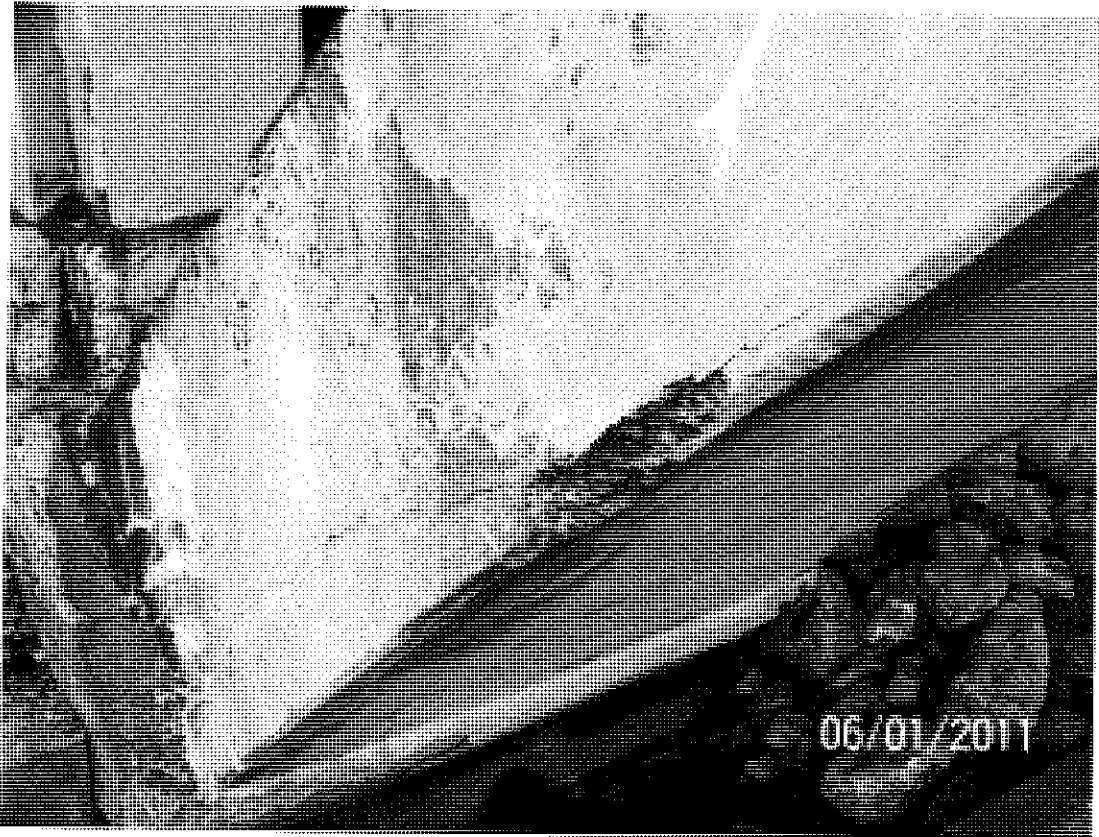
There is cracked and delaminated concrete starting at the bottom of the arch extending to spandrel column 2 (Photos 13, 14, & 15). There is an 8" x 20" spall with no exposed reinforcement 58" up from the bottom of the arch top edge (Photo 13). Around this spall there is a large area of cracked and delaminated concrete. Directly beneath spandrel column 2, there is a 12" x 28" spall with no exposed reinforcement (Photo 14). Directly beneath spandrel column 1 bottom edge, there is a 6" x 30" spall with no exposed reinforcement (Photo 15). There is cracked and delaminated concrete around this spall. On the top edge starting just north of spandrel column 3 and extending 8' towards spandrel column 2, there is cracked, delaminated and spalled concrete. Starting north of spandrel column 5 extending towards spandrel column 4 there is a 10'6" area of cracked and delaminated concrete along the top edge down to the middle of the arch. There are scattered vertical cracks that extend the entire thickness of the arch 7" deep as seen from the top of the arch. These cracks are located between spandrel columns 9 & 10, 10 & 11, 11 & 12, and 12 & 13. There is a 6" x 16" spall with no exposed reinforcement 4' north of spandrel column 13 (Photo 16). Starting south of spandrel column 16 extending to spandrel column 15 there is an area of horizontal and random cracking and scattered small delaminations (Photo 17). This cracking extends into the bottom face of the arch 2'6".

Photo 14 - East Arch South End @ Spandrel Column 2

Photo 15 - East Arch South End @ Spandrel Column 1

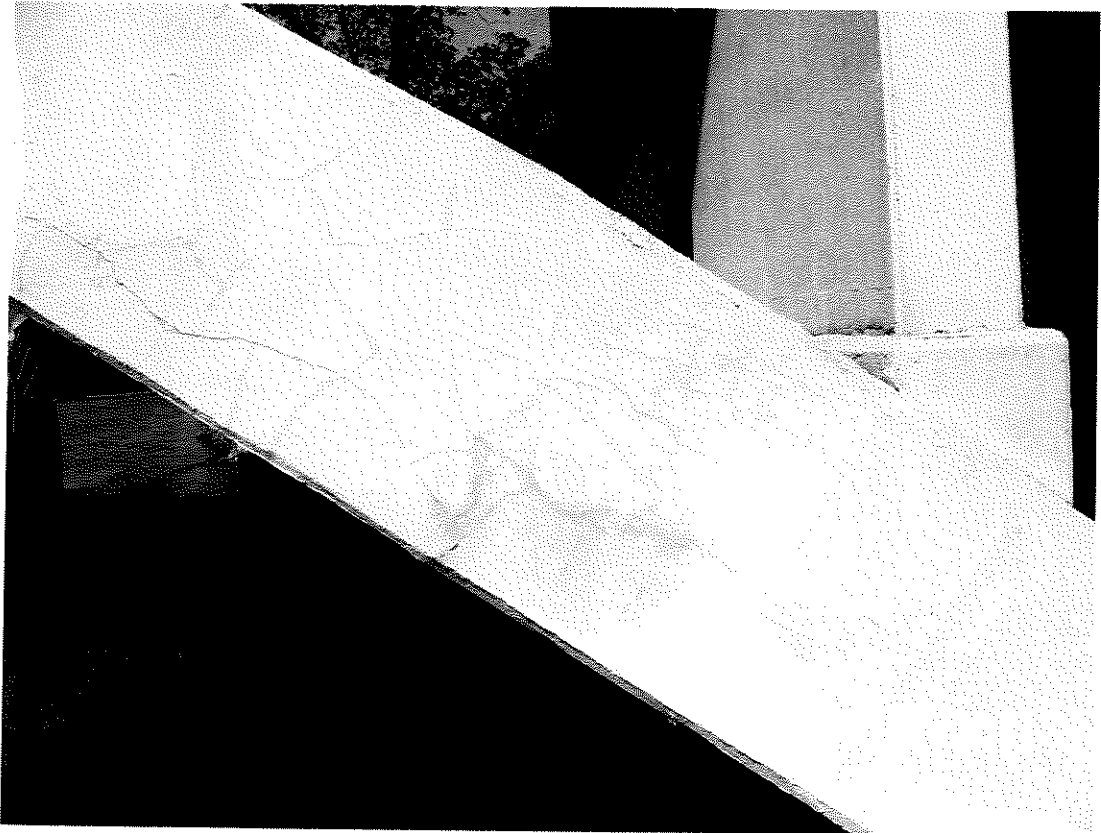
Photo 17 - East Arch Between Spandrel Columns 15 & 16

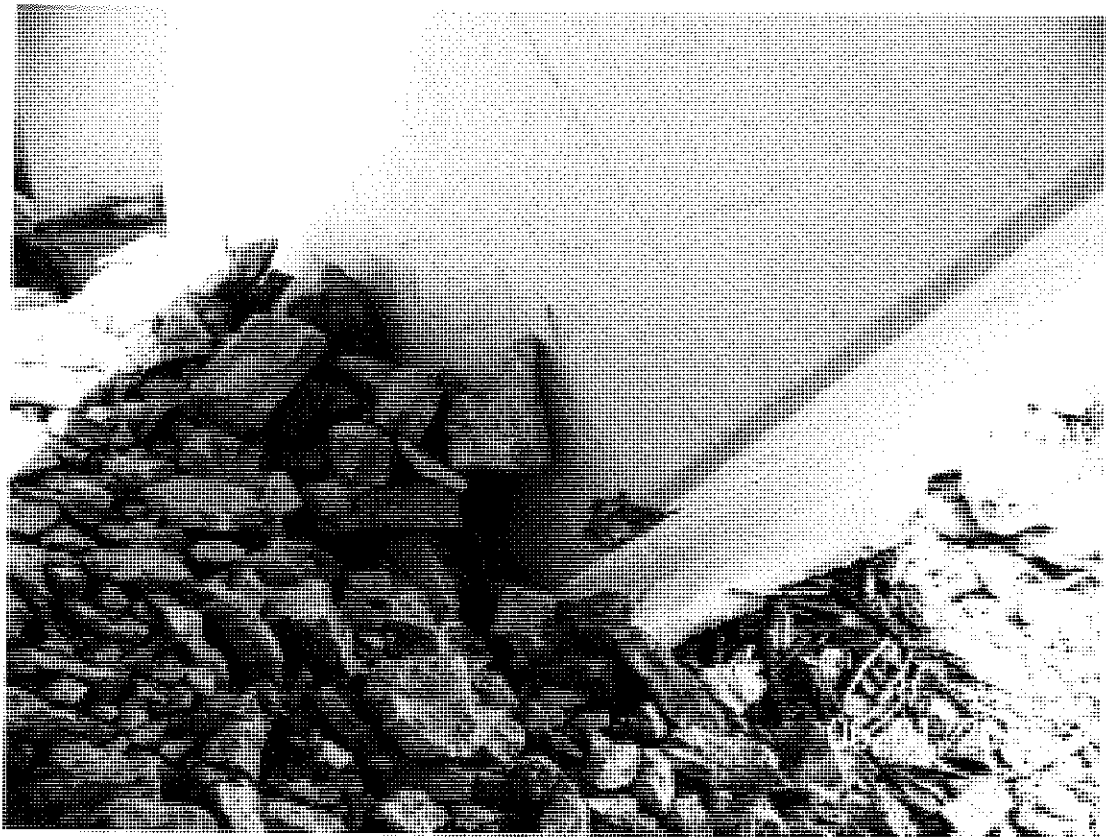
Starting from the north end of the arch 34" in from the west face, there is an 18'6" long longitudinal hairline crack. This crack starts and terminates as a horizontal crack. From the bottom north end there is an 8" long x 5" wide x 6" deep spall that extends up the west face (Photo 18). There was no exposed reinforcement in this spall. Starting from the

Photo 18 - East Arch North End West Face

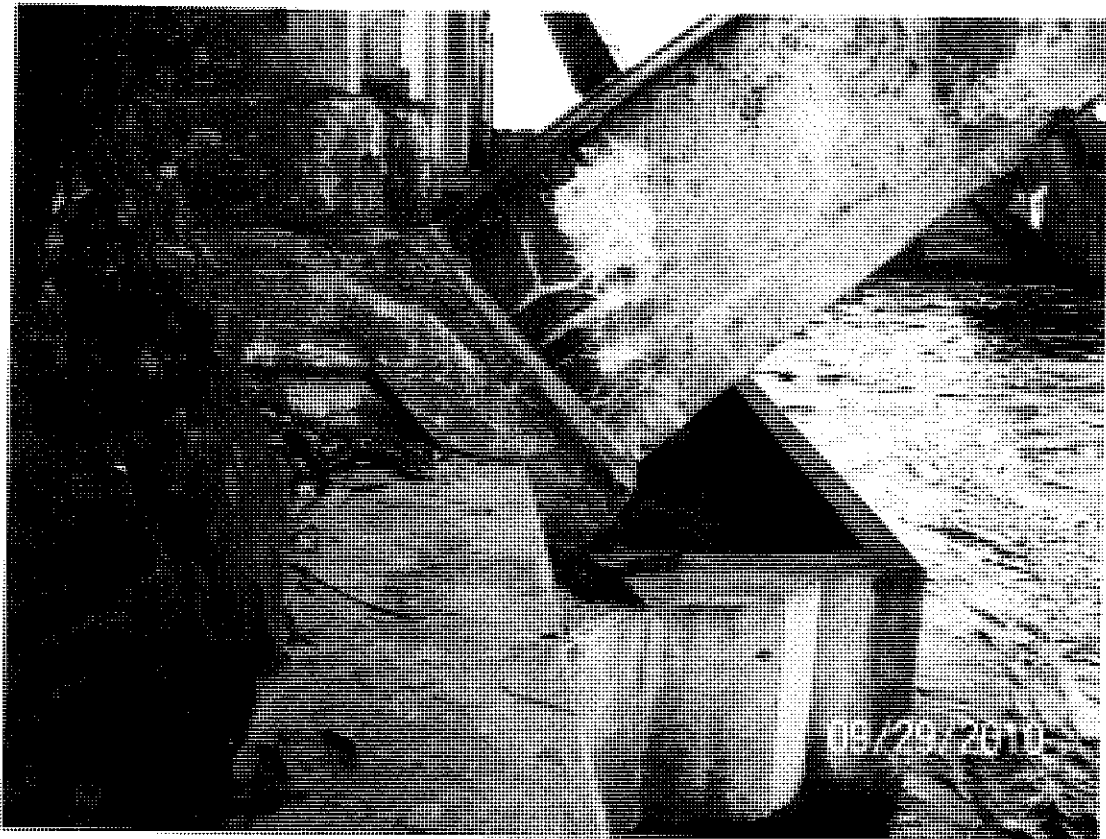
bottom south end of the arch 30" in from the east face extending up to spandrel column 3, there is an area of longitudinal and random cracking. This area corresponds to a repair patch completed in the past. The south end thrust block east side is cracked, spalled and delaminated (Photo 13 & 20).

Photo 20 - East Arch East Face @ Thrust Block

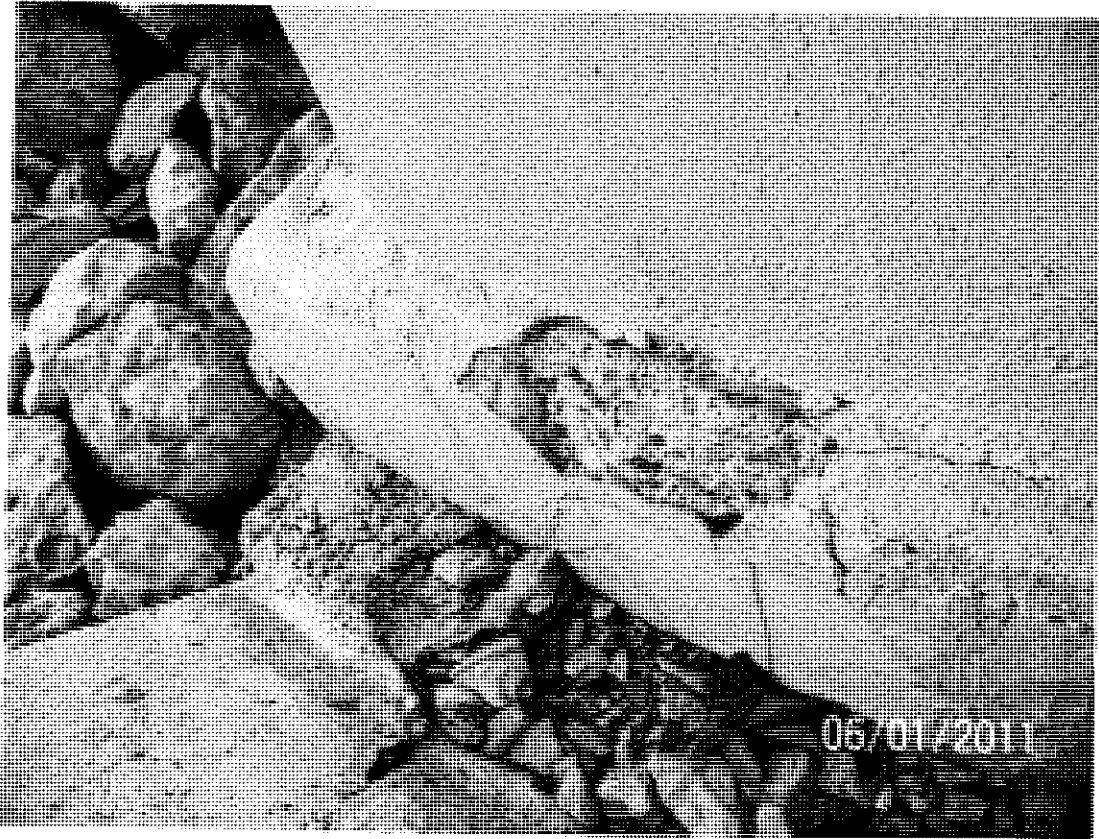
Photo 21 - West Arch North End South Side Column 1

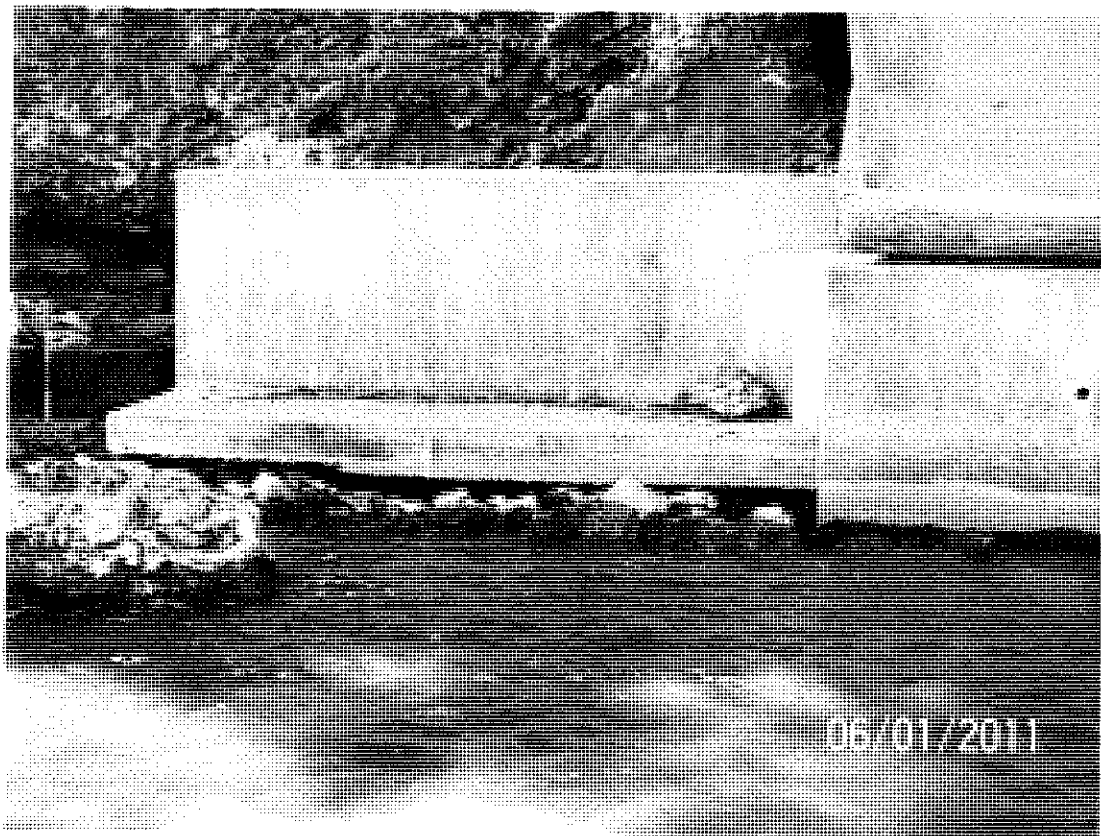
Photo 29 - North End Approach East Fascia Beam

North approach span east fascia beam bottom flange has a patched area on the east side of the beam 8' from the north abutment (Photo 29).
