Incorporation of Fatigue Detail Classification of Steel Bridges into the Minnesota Department of Transportation Database

1. Report No. MN/RC-2007-22	2.	3. Recipients Accession No.	
4. Title and Subtitle Incorporation of Fatigue Detail Classification of Steel Bridges into the Minnesota Department of Transportation Database		5. Report Date June 2007

7. Author(s) Adam Y. Lindberg Arturo E. Schultz		6.	
9. Performing Organization Name and Address University of Minnesota Department of Civil Engineering 500 Pillsbury Drive SE Minneapolis, MN 55455-0220		8. Performing Organization Report No.

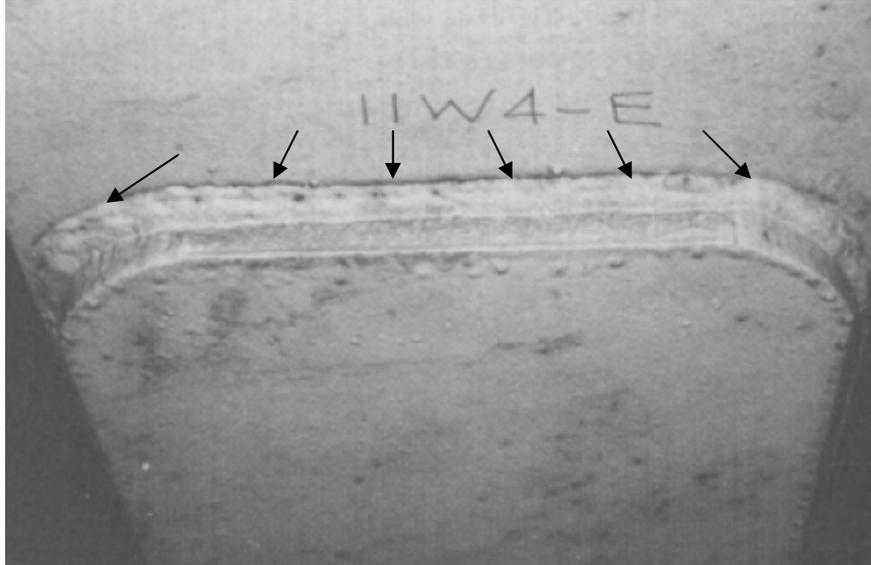
Figure 2.8 Typical cracking at weld toe of cover plate (Adapted from Fisher 1984)

The first example of this deficiency was discovered on Yellow Mill Pond Bridge in Connecticut. Cracking occurred at the ends of cover plates located on the bottom flange of girders (Figure 2.8). The cracks began at the toe of the weld and penetrated through the flange, severing it in two. It proceeded 7 in. up the web before termination (Figure 2.9). (Fisher 1984)

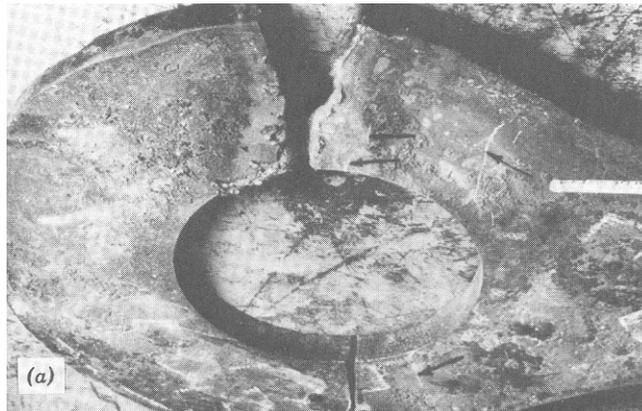
Figure 3.4 Eyebars fracture from Point Pleasant (Silver) Bridge failure (Fisher 1984)

The failure Point Pleasant Bridge is one of the most famous. It opened in 1926, and on December 15, 1967 all three spans collapsed and 46 lives were lost (Figure 3.3). The temperature was 30°F. The failure is attributed to either overextension, or brittle fracture of corrosion cracks on one of the eyebars near the pinhole (Figure 3.4).

The reason for the catastrophic collapse was the lack of redundancy in the structure, making the eyebars fracture critical. It was determined that the fatigue resistance of the setup was significant enough to prevent collapse. The prospect of traffic being more than allowed by design is still a possibility. Certainly though, corrosion and a high hardness were the main causes of cracking. This detail is certainly one that is volatile in its ability to crack catastrophically.

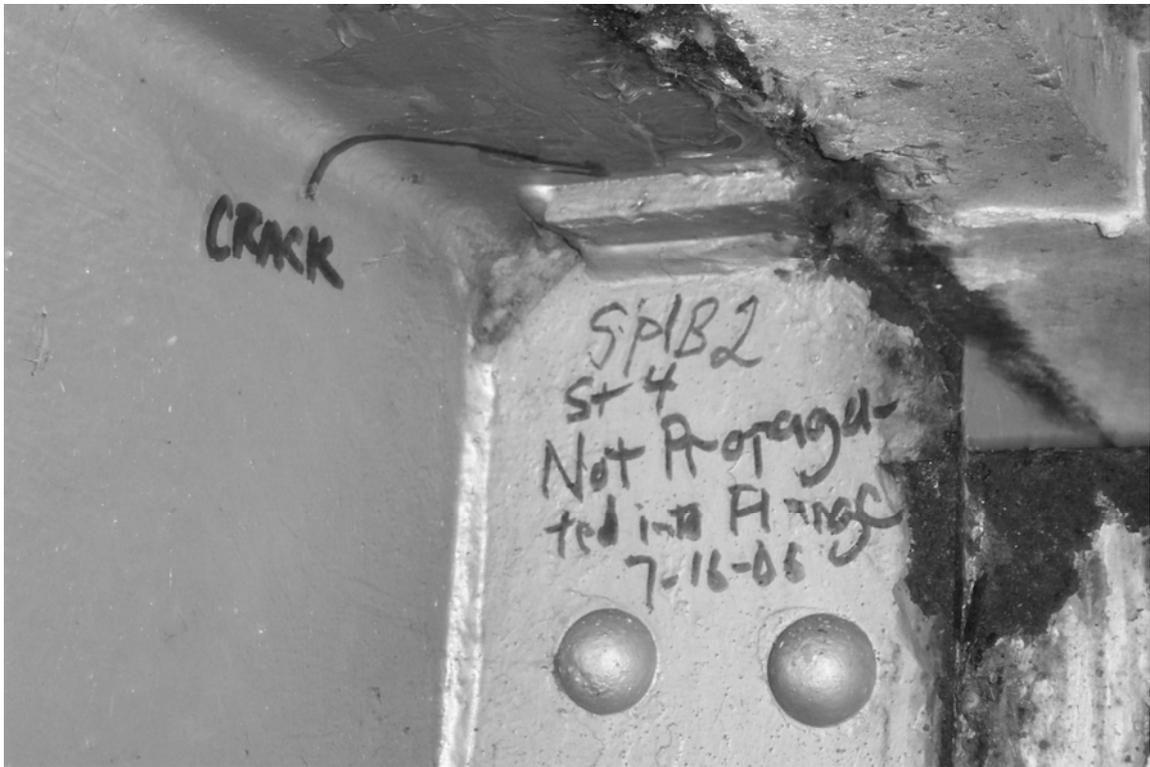
Figure 5.1 Tack welded web gap filler plate - Bridge #55803 (Wilson, October 2006)

Before 1985, gaps were left between transverse stiffeners and girder flanges in an attempt to avoid welding to the tension flange and transferring torsion to the lateral bracing systems. Geometric factors affecting stress levels are identified for this detail in section 0. Web gaps in Minnesota usually varied between tight fit and two inches, with fewer problems occurring on the bottom flange than the top (Wilson, May 2006). Many small cracks have even been found in the base metal of girders containing these details. Small plates parallel to girder flanges were sometimes added as a retrofit, filling the gap; however, these were commonly welded to stiffeners and only tack welded to the girder flange. They too developed cracks as seen in Figure 5.1 and 5.2.

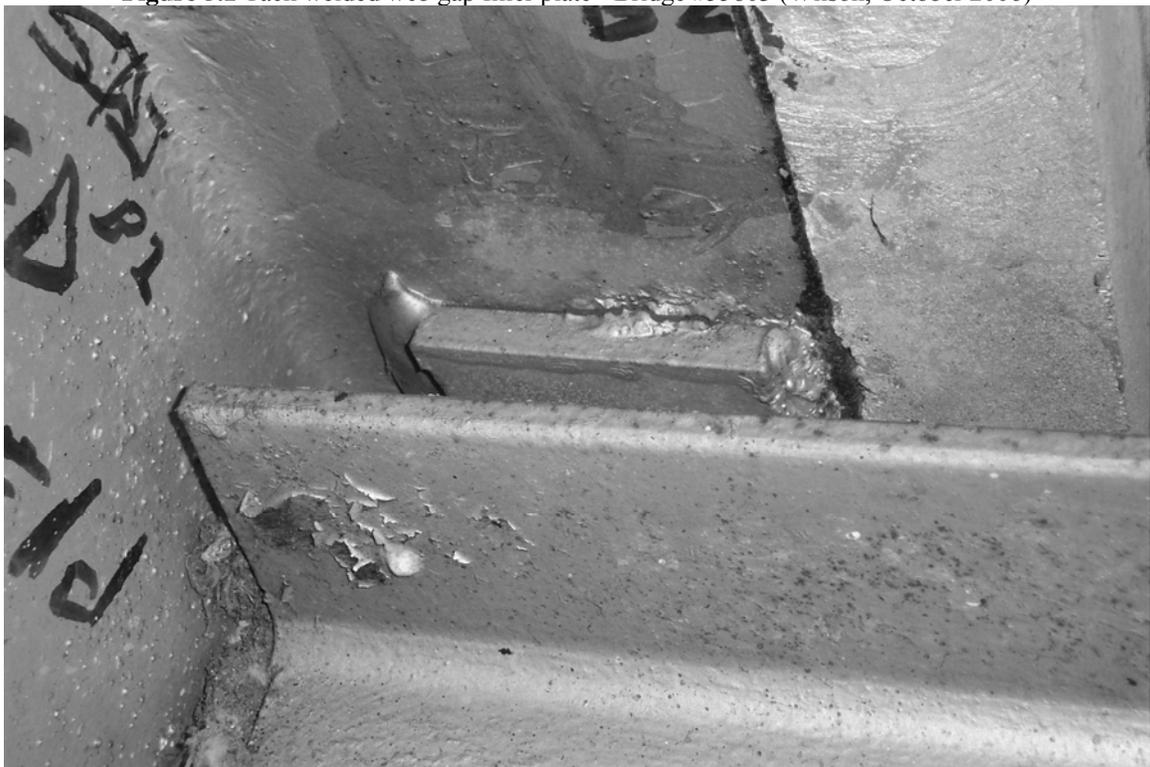
Figure 5.2 Tack welded filler plate - Bridge #55804 (Wilson, October 2006)

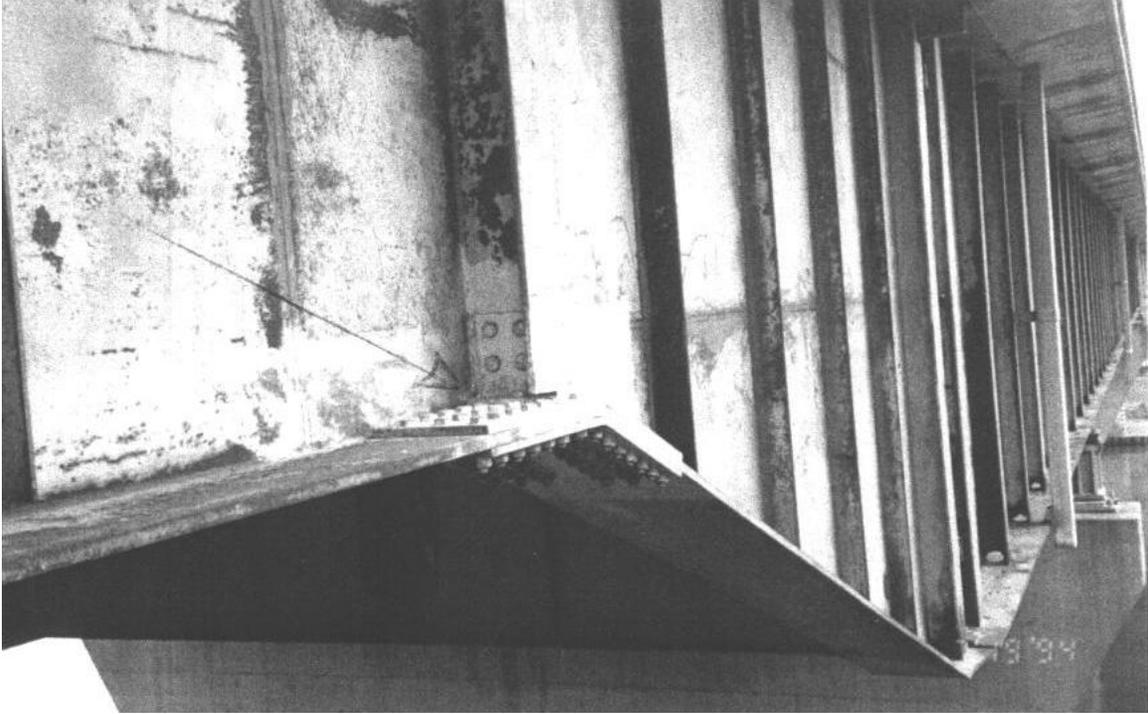
Figure 5.3 Haunch insert cracking - Lexington Avenue Bridge (Wilson, October 2006)

Very few haunch inserts are present in the Minnesota bridge inventory. Where they do occur, cracking may be present at their ends. An example of this was the cracking that occurred on the Lexington Avenue Bridge (35E over Mississippi River) (Wilson, May 2006). However, this cracking is most likely a result of distortional stresses and not in-plane stresses (See Figure 5.3 and Figure 5.4).

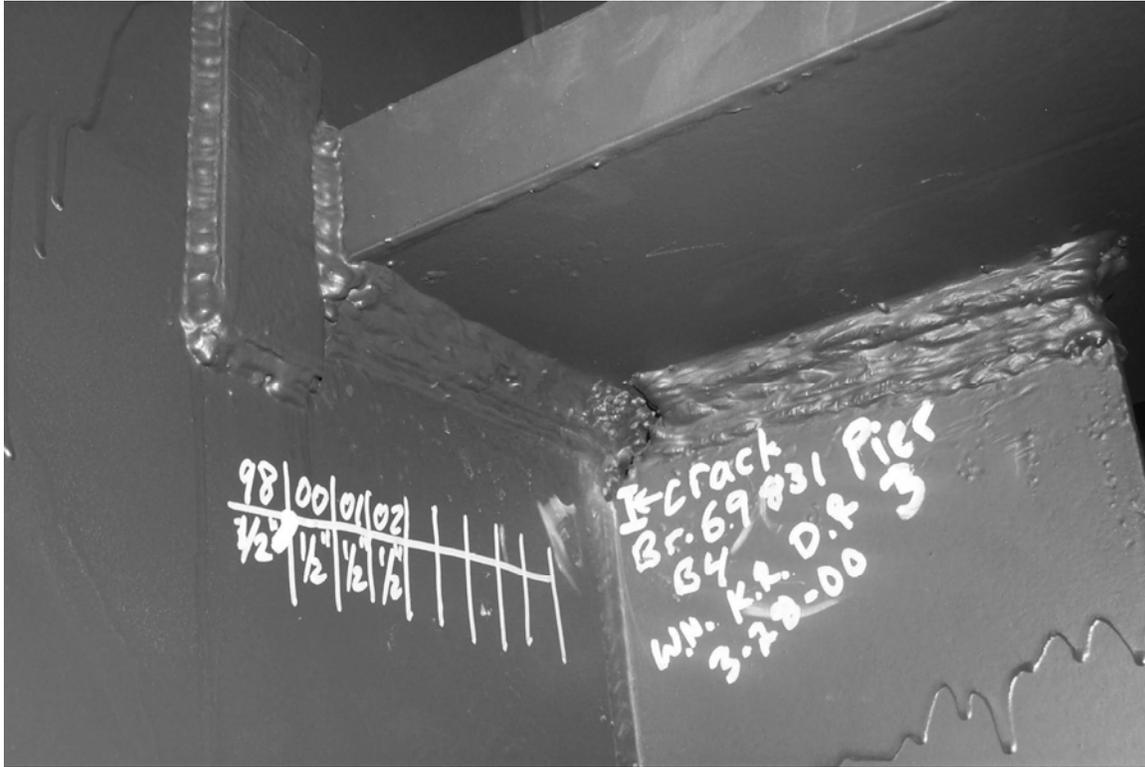
Figure 5.5 Cracking at sealed web penetration - Bridge #69831 (Wilson, October 2006)

Web penetrations in Minnesota bridges commonly occur in pier caps, where box girders intersect piers. Cracks have been found on both the inside and outside of box girders, at the welds connecting the web penetration (Figure 5.5 and Figure 5.6). Most of these cracks originate where backing bars are still in place.

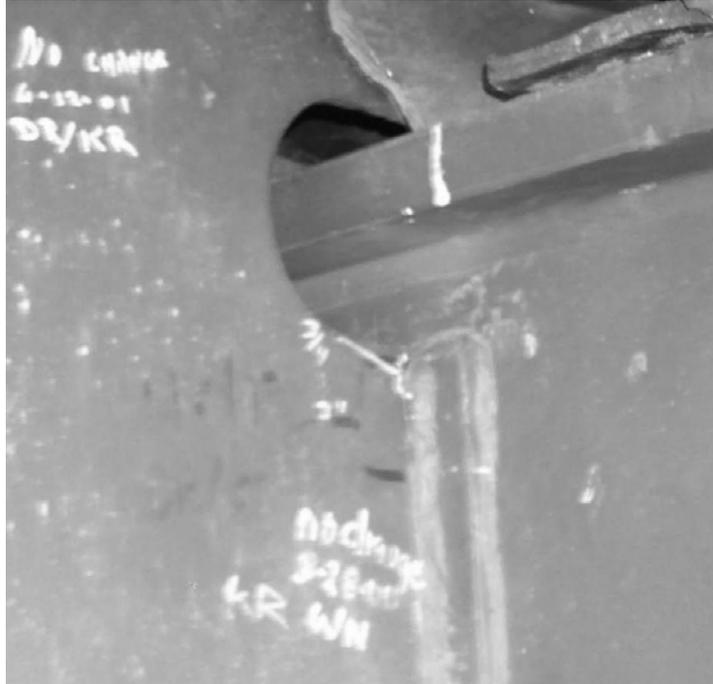
Figure 5.6 Cracking at coped web penetration - Bridge #69831 (Wilson, October 2006)

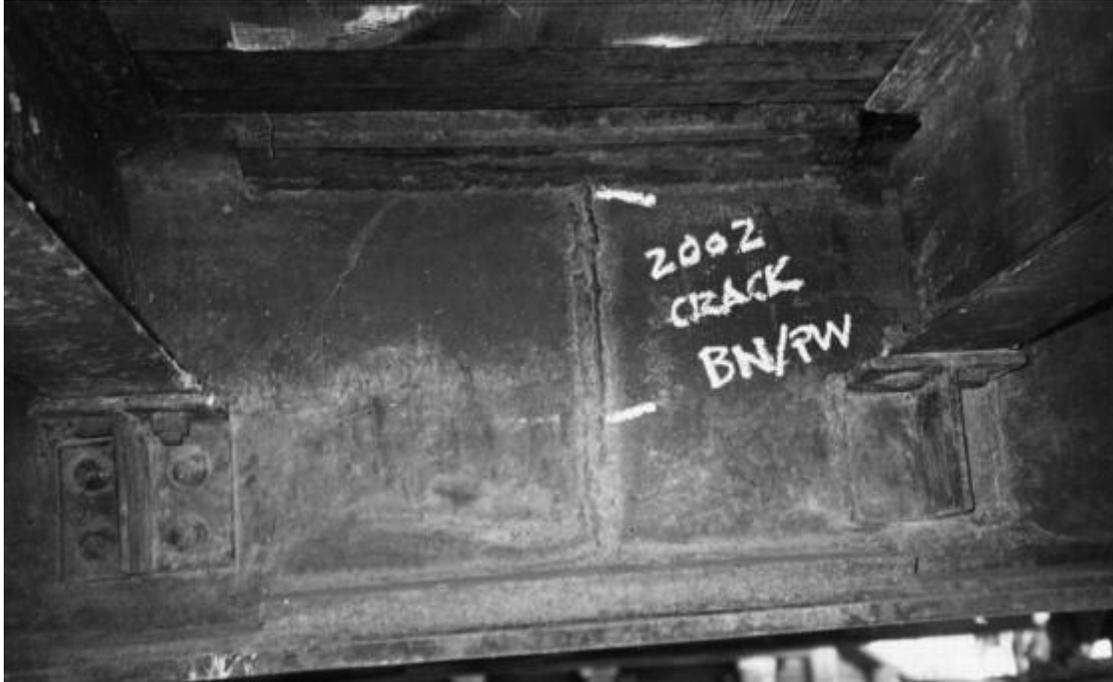
Figure 5.7 Field welded splice – Bridge #90856 (Wilson, October 2006)

Cracks have been found in field welded splices of floor beams as seen in Figure 5.7. Occasionally, when a small bridge was widened, local bridge owners (e.g., municipalities and counties) welded the floor beams on-site with little care. Plans are unlikely to show these poorly-welded splices. About 50-60 bridges have this detail, the task is to identify those bridges having this detail.

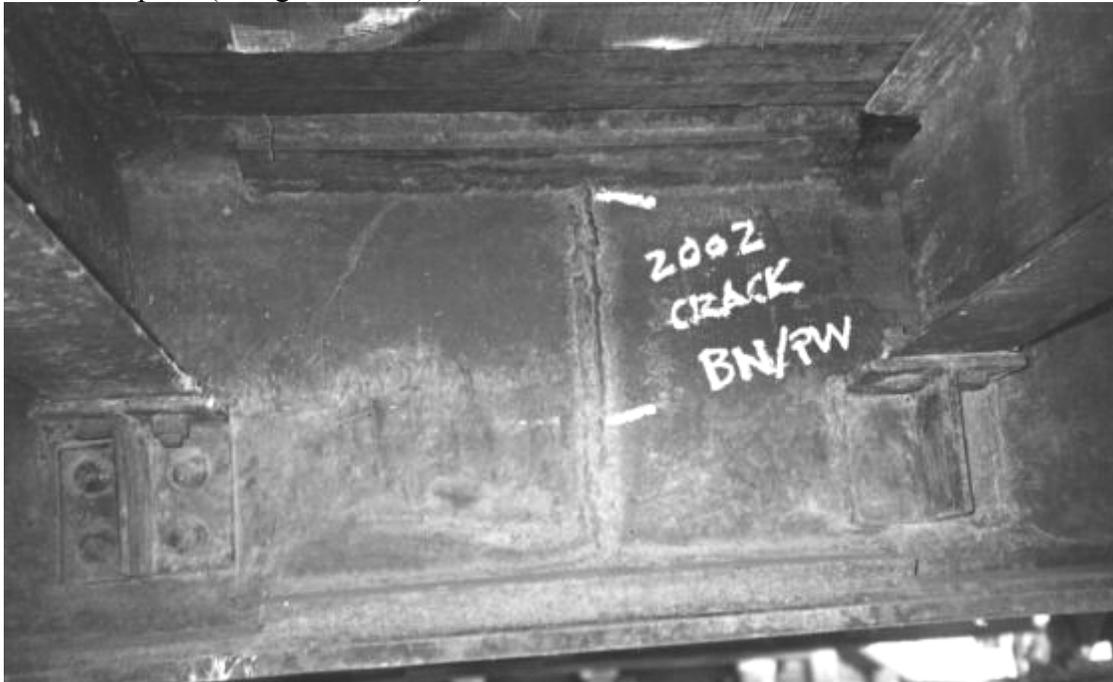
Figure 8.16 Field welded splice (Bridge # 90856)

Field Welded Splice (Bridge # 90856)

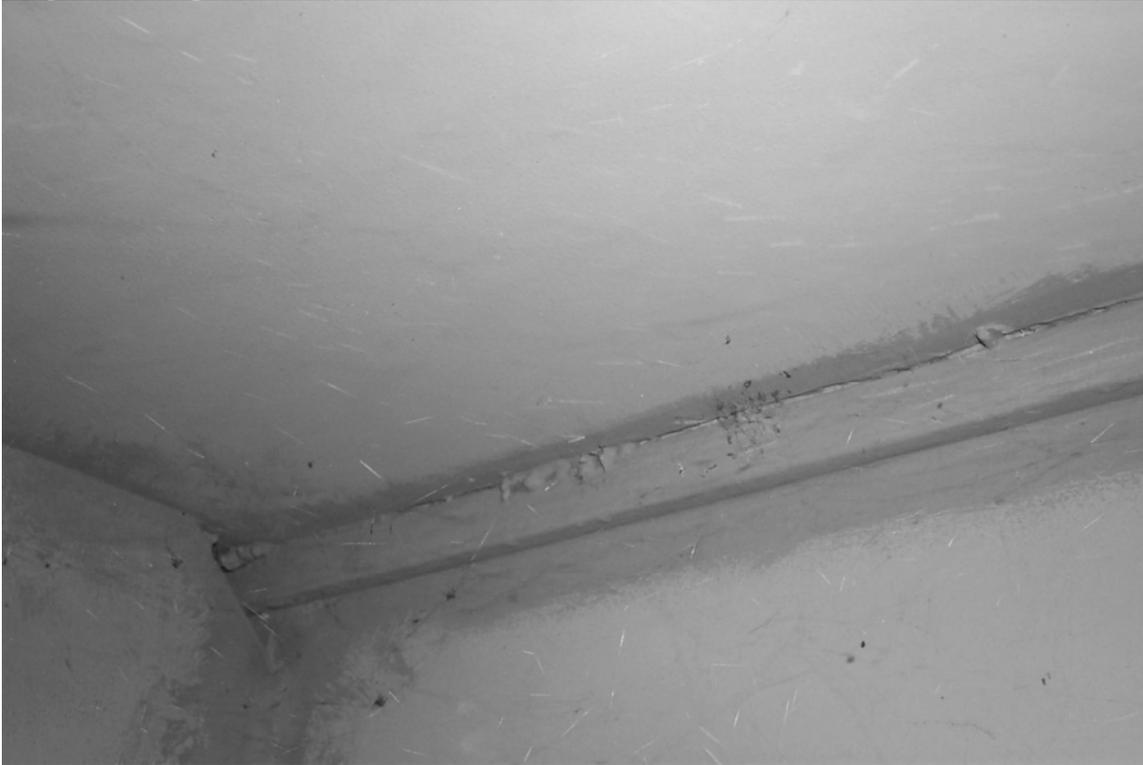
Figure 8.19 Backing bar (Bridge # 27636)

Backing Bar (Bridge # 27636)

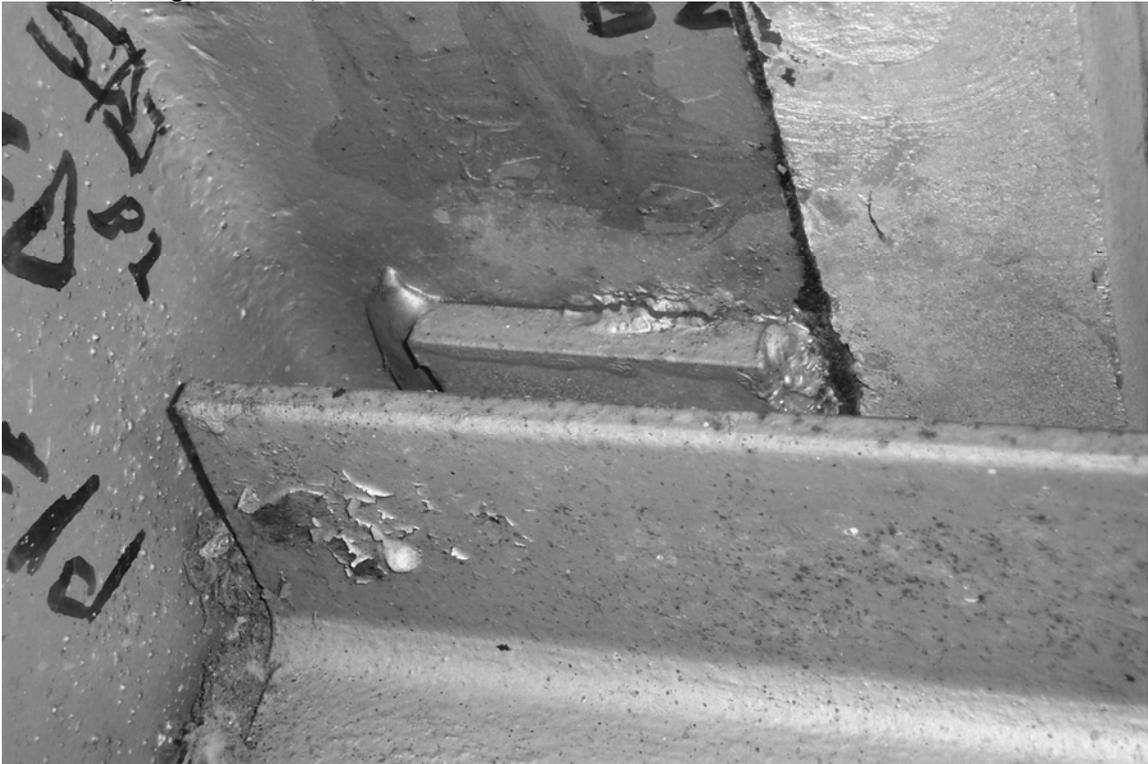
Figure 8.21 Tack weld (Bridge # 55804)

Tack Weld (Bridge # 55804)

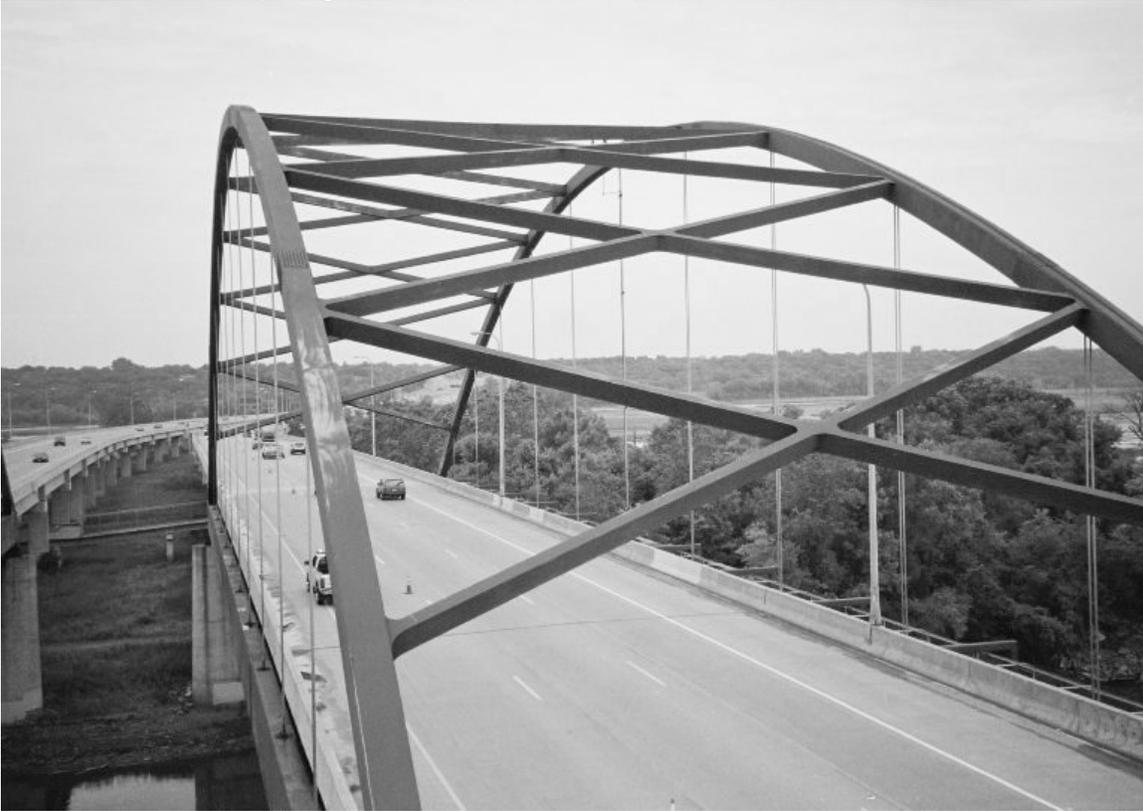
Figure 8.22 Tied arch bridge (Bridge # 9600N)

Tied Arch Floor-Beam (Bridge # 9600S)

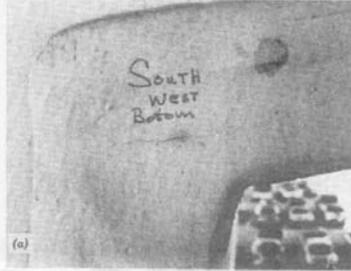
0 Lamellar Tearing – Separation of layers of metal *within* a solid piece. Cracking is usually found in highly restrained members or in cantilevers.
