# A Research Plan and Report on Factors Affecting Culvert Pipe Service Life in Minnesota

Jeff Marr, Principal Investigator  
St. Anthony Falls Laboratory  
University of Minnesota

**September 2012**

Research Project  
Final Report 2012-27

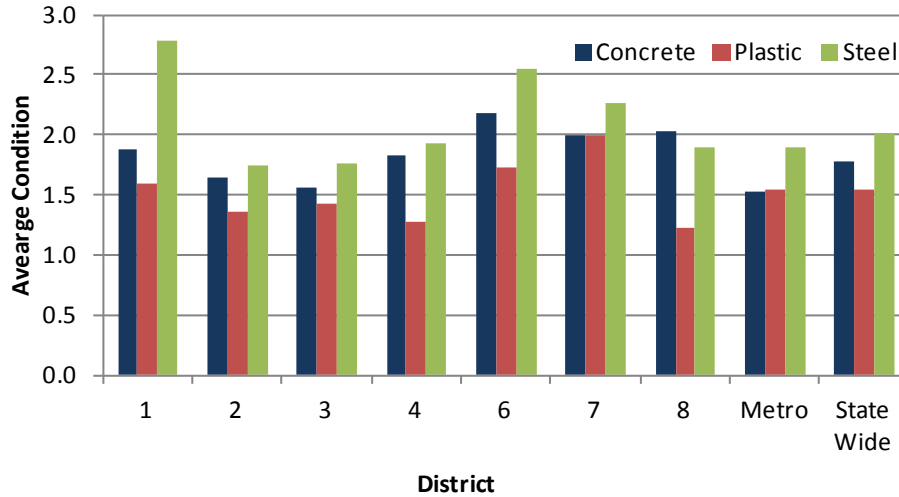
**Figure 9 – Average pipe condition by district for all pipes with a non-zero condition rating**

Figure 9 provides pipe condition by district and pipe material. Overall pipe condition codes have the values of 1 = good, 2 = fair, 3 = poor, 4 = very poor and 0 = not inspectable. In general, the in place steel pipe is in a poorer condition than concrete. Plastic pipes have the best condition ratings on average, but they are the most recently installed, in general. The worst pipes are in Districts 1, 6, and 7. This could be attributed to these districts having old roads, steep slopes, or more organic soils.

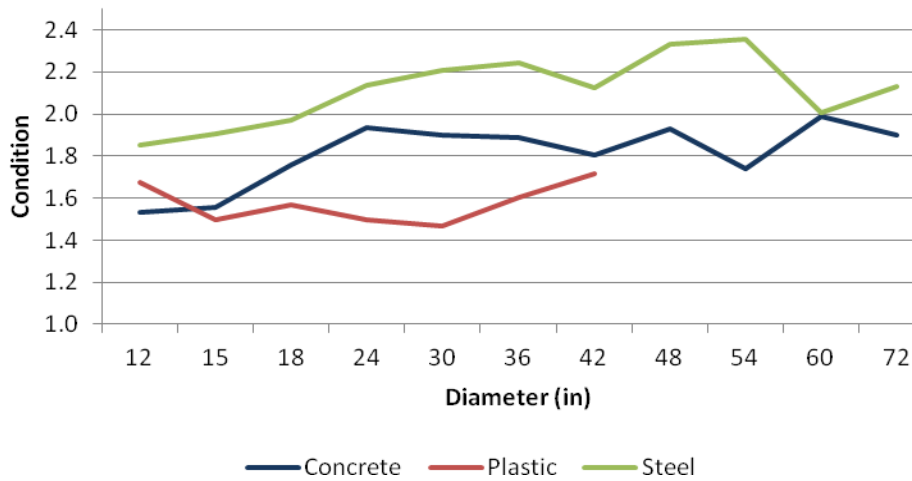
**Figure 10 – Average condition by pipe diameter for all pipes excluding pipes with a condition 0 rating.**

Tables 5 and 6 and Figure 10 explore the influence of pipe shape and size on condition. The average size and length for each pipe type does not vary much; although, concrete pipe seems slightly favored for larger installations. This is consistent with the finding of Task 2. Figure 10 shows a trend of poorer condition for larger diameter pipes of all material types. This could be because large diameter pipes are more difficult to install, or larger diameter pipes are more difficult to replace and therefore older. The condition does not vary much for the different

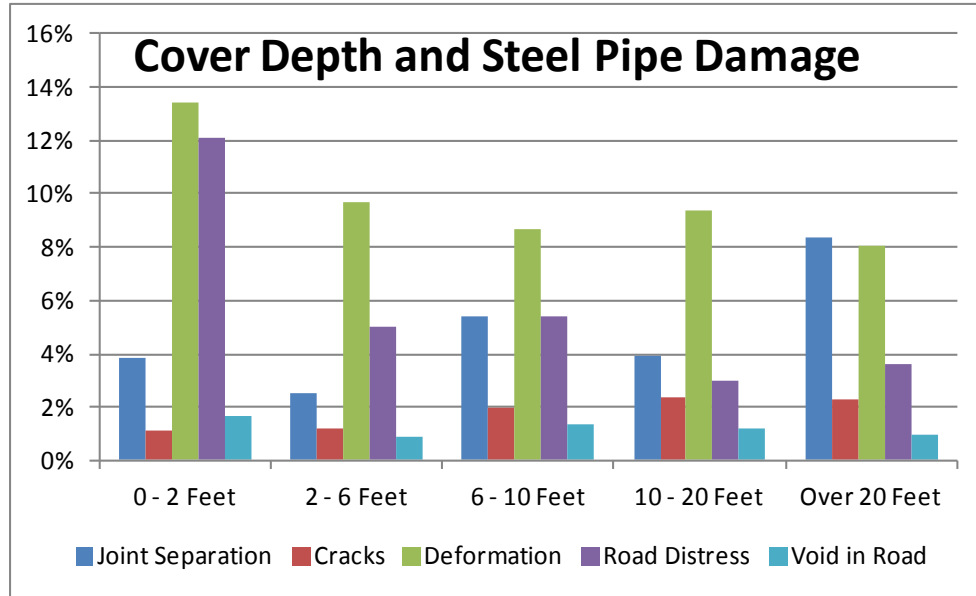
**Figure 14 – Influence of cover depth on steel pipe damage for both centerline and entrance pipes**

The influence of cover depth on concrete and steel pipe damage is reviewed in Figures 13 and 14. For concrete pipe the number of joint separations increase with the first 20 feet of cover. Cracks also increase with depth, but road distress and road voids both decrease with increasing cover. It is expected that there is less road damage for pipe with higher cover depth. For higher cover depths there is more soil matrix above the pipe to bridge the small scale voids caused by material shifting around the pipe. Higher cover depth also apply more earth pressure to the pipes; thereby resisting pipe movement. For steel pipe joint separation and cracks increase with increasing cover depth; however, deformation, road distress, and road voids all decrease with increasing cover depth.
