TECHNICAL SUMMARY

RESEARCH SERVICES & LIBRARY

Adjusting Lane Markings and Signage Improves Safety at Two-Lane Roundabout

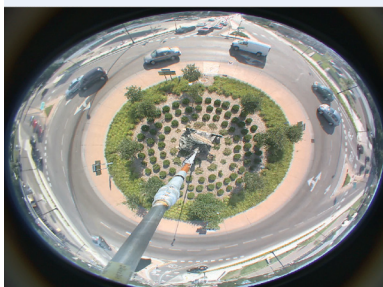
Video footage allowed investigators to monitor all parts of the roundabout at once.

Researchers used driver behavior as a surrogate for crash rates to expedite the evaluation and produce results in less than one year. (Using crash rates traditionally requires three to five years of data after changes are implemented.) They studied 216 hours of video to identify and count traffic violations, with equal amounts of footage from before the changes, shortly after the changes and one year after the changes. The before-changes video had already been collected as part of the [Investigation of Pedestrian/Bicyclist Risk in Minnesota Roundabout Crossings](#) project.

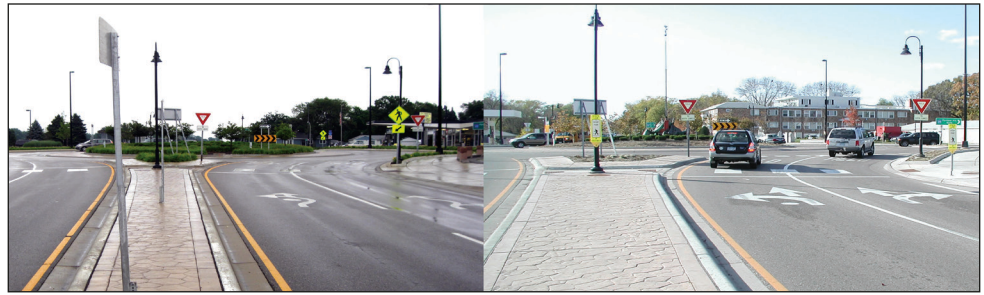
Fish-hook arrows (left), which include curvature to represent the radial direction of a roundabout, are permitted in the federal Manual on Uniform Traffic Control Devices, but this project suggests that standard arrows (right) may be less confusing to drivers and reduce the rate of turning violations.

- Turn arrows on the roundabout lanes and approaches and on signs were changed from the curved “fish-hook” style, intended to represent the flow of traffic around the center island, to the standard style.
- Additional turn arrows and lane designation signs were added approximately 450 feet upstream of yield lines.
- The solid line extending from the yield line was lengthened from 50 to 250 feet.
- Lane marking widths were increased from 4 to 6 inches, lane markings in the middle of the roundabout were made 3 feet long with a 1-foot gap, and 4-by-4-inch “cat track” concentric-spiral lane markings replaced solid lane markings.
- Signs were lowered to improve visibility, and “Roundabout Ahead” signs were moved to 500 feet from the roundabout.

“The more you look at a roundabout, the more you realize that it’s very similar to a regular intersection: A driver turns left from the left-hand lane. Adding a fish-hook sign just adds confusion. Familiar things like standard signs help drivers make the transition to roundabouts.”
